Environmental Assessment Final - Appendices

**City of Kingman Parks Repair and Flood
Hazard Mitigation**

Project Number PA-07-KS-4449-PW760- GM137376

December 2022

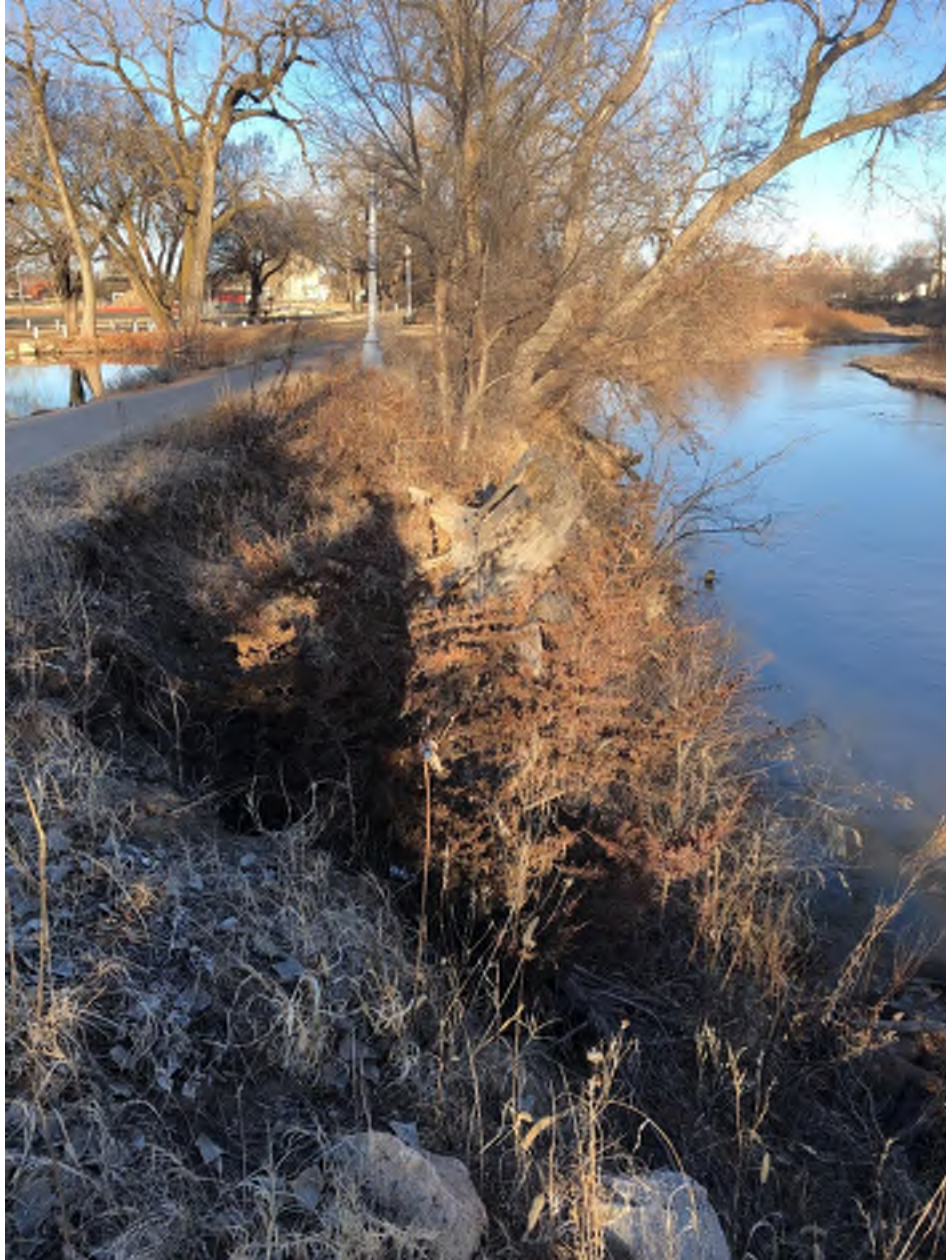
Figure 4: Ground Level Photo of the 2021 Slope Conditions

Based on aerial images (See Figure 2) of the site prior to the disaster, it appears that the slope prior to 2019 has a large tree that is no longer on the slope. This removal of the tree has created a 30-ft hole on the slope that is within 3-feet of impacting the sidewalk and park pond embankment (See Figure 3). If this slope The City has indicated that this hole is continuing to grow along the embankment to impact other sections. The geographical limits of the damage is included in Figure 2 below.

Along with rebuilding the embankment, riprap will need to be replaced on the slope. The image below shows that riprap is located on the slope to protect against the Ninescah River velocities. The Engineers estimate listed on the next page will outline the requirements to bring the slope back to pre-disaster conditions.

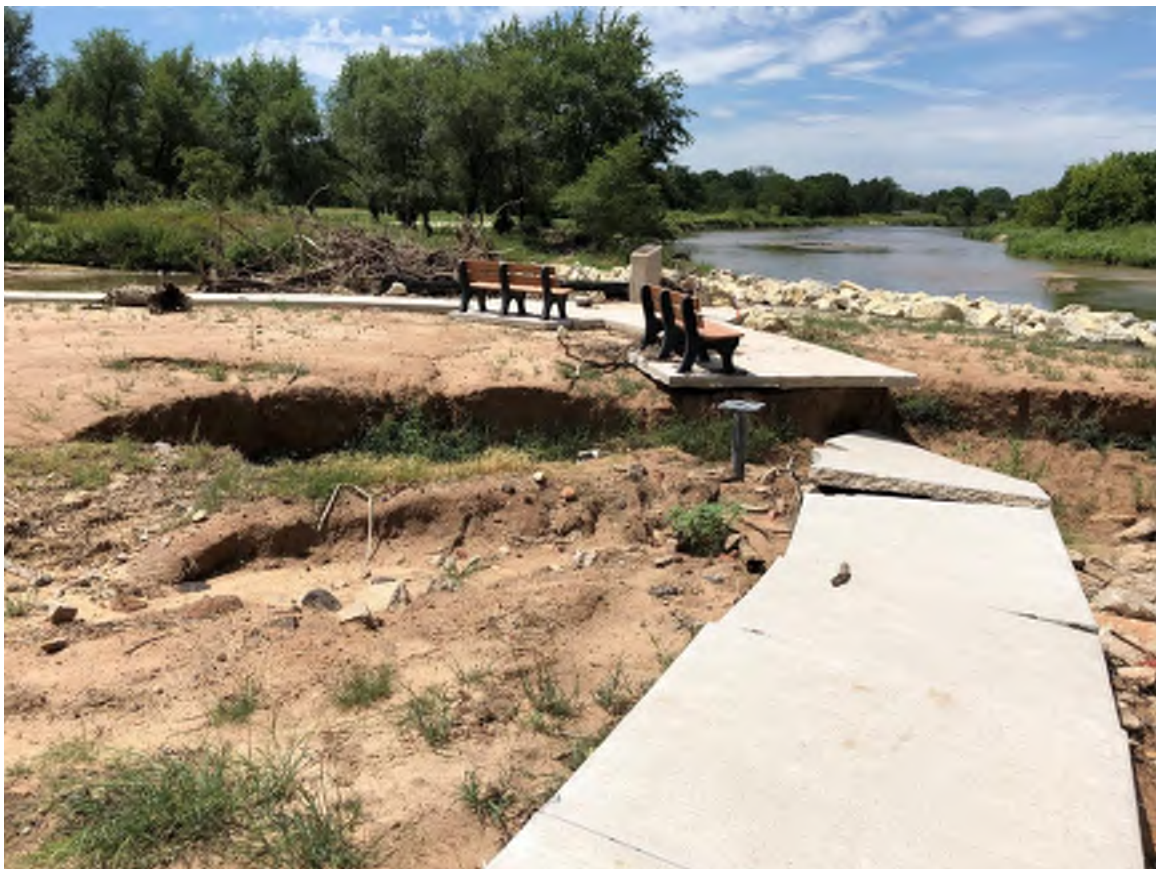
Figure 6: 2019 South Fork Ninescah River South Bank Damage Conditions

In addition to improving the interior park conditions on the western portion of the facility, nearly 100 feet of the Ninescah River south bank and over 900 feet of the Mill Race north bank should be protected as erosion is continuing to encroach on the park facilities in these locations. Ground level photos in Figures 4 and 5 show the disaster conditions from 2019 at the Ninescah River and Mill Race, respectively.

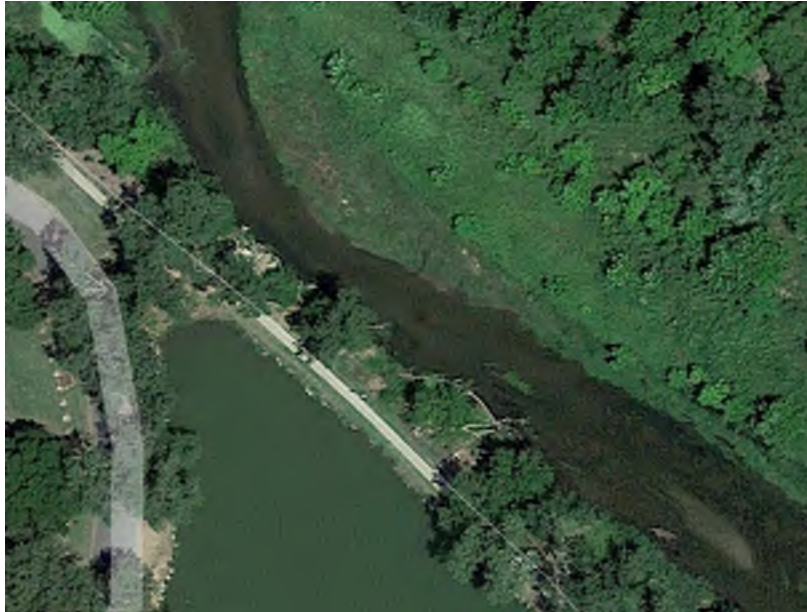
Figure 9: 2016 Aerial Image of the Eastern Bank Stabilization Conditions

Park pond on the eastern portion of the facility. Aerial images from 2016, shown in Figure 7, show that significant large trees were established on the bank with at least 6-ft of distance between the northern edge of the sidewalk and the top of bank. Ground level photos from 2021, shown in Figure 8, show that a large portion of the bank has either been removed by the removal of a tree with large roots or erosion and the top of bank is now within 3 feet of the edge of sidewalk. Outside of this being a pedestrian safety hazard, there is significant concern that the existing pond embankment would be breached if this embankment were to fail.

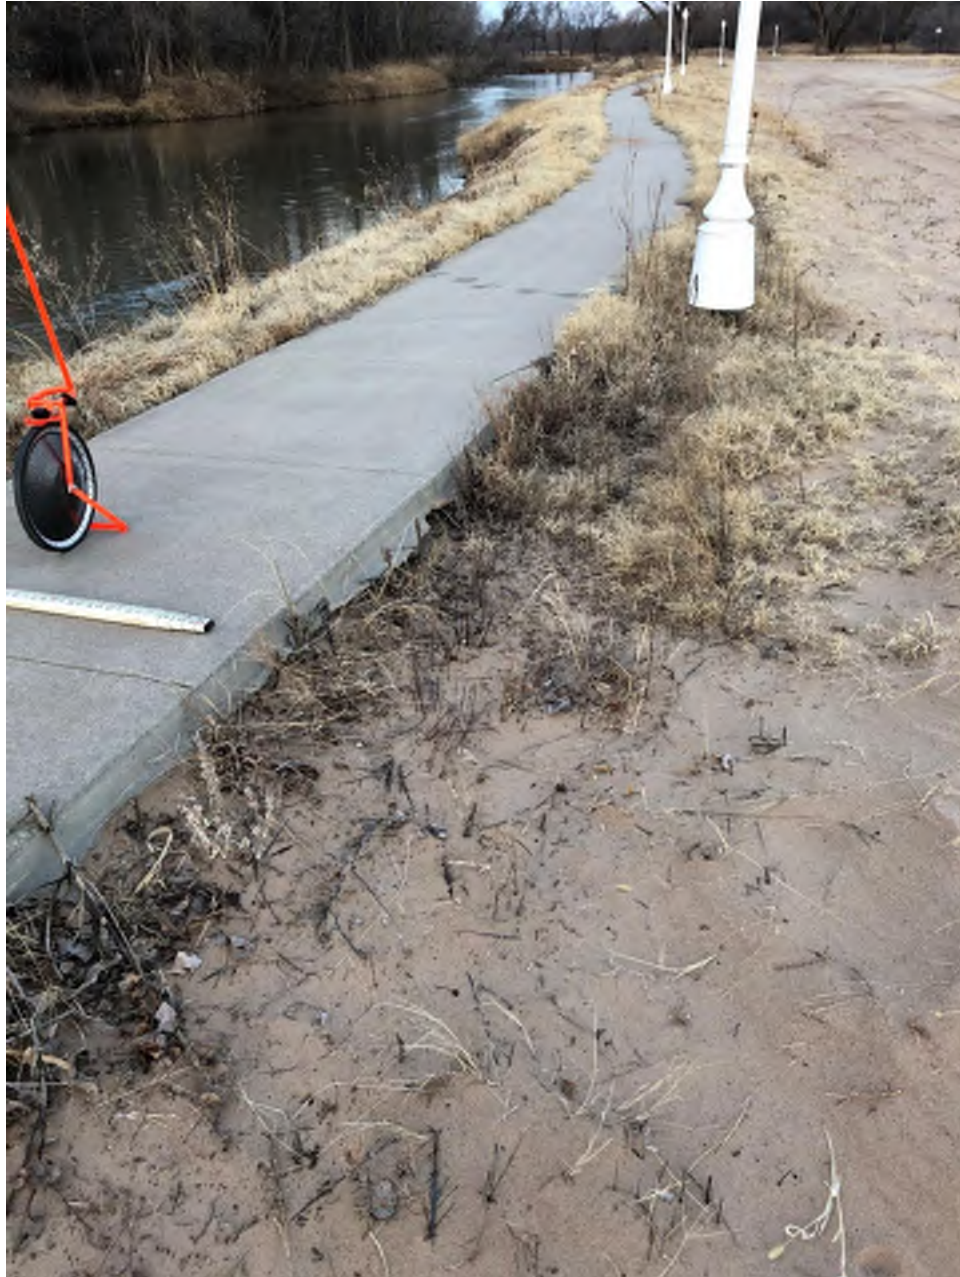
Photo 1

- Station 6+00.00 to Station 8+00.00 – Replace 35 cubic yards of Sidewalk Embankment, which was washed away during the flood events. Replacement will consist of 3-feet of sidewalk shoulder at 6" and then slope down at a 3:1 side slope to existing ground.

Replace 35 cubic yards of Sidewalk Embankment

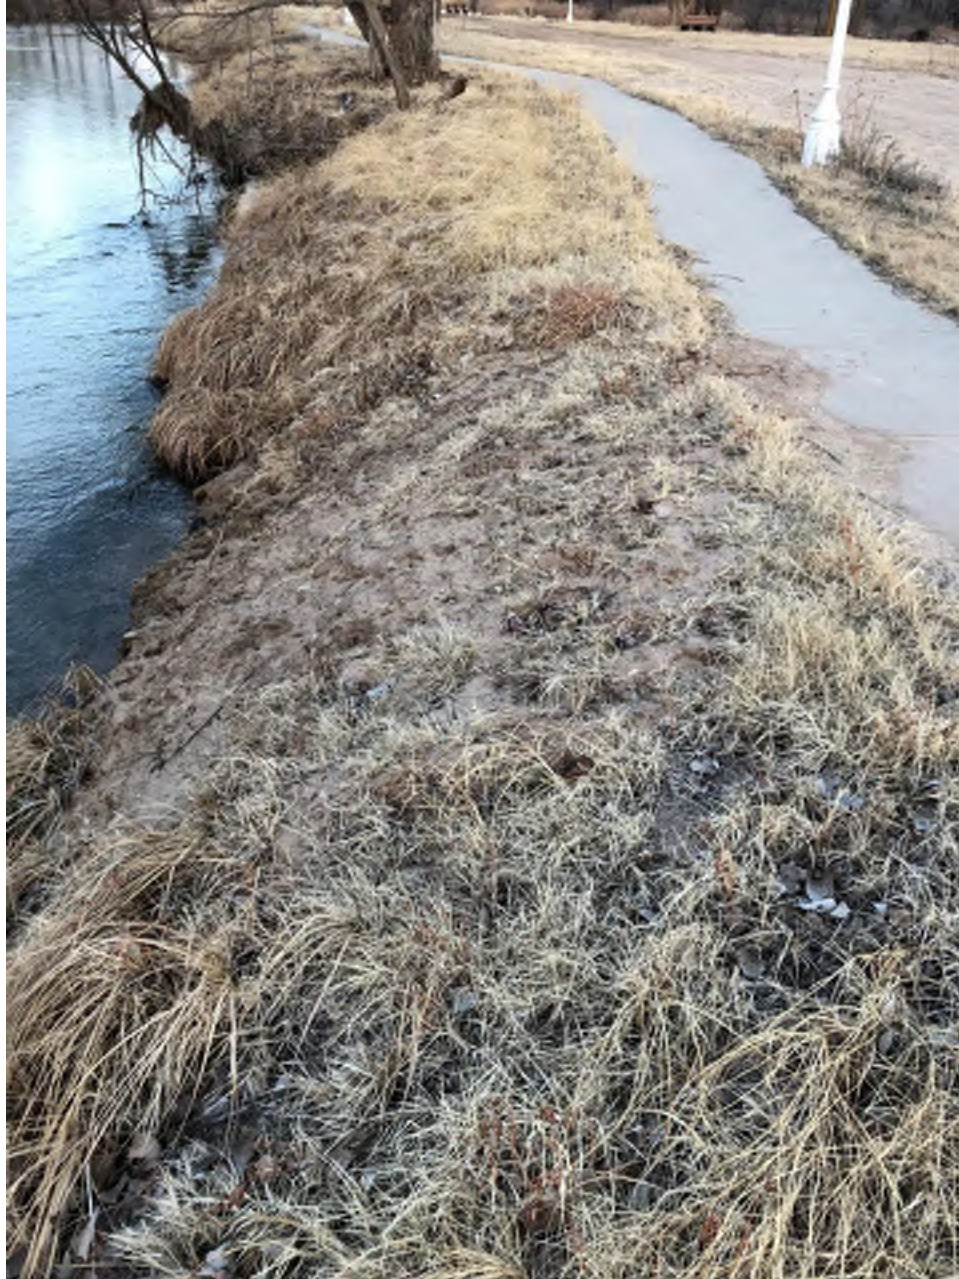
Photo 2

- Station 7+06.60 to Station 7+87.31 – Replace 45 cubic yards of Mill Race North Bank, which washed back approximately 5-feet during to flood events. Replacement will consist of a 2:1 slope to existing bank toe at 6.5-feet high.

Replace 45 cubic yards of Mill Race North Bank

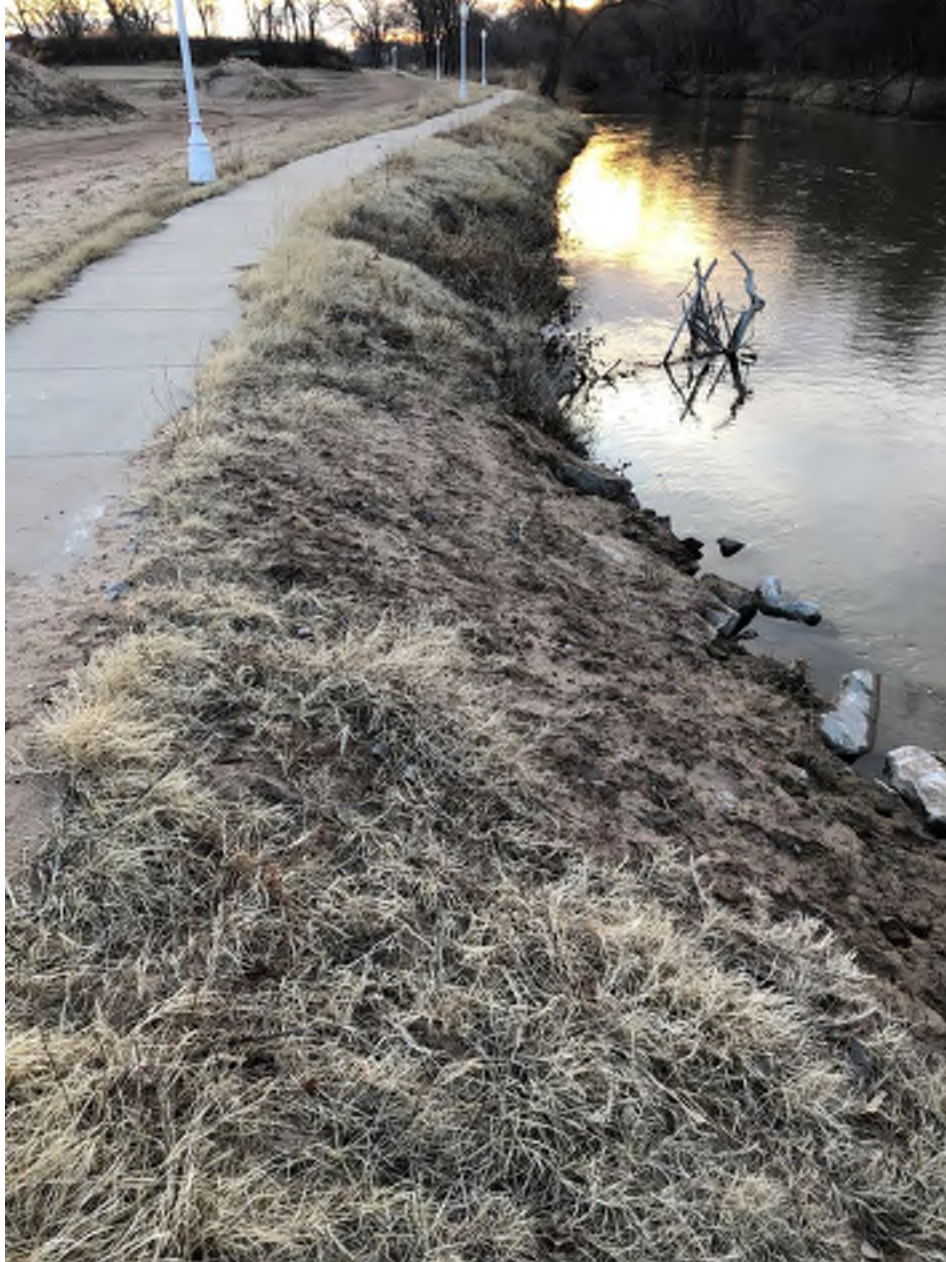
Photo 3

- Station 8+67.38 to Station 9+94.19 – Replace 155 cubic yards of Mill Race North Bank, which washed back approximately 5-feet during to flood events. Replacement will consist of a 2:1 slope to existing bank toe at 6-feet high.

Station 8+67.38 to Station 9+94.19
Replace 155 cubic yards of Mill Race North Bank

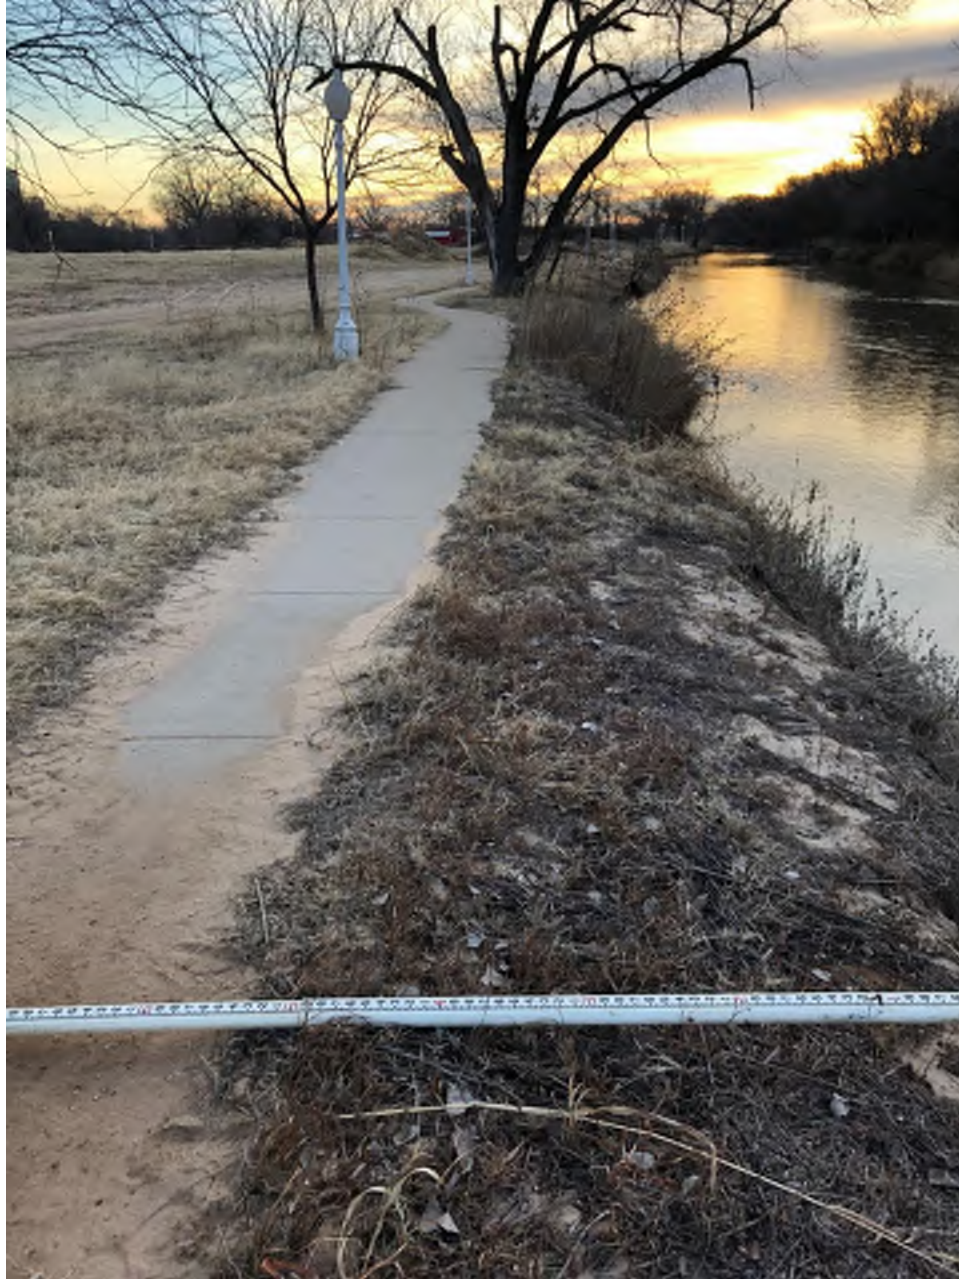
Photo 4

- Station 11+31.17 to Station 12+01.23 – Replace 80 cubic yards of Mill Race North Bank, which washed back approximately 5-feet during to flood events. Replacement will consist of a 2:1 slope to existing bank toe at 6-feet high.

Replace 80 cubic yards of Mill Race North Bank

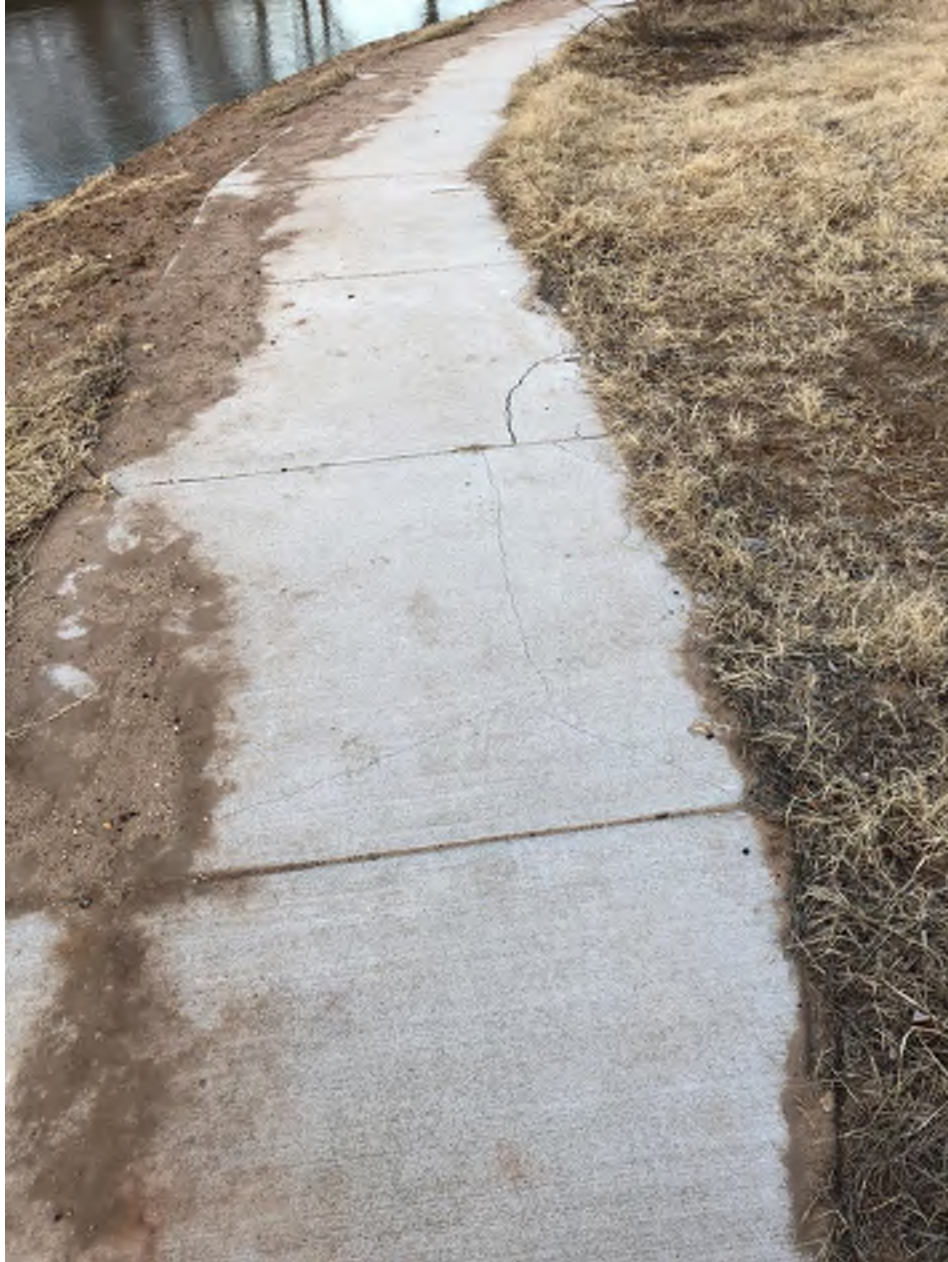
Photo 5

- Station 12+50.00 to Station 12+69.08 – Replace 50 square feet of 6" Concrete Sidewalk, which cracked at several locations due to removal of gravel base by storm events. Replacement will consist of 5-feet wide 6" standard KDOT sidewalk concrete.

Replace 50 square feet of 6" Concrete Sidewalk

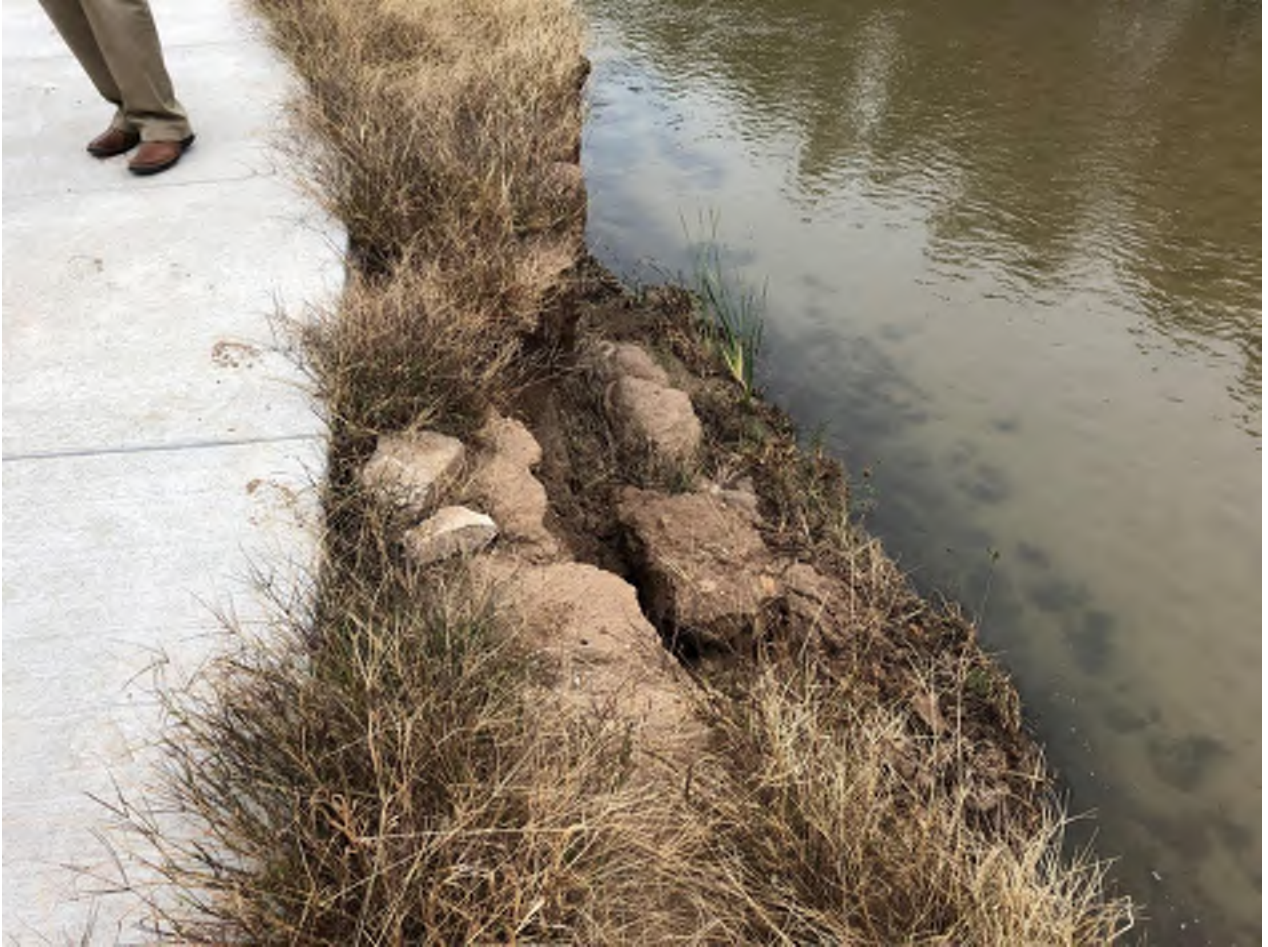
Photo 6

- Station 12+54.89 to Station 13+30.06 – Replace 145 cubic yards of Mill Race North Bank, which washed back approximately 10-feet during to flood events. Replacement will consist of a 2:1 slope to existing bank toe at 7-feet high.

Replace 145 cubic yards of Mill Race North Bank

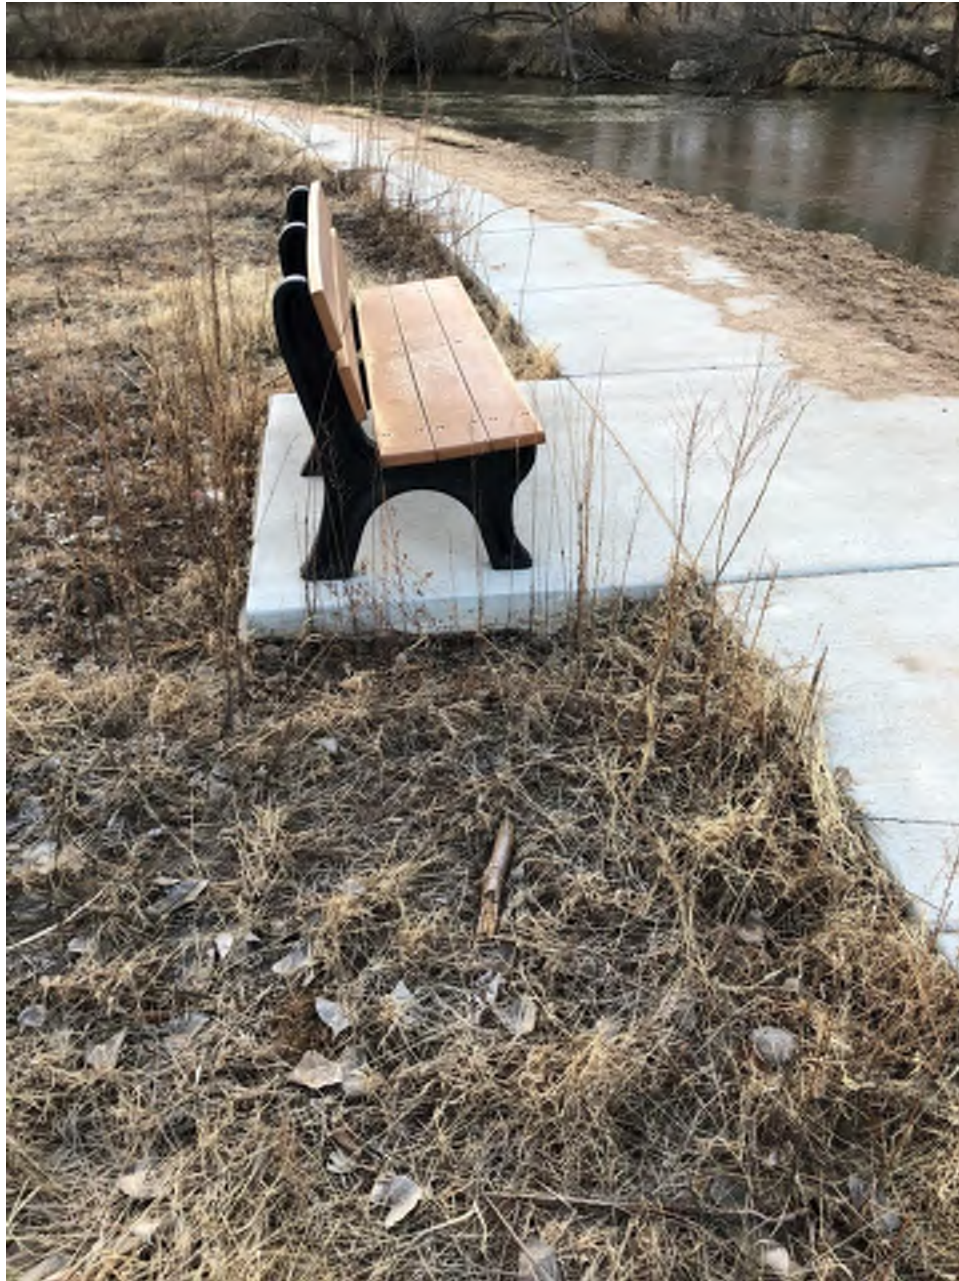
Photo 7

- Station 12+96.98 to Station 13+29.19 – Replace 2 cubic yards of Sidewalk Embankment, which was washed away behind the park bench foundation during the flood events. Replacement will consist of 3-feet of sidewalk shoulder at 6" and then slope down at a 3:1 side slope to existing ground.

Replace 2 cubic yards of Sidewalk Embankment

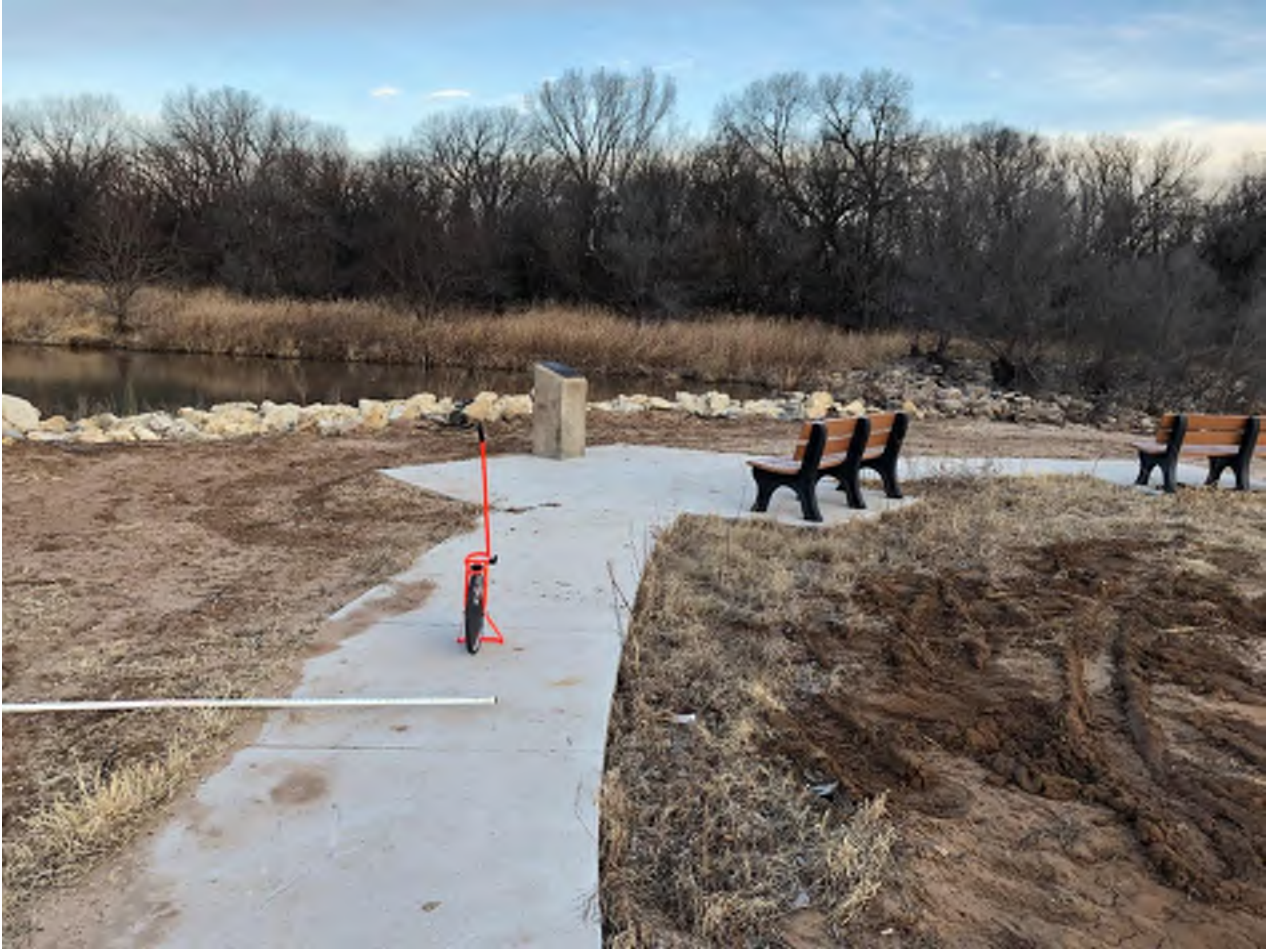
Photo 8

- Station 13+43.16 to Station 13+64.71 – Replace 2 cubic yards of Sidewalk Embankment, which was washed away behind the park bench foundation during the flood events. Replacement will consist of 3-feet of sidewalk shoulder at 6" and then slope down at a 3:1 side slope to existing ground.

Replace 2 cubic yards of Sidewalk Embankment

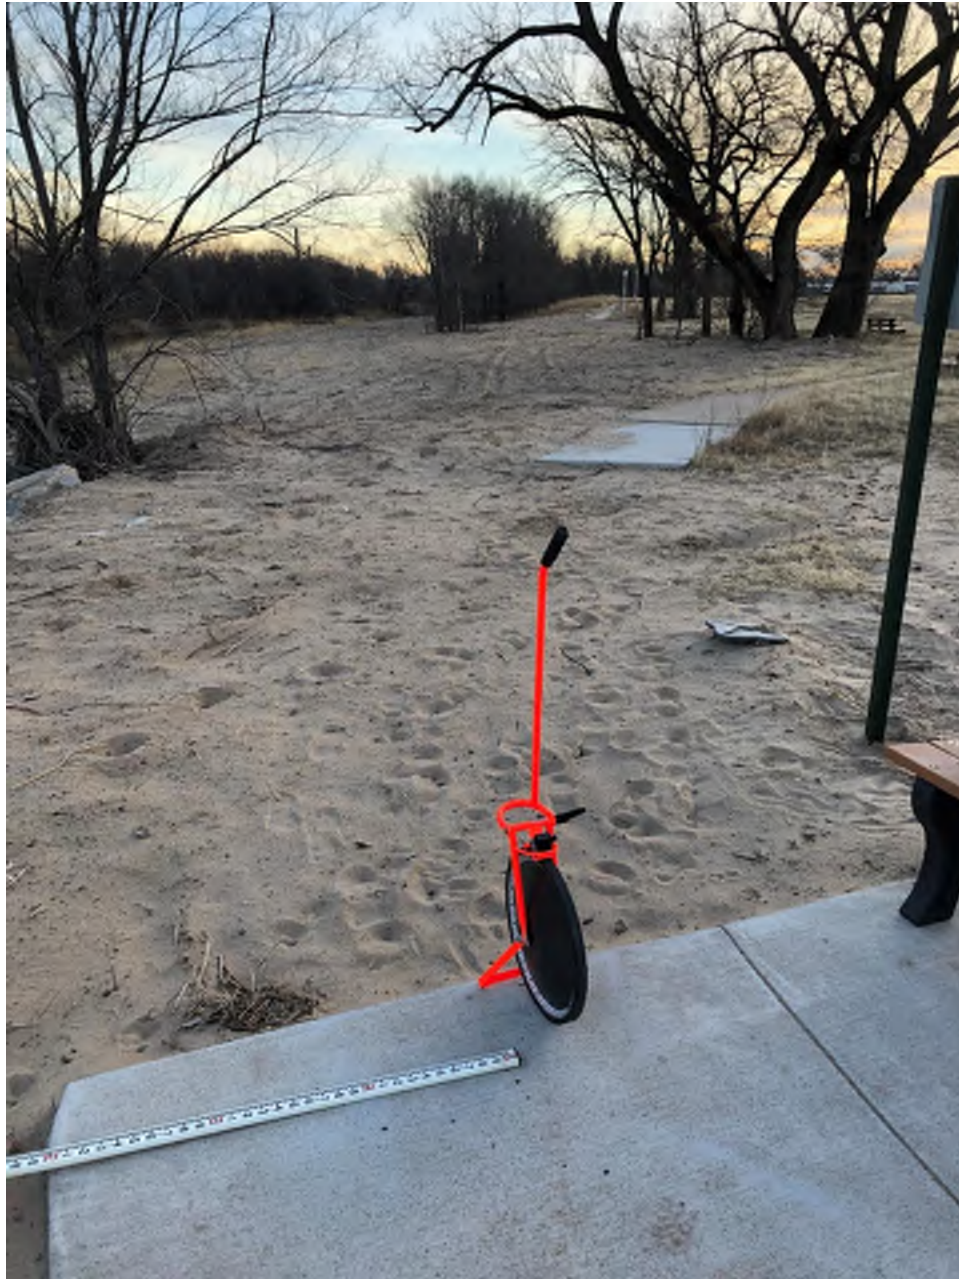
Photo 9

- Station 13+75.15 to Station 14+00.00 – Replace 125 square feet of 6" Concrete Sidewalk, which was completed undermined and displaced through the entire length due to removal of gravel base by storm events. Replacement will consist of 5-feet wide 6" standard KDOT sidewalk concrete.

Replace 125 square feet of 6" Concrete Sidewalk
