6 Observations on Personal Protection and Sheltering

6.1 SHELTERS

6.1.1 Types of Shelters

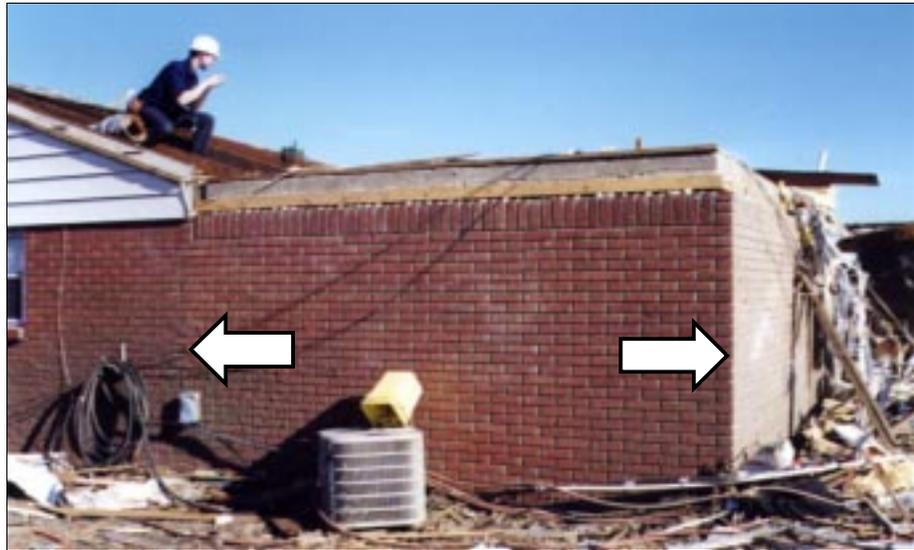
FIGURE 6-1 Above ground in-residence shelter hit by strong inflow winds near the vortex of a violent tornado in Del City, Oklahoma. Arrows indicate the extent of this reinforced concrete shelter that cannot be seen due to the exterior brick masonry veneer.

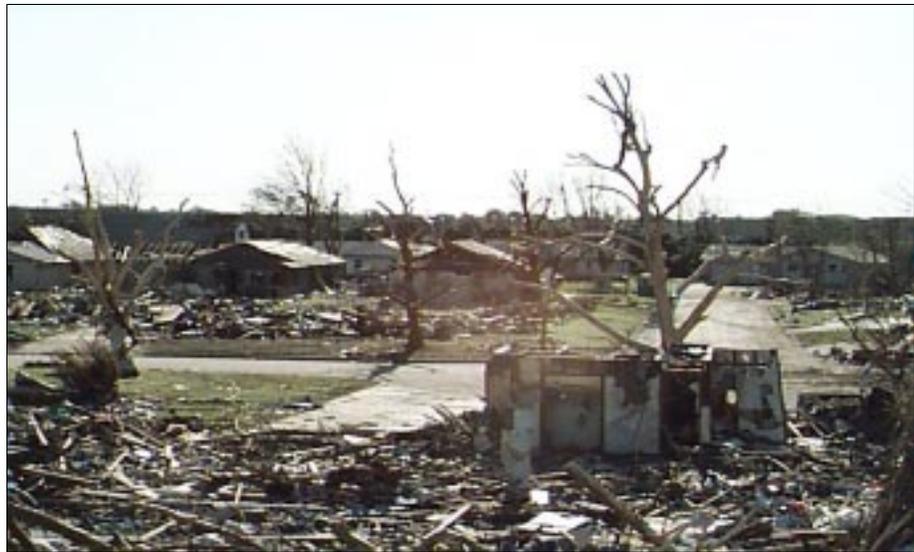
FIGURE 6-2: Damage to houses near the home in Figure 6-1.

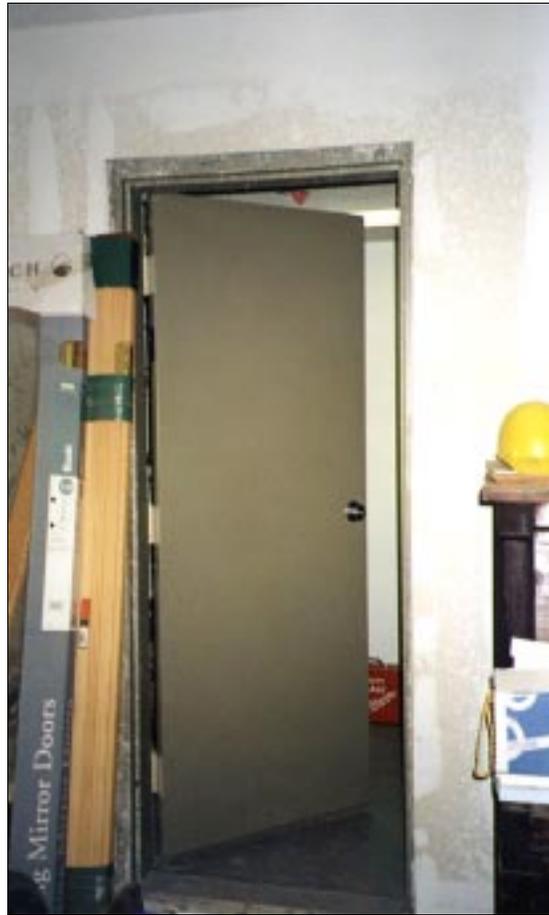
FIGURE 6-3: Entrance to the ICF shelter in Bridge Creek, Oklahoma. This residence and shelter were on periphery of the inflow winds of a violent tornado, and damage was limited to light missile impacts.

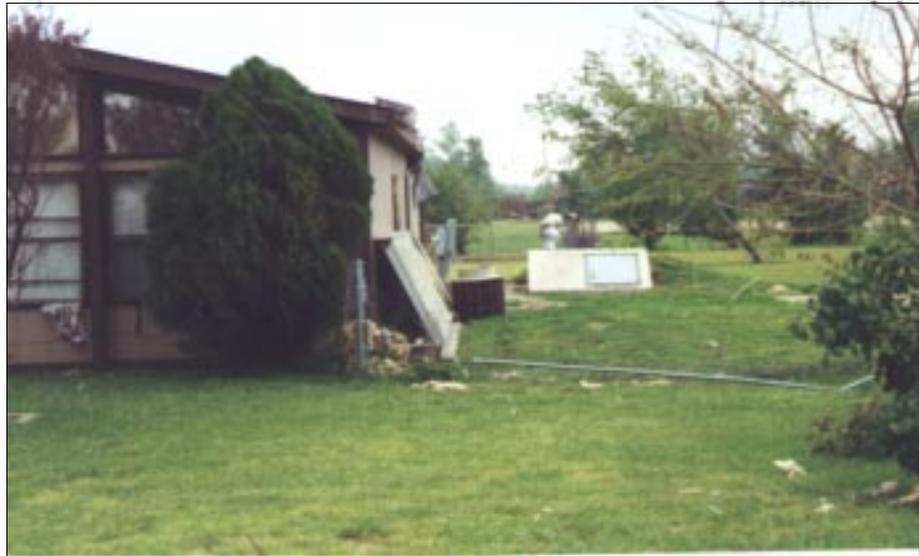
FIGURE 6-4: *This precast concrete storm cellar was located immediately behind a residence in Sedgwick County, Kansas. This residence and shelter were on the periphery of a violent tornado path.*

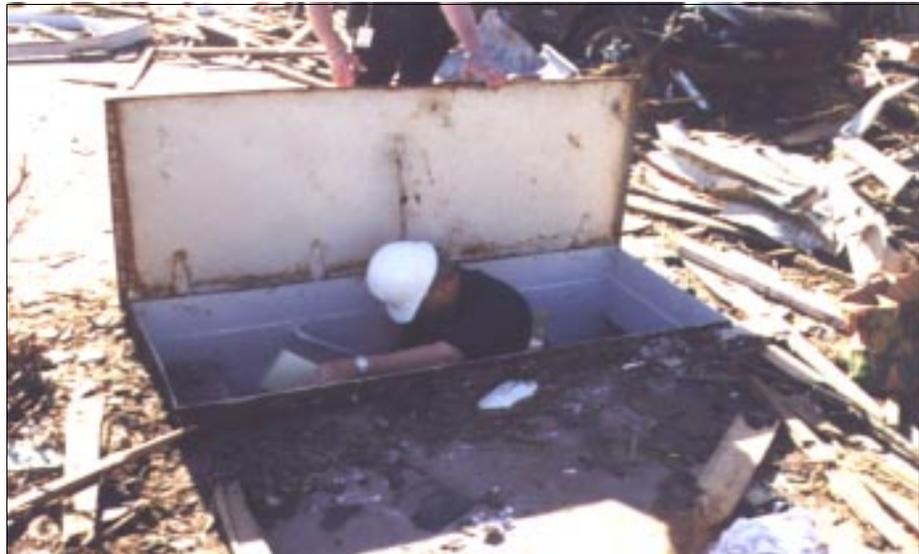
FIGURE 6-5: *Del City storm cellar constructed of steel sheets with a concrete cover. This area was directly struck by the vortex of a violent tornado.*

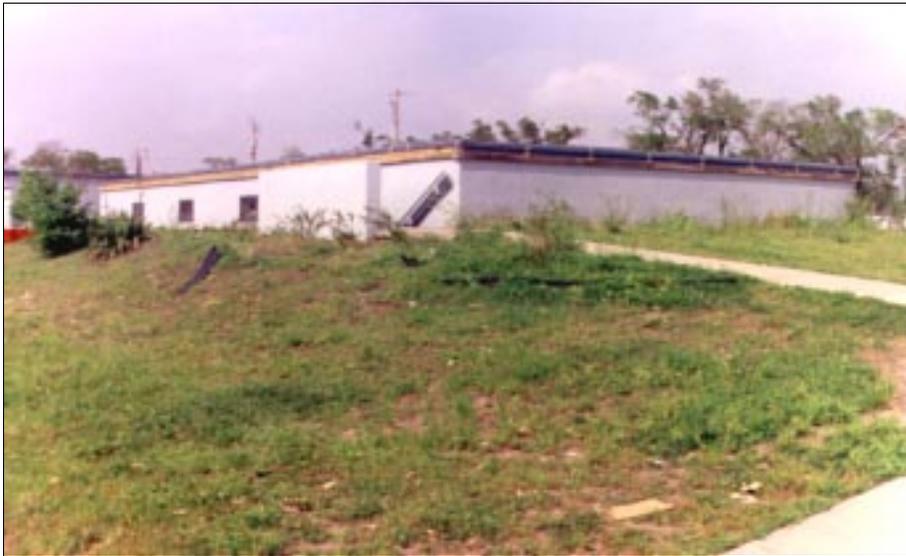
FIGURE 6-6: Community Shelter at a Wichita, Kansas, manufactured home park. While the park was directly hit by a severe tornado, the shelter was not within the damaged area.

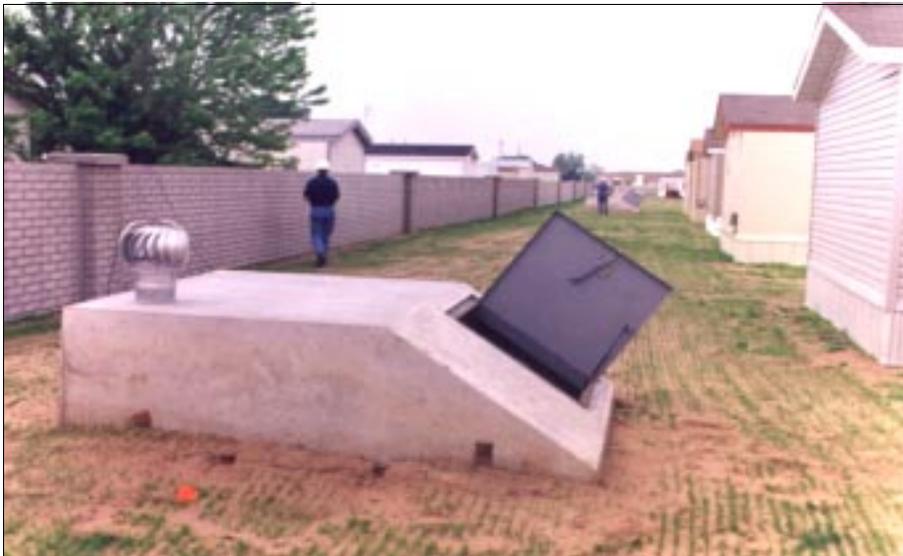
FIGURE 6-9: Group shelters at a manufactured home development in Wichita, Kansas.

mechanism observed were vent pipes (Figure 6-18) or turbine ventilators (Figure 6-9). The vent pipe in Figure 6-18 was sufficiently thick enough to not be broken by windborne debris and was capped to prevent the intrusion of debris. The turbine ventilator observed in Figure 6-9 was 8-inches in diameter and made of light gauge metal. It would have been easily destroyed by flying debris if impacted by even a moderate tornado, thereby allowing free-falling debris to enter the shelter through the 8-in diameter opening in the roof of the shelter, placing the safety of the occupants at risk.

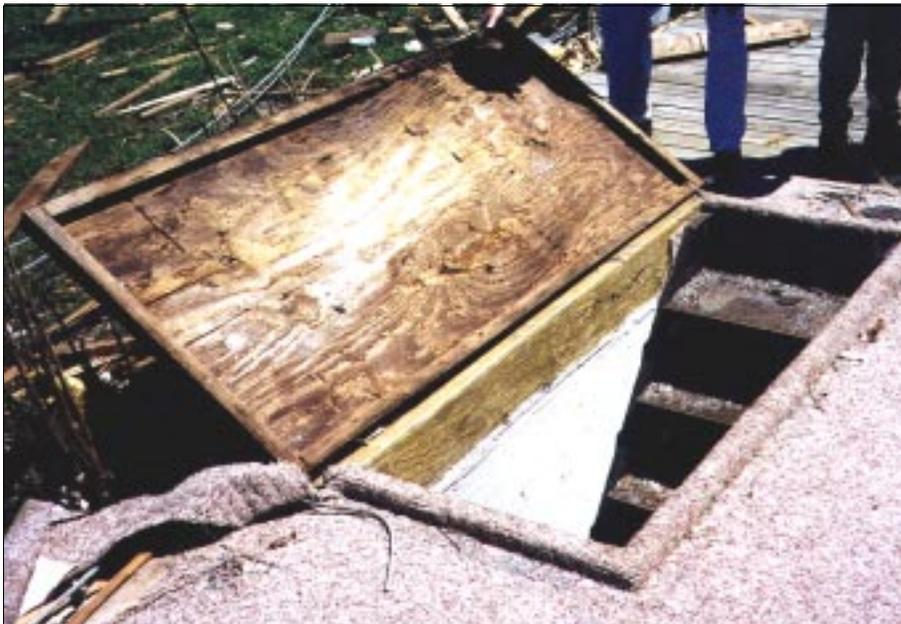
In numerous cases, the BPAT observed that poor selection of building materials and maintenance of painted items such as hinges and latches led to failures or poor performance (Figure 6-12). Storm cellar doors observed by the BPAT were often covered with thin gauge sheet-metal and exhibited deterioration of the zinc galvanization resulting from corrosion. The sheet-metal storm cellar doors were often backed with untreated plywood that was usually found to be rotted, delaminated, or otherwise deteriorated to the point where it was no longer useful in providing protection to the shelter opening.

FIGURE 6-12: Door to underground shelter with rotting wood and corroded hinges.

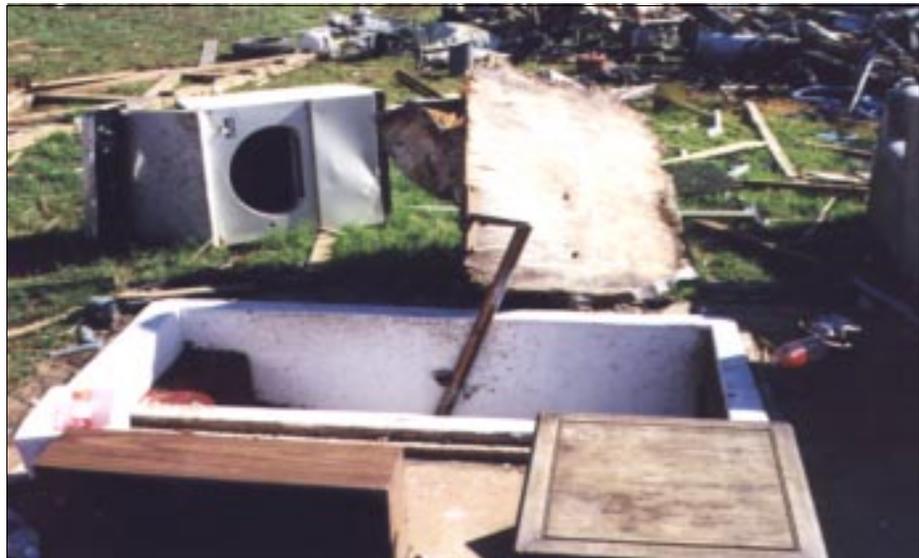
and one observed failure resulted in the door destruction and the partial filling of the storm cellar with debris (Figure 6-13). Widespread door failures were observed on the below-ground shelters; this included both metal and wooden doors. The above ground in-resident shelters observed had hollow metal doors and three hinges on one side and an insufficient single deadbolt locking device (Figure 6-14). The door metal skin thickness and the single lock would have probably been insufficient to secure the door had they experienced a direct missile strike from a violent tornado vortex or near vortex inflow area.

FIGURE 6-13: Failed wooden door at a below ground shelter in Oklahoma.

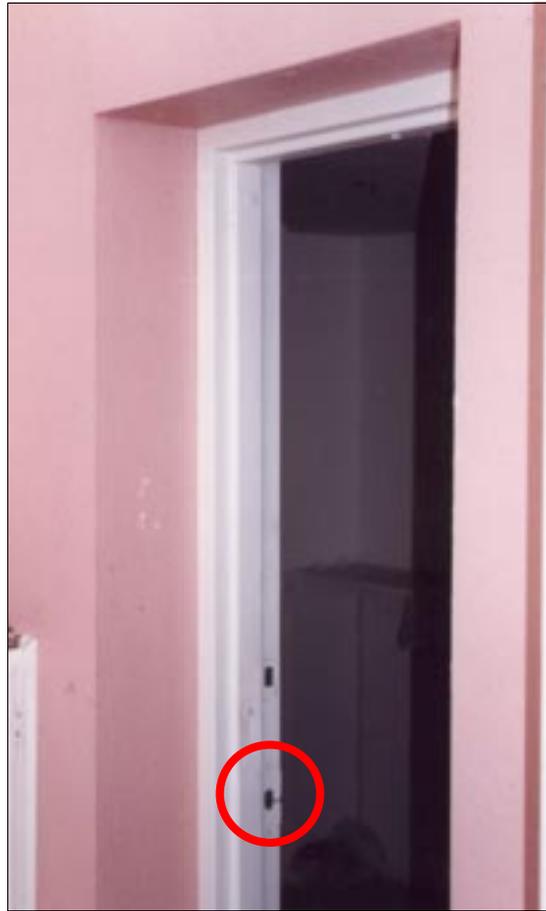
FIGURE 6-14: Shelter door of home in Del City, Oklahoma, showing an insufficient deadbolt locking device. The circled area on the door frame is the catch for the only latching mechanism on the door.

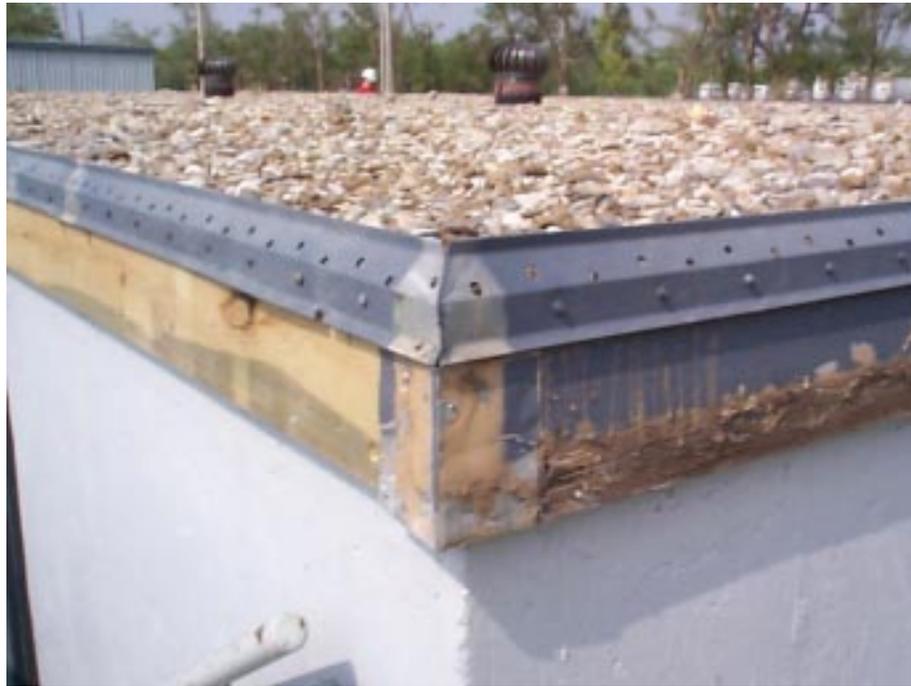
Other shortcomings of shelters were observed by the BPAT. The community shelter in Figure 6-15 produced a potential safety hazard to nearby buildings resulting from missile generation from a fence and a ballasted roof covering. Figure 6-15 shows the aggregate ballast roof covering on the community shelter in Wichita, Kansas. A security fence that surrounded this roof area was damaged and removed by the winds of the violent tornado that impacted the opposite side of this community. Aggregate ballast shown in the photo may become airborne during high wind events and cause damage to other properties and injure individuals attempting to access the shelter.

FIGURE 6-15: Ballast roof covering on a community shelter in Wichita, Kansas was a potential source of deadly windborne missiles to those seeking to access the shelter.

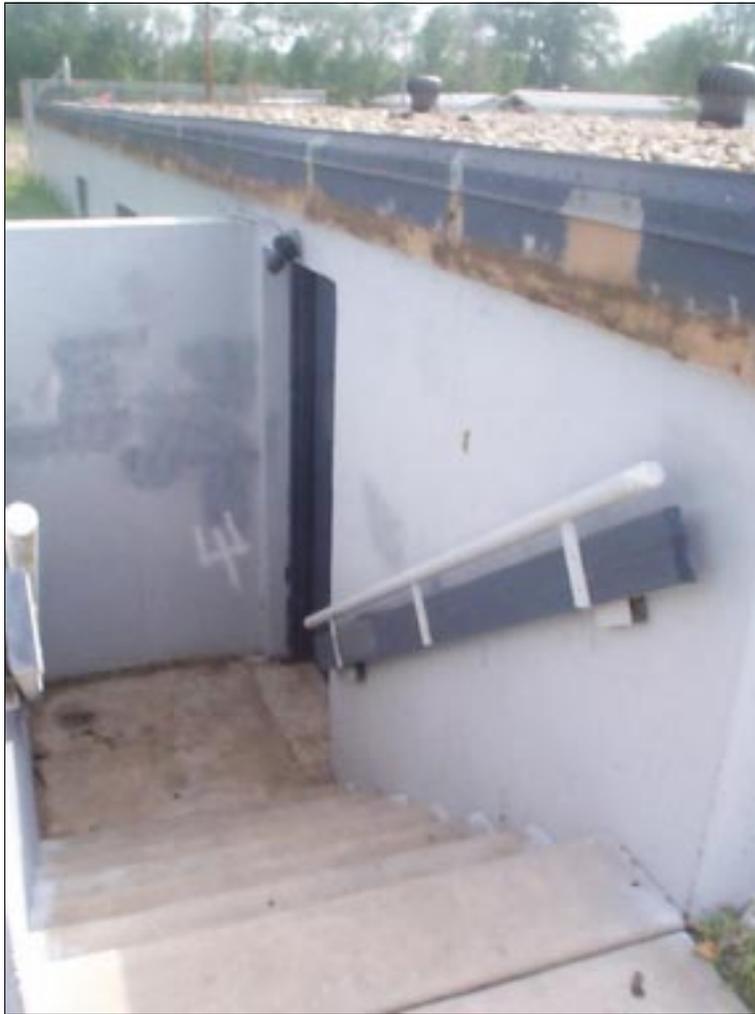
FIGURE 6-16: *Stairway leading to entrance of manufactured home community shelter, Wichita, Kansas. The only means of accessing this structure were this stairway and an identical one at the other side of the shelter.*

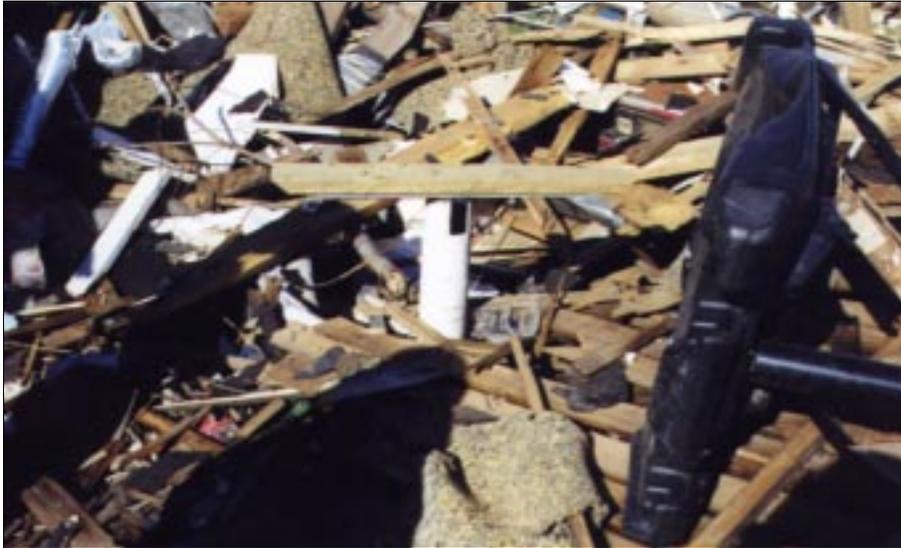
FIGURE 6-18: Heavy gauge ventilation pipe for a below ground shelter in Oklahoma withstood considerable debris impact.

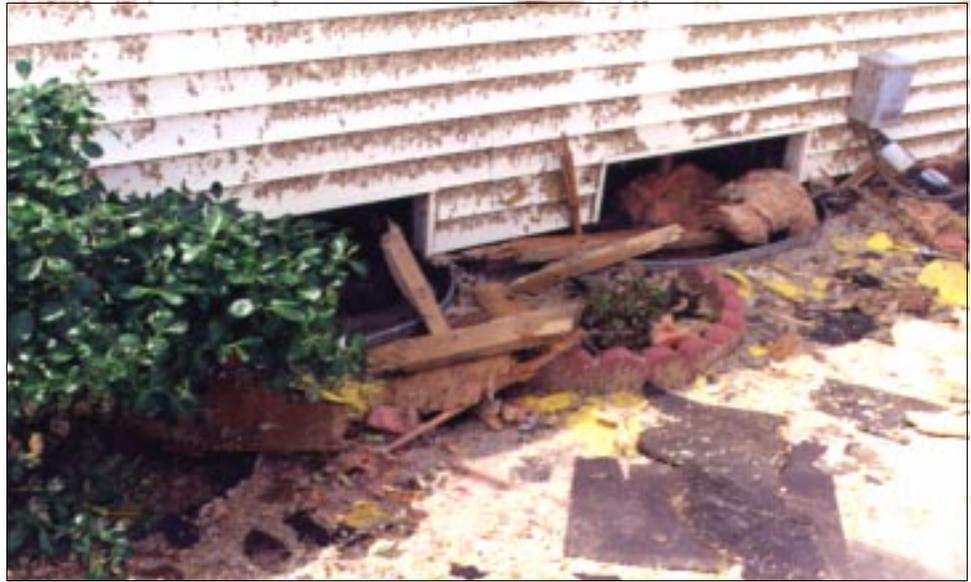
Most above ground in-resident shelters observed were easily accessible by the occupants. Their location within the house allowed access with minimal threat to wind and windborne debris. Basements and basement shelters offered the same advantages, but posed an access problem to occupants with disabilities. Basement windows and wells, however, were poorly protected and vulnerable to windborne debris (Figure 6-19). In addition, basement shelters only offered minimal protection when the house was blown off the foundation, leaving those seeking shelter in the basement subject to windborne missiles.

FIGURE 6-19: Basement windows of residential home, showing vulnerability to debris.

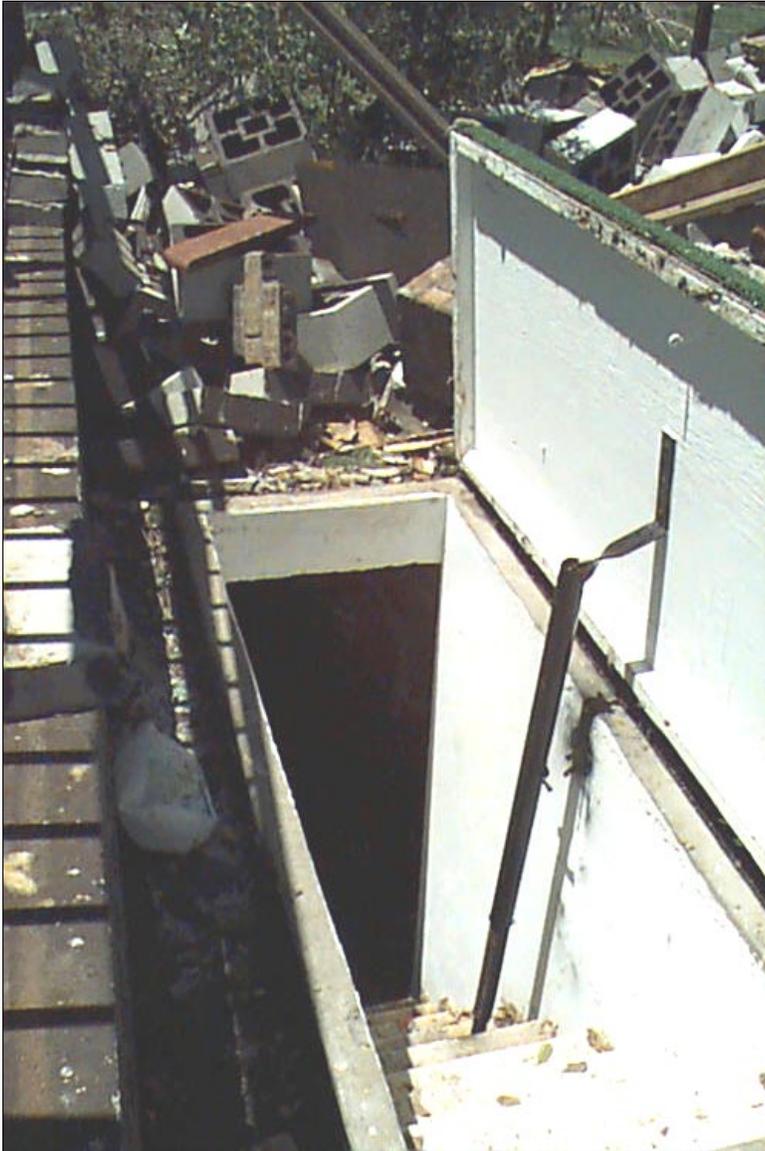
Storm cellars (underground cellars) were located either in the front, side, or rear yards of the homes. Front yard locations were vulnerable to vehicular traffic and water runoff. The side and rear yard cellars were also vulnerable to water runoff (Figure 6-20). In many cases, the cellar entrance was insufficiently raised above grade and would have allowed for easy entrance of water.

FIGURE 6-20: *This below ground shelter is susceptible to water runoff.*

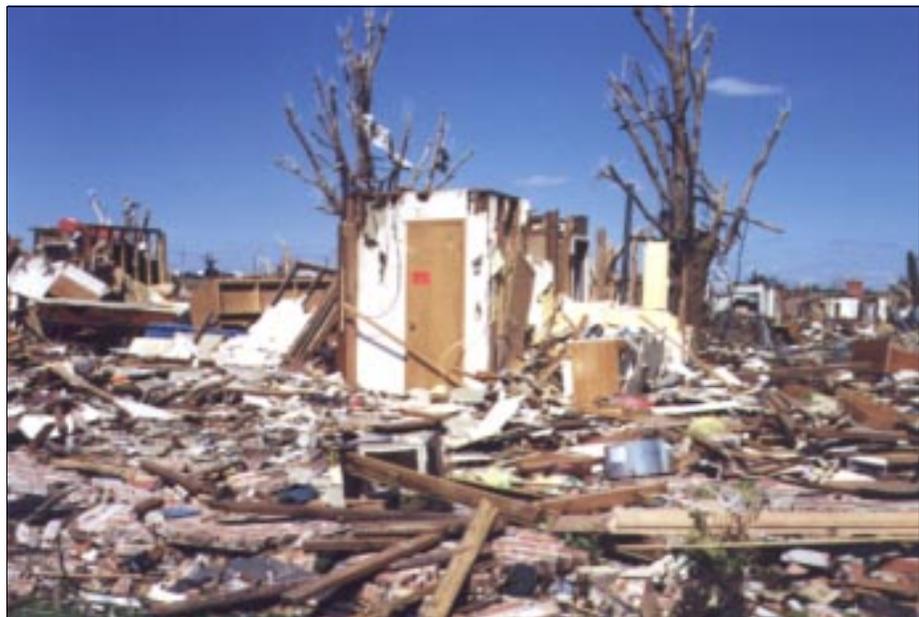
FIGURE 6-21: Remains of an interior room or core of a home in a Moore, Oklahoma, subdivision that was hit by a violent tornado.

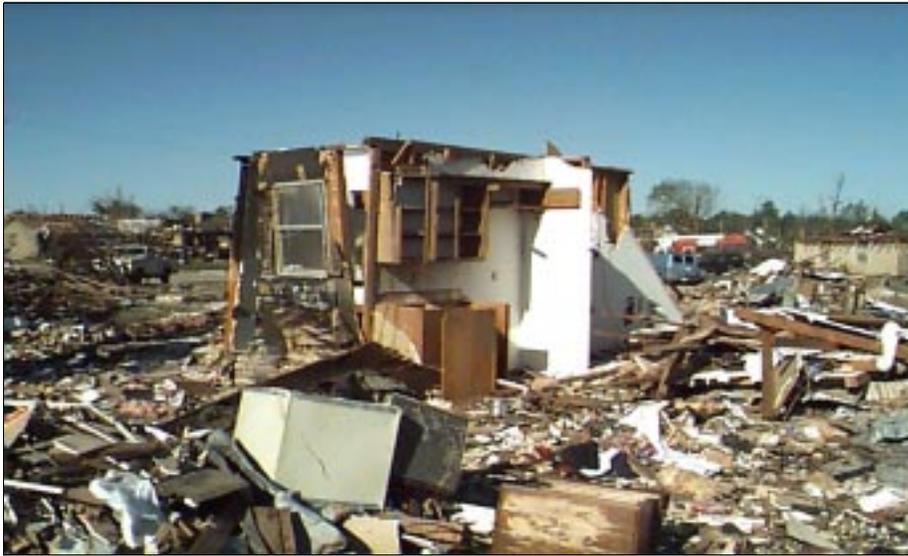
FIGURE 6-22: Interior core of house remains, consisting of a bathroom, closets and a wall with kitchen cabinets after being struck by a severe tornado.

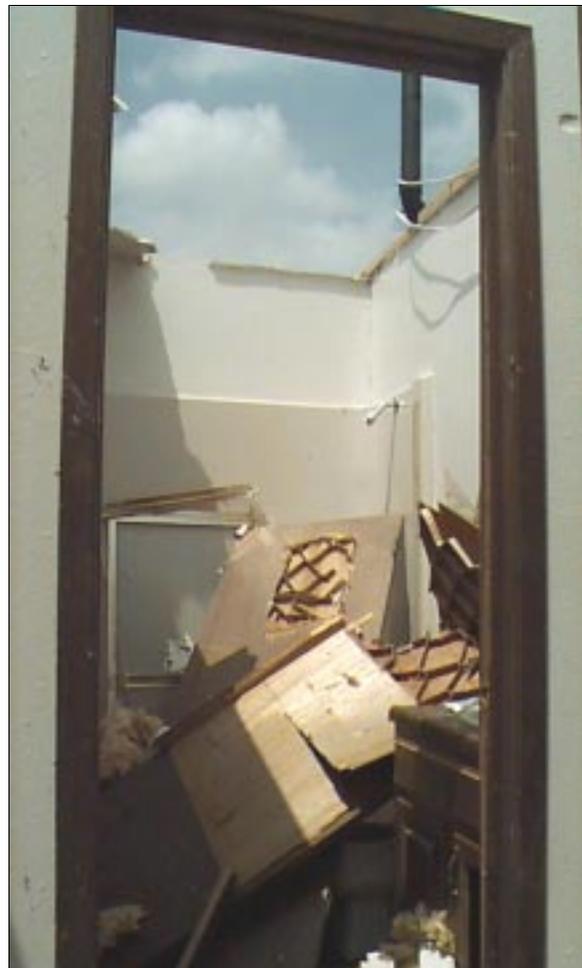
FIGURE 6-23: This house outside of Moore, Oklahoma, was affected by inflow winds associated with a severe tornado. The roof and ceiling were blown off of the interior bathroom of this house, the door was blown into the bathroom, and the tub was full of debris. This bathroom was not a safe refuge.

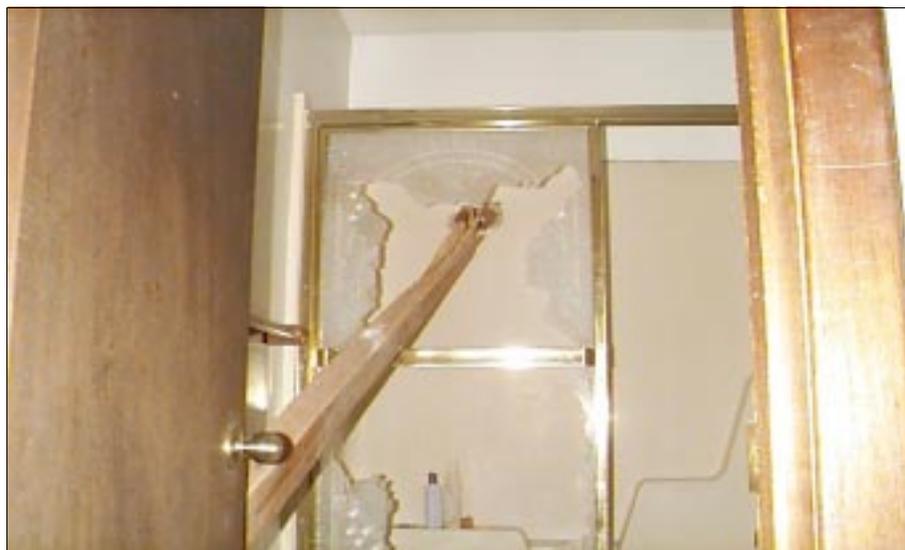
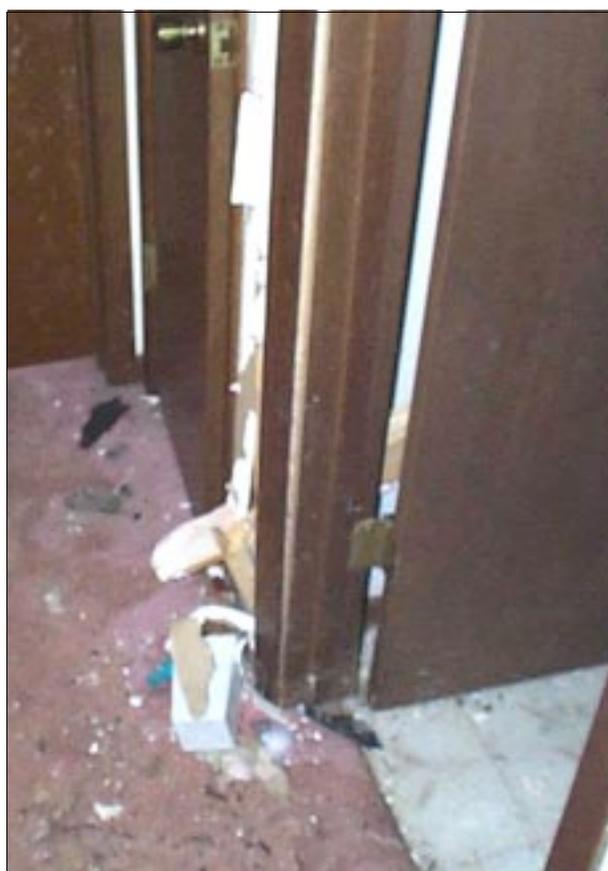
FIGURE 6-24: A 10-ft long 2-in by 6-in missile penetrated the exterior wall of this house in Wichita, Kansas, which was sheathed with hardboard panels. The missile, which was generated from the vortex of a severe tornado, then penetrated the gypsum board and tile tub enclosure, the tempered glass shower door, and the interior partition near the door frame. At the interior partition, it pierced through a wall stud and projected a few inches into the hallway (Figure 6-25).

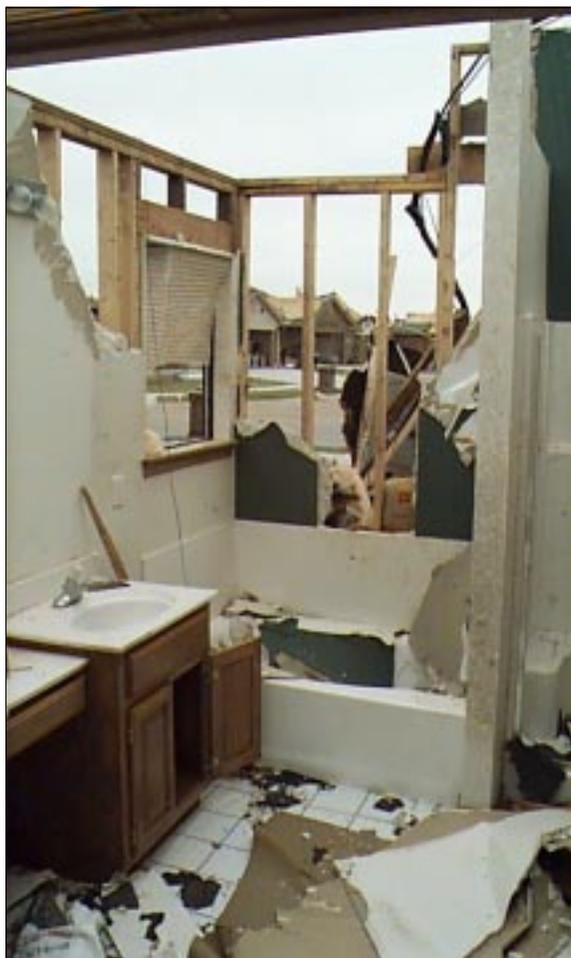
FIGURE 6-26: *This bathroom was on an exterior wall and had a window. It was not a safe refuge.*

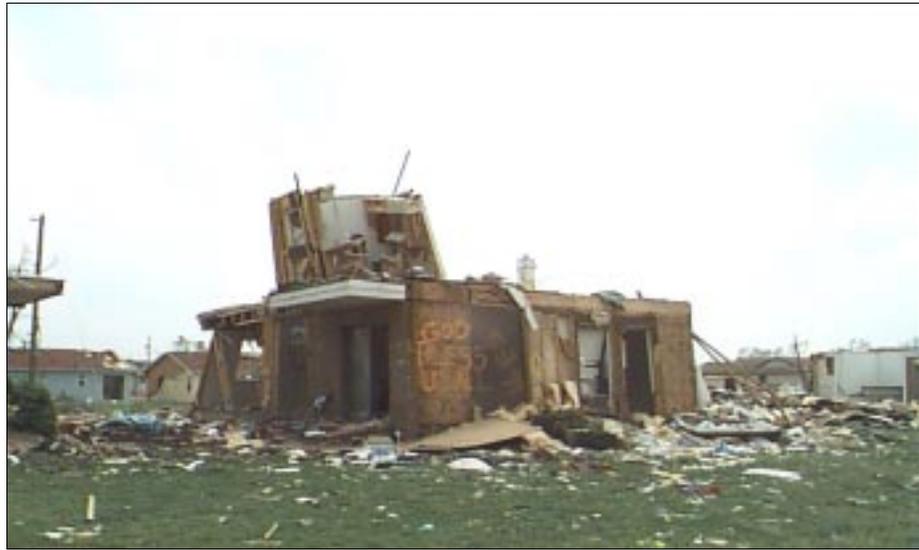
FIGURE 6-27: The second story of single and multi-family houses typically experienced far greater damage than the first story. This multi-family home in Wichita, Kansas, was affected by inflow winds of a severe tornado.

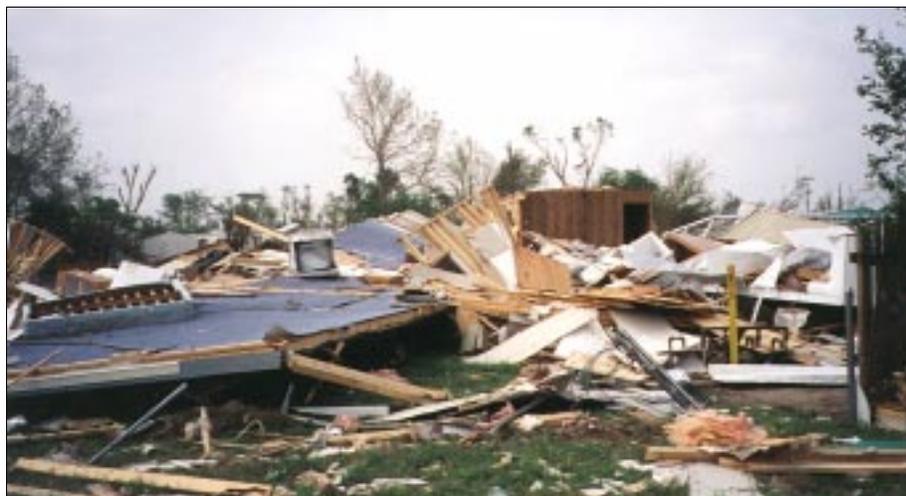
Based on the BPAT observations, persons taking refuge in bathrooms or closets in manufactured houses not attached to properly constructed permanent foundations appear to be at significantly greater risk of injury or death than persons taking similar refuge in conventionally constructed housing (Figure 6-28). The bathrooms and closets of manufactured houses typically provide very little protection. The BPAT observed a possible exception in some of the newer manufactured homes placed on proper

FIGURE 6-28: Damaged and destroyed manufactured homes in Wichita, Kansas, that were in the direct path of a severe tornado.

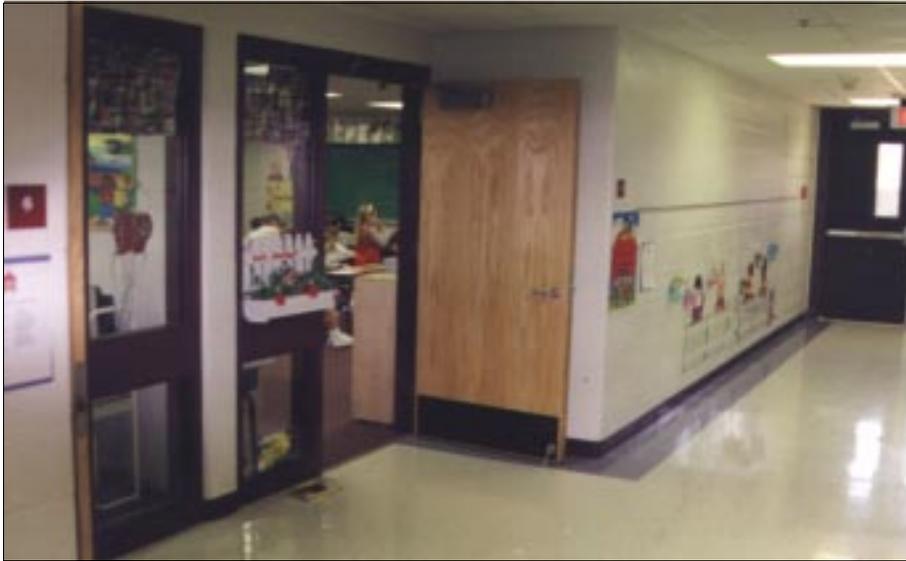
Eastlake Elementary in Moore, Oklahoma, was on the outer periphery of a violent tornado and received minor building envelope and cladding damage. The building construction consists of CMU walls with brick veneer and built-up roof over steel decking and steel bar joists. Interior classroom walls were also built of CMU. The tornado plan for the school indicated that the places of refuge consisted of each classroom within the building, even though each classroom entrance door (from the interior hallway) was flanked by a large glass sidelight (Figure 6-30). There were no exterior windows in the exterior wall of the classrooms. Centrally located offices were also identified as places of refuge with the building. None of the identified areas appeared sufficiently constructed to withstand a direct hit by a violent tornado.

FIGURE 6-30: Eastlake Elementary, Moore, Oklahoma, glazed sidelight at classroom entrance.

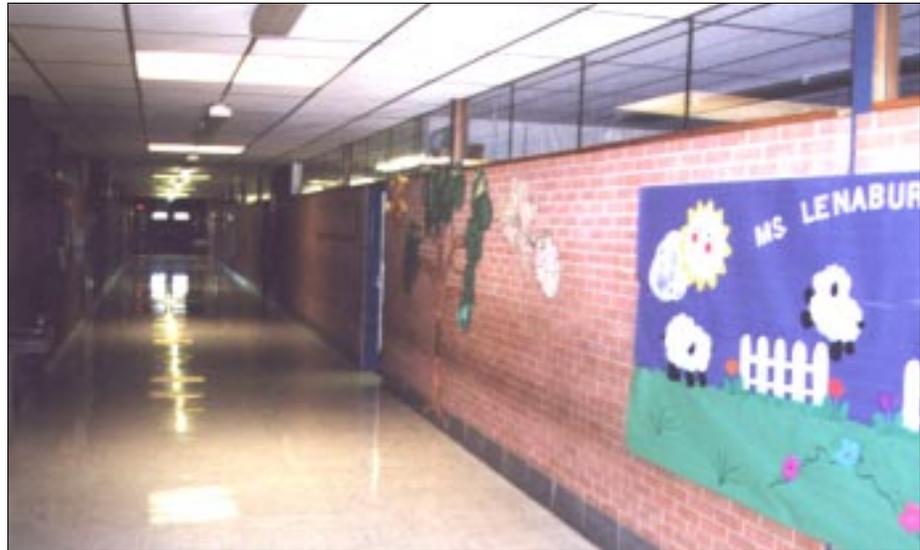
FIGURE 6-31: Northmoor Elementary place of refuge, Moore, Oklahoma - double loaded corridor with clerestory windows. This corridor offers little protection from a violent tornado as shown in a school of similar design in Figure 6-32.

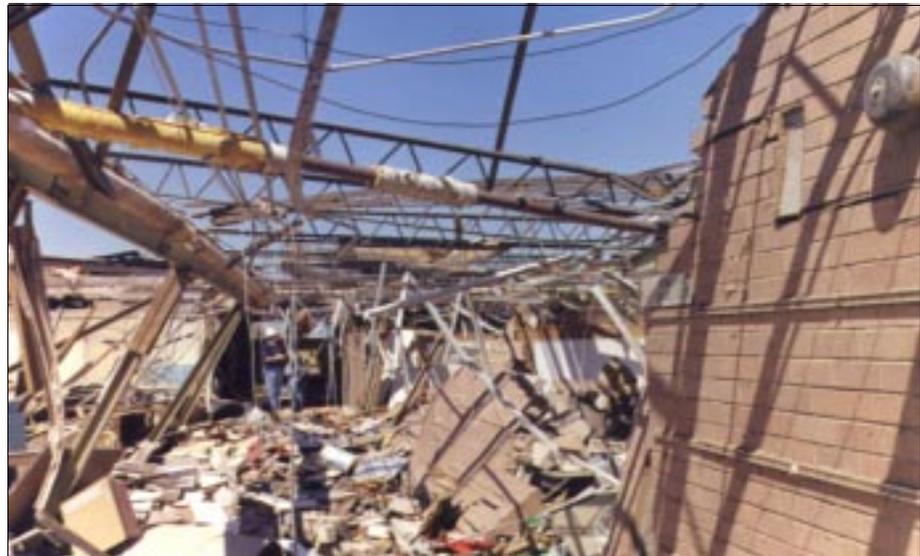
FIGURE 6-32: Kelly Elementary School, Moore, Oklahoma, place of refuge - double loaded corridor with clerestory windows. These interior corridor walls had brick masonry up to a height of approximately 7 feet. Glass extended from the top of the masonry to the top of the wall.

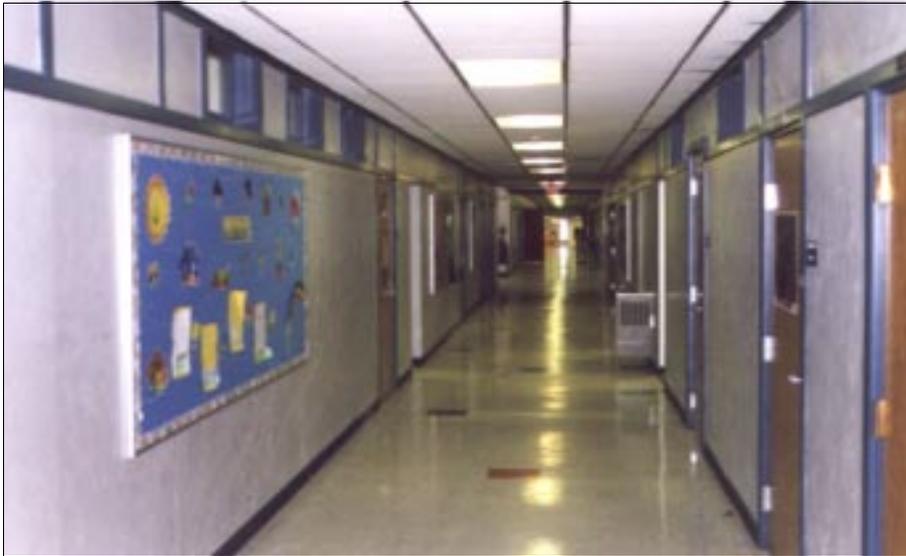
FIGURE 6-33: Sooner Rose Elementary School, Mid West City, Oklahoma. According to the tornado plan for this school, this hallway is designated as a place of refuge – double loaded corridor.

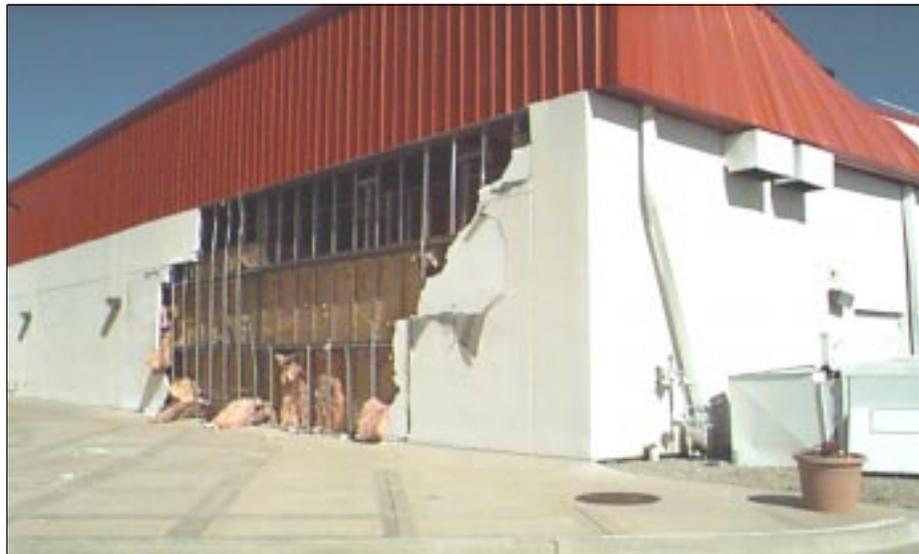
FIGURE 6-34: EIFS wall system torn from metal wall studs.

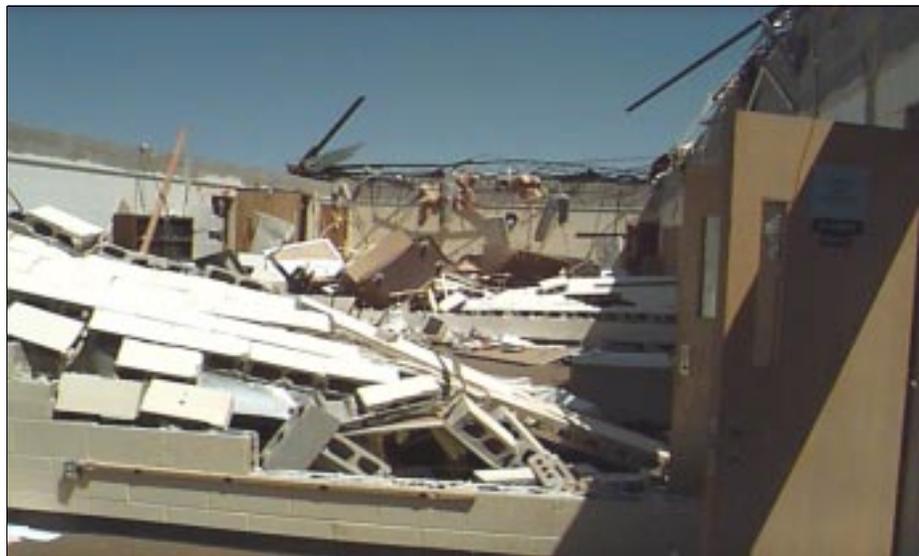
FIGURE 6-35: The non-reinforced interior CMU walls in this area of Kelly Elementary collapsed after the roof system was removed by vortex winds of a violent tornado.

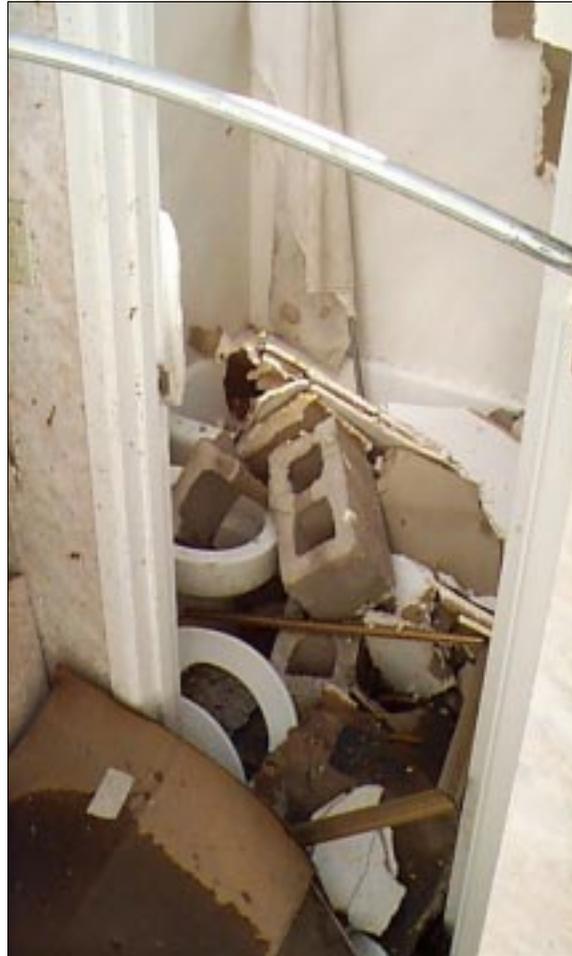
FIGURE 6-36: The roof and ceiling over this interior bathroom blew off. CMU from a firewall a few feet away blew into the bathroom, which was located on a motel's second floor in Mid West City, Oklahoma. This bathroom was not a safe refuge when impacted by the vortex of a severe tornado.
