4 Observations on Residential Property Protection

4.1 Single-Family Conventional Construction

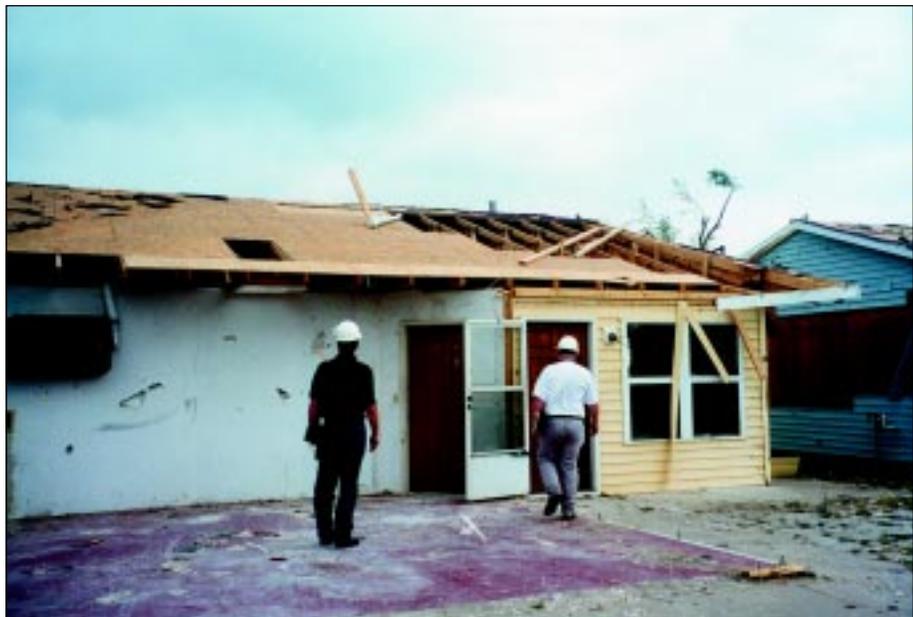
FIGURE 4-4: Although roof sheathing was lost at this Wichita, Kansas, home, code requirements of staggering joints in sheathing applications was observed. This house experienced inflow winds from a strong tornado.

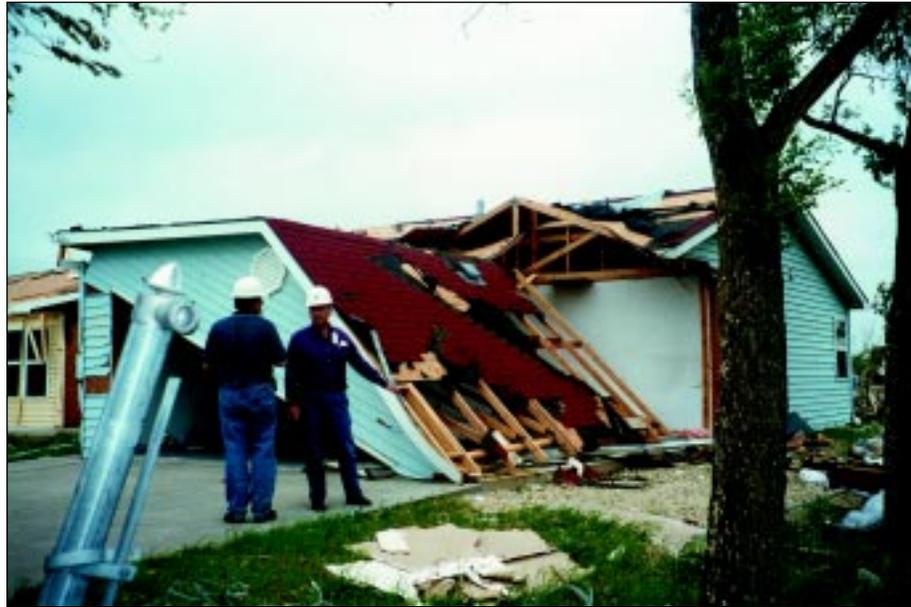
Wall sheathing observed consisted primarily of wood fiberboard or combination siding/sheathing. With the exception of garage end walls, it was difficult to ascertain any consistent failure of wall sheathing because it appeared the entire wall was either lifted or blown inward or outward as the result of windward pressure or a combination of windward/leeward pressure (Figure 4-6).

FIGURE 4-6: Wall failure due to inadequate lateral load resistance in Wichita, Kansas. The return wall at this garage was inadequate to carry wind loads and may have led to this failure.

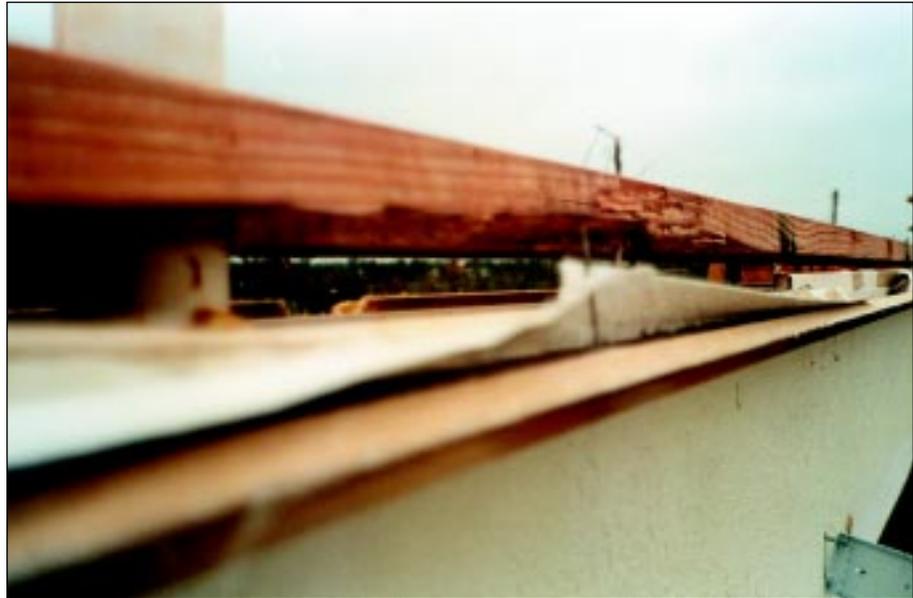
Figure 4-8 shows a seldom seen type of failure caused strictly by uplift of the roof truss attached to the double top-plate. There were few observed failures of the connection of the double-top-plate to the supporting studs below, although one example is shown in Figure 4-9.

FIGURE 4-8: Failure of a double top-plate. The uplift of the roof truss previously attached to this double top-plate caused separation of the two members that comprise this top-plate.

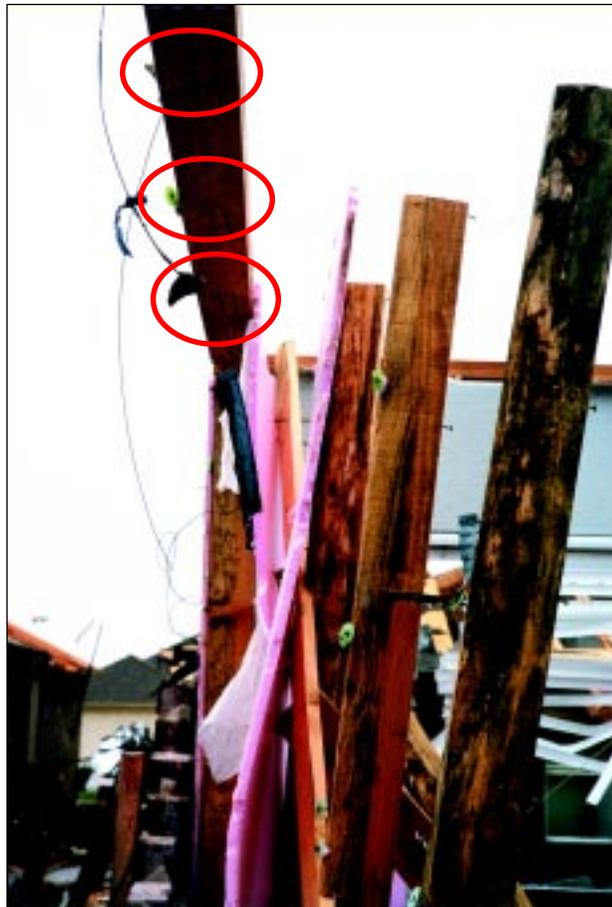
FIGURE 4-9: Failures of the connection of the double-top-plate to the supporting studs below at a home in Moore, Oklahoma. This home was located along the periphery of a violent tornado.

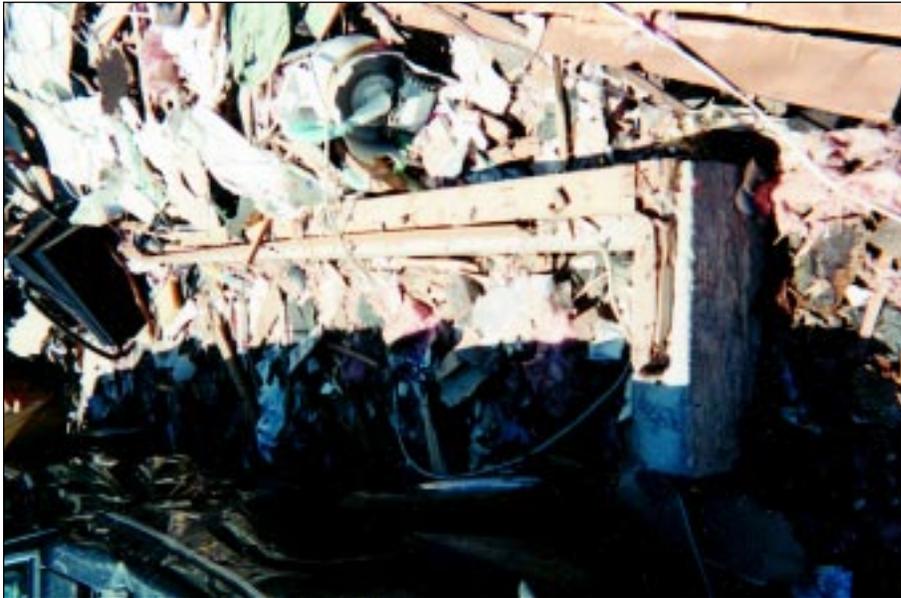
FIGURE 4-10: Wall framing to bottom plate failure. This house in Del City, Oklahoma, experienced a direct hit from the vortex of a violent tornado.

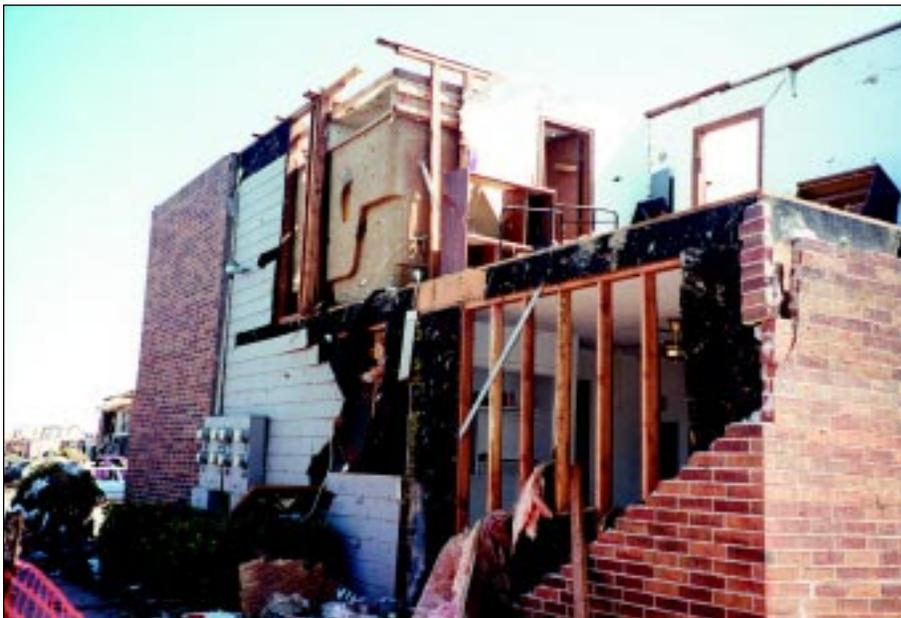
Failures between the bottom plate and the foundation or floor below were observed. Some of these failures occurred when the bottom plate itself failed due to extreme winds associated with the vortex of a violent tornado, as seen in Figure 4-11. In this figure, nails were used to secure the bottom plate to the second story floor system.

FIGURE 4-11: Stud-wall and sole-plate-to-floor failure on a second story wall. This multi-family residence in Moore, Oklahoma, was located a few hundred feet from the vortex of a violent tornado and was exposed to inflow winds.

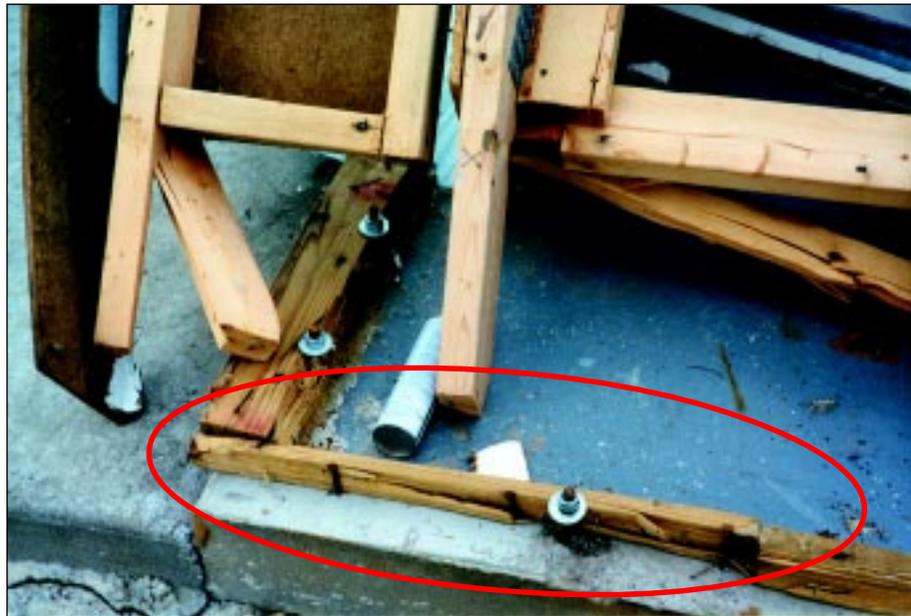
Another factor observed that contributed to failures of wall systems was that the bottom-plate (sole- or sill plate) was not integral with the siding or other means of transferring the force. The connection was weak as seen in Figure 4-12. In both Oklahoma and Kansas, bolts, nails, and epoxy anchors were observed securing bottom plates to foundations. In one instance in Oklahoma, straps from the foundation were observed securing the bottom plate to the foundation.

FIGURE 4-12: Failure at base of wall between wall studs and bottom plate. The bottom plate, which was connected to the foundation slab with anchor bolts and nails, has splintered.

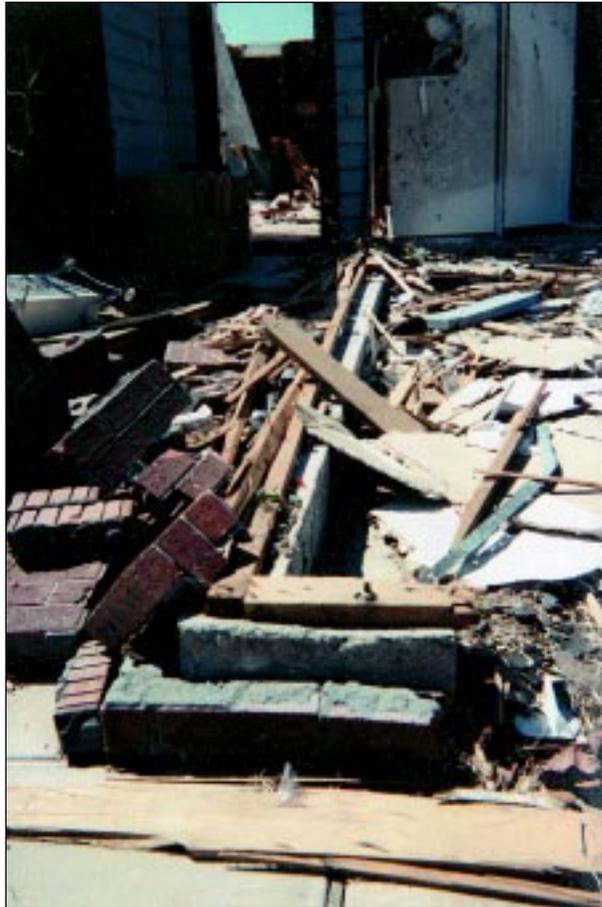
FIGURE 4-13: Failure of this bottom plate to wall stud connection occurred at this home outside Oklahoma City, Oklahoma. The vortex of a violent tornado passed very close to this home.

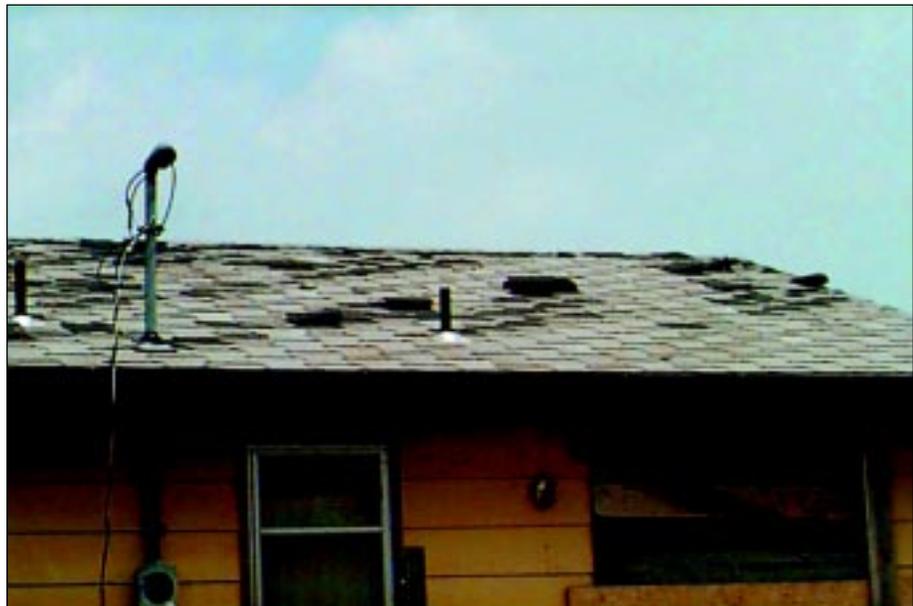
FIGURE 4-15: *Several T-lock shingles on this house were lifted and torn. This house was on the periphery of a weak tornado in Wichita, Kansas.*

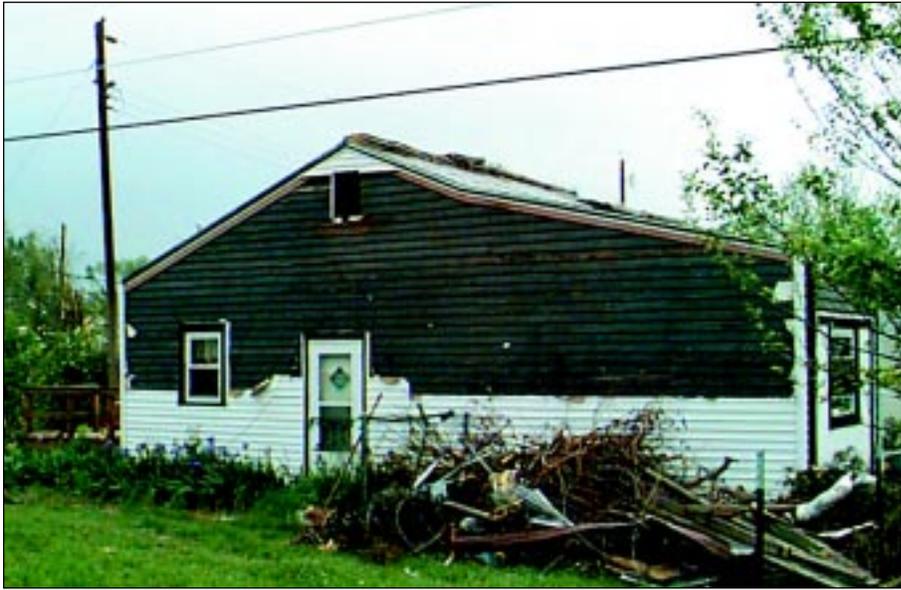
FIGURE 4-16: The vinyl (white) that was installed over wood siding experienced damage; however, the wood siding was undamaged. The home was located along the periphery of a violent tornado in Wichita, Kansas.

The siding of the home in Figure 4-16 was attached with roofing nails. In one area, the nails were 30-in and 21-in apart. The failure of the siding occurred when the vinyl pulled over the nailheads. Additionally, the home in Figure 4-16 suffered some asphalt shingle damage. Houses with vinyl siding that were closer to the vortex commonly had extensive missile damage (Figure 4-17). The siding on the home in Figure 4-17 was fastened with roofing nails placed at 13.5-in, 10-in, and 20-in along one length of siding. The vinyl pulled over the nailheads. Most of the siding failures observed were in areas that experienced straight inflow winds from the tornadoes that were likely at or slightly above the design wind speeds of the current building codes wind speeds (e.g., 70-80 mph, fastest mile or 90-mph 3-second peak gust).

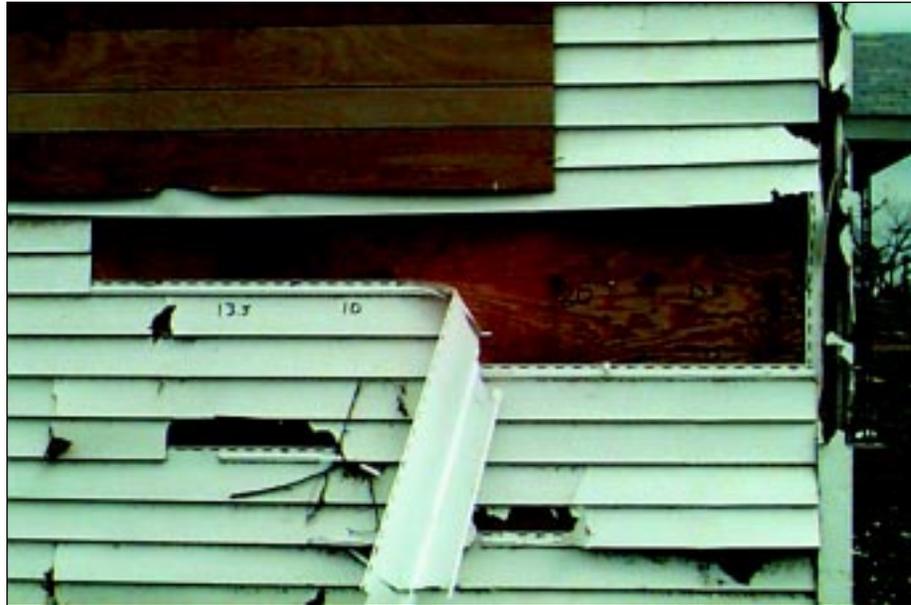
FIGURE 4-17: *Some pieces of vinyl siding were blown off and in other areas the siding was torn away by missiles. The home was located along the periphery of a violent tornado in Mullhall, Oklahoma.*

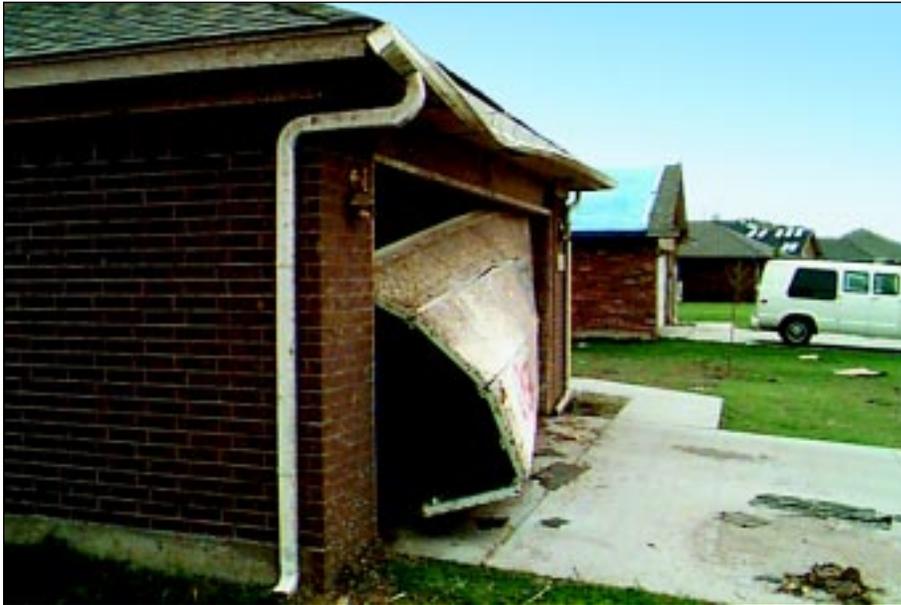
Along the track periphery, it was common to see residential garage door failures (Figure 4-18). The door in this figure likely had a laboratory tested positive load resistance of 12.5 psf, a common test pressure for doors of similar construction. The design load on this door would be 13 psf negative and 11 psf positive using UBC 1997 and 18 psf negative and 14 psf positive using ASCE 7-98. Hence using a 1.5 safety factor, the positive load derived from ASCE 7-98 is 68 percent higher than the resistance of the door. Had this door met the wind loading derived from ASCE 7-98, this failure may have been avoided. This observation is important because it highlights the advanced guidance given by engineering standards as opposed to the basic guidance given by the model building codes for components and cladding elements such as exterior wall systems, windows and doors, and garage doors.

FIGURE 4-18: This double-width garage door failed under a suction load in Moore, Oklahoma.

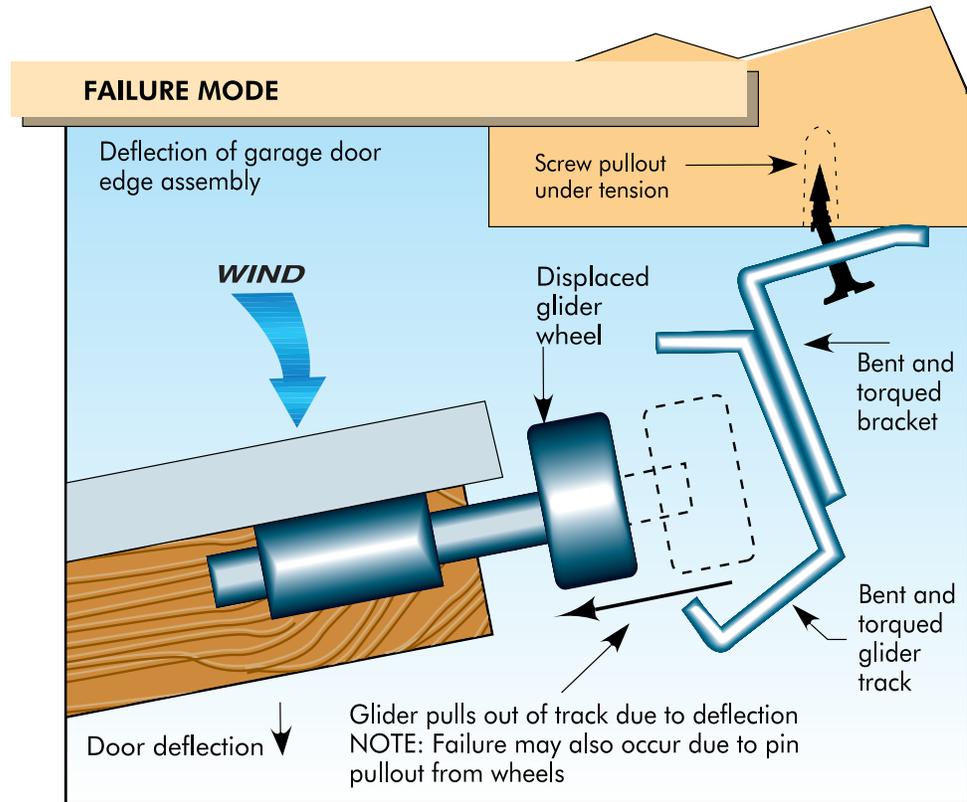
Most of the doors investigated were made of thin metal. Failures were typically caused by wind pressure, rather than by missiles. The most common failure mode observed was the door rollers disengaging from the door tracks, most likely caused by excessive door deformation (see Figures 4-19 and 4-20). Door failure resulted in increased load on the buildings.

FIGURE 4-20: Detail B from Figures 4-19. Garage door failure at track and recommend assembly improvements.

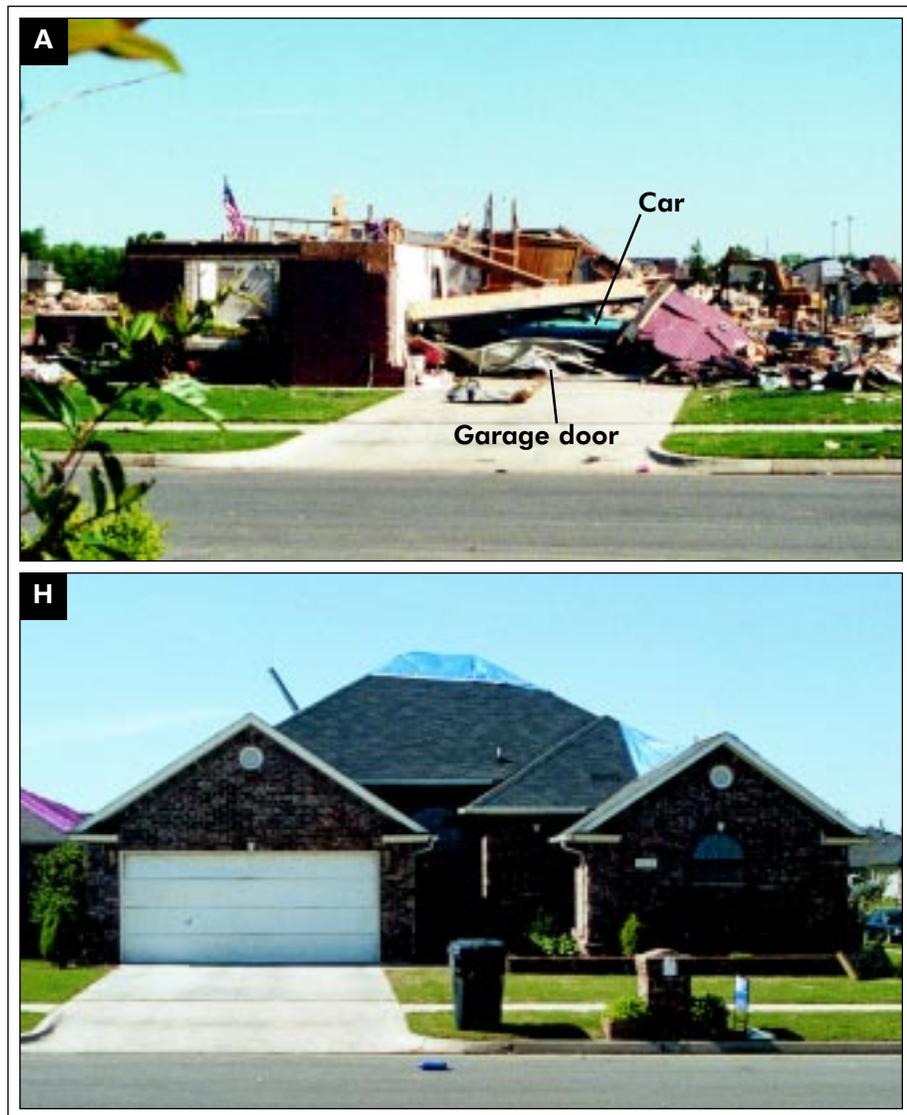
Homes located at H and A are shown in Figure 4-22. The damage states of the two homes are significantly different even though they are located directly across the street, approximately 95 feet apart, from one another and may have experienced relatively similar wind conditions based on the approximate track location (Figure 4-21). The home located at H had seven broken windows, primarily at the back of the home as a result of debris generated from a failed wooden fence. It also had one breached glass entry door, and lost approximately 60% of its roof covering. The home located at A lost its entire roof structure and several exterior walls. This was likely due to the failure of the garage door from inward wind forces. For the remaining houses, similar “across-the-street” damage gradients were observed between the homes, A through G and H through N, with the exceptions of the home at location F, which did not lose its entire roof structure, and the home at location G, which did not lose any roof structure, but did sustain severe roof framing damage due to uplift.

Several failed garage doors were observed lying at the back of the garage for many homes (A through G), indicating that the garage doors failed due to positive (inward) pressure. These failures of the garage doors are believed to have initiated or contributed to the catastrophic roof and exterior wall failures for homes A through G, a direct consequence of load increase due to a large breach in the building envelope. Examples of this may be seen in Figures 4-22 and 4-23. Note that the failed garage door in Figure 4-22 is crumpled up against the car, suggesting a door failure under positive pressure. A partial roof failure (house F) is depicted in Figure 4-23. In this case, the garage door was also found within the garage as shown in the picture inset. The observed location of the failed garage door and the localized roof damage suggests that the failed garage door may have initiated or played an important role in the roof failure. Many of the moderately to severely damaged homes observed had a significant amount of structural damage to the garage area and to the immediate surrounding area, but did not necessarily have the same magnitude of structural damage at the opposite side of the building where no garage was located.

FIGURE 4-22: Home in Moore, Oklahoma, with partial roof loss and garage door in place (H) vs. home with total roof loss due to garage door failure (A) under positive pressure.

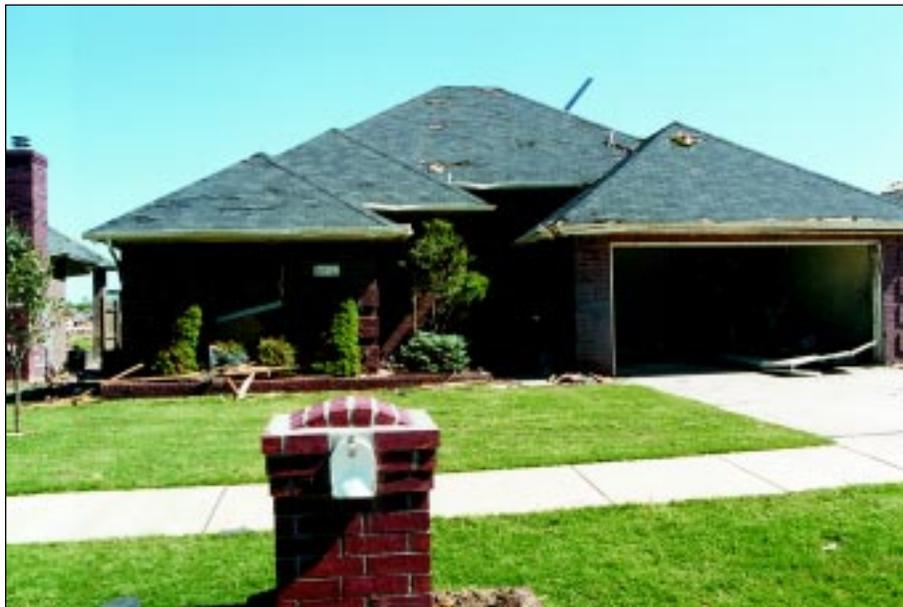
A final example of observed internal pressurization and roof uplift is shown in Figures 4-24 and 4-25 for the house located at G. The garage door failed by positive pressure and was found inside the garage. Figure 4-24 shows strong evidence of the early stages of roof uplift between the garage roof and exterior wall. The ceiling was observed to have pulled away from the exterior wall perimeter, indicating that the whole roof frame was lifted up. The space shown in Figure 4-25 was apparent along most of the perimeter of the garage ceiling. Figure 4-26 shows an exterior view of the roof and wall interface where the initiation of roof uplift was observed. Tension cracks in the brick veneer and a large gap along the length of the right exterior wall between the roof and top plate were also observed.

FIGURE 4-24: A view of home G with a garage door that failed due to positive (inward) acting wind loads.

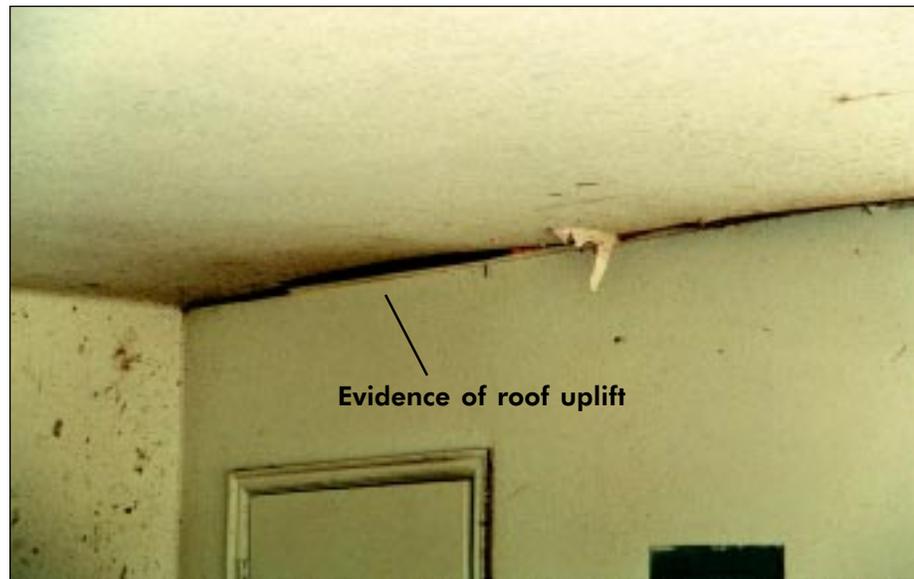
FIGURE 4-25: *Roof uplift between garage ceiling/roof structure and exterior wall at home G.*

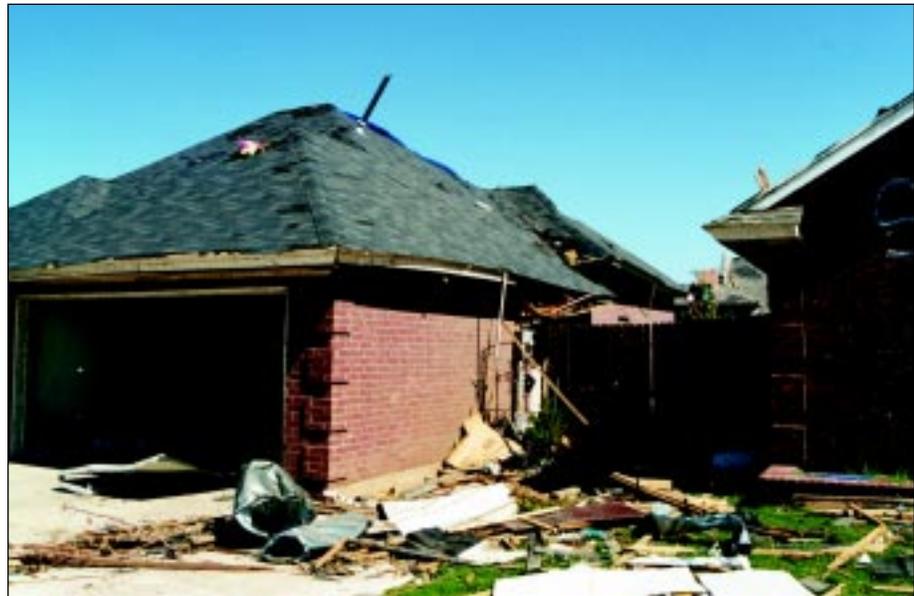
FIGURE 4-26: *A 2x4 member extends out of the gap that runs the length of this garage wall between the top of the wall and the roof framing.*

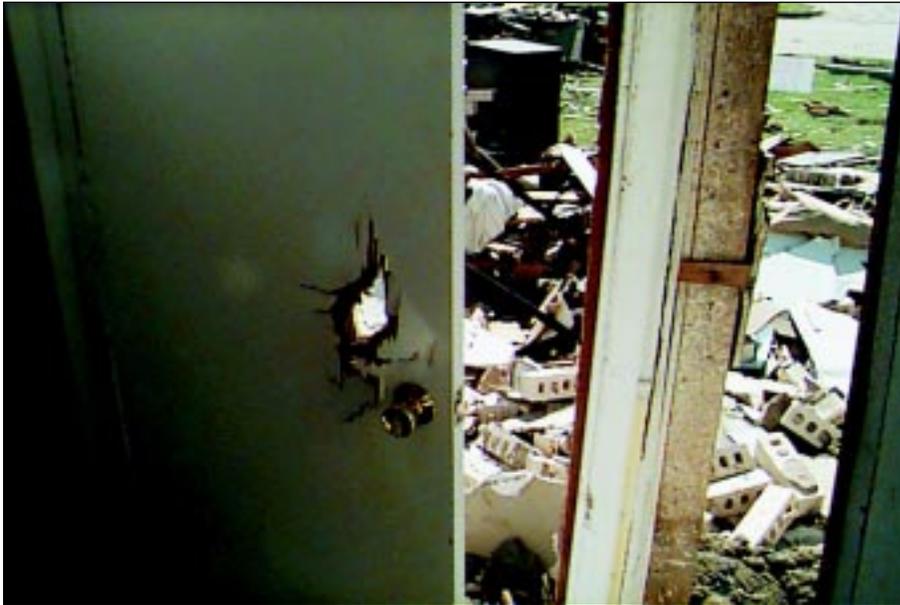
FIGURE 4-27: A missile penetrated this exterior door in Del City, Oklahoma. Interior hollow-core doors typically offer even less missile protection than common exterior doors.

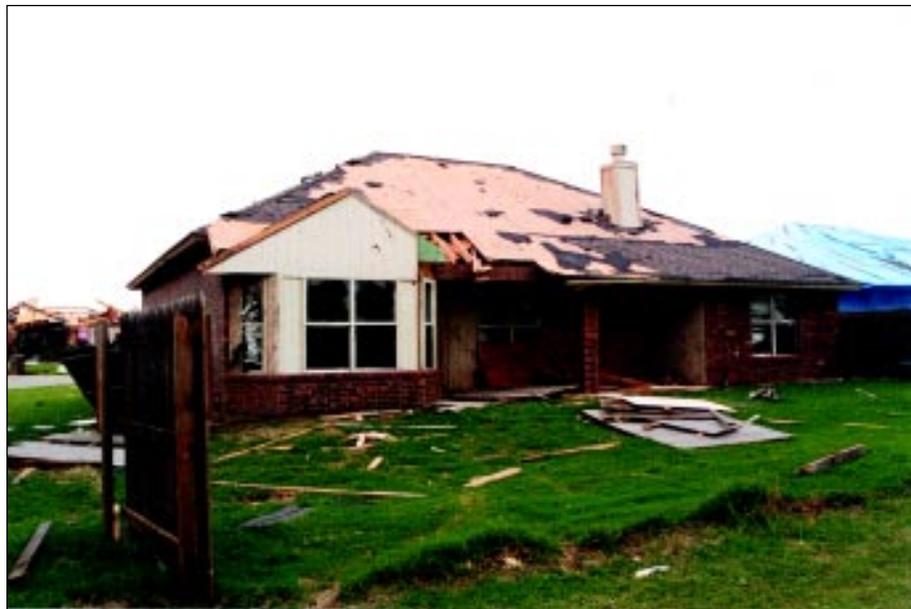
Several window failures at the back of the home located in Country Place, a subdivision of Oklahoma City, are shown in Figure 4-28. This home was located along the periphery of a violent tornado. Other than a small piece of sheathing missing from the roof edge, the roof damage in the back of the home is limited to the loss of roof covering material only. In contrast, several pieces of roof sheathing failed on the front portion of the roof as depicted in Figure 4-29. Note that no breaches to the front exterior wall were observed. Figure 4-30 shows a view of the interior of the same dwelling taken from outside the left-hand window breach seen in Figure 4-28. The photograph of the interior suggests the possibility that internal pressurization may have contributed to the roof sheathing loss. This is suggested by the holes in the ceiling, in particular the right-hand hole above the interior doorway. There was evidence to suggest that internal pressure may have pushed the ceiling away from the top of the interior wall where the ceiling drywall failed. Note that there was no evidence of drywall debris on the floor directly below the drywall failure, suggesting the drywall was ejected into the attic. Internal pressurization may have caused the ceiling drywall to fail between the roof structural members that led to the pressurization of the attic space and contributed to the

FIGURE 4-28: Damage to back of home in the Country Place Subdivision in Oklahoma City, was limited to several window failures and roof covering damage. The home was located along the periphery of a violent tornado.

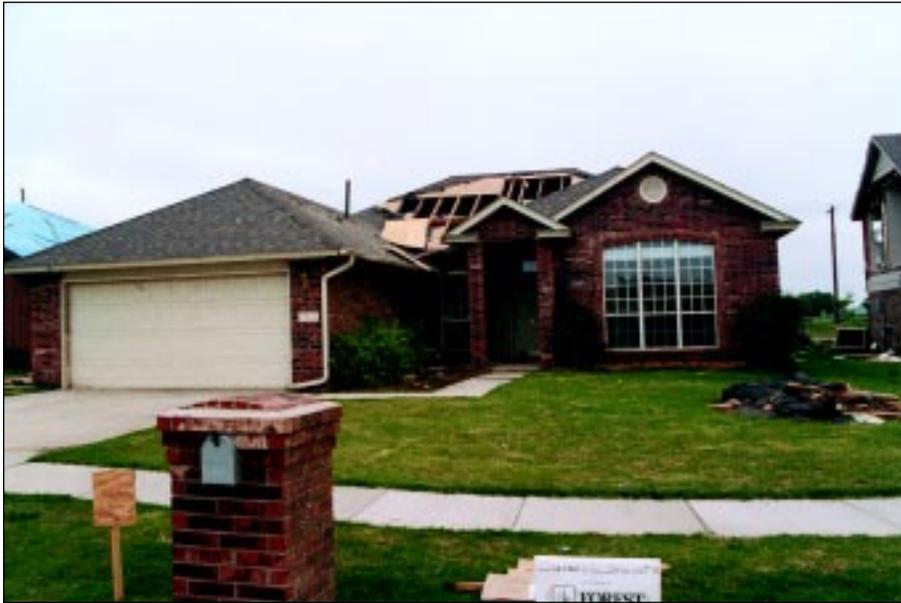
FIGURE 4-29: Front of home in Figure 4-28 where several pieces of roof sheathing failed.

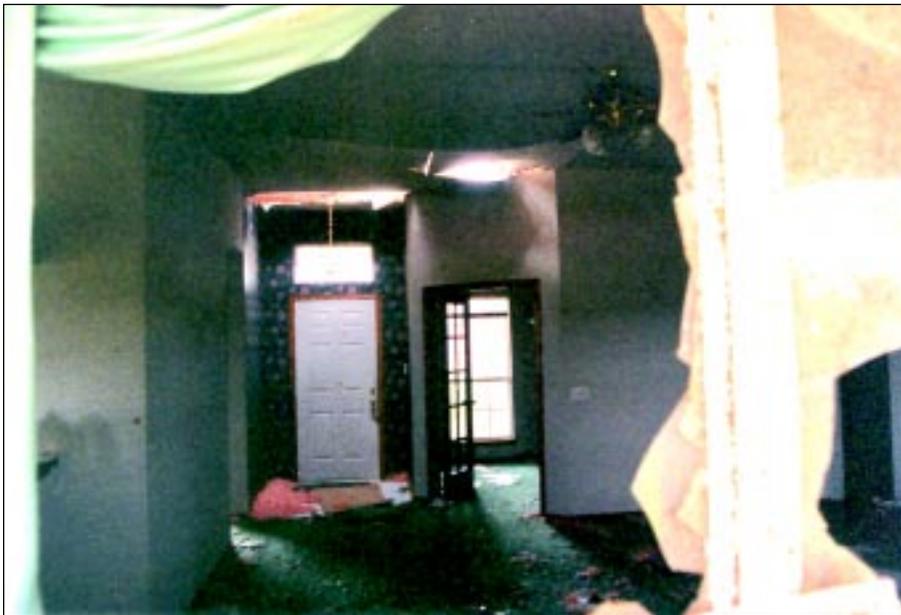
FIGURE 4-30: View of interior of the home shown in Figures 4-28 and 4-29.

sheathing failure shown in Figure 4-29. Drywall debris on the floor in front of the door belonged to the collapsed ceiling drywall to the left and was likely the result of rain water damage entering through the roof.

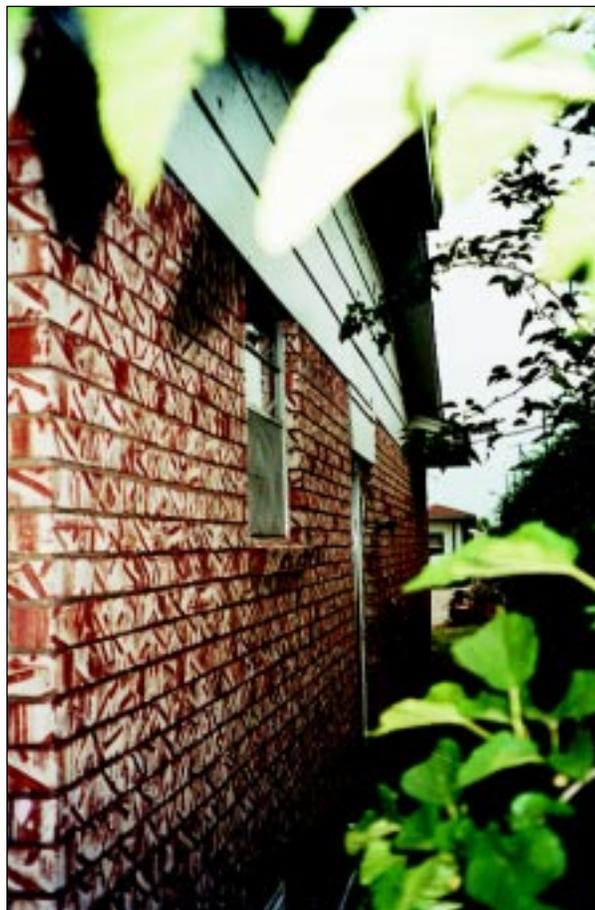
FIGURE 4-31: *This brick veneer appears to be undamaged but close inspection indicated that this wall could be deflected inward with only hand pressure.*

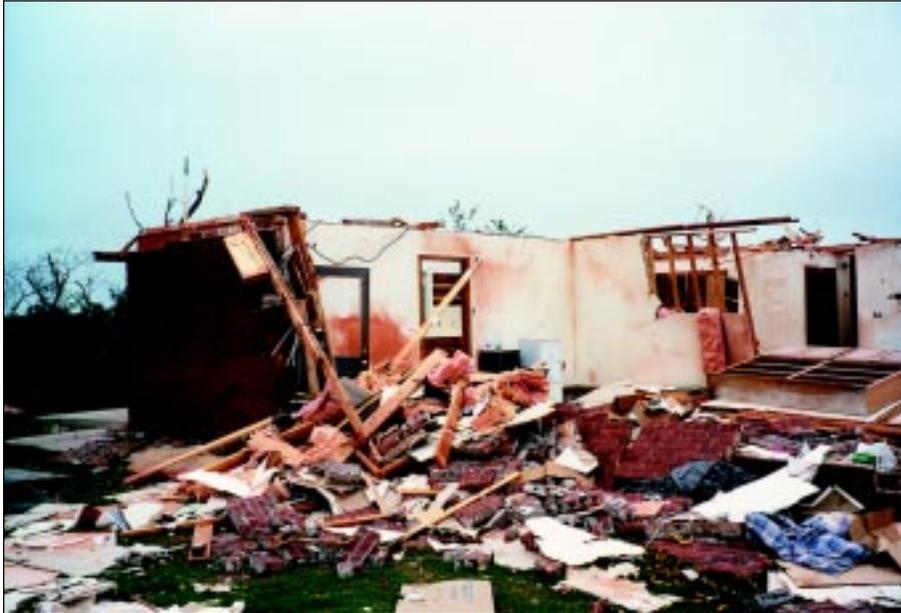
FIGURE 4-32: Failure of brick masonry veneer construction. The vortex of the strong tornado that caused the winds at this site passed approximately 300 feet from this building in Bridge Creek, Oklahoma.

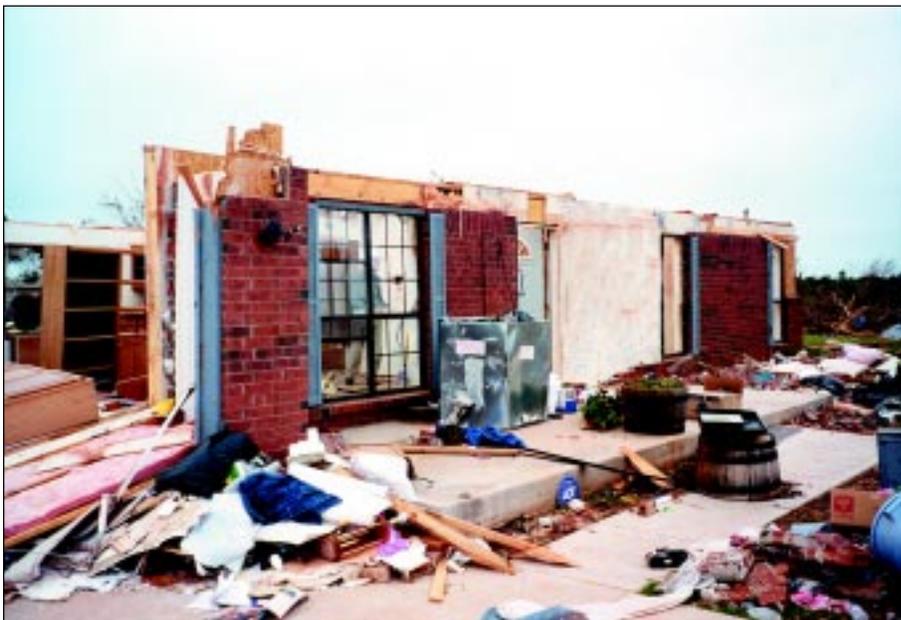
FIGURE 4-33: Brick veneer failure at the house shown in Figure 4-32.

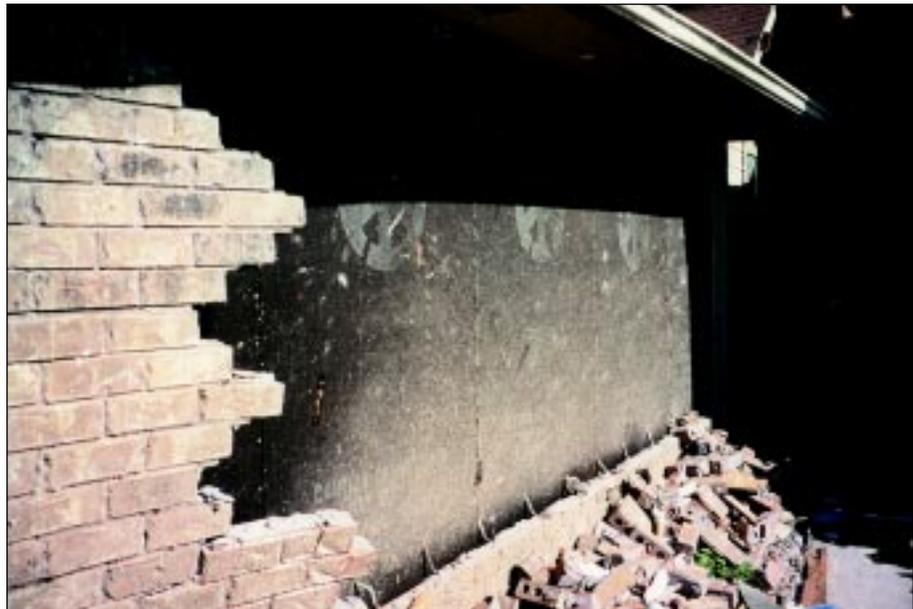
At Country Place and Eastlake Estates in the southwest suburbs of Oklahoma City, the BPAT observed a large number of 1- to 5-year-old homes with brick veneer failures. The wind speeds at these locations could not be determined. However, based on the team's observation of the damage and debris, including standing wood framed walls, it appeared that most homes with brick veneer failure were outside the vortex of a violent tornado (Figure 4-34).

FIGURE 4-34: Failure of masonry veneer wall of a home located along the periphery of a violent tornado near Moore, Oklahoma.

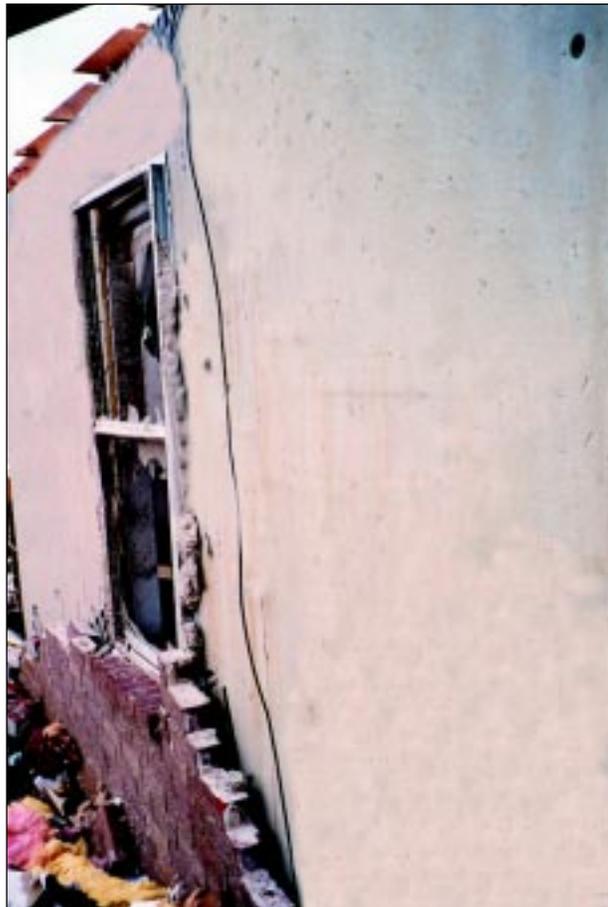
The BPAT also observed several problems that led to failure of the brick veneer, such as inadequate bonding of mortar to galvanized brick ties, inadequate bonding of mortar to brick, corroded brick ties, and nail pull-out at brick ties. The BPAT observed that brick veneer was generally constructed using 3-in brick. Location and number of brick ties varied considerably, from 16-in on center vertically and horizontally, to ties at top, midheight, and near bottom of walls. There were several walls with up to 1.5-in to 2.0-in gaps behind brick and with brick ties only inserted $\frac{3}{4}$ -in to 1.0-in into mortar joints. Most ties were fastened through plastic foam insulation sheathing into studs with one 6d common nail per tie.

FIGURE 4-35: Inadequate bonding of mortar to galvanized brick ties contributed to this masonry failure at a home in Bridge Creek, Oklahoma.

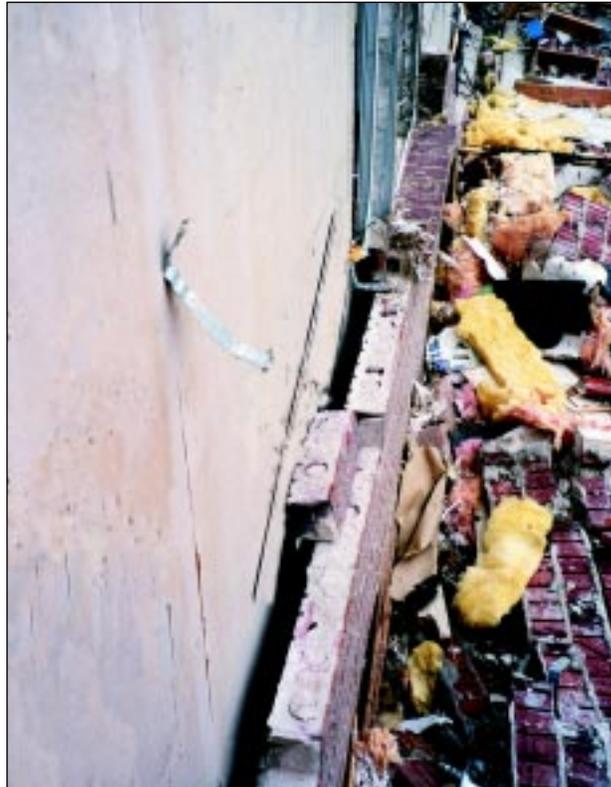
FIGURE 4-36: *Inadequate bonding of mortar to galvanized brick ties, Bridge Creek, Oklahoma.*

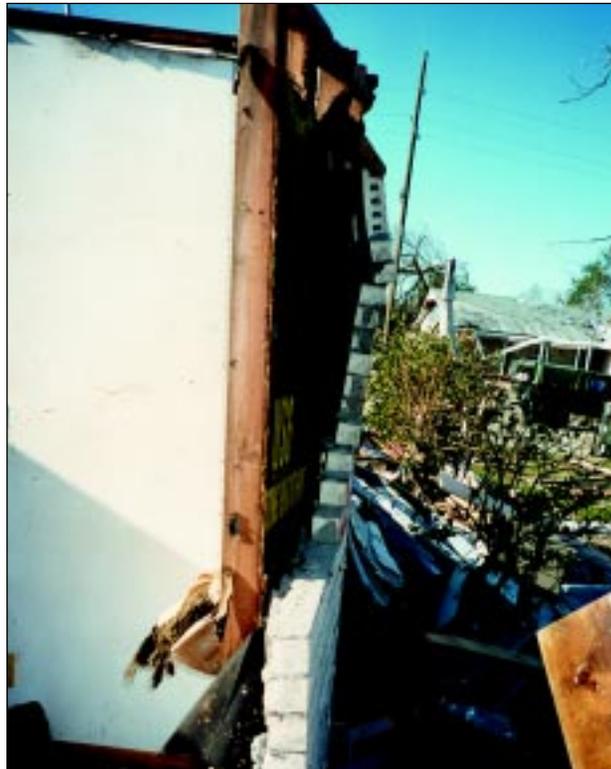
FIGURE 4-37: *Failure of brick veneer wall, Del City, Oklahoma.*

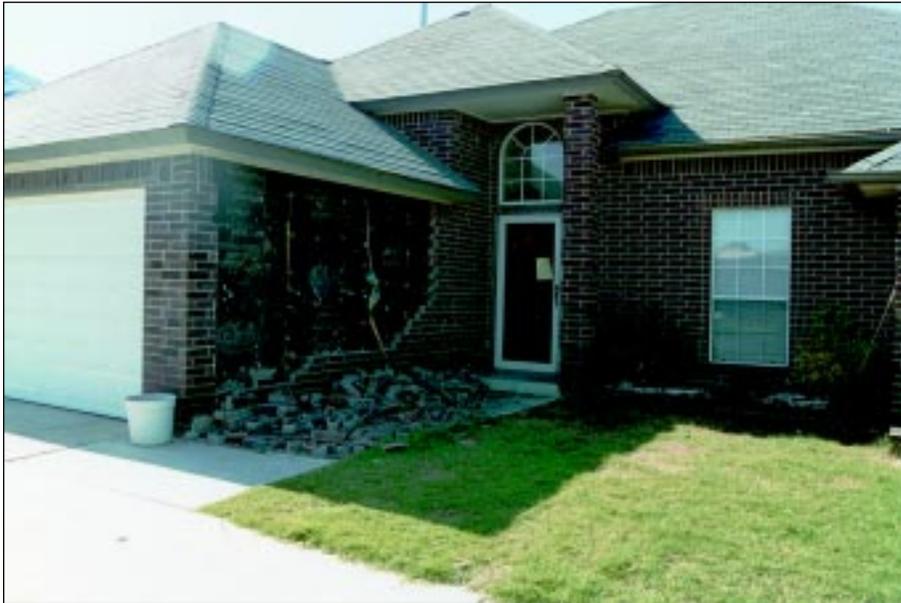
FIGURE 4-38: Failure of brick veneer wall, collapsed on the ground. This home, located outside Oklahoma City was on the periphery of a violent tornado.

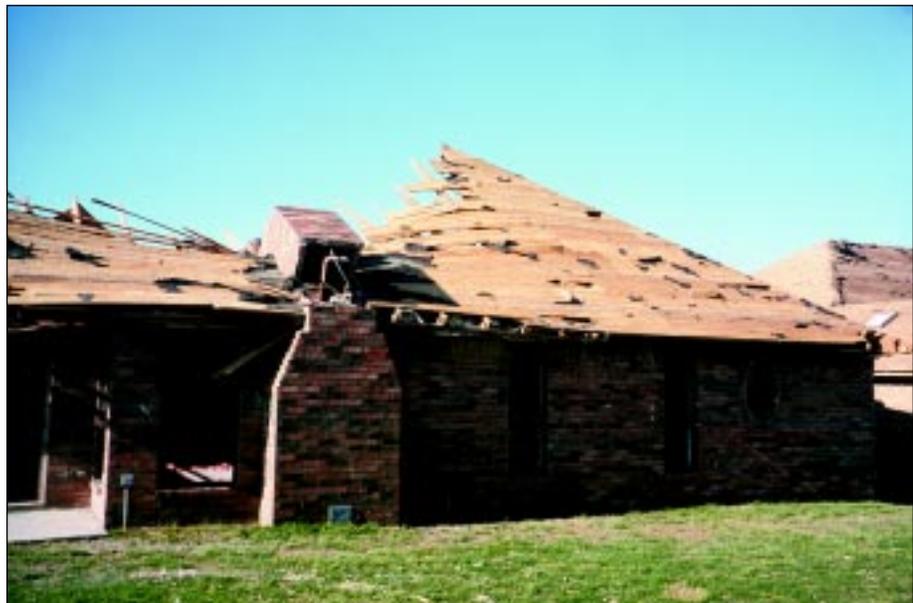
FIGURE 4-40: Failure of brick chimney onto roof of home located along the periphery of a violent tornado, Moore, Oklahoma.

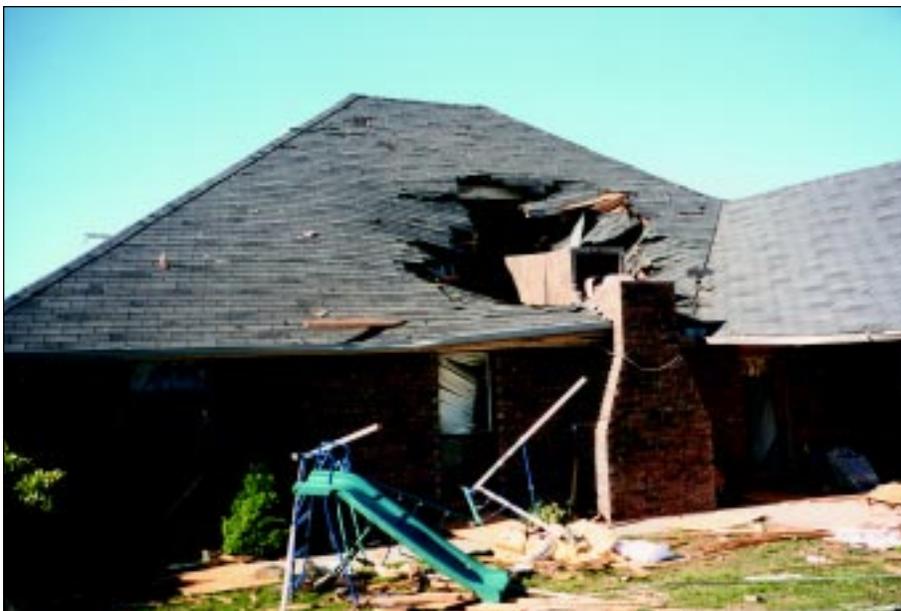
FIGURE 4-42: Failure of brick chimney onto top of home located along the periphery of a violent tornado, Moore, Oklahoma.

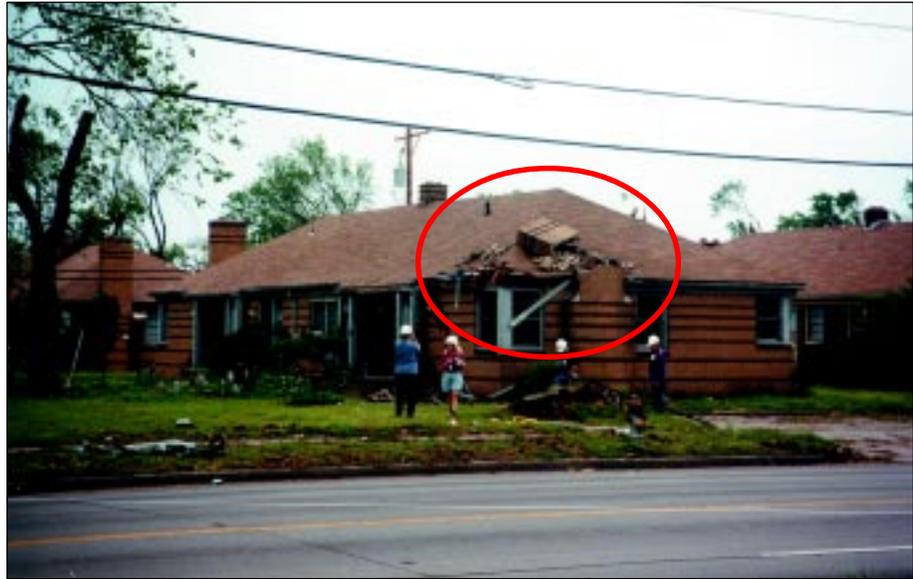
FIGURE 4-44: Chimney failure onto roof of single-family attached housing located along the periphery of a strong tornado, Wichita, Kansas.

was similar to the chimneys presented in Figures 4-43 and 4-44. These rectangular chimneys were calculated to have failed at wind speeds ranging from 75-85 mph (fastest mile). No reinforcing bars were observed in any of the chimneys in which calculations were performed.

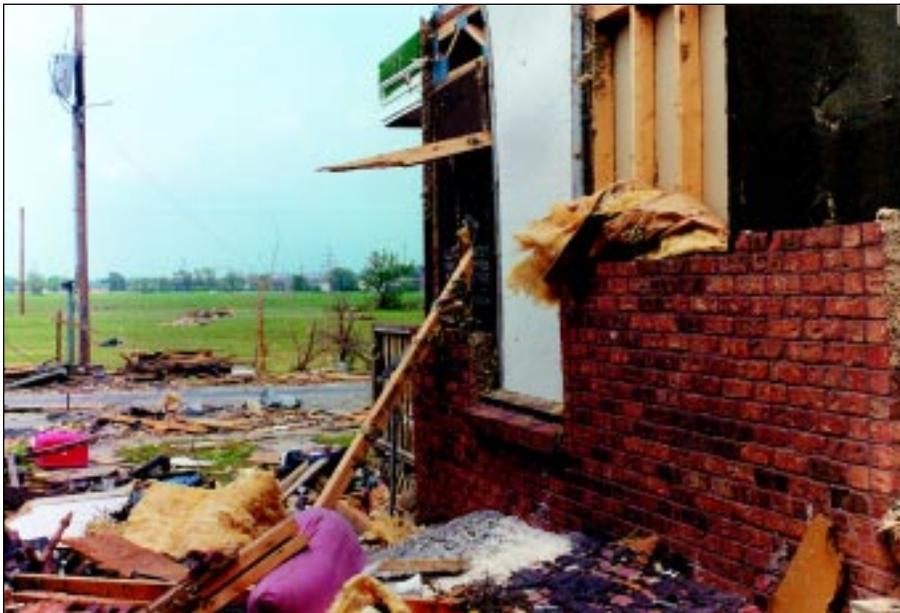
FIGURE 4-45: Failure of brick veneer at a multi-family housing unit in Wichita, Kansas. This building experienced inflow winds from a strong tornado.
