4 Observations on Residential Property Protection

4.1 Single-Family Conventional Construction

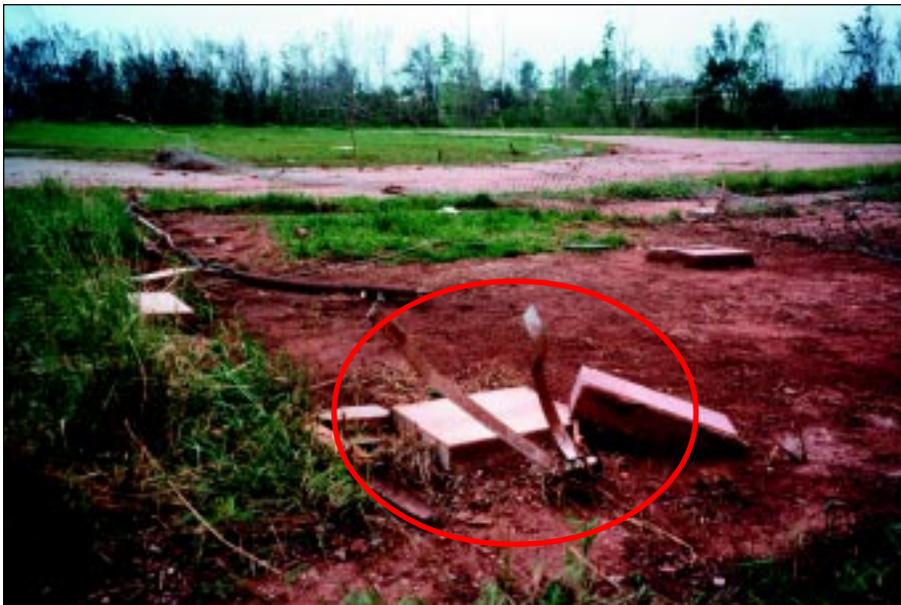
FIGURE 4-48: Failed straps at the anchorage of a manufactured home in Bridge Creek, Oklahoma. This site was 300-400 feet from a violent tornado vortex.

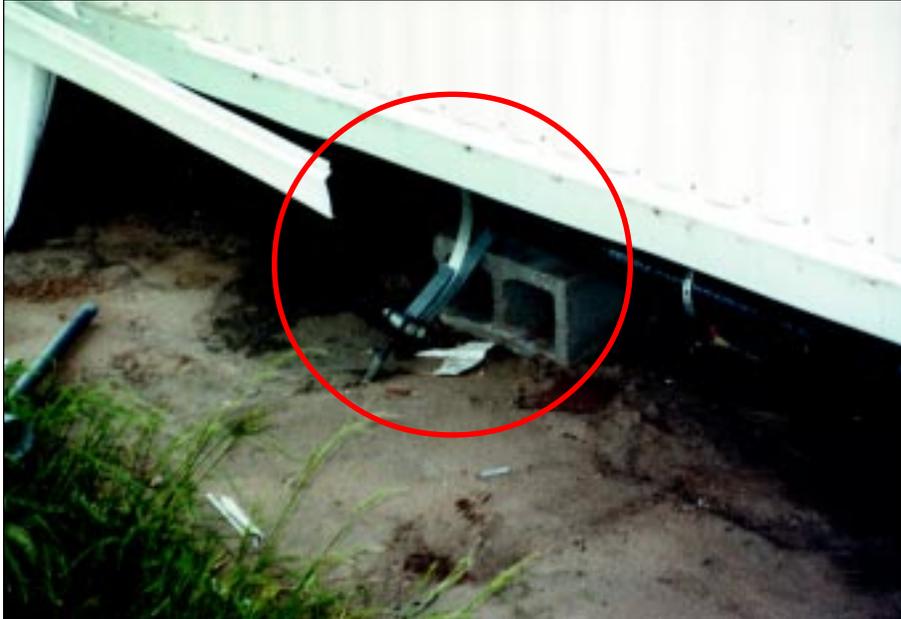
ment of the unit. Anchor depth into the loose sandy soil did not appear to be adequate to resist wind uplift and overturning forces (Figures 4-51 and 4-52) generated by a strong tornado whose vortex passed nearby, but did not directly strike the homes.

FIGURE 4-51: Anchor of manufactured home bent and pulled up from soil. This home in Wichita, Kansas, was located within the inflow area of a strong tornado.

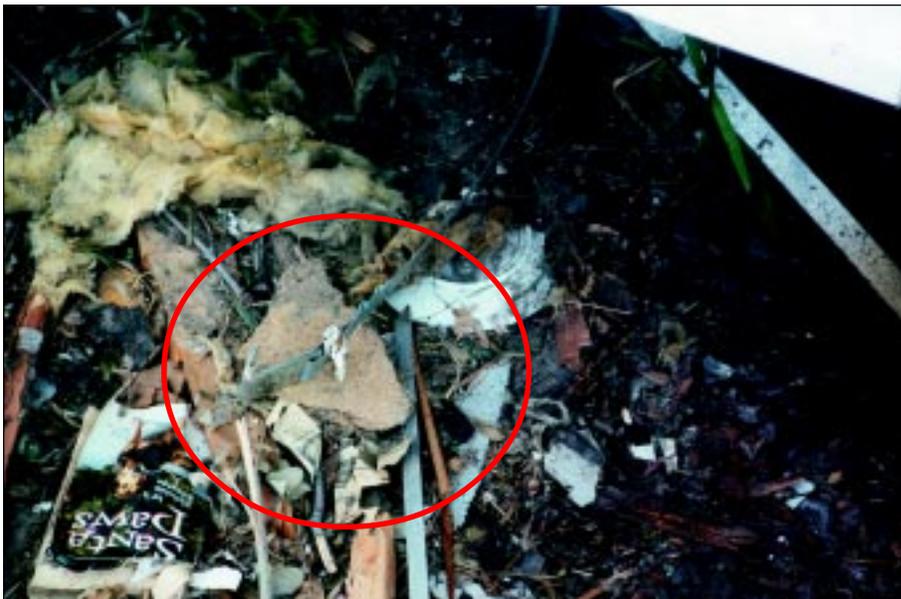
FIGURE 4-52: Strap torn off from chassis of manufactured home. This home in Wichita, Kansas, was located within the inflow area of a strong tornado.

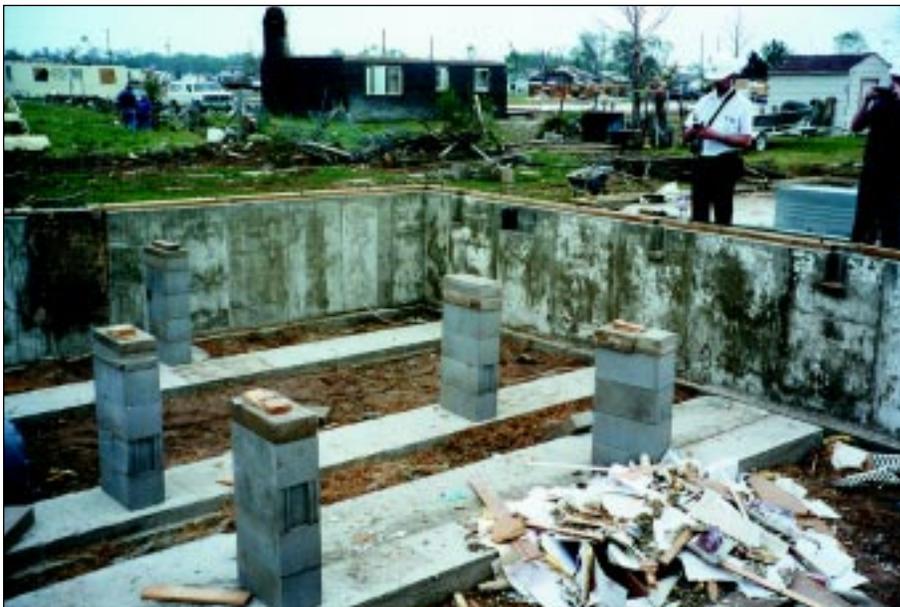
FIGURE 4-55: *Lack of bolts or positive connectors present between the chassis and foundation of a double-wide manufactured house, Haysville, Kansas. The floor framing of the house was still resting on the foundation after the tornado passed.*

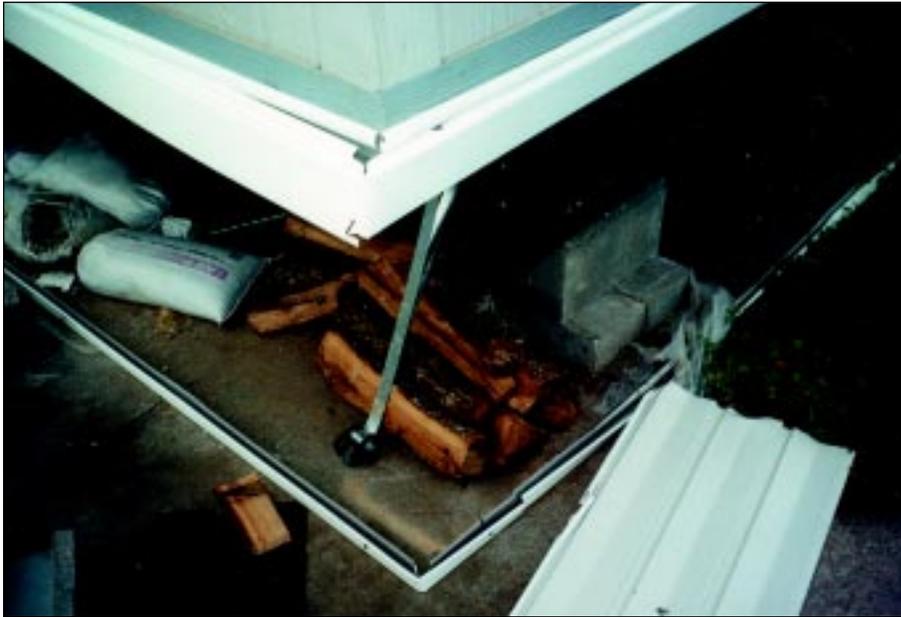
FIGURE 4-58: View of anchor strap and attachment indicating lateral shifting of a manufactured home, Haysville, Kansas. This home was located along the periphery of a violent tornado.
