5 Observations on Non-Residential Property Protection

This section presents the BPAT's observations on non-residential property protection. The non-residential buildings were categorized into the various engineered types of construction focusing on the structural performance of each type of building. Important observations were also made concerning exterior architectural systems (e.g., roof and wall coverings, windows and doors).

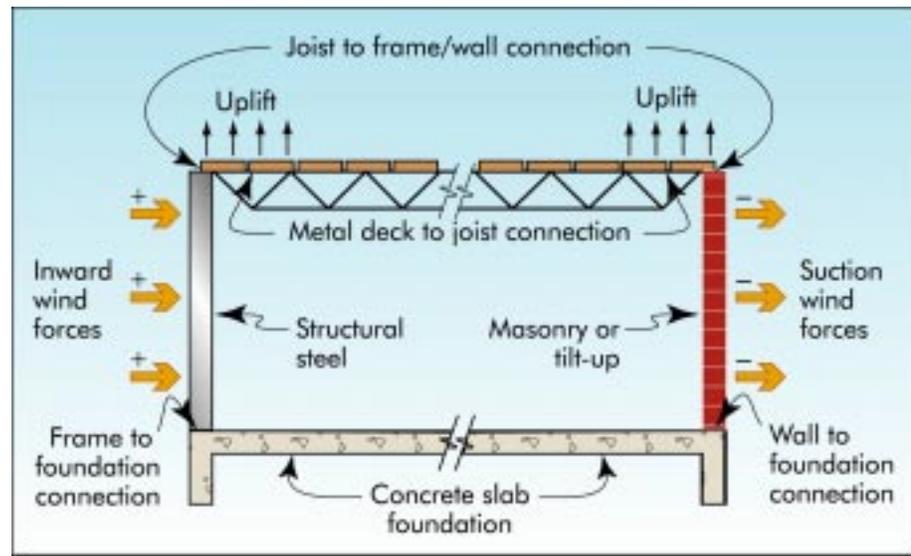
A continuous load path from the roof structure to a building foundation is essential for a building to resist not only gravity loads, but lateral and uplift loads generated by high winds as well. Figure 5-1 shows critical connections in the continuous load paths for representative types of non-residential buildings that sustained structural damage. To resist these loads, adequate connections must be provided between the roof sheathing and roof structural support, steel joists or other structural roofing members and walls, and foundation and walls or structural columns. Each of these connections must be capable of resisting uplift and lateral loads as well as gravity loads.

FIGURE 5-1: Critical connections that failed in the load path, resulting in structural damage or collapse.

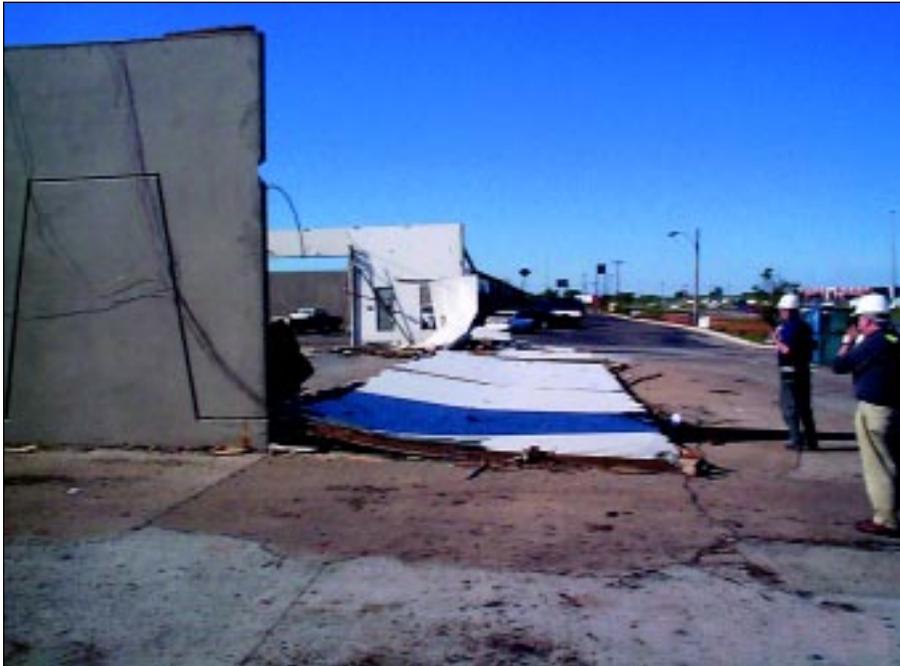
Inspection of a damaged tilt-up precast concrete wall building in Moore, Oklahoma, found no deficiencies with connections between the tilt-up walls and the foundation. However, connections between the roof system and the tilt-up walls failed in some buildings. In a commercial building along Interstate I-35 outside Del City, Oklahoma, failure of these connections caused a loss of diaphragm action, which then led to collapse of the endwalls of this building. This will be discussed further in Section 5.2.1. Figure 5-2 is a photograph of this building. The vortex of a violent tornado passed approximately 200 yards from this building, generating inflow winds that removed the roof of this structure. Once the roof of the building was removed and diaphragm action was lost, the endwall that was already being acted upon by outward (suction) wind forces failed.

FIGURE 5-2: Tilt-up precast concrete walls at a storage building located outside Del City, Oklahoma. After the roof joists separated from the walls, this end wall became unable to withstand suction forces and failed.

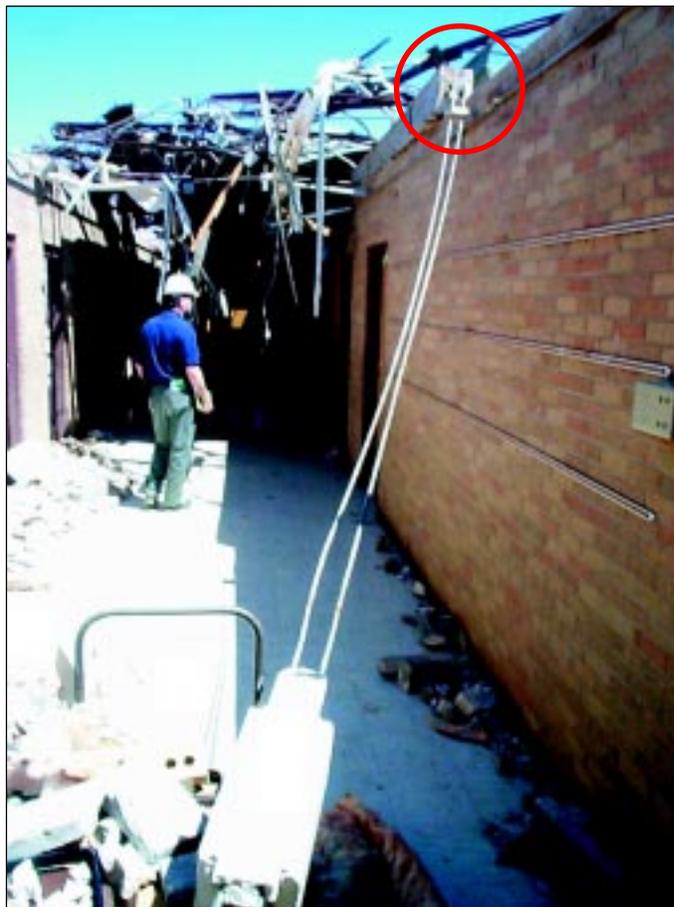
This section discusses the damage associated with the masonry wall section of the building; Section 5.1.3 will discuss the steel frame section of the school. Figure 5-3 shows damage to the Kelly Elementary School. A circle indicates the separation between the bond beam and its supporting wall. Connections between the bond beam, joists, and walls were adequate for gravity load, but could not carry the high uplift loads that were caused by winds associated with the vortex of violent tornado.

FIGURE 5-3: Kelly Elementary School, in Moore, Oklahoma, hit by vortex of violent tornado. Damage to school displaying separation between the bond beam and supporting wall and separation between bond beam and roof bar joists.

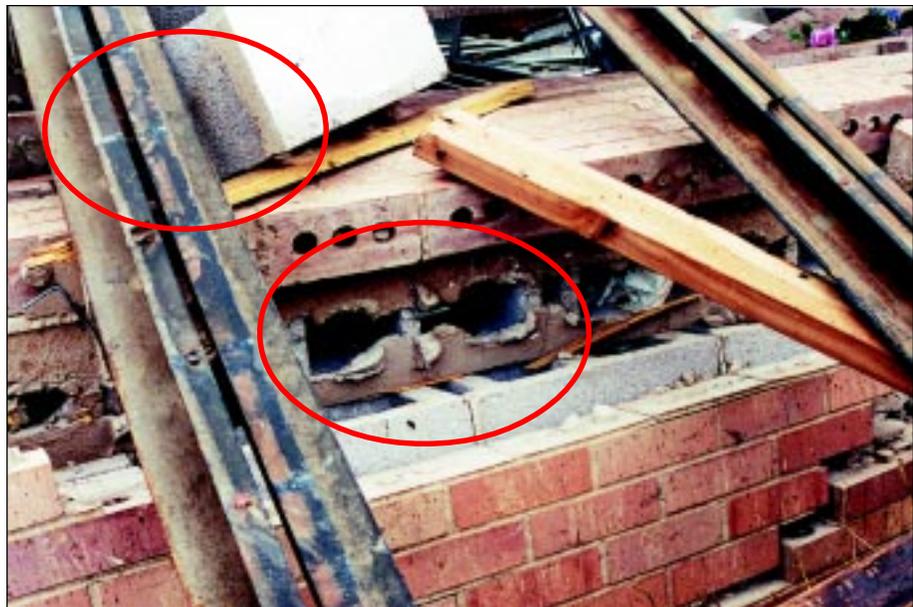
Figure 5-4 shows a close-up of a joist end over the cafeteria. The circle shows a location where the roof deck was supported for gravity load, but not sufficiently welded for uplift. Below the circle, broken welds can be seen. Some of the welds appeared to provide adequate diaphragm action based on deck material that remained at the welds; the deck appeared to fail at the welds only due to uplift. Spacing of the welds appeared to be consistent with standard weld spacing for deck welds.

Also visible in Figure 5-4 is the lower portion of the exterior wall. As illustrated in the photograph, no effective vertical reinforcement was found in the wall. Consequently, the wall had low resistance to uplift in combination with high lateral wind loads.

FIGURE 5-4: Failed structure showing broken deck welds (top circle), and no effective vertical reinforcement (bottom circle). Kelly Elementary School, Moore, Oklahoma, hit by vortex of violent tornado.

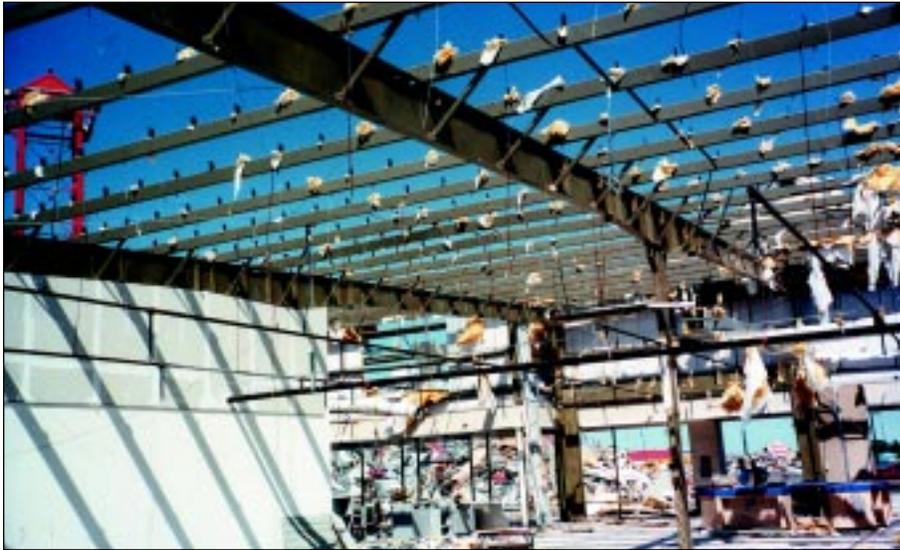
The BPAT visited a regional outlet mall in Stroud, Oklahoma, where most of the roof covering was blown away and significant damage to the building was evident. This mall was struck by a strong tornado that collapsed the central portion of the building's steel frame and damaged many of its masonry and steel frame walls. Figure 5-5 shows standing seam metal roof clips still attached to the purlins in one area of the mall that failed under the uplift loading. It was observed that metal wall panels attached with exposed fasteners performed better than the standing seam roof panels.

FIGURE 5-5: Metal roof deck (missing in photo) of regional outlet mall, Stroud, Oklahoma, was blown off when hit by a strong tornado vortex.

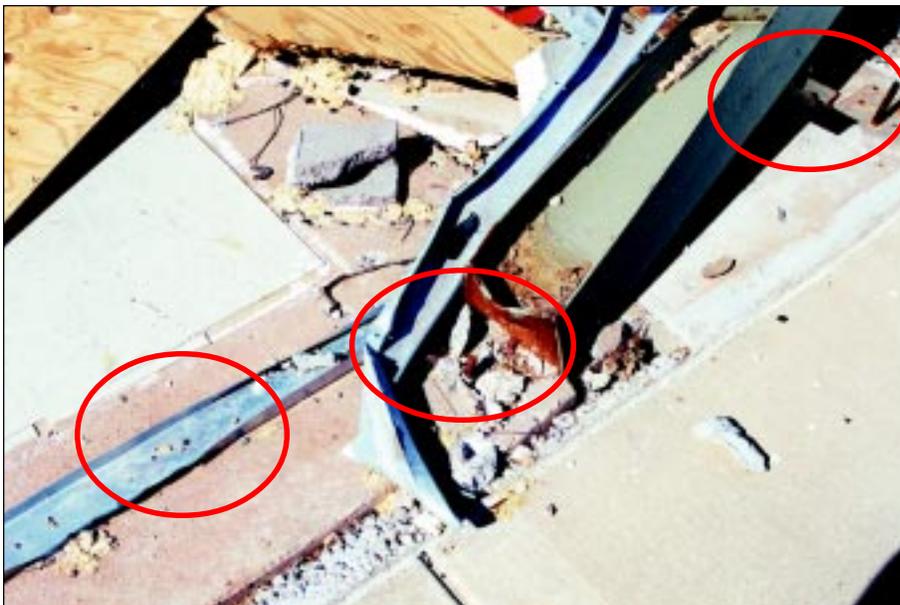
Figure 5-6 shows the attachment of columns to the foundation and attachment of the wall bottom plates to slab concrete. At the circle on the right in Figure 5-6, anchor bolts were provided, but the apparent lack of nuts on the anchor

FIGURE 5-6: Attachment of columns to foundation and attachment of wall bottom plates to concrete slab. Regional outlet mall, Stroud, Oklahoma, hit by a strong tornado vortex.

bolts permitted the column to lift off of the foundation. At the center circle, anchor bolts with properly attached nuts provided a high level of restraint to column uplift. The circle at the left shows a wall bottom plate that was attached to the concrete slab by powder-driven fasteners. Although the plate held at this location, lack of penetration by the nails into the concrete permitted the plate to pull out at many other locations. Additional fastener penetration would be needed to ensure consistent attachment of wall bottom plates to the slab.

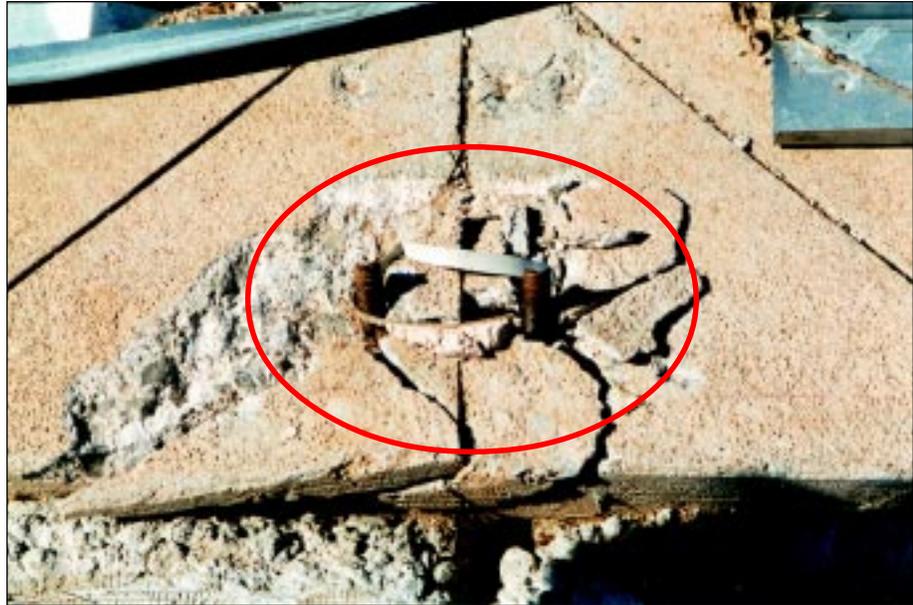
Most bolts with nuts exhibited a ductile steel failure as shown in Figure 5-7. This was the failure mode observed in most cases. This was also the failure mode for the anchorages at the steel water tower in Mulhall, Oklahoma. However, some of the bolts observed at the mall did pull out of the concrete foundation, indicating a failure either in the concrete bond or inadequate embedment of the anchor bolts (see Figure 5-8).

FIGURE 5-7: Column anchors that exhibited ductile failure at the regional outlet mall in Stroud, Oklahoma, hit by a strong tornado vortex.

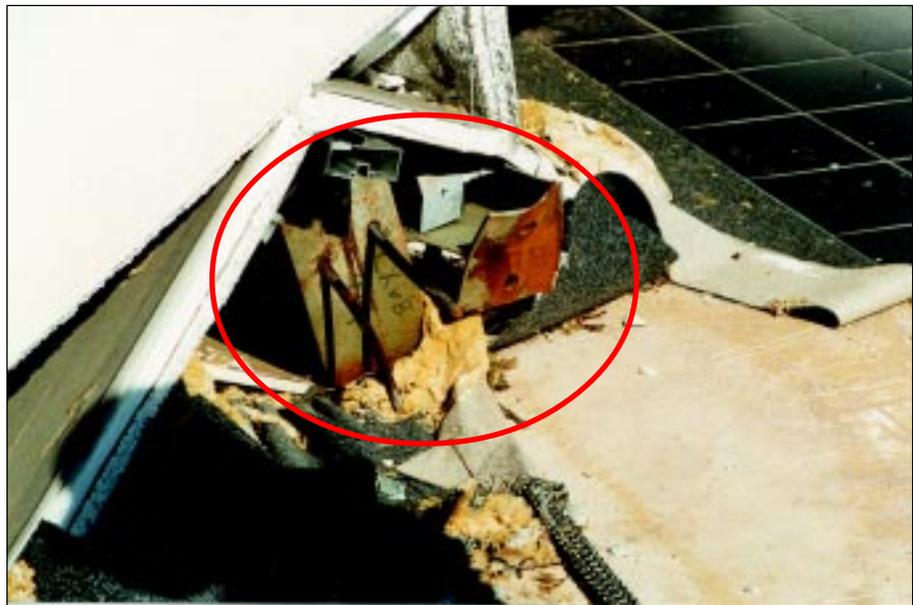
FIGURE 5-8: Column anchors that withdrew from concrete foundation at the regional outlet mall in Stroud, Oklahoma, hit by a strong tornado vortex.

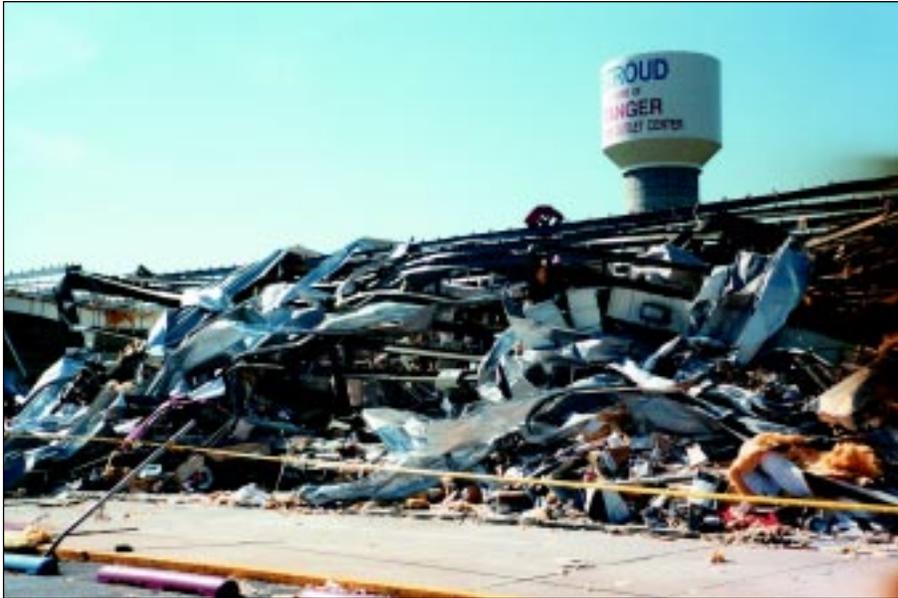
The BPAT investigated the regional outlet mall that was destroyed in Stroud, Oklahoma. Figure 5-9 shows damage to the outlet mall. In this structure, most of the metal roof panels were blown off by the tornado. In addition, most of the glass curtainwalls at the storefronts experienced failures.

FIGURE 5-9: *Stroud Regional Outlet Mall, Stroud, Oklahoma, was struck by the vortex of a weak tornado.*

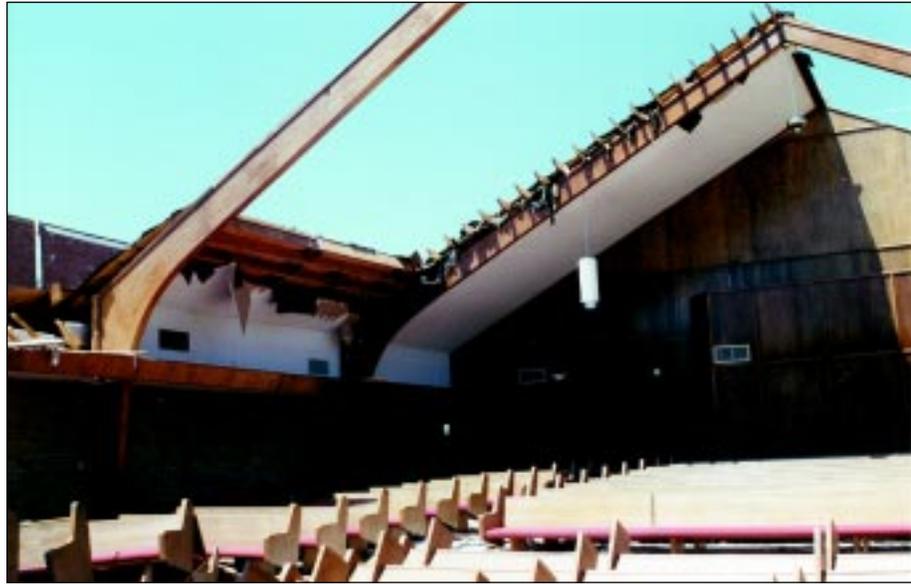
Lack of load path resulted in severe damage to the Regency Park Baptist Church in Moore, Oklahoma. This building was approximately one block north and across the street from Kelly Elementary School. The vortex of a violent tornado passed approximately a few hundred yards to the south. Figure 5-10 shows the rigid frames remaining after the roof had been removed by the tornado. Loss of load path between the rigid frames and the roof purlins resulted in severe damage to the facility.

FIGURE 5-10: *This church suffered loss of roof due to lack of load path between the rigid laminated wood arches and the roof purlins (missing in photo) that supported roof sheathing. Inflow area of a violent tornado, Moore, Oklahoma.*

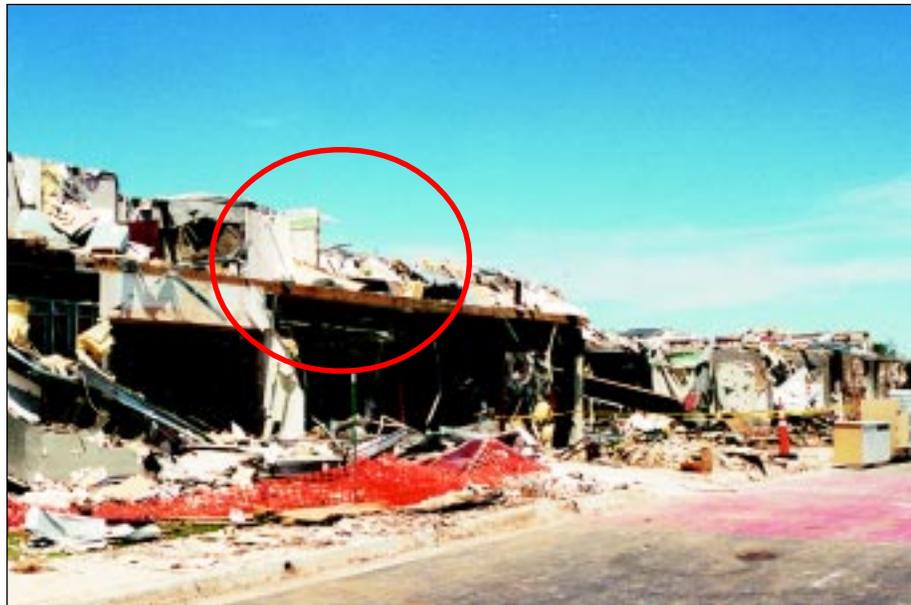
In several locations, combined effects of wind uplift and horizontal wind loads caused damage to structures. A continuous load path is often observed in this type of construction at the connection of the floor slabs to the walls. However, at many of the buildings of this type of construction, a continuous load path for uplift and lateral loads did not exist and roof failures and upper level floor failures were observed. Figure 5-11 shows the remains of a motel in Midwest City, Oklahoma, hit by a violent tornado vortex. The circle shows a steel beam

FIGURE 5-11: *Motel in Midwest City, Oklahoma that experienced major damage when struck by the vortex of a violent tornado.*

that had been deflected inward significantly when the floor slab was lifted during the tornado. There was no positive connection between the steel beam and the floor above.

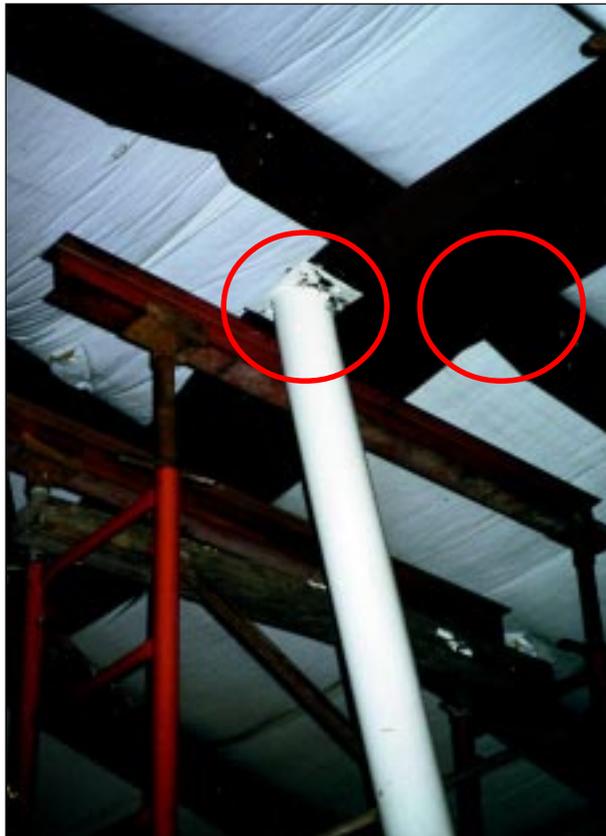
At a plastics manufacturing plant in Haysville, Kansas, a combination of uplift and horizontal wind caused out-of-plane buckling of the bottom flange of a main girder supporting the roof (Figure 5-12) when the plant site was struck by a strong tornado. One circle shows the column that supports the girder, while the other circle shows the bottom flange of the girder. It can be seen that the bottom flange has displaced significantly sideways in relation to the top flange of the girder. Inspection along the length of the girder indicated that the bottom flange was braced along its length at every purlin except at the location of the supporting column. This lack of bracing permitted buckling and out-of-plane displacement of the bottom flange. However, due to the light gravity loads left on the roof after the wind forces diminished, collapse did not occur.

FIGURE 5-12: Out-of-plane buckling of the main girder supporting the roof created by a combination of uplift and horizontal wind loads. Plastics plant, Haysville, Kansas, hit by violent tornado. This building was in the inflow area of a strong tornado.

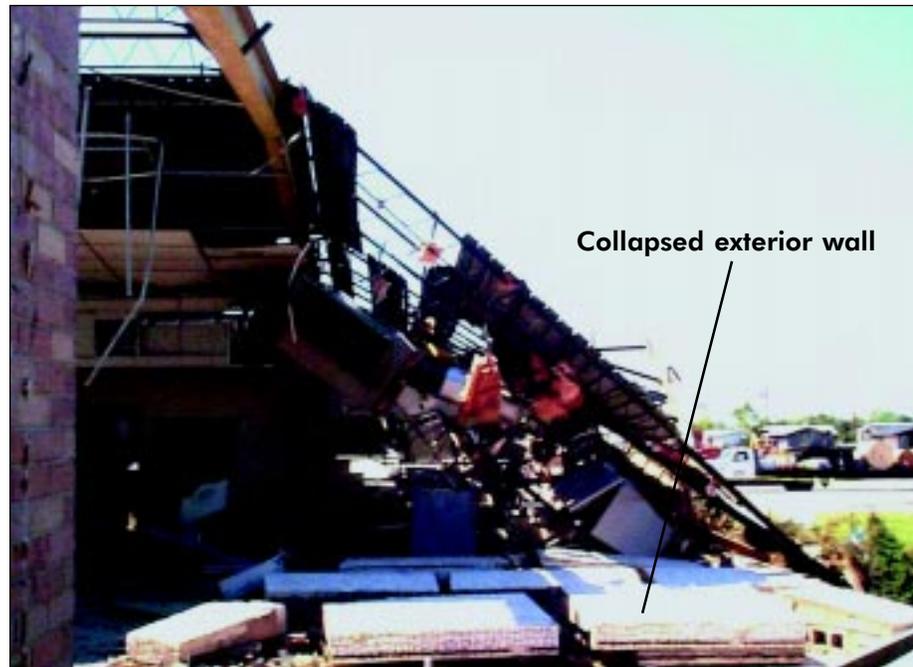
Another example of the effects of uplift and horizontal wind forces is seen in Figure 5-13 at Kelly Elementary School in Moore, Oklahoma. The exterior wall collapsed inward, indicating that the roof had lifted up as the wind loads acted inward on the wall. Failure to have a continuous load path from the joists supports into the masonry wall to resist uplift forces contributed to collapse of the wall. The exterior masonry wall is seen lying on the floor beneath the collapsed roof structure.

FIGURE 5-13: Collapsed roof structure and exterior wall at Kelly Elementary School in Moore, Oklahoma, struck by the vortex of a violent tornado.

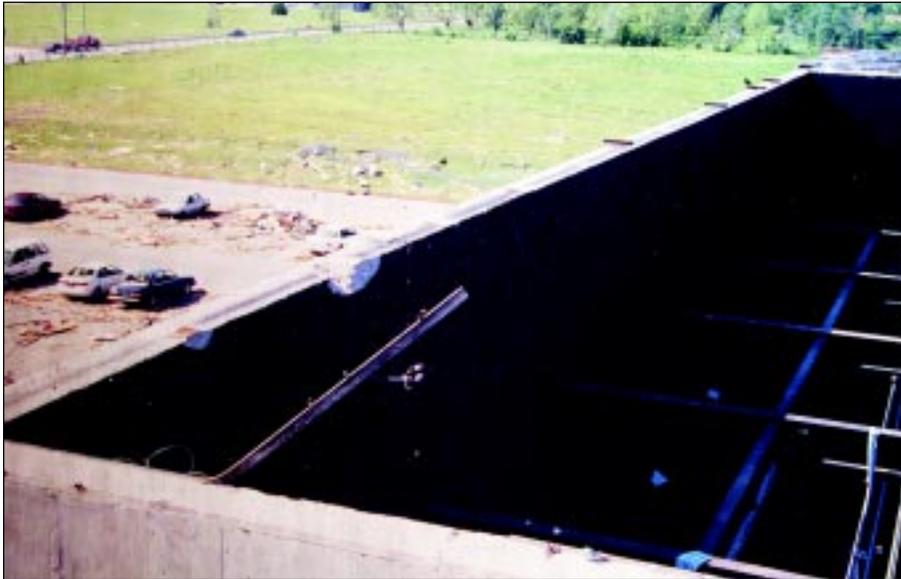
The Westmoore High School in Moore, Oklahoma, was a relatively new structure that was within 100 yards of the vortex of a violent tornado. A portion of the roof deck and supporting steel joists over the auditorium stage was blown off. Figure 5-14 shows the walls where the steel joists had been attached prior to the tornado. In all cases, welds failed between joist ends and embedments in the walls. This loss of continuous load path permitted the roof to be lifted up off of the reinforced concrete walls.

FIGURE 5-14: Roof blown off over top of auditorium at Westmoore High School, Moore, Oklahoma, hit by inflow winds of violent tornado.

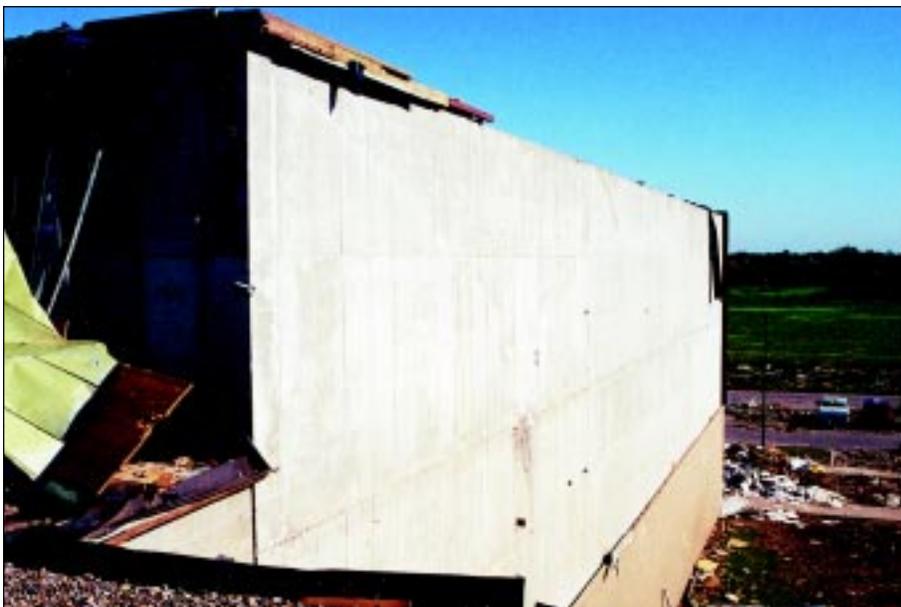
Figure 5-15 shows the exterior of the reinforced concrete wall at Westmoore High School following the tornado. This 12-in thick by approximately 35-ft-tall wall remained essentially undamaged, except for loss of the metal wall covering, even though the diaphragm action of the roof was lost. The construction of the stage area integrated an I-beam horizontal frame, shown in Figure 5-14, with the reinforced concrete walls. This frame helped to stabilize the walls. Prior to the tornado, the bare concrete had been covered with a decorative metal curtainwall. The entire curtainwall blew off during the tornado, while brick masonry veneer on the lower wall remained, with virtually no damage.

FIGURE 5-15: Exterior view of an undamaged reinforced concrete wall, Westmoore High School, Moore, Oklahoma, hit by inflow winds of a violent tornado. Note: decorative metal wall covering was peeled from this wall.

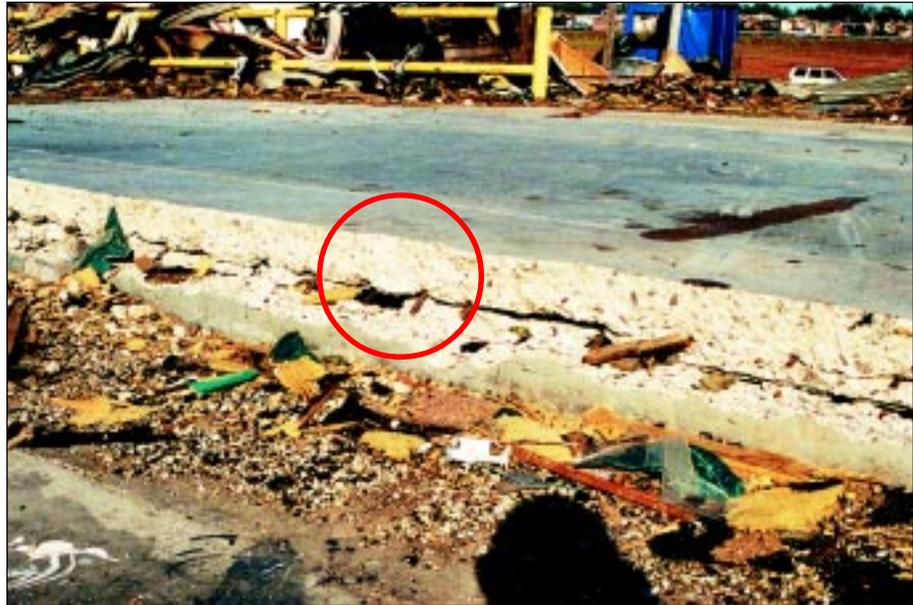
Figure 5-16 shows a tilt-up concrete wall that failed after loss of a roof diaphragm made up of steel joists and metal deck. This building was located

FIGURE 5-16: Failure of tilt-up concrete wall in Del City, Oklahoma, hit by inflow winds of a violent tornado.

approximately 200 yards from a violent tornado vortex near Del City, Oklahoma. As can be seen in Figure 5-16, the wall was heavily reinforced at the foundation level. However, lack of support at the top of the wall permitted the wall to blow outward and collapse.

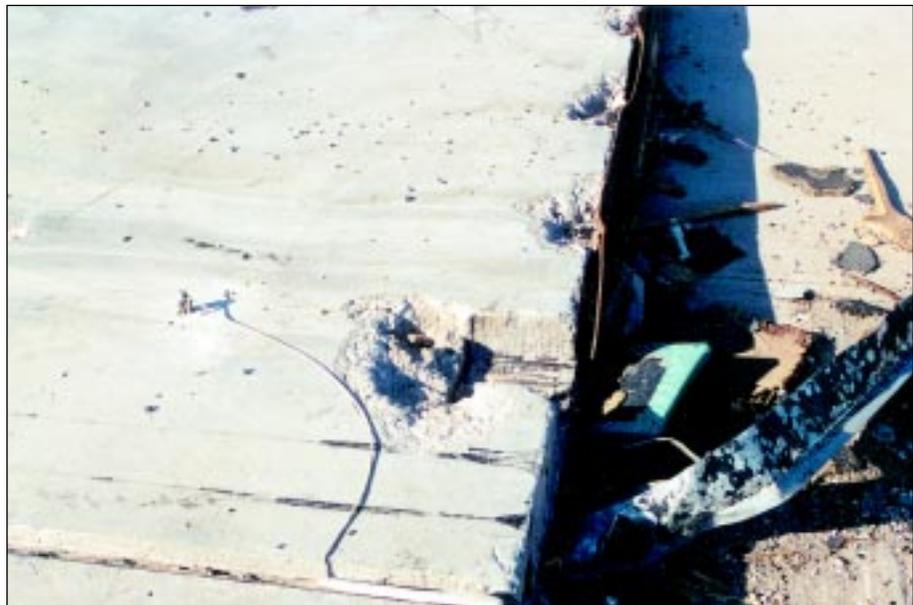
Figures 5-17 and 5-18 show the top of the tilt-up precast concrete wall that failed. Figure 5-17 shows that lateral resistance provided by a beam supported by the wall was lost when the beam pulled out of the wall pocket. Failed welds

FIGURE 5-17: Top of failed tilt-up end wall.

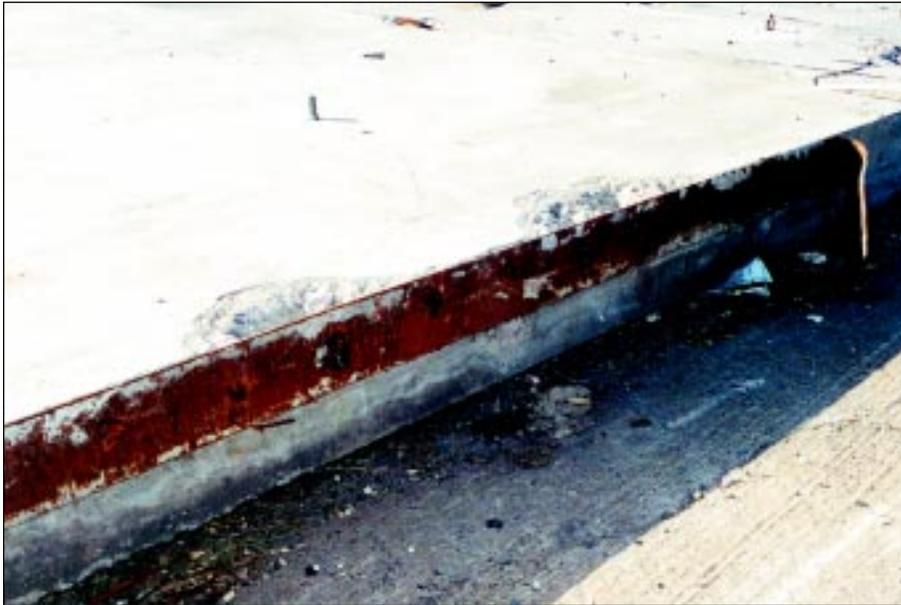
FIGURE 5-18: Top of failed tilt-up wall.

tying the roof joist into plates embedded in the top of the tilt-up wall can also be seen in Figure 5-18. Visual inspection showed that only one of the four walls of the building collapsed. The other walls continued to provide lateral resistance because portions of the roof remained.

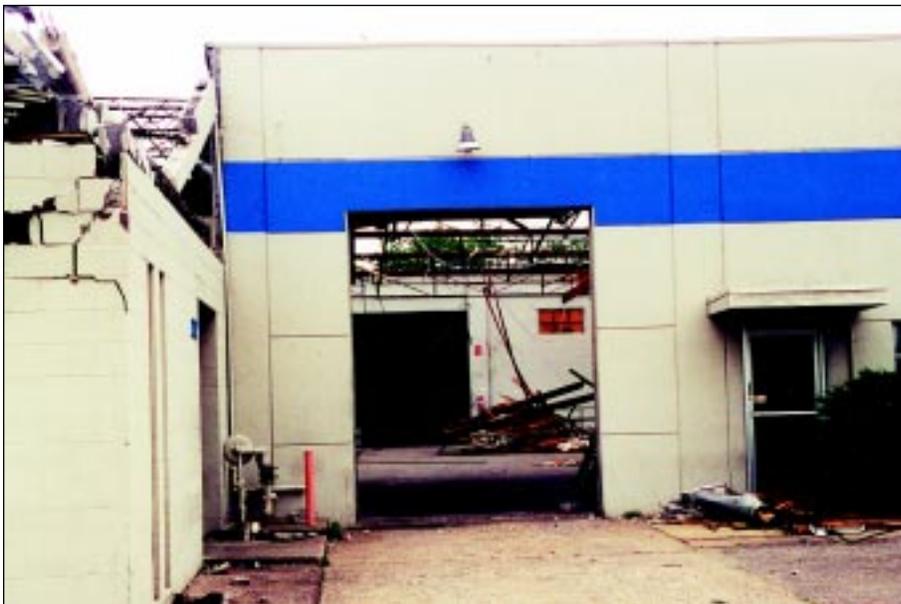
Tilt-up walls at a facility that was located under the vortex of a weak tornado in Wichita, Kansas, survived virtually undamaged, despite loss of metal roof decking. As can be seen in Figure 5-19, trusses spanning the open area maintained enough lateral support for the walls that failure did not occur.

FIGURE 5-19: The tilt-up precast concrete walls in this building did not fail when the roof system failed. The masonry walls shown at the left of the photo were damaged. Note: many roof joists are still in place. Building was located in Wichita, Kansas, and was hit by weak tornado vortex.

In Figure 5-19, damage to a portion of the building having steel roof joists supported on masonry walls can be seen at the left. Walls in this portion of the building collapsed when subjected to the vortex winds of a weak tornado. Even though some diaphragm action was maintained, the masonry walls did not have enough lateral load resistance under the combined uplift and horizontal load of the tornado.

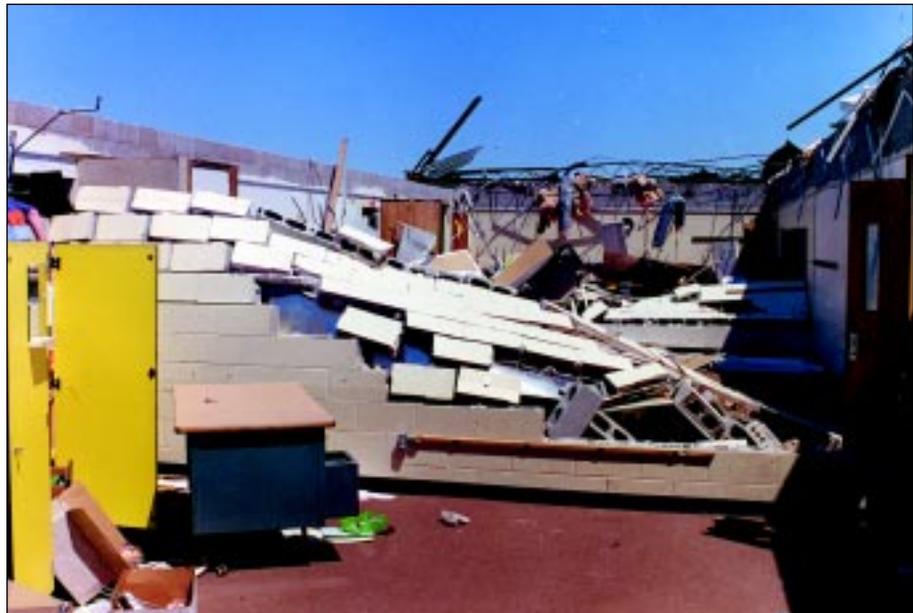
Figure 5-20 shows damage to both interior and exterior unreinforced masonry walls (URM) at Kelly Elementary in Moore, Oklahoma. Wind loads due to the vortex of a violent tornado lifted the roof system until the bond beam atop the URM wall failed. When this bond beam failed, the roof separated from the building and some interior walls failed.

Figure 5-20: Damage to interior and exterior unreinforced masonry walls when bond beams failed at Kelly Elementary School in Moore, Oklahoma. The school was struck by the vortex of a violent tornado.

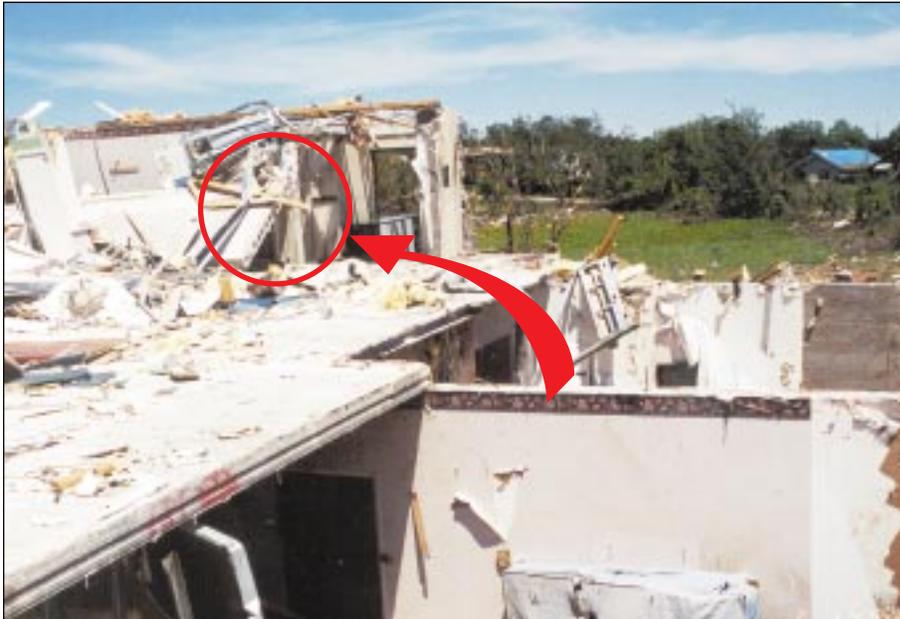
Figure 5-21 shows the location where hollow core planks had formed the second floor. The circle at the right shows a dowel from the masonry wall into grout between the ends of two hollow core panels. One of the panels that had been at the edge of the building was found up on the second level and across on the far side of the building as shown by the circle on the left of Figure 5-21. The wind uplift forces from the tornado were large enough to

FIGURE 5-21: Hollow-core plank formed on second floor of a Midwest City, Oklahoma, hotel that was struck by the vortex of a strong tornado.

overcome the tie-down force provided by the very short dowels. The hollow core planks were been lifted and blown across the width of the building.

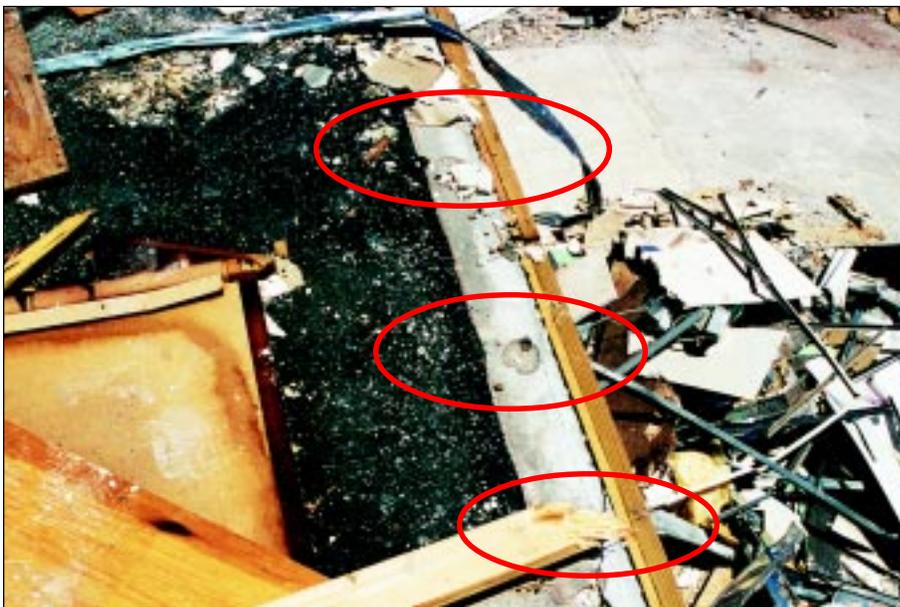
Elsewhere along the edge of the second floor of the motel, failure occurred between the hollow core planks and exterior walls of the building. As shown in Figure 5-22, lower plates for the walls had been attached to the hollow core planks using powder-driven anchors. As indicated by the circles, the powder-driven anchors pulled out during the tornado.

FIGURE 5-22: Attachments of lower plates for wall to hollow core plank using powder driven anchors failed when required to carry loads generated by the winds of a strong tornado vortex. This motel was located in Midwest City, Oklahoma.

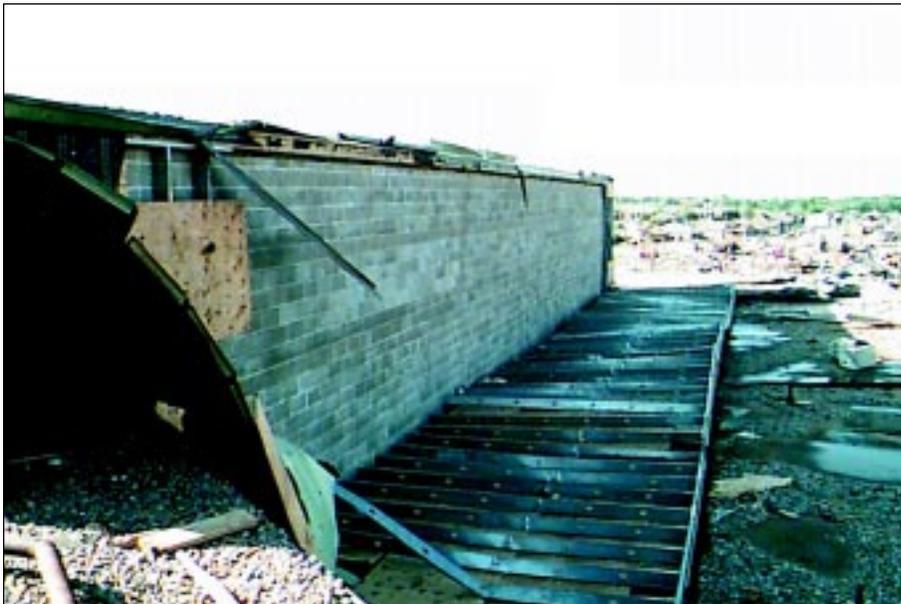
Brick veneer is discussed in Section 4.1.9. Some metal wall coverings over steel studs collapsed (Figure 5-28). All the metal wall systems at this building that experienced suction wind forces failed at this site. Although it did result in structural failures it exposed some internal areas to tornado winds. Some exterior insulating finishing system (EIFS) failures were observed (Figure 3-10). EIFS wall failures observed were the result of impact of windborne missiles and suction wind forces.

FIGURE 5-28: *This metal-clad wall covering collapsed and in other areas it was blown completely away.*

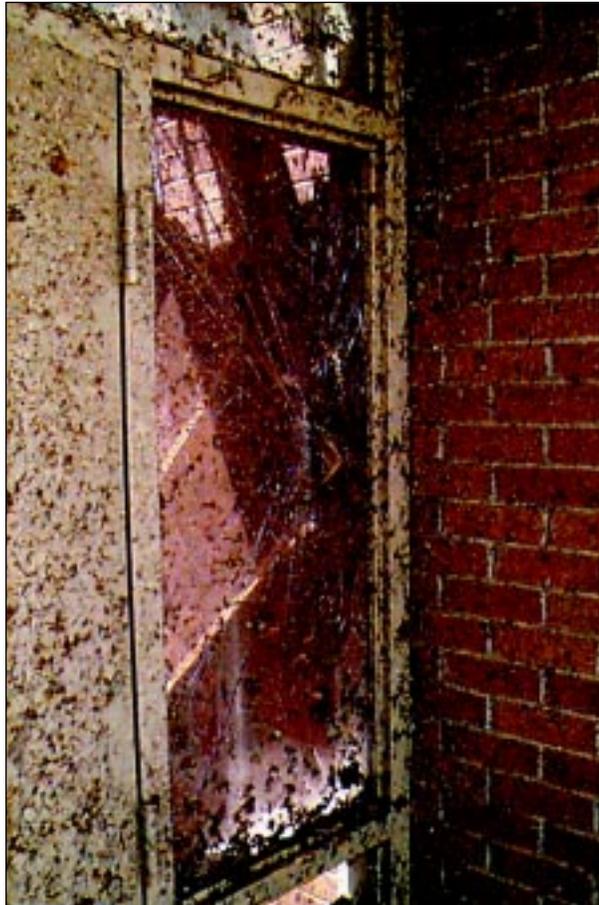
In a few instances, examples of laminated glass performance were observed. In some cases, the glass remained in the frame after missile impact (Figure 5-29). In another case, the glass was punched out of its frame. The school in Figure 5-29 is located adjacent to the Regency Park Baptist Church in Moore, Oklahoma, shown in Figure 5-10. The vortex of a violent tornado passed a few hundred yards south of this building.

FIGURE 5-29: *The corner of a table penetrated this laminated glass, but the glass remained in its frame. This school suffered major damage from inflow winds of a violent tornado in Moore, Oklahoma.*

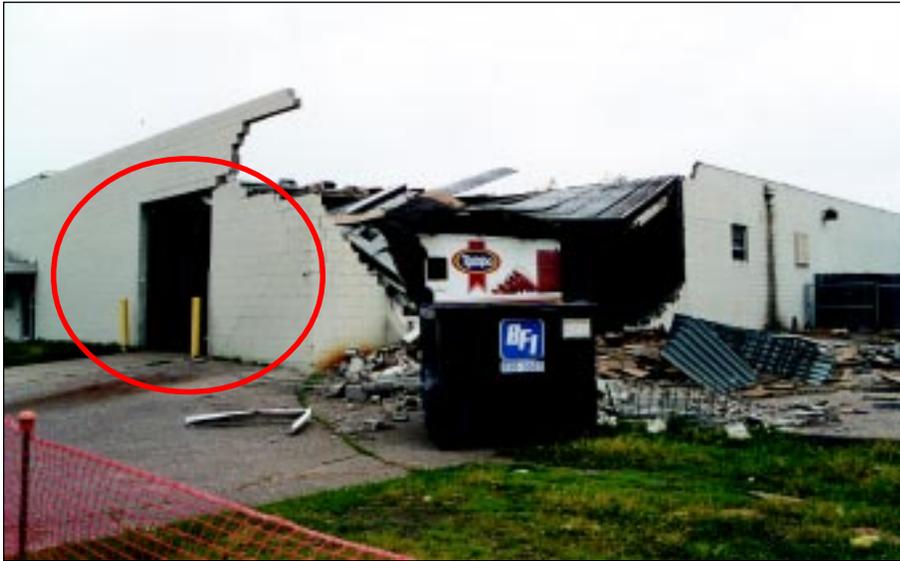
The breach of overhead rollup commercial doors resulted in internal pressurization of several structures leading to significant load increases. Not unlike the residential case, where a breach in the building envelope was observed at a roll-up door, this breach initiated a partial or total failure of primary structural systems. This was particularly true for pre-engineered buildings, which typically had little redundancy in load transfer of their structural systems. Figure 5-30 shows a breached commercial rollup door at a bread manufactur-

FIGURE 5-30: Failure of roof and walls on structure due to increased loads caused by initial failure of a rollup door, Wichita, Kansas.

ing and distribution center in Wichita, Kansas. The building exterior walls were constructed using both CMU and tilt-up concrete panels. The standing seam metal roof panels were on a Z purlin system. The rollup door failure appears to be a result of positive (inward) pressure. The breach may have caused a sufficient enough rapid increase in load to produce failure of the URM wall. Note the location of the failed door near a corner where high suction (outward) pressure is likely to occur on the adjacent wall. As a result of the exterior wall collapse, severe damage to the roof system occurred due to the loss of the load bearing exterior support wall. However, notice that the roof collapsed to the interior of the building, which may indicate that uplift loads acting on the roof were insufficient to cause progressive peeling failure of the roof decking.

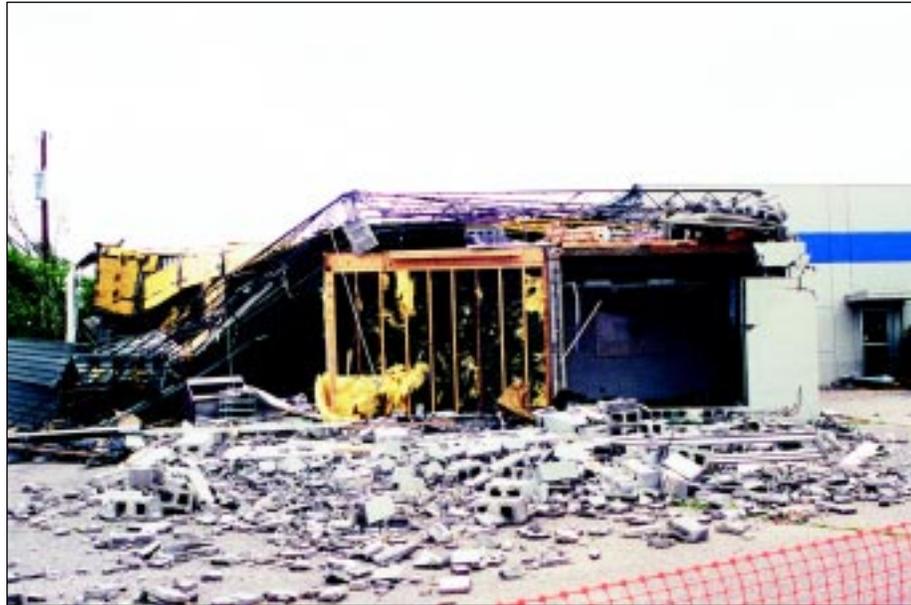
Figure 5-31 illustrates another condition in Wichita, Kansas, where breach of the building envelope contributed to additional structural damage. In this case, loss of showroom windows and a rollup door greatly increased loads in the showroom and on the wall at the left of the photograph. These increased loads caused the walls to fail and the roof to partially collapse, thereby greatly increasing structural damage.

FIGURE 5-31: *Additional structural damage caused by breach of envelope in Wichita, Kansas.*

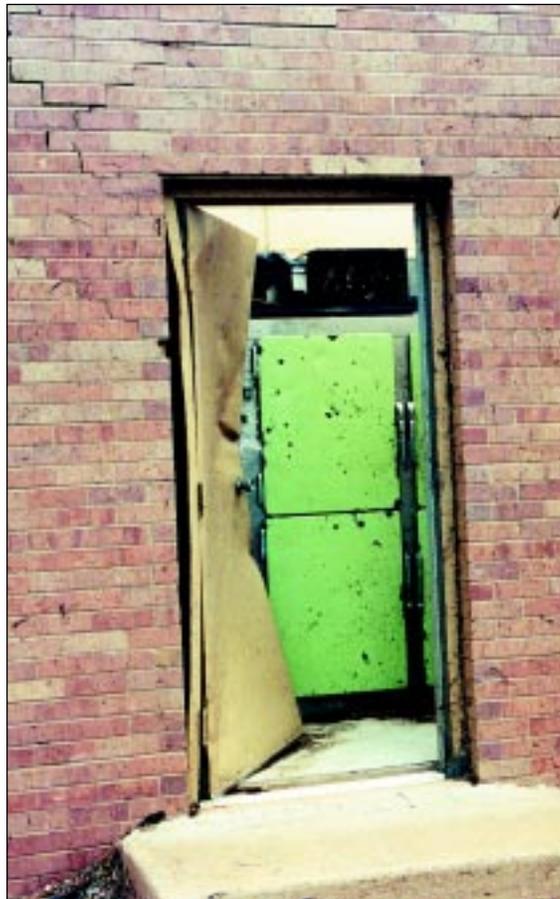
Figure 5-32 shows a steel door that appears to have been opened by impact of a heavy object. This door at Kelly Elementary School in Moore, Oklahoma, led into an area where the roof was completely missing. The breached door may have caused an increase in load that propagated damage to that part of the building envelope. A nearby door, which was also heavily impacted, but did not open, was located in an area of the school that saw less damage to the wall and roof of the building.

FIGURE 5-32: *Damaged door most likely opened by impact with heavy object. Kelly Elementary School, Moore, Oklahoma.*
