6 Observations on Personal Protection and Sheltering

6.1 Shelters

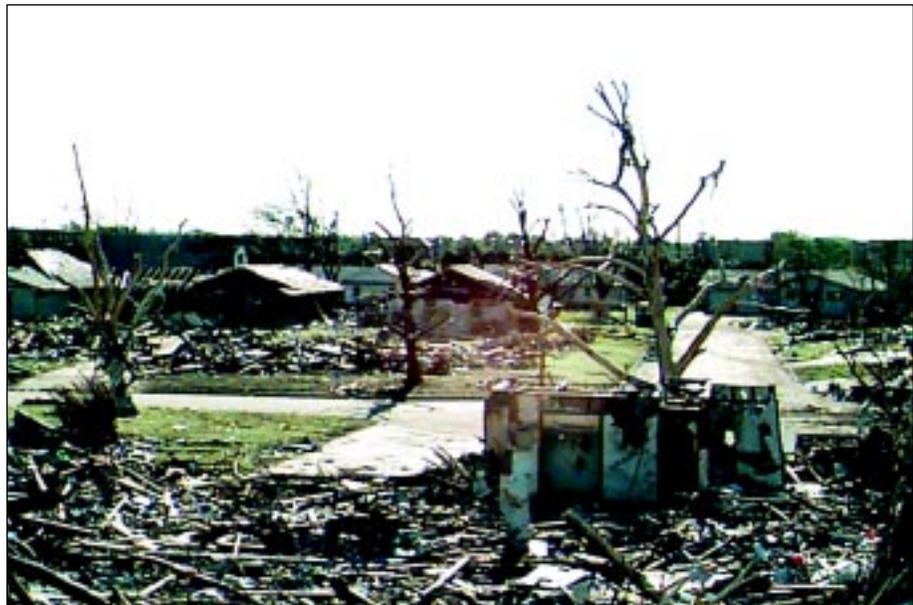
FIGURE 6-2: Damage to houses near the home in Figure 6-1. This photo is taken from the roof of the concrete shelter.

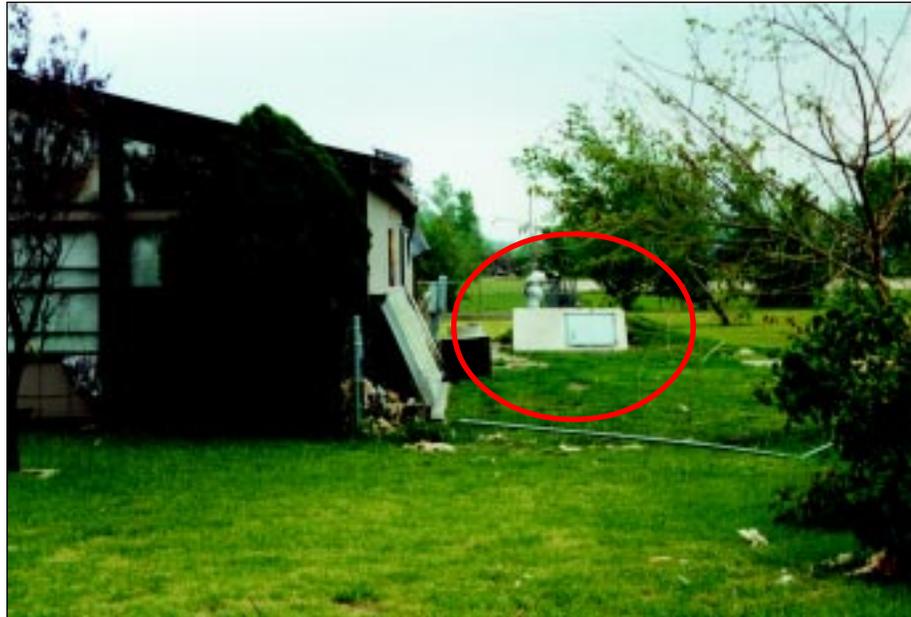
FIGURE 6-4: *This precast concrete storm cellar was located immediately behind a single-family residence in Sedgwick County, Kansas. This residence and shelter were on the periphery of a violent tornado path.*

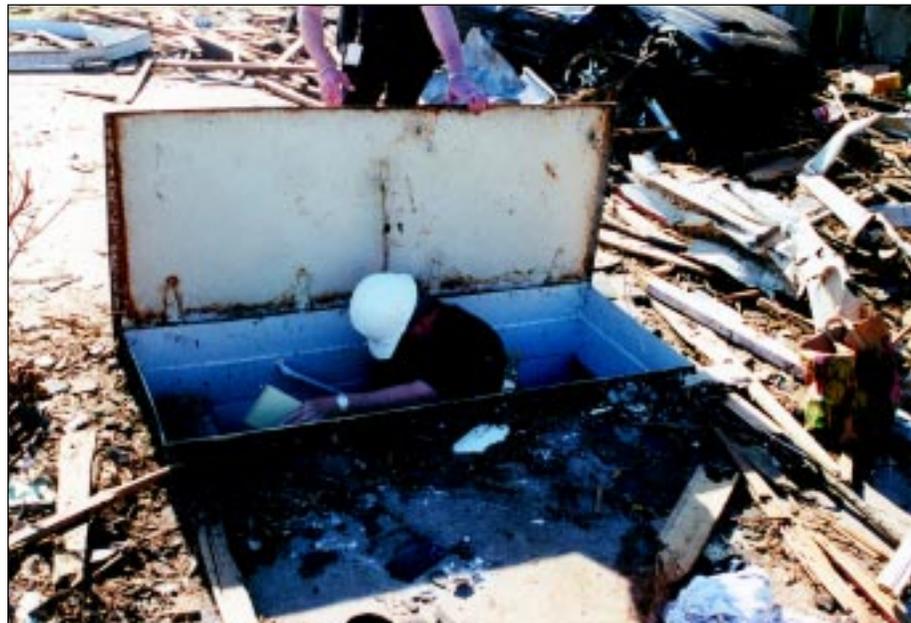
FIGURE 6-5: *Del City storm cellar constructed of welded steel sheets with a concrete roof slab. This area was directly struck by the vortex of a violent tornado.*

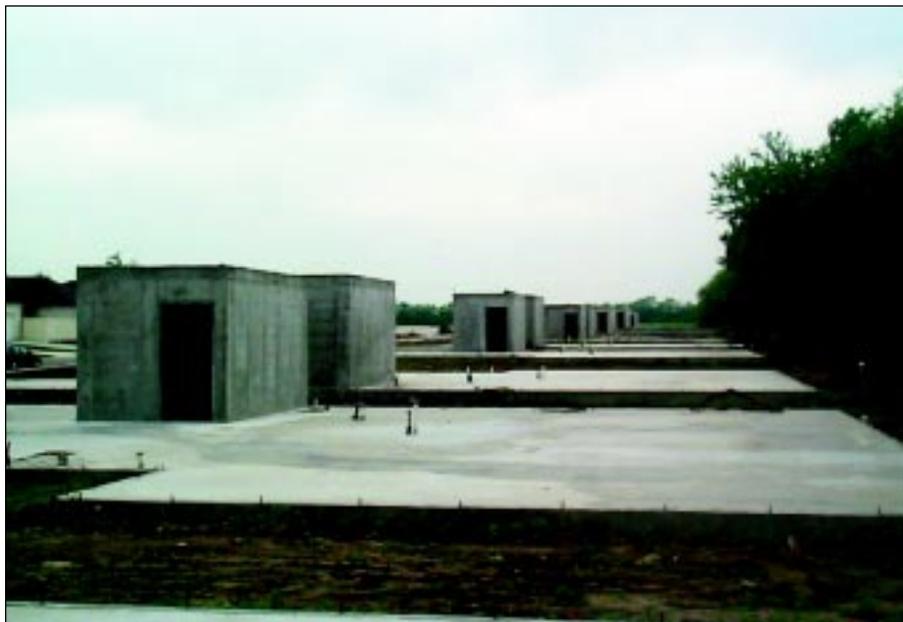
FIGURE 6-6: Aboveground in-residence shelters under construction in Wichita, Kansas.

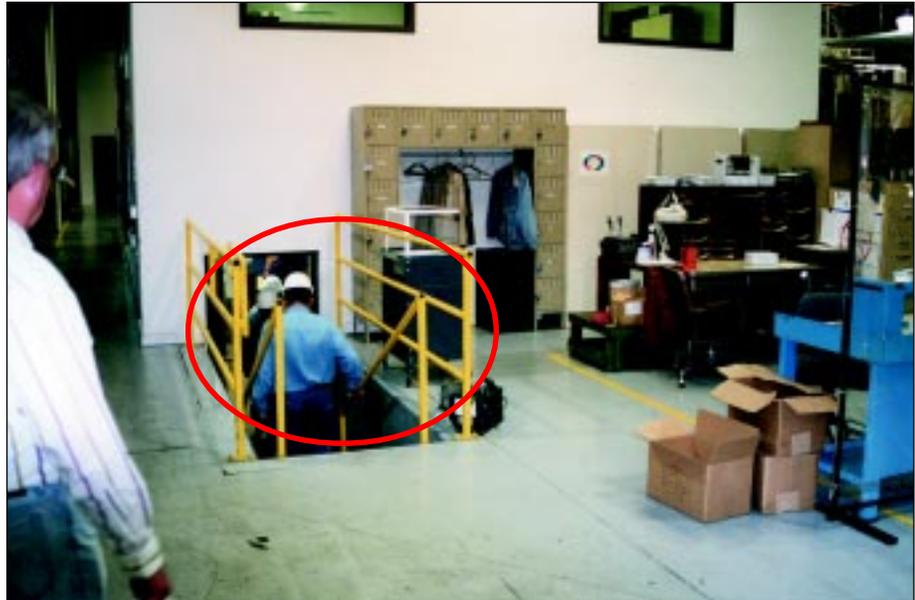
Deficiencies and vulnerabilities were observed in the group shelter presented in Figures 6-7 and 6-8. The shelters in both figures are only accessible by stairs and, depending upon the emergency plan, are possibly non-compliant by ADA requirements. The interior of the shelter in Figure 6-7 was also very damp, signifying a moisture problem that may be a problem for long duration stays within the shelter. The group shelter in Figure 6-8 has a vent on the top that is

FIGURE 6-7: Entrance to the plastics manufacturing plant group shelter in Haysville, Kansas.

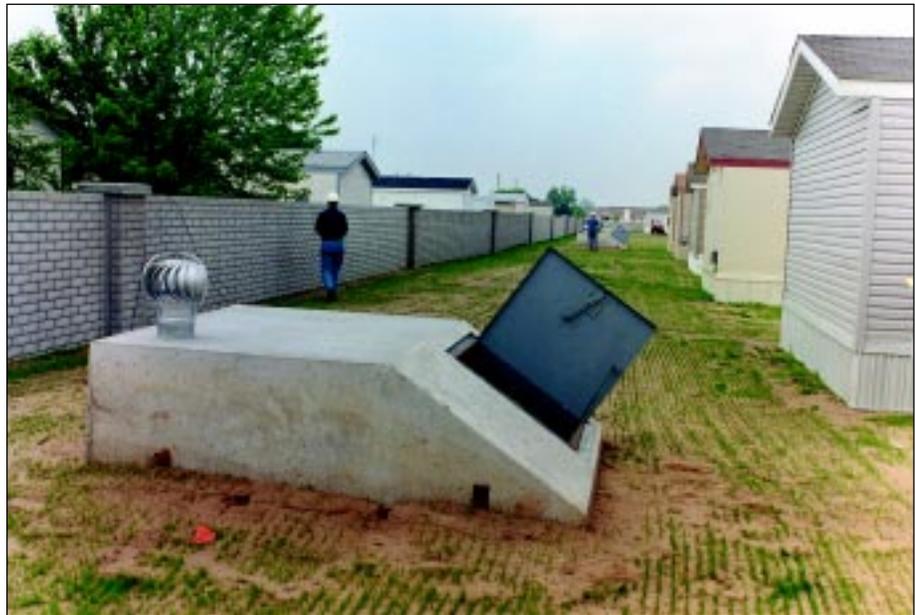
FIGURE 6-8: Group shelters at a manufactured home rental community in Wichita, Kansas.

very susceptible to damage and removal by wind and windborne debris. The door, specifically the latch mechanism, is vulnerable to windborne debris. Damage to either of these two elements would result in experiencing wind, windborne debris, and hail and rain from a storm event within the shelter.

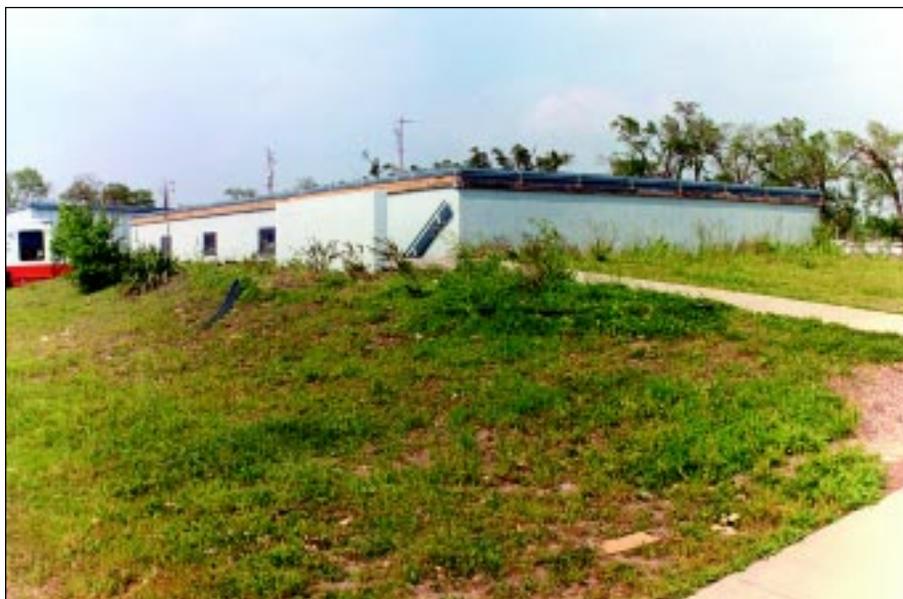
FIGURE 6-9: Partially belowground community shelter in a manufactured home park in Wichita, Kansas.

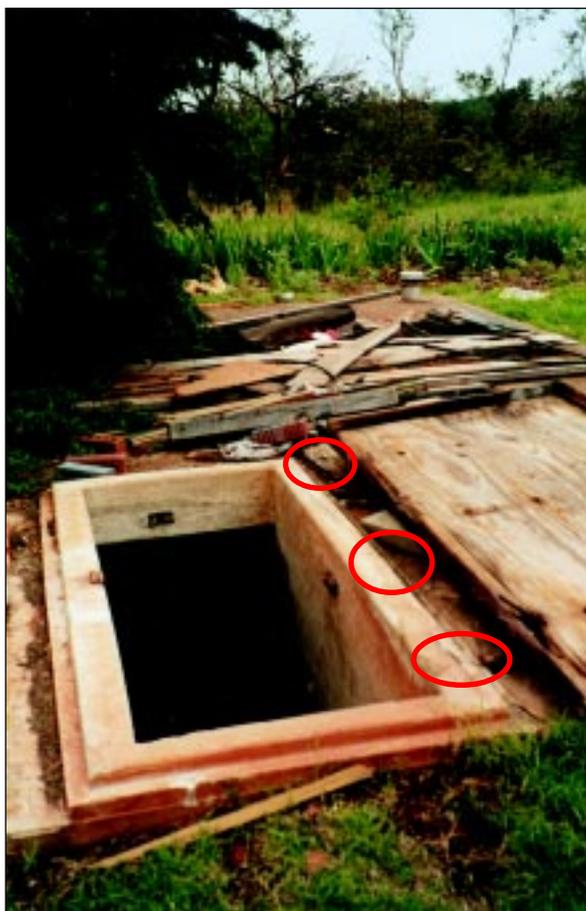
In numerous cases, the BPAT observed that construction practices, the selection of materials, and maintenance can impact the effectiveness of shelters (Figure 6-11). Storm cellar doors observed by the BPAT were often covered with thin gauge sheet-metal and exhibited corrosion. The sheet-metal storm cellar doors were often backed with untreated plywood that was usually found to be rotted, delaminated, or otherwise deteriorated to the point where it was no longer useful in providing protection to the shelter opening.

FIGURE 6-11: Door to underground shelter with rotting wood and corroded hinges.

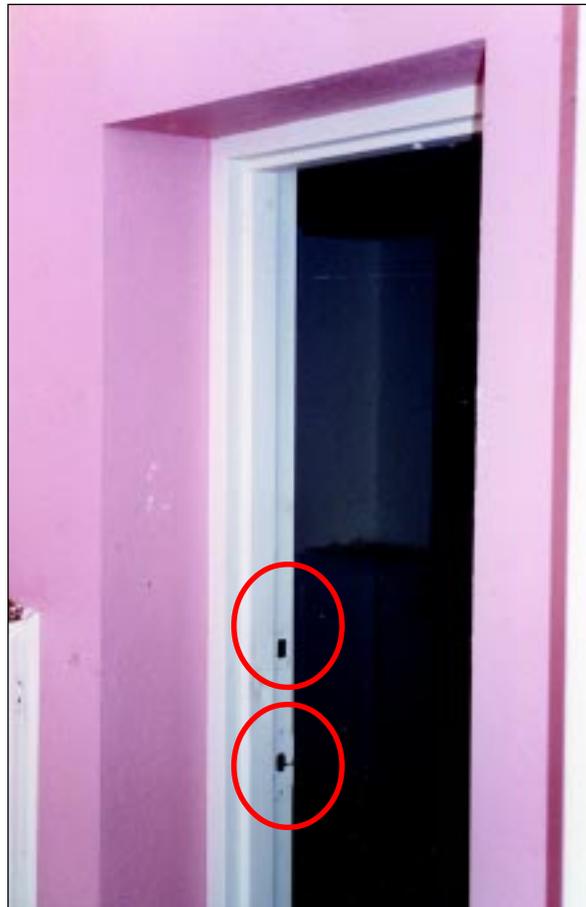
FIGURE 6-13: Shelter door of home in Del City, Oklahoma, showing an insufficient deadbolt locking device. The bottom circled area on the door frame is the catch for the only latching mechanism on the door. Note: the second opening in the door frame was not used to provide a second latching point (top circled area).

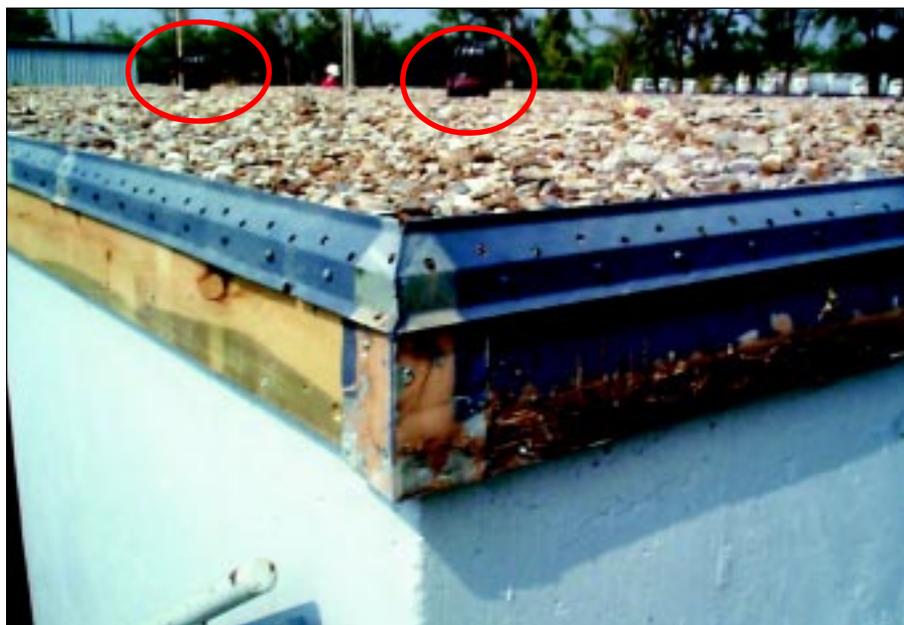
Other shortcomings of shelters were observed by the BPAT. The community shelter in Figure 6-14 produced a potential safety hazard to nearby buildings resulting from windborne missile generation from a fence and roof ballast. A security fence that surrounded this roof area was damaged and removed by the winds of the violent tornado that impacted the opposite side of this community. Aggregate ballast shown in the photo may become airborne during high wind events and cause damage to other properties and injure individuals attempting to access the shelter. In addition, the ventilation covers are inadequate to stop free-falling debris via the penetrations that are in the roof for ventilation.

FIGURE 6-14: Ballast roof covering on a community shelter in Wichita, Kansas was a potential source of deadly windborne missiles to those seeking to access the shelter. Circles identify covers protecting roof penetrations intended for ventilation, but unable to provide adequate resistance to windborne debris.

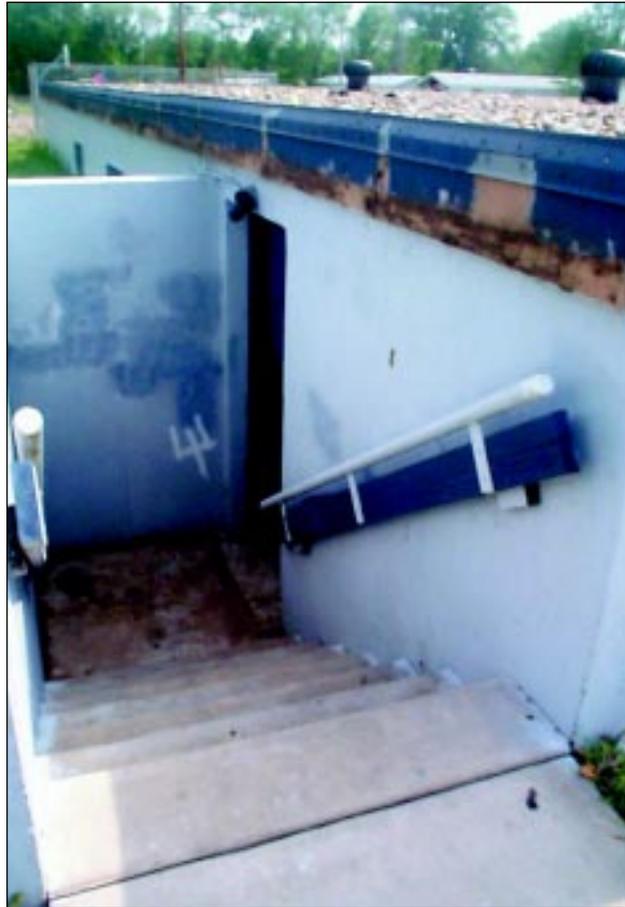
FIGURE 6-15: Stairway leading to entrance of manufactured home community shelter, Wichita, Kansas. The only means of accessing this structure were this stairway and an identical one at the other side of the shelter.

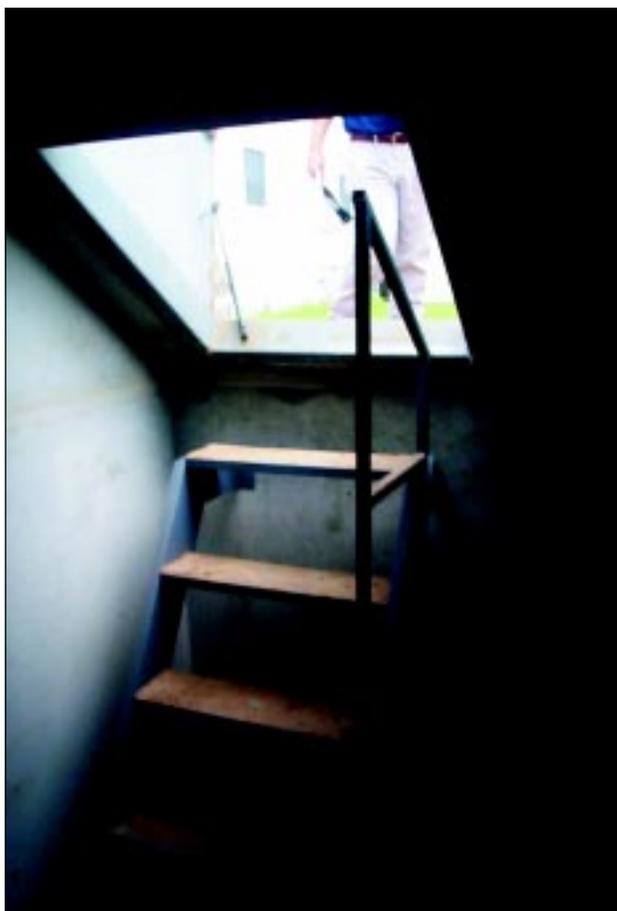
FIGURE 6-16: Stairway access to group shelter at manufactured home rental development, Wichita, Kansas, shown in Figure 6-9. This development was not affected by any of the tornadoes that struck on May 3, 1999.

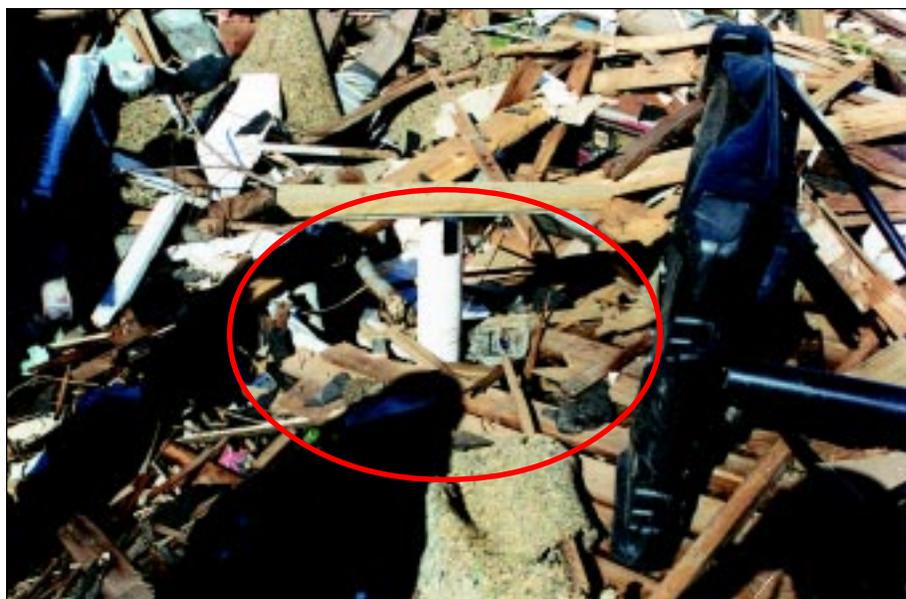
FIGURE 6-17: Heavy gauge ventilation pipe for a belowground shelter in Oklahoma withstood considerable debris impact.

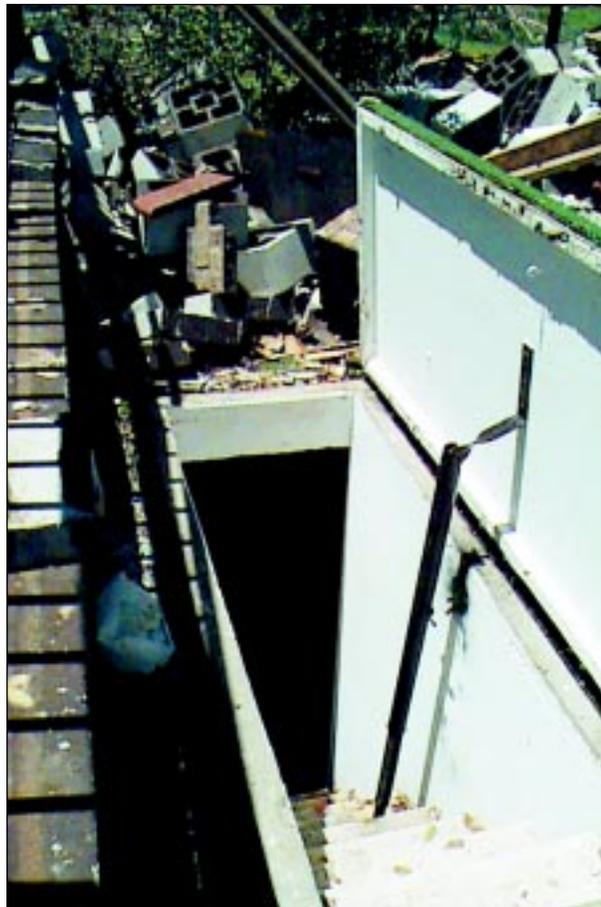
FIGURE 6-18: *This belowground shelter is susceptible to water runoff.*

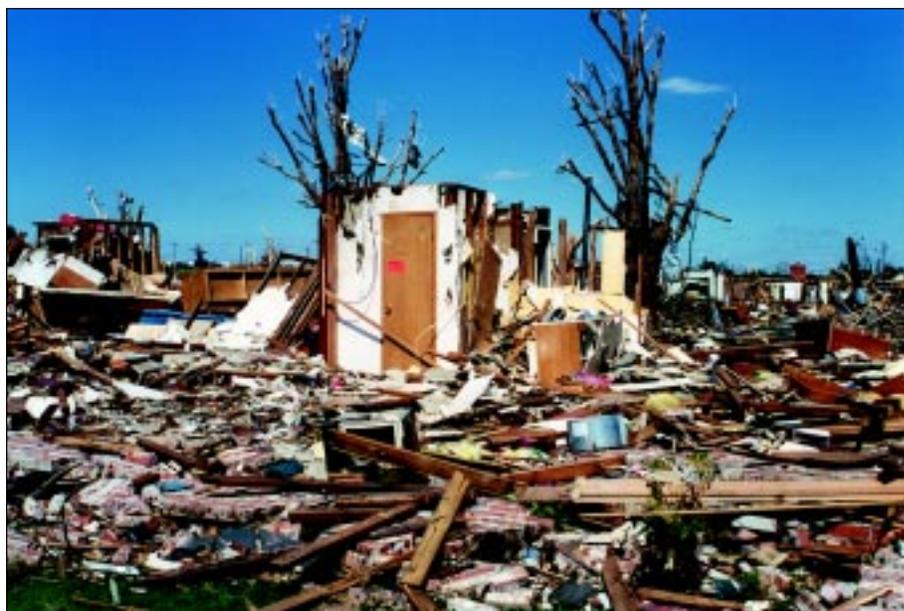
FIGURE 6-19: *Remains of an interior room (or core) of a home in a Moore, Oklahoma, subdivision that was hit by a violent tornado.*

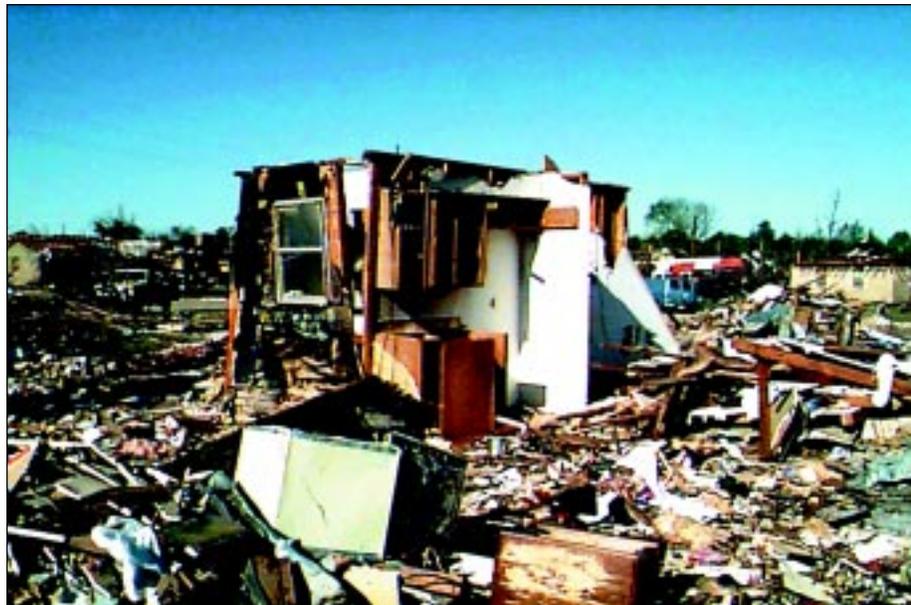
FIGURE 6-20: Interior core of house remains, consisting of a bathroom, closets, and a wall with kitchen cabinets after being struck by a strong tornado.

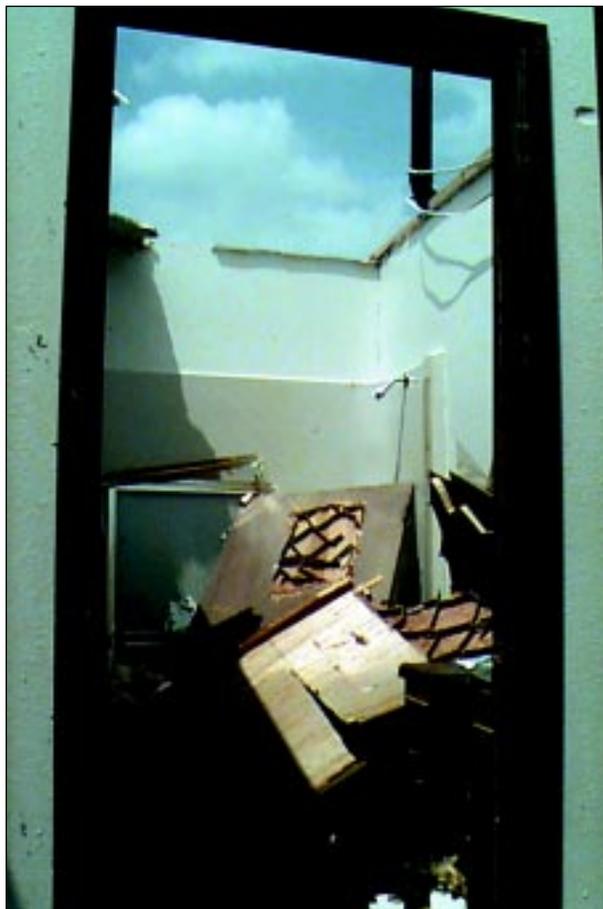
FIGURE 6-21: This apartment complex in Kansas was affected by inflow winds associated with a strong tornado. The roof and ceiling were blown off of the interior bathroom of this house, the door was blown into the bathroom, and the tub was full of debris. This bathroom would not have provided a safe place of refuge.

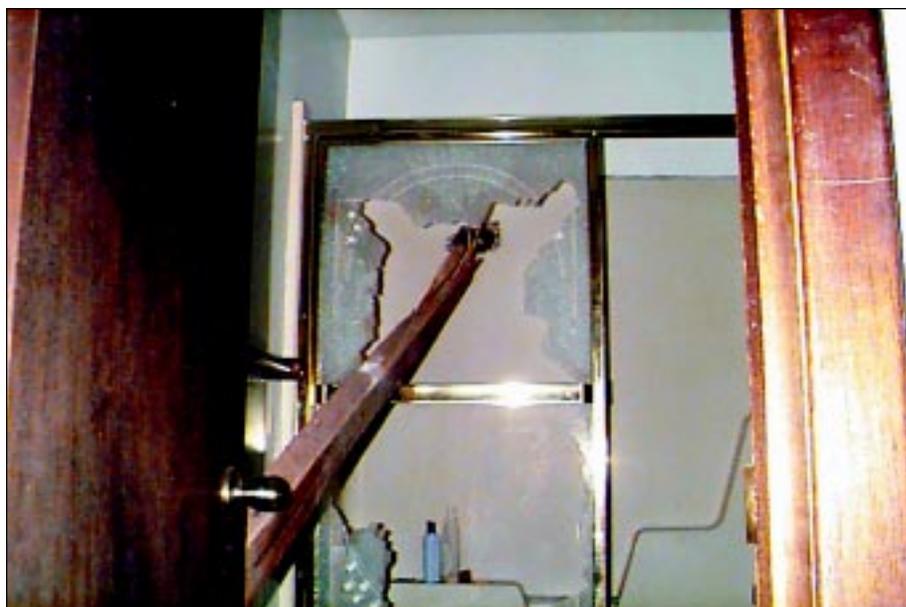
FIGURE 6-22: A 10-ft long 2-in by 6-in missile penetrated the exterior wall of an apartment in this multi-family house, which was sheathed with hardboard panels. The missile, which was generated from the vortex of a strong tornado, then penetrated the gypsum board and plastic tile tub enclosure, the tempered glass shower door, and the interior partition near the door frame. At the interior partition, it pierced through a stud and projected a few inches into the hallway (Figure 6-23).

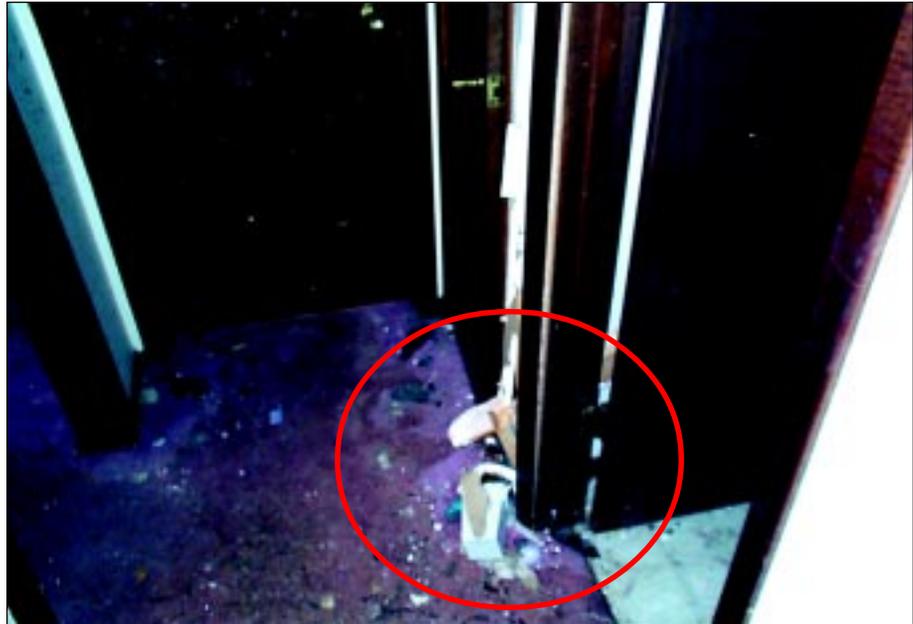
FIGURE 6-23: The missile in Figure 6-22 impacted and broke a 2-in by 4-in stud after traveling through the bathroom.

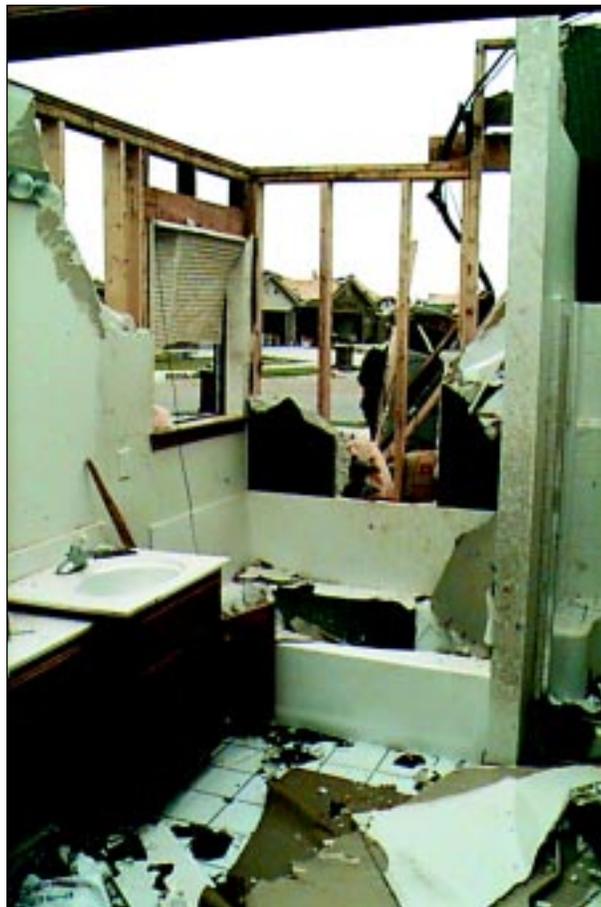
FIGURE 6-24: This bathroom was on an exterior wall and had a window. It did not provide a safe place of refuge.

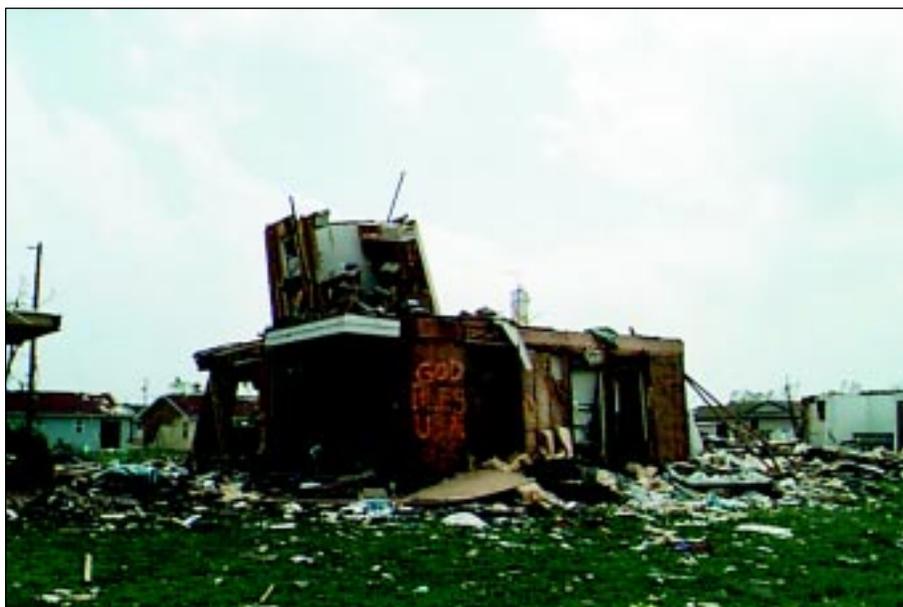
If the residence was more than one floor above grade, the first floor consistently was found to suffer less structural damage than the second floor (Figure 6-25). Therefore, greater protection was afforded when refuge was taken in interior bathrooms or closets on the first floor rather than the second.

FIGURE 6-25: *The second story of single-and multi-family houses typically experienced far greater damage than the first story. This multi-family home in Wichita, Kansas, was affected by inflow winds of a strong tornado.*

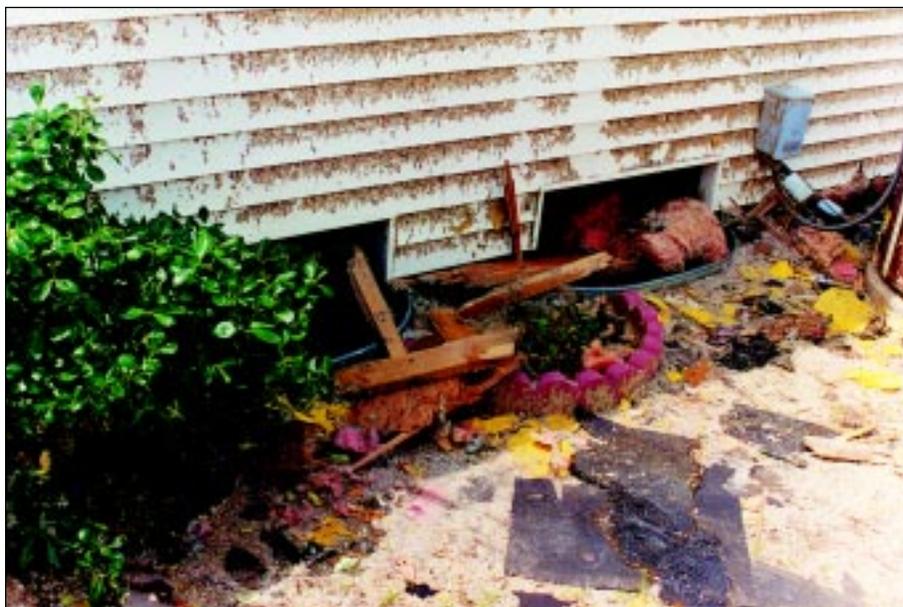
down the stairway to the basement and flew into rooms at the bottom of the stairway. Basements, that were partially above grade and had windows, were observed to be susceptible to missile penetration (Figure 6-26).

FIGURE 6-26: *Basement windows of a single-family residence, showing vulnerability to debris.*

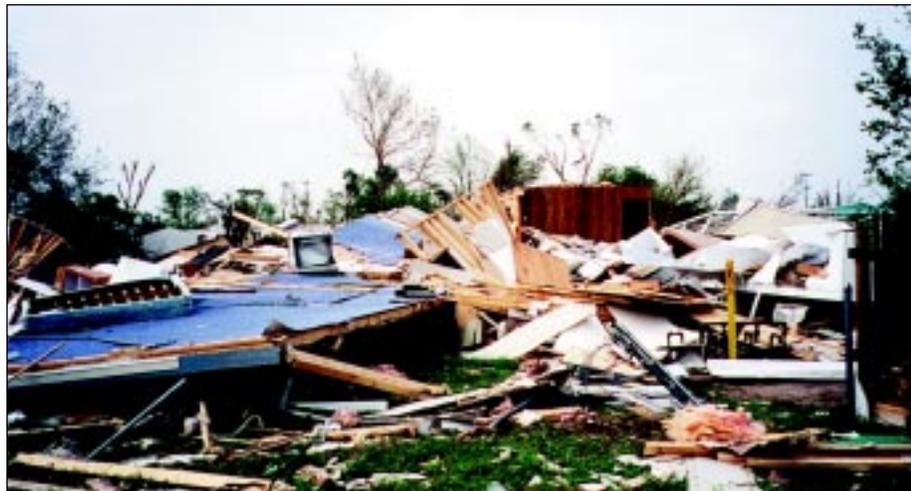
FIGURE 6-27: Damaged and destroyed manufactured homes on non-permanent foundations in Wichita, Kansas, that were in the direct path of a strong tornado.

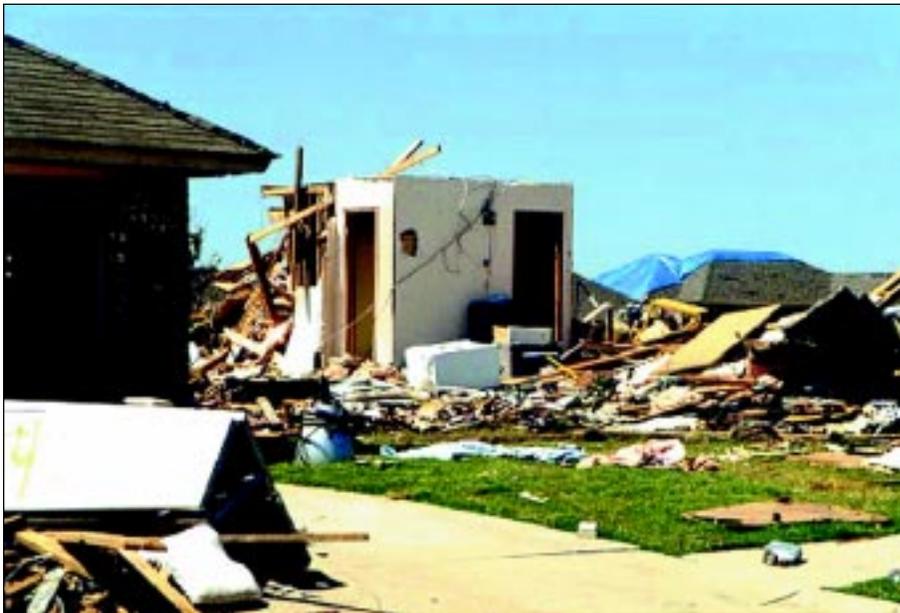
FIGURE 6-28: *The core remnant of this house consisted of a central room and closets.*

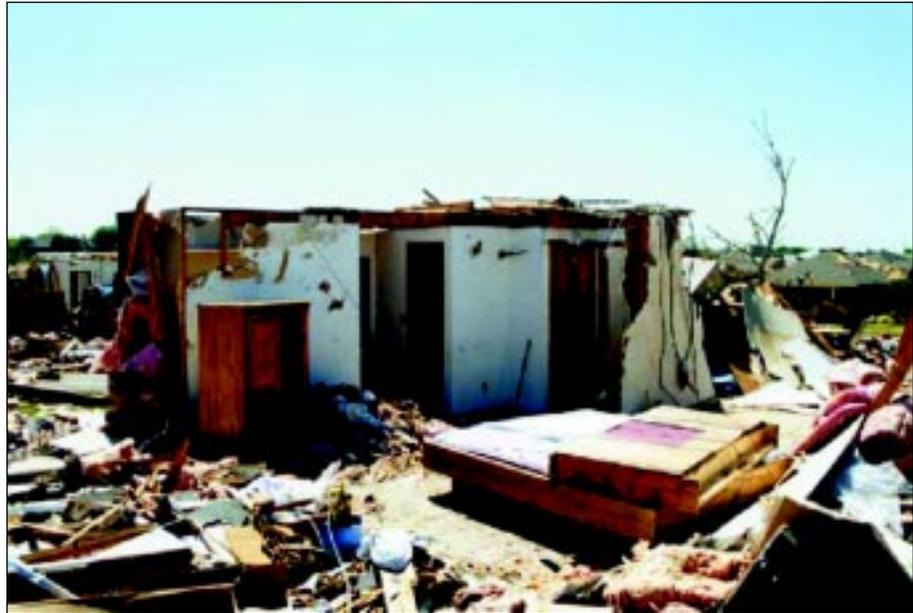
FIGURE 6-29: *The core remnant of this house consisted of a central room and adjacent closets.*

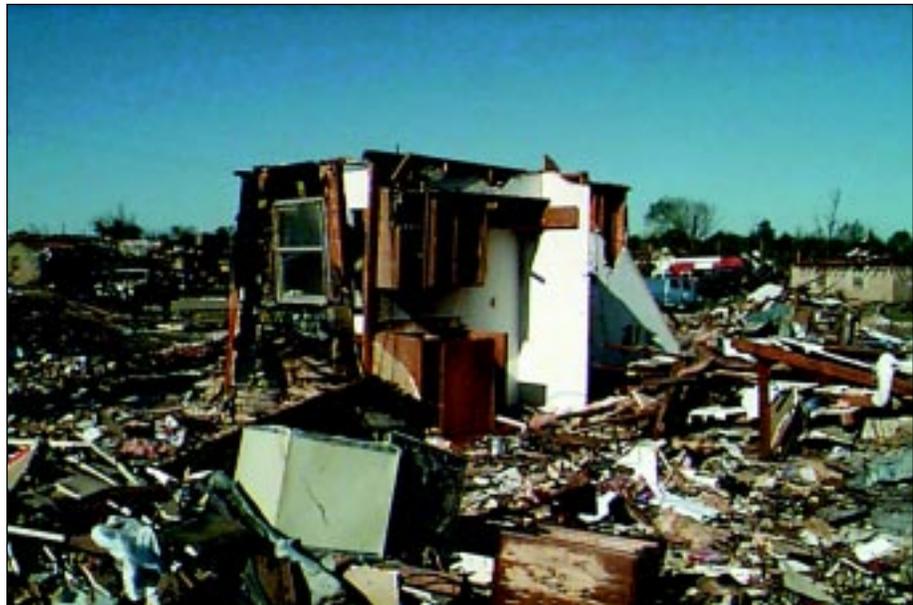
FIGURE 6-30: *The core remnant of this house was a central room on the back of the kitchen.*

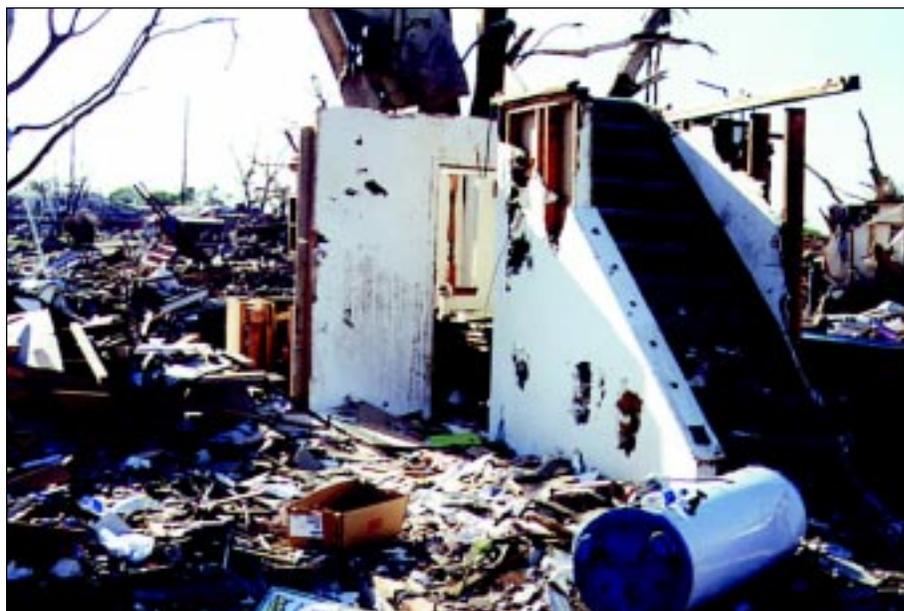
core remnant. Other observed core remnants had kitchen cabinets and counter tops mechanically attached to a least one surviving wall of the core remnant. In other cases, it is the added framing from staircases that may have provided the added stiffness to resist wind loads (Figure 6-31).

FIGURE 6-31: *The core remnant of this house was beneath the staircase to the second floor.*

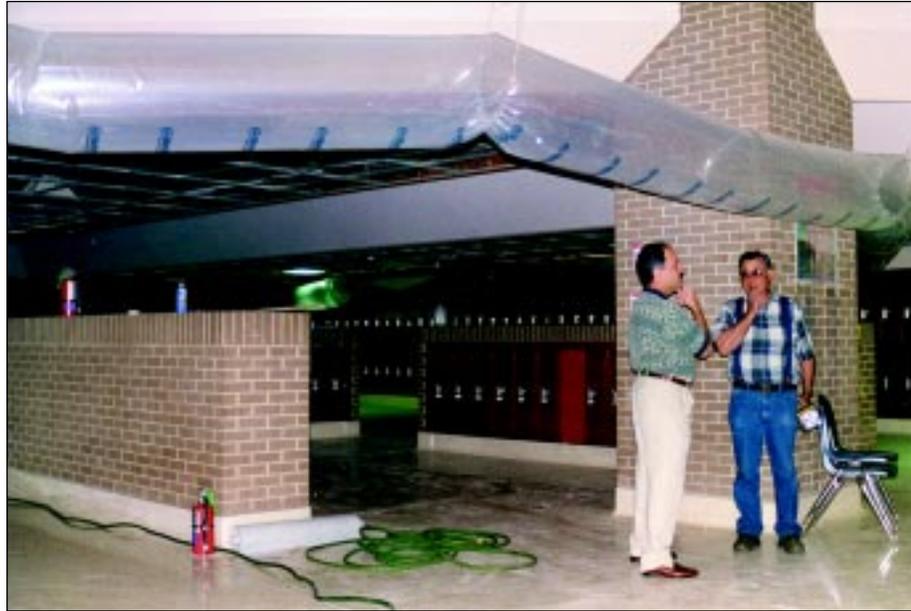
FIGURE 6-32: Westmoore High School, Moore, Oklahoma, central locker core – a designated place of refuge.

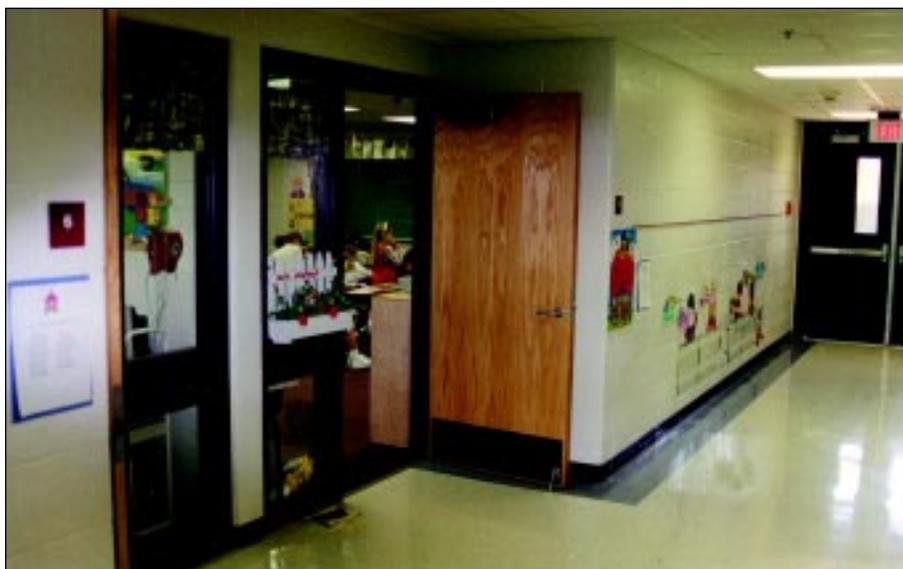
Eastlake Elementary in Moore, Oklahoma, was on the outer periphery of a violent tornado and received minor building envelope damage. The building construction consists of CMU walls with brick veneer and built-up roof over steel decking and steel joists. Interior classroom walls were also built of CMU. The tornado plan for the school indicated that the places of refuge consisted of each classroom within the building, even though each classroom entrance door (from the interior hallway) was flanked by a large glass sidelight (Figure 6-33). There were no exterior windows in the exterior wall of most of the classrooms. Centrally located offices were also identified as places of refuge with the building. None of the identified areas appeared sufficiently constructed to withstand a direct hit by a violent tornado.

FIGURE 6-33: *Eastlake Elementary, Moore, Oklahoma, glazed sidelight at classroom entrance.*

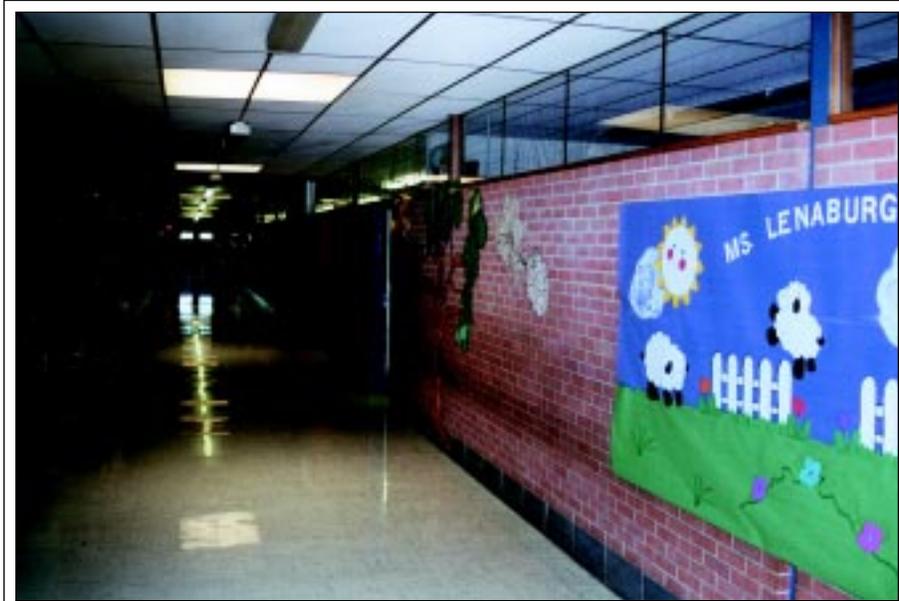
Figure 6-34 shows a central corridor of Northmoor that illustrates the corridor masonry walls topped with windows, called “clerestory”. These types of walls have limited capacity to resist lateral forces because of the windows located along the tops of the wall systems. Figure 6-35 shows a corridor in Kelly Elementary of nearly identical construction to the hallway in Figure 6-34. The inability of the corridor walls to withstand extreme loads due to lateral and uplift wind forces resulted in the collapse of this corridor. Many schools identify their central corridors as places of refuge in their tornado plans. Obviously, had these corridors been used for shelter during the tornado, numerous injuries or deaths would have occurred. Sooner Rose Elementary was a different construction type from the above, but contained similar windowed corridors (see Figure 6-36).

FIGURE 6-34: Northmoor Elementary place of refuge, Moore, Oklahoma – corridor with clerestory windows. This corridor offers little protection from tornadoes as shown in a school of similar design in Figure 6-35.

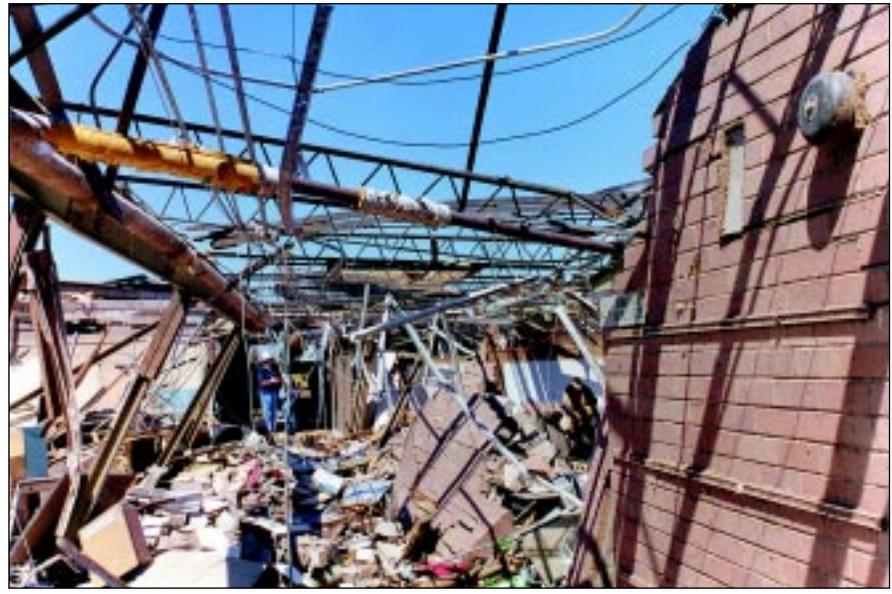
FIGURE 6-35: Kelly Elementary School, Moore, Oklahoma, place of refuge – corridor with clerestory windows. These interior corridor walls had brick masonry up to a height of approximately 7 ft. Glass extended from the top of the brick masonry to the top of the wall.

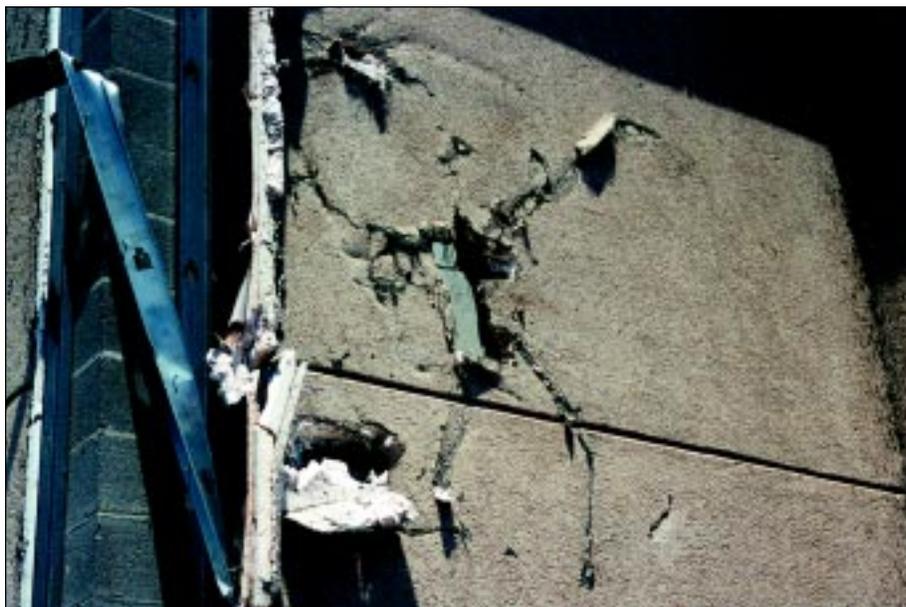
gypsum board that is supported by studs, and a layer of gypsum board on the interior side of the studs (Figure 6-37). Brick and CMU walls can also be deceiving. If they are adequately reinforced and braced, they can offer a significant level of protection. But if they are inadequately reinforced or braced, they can collapse, thereby trapping and crushing people (Figure 6-38).

FIGURE 6-37: *This EIFS wall system was penetrated by numerous windborne missiles.*

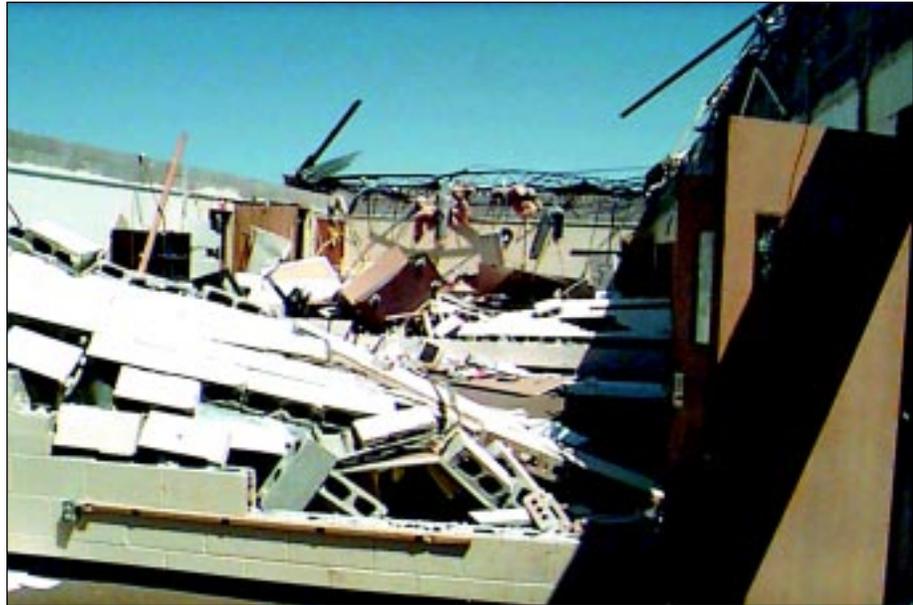
FIGURE 6-38: *The non-reinforced interior CMU walls in this area of Kelly Elementary collapsed after the roof system was removed by vortex winds of a violent tornado.*

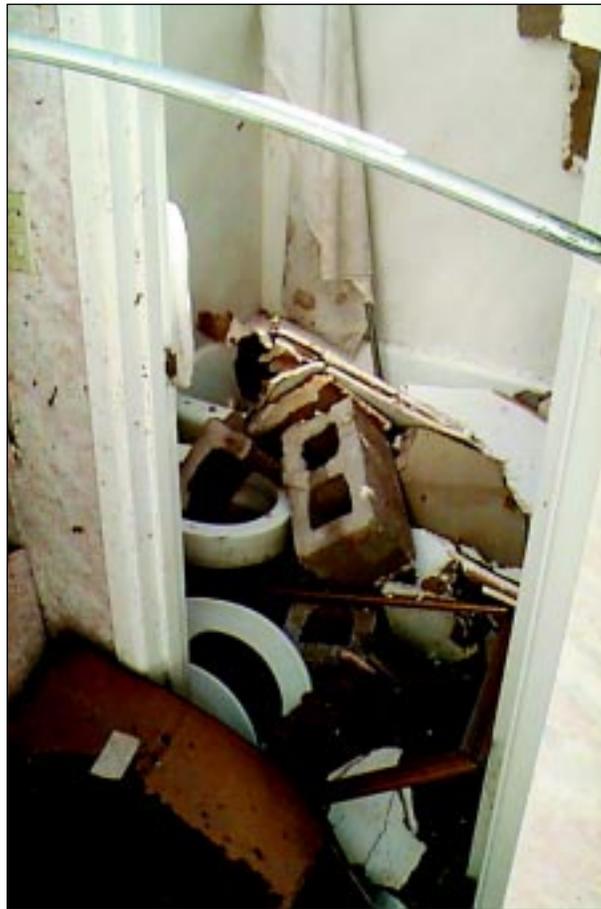
FIGURE 6-39: *The roof and ceiling over this interior bathroom blew off. CMU from a firewall a few feet away blew into the bathroom, which was located on a motel's second floor in Midwest City, Oklahoma. This bathroom would not have provided a safe refuge.*
