7 Conclusions

7.1 Residential Property Protection

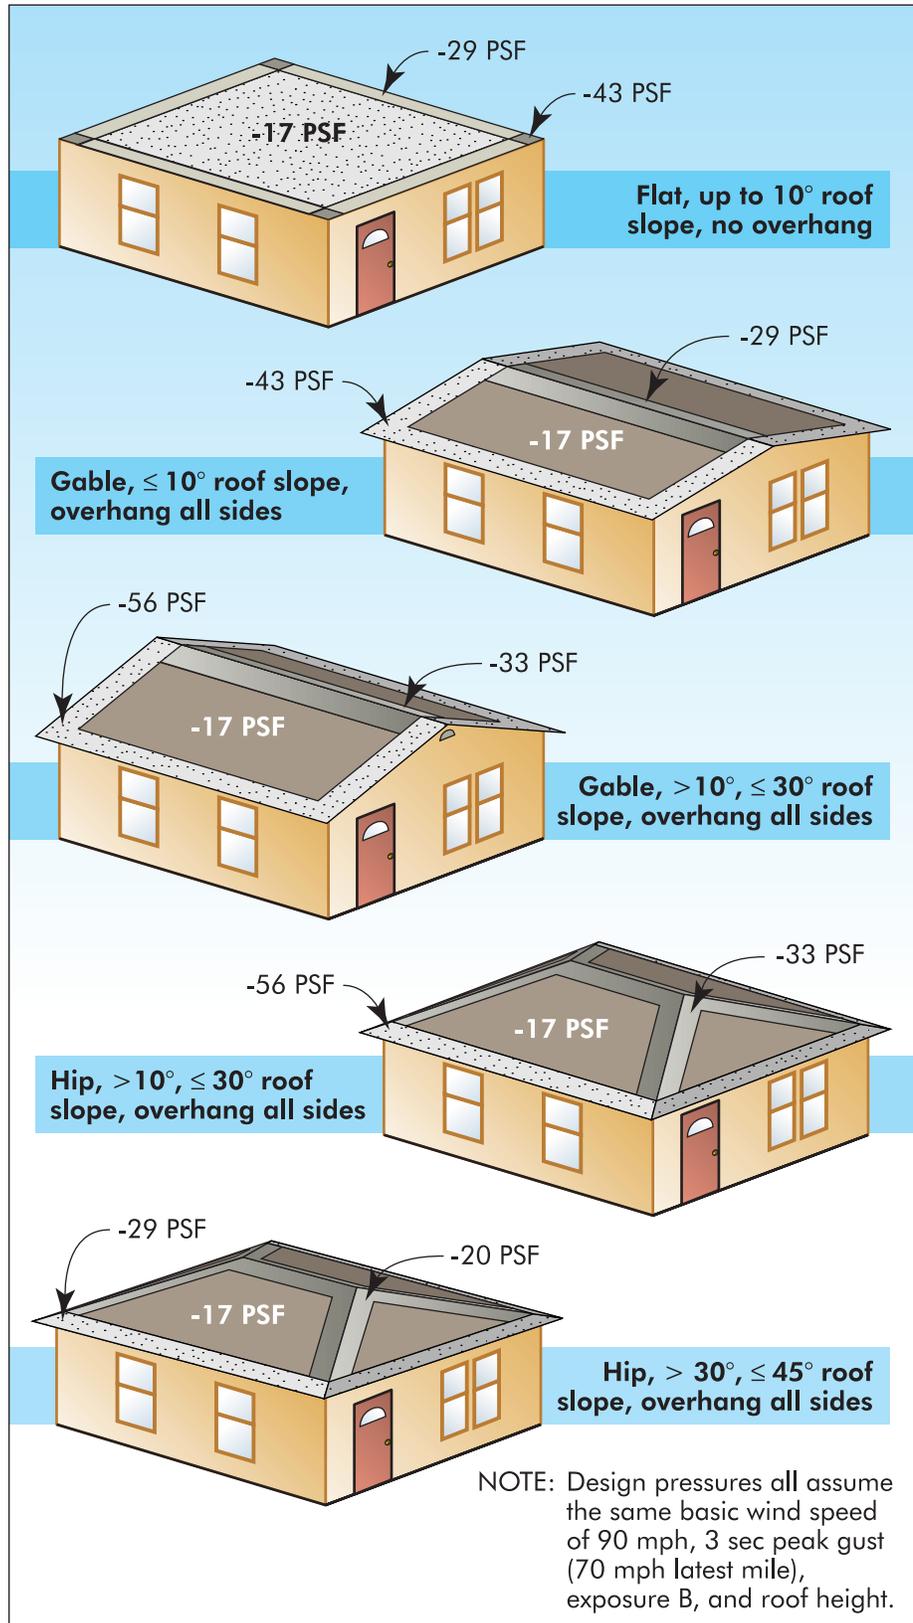
In general, for flat, gable, and hip roof geometry, the largest uplift loads occurred near the corners, the gable ends, and the edges of the roof ridge. However, the largest localized loads for gable roofs are noticeably higher than those for hip roofs. Although a localized load may fail a single piece of roof sheathing, it will not always cause the entire roof to fail. Such localized roof failures often allow rainfall to enter the structure, causing significant collateral damage to the building interior and furnishings. When the roof fails as a single entity, it is the overall combination of all wind loads that will cause this failure. The magnitude of the loads that will cause roof failures are influenced by the roof geometry, slope, pressure of roof overhangs, and location on the roof. Roof geometry and their effect on resultant wind loads are illustrated in Figure 7-1.

FIGURE 7-1: Relative uplift pressures as a function of roof geometry, roof slope and location on roof. Negative values indicate that wind pressures act upward and perpendicular to the roof surface.

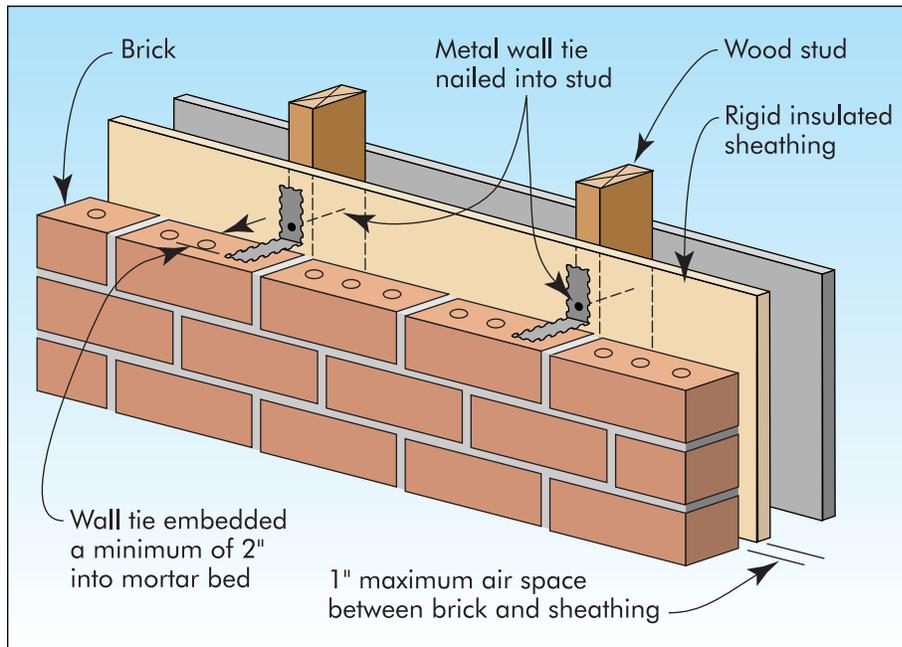
There were a few instances of nail pull-out at brick ties fastened to wall studs. Therefore, in these cases, the wind suction pressure exceeded the withdrawal strength of the one nail holding the brick tie. Causes of failure could be insufficient nail length or diameter, low withdrawal resistance, or ties having too high a tributary area. There were many instances of brick ties spaced at greater distances than stated in the building codes. Proper connection of brick masonry to a wood frame wall system is shown in Figure 7-2.

FIGURE 7-2: Illustration of a proper connection of brick masonry to a wood frame wall system.

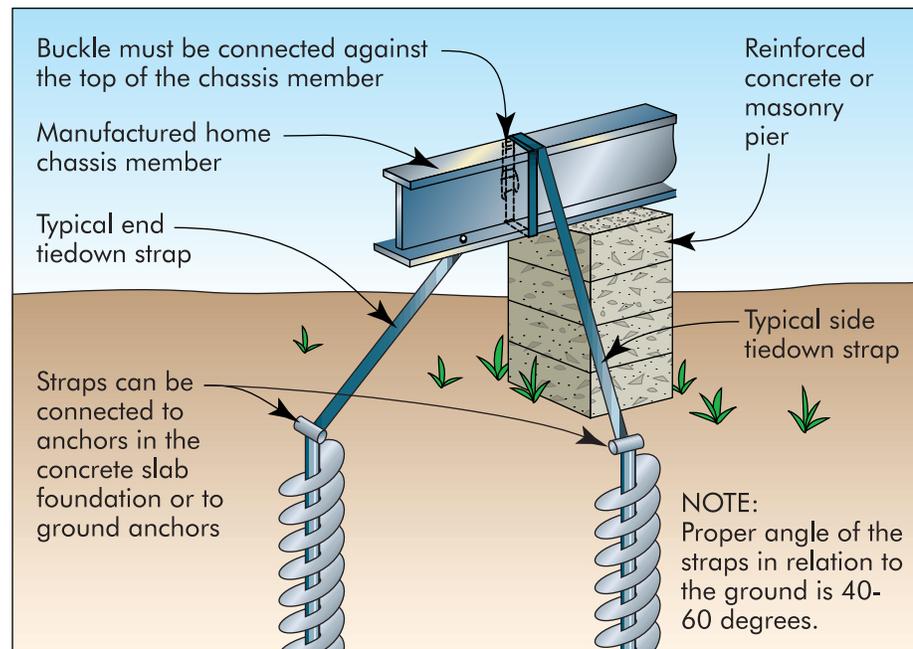
FIGURE 7-3: Illustration of a proper connection of a manufactured home to a dry-stacked CMU foundation using straps only; L-clips are not illustrated here.
