**Issues, Resolutions, and Research Needs Related to Dam Failure Analysis Workshop
Oklahoma City, Oklahoma
June 26 -28, 2001**

Embankment Dam Failure Analysis

Dayton Dam Canal Embankment Failure & Repair

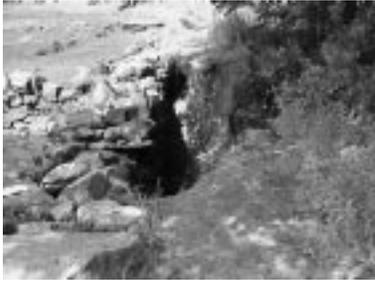
View of breach across crest with masonry wall on upstream face

The masonry wall along the upstream face of the Edison Pond Dam was approximately 3 feet wide. This, in combination with the narrow breach width downstream and a low hydraulic head on the wall probably prevented the total failure of the wall. But, had this dam overtopped for an extended period of time, a more significant portion of the earthen dam may have been eroded making a wider area of exposed masonry wall. This wall may not have been able to withstand the water pressures and may have experienced a total structural failure. With no earth pressures on the downstream side of the wall, a near instantaneous failure could have been expected, resulting in a large release of stored water.

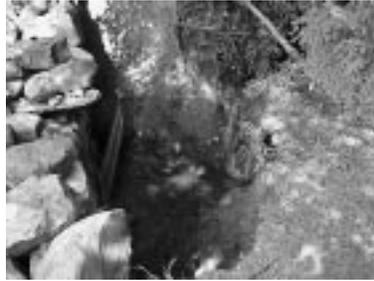
View of breach immediately below masonry wall

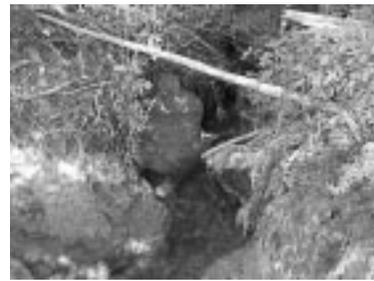
View of breach through earthen embankment

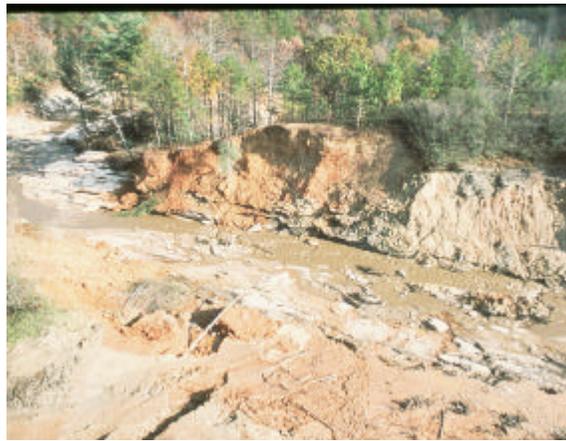
Kelly Barnes Dam Failure
Toccoa Georgia

A few of these dam failures have had good investigative follow-up where the size of the breach, initial conditions, and the resulting flood wave depths were measured. For instance, the Kelly Barnes Dam failure was thoroughly detailed by a Federal Investigative Board. The following breach parameters were detailed in the report for the Kelly Barnes Dam which was 38 feet tall:

- Breach side slopes - right 0.5 H to 1.0V
- left 1.0 H to 1.0 V
- Base width of breach - 40 ft
- Sudden failure
- Estimated peak flow - 24,000 cfs

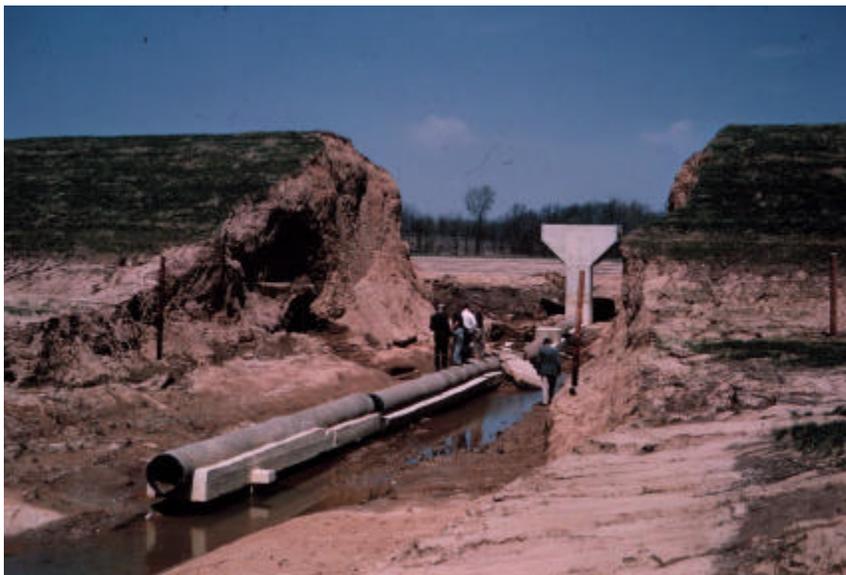
Figure 3 – Obion Creek #36 – looking upstream into reservoir

Obion Creek #36 is a typical NRCS flood control dam from the 1960's. It was built in 1963 and failed a year later during the first reservoir filling storm. An Engineering Investigation concluded that dispersive soils were a major factor in the failure. Note that the dam was constructed with anti-seep collars along the principal spillway pipe as was typical at the time.

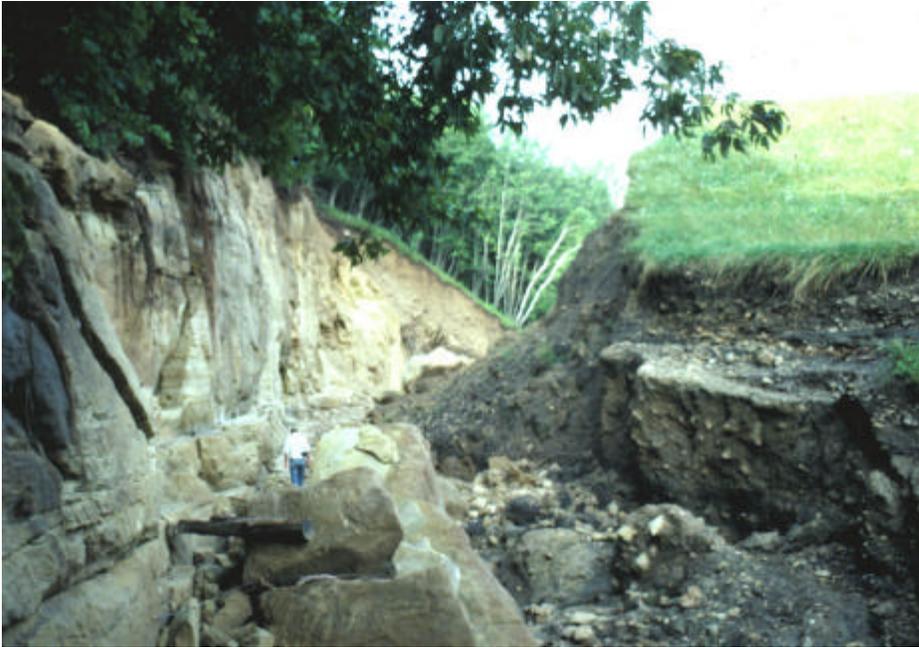
Figure 4 – Coon Creek #41 – note remaining embankment in upper right

Coon Creek #41 is also a typical NRCS flood control dam from the 1960's. It was built in 1962 and failed in 1978 during the first significant reservoir filling. An Engineering Investigation concluded that stress relief fractured rock in the steep abutment was the major factor in the failure. This site was constructed with minimal foundation investigation and foundation treatments as was typical at the time. Although this site failure occurred several years ago, it is still representative of similar dams that were built in similar geologic settings around the same or earlier time periods before such foundation hazards were widely recognized or routinely investigated. NRCS has similar flood control dams which have not yet experienced a significant first filling. Most recently, Bad Axe #24, a similar site in a similar setting built in 1963, failed in a similar fashion last year.

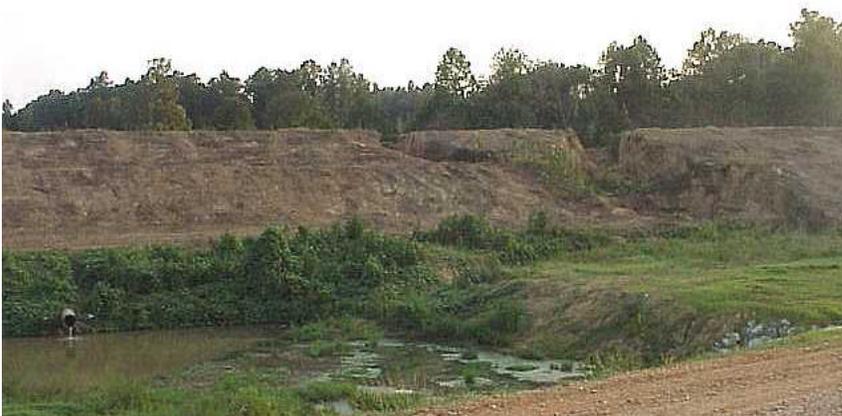
Figure 4 – Ascalmore #11 – looking upstream, note pipe outlet on left

Ascalmore #11 was built in 1959 and failed last year after trash blocked the pipe spillway and a storm quickly filled the flood reservoir. An Engineering Investigation concluded that dispersive soils and animal burrow damage in the upper portions of the embankment were major factors in the failure. The rough appearance of the embankment surface is due to removal of extensive woody vegetation after the breach occurred and before the picture was taken. It is interesting to note that the embankment breached in two separate locations and the energy of the stored water was not sufficient to erode either breach to the base of the dam.

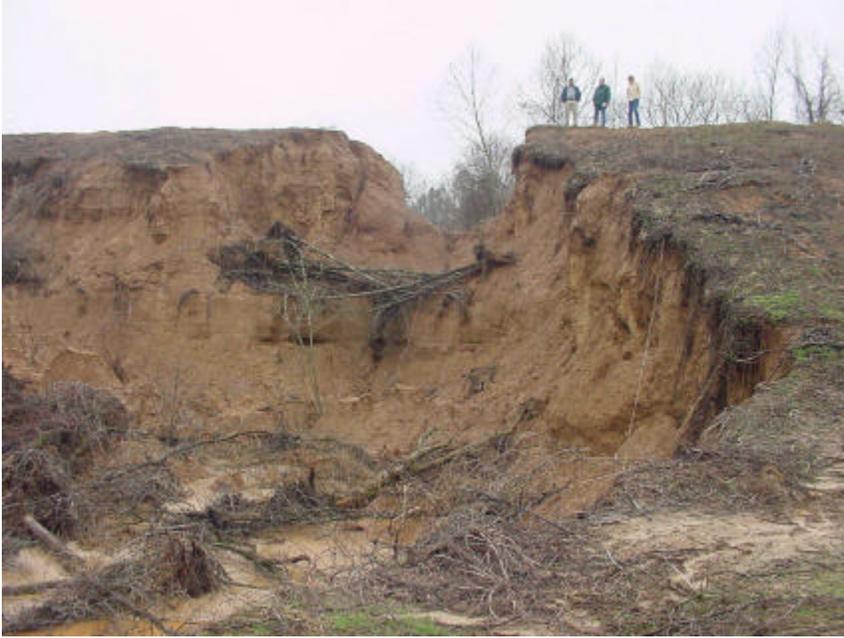
Figure 5 – Ascalmore #11 – looking upstream

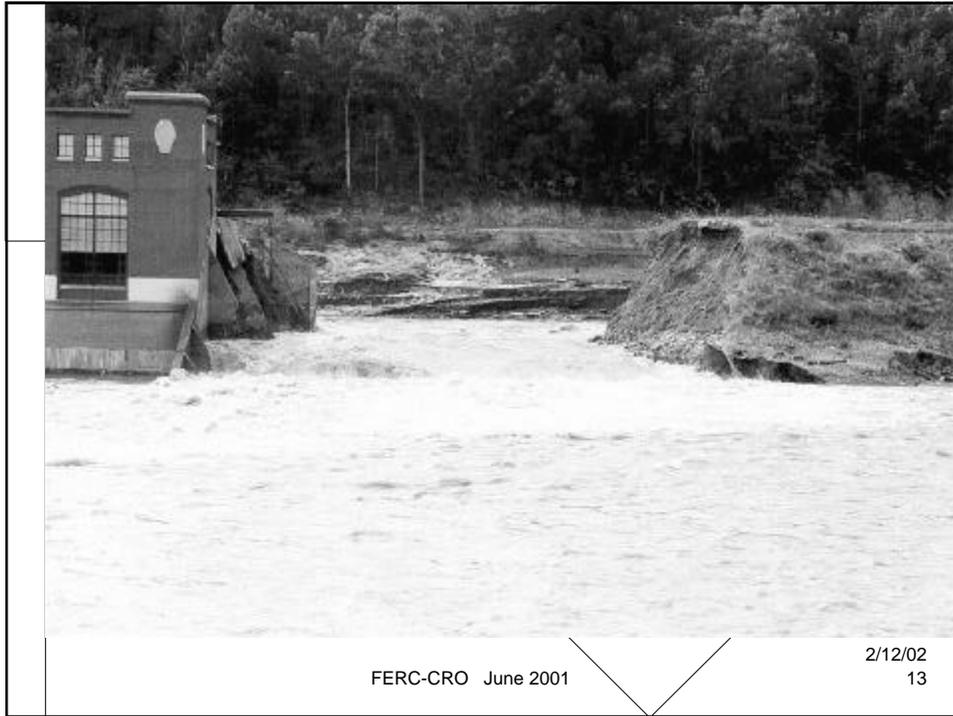
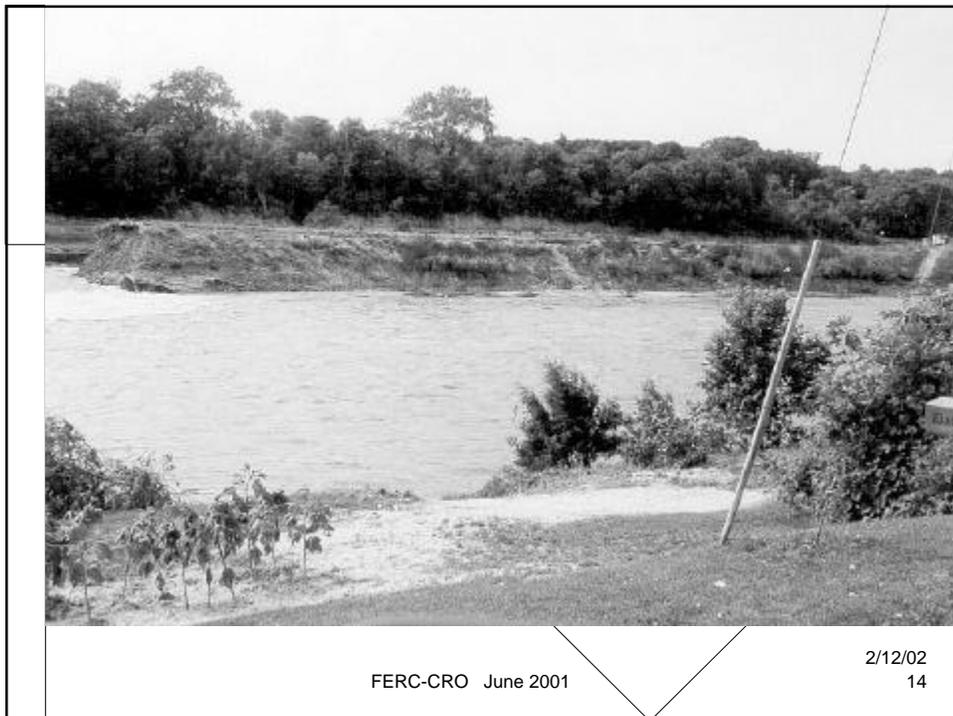
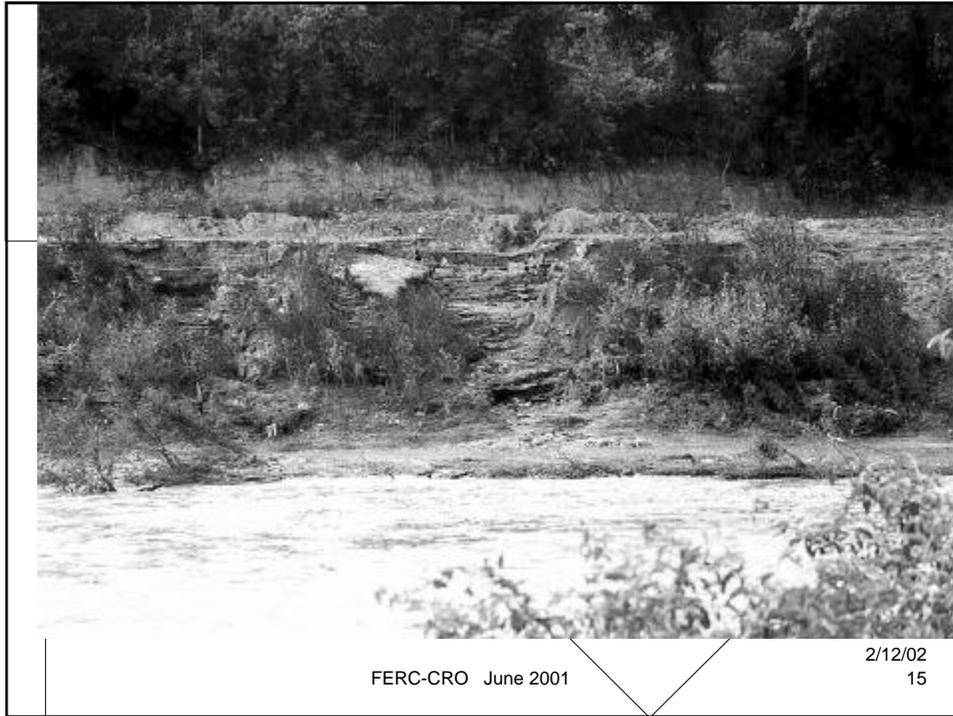
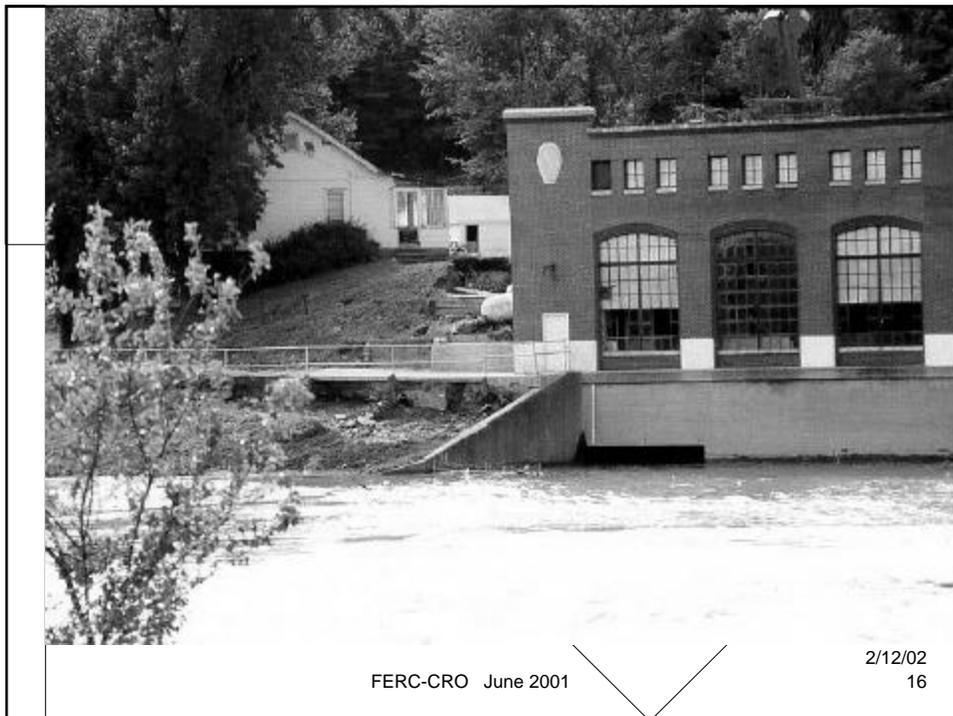
July 20, 1996 Inspection

- The next four photographs show the condition of the project structures two days after the breach.
- The inspection was unannounced and was done on a Saturday. Access to the site was limited to the left bank opposite the side of the canal.
- The tailrace had receded about 15 feet since the breach.

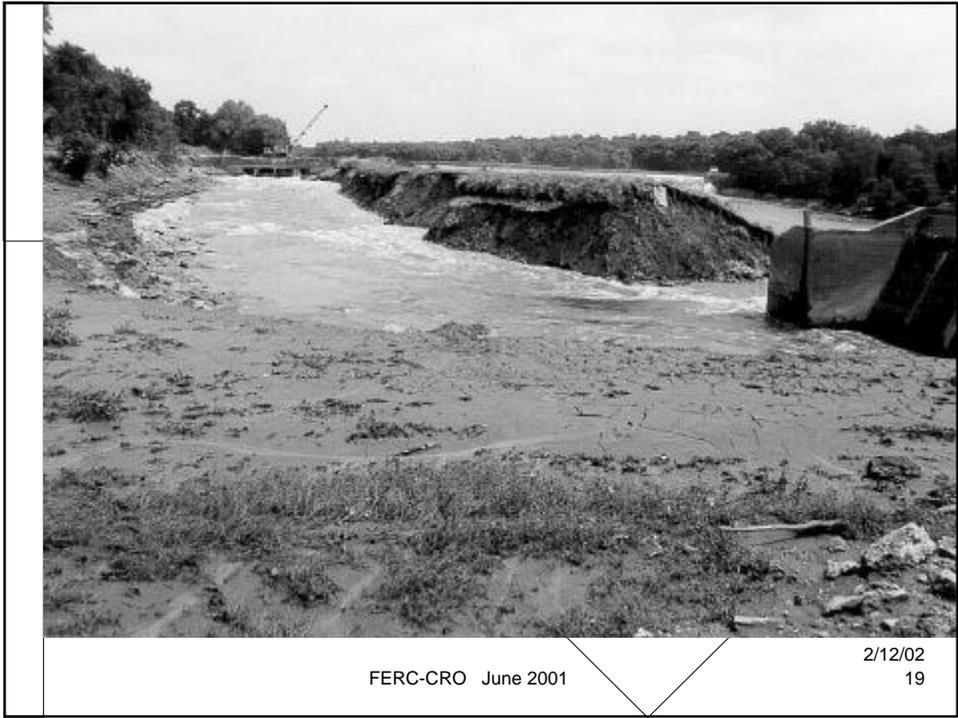
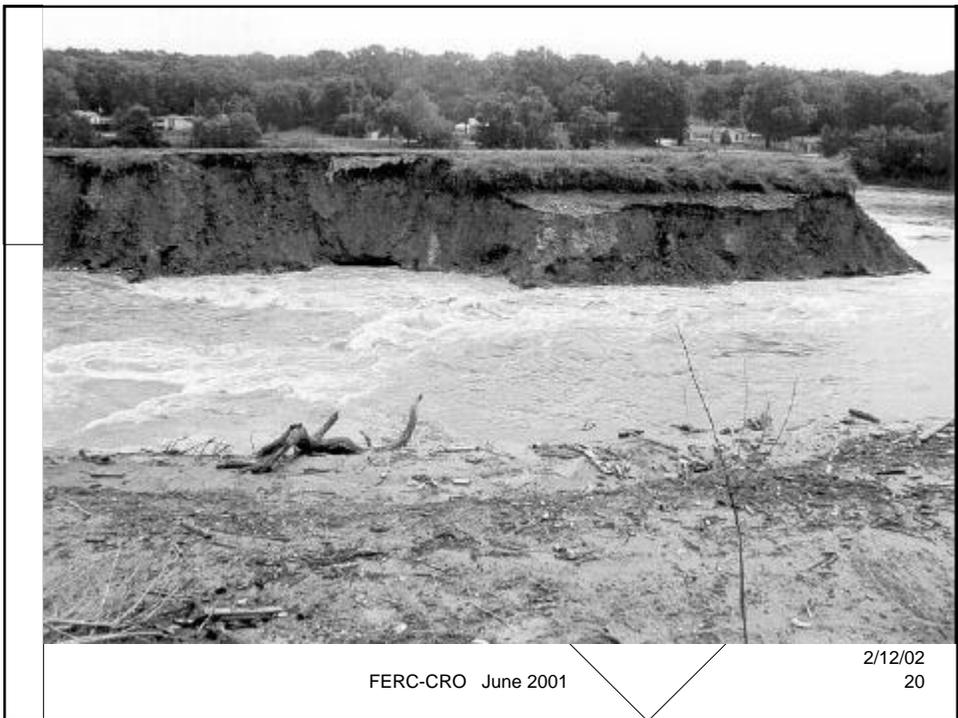
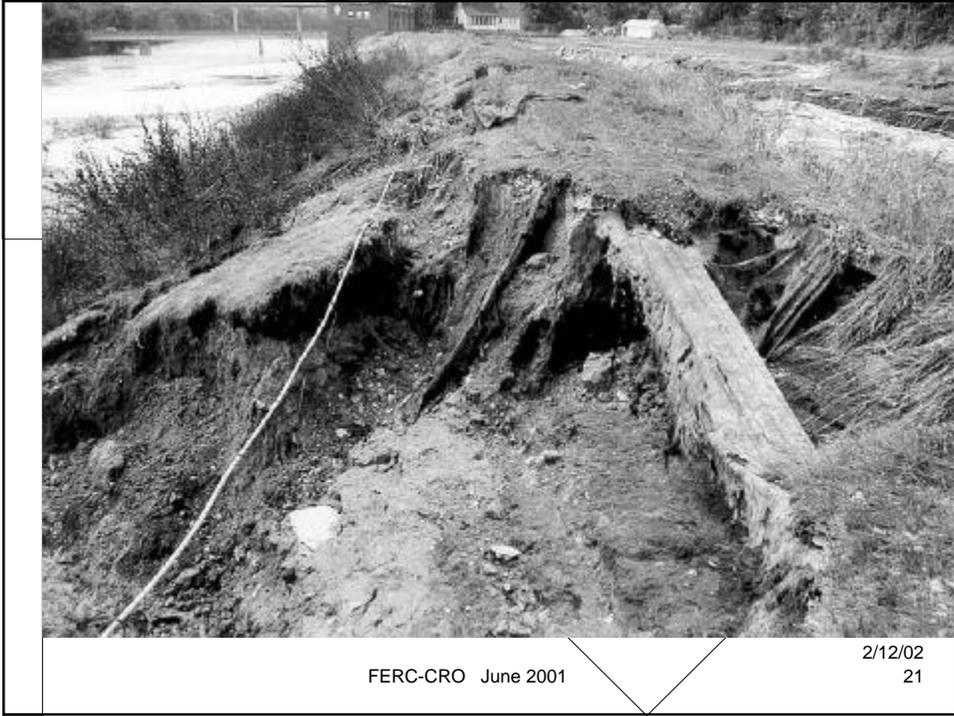
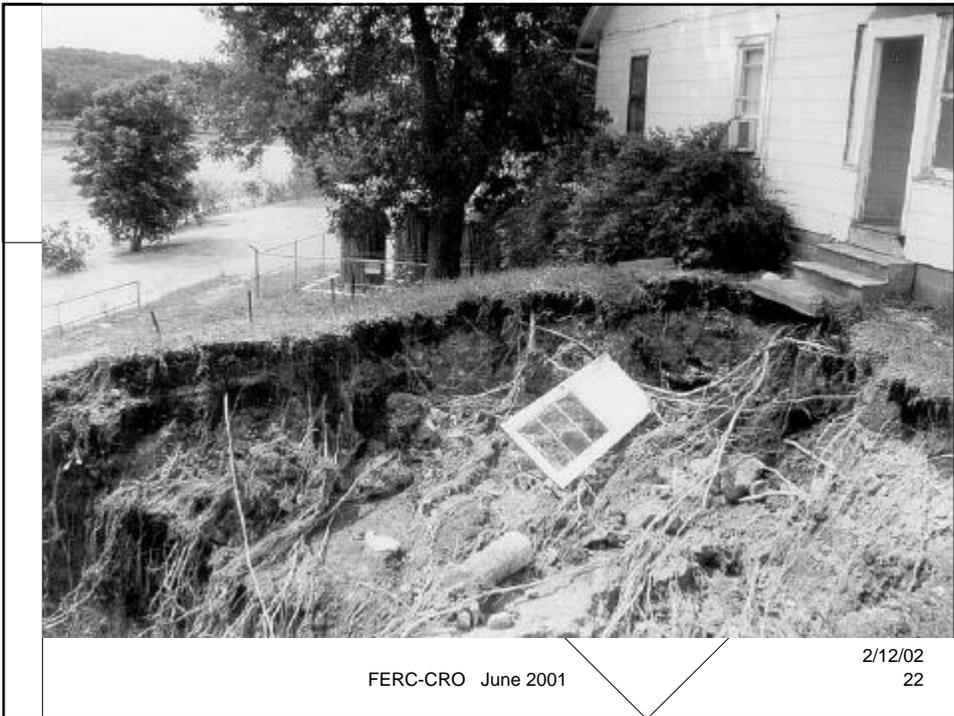
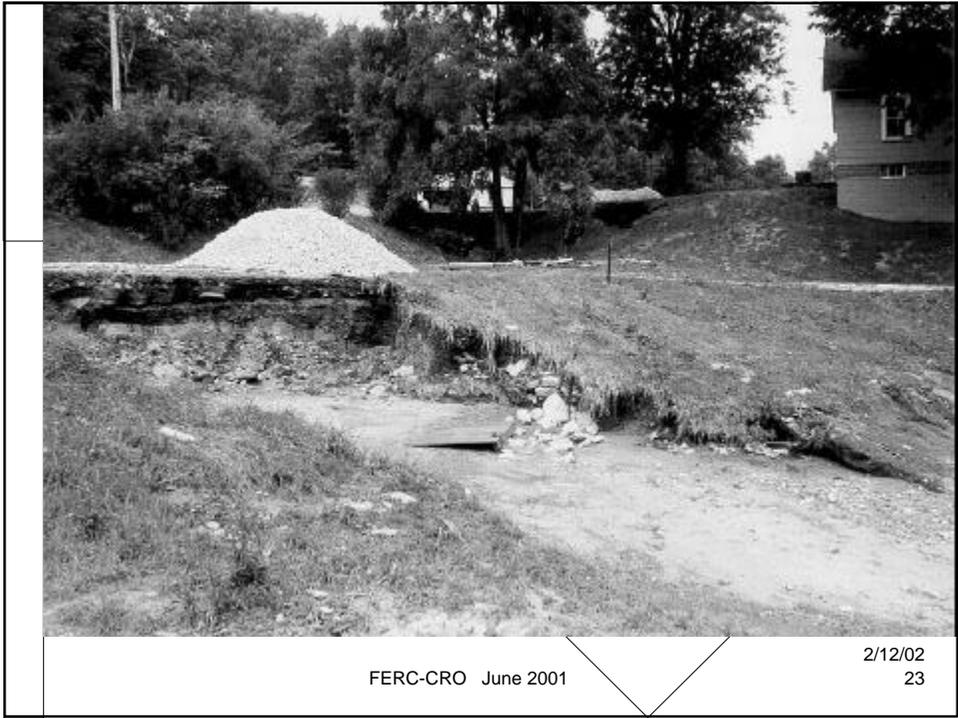
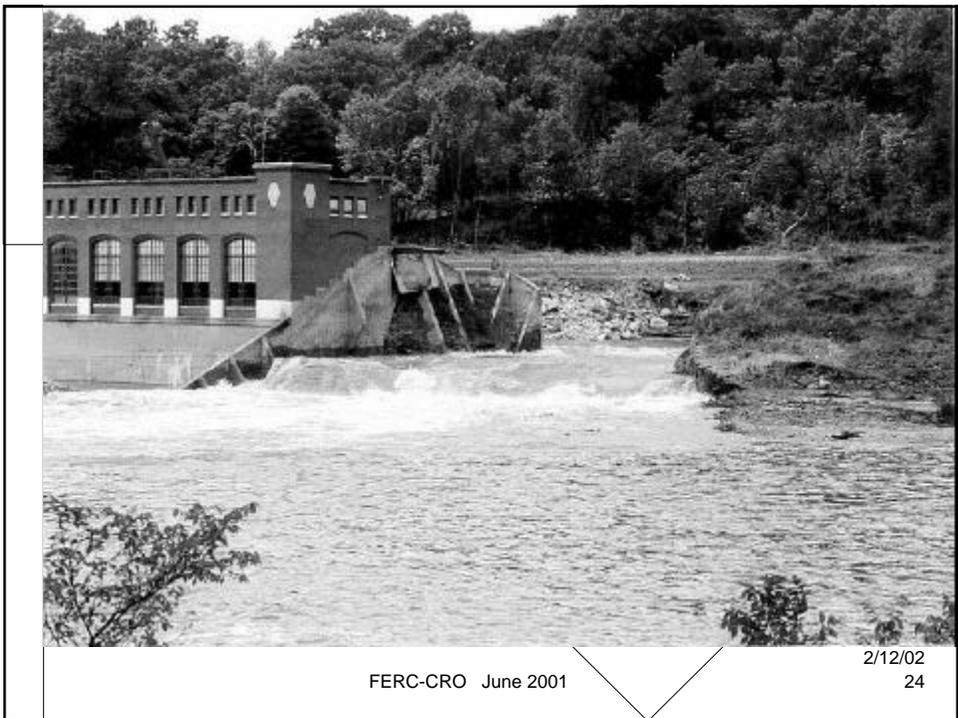
July 22, 1996 Inspection

- The next nine photographs show the condition of the project structures four days after the breach.
- The tailrace had receded about another 6 to 8 feet since the July 20 inspection.

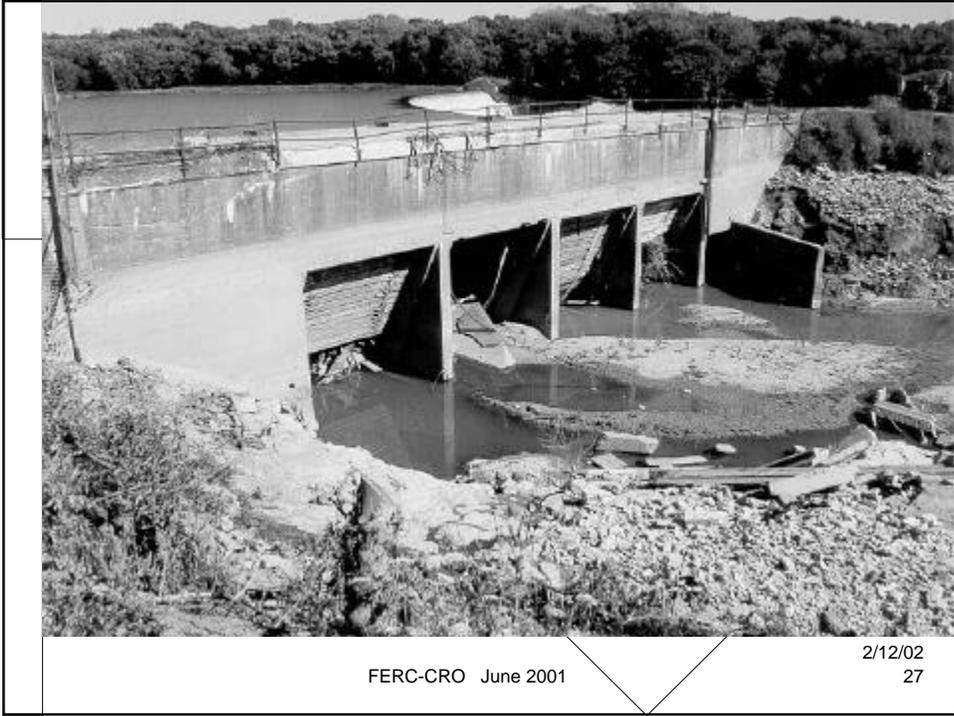
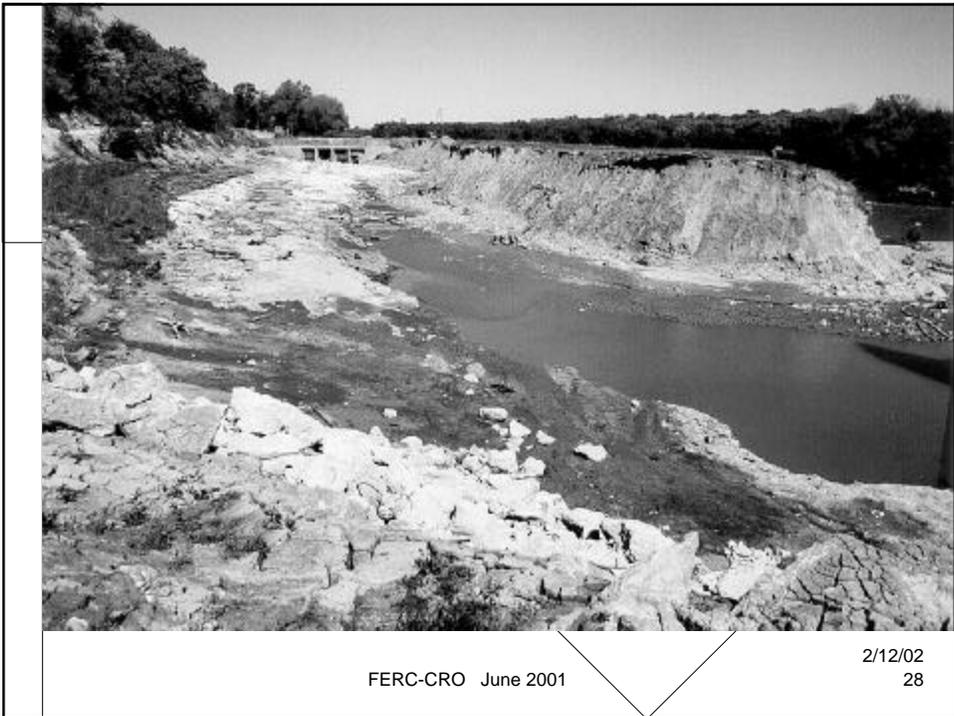
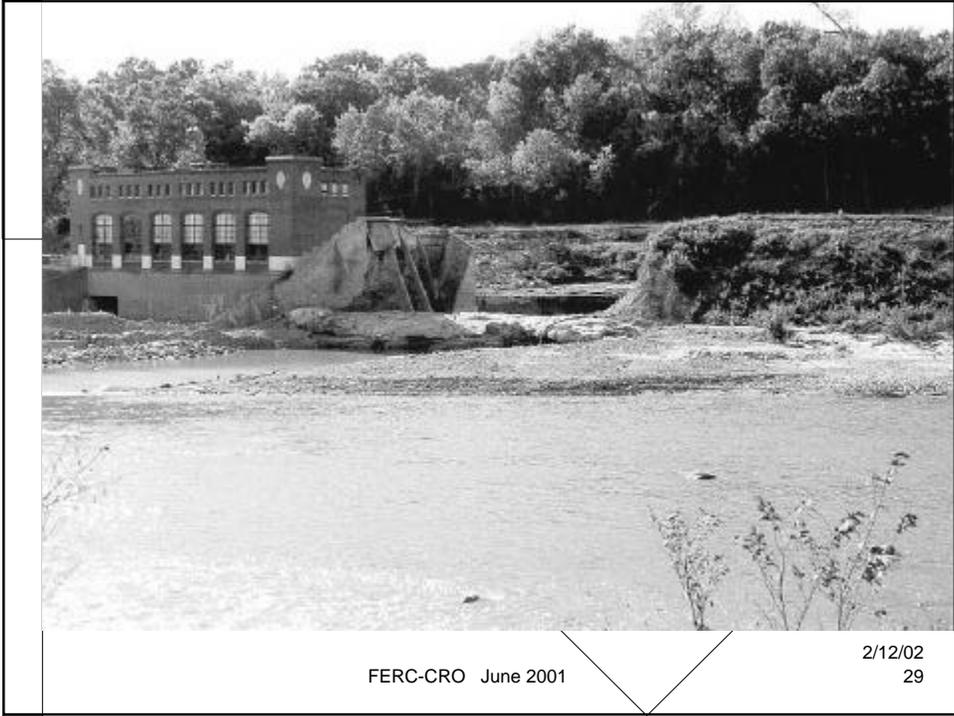
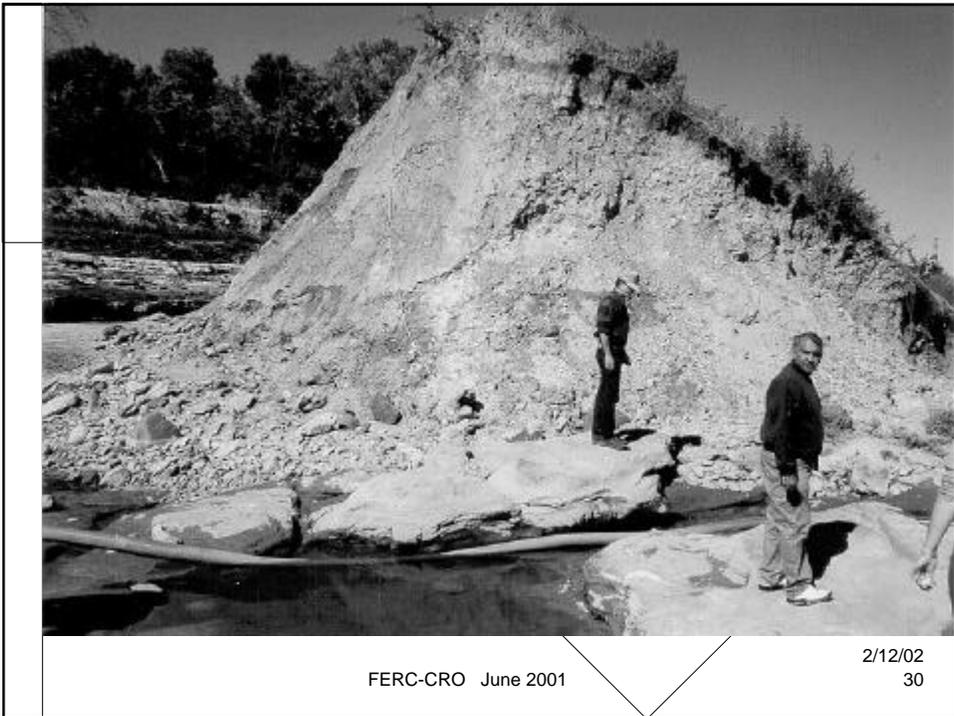
September 30, 1996 Inspection

- On July 25, 1996, the licensee began to place large trap rock upstream of the headgate structure to cut off the flow.
- The cofferdam was completed on July 30, 1996.
- The next four photographs show the condition of the substantially dewatered canal.

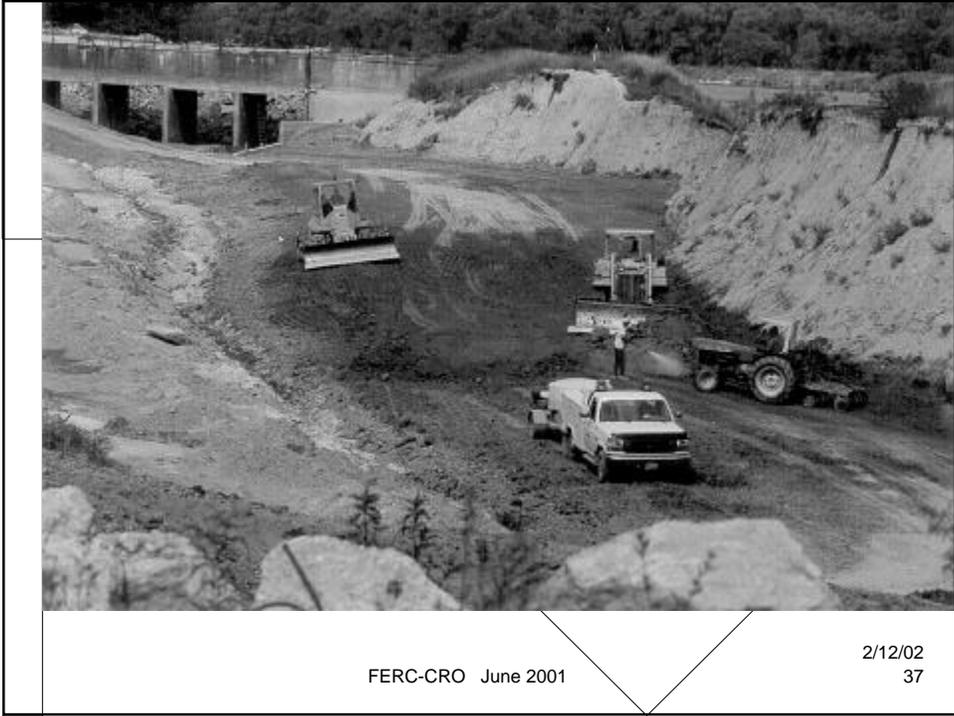
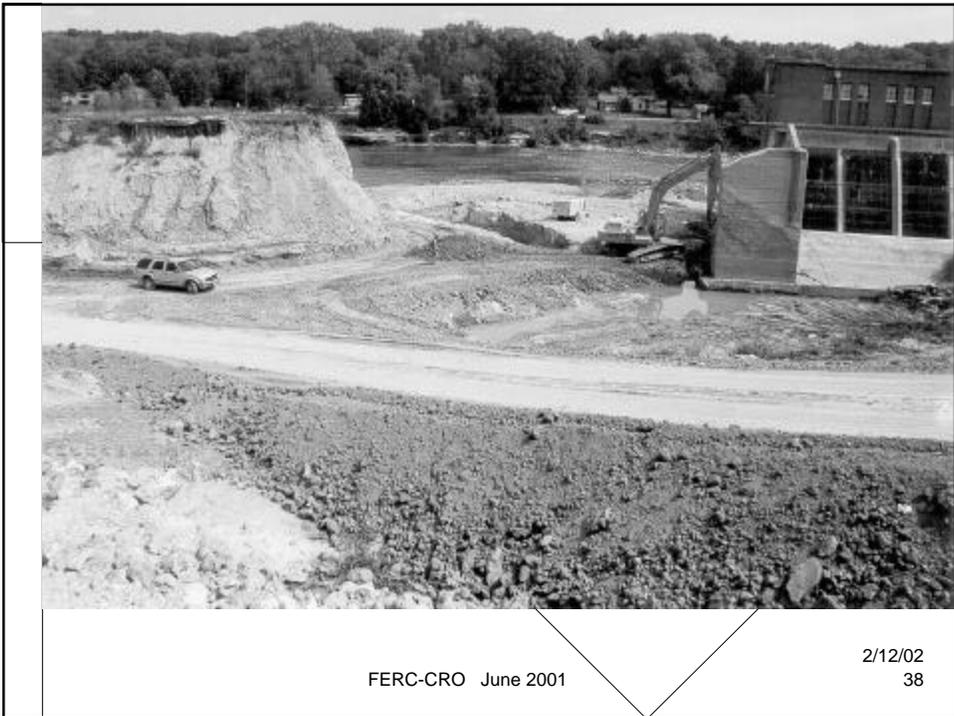
August 27, 1997 Inspection

- The following two photographs show the progress of the reconstruction work.
- At the time of this inspection, the contractor was reconstructing the canal invert.

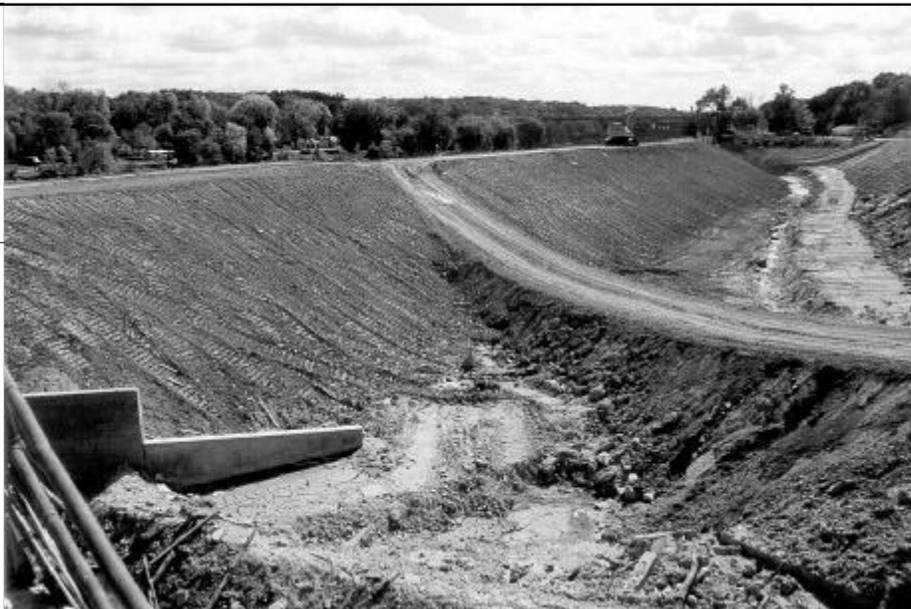
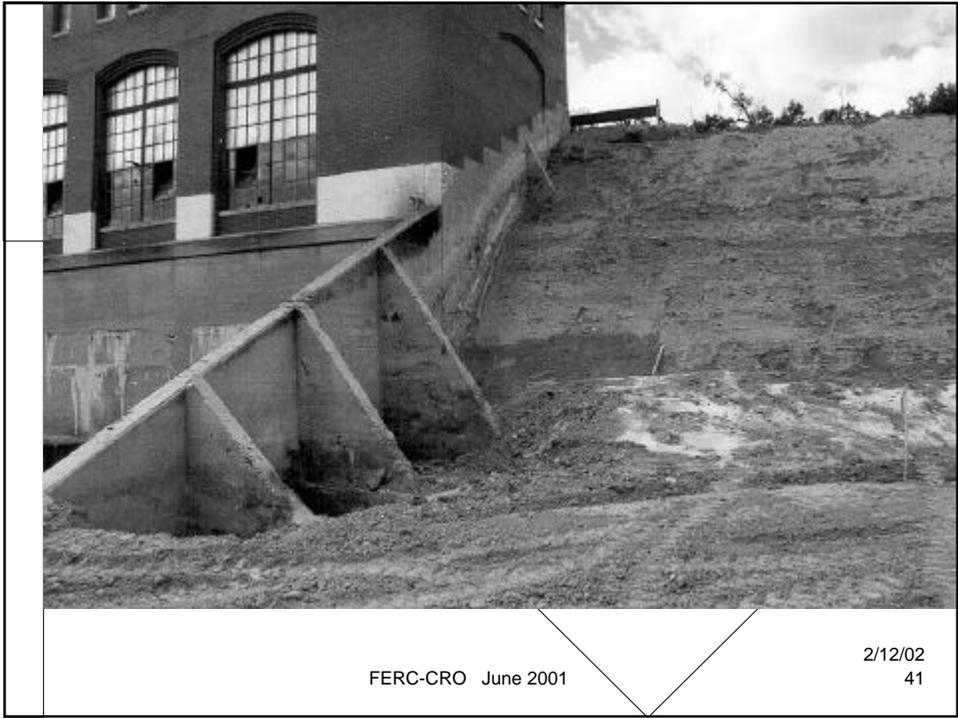
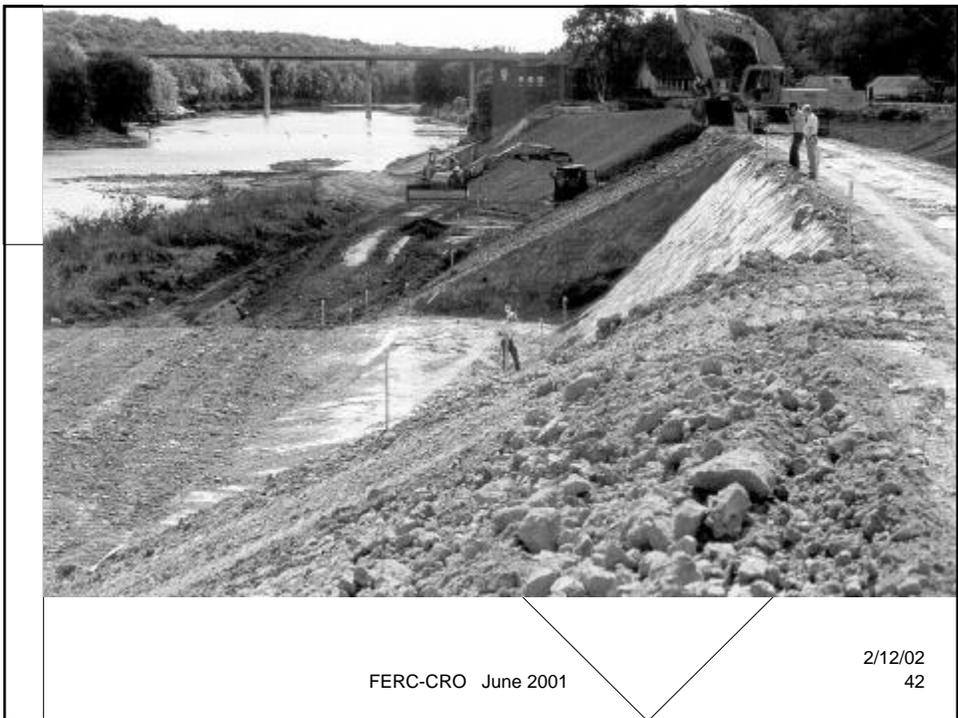
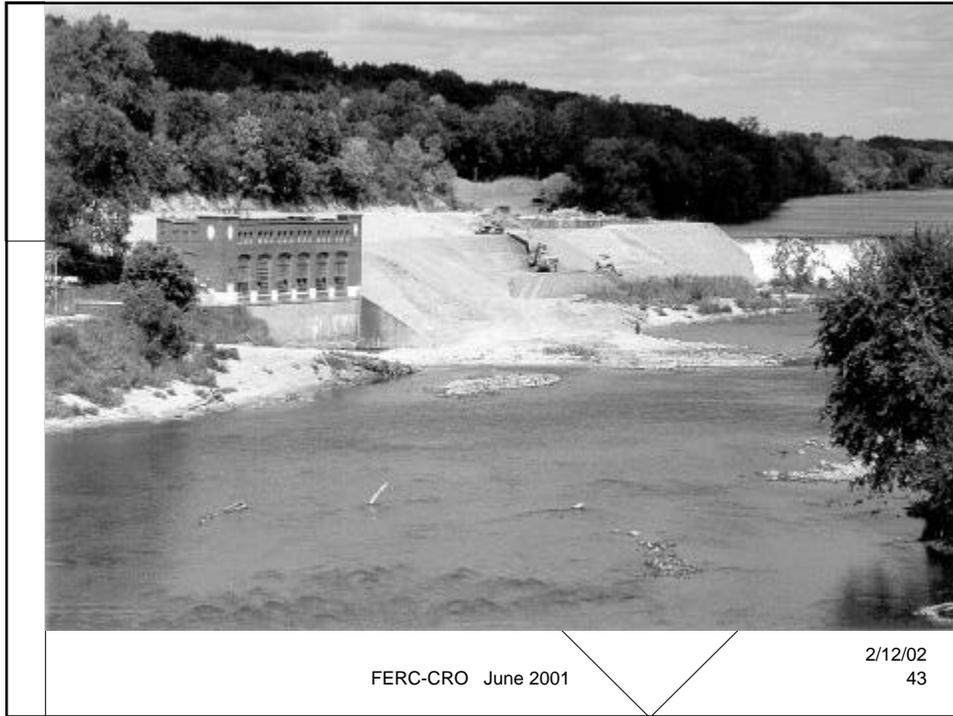
September 30, 1997 Inspection

- The next four photographs show the canal embankment substantially completed.
