# General Characterization of Damage

# 3

## 3.1 Flood Effects

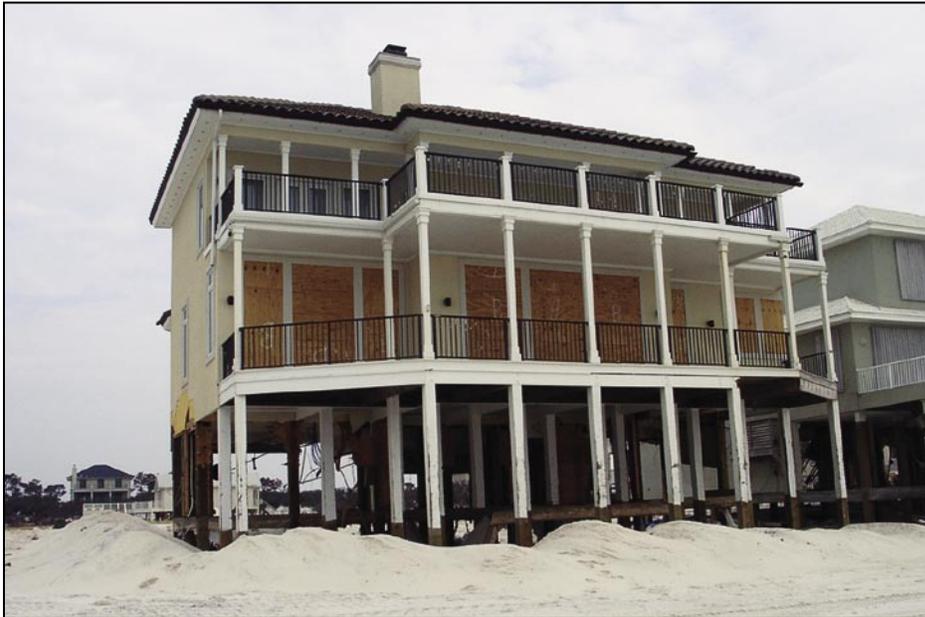
**Figure 3-1.** Buildings constructed on deep pile foundations performed well; however, significant damage occurred to lower-level enclosed areas and to stairways, utilities, and non-structural parking slabs below the elevated portion of the building.

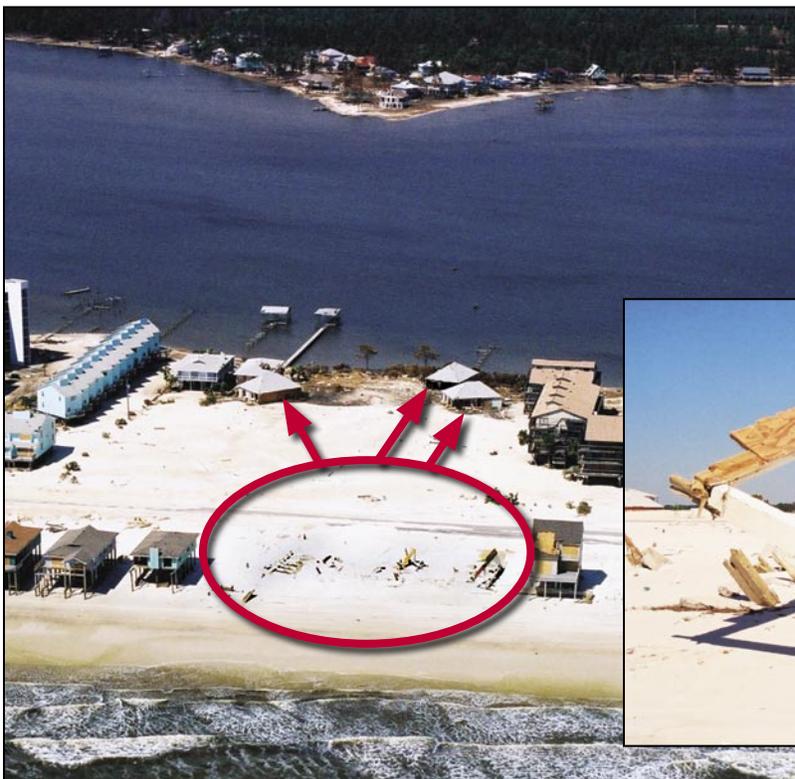
**Figure 3-2.** Insufficient pile embedment caused displacement of houses (Gulf Shores, West Beach)

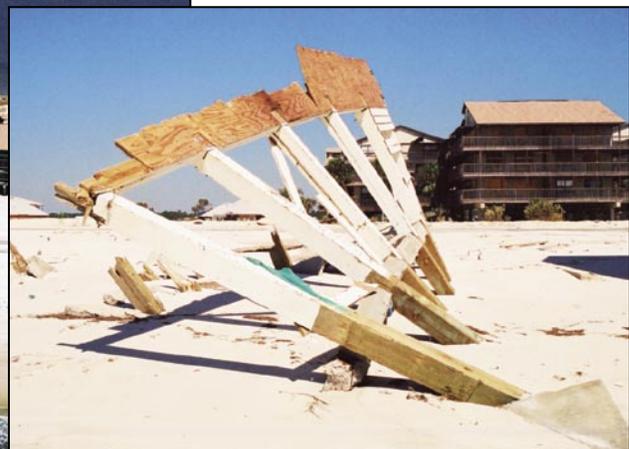
**Figure 3-3.** This building, which was less than 2 years old, was constructed on piers at the current BFE of 9 feet. It was severely damaged by high storm surge, and wave and debris impacts. (Big Lagoon)

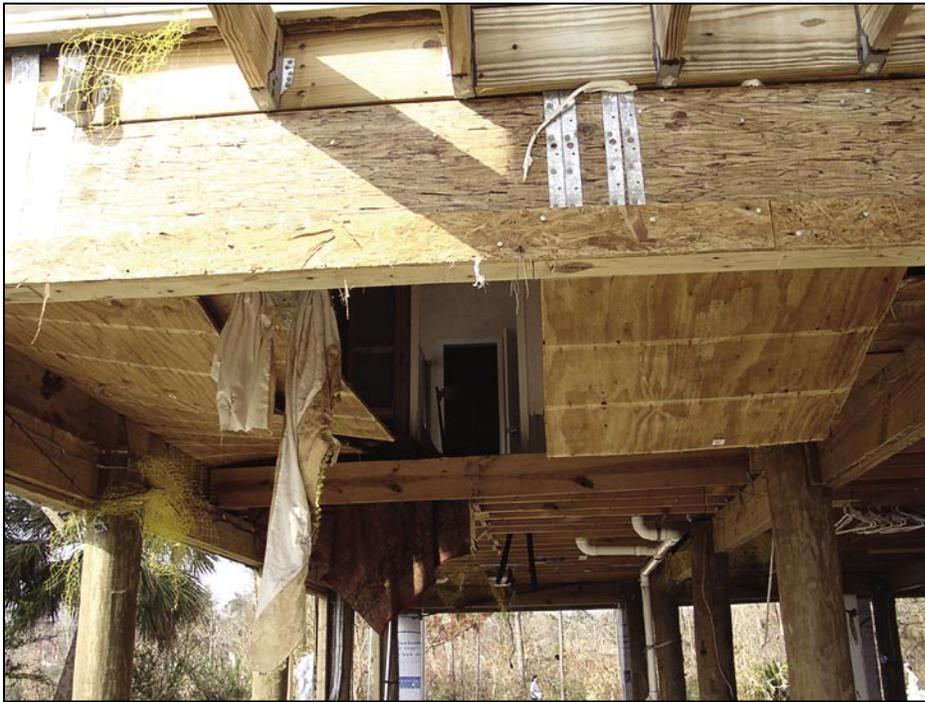
Even in areas where buildings were designed and elevated for high wave impacts, buildings suffered severe waterborne debris, surge, and wave damage when flood levels exceeded FIRM elevations by several feet, as shown in Figure 3-4.

Figure 3-4. Damage to NFIP-compliant elevated structure in a V Zone (north end of Escambia Bay-Floridatown)

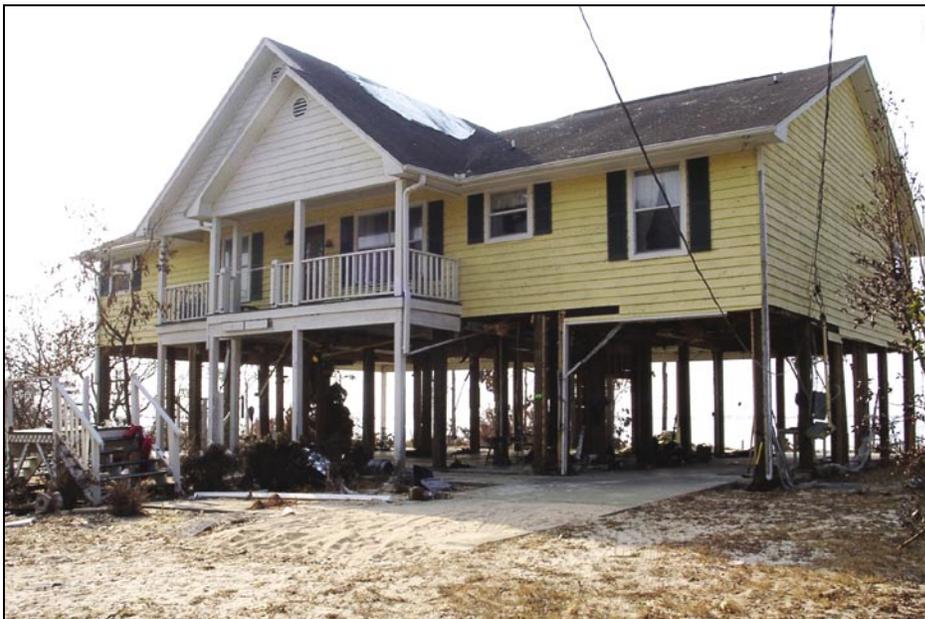
Figure 3-5. Buildings constructed on piles and elevated several feet above the BFE sustained less flood damage than adjacent buildings at lower elevations. (Big Lagoon)

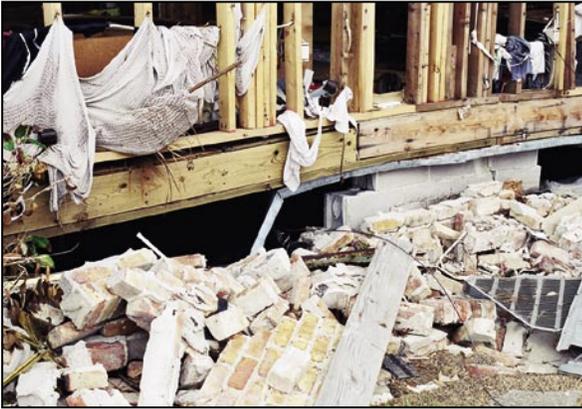
Figure 3-6. Surge, wave, and debris damage (Little Lagoon)

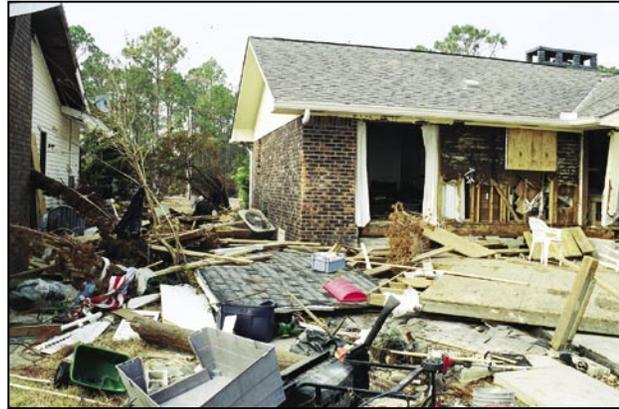
Figure 3-7.  
Older buildings below the  
current BFE sustained  
severe flood damage  
throughout the back  
bays. (Little Lagoon)

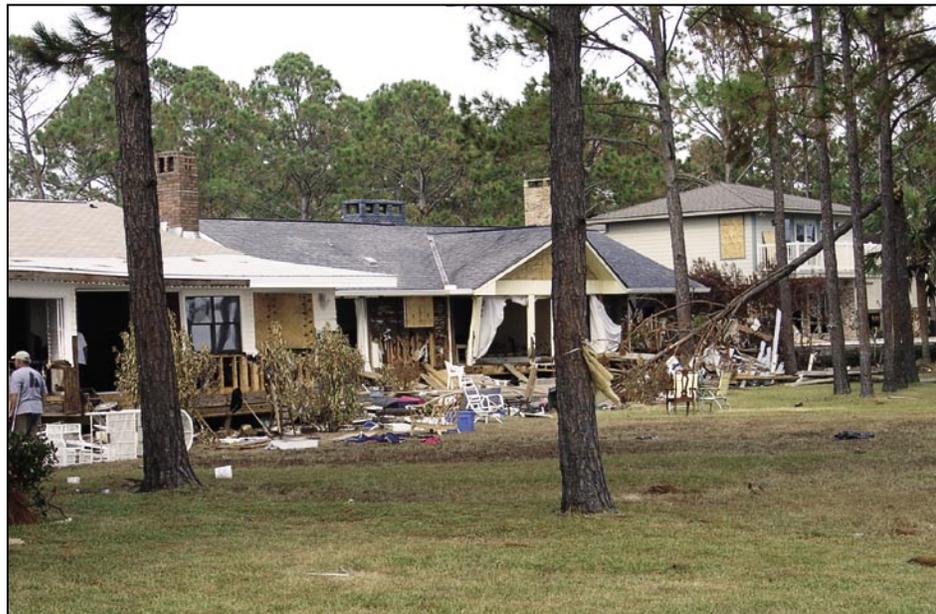
**Figure 3-8.** This new building was constructed to the BFE, but was wiped off its foundation (slab atop stem walls) by Ivan. The destruction was likely due to storm surge, wave action, and floodborne debris, although wind could have contributed to the breakup of the building (note pine tree leaning over slab). (Big Lagoon)

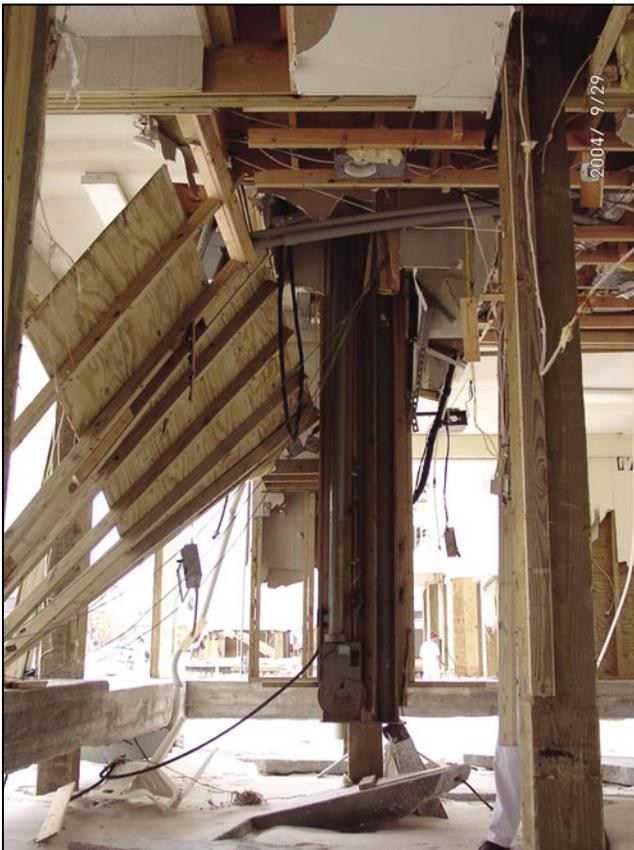
**Figure 3-9.** Utilities, parking slabs, and enclosed areas under an elevated building were severely damaged by the high flood elevations and wave action. (Gulf Shores)

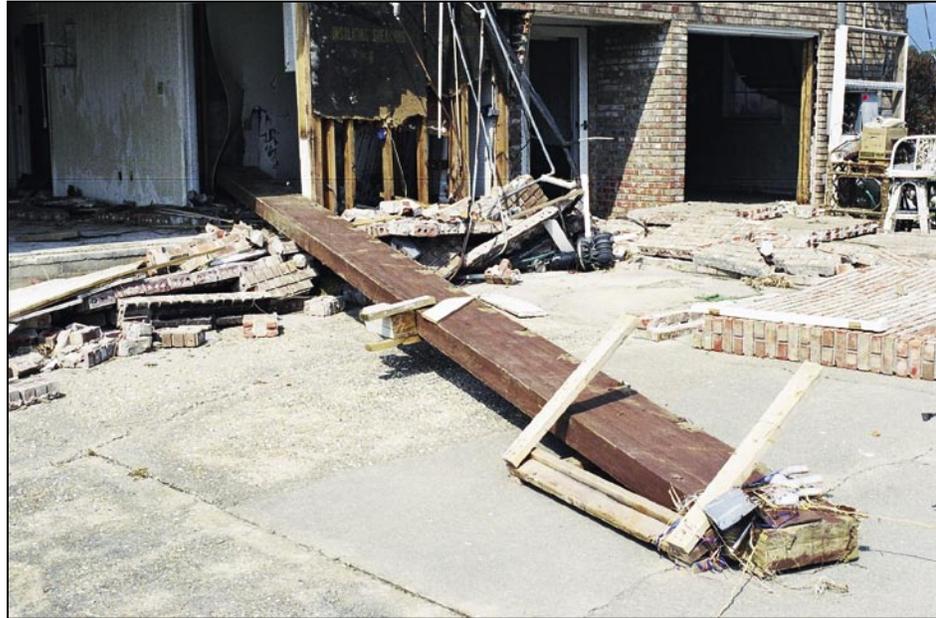
**Figure 3-10.**  
Large timbers washed  
from developments on  
Santa Rosa Island, across  
Santa Rosa Sound, and  
into several homes.  
(Santa Rosa Sound  
– Oriole Beach)

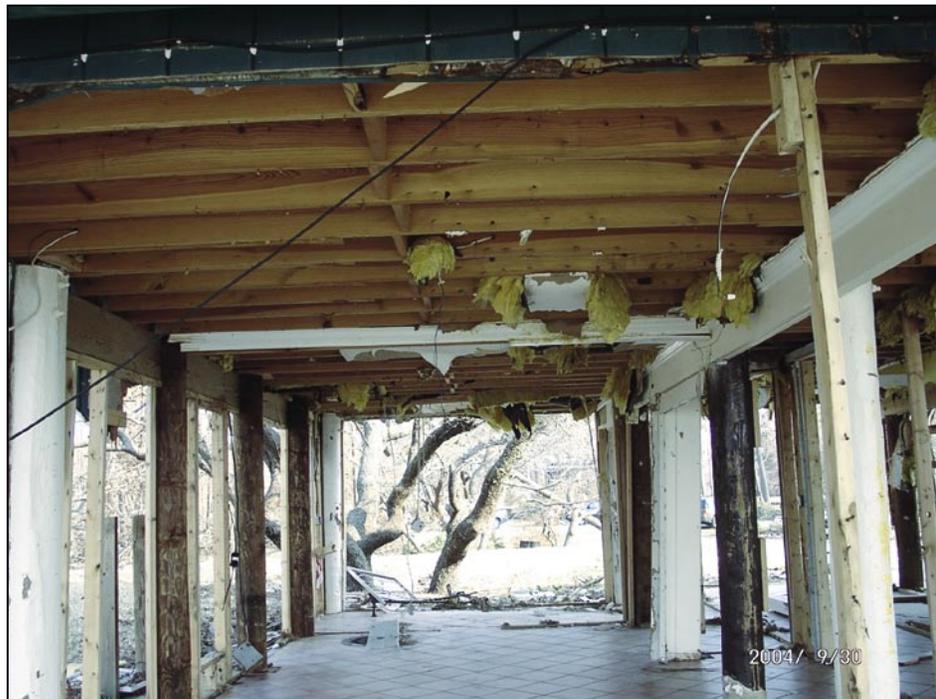
**Figure 3-11.**  
Significant floodborne  
debris contributed to  
the severe damage of  
at-grade enclosed area  
beneath an elevated  
building. (Big Lagoon)

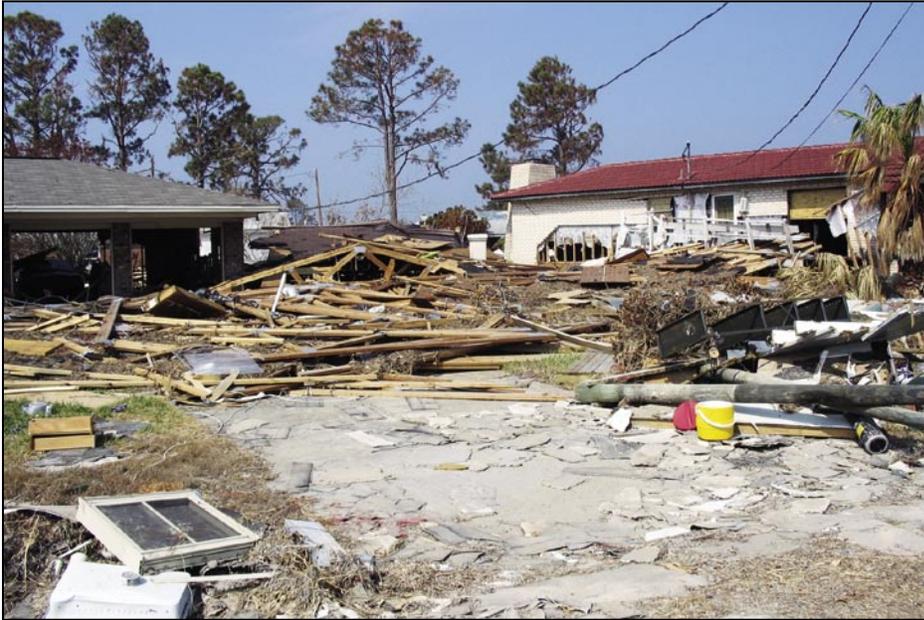
Figure 3-12. Significant floodborne debris contributed to the severe damage of buildings throughout the back bays and sounds in areas mapped as Zone AE. (Oriole Beach – Santa Rosa Sound)

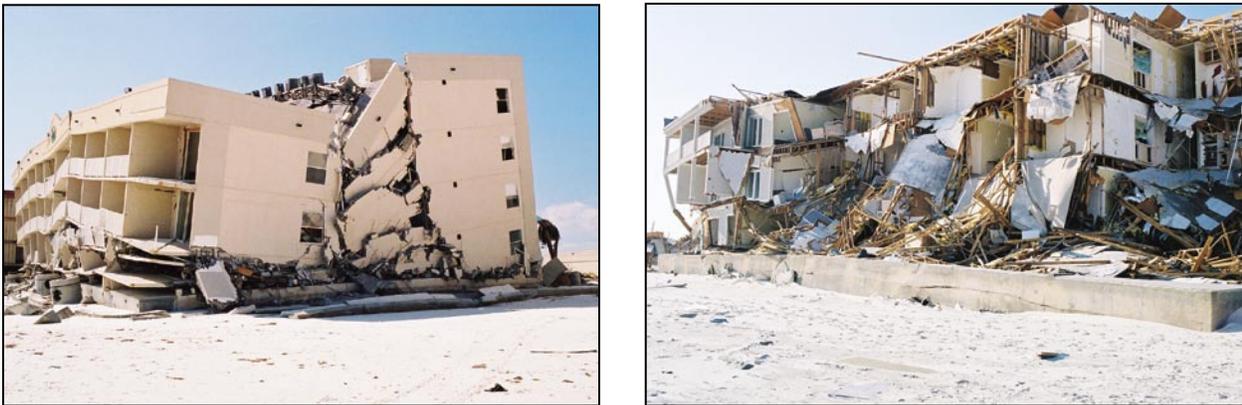
Many multi-story buildings (e.g., multi-family and commercial) along the Gulf shoreline suffered extensive surge, debris, and erosion damage to their lowest floor levels, pool decks, and bulkheads. The most extreme cases were complete building collapse due to undermining of shallow foundations (see Figure 3-13).

Figure 3-13. Collapse of 5-story, multi-family buildings on shallow foundations (Orange Beach)

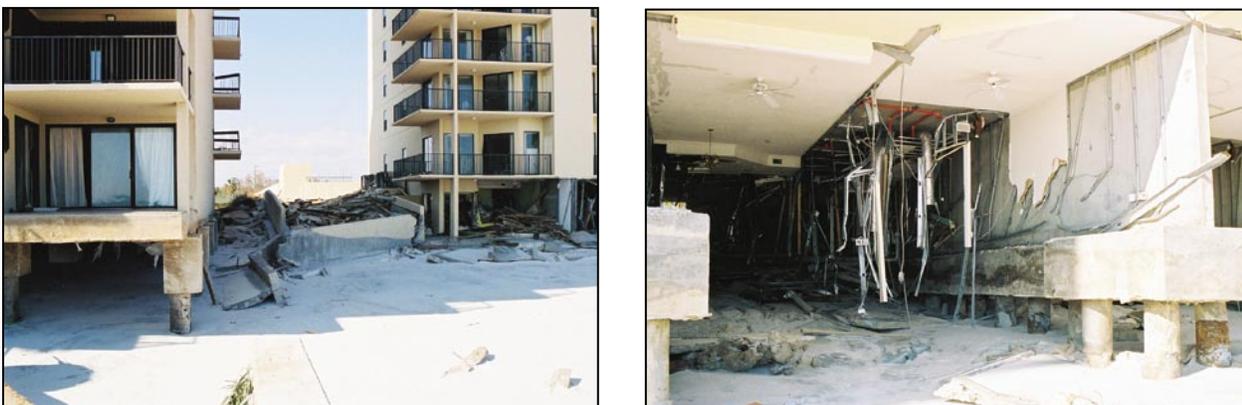
Figure 3-14. Pile foundations performed well, but non-structural floor slabs collapsed and low-elevation living units were destroyed. (Orange Beach)

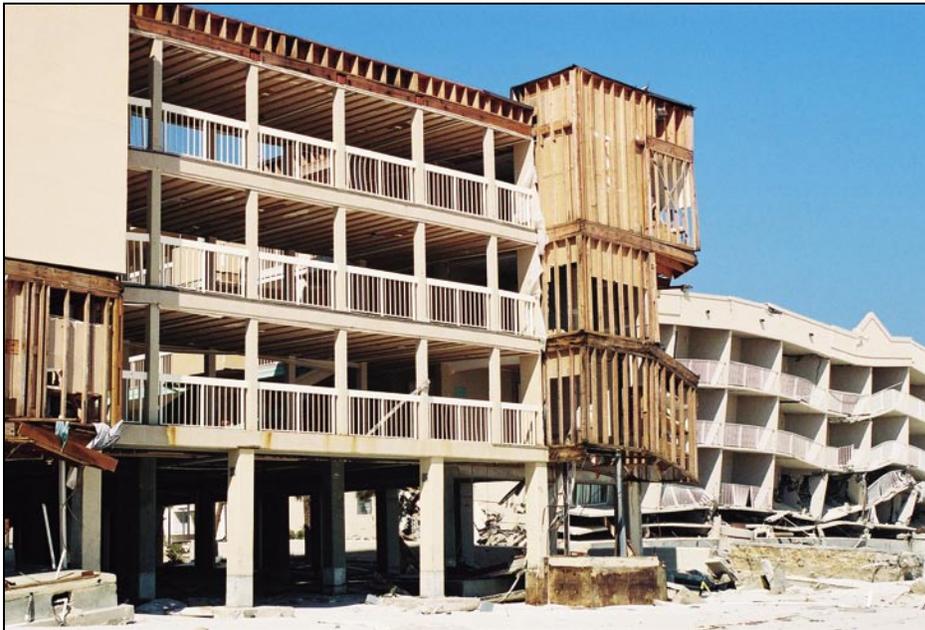
Figure 3-15. Building supported on pile foundation (foreground) survived while building on shallow foundation (background) collapsed. (Orange Beach)

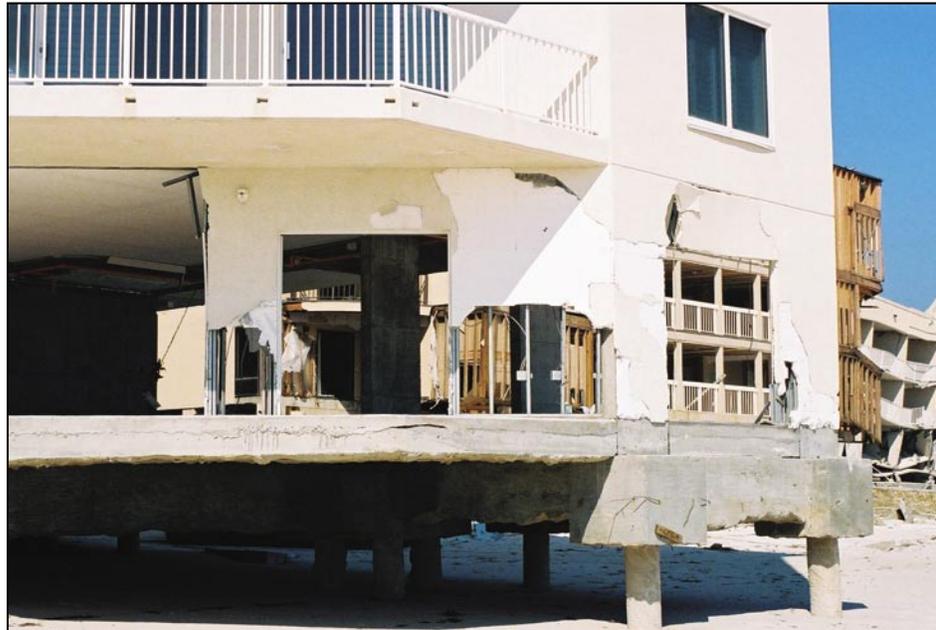
The study also found that the most common damage state was with the lowest floor intact and the non-structural walls destroyed (see Figures 3-16 and 3-17; this occurred in 21 of the 39 buildings, in 101 of the 233 lowest floor living units). The next most common damage state was lowest floor and walls destroyed (this occurred in 15 of the 39 buildings, in 58 of the 233 lowest floor living units). Fully intact conditions (no damage to the lowest floor or lowest floor living units) occurred at only 6 of the 39 buildings, and 28 of the 233 lowest floor living units.

**Figure 3-16.**  
Foundation and structural floor slab survived but lowest floor non-structural exterior walls were destroyed by surge and waves (Orange Beach)

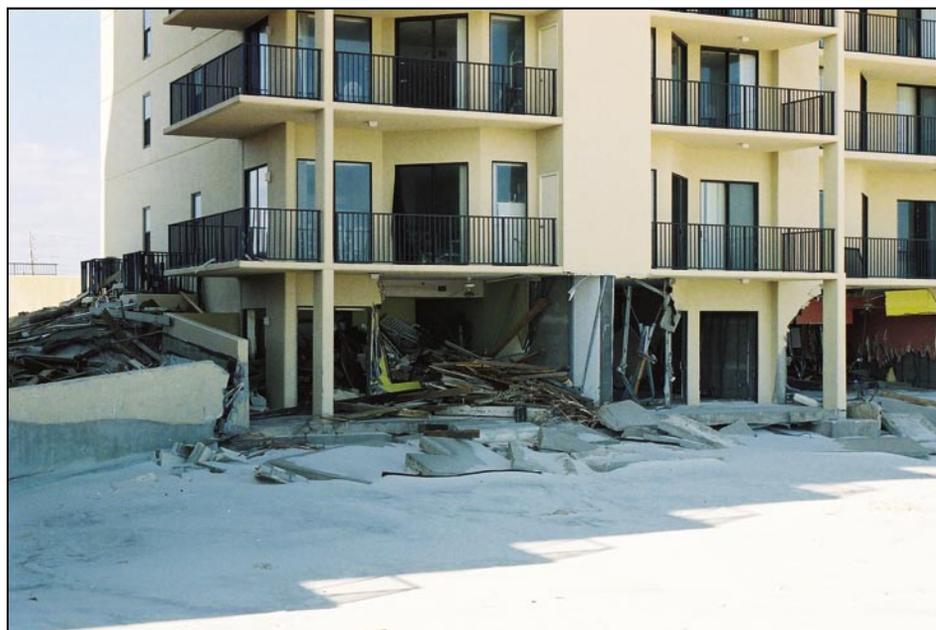
**Figure 3-17.**  
Destruction of low-elevation living units by surge and waves, while second floor units survived intact (Orange Beach)

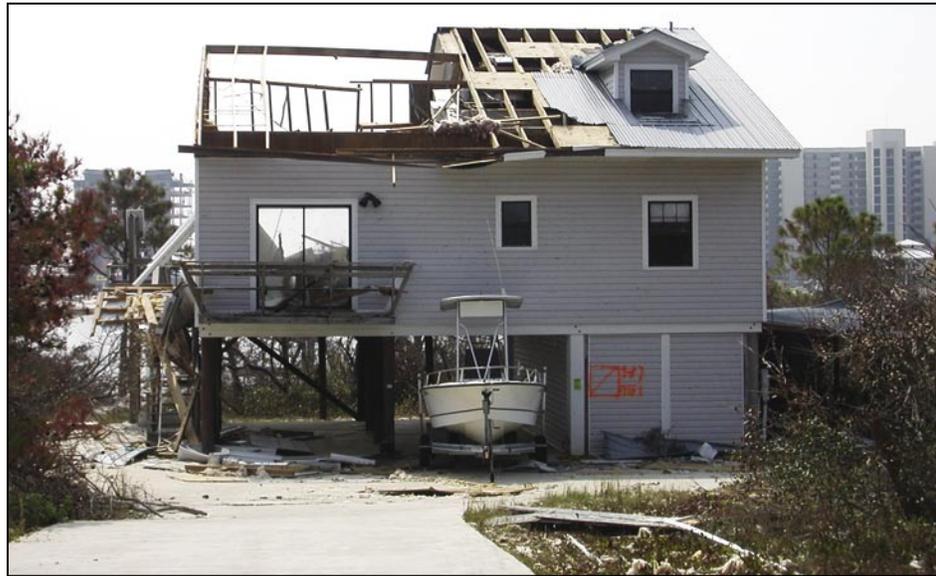
**Figure 3-18.**  
Typical wind damage  
showing loss of roof  
sheathing and damage  
to structural roof framing  
(Ono Island)

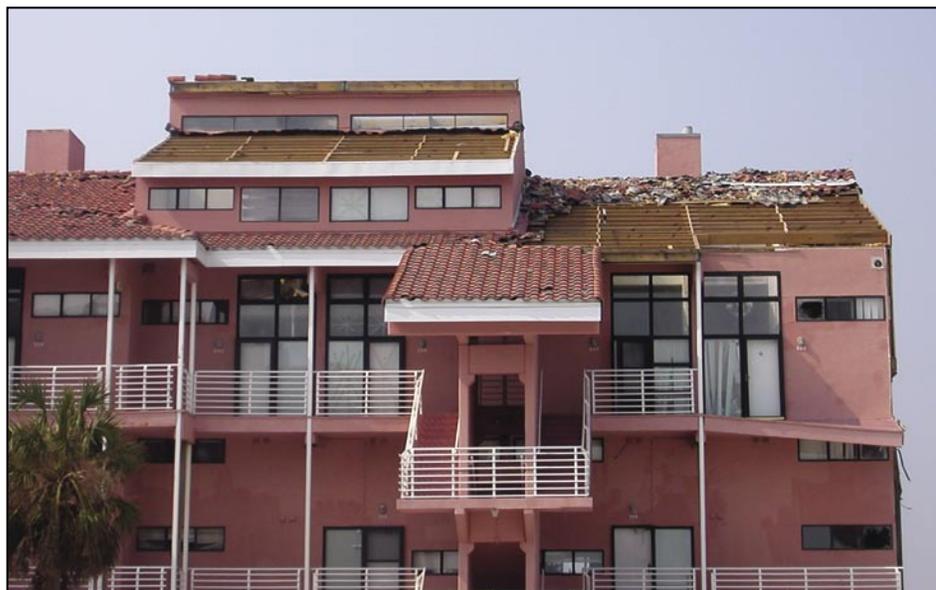
**Figure 3-19.**  
Typical roof sheathing  
and covering loss  
(Pensacola Beach)

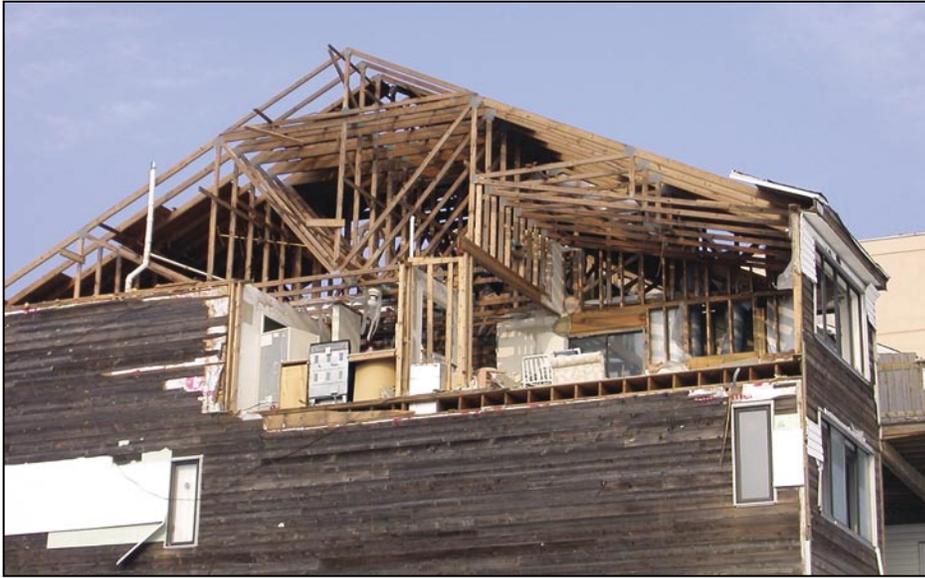
Figure 3-20.  
Typical gable end wall  
failure and loss of roof  
sheathing and wall  
(Perdido Key)

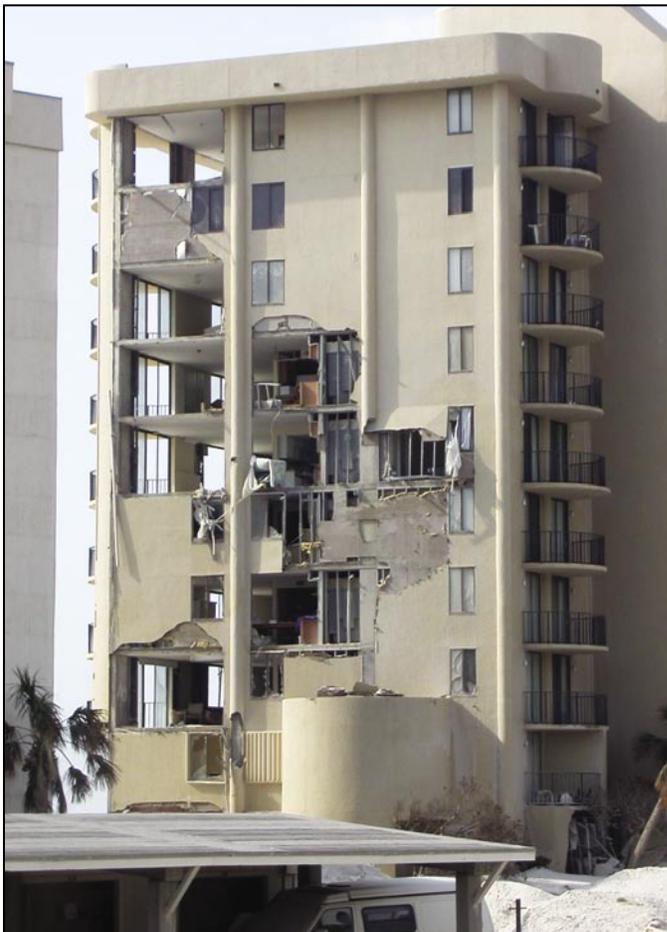
Figure 3-21.  
Typical high rise cladding failure (Perdido Key)

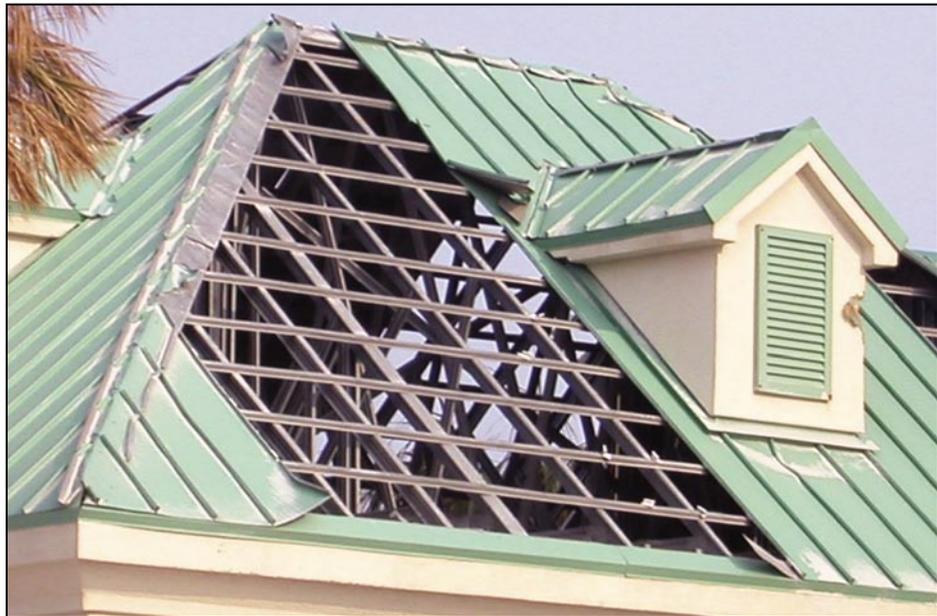
Figure 3-22.  
Commercial building  
roof covering failure  
(Pensacola Beach)

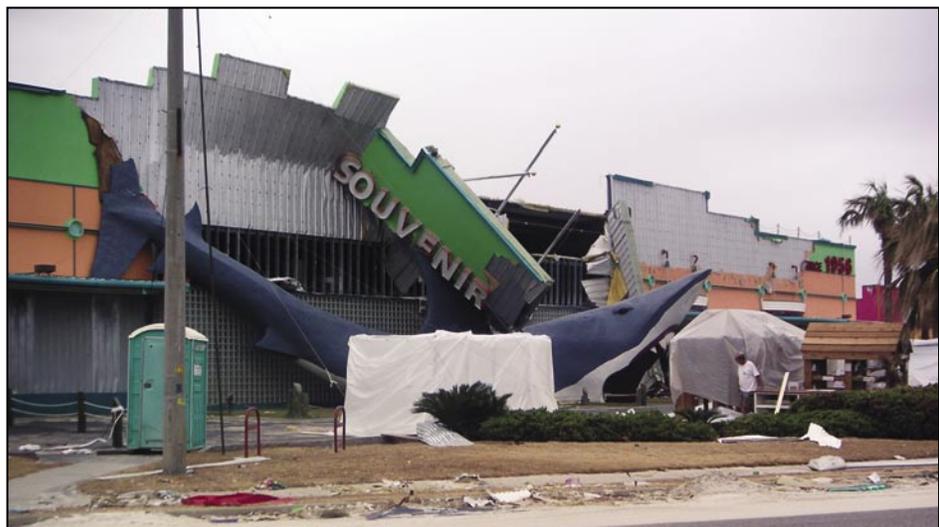
Figure 3-23.  
Commercial building wall  
cladding and secondary  
structure failure  
(Gulf Shores)

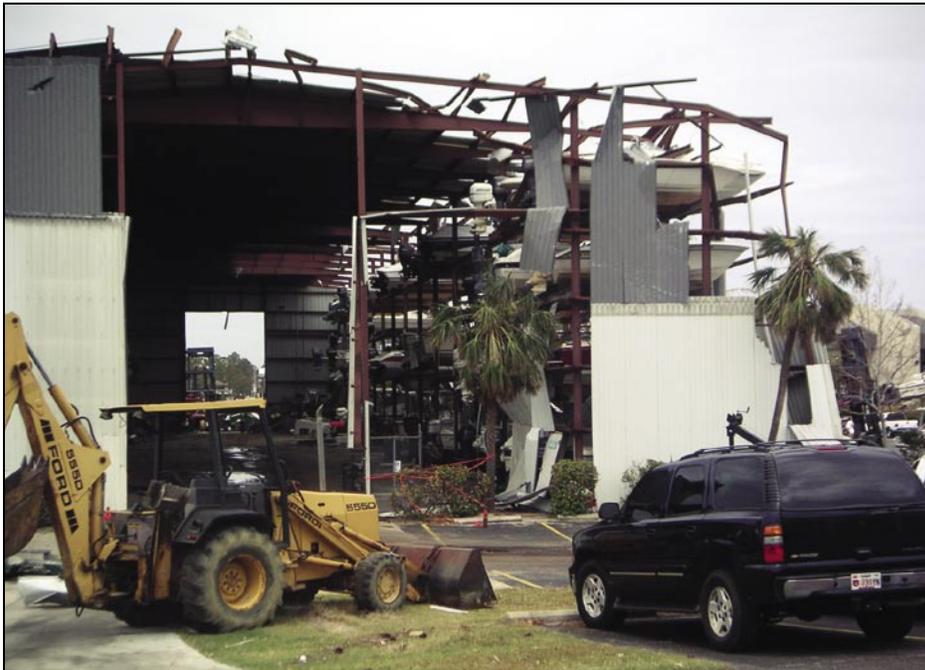
Figure 3-24.  
Pre-engineered metal  
building damage  
(Orange Beach)

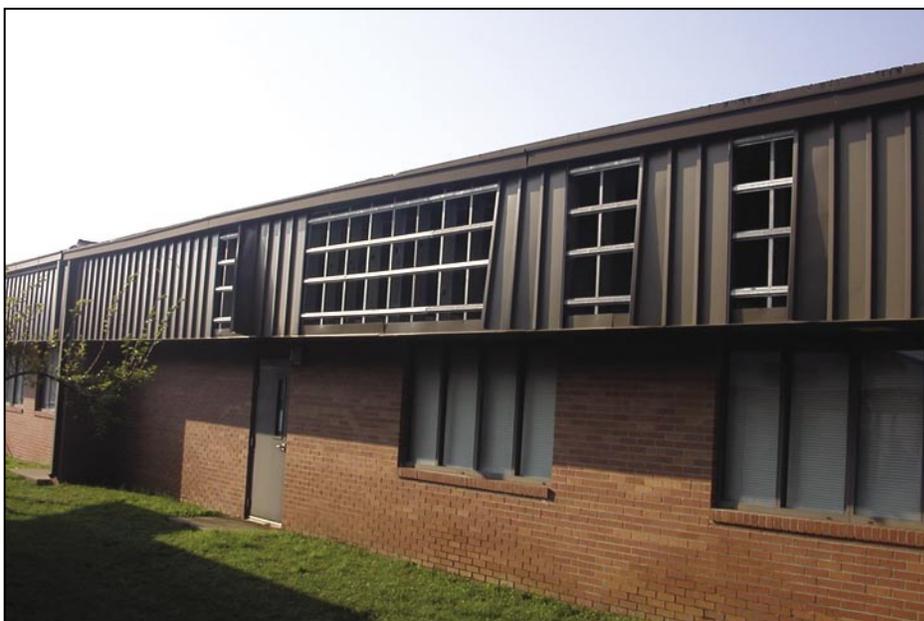
Figure 3-25.  
Metal wall panel damage  
to middle school  
(Gulf Breeze)

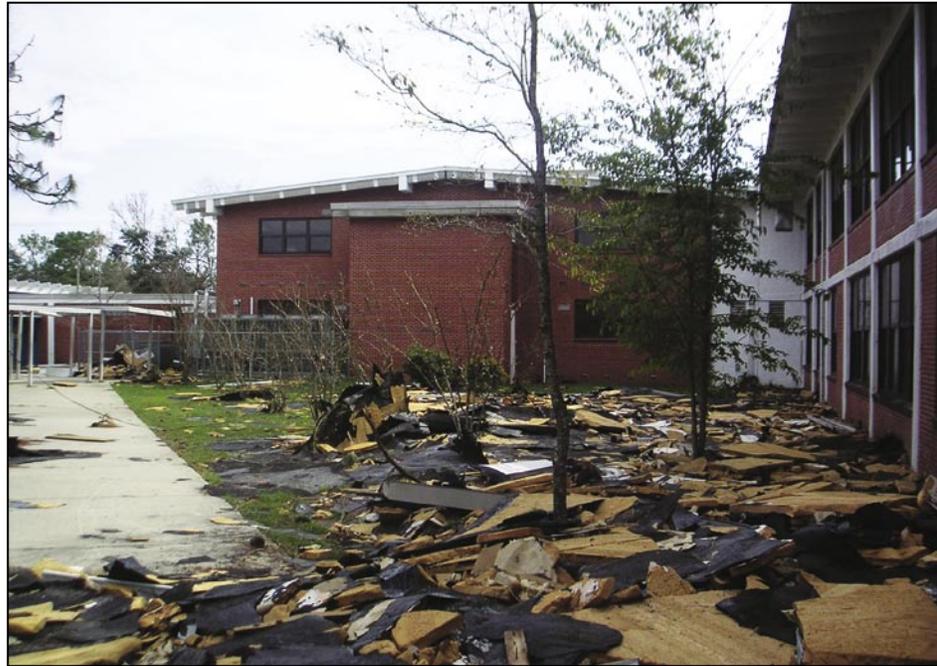
Figure 3-26.  
Roof covering and roof  
deck damage to middle  
school (Pensacola)

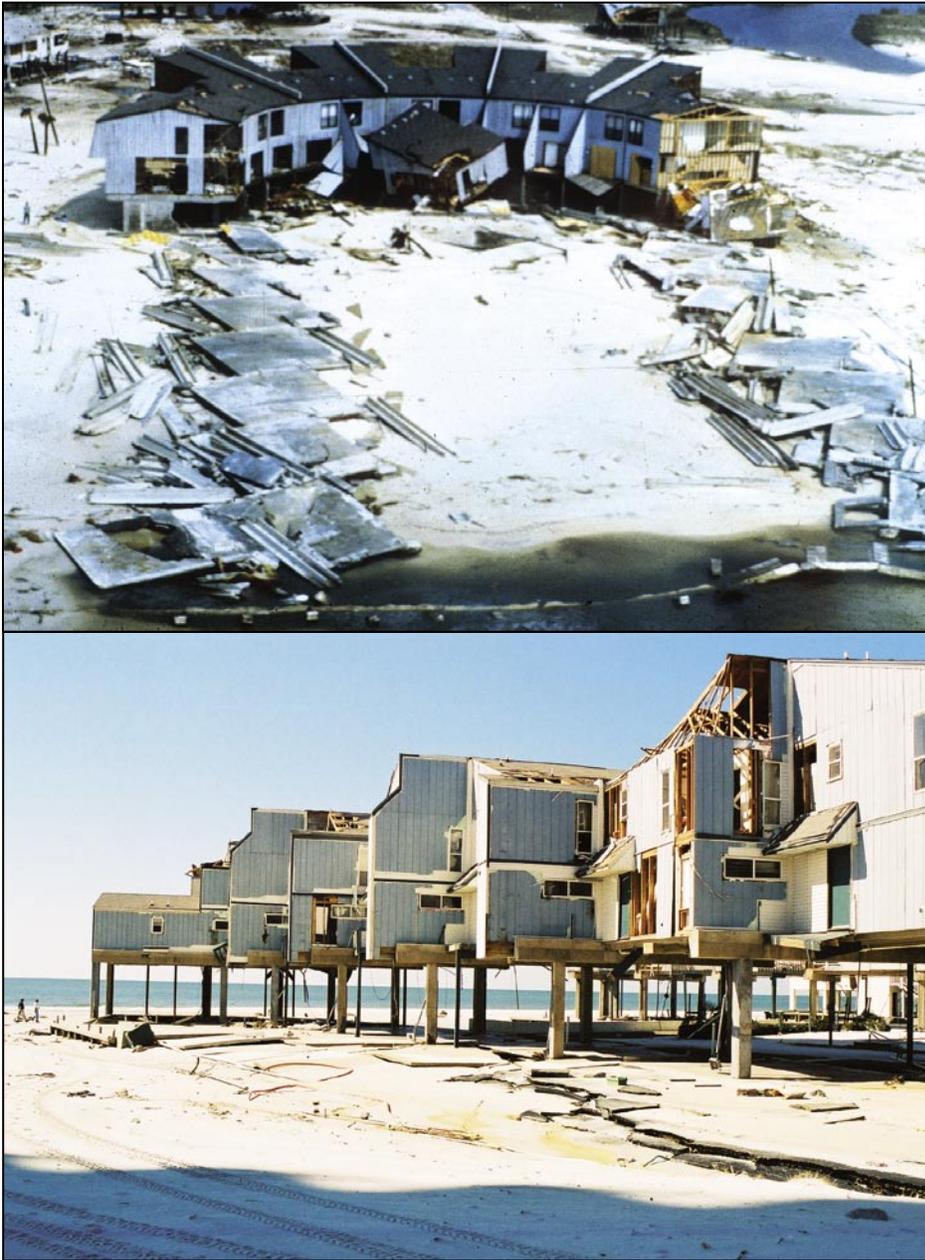
One of the best known examples is a U-shaped condominium in Gulf Shores. The original building was elevated on solid walls and was destroyed by surge and wave effects during Hurricane Frederic in 1979 (see Figure 3-27, upper photo). The building was reconstructed after Frederic on an open foundation (concrete columns atop pile caps and deep pilings). Even though the foundation survived Hurricane Ivan (Figure 3-27, lower photo), the MAT team observed significant wind damage and corrosion. Closer inspection (Figure 3-28) revealed the concrete columns elevating the building had been deteriorating for some time (i.e., chloride penetration into the concrete, corrosion of the reinforcing steel, and spalling of the concrete cover), and prior efforts to patch the columns were evident. This points out the need for constructing near the coast with sound, durable materials and high-quality workmanship.

Figure 3-27. After this building was destroyed by Hurricane Frederic in 1979 (upper photo), it was re-constructed on concrete columns, pile caps, and deep piles. The foundation survived Hurricane Ivan; however, the building experienced significant wind damage (lower photo). (Gulf Shores)

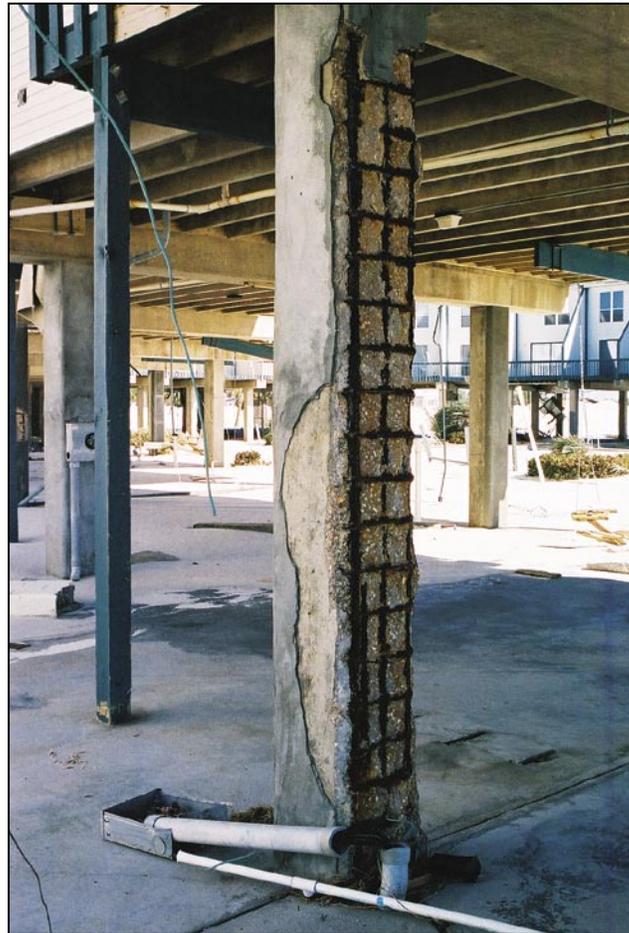
**Figure 3-28.** Severe corrosion of reinforcing steel and spalling of the concrete columns supporting the post-Frederic building shown in Figure 3-27. Note evidence of prior attempts to repair the columns.

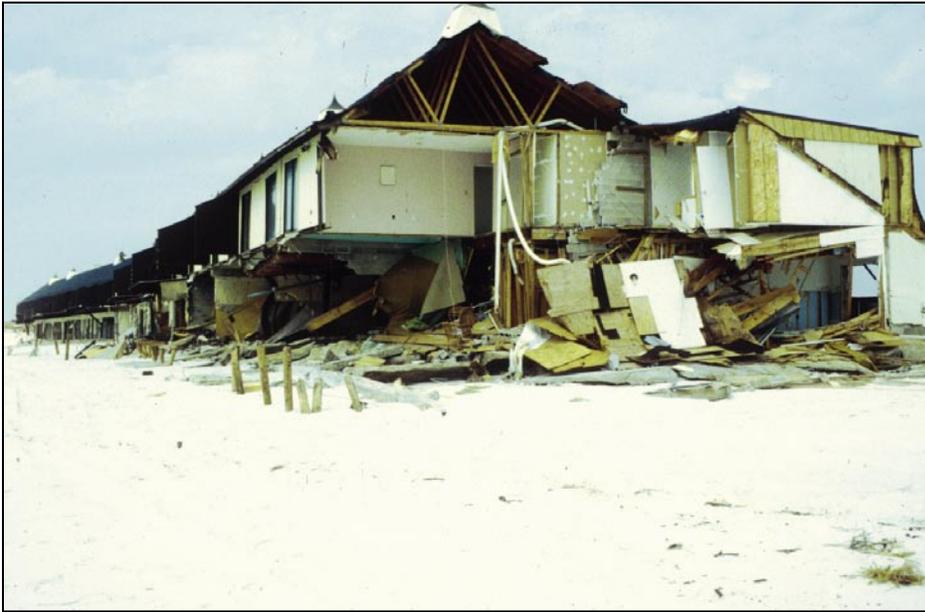
Figure 3-29.  
Hurricane Opal (1995)  
flood damage to one of  
the four original buildings

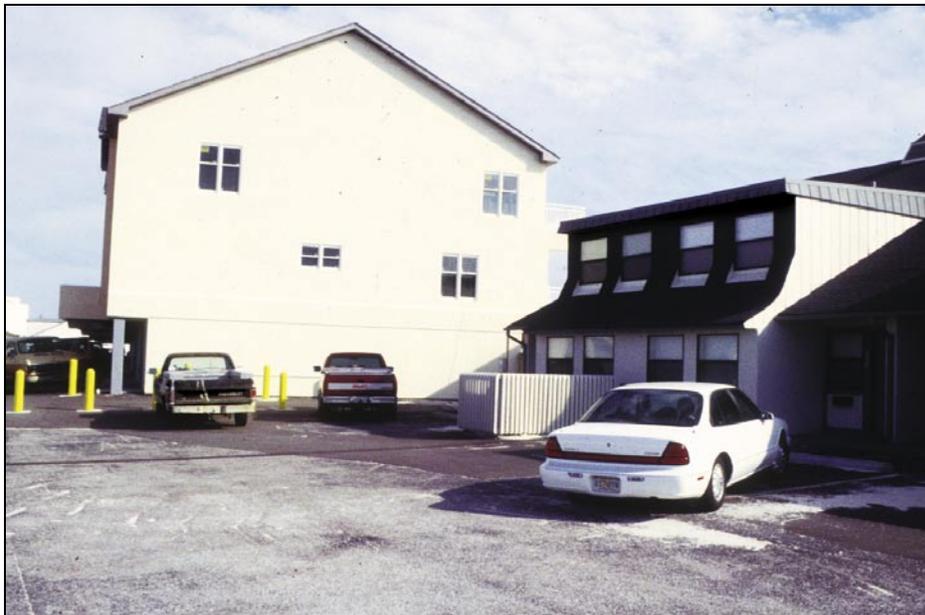
Figure 3-30.  
1998 photograph  
showing the post-  
Opal replacement (pile  
supported) building  
(background) and one of  
the three remaining older  
buildings (foreground)

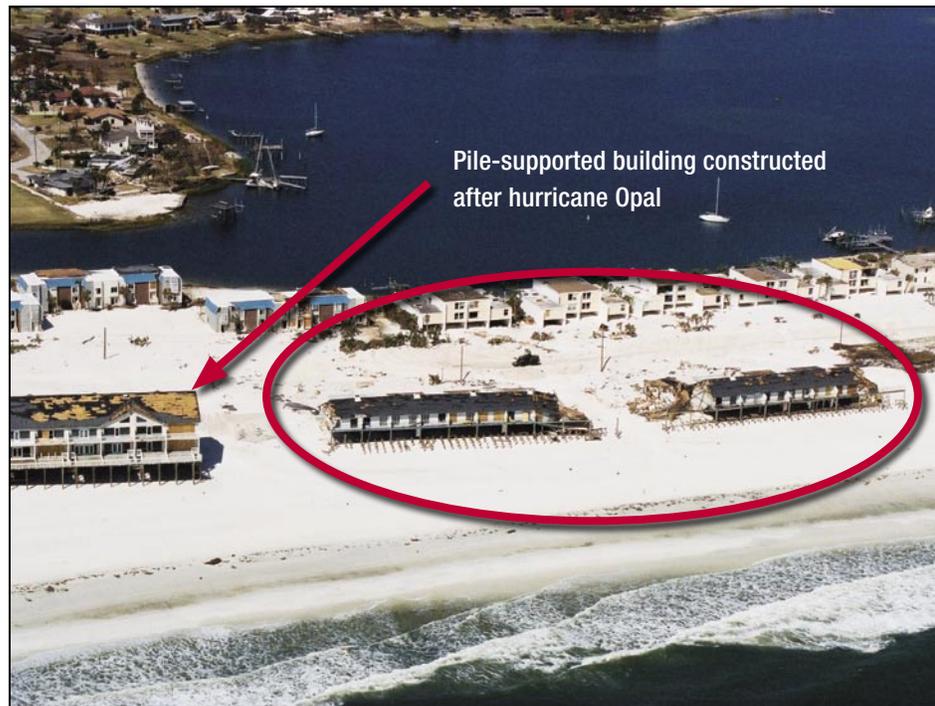
Figure 3-31.  
Post-Ivan aerial  
photograph showing  
severe flood damage to  
two of the three older  
buildings, with newer,  
pile-supported building  
intact (left side)

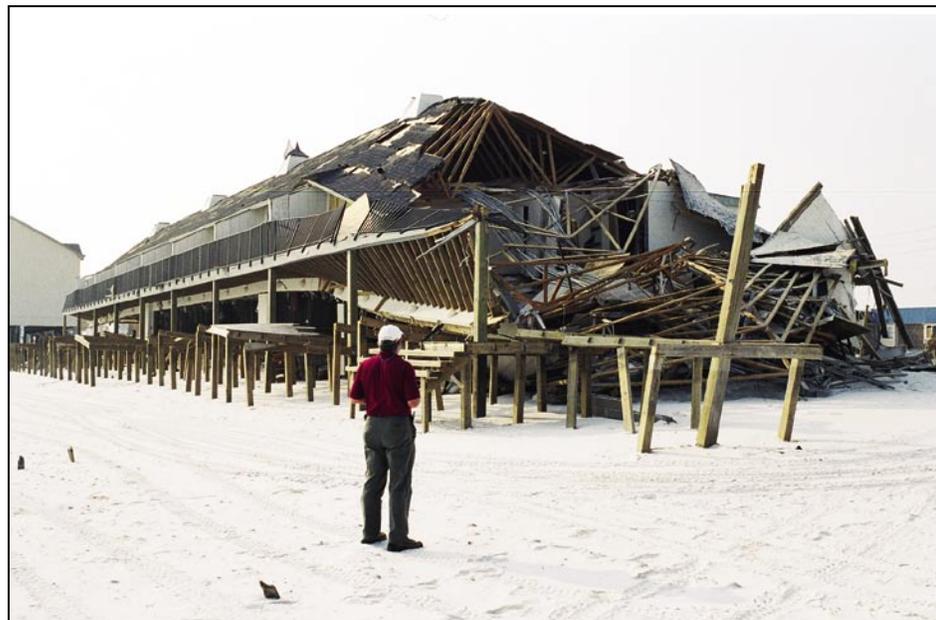
Figure 3-32.  
Ivan flood and wind  
damage to older building  
(post-Opal building  
visible at far left)

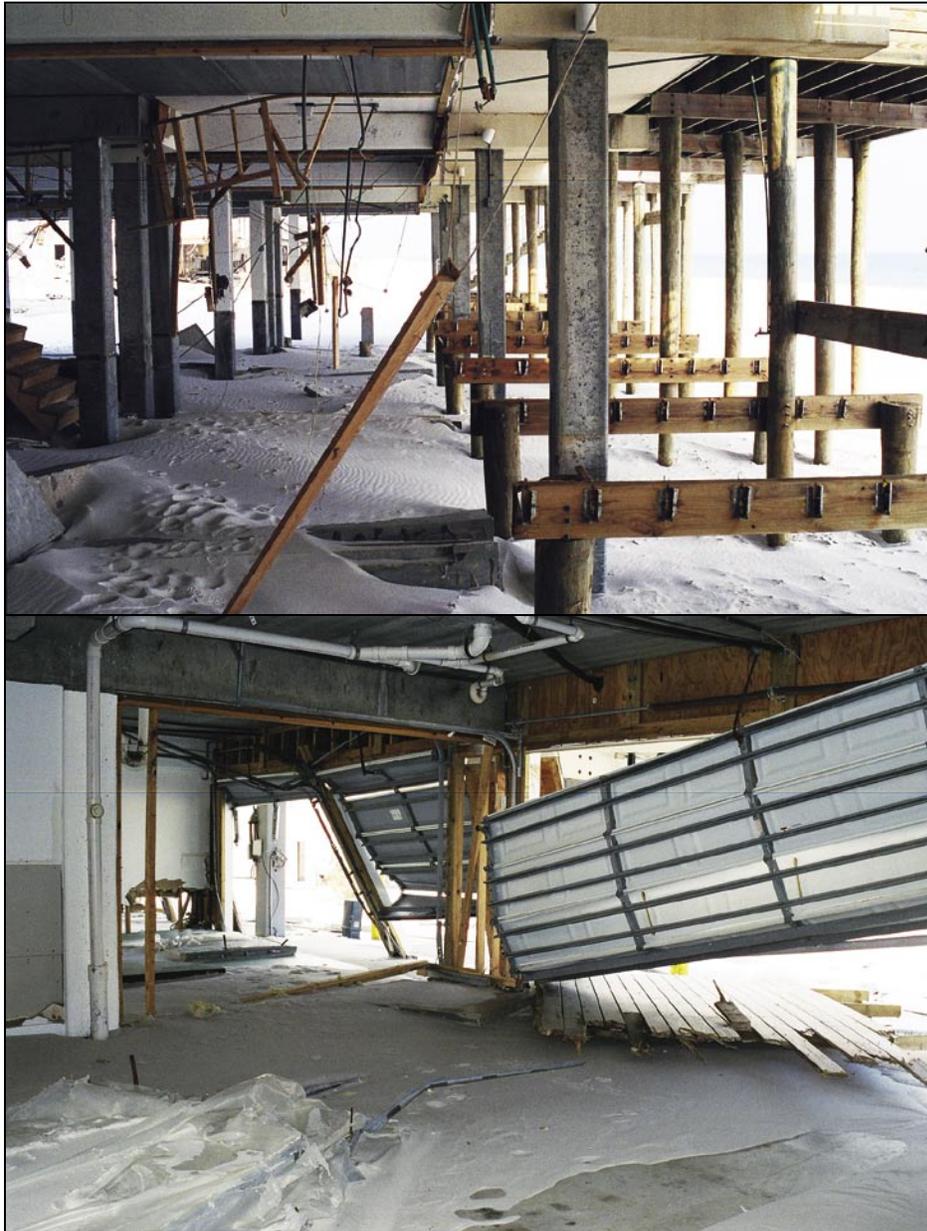
Figure 3-33.  
Hurricane Ivan, non-  
structural enclosure and  
deck damage below  
newer building

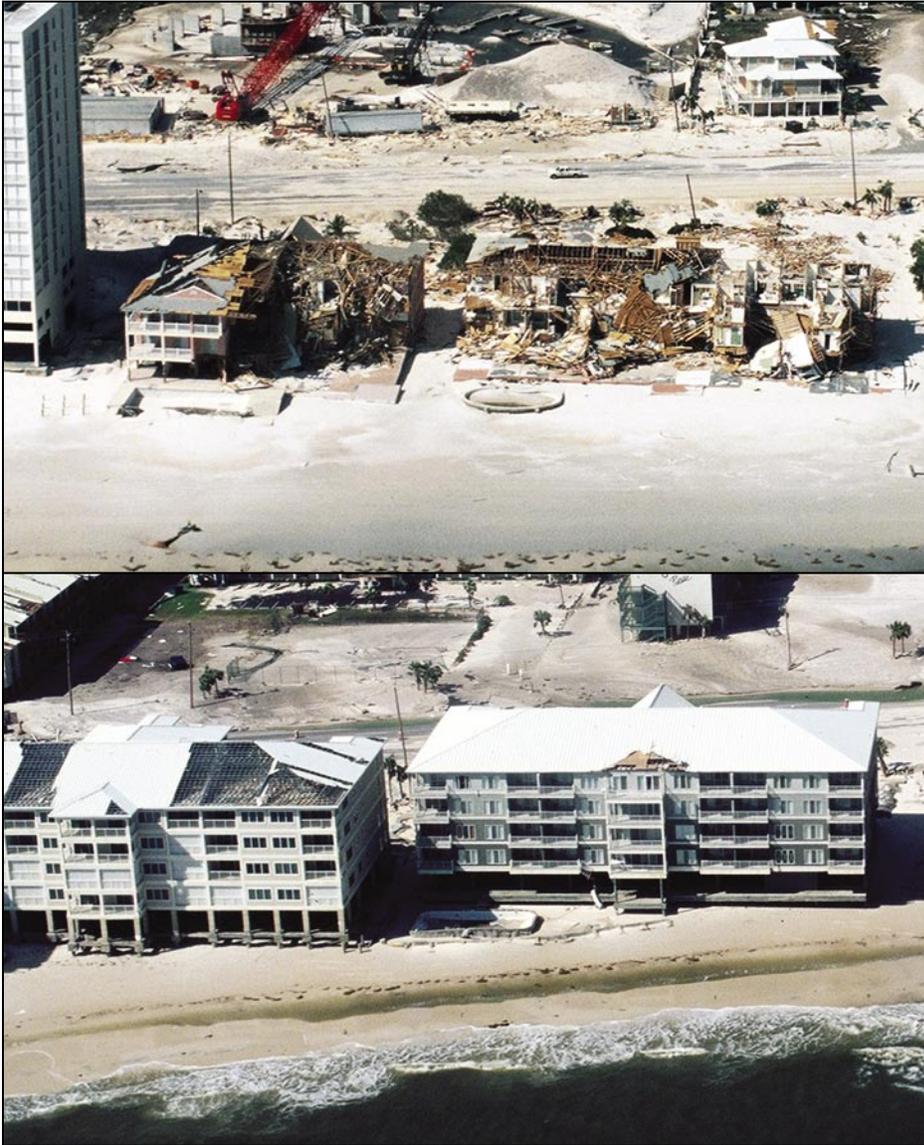
The MAT observed 4 condominiums in close proximity to each other on Perdido Key. They are shown in their pre-Ivan condition in Figure 3-34, and after Ivan in Figure 3-35. The lower pairs of buildings in each figure were newer, having been rebuilt after their predecessors (built on shallow foundations) collapsed during Hurricane Georges (1998). The upper pair of buildings (also on shallow foundations) survived Georges but collapsed during Ivan.

The lessons learned in Hurricane Georges served the owners of the bottom pair of buildings well during Ivan. These buildings were re-constructed following Georges with deep-pile foundation systems, and the foundations performed well during Ivan. The building on the left lost the ground floor parking slab as seen in Figure 3-36, and suffered substantial roof covering loss due to wind. The building on the right had a structural parking slab, which was undermined by Ivan but undamaged. The building had only minor cladding damage due to the wind.

Figure 3-35. The four condominiums in Figure 3-34 after Hurricane Ivan. The newer buildings on pile foundations survived, while the older buildings on shallow foundations collapsed. However, the newer building on the lower left experienced significant interior water damage due to roof loss. (USGS)
