# General Characterization of Damage

# 3

## 3.1 Flood Effects

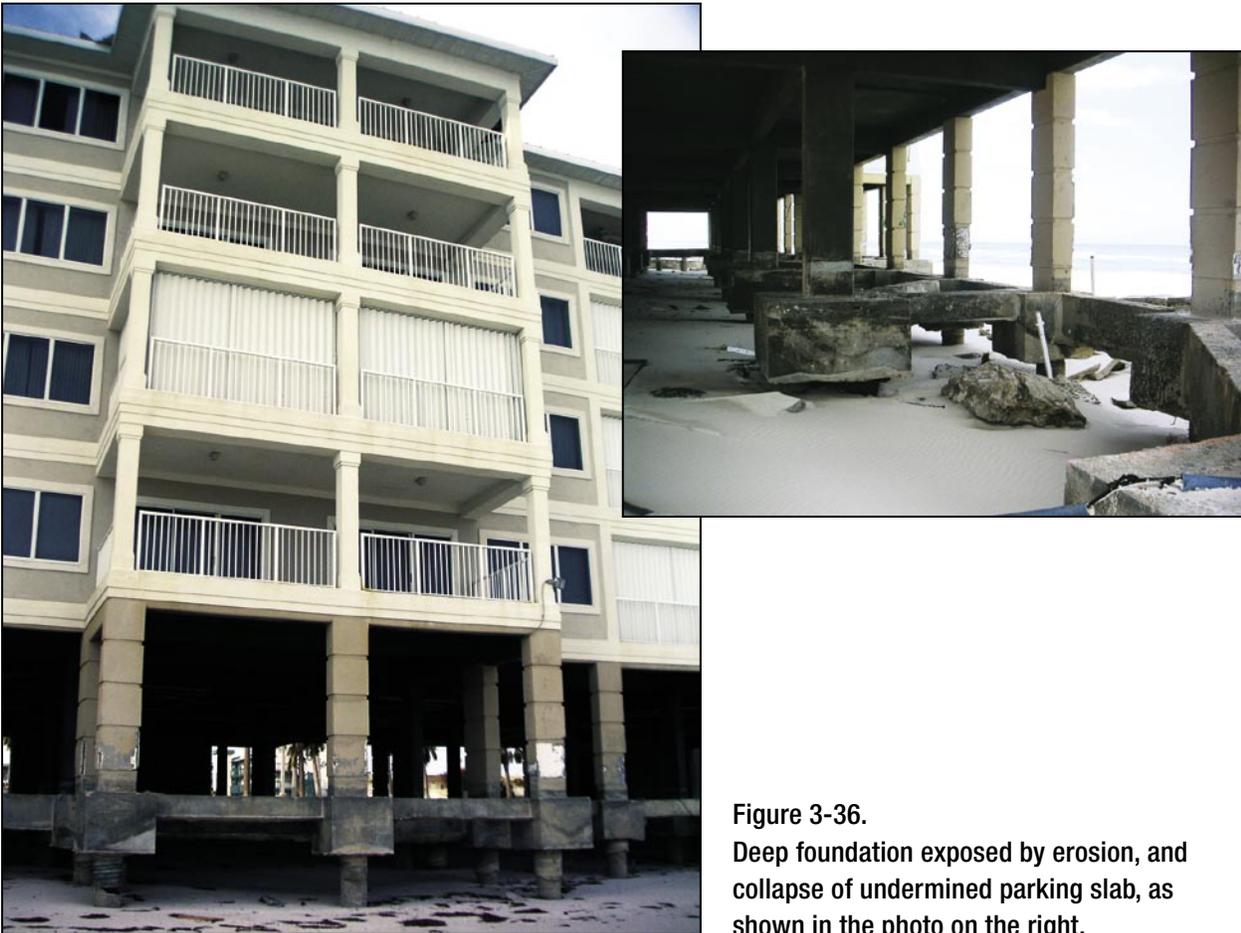
**Figure 3-36.**  
Deep foundation exposed by erosion, and collapse of undermined parking slab, as shown in the photo on the right.

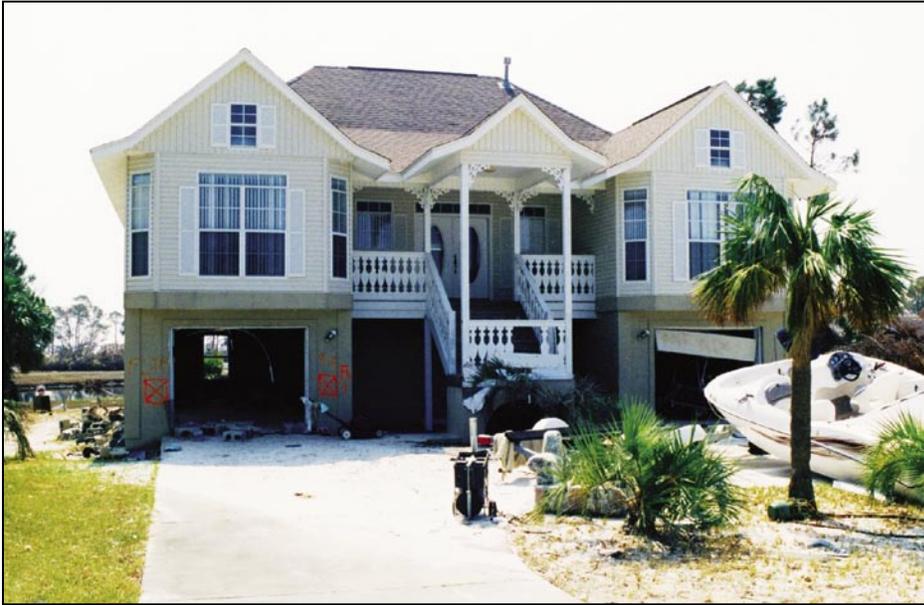
Figure 3-37.  
Elevated building  
constructed to newer  
code that survived  
Hurricane Ivan (Big  
Lagoon)

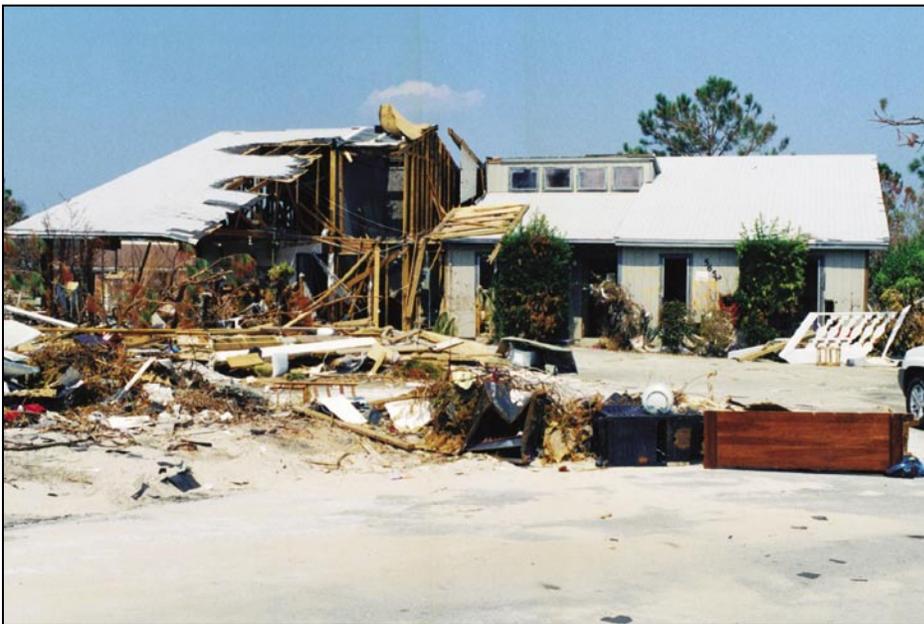
Figure 3-38.  
Older, non-elevated  
building (near building  
in Figure 3-37) severely  
damaged in Hurricane  
Ivan (Big Lagoon)

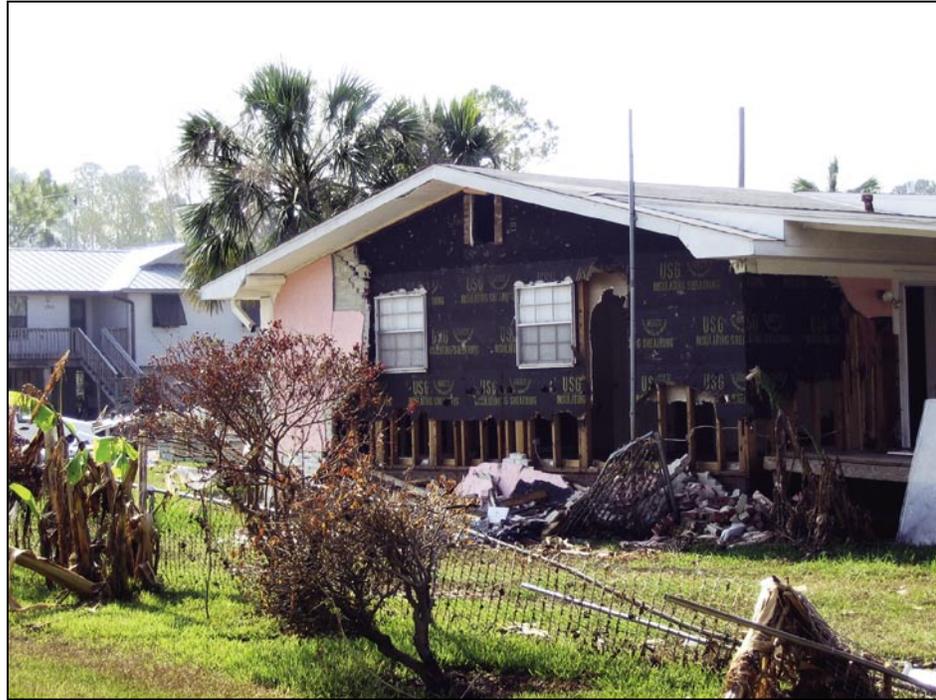
**Figure 3-39.**  
House on La Paz Street  
that was not elevated to  
the current BFEs, and,  
therefore, was severely  
damaged by the high  
coastal flooding and  
wave impacts

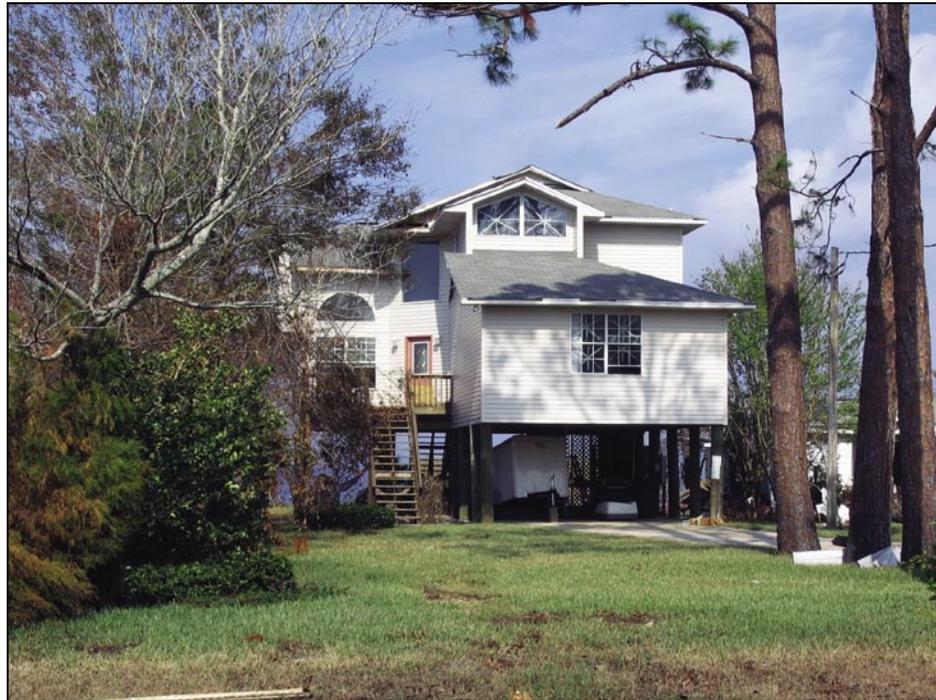
**Figure 3-40.**  
House on La Paz Street  
that was elevated on  
piles, which prevented  
severe damage from  
coastal flooding

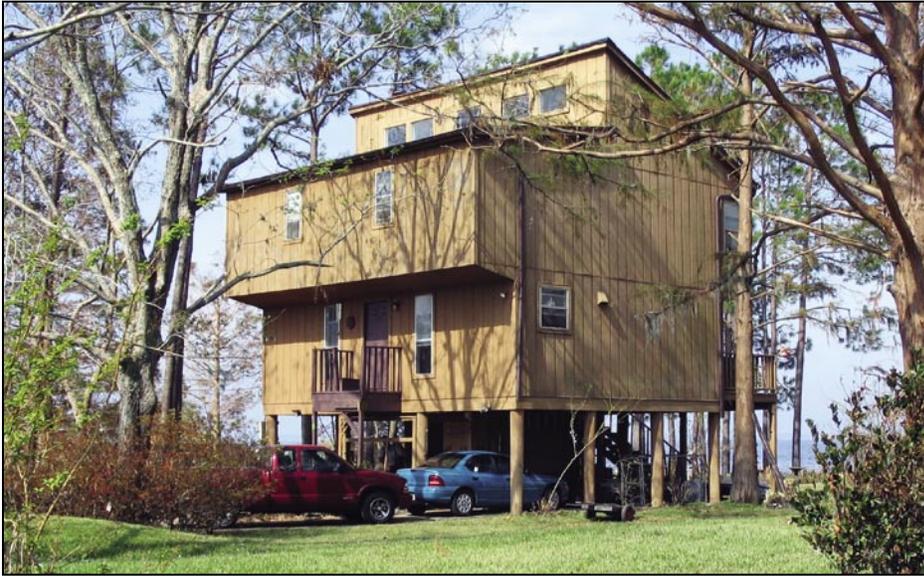
Figure 3-41.  
House on La Paz that  
was elevated on piles,  
which prevented major  
flood damage

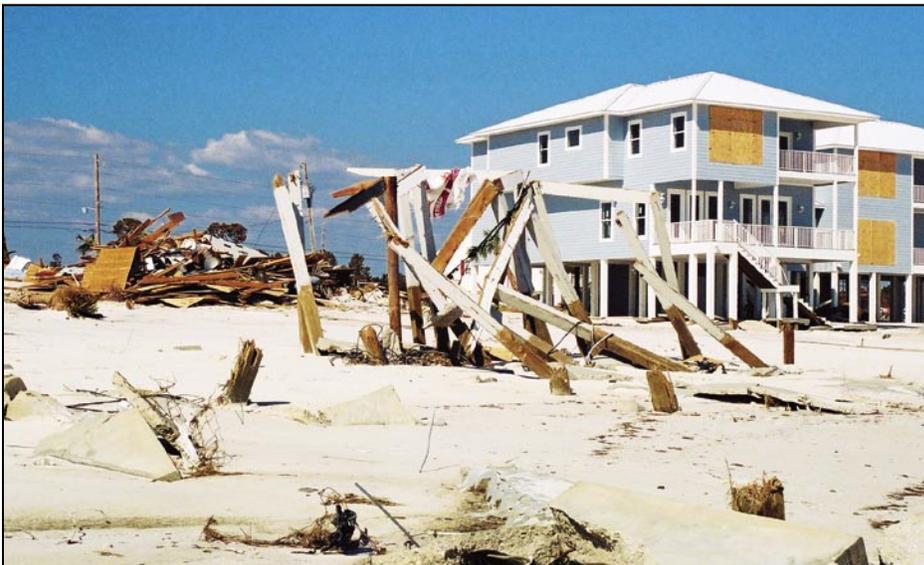
Figure 3-42.  
The surviving house  
was built to incorporate  
the provisions of the  
new building code (IRC,  
IBC) even before it was  
adopted. (Orange Beach)
