Conclusions

7.1 Flood Hazard Conclusions

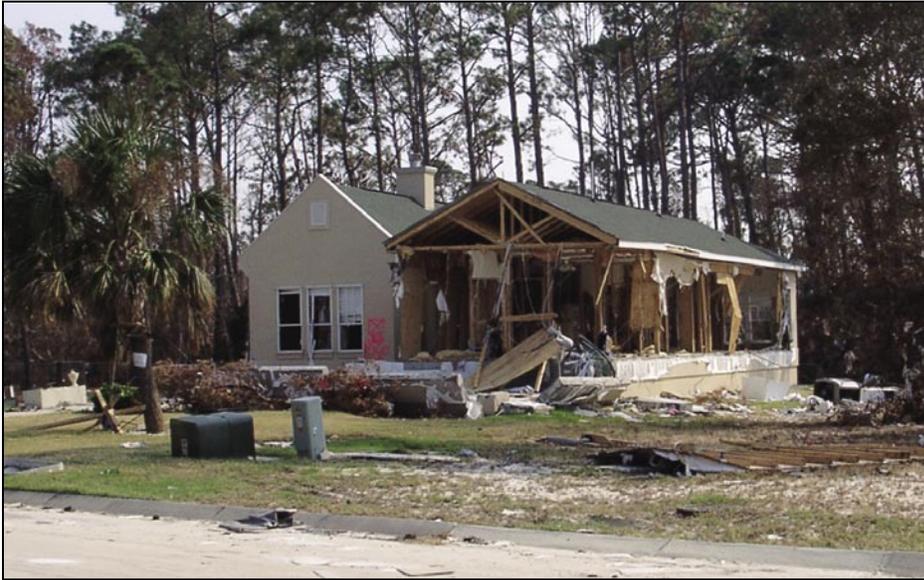
Flood levels from Hurricane Ivan exceeded the mapped BFEs throughout many bays and sounds by several feet. Flood levels along Gulf front shorelines also exceeded the mapped BFEs but to a lesser extent. As discussed in Chapters 1 and 2, HWMs were clearly higher than the stillwater levels used to develop the flood maps and were also higher than the BFEs, which include wave heights that are not accounted for in the HWMs. Due to these high flood levels, the flooding extended beyond the SFHAs in most communities investigated. Since many homes were pre-FIRM construction and/or constructed to the minimum standards in mapped A Zones and the flooding extended beyond the current SFHAs, there was severe damage of single and multi-family buildings throughout the inland bays and sounds, and along the barrier islands in Baldwin County, Alabama, and the western Florida Panhandle (see Figure 7-1).

Figure 7-1. Newly constructed house in Zone AE, which was damaged due to high flood levels and impacts from waves and floodborne debris. The effective FIRM shows the BFE as 9 feet, but the flood levels exceeded this by 3-5 feet. (Big Lagoon)

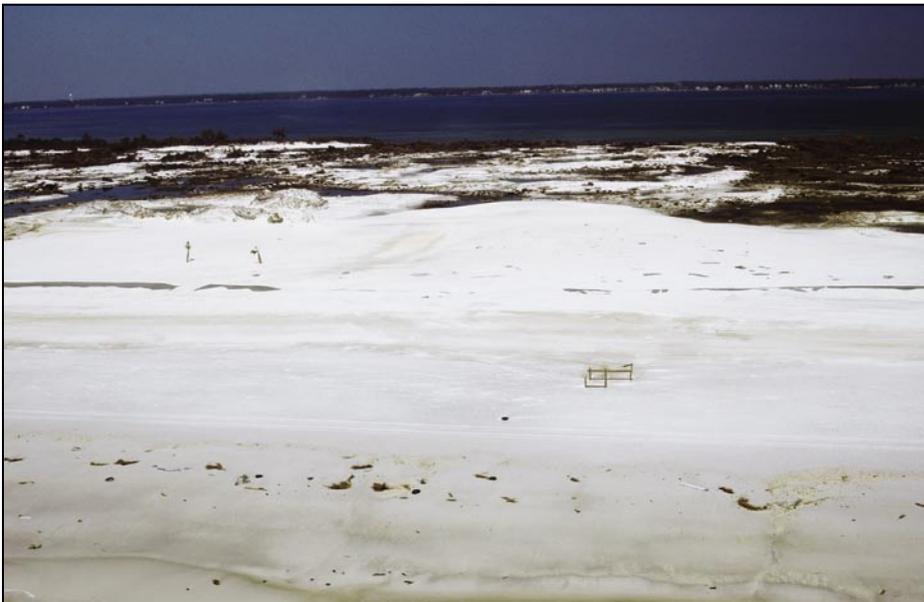
- 2) The storm surge overwashed the barrier islands, thus allowing more water to enter into the back bays and sounds, especially in those areas immediately behind the barrier islands (see Figure 7-2). This overwash effect was not accounted for in the initial storm surge modeling used to develop the stillwater elevations, which are the main input parameters in the wave height analysis to determine the BFEs and zone designations. Without the overwash effect, the flood levels in these back bays and sounds would be underestimated. In addition, the storm surge modeling was performed over 25 years ago and did not account for possible subsequent changes in the topography of the barrier islands. The barrier islands have been significantly altered over these last two decades as a result of numerous tropical storms and hurricanes, including Hurricane Opal, which drastically altered and destroyed many of the dunes on the barrier islands. When these dunes stood higher than 15-25 feet, as they did when the initial surge model was developed, they prevented the floodwaters from overwashing the barriers; the only way the storm surge entered the bays and sounds was through the inlets. Now that the barrier islands have been impacted and altered by Hurricane Ivan, the contribution of the overwash into the back bays and sounds will continue to be a factor for future events.

Figure 7-2. Barrier island on Santa Rosa Island, east of Pensacola Beach, which was completely overwashed by storm surge. The storm surge then inundated the Santa Rosa Sound.

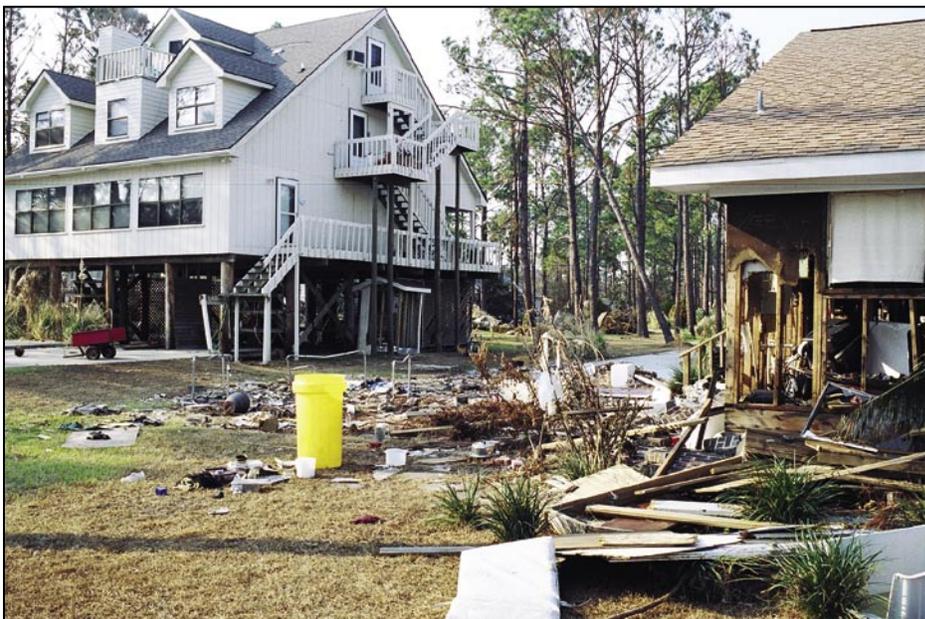
One of the critical factors for this event was that the amount of damage to the building was in direct correlation with the elevation of the lowest floor (see Figure 7-3). Generally, the lowest floor elevation was a function of the type of foundation chosen for the building. Pile foundations had the advantage of getting the lowest floor up a full story, which usually placed it several feet above BFE. Other foundation types often resulted in buildings that were at BFE or only slightly higher. For Hurricane Ivan, this difference in elevation made a great difference in flood and debris damages.

Figure 7-3. Lowest floor elevation was one of the most important factors in determining building damage during Ivan (Gulf Shores, Little Lagoon)

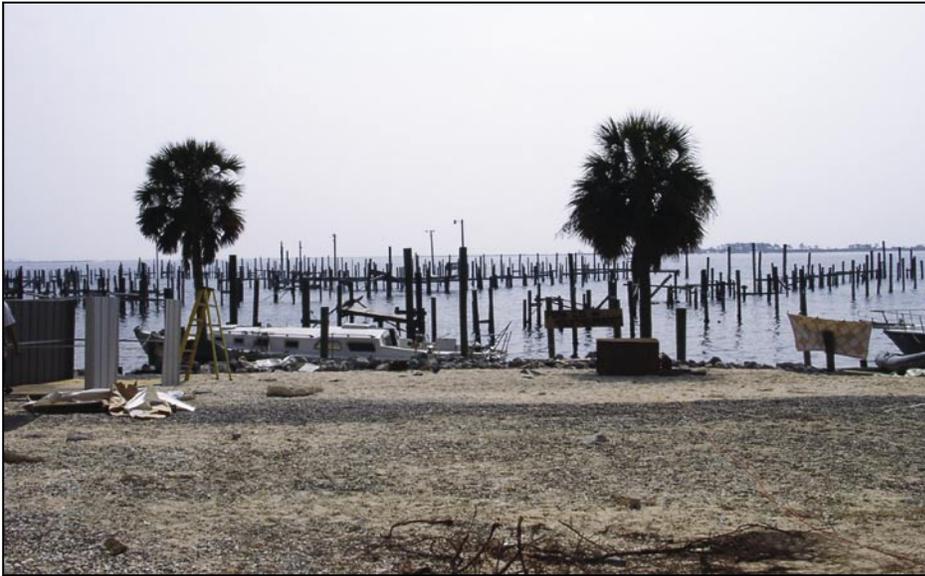
The construction of pier and docks, which extend several hundred feet in the bays and sounds, was prevalent throughout the impacted coastal areas. Damage to these systems was extensive, and dock materials and pilings provided a significant source of damaging debris. Piles and dock sections were found in the lower areas of buildings, which contributed to the destruction of many homes.

Figure 7-4.
Docks along back bays
contributed to flood
debris causing extensive
damage.

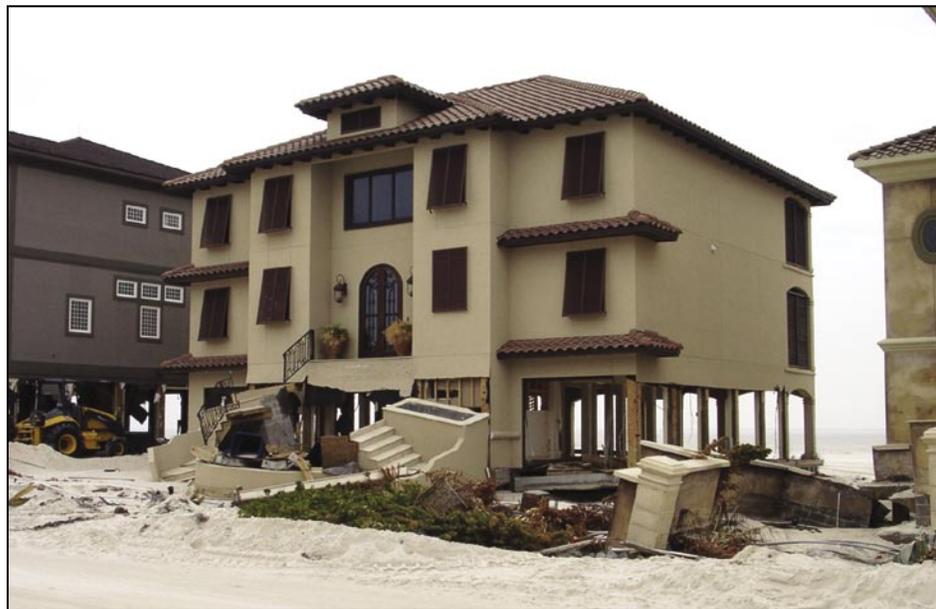
Figure 7-5.
Access stairs and enclosures that were constructed below the lowest floor were severely damaged.

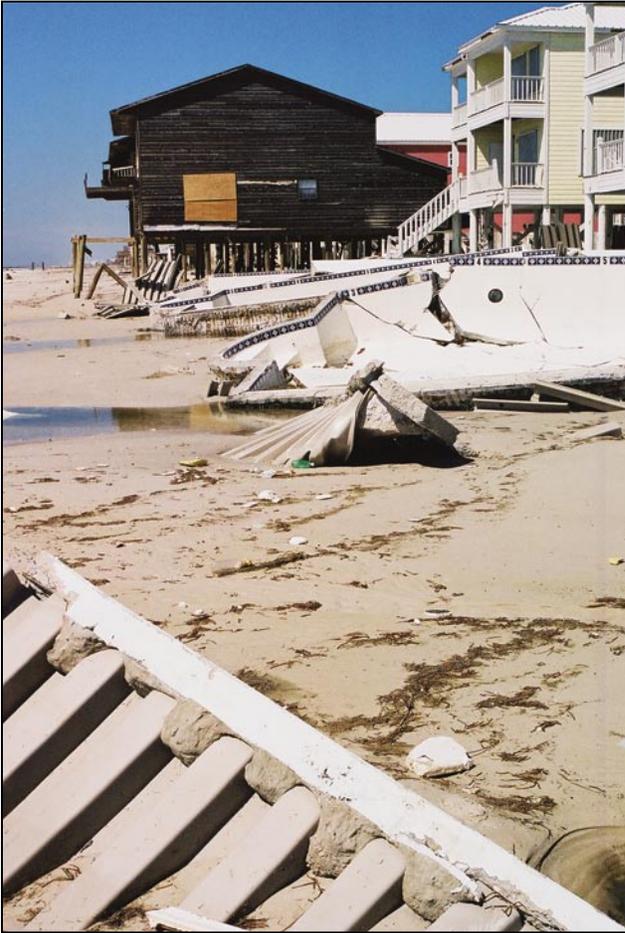
Pools and bulkheads suffered extensive damage and should be viewed as sacrificial features during a major hurricane.

Figure 7-6.
Typical failure of swimming pools and bulkheads
(Gulf Shores)

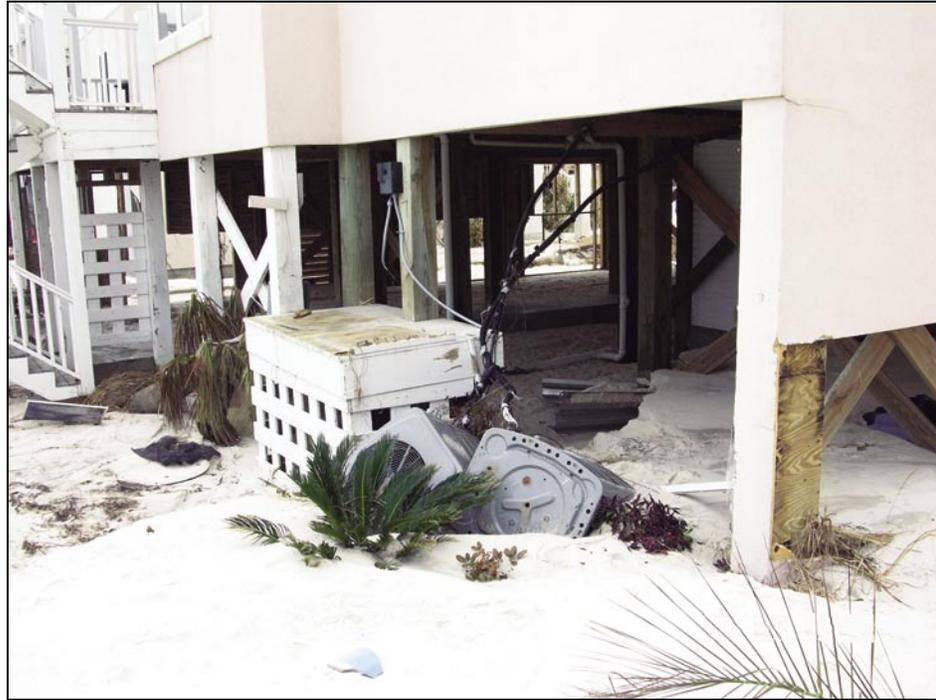
Exterior utilities suffered extensive flood damage when not elevated or sited properly. The lack of design and installation attention resulted in destruction of building service utility lines, systems, and equipment, and led to the loss of function of the occupied space. Compliance with current FEMA publications and codes is essential to the future prevention of damages of this type. Figure 7-7 shows an inappropriately mounted condenser that was carried off its platform by high floodwaters.

Figure 7-7.
Inappropriately mounted
condensers for a
coastal residential site
that should have been
mounted at a higher
elevation and securely
anchored to their
platform

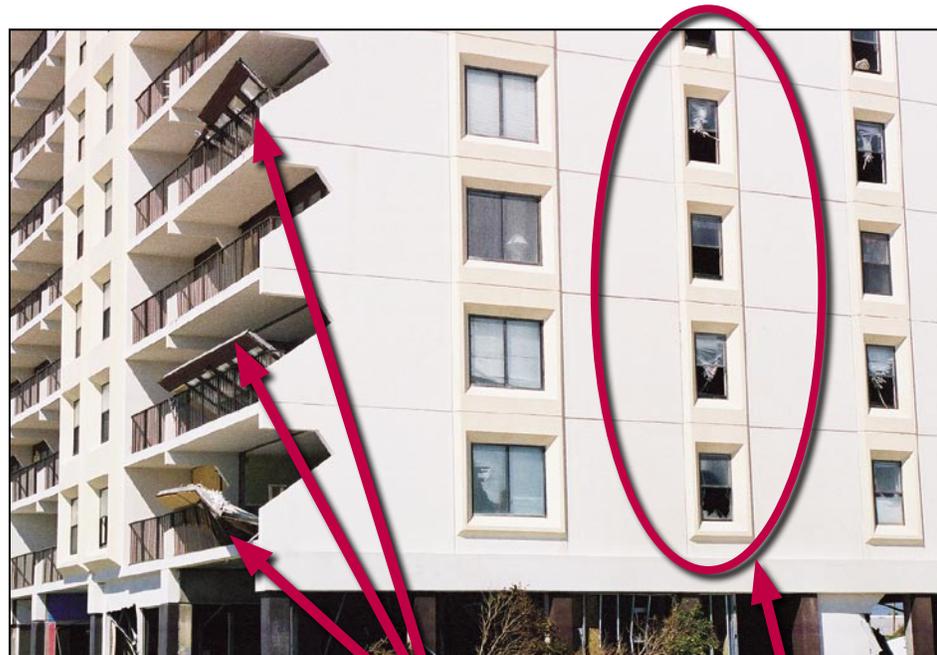
The MAT observed window failures that resulted in interior partition failure and failure of exterior walls, as seen in Figures 7-8 and 7-9 (this failure is fully described in Subsection 5.5.1). The MAT saw other examples where wall materials or framing in the gable end walls failed, causing the attic space to become pressurized. In some cases, the pressurized attic pushed off the roof sheathing. In other cases, the pressurized attics failed the ceilings below them, pressurizing the interior spaces, and caused failures in the building envelope from the inside.

Figure 7-8.
Window damage caused
exterior wall failure
(Gulf Shores)

Internal and external pressures combined
to cause exterior wall failure

Window breaches caused
an increase in internal
pressure

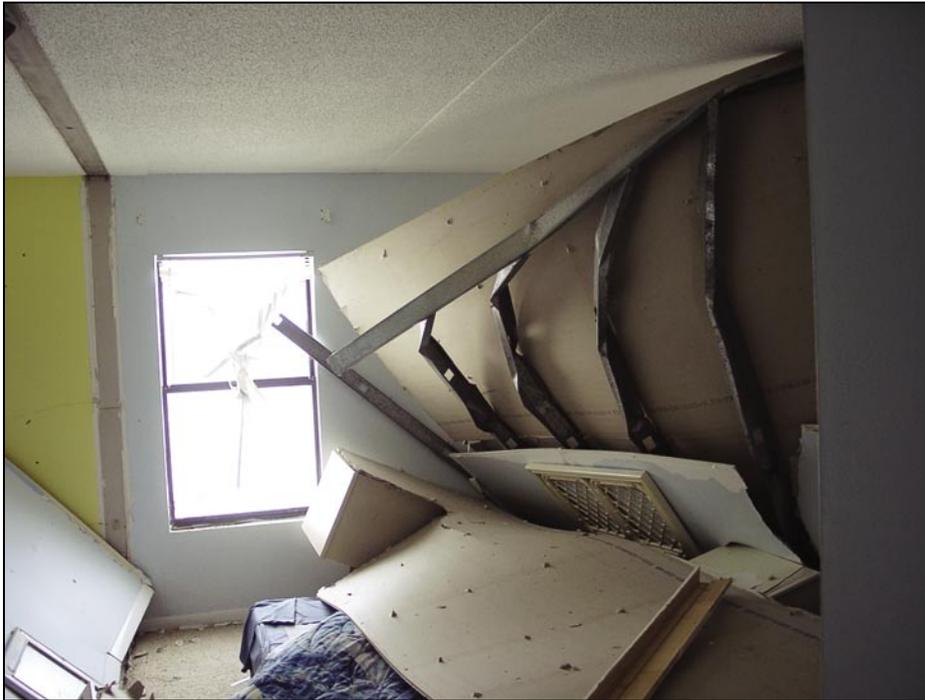
Figure 7-9.
Partition walls destroyed
by interior pressurization
due to window damage
(Gulf Shores)

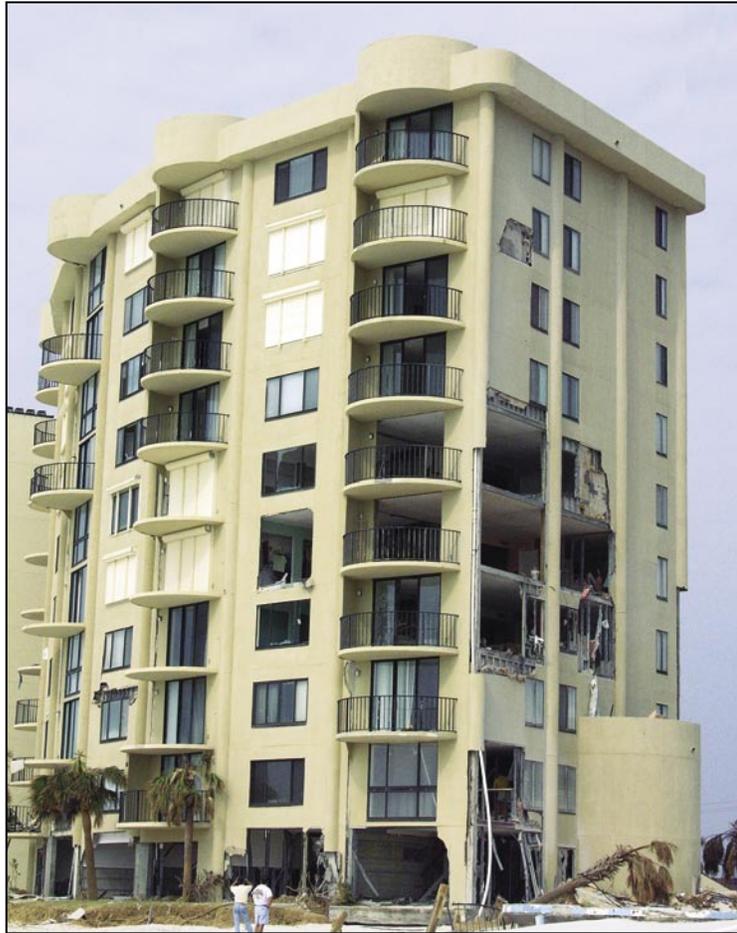
The importance of the building envelope is illustrated by Figure 7-10. Although the structural frame performed well, poor performance of the building envelope resulted in significant damage. Balcony railings, stucco wall covering, and entire portions of the non-load-bearing walls were blown away. Glazing damage was extensive, although as shown in Figure 7-10, shutters were successful in preventing damage to those windows and glazed doors that were protected.

Figure 7-10. Although this was a structural success, except for the excellent shutter performance, this building was an envelope failure.

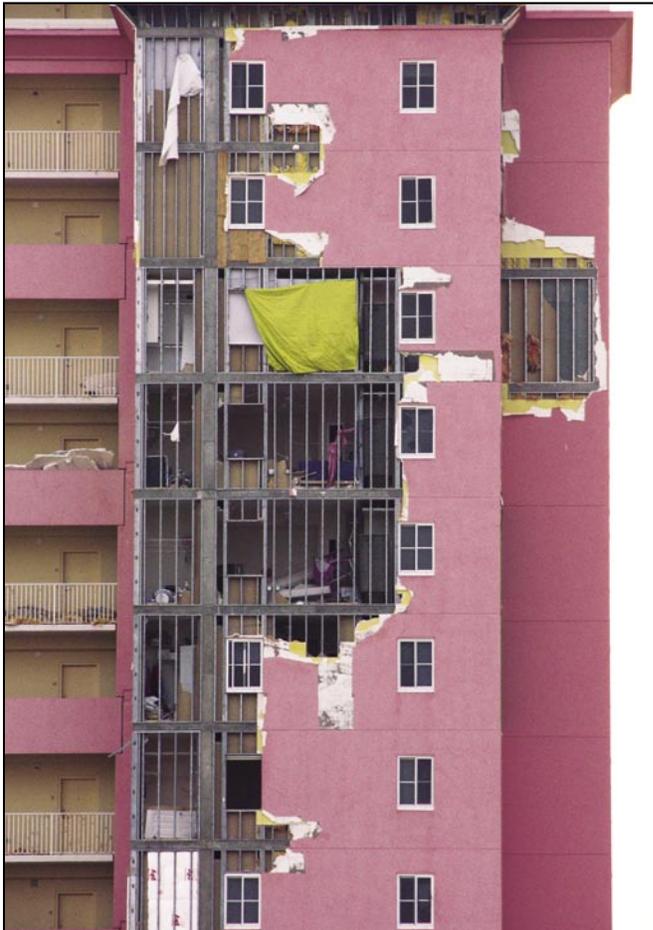
Figure 7-11:

- In general, EIFS performed very poorly. For many buildings, the poor performance resulted in significant rainwater infiltration damage (see Figure 7-11). Much greater attention is needed in the design and application of EIFS, and improvements are needed in design guides and testing.

In this EIFS failure, the majority of the gypsum board detached from the studs. At some living units, the gypsum board on the interior side of the studs was also blown off, thus exposing the units directly to the hurricane.

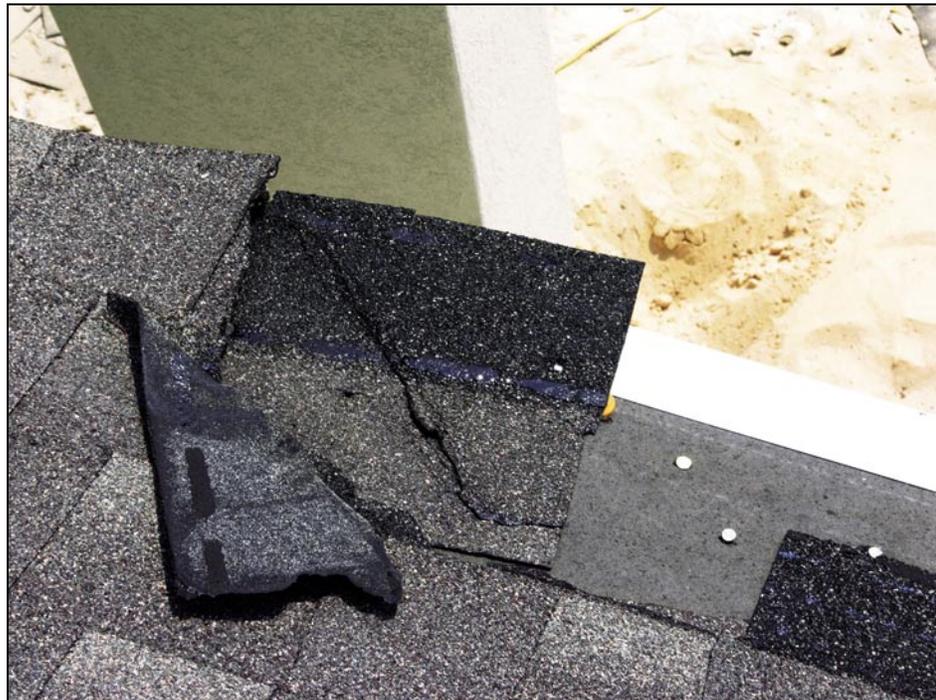
Figure 7-12. Rather than cutting off the tabs, the starter course on this new roof was turned 180 degrees. Hence, the tabs of the first row were free to lift because they were not adhered in the self-seal adhesive on the starter.

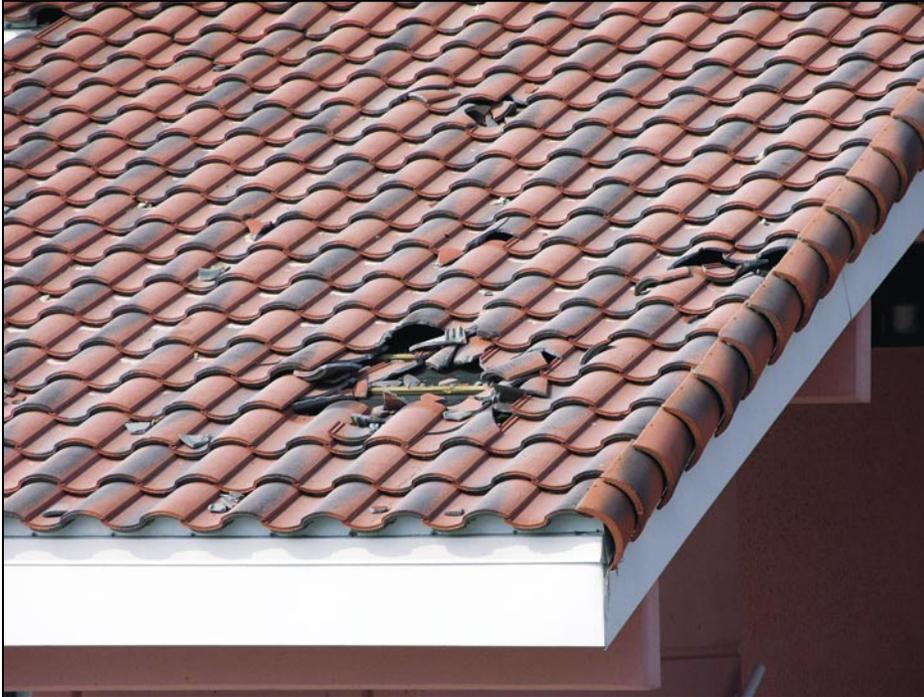
failures (Figure 7-13). Tiles on hips, ridges, and edges of the roof were a frequent point of failure. Hip and ridge tiles rarely were attached using mechanical anchors.

Figure 7-13. These batten-attached tiles were damaged by windborne debris. Much of the damage was caused by tile impacting other tiles. A tile was blown 140 feet from this building.

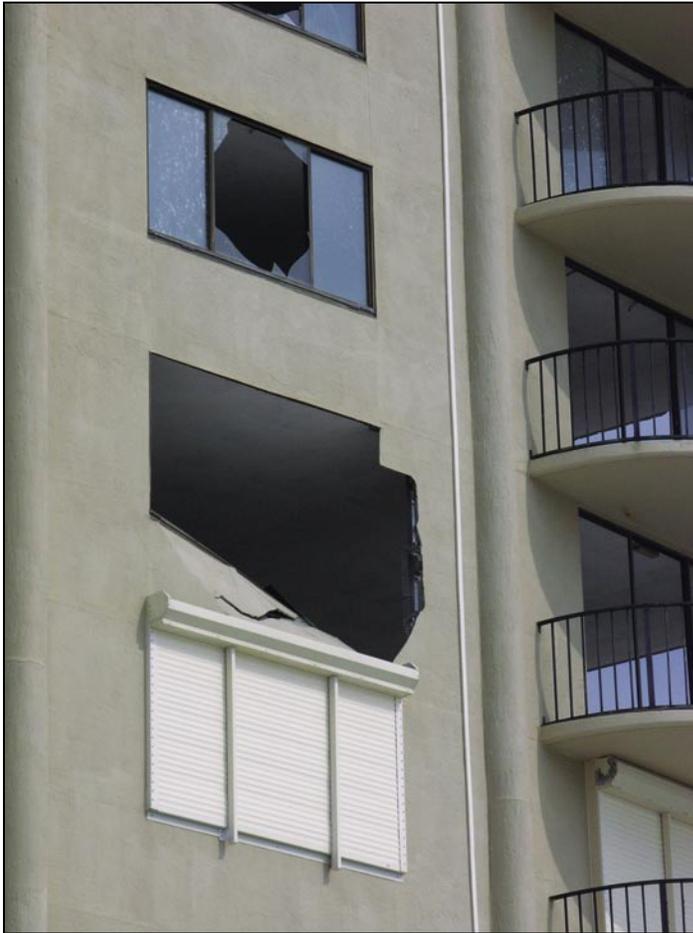
- Many homes and businesses that experienced only contents damage could have prevented these losses if their openings were protected. Success in designing the structural frame to resist wind loads and internal pressures was partially negated by significant losses to building contents (Figure 7-14).

Figure 7-14.
Glazing at the top two window units broken by debris, while the entire middle window unit was blown away. The shuttered window unit was not damaged.

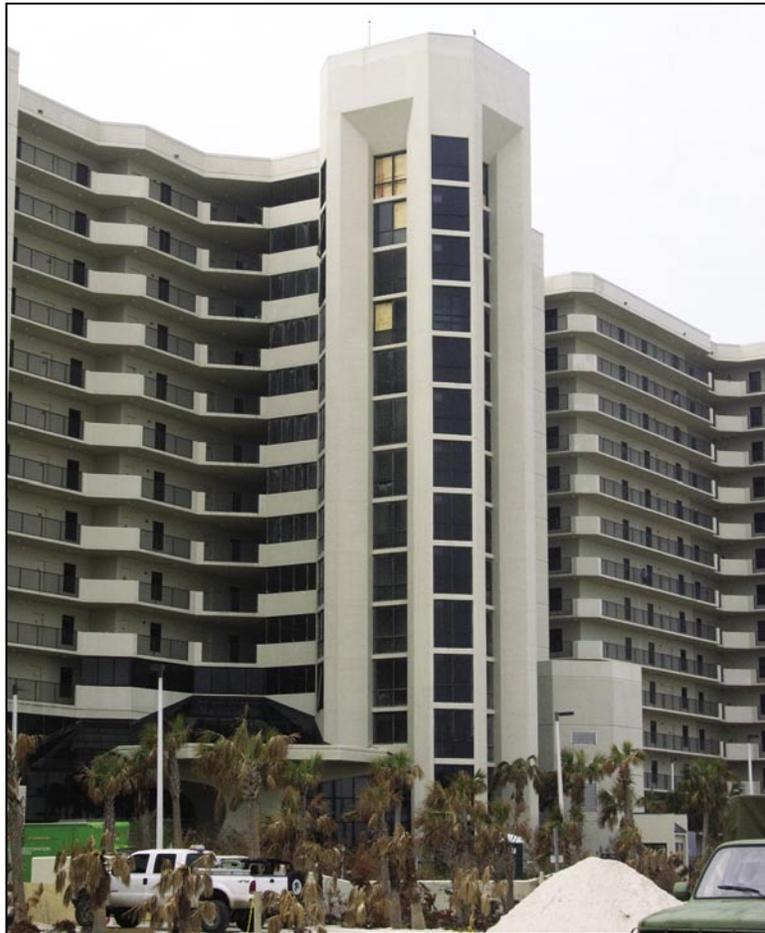
Figure 7-15.
A few of the upper level windows were broken.

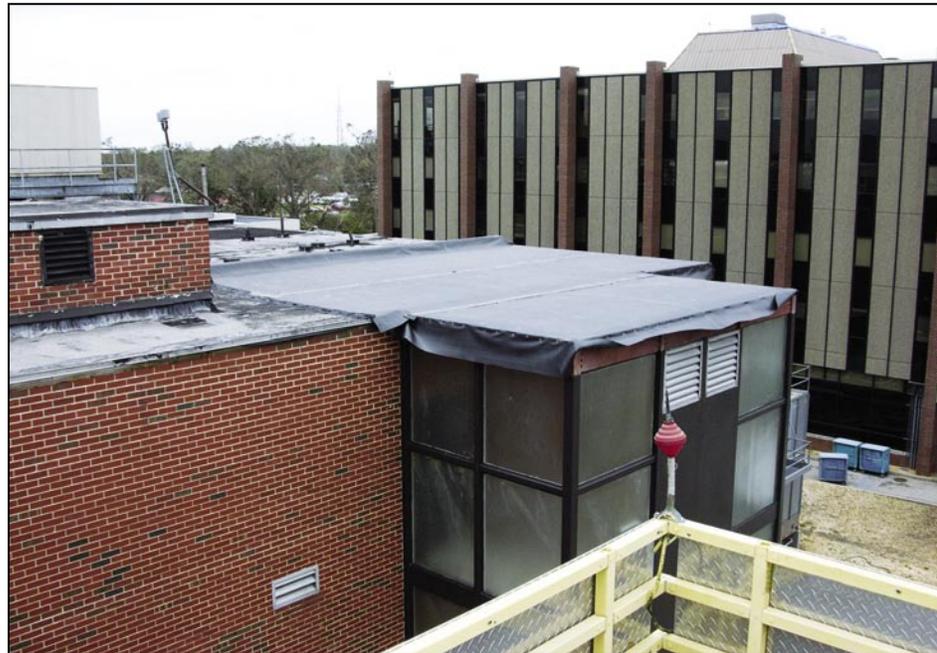
- When older buildings are used as critical and essential facilities, damage will likely occur to the roof covering, wall coverings, window and door systems, and rooftop equipment. This damage leads to significant loss of function at the facilities (Figure 7-16).

Figure 7-16.
An older hospital that experienced blown off roof coverings, gutters, downspouts, rooftop equipment (including lighting protection system components), and broken glazing

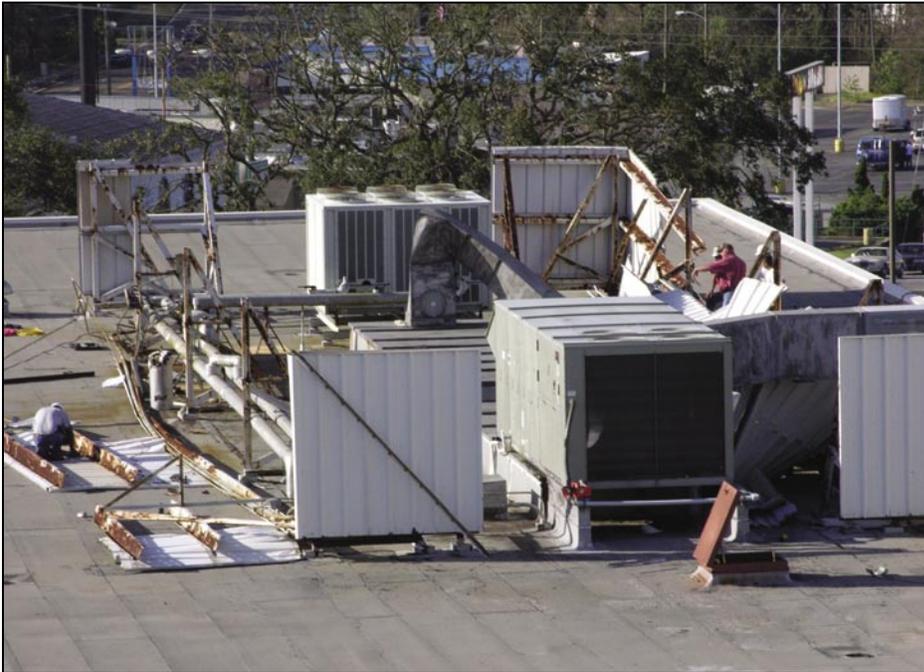
- Some buildings designed to critical and essential facility requirements experienced damage and partial failures during the hurricane due to lack of protection from windborne debris. Lack of protection of windows was common at hospital and medical office buildings, and led to window failures and severe damage to building contents.
- Rooftop equipment loss such as loss of HVAC units and vents, antennas, communication dishes, and lightning protection systems was prevalent. In almost all cases, these failures caused damage to roof coverings that often resulted in rainwater intrusion into the facilities (Figure 7-17).

Figure 7-17. Rooftop mechanical equipment damage at a hospital. Several of the equipment screen panels were blown away. Loose panel debris can break glazing and puncture roof membranes.
