Mitigation Assessment Team Report

Hurricane Ivan in Alabama and Florida

Observations, Recommendations,
and Technical Guidance

FEMA 489 / August 2005

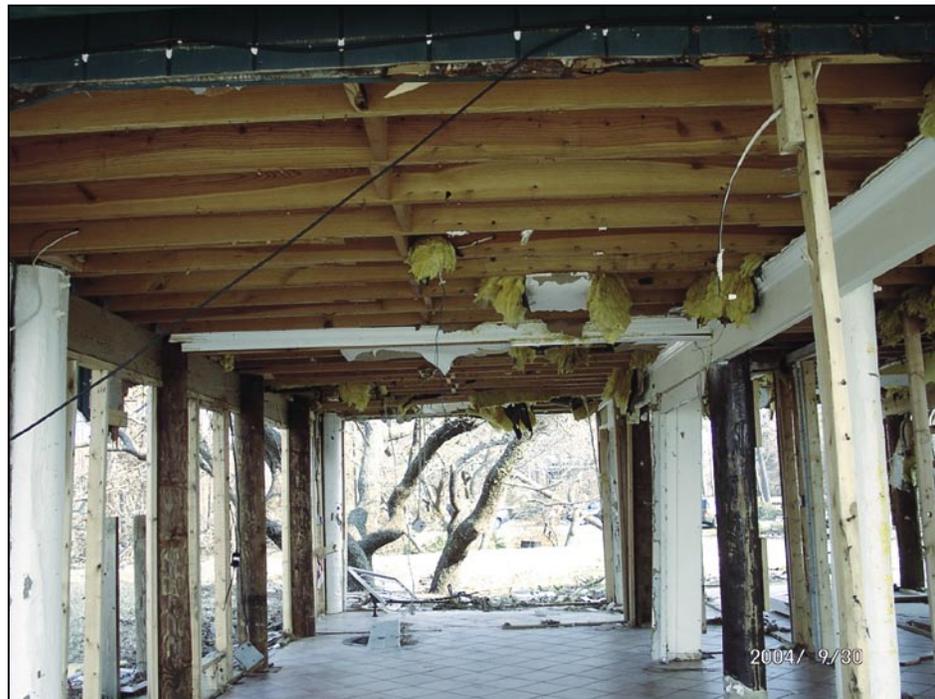
Figure 3-11.
Significant floodborne
debris contributed to
the severe damage of
at-grade enclosed area
beneath an elevated
building. (Big Lagoon)

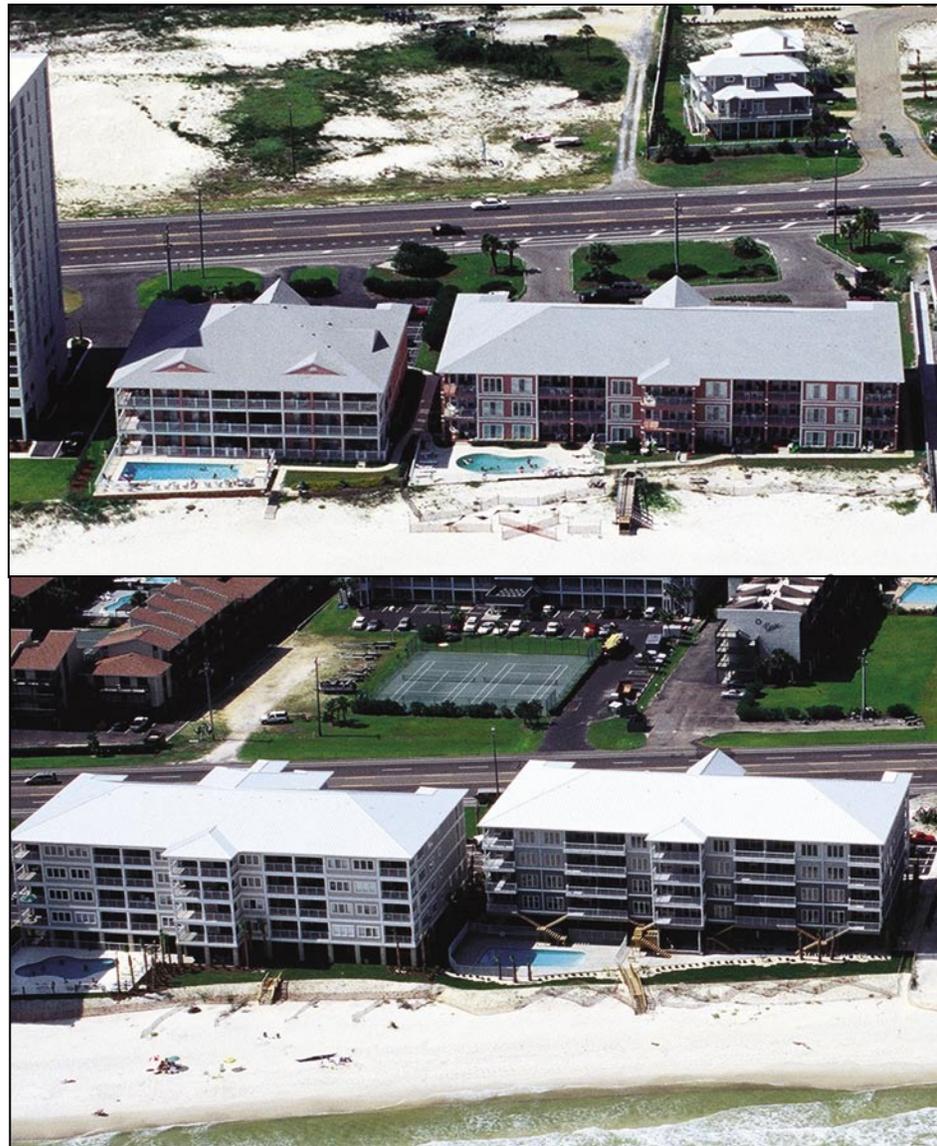
Figure 3-35. The four condominiums in Figure 3-34 after Hurricane Ivan. The newer buildings on pile foundations survived, while the older buildings on shallow foundations collapsed. However, the newer building on the lower left experienced significant interior water damage due to roof loss. (USGS)

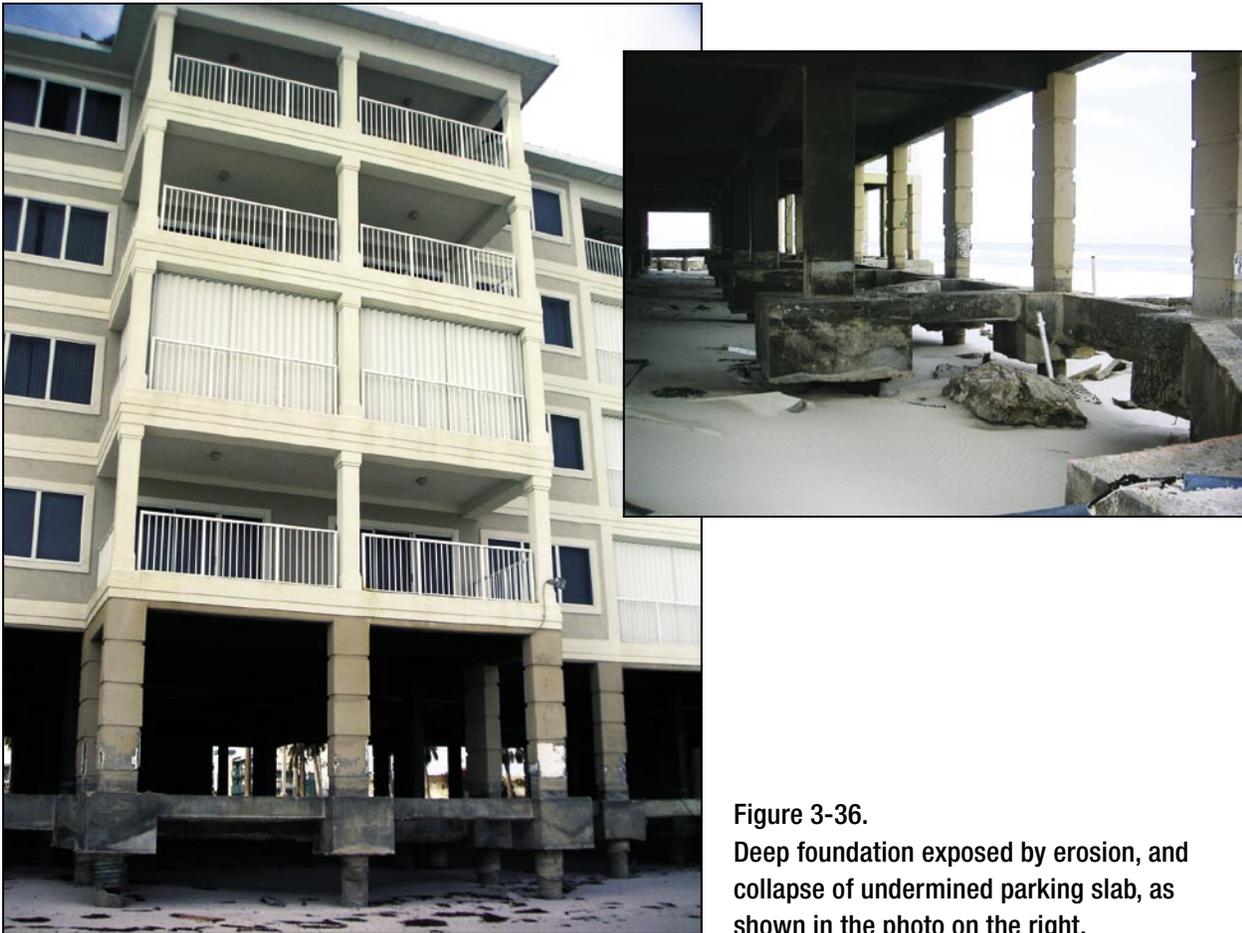
Figure 3-36.
Deep foundation exposed by erosion, and collapse of undermined parking slab, as shown in the photo on the right.

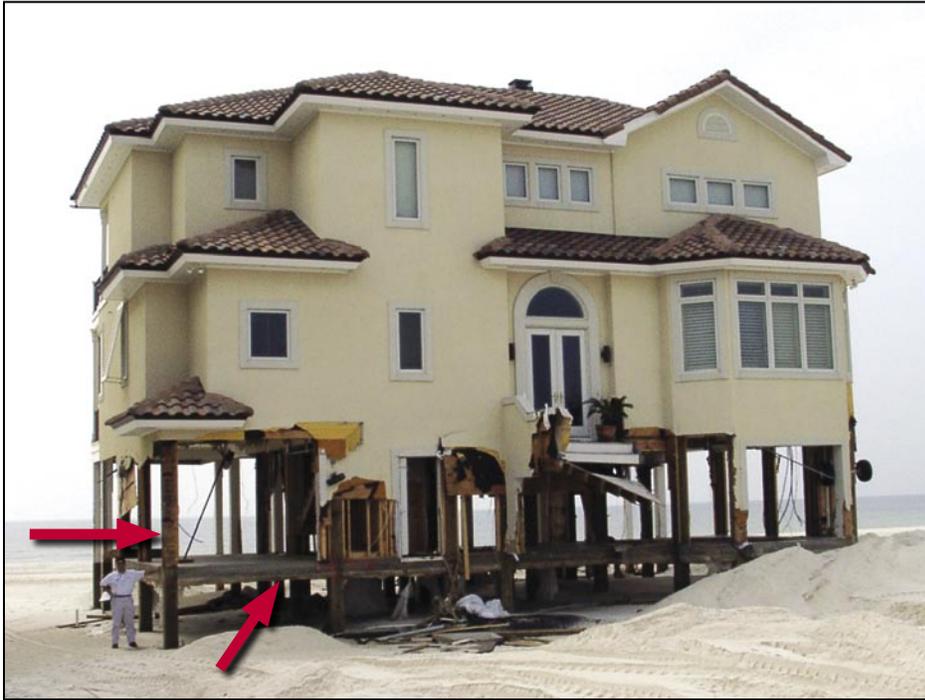
Figure 4-1. House on a pile foundation that performed well. It experienced 5 feet of erosion that resulted in failure of a non-structural slab. Breakaway walls in lower level also failed as expected. (Gulf Shores)

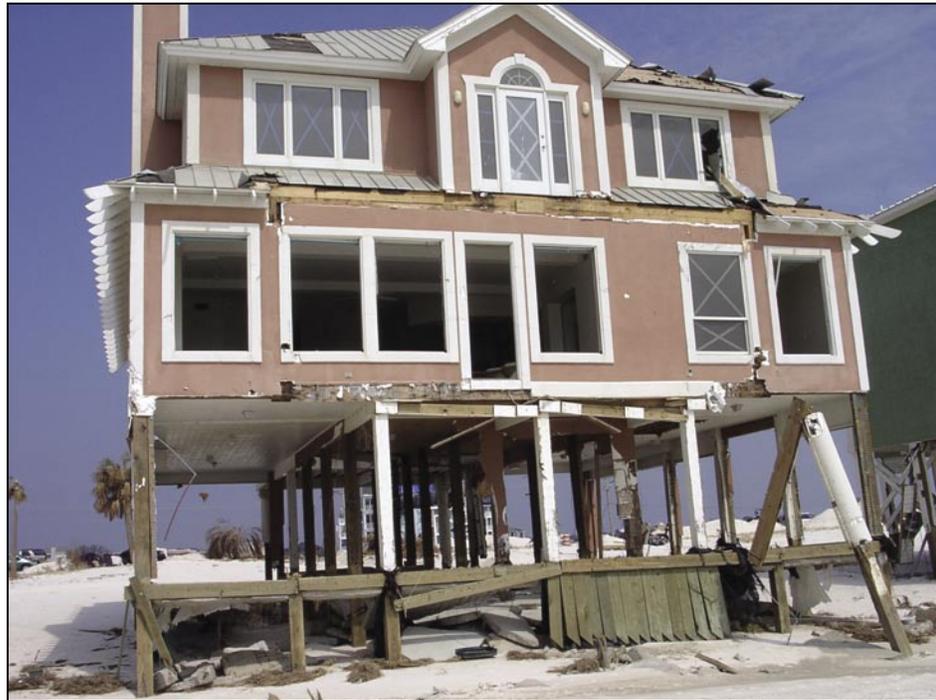
Figure 4-8. The pile foundations in the foreground failed. These houses were washed away (see Figures 3-2 and 4-9).

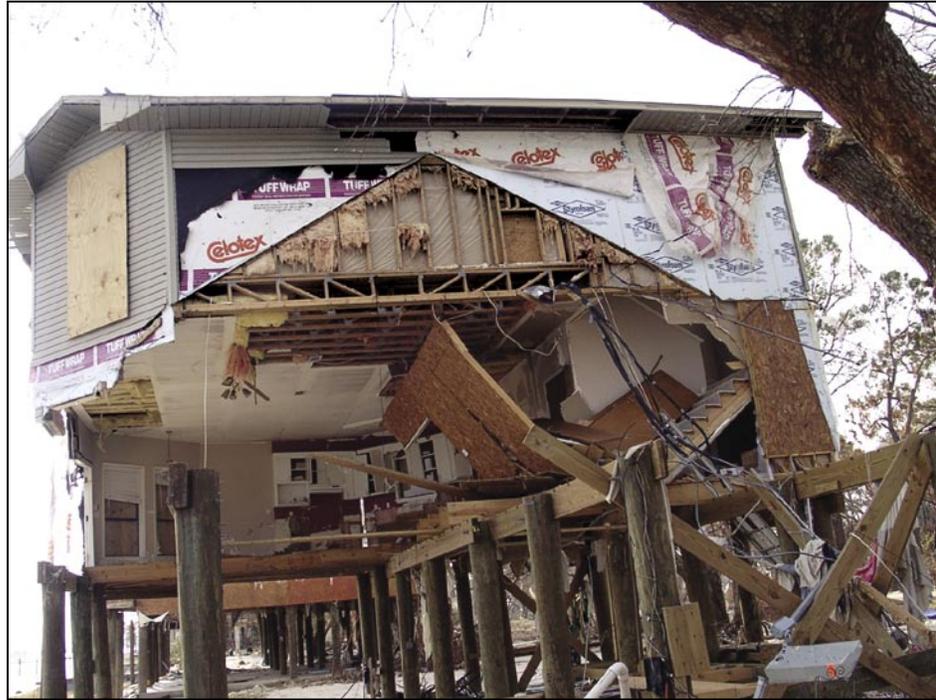
Figure 4-11.
Damage to pile-supported house on a bay shoreline, when flooding and waves exceeded the lowest floor elevation (Gulf Breeze, Pensacola Bay)

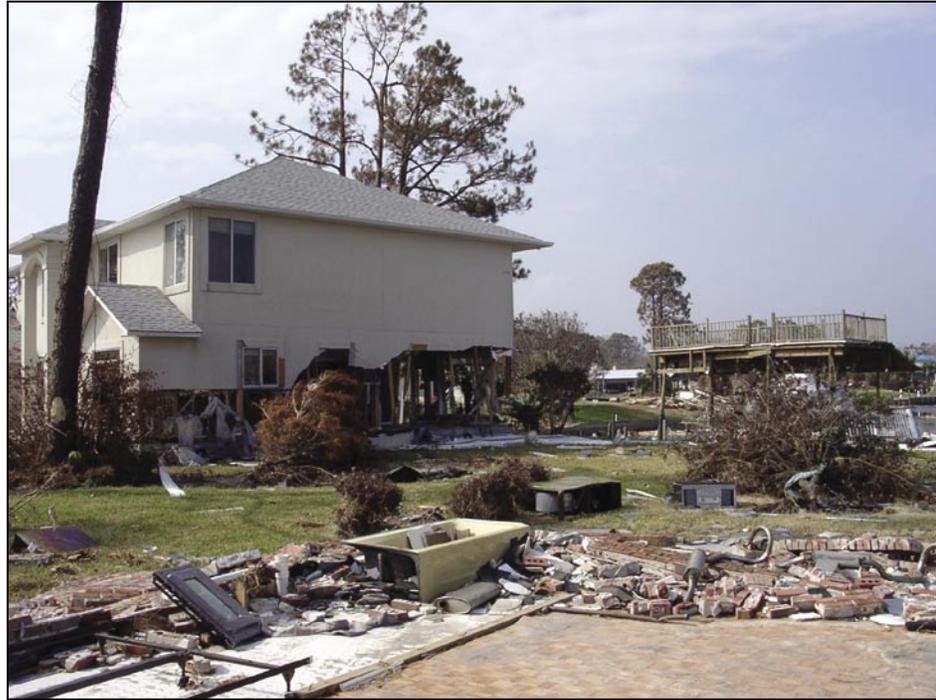
Figure 4-22.
This slab-on-grade building located on the back side of the barrier island but directly on the sound was heavily damaged by wave action. (Pensacola Beach)

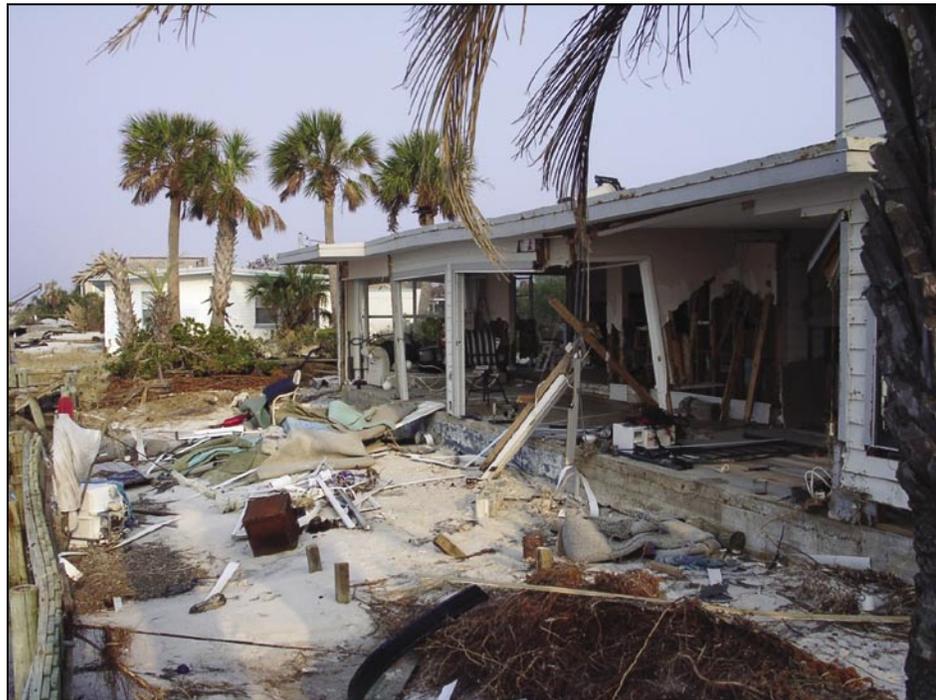
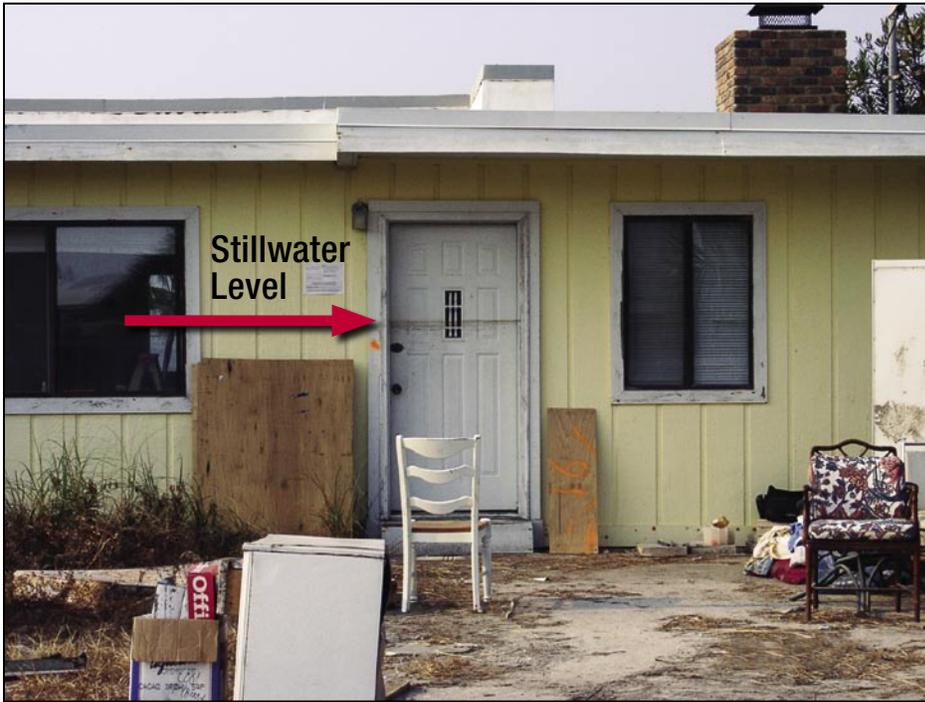
Figure 4-23. The slab-on-grade building located near the back side of the barrier island was protected from wave action by other houses, but had 4 to 5 feet of water inside. (Pensacola Beach)

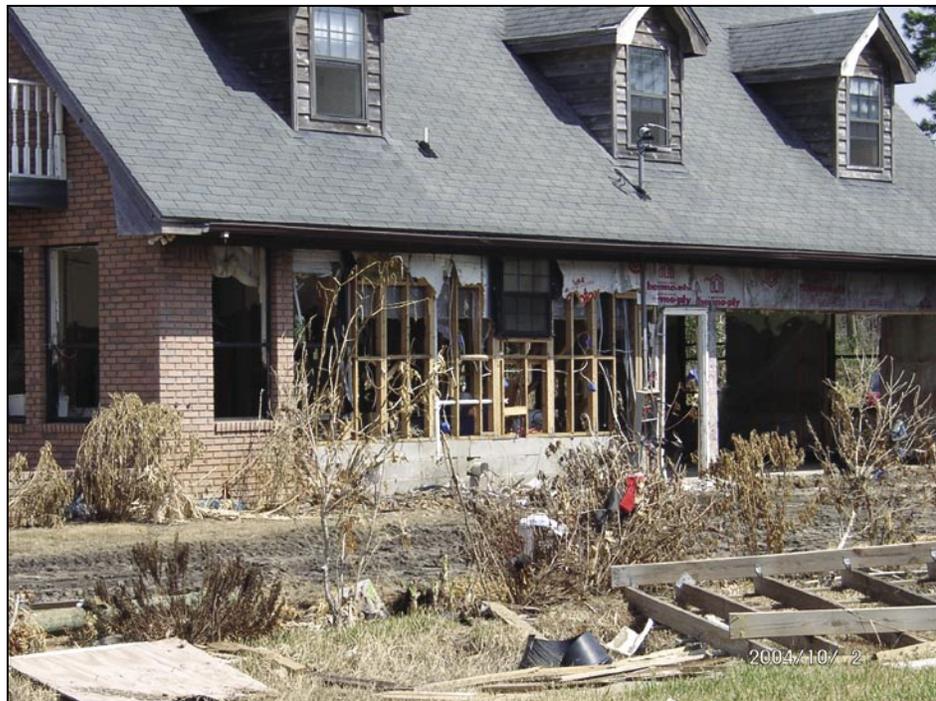
Figure 4-25.
Stem wall foundation
where floodwater
exceeded required
flood elevation by
approximately 4 feet
(Garcon Point, Escambia
Bay)

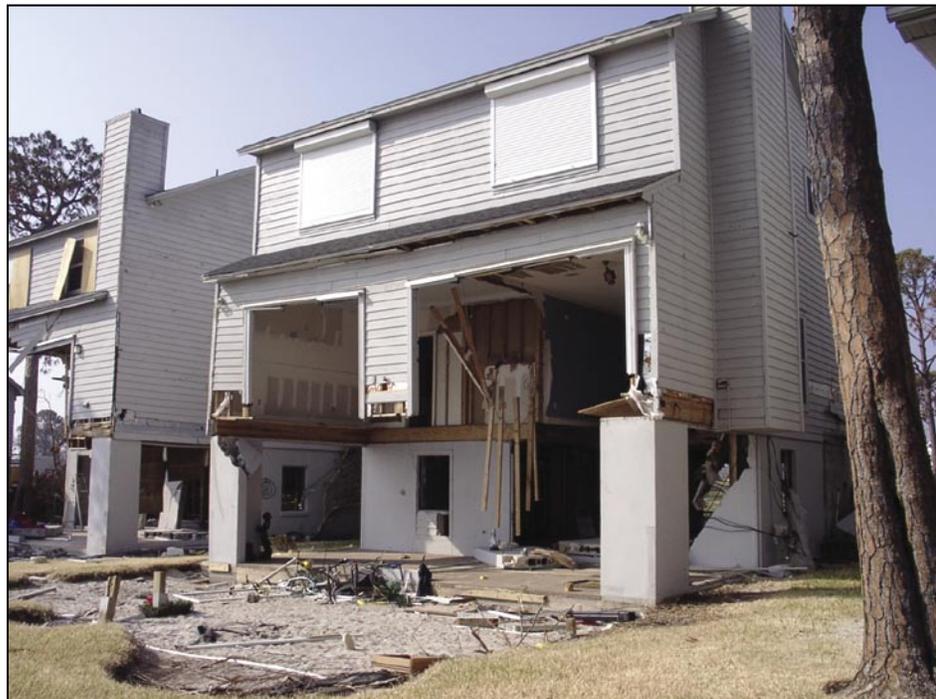
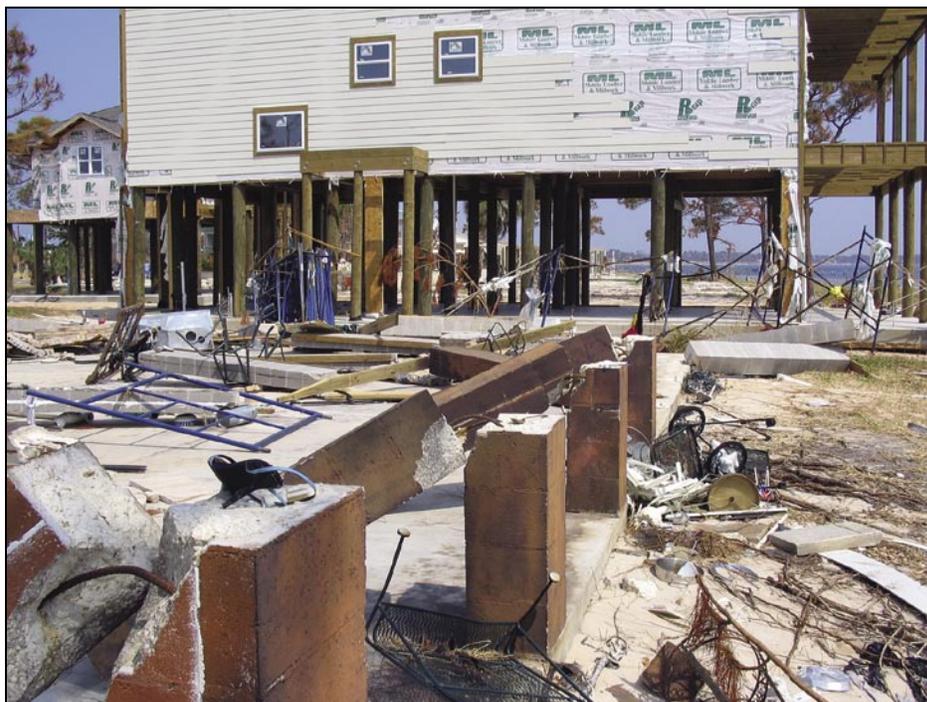
Figure 4-29. Tall, lightly reinforced masonry piers failed due to lateral loads from surge and wave action. The pile supported houses under construction in the background are the same ones indicated (by arrows) in Figure 4-12. (Big Lagoon)

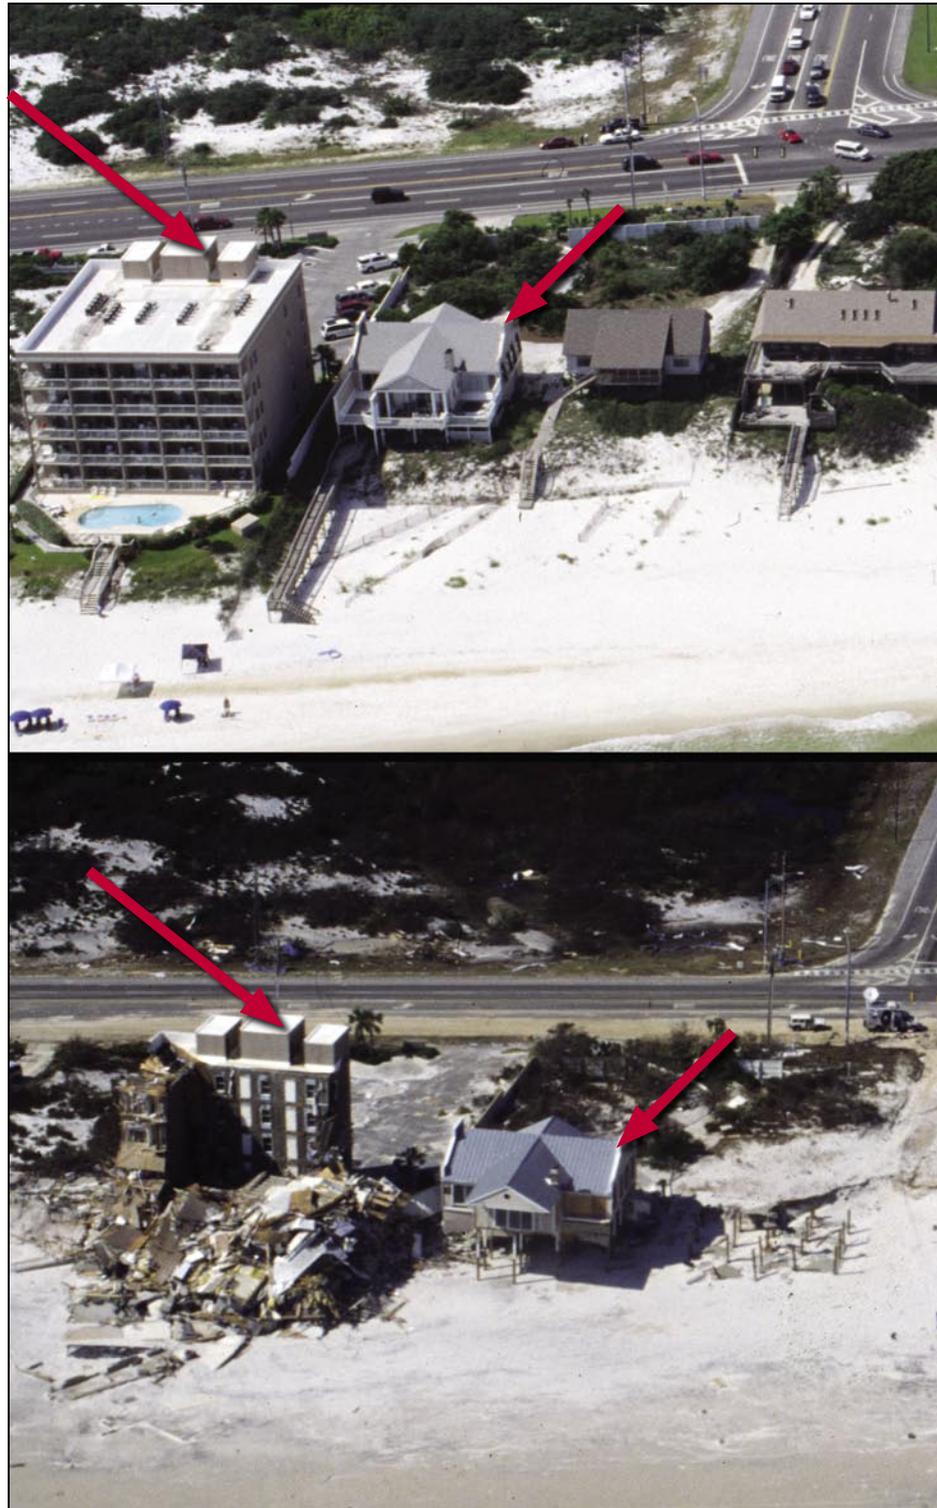
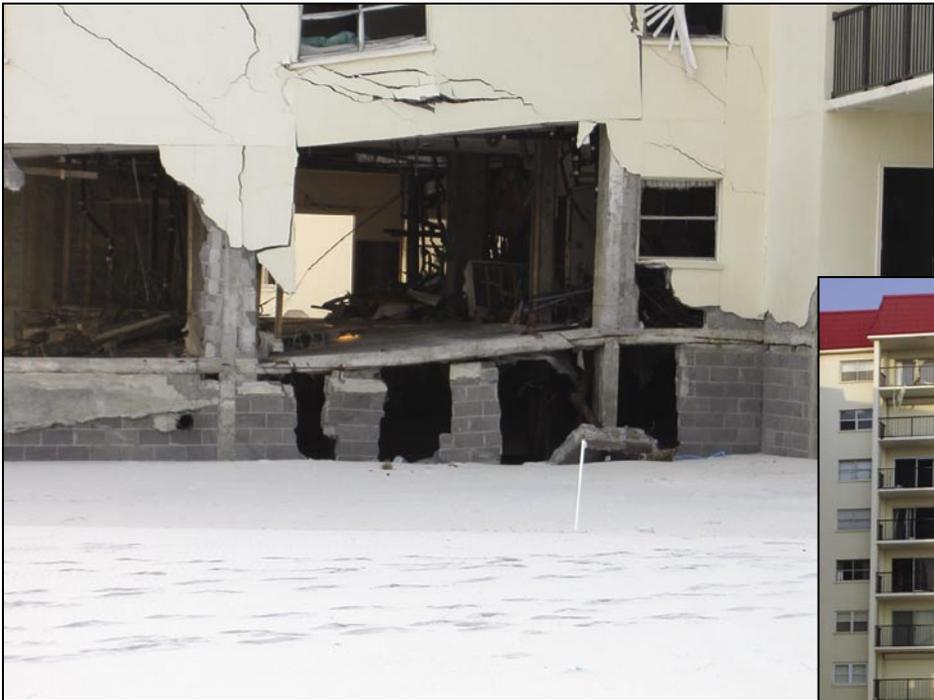
Figure 4-37.
Collapse of the seaward portion of a high-rise building supported by a shallow foundation (Perdido Key)

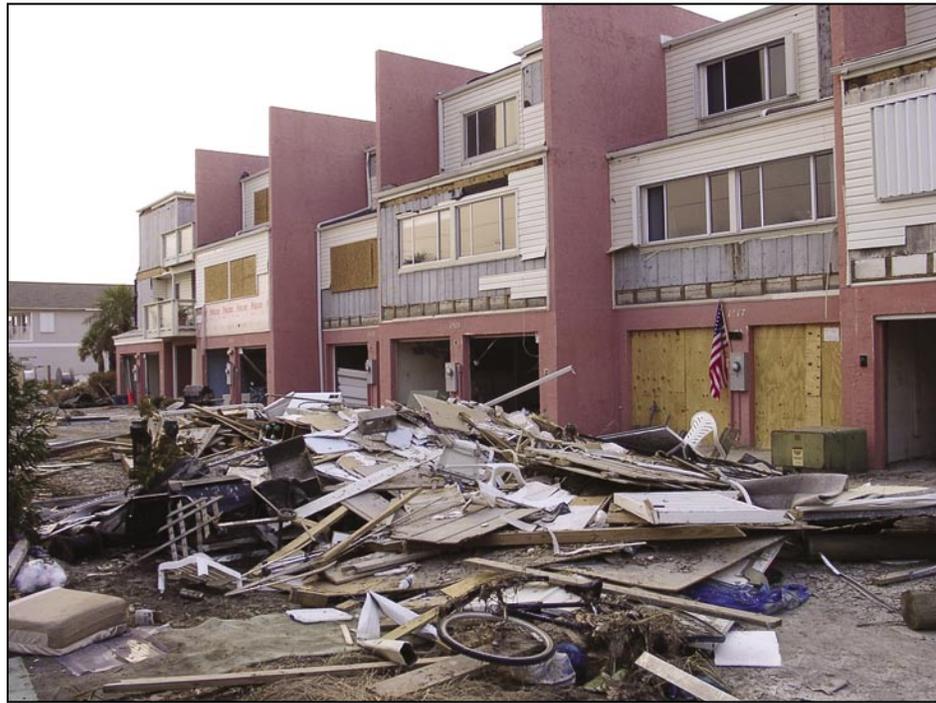
Figure 4-39.
This building has been flooded by Hurricane Ivan and four prior storms. (Pensacola Beach)

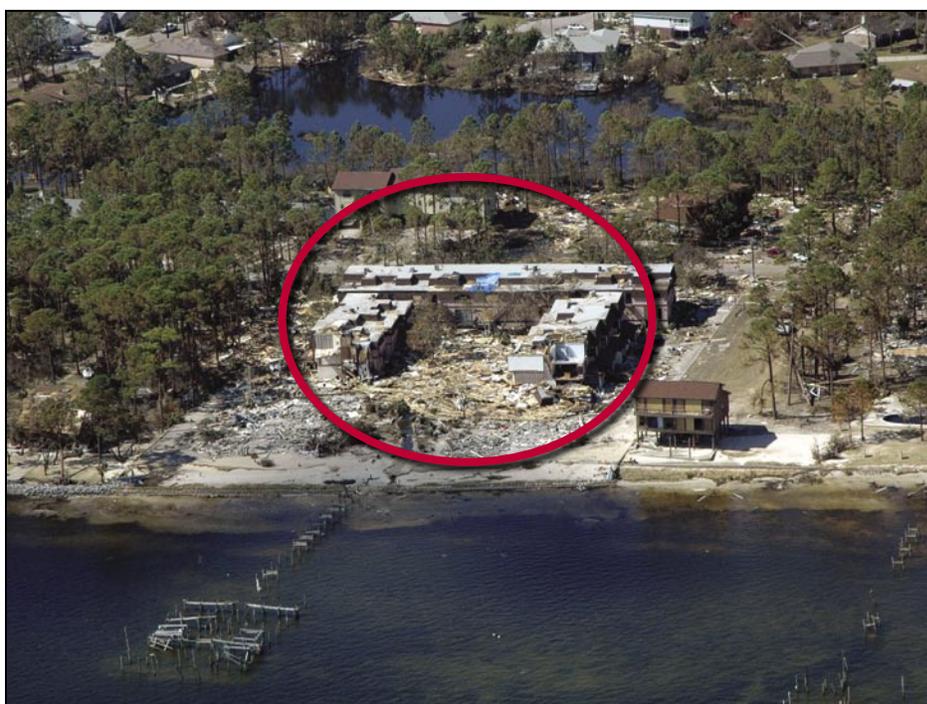
Figures 4-40 and 4-41 show another pre-FIRM multi-family building on a slab foundation that was heavily damaged by storm surge, waves, and debris, this one on the north side of Santa Rosa Sound.

Figure 4-40.
Multi-family building on a bay shoreline, heavily damaged by surge, waves, and floating debris (Oriole Beach, Santa Rosa Sound)

Figure 4-41.
Aerial view of building in Figure 4-40 (circled)

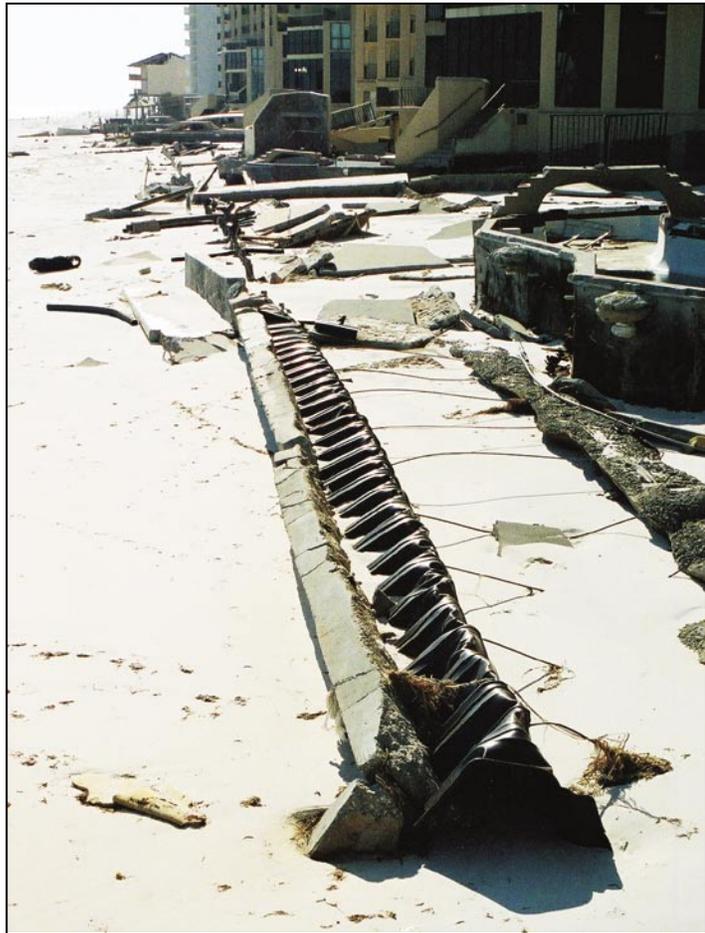
Figure 4-53.
Bulkhead remained intact, but short return wall allowed erosion
(Orange Beach)

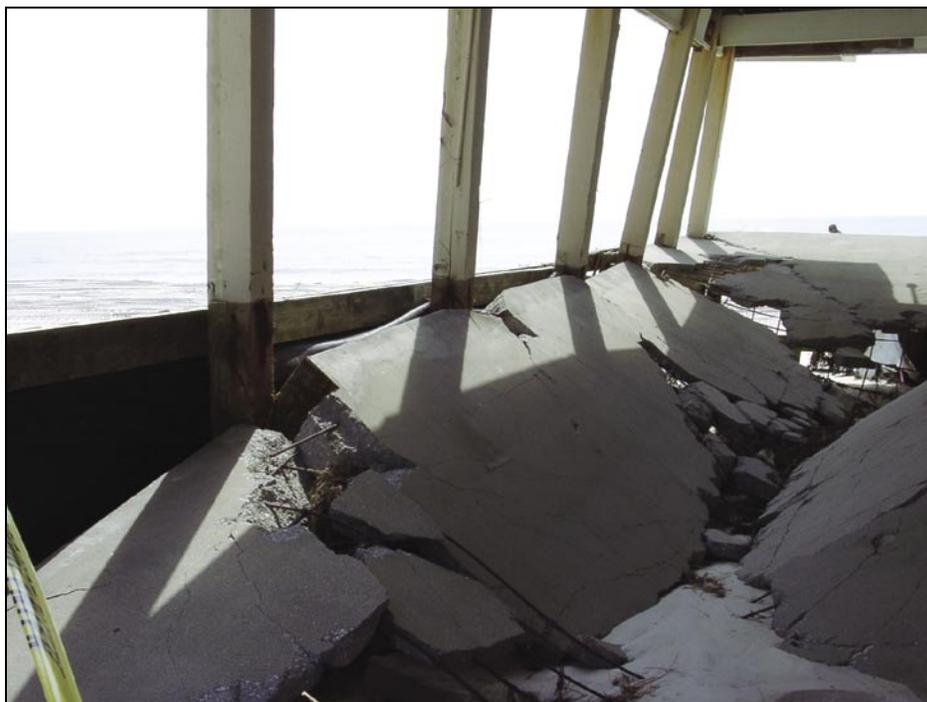
Figure 4-58. This slab failed but did not break into small pieces due to the reinforcing steel. The incomplete slab failure might have transferred flood forces to the foundation and contributed to the pile failure (piles in background were partially pulled out of the ground and are leaning). (Orange Beach)

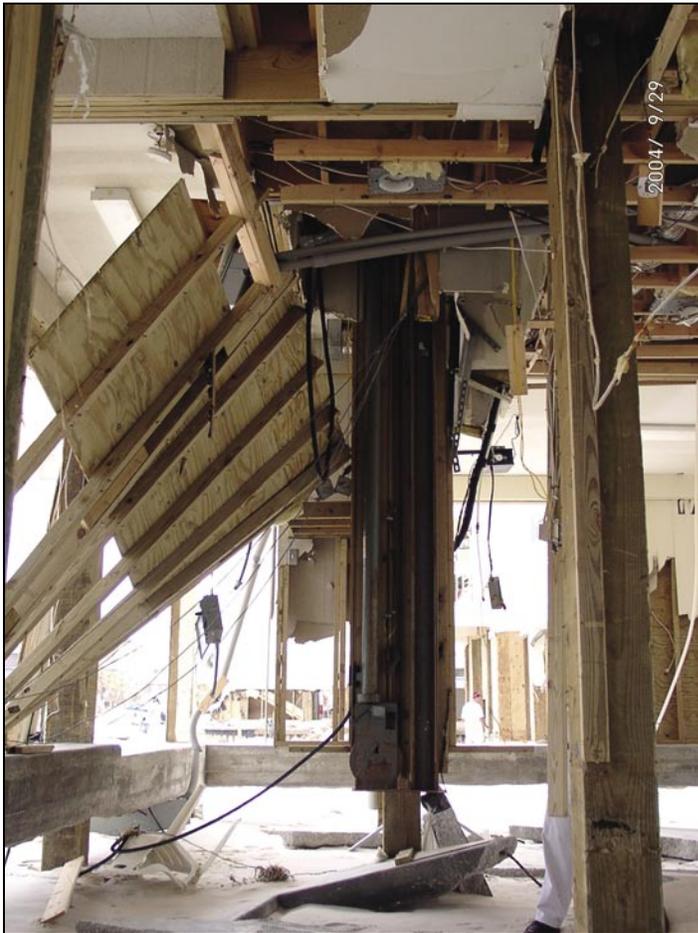
Figure 4-65.
Elevator system severely damaged by surge,
waves, and debris (Gulf Shores)

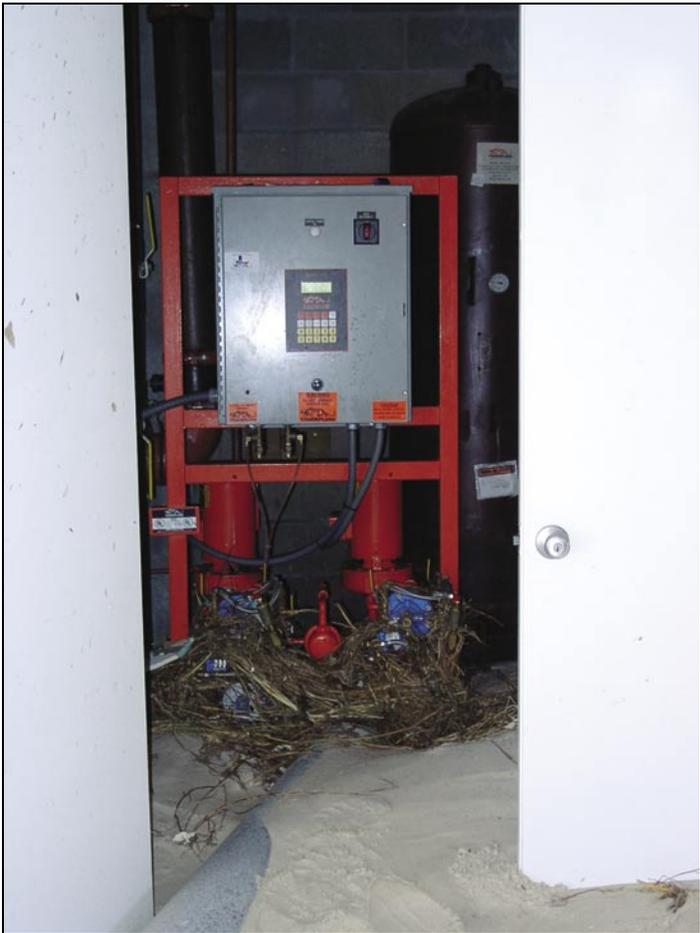
Figure 4-69.
Debris and sand in low-elevation mechanical room (Perdido Key)

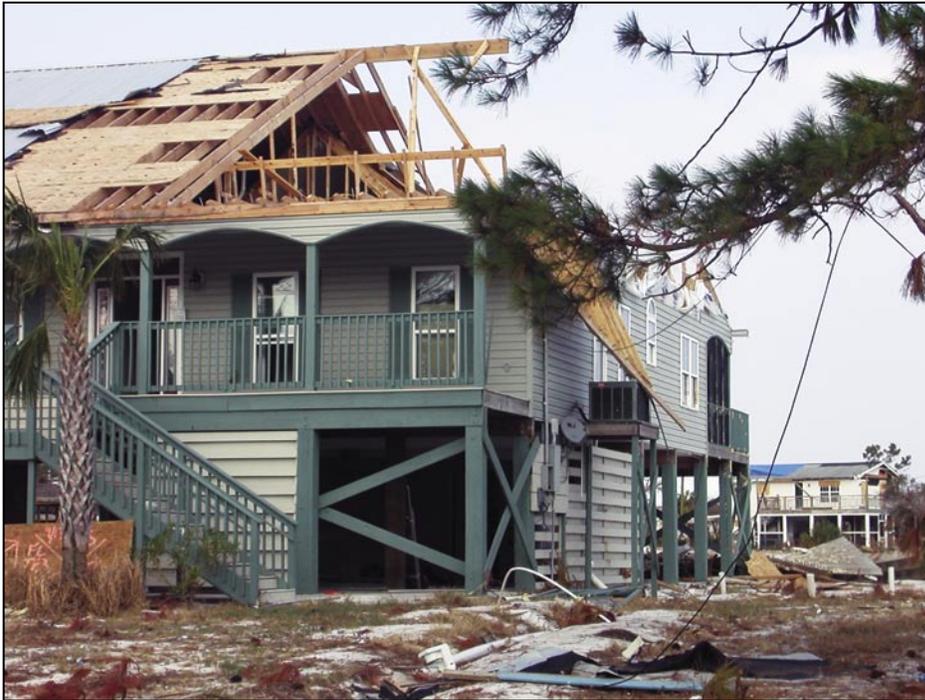
Figure 4-84.
Progressive failure
of wood roof framing
(Perdido Key)

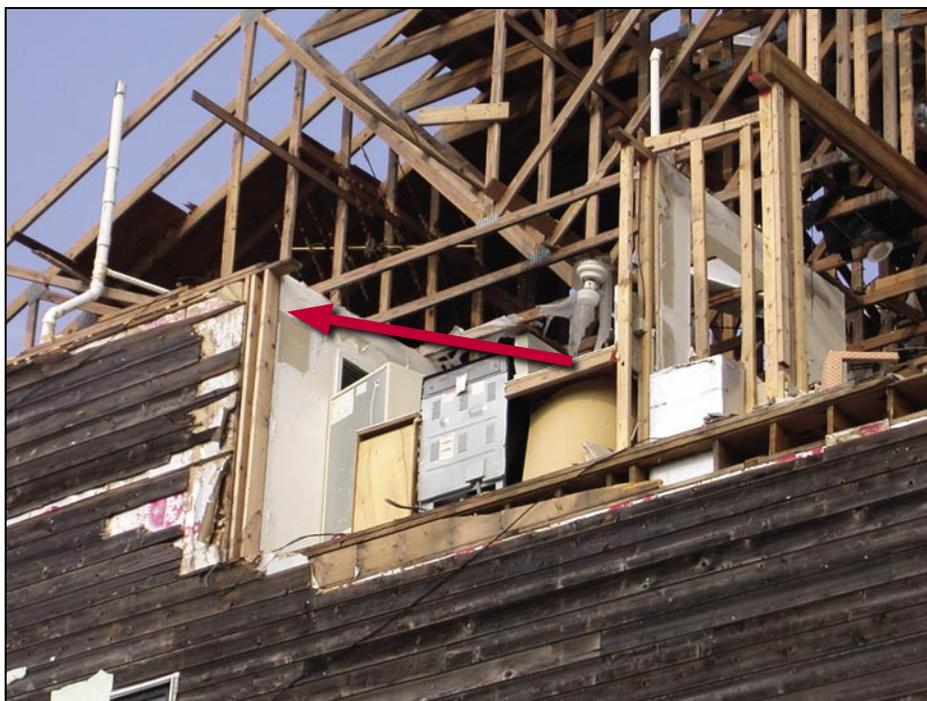
Figure 4-87.
Gable end wall failure
due to lack of bracing at
hinge point in wall (see
arrow) (Perdido Key)

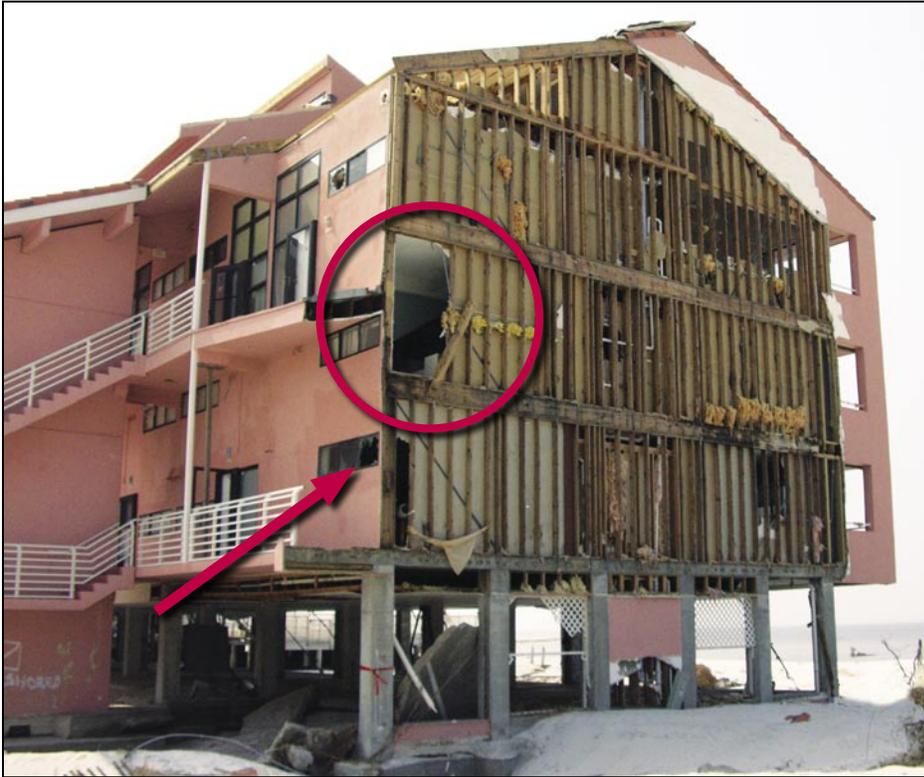
Figures 5-10 through 5-12 show dry rotted studs and sheathing, indicating long-term moisture intrusion behind the molded expanded polystyrene (MEPS) insulation. Both of these buildings used a barrier EIFS design, rather than the newer drainable EIFS design. (No drainable EIFS designs were observed.) At the condominium in Figure 5-10, the synthetic stucco was installed over MEPS over gypsum board over wood studs. Essentially all of the gypsum board blew off (the boards typically pulled over the fasteners). Some of the gypsum board on the interior side of the studs was also blown off. Note the missing studs on the second level at the left. Stud failure may have initiated the EIFS blow-off. Note the metal diagonal stud bracing straps. Two of the windows were broken by debris.

Figure 5-10.
All gypsum board blown off and two windows broken by debris. Note the missing studs.
(Pensacola Beach)
