3.0 OBSERVATIONS OF WIND DAMAGE AND SUCCESSFUL BUILDING PERFORMANCE UNDER WIND LOADING CONDITIONS

3.3 DIAGNOSTIC MODES OF STRUCTURAL FAILURE

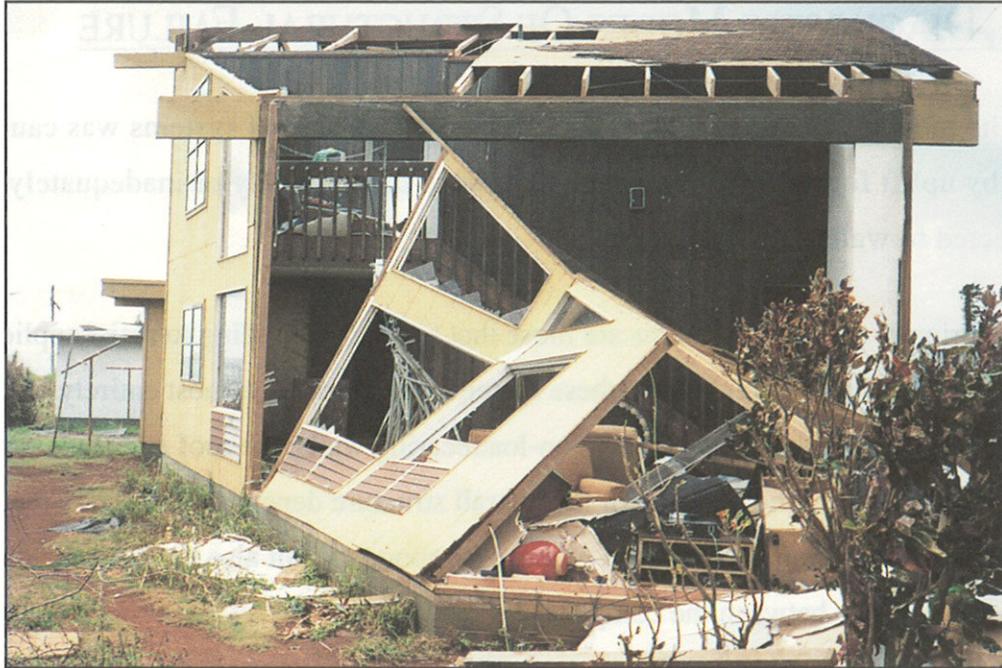
One- and two-story wood light-frame buildings were the most severely damaged type of construction. Building failure was primarily a result of 1) wind overload to roof systems caused by uplift forces, and 2) wall failure from direct wind pressure on interior and exterior walls which lost top support once all or part of the roof was lost. Simply stated, the roof system is a key component that provides stability by supporting the tops of exterior and interior loadbearing walls and exterior non-loadbearing walls of the building. Geometric stability of the wall system is generally dependent on the roof as a top lateral support. Buildings whose walls did not fail even after the loss of the roof may have been geometrically stabilized by the interior partition walls, such as in the smaller residences with numerous interior walls. Once the roof is partially or fully lost, the ability of the walls to withstand wind pressure is greatly diminished (FIGURE 21).

FIGURE 21. *Once the roof system is compromised, the ability of the wood-frame exterior walls to withstand external wind pressure is greatly diminished.*

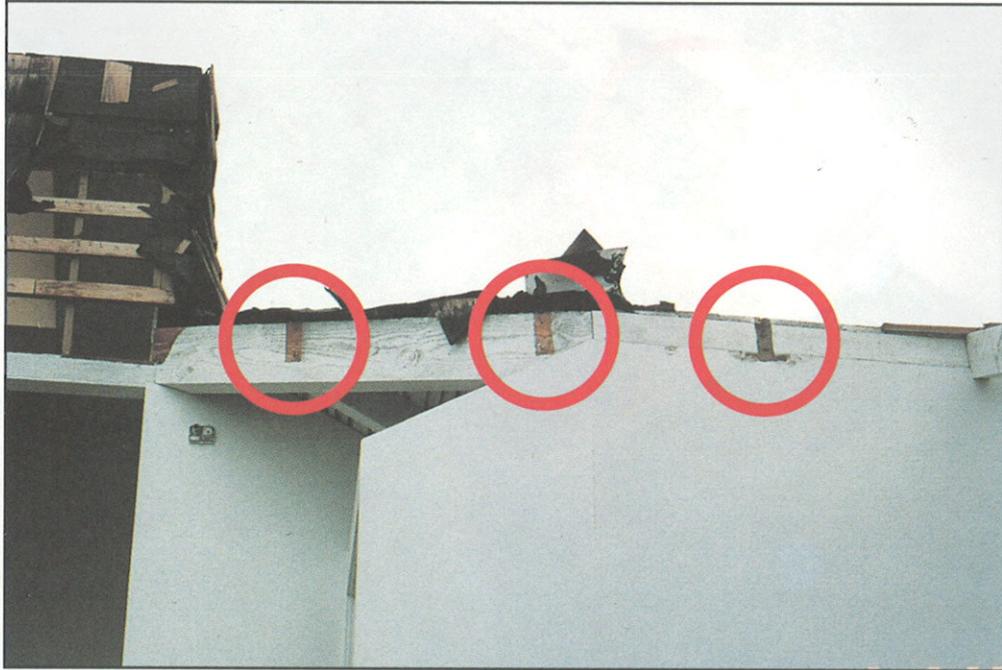
FIGURE 22. *Roof rafter construction with simple nailing or toenailing failed under uplift forces. Note two nails used to connect each rafter to hip beam.*

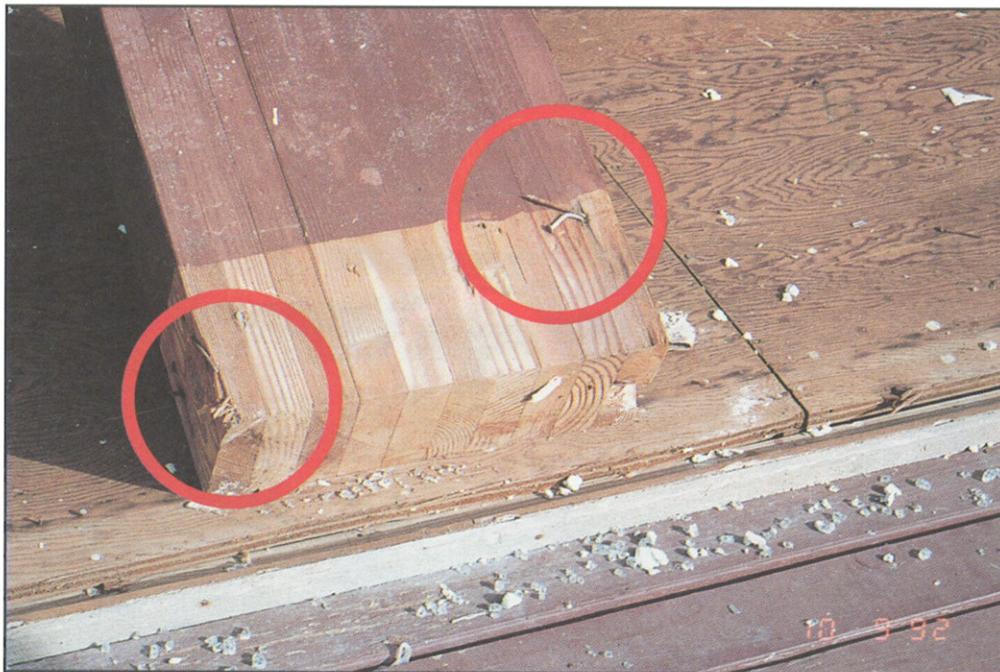
FIGURE 23. *Toenailing of ridge beam to gable-end support. Roof failure from uplift.*

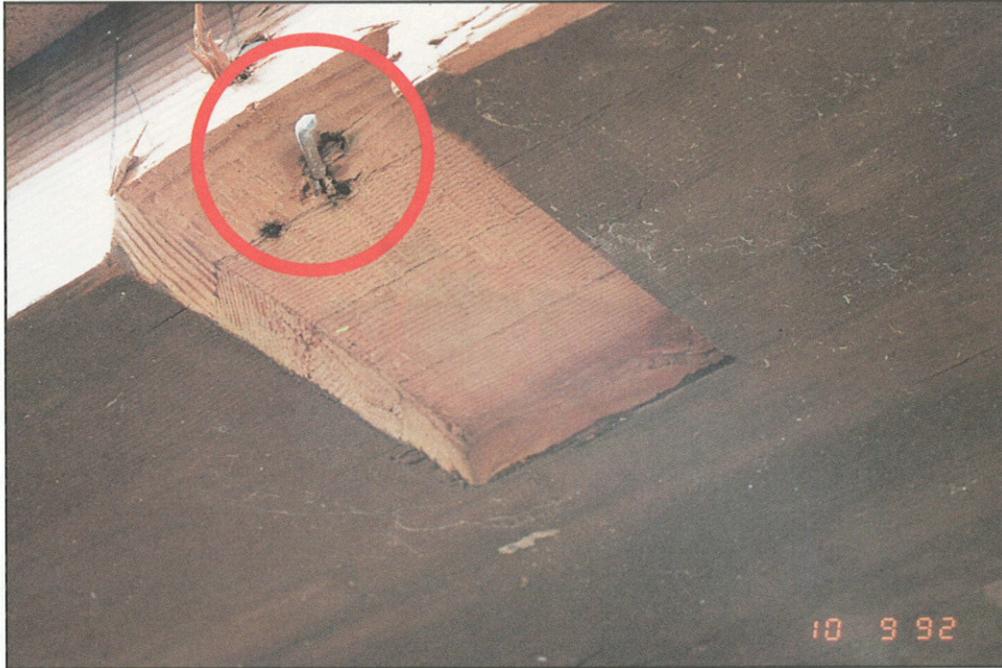
FIGURE 24. *Toenailing of rafter to ridge beam. Roof failure from uplift.*

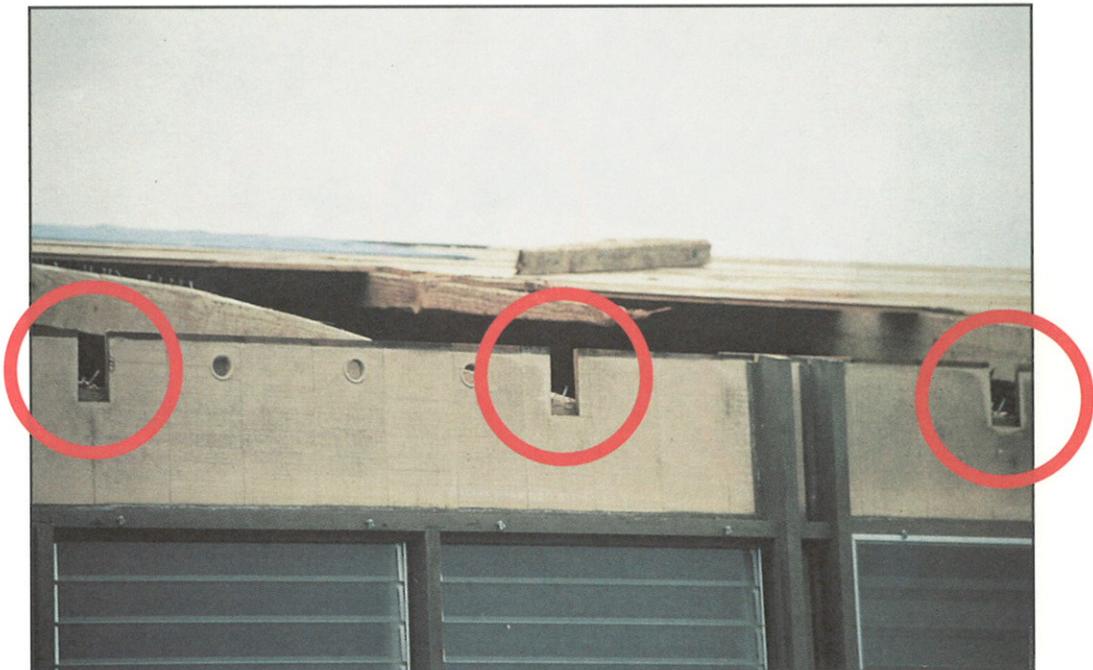
FIGURE 25. *Toenailing of roof rafters to wall system. At this critical connection, toenailing does not provide the load transfer path necessary to withstand uplift forces.*

The simplistic nailing procedures (generally toenailing) used to construct roof systems such as rafter tie-ins to the ridge beam or rafter attachments at stud wall sides or corners were not adequate to withstand significant wind loading. This is especially true in exposed areas along coastlines or other areas subjected to terrain-amplification of wind speed and subsequent forces. Simple toenailing of rafters and wood trusses to stud walls was a regularly observed failure point. Such toenailing did not provide the

complete load path to distribute the uplift and lateral loads from the roof to the walls and therefore should be eliminated as an accepted practice.

Shortcomings in design and construction practices such as toenailing were technically allowed due to reliance on implicit provisions in the 1985 UBC. Appendix Section 2518 of the 1991 UBC is very explicit in its requirements and contains graphical presentations not contained in older versions of the Code. For new and repair construction, much of the structural damage observed due to wind forces can be prevented if provisions in Appendix Section 2518 are correctly implemented.

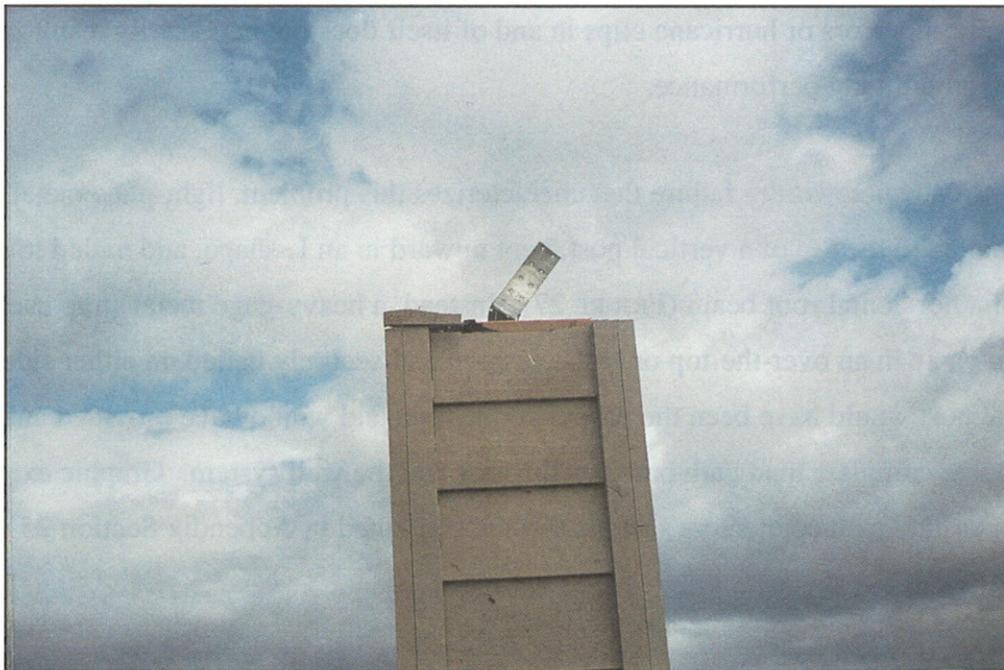
- Improperly sized, designed, or connected metal straps, fasteners, or hangers used to construct roof systems and/or connect roof and wall systems (FIGURE 26).

FIGURE 26. *Example of improperly sized and placed metal fastener, which led to roof failure from wind uplift forces.*

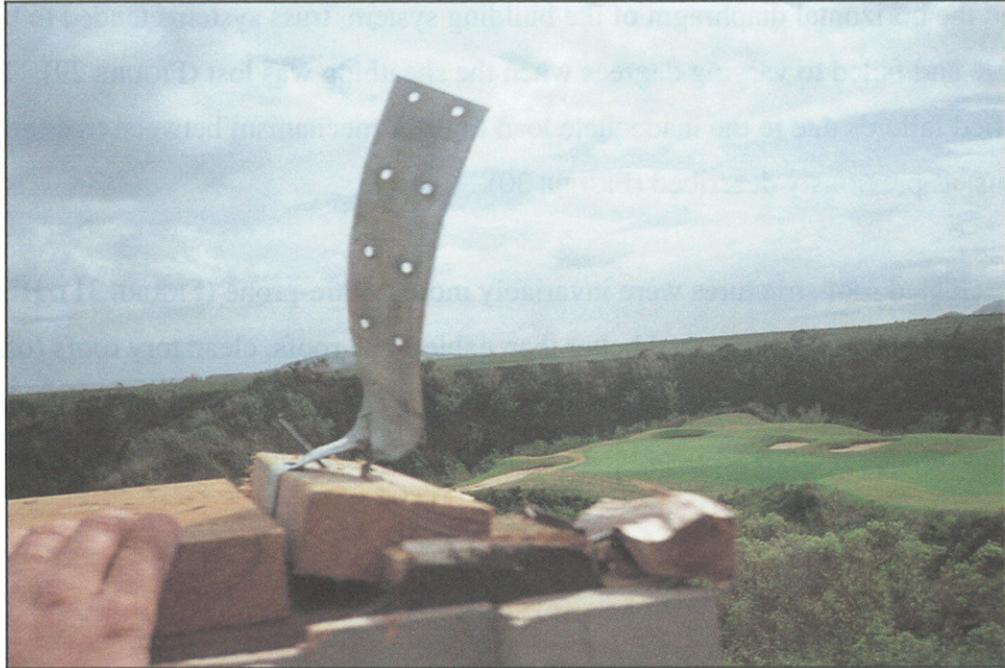
In one noteworthy failure that characterizes this problem, light-gage metal straps were nailed to the top of a vertical post, bent upward in an L-shape, and nailed to one side of a horizontal roof beam (FIGURE 27). Instead, a heavy-gage metal strap used continuously in an over-the-top or collar fashion and securely nailed on either side of the vertical post would have been the proper connection and would have provided an acceptable complete load path between the roof and the wall system. Graphic examples of proper load path connectors such as this are contained in Appendix Section 2518 of the 1991 UBC.

FIGURE 27. *Undersized and improperly attached metal fasteners led to roof damage from uplift forces.*

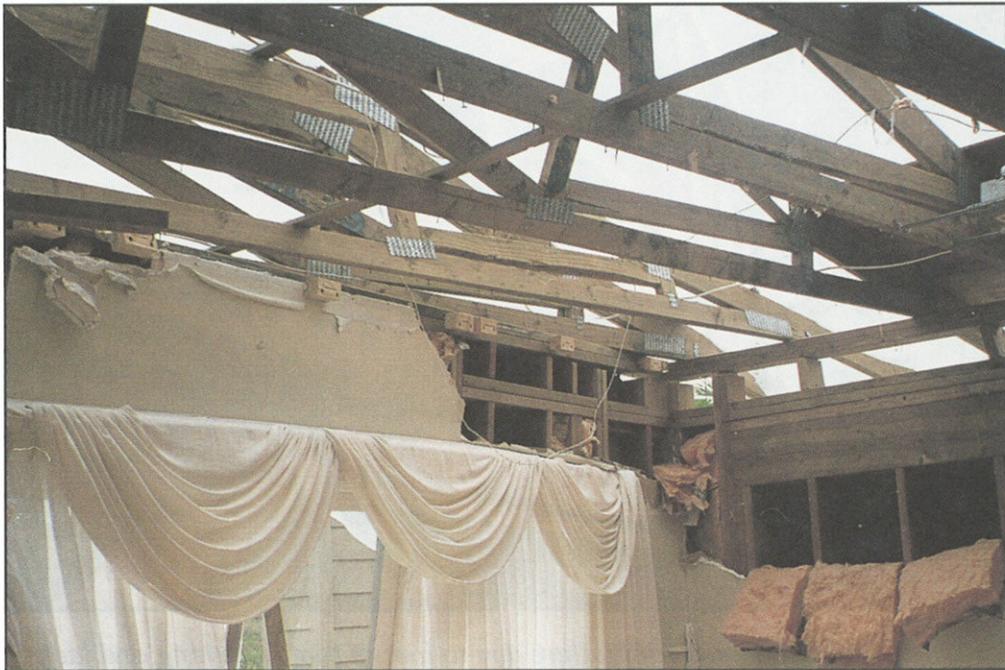
FIGURE 28. *Individual prefabricated wood roof trusses performed relatively well.*

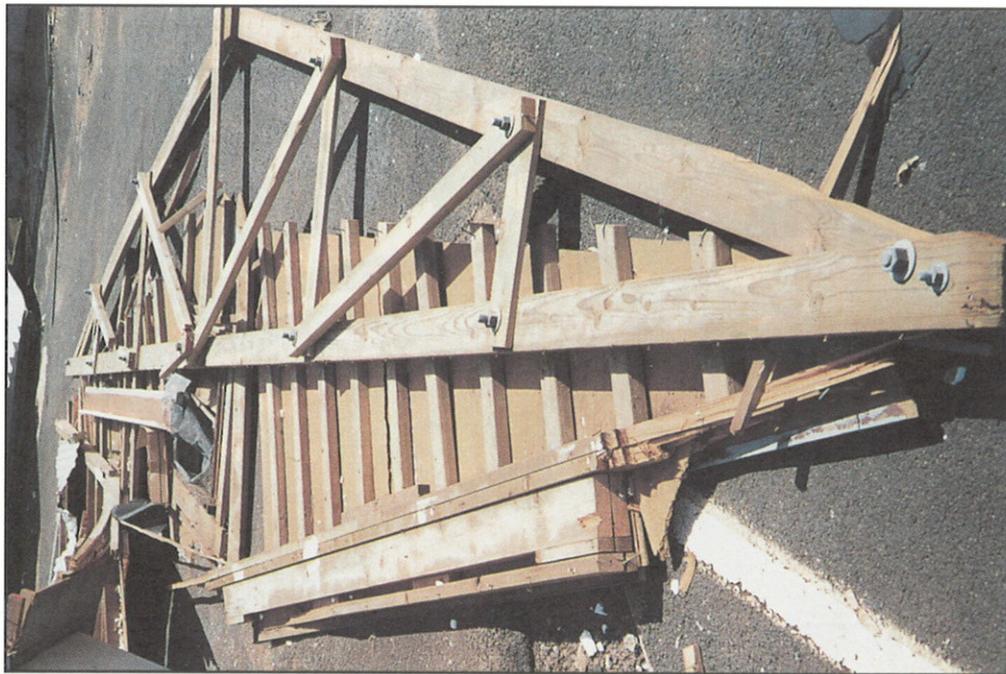
formed the horizontal diaphragm of the building system, truss systems tended to become unstable and failed to varying degrees when the sheathing was lost (FIGURE 29). This amplified failures due to the inadequate load transfer mechanism between truss and wall systems, as previously described (FIGURE 30).

FIGURE 29. Gable-end roof failure due to loss of roof sheathing and lack of gable bracing.

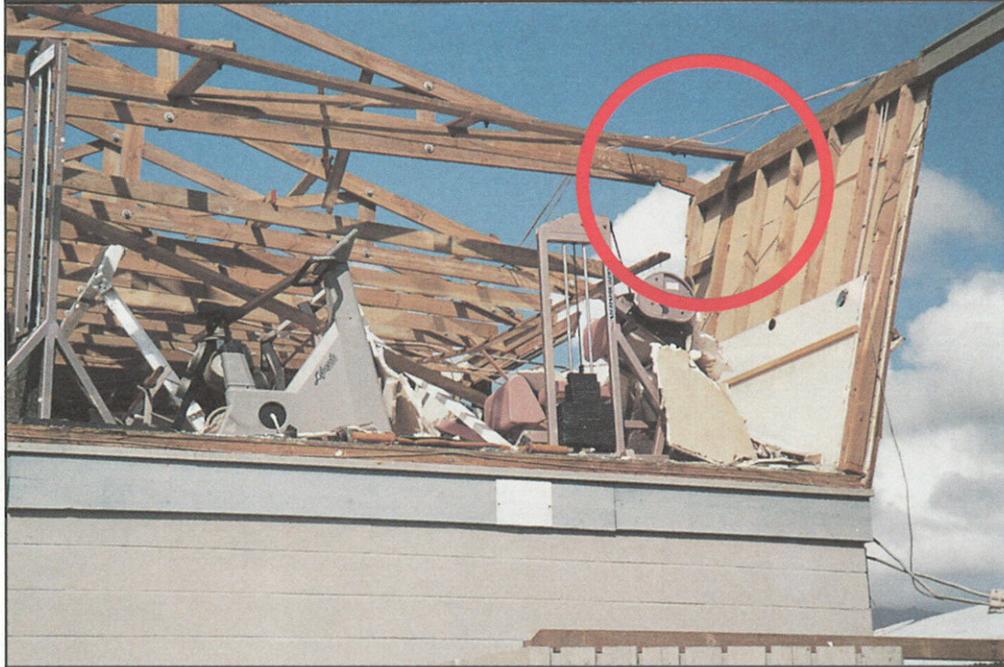
FIGURE 30. *Improper connection (toenailing) between roof trusses and wall systems. When roof sheathing was blown off by wind, unbridged trusses failed, as did the exterior wall.*

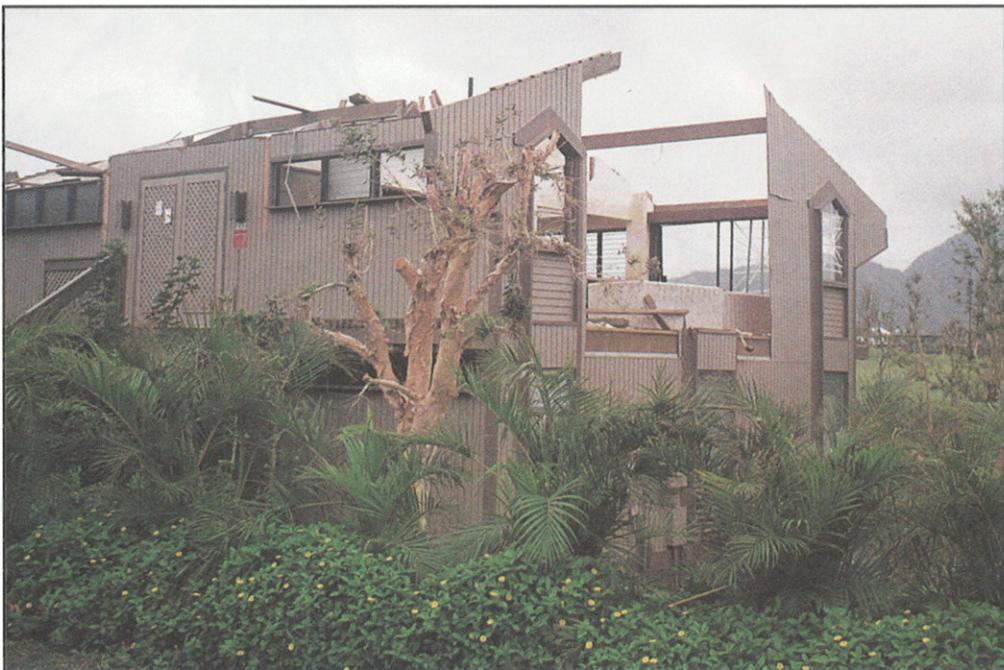
Gabled roof structures were invariably more failure-prone (FIGURE 31). Hip roofs (FIGURE 32) generally performed better than gabled-end roofs, clearstory roofs (offset roof peak), and other steeply pitched roof systems . The geometric discontinuity in these roof lines made the roofs susceptible to high localized wind-induced external pressure on eaves and soffits (FIGURE 33).

FIGURE 31. *Gable-end roof designs tended to be more failure-prone.*

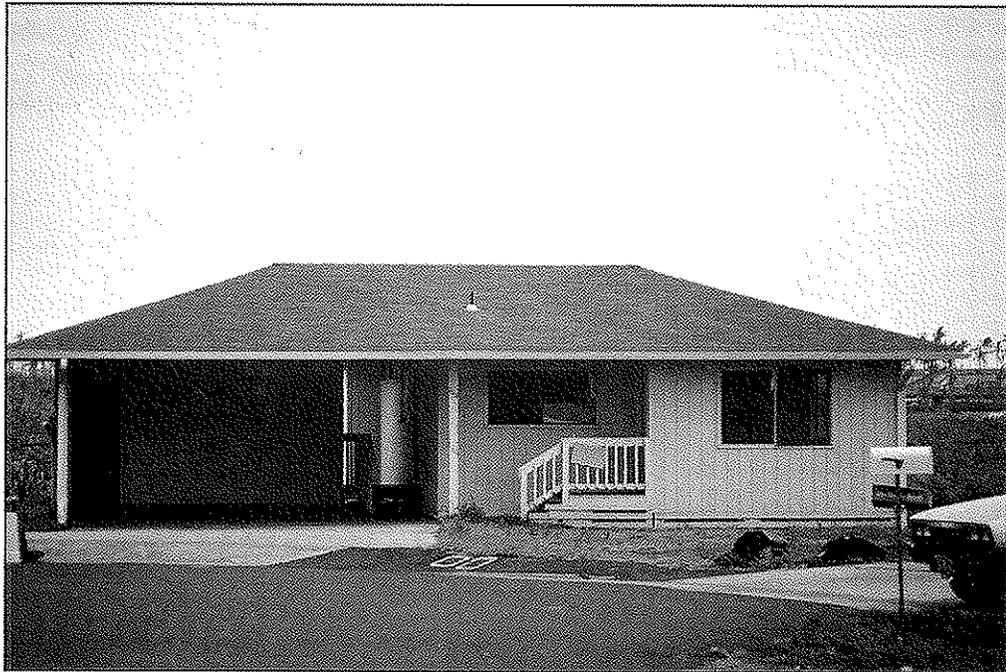
FIGURE 32. *Low-pitched hip roofs are aerodynamically superior and generally performed better than steeply pitched gable-end roofs.*

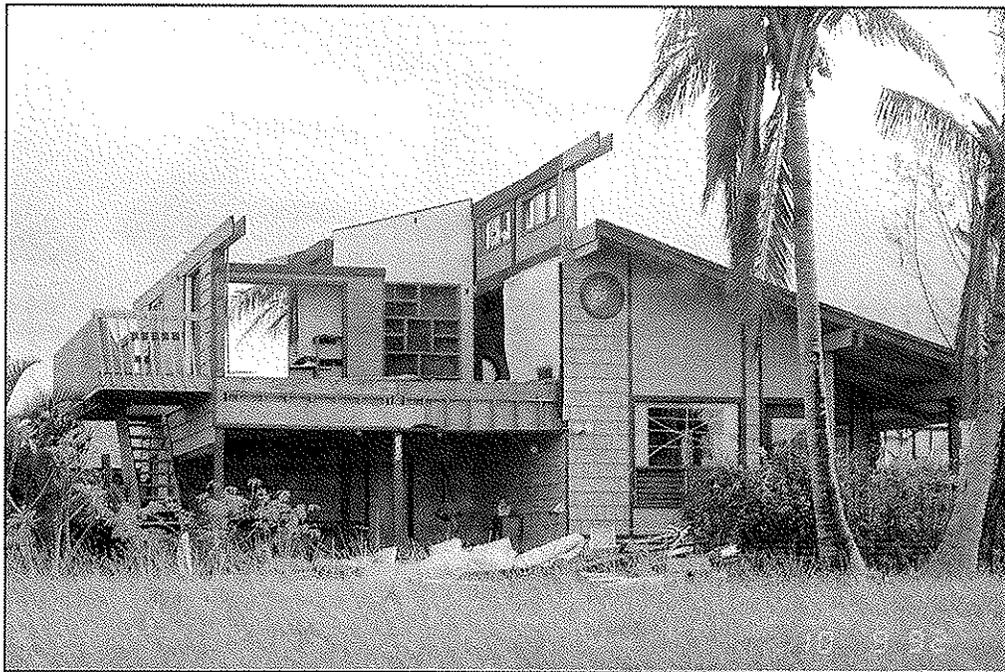
FIGURE 33. *Offset roof peak provides geometric discontinuity and results in greater localized wind-induced pressure, which can lead to roof and then wall failure.*

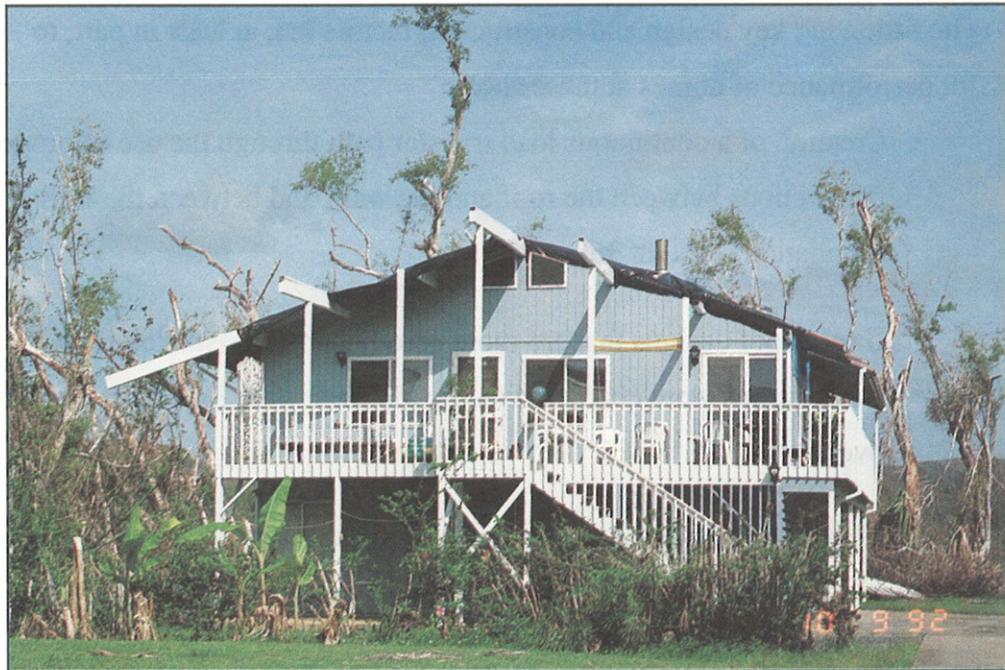
Roof overhangs or soffits 3.0 feet long or less, with adequate venting, suffered comparatively less damage from wind forces. Overhangs exceeding 3.0 feet in many instances failed to resist the uplift forces and were the source of progressive roof structure failure (FIGURE 34). Much of this failure was due to inadequate installation, lack of proper engineered enclosure of extended soffits, lack of tie-back from rafters to wall, and improper sheathing and venting.

FIGURE 34. *Excessive roof overhang and poor connections in many instances led to roof failure.*

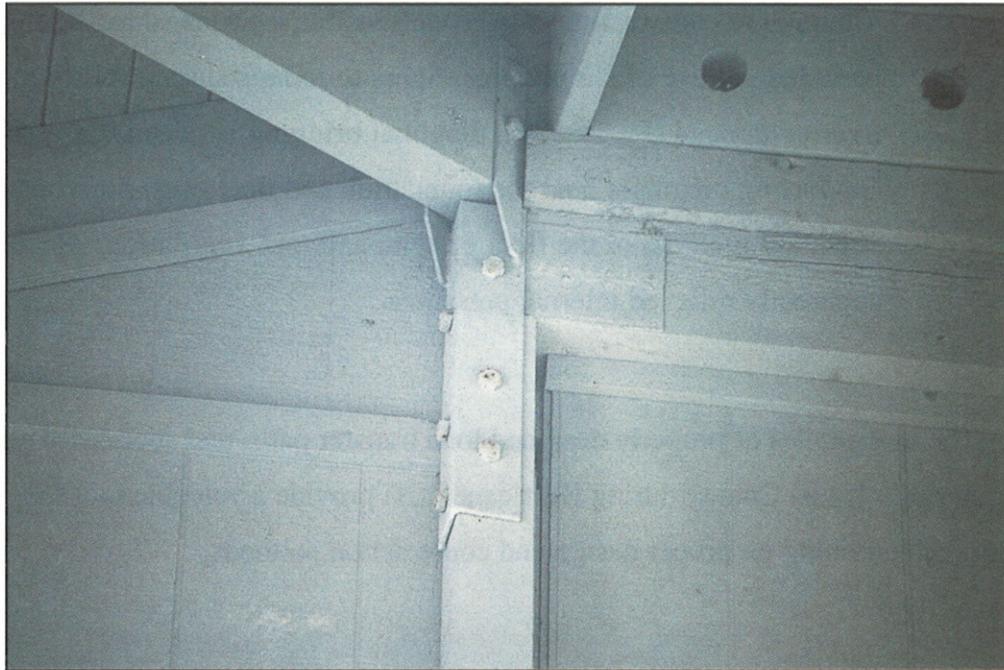
FIGURE 35. *Example of very successful heavy-gauge metal fastener connecting roof and wall systems. Note the over the top application and the number and size of lag bolts used for attachment.*

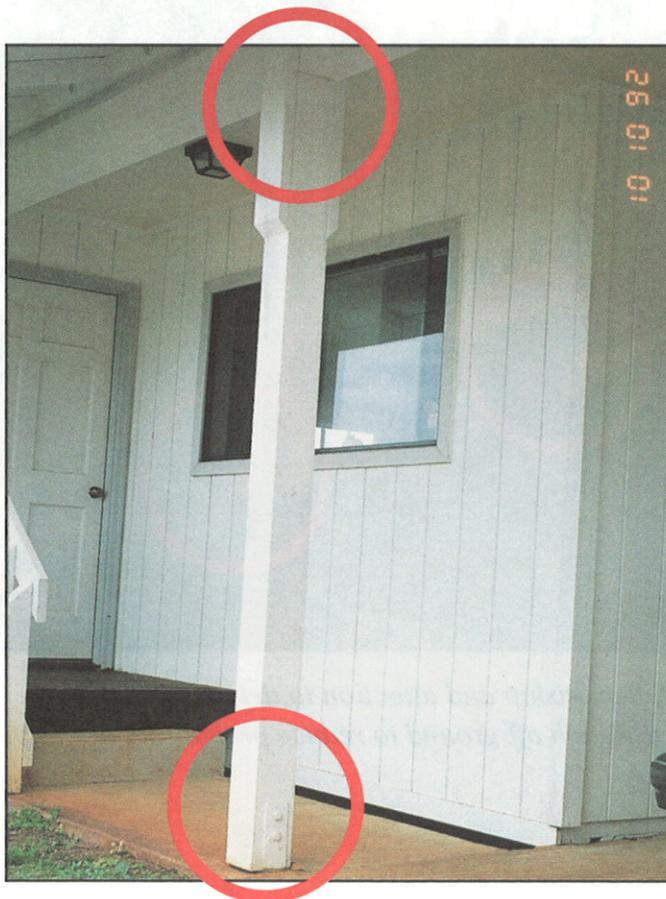
FIGURE 36. *Wood splice or strap provides a secure connection between wall and roof systems. Bolted metal anchor provides secure connection between vertical member and foundation. This is a fine example of a continuous load path.*

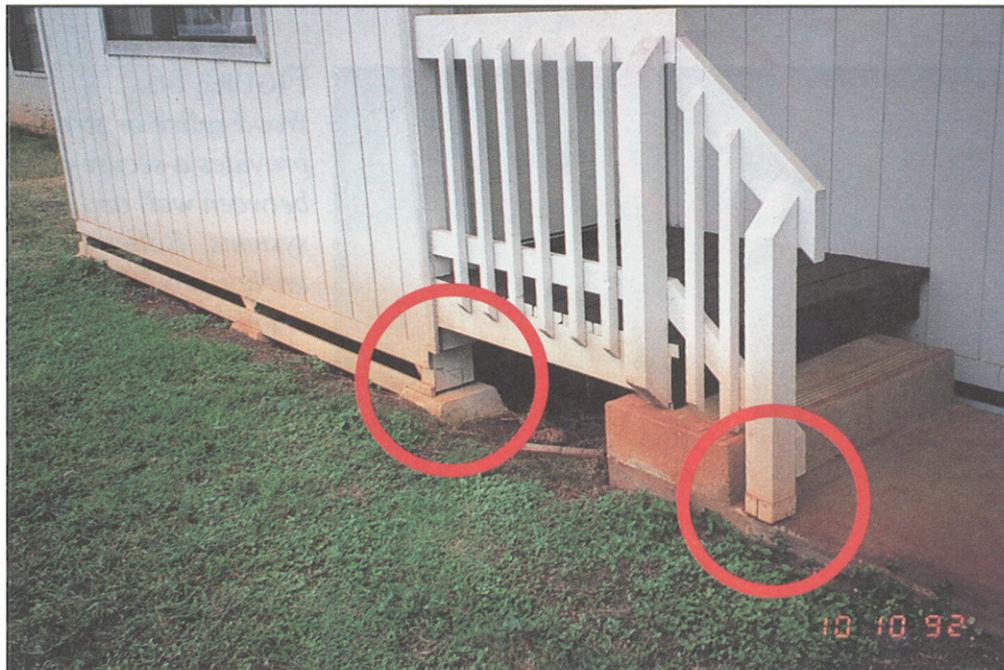
FIGURE 37. *Sensitive craftsmanship and attention to detail: Vertical preservative-treated posts 1/4 inch off ground to reduce probability of termite infestation and decay.*

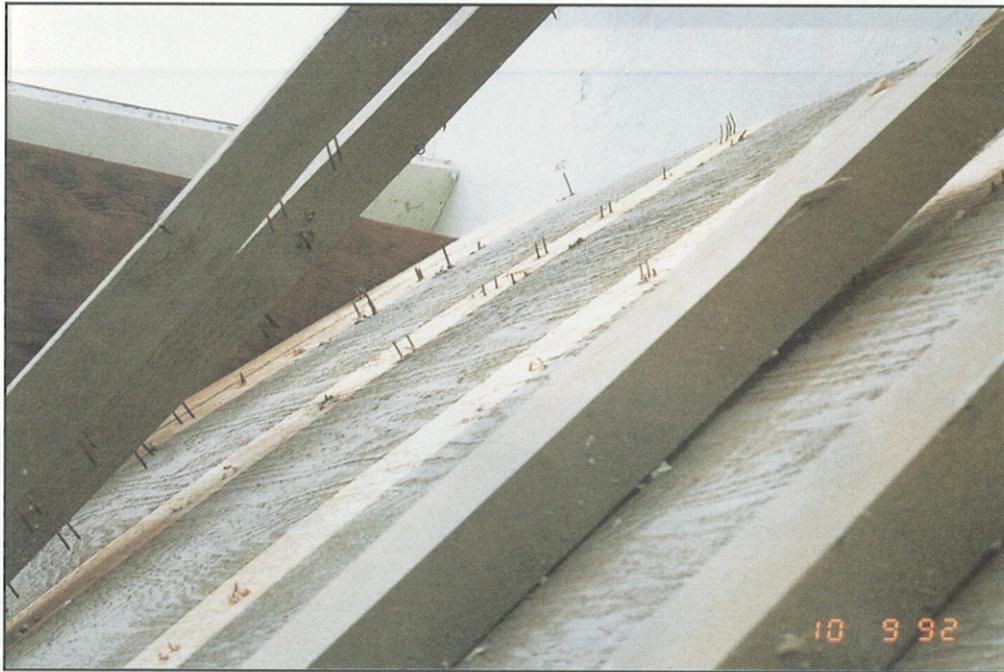
FIGURE 38. *Improper attachment of sheathing to purlins. Note wide spacing, shallow penetration, misalignment, and corrosion of staples.*

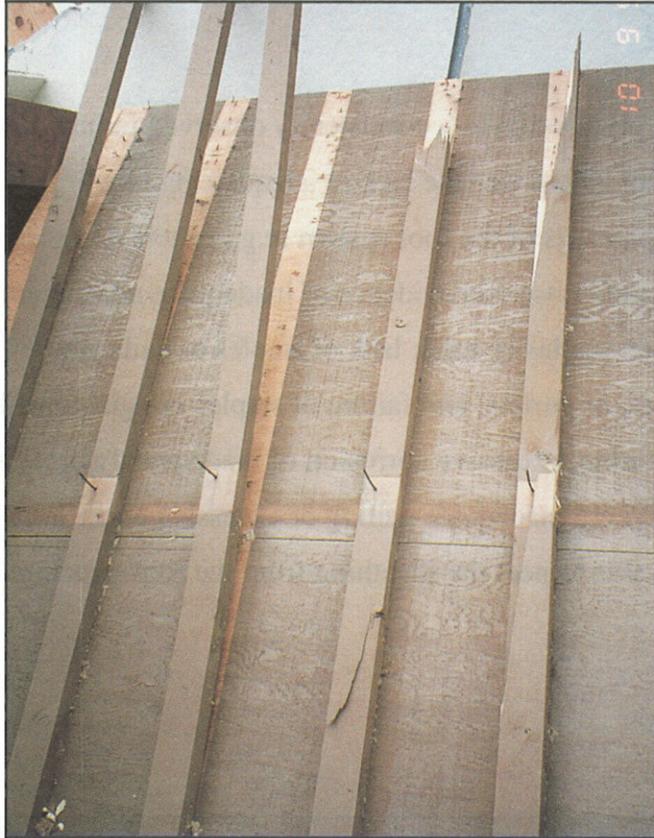
FIGURE 39. *Improper nailing design and schedule for purlin-to-rafter attachment. Note infrequency of nails for large surface area. Nowhere is the plywood sheathing directly nailed to the rafter system.*

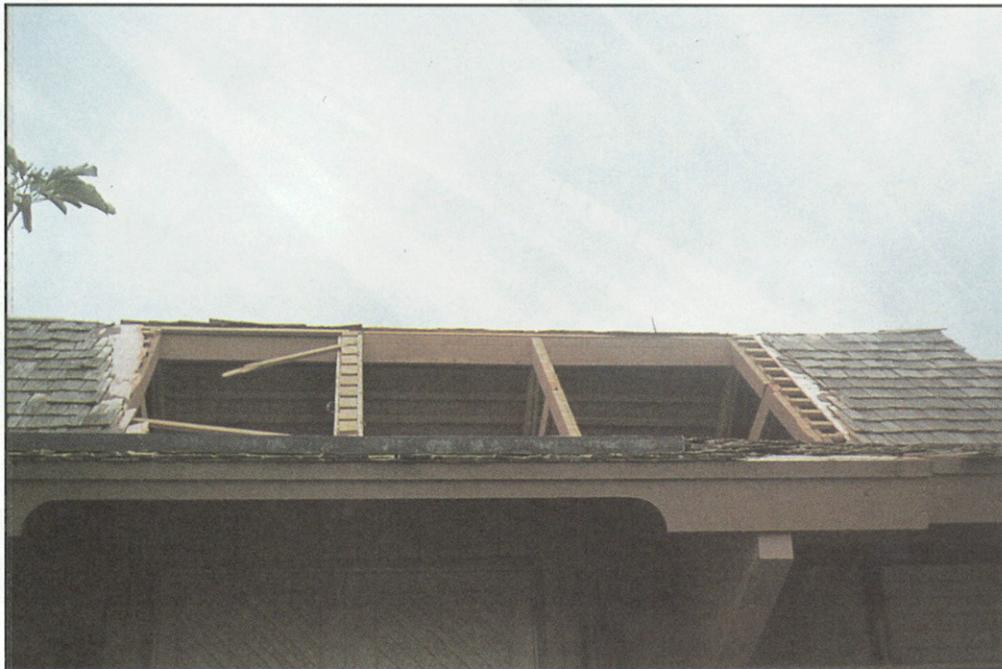
FIGURE 40. *Loss of roof sheathing due to improper nailing design and schedule.*

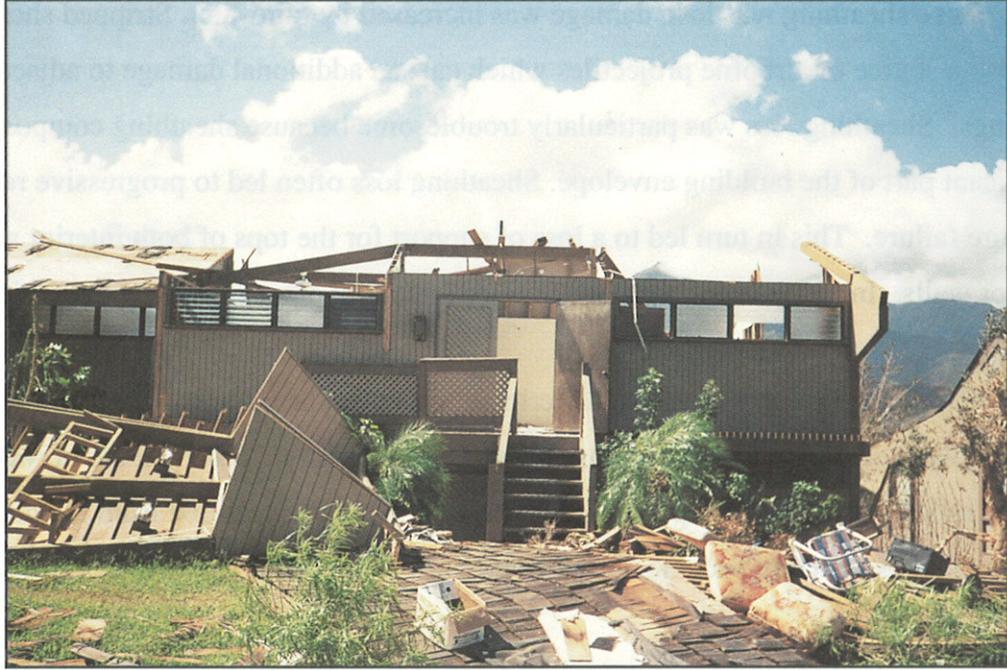
Loss of sheathing was especially critical where roof structures (rafter or truss systems) were engineered. In these instances, the roof structure relied on the plywood to provide rigidity to the roof diaphragm. Once the sheathing was peeled from the purlins or trusses, the roof structure became unstable and highly susceptible to damage (FIGURE 41).

FIGURE 41. *Total roof failure due to loss of sheathing.*

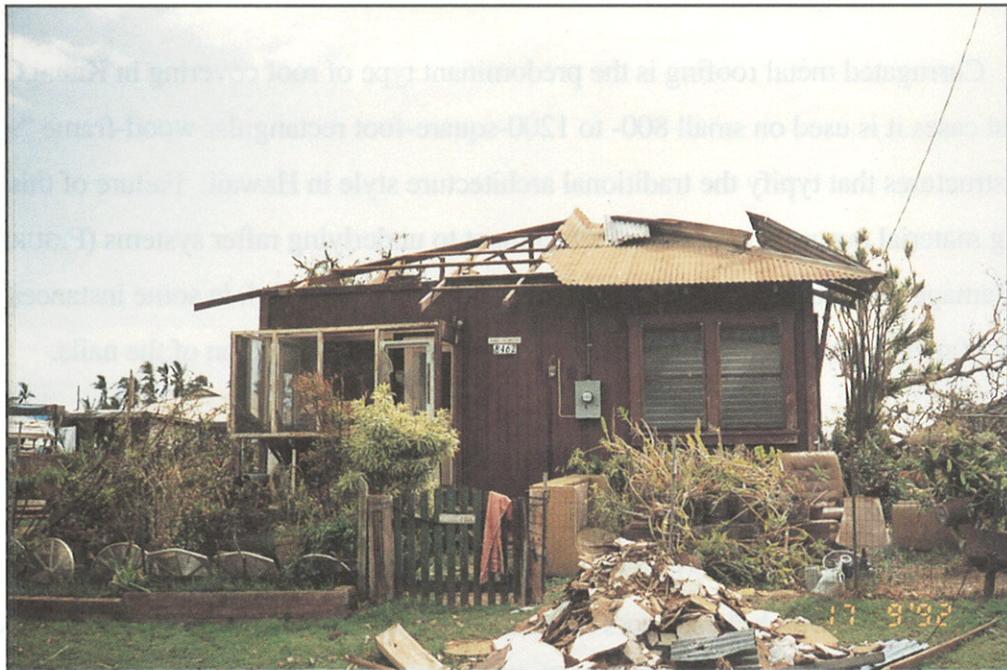
FIGURE 42. *Failure of corrugated metal roof at attachment points. These small, geometrically stable, “single wall,” rectangular structures with numerous interior partition walls often remained structurally intact after loss of metal coverings.*

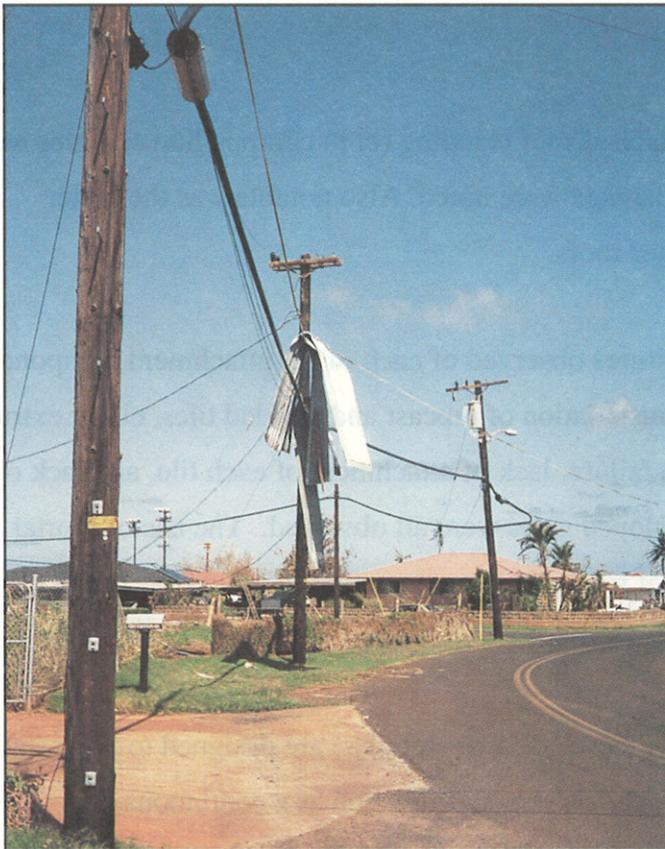
Loss of corrugated metal roofing was nonetheless a significant problem because of the resulting rainwater damage and the generation of windborne projectiles (FIGURE 43). Thus, considerable effort should be given to teaching building contractors, and especially homeowners, the proper fastening of corrugated metal roofing to the underlying rafters and purlins.

FIGURE 43.
Metal roof loss generates large airborne projectiles, which often cause additional damage.

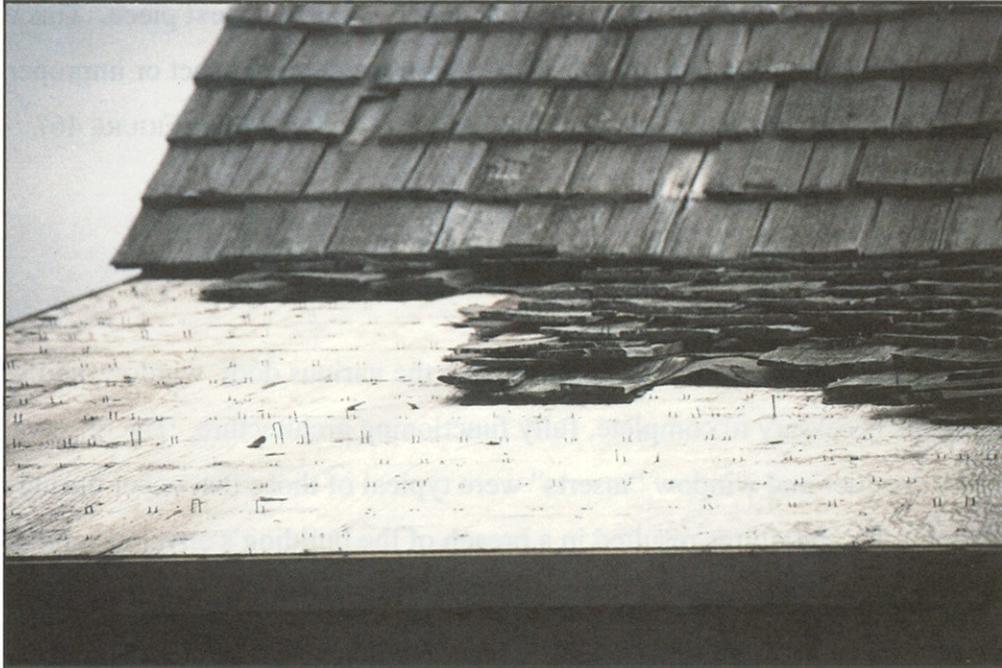
Close observation revealed that attachment procedures (stapling or nailing) for cladding types were deficient at many locations (FIGURE 44). Rarely was material failure caused solely by wind pressure. It was observed that less damage occurred to roofs where either staples or nails were sized and installed to generally accepted standards of construction practice. In some instances, individual tiles were observed that had not been nailed (FIGURE 45).

FIGURE 44. *Loss of roof cladding due to failure at attachment points. Notice that many staple crowns have corroded away on staples used to attach wood shake roofing to plywood roof sheathing.*

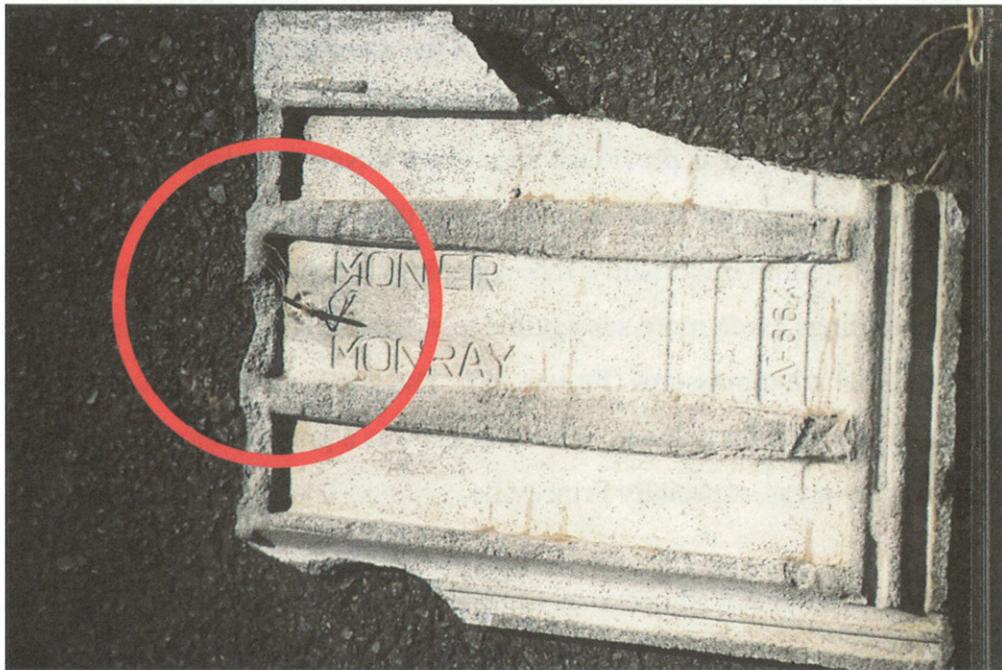
FIGURE 45. *Heavy concrete tile attached at one point with undersized nail. It was also observed that neighboring tiles had not been nailed.*

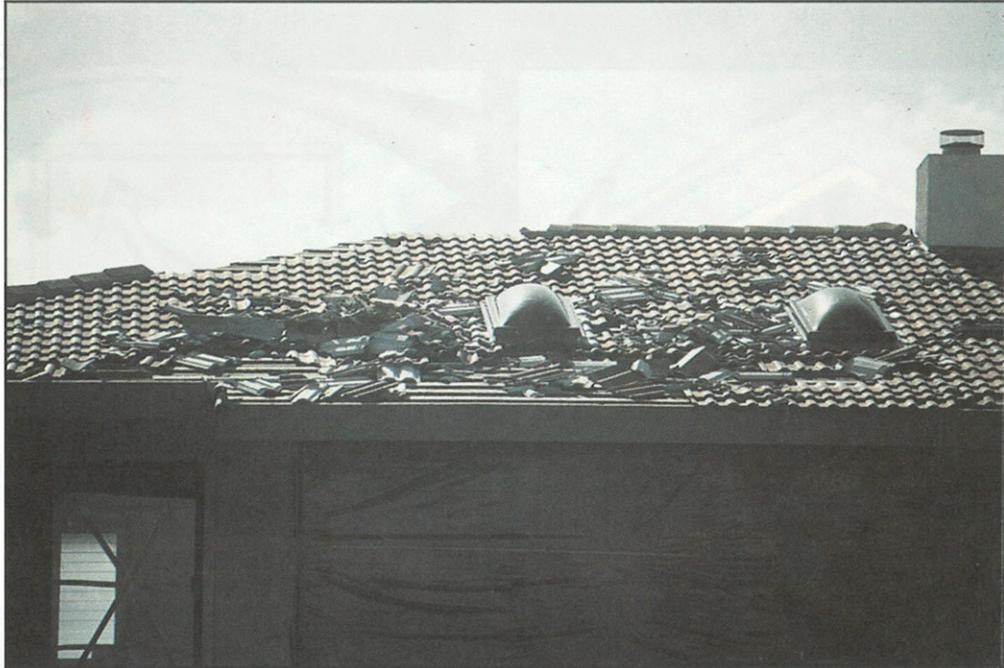
one piece allows wind to effectively penetrate under and lift the next piece. This explains the chain-reaction failure mode of shakes and tiles once debris impact or improper attachment allowed wind to remove the first few pieces of cladding (FIGURE 46).

FIGURE 46. *Roof cladding system composed of interdependent elements. Failure of one tile led to failure of adjacent tiles in a “chain reaction” effect.*

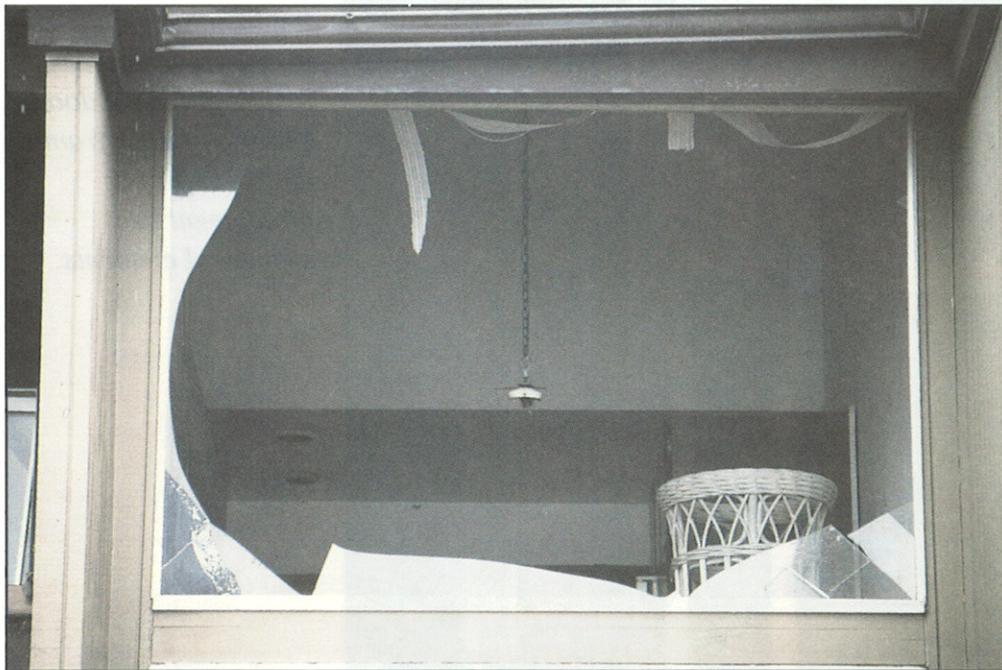
FIGURE 47. *Glazing broken by windborne debris or direct wind pressure.*

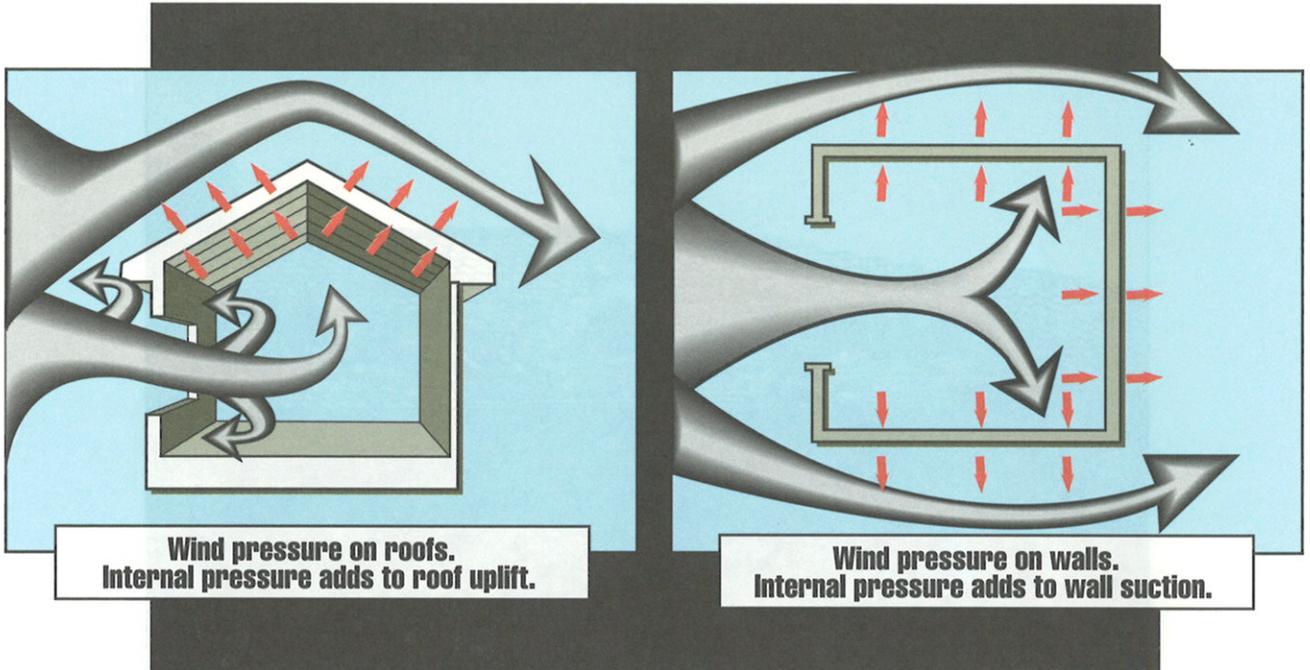
FIGURE 48. *Loss of opening protection allows wind entry and increases internal exposure.*

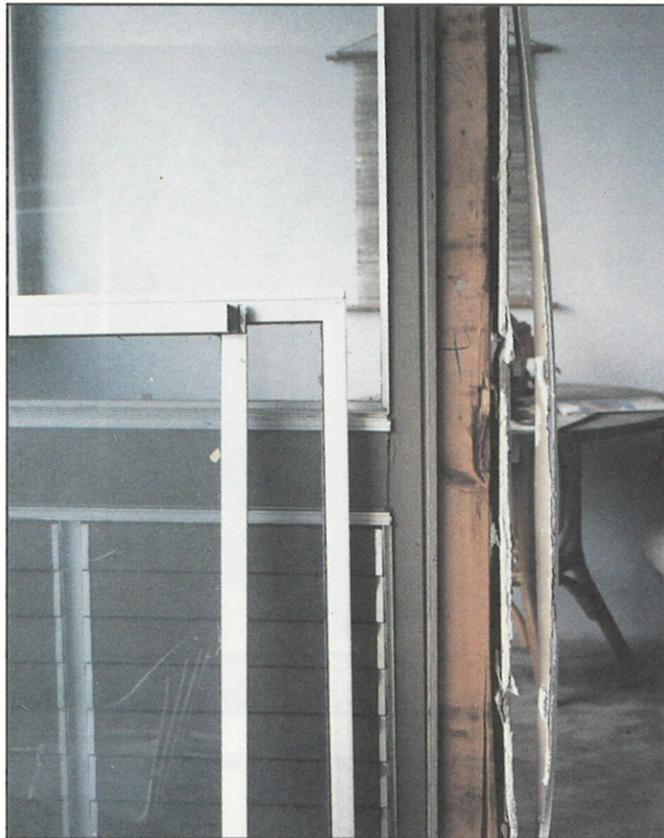
FIGURE 49. *Implosion of transparent shatter-resistant sliding door. Failure of door frame due to improper attachment to structural elements.*

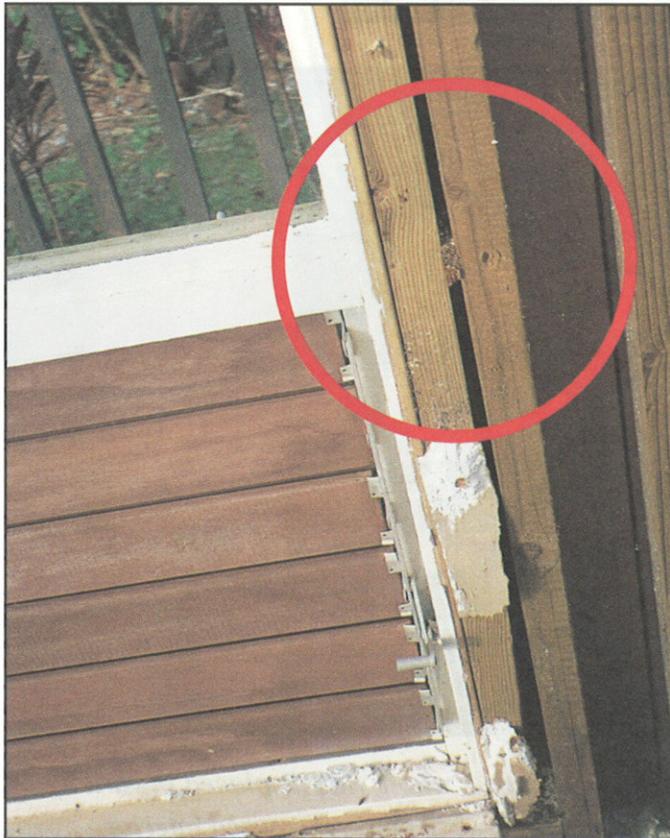
Improper installation, for example, inappropriate attachment of window frames to the structural elements of the wall (FIGURE 50), and weak connections of expansive sliding doors (FIGURE 51), were consistently observed causes of the failure of glazing units. Where shatter-resistant material was used, failure was frequently observed where the material remained intact, but the unit, as a whole, was displaced inward by wind pressure (FIGURE 52) due to bowing and subsequent failure at the perimeter connections.

FIGURE 50.
Improper attachment of window unit. Note only one connection (nailing) point between unit and wall structure at the single shim.
