3.0 OBSERVATIONS OF WIND DAMAGE AND SUCCESSFUL BUILDING PERFORMANCE UNDER WIND LOADING CONDITIONS

3.3 DIAGNOSTIC MODES OF STRUCTURAL FAILURE

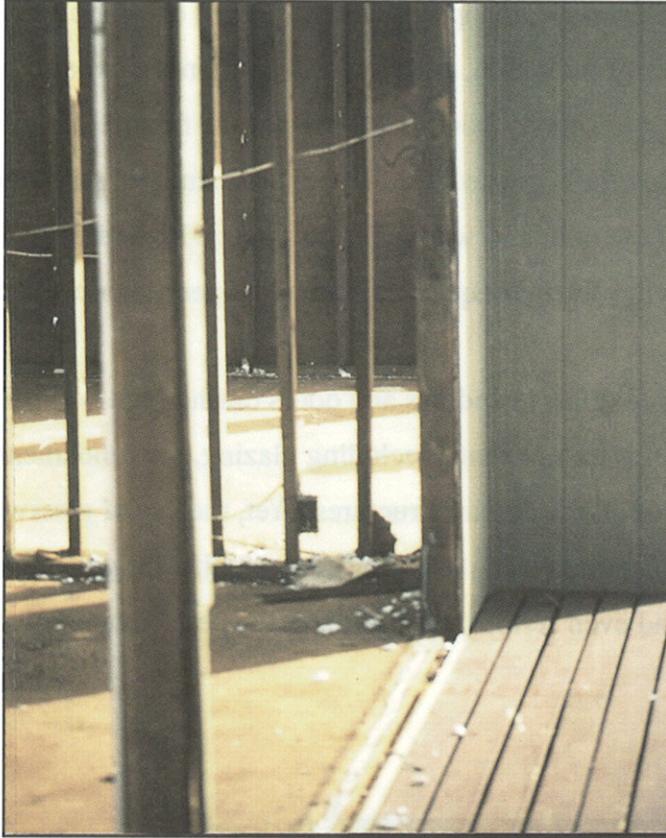
FIGURE 51.
Improper connection of sliding glass door. Track attached with only three screws in vertical member. Sliding track on floor attached with caulk only.

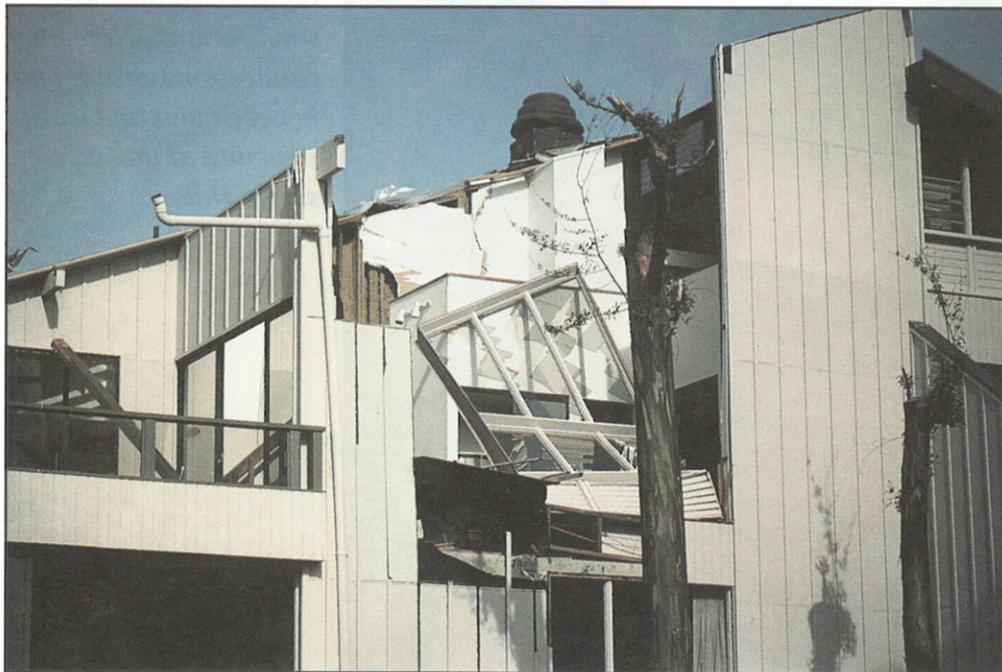
FIGURE 52. *Gable-end window unit as a whole was displaced inward by wind pressure. Apparently, this allowed wind entry, increased interior pressure, and caused roof uplift.*

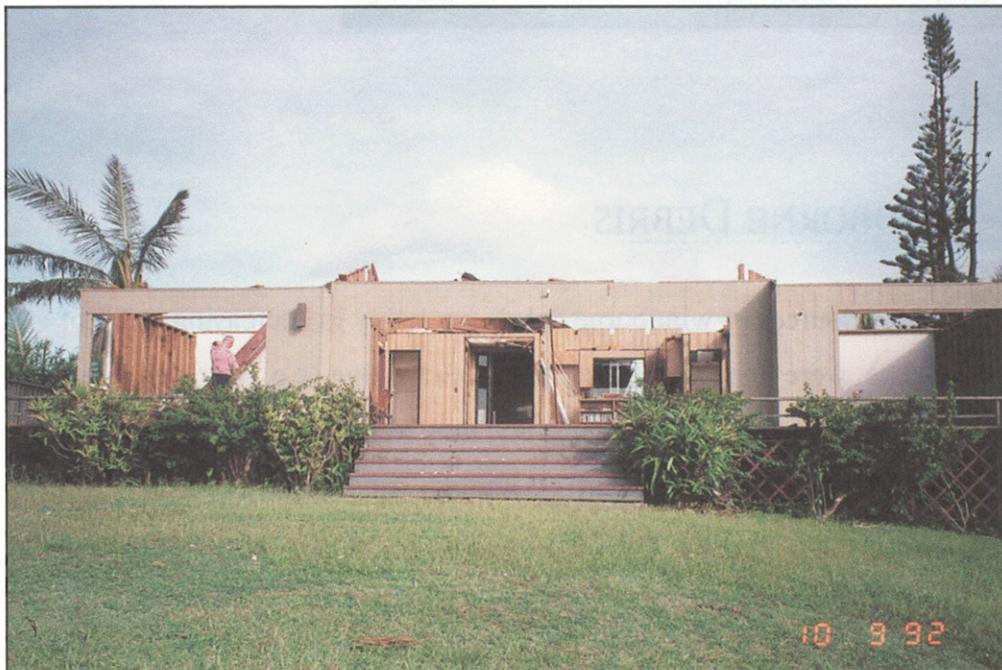
FIGURE 53. *Extensive use of glazing on windward side can significantly compromise a building's envelope and lead to roof failure.*

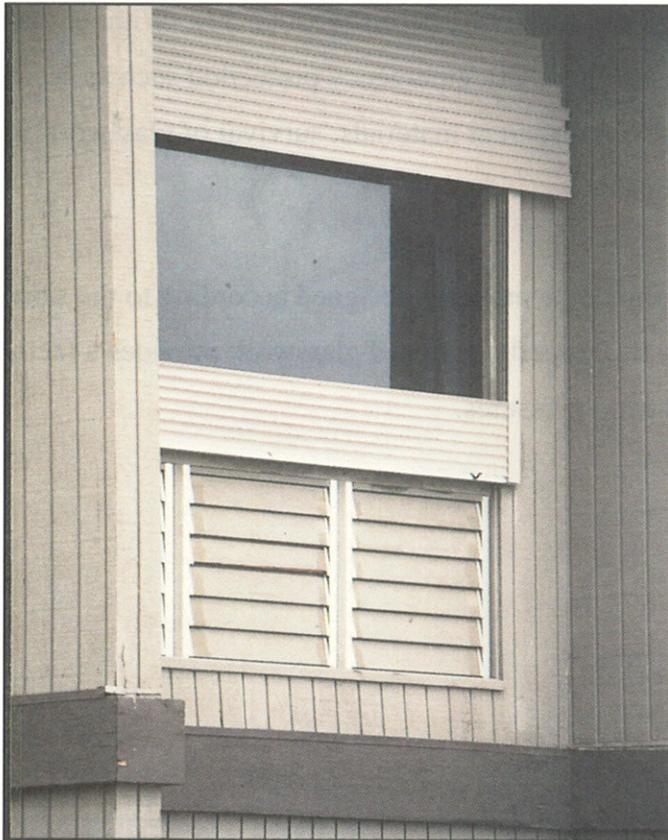
FIGURE 54.
In-place protective devices for glazing reduced the occurrence of building envelope failures.

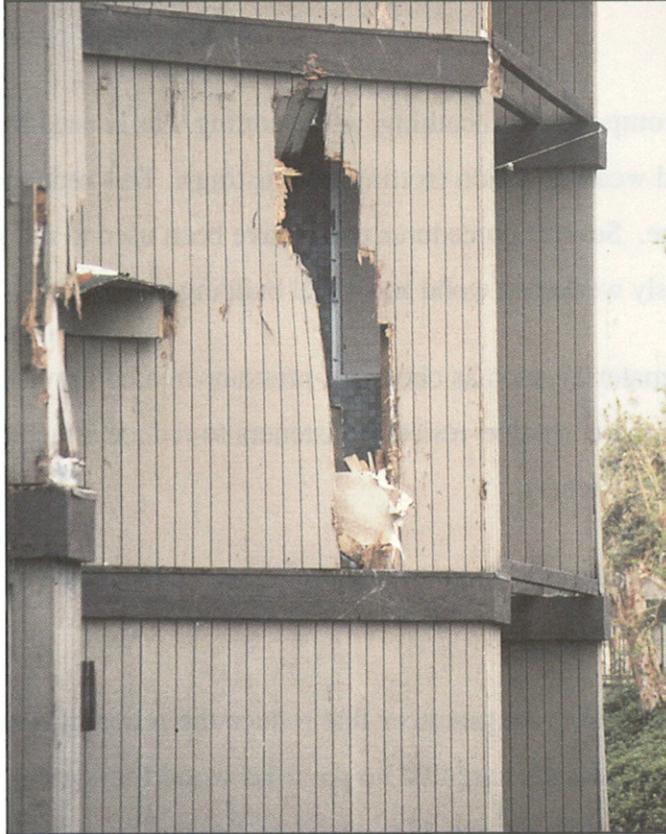
FIGURE 55.
Windborne debris impact can puncture building and allow buildup of internal wind pressure.

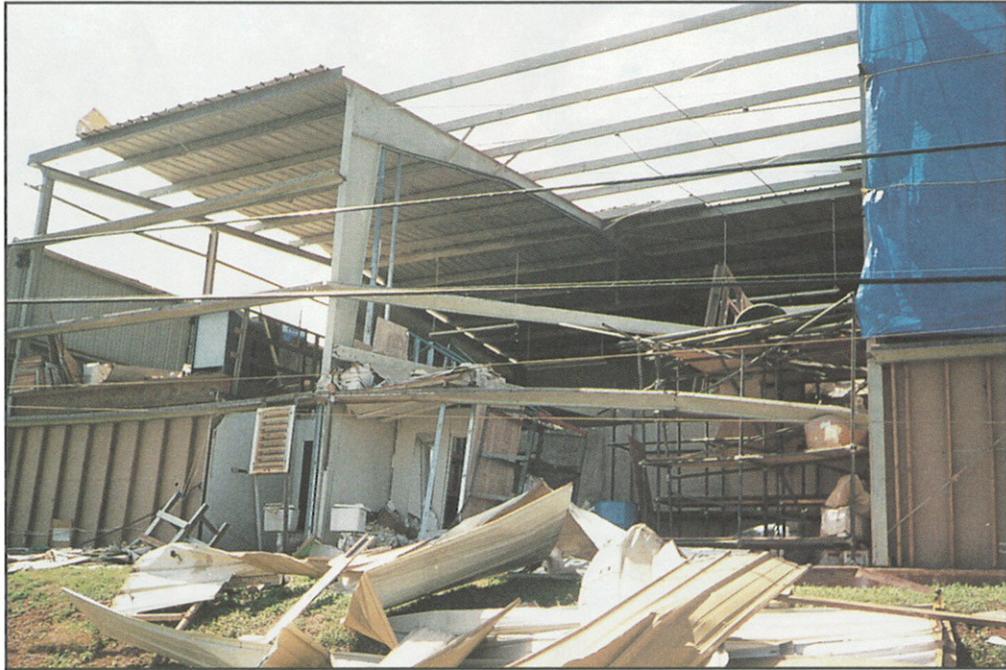
FIGURE 56. *Steel warehouse failure commonly was due to loss of light-gauge metal sheet cladding.*

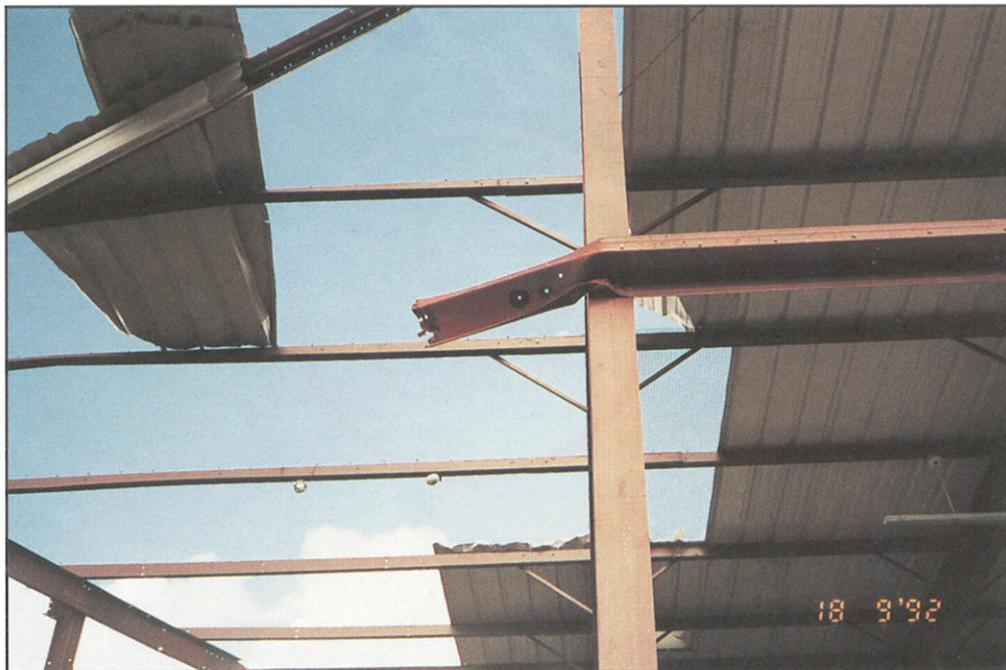
FIGURE 57. *Steel warehouse failure was also due to failure of structural steel members.*

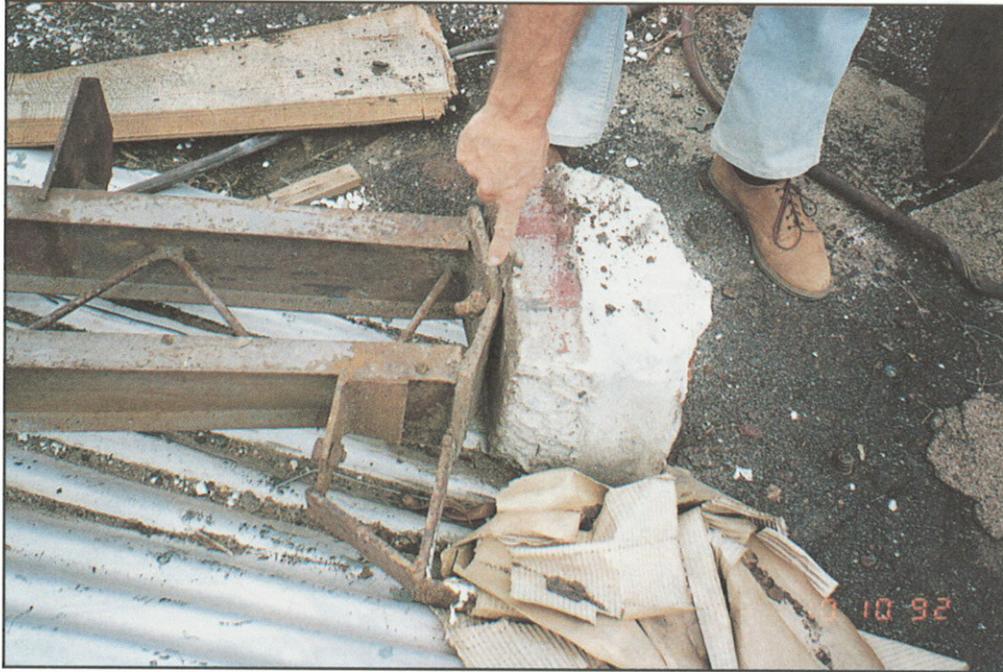
FIGURE 58. *Failure of steel warehouse due to age and weatherization and insufficient anchorage to resist uplift.*

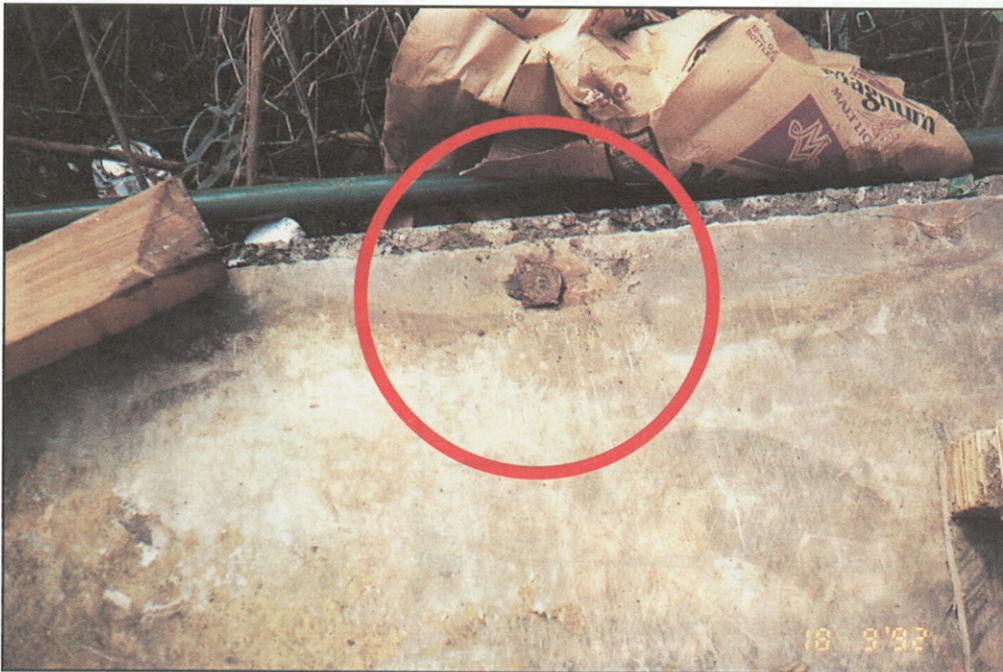
FIGURE 59. *Steel warehouse, sill-to-concrete-foundation failure at anchoring points.*
