6 Mississippi Observations

6.1 Flood Observations: Damages and Successes

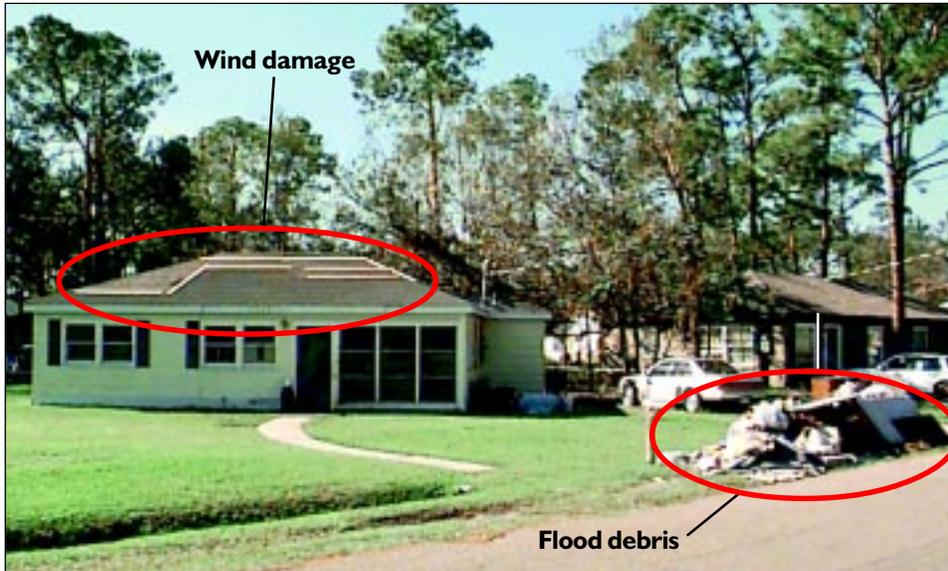
Typical of the flood damage observed in the Pascagoula area is the home shown in Figure 6-1. In addition to flood damage, some homes in this area also suffered roof damage due to high winds. Many homes in low-lying areas of Pascagoula, such as those shown in Figures 6-2 and 6-3, have been flooded previously. The frequent flooding in this area is likely a result of the inability of the storm drains to convey the rainfall runoff and the inability of the storm drainage system to discharge into the Gulf during periods of coastal surge, or a combination of both of these factors. During Hurricane Georges these homes were flooded to a depth of 3 to 4 feet. No structural damage to homes was observed; however, there were significant losses to contents, interior finishes, wallboard, insulation, and electrical systems.

FIGURE 6-1 Home in Pascagoula that sustained wind and flood damage.

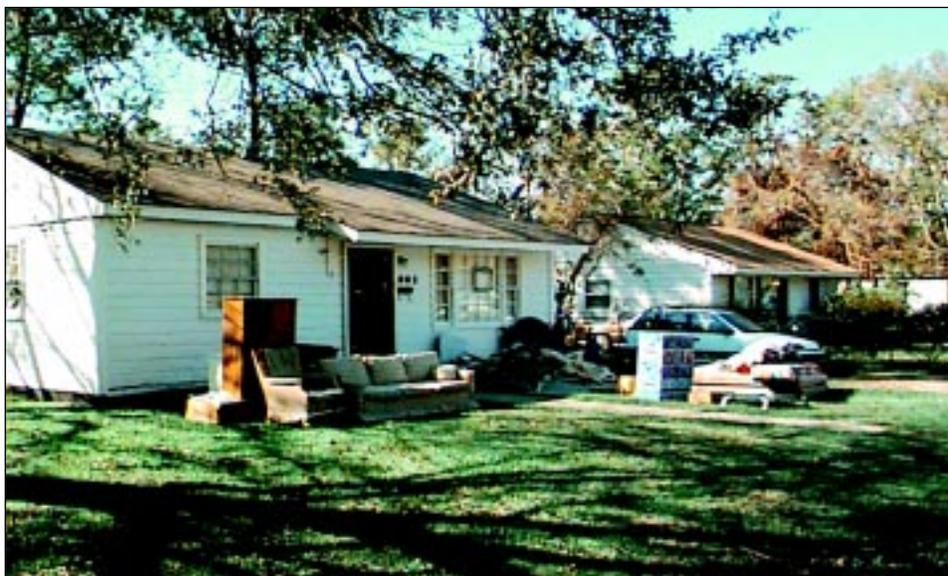
FIGURE 6-2 Typical pre-FIRM at-grade house flooded several feet in Pascagoula.

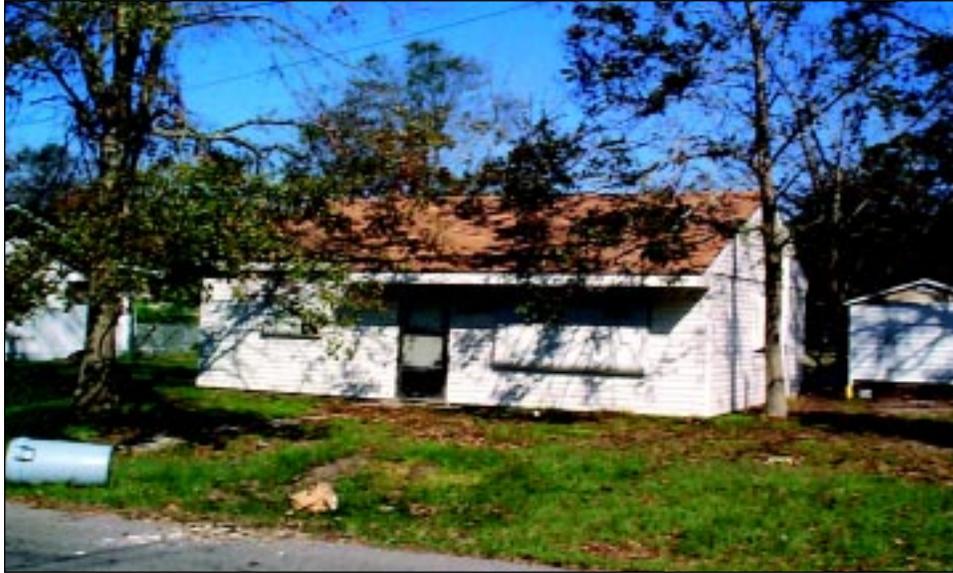
FIGURE 6-3 This home has suffered flood damage on numerous occasions. During Hurricane Georges it flooded several feet.

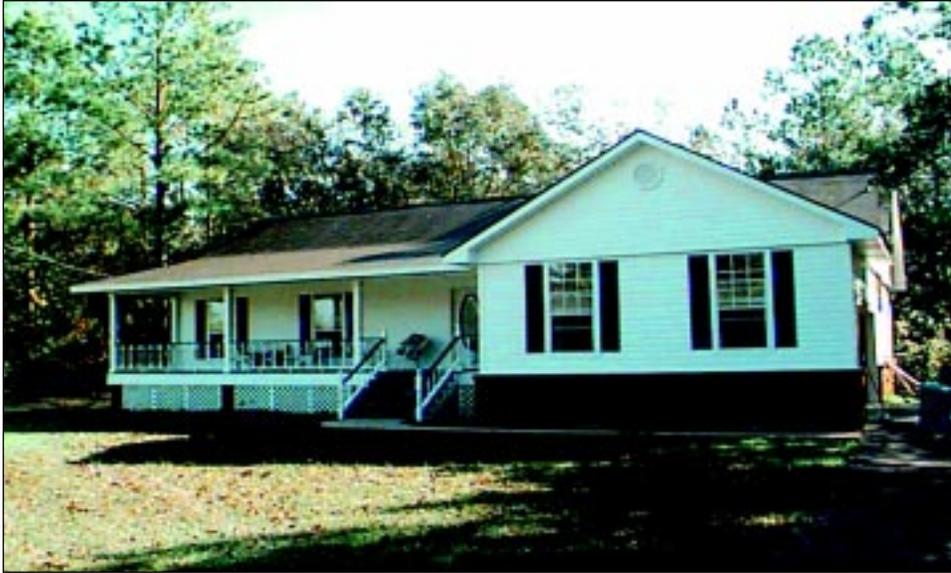
The house shown in Figure 6-4, located in the Franklin Creek watershed, was elevated in 1996 under FEMA's HMGP. It was elevated 40 inches, bringing the lowest floor to an elevation of 16 feet NGVD which is one foot above the 100-year flood elevation (approximately 15 feet NGVD). Prior to Hurricane Georges, floods have threatened the home four times since it was elevated but it has not sustained any damage. Unfortunately, flooding from Hurricane Georges inundated this house approximately 3 inches above the lowest floor (Figure 6-5). Given the estimated recurrence interval of approximately 25 years, flood elevations exceeding the 100-year flood could be attributed to backwater effects from where Franklin Creek meets the Escatawpa River.

While the 3 inches of flooding did cause damage, if the house had not been elevated it would have received 43 inches of flooding. Elevating homes has been proven to reduce flood damages; however, there is still a residual risk that a flood greater than the 100-year flood will cause damage. The only way to completely eliminate the risk is to relocate well outside the 100-year floodplain.

FIGURE 6-4 Home in eastern Jackson County elevated approximately 40 inches.

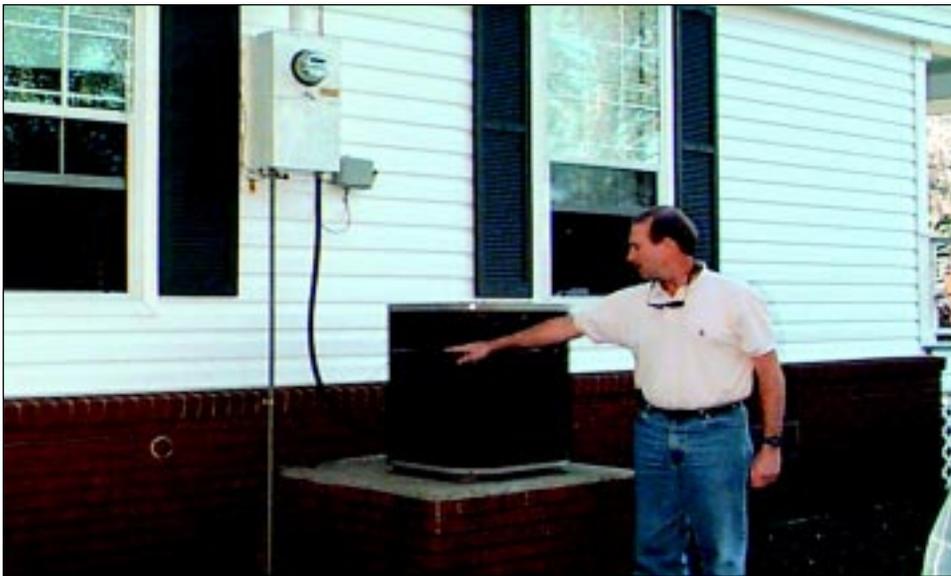
FIGURE 6-5 The high water mark on the air conditioner compressor indicates that the flood level was approximately 3 inches above the lowest floor.

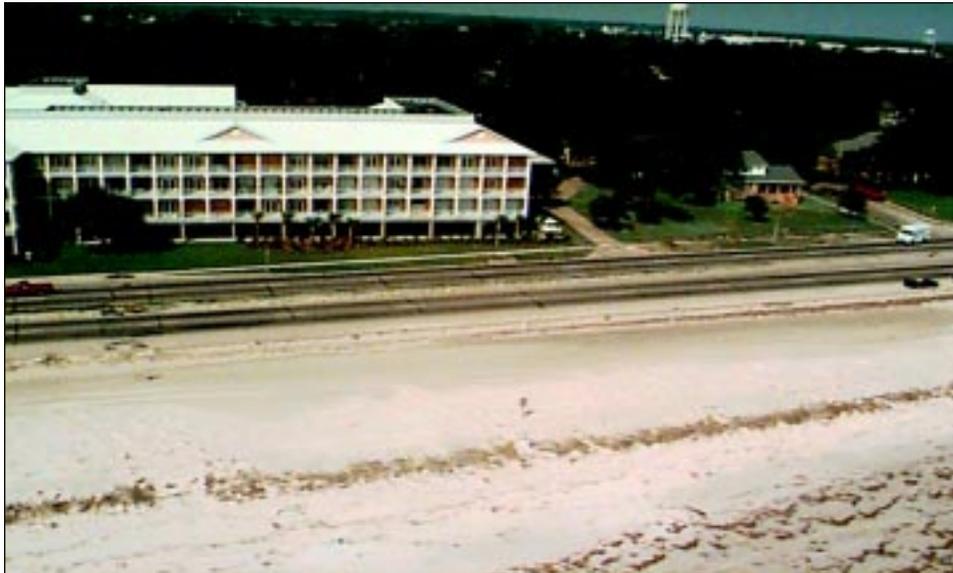
Coastal surge from Gulfport to Biloxi caused only minimal structural damage. In these areas, buildings are well set back from the shoreline as shown in Figures 6-6 and 6-7. The impacts of storm surge, wave action, erosion, and scour were reduced to set back structures. In addition, Hurricane Georges' impact on these beaches appeared to be minimal. As shown in these figures, no appreciable road damage or overwash of sand onto Highway 90 was observed where the road followed the shoreline in Gulfport and Biloxi.

FIGURE 6-6 Coastal area near Gulfport. Note how buildings are set back from the shore.

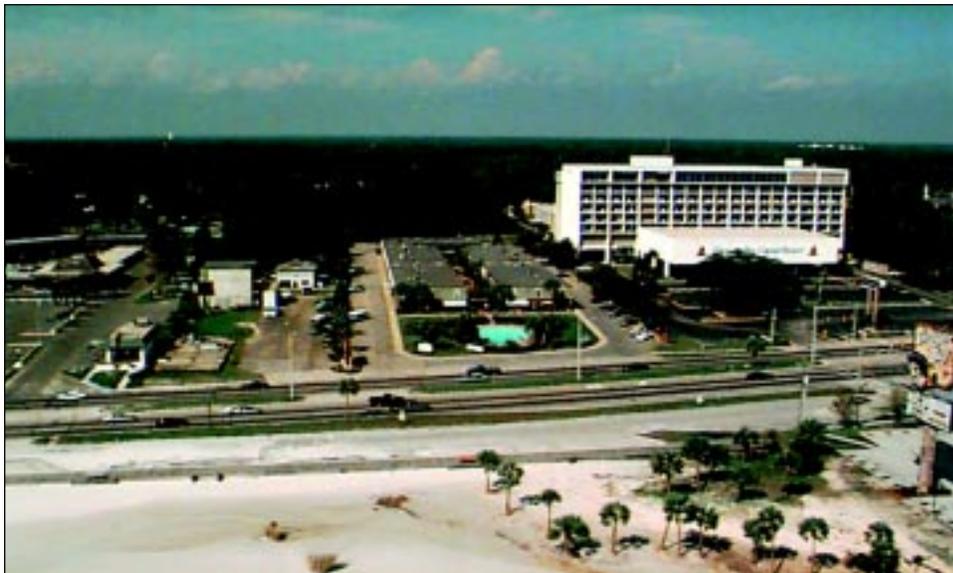
FIGURE 6-7 Another coastal area near Gulfport.

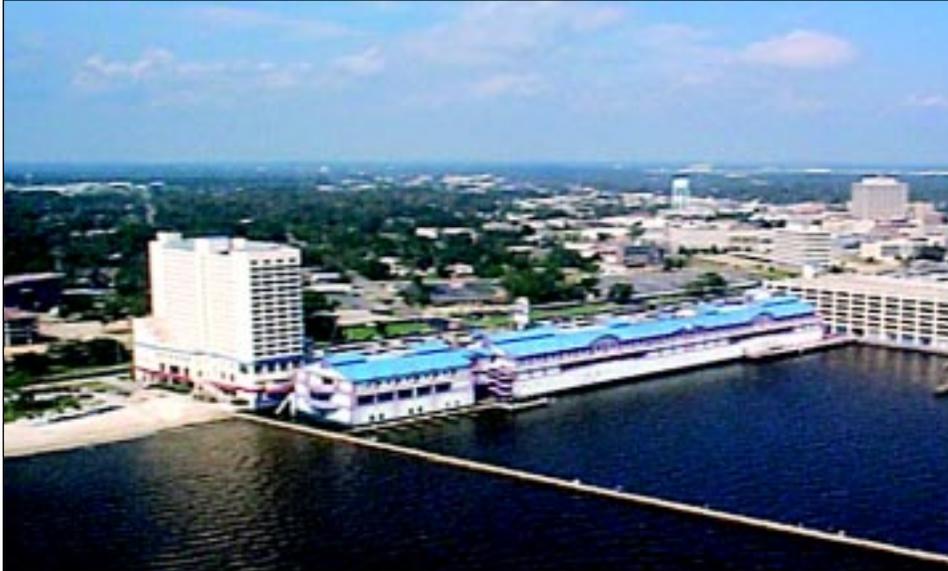
Casino barges in Gulfport and Biloxi suffered minimal damage and disruption of business from coastal surge. Some roof damage due to high winds, as discussed in Section 6.2, resulted in rain infiltration damage to some casinos (Figure 6-8). The shipyards in Pascagoula were inundated by coastal storm surge and suffered some damage (Figure 6-9). Ingalls Shipbuilders, the area’s largest employer, has already retrofitted its shipyard, thereby protecting its means of production from the effects of Hurricane Georges and making the region’s economic base more secure.

FIGURE 6-8 Casinos suffered minimal damage from coastal storm surge.

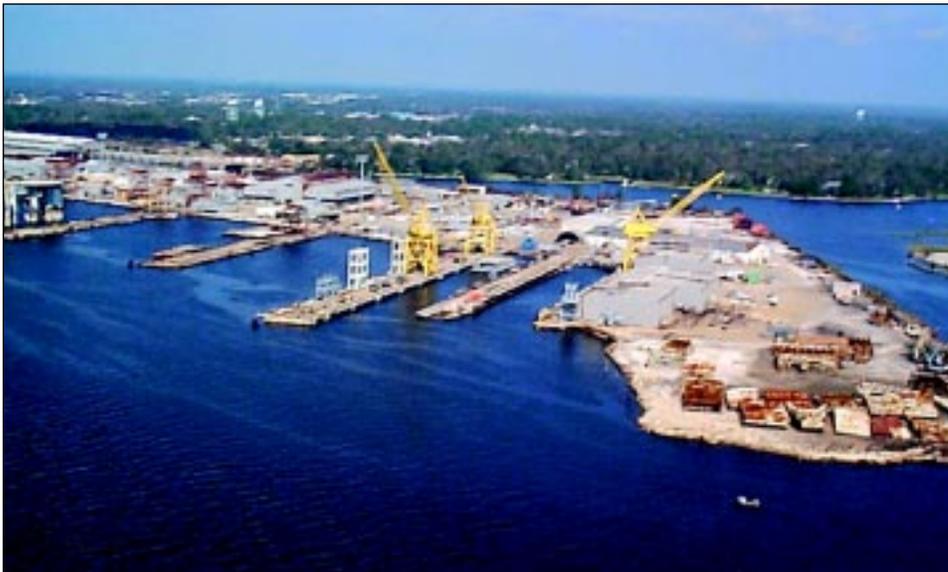
FIGURE 6-9 Ingalls shipyard only suffered minor damage due to coastal storm surge.

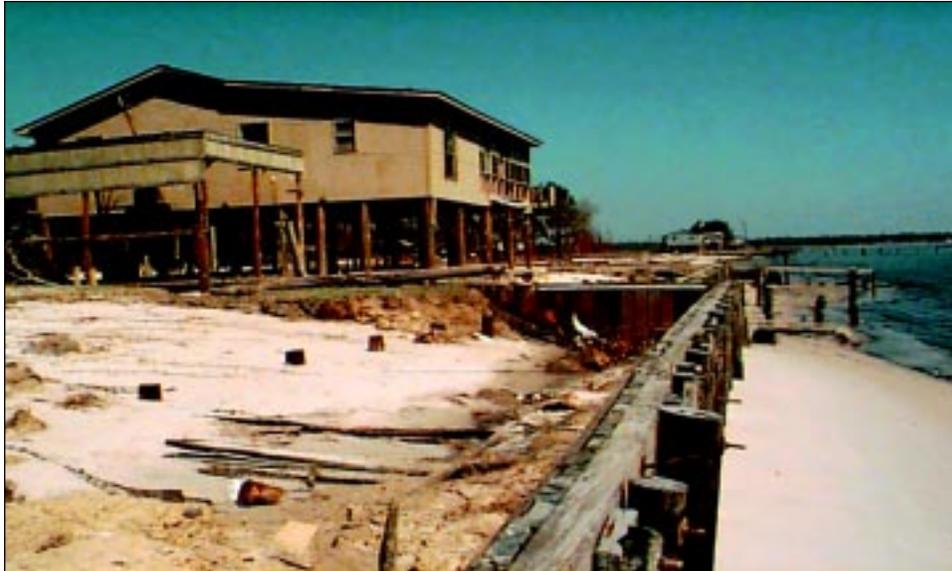
Further eastward along the Mississippi Gulf Coast in the Belle Fontaine/Fontaine Bleu area (located between Ocean Springs and Gautier), more significant damage due to coastal surge was observed. The shoreline in this area consists of alternating sections of natural beach and bulkheads, dominated by narrow beaches without dunes (Figures 6-10 and 6-11).

FIGURE 6-10 Scour behind bulkhead near Belle Fontaine.

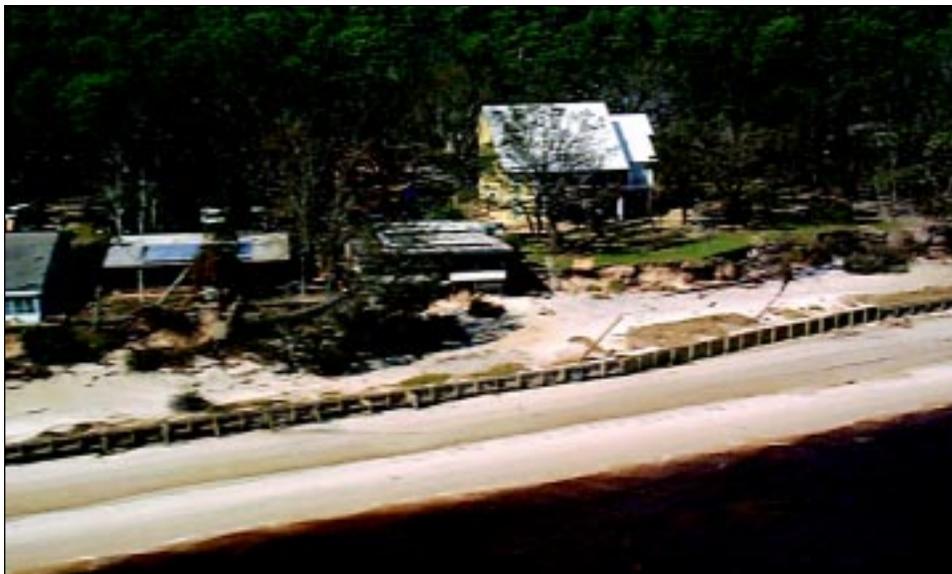
FIGURE 6-11 Severe beach erosion caused by wave action and storm surge.

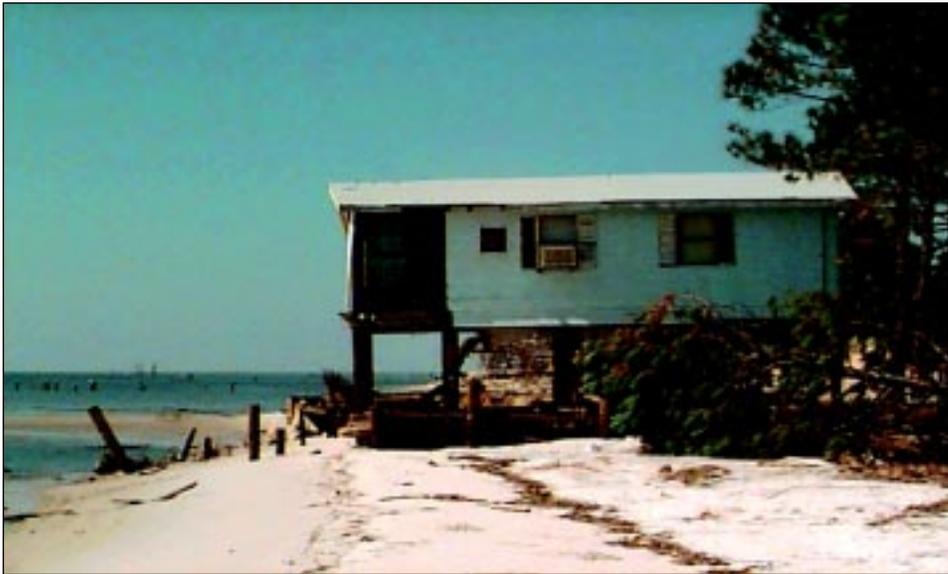
Rip-rap at a public beach, old abandoned bulkheads, and old foundation piles, suggest a history of episodic and long-term erosion issues. Overwash was common, covering the roadway in the western areas. Vertical beach loss of several feet occurred, as did localized scour around bulkheads. Lack of adequate building setbacks from the shoreline in combination with inadequate foundation systems left many houses extremely vulnerable to storm surge and wave-induced damage in the Belle Fontaine/Fontaine Bleau area (Figures 6-12 to 6-16). Adequately sited and elevated homes performed well (Figure 6-17).

FIGURE 6-12 Highly exposed structure that suffered damage from storm surge and high winds.

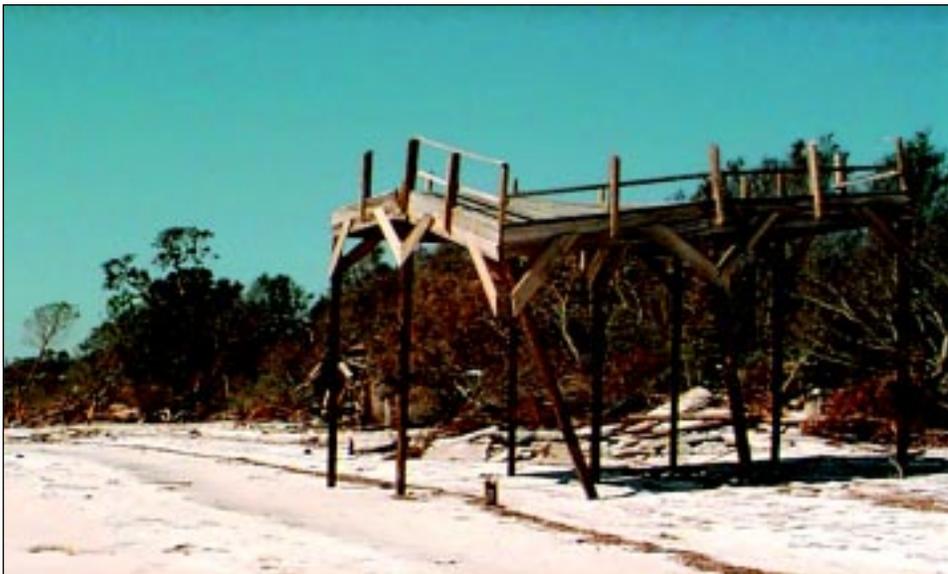
FIGURE 6-13 Only the deck remains standing on this home. House debris can be seen in the background. Storm-induced beach erosion and inadequate pile embedments contributed to the failure of this home.

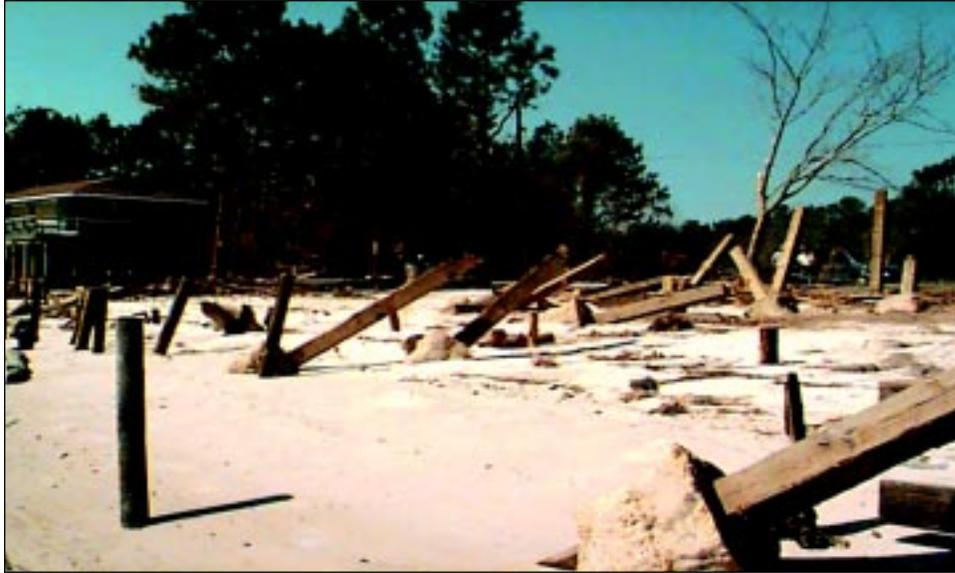
FIGURE 6-14 The houses in this area were destroyed. Piles were embedded in concrete to a depth of only 2 feet. Storm-induced erosion of 2 to 3 feet resulted in complete failure of the foundation systems.

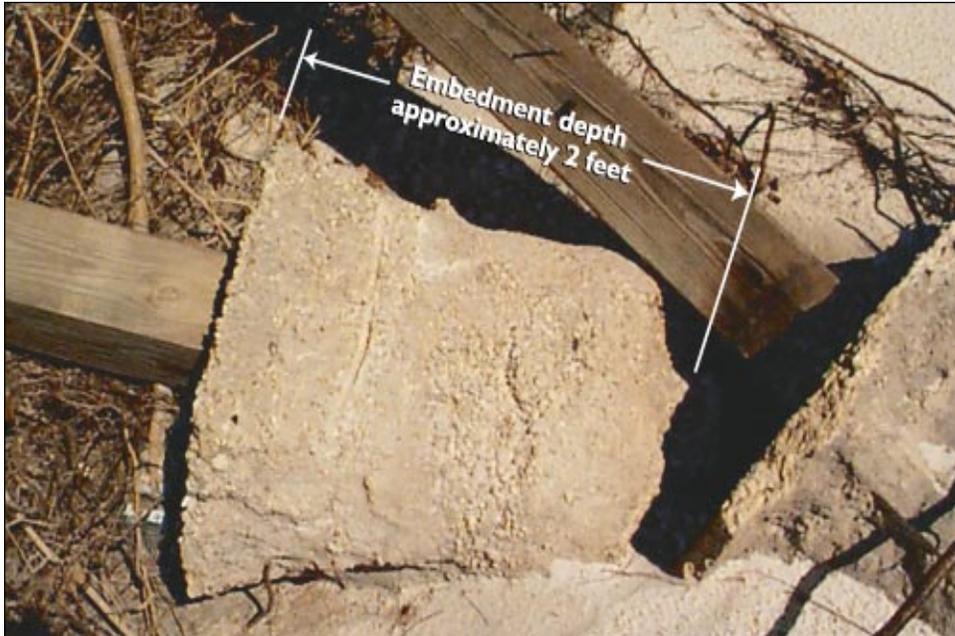
FIGURE 6-15 Inadequate embedment of piles from a destroyed home.

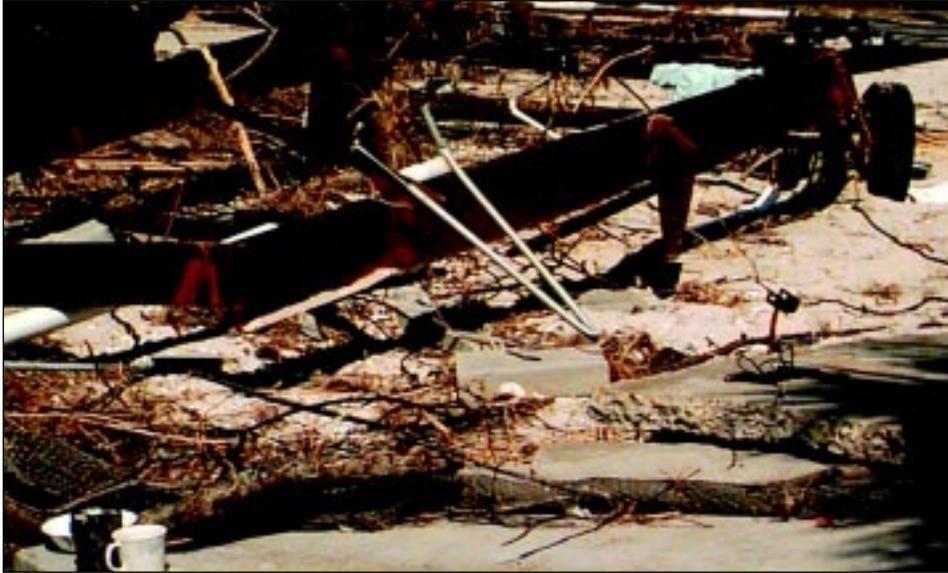
FIGURE 6-16 All that remains of this oceanfront manufactured home that was located on this lot is the bent metal frame. The foundation system was dry-stacked blocks. Tiedown anchors on the Gulf side of the home failed due to erosion and flood forces.

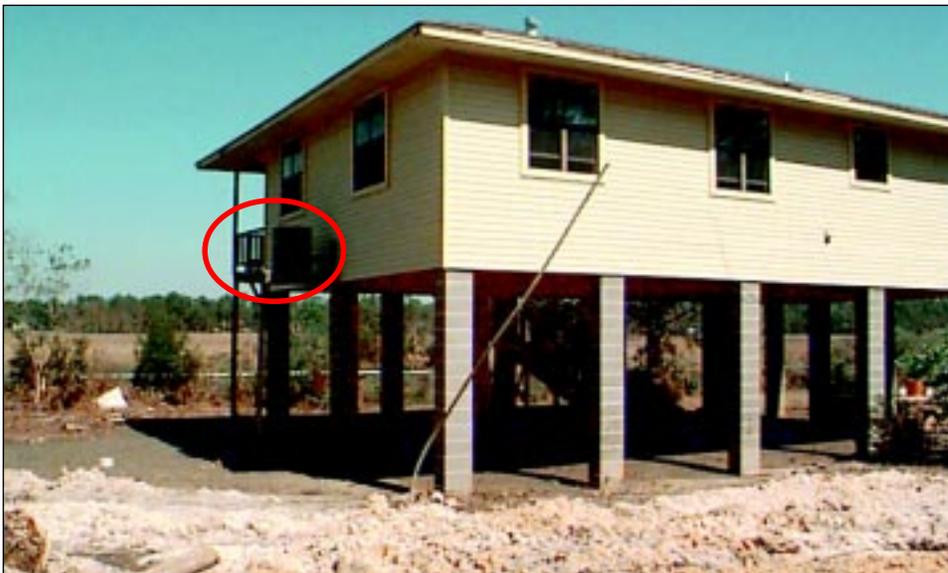
FIGURE 6-17 This house was set back 100 feet or more from the open coast out of reach of velocity flow and wave action. Note elevated utility platform.

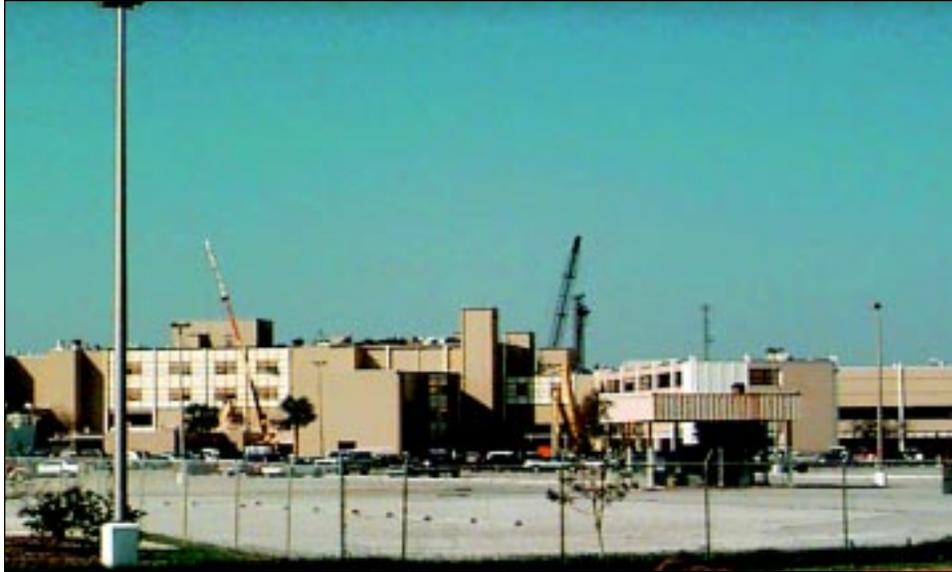
The effects of hurricane-force winds were more obvious in the Gulfport-Biloxi area than the BPAT observed in either Alabama or Florida. Numerous built-up flat roofs on large institutional buildings failed, leaving the buildings open to rain damage. For example, the roof of the Singing River Hospital, a regional medical center in Pascagoula, was partially torn off. The loss of portions of the roof resulted in the evacuation of patient rooms and other areas of the hospital, including delivery rooms. Figure 6-18 shows the roof of the hospital being repaired.

FIGURE 6-18 Singing River Hospital, where emergency roof repairs are underway.

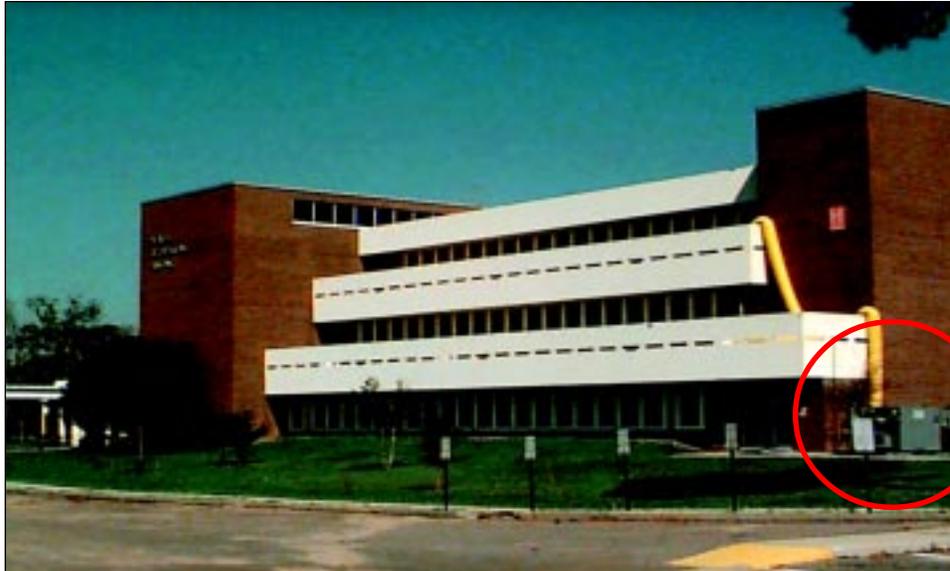
Damage occurred to the roofs of several buildings at the Mississippi Gulf Coast Community College in Gautier. Infiltration of rainwater due to the roof damage resulted in damage to interior areas (Figure 6-19). Loss of roof shingles and damage to signs was evident throughout the area (Figures 6-20 to 6-22).

FIGURE 6-19 Mississippi Gulf Coast Community College in Gautier, where restoration services are underway to dry out interior areas.

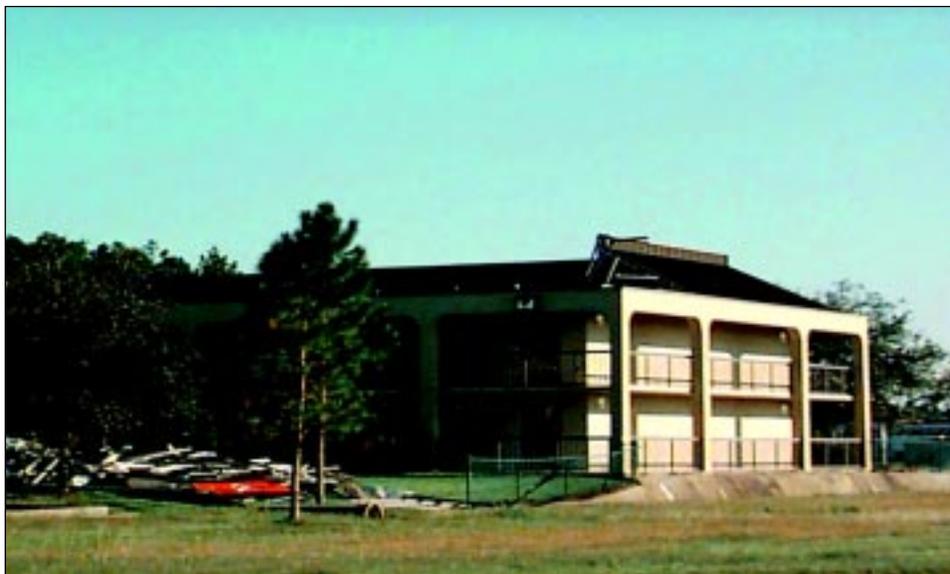
FIGURE 6-20 Roof damage to a hotel in Pascagoula.

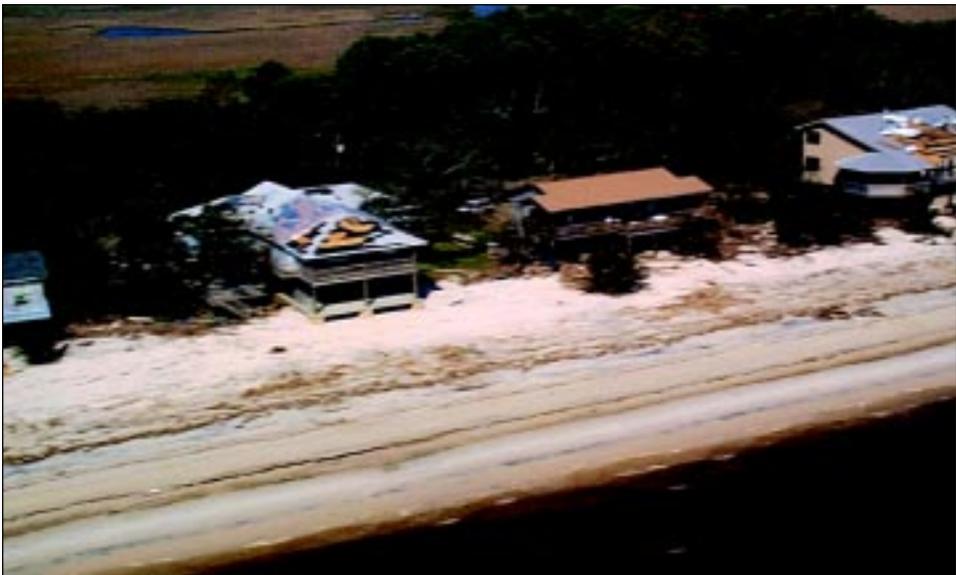
FIGURE 6-21 Shingle roof damage to homes along the open Mississippi coast.

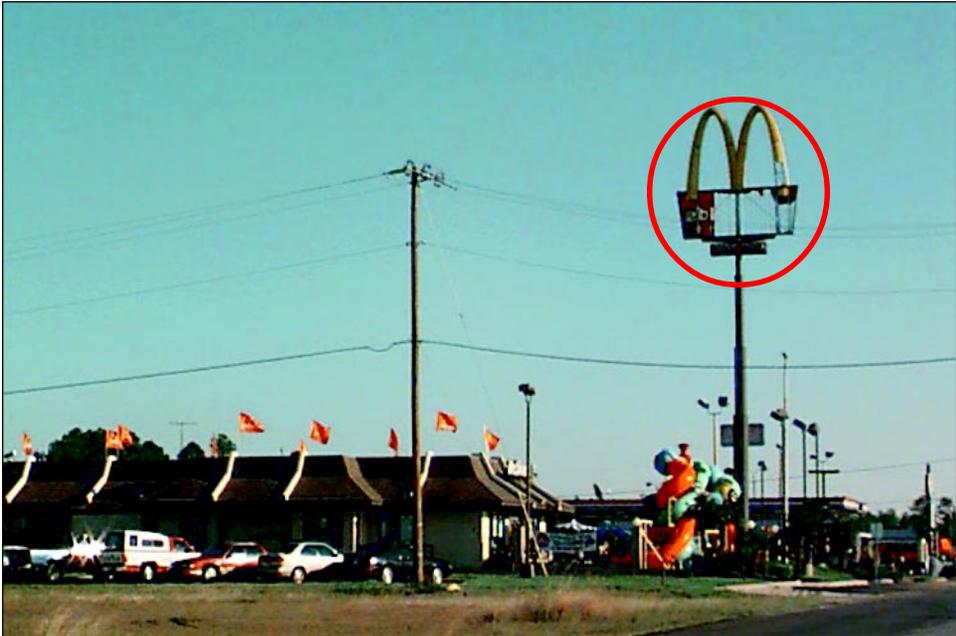
FIGURE 6-22 Sign damage in Pascagoula.

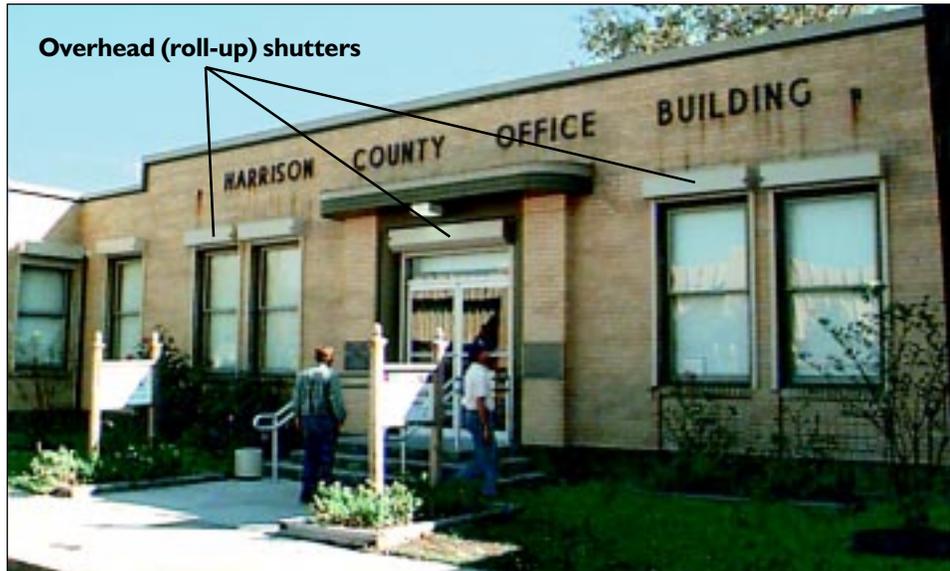
The team assessed the performance of several window and door shutter projects funded under FEMA's HMGP. The shutters were installed on public buildings. While there was little evidence of damage to the windows and doors of buildings from wind loads and airborne debris in the areas where these shutters were installed, it is worth noting that the buildings with shutters showed no damage as well and provided safe and secure shelter during the hurricane (Figure 6-23).

FIGURE 6-23 Window and door shutters on the Harrison County Municipal Building.
