4 Structural Performance

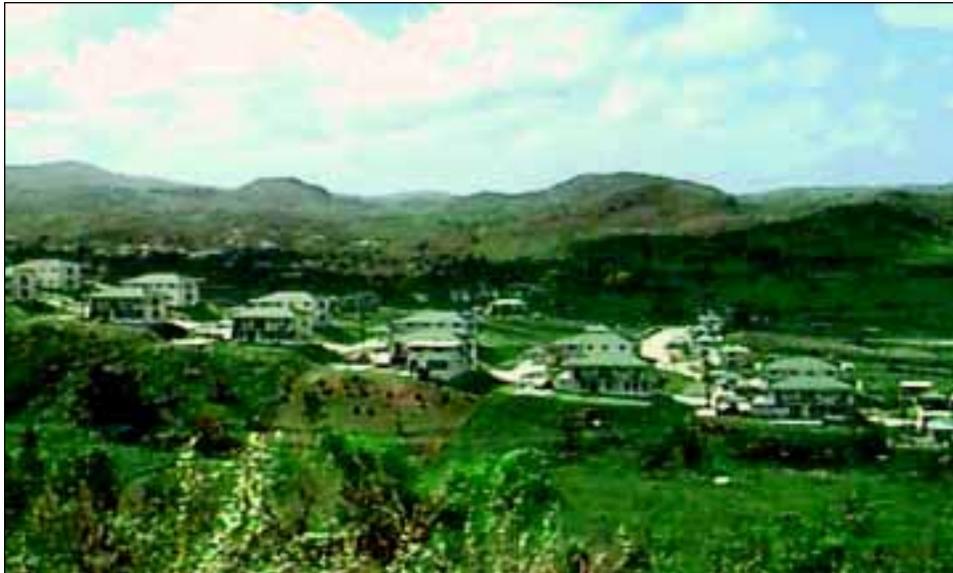
FIGURE 4-2 A residential community constructed of concrete and masonry buildings with concrete roof structures. This community, located to the west of Luquillo experienced no complete building failures. The eye of the hurricane passed to the south of this community, placing it in the strongest wind quadrant of the hurricane.

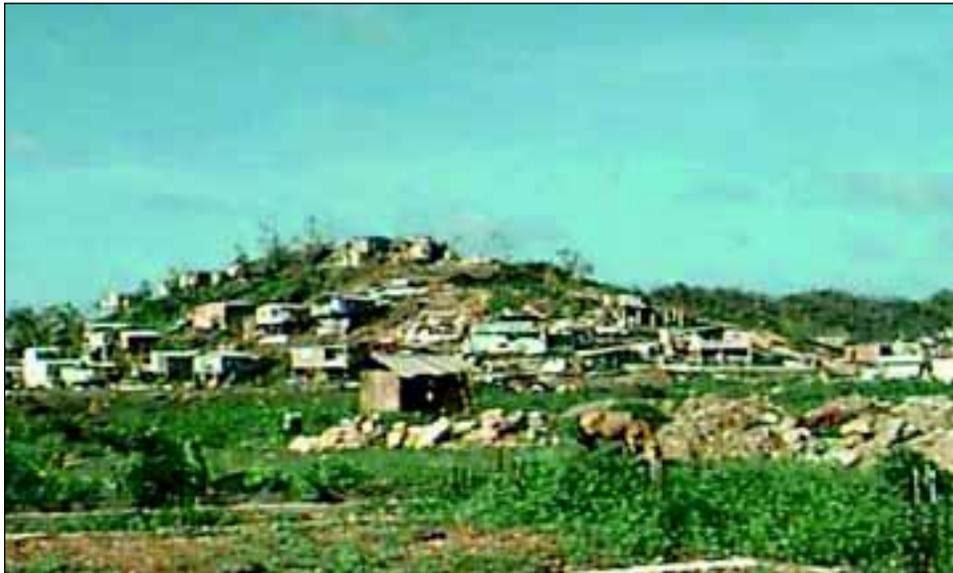
FIGURE 4-3 A residential community constructed of wood-frame structures only. This community located to the north of Canóvanas, experienced significant structural damage and failure to almost all of its buildings. The eye of the hurricane also passed to the south of this community, which is located approximately the same distance from the path of the hurricane as the community in Figure 4-2.

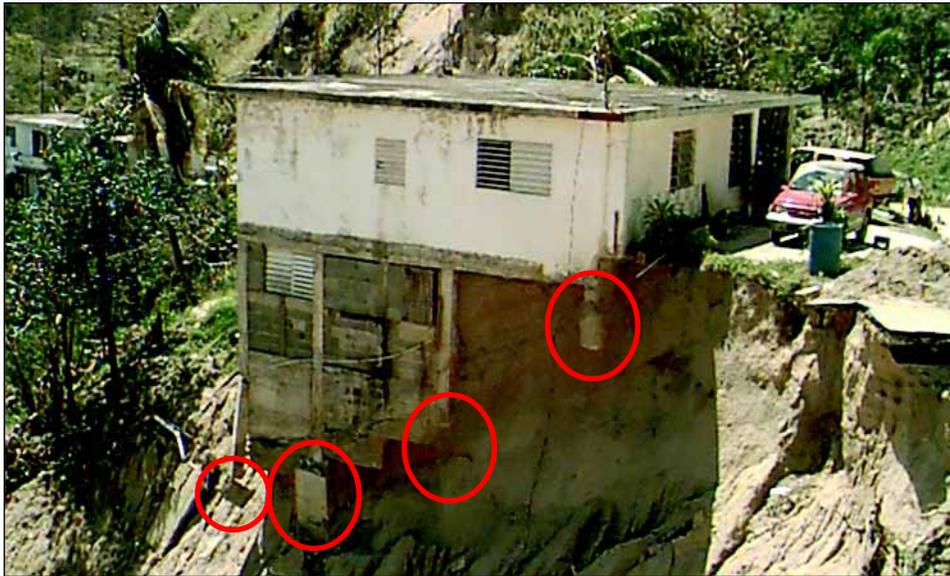
Residential reinforced concrete/masonry structures with concrete roof decks performed well regardless of wind direction or velocity. Concrete/masonry structures with wood wall and roof framing generally performed poorly, regardless of siting. High velocity flood waters caused structural damage in SFHAs. Lower velocity floodwaters (also in SFHAs) inundated houses, causing considerable damage inside the buildings. Several concrete and masonry structures were left unstable from riverine and coastal erosion and mountain landslides (Figure 4-4).

FIGURE 4-4 Concrete residential structure with foundation damage caused by a landslide. Note unstable footings (circled).

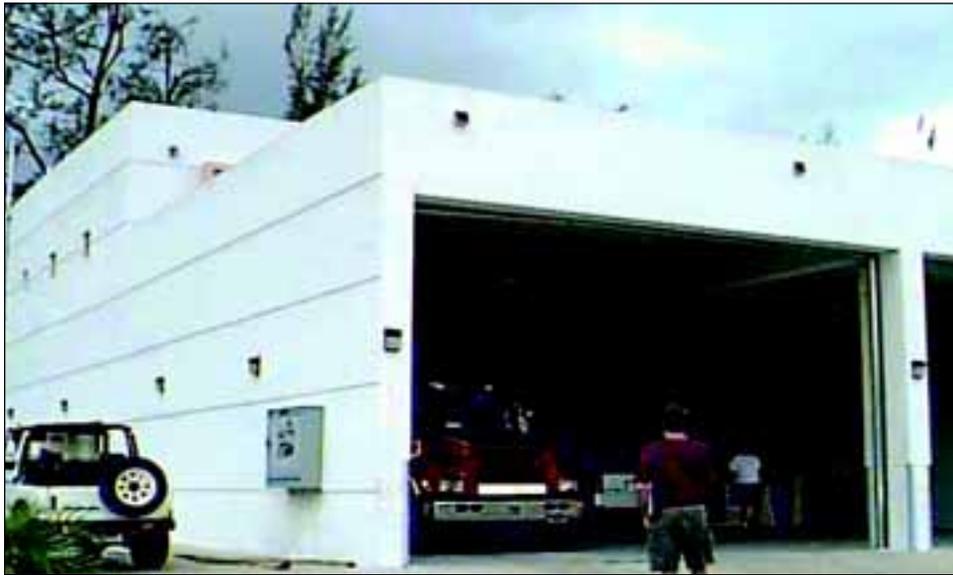
FIGURE 4-5 Fire station in Adjuntas.

The BPAT inspected two fire stations, one in Adjuntas and the other on the island of Culebra, located approximately 20 miles east of the main island. Both fire stations had concrete roof decks. The stucco finish on both buildings prevented a direct observation of the wall systems that reportedly consisted of concrete columns with CMU infill. These structures also had open security grilles in the truck bays rather than large rolling doors. Neither station sustained structural damage during the hurricane. The Adjuntas fire station, which completed construction in 1998, featured a small percentage of exterior windows and an emergency electrical generator that was protected and enclosed within the building envelope (Figure 4-5). The BPAT was unable to determine the seismic resistance of either fire station.

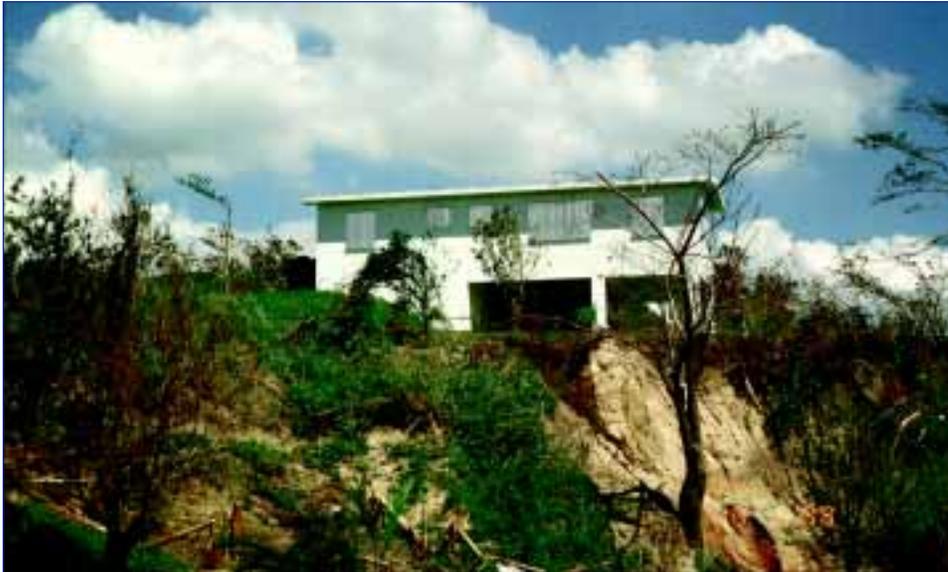
Reinforced concrete buildings (single-family homes) with reinforced concrete roof decks generally did not sustain structural damage (Figure 4-6). First floor walls in reinforced concrete residential buildings were usually 6-in to 8-in thick and constructed of reinforced concrete columns with masonry infill, or were solid concrete walls. CMU walls had varying amounts of reinforcement within the cells. Roof decks typically were flat and constructed of reinforced concrete. Many were exposed concrete with no roof covering. This structure type performed extremely well. Even buildings with unprotected wall openings did not experience structural damage.

FIGURE 4-6 Residential home constructed of reinforced concrete and masonry with a reinforced concrete roof deck in the mountains outside Adjuntas.

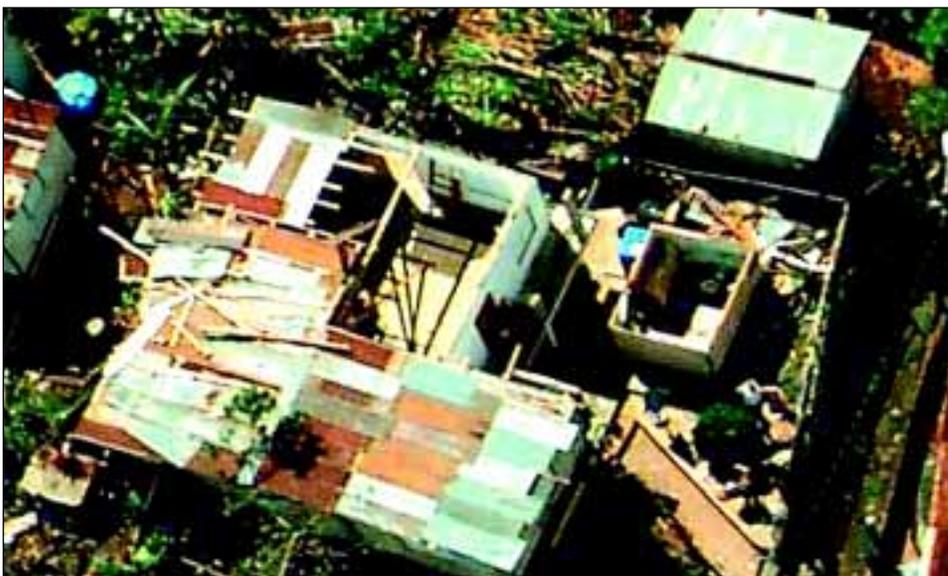
The BPAT investigated a limited number of residential and nonresidential masonry buildings. Most of the buildings observed had wood-frame roof structures that were damaged during the hurricane (Figure 4-7).

FIGURE 4-7 Typical roof system failure between wooden roof system and concrete or masonry wall system.

Rafters ranged from nominally sized lumber, 2-in by 4-in or 2-in by 6-in that spanned 10 feet to 16 feet, and were spaced from 2-feet to 4-feet on center. Rafters were typically toe-nailed to the sill plate and not connected with hurricane clips or straps. The ridge rafters bore on a ridge beam (although sometimes the ridge beam was omitted). No connection other than nailing was generally made at the ridge line. Self-built trusses were also used. Similar to rafters, these trusses were connected only by nails to the sill plate. These trusses were sometimes manufactured by nailing the truss members together by toe-nailing, or by use of nominal 1-in lumber, or plywood for gusset plates. These self-built trusses were inadequate for the wind loads. As a result, widespread wood-frame roof failures were observed (Figure 4-7).

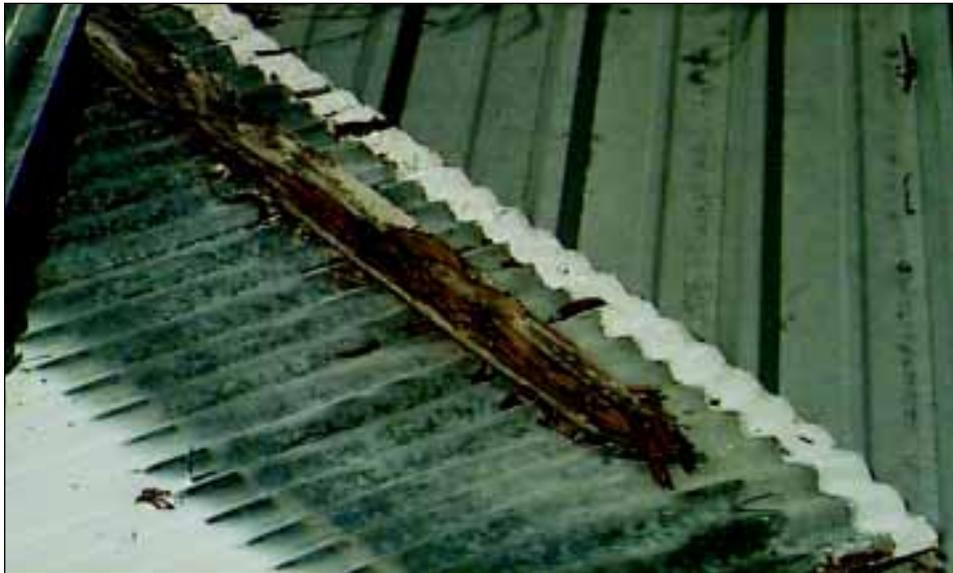
FIGURE 4-8 Termite-damaged wood purlin attached to metal roof panel. The entire roof system of this building failed and is shown in Figure 4-9.

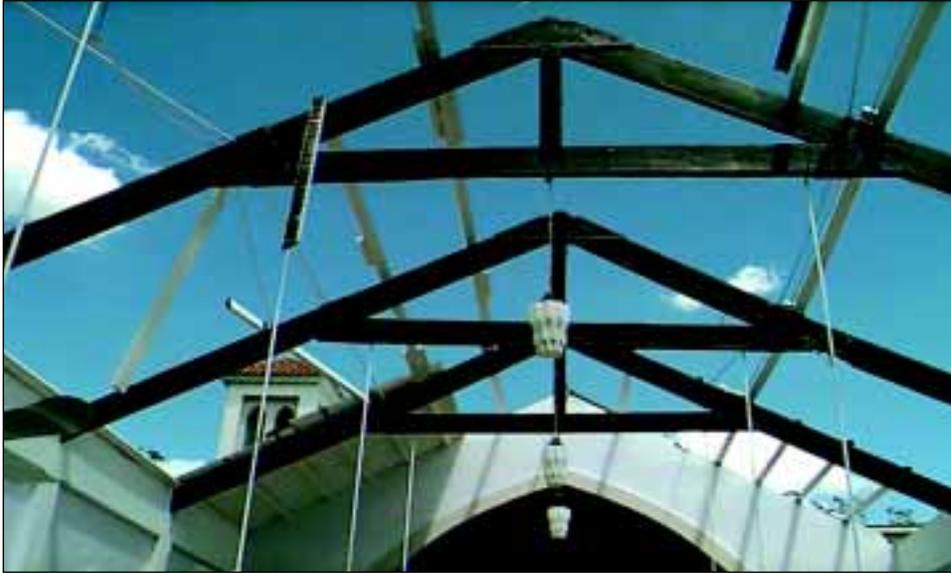
FIGURE 4-9 Masonry wall church that lost roof purlins and its corrugated metal roof. Nails were the only connections used to resist wind loads. The gable ends of this church were unsupported except for purlins resting in the masonry.

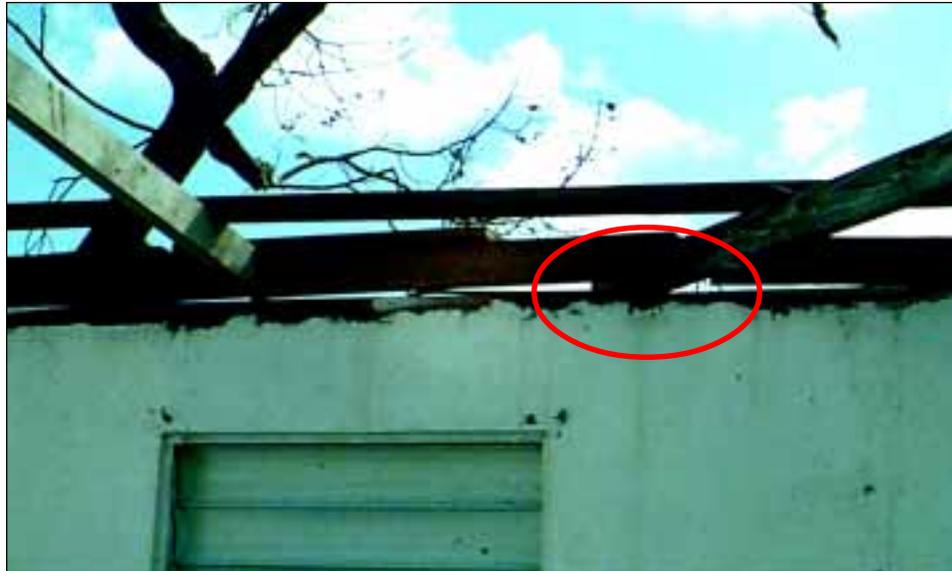
Successes and failures in masonry residential buildings were the same as those observed for concrete buildings. Success depended upon the existence of a continuous load path from the roof structure to the foundation for lateral and uplift loads. Conversely, wood-frame roof structures typically did not have a continuous load path to the foundation and widespread failure due to wind-induced uplift was observed. Figure 4-11 shows a typical nail withdrawal failure of a wood-frame roof/masonry wall connection.

FIGURE 4-11 Typical nail withdrawal failure in a wood-frame structure supported by a masonry wall with little uplift capacity at the connection.

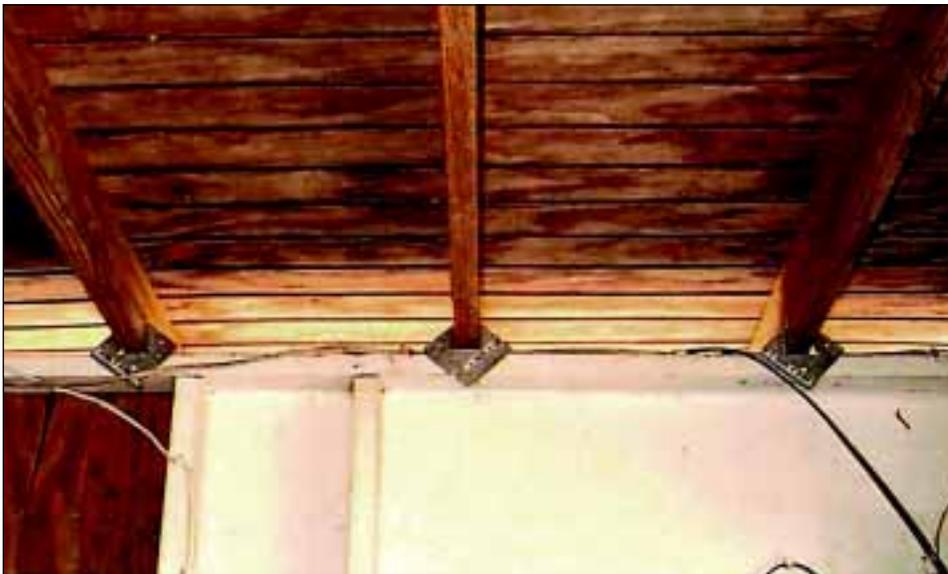
Some residents installed hurricane clips as part of their mitigation efforts after hurricanes in 1995 and 1996. Figure 4-12 shows positive mitigation efforts implemented in a wood-frame house on the island of Culebra in 1996, as observed after Hurricane Georges. Utilization of clips and straps, however, was not typical in wood-frame buildings in Puerto Rico.

FIGURE 4-12 Hurricane clips installed in a wood-frame house on Culebra.

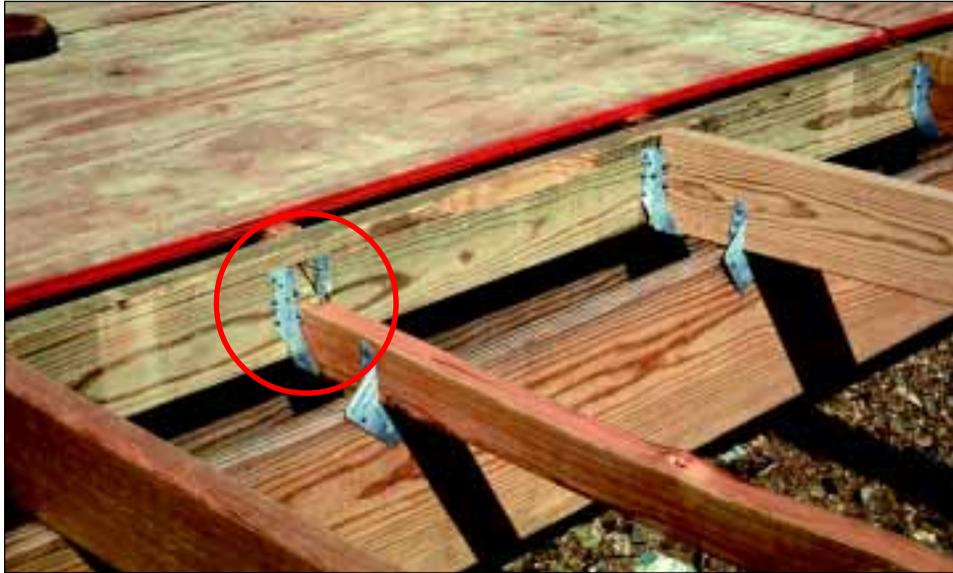
Traditional and inadequate nailing techniques were used on this structure while state-of-the-art clips, brackets, and fasteners were found lying beneath the building. Clips and hangers that were used did not employ the proper nails and failure resulted (Figure 4-13).

FIGURE 4-13 Example of the failure of wood member in the floor joist hanger due to the use of improper nails. The hurricane clip was used to secure the floor joist to the support beam. This house was located on the island of Culebra.

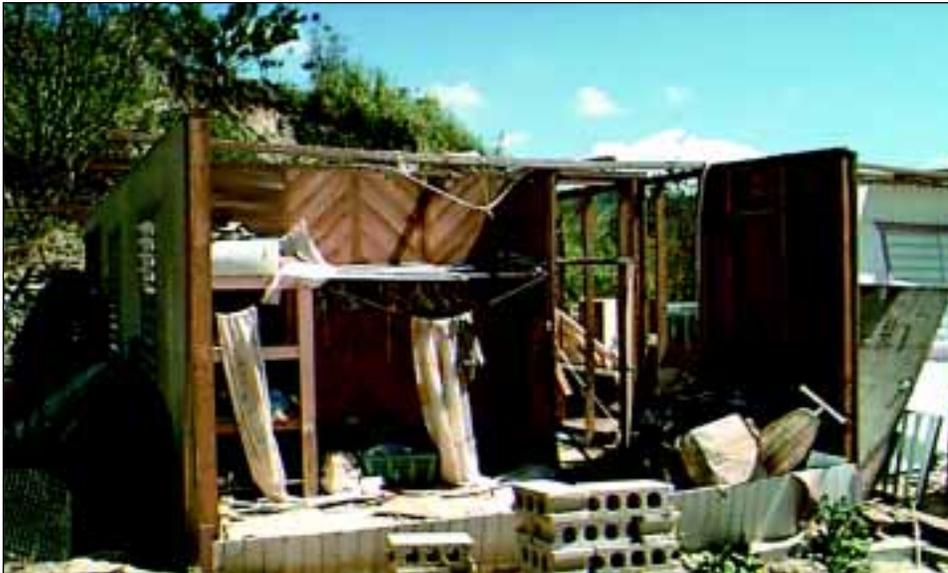
Framing layout and construction techniques used in almost all self-built wood-frame homes were not in compliance with Planning Regulation 7. Wall framing was constructed from nominal 2-in by 3-in and 2-in by 4-in studs. These studs were not properly supported laterally and not connected to the sill, bottom, or top plates with straps or connectors (Figure 4-14). The sill plate was inadequately (and often not) connected to the floor system with fasteners capable of resisting lateral and uplift forces. Top sill plates typically were single nominal 2-in by 4-in members that support the roof structure for gravity loading only. Nails appeared to be the primary connector used, with most connections being “toe-nailed.” End column (nominal 4-in by 4-in) members were observed in the wall sections of some wood-frame houses (Figure 4-15).

FIGURE 4-14 Example of wood-frame wall construction that failed during Hurricane Georges. This building was not constructed with any hurricane clips or straps.

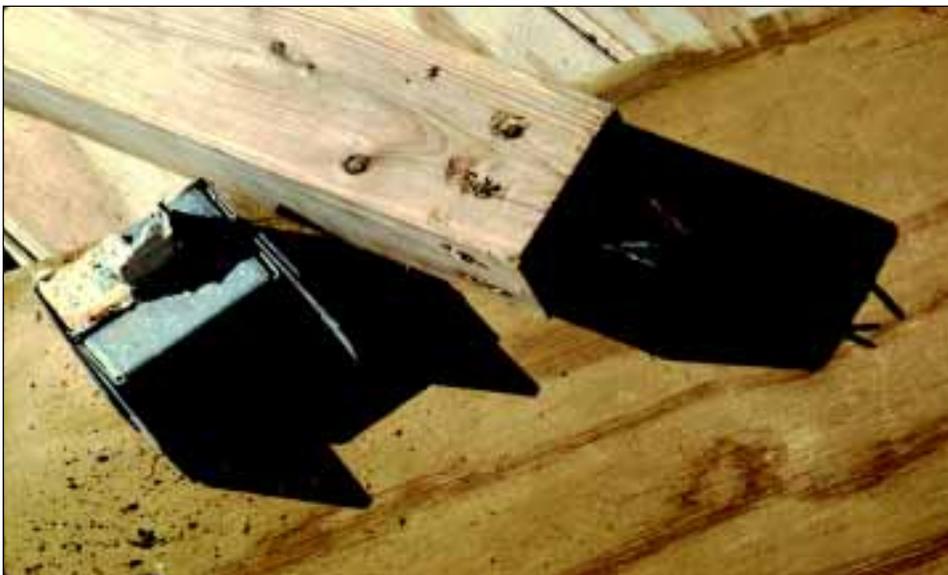
FIGURE 4-15 Wood wall column that failed at connection to sill plate. This building was only two months old but was only partially constructed with clips, straps, and fasteners. The proper column fastener in the photograph was found unused beneath the house. This column was from the same house presented in Figure 3-13.

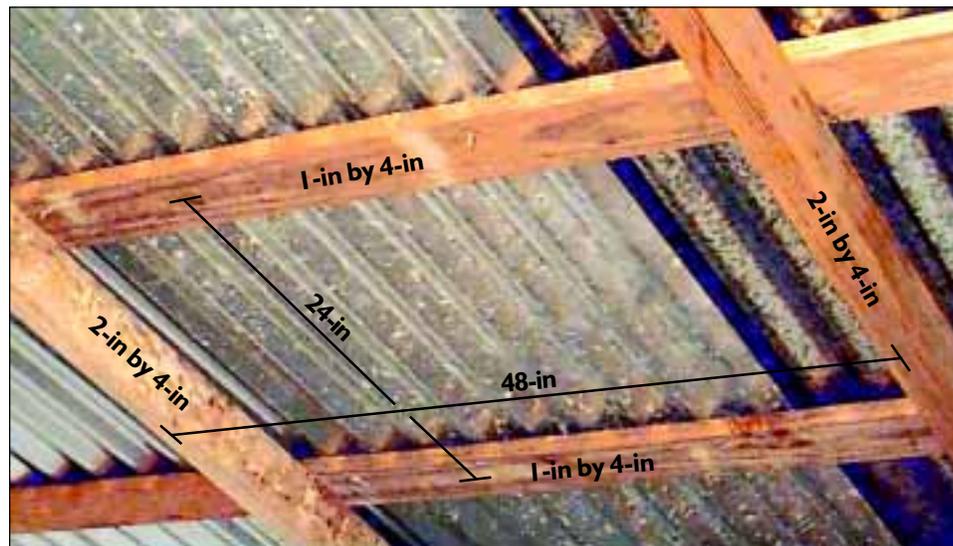
FIGURE 4-16 Typical wooden roof structure with metal roof panels above. Nails connected the metal panels to the nailers and the nailers were nailed to the joists.

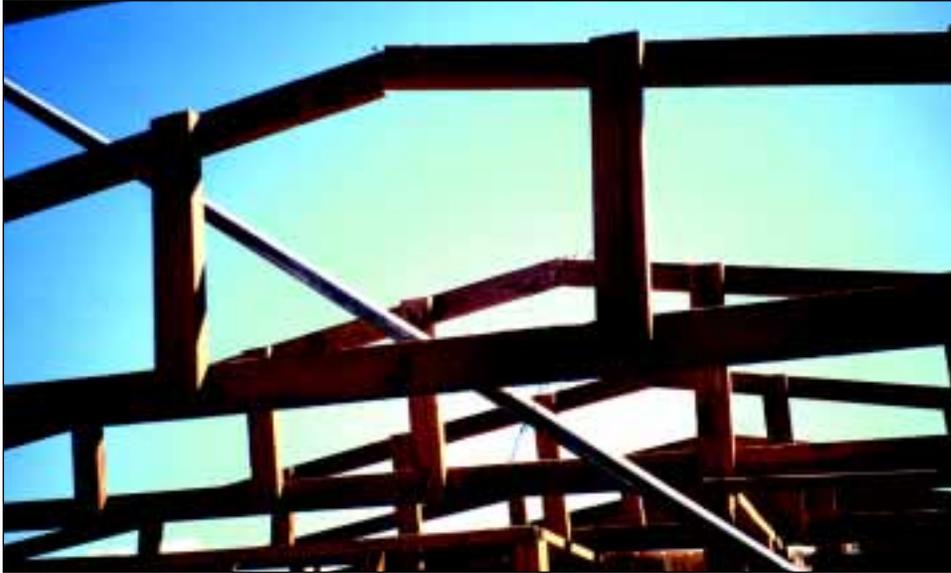
Roofs were constructed of rafters, self-built trusses or pre-manufactured trusses. Rafter roof systems typically used nominal 2-in by 4-in to nominal 2-in by 6-in members. Lateral support or bracing was only provided by nominal 1-in by 3-in to nominal 1-in by 6-in nailers. Roof rafters and trusses were spaced on intervals ranging from 2-feet to 4-feet on center. Roof nailers for metal roof panels were observed on most wood-framing at 3-feet to 4-feet on center (Figure 4-16). Nailers did not typically provide adequate load capacity for the 110 mph design wind indicated in the 1987 amendment to Planning Regulation 7. In addition, the nailer/joist connections and the nailer/rafter connections observed generally were only connected with one or two nails. This simple nailed connection does not provide adequate resistance to shear and uplift forces that may be experienced during a high wind or seismic event. Figure 4-17 shows a typical self-built, wooden roof truss.

FIGURE 4-17 Example of a self-built, wooden roof truss.

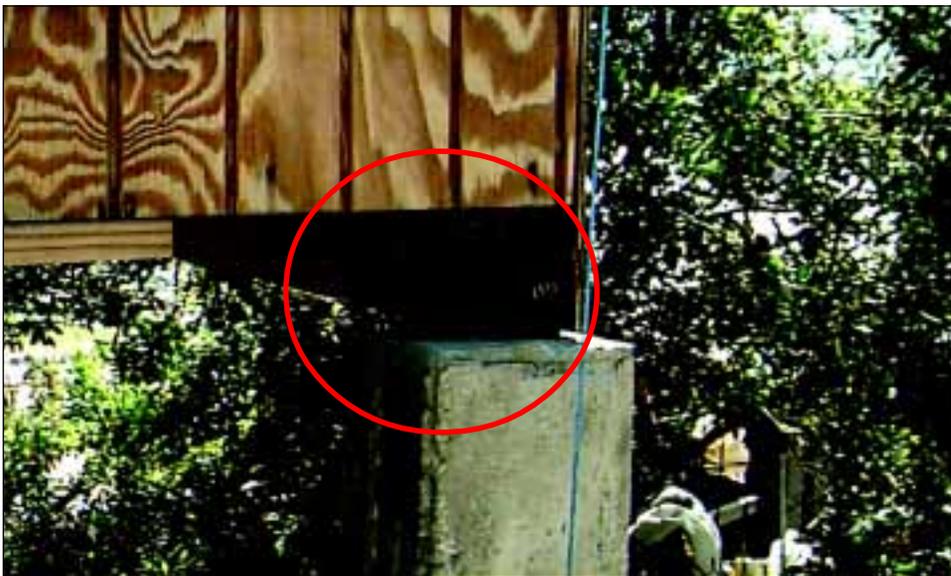
FIGURE 4-18 Example of a non-engineered connection between the building foundation (concrete column) and the floor system. The wooden floor beam is connected to foundation rebar with an improper nailed connection.

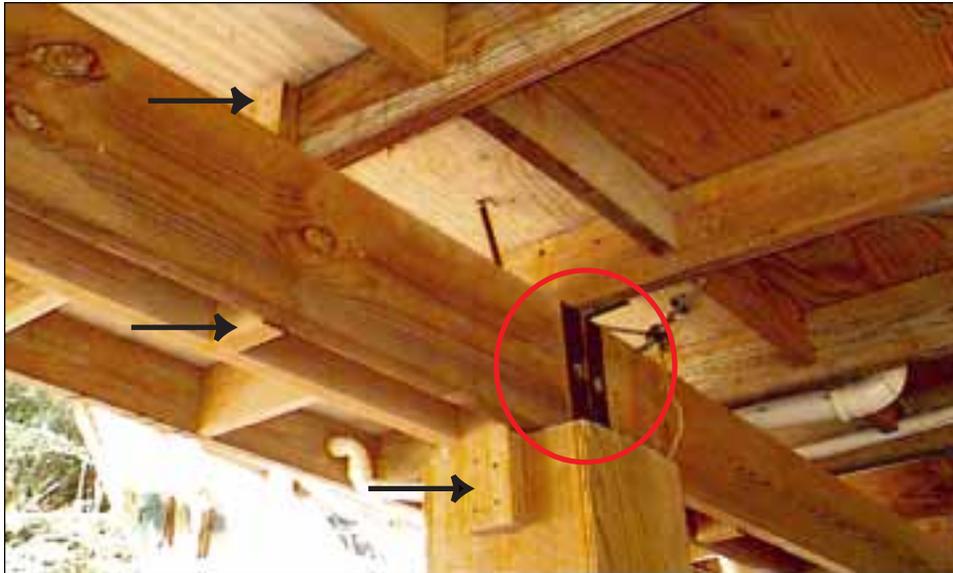
FIGURE 4-19 Example of an engineered connection between the floor beam and a concrete column (concrete column is enclosed in plywood). Vertical members (identified by arrows) provide continuous load path from floor joist to floor beams. Floor beams are connected to concrete columns with metal straps (circled). This house was located on the island of Culebra.

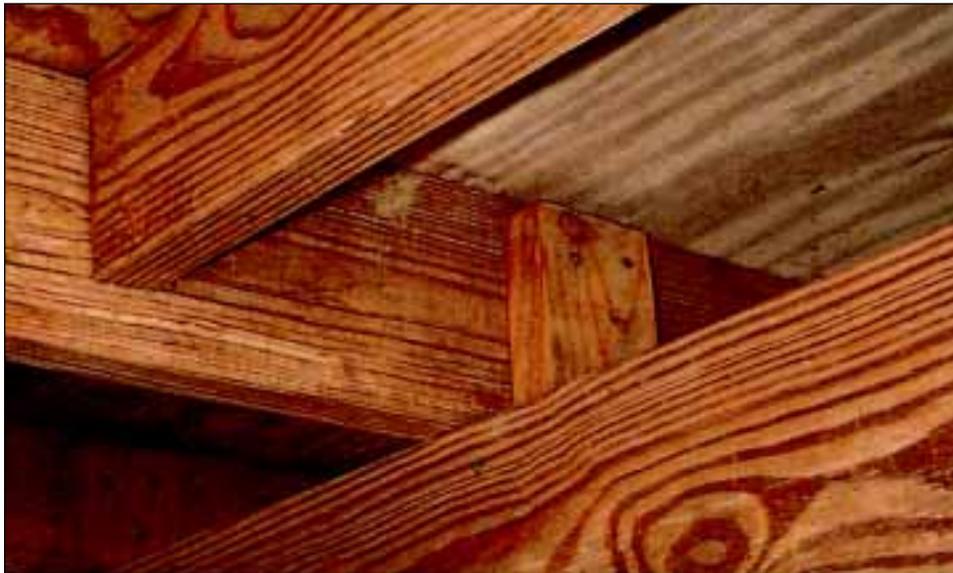
FIGURE 4-20 Example of a successful wood connection between support beam and floor joists. This is the same house shown above in Figure 4-19.

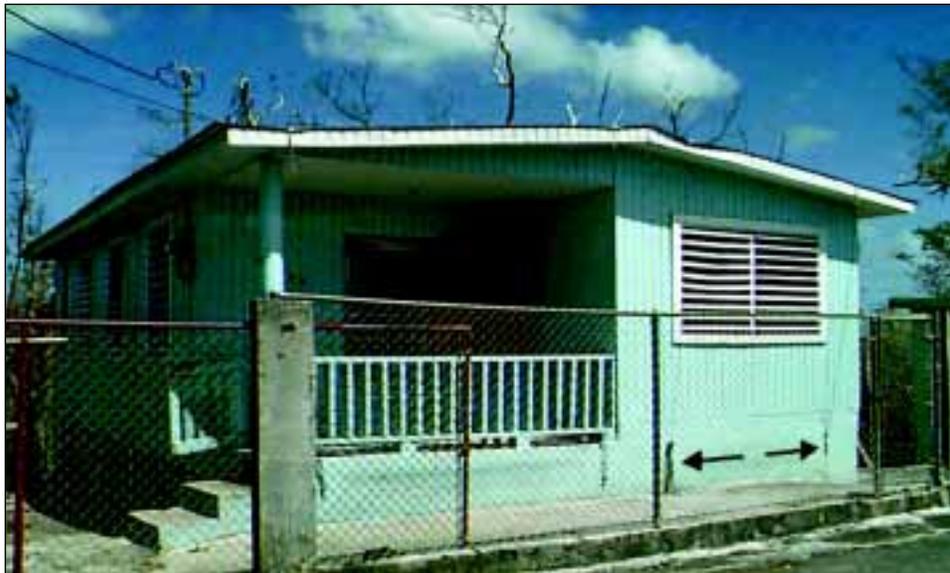
A majority of hold-down cables observed crossed over the ridge-line of the roof of the house at 10-foot spacing. A smaller percentage was observed running parallel to roof ridge-lines at 4-foot to 6-foot spacing as illustrated in Figure 4-21. The hold-down cables ranged from single strand steel wire to multi-strand steel cables.

FIGURE 4-21 Wood-frame house with metal roof covering with hold-down cables that run parallel (see arrows) and perpendicular to the roof ridge line. This house was set atop a ridge that experienced significant winds. The lack of damage can be attributed to the extra care taken in fastening down the corrugated metal roofing. The strapping would not have prevented buckling of the roofing or uplift at the eave.

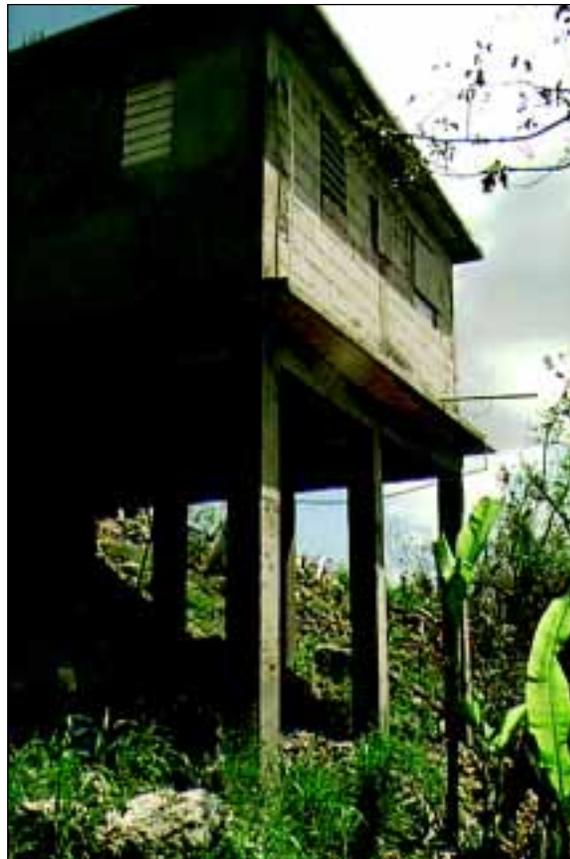
Nonresidential buildings were not investigated for compliance with the 1987 amendment to Planning Regulation 7 and the current structural seismic guidelines of the 1997 UBC. One- and two-family homes, however, were investigated for their ability to sustain a seismic event. Inspections revealed that most of these homes constructed of concrete, masonry, and wood appeared to lack the lateral stability necessary to survive a design seismic event. Many residential buildings were constructed on piles and columns with no visible lateral bracing. Connections between foundation systems and the building did not appear to have moment capacity required to withstand lateral forces induced by a design seismic event (Figure 4-22). shows an elevated residential building with no lateral support bracing its long columns. Figure 4-23 is a close-up of one of the footings for the tall columns shown in Figure 4-22. This type of small footing "setting" atop a rock outcropping was typical for houses built on hillsides.

FIGURE 4-22 Residential building supported atop tall, unbraced concrete columns. This type of unbraced support column was common in many areas.

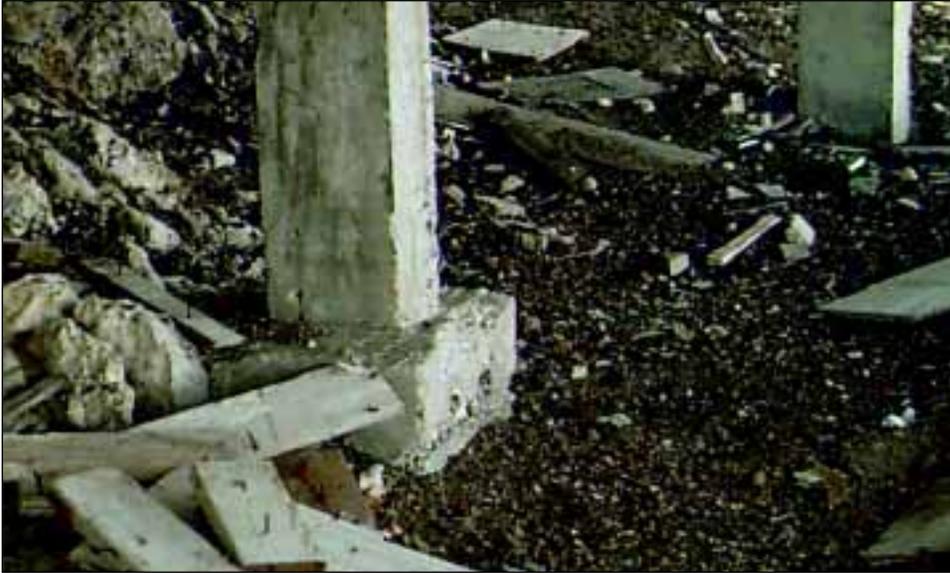
FIGURE 4-23 Footing for tall columns in Figure 4-22. This footing is not adequately anchored to the supporting rock to resist lateral forces that may be induced during a design seismic event.
