## HURRICANE

*Katrina*

## IN THE GULF COAST

## 5. Building Envelope Performance

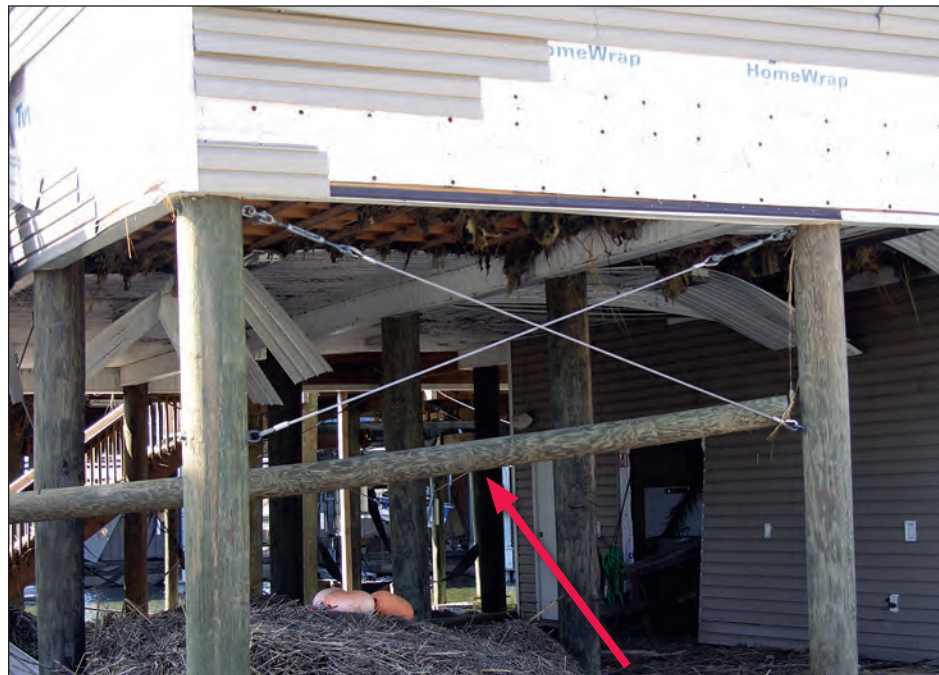
**Figure 5-4.**  
Loss of vinyl siding from the underside of an elevated residence in Exposure C. Note the large floodborne pole debris near the steel cable "x" brace (estimated wind speed: 130 mph. St. Bernard Parish, Louisiana).

Fast-moving floodwater and breaking waves can cause sheathing loss and floodborne debris can cause gouging. However, the loss of the fiber-cement sheathing appeared to be caused by wind accelerating as it passed beneath the elevated building. Neither ASCE 7, IBC, or IRC provide guidance for determining design wind loads for sheathing on the underside of elevated buildings. Therefore, professional judgment in specifying attachment is needed.

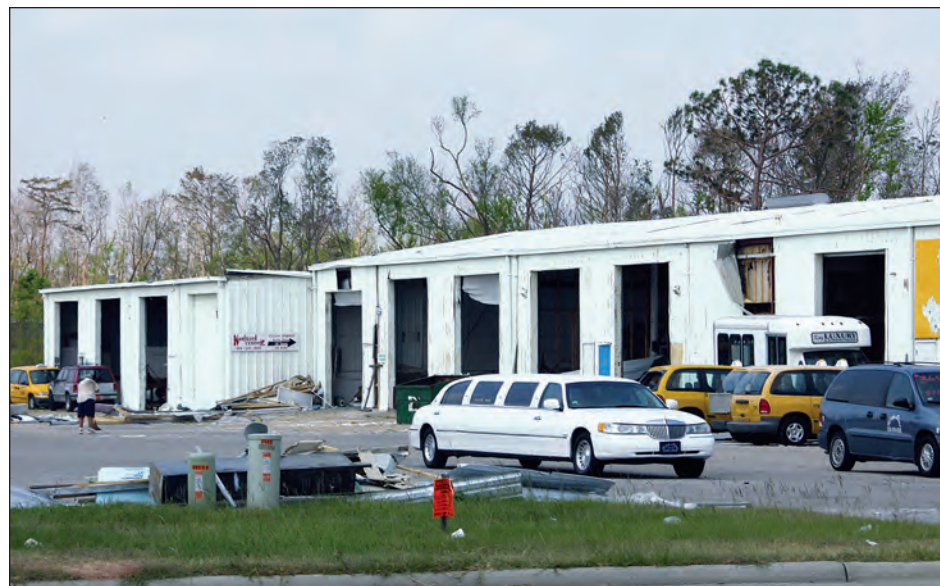
**Figure 5-7.**  
Wind-induced damage to several roll-up doors (estimated wind speed: 130 mph. Gulfport, Mississippi)

two doors the tracks pulled from the wall. The tracks were fastened with 1/4-inch diameter lag screws spaced at 2 feet on center. The tracks were lag-screwed to 1x wood framing, which was inadequately nailed to the 6x columns.

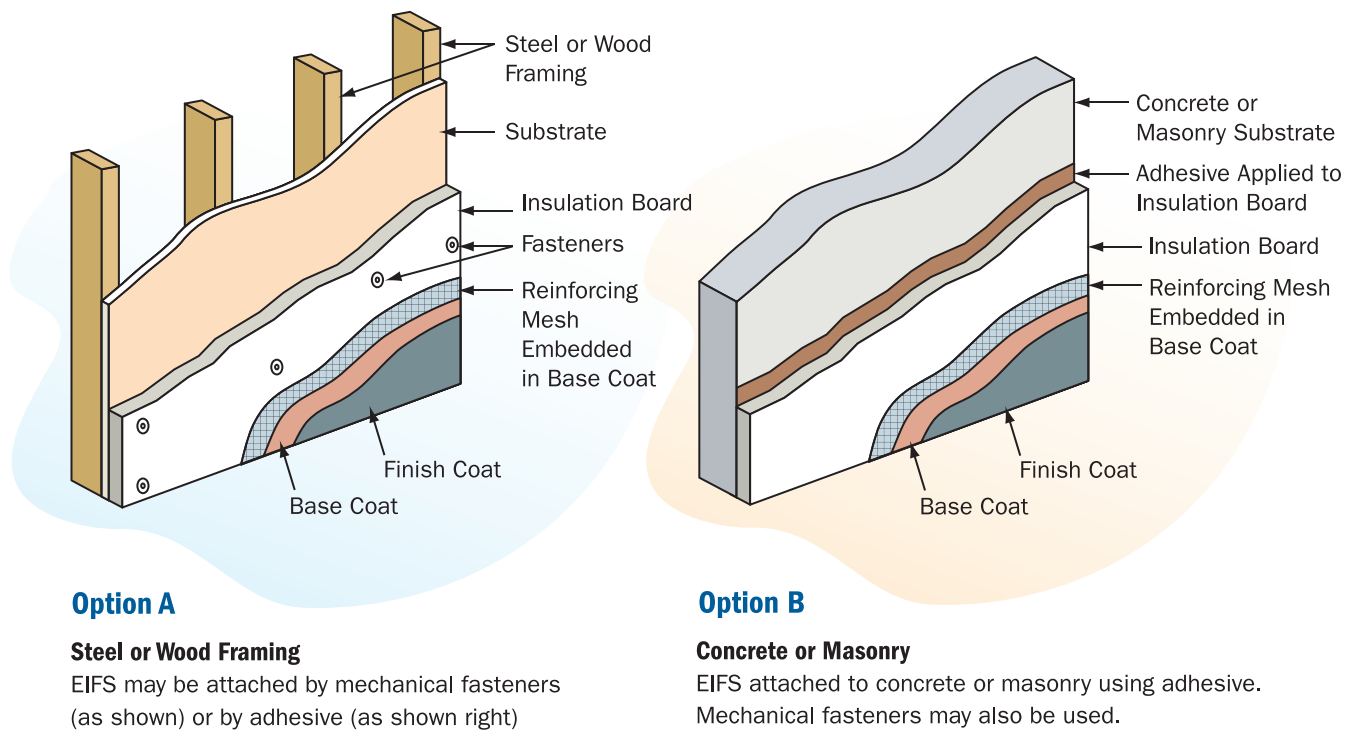
Figure 5-8. Typical EIFS assemblies

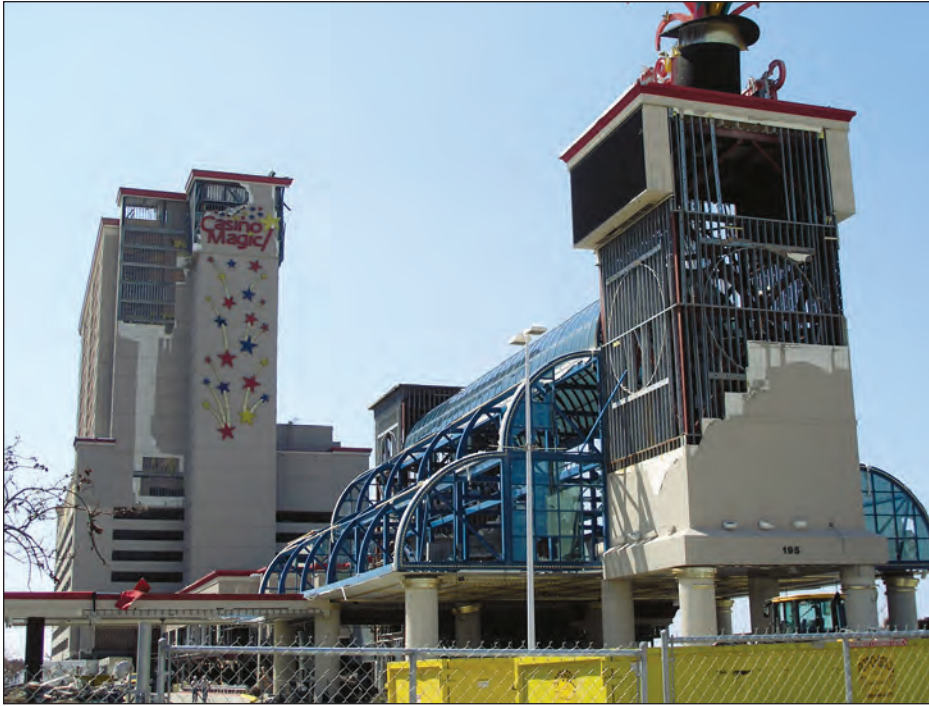
Figure 5-9. Multi-story building in Exposure C, showing severe EIFS damage. The gypsum board typically detached from the studs. In some areas, the gypsum board on the interior side of the studs was also blown away (estimated wind speed: 120 mph. Biloxi, Mississippi).

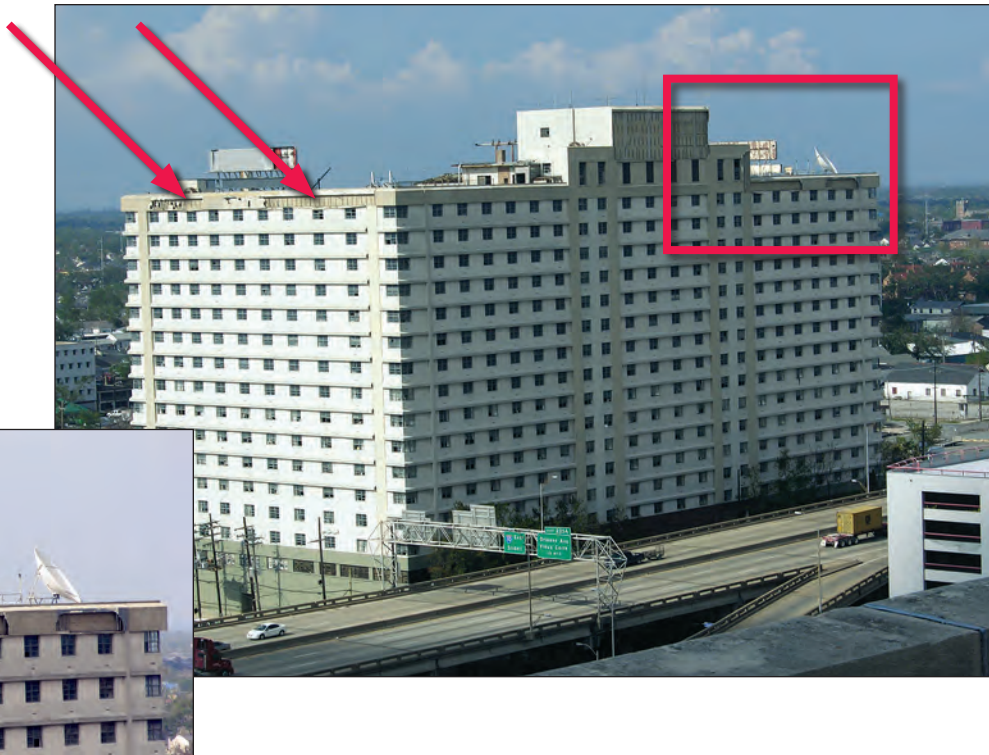
This building had been re-skinned with EIFS. In some areas, the gypsum board blew off the studs (arrows). In other areas, the metal framing was blown away (square/ inset) (estimated wind speed: 105 mph. New Orleans, Louisiana).

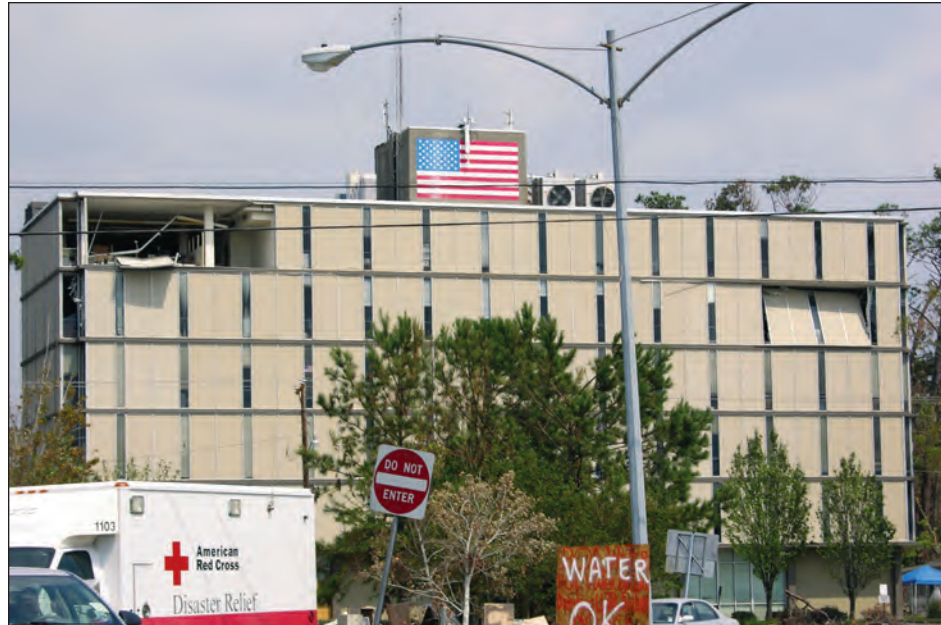
Figure 5-13 shows collapsed wall panels. The tracks at the top of the panels were inadequately anchored to the concrete floor slabs. Figure 5-14 shows collapse of non-load-bearing walls at a hotel. These types of failures can be avoided by designing and constructing the wall panels and their connections to the structure to resist the design wind loads.

Figure 5-13.  
Collapse of panelized  
wall system (estimated  
wind speed: 115 mph.  
Slidell, Louisiana)

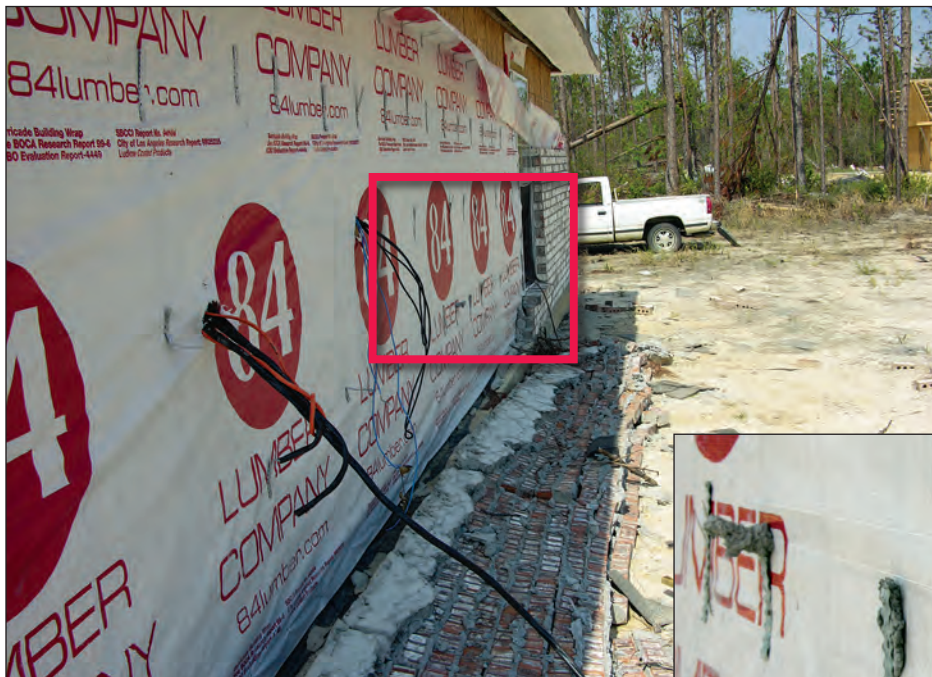
Figure 5-15. Collapsed brick veneer wall that was under construction. Several of the ties had not been embedded into the mortar joints (square/inset) (estimated wind speed: 125 mph. Waveland, Mississippi).

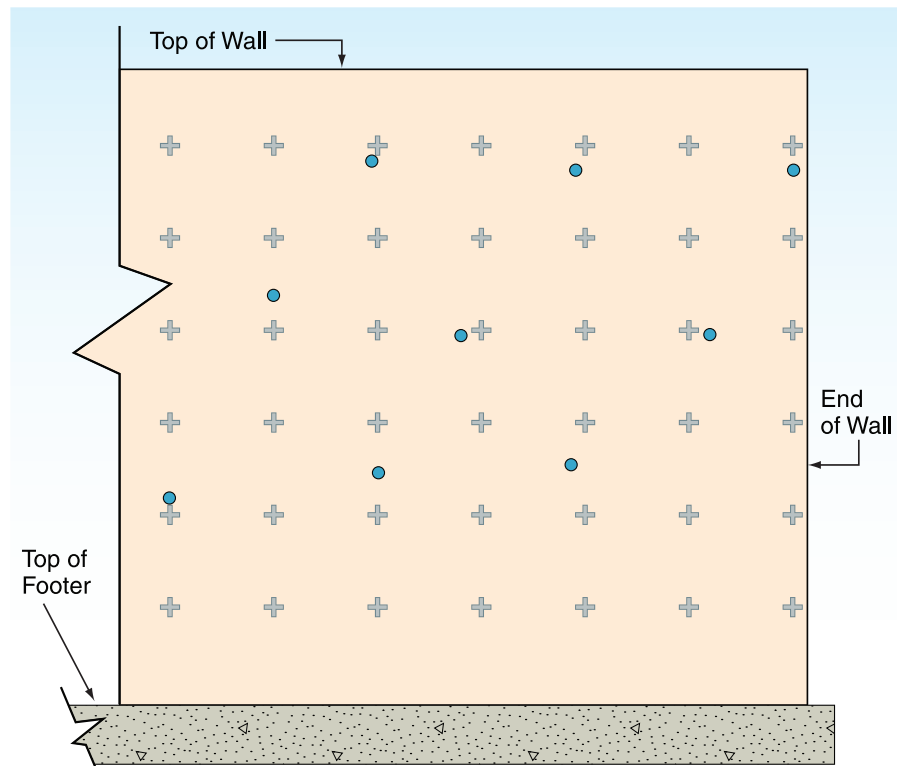
The ties at this house did not comply with the vertical or horizontal spacing specified in *Technical Notes 28*. This house is located in an area with a basic wind speed of 140 mph; ACI 530-02 does not provide prescriptive tie spacings for this speed. The FEMA Hurricane Katrina Recovery Advisory *Attachment of Brick Veneer in High-Wind Regions* (Appendix E) recommends a maximum horizontal tie spacing of 16 inches and a maximum vertical spacing of 13.7 inches for a 140-mph design wind speed. Figure 5-16 also illustrates location of ties as recommended in the advisory.

**Figure 5-16.**  
Brick ties at house under construction in Ocean Springs, Mississippi. At this wall, nine ties were installed (blue circles); however, 42 ties ("+" symbol) are needed to comply with the advisory.

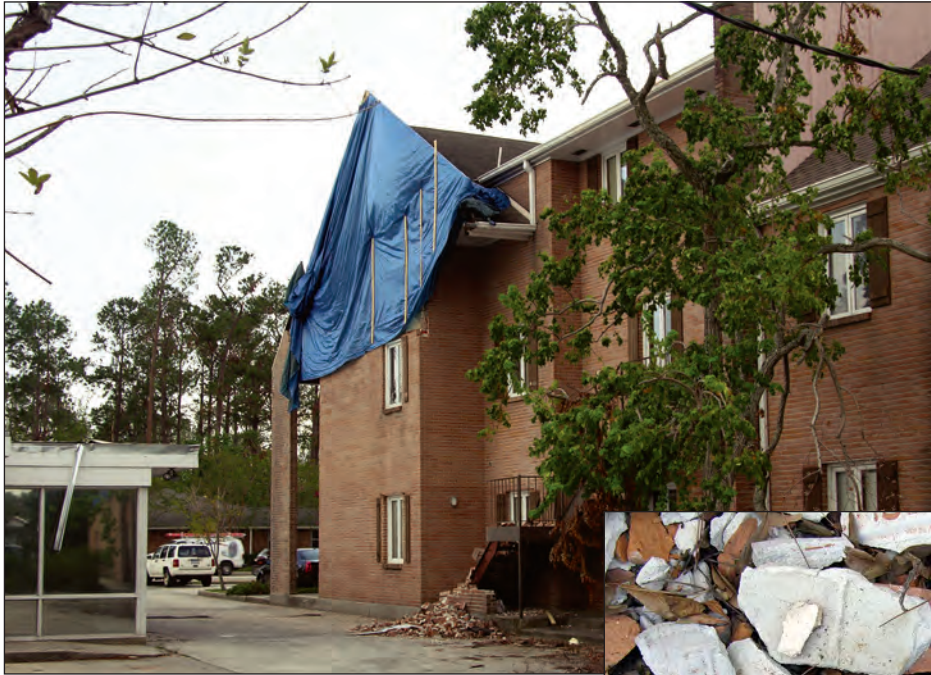
Figure 5-17.  
Partial collapse of  
brick veneer at an  
apartment building;  
the ties were corroded  
(inset) (estimated wind  
speed: 115 mph. Slidell,  
Louisiana).

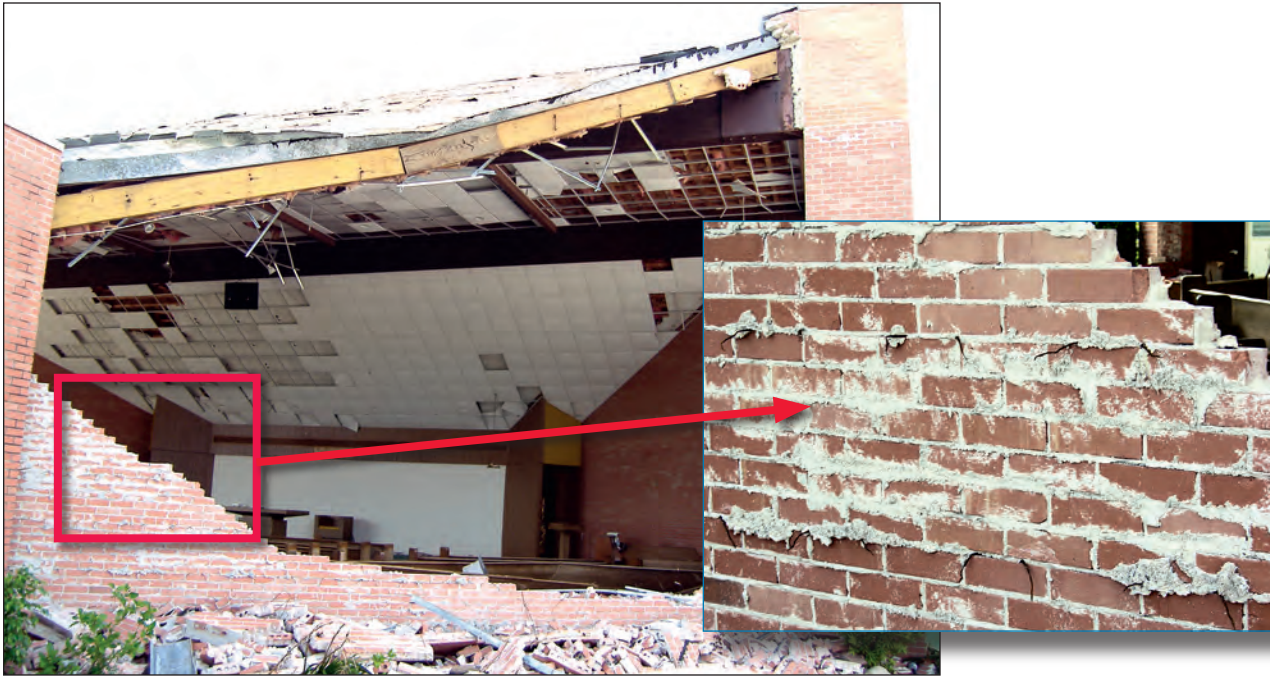
Figure 5-18.

At the old church shown in Figure 5-18, the ties between the roof framing and brick wall, and the continuous wire truss type horizontal joint reinforcement between the two wythes were severely corroded.

The ties and wire truss type horizontal joint reinforcement in this double-wythe cavity wall were severely corroded (inset) (estimated wind speed: 105 mph. Pascagoula, Mississippi).

FEMA Hurricane Katrina Recovery Advisory *Attachment of Brick Veneer in High-Wind Regions* (Appendix E) provides recommended practices for brick veneer attachment. This advisory was based on observations from Hurricanes Ivan and Katrina.

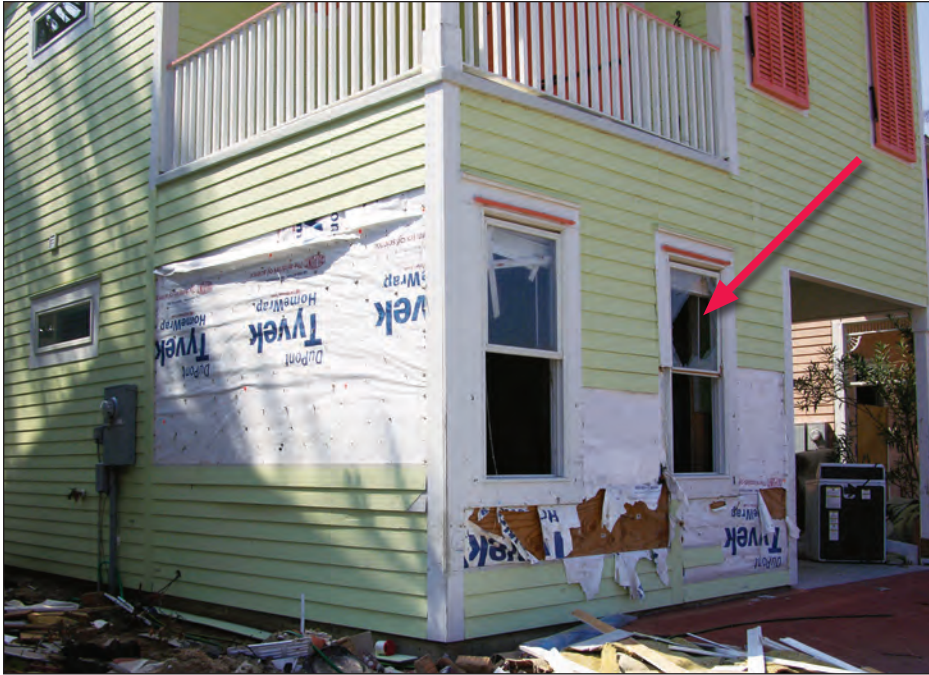
Only a very small number of buildings with fiber-cement siding were observed. Figure 5-19 shows a newly constructed house that experienced wind-induced loss of fiber-cement siding. Along one of the 6-1/4-inch-wide siding panels, the concealed nails were located 1 inch from the end of the panel, then 12, 14, and 12 inches. One of the nails was 5/8 inch from the top of the panel and another was 3/4 inch. At a house in Saint Bernard Parish, Louisiana, along one of the 7-1/4-inch-wide siding panels, the concealed nails were spaced at 8 inches on center and were located 7/8 inch from the top of the panel. At both of these buildings, the siding pulled over the nail heads. The manufacturer recommends that, when using the concealed nailing method, the nails be placed at studs spaced at a maximum of 24 inches on center and that the nails be located 1 inch from the top of the panel.

Figure 5-19.  
Blow-off of fiber-cement siding. Note the broken window at the right (arrow) (estimated wind speed: 125 mph. Bay St. Louis, Mississippi).

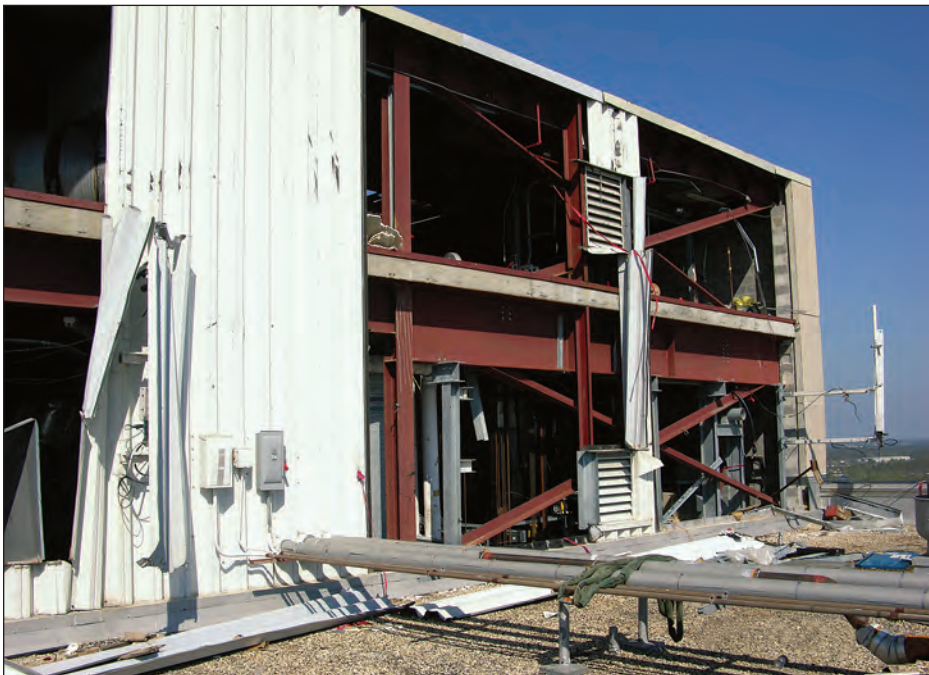
The MAT observed a limited number of metal wall panel failures. A massive failure occurred at the penthouse on a 15-story office building (Figure 5-20). With loss of the wall panels, the elevators were no longer operational due to wind-driven rainwater damage to the elevator controls.

Figure 5-20.  
The metal wall panels blew off the penthouse on this 15-story building. Rainwater infiltration damaged the elevator controls (estimated wind speed: 130 mph. Gulfport, Mississippi).

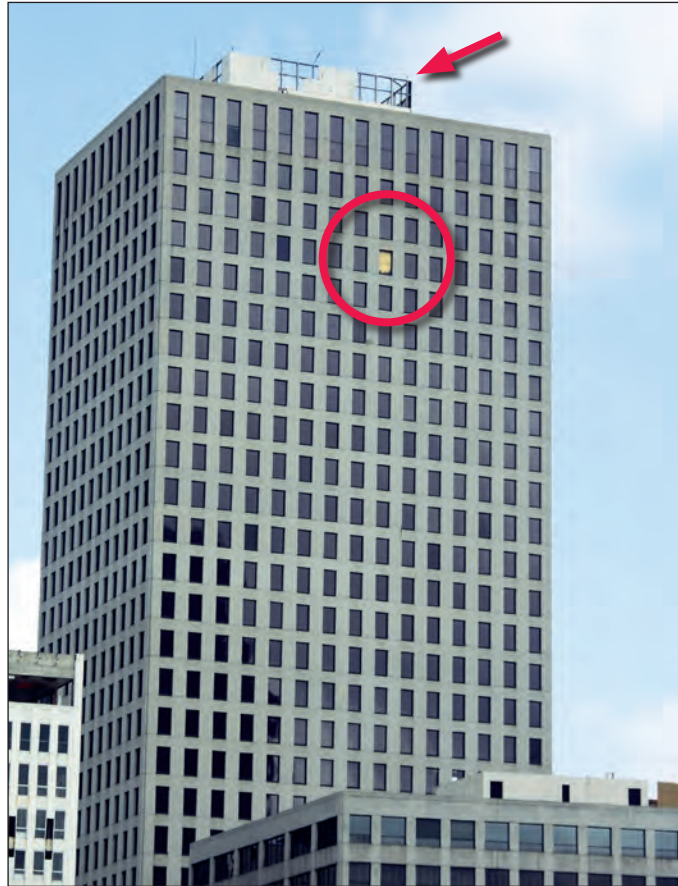
Loss of metal panels from equipment screen walls (arrow). Note the broken window (circle) (estimated wind speed: 105 mph. New Orleans, Louisiana).

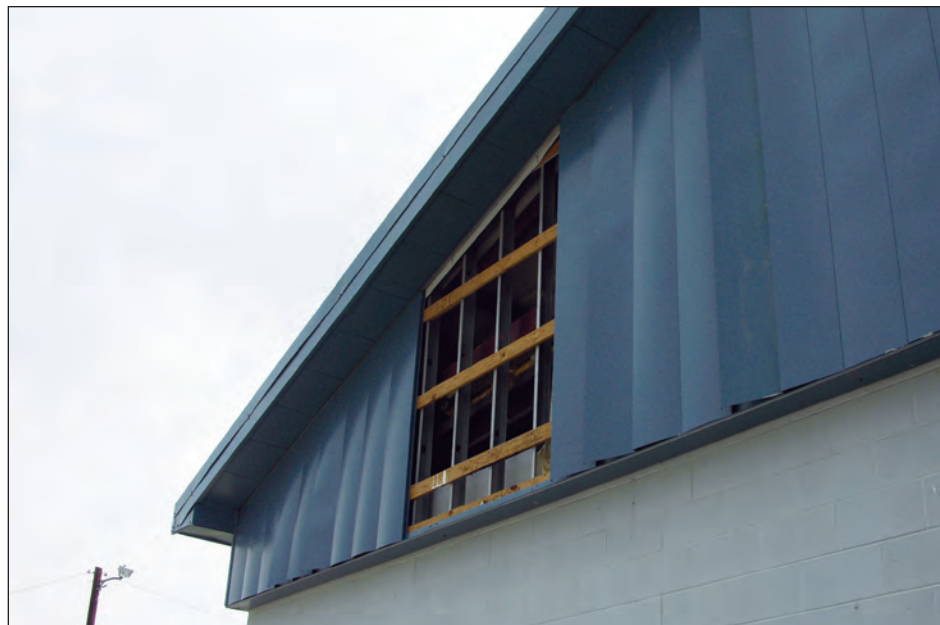
Figure 5-22 shows panels at a police station that unlatched and were blown away. The panels were attached with concealed staples to 1x wood nailers.

Loss of metal panels at a police station. In addition to generating windborne debris, loss of panels allowed rainwater infiltration (estimated wind speed: 130 mph. Long Beach, Mississippi).

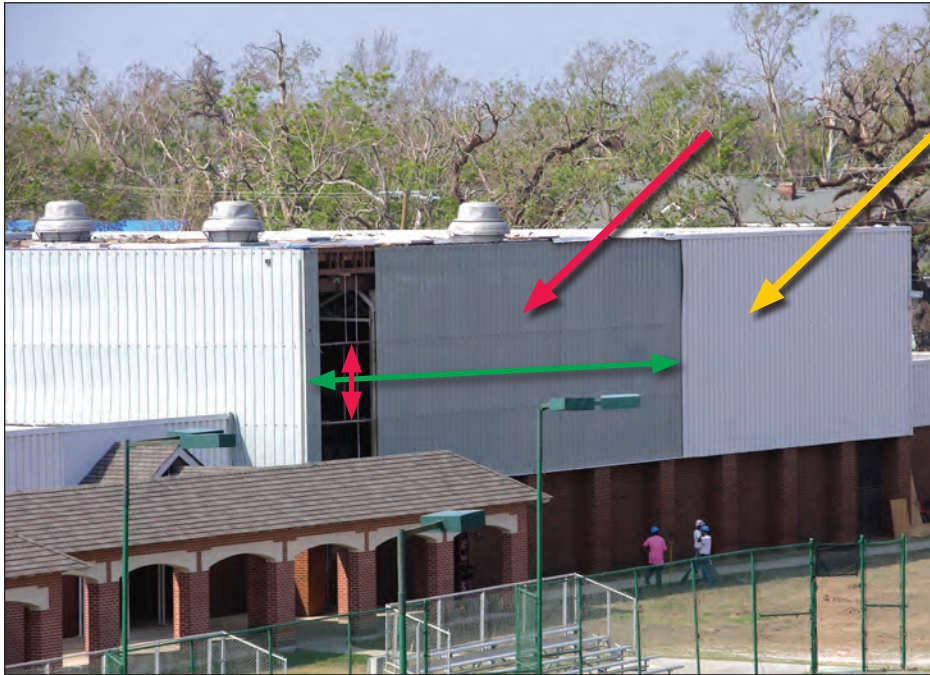
Figure 5-23.

Another wall panel failure was observed at a university building (Figure 5-23). New metal panels had been installed over older metal panels. The newer panels were attached with concealed clips installed over the older panels. The clips were placed at horizontal girts that were far apart. At a corner area both the newer and older panels blew off; the blow-off may have initiated with failure of the older panels, or the failure of the older panels may have been a secondary failure.

The white metal panels had been installed over a previous metal panel system. Most of the underlying original panels (red arrow) remained in place, but many of the newer panels (yellow arrow) blew off due to inadequate attachment (green double-arrow shows the area that is missing the newer overlying panels). Note that the girts (red double-arrow) were very far apart (estimated wind speed: 125 mph. Waveland, Mississippi).

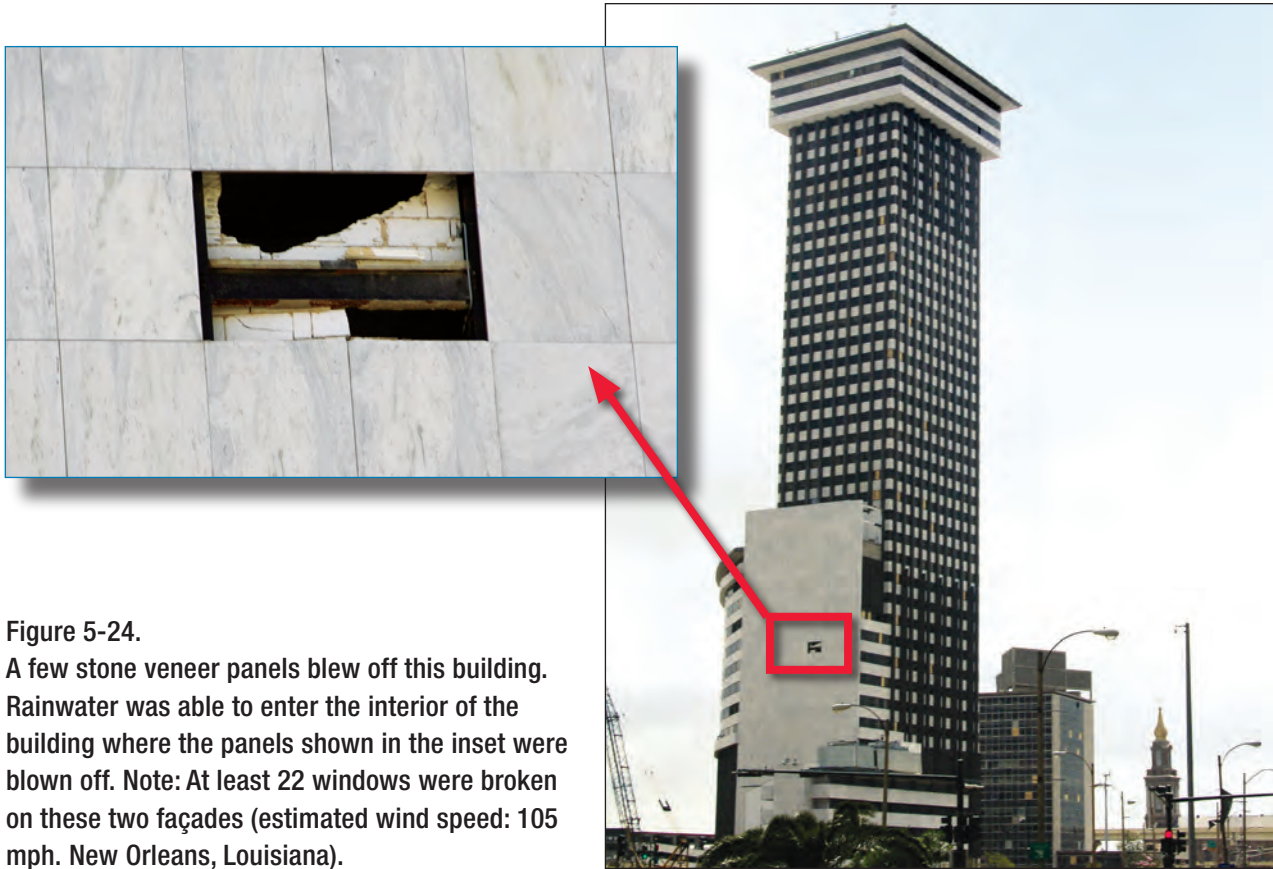
Several mid- and high-rise buildings in New Orleans were sheathed with stone veneer. No buildings were observed to have experienced widespread loss of stone veneer; however, a small number of buildings lost a few panels, as shown in Figure 5-24. Blown-off panels can damage buildings and vehicles, and can cause injury.

Figure 5-24.  
A few stone veneer panels blew off this building. Rainwater was able to enter the interior of the building where the panels shown in the inset were blown off. Note: At least 22 windows were broken on these two façades (estimated wind speed: 105 mph. New Orleans, Louisiana).

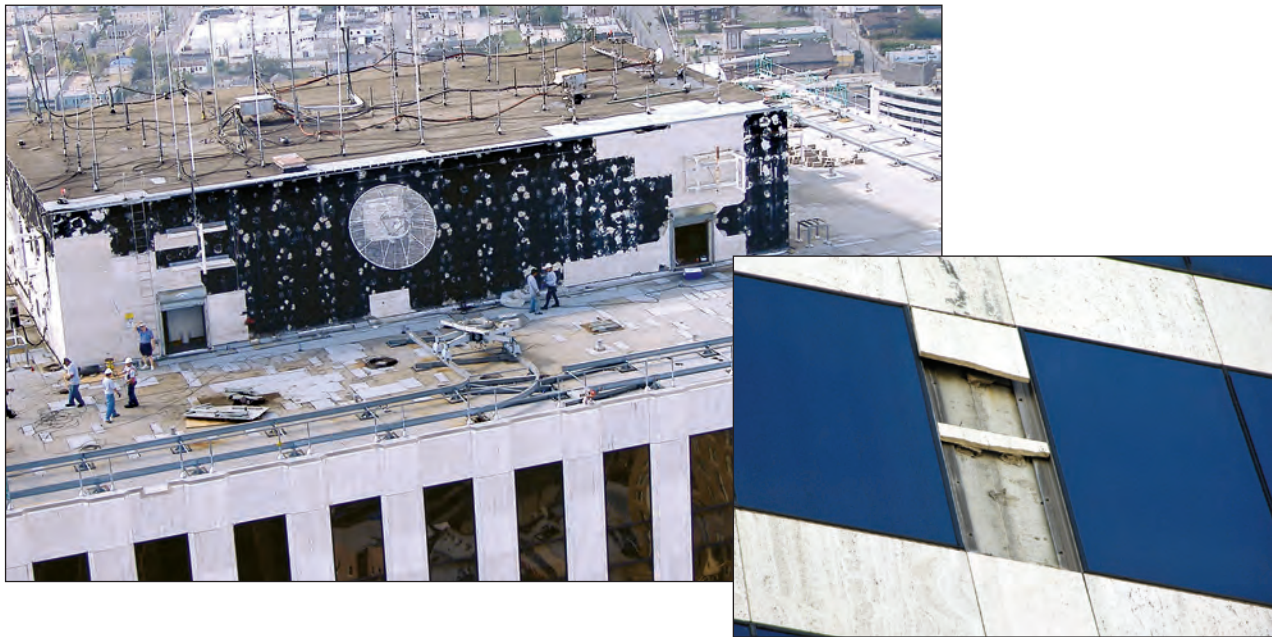
Figure 5-25.  
Several stone veneer panels blew off the penthouse and caused significant puncturing damage to the modified bitumen membrane roof. A few panels were also blown off the main walls (inset) (estimated wind speed: 105 mph. New Orleans, Louisiana).

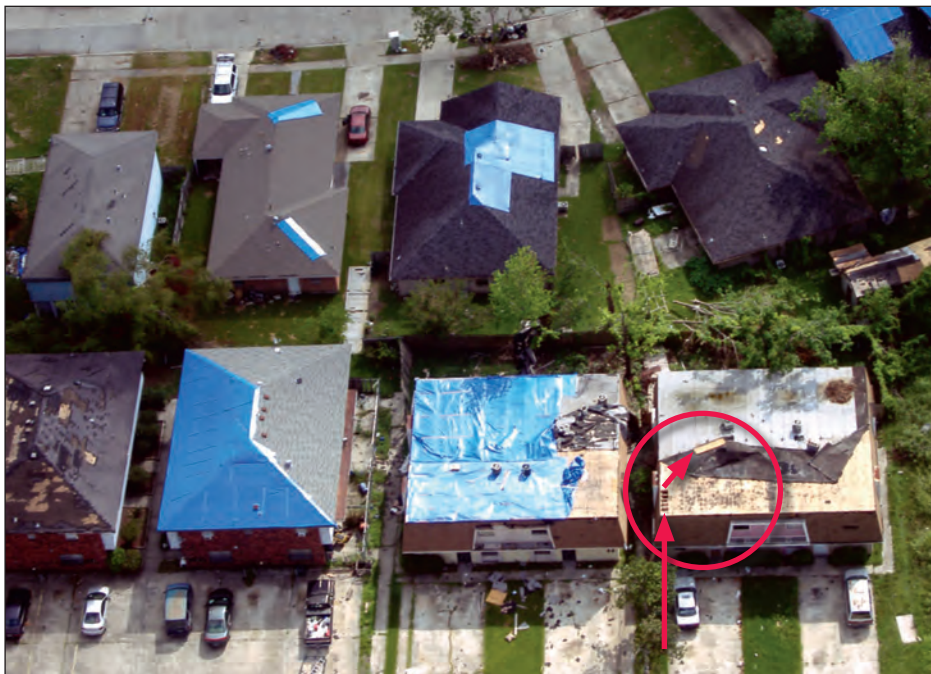
Figure 5-34. Asphalt shingles were damaged on seven of these houses. The two houses on the lower right had built-up or modified bituminous cap sheets. The blow-off at the lower right was likely initiated by blow-off of a deck panel from the corner (estimated wind speed: 105 mph. New Orleans, Louisiana area).

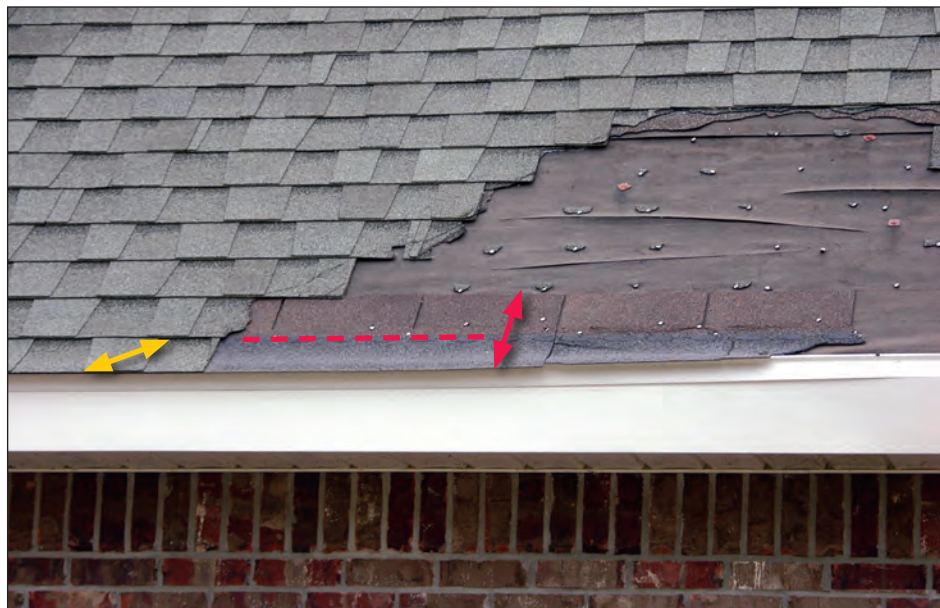
**Figure 5-39.** These two failures likely initiated at the eave due to an incorrectly installed starter course. Note that, at both roofs, a portion of the underlayment and some of the hip shingles were blown away (estimated wind speed: 115 and 105 mph. Slidell, Louisiana, and Pascagoula, Mississippi, respectively).

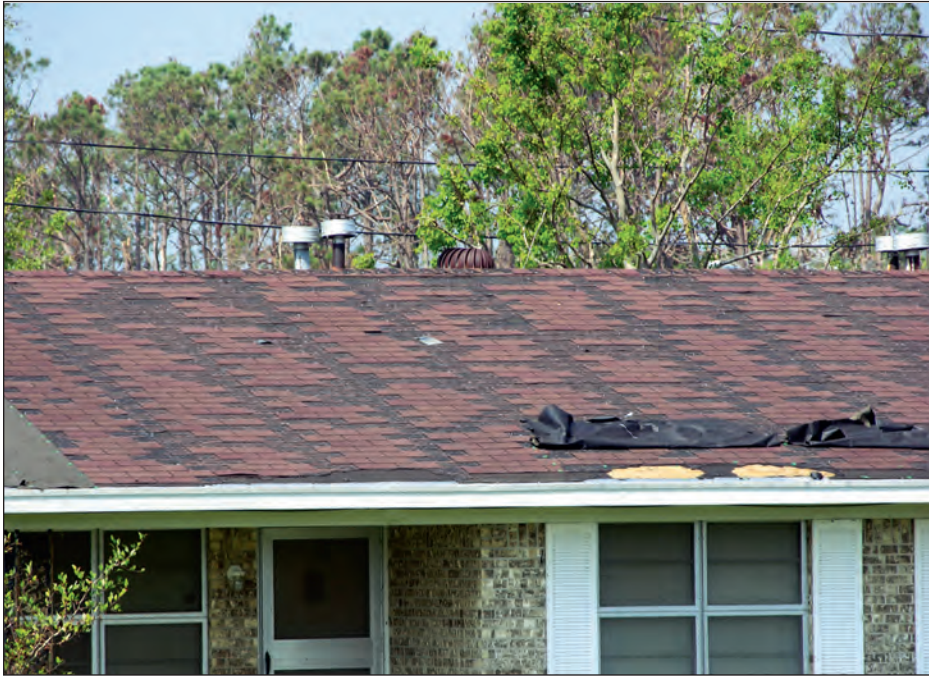
**Figure 5-49.**  
The vertical lines of missing tabs are indicative of installation by the raking method. When raked, end nails are frequently not installed. Some shingles and underlayment were also blown from the eave and rake (estimated wind speed: 125 mph. Waveland, Mississippi).

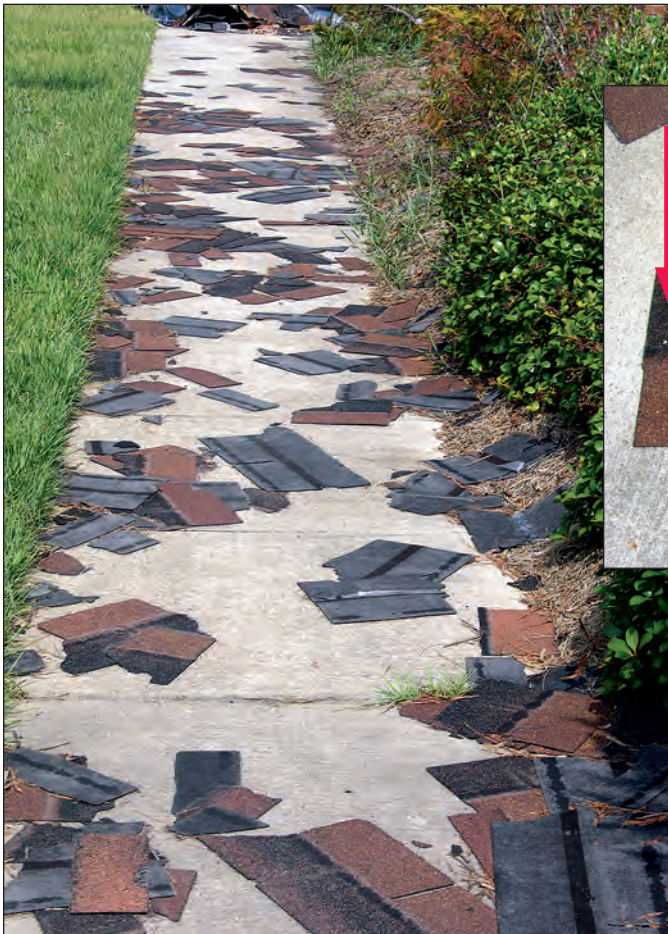
**Figure 5-50.**  
Many shingles were blown from a nursing home. Limited checking found three shingles that were missing the right end nail (see inset for one of these). The nails that were installed were placed very high (red arrows); many missed or just nicked the underlying headlap (estimated wind speed: 130 mph. Gulfport, Mississippi).

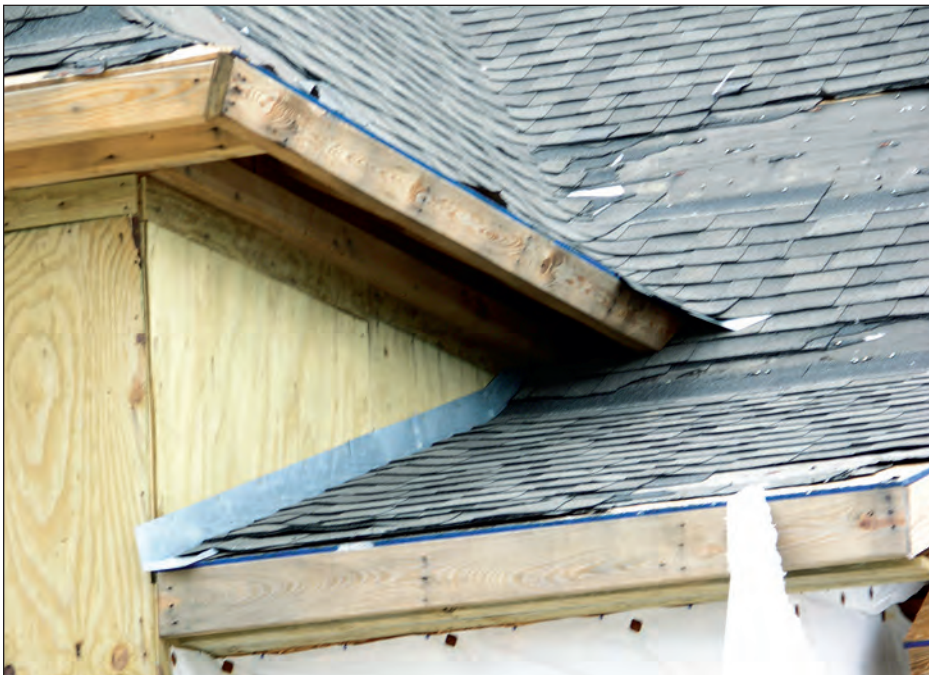
**Figure 5-53.** Continuous metal flashing at the roof-to-wall intersection of a house under construction. This detail is susceptible to leakage and subsequent dry rot of the deck sheathing (estimated wind speed: 115 mph. Slidell, Louisiana).

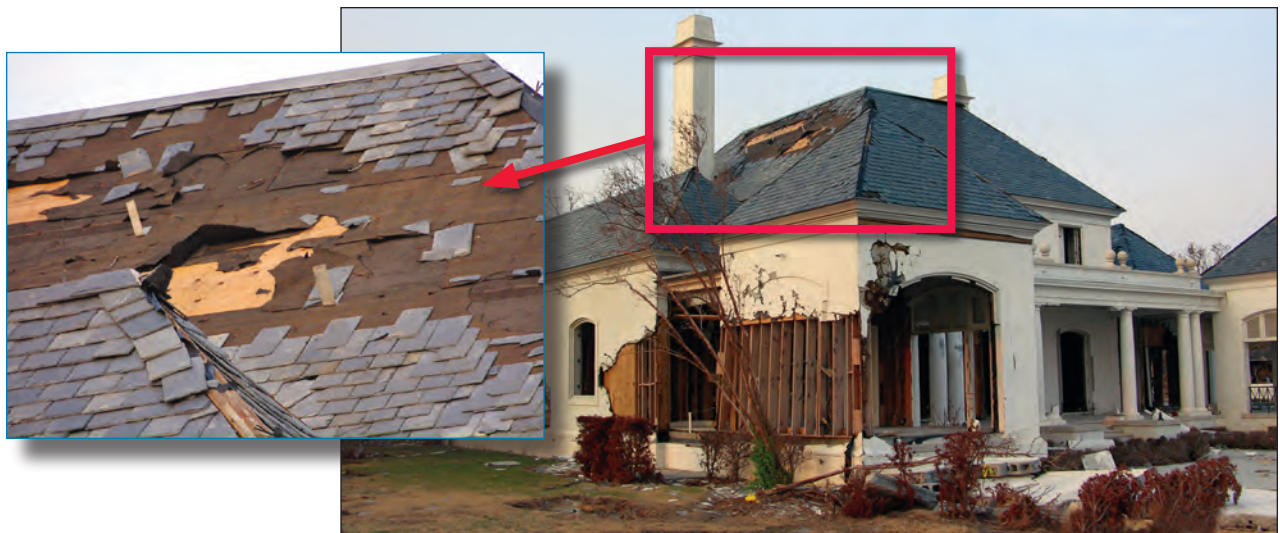
**Figure 5-56.** Damaged slate roof. The nails typically pulled out of the deck. However, as shown in the square/inset, some of the slates broke and small portions remained nailed to the deck. This house was located in Exposure C (estimated wind speed: 130 mph. Gulfport, Mississippi).

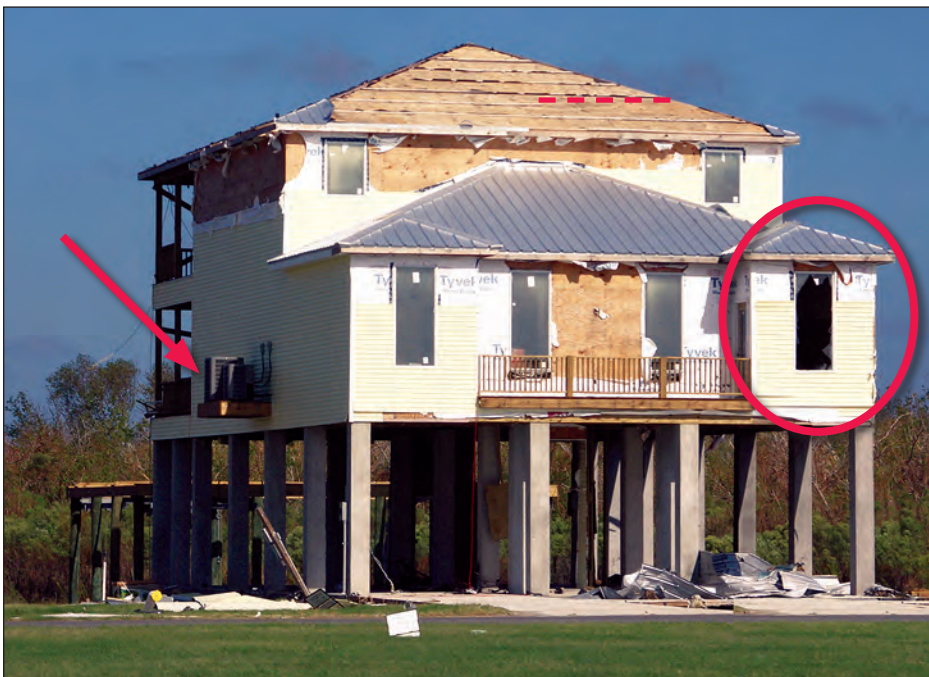
Figure 5-62.  
Blow-off of one of the nailers (dotted line) caused these panels to progressively fail. Note the cantilevered condenser platform (arrow), a good practice, and the broken window (circle). The house was located in Exposure C (estimated wind speed: 130 mph. St. Bernard Parish, Louisiana).

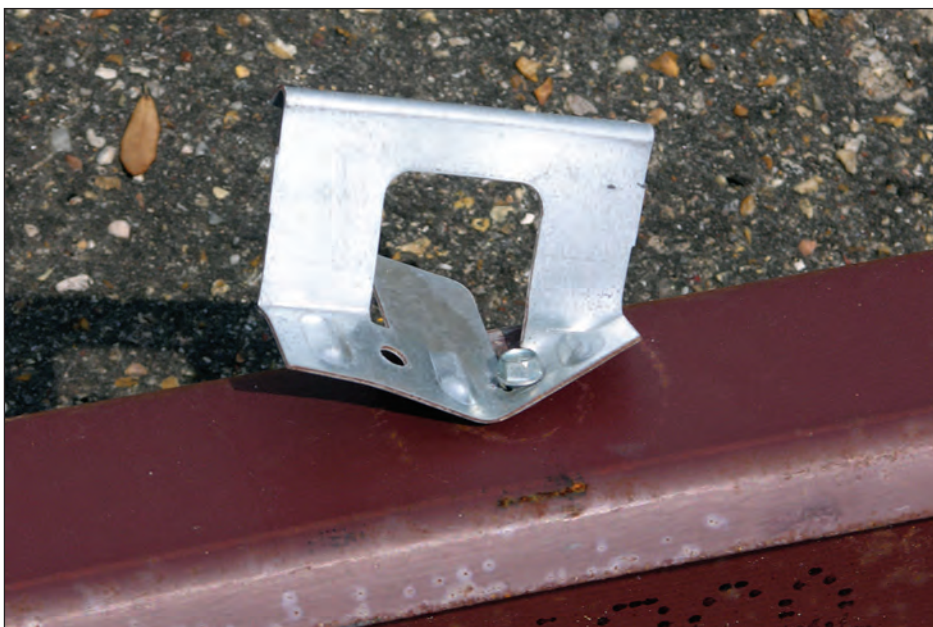
**Figure 5-66.**  
The clips for this structural standing seam panel were intended to be attached with two screws. With only one screw, the clips were eccentrically loaded (estimated wind speed: 130 mph. Long Beach, Mississippi).

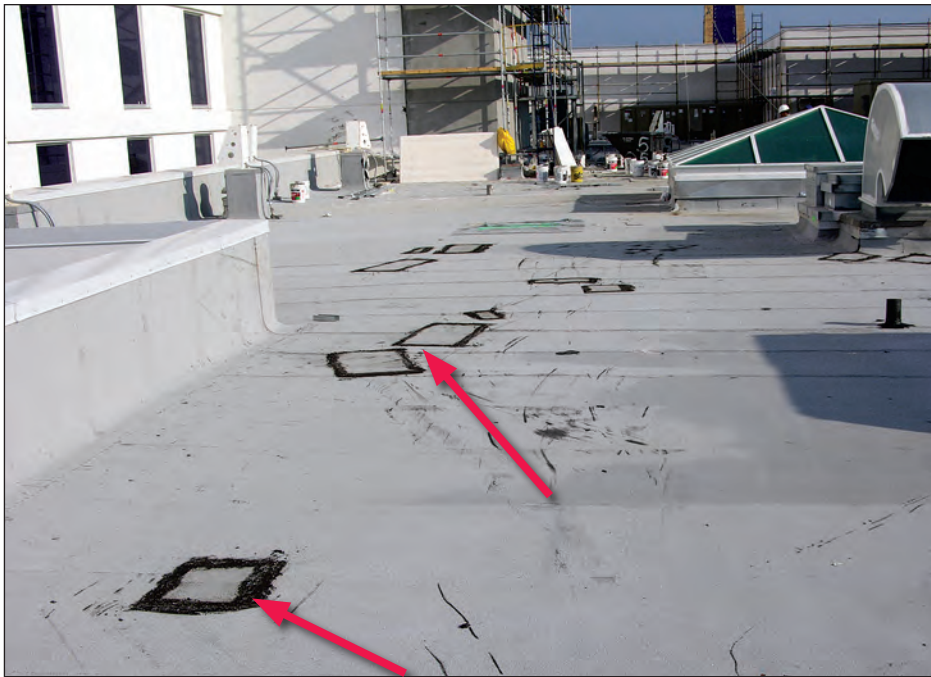
**Figure 5-71.**  
This modified bitumen membrane was punctured in several locations by windborne debris. This building was located in Exposure C (estimated wind speed: 120 mph. Biloxi, Mississippi).

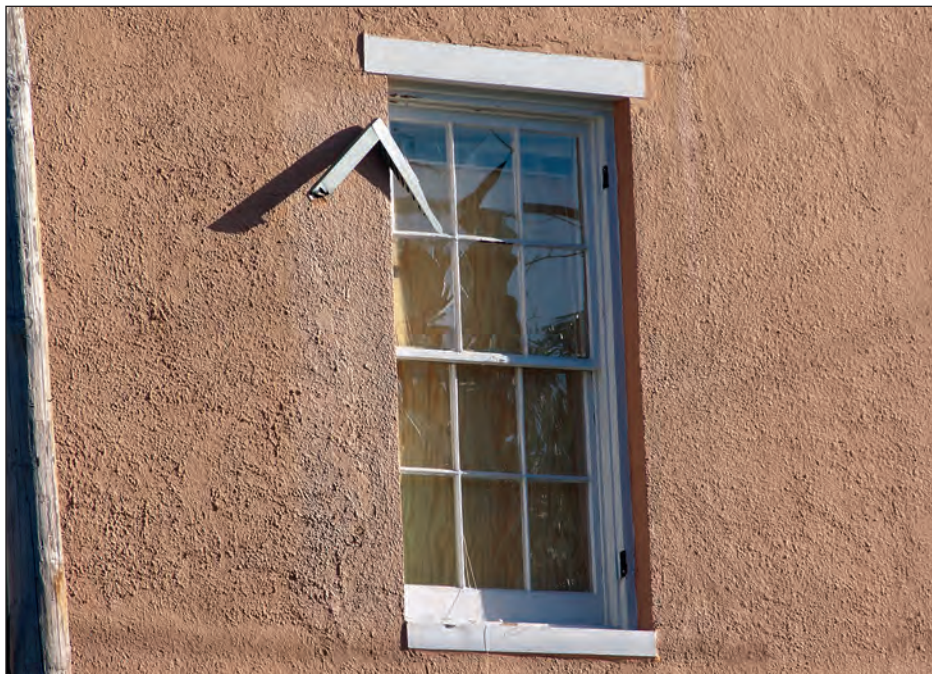
**Figure 5-76.**  
This window was broken by a fragment from a shutter (estimated wind speed: 105 mph. New Orleans, Louisiana).

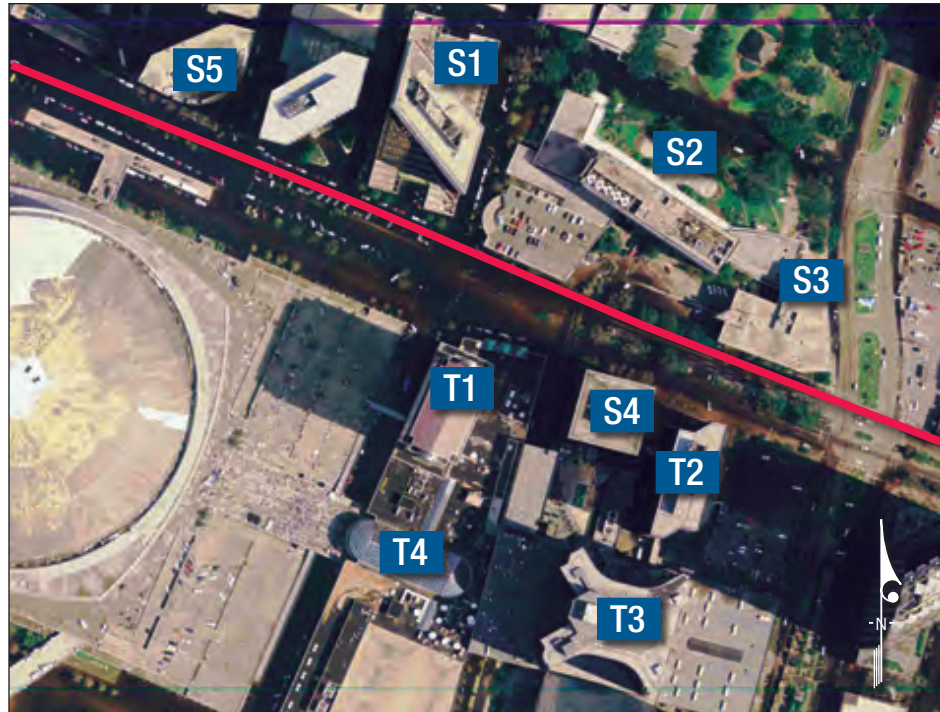
Figure 5-82.  
View of glazing damage  
at T1 - T3 and S4.  
Building S1 had an  
aggregate ballasted roof  
membrane; aggregate  
from this roof was one  
of the likely sources of  
debris (estimated wind  
speed: 105 mph. New  
Orleans, Louisiana).

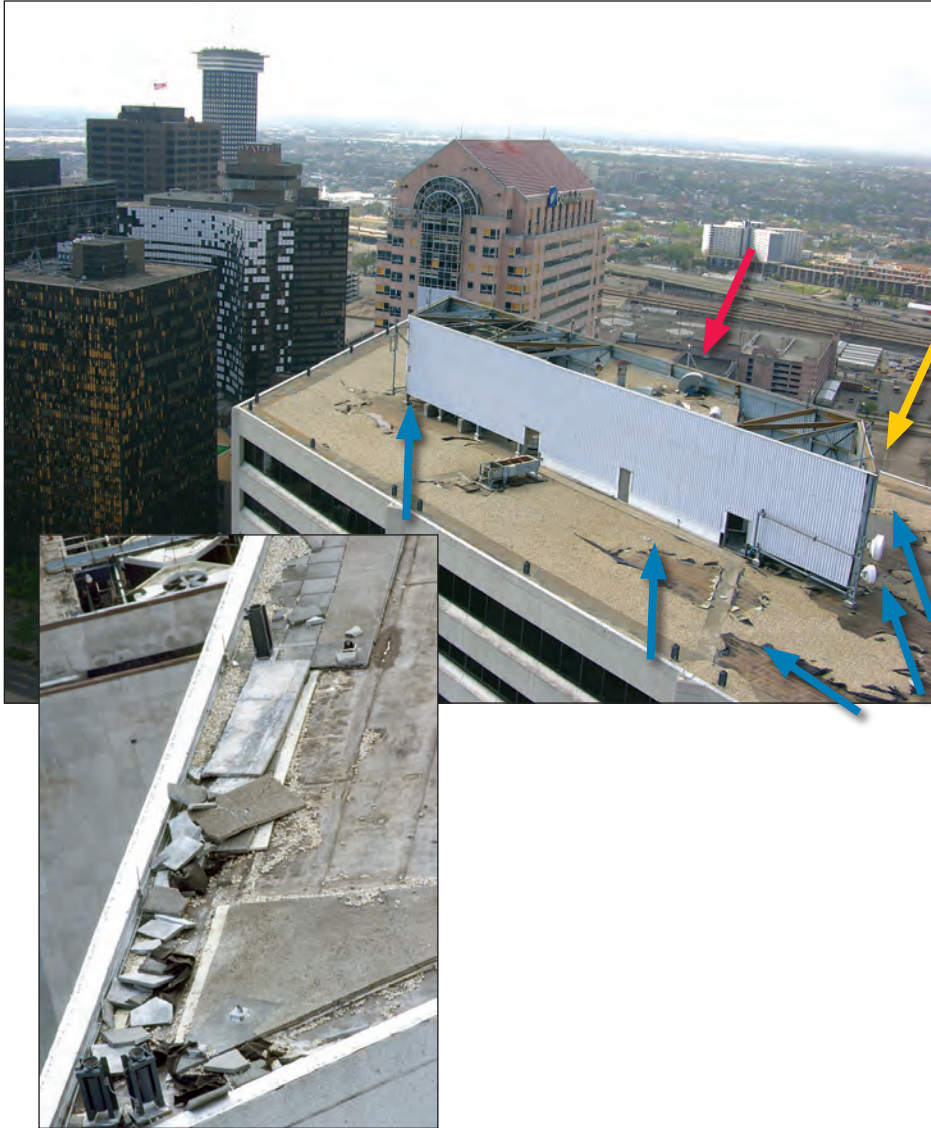
Figure 5-87. Scoured aggregate at Building T1 is shown by the blue arrows. Aggregate was ramped behind the parapet (yellow arrow). A gooseneck lifted from its curb but did not blow away (red arrow). The inset shows displaced pavers and concrete walkway at the windward corner (out of view at the bottom right of the figure) (estimated wind speed: 105 mph. New Orleans, Louisiana).
