## HURRICANE

*Katrina*

## IN THE GULF COAST

## 5. Building Envelope Performance

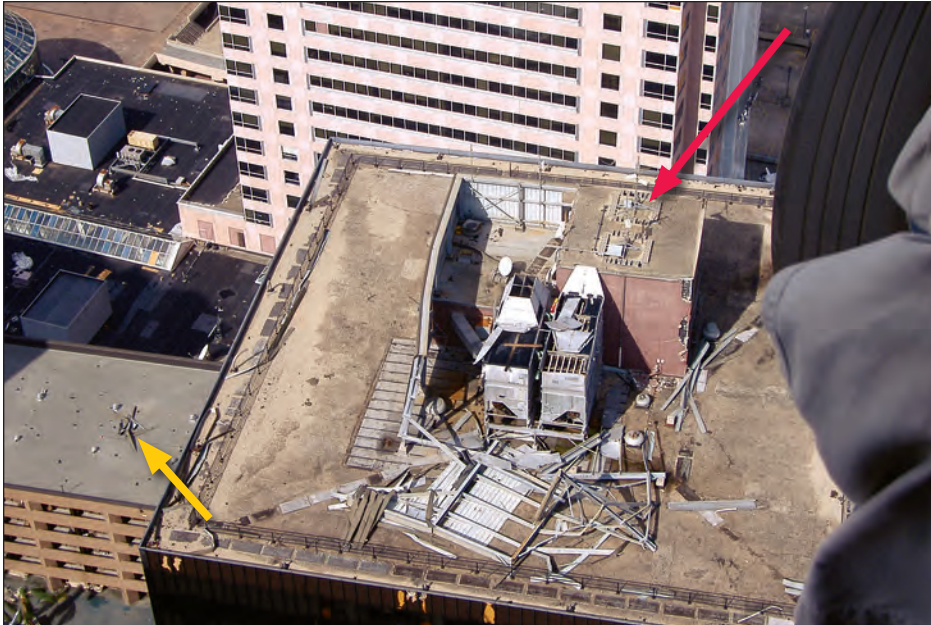
Figure 5-88. View of the roof of S4. Note the glazing damage on the east side of S4 (bottom of figure). Equipment screen wall panels landed on a lower roof (yellow arrow). The penthouse roof (red arrow) did not have a parapet (estimated wind speed: 105 mph. New Orleans, Louisiana).

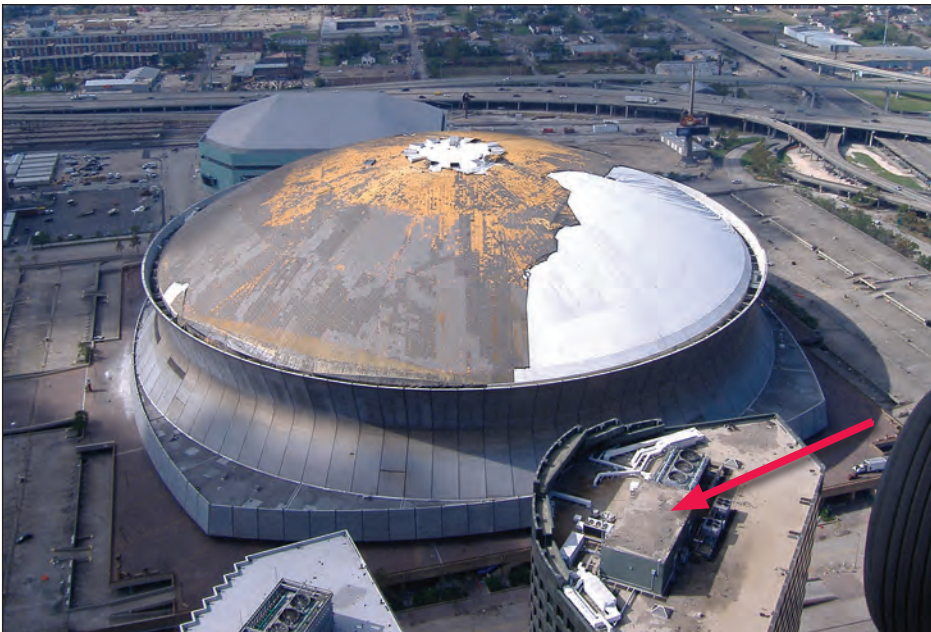
Figure 5-89. Aggregate was scoured on the main roof of Building S5 and blown from the penthouse (red arrow). The building to the left of S5 did not have an aggregate surfaced roof, nor did the lower roofs of the Superdome (estimated wind speed: 105 mph. New Orleans, Louisiana).

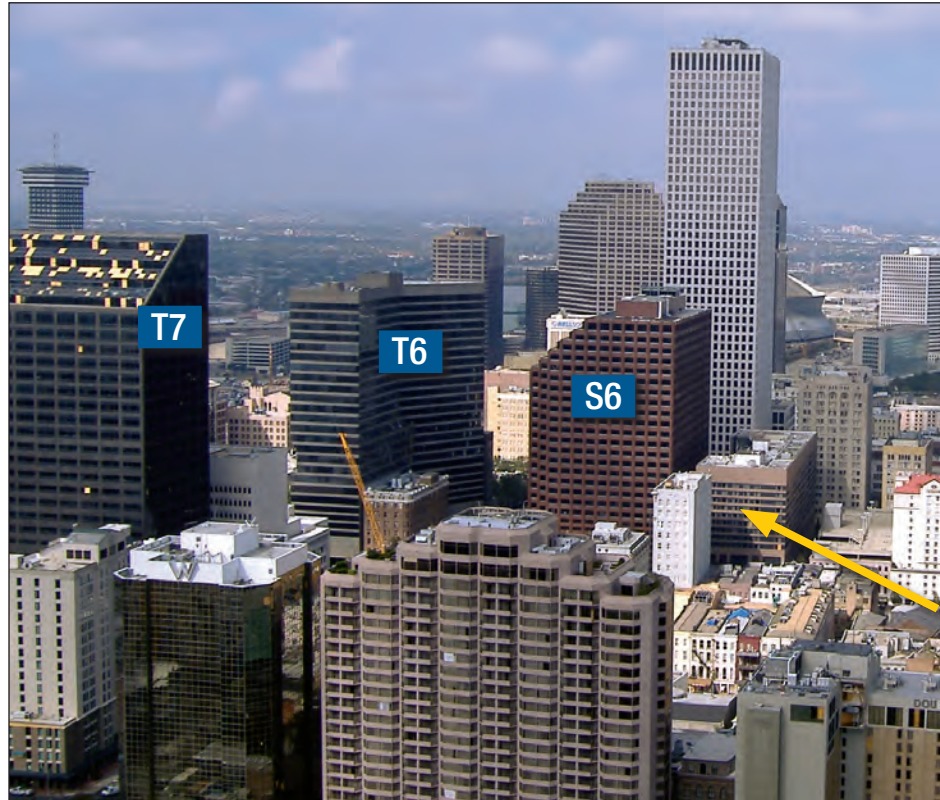
Figure 5-94.  
The stair-stepped roofs  
of S6 (red arrow) were  
aggregate surfaced.  
Some of the metal  
roof panels had also  
blown away (yellow  
circle). The black area  
(yellow arrow) is a roof  
membrane installed after  
the hurricane (estimated  
wind speed: 105 mph.  
New Orleans, Louisiana).

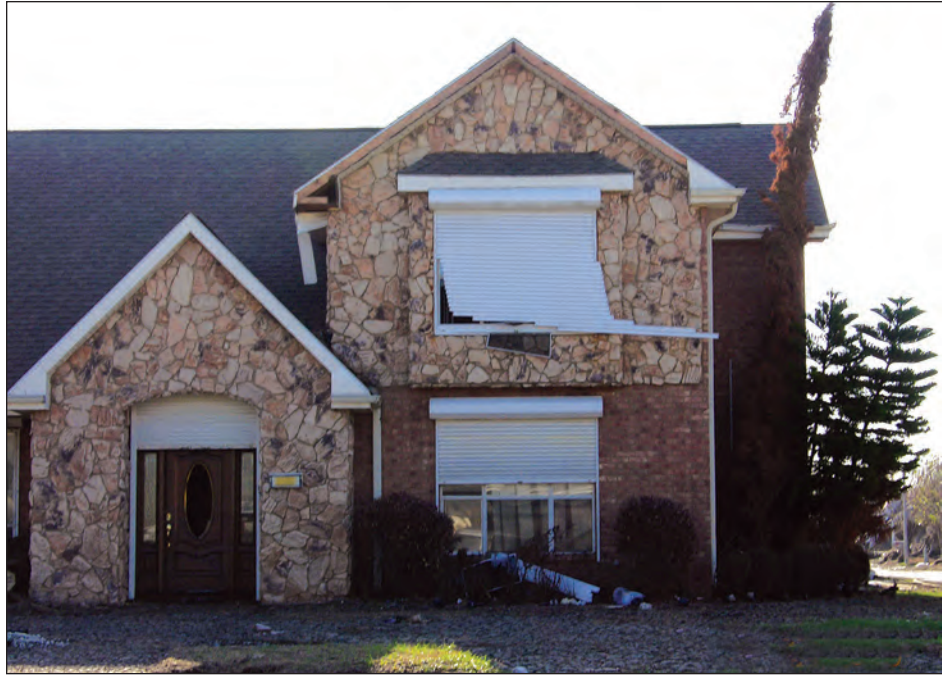
**Figure 5-100.**  
This plastic shutter did not completely cover the  
window. The lower window was broken (estimated  
wind speed: 105 mph. Pascagoula, Mississippi).

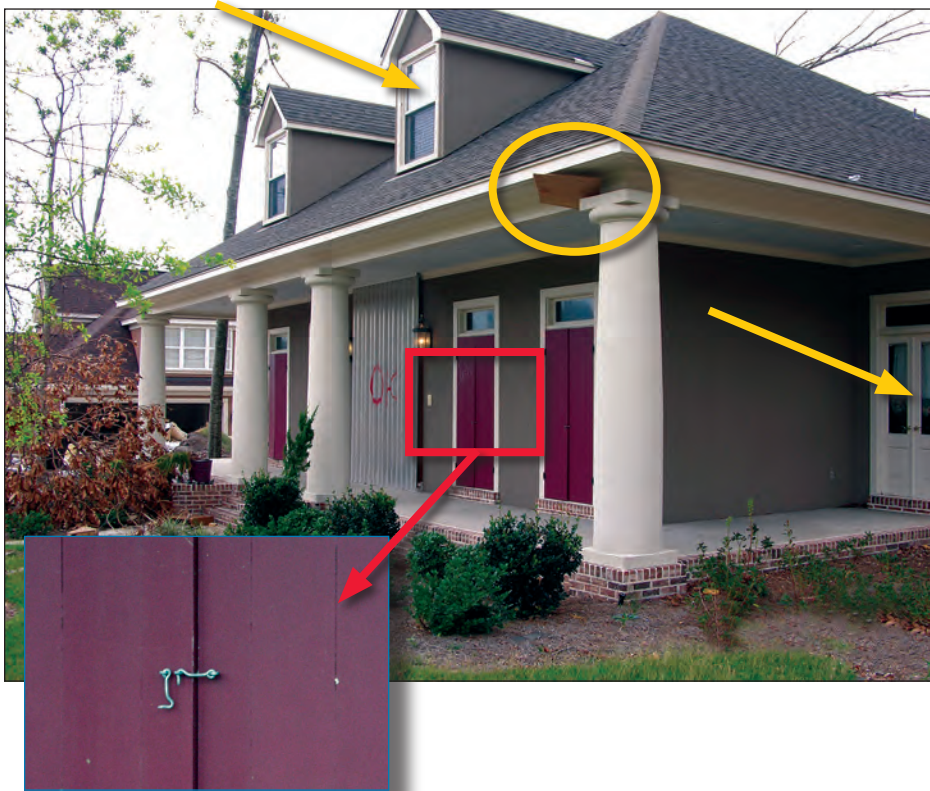
**Figure 5-101.** Metal shutters were over the main doors, and swinging wood shutters were over the larger first floor windows. However, several windows were unprotected (yellow arrows). The shutter latch (inset) was susceptible to unlatching. Note the wood sheathing debris (yellow circle) (estimated wind speed: 130 mph. Long Beach, Mississippi).

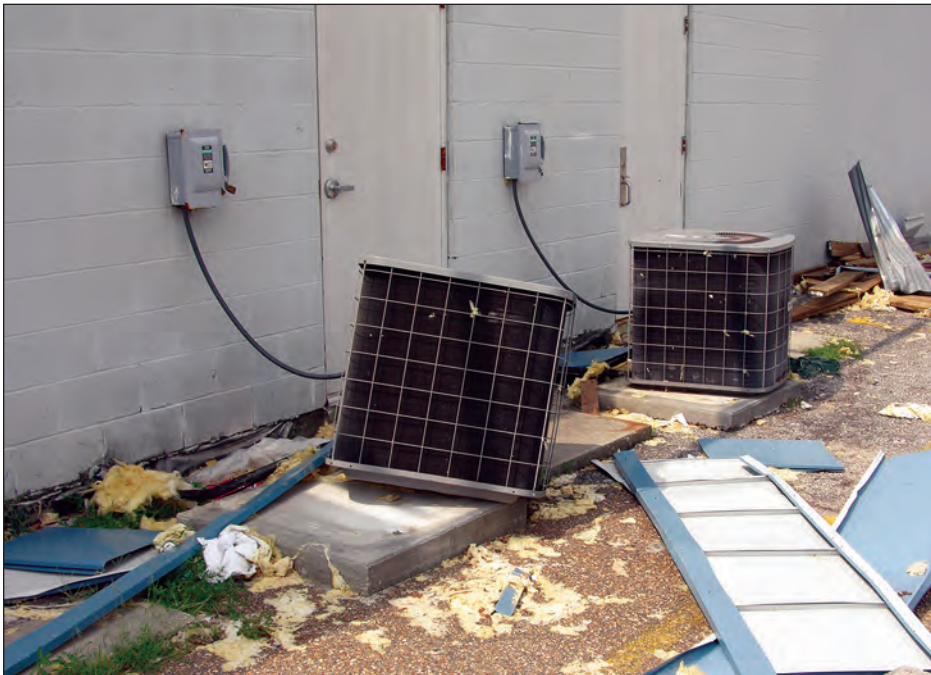
Figure 5-110.  
Inadequately attached condenser at the police station shown in Figure 3-54 (estimated wind speed: 130 mph. Long Beach, Mississippi).

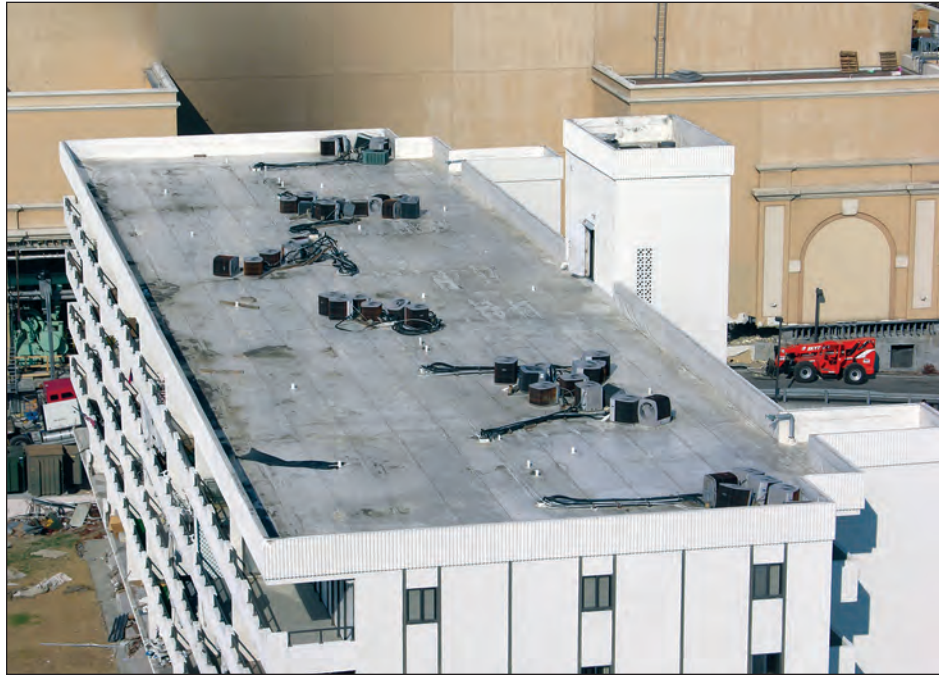
**Figure 5-112.**  
The condensers on this new medical office building were anchored to structural steel equipment support stands (estimated wind speed: 130 mph. Gulfport, Mississippi).

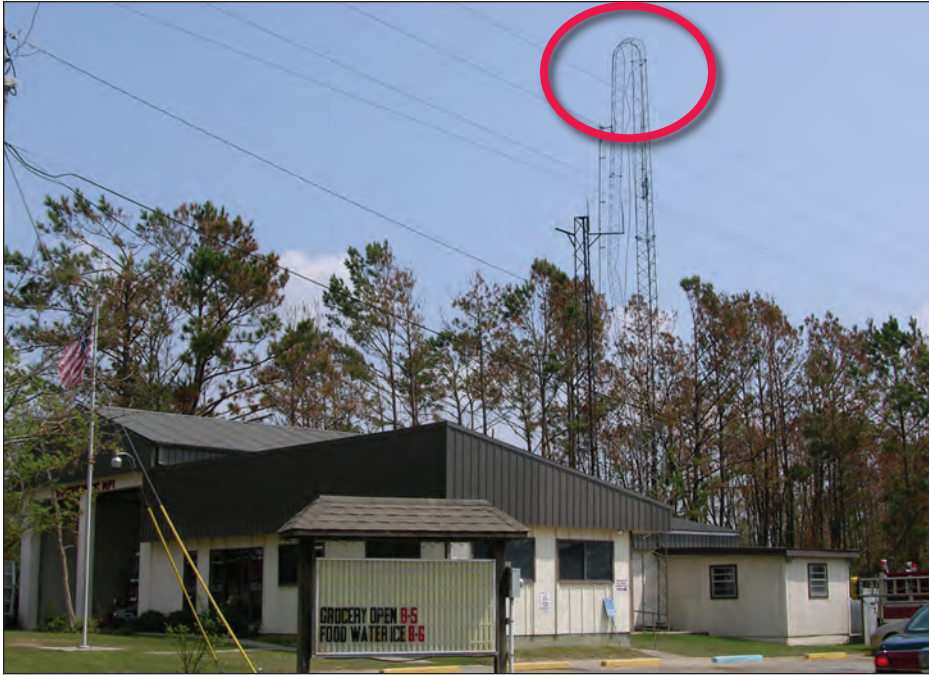
**Figure 5-119.**  
The antenna tower at this fire station buckled (estimated wind speed: 120 mph. Diamondhead, Mississippi).

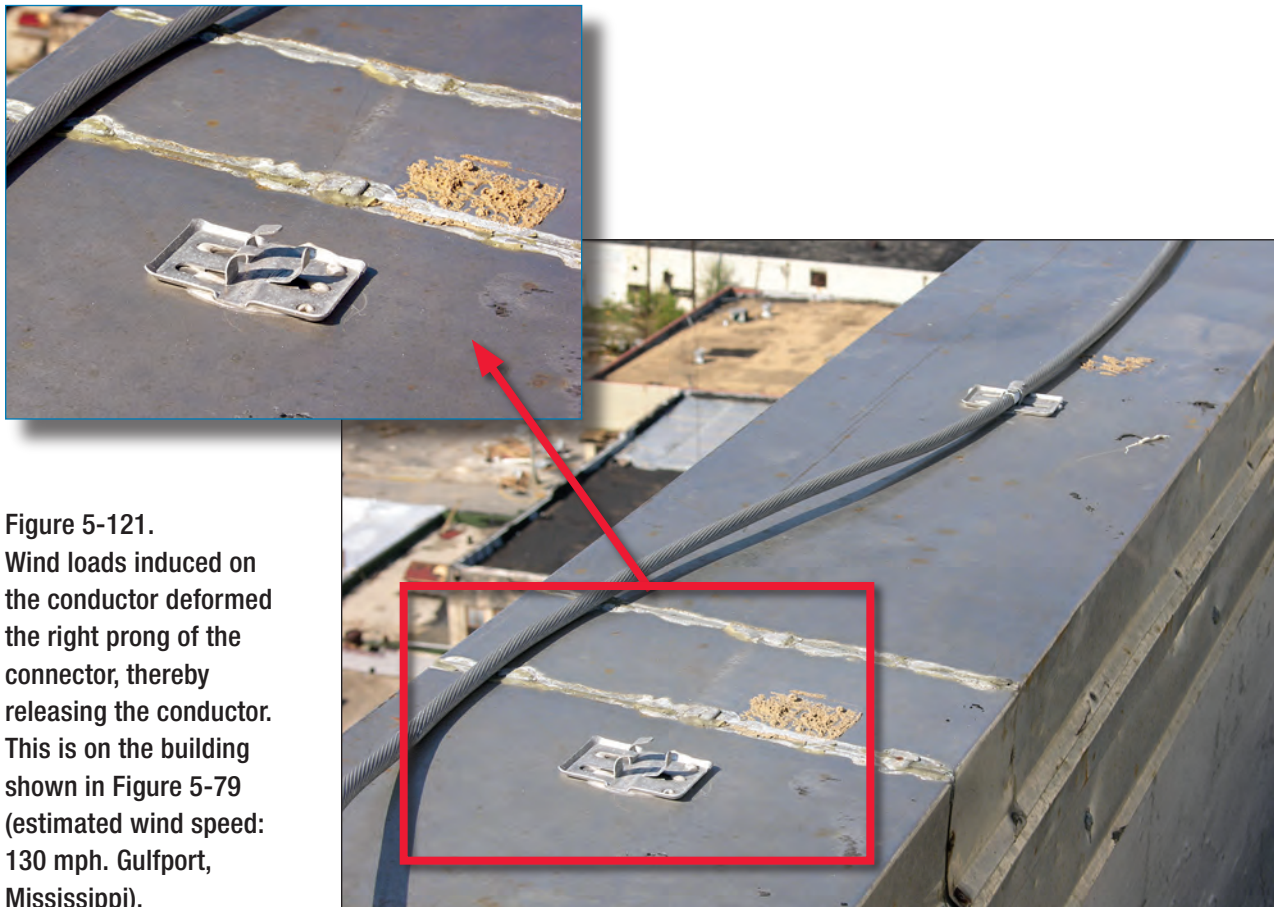
Figure 5-121.  
Wind loads induced on the conductor deformed the right prong of the connector, thereby releasing the conductor. This is on the building shown in Figure 5-79 (estimated wind speed: 130 mph. Gulfport, Mississippi).
