House Built to Code Survives Katrina

Full Mitigation Best Practice Story

Hancock County, Mississippi

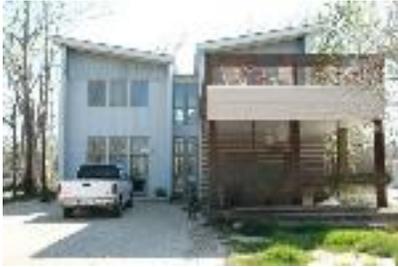
Four windows were destroyed on the first floor. Other windows survived the high winds and debris impact because Mr. Anderson had boarded up the windows with exterior half-inch oriented strand boards before evacuating. Kitchen appliances and walls below the water line were damaged, and there was minor damage to the roof, but there was no other structural damage.

The Andersons' house in Bay St. Louis, MS.

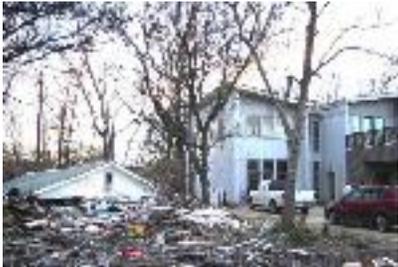
Neighbor's house was destroyed by Katrina.
