## Waterfront High-Rise Survives Katrina

### Full Mitigation Best Practice Story

#### *Harrison County, Mississippi*

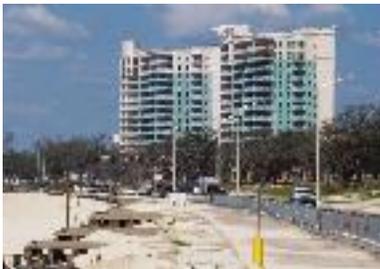
Legacy Towers remains standing along the Gulf front after Hurricane Katrina.

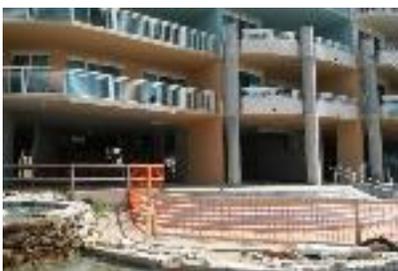
The breakaway walls on the first floor successfully performed their task by releasing outward from the foundation, thereby allowing water and wind to flow freely through the structure and preventing damage to the 13 remaining floors of the building. Concrete walls separating each unit and built perpendicular to the wave crest were another vital structural element. The reinforced steel walls were "tied" to concrete-augured pilings embedded 85 feet into the ground.

The hardest hit areas were the first and second floors and the southeast corner of the building that was directly in the path of the wind. The first floor received 10 feet of water, which led to mold and mildew. The damaged materials were removed and the walls dried out before renovation began.

Breakaway walls on the first floor successfully blew out to save the building.
