Historic Home Retrofit

Full Mitigation Best Practice Story

Kitsap County, Washington

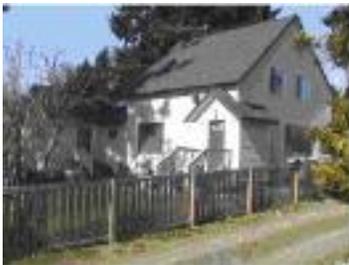
Extensive retrofitting of this historic home protected it from damages during the Nisqually earthquake.

At the time of purchase, a building inspector suggested that Chapot have an earthquake retrofit done to ensure positive connections among beams, posts, and pier blocks. Forty piers were braced with a gusset system that included a two-foot, triangle-shaped plywood tying the posts to the concrete pier. All of the posts around the perimeter were tied together in the front and the back with 2-foot by 6-foot posts, and nails were strategically placed. Because pier blocks were different shapes, bendable metal connections were used for attaching the posts.
