Hazard Mitigation Saves Historic Galveston Home

Full Mitigation Best Practice Story

Galveston County, Texas

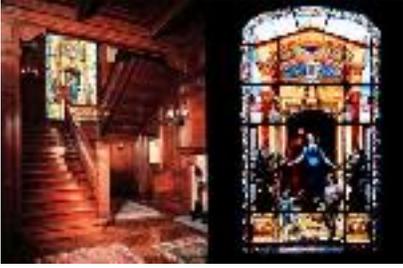
During Hurricane Ike, winds hurled debris broadside into the stained-glass window, but the window had been covered with safety glass to protect it in a storm. Mary Hoehne, Moody Mansion facility manager, said, "The covering did its job. There's no question that without the safety glass we would have lost that window."

A 12-foot-tall stained glass window welcomes visitors to the Moody Mansion.
