Mitigation Assessment Team Report

Hurricane Ian in Florida

Building Performance Observations,
Recommendations, and Technical Guidance

FEMA P-2342/December 2023

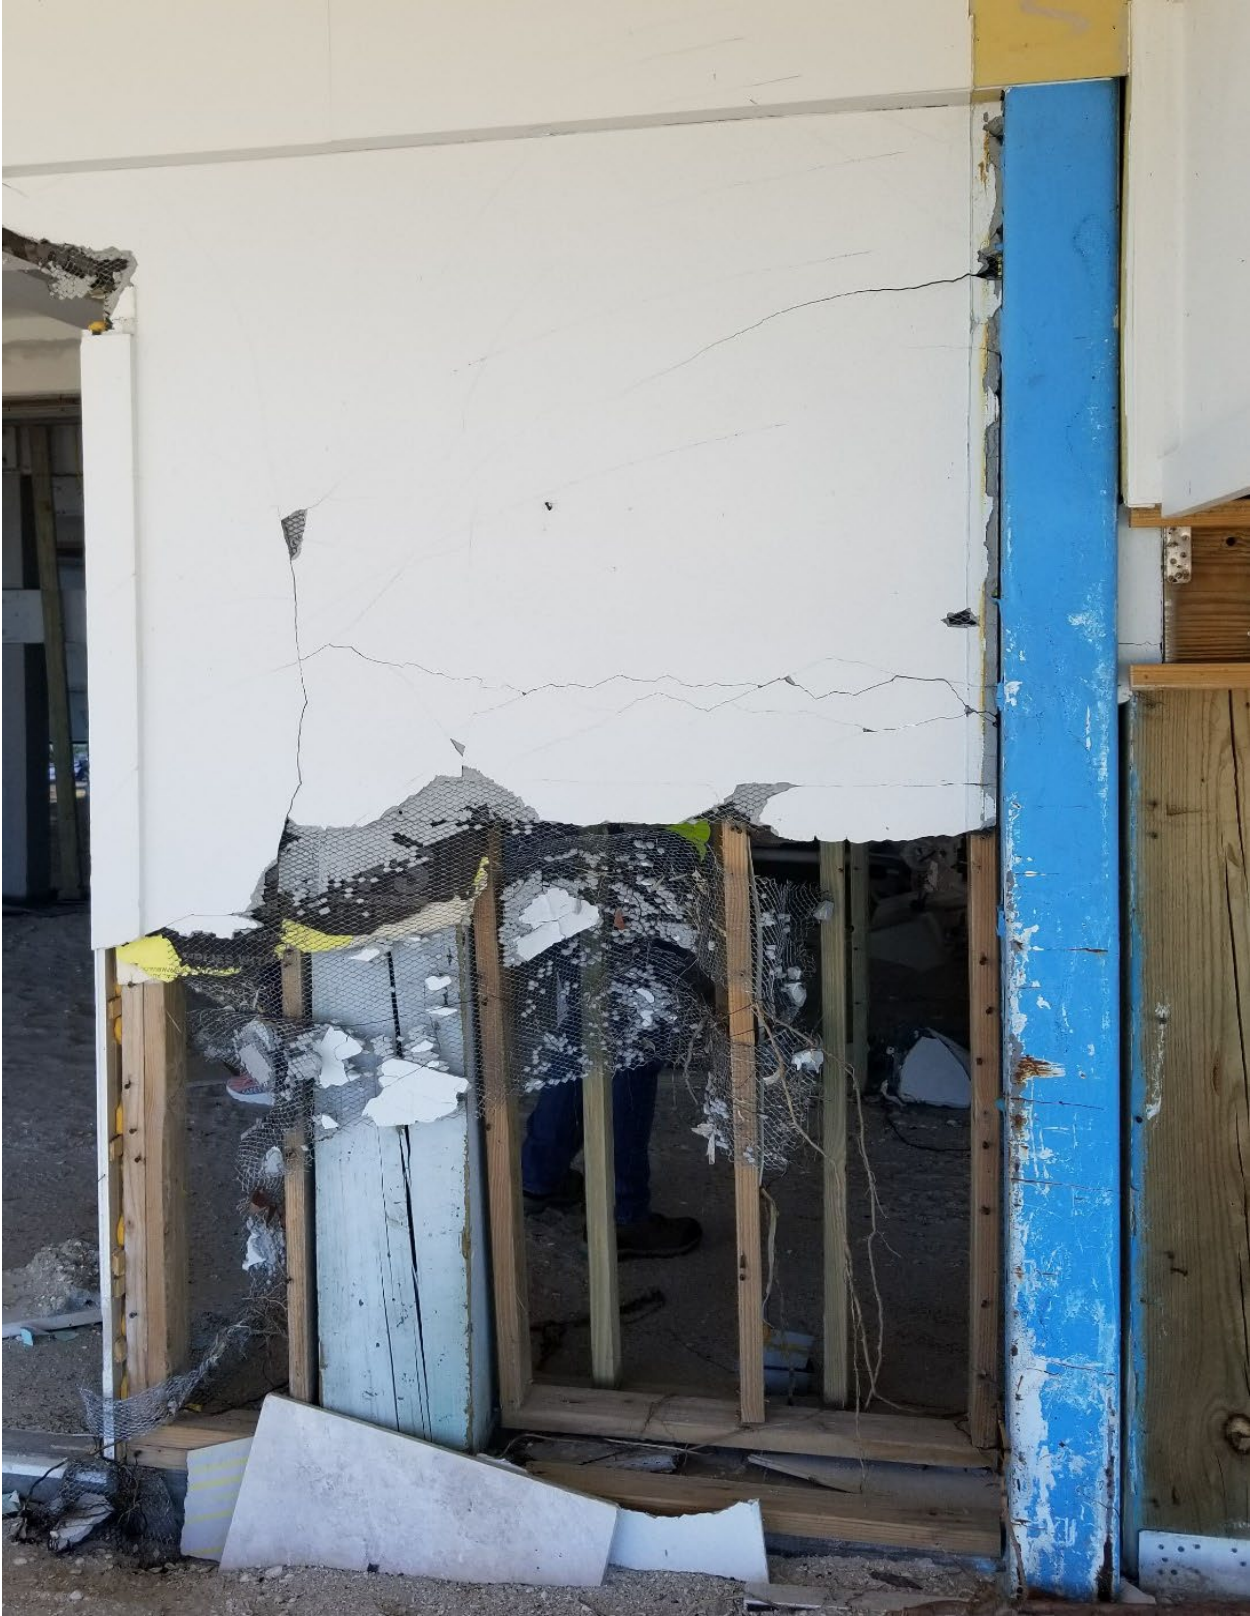
A structure (shown in Figure 3-14 and Figure 3-15) along the Gulf of Mexico coast on Sanibel Island built in 1987 with breakaway walls that partially failed was visited by the MAT. The enclosure was constructed with wood-framed breakaway walls finished with wall sheathing coated in lath and plaster (stucco). The structure is seaward of the CCCL. According to the Elevation Certificate, the top of the enclosure floor is 7.3 feet NAVD 88 and the bottom of the lowest horizontal structural member of the elevated floor is 12.0 feet NAVD 88. StEER recorded an HWM (surge only) of 15.4 feet NAVD 88 at the neighboring house. As shown in Figure 3-14, one of the Gulf front shore-parallel breakaway walls did not completely breakaway; the bottom 2x4 plate separated from the bottom permanent 2x4 nailer plate, but the top 2x4 plate did not separate from the top permanent 2x4 nailer plate. The wall appears to be properly framed to enable separation and failed in a typical manner in which the bottom plate disconnected and the wall swung from the top. The exterior finish of stucco and netting was continuous across a support column, which can prevent proper breakaway performance, but did not hinder performance in this instance. Figure 3-15 depicts shore-perpendicular breakaway walls for which the wood-framing remained in place. These breakaway walls also appear to be properly framed to enable separation, but the exterior finish of stucco and netting appears continuous across support columns. The shore-perpendicular breakaway wall wood framing remained in-place. This may have been a result of the interior and exterior finishes breaking away below the design load and, therefore, reducing the overall load on the wood frame. No structural damage was observed as a result of the partial failure of the breakaway walls.

Figure 3-14: Partial failure of shore-parallel breakaway wall on Sanibel Island (Lee County, Zone VE, Seaward of CCCL)

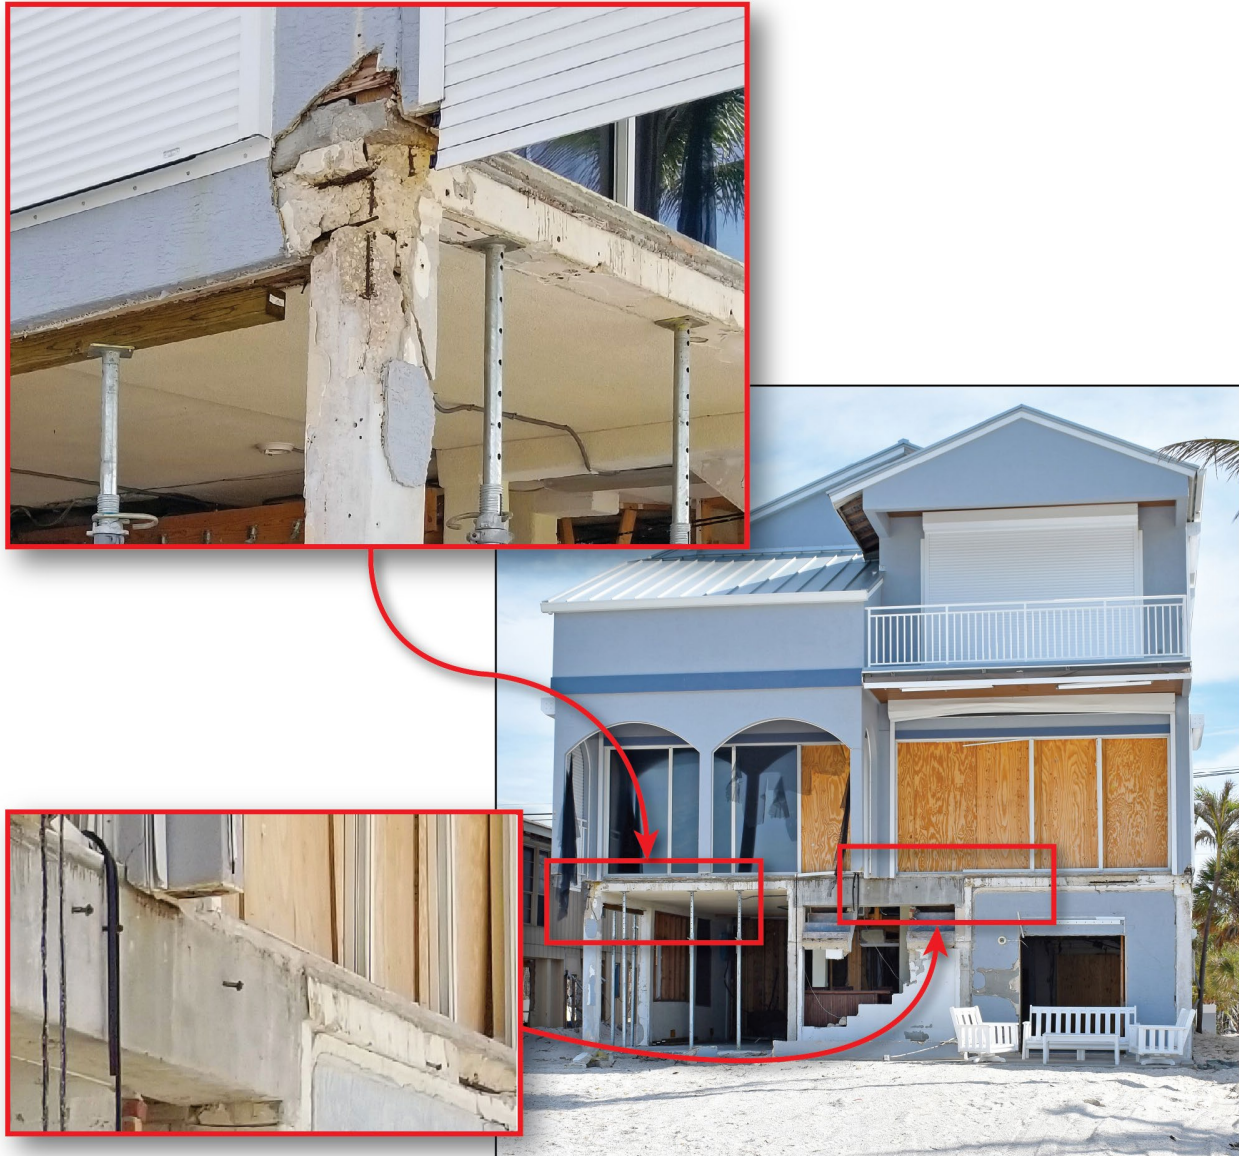
In some instances, the failure of attached structures resulted in significant damage to the main structure. Figure 3-17 depicts a beachfront residence in Zone VE, seaward of the CCCL, in Bonita Springs, that experienced the loss of an elevated porch. The porch was likely anchored to the main structure, as indicated by the remaining anchors, which are depicted at the bottom right in Figure 3-17. The residence's main structure also exhibited structural damage as observed through a visual assessment of the corner column and the presence of temporary support (lally) columns. The separation of the elevated porch may have contributed to the corner column damage. Signs of possible pre-existing corrosion of reinforcing steel within the concrete framing, were also observed on the damaged corner column.

Bottom right: Post-event photo from January 2023. Top left: Corner column damage. Bottom left: Remaining anchors in the main structure.

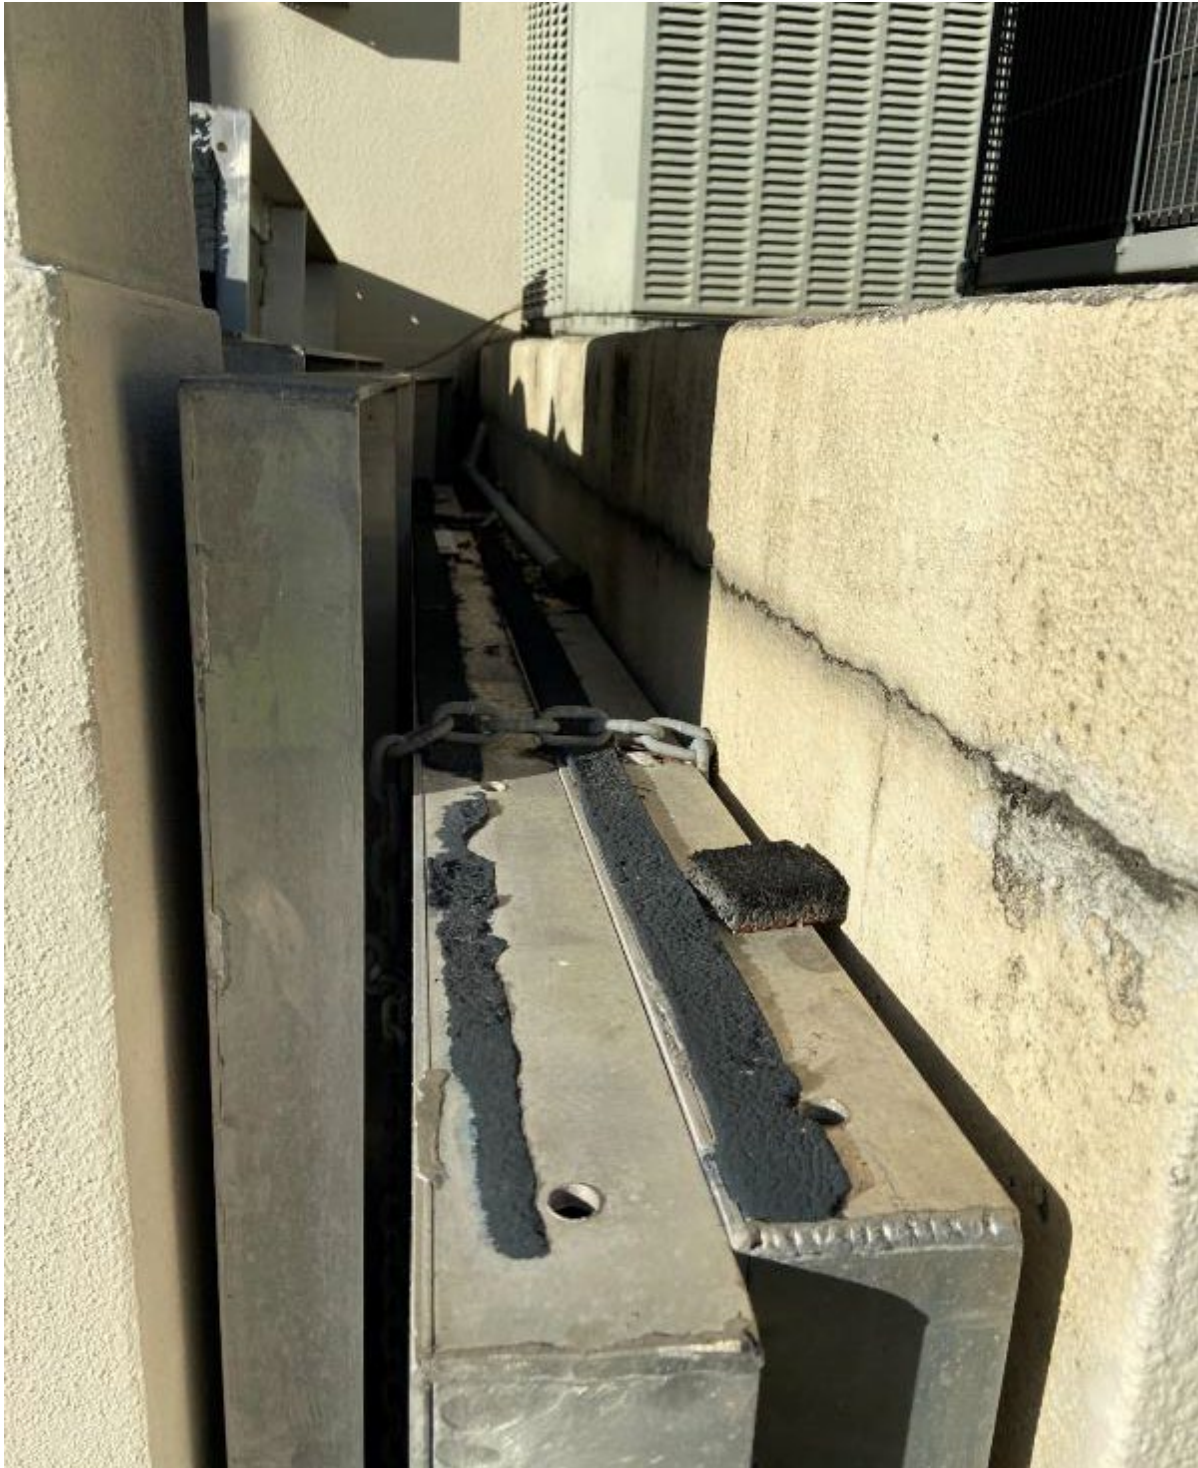
Figure 3-71: Opening barriers for an office building that were not deployed (Collier County, Zone AE)

These opening barriers did not appear to have been moved from this onsite storage location for several months/years. The seals on these barriers were worn and corroded as well.

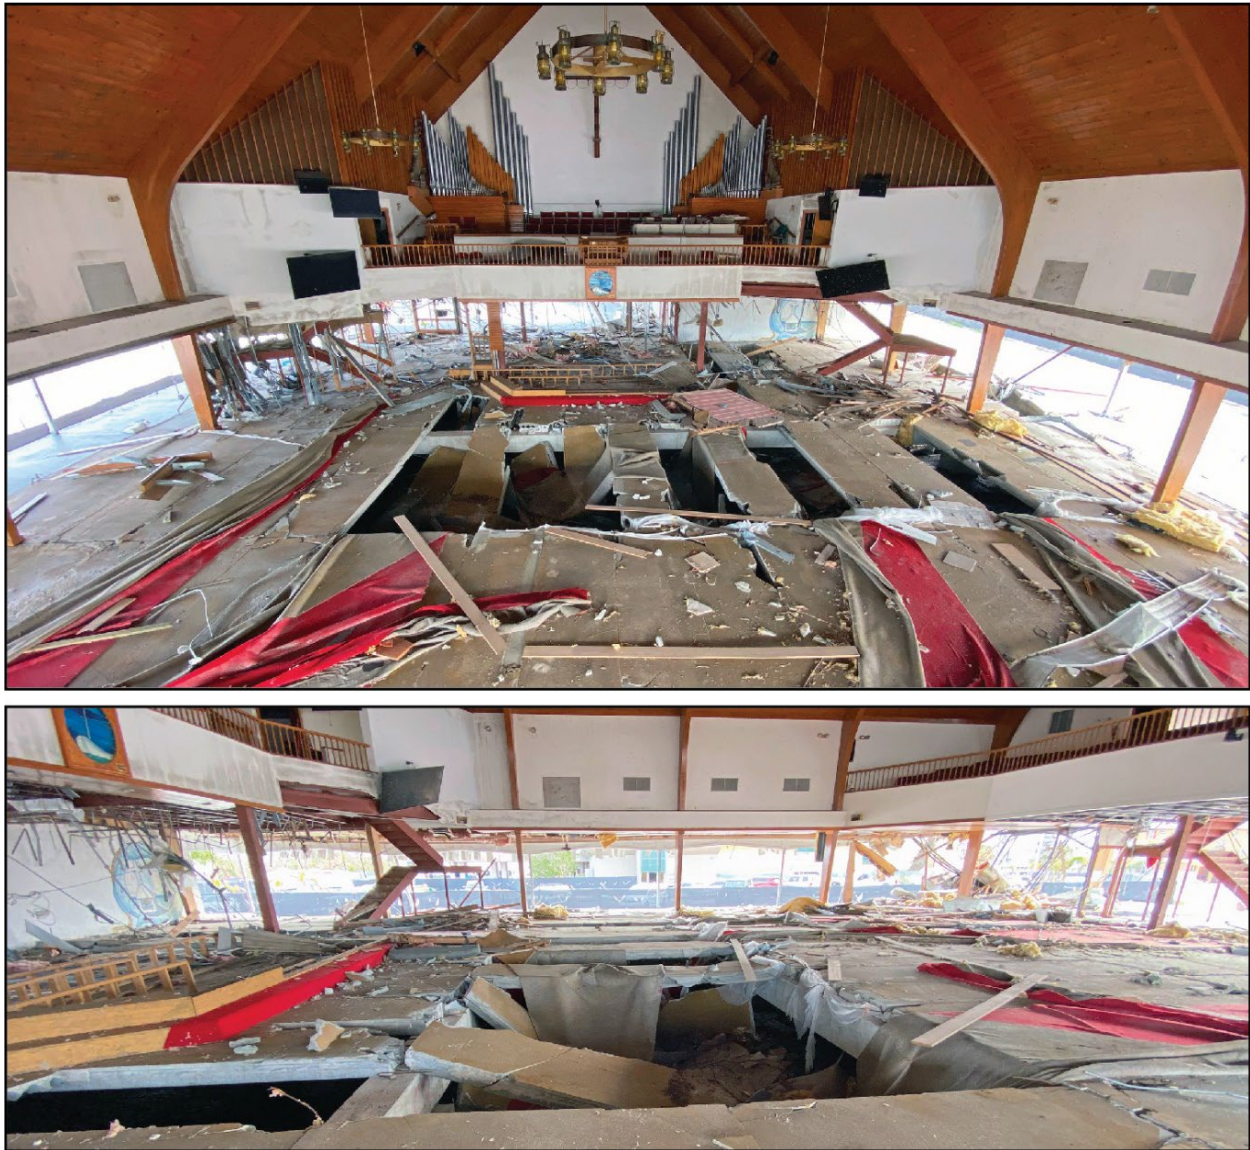
An inspection of the Chapel by the Sea's foundation in 2010 noted that structural support elements had deteriorated due to salt air and saltwater exposure. After the inspection, the foundation was structurally repaired and included the addition of waterproof paint. The foundation was re-inspected 1 month before Hurricane Ian, and the repairs were deemed successful and structurally sound. During Hurricane Ian, floodwater moved through and around the building, causing extensive damage and depositing widespread piles of debris around the church. Figure 3-98 shows the extent of debris in the area. The building also experienced wind damage, which led to additional water intrusion.

Figure 3-100: Damaged precast concrete floor panels at Chapel by the Sea

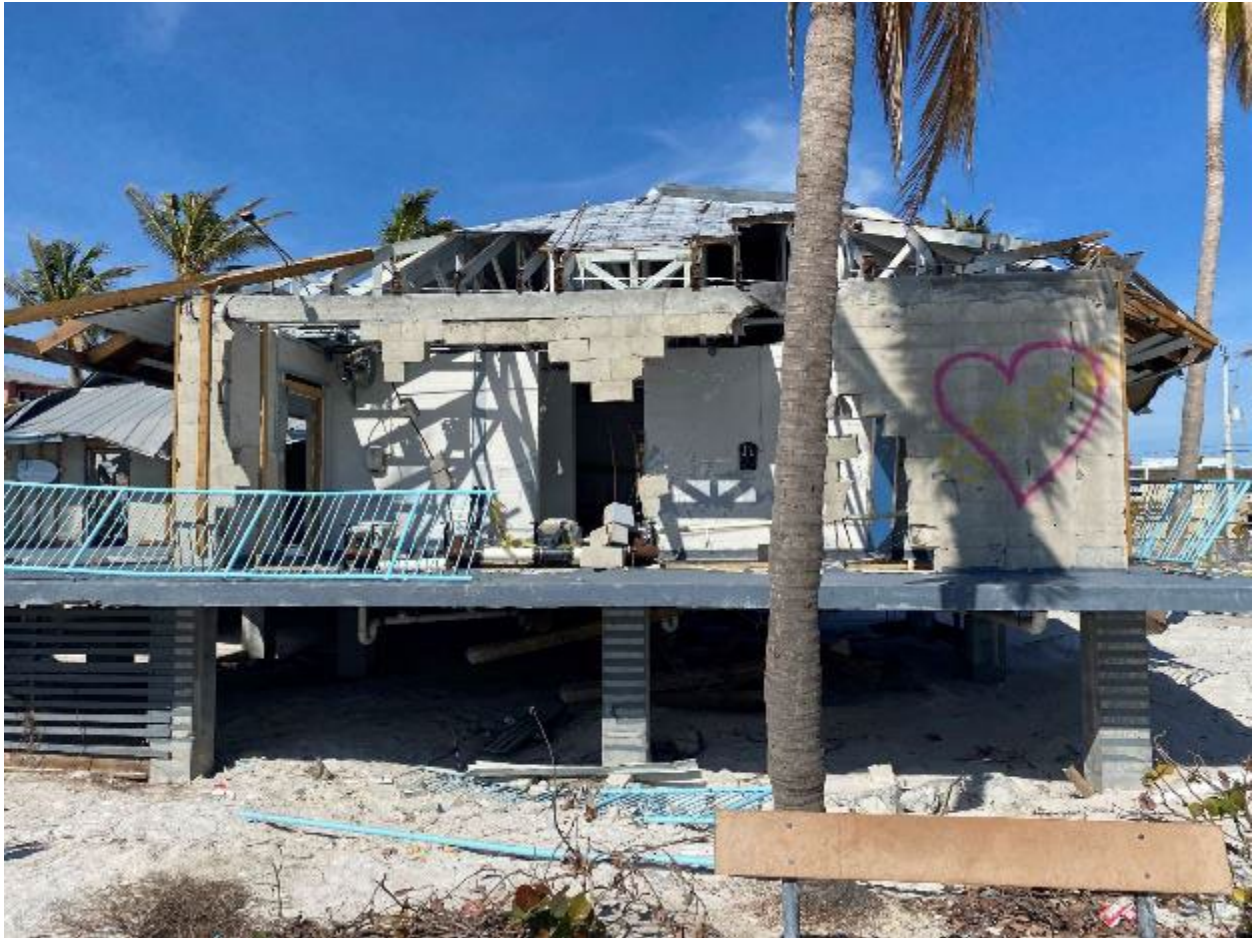
Figure 3-106: Elevated restrooms at the north end of Fort Myers Beach in the Bowditch Point Park (Lee County, Zone VE, Seaward of CCCL)

The building likely had 8 feet or more of flooding over the lowest floor, which contributed to extensive structural damage.

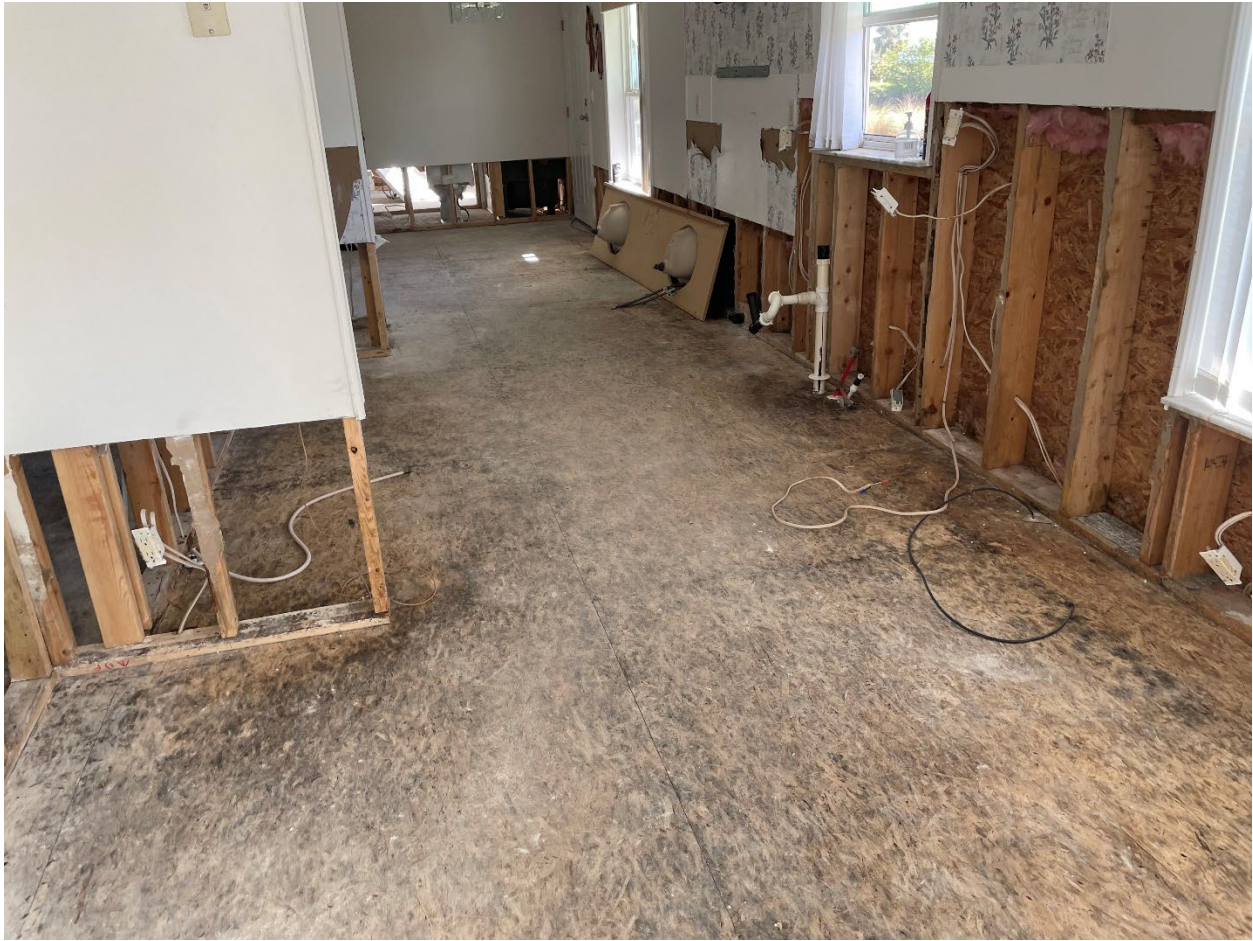
Figure 3-115: Common manufactured home interior finishing damage observed in Old Bridge Village (Lee County, Zone AE)

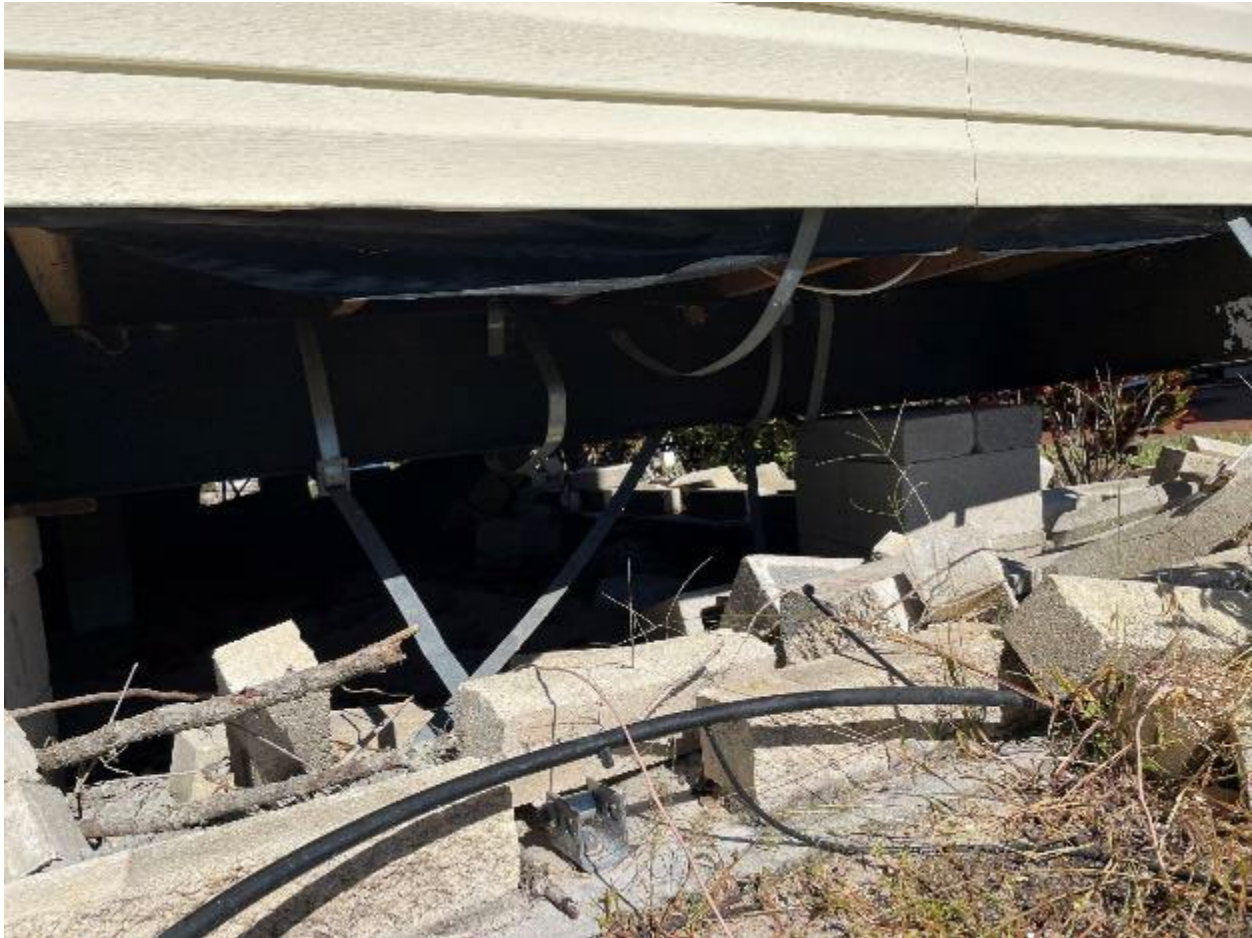
Figure 3-117: Damaged tie downs, unreinforced masonry piers, and skirting below a manufactured home in Old Bridge Village (Lee County, Zone AE)

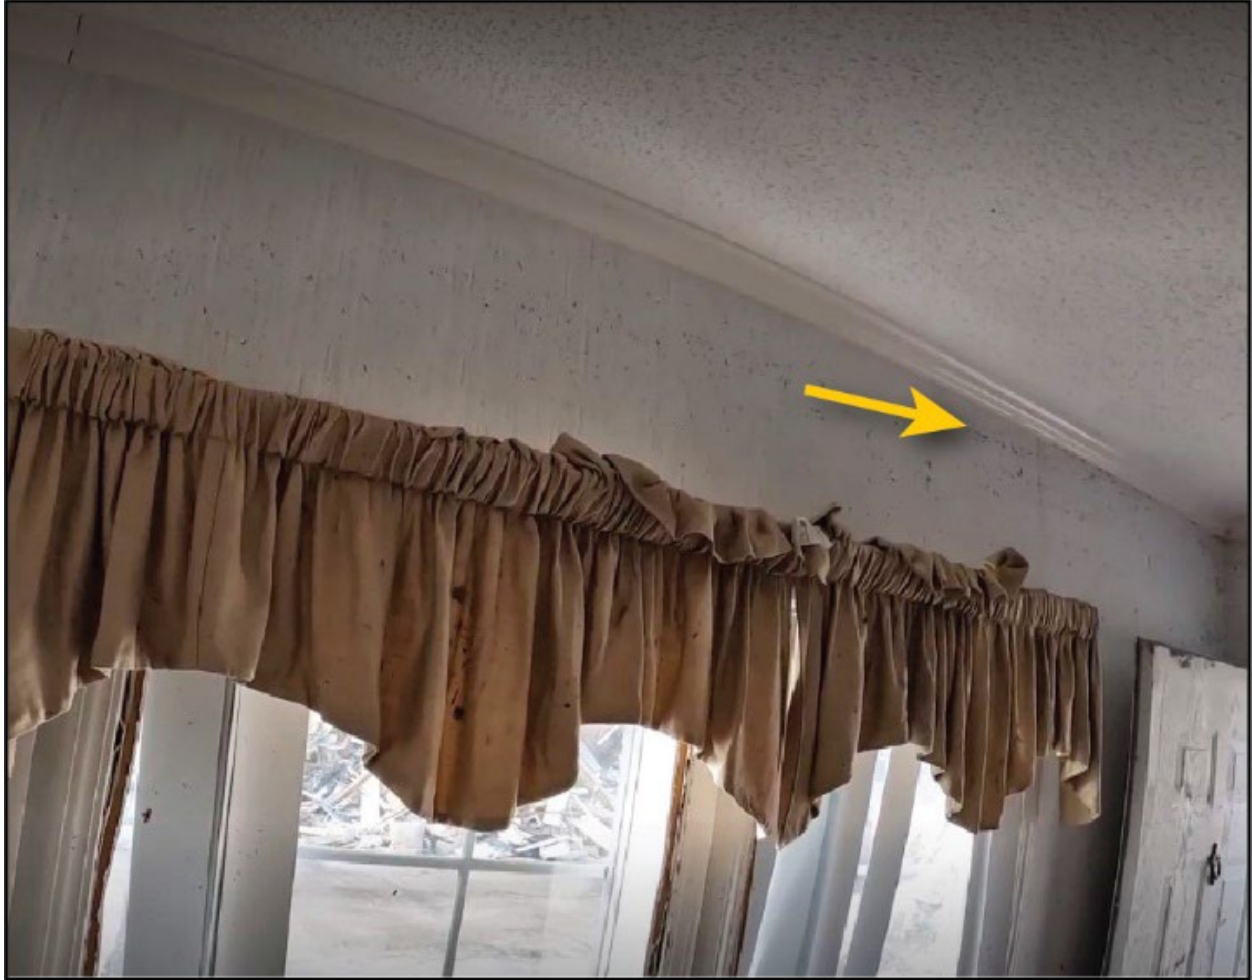
Figure 3-125: HWM near ceiling in Port Carlos Cove manufactured home (Lee County, Zone VE)

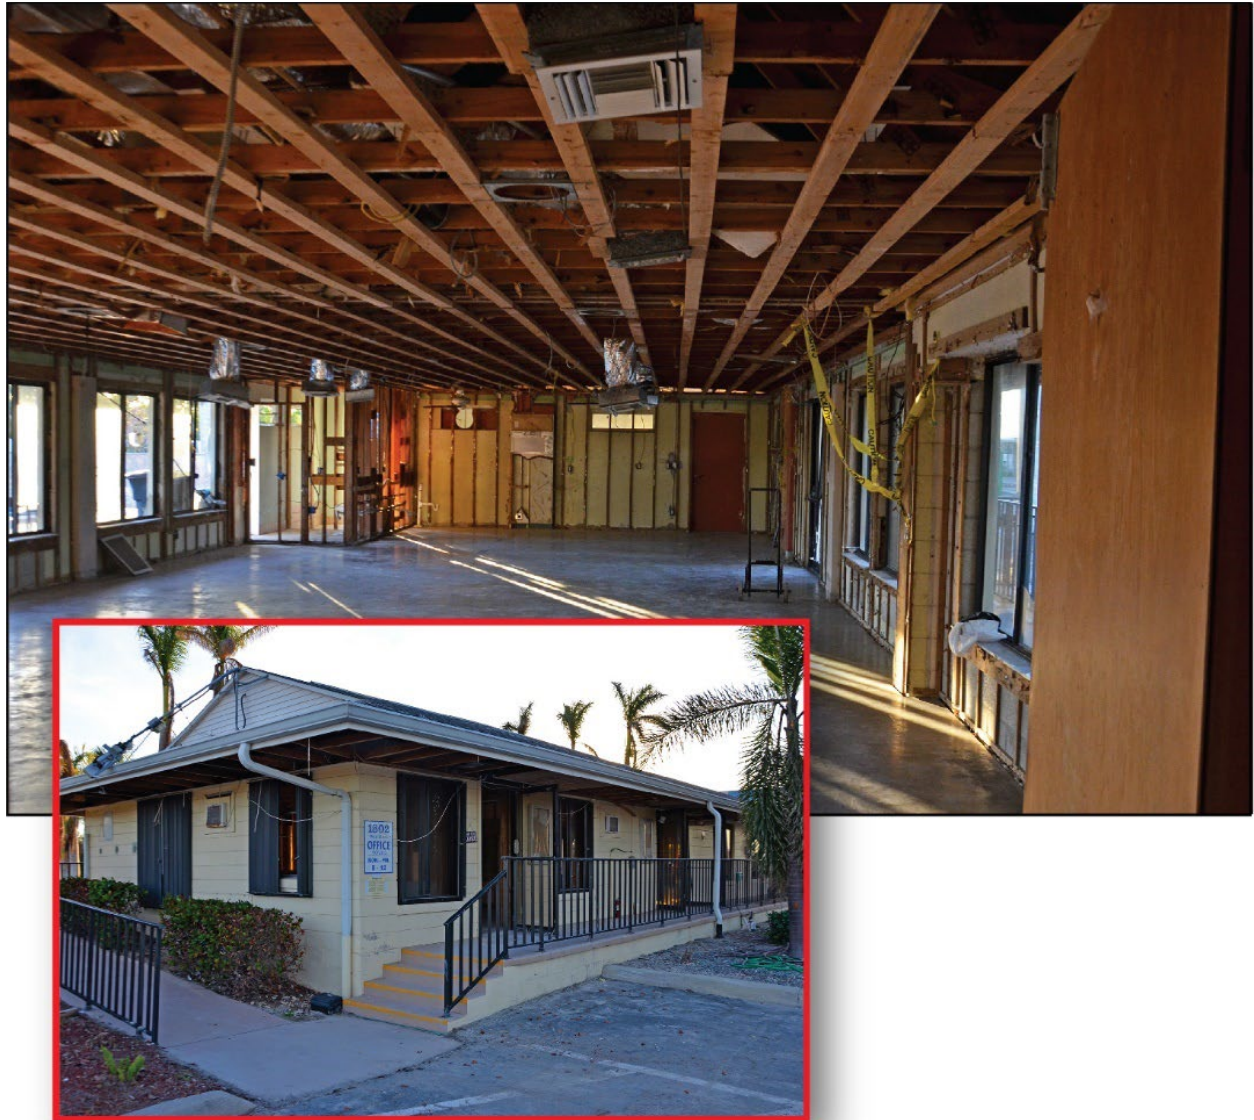
Figure 3-126: Representative interior damage in the office building for Port Carlos Cove (Lee County, Zone VE)

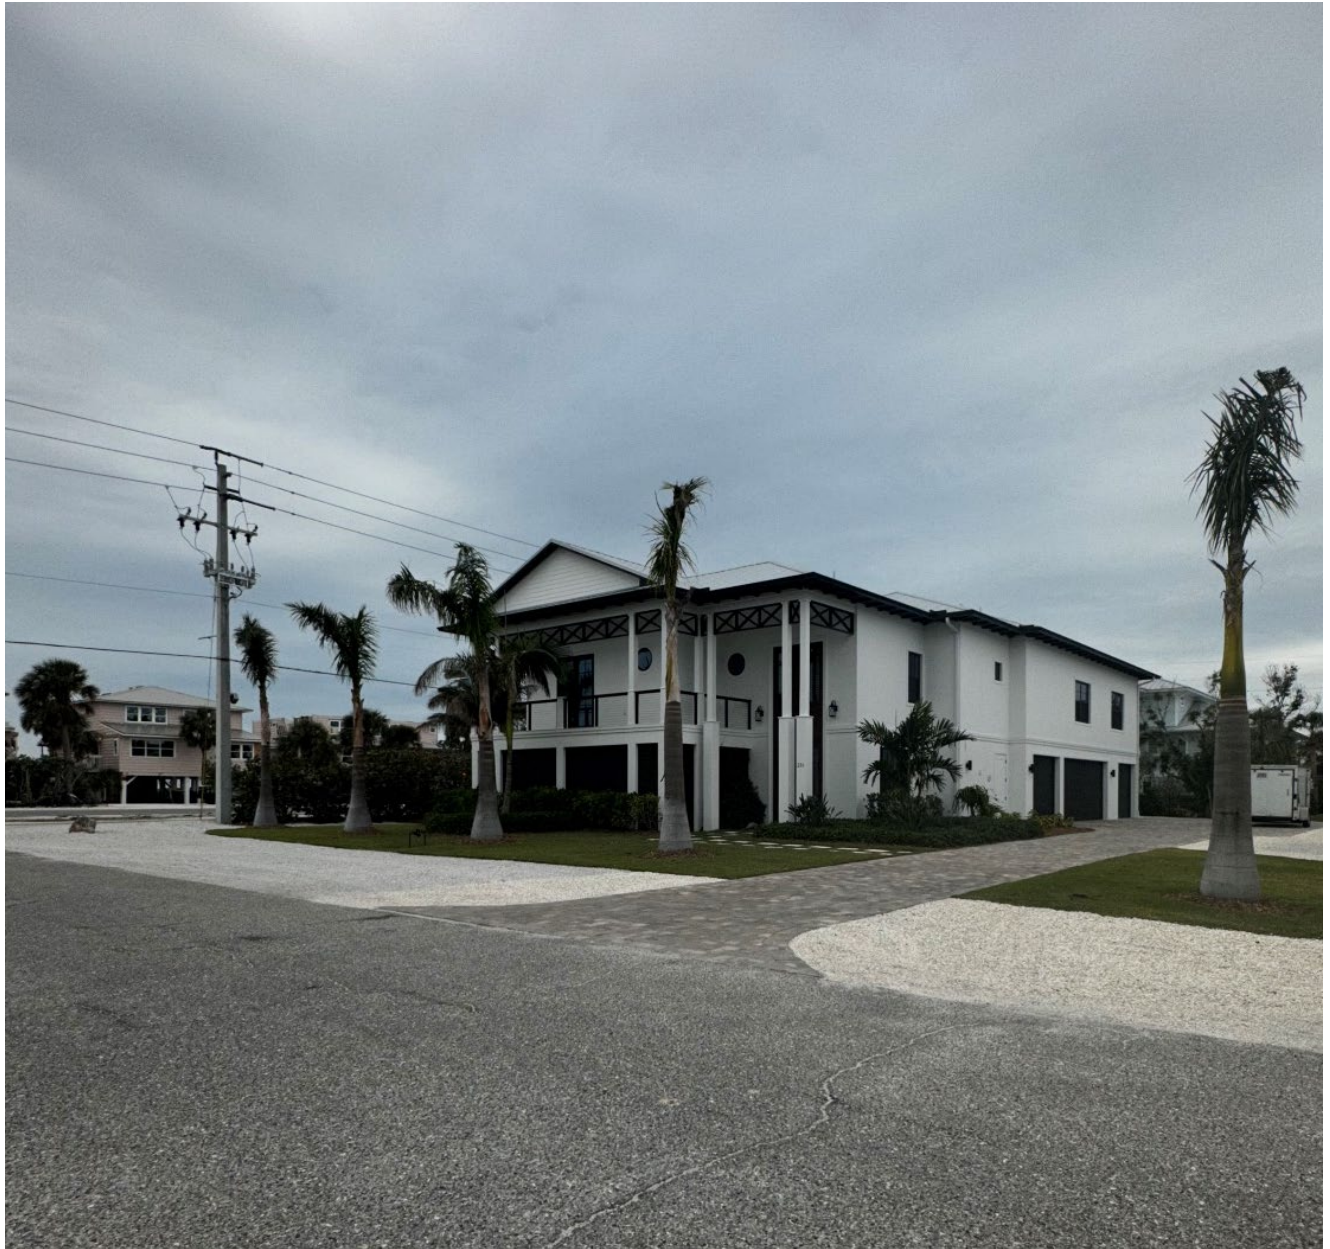
Figure 4-49: A house built in 2022 that had no visible signs of damage (EWS = 130 mph; DWS = 150 mph) (Boca Grande)

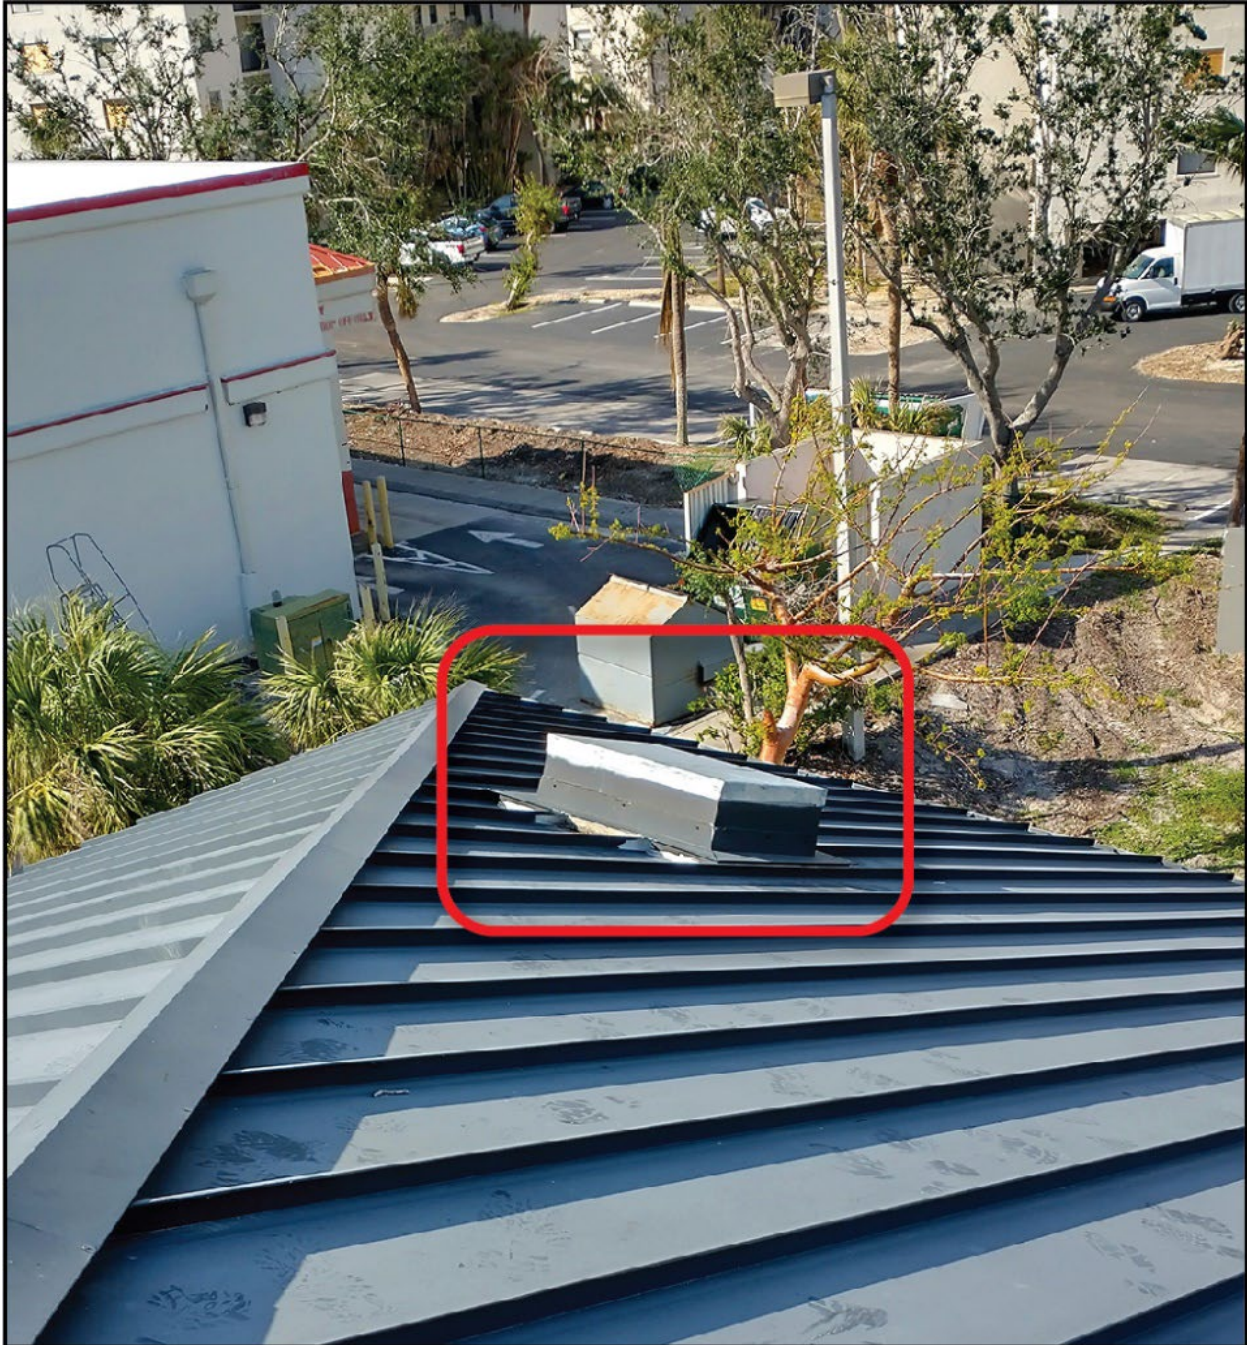
Figure 5-57: Roof-mounted exhaust fan lost during Hurricane Ian (Lee County)

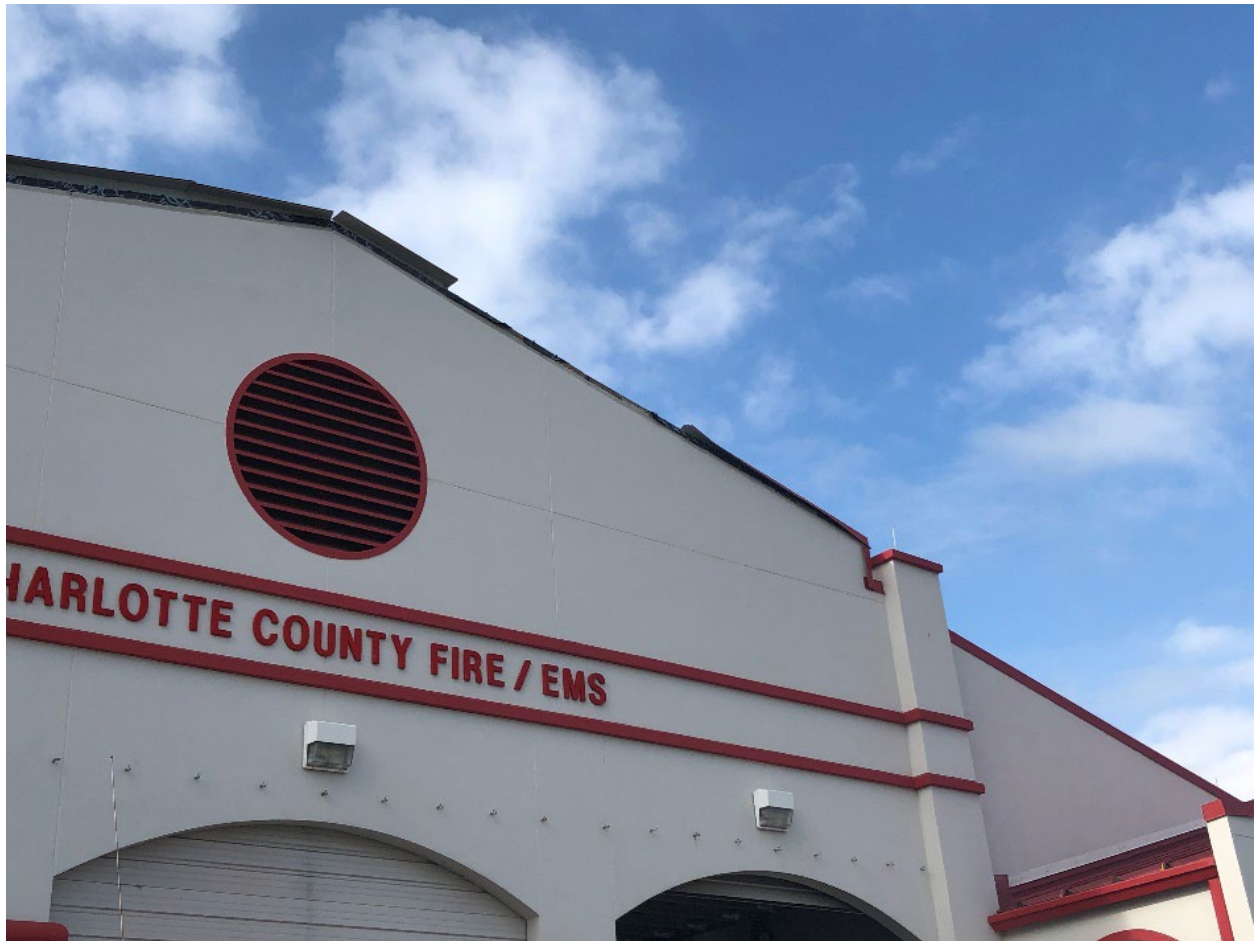
Figure 5-68: Damaged coping above the apparatus bays (Charlotte County)

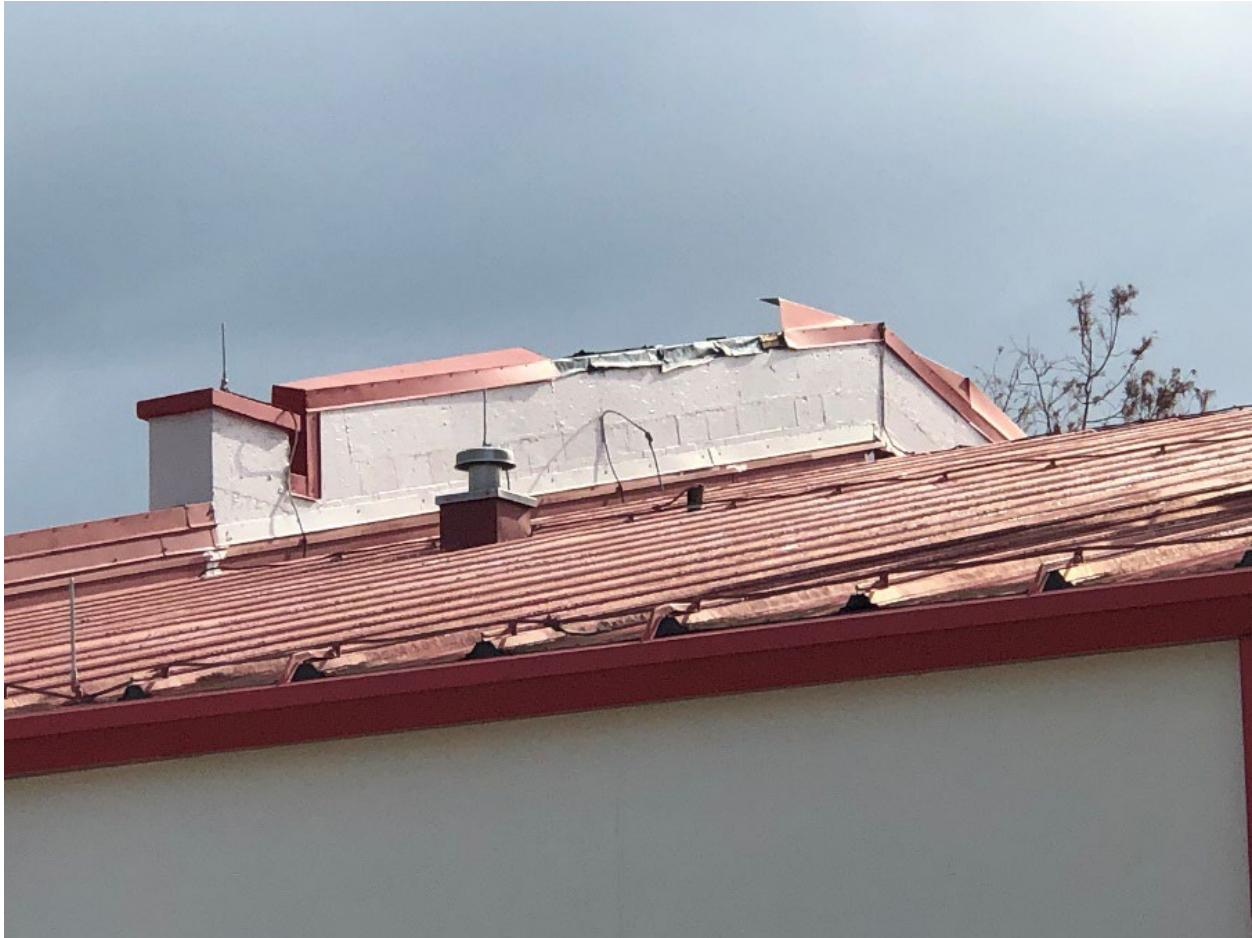
Figure 5-69: Damaged coping above the apparatus bays (Charlotte County)
