**Presentation 12:  
Vegetated Earth Spillways — Inspection,  
Maintenance, and Monitoring**

# Vegetated Earth Spillways Inspection – Maintenance & Monitoring

Denver, CO  
August 26-27, 2003

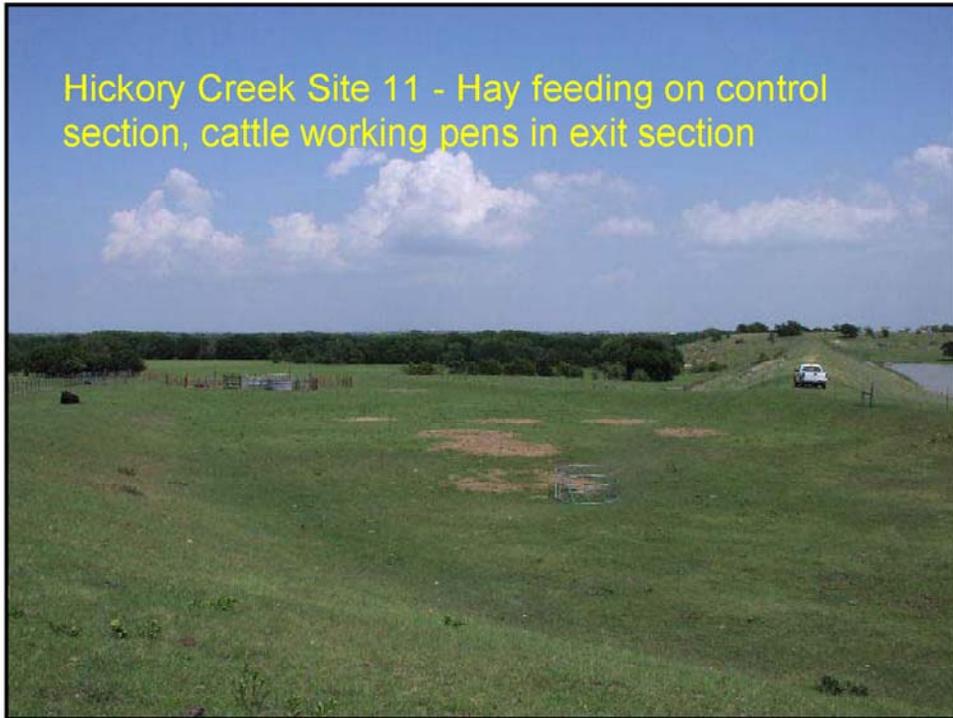
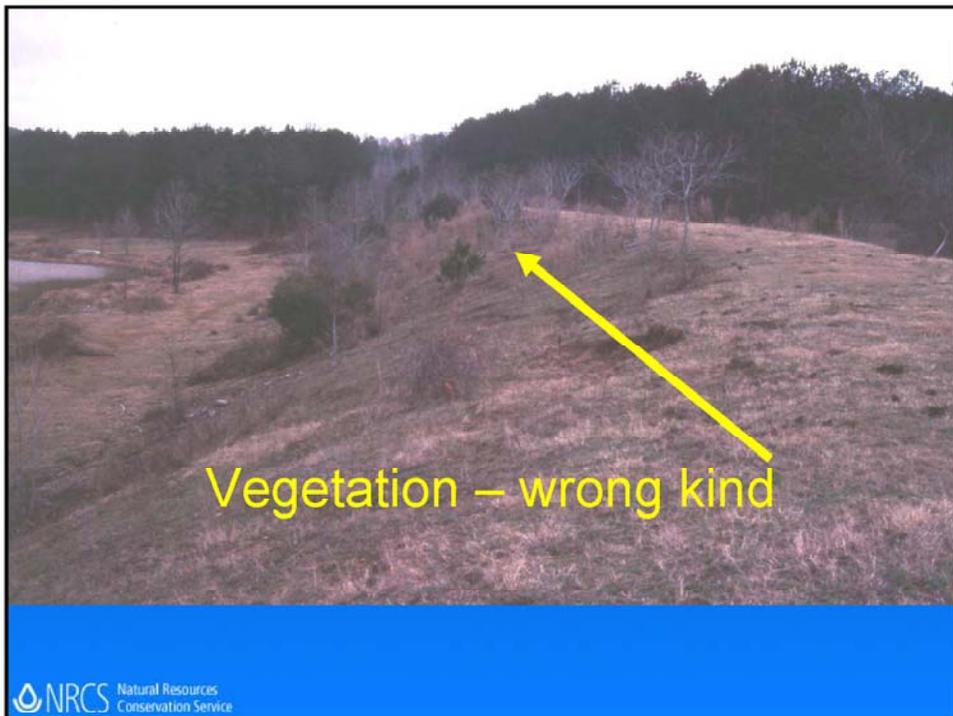
Hickory Creek Site 11 - Hay feeding on control section, cattle working pens in exit section

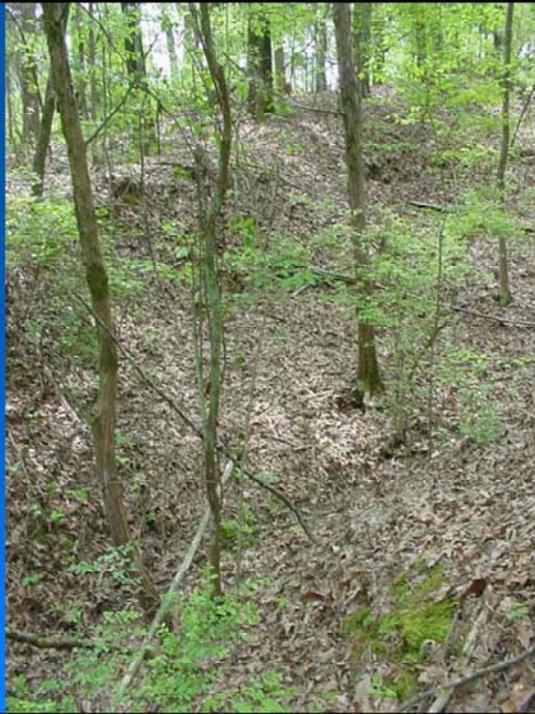
Vegetation –  
when was the  
last time the  
spillway was  
mowed?

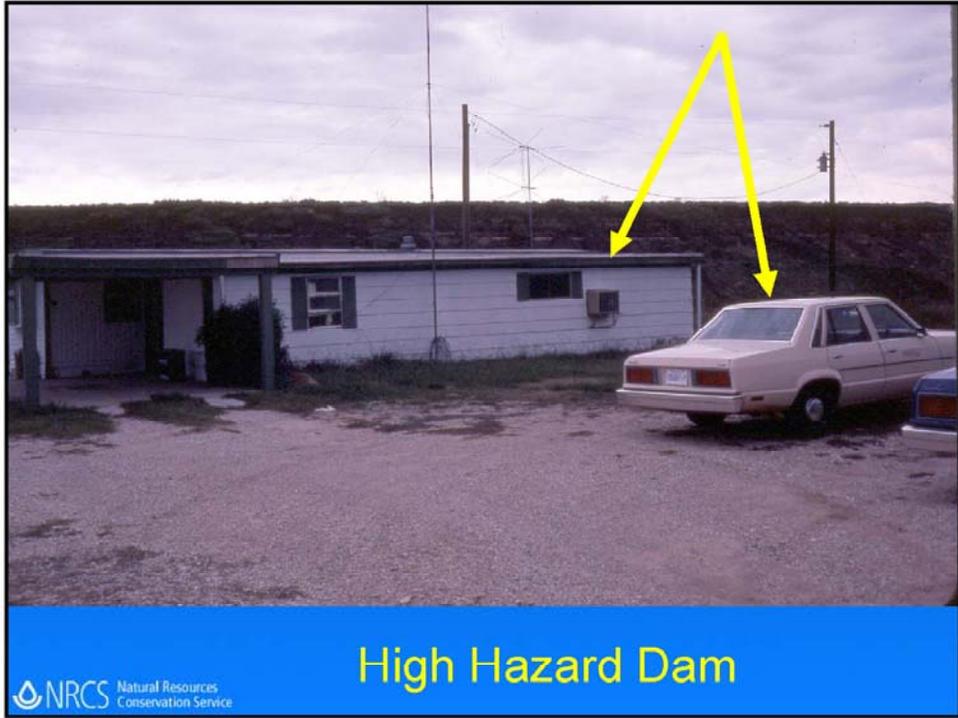
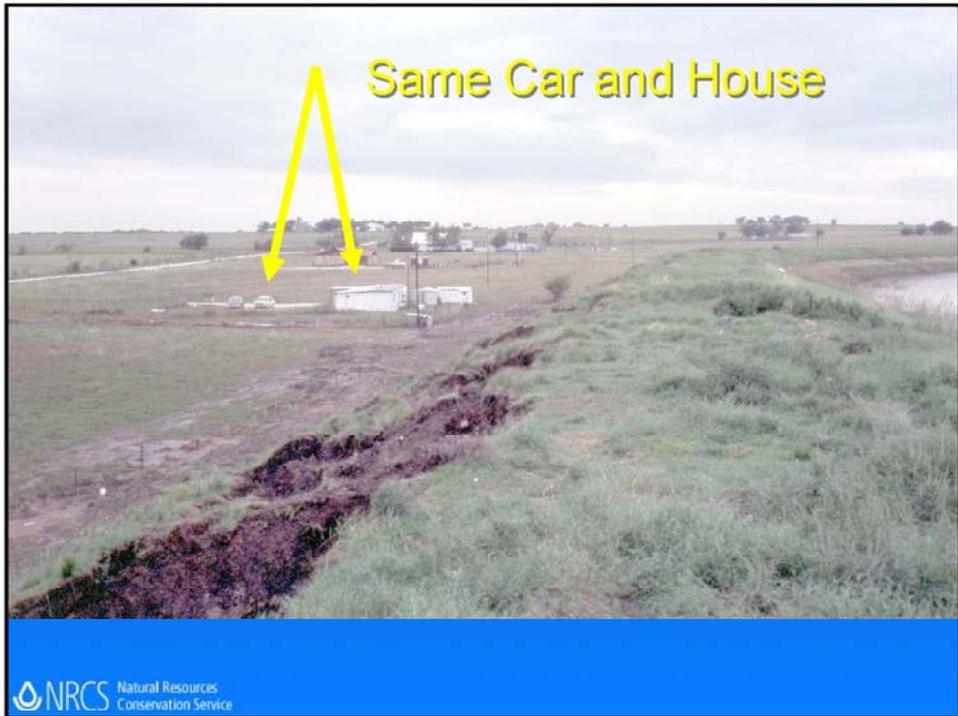
Dam overtopped about  
0.5' and the spillway had  
about a 5.2' Hp on it.

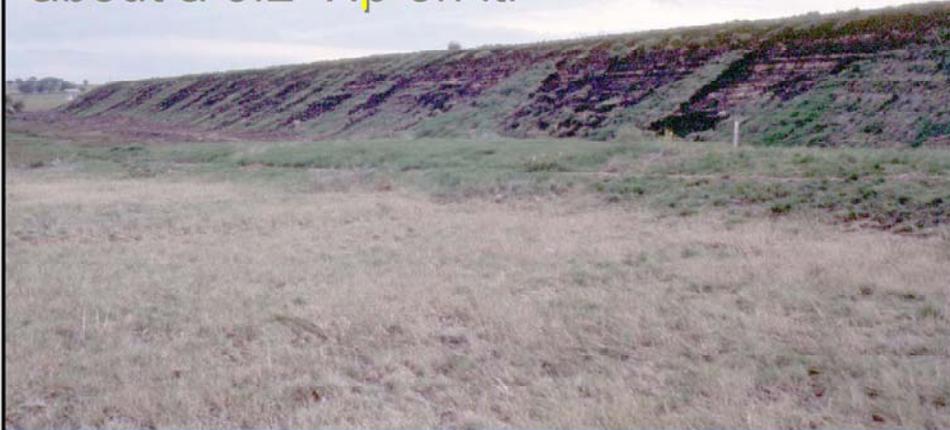
5.2' Hp on crest of this spillway  
– little or no damage

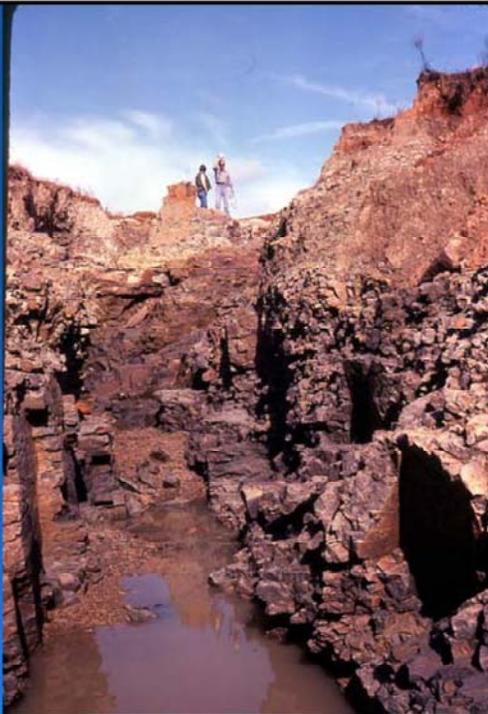
Headcut  
erosion  
from  
flow  
event.
