Prattsville Fire District
Facility Relocation Project

Appendix C
Phase I
Environmental Site Assessment (ESA)

Phase I Environmental Site Assessment

Tax Map No. 74.10-2-20 & 74.14-2-2
Prattsville Fire District Replacement Project
Main Street, Prattsville, NY

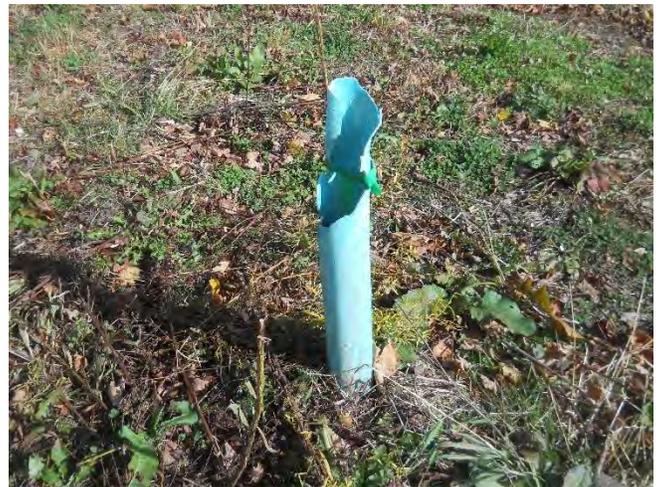
5

The Subject Site consists of approximately 3.33 acres of undeveloped property (see attached photo 23). No evidence of onsite buildings, structures, foundations or old ruins were identified during the site inspection. The Cangelosi property was last occupied August 28, 2011 prior to Hurricane Irene. The house was severely damaged and was demolished. The only remnant from the house that was observed appears to be a pvc pipe for a downspout (see attached photo 5). In Appendix A, Site Aerial Tax Map shows the property boundary.

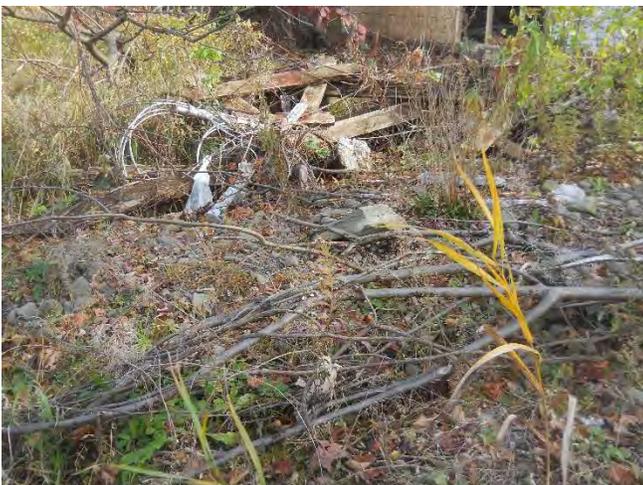
Asbestos inspection or investigation is beyond the scope of this Phase I ESA and was not conducted by KA. However, there was no construction debris from the demolition of the Cangelosi house observed that could have contained asbestos containing material (ACM). There was a small pile of debris that consisted of wood and steel cabling (see attached photos 15 & 18).

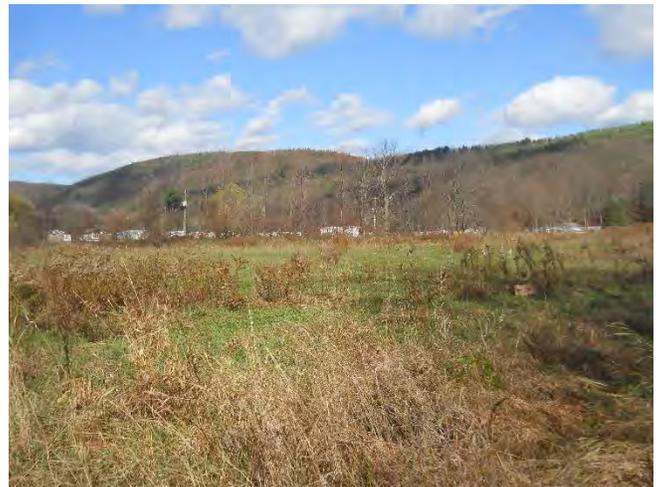
23

The Subject Site consists of 3.33 acres of unmowed field (see attached photo 23-25), with a steep wooded area to the east and rear of the property (see attached photos 43-45, 50-54). No areas of wet soils were observed onsite.

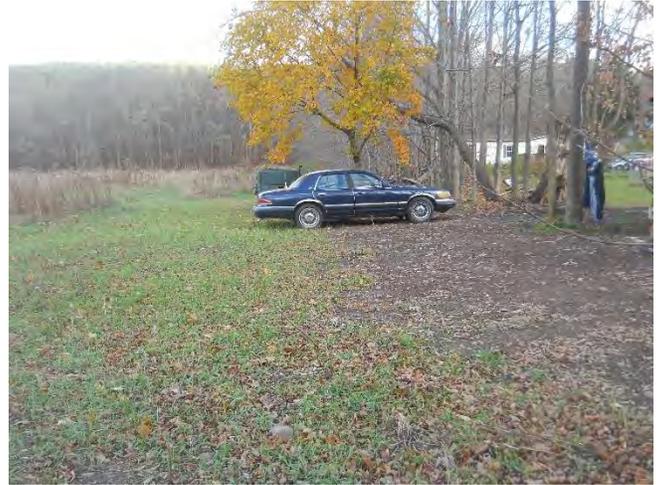
28

No heavy equipment and/or hydraulic equipment was observed during the site inspection except for what appeared to be a neighbors portable generator (see attached photo 29) and an automobile (see attached photo 28) that appeared to be parked over the property line of the neighboring property located along the south property line.
