Performance of Buildings and Nonstructural Components in the 2014 South Napa Earthquake

FEMA P-1024 / February 2015

APPLIED TECHNOLOGY COUNCIL
201 Redwood Shores Parkway, Suite 240
Redwood City, California 94065
<http://www.atcouncil.org/>

FEDERAL EMERGENCY MANAGEMENT AGENCY
Michael Mahoney, Project Officer
Washington, D.C.

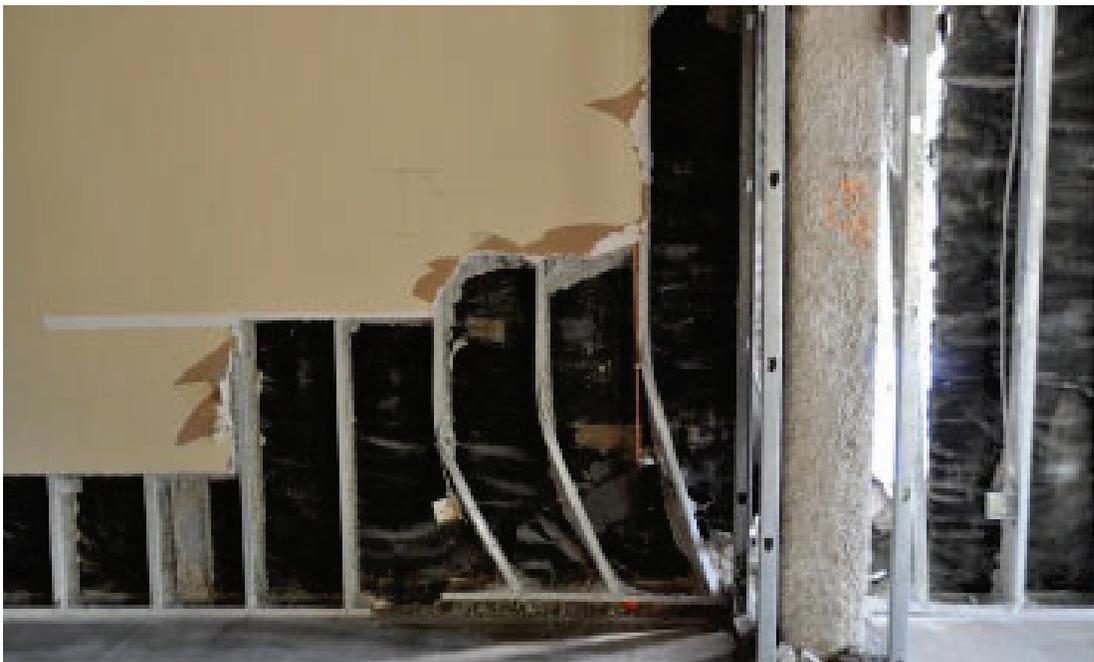
yielding mechanism. Consequently, the wall suffered several types of damage due to in-plane displacement, including failure of connections at the floors causing separation and bowing of the wall (Figure 4-10 and 4-11), distressed studs, and plaster and gypsum wallboard cracking (Figure 4-12). In addition, the following damage was reported and/or observed: (1) Some adhered cast-stone foam-backed veneer and stone veneer became dislodged (Figure 4-12); (2) a water heater at the second floor, which was reportedly strapped, became dislodged, broke a water pipe and caused water to flow into an electrical room below where metering equipment suffered water damage; and (3) the glass in an interior room partition was broken.

Figure 4-7 Damaged studs in exterior wall.

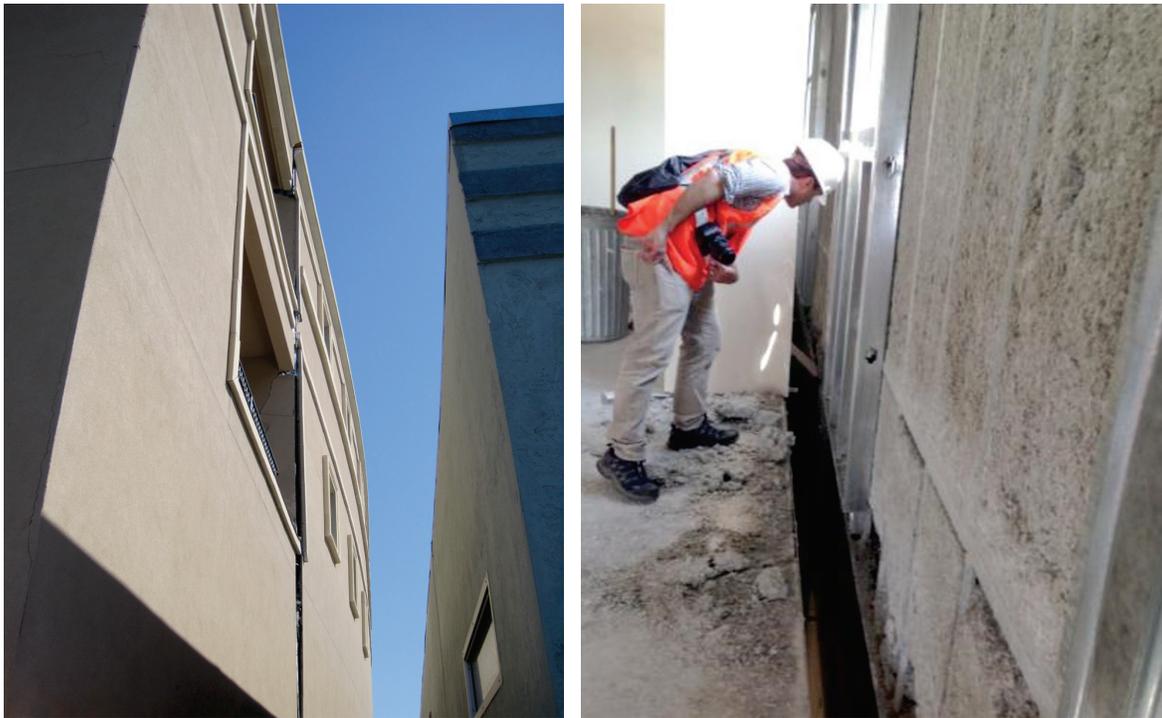
Figure 4-8 Bowed wall separated from floor (photo on right from Lauren Biscombe).

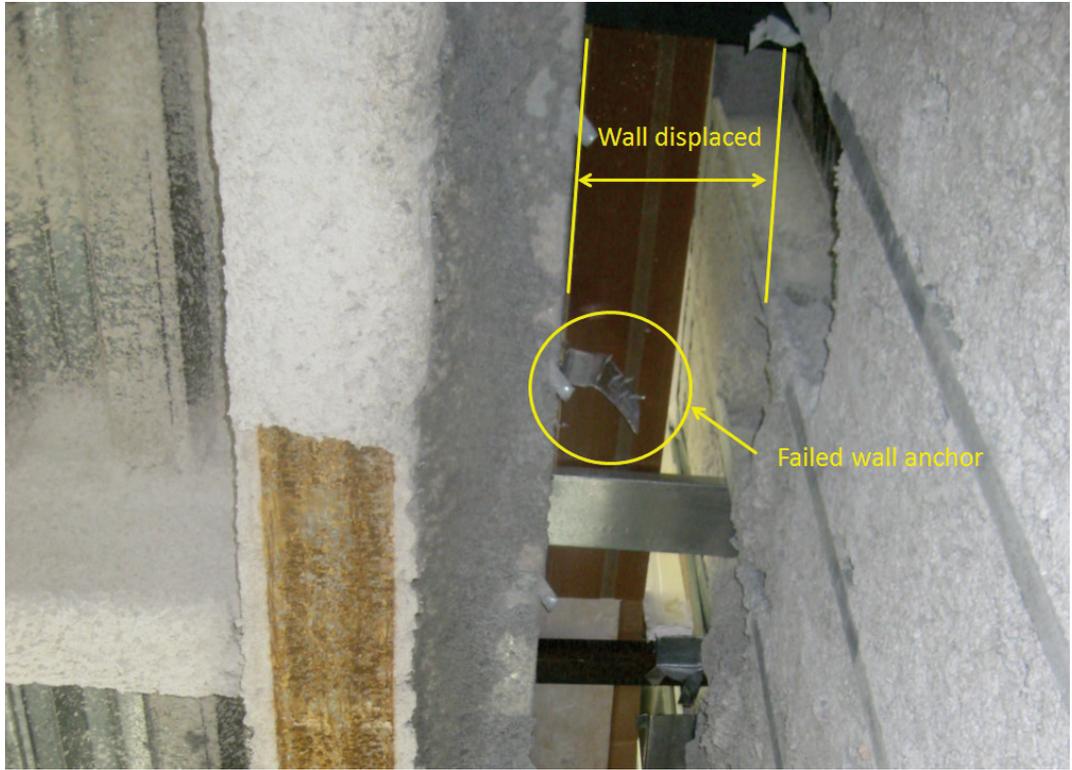
Figure 4-10 Failed wall anchor at bowed wall.

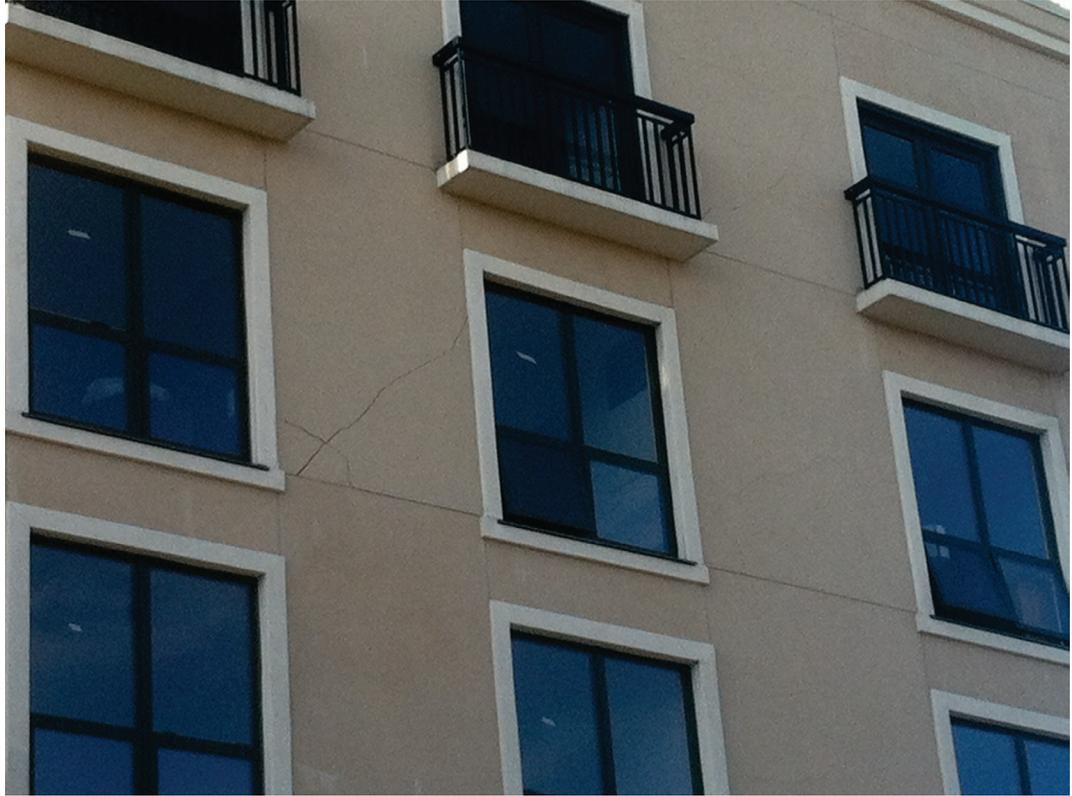
Figure 4-11 Exterior wall, cracked plaster.

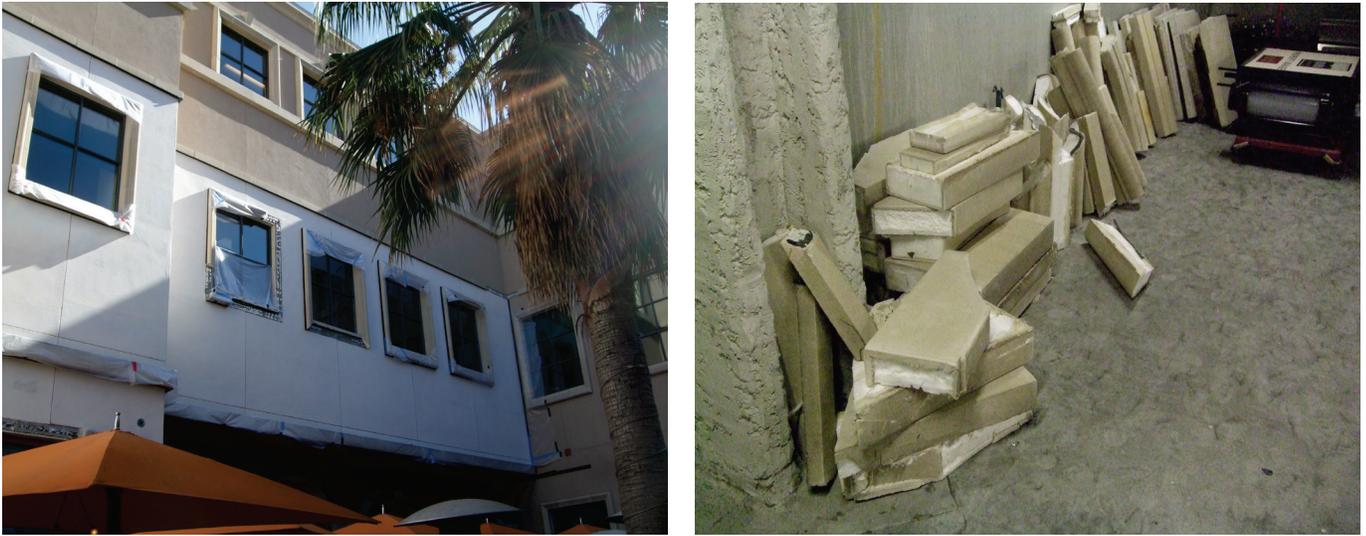
Figure 4-12 Dislodged adhered veneer.

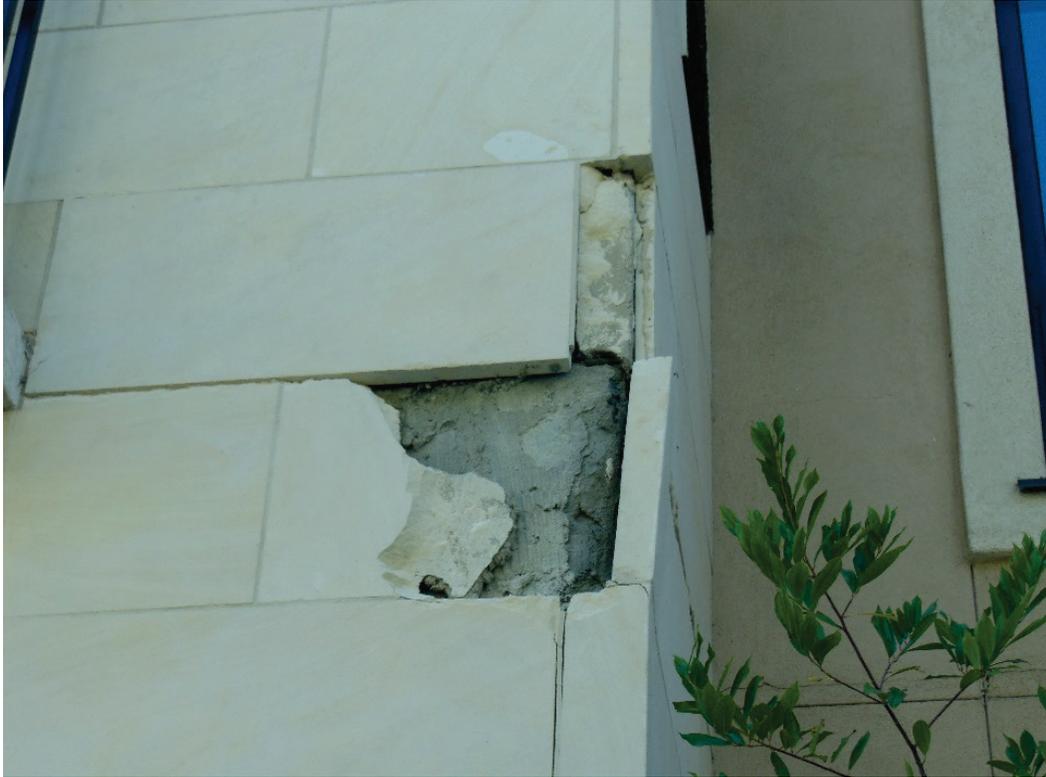
Figure 4-15 Adhered veneer damaged during the earthquake.

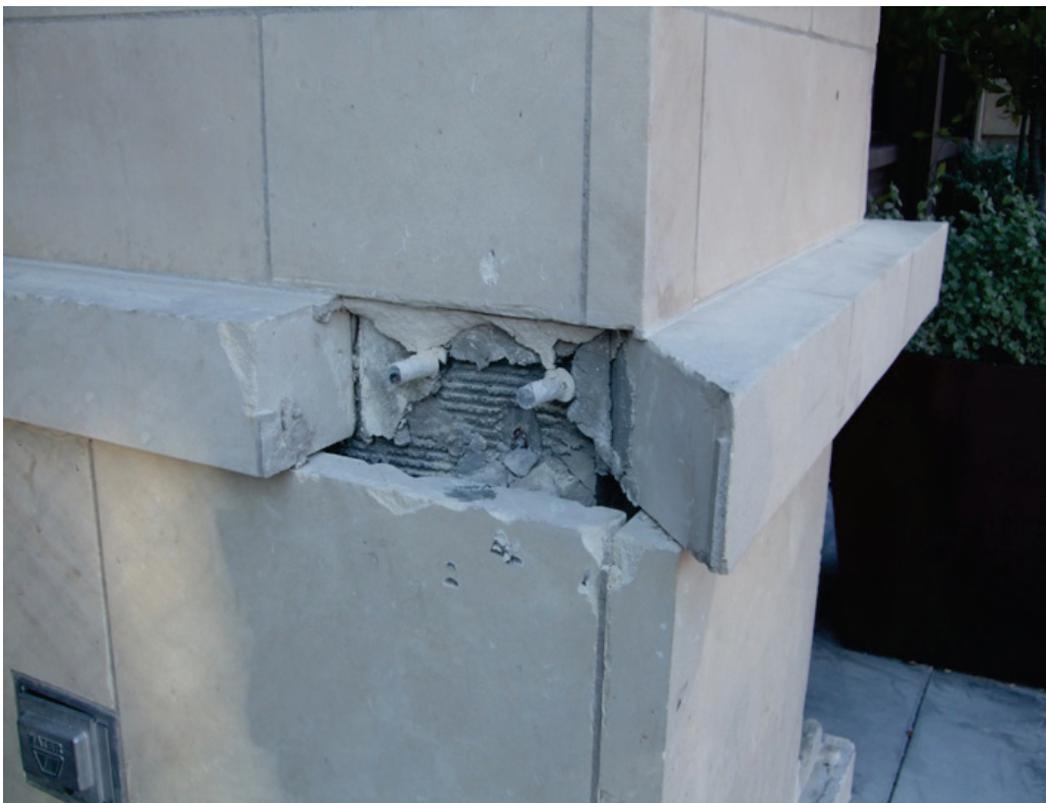
Figure 4-16 Photo showing failed anchored veneer.

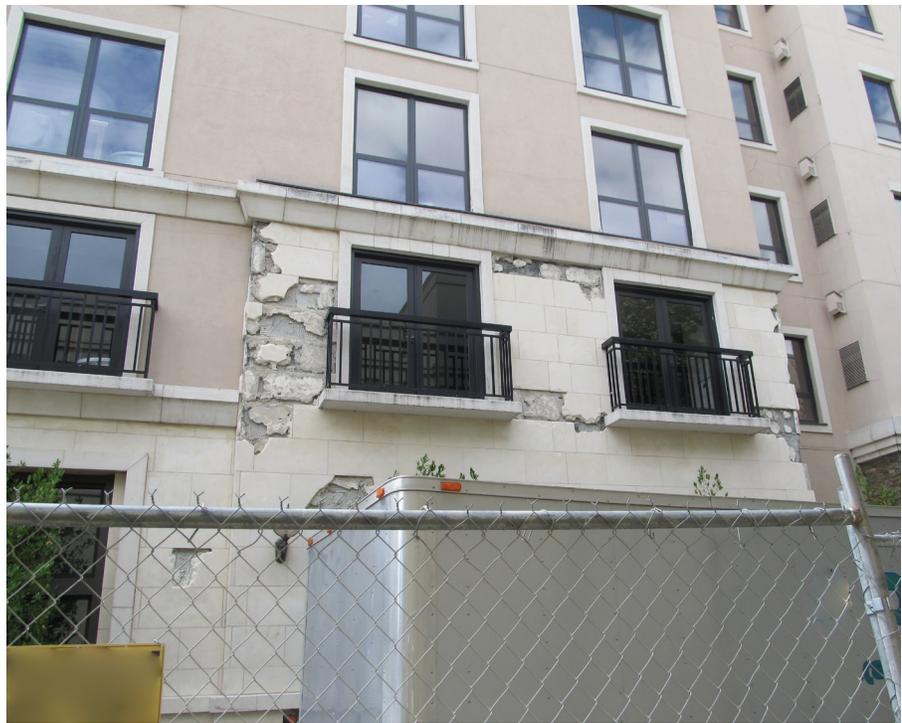
Figure 4-17 Stone masonry veneer, showing where loose units have been removed.

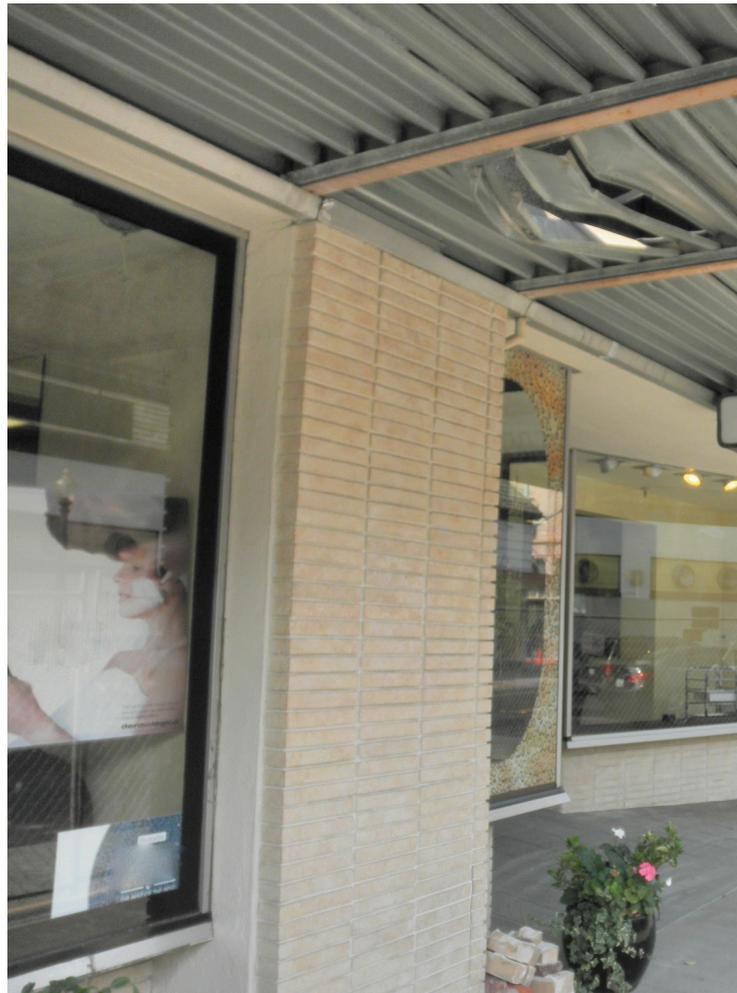
- **Nonstructural Performance:** A few bricks fell from the façade, penetrating the cold-formed steel canopy over the sidewalk (Figure 4-20). About 30% of the windows in the first floor storefront were damaged. Damage to lath and plaster wall finishes was widespread. There was minor damage to suspended ceilings in some areas (Figure 4-21). A support leg of a commercial convection oven failed (Figure 4-22). Unanchored and marginally anchored rooftop equipment displaced but did not fail. No damage to the fire sprinkler system was reported.
- **Time until Full Occupancy:** Portions of the building were inaccessible to the public following the earthquake due to fallen debris. At the time of the field investigation, some of the retail establishments on the ground floor were open. The use of the upper floor spaces was restricted due to nonstructural damage.

Figure 4-20 Damage to canopy due to falling brick.

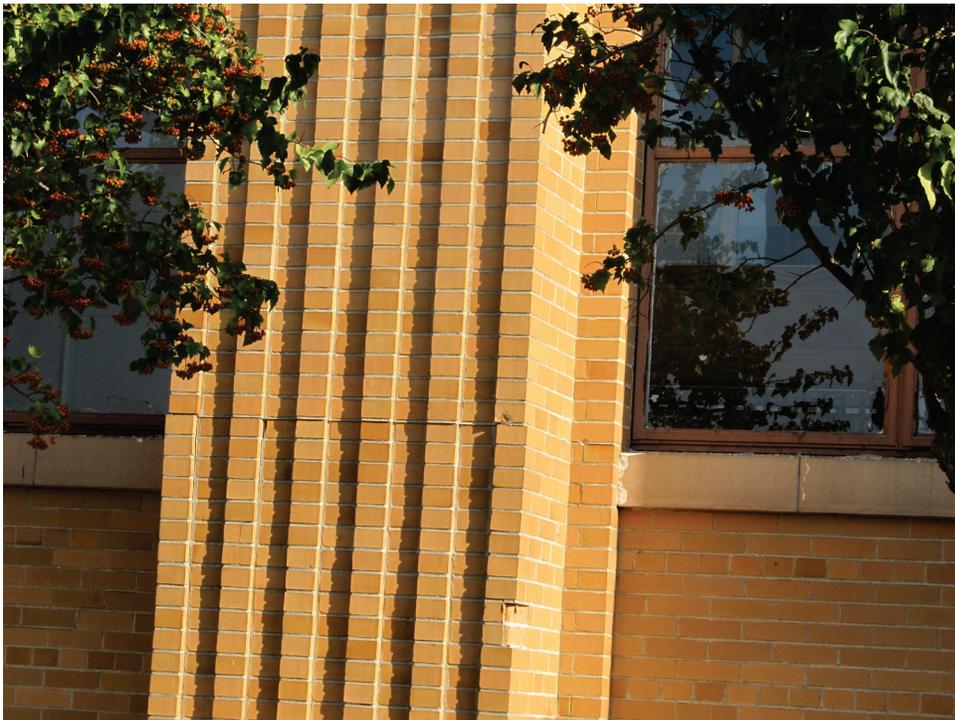
Figure 4-25 Lateral shifting at sill line.

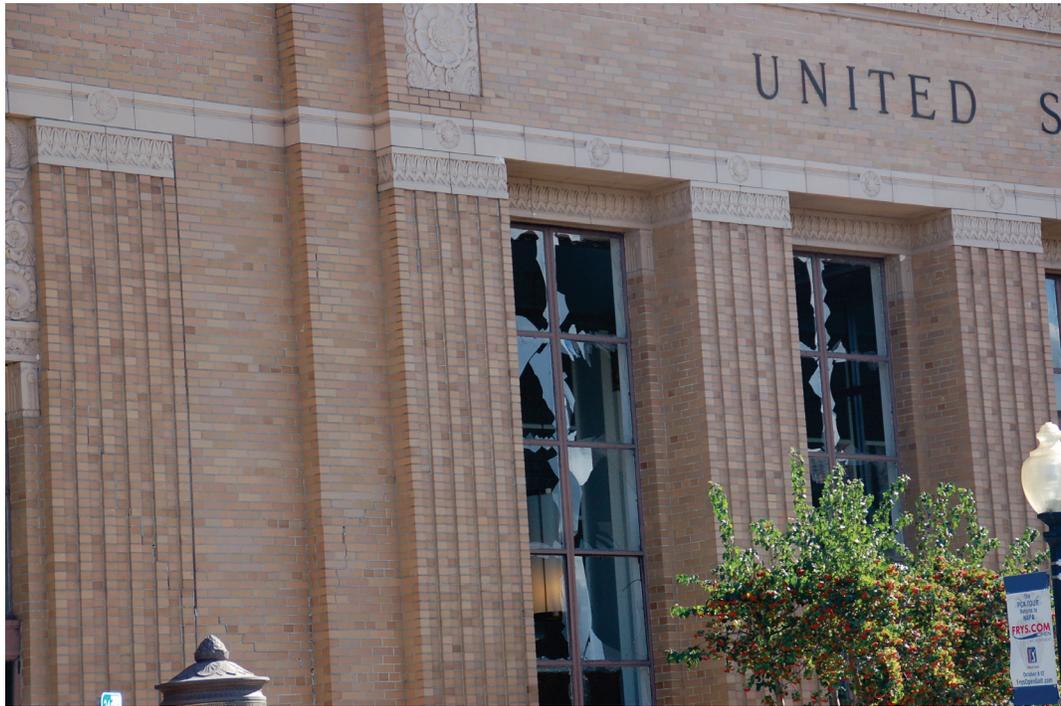
- Nonstructural Performance:** Significant cracking was observed to the exterior brick veneer of the building, which is mostly a true veneer with anchor ties. Interior finish on exterior wall and interior partitions are hollow clay tile with plaster. These were heavily damaged, especially near the front corner piers, with significant fallen clay tile units and debris. Plaster ceilings were damaged, especially in the vicinity of the corner piers. Heavy glazing damage was also observed (Figure 4-26).

Figure 4-26 Glazing damage.

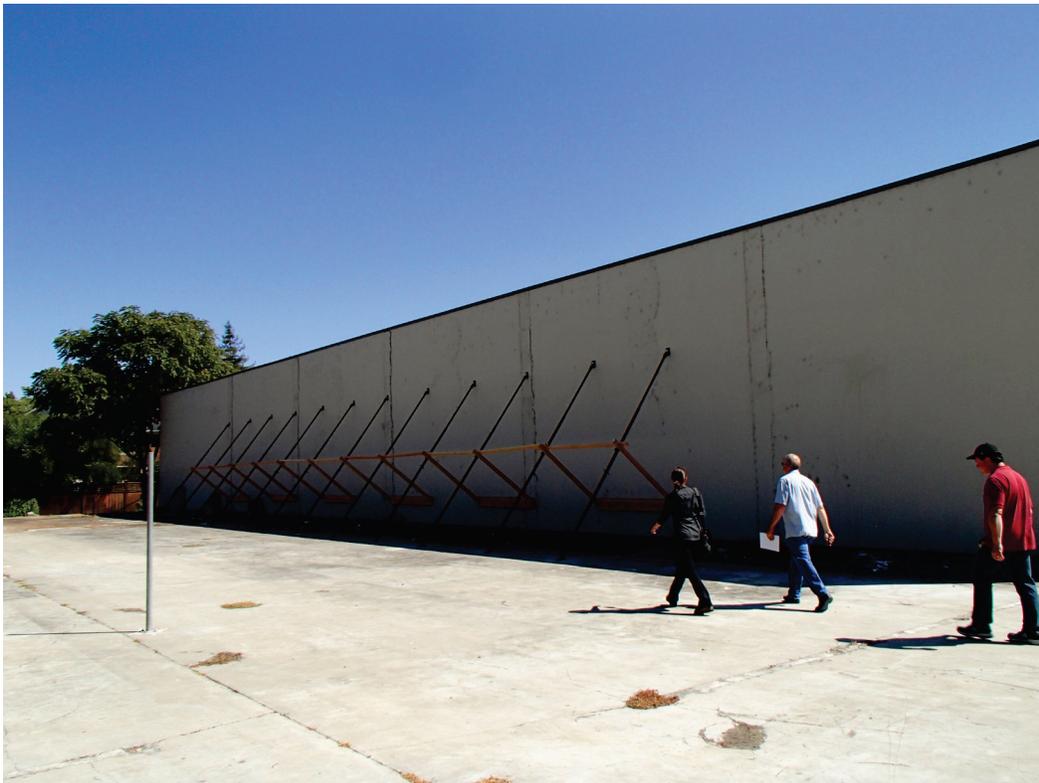
- **Occupancy Type:** Retail store.
- **Posting Placard:** Building was inspected by a structural engineer on the day of the earthquake and evacuated until emergency shoring was installed. On August 26, 2014, following the installation of out-of-plane wall bracing (Figure 4-27) and shoring of damaged glulam beams, the building was posted RESTRICTED USE.

Figure 4-27 Shoring of wall with damaged pilasters.

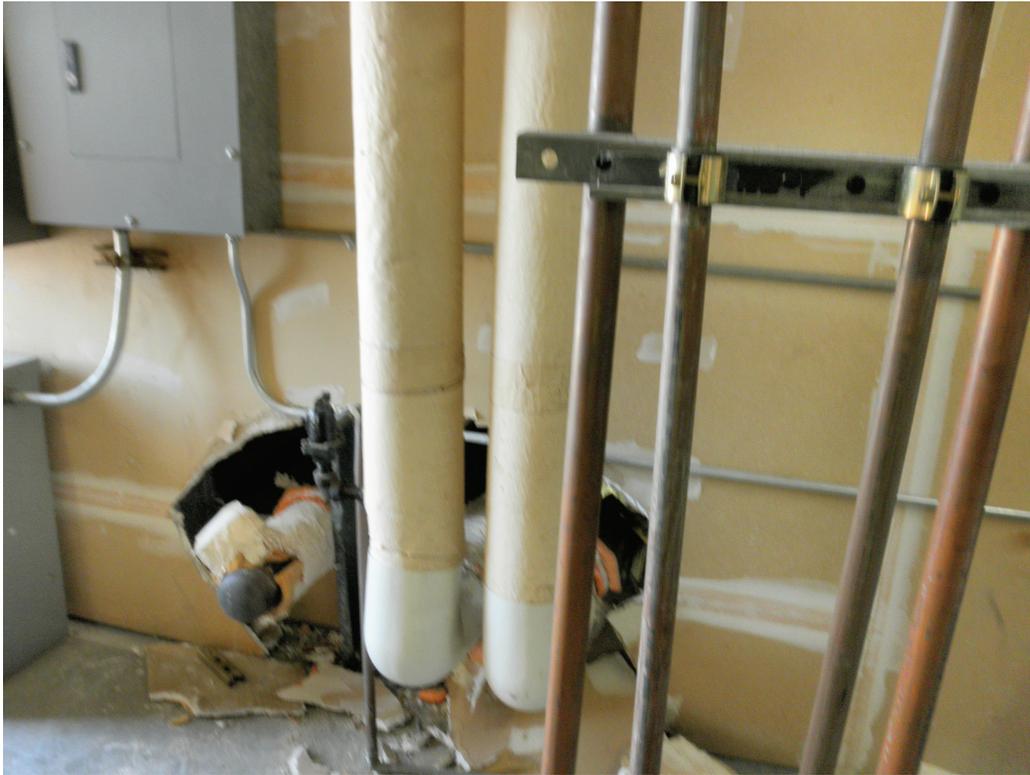
Figure 4-32 Evidence of pipe motion in penthouse partition wall.

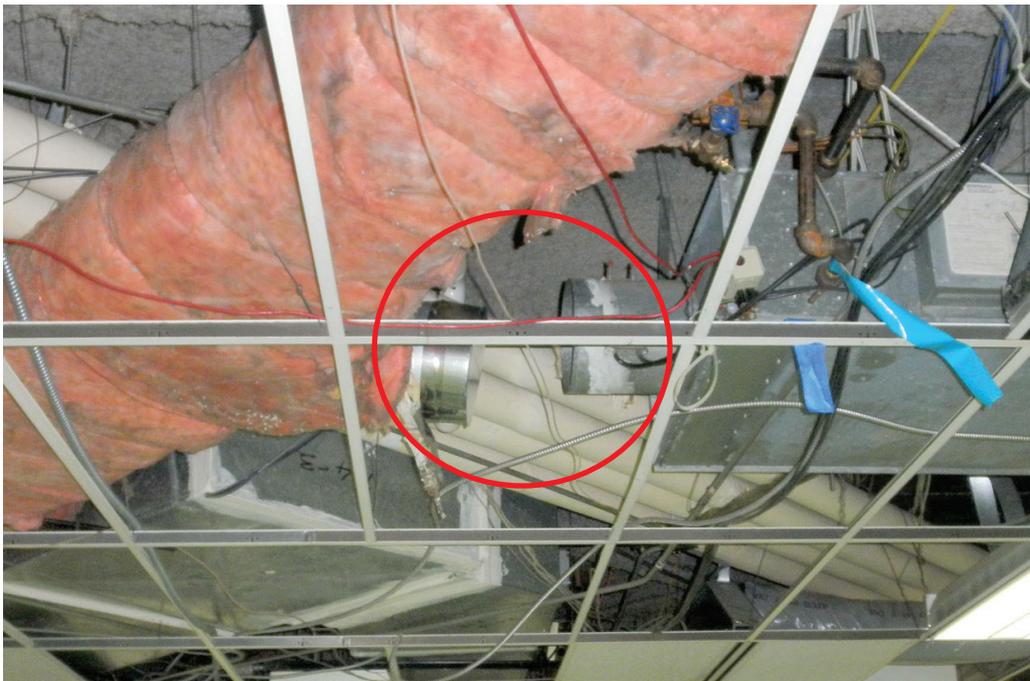
Figure 4-33 Ceiling and duct damage. The duct separated from the in-line HVAC unit to the right.

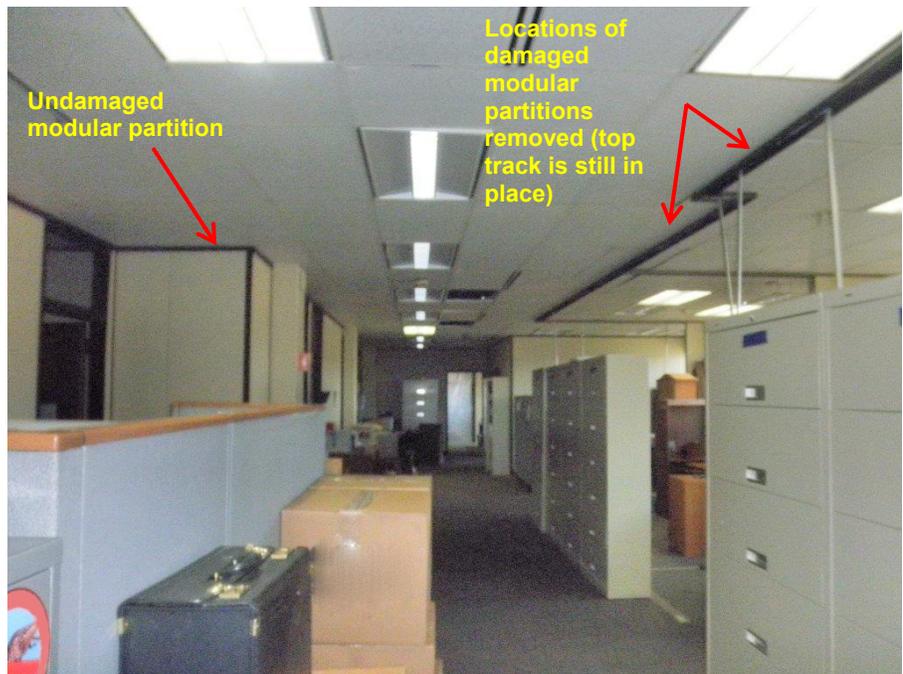
Figure 4-35 Third floor of building after the earthquake. Modular partitions similar to those at the left were damaged and removed.

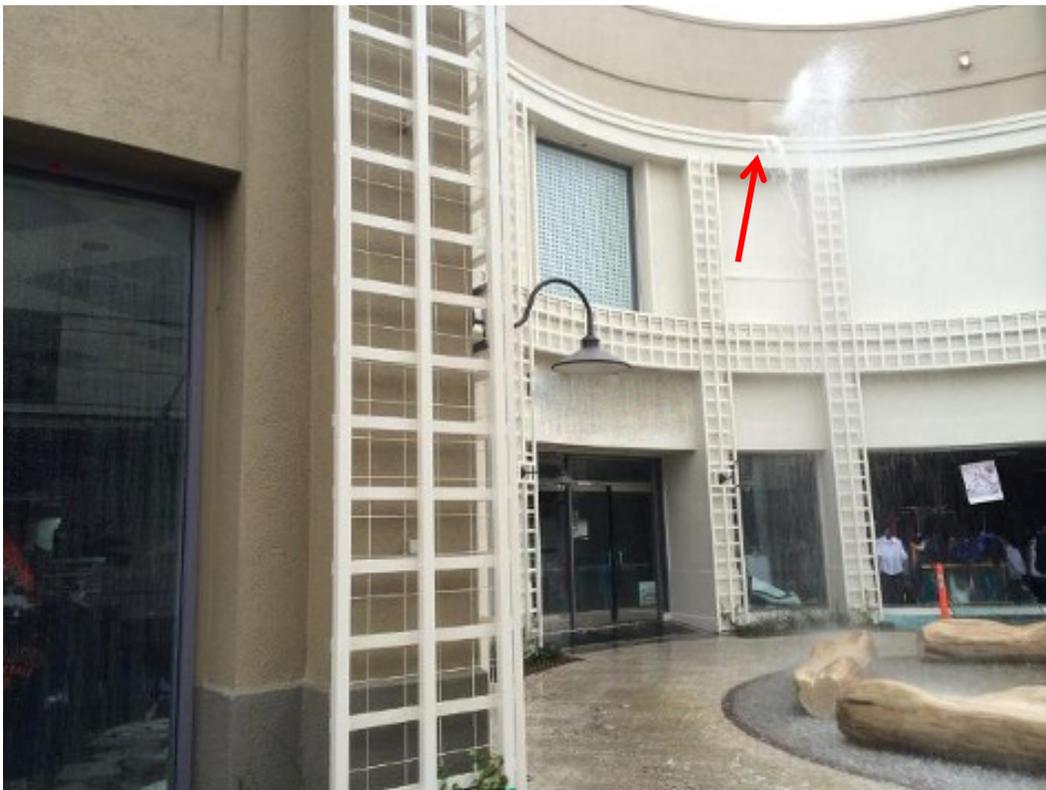
some merchandise racks were overturned. Considerable amounts of gypsum wallboard were water damaged and required removal. The suspended acoustic tile ceiling was severely damaged, including damage to the grid (“free” ends came off ledger angle supports, “fixed” ends pulled out of the wall, and splices failed). A distance of up to approximately 70 feet was measured between parallel fixed- and free-ends of the ceiling assembly. The ceiling contained splay wire bracing, but no compression posts. Suspended lights were installed with independent wire supports. Partitions were braced by the ceilings and may have contributed to the ceiling damage at some locations. Anchored air-handling units on the roof reportedly slid off their supports.

Figure 4-45 Water pressure from broken sprinkler line created a hole in the exterior cladding (photo by KCRA.com).

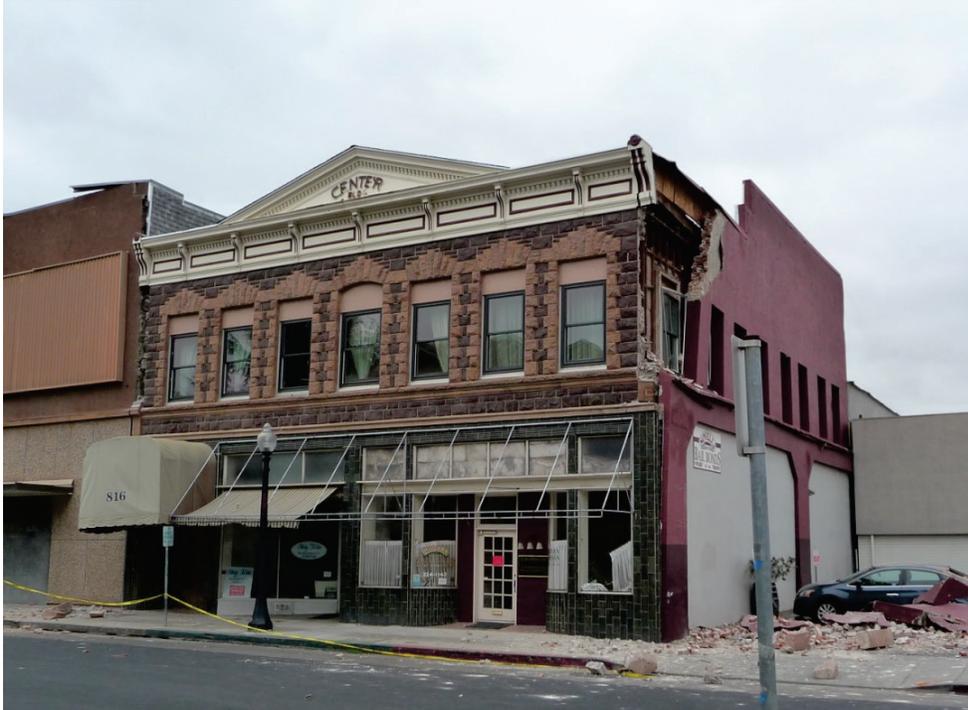
Figure 4-49 Failure of URM south wall (photo courtesy of Marko Schotanus).

- **Structural Performance:** The masonry wall on the south side of the building separated from the structure and portions of it fell into the neighboring parking lot, striking an unoccupied, parked car (Figure 4-49). Stones fell off the back of the building into the alleyway that separates the building from several retrofitted URMs (Figure 4-51). Large parapet stones fell into the attic space, which was used for storage. A large X-crack was observed in the north masonry wall.

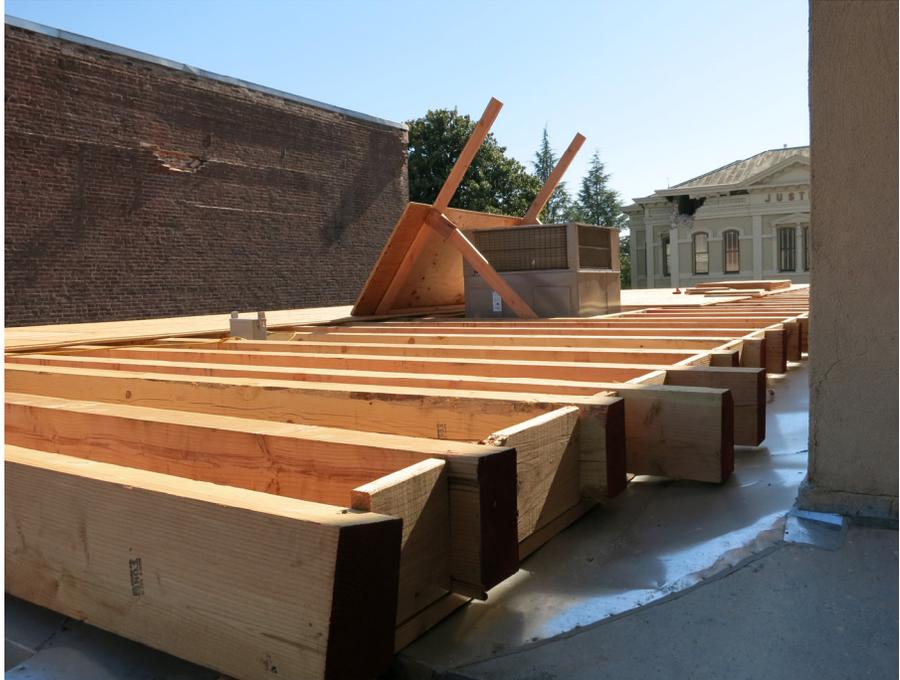
Figure 4-50 Wooden barrier constructed on the roof a building neighboring a masonry wall at risk of collapse.

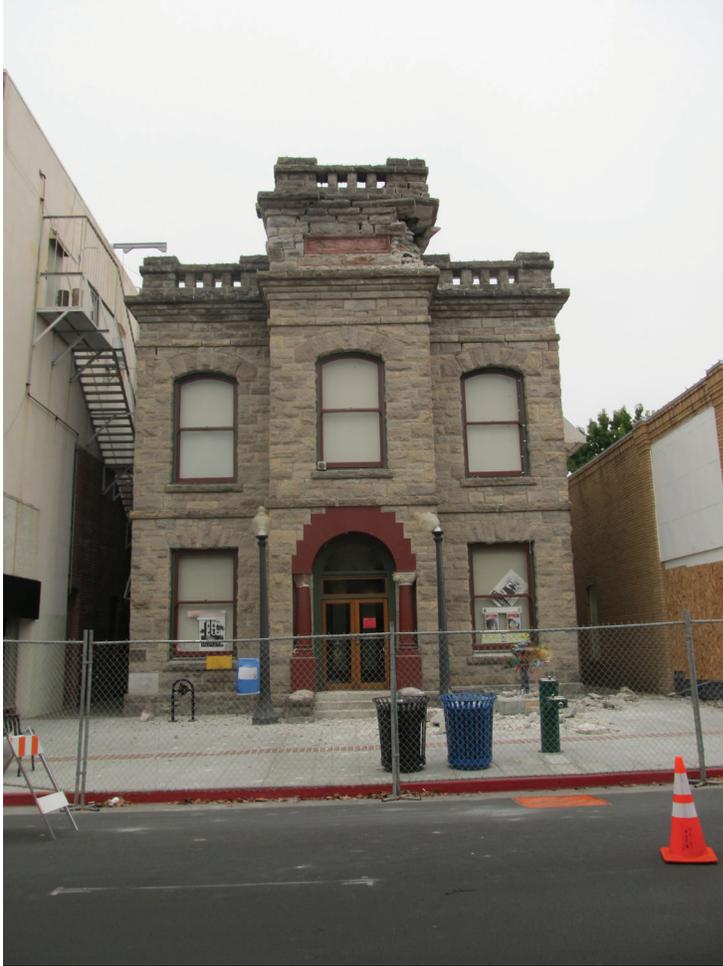
Figure 4-59 Front façade showing damage and UNSAFE placard before scaffolding was installed.

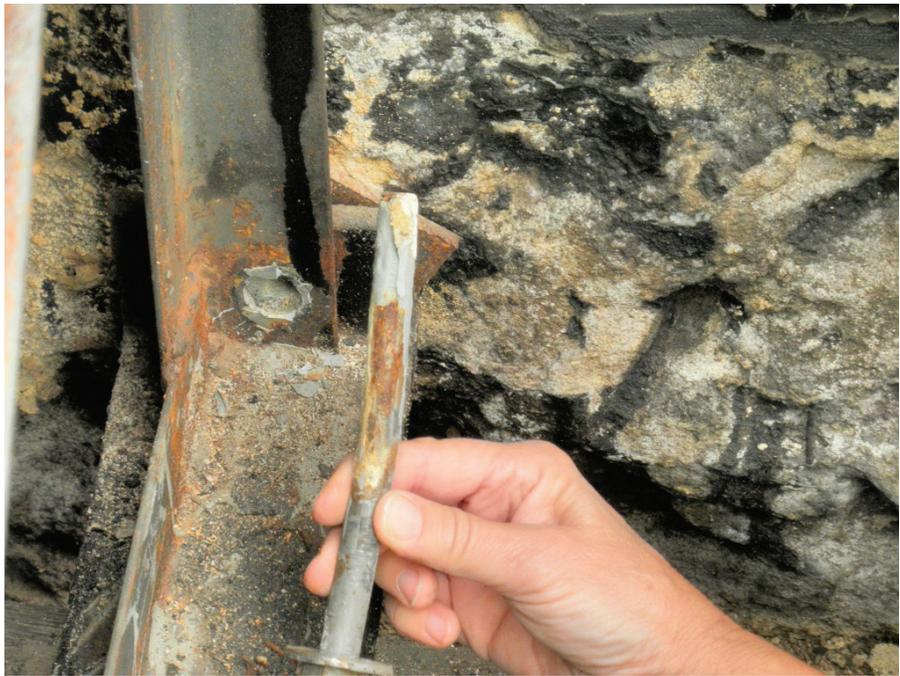
Figure 4-87 Failed wall anchor, north elevation.

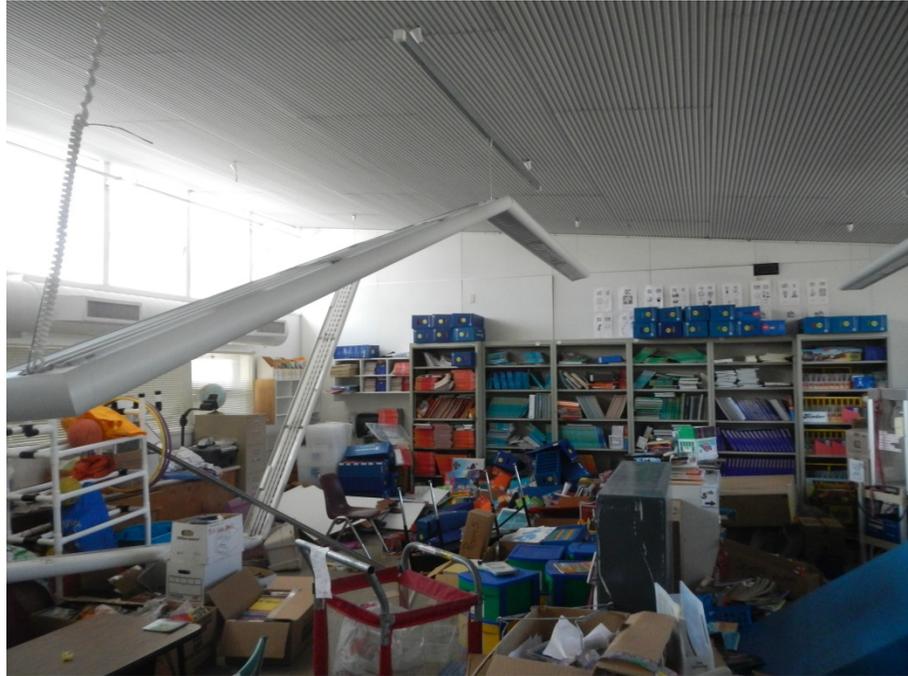
Figure 6-2 Damaged light fixtures in classroom at Pueblo Vista Elementary School (photo by Quattrocchi Kwok Architects).

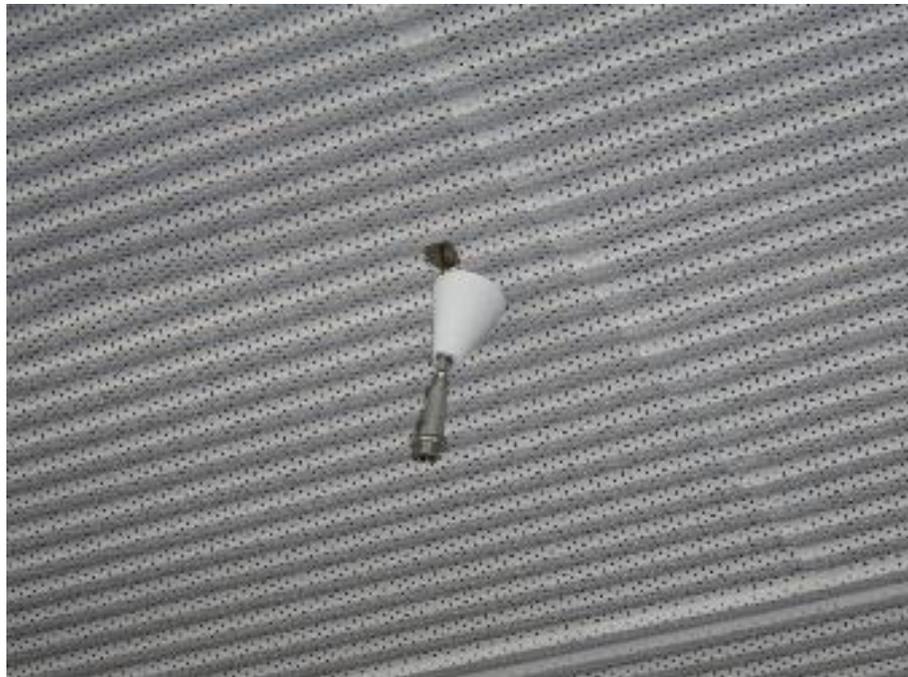
Figure 6-3 Aircraft cable slipped out of the cable gripping support fixture at Pueblo Vista Elementary School (photo by Quattrocchi Kwok Architects).

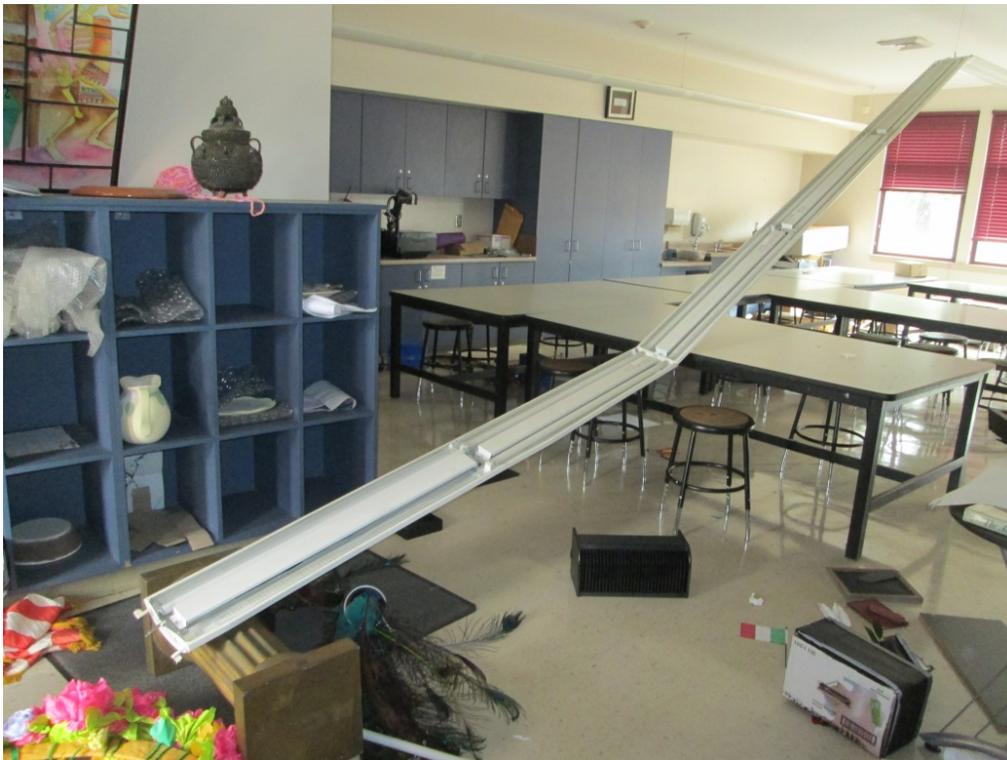
Figure 6-5 Damaged light fixtures in Napa Valley Language Academy (photo by Quattrocchi Kwok Architects).

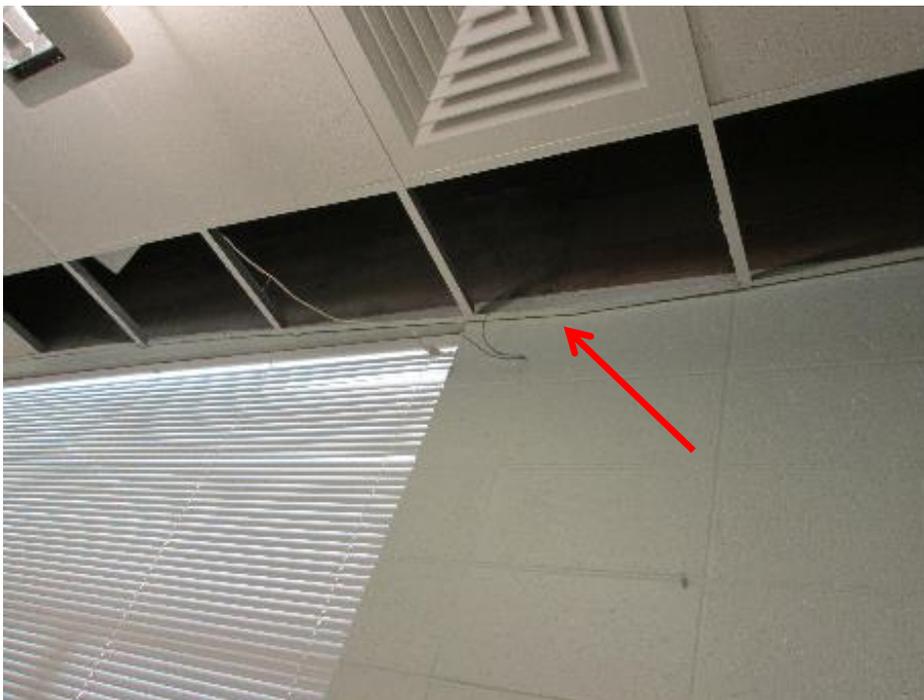
Figure 6-18 Dislodged tiles and bent edge angle in a Silverado Middle School classroom (photo by Quattrocchi Kwok Architects).

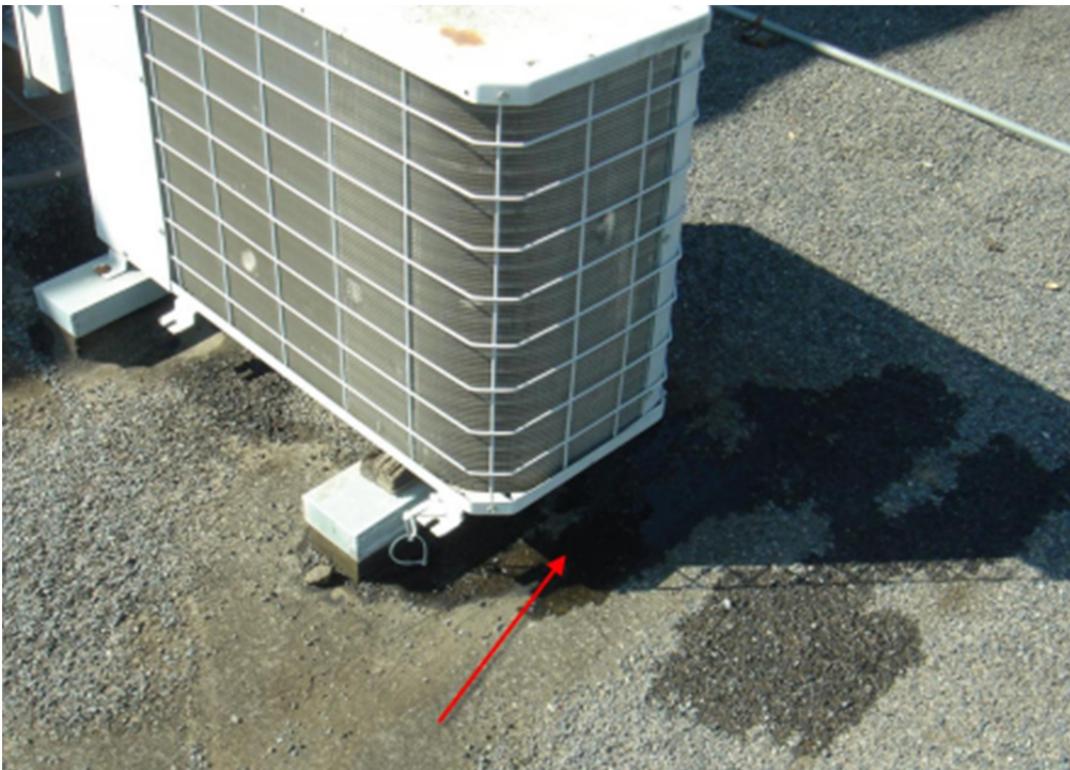
Figure 6-25 Shifted rooftop condensate unit at Redwood Middle School (photo by Quattrocchi Kwok Architects).

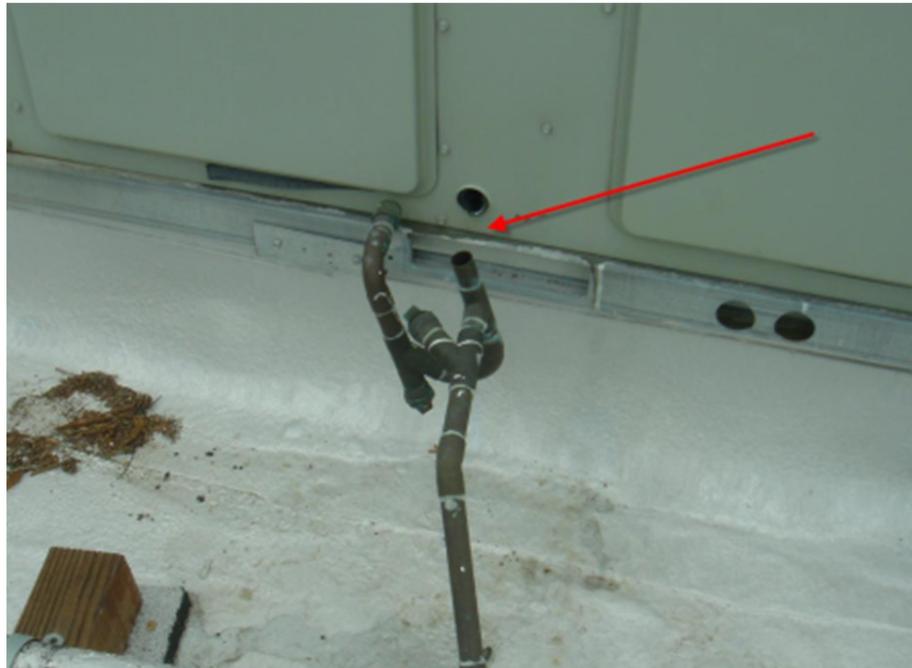
Figure 6-27 Broken condensate connection at air conditioning unit, Redwood Middle School (photo by Quattrocchi Kwok Architects).

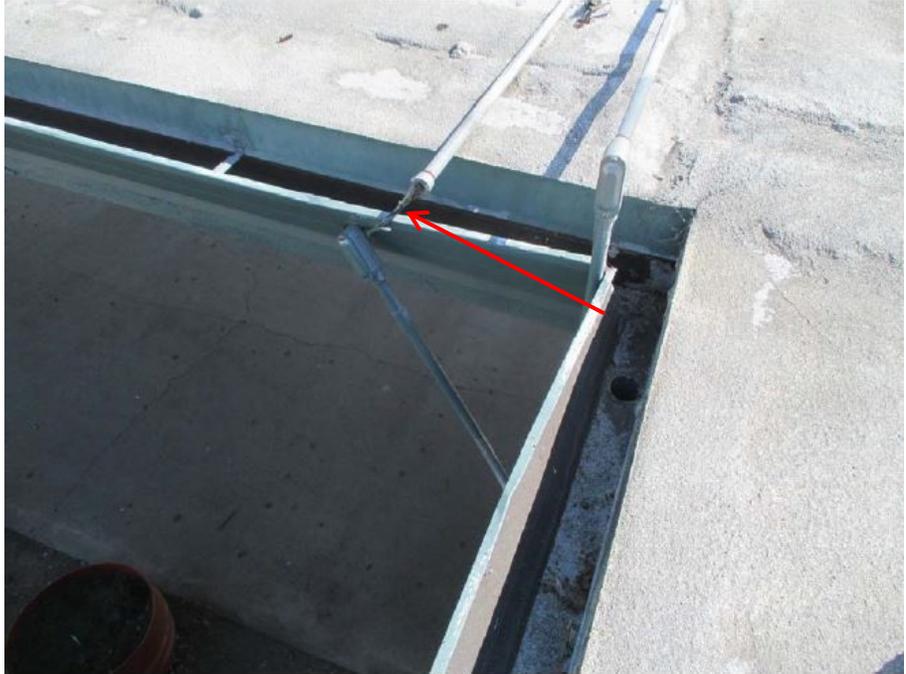
Figure 6-30 Exposed wires at failed conduit fitting, Harvest Middle School (photo by Quattrocchi Kwok Architects).

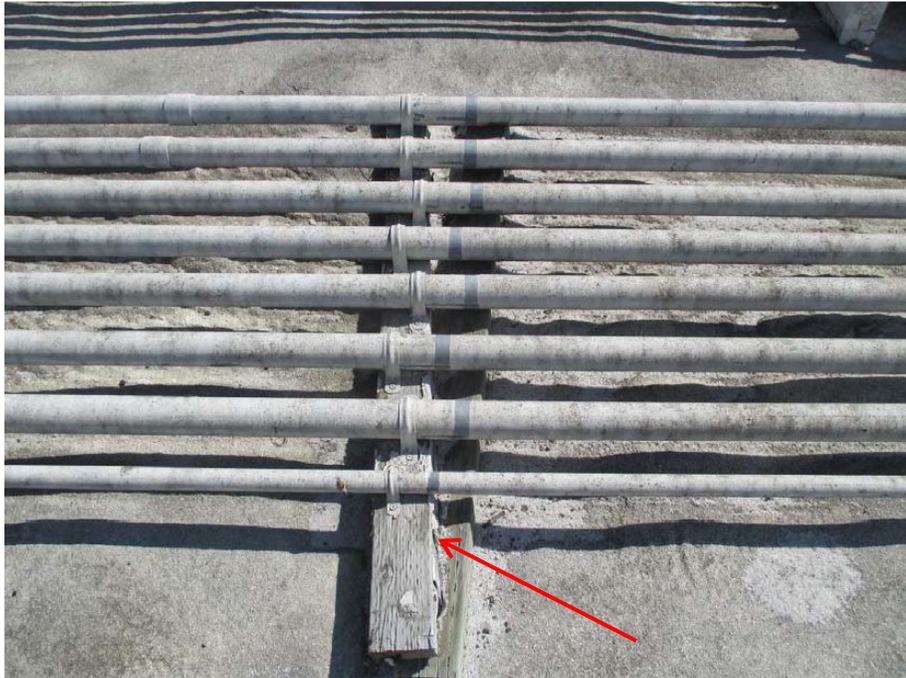
Figure 6-31 Shifted conduit at sleeper support, Harvest Middle School (photo by Quattrocchi Kwok Architects).

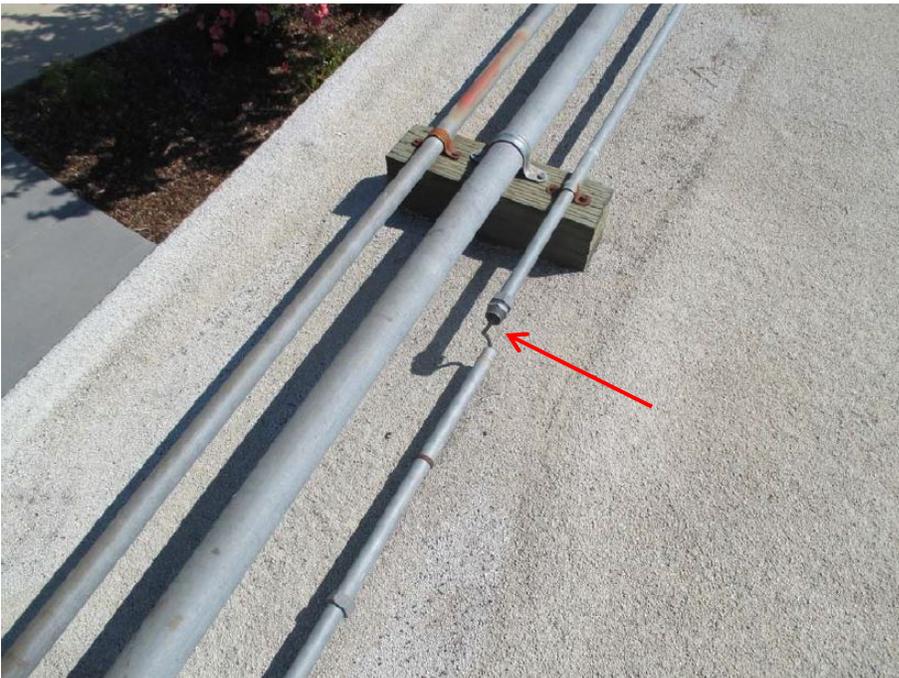
Figure 6-33 Broken low voltage conduit coupling at Redwood Middle School (photo by Quattrocchi Kwok Architects).

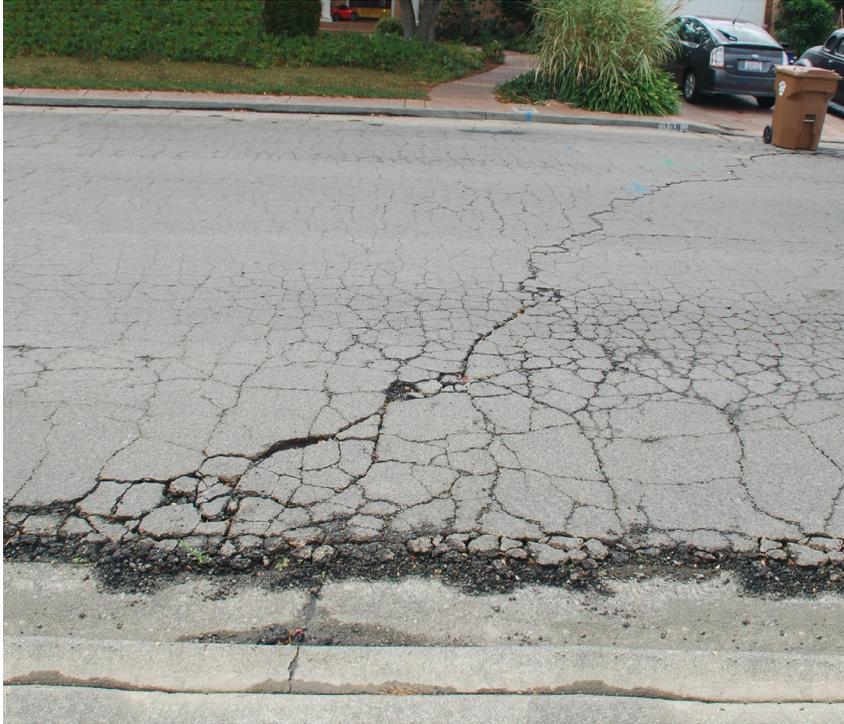
Figure 7-2 Surface feature of fault rupture observed on street.
