Performance of Buildings and Nonstructural Components in the 2014 South Napa Earthquake

FEMA P-1024 / February 2015

APPLIED TECHNOLOGY COUNCIL
201 Redwood Shores Parkway, Suite 240
Redwood City, California 94065
<http://www.atcouncil.org/>

FEDERAL EMERGENCY MANAGEMENT AGENCY
Michael Mahoney, Project Officer
Washington, D.C.

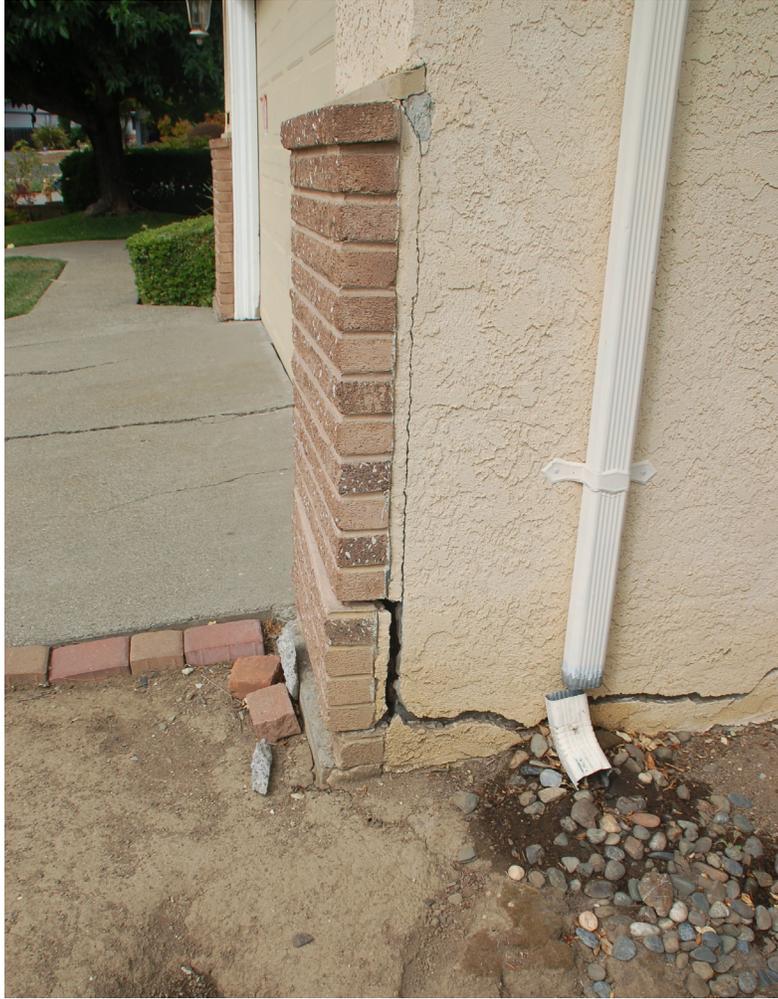
Figure 7-4 Crack continuing around the base of structure.

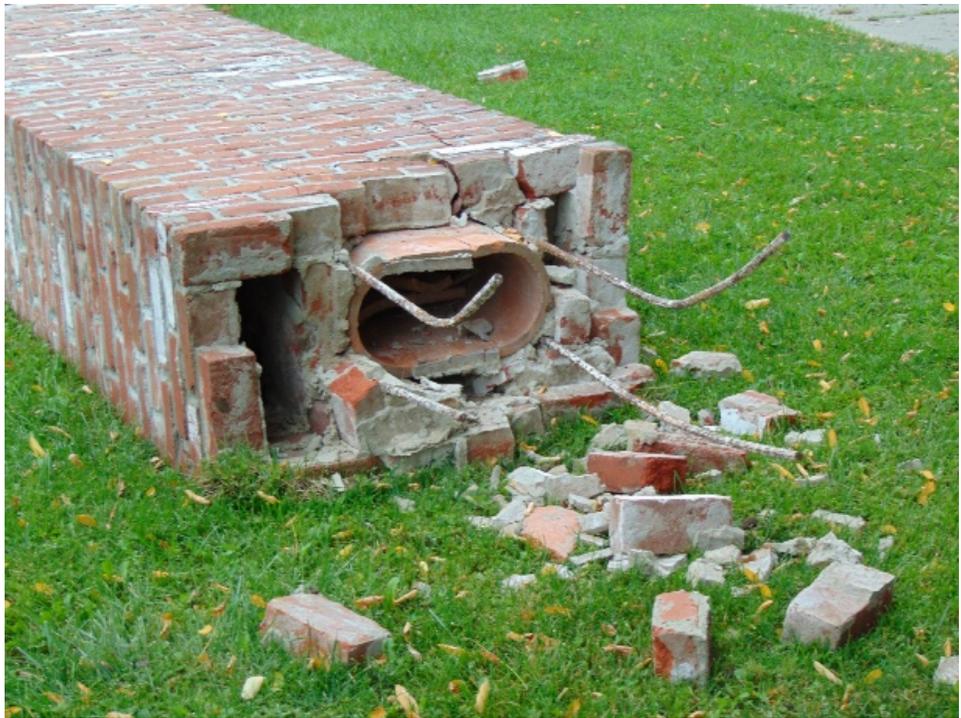
Figure 7-24 Photo of chimney laying on front yard of home (photo from Janiele Maffei).

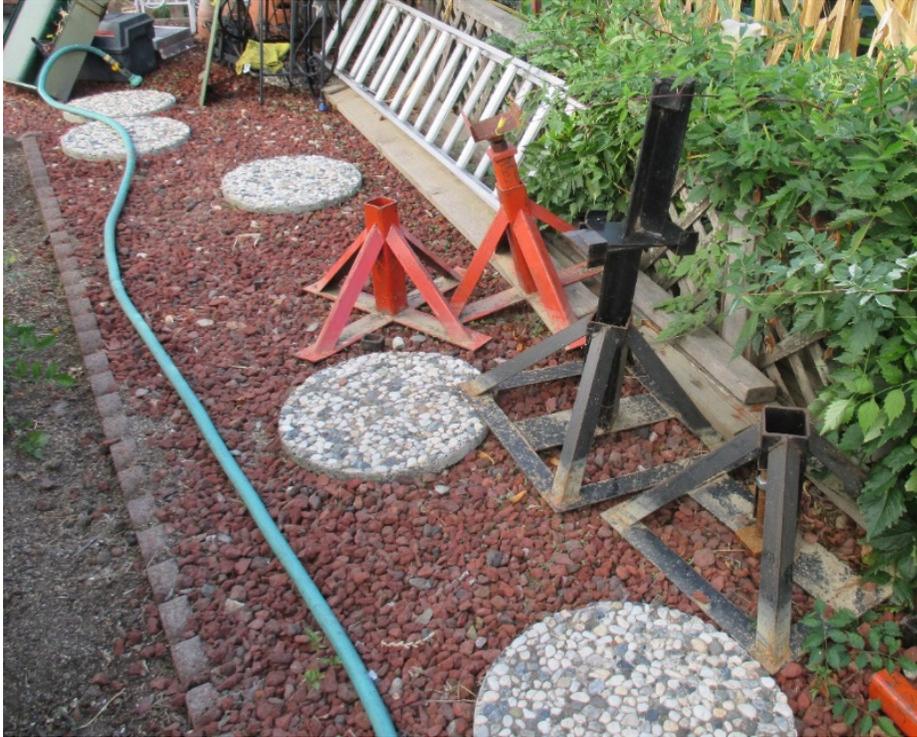
Figure 8-8 ETS removed from homes during reinstallation. These “cantilevered” piers had no allowance for anchorage to the supporting wood boards.

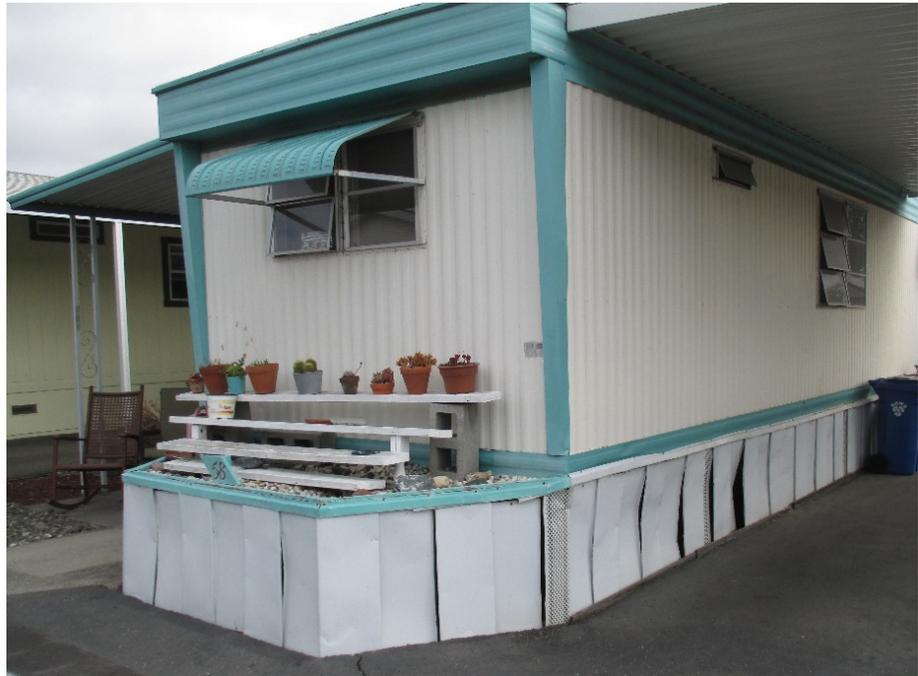
Figure 8-12 Damaged skirt on older home.

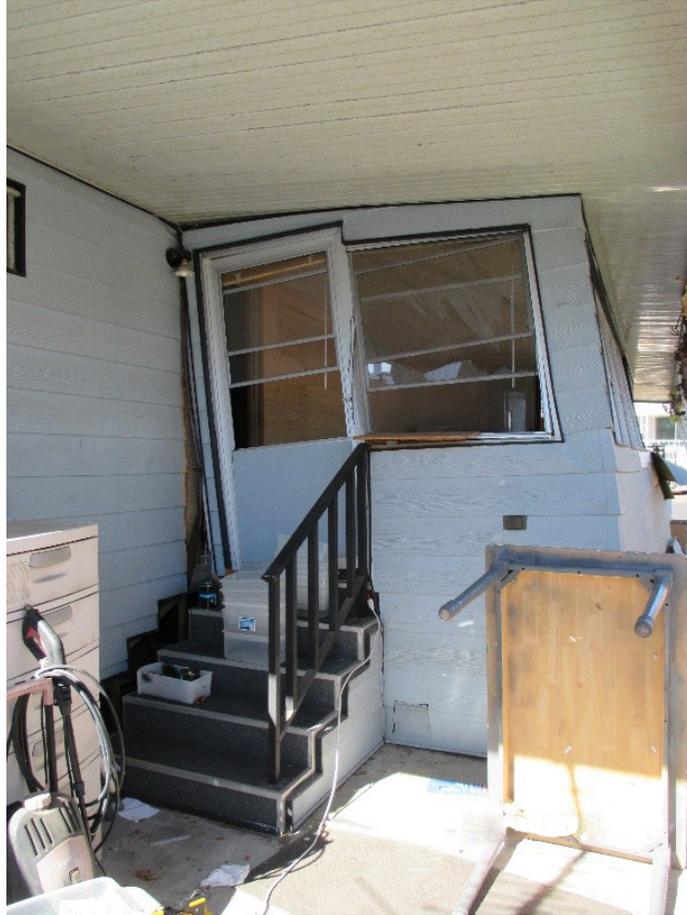
Figure 8-16 Add-on porch structure severely damaged by the earthquake.

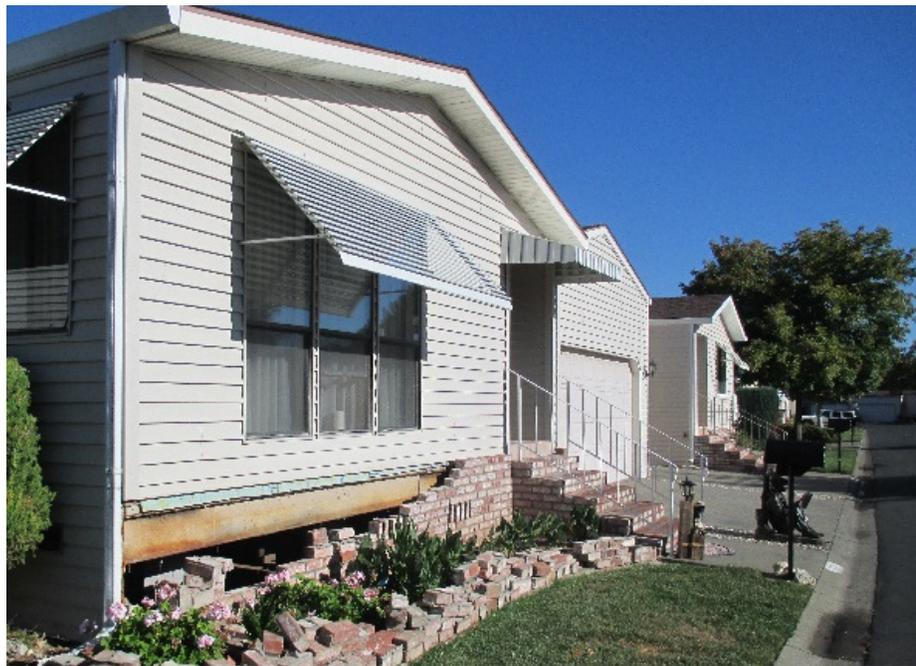
Figure 8-19 Damage to brick masonry skirt wall.

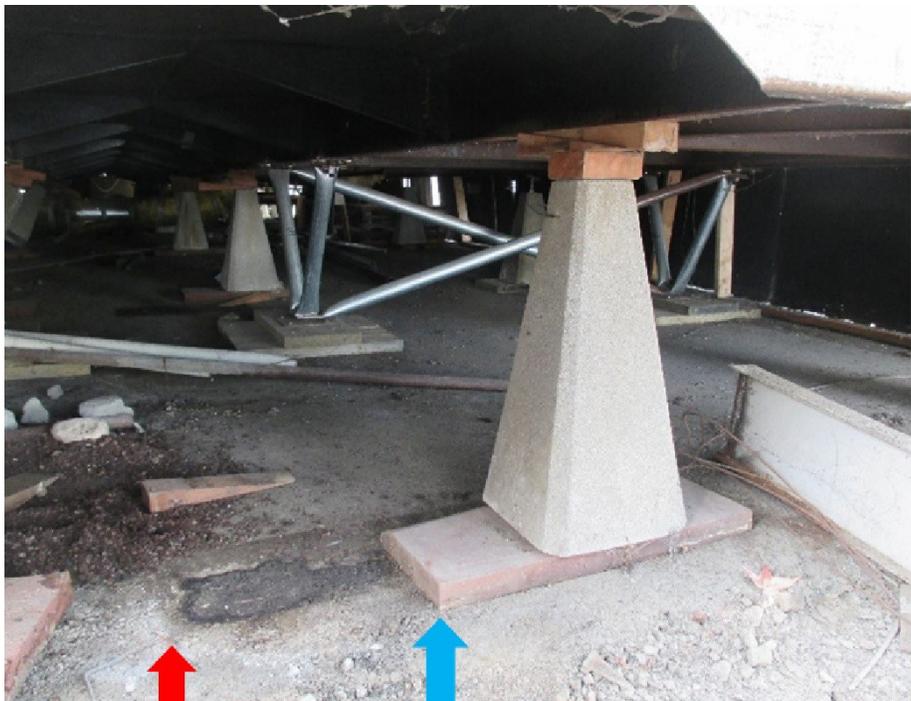
Figure 8-22 Extent of home sliding. Red arrow is initial wood board position, blue arrow is final position. ERBS can be observed in the background.

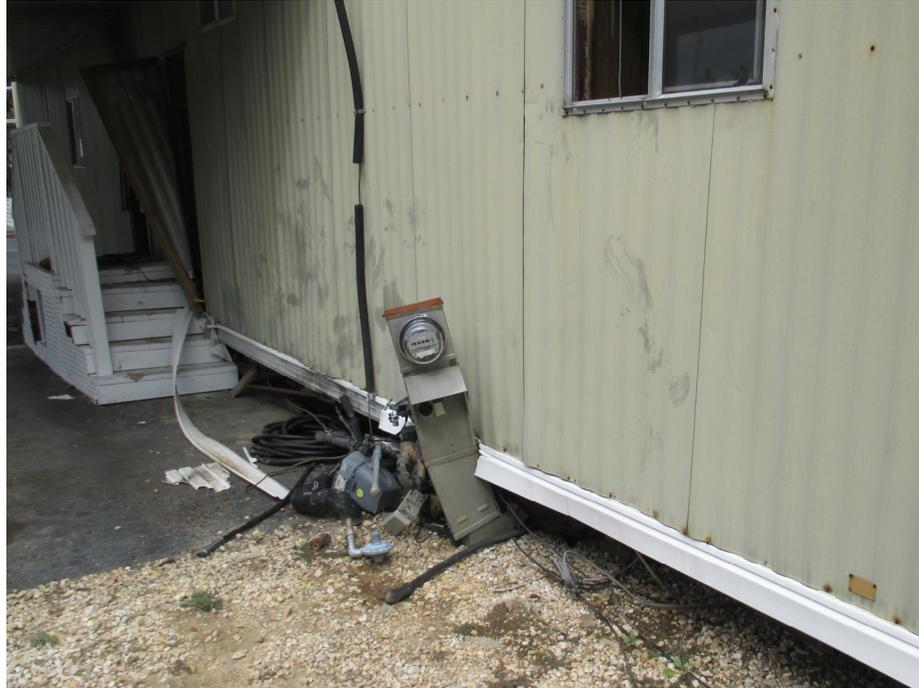
Figure 8-23 Manufactured home that slid and fell onto its utility hookup.

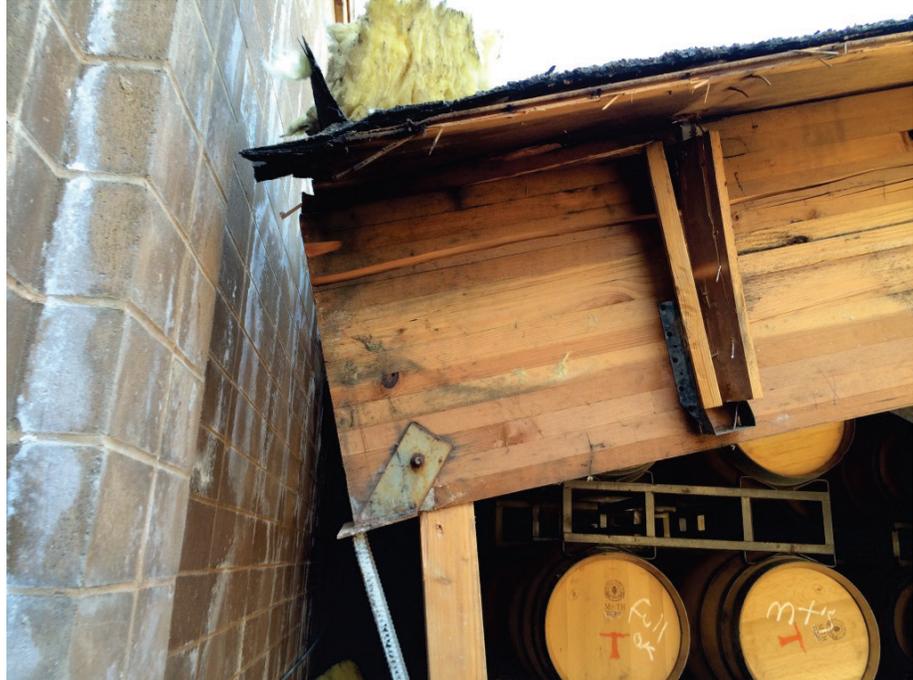
Figure 9-5 Failure of glulam beam to wall connection resulted in roof collapse.

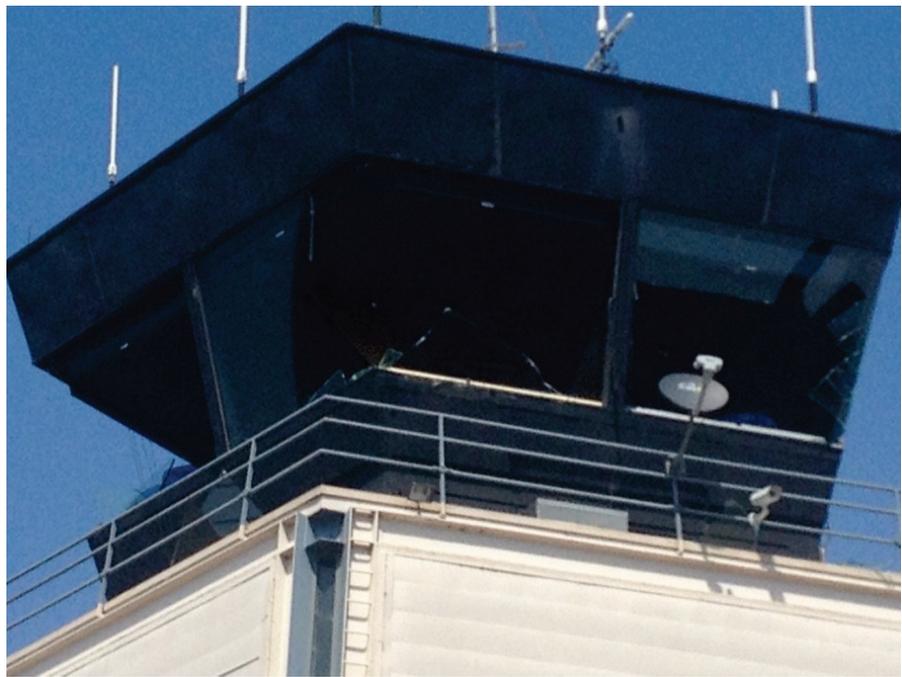
Figure 10-3 Broken glass in Napa County air traffic control tower (photo by J.L. Sousa/Napa Valley Register/ZUMAPress.com).

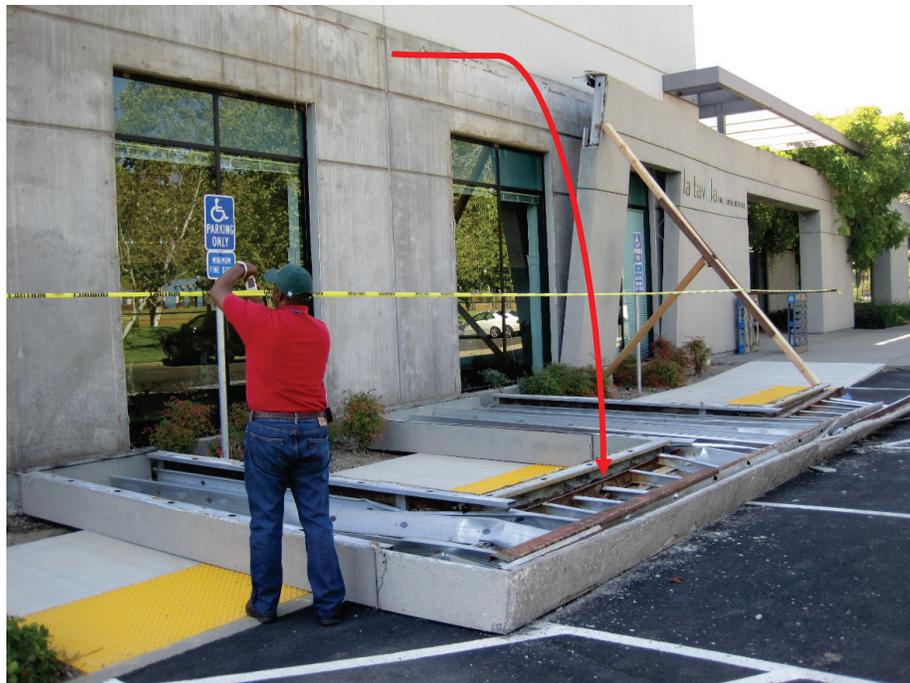
Figure 10-5 Metal stud and stucco framed cladding dislodged from concrete wall.

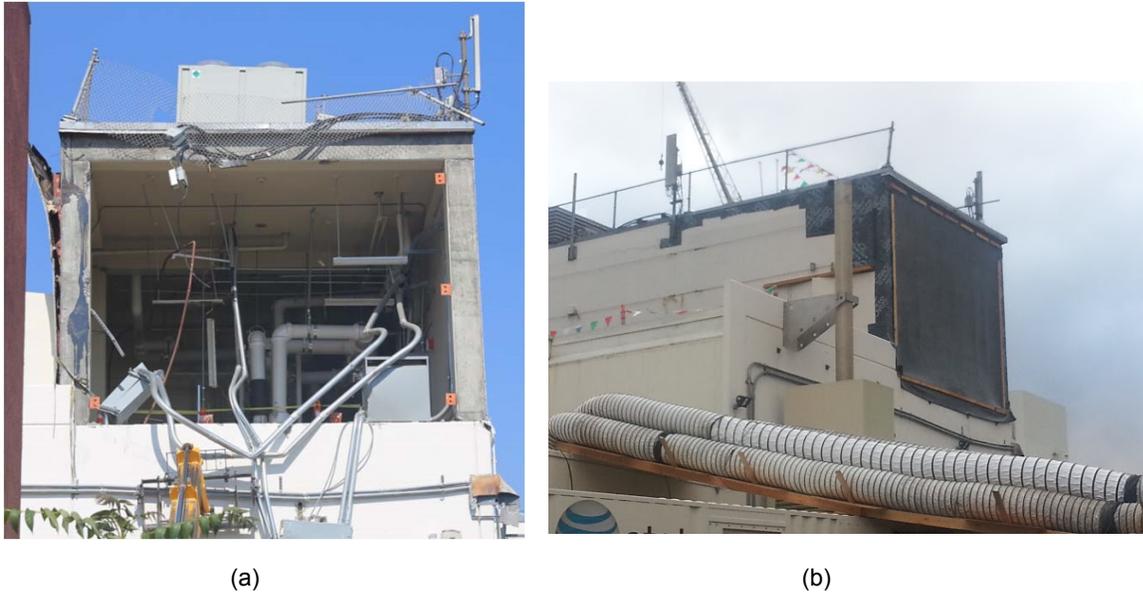
Figure 10-6 Dislodged precast panel in telephone operations facility: (a) missing panel with orange brackets remaining in place (photo from PEER (2014)); (b) temporary covering after the earthquake.

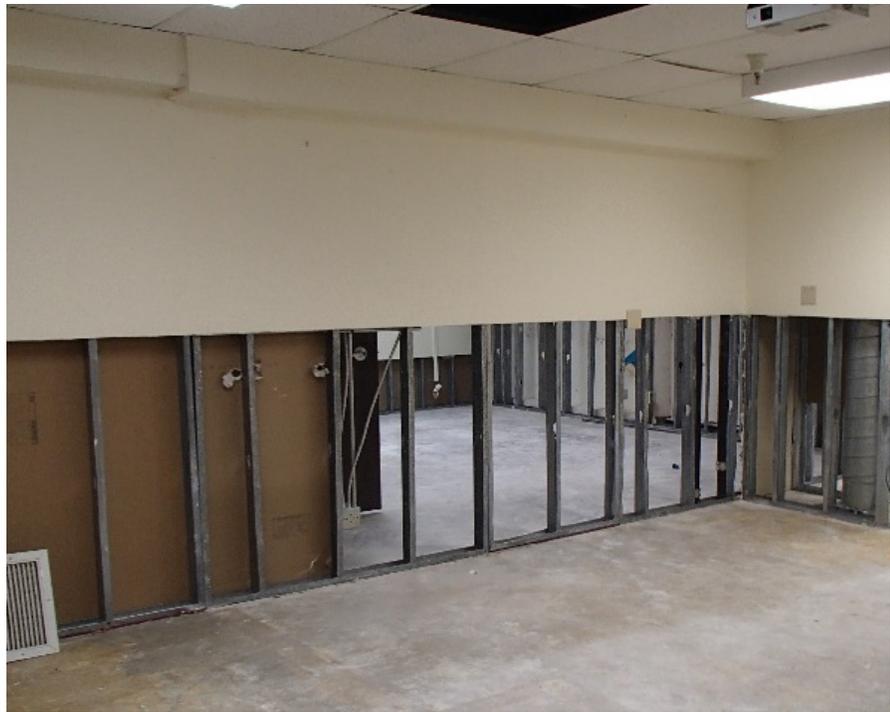
Figure 10-7 Gypsum wallboard was removed from partition walls where water damage from a broken sprinkler head occurred.

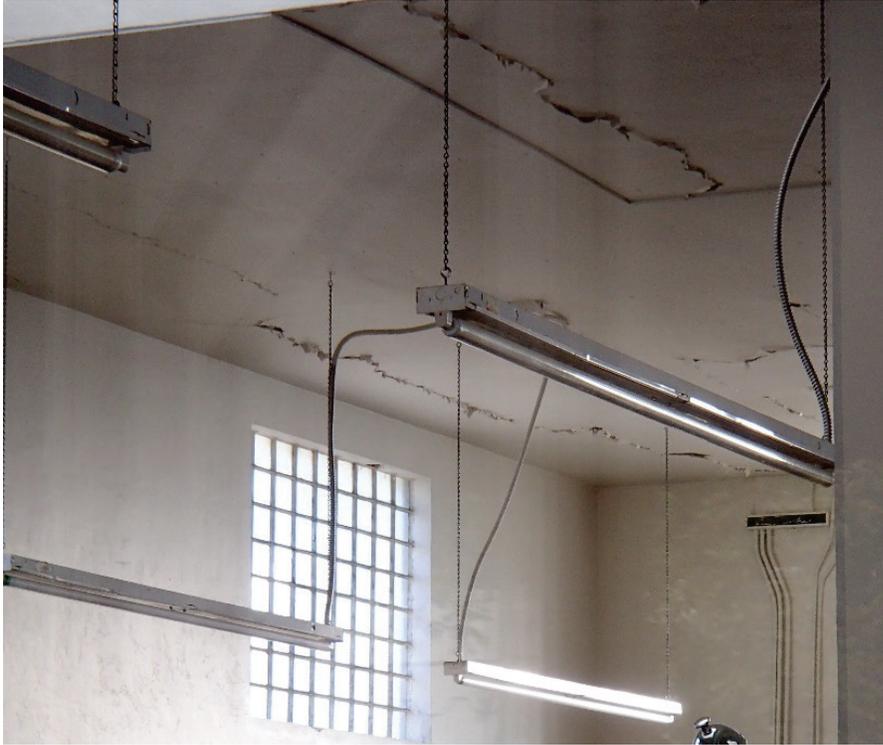
Figure 10-13 Cracking and spalling of a plaster ceiling in an older reinforced concrete building in downtown Napa.

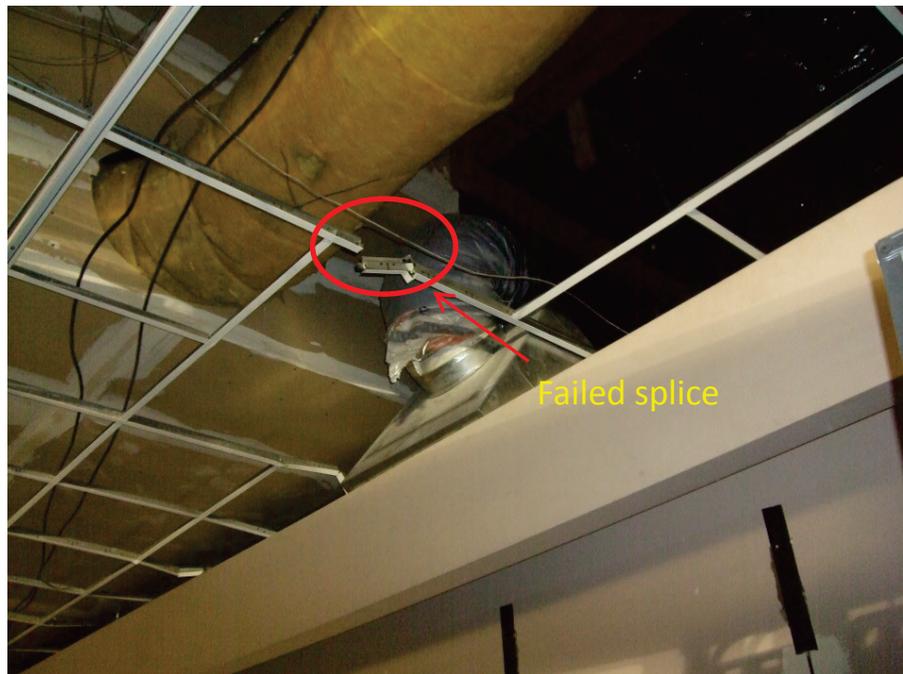
Figure 10-15 Failure of a splice of acoustical tile ceiling grid in a two-story retail store in downtown Napa.

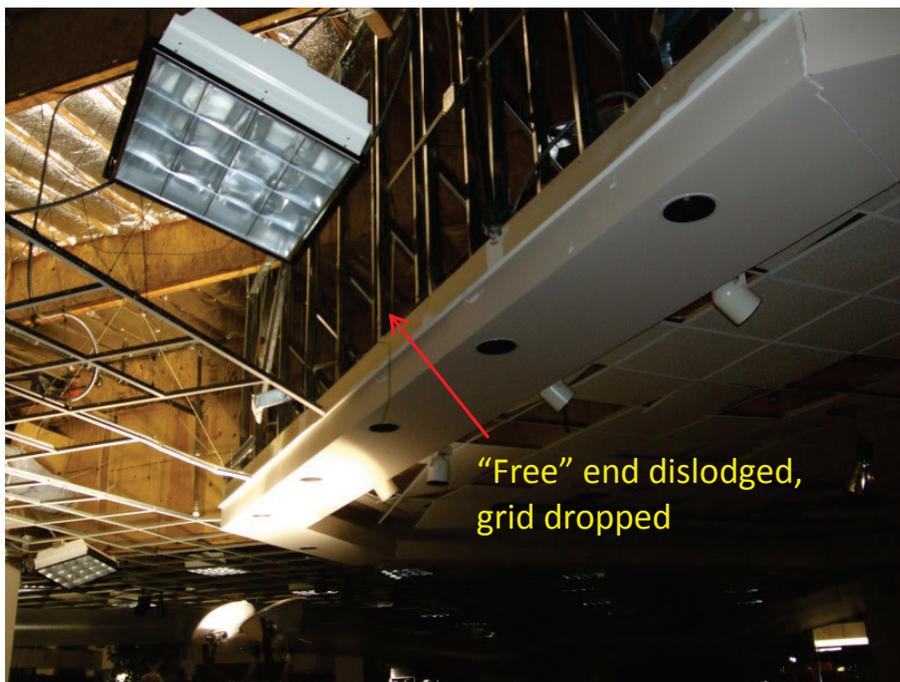
Figure 10-17 Failure of “free” end support of the acoustical tile ceiling grid in a two-story retail store in downtown Napa.

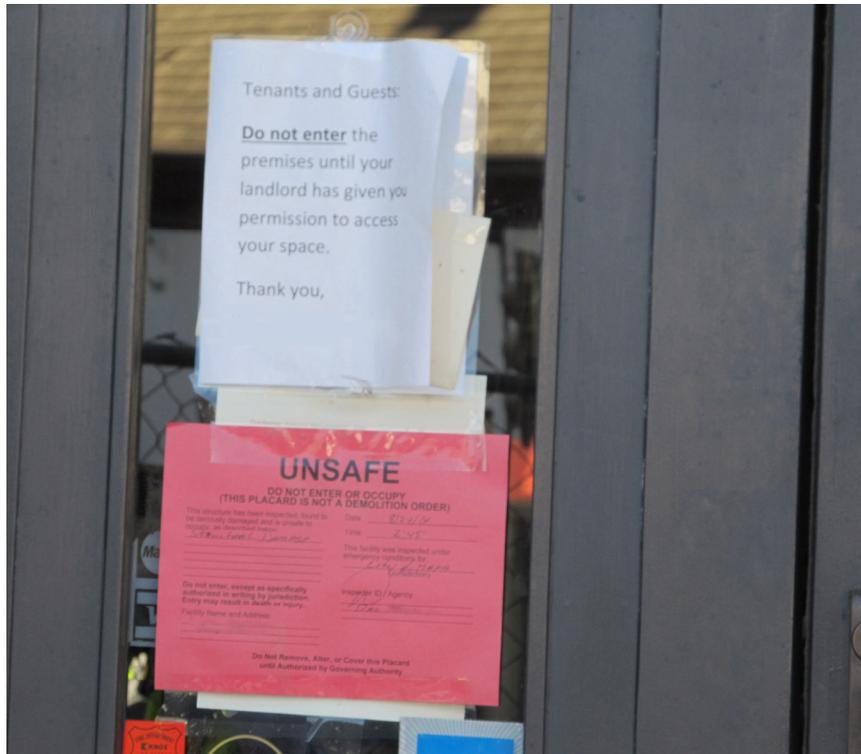
Figure 11-6 An UNSAFE placard with an adjacent inconsistent placard by the owner.
