Building Envelope Performance

5.1 Sheathing on the Underside of Elevated Buildings

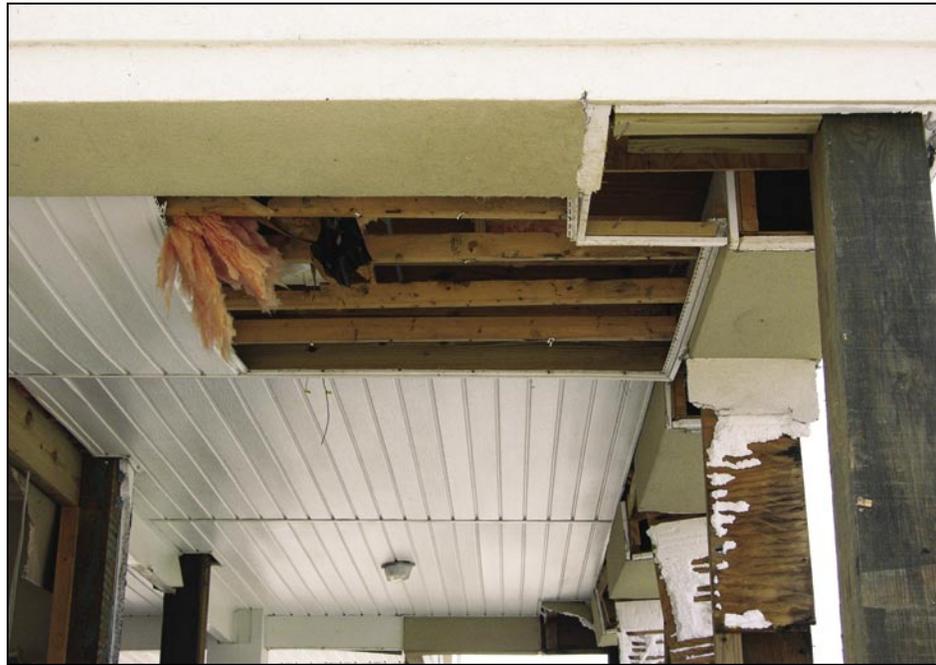
Sheathing was typically installed on the underside of bottom-floor joists on elevated buildings. Besides protecting batt insulation that is placed between joists, sheathing can also protect electrical and plumbing lines from floodborne debris. A variety of sheathing materials were observed. Vinyl siding and plywood were the most common, but gypsum board was observed on three buildings, and corrugated metal was observed on one building. The majority of the buildings with vinyl experienced sheathing loss (Figure 5-1). For further discussion of vinyl siding, see Section 5.3.2.

Figure 5-1.
Loss of vinyl siding panels from the underside of an elevated residence in Gulf Shores (Laguna Key)

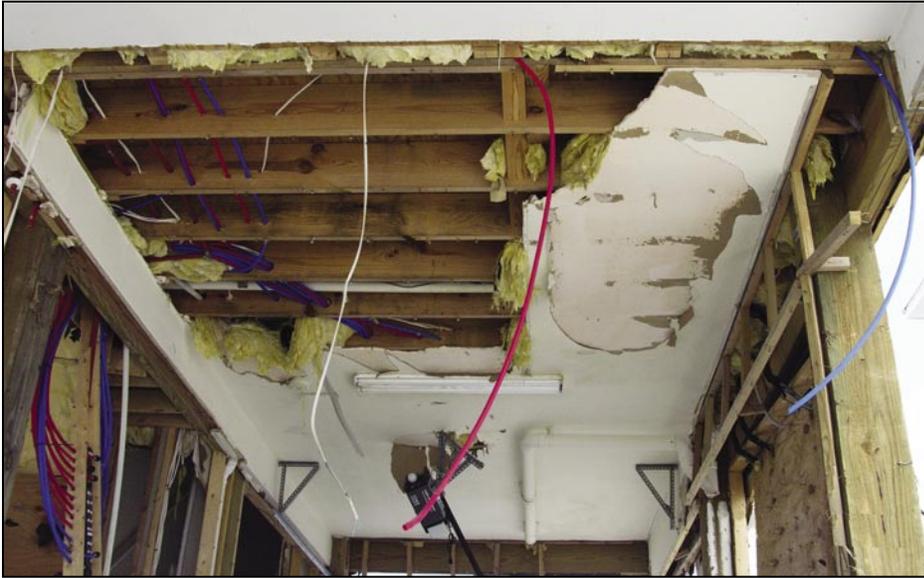
All of the buildings with gypsum board experienced sheathing loss (Figure 5-2). One of these buildings was a large apartment or condominium – essentially all of the gypsum board was torn away (the gypsum board typically pulled over the nail heads).

Figure 5-2.
Loss of gypsum board
from the underside of an
elevated residence in Gulf
Shores (Laguna Key)

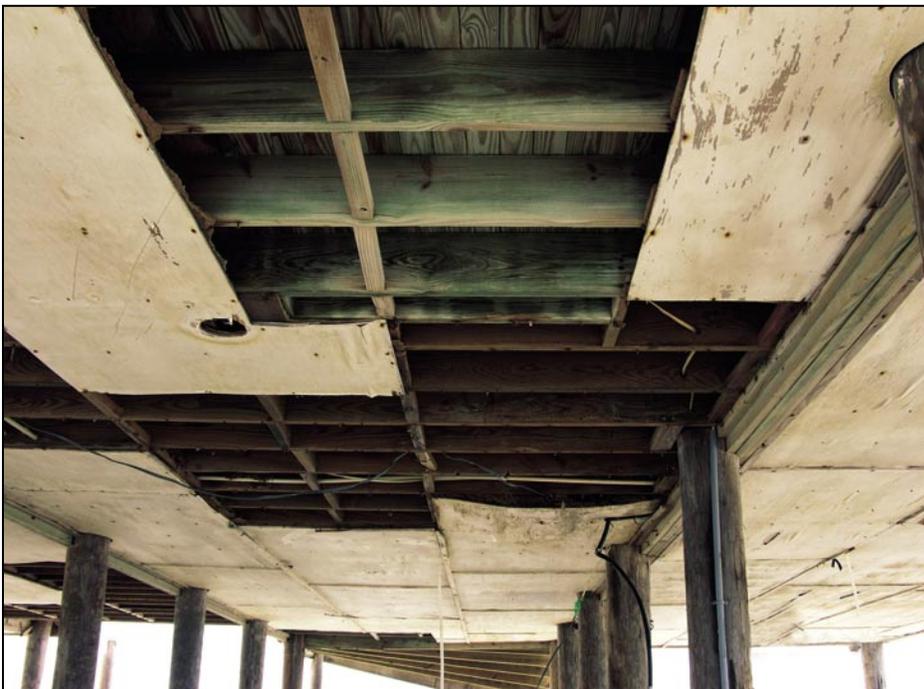
The plywood panels typically performed well, but some losses were experienced (Figure 5-3). Nails were typically used to attach the sheathing. Fastener corrosion was common and some of the nail heads were totally corroded away. Fastener spacing along the joists was often about 12 inches on center. Although the long edge of the sheathing typically occurred over blocking, fastener spacing along the long edge was often only about 16 inches on center.

Figure 5-3.
Loss of plywood from the
underside of an elevated
residence in Gulf Shores
(West Beach)

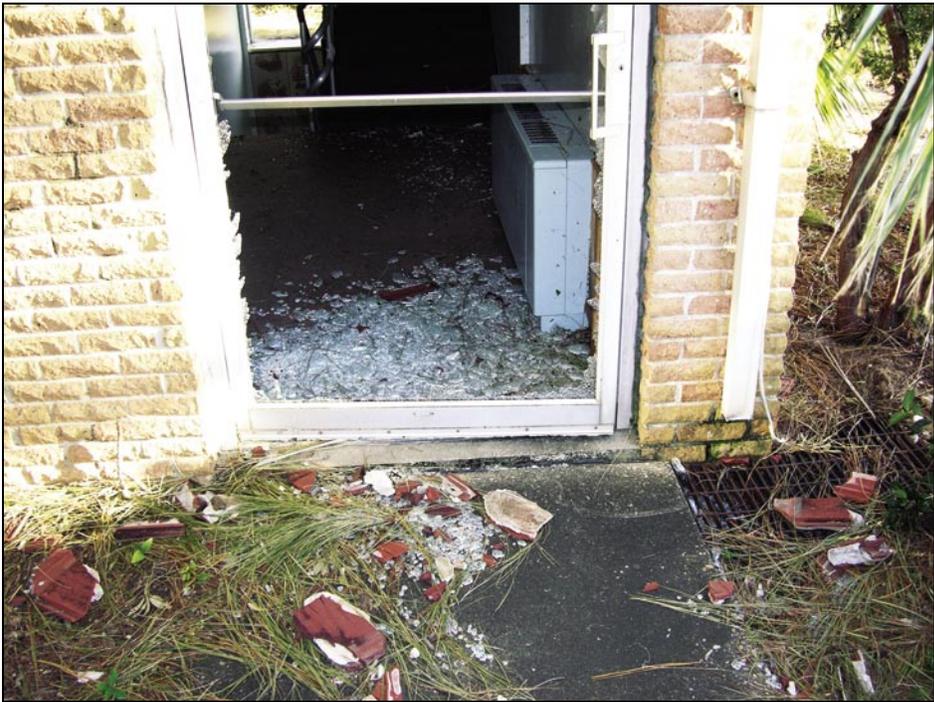
Figure 5-4.
Tempered glass door
broken by debris from
a mortar-set tile roof
(Pensacola)

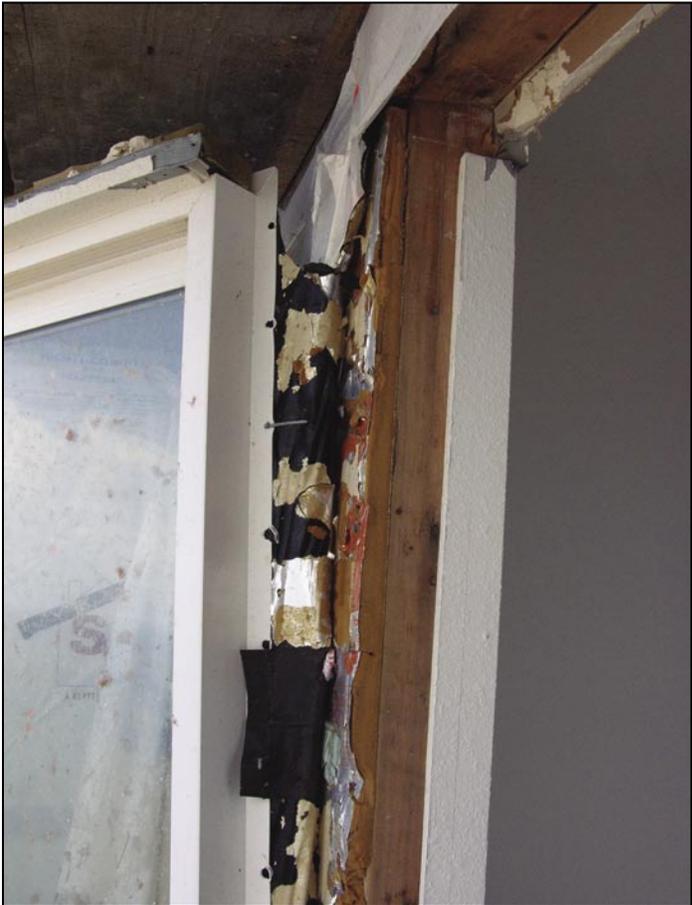
Figure 5-5.
Sliding glass door frame blown from the wall

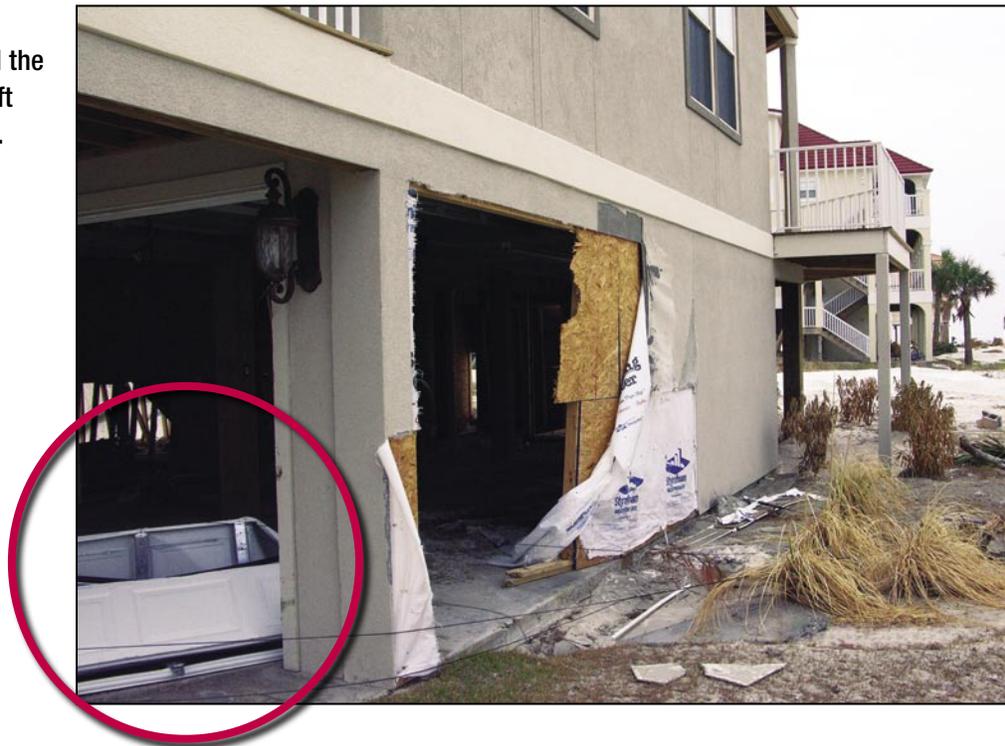
Figure 5-6.
Floodwater collapsed the
garage door at the left
end of this residence.
(Laguna Key)

Fast-moving floodwater initiated damage at the residence shown in Figure 5-6, but a projecting wall band limited progressive peeling of the EIFS in the vertical direction. The synthetic stucco was applied over a cementitious board that was installed over housewrap. Floodwater broke away the wall and initiated progressive peeling of the synthetic stucco and cementitious board. However, the presence of the white band that projected about 2 inches out from the face of the wall inhibited vertical peeling.

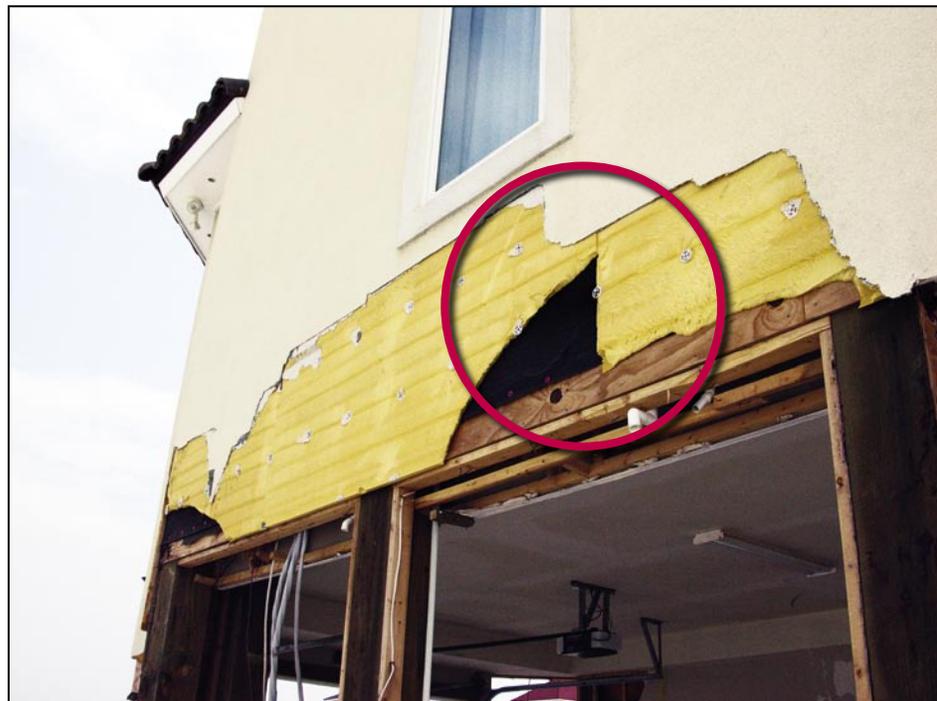
Figure 5-9.
Vertical peeling on a home in Gulf Shores due to lack of a projecting band or reveal after the breakaway wall failed (Laguna Key)

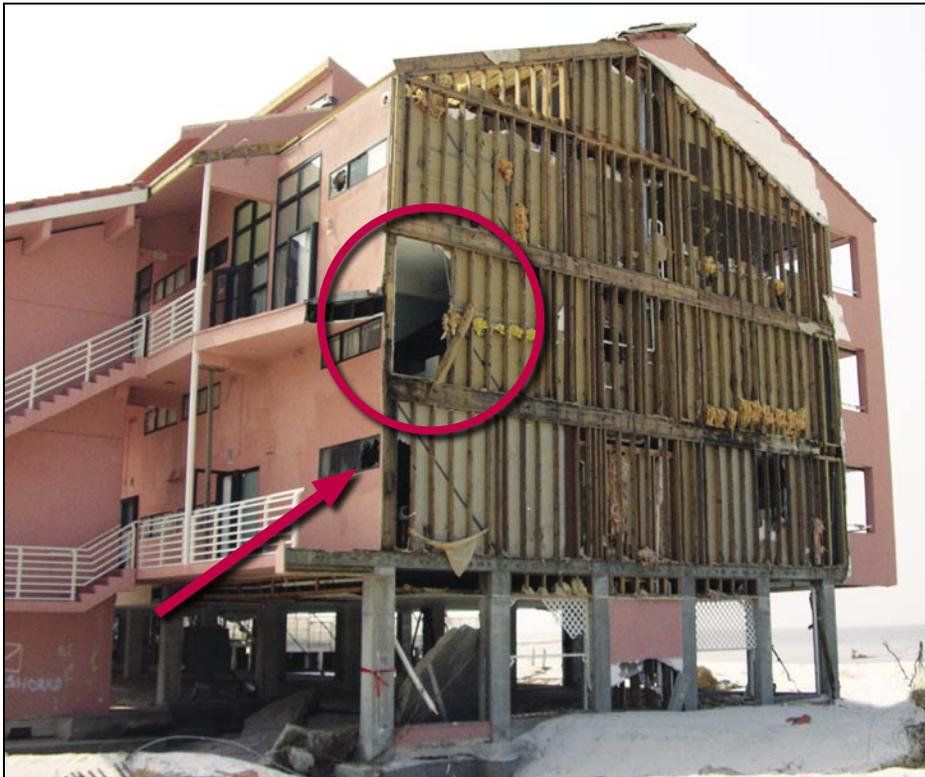
Figures 5-10 through 5-12 show dry rotted studs and sheathing, indicating long-term moisture intrusion behind the molded expanded polystyrene (MEPS) insulation. Both of these buildings used a barrier EIFS design, rather than the newer drainable EIFS design. (No drainable EIFS designs were observed.) At the condominium in Figure 5-10, the synthetic stucco was installed over MEPS over gypsum board over wood studs. Essentially all of the gypsum board blew off (the boards typically pulled over the fasteners). Some of the gypsum board on the interior side of the studs was also blown off. Note the missing studs on the second level at the left. Stud failure may have initiated the EIFS blow-off. Note the metal diagonal stud bracing straps. Two of the windows were broken by debris.

Figure 5-10.
All gypsum board blown off and two windows broken by debris. Note the missing studs. (Pensacola Beach)

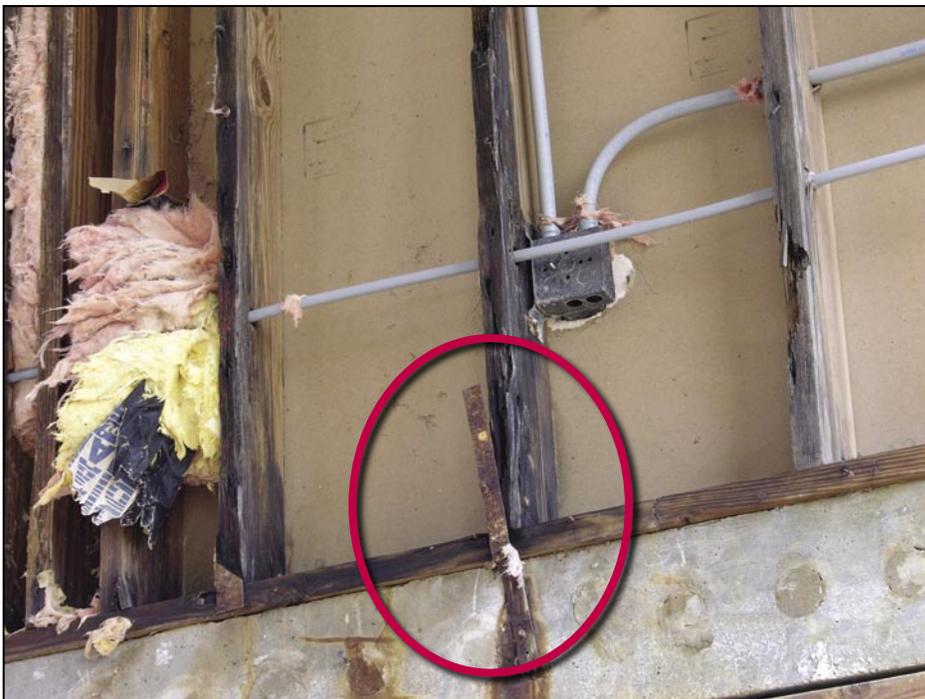
Figure 5-11 is another view of the condominium complex shown in Figure 5-10. The studs were severely rotted and the metal connectors were very corroded.

Figure 5-11.
Severely deteriorated studs and corroded metal connectors

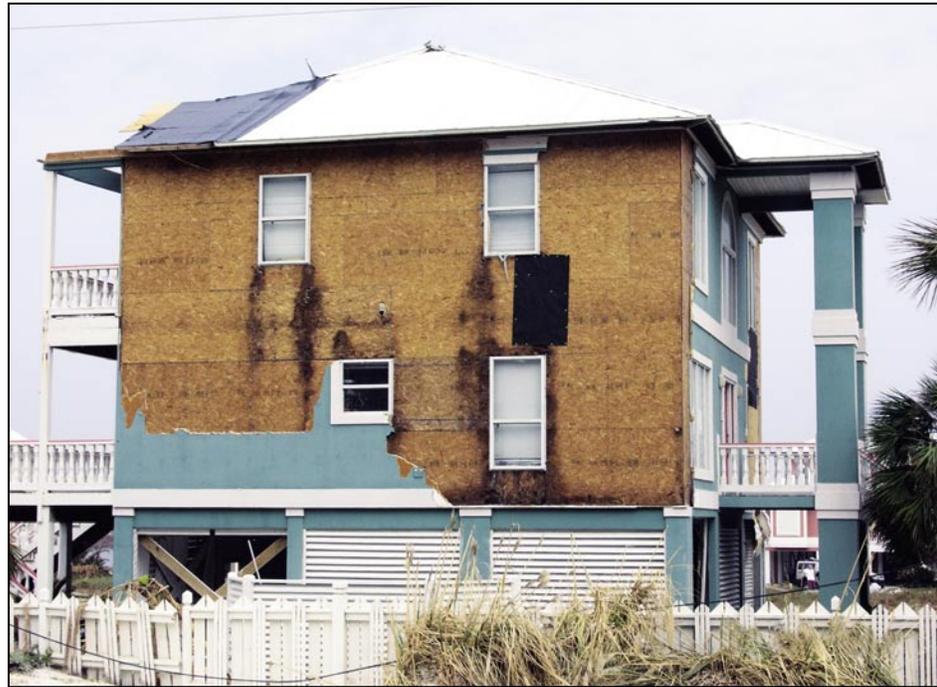
Figure 5-12.
Blown off EIFS revealed severely rotted oriented strand board (OSB) due to water infiltration at windows and wall penetrations. Roof decking blown off of a building with a 5-V crimp metal panel roof.

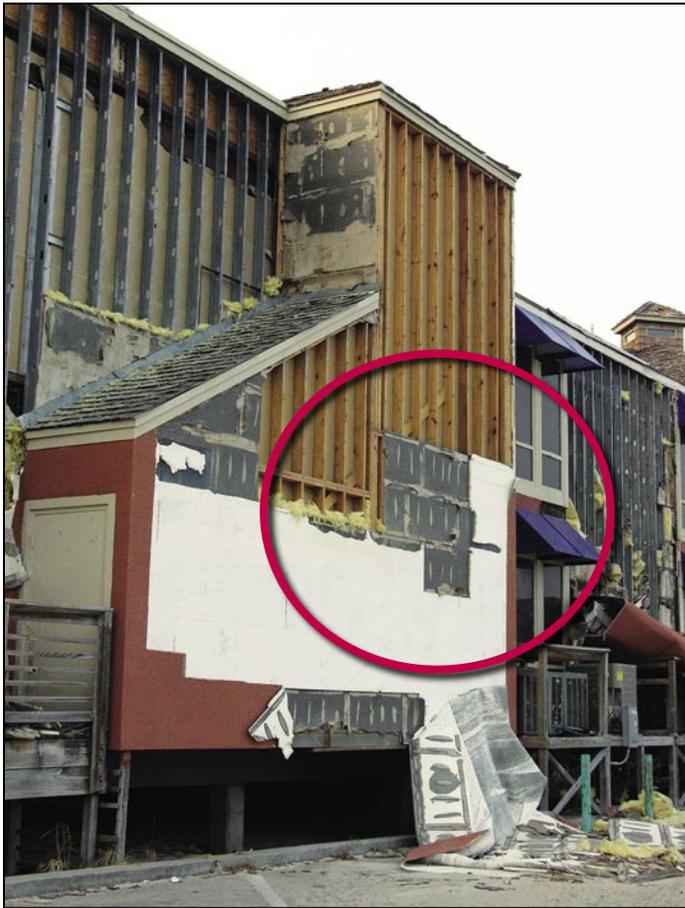
On the building shown in Figure 5-13, wood studs were used in the center section and metal studs were used on adjacent sections. In the center area, gypsum board detached from the studs. Near the bottom of the wall and above the MEPS, the gypsum board is still attached, but the MEPS separated from the gypsum board. At the white area, the synthetic stucco separated from the MEPS. Note the attachment of the MEPS to the gypsum board. Adhesive is nearly continuous at the perimeter of the MEPS boards, and four vertical lines of adhesive occur in the field of the boards (the vertical lines are of different lengths and none of them extend all of the way to the board edges). Adhesive should have been continuously applied throughout the entire board area.

Figure 5-13.
Loss of EIFS on a commercial building

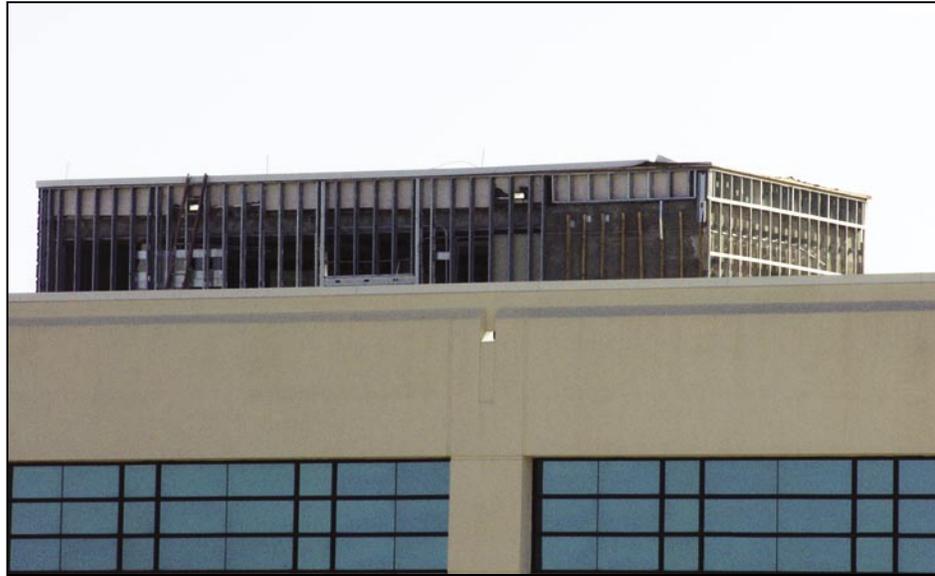
Figure 5-15 shows extensive damage to non-load-bearing EIFS penthouse walls on a mid-rise medical office building (MOB) at a hospital. After failure of the EIFS, rainwater was able to blow into the elevator penthouse and damage the elevator controls. Loss of vertical transportation in mid- and high-rise buildings can severely interrupt functionality.

Figure 5-15.
The gypsum board detached from the studs at the penthouse. Rainwater infiltration damaged the elevator controls. (Pensacola)

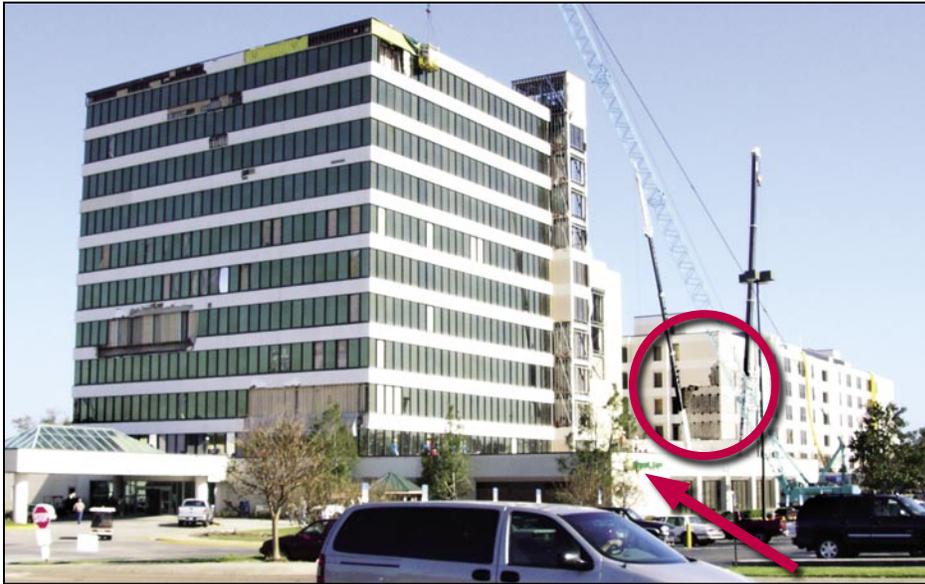
EIFS debris from the hospital shown in Figure 5-16 broke numerous windows in the MOB and several of the windows in the connecting walkway between the MOB and hospital. The projection from the right rear of the MOB is an elevator. The side walls of the elevator shaft were EIFS and windows were located in the front wall. Several windows were broken by EIFS debris. The EIFS (including the gypsum board substrate) blew off the metal studs in several areas. Water infiltration damaged the elevator controls. Several people were trapped in the elevator during the hurricane. Fortunately, the MOB had another bank of elevators, so vertical transportation was still possible, though handicapped by loss of this elevator.

Figure 5-16. EIFS blew off the hospital building in the background (see red circle and Figures 5-18 and 6-2). EIFS debris broke numerous windows in the MOB in the foreground. (Pensacola)

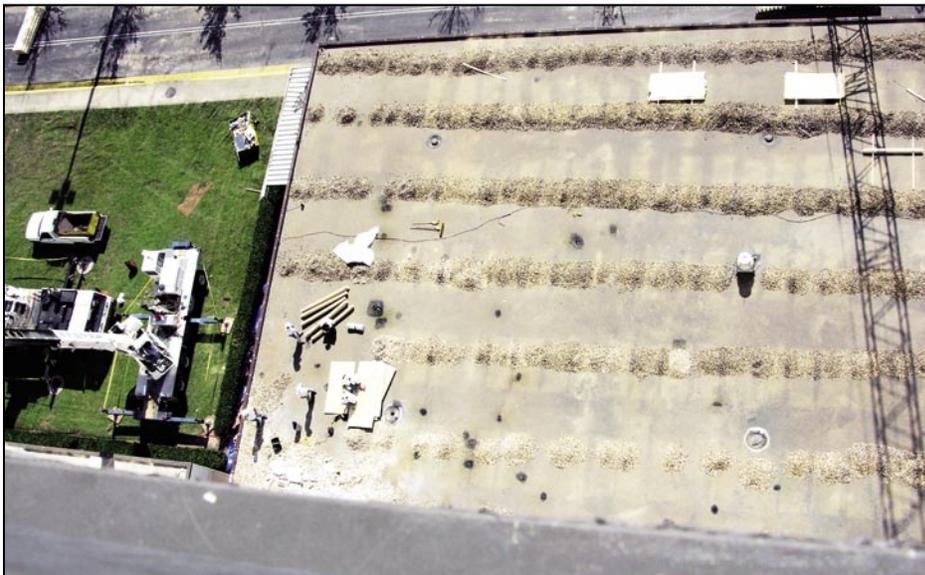
Glass shards punctured the one-story roof (Figure 5-17) at the right of the MOB (red arrow in Figure 5-16), which housed the urgent care facility and regional dialysis unit. However, by quickly performing emergency roof repairs and cleaning up the interior, the dialysis unit was non-operational for only one day. The roof over the dialysis unit was a ballasted ethylene propylene diene monomer (EPDM) membrane roof. The roof deck was a concrete or lightweight insulating concrete topping over metal decking. The deck was effective in minimizing water infiltration into the facility. (Note: At the time the photo in Figure 5-17 was taken, the ballast had been repositioned into rows in preparation for removal.)

Figure 5-17. Looking down at the one-story roof to the right of the MOB in Figure 5-16. The small dark areas are locations where emergency patches had been placed to repair punctures from falling glass shards.

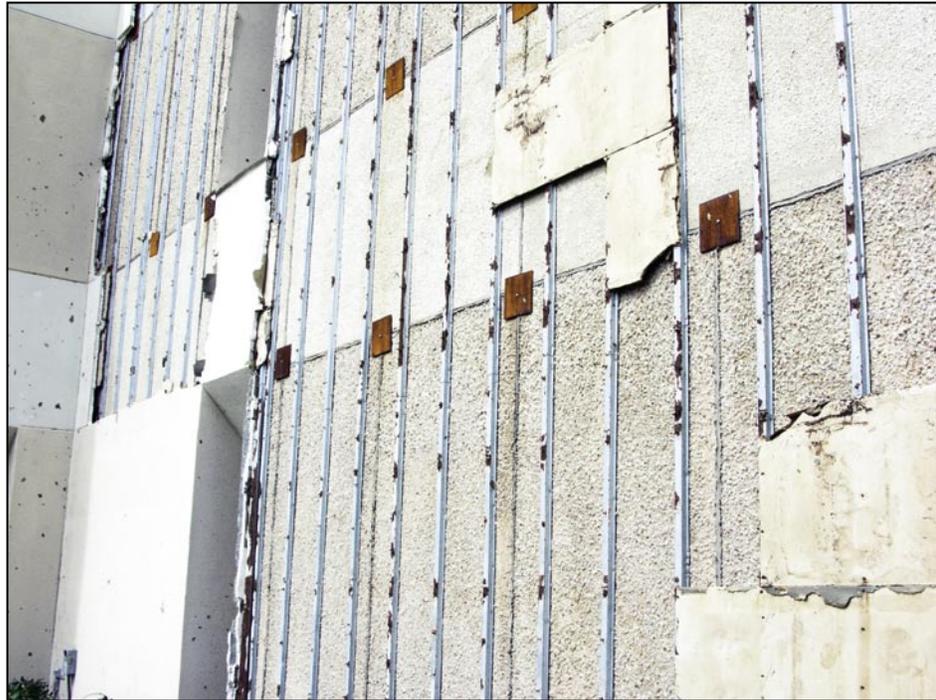
The hospital's original concrete wall panels had been furred with metal hat channels and covered with EIFS (Figure 5-18). The majority of the gypsum board panels had blown off. The boards pulled over the screw heads. The screws and hat channels were moderately corroded.

Figure 5-18.
Close-up of the damaged
EIFS at the hospital

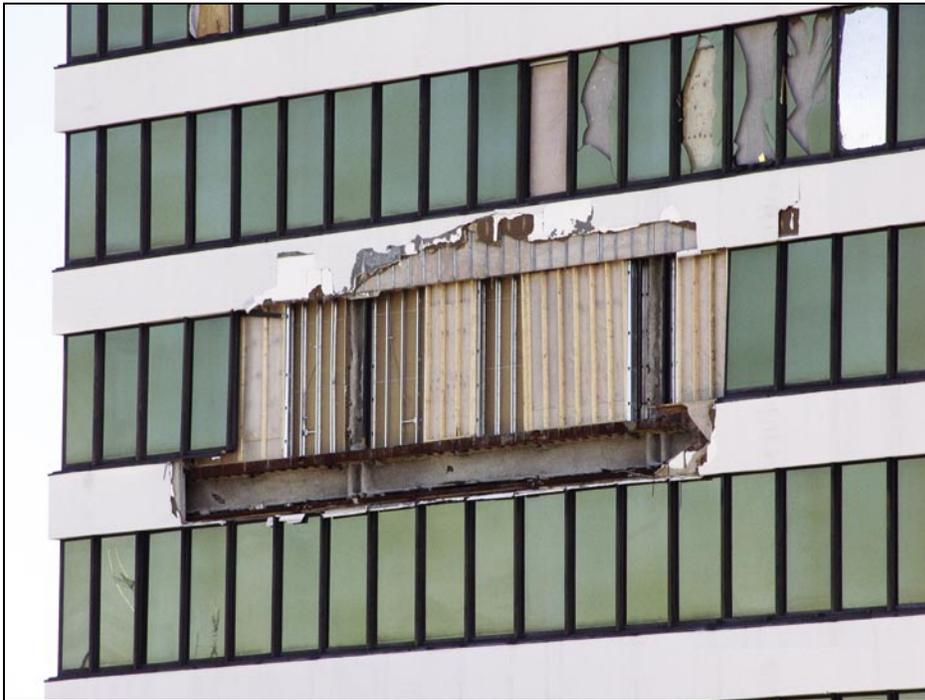
Figure 5-19 shows a close-up of the EIFS spandrel damage and glazing damage at the MOB. Although the majority of the glazing damage was caused by EIFS debris, some window frames were reportedly blown out. These failures were likely due to development of high internal pressure after windows on windward surfaces were broken by debris, combined with suction pressure on the exterior surface of windows on the leeward side of the building.

Figure 5-19. Wood studs and gypsum board had been temporarily installed after the hurricane to prevent patients from inadvertently falling out of the MOB.

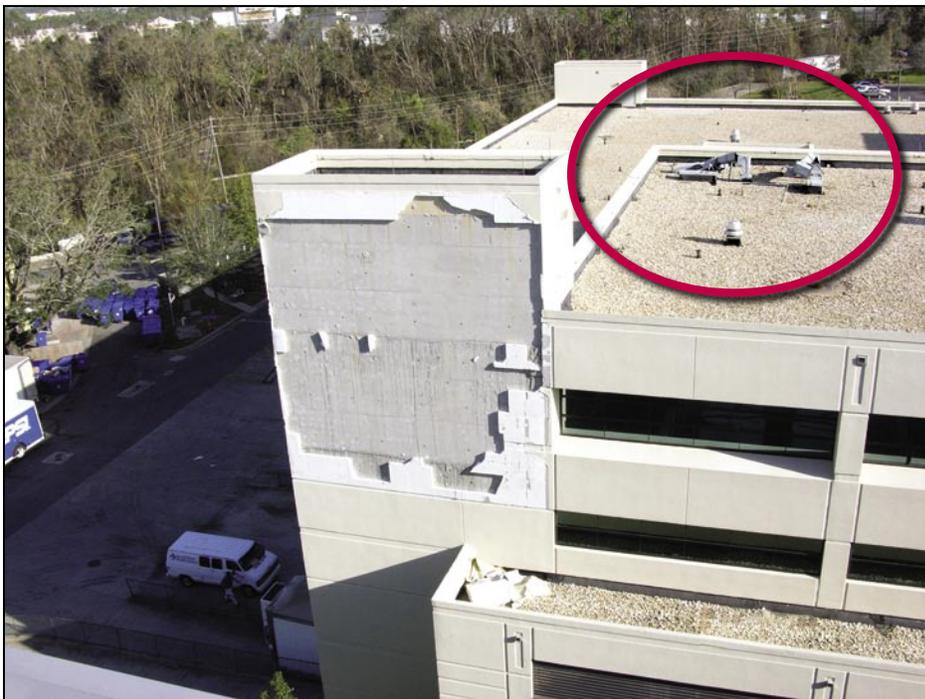
Figure 5-20. Hospital with EIFS blown off a cast-in-place concrete wall. Note the damaged rooftop ductwork. (Pensacola)

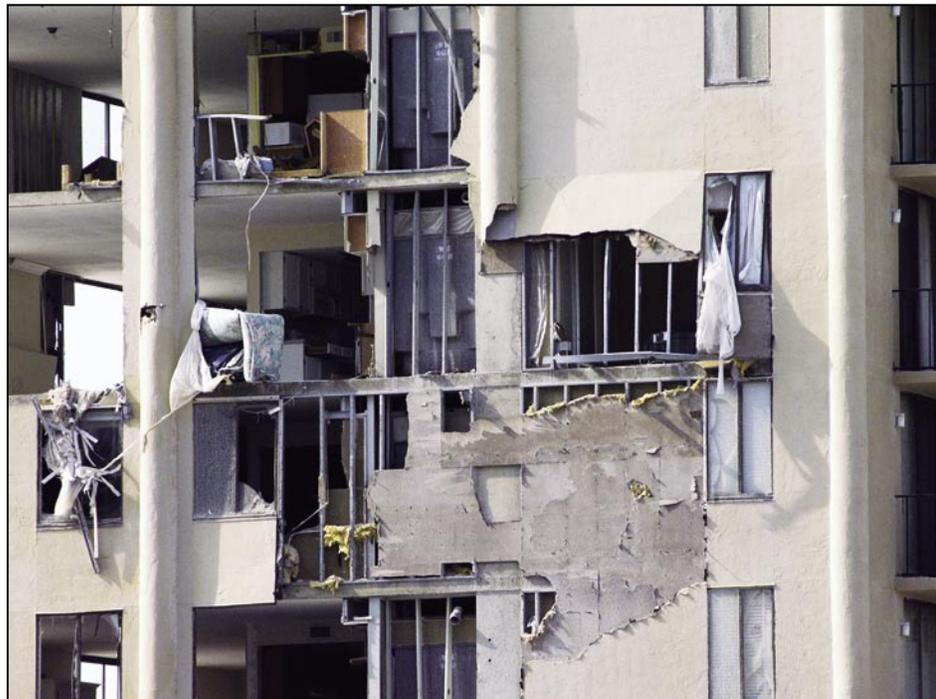
A few buildings with traditional stucco walls were observed. Figures 3-21, 5-22 and 5-23 show significant damage to non-load-bearing stucco walls on two mid-rise condominiums. In several areas, the metal stud system failed; in other areas, the gypsum sheathing blew off the studs; and in other areas, the metal lath and stucco blew off the gypsum. It appeared that failure of the stud track connections initiated most of these failures. Figure 5-23 illustrates a serious potential risk to residents.

Figure 5-22.
Failure of non-load-bearing stucco wall
(close-up of Figure 3-21)
(Perdido Key)

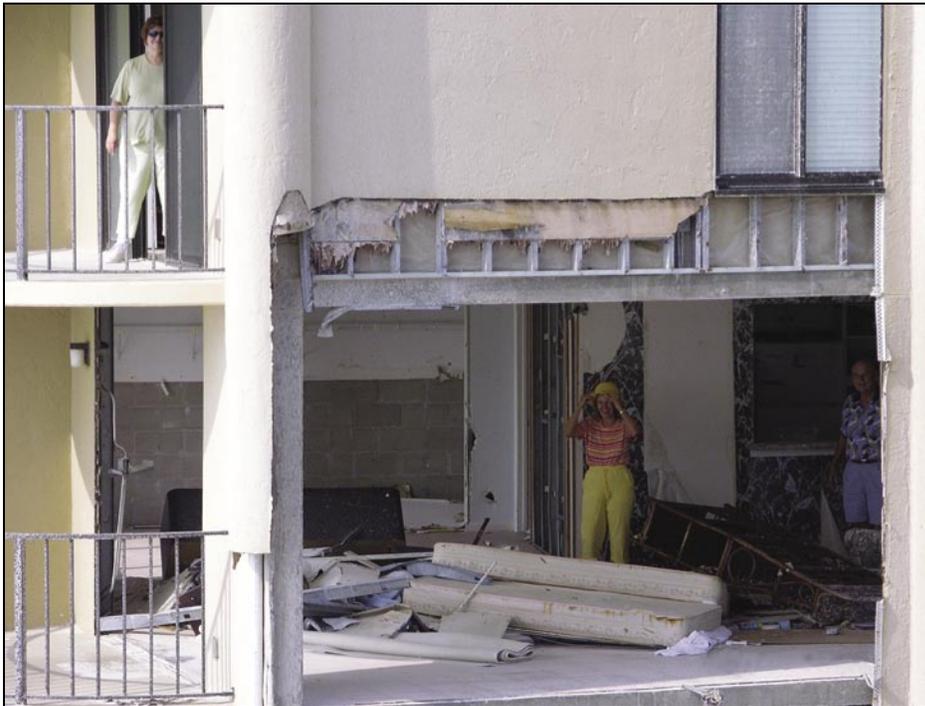
Figure 5-23. Close-up of Figure 3-21. With complete loss of the walls, the residents could have inadvertently fallen from the building. Although not shown in this photograph, several of the balcony railings had blown away. (Perdido Key)

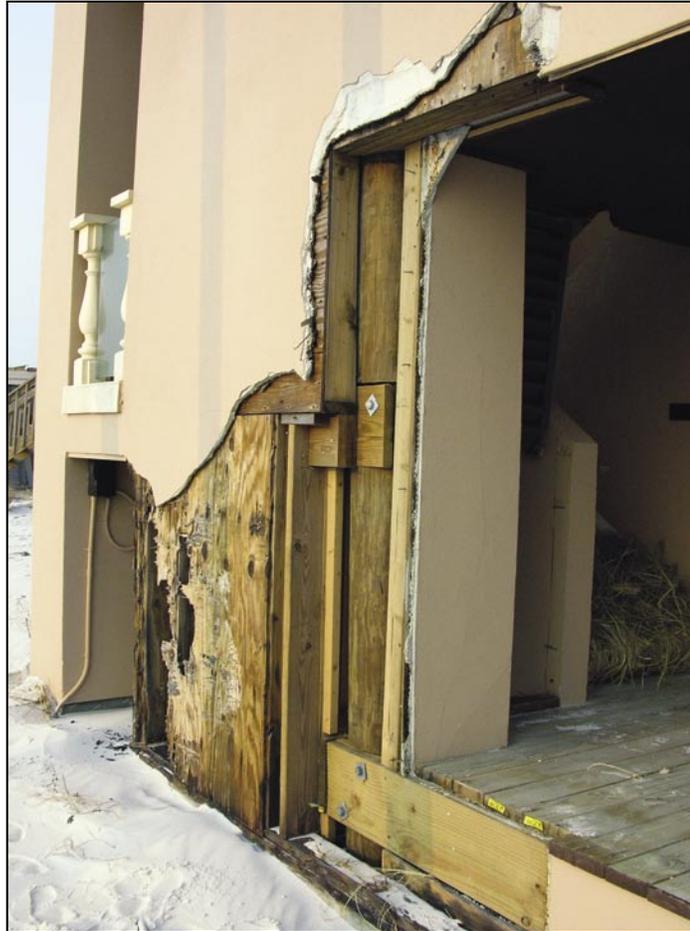
On a few buildings, stucco was applied over plywood over wood studs. At the residence shown in Figure 5-24, the plywood was severely rotted. Figure 5-25 shows failure of stucco applied over cast-in-place concrete. Similar failures were observed in Puerto Rico following Hurricane Georges (see FEMA 339, *Hurricane Georges in Puerto Rico*, March 1999).

Figure 5-25.
At the end wall of the center building, stucco blew off the concrete substrate. Some of the chimney walls made of stucco over gypsum board over wood studs were also blown away.

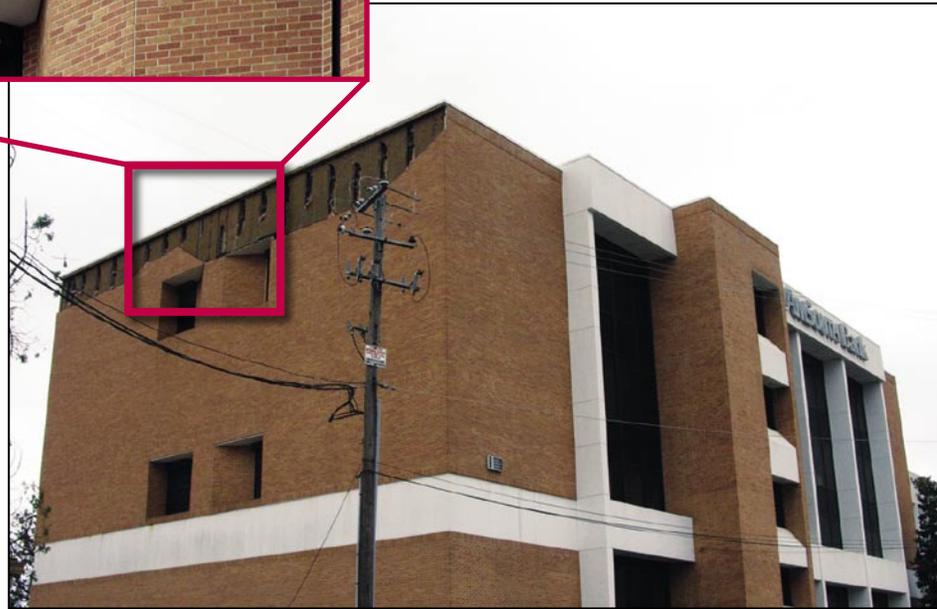
Several buildings with brick veneer were observed. Figure 5-26 shows failure on an office building. The majority of the corrugated ties remained attached to the steel studs. The ties were spaced approximately 18 inches on center vertically and 16 inches on center horizontally. According to another investigation team that had access to the building, the primary mode of failure was tension failure of the ties due to severe corrosion. Based on the Brick Industry Association's (BIA) *Technical Notes 28B – Brick Veneer/Steel Stud Walls*, “corrugated ties are not permitted when brick veneer is supported by steel stud backing.” In part, this provision is based on the greater corrosion susceptibility of corrugated ties versus round ties (i.e., water is more likely to remain for a longer period of time on the flat surface of corrugated ties). The tie spacings were closer than the maximum recommended in *Technical Notes 28B*, which is 18 inches on center vertically and 32 inches on center horizontally, yet still failed due to corrosion.

Figure 5-26.
Brick veneer failure on an office building
(Pensacola).

For the building shown in Figure 5-26, because the contract documents were not available, it is unknown whether use of the incorrect ties was a design or application error. For the residence shown in Figure 5-27, failure to embed the ties into the mortar joints was a major workmanship error. Failure to embed ties was documented in a Hurricane Opal report by The Masonry Society (*An Investigation of the Effects of Hurricane Opal on Masonry*, The Masonry Society, July 1996). Opal struck the Florida Panhandle in 1995.

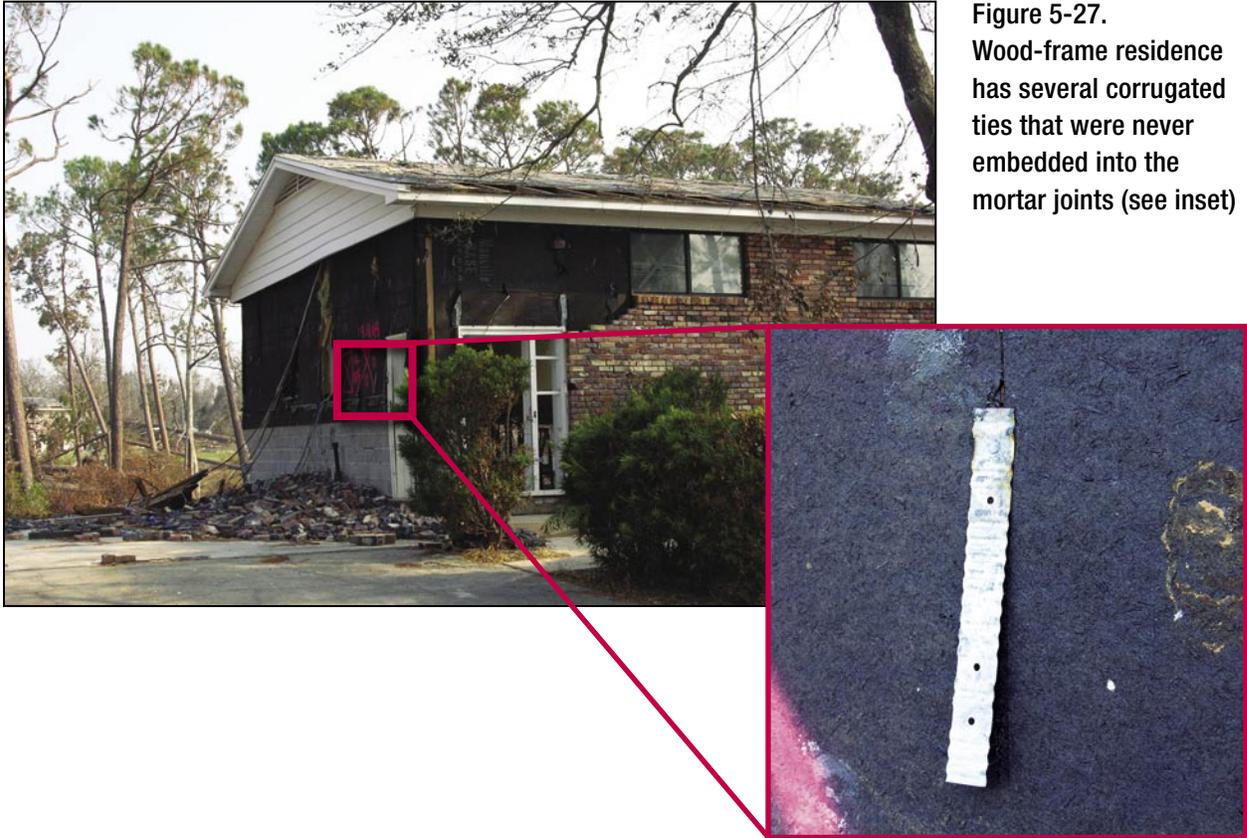
Figure 5-27 shows failure at an older wood-framed residence. There were several failure modes:

- Several ties had never been embedded into the mortar joints
- The tie nails pulled from the studs
- Lack of bonding between mortar and brick
- Tie tension failure due to severe corrosion (this occurred on a tie embedded into the CMU foundation wall that extended about 4 feet above grade)

Figure 5-27. Wood-frame residence has several corrugated ties that were never embedded into the mortar joints (see inset)

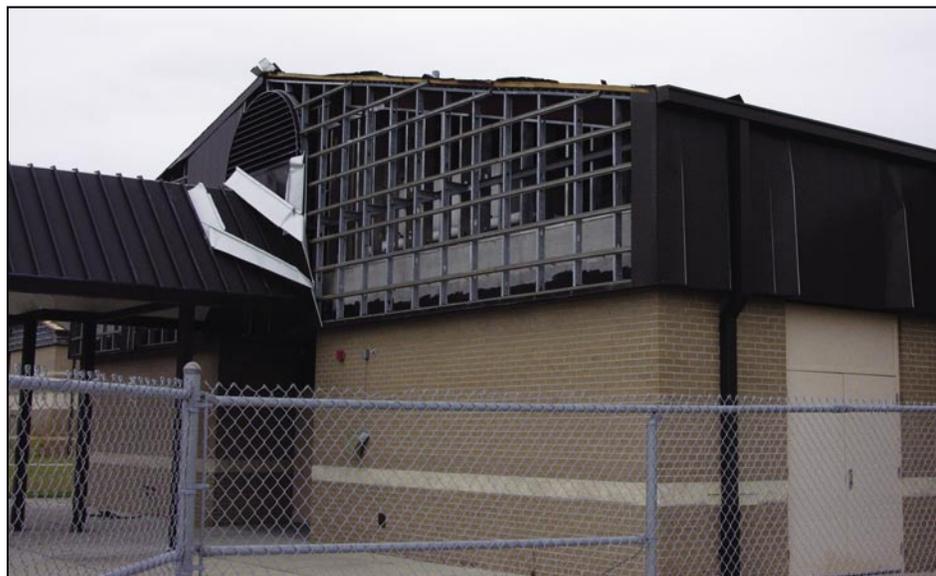
The MAT observed a limited number of metal wall panel failures. Failures were observed at two schools (Figures 3-25 and 5-28). Both schools used similar panels. The panels were attached with concealed screws. The screws were installed through concealed portions of the standing seams. The failures occurred due to unlatching of the seams.

Figure 5-28. These panels were attached with concealed fasteners. They unlatched at the standing seams. In addition to generating windborne debris, loss of panels allowed significant rainwater infiltration.

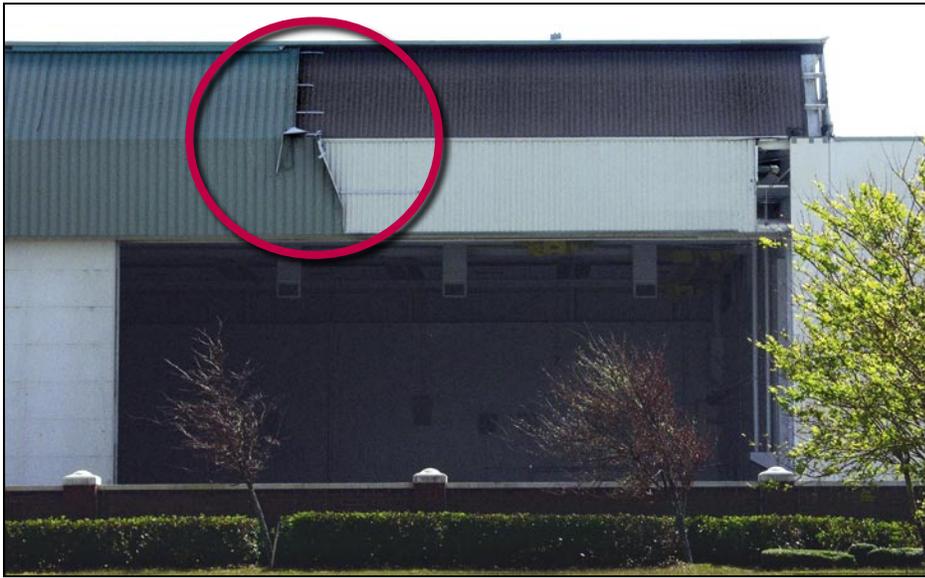
Another wall panel failure was observed at a hangar (Figure 5-29). New panels had been installed over older panels. In one area, the top leg of a channel had been screwed at 63" and 43" to the old panels. The bottom leg had been screwed at 21" and 43". The new panels were attached with clips that were screwed at 12" on center to the hat channels. There were two screws per clip. The connections of the new panels to the hat channels were much stronger than the connections between the hat channels and old panels.

Figure 5-29. The green fascia panels had been installed over a previous metal panel system. The original panels remained in place, but the newer panels blew off due to inadequate hat channel attachment. (Pensacola)

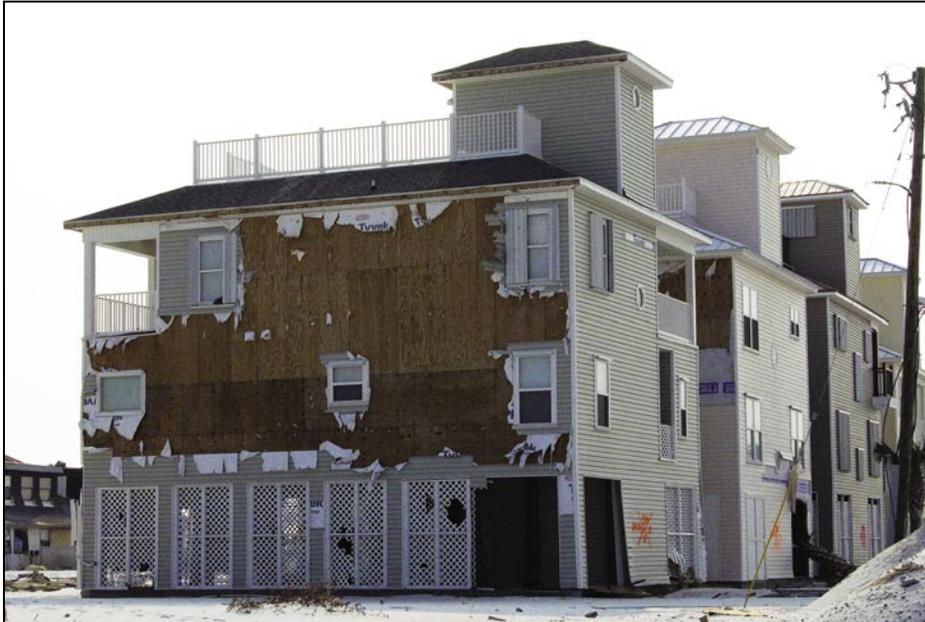
Vinyl siding manufactured for high-wind areas is available, but was observed on only one building (Figure 5-31). With high-wind siding, the nailing flange is folded over, so there is a double thickness of vinyl at the fastener points (Figure 5-32).

Figure 5-31. Although a high-wind panel was used, extensive loss of siding and housewrap underlayment occurred. See Figure 5-32.

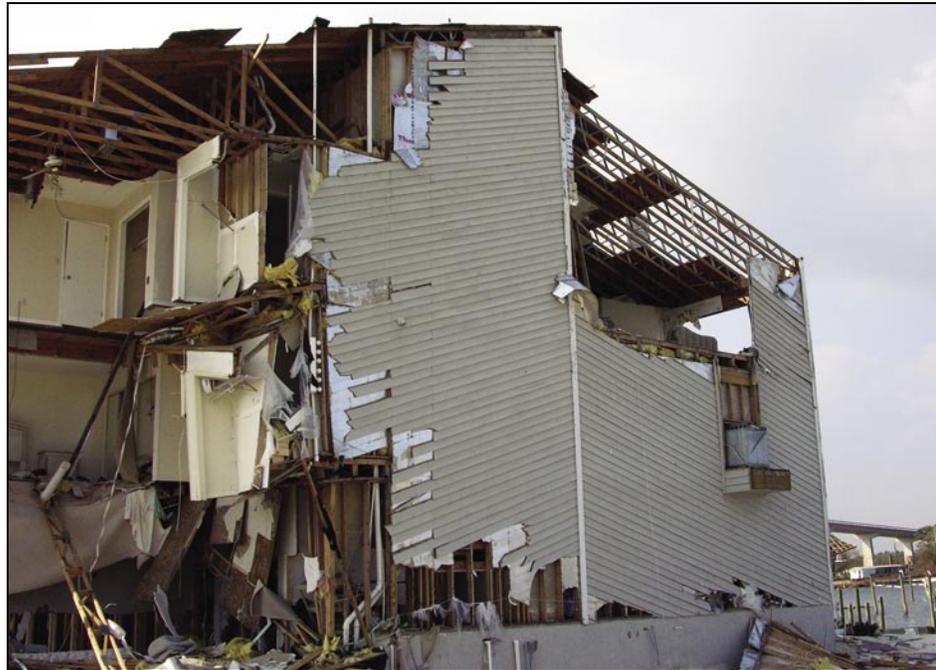
Figure 5-35.
Vinyl siding had been installed over textured plywood siding. Although a large area of vinyl blew off, the plywood was not damaged, leaving the building envelope intact. This scenario was observed on several buildings.

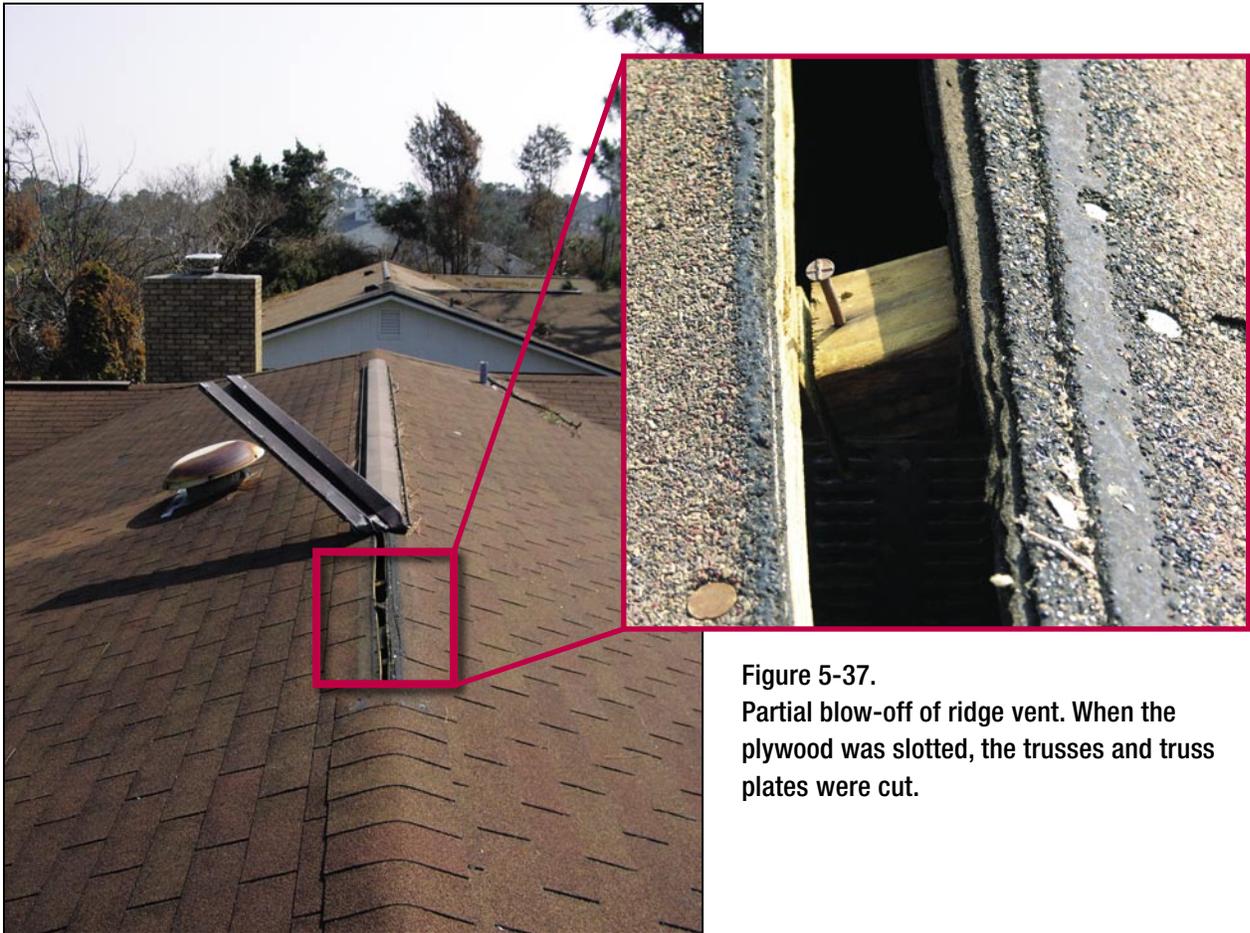
A limited number of ridge vents were investigated. Figure 5-37 shows a metal ridge vent failure. Where the vent lifted, it was attached with roofing nails spaced at 22 ½" and 19¾" on one side of the ridge, and 21" and 17 ¾" on the other side. In an area where the vent was not blown off, the nails were spaced at 18 ½", 10", 11 ½" and 11 ½". The nails were moderately corroded. This residence was not originally constructed with a continuous ridge vent. The slot through the plywood roof decking was cut during a reroofing project. When the slot was cut, the blade of the power saw was not adjusted to suit the deck thickness. As a result, a deep cut was made through the trusses and metal connectors (Figure 5-37 inset).

Figure 5-37.
 Partial blow-off of ridge vent. When the plywood was slotted, the trusses and truss plates were cut.

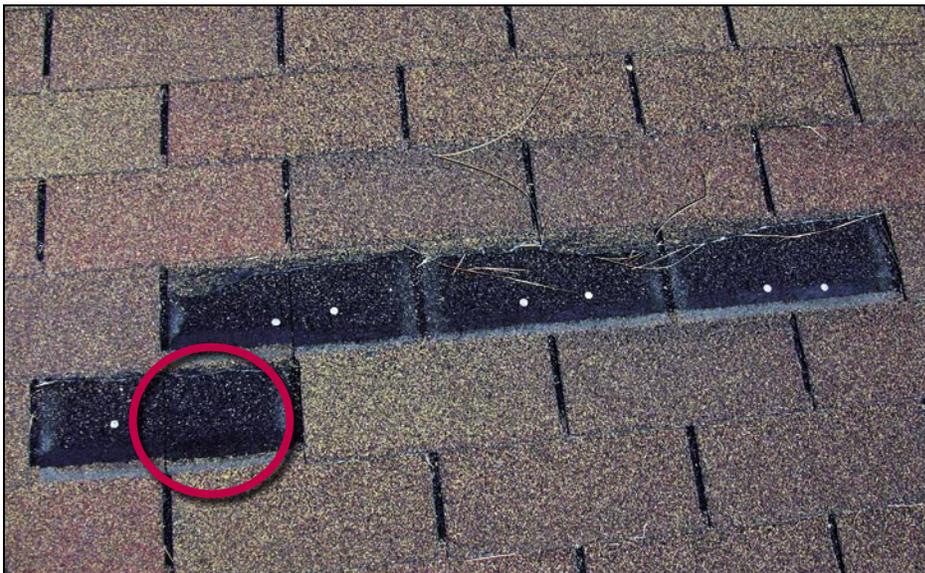
Figure 5-38.
 Missing tabs. All of the nails were installed too high, and two of the end nails were too far from the end. An end nail had not been installed at the lower tab.

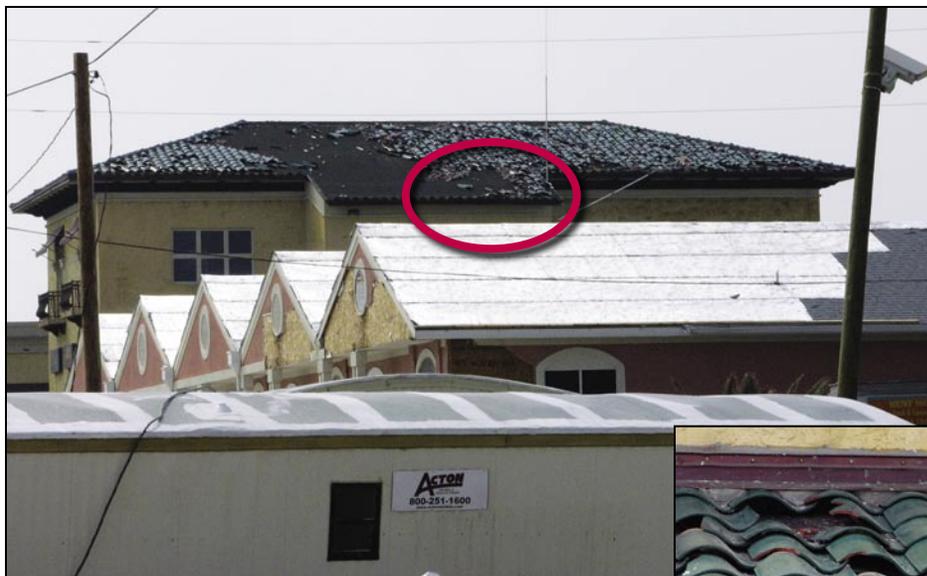
Figure 5-40. Direct-to-deck mechanically attached clay tile. The tiles were attached with two nails per tile. The nails typically remained in the deck. See Figure 5-41.
