Building Envelope Performance

5.1 Sheathing on the Underside of Elevated Buildings

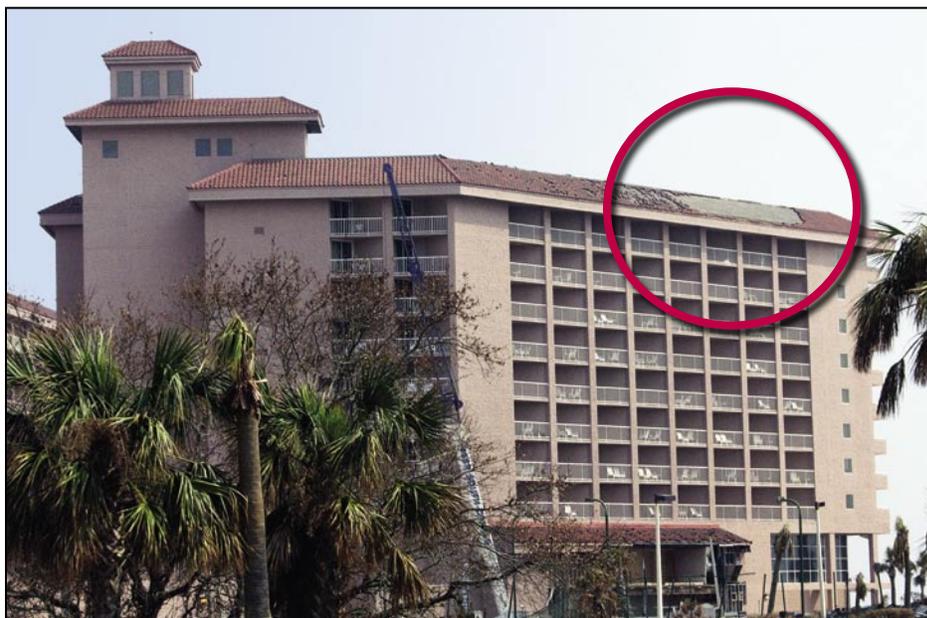
Several batten-attached roofs were observed. Tiles flying from a mid-rise building, such as that shown in Figure 5-43, can sail a considerable distance and have very destructive energy.

Figure 5-43.
Loss of several batten-attached tiles from a mid-rise building

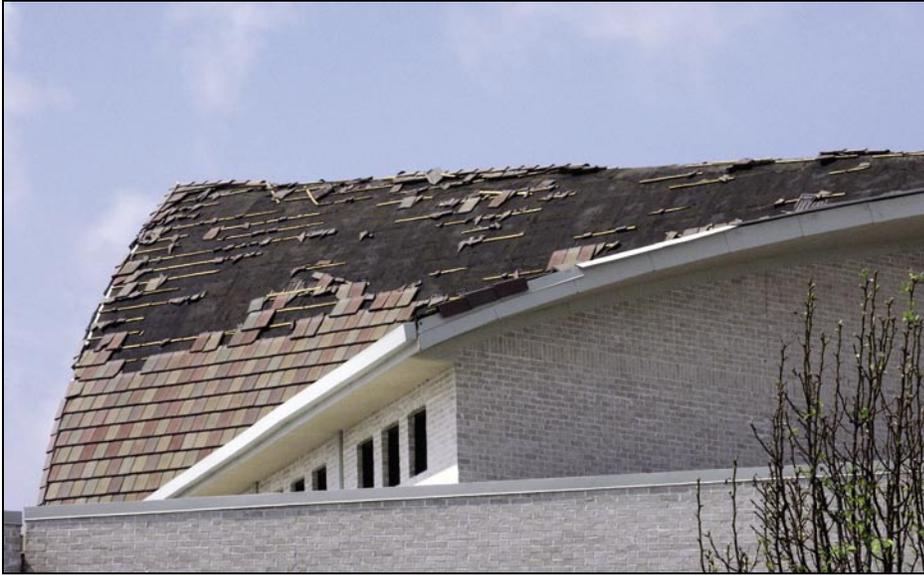
The batten-attached tile damage shown in Figure 5-46 was primarily caused by wind pressure. Several of the battens were blown away, thus indicating inadequate attachment of the battens.

Figure 5-46. The majority of these batten-attached tiles were displaced by wind pressure. Many battens were blown away. See Figure 5-47 for a view of the lower-sloped roof.

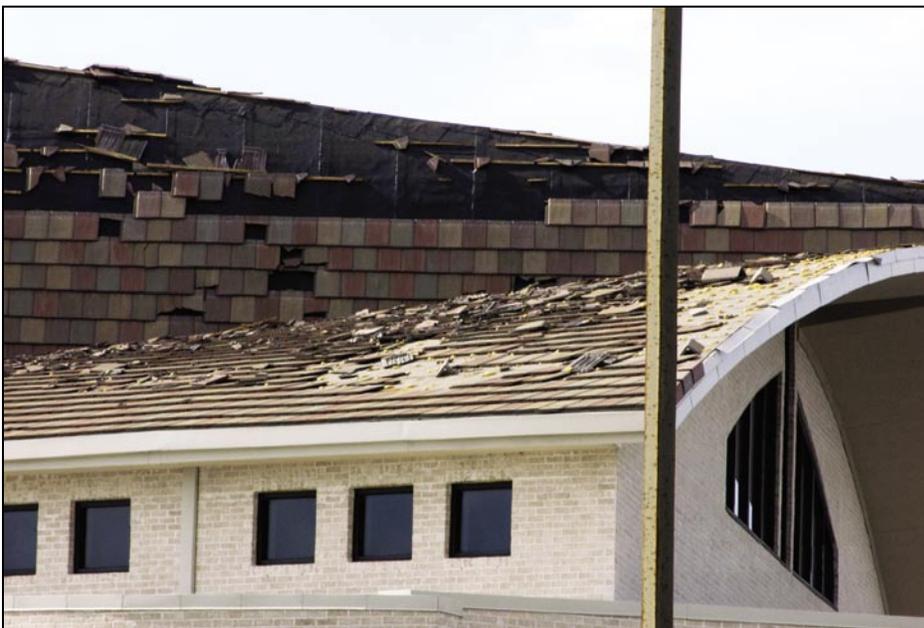
Figure 5-47. The tiles on the lower sloped roof were foam-set. The damage on this roof was due to a combination of wind pressure and windborne debris.

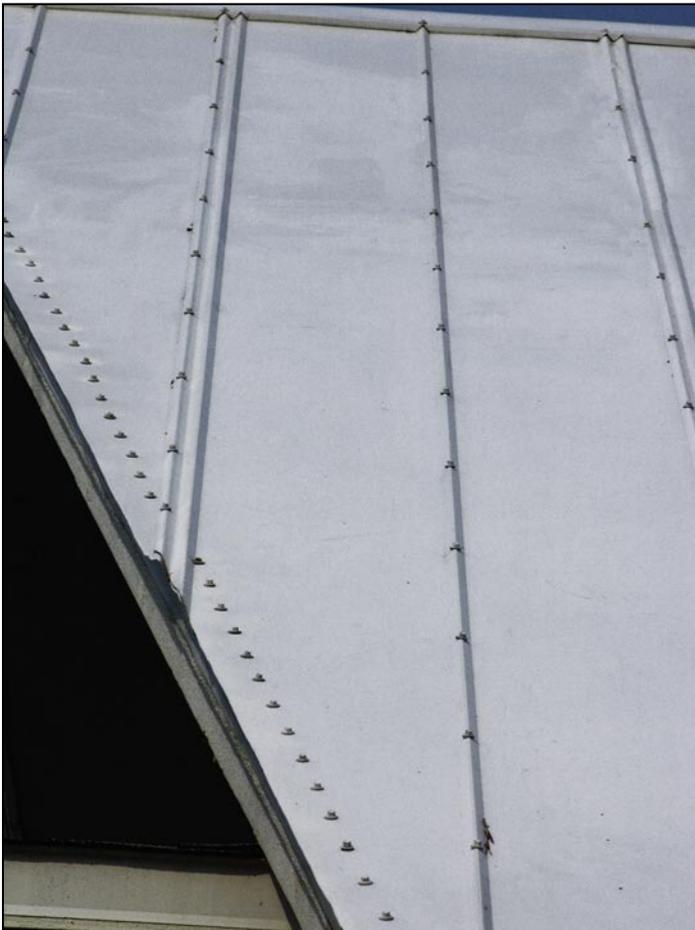
Figure 5-55. This 5-V crimp metal panel roof performed very well. The screws along the rake were very closely spaced; thus, this potentially vulnerable edge condition was well secured.

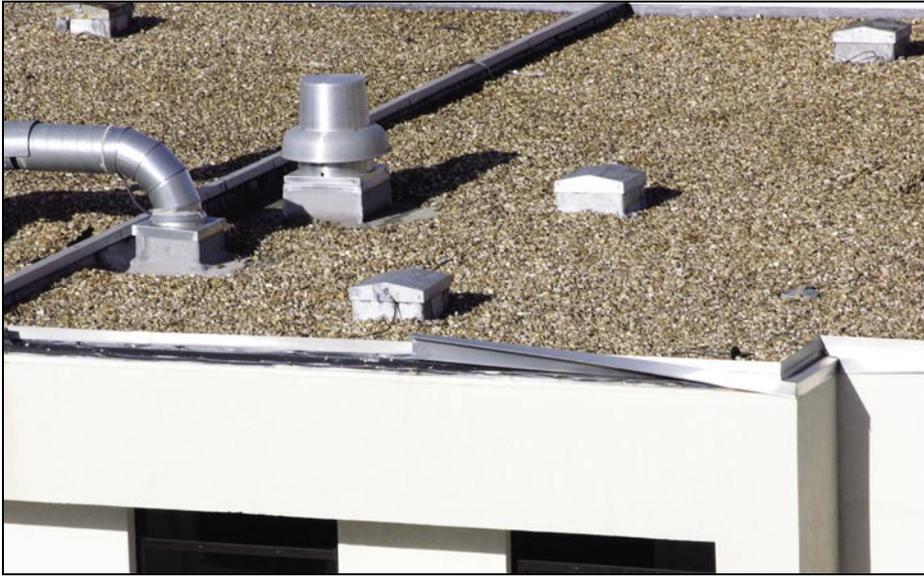
Figure 5-57. Although the metal edge flashing lifted, a progressive membrane lifting and peeling did not occur. Some aggregate ballast was blown off an adjacent higher roof. (Pensacola)

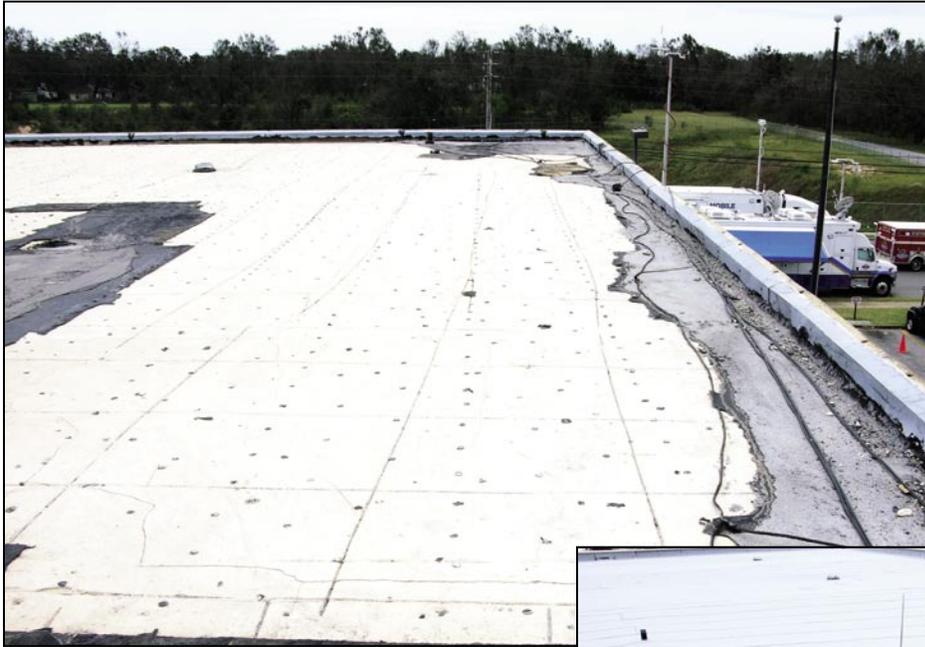
Figure 5-59 shows blow-off of a large portion of a BUR on an Emergency Operations Center (EOC). The membrane was mechanically attached to a lightweight insulating concrete (LWIC) deck. In one area the base sheet had been attached along the side lap with fasteners spaced at 8 ½", 9 ½" and 8 ½". At one of the adjacent intermediate rows, the fasteners were at 32 ½" and 32". The typical base sheet attachment specification is 9" at the laps and 18" at two intermediate rows. The failure may have been initiated because of inadequate attachment of the base sheet; however, it may have initiated at the parapet base flashing. The base flashing was mechanically attached to the parapet. Turbulence at a corner area (inset in Figure 5-59) likely generated high suction loads on the base flashing, which may have been sufficient to pull the base flashing off the parapet and cause a progressive lifting and peeling of the membrane. Parapet base flashing damage was also observed on a new hospital addition (Figure 5-60).

Figure 5-59. Loss of a mineral-surfaced BUR installed over LWIC. Failure may have been due to inadequate attachment of the base flashing to the parapet (see inset). (Pensacola)

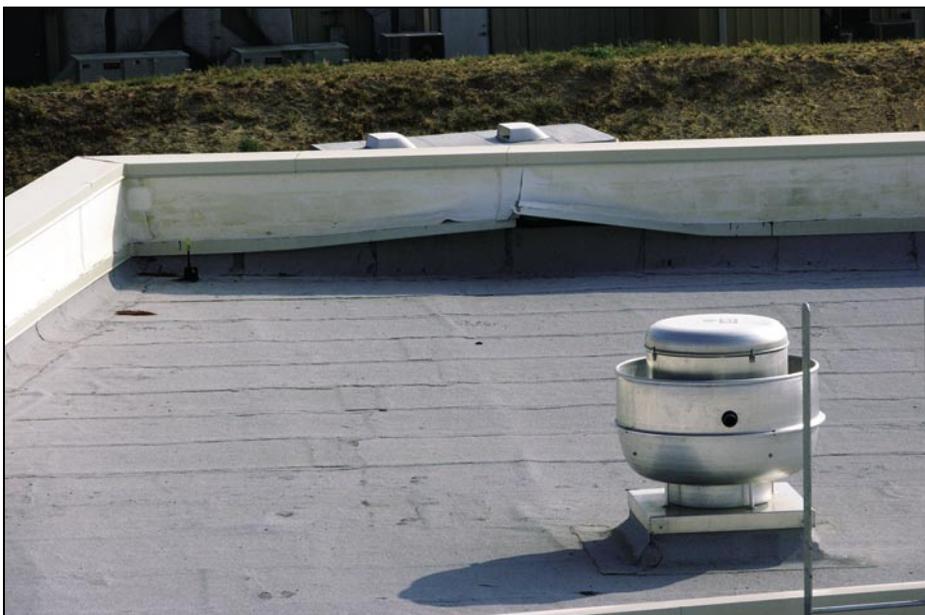
Figure 5-60. Minor base flashing displacement on a new hospital roof (Gulf Breeze)

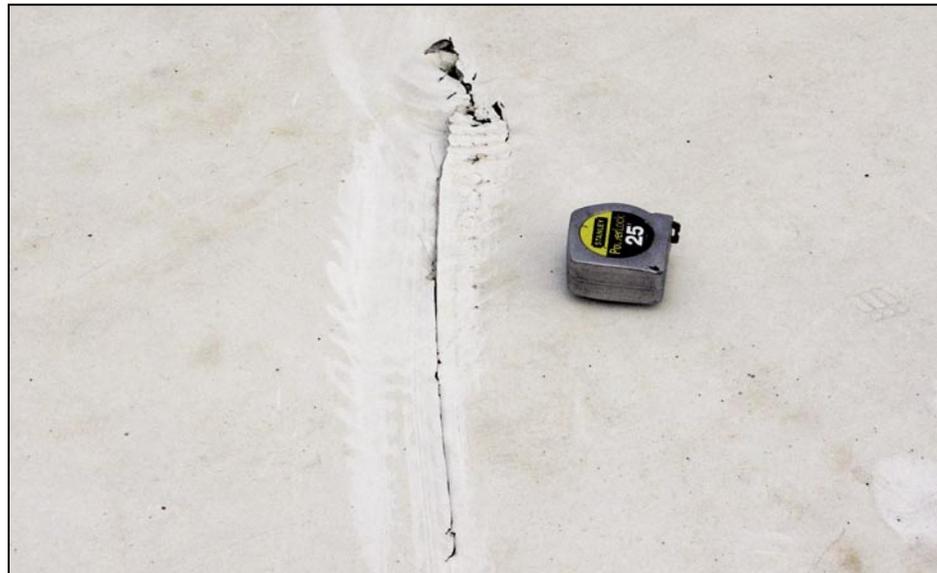
Figure 5-62.
This hospital roof had
been punctured in
several locations by
windborne debris. When
punctured, a secondary
membrane, as discussed
in FEMA 424, is needed
to avoid water infiltration.
(Pensacola)

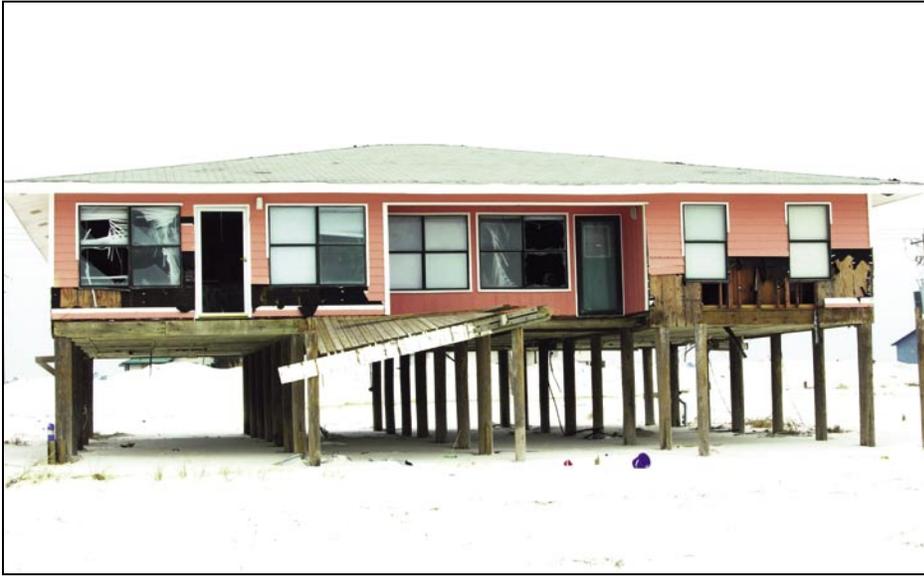
Figure 5-63.
Several windows on this ocean-front home were broken by windborne debris.

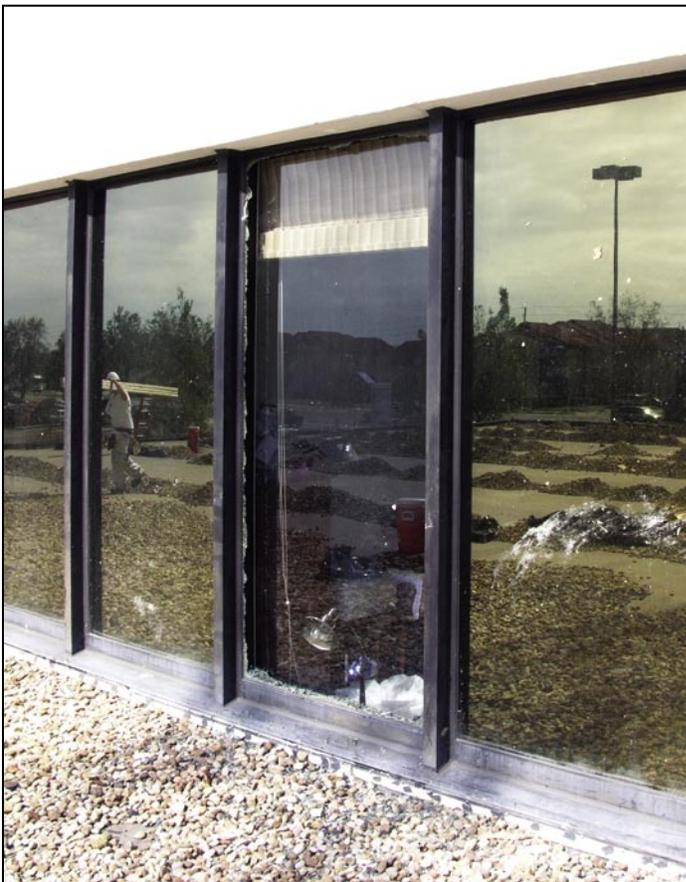
Figure 5-64.
The outer pane of this tempered glass window was broken by windborne debris (aggregate roof ballast, falling glass shards from windows above, or EIFS). (Pensacola)

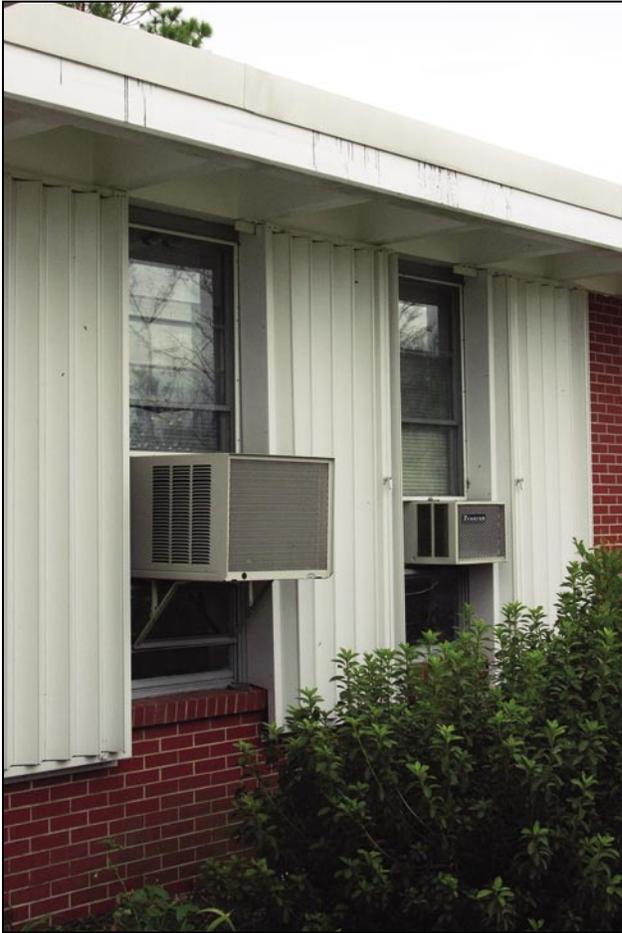
Figure 5-66.

A few problems were observed with shutters. At the school shown in Figure 5-66, shutters had been retrofitted. However, shutters were not placed over the windows above and below window air conditioners or over the glazed entrance doors. Although the shutters that were installed decreased the amount of exposed glass and, as a result, reduced the probability of glazing damage, a shuttering project should protect all exterior glazing. Another problem is illustrated by Figure 5-67, wherein metal panels did not completely cover the glazing. Also, at that shutter, wing-nuts were installed at only every other fastener stud. Installation of nuts on every other stud was observed on several different buildings. When all of the nuts are not installed, shutters are more susceptible of being blown away.

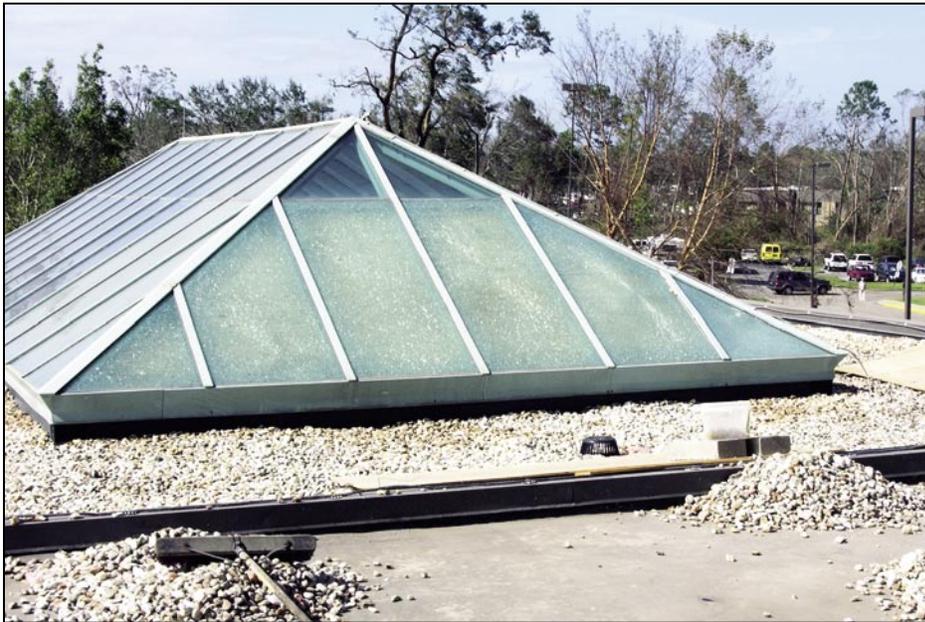
Figure 5-69. Several laminated glass panes were broken, but they remained in their frames. The panes were likely broken by ballast, although falling glass shards or EIFS may have caused the damage. (Pensacola)

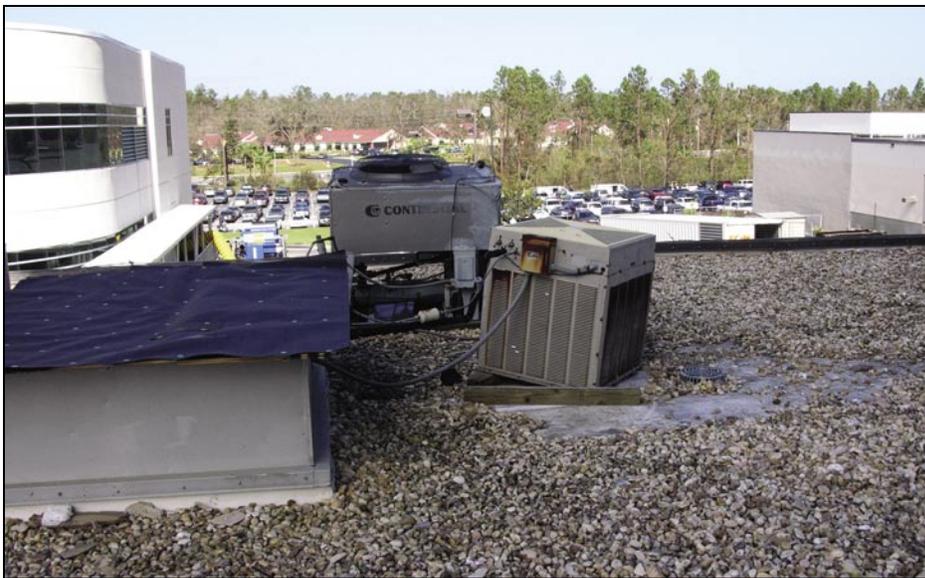
Figure 5-72.
At this hospital, the condenser moved off the sleepers and a nearby relief air hood was blown away. (Pensacola)

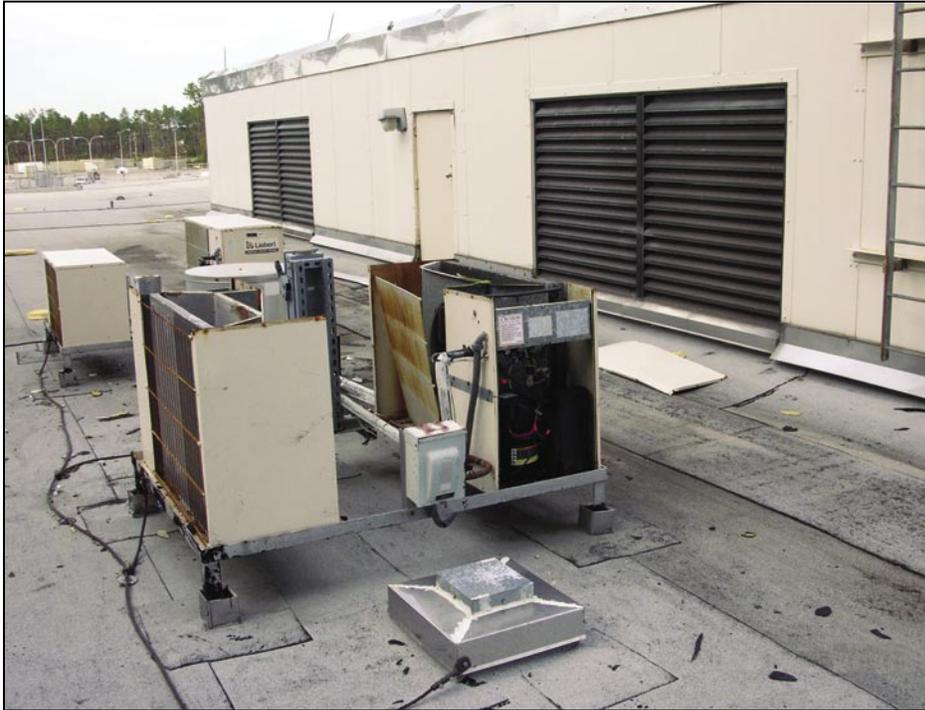
Another observed problem was loss of HVAC access panels (Figure 5-74). This type of problem was observed at two hospitals. Windblown panels can tear roof membranes and break unprotected glazing. Damaged rooftop ductwork was also observed at hospitals and an EOC (Figures 5-75 – 5-77). The damaged ductwork provided a direct path for water to enter the buildings. The majority of the damage was caused by wind pressure; however, the damage ductwork shown in Figure 5-77 was likely caused by roof membrane debris.

Figure 5-74. Sheet metal access panels and shrouds were blown off this equipment at a hospital. Displaced panels can tear roof membranes and break glazing. (Pensacola)

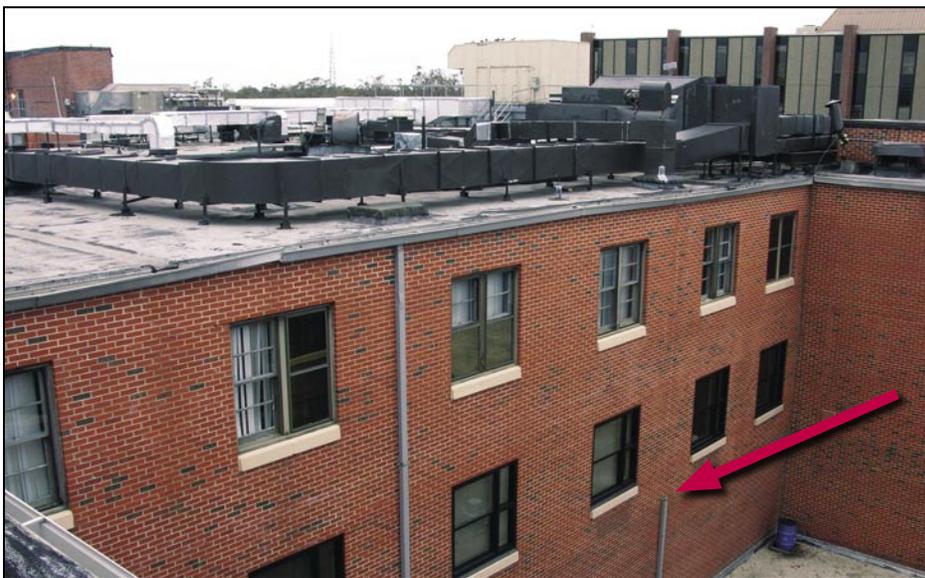
Figure 5-75. Ductwork and fan units on this hospital were damaged in several locations. Some of the windows in this area were also broken. Note the missing downspout. (Pensacola)

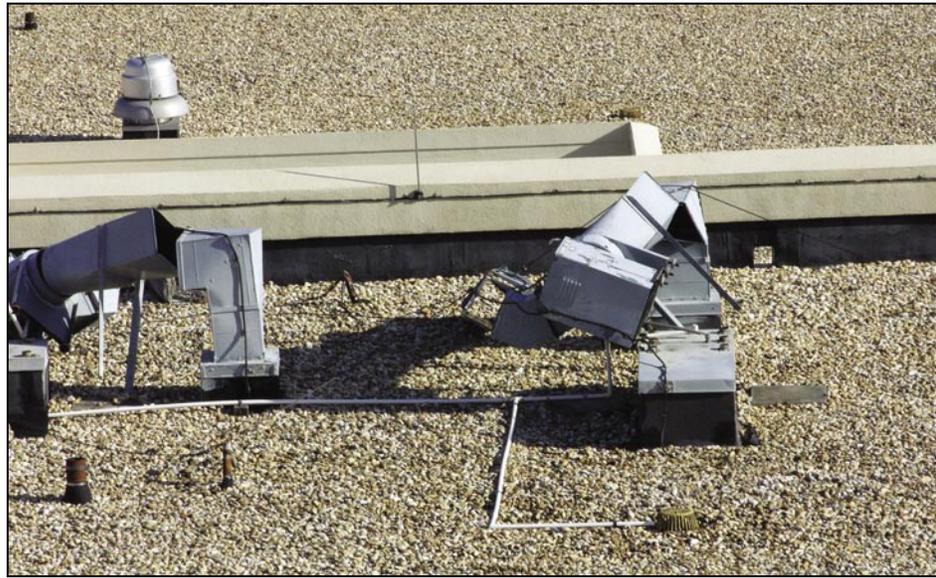
Figure 5-77.
Damaged ductwork at
an EOC. This damage
was likely caused by roof
membrane debris that
blew off a nearby area.
(Pensacola)

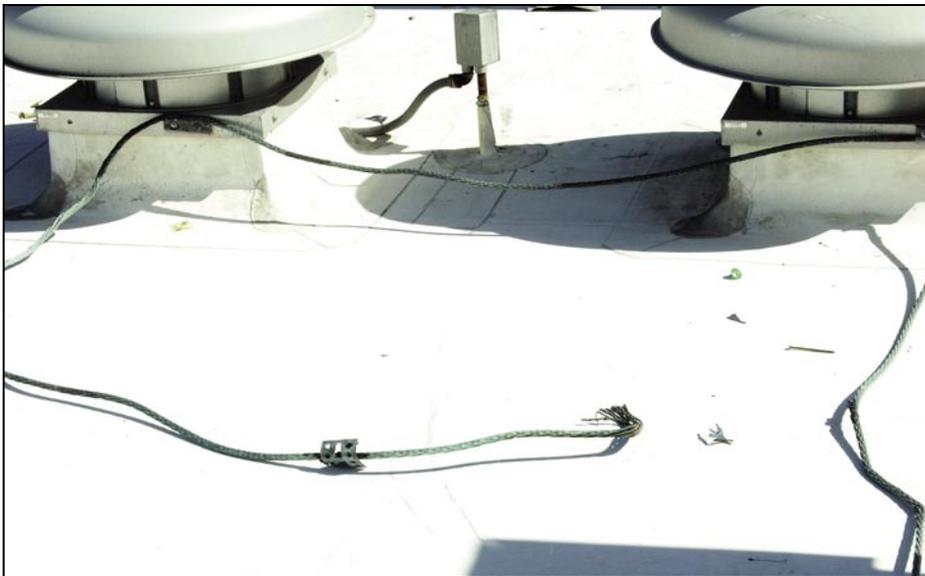
Figure 5-78.
The LPS on this hospital became detached. Loose LPS can severely damage roof membranes, and loose LPS does not provide the intended lightning protection. (Pensacola)

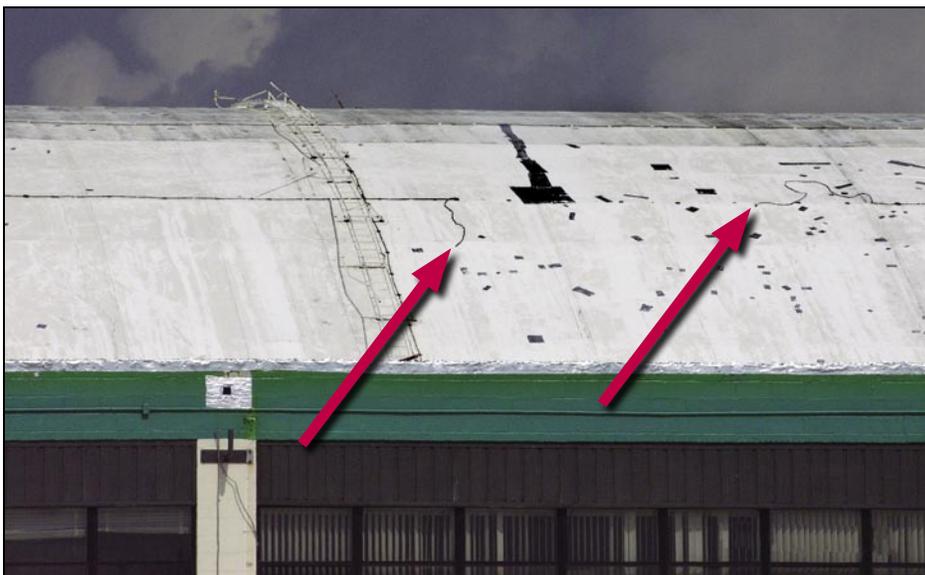
Figure 5-79.
The LPS conductor on this hangar became detached and punctured the roof membrane in several locations. (Arrows show ends of loose cable.) (Pensacola)

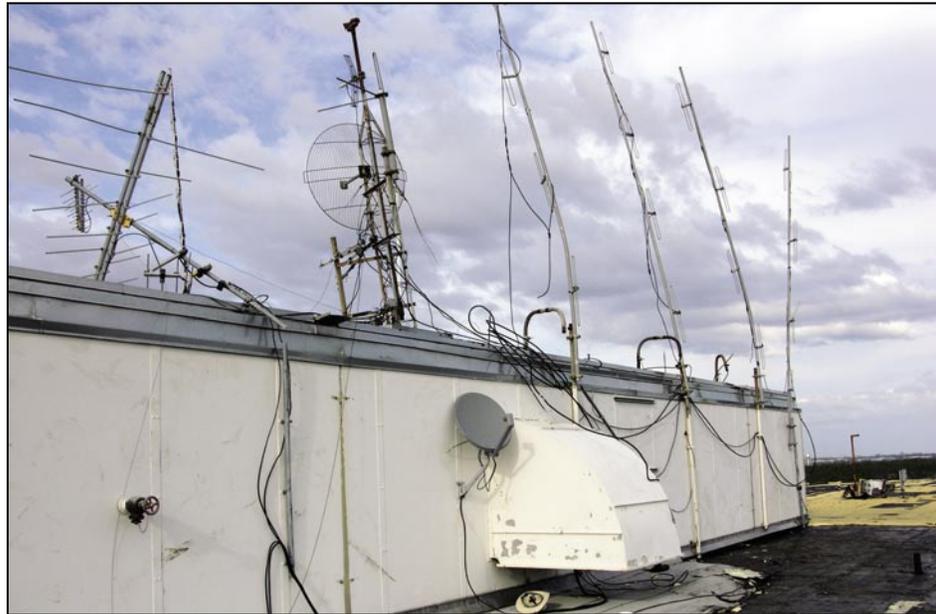
Figure 5-81.
The antenna at this hospital collapsed. The LPS was also displaced in a few areas (red arrows). Rooftop equipment was also damaged. (Pensacola)
