Structural Systems Performance

4.1 Flood

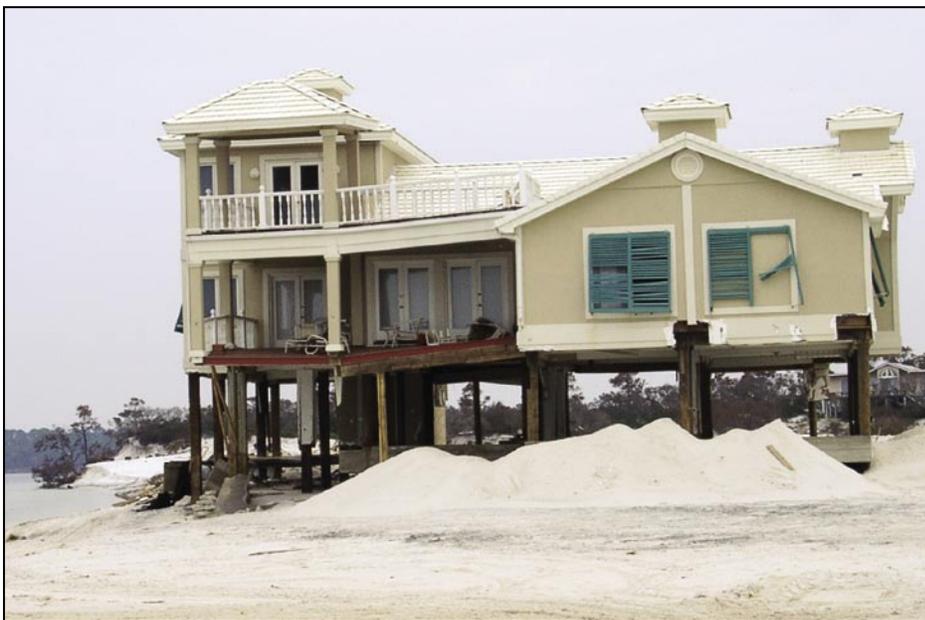
Figure 4-2. House on pile foundation, adjacent to breach in the barrier island, that experienced erosion and significant non-structural damage below the lowest floor (Gulf Shores).

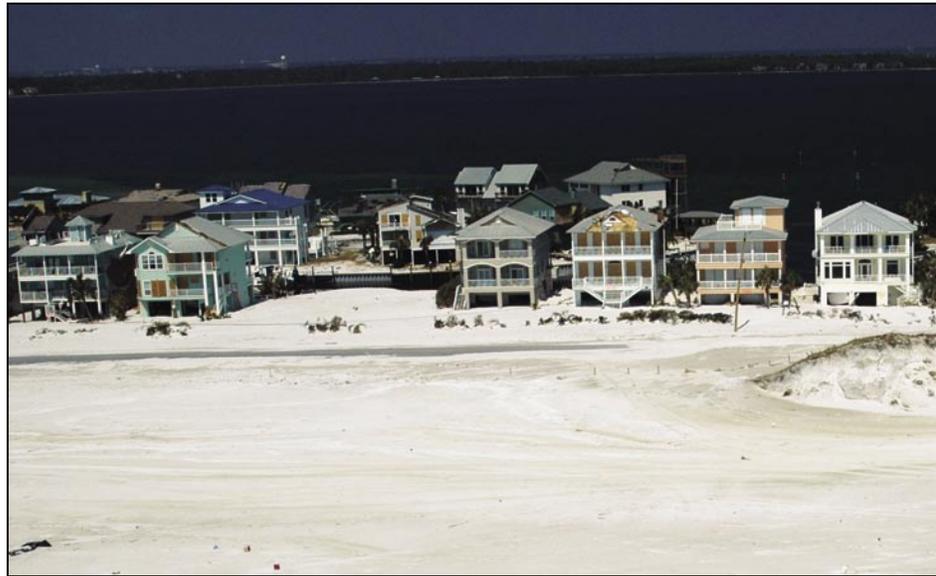
Figure 4-4.
Row of newer houses on pile foundations that experienced significant damages below the lowest floor, but overall the pile foundation systems performed well. Improper pile embedment for decks remains a concern as shown in the two houses in the center; one house shows the deck is sagging, and the other deck was destroyed. (Gulf Shores)

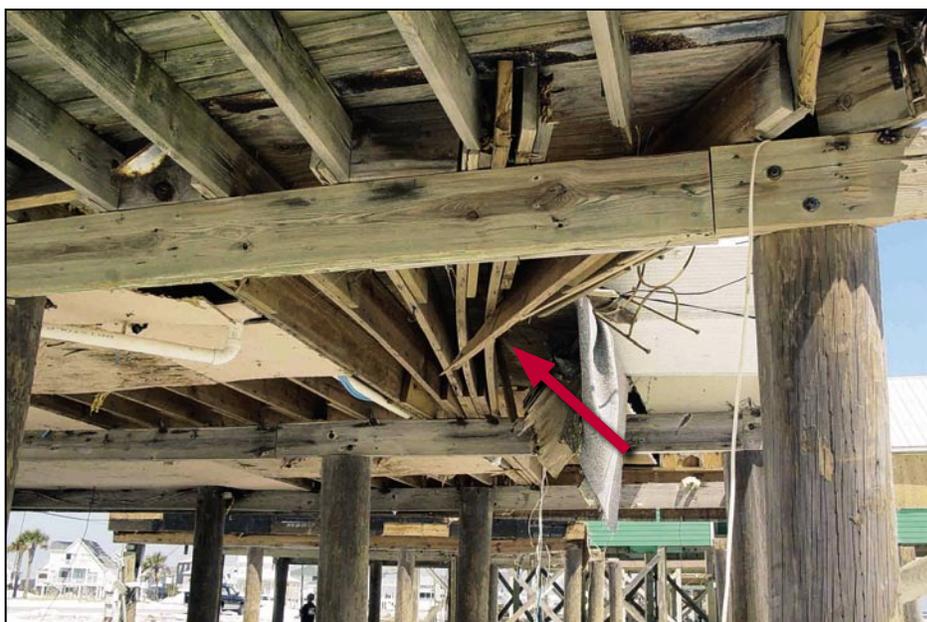
In instances where pile-elevated buildings had their lowest floor at or just below the wave crest elevation during Ivan, damage to the floor system was observed. Figure 4-5 shows a typical example, where the piles and shore-perpendicular floor beams performed as intended, but where the wave crests struck the shore-parallel floor joists. The

lateral forces exceeded the capacity of the joist connections, and the joists were pushed landward. The collapse of the joists was usually accompanied by damage to the floor and the building interior.

Figure 4-5. Floor joists were pushed landward when the wave crest elevation was above the floor beam. (Gulf Shores)

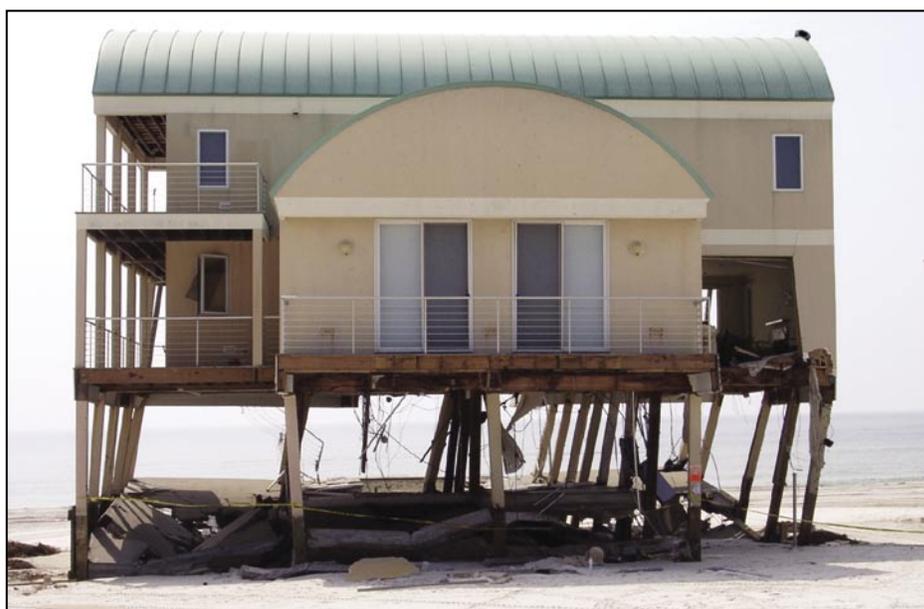
Figure 4-6. Significant erosion caused the non-structural parking slab to fail, and insufficient pile embedment caused the structure to lean. The high storm surge and waves caused destruction of the enclosure below the lowest floor. (Orange Beach)

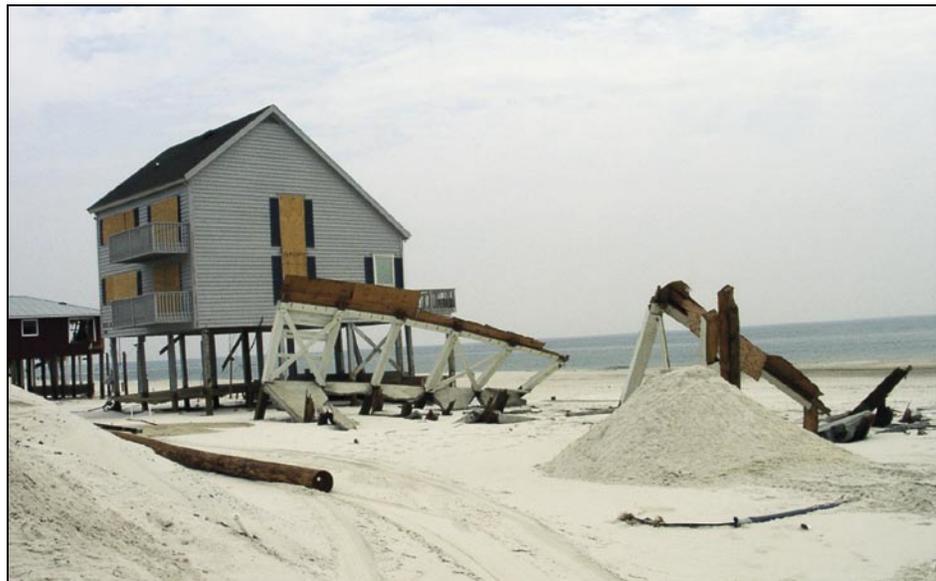
Figure 4-9. These houses floated off their pile foundations (shown in Figures 4-8 and 3-2), probably a result of inadequate pile embedment.

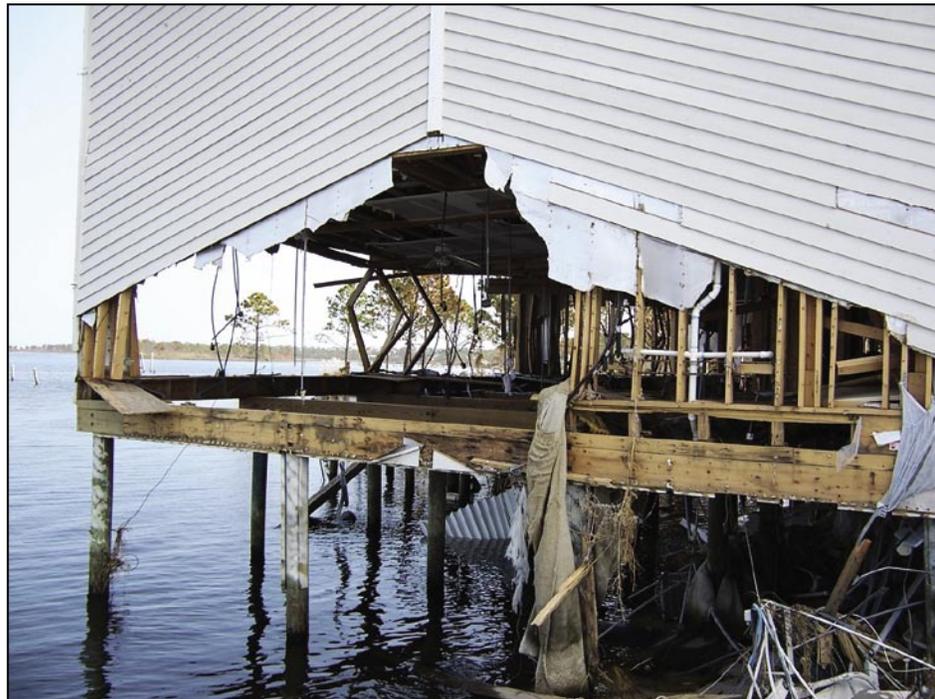
Figure 4-12. House at left (circle) was torn from its pile foundation. New houses under construction (arrows, see Figure 4-31 also) survived Ivan (Big Lagoon).

The destroyed house on the left side of Figure 4-12 was in the Grande Lagoon neighborhood, approximately $\frac{3}{4}$ mile across Big Lagoon from the barrier island, Perdido Key. Perdido Key was completely overwashed by Ivan, and stillwater flood levels in the vicinity of Grande Lagoon were approximately 13 to 14 ft NGVD (see Figure 1-11), with wave crest elevations higher. Flood hazard zones and BFEs shown on the FIRMs for this area ranged from VE, elevation 11 feet NGVD, to AE, elevation 9 feet NGVD. Figure 4-13 shows the same house (circled) with several nearby, pile-elevated houses that were also destroyed. It should be noted that some older but intact houses in the neighborhood were observed to have poor connections between the floor beams and the elevated houses. Wind might also have contributed to the structural failures seen in Figures 4-12 and 4-13.

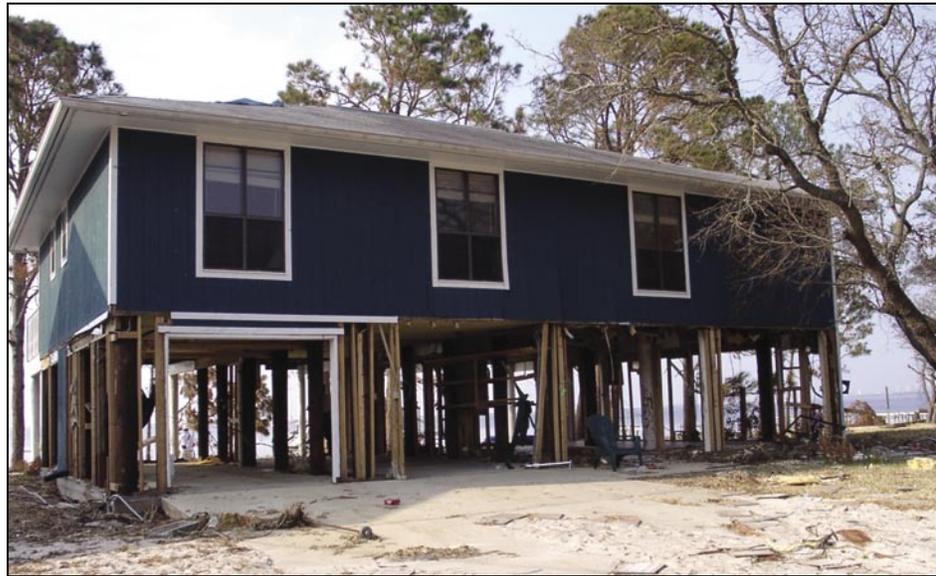
Another nearby neighborhood also illustrates the value of a sound pile foundation along bay and sound shorelines. Figure 4-14 shows an older pile-elevated house near the east end of Seaglade Drive, approximately one mile east of the Grande Lagoon neighborhood and exposed to similar flood conditions during Ivan. This house is in an area mapped as Zone AE, elevation 9 feet NGVD. The enclosure at ground level was destroyed, but, otherwise, the house sustained little flood damage.

Figure 4-14.
House constructed on piles several feet higher than the BFE. Floodwater, waves, and debris caused damages to the ground level enclosed area of the house, but not to the elevated portion.
(Big Lagoon)

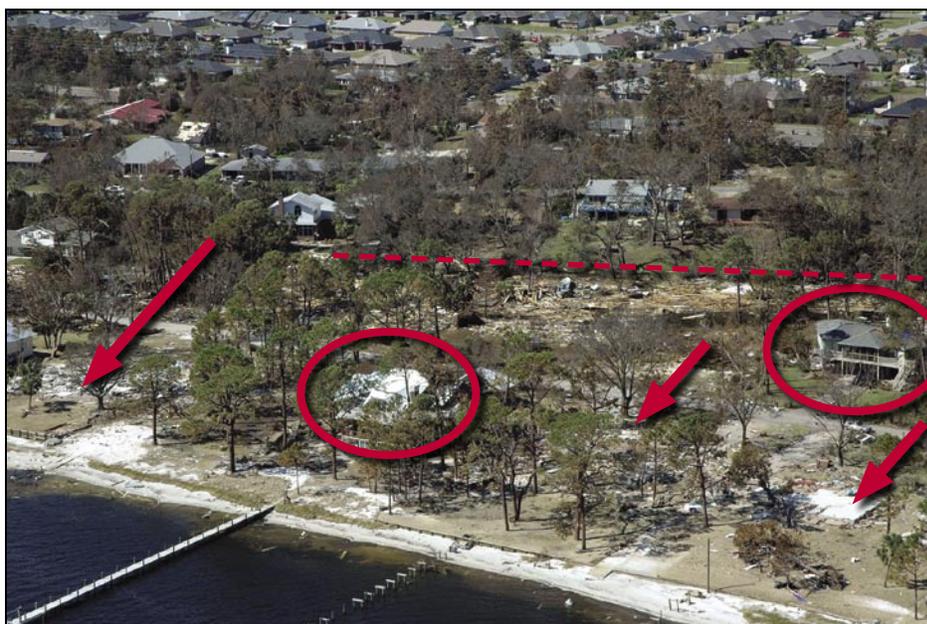
Figure 4-15 shows the region just to the west of the house in Figure 4-14. Older unreinforced masonry houses on slab foundations (arrows) were destroyed, but other houses elevated on piles above the BFE (circled) survived. MAT team members observed many debris scars 5-to-7 feet above the base of trees in the area, giving an indication of flood depths during Ivan. Debris scars were also evident on the underside of the joist sheathing of the house circled on the right side of Figure 4-15. The house was elevated one full story to allow for under-house parking. The dashed line in Figure 4-15 shows the landward limit of floodborne debris in the area; Figure 4-16 shows some of the debris.

Figure 4-15. Area just to the west of the house shown in Figure 4-14. Pile-elevated houses above the BFE (circled) survived, while older houses on slab foundations were destroyed. Dashed line indicates landward limit of debris that washed through the area.

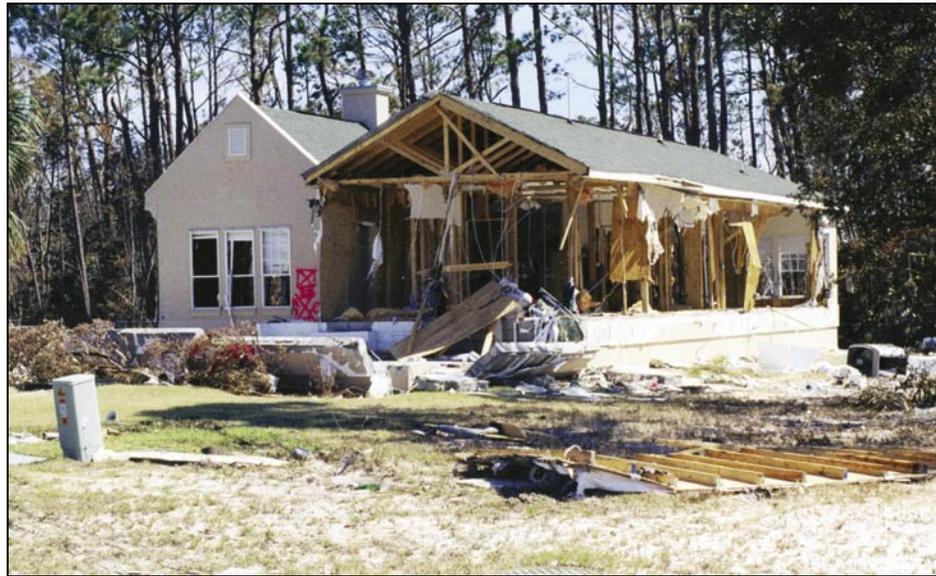
Figure 4-25.
Stem wall foundation
where floodwater
exceeded required
flood elevation by
approximately 4 feet
(Garcon Point, Escambia
Bay)

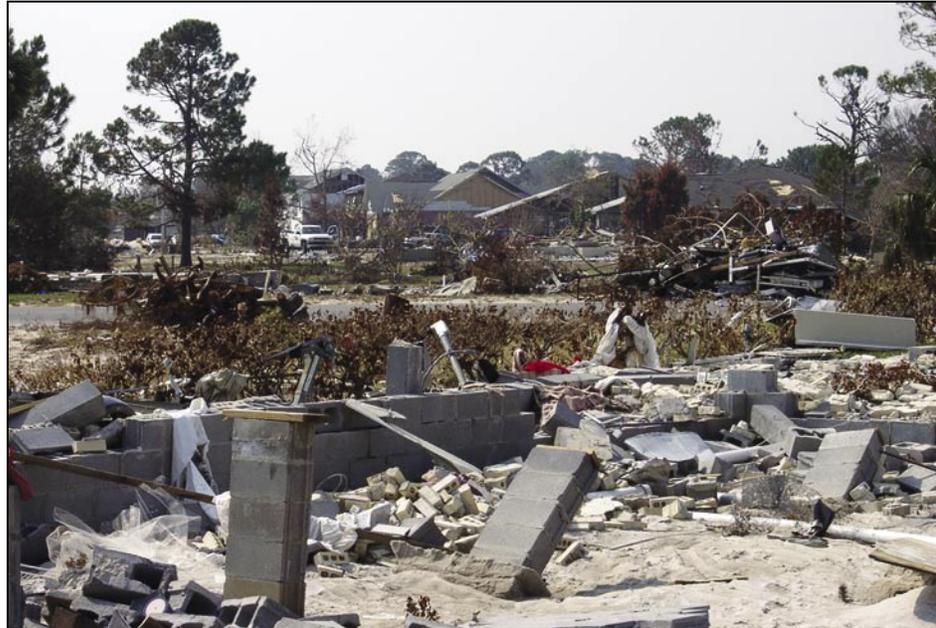
Figure 4-28.
Center pier failed causing the elevated floor to collapse. Other adjacent buildings were elevated on pilings and solid foundation walls; the piers performed better than the solid walls, but not as well as the pilings (Santa Rosa Sound)

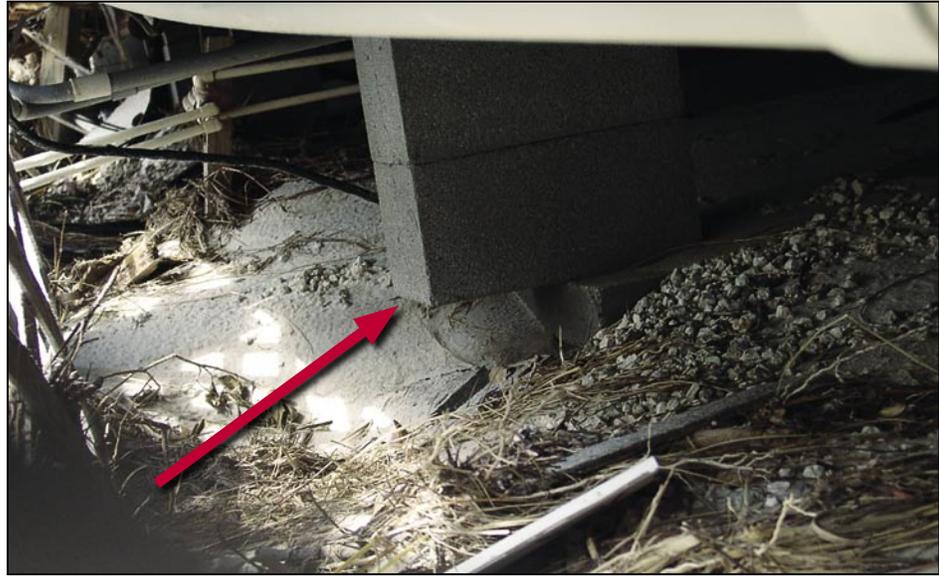
Figure 4-32.
Dry-stacked pier failure
(Orange Beach)

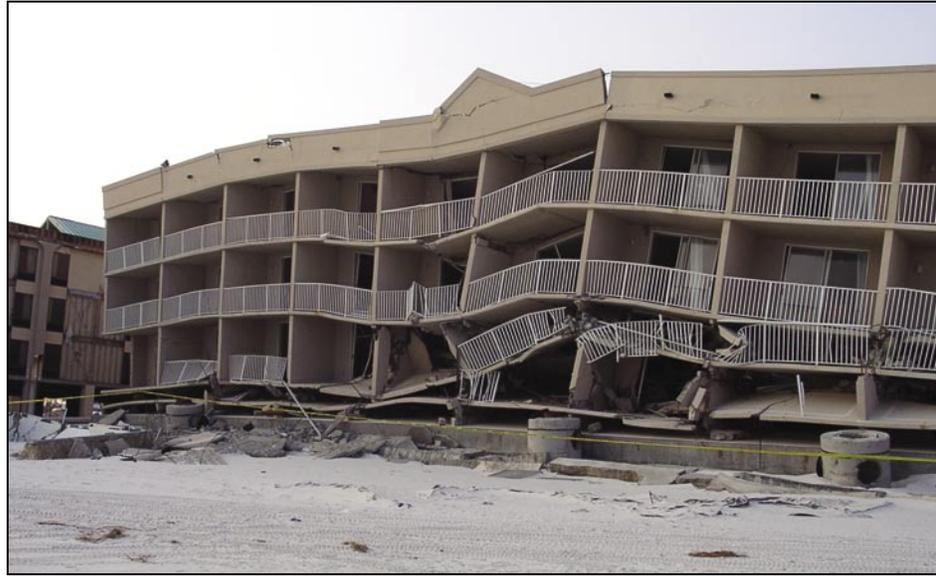
Figure 4-34.
Close-up of building
shown in Figure 4-33
(Orange Beach)

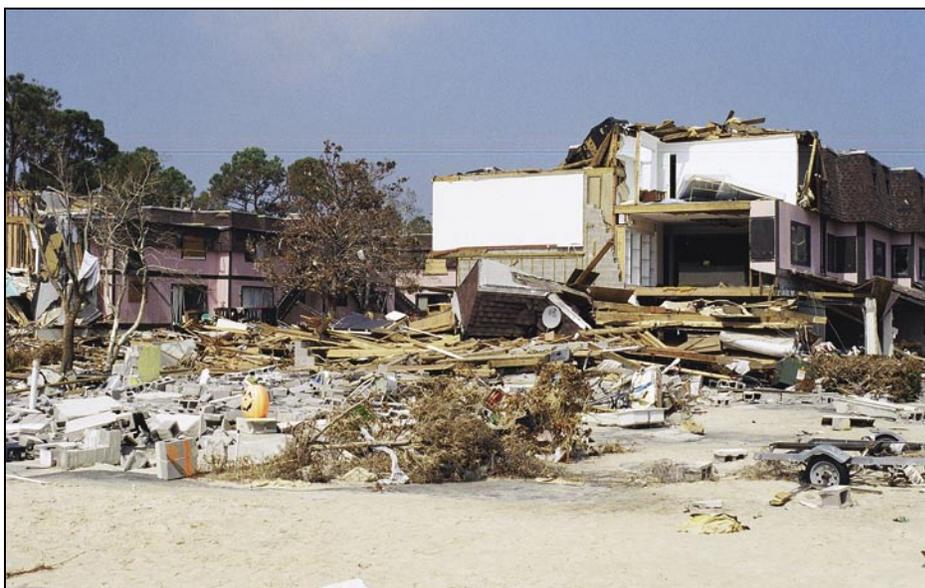
Figure 4-40.
Multi-family building on a bay shoreline, heavily damaged by surge, waves, and floating debris (Oriole Beach, Santa Rosa Sound)

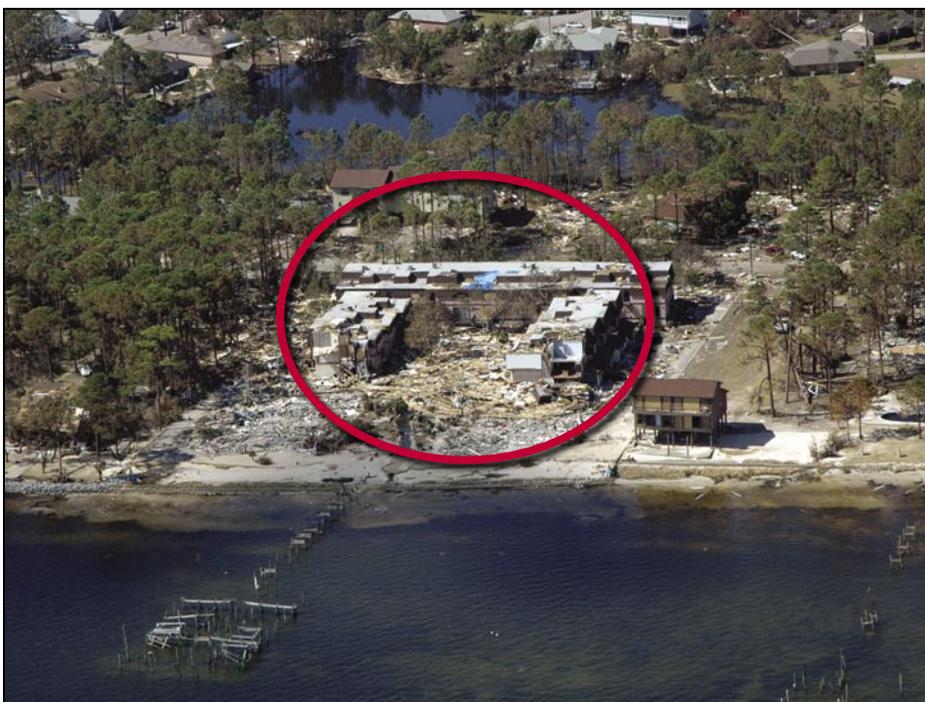
Figure 4-41.
Aerial view of building in Figure 4-40 (circled)

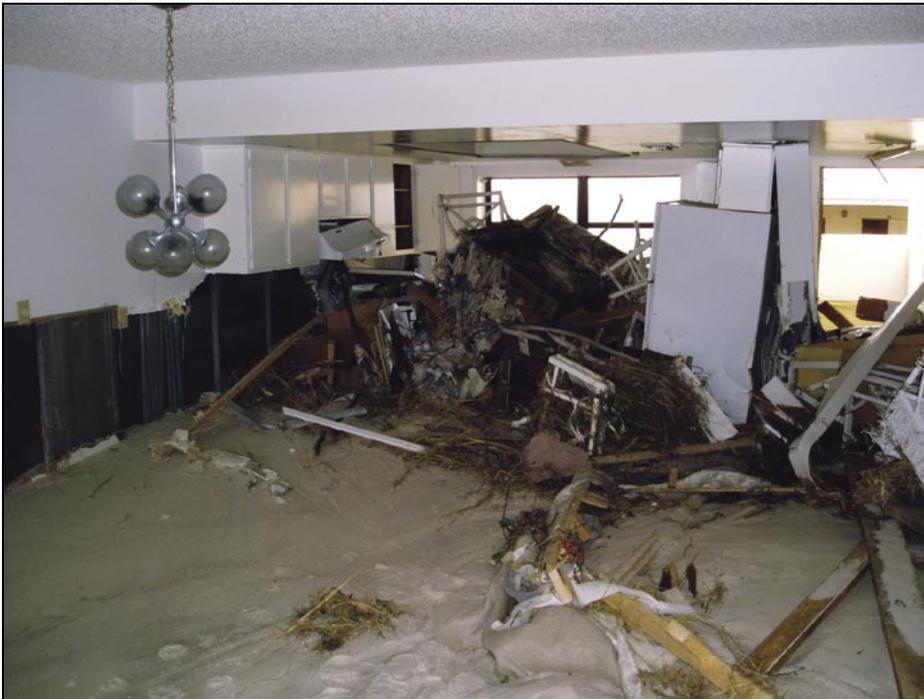
Figure 4-47. Building with flood and wave damage to the lowest floor living units. Some units had up to two feet of sand deposited inside. (Perdido Key)

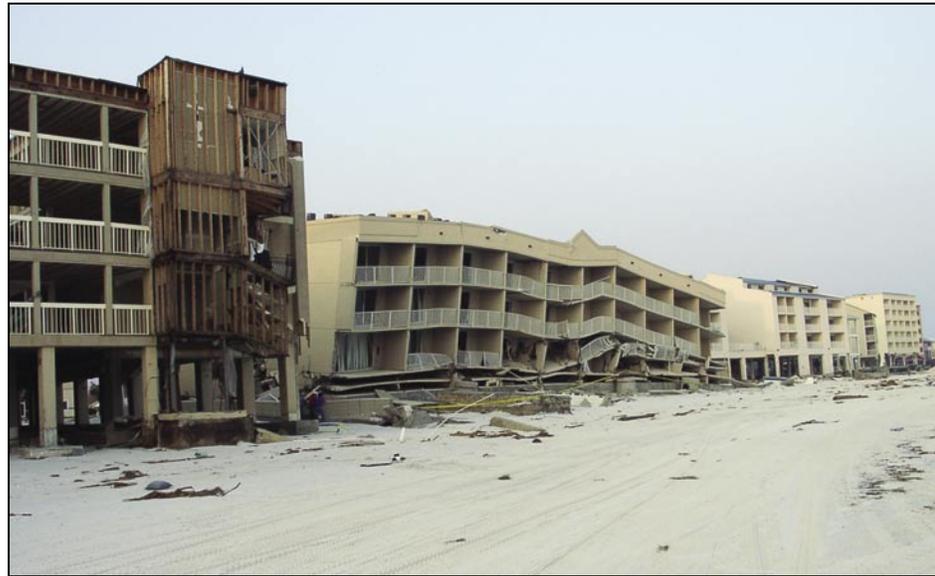
Figure 4-49. Pile-supported buildings performed much better than buildings constructed on shallow foundations as shown in the building in the center, which collapsed. (Orange Beach)

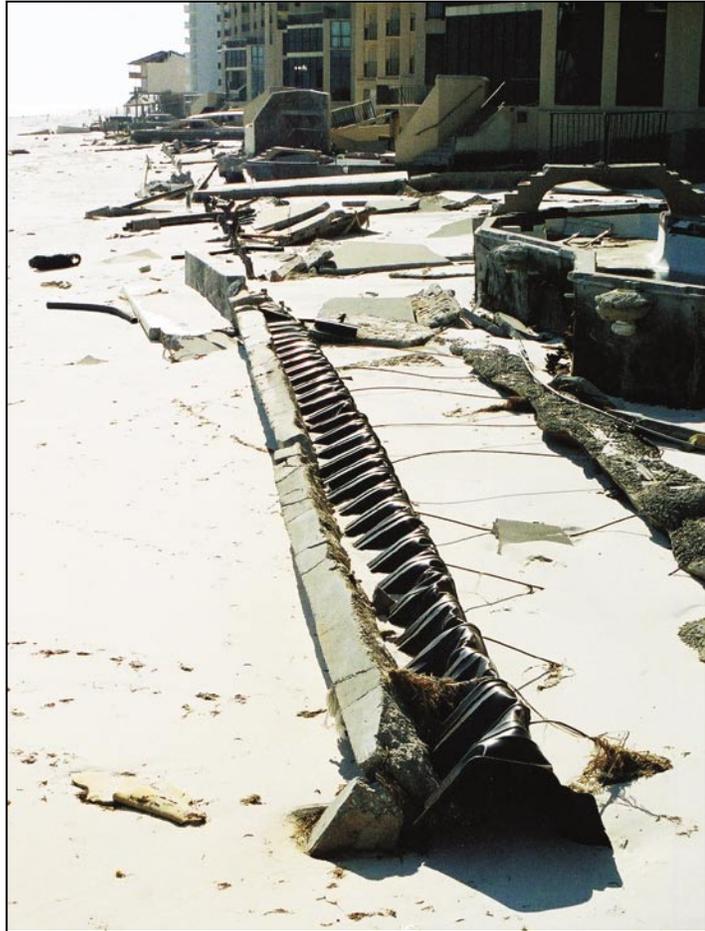
Figure 4-53.
Bulkhead remained intact, but short return wall allowed erosion
(Orange Beach)

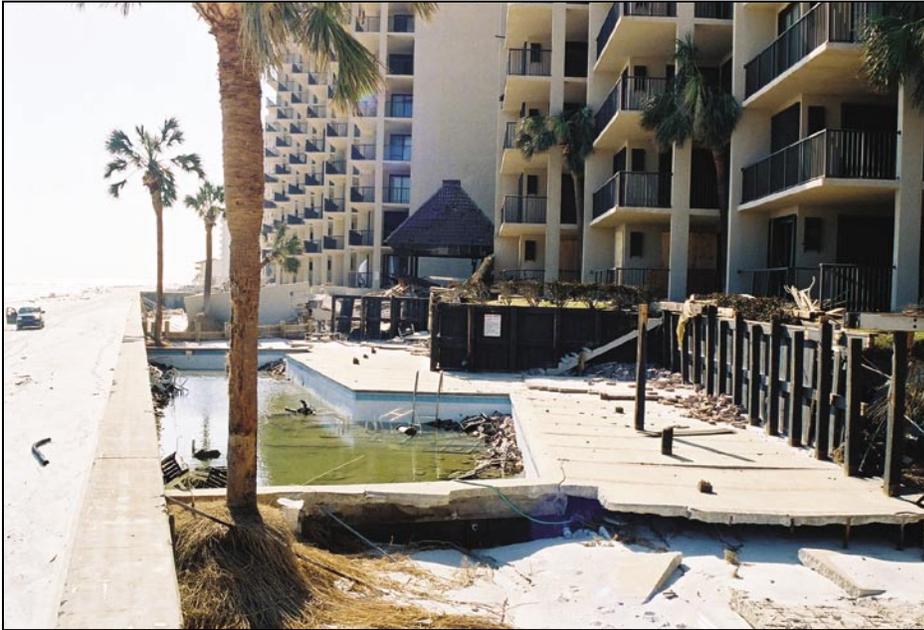
Figure 4-54. Bulkhead shown in Figure 4-53 remained in-place, but surge and wave overtopping, coupled with erosion at the short return wall, led to deck and retaining wall failure. (Orange Beach)

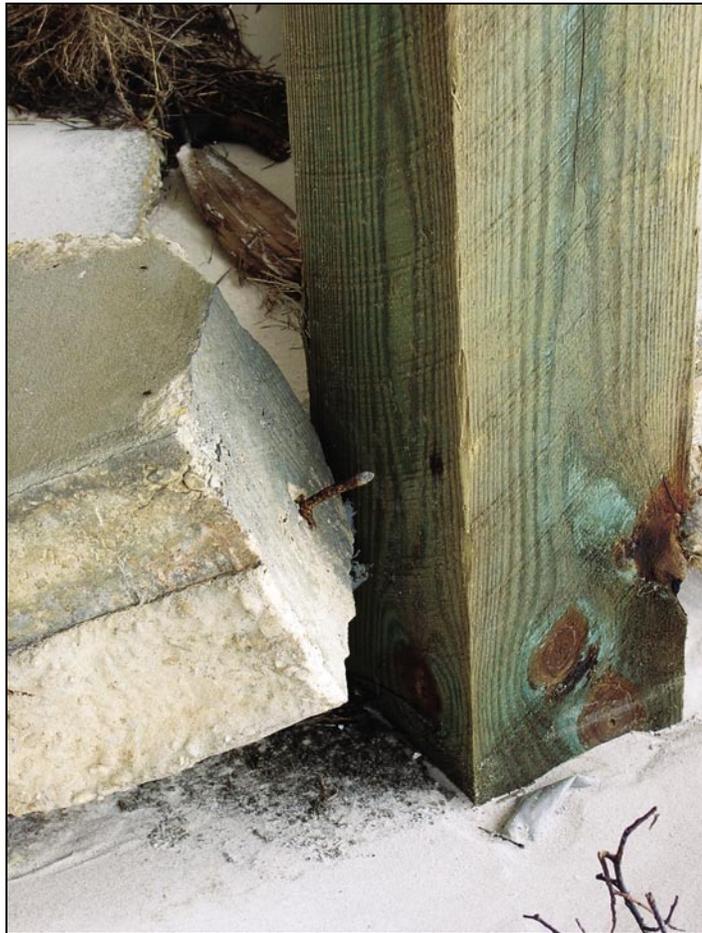
Figure 4-57.

Typical non-structural concrete slab failure. Horizontal line indicates previous location of soil level and slab. (Orange Beach)

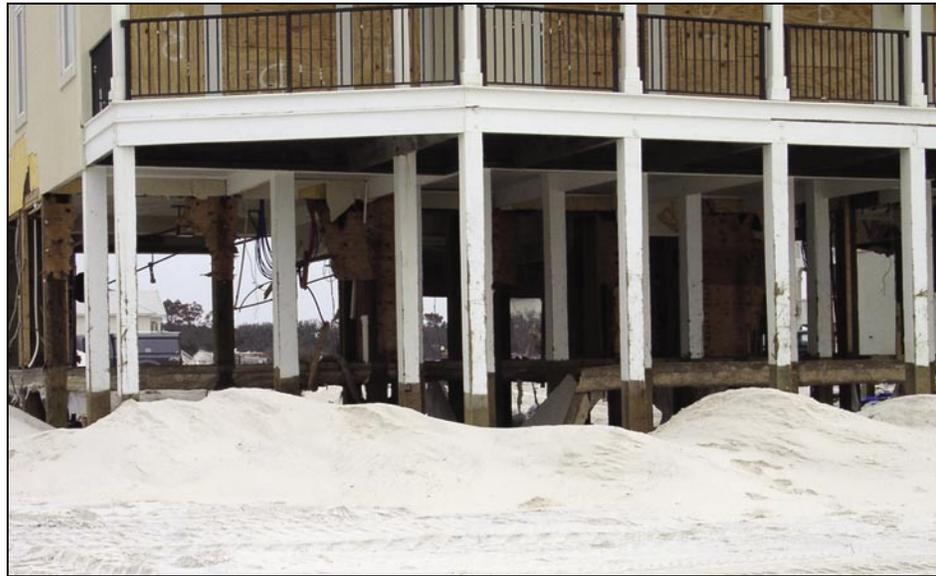
Figure 4-60.
Poor detailing of the joint
between the breakaway
wall and the wall above
contributed to loss of wall
covering above the floor
beam. (Pensacola Beach).

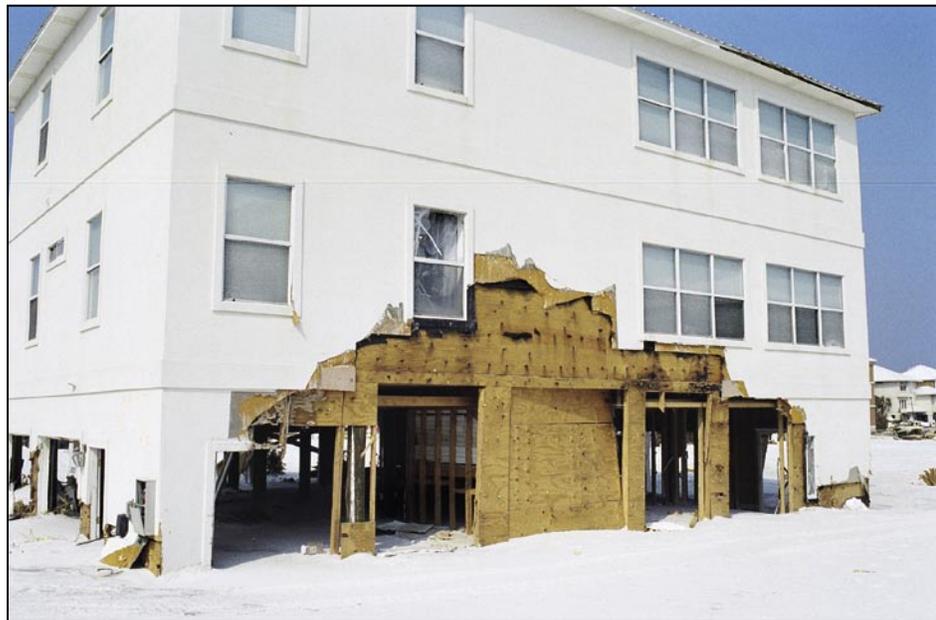
Figure 4-61.
Failure of interior partition to break away cleanly due to the attachment of utilities (Gulf Shores)

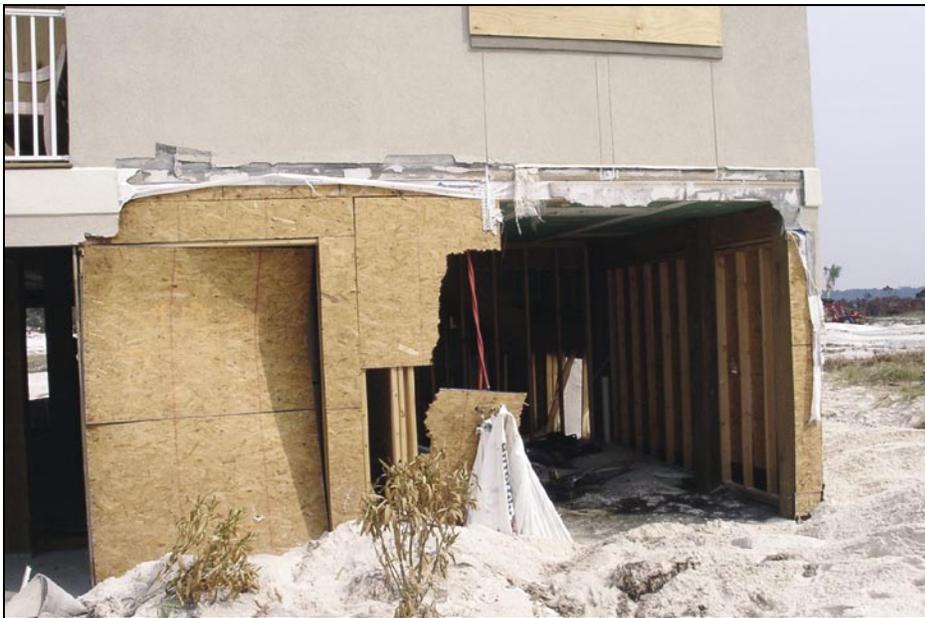
Figure 4-62.
Breakaway walls were nailed over the piles and floor beam, preventing a clean break. (Gulf Shores)

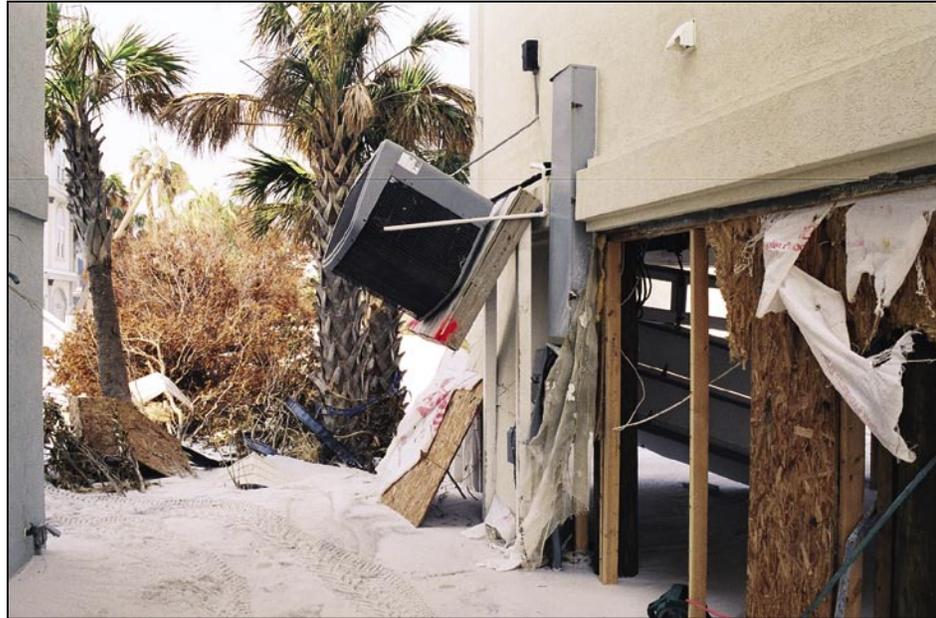
Figure 4-64.
Diagonal condenser platform members are
susceptible to wave and waterborne debris
damage. Cantilevered condenser platforms are
preferable (see Figure 8-3). (Gulf Shores)

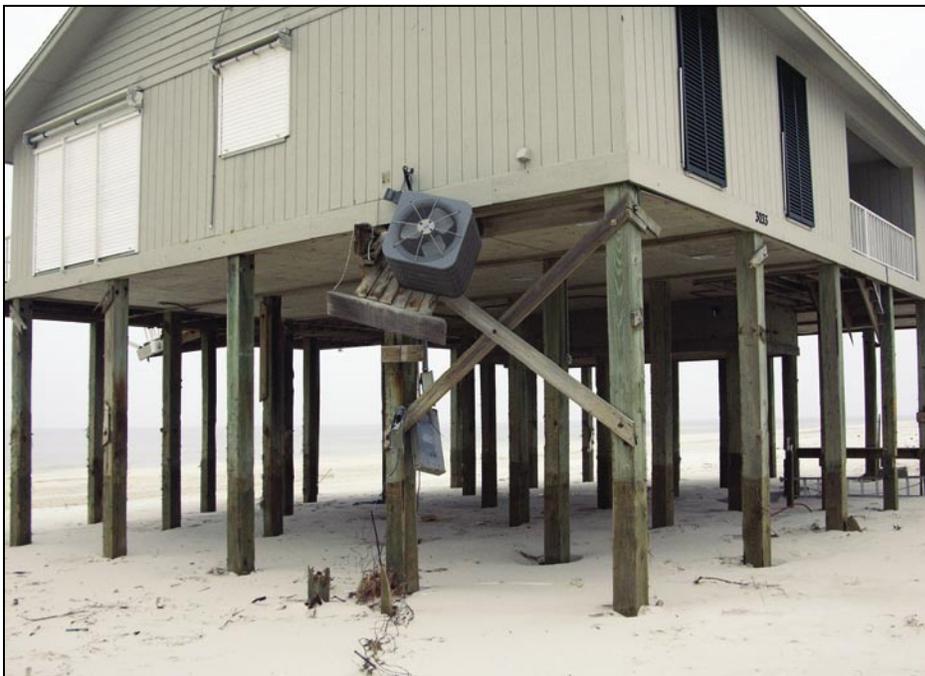
Figure 4-66.
Loss of platform supports
and air conditioning unit
due to erosion and flood
forces (Gulf Shores)

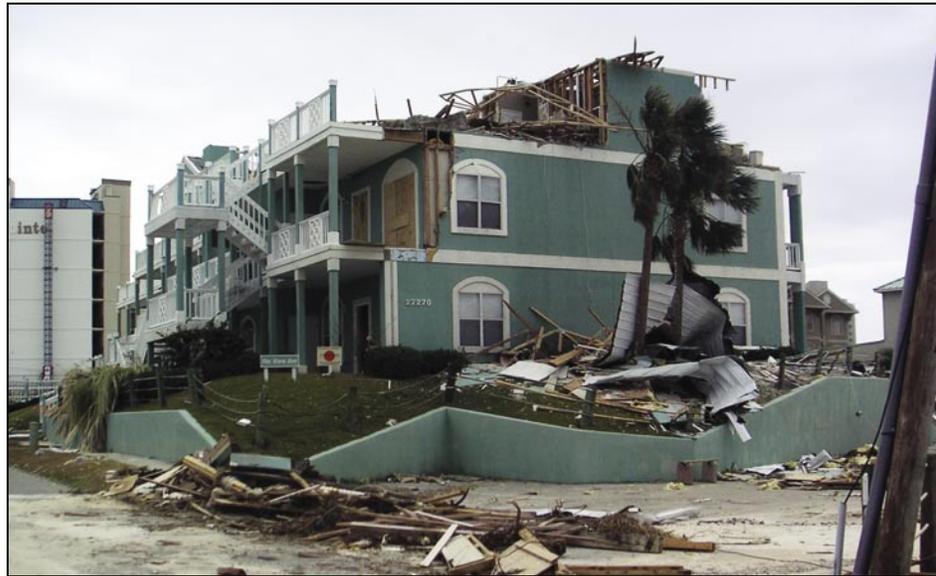
Figure 4-89.
Roof framing damage due
to lack of connections
from roof to wall
(Pensacola Beach)

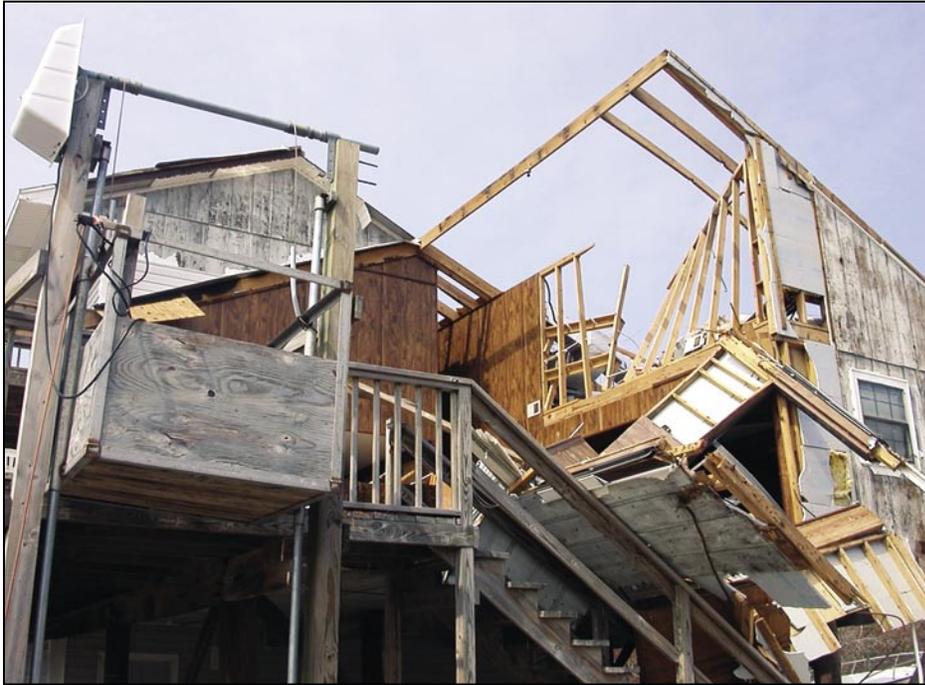
Figure 4-90.
Roof framing damage due to lack of connections from roof to wall (Ono Island)

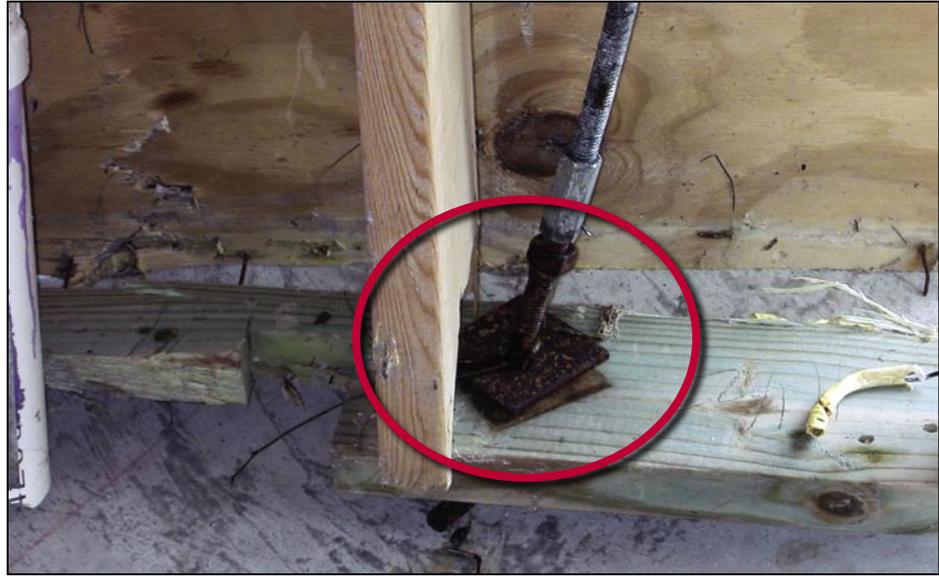
Figure 4-93.
Improper strapping
(Ono Island)

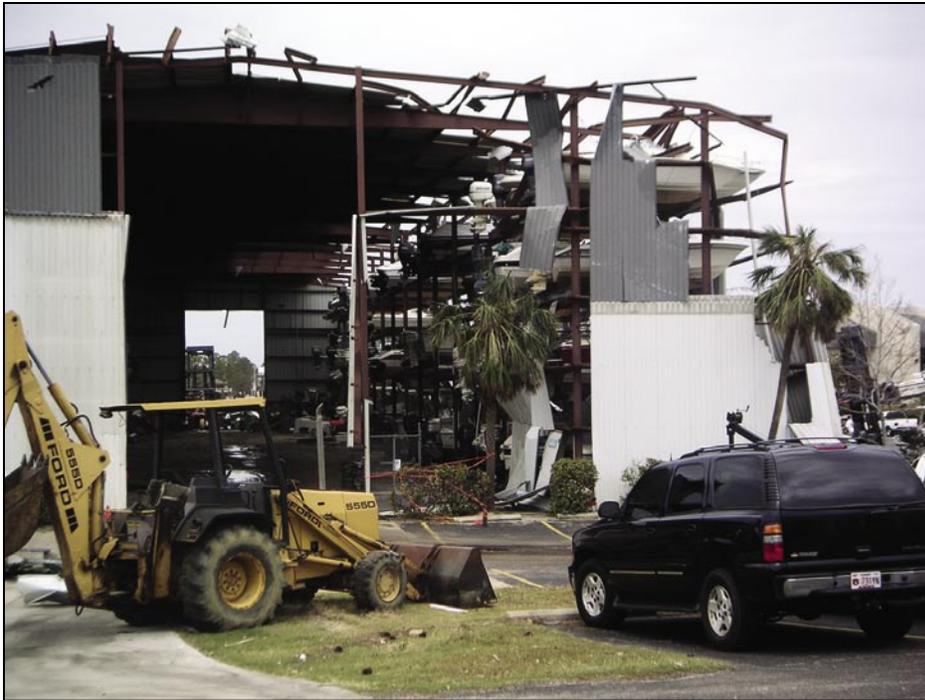
Figure 4-96.
Heavily damaged pre-engineered boat storage building (Orange Beach)

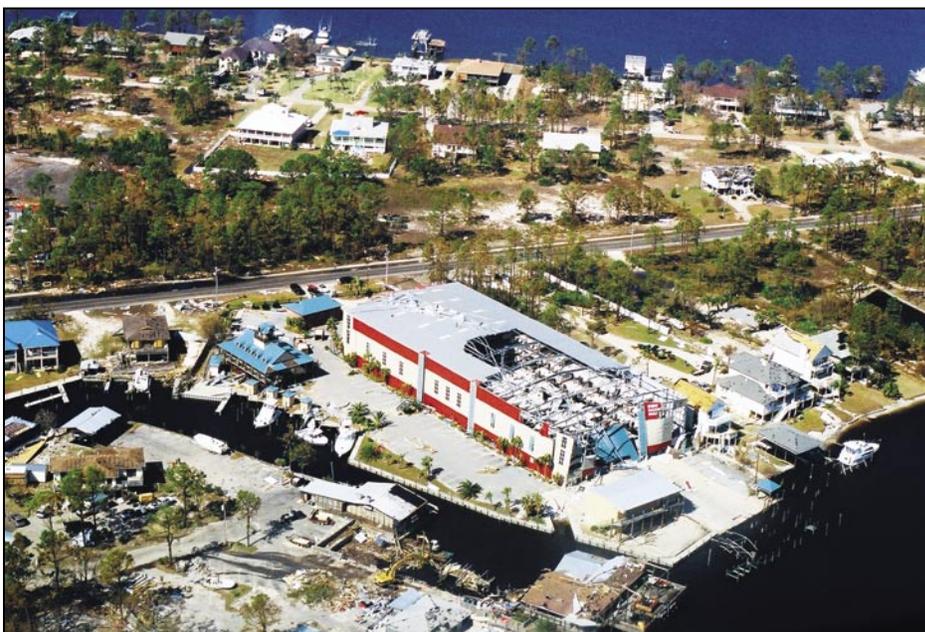
Figure 4-97.
Heavily damaged pre-engineered boat storage building (Orange Beach)
