C *Limited Metallurgical Examination*

C.1 Introduction

Two structural steel members with unusual erosion patterns were observed in the WTC debris field. The first appeared to be from WTC 7 and the second from either WTC 1 or WTC 2. Samples were taken from these beams and labeled Sample 1 and Sample 2, respectively. A metallurgic examination was conducted.

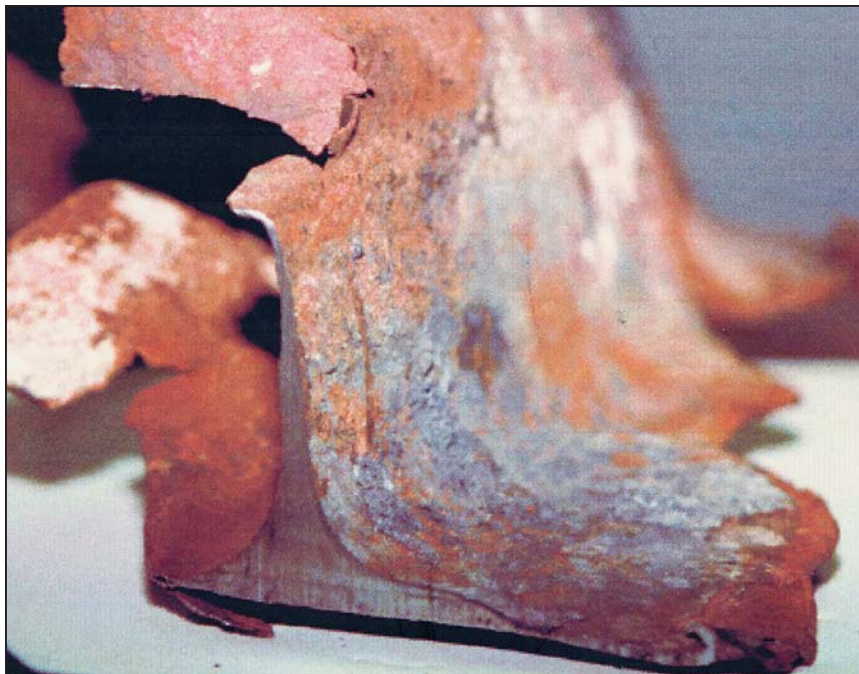
Figure C-2
Closeup view of eroded wide-flange beam section.

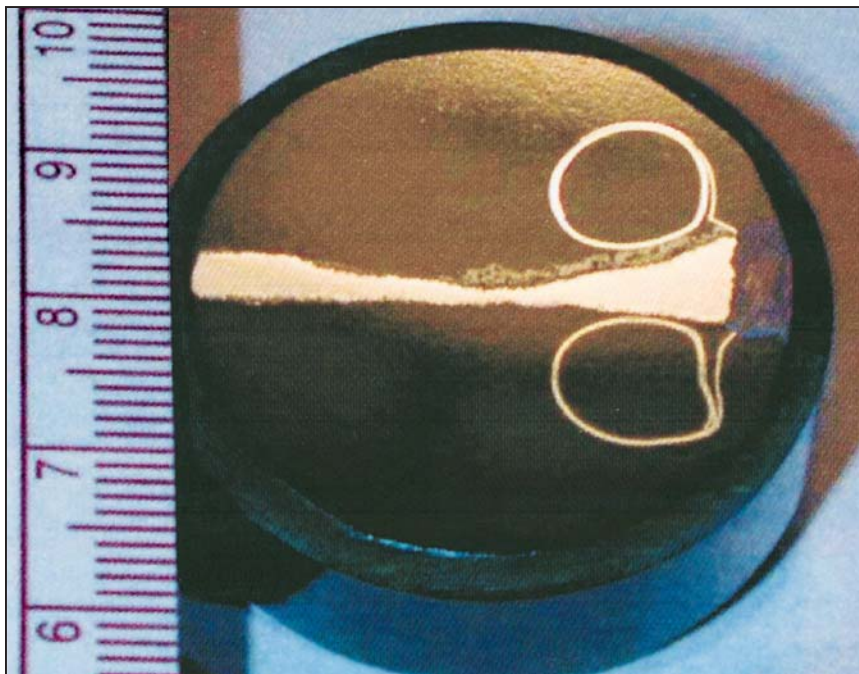
Figure C-3
Mounted and polished severely thinned section removed from the wide-flange beam shown in Figure C-1.

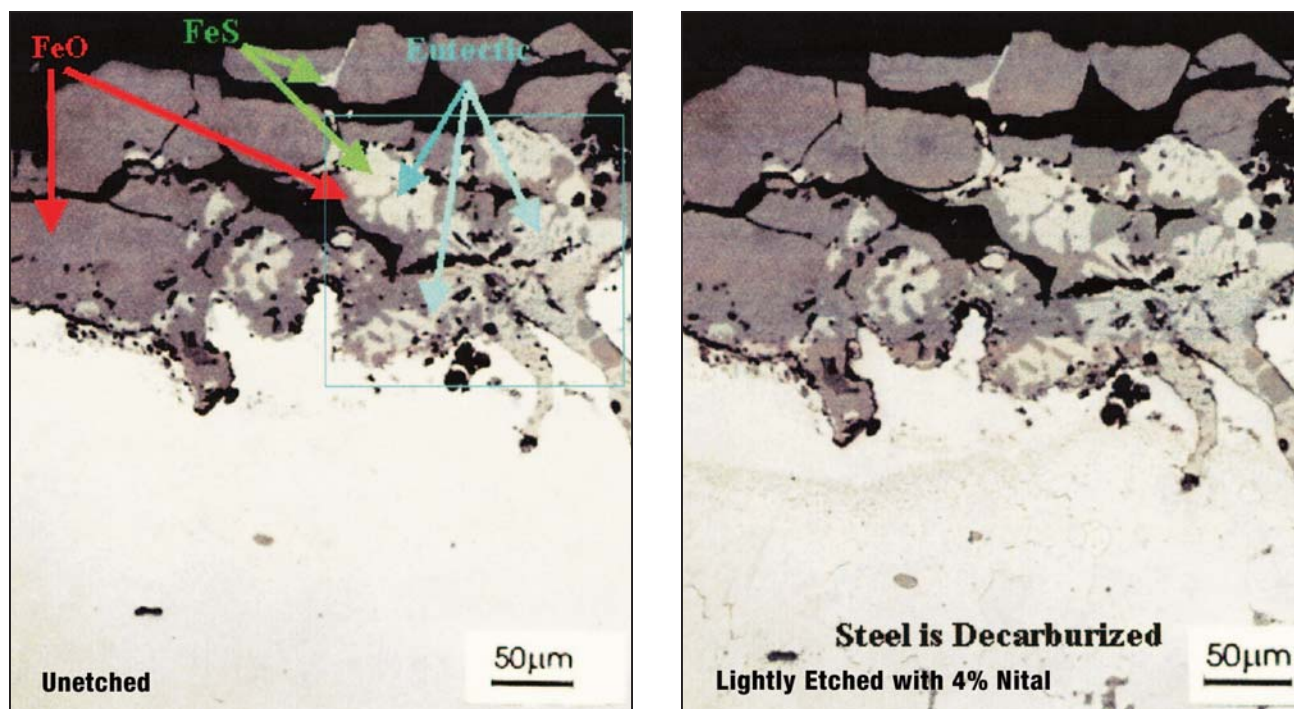
Figure C-4 Optical microstructure near the steel surface.

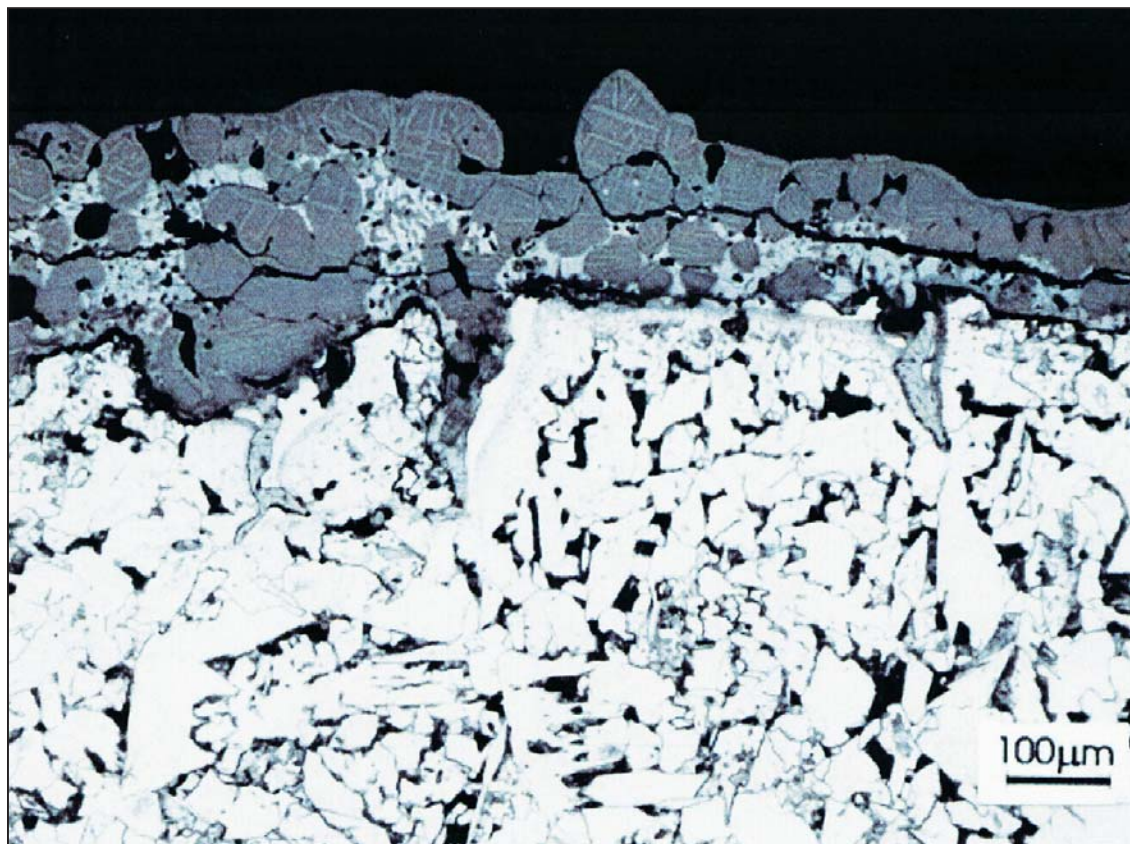
Figure C-5 Another hot corrosion region near the steel surface (etched with 4 percent nital). (Note: (1) Oxide rounding where the FeO-FeS eutectic product is present. (2) Reduction in banding of the steel when re-transformation occurs on cooling from austenite to ferrite and pearlite.)

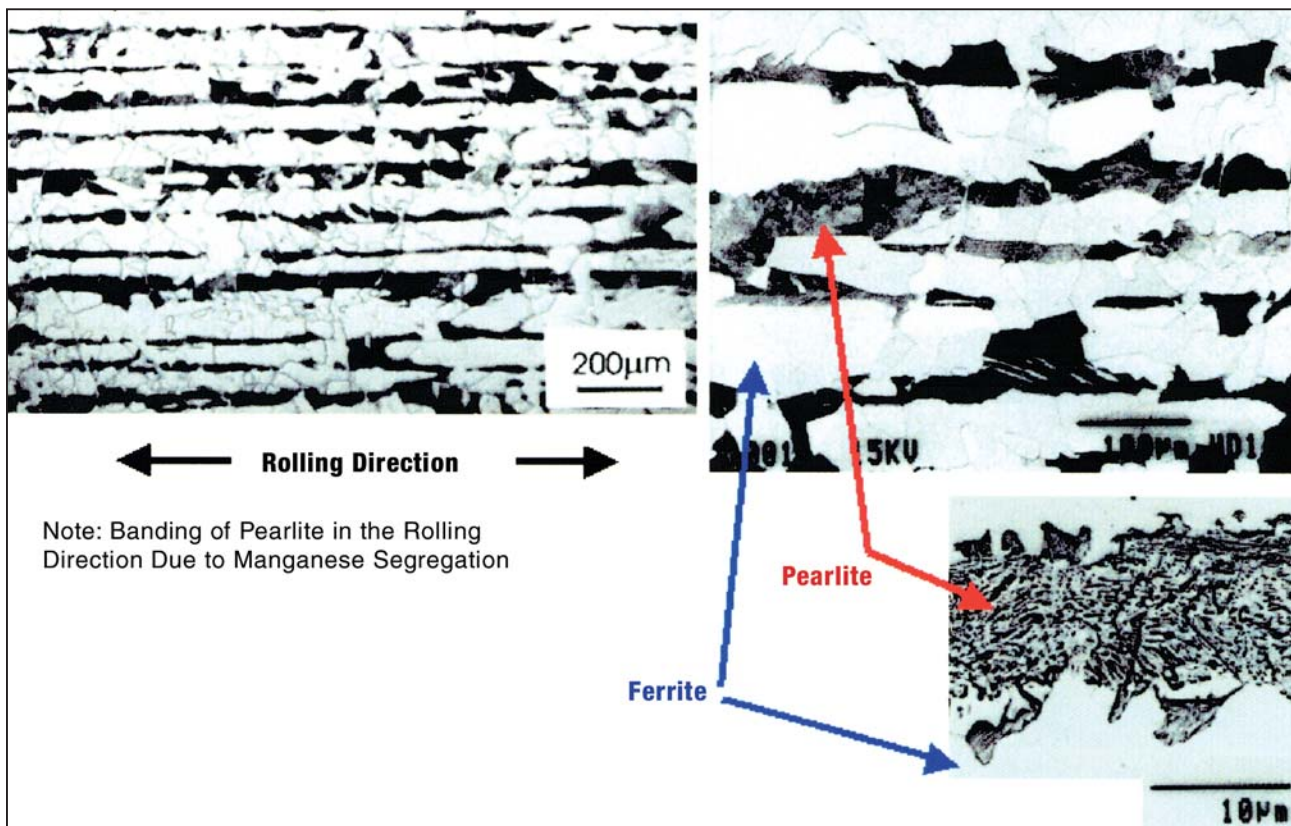
When steel cools below the eutectic temperature, the liquid of eutectic composition transforms to two phases, iron oxide, FeO, and iron sulfide, FeS. The product of this eutectic reaction is a characteristic geometrical arrangement that is unique and is readily visible even in the unetched microstructure of the steel. Figures C-4 and C-5 present typical near-surface regions showing the microstructural changes that occur due to this corrosion attack. Figure C-6 presents the microstructure from the center of a much thicker

Figure C-6 Microstructure of A36 steel.

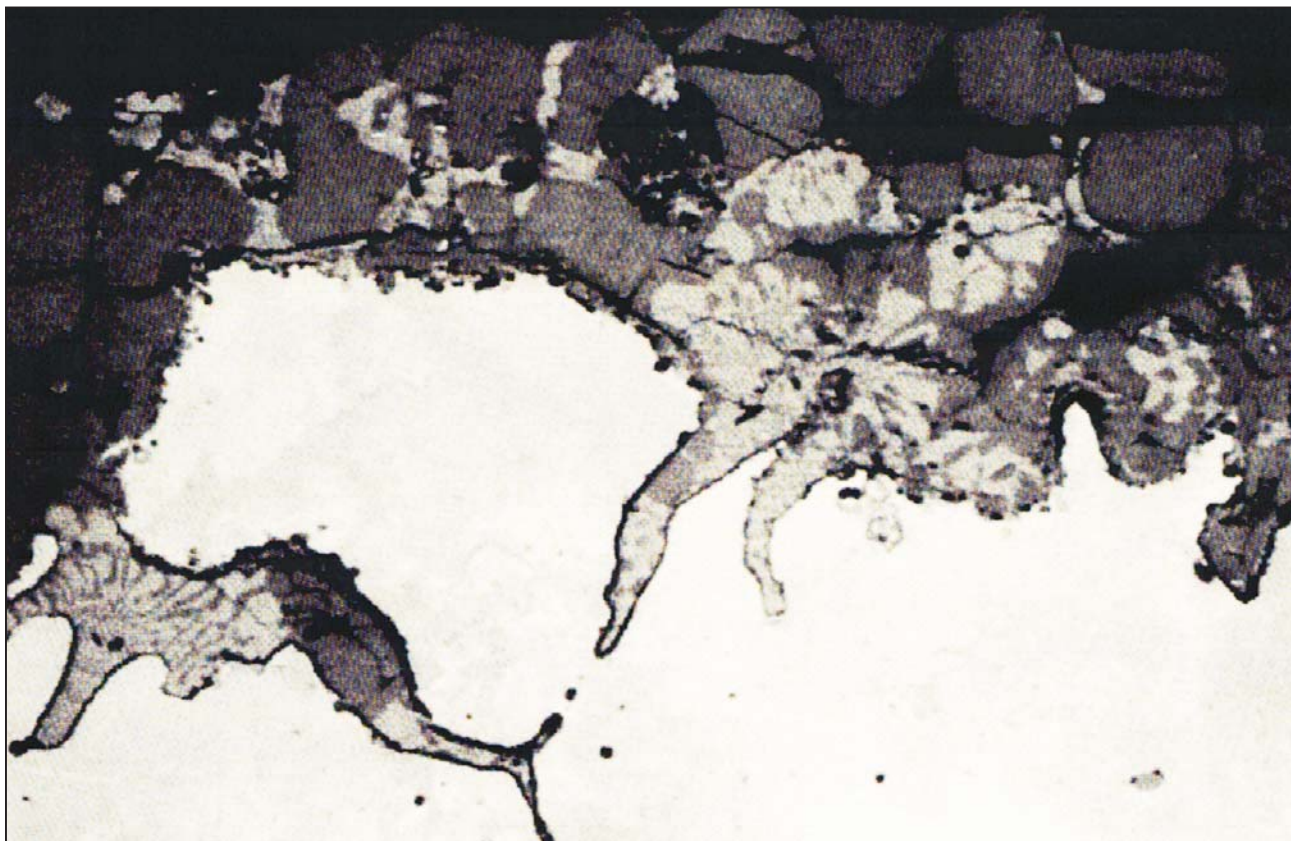
Figure C-7 Deep penetration of liquid into the steel. (Note: Hot corrosion of the steel can produce "islands" of steel surrounded by liquid, which will make erosion of the steel much easier.)

section of the steel that is unaffected by the hot corrosion. Figure C-7 illustrates the deep penetration of the liquid into the steel's structure. In order to identify the chemical composition of the eutectic, a qualitative chemical evaluation was done using energy dispersive X-ray analysis (EDX) of the eutectic reaction products. Figure C-8 illustrates the results of this analysis.

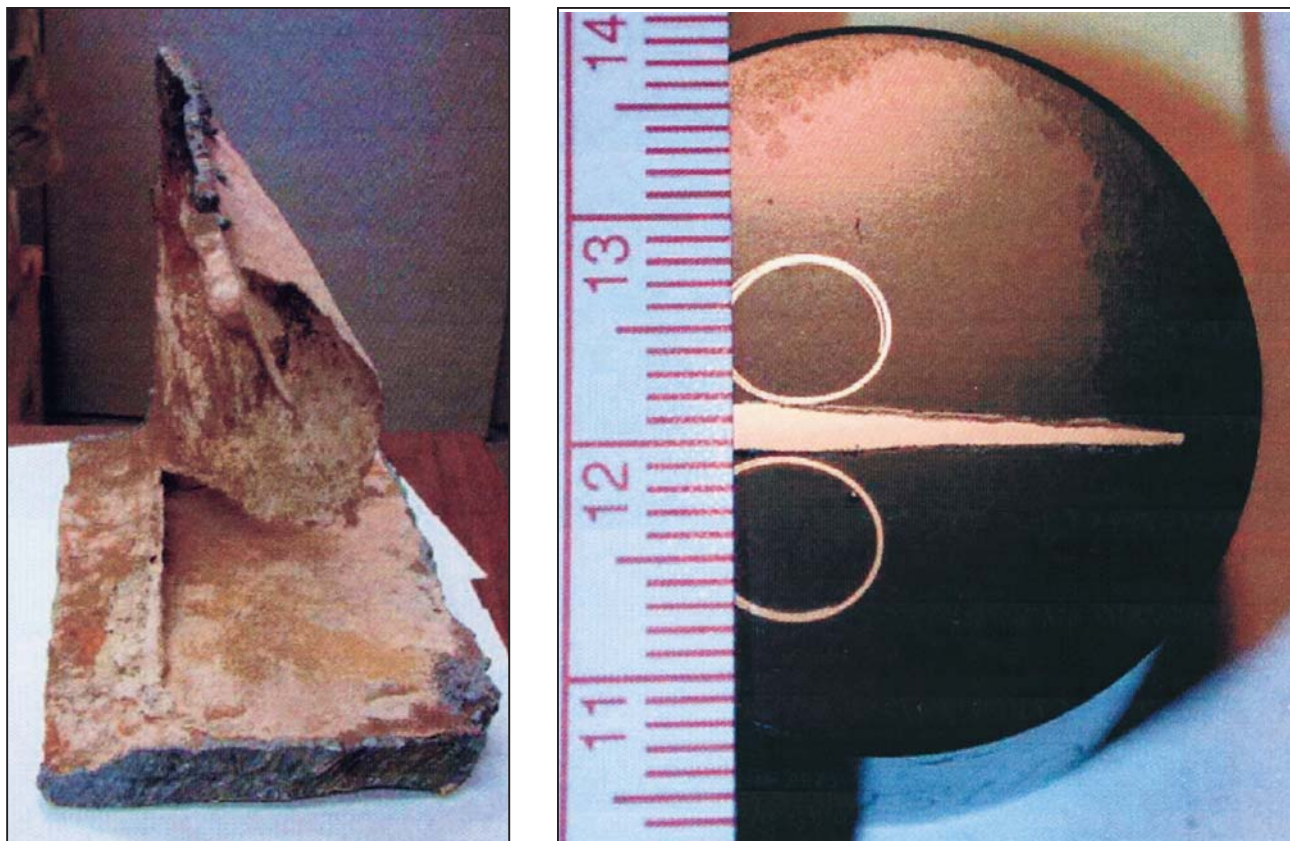
The origin of the steel shown in Figure C-9 is thought to be a high-yield-strength steel removed from a column member. The steel is a high-strength low-alloy (HSLA) steel containing copper. The unusual thinning of the member is most likely due to an attack of the steel by grain boundary penetration of sulfur forming sulfides that contain both iron and copper. Figures C-10, C-11, and C-12 show the region of severe corrosion at different levels of magnification.

Figure C-9 Qualitative chemical analysis.

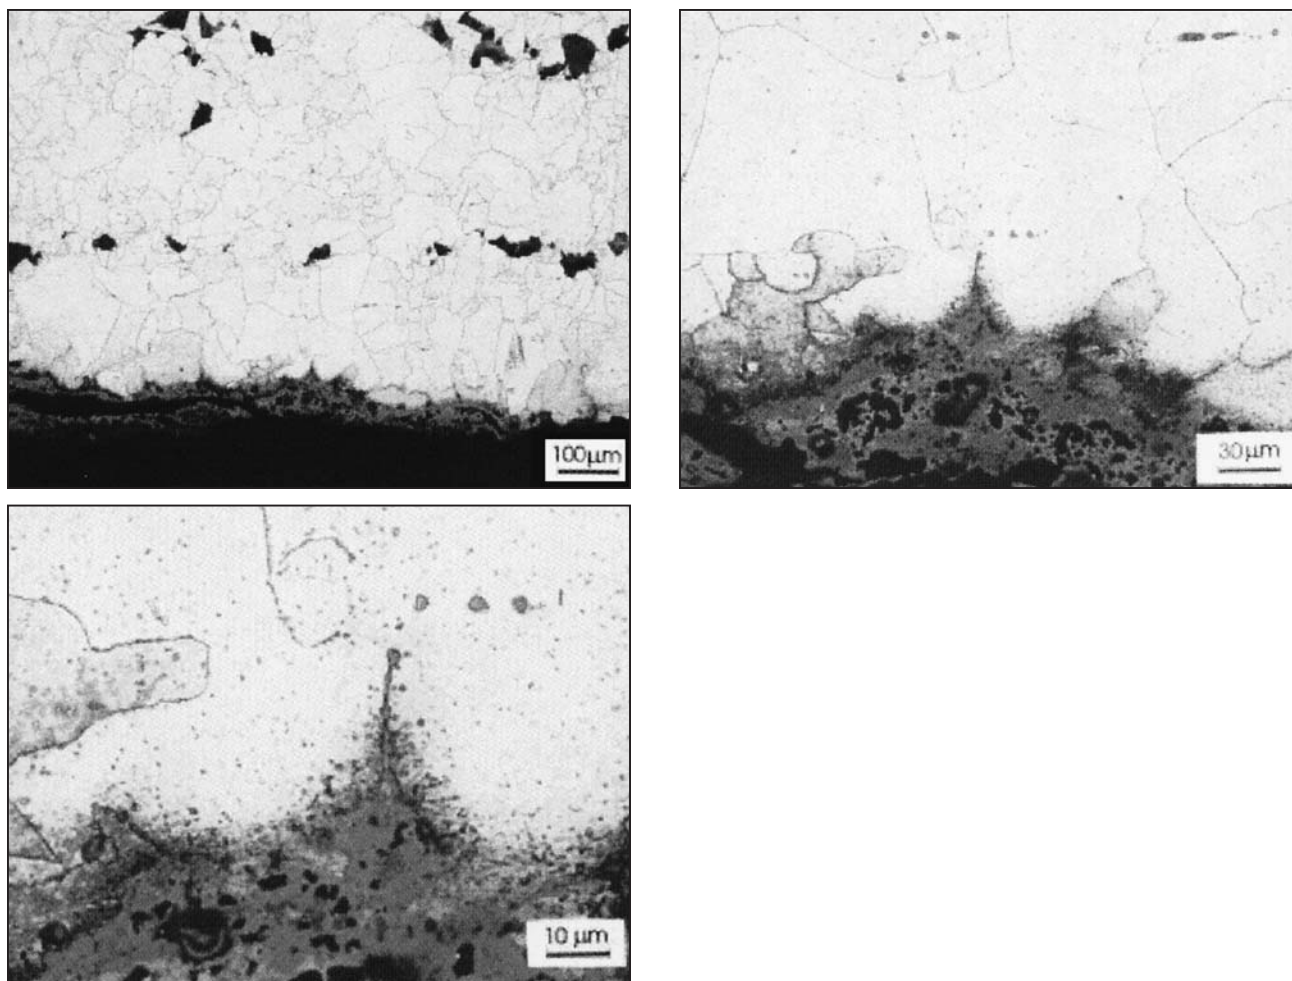
Figure C-11 Microstructure of a typical region showing the surface and grain boundary corrosion attack of Sample 2.

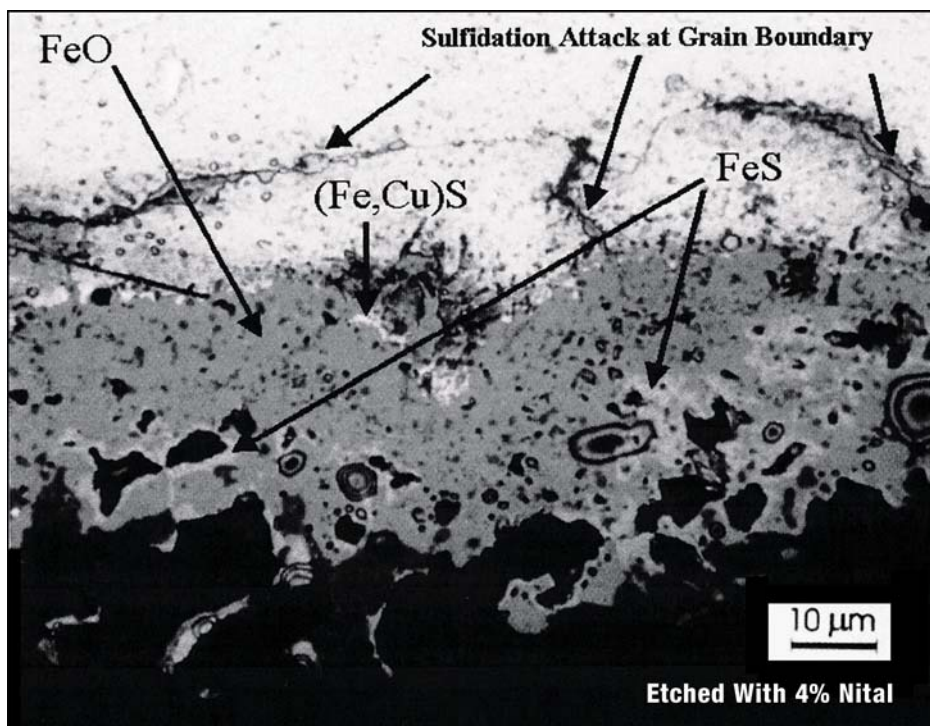
Figure C-12
Higher magnification of the region
shown in Figure C-10.

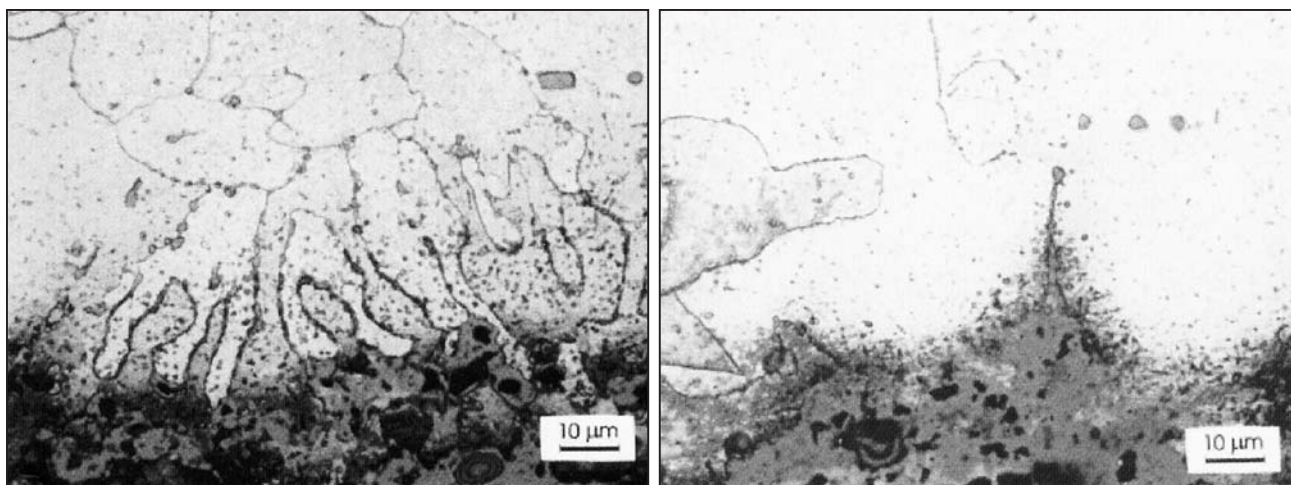
Figure C-13 shows the region where a qualitative chemical analysis of the eroded region was performed. The comparison of the EDX spectra from the specific regions identified in Figure C-13 shows concentration of copper and sulfur in the grain boundaries in addition to iron sulfide formation adjacent to iron oxide in the oxidized surface layer. Sulfide formation within the steel microstructure increases in concentration as the oxidized region is approached from the steel side. This is clearly shown in Figure C-14.

The larger sulfides further into the steel are the more stable manganese sulfides that were formed when the steel was made. The smaller sulfides that have formed as a result of the fire do not contain significant amounts of manganese, but rather are primarily sulfides containing iron and copper. These sulfides have a lower melting temperature range than manganese sulfide. It is much more difficult to tell if melting has occurred in the grain boundary regions in this steel as was observed in the A36 steel from WTC 7. It is possible and likely, however, that even if grain boundary melting did not occur, substantial penetration by a solid state diffusion mechanism would have occurred as evidenced by the high concentration of sulfides in the grain interiors near the oxide layer. Temperatures in this region of the steel were likely to be in the range of 700–800 °C (1,290–1,470 °F).

Figure C-14 Gradient of sulfides into the steel from the oxide-metal interface.
