Appendix A

History of Antiseep Collars

Conduits through Embankment Dams

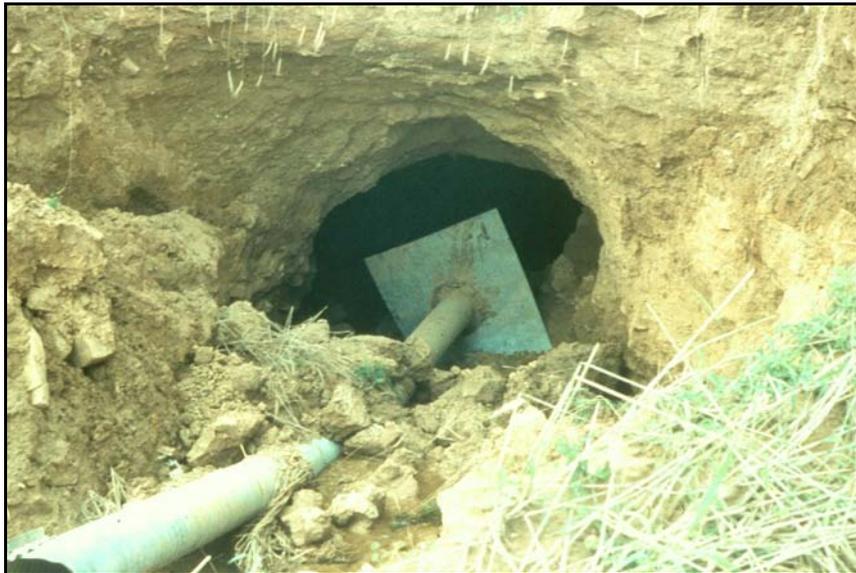
Figure A-1 shows a conduit with antiseep collars with hand compacting of earthfill next to the conduit. Figure A-2 shows a failure of a conduit with antiseep collars constructed around the conduit.

Figure A-2.—Internal erosion failure along a conduit with antiseep collars.

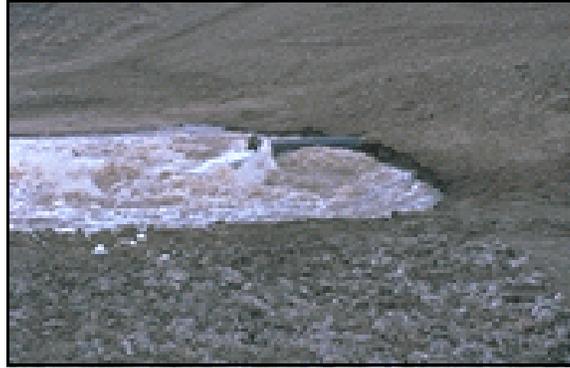
During the spring runoff of 1997, unusually heavy snowpack caused the reservoir to fill in the 4 days immediately prior to the failure. On the morning of March 26, a large leak beside the outlet conduit was noticed (figure B-1). Emergency response teams were dispatched to the site.

Figure B-1.—Outflow of water at downstream end of outlet conduit during failure. Note flow from conduit itself and from the area adjacent to the conduit.

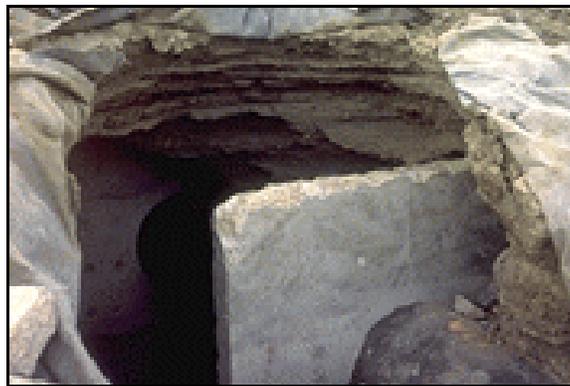
The reservoir completely drained through the outlet conduit and caverns in the earthfill adjacent to the conduit, concluding on March 27, 36 hours after initiation of the incident. Complete embankment dam collapse did not occur. Following drainage of the reservoir, inspections indicated that the embankment material had been completely eroded from around the outside of the conduit (figure B-2). The open tunnels immediately adjacent to the outlet conduit extended from the upstream embankment toe completely through the embankment dam to the downstream toe.

Figure B-2.—A view of upstream end of outlet conduit following failure. Note formation of caverns immediately adjacent to seepage cutoff collars. These caverns extend to the downstream embankment toe.

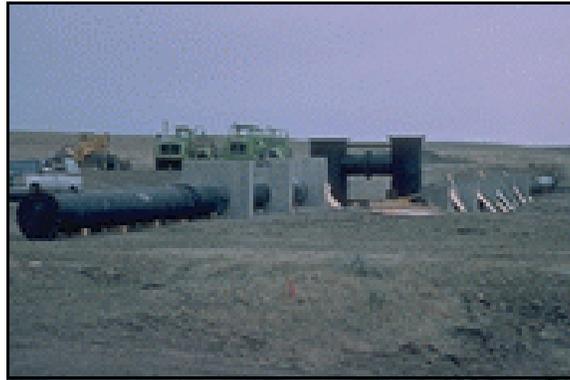
Figure B-3.—Initial construction of embankment dam and outlet conduit (upstream is to left). Note presence of antiseep collars surrounding conduit.

The cause of the failure was likely the combination of the dispersive clay embankment material, hydraulic fracture, antiseep collars (figure B-3) around the conduit that required the use of hand tampers (figure B-4), “flowable” backfill for conduit support in lieu of a continuous concrete conduit support, and lack of a filter and drain around the outlet conduit in the downstream portion of the embankment dam. Cold air flowed through the conduit during the winter preceding the failure. This caused lenses of frozen material in the conduit’s backfill. These lenses may have provided a path for concentrated leakage when they were thawed by the initial flow of water in the conduit during the runoff.

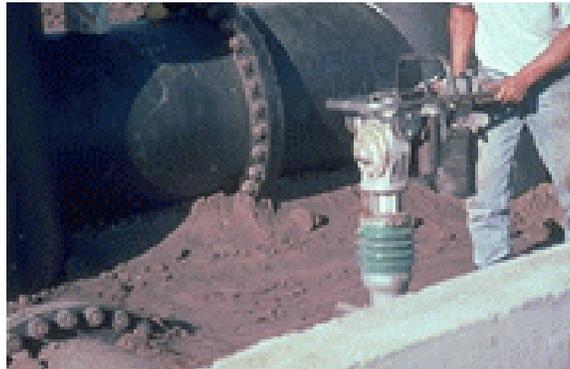
Figure B-4.—Initial construction. Note hand tampers being used to compact earthfill adjacent to outlet conduit.

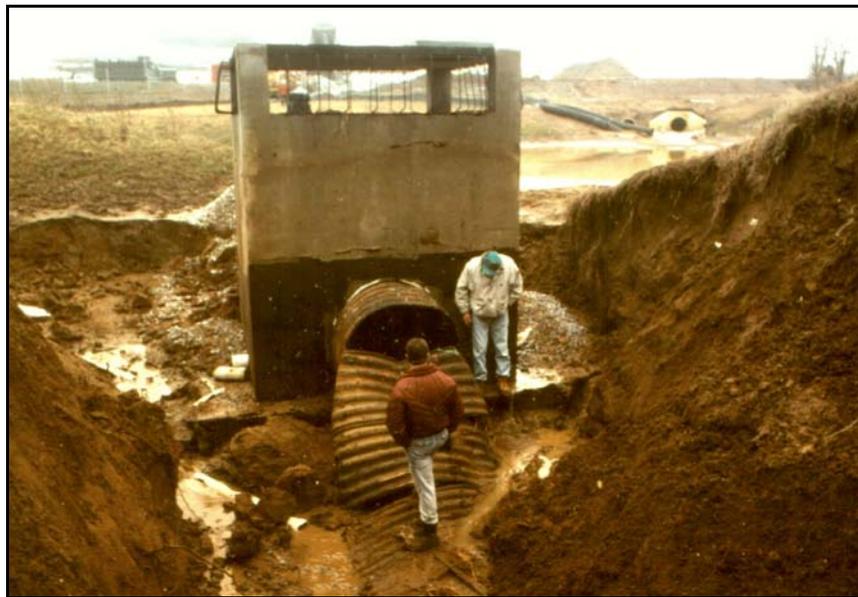
Figure B-5.—The upstream section of the 54-inch diameter CMP spillway conduit completely collapsed when the water level reached the elevation of the weirs on the inlet structure. Site personnel reported a “vortex” in the pool adjacent to the structure shortly before collapse.

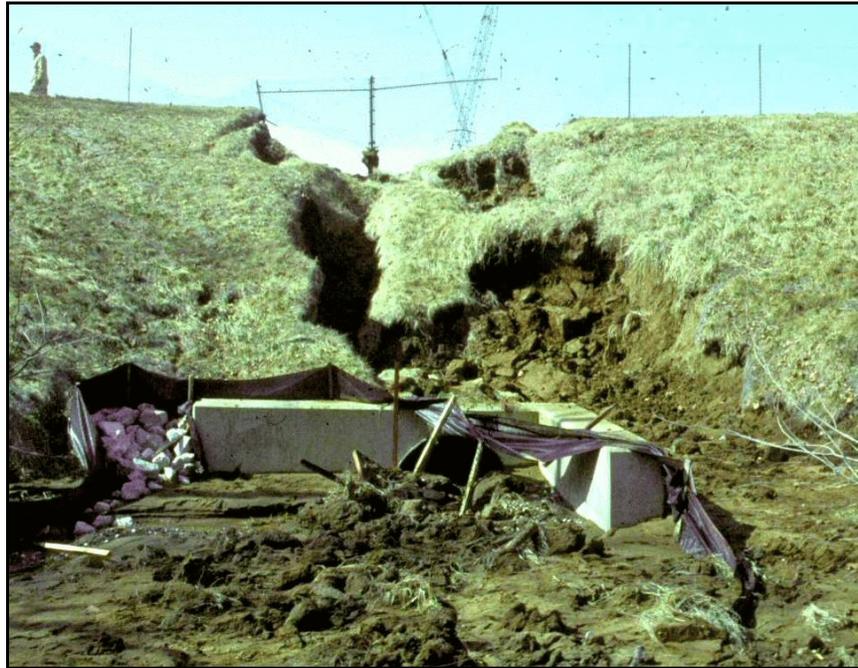
Figure B-6.—The downstream section of the CMP spillway remained partially intact, but deep troughs were visible directly above each side of the conduit.

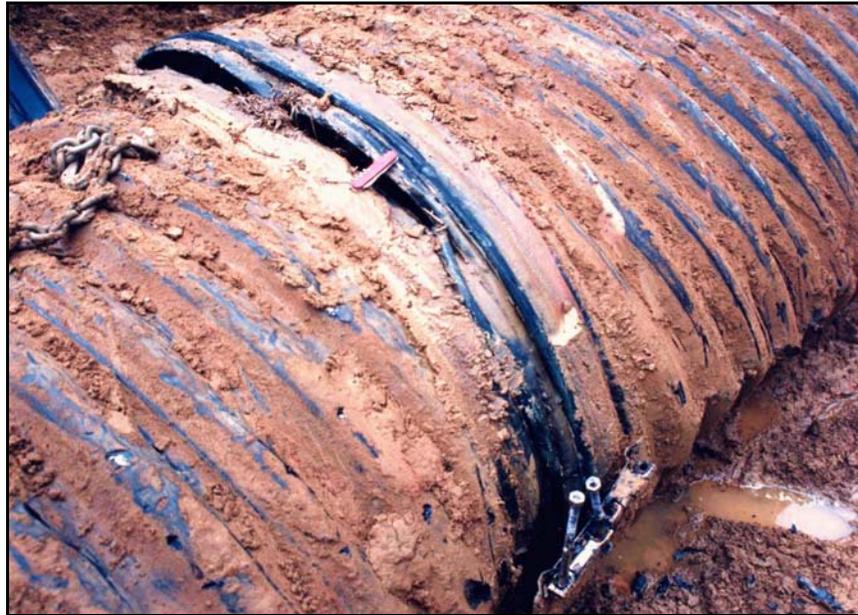
Figure B-9.—When the “hugger band” at the most downstream conduit joint was removed, the o-ring gasket was found to have been displaced. In addition, debris from the pool was found under the band, indicating that water may have flowed unrestricted along the outside of the conduit from the pool and into the joint.

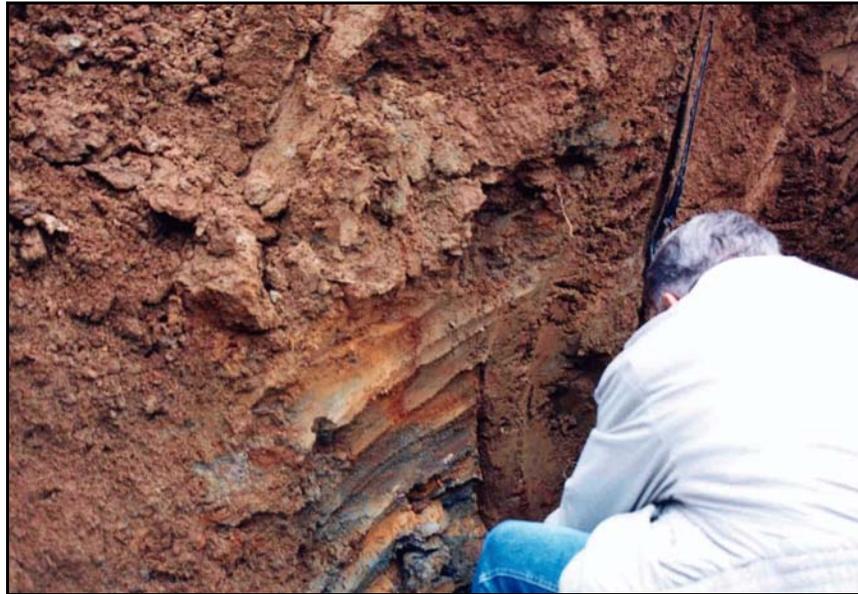
Figure B-10.—The presence of undisturbed foundation soils confirmed that the conduit was placed in a trench with nearly vertical sides, making it difficult to obtain good compaction of the fill soils under and along the CMP and around the antiseep collars.

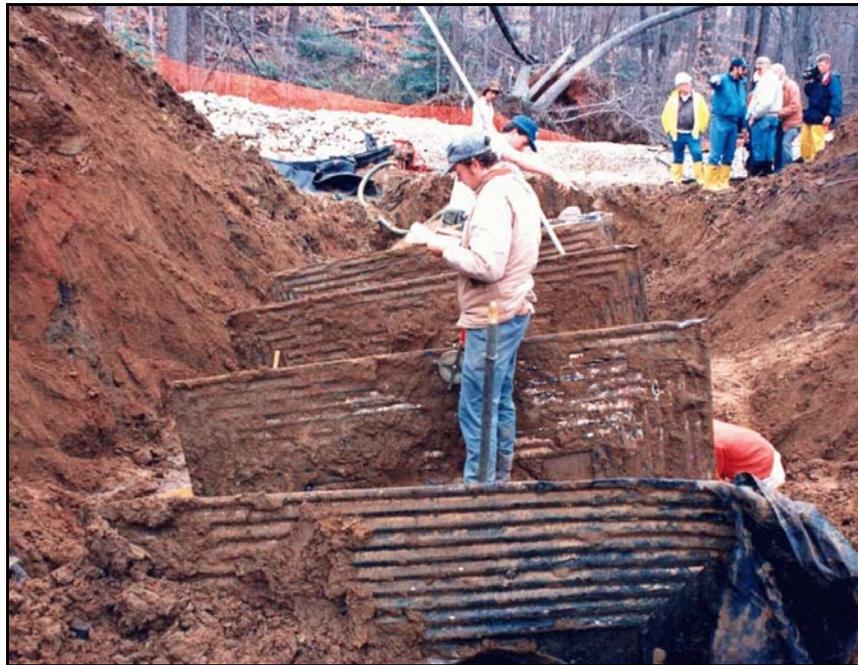
Figure B-11.—Seepage along the sides of the CMP resulted in loss of soil support, causing conduit and joint deformation.

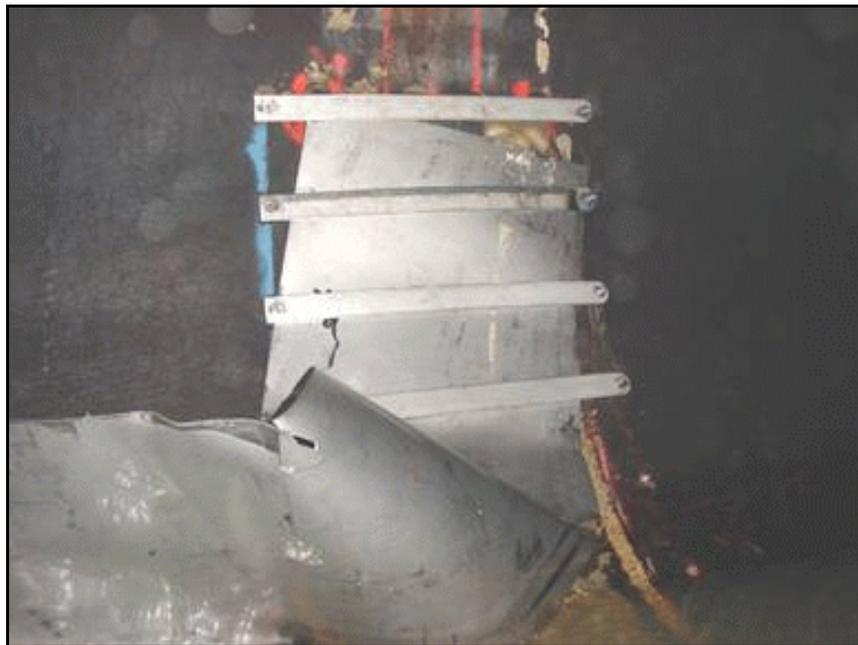
As of September 2004, the USACE had yet to determine why the patch did not stay in place and can only speculate that a log may have hit it. Currently, the USACE is evaluating installation of a steel liner as the only reliable solution for the defective joints.

Figure B-15.—Damaged metal plate.

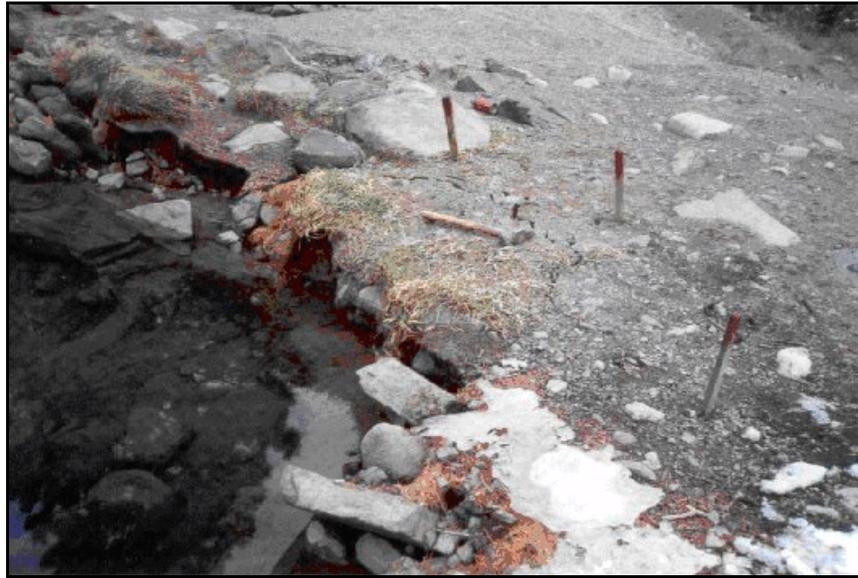
Figure B-16.—Cracking at the embankment dam crest above the sinkhole on the upstream slope of the embankment dam. Note the simple staking of the area to monitor movement of the crack.

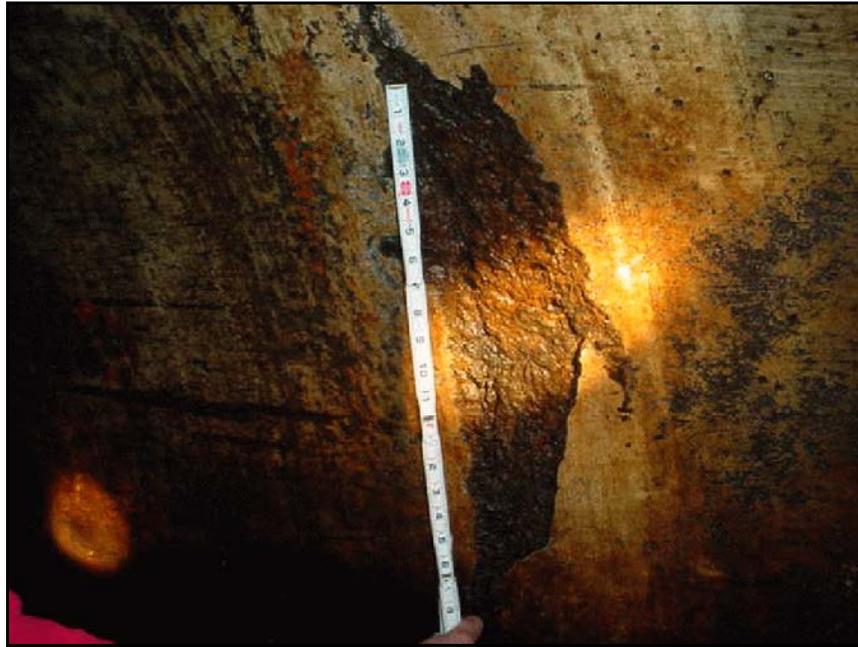
Figure B-20.—Large spall at the construction joint located at station 12+13.

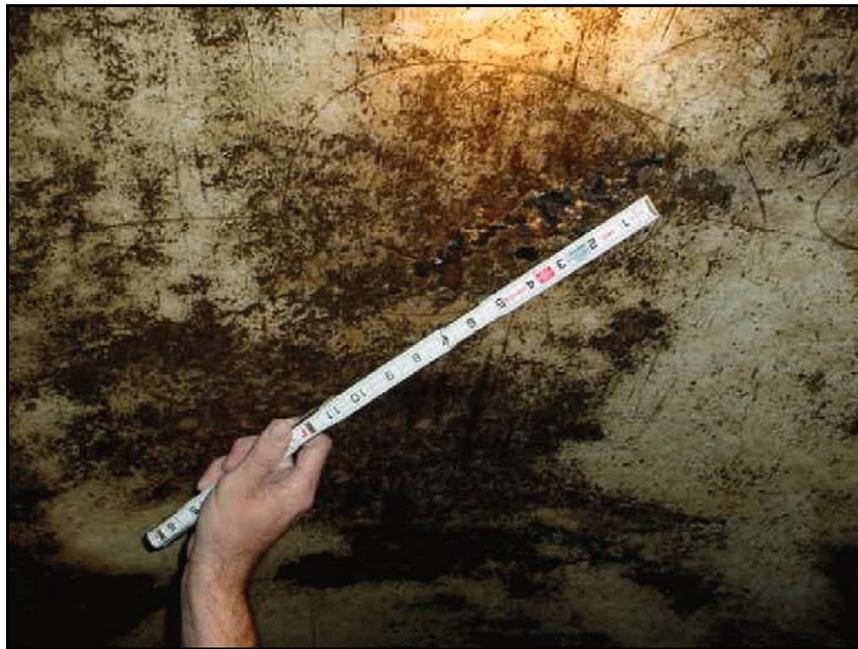
Figure B-21.—Exposed aggregate located at station 11+28.

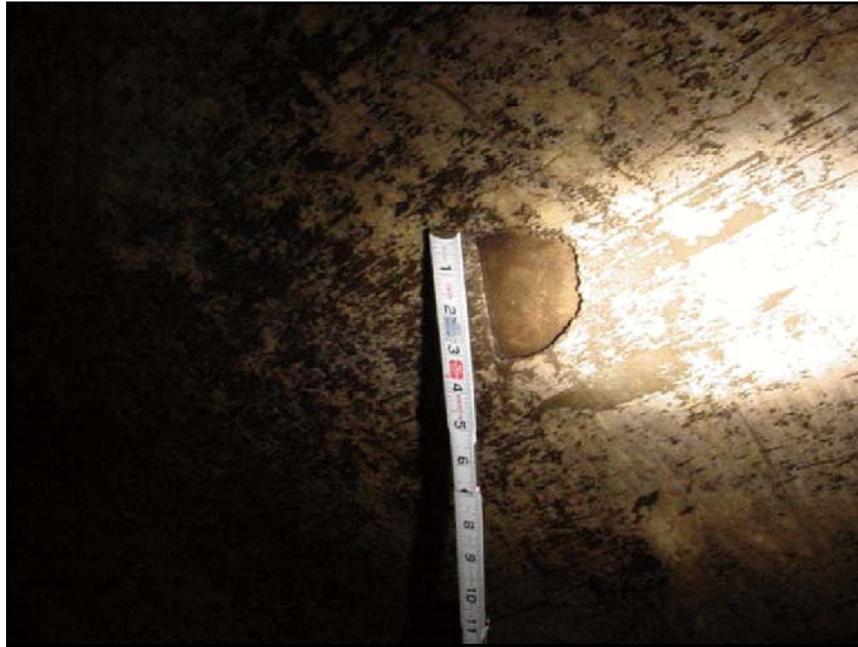
Figure B-22.—Popout located at station 10+79.

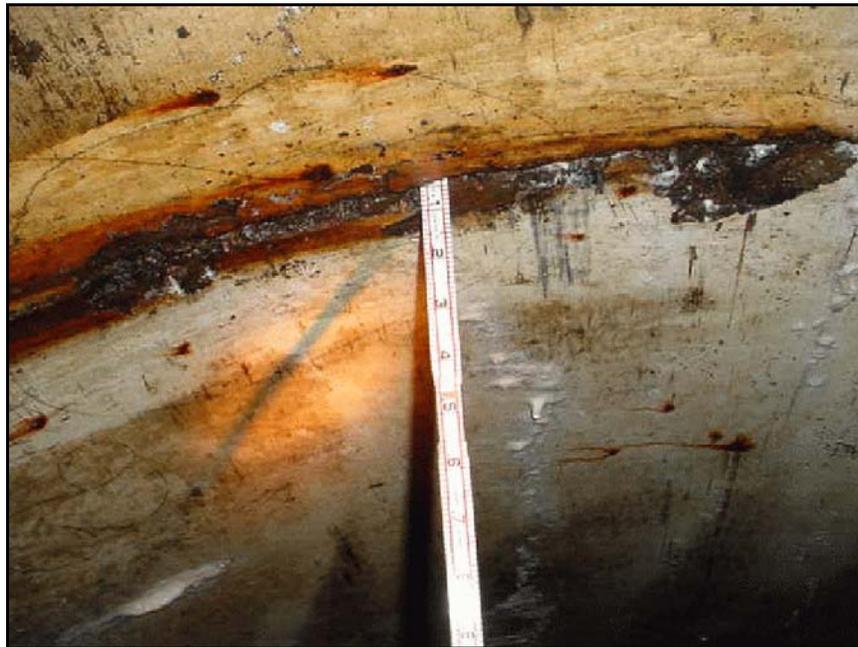
Figure B-23.—Spall at the construction joint located at station 4+93.

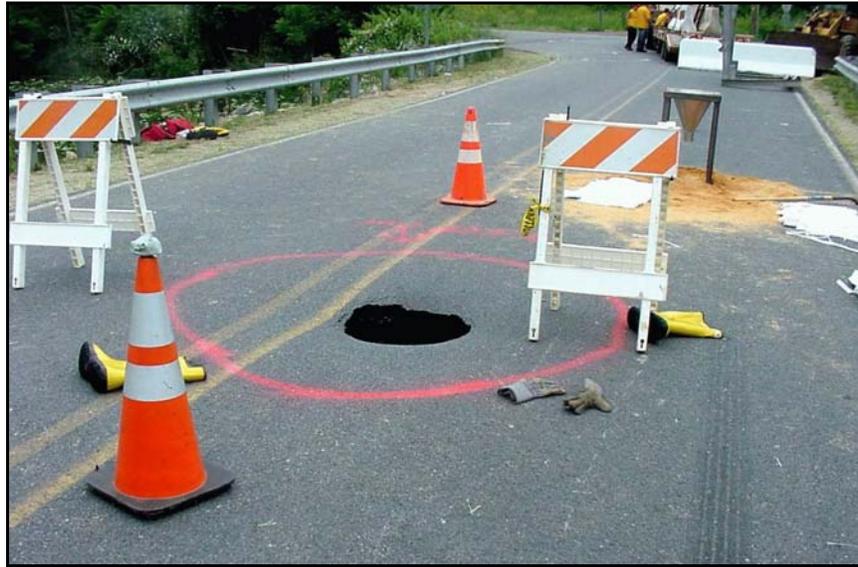
Figure B-26.—Less than 2 years later, an engineer inspecting the bridge over the spillway reported that seepage flow was visible from under the downstream end of the spillway. The seepage flow was clear, and no migration of soils was evident. A few months later, the roadway on the dam crest collapsed, and large quantities of sediment were observed in the pool below the dam.

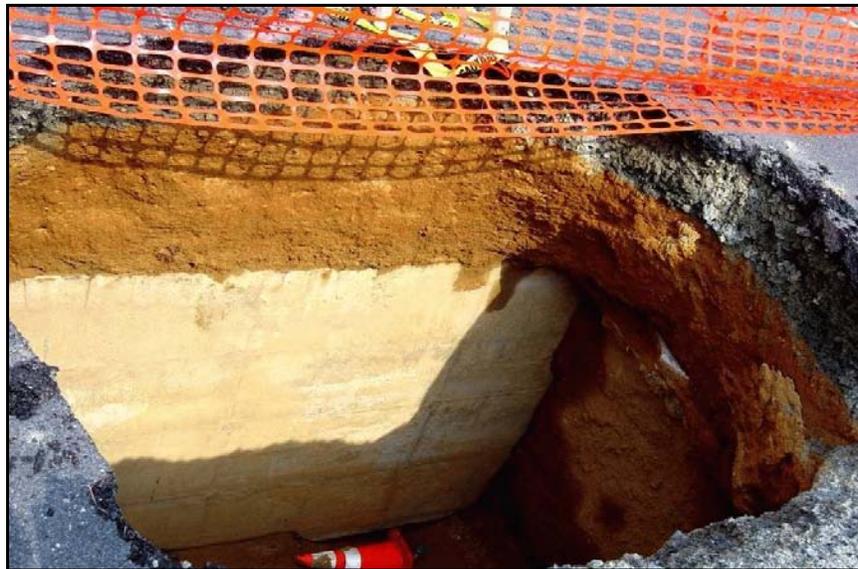
Figure B-27.—The road was closed immediately, and lake level was lowered. However, the sinkhole rapidly enlarged.

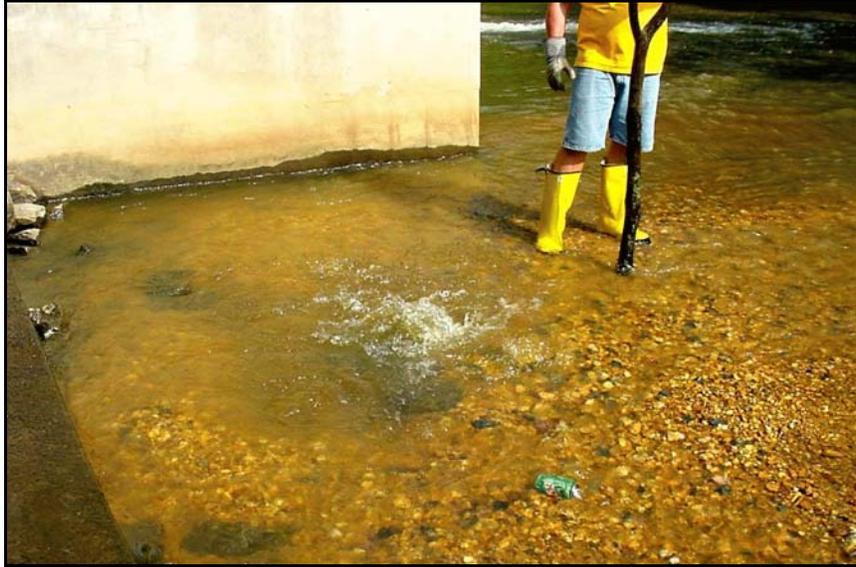
Figure B-28.—Seepage flow at the downstream end of the spillway appeared to be boiling. Attempts to create a sandbag weir around the boil to reduce leakage under the spillway were unsuccessful.

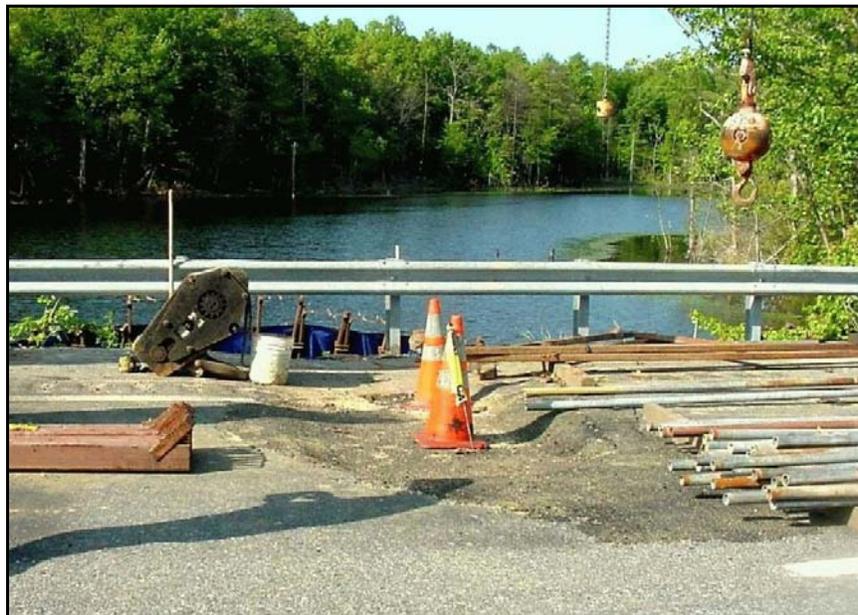
Figure B-29.—A sinkhole, which appeared in a heavily traveled roadway above a 20-year old CMP spillway, was filled with asphalt. Part of the roadway was closed when the asphalt patch subsided a few hours later.

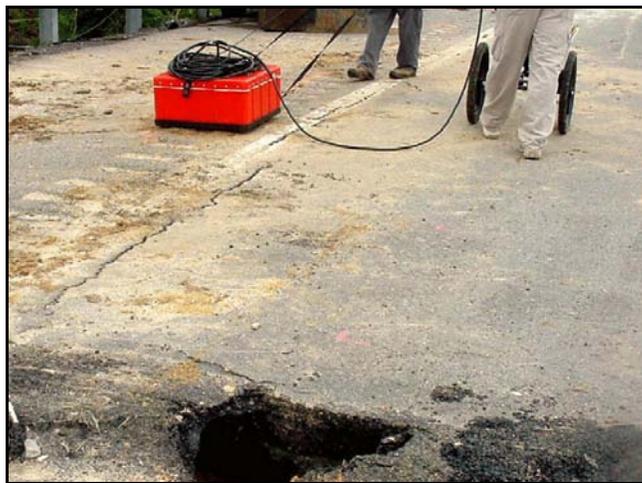
Figure B-31.—Ground penetrating radar identified the location of voids along the CMP.

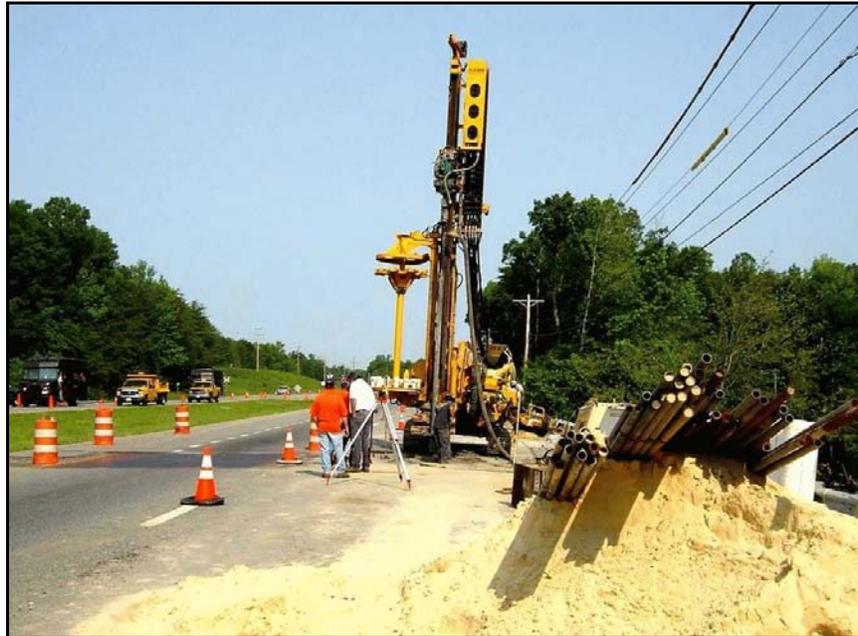
Figure B-32.—The failed CMP and voids were filled with a stiff compaction grout.

- 200 pounds of Type I Portland cement
- 850 pounds of flyash

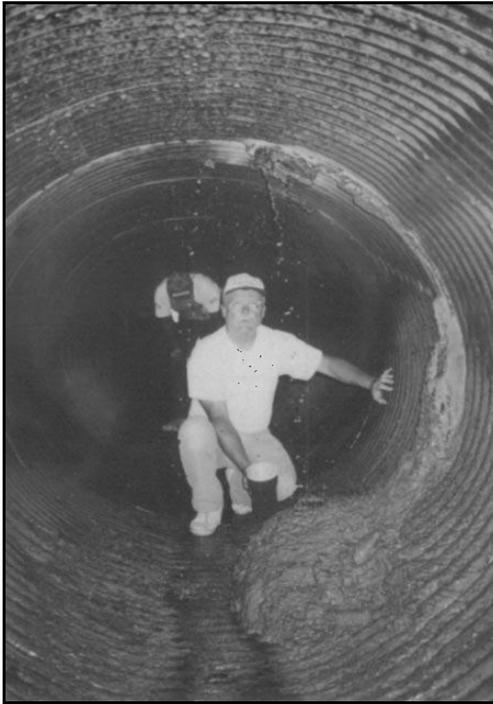
Figure B-36.—A man-entry inspection of this 60-inch CMP noted seepage and extensive loss of embankment soil at two locations.

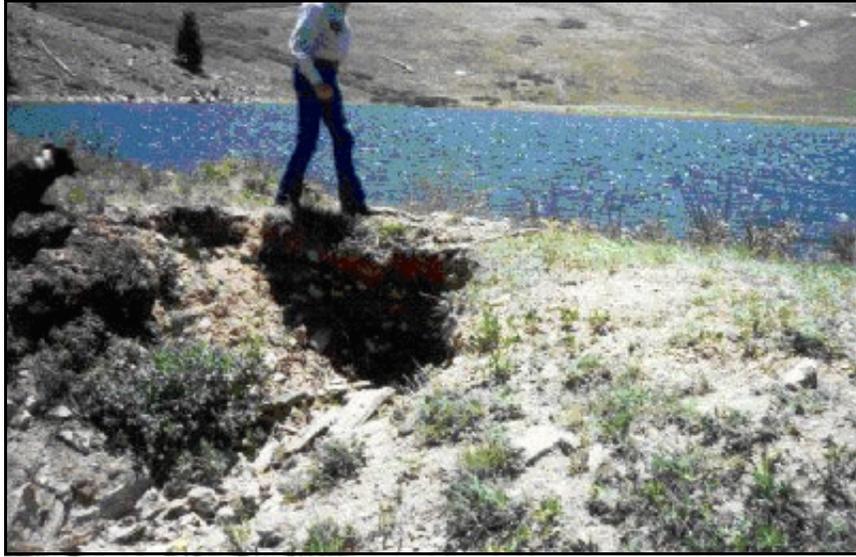
Figure B-37.—Erosion scarp on downstream slope of the embankment dam at the location of the overtopping of the dam crest.

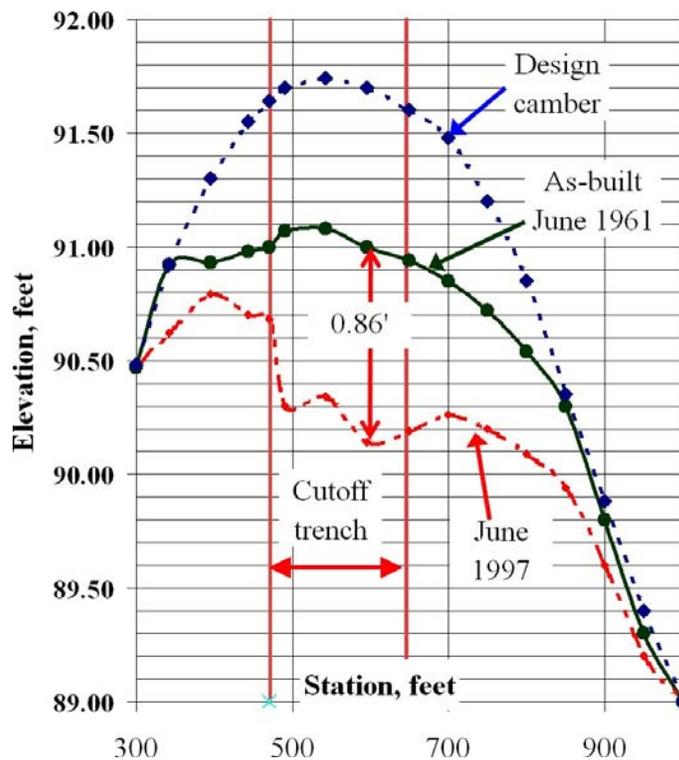
Figure B-42.—Settlement of the outlet conduit at Hernandez Dam.

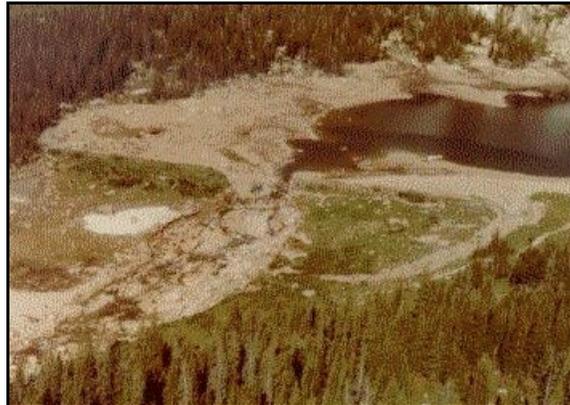
The embankment dam failure occurred when a large leak developed in a pressurized outlet conduit. Flow from the leak quickly eroded the surrounding low plasticity embankment soils. The probable cause of the defect in the outlet conduit system that led to the embankment dam failure was deterioration of the lead caulking at the joint between the steel outlet conduit and the gate valve used to control releases through the conduit. The opening at this juncture in the conduit allowed pressurized water to escape the conduit, because the gate valve was closed, and the reservoir was full.

Figure B-46.—Aerial view of the breached Lawn Lake Dam and downstream floodplain.
