HURRICANE

Katrina

IN THE GULF COAST

5. Building Envelope Performance

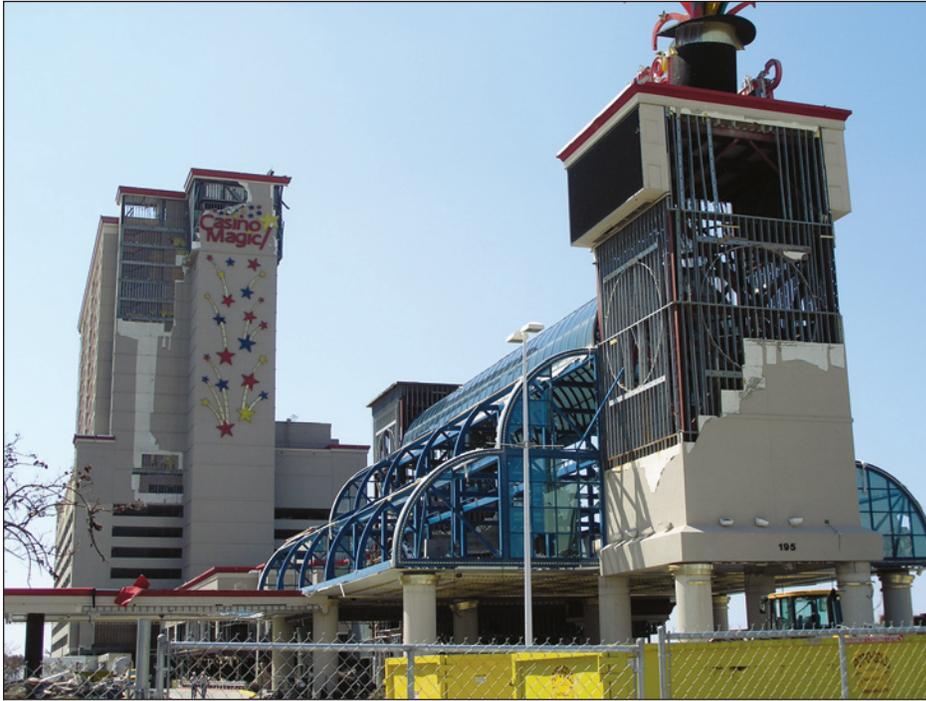
Hurricane Katrina produced large areas of EIFS failure on many low-rise and multi-story buildings (see Figure 5-9). In addition to puncture by windborne debris, common planes of failure of EIFS assemblies included (typically as a secondary failure plane) separation of the synthetic stucco from the insulation and (as primary failure planes) detachment of the insulation from the gypsum board substrate, detachment of the gypsum board from the studs, and failure of the studs. When the insulation detaches from the gypsum board, the gypsum board can suffer strength reduction due to wetting from the wind-driven rain, and it too often will then blow off during a hurricane.

Figure 5-9. Multi-story building in Exposure C, showing severe EIFS damage. The gypsum board typically detached from the studs. In some areas, the gypsum board on the interior side of the studs was also blown away (estimated wind speed: 120 mph. Biloxi, Mississippi).

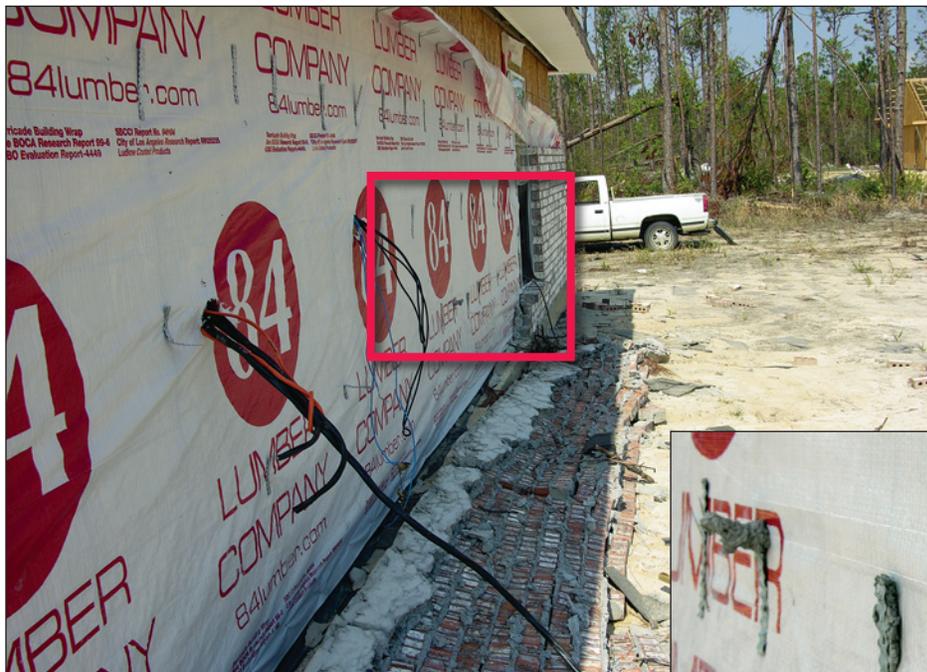
Several buildings with failed brick veneer were observed. The majority of the failed brick veneers were applied over wood stud framing; however, some of the failed veneers were applied over CMU (in some instances, the CMU also failed). Figure 5-15 shows failed brick at a house that was under construction. The ties were typically spaced at 16 inches on center horizontally. Vertical spacing varied. The first row was 19 and 21 inches above the footer. The second row was 22 and 24 inches above the first row, and the third row was 18 inches above the second row. Some of the smooth-shank tie nails pulled from the studs. Many of the ties had never been embedded into the mortar joints, which was a major workmanship error.

Figure 5-15. Collapsed brick veneer wall that was under construction. Several of the ties had not been embedded into the mortar joints (square/inset) (estimated wind speed: 125 mph. Waveland, Mississippi).

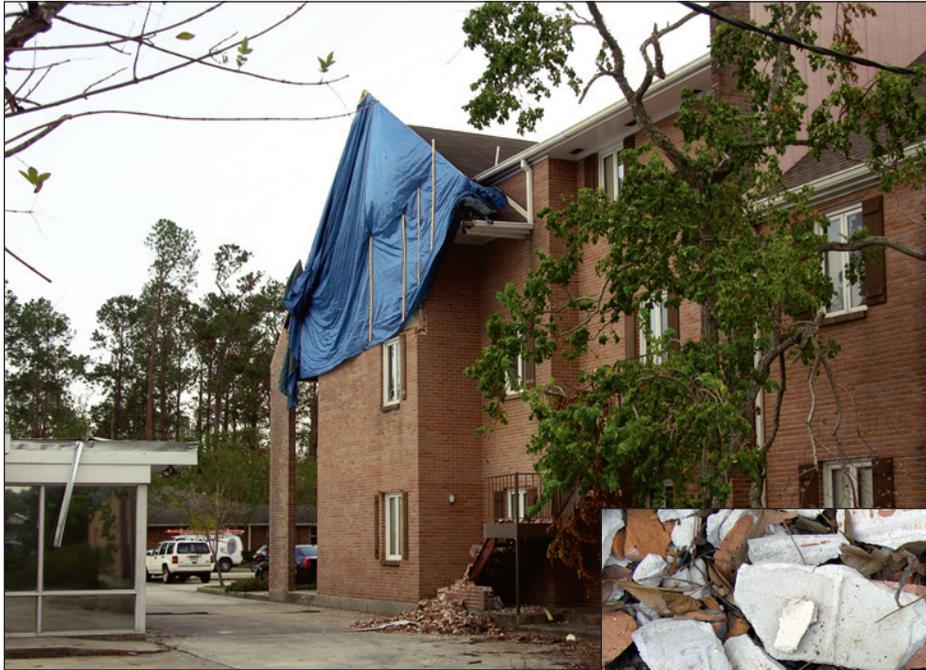
Most of the failed brick veneers that were investigated failed because of inadequate tying between the brick and studs. Inadequacies included excessive vertical and/or horizontal spacing of ties, inadequate pull-out resistance of tie nails (all nails observed were smooth-shank, with a length of either 1-3/8 or 1-3/4 inches), failure to embed ties into the mortar joints, and poor bonding between ties and mortar. However, some of the failures were due to tie corrosion as shown in Figures 5-17 and 5-18. The apartment building shown in Figure 5-17 was occupied at the time of the investigation. The area in the vicinity of the partially collapsed walls had not been barricaded, leaving pedestrians and vehicular traffic susceptible to injury if further collapsing occurred.

Figure 5-17. Partial collapse of brick veneer at an apartment building; the ties were corroded (inset) (estimated wind speed: 115 mph. Slidell, Louisiana).

FEMA Hurricane Katrina Recovery Advisory *Attachment of Brick Veneer in High-Wind Regions* (Appendix E) provides recommended practices for brick veneer attachment. This advisory was based on observations from Hurricanes Ivan and Katrina.

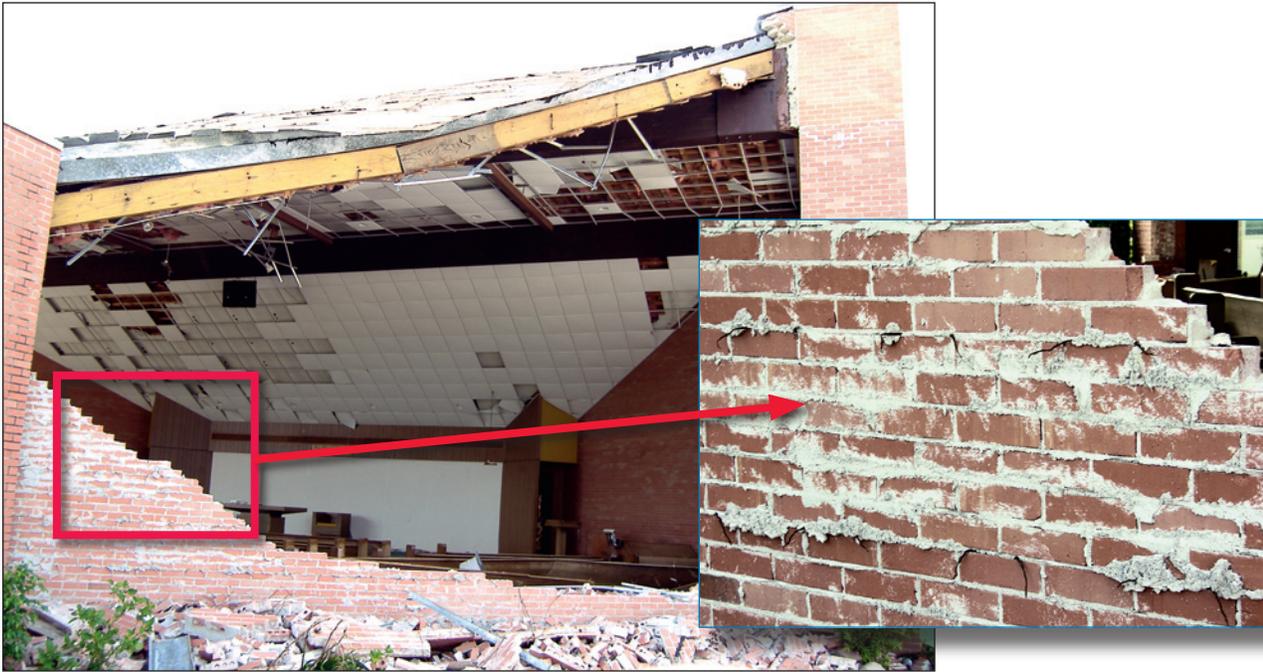
Figure 5-18.

At the old church shown in Figure 5-18, the ties between the roof framing and brick wall, and the continuous wire truss type horizontal joint reinforcement between the two wythes were severely corroded.

The ties and wire truss type horizontal joint reinforcement in this double-wythe cavity wall were severely corroded (inset) (estimated wind speed: 105 mph. Pascagoula, Mississippi).

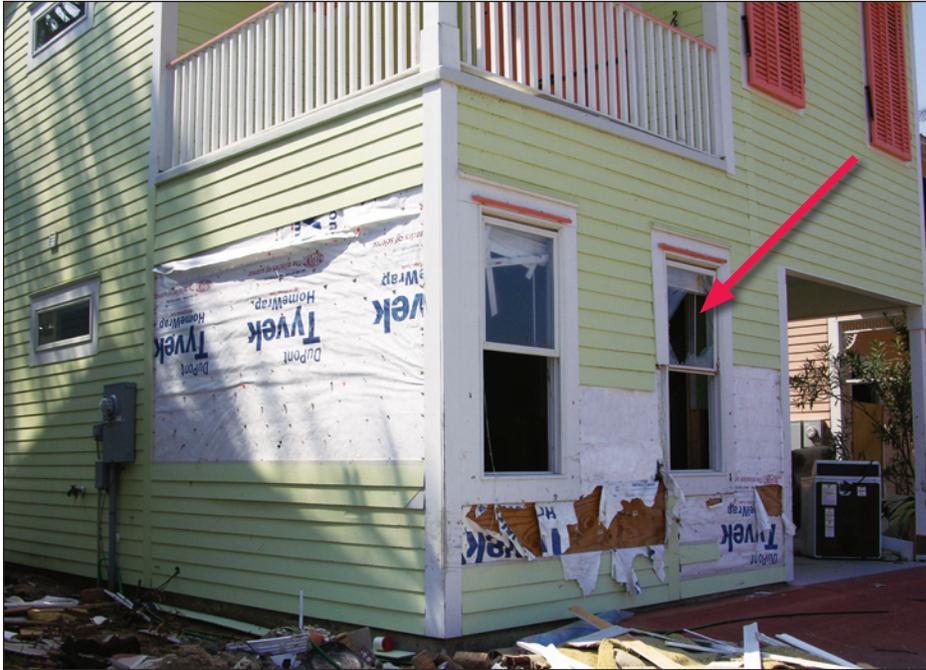
Only a very small number of buildings with fiber-cement siding were observed. Figure 5-19 shows a newly constructed house that experienced wind-induced loss of fiber-cement siding. Along one of the 6-1/4-inch-wide siding panels, the concealed nails were located 1 inch from the end of the panel, then 12, 14, and 12 inches. One of the nails was 5/8 inch from the top of the panel and another was 3/4 inch. At a house in Saint Bernard Parish, Louisiana, along one of the 7-1/4-inch-wide siding panels, the concealed nails were spaced at 8 inches on center and were located 7/8 inch from the top of the panel. At both of these buildings, the siding pulled over the nail heads. The manufacturer recommends that, when using the concealed nailing method, the nails be placed at studs spaced at a maximum of 24 inches on center and that the nails be located 1 inch from the top of the panel.

Figure 5-19. Blow-off of fiber-cement siding. Note the broken window at the right (arrow) (estimated wind speed: 125 mph. Bay St. Louis, Mississippi).

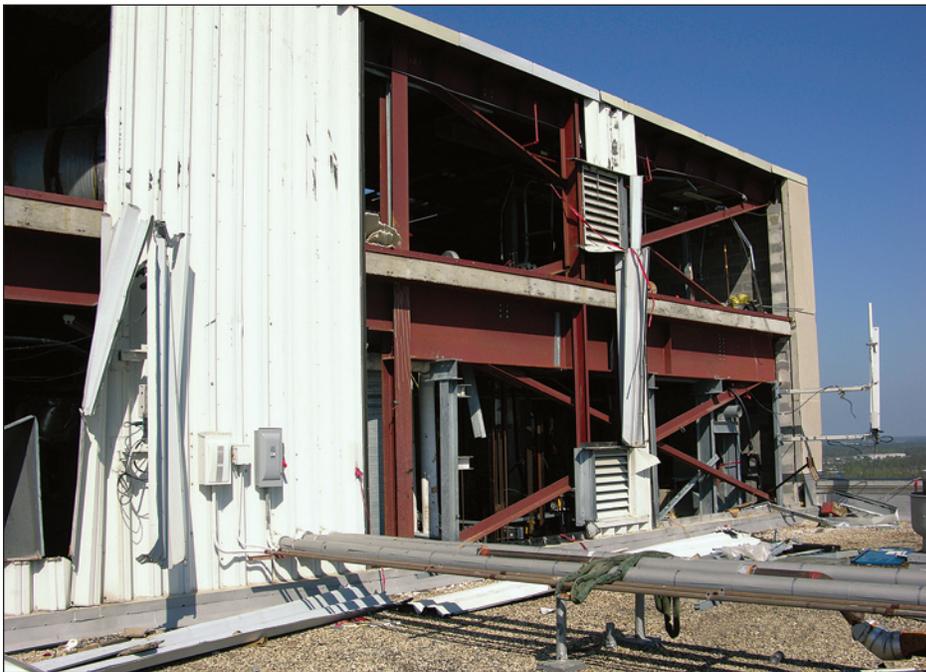
The MAT observed a limited number of metal wall panel failures. A massive failure occurred at the penthouse on a 15-story office building (Figure 5-20). With loss of the wall panels, the elevators were no longer operational due to wind-driven rainwater damage to the elevator controls.

Figure 5-20. The metal wall panels blew off the penthouse on this 15-story building. Rainwater infiltration damaged the elevator controls (estimated wind speed: 130 mph. Gulfport, Mississippi).

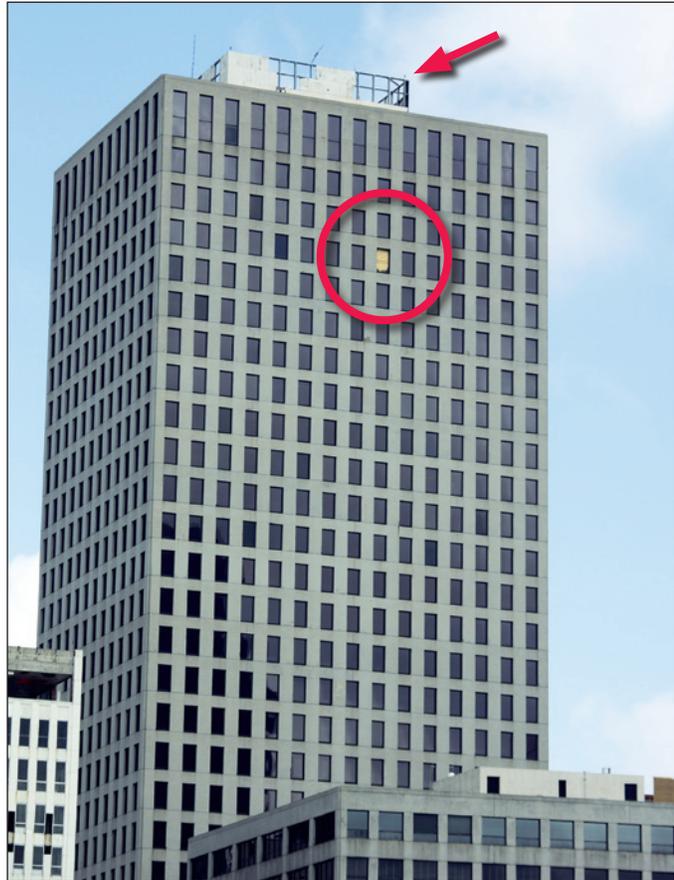
A few high-rise buildings in New Orleans also lost metal panels from equipment screen walls (see Figure 5-21). Blown-off panels from tall buildings can damage other buildings and vehicles, and cause injury. The panels at one of these buildings were composite panels (i.e., inner and outer metal skins with a plastic foam insulation core).

Figure 5-21.
Loss of metal panels from equipment screen walls (arrow). Note the broken window (circle) (estimated wind speed: 105 mph. New Orleans, Louisiana).

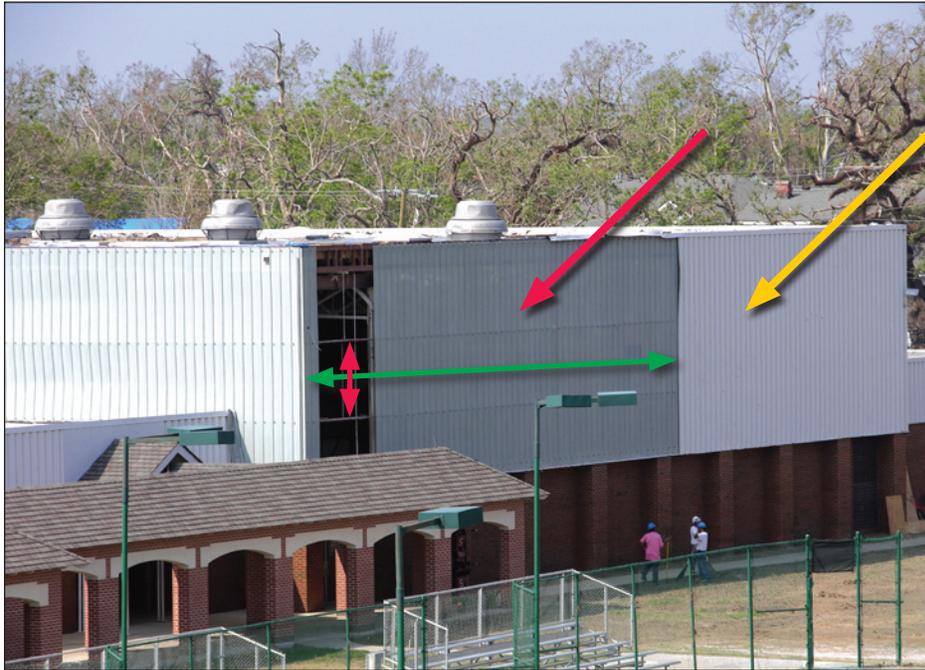
Another wall panel failure was observed at a university building (Figure 5-23). New metal panels had been installed over older metal panels. The newer panels were attached with concealed clips installed over the older panels. The clips were placed at horizontal girts that were far apart. At a corner area both the newer and older panels blew off; the blow-off may have initiated with failure of the older panels, or the failure of the older panels may have been a secondary failure.

Figure 5-23. The white metal panels had been installed over a previous metal panel system. Most of the underlying original panels (red arrow) remained in place, but many of the newer panels (yellow arrow) blew off due to inadequate attachment (green double-arrow shows the area that is missing the newer overlying panels). Note that the girts (red double-arrow) were very far apart (estimated wind speed: 125 mph. Waveland, Mississippi).

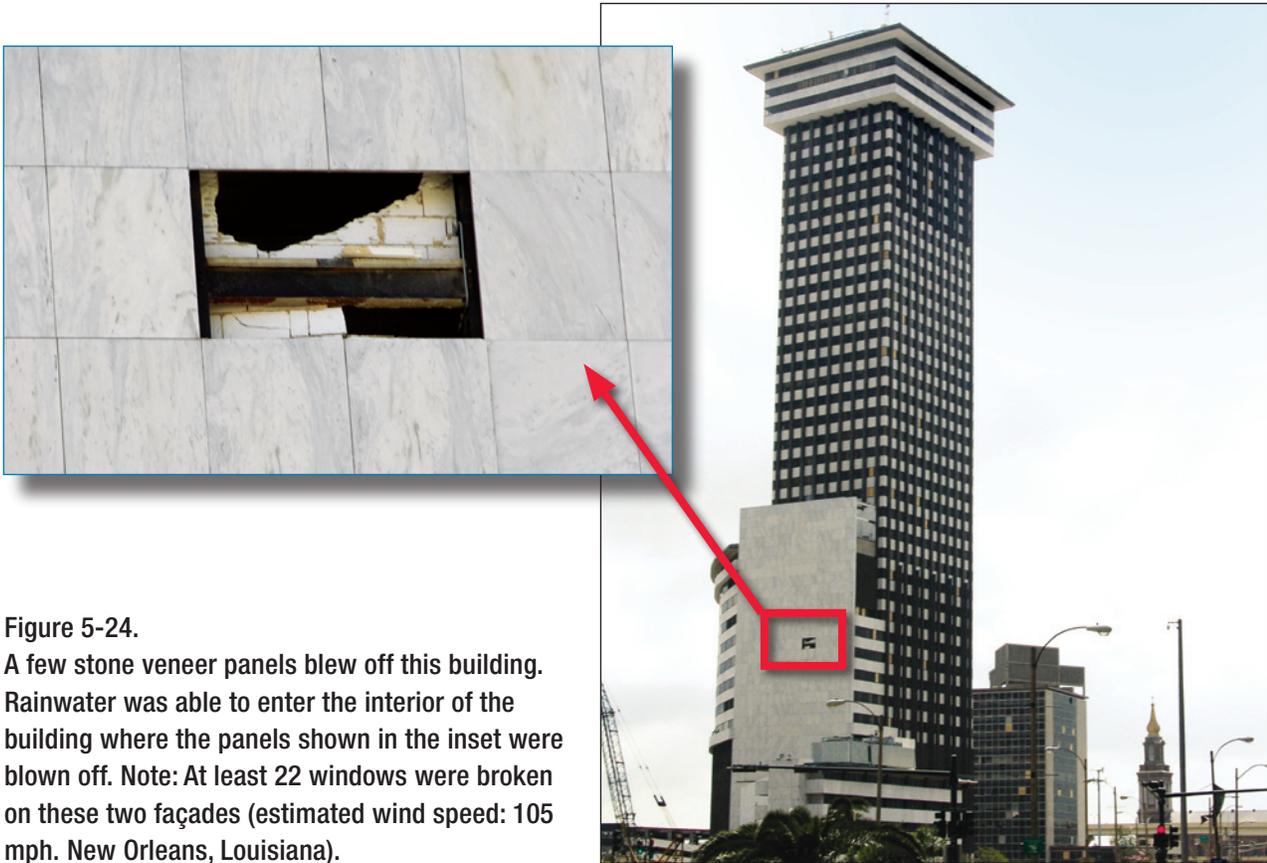
Figure 5-24.
A few stone veneer panels blew off this building. Rainwater was able to enter the interior of the building where the panels shown in the inset were blown off. Note: At least 22 windows were broken on these two façades (estimated wind speed: 105 mph. New Orleans, Louisiana).

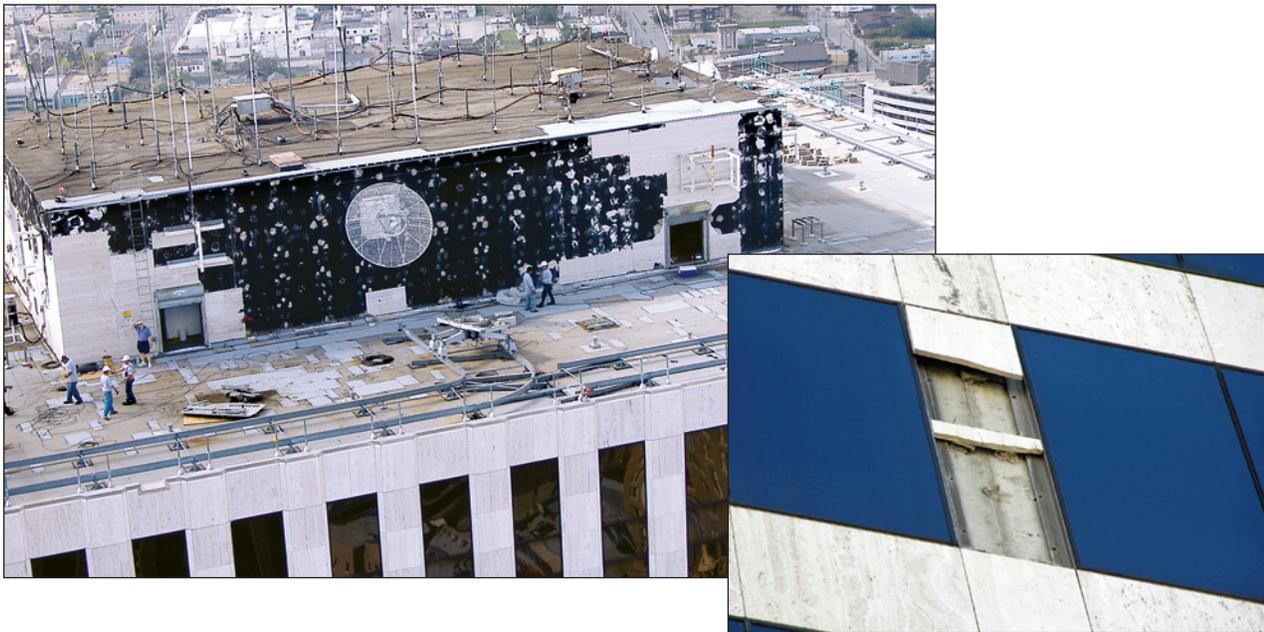
Figure 5-25.
Several stone veneer panels blew off the penthouse and caused significant puncturing damage to the modified bitumen membrane roof. A few panels were also blown off the main walls (inset) (estimated wind speed: 105 mph. New Orleans, Louisiana).

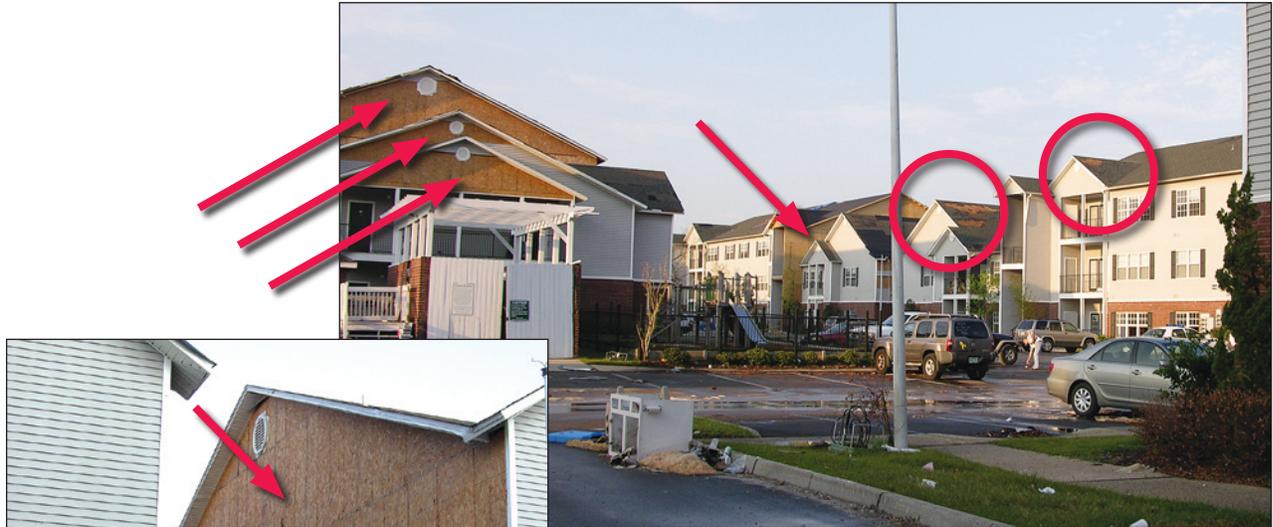
Figure 5-26. Many of the buildings in this apartment complex lost a substantial amount of vinyl siding (arrows) and asphalt shingles (circles). Underlayment had not been installed underneath the siding (estimated wind speed: 120 mph. D'Iberville, Mississippi).

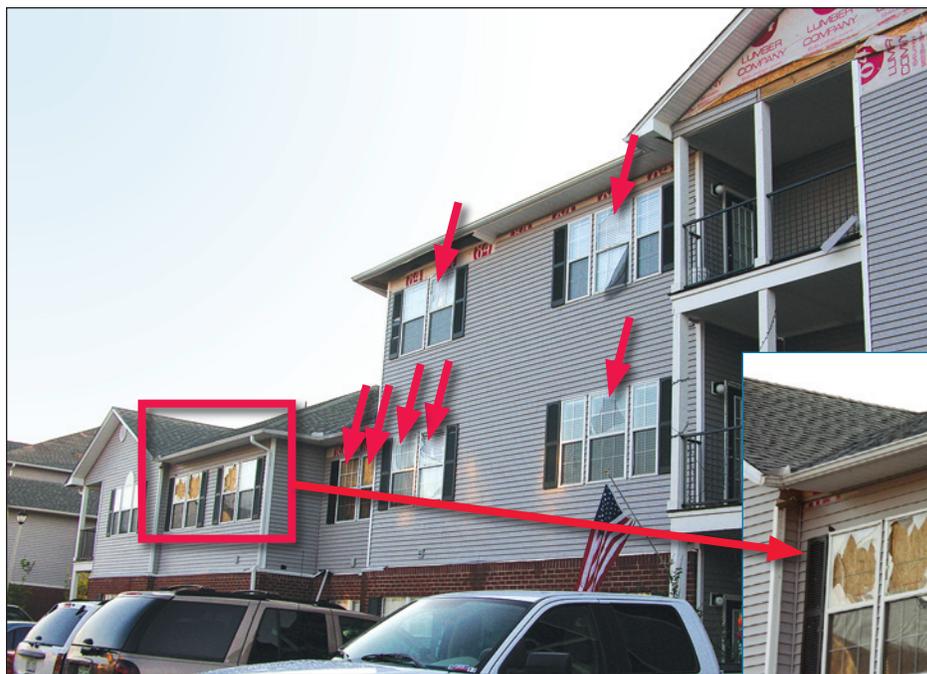
Figure 5-27. These windows were broken by windborne debris (inset and arrows). Note the missing vinyl siding and soffit (estimated wind speed: 120 mph. D'Iberville, Mississippi).

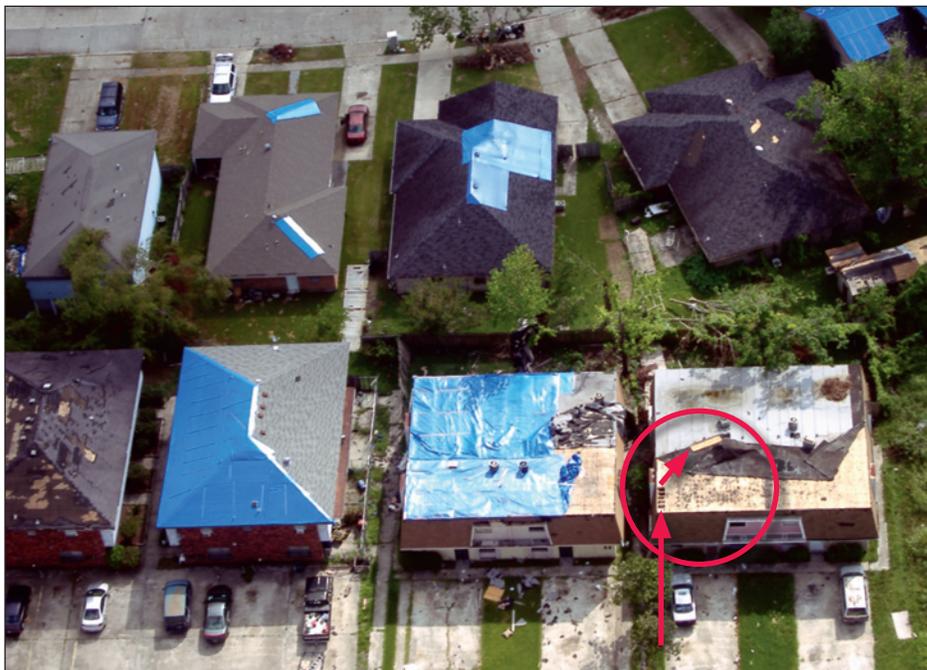
Figure 5-34. Asphalt shingles were damaged on seven of these houses. The two houses on the lower right had built-up or modified bituminous cap sheets. The blow-off at the lower right was likely initiated by blow-off of a deck panel from the corner (estimated wind speed: 105 mph. New Orleans, Louisiana area).

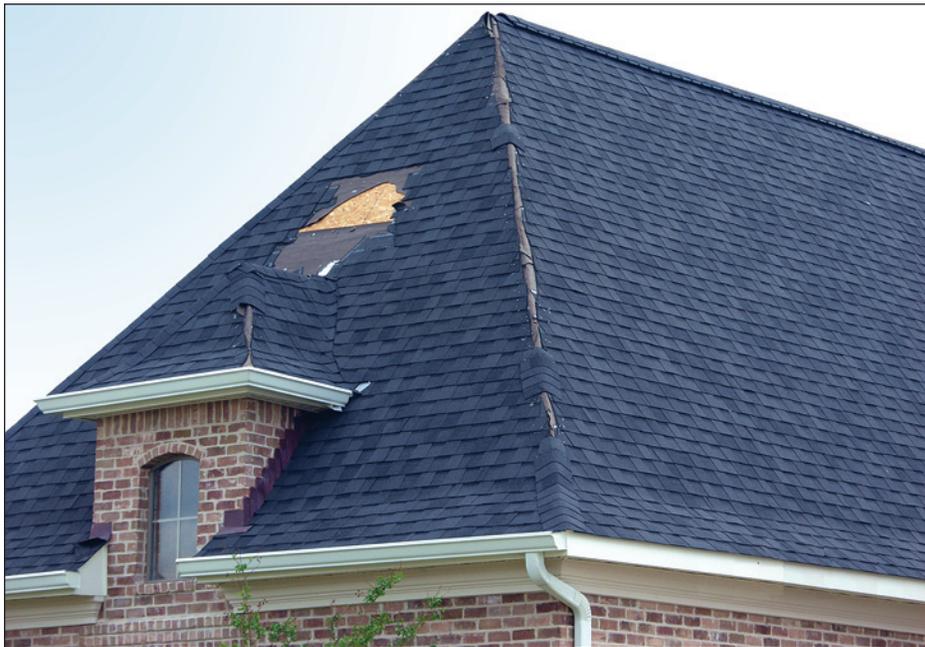
Figure 5-36. Loss of hip shingles. The underlayment above the dormer was likely blown off due to increased turbulence caused by the dormer (estimated wind speed: 115 mph. Slidell, Louisiana).

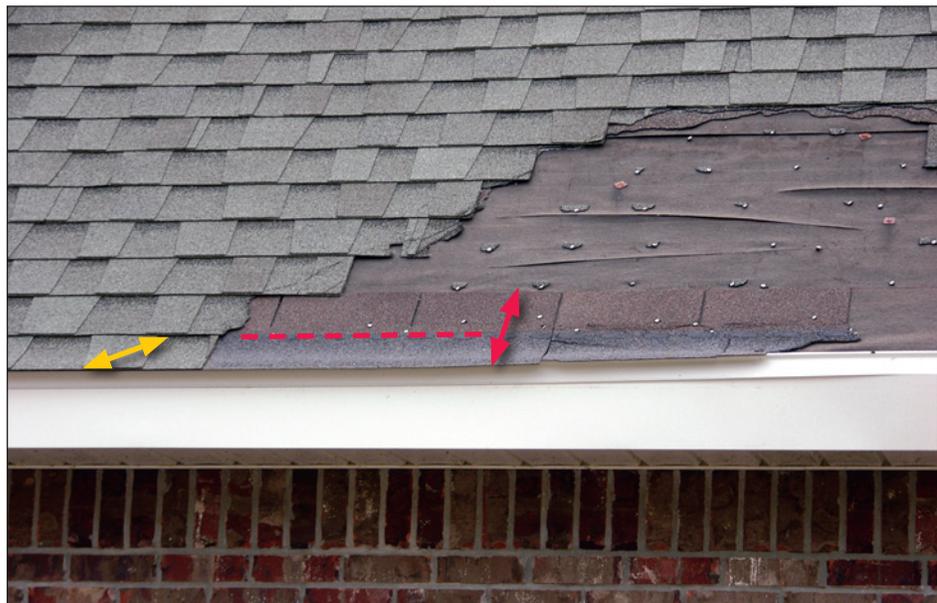
Figure 5-39. These two failures likely initiated at the eave due to an incorrectly installed starter course. Note that, at both roofs, a portion of the underlayment and some of the hip shingles were blown away (estimated wind speed: 115 and 105 mph. Slidell, Louisiana, and Pascagoula, Mississippi, respectively).

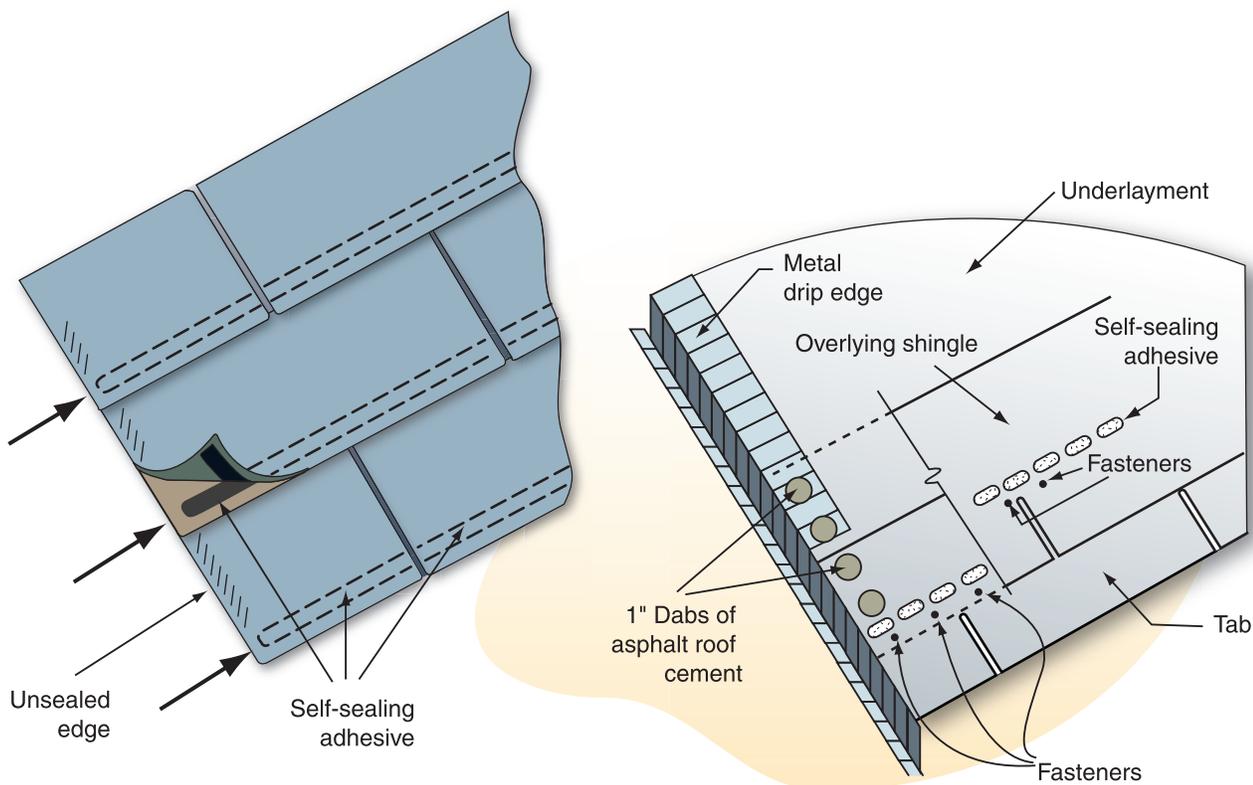
Figure 5-41. Uplift loads along the rake are transferred (illustrated by the arrows) to the ends of the rows of self-sealing adhesive. When loads exceed resistance of the adhesive, the tabs lift and peel. The detail at the right is from Technical Fact Sheet 20 in FEMA 499. It shows installation of asphalt roof cement along the rake. The cement adheres the unsealed area shown by the hatched lines of the drawing to the left.

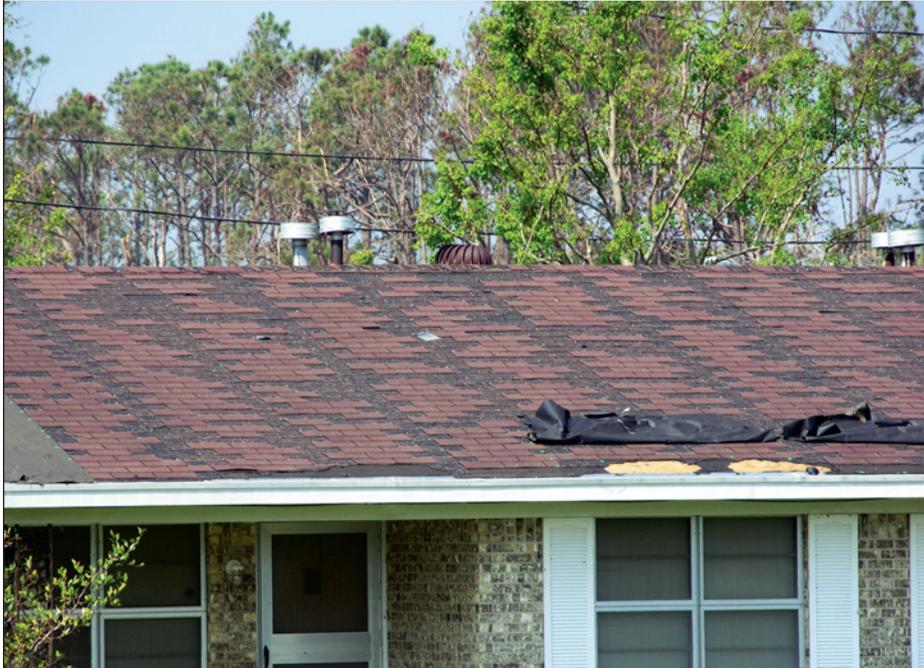
Figure 5-49.
The vertical lines of missing tabs are indicative of installation by the raking method. When raked, end nails are frequently not installed. Some shingles and underlayment were also blown from the eave and rake (estimated wind speed: 125 mph. Waveland, Mississippi).

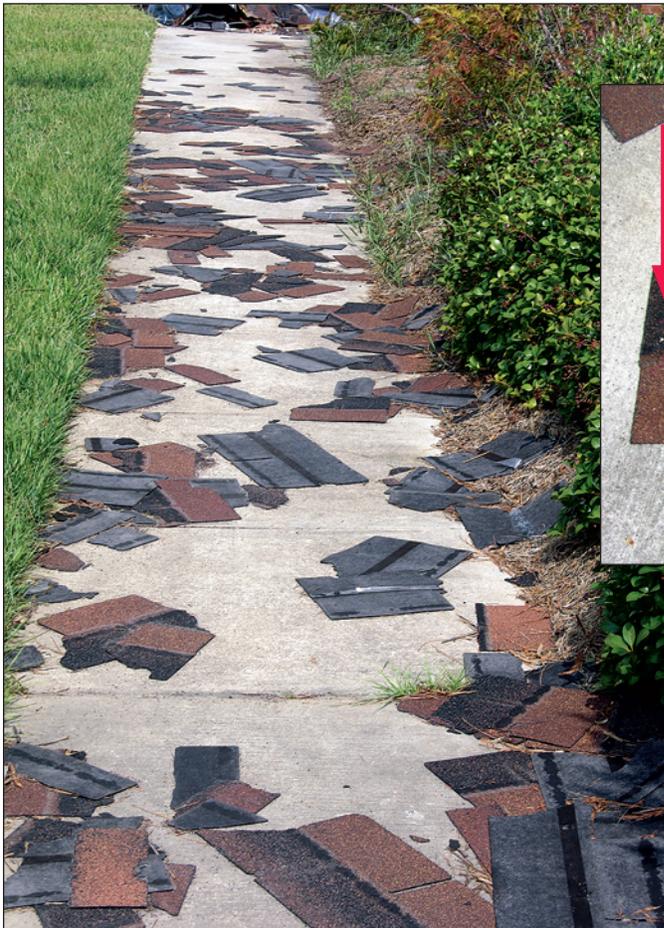
Figure 5-50.
Many shingles were blown from a nursing home. Limited checking found three shingles that were missing the right end nail (see inset for one of these). The nails that were installed were placed very high (red arrows); many missed or just nicked the underlying headlap (estimated wind speed: 130 mph. Gulfport, Mississippi).

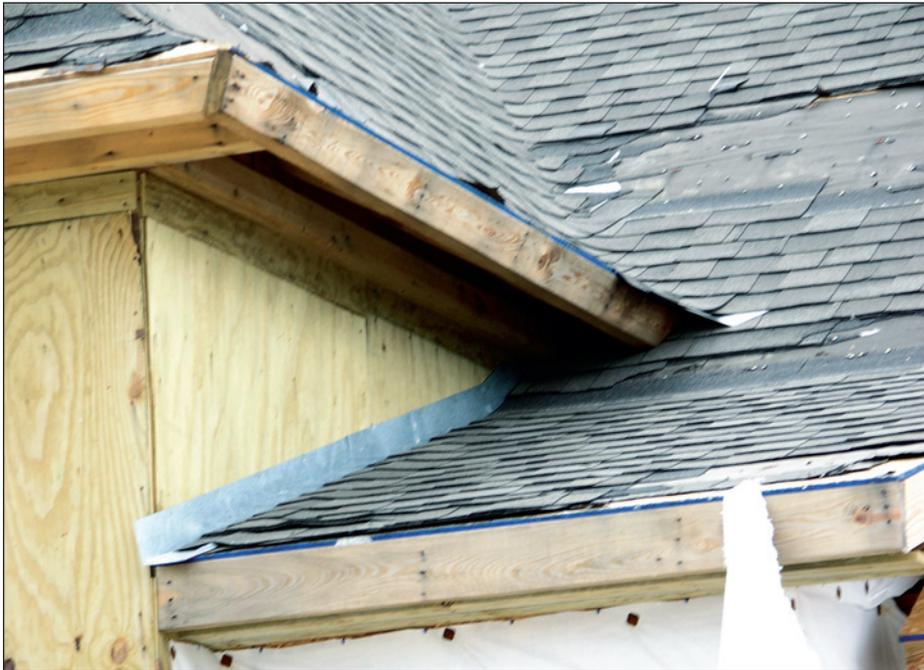
Figure 5-53. Continuous metal flashing at the roof-to-wall intersection of a house under construction. This detail is susceptible to leakage and subsequent dry rot of the deck sheathing (estimated wind speed: 115 mph. Slidell, Louisiana).

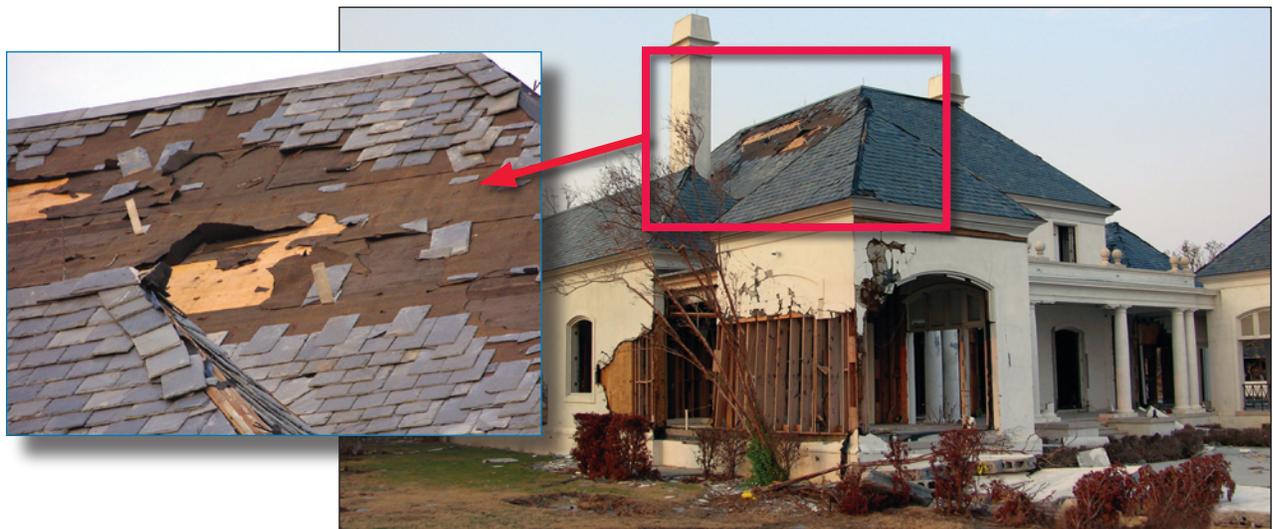
Figure 5-56. Damaged slate roof. The nails typically pulled out of the deck. However, as shown in the square/inset, some of the slates broke and small portions remained nailed to the deck. This house was located in Exposure C (estimated wind speed: 130 mph. Gulfport, Mississippi).

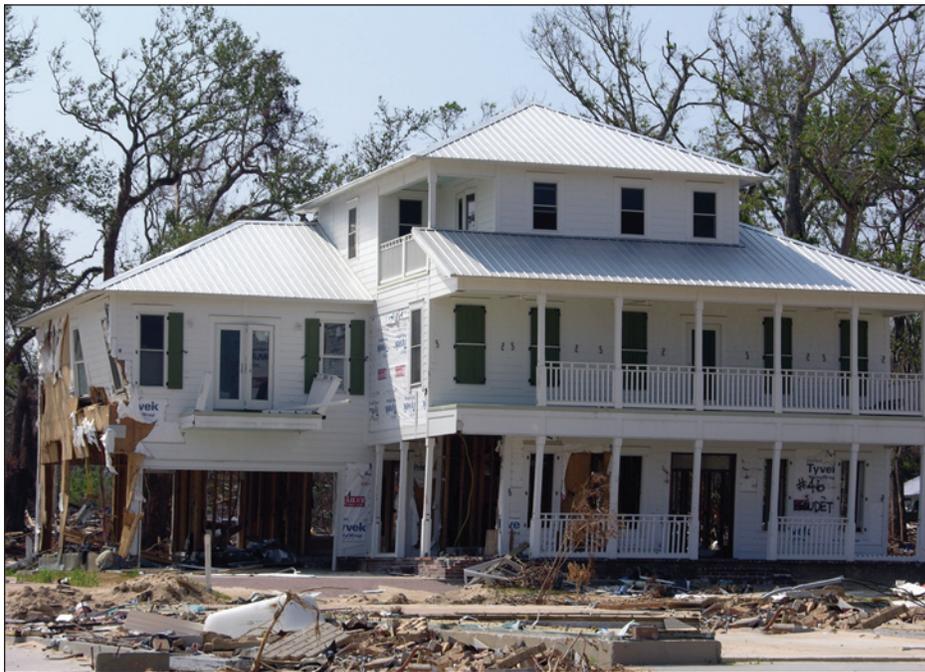
Figure 5-59. This R-panel roof was not damaged. This house was located in an area that received some of the highest winds (estimated at 125 mph). The damage at the first and second floors was caused by storm surge. The surge pushed the first floor to the right. This "leaner" is considered to be a "survivor" (estimated wind speed: 125 mph. Bay St. Louis, Mississippi).

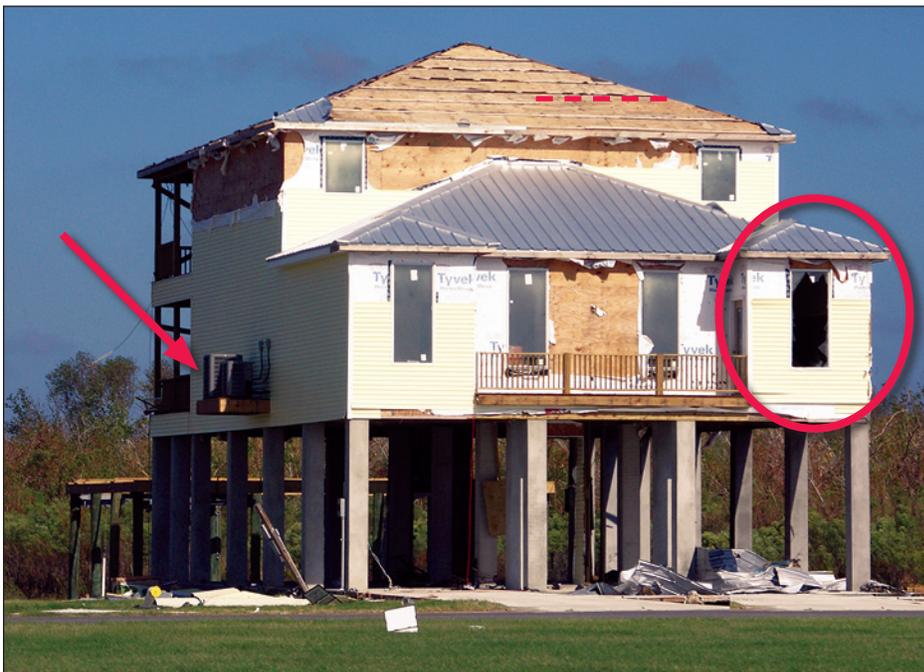
Figure 5-62.
Blow-off of one of the nailers (dotted line) caused these panels to progressively fail. Note the cantilevered condenser platform (arrow), a good practice, and the broken window (circle). The house was located in Exposure C (estimated wind speed: 130 mph. St. Bernard Parish, Louisiana).

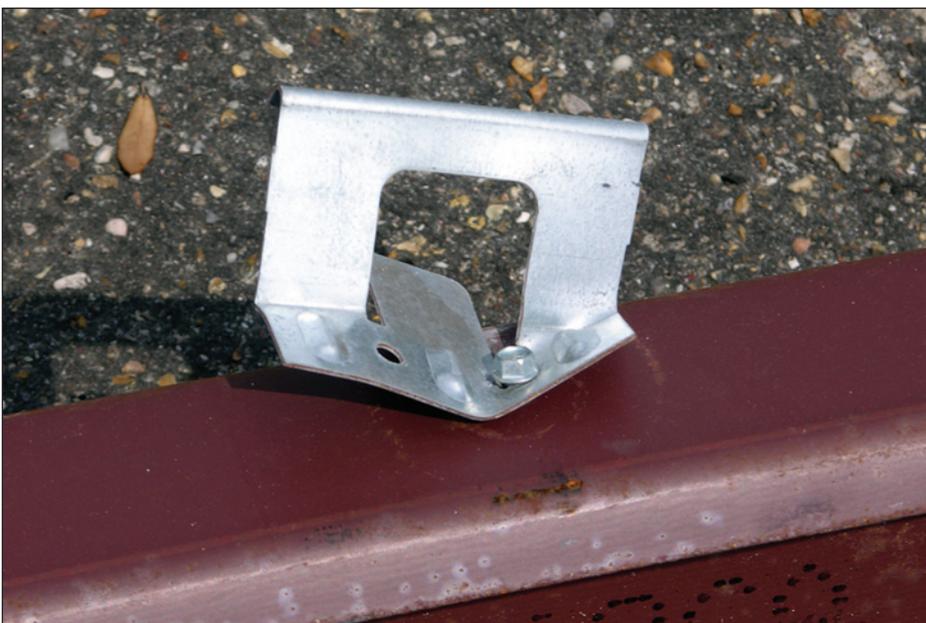
Figure 5-66.
The clips for this structural standing seam panel were intended to be attached with two screws. With only one screw, the clips were eccentrically loaded (estimated wind speed: 130 mph. Long Beach, Mississippi).

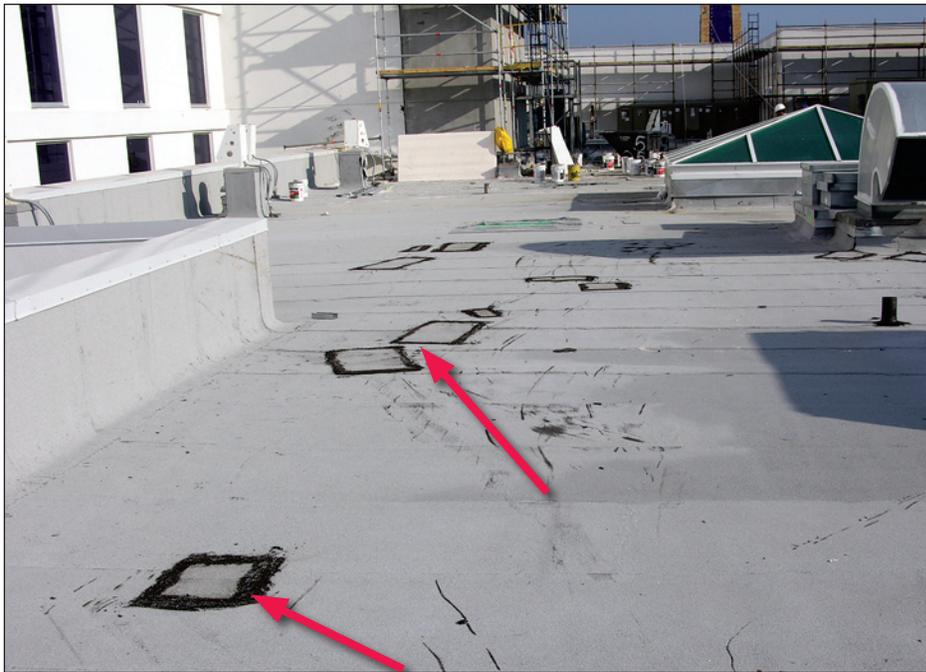
Figure 5-71. This modified bitumen membrane was punctured in several locations by windborne debris. This building was located in Exposure C (estimated wind speed: 120 mph. Biloxi, Mississippi).

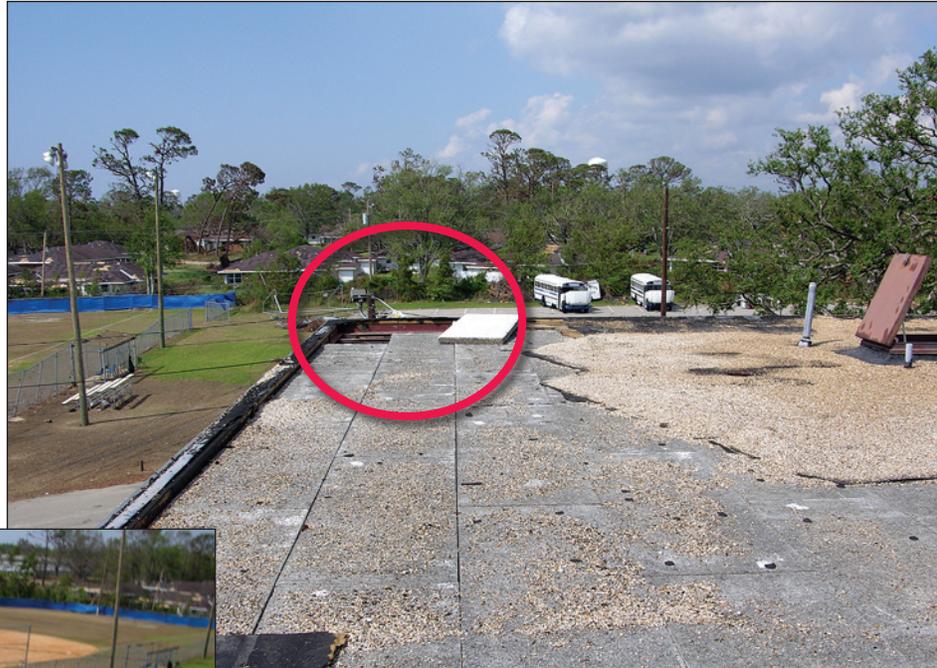
Figure 5-73.
The BUR on this school was blown off after a few of the rotted wood planks detached from the joists (estimated wind speed: 120 mph. Biloxi, Mississippi).

When buildings in hurricane-prone regions are reroofed, it is prudent to tear off the existing roof system down to the deck, so that the entire deck surface can be checked for attachment and deterioration. If inadequately attached or deteriorated decking is discovered, remedial action should then be taken as part of the reroofing project. By doing so, future wind damage associated with deck deficiencies can be avoided.

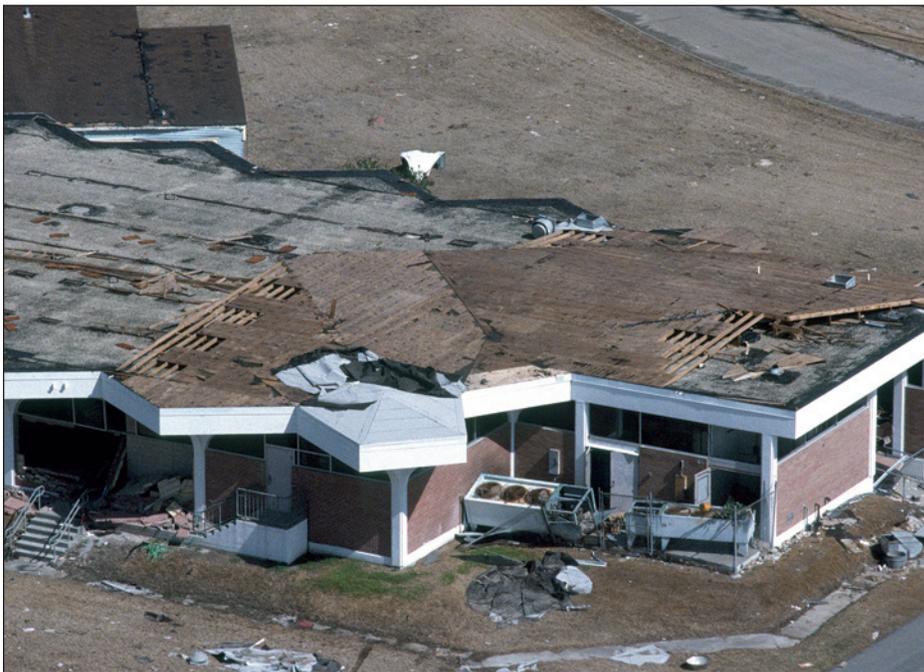
Figure 5-74.
The wood superstructure that was installed on this school as part of a steep-slope conversion blew away because of inadequate attachment (estimated wind speed: 125 mph. Port Sulphur, Louisiana).

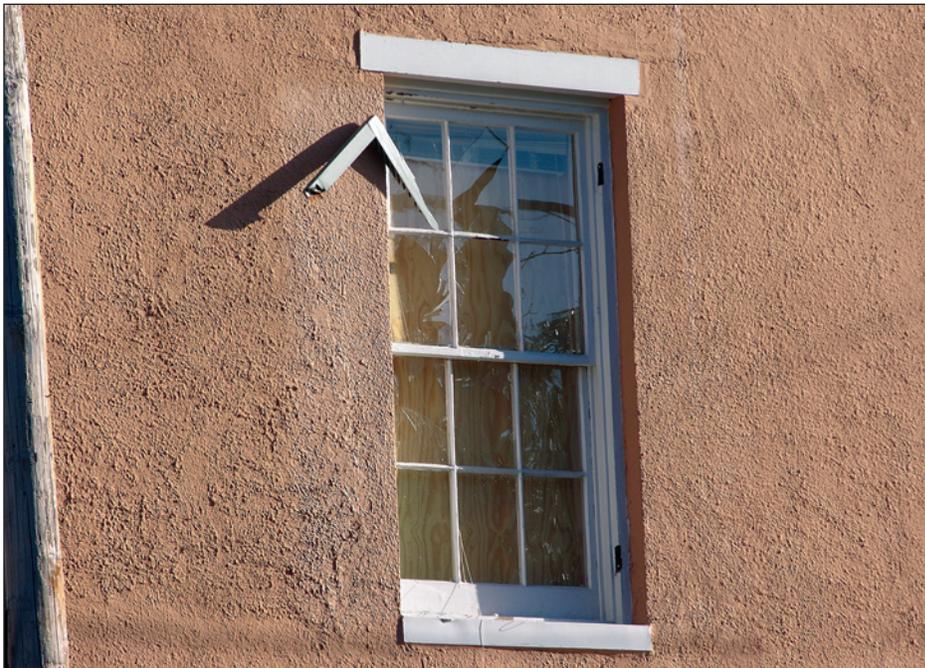
Figure 5-76.
This window was broken by a fragment from a shutter (estimated wind speed: 105 mph. New Orleans, Louisiana).

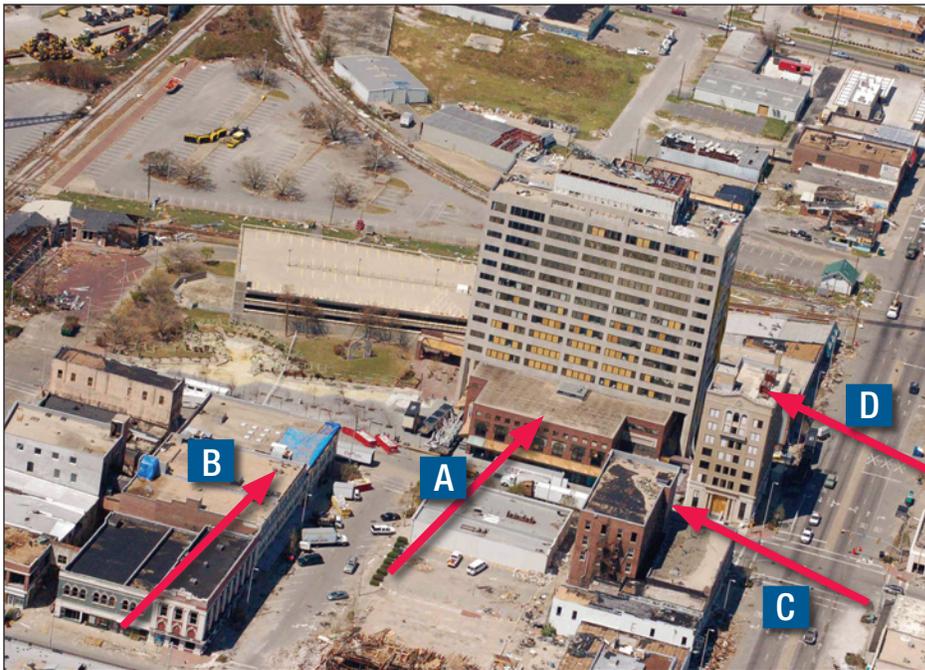
The majority of the windows in the mid-rise building shown in Figures 5-78 and 5-79 were broken by aggregate from BURs. Most of the damage to the lower level windows was likely caused by aggregate from the podium roof adjacent to the tower (roof “A” in Figure 5-78). The south edge of the podium roof (the edge near the arrowhead in Figure 5-78) had a metal edge flashing. The roof sloped toward the tower; therefore, a parapet occurred along the east-west walls. The maximum height of the parapet was about 6 inches. Most of the aggregate that had been embedded in the flood coat was still embedded, but most of the loose aggregate had been blown away.

Figure 5-78.
The south façade of the 15-story building had a large number of windows broken by aggregate from BURs. Damage was caused by aggregate from roof A, and likely from roofs B and C. Damaging aggregate may have also been blown from roof D (estimated wind speed: 130 mph. Gulfport, Mississippi).

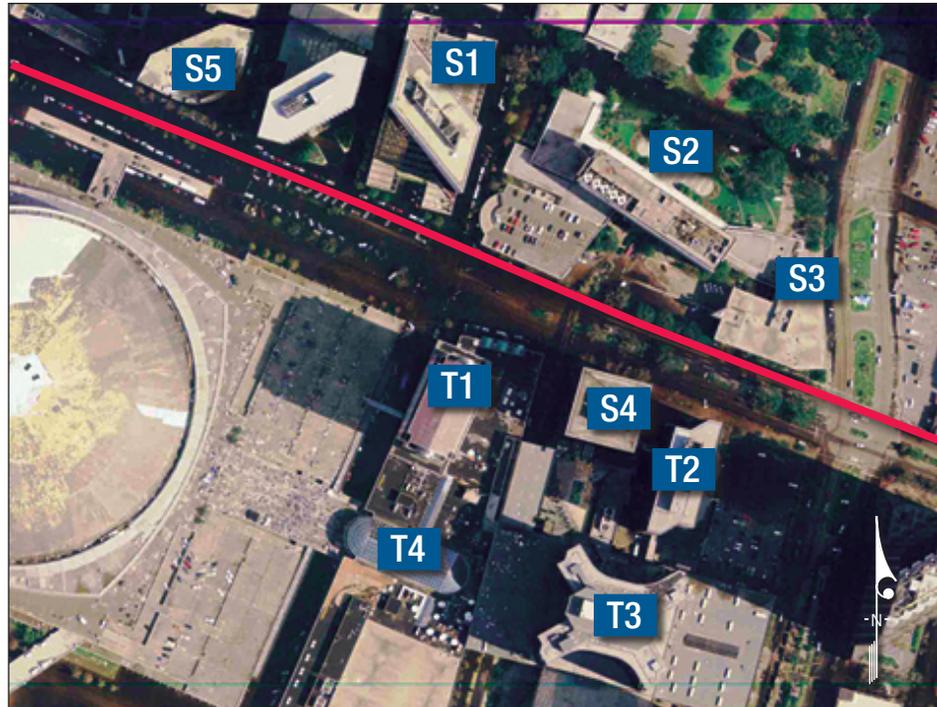
Figure 5-82.
View of glazing damage
at T1 - T3 and S4.
Building S1 had an
aggregate ballasted roof
membrane; aggregate
from this roof was one
of the likely sources of
debris (estimated wind
speed: 105 mph. New
Orleans, Louisiana).
