HURRICANE

Katrina

IN THE GULF COAST

5. Building Envelope Performance

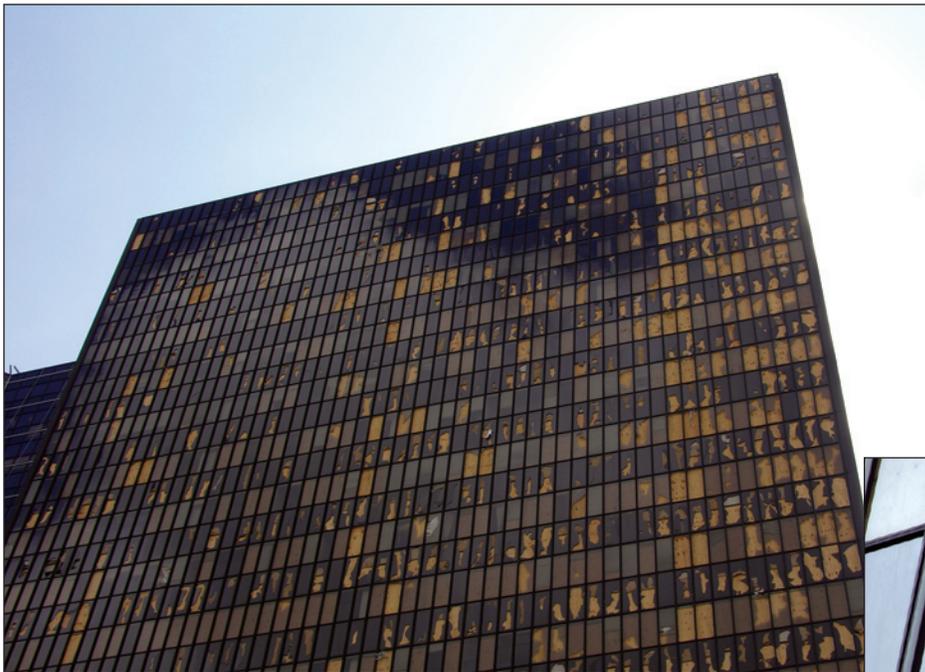
Figure 5-84.
Closeup view of the north façade of S4. The inset (west façade) shows broken windows and spandrel panels. The broken glass at the circle is indicative of impact by a large piece of aggregate (estimated wind speed: 105 mph. New Orleans, Louisiana).

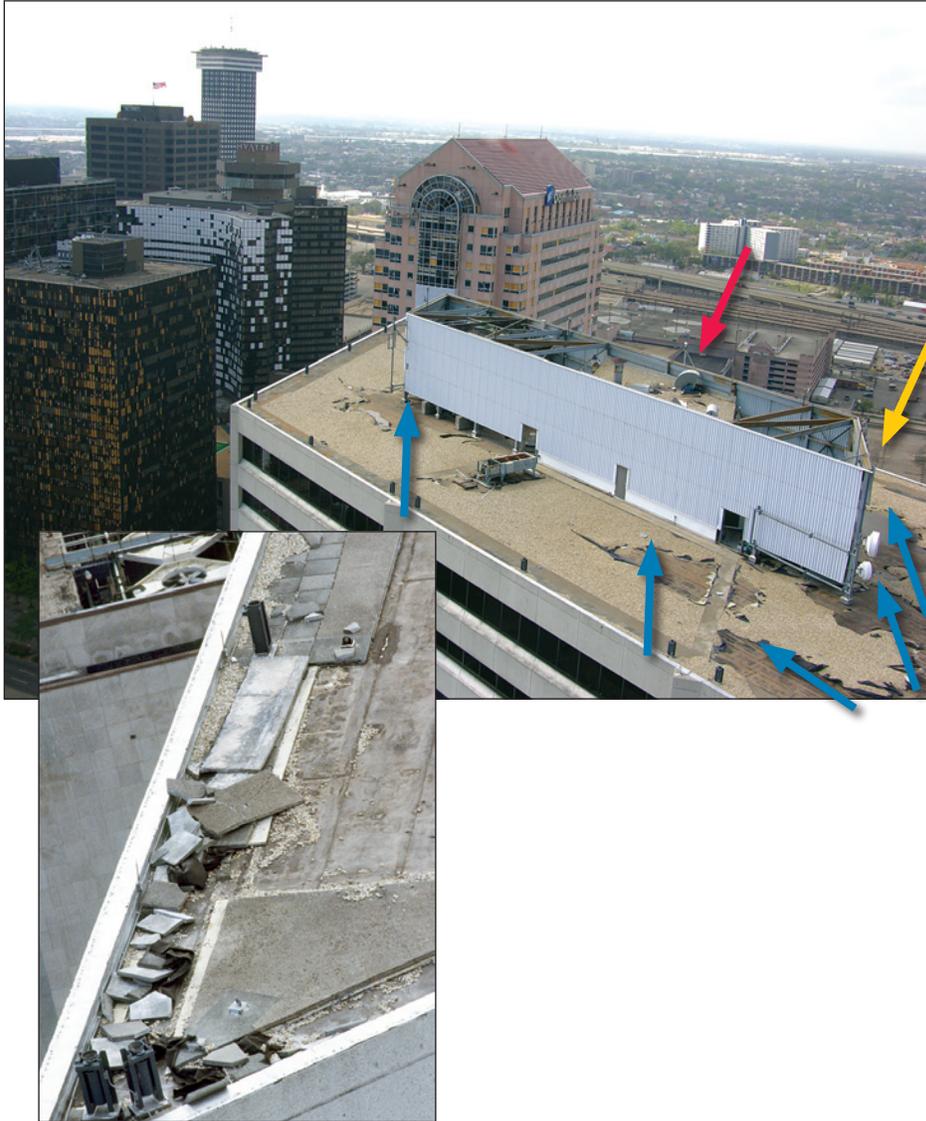
Figure 5-87. Scoured aggregate at Building T1 is shown by the blue arrows. Aggregate was ramped behind the parapet (yellow arrow). A gooseneck lifted from its curb but did not blow away (red arrow). The inset shows displaced pavers and concrete walkway at the windward corner (out of view at the bottom right of the figure) (estimated wind speed: 105 mph. New Orleans, Louisiana).

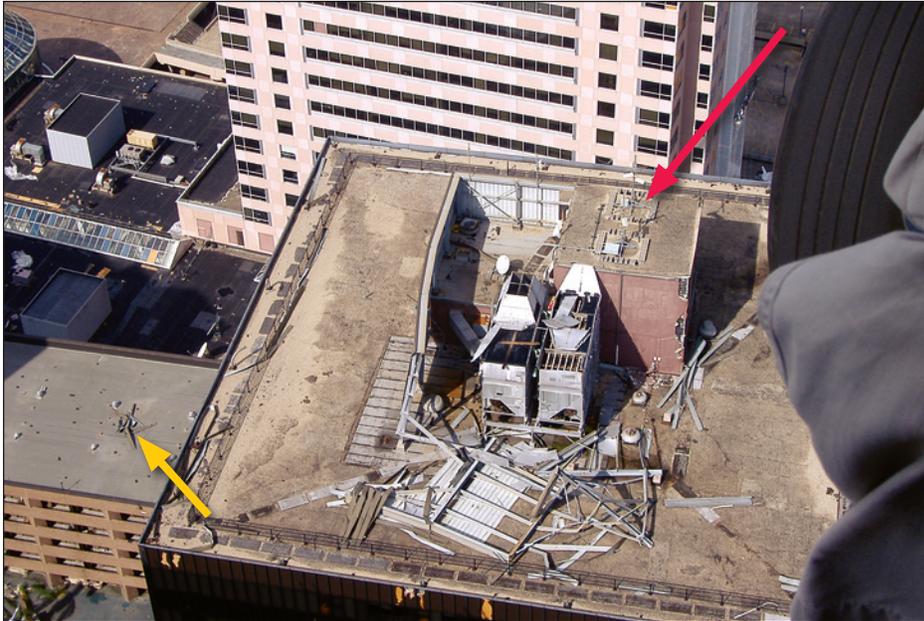
Figure 5-88. View of the roof of S4. Note the glazing damage on the east side of S4 (bottom of figure). Equipment screen wall panels landed on a lower roof (yellow arrow). The penthouse roof (red arrow) did not have a parapet (estimated wind speed: 105 mph. New Orleans, Louisiana).

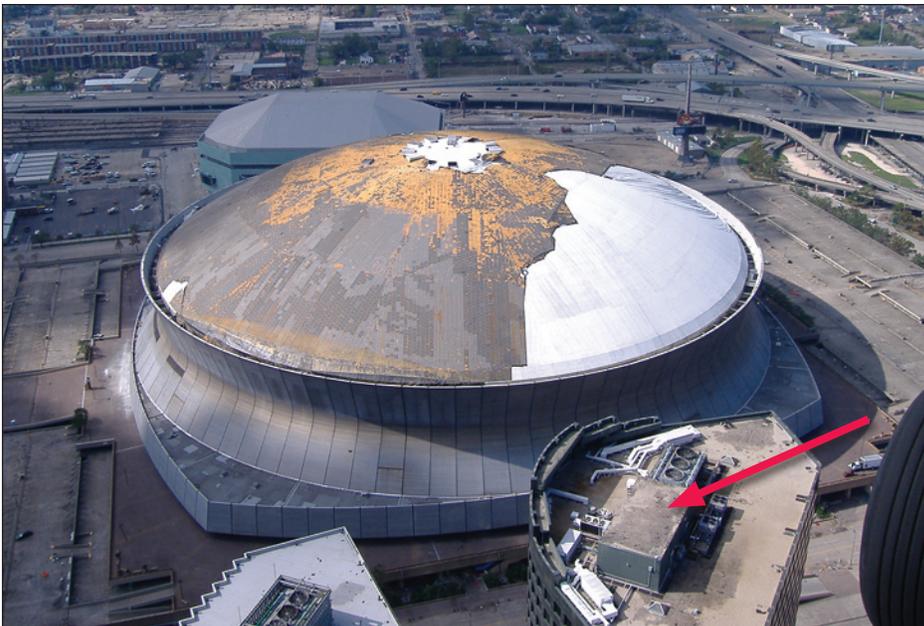
Figure 5-89. Aggregate was scoured on the main roof of Building S5 and blown from the penthouse (red arrow). The building to the left of S5 did not have an aggregate surfaced roof, nor did the lower roofs of the Superdome (estimated wind speed: 105 mph. New Orleans, Louisiana).

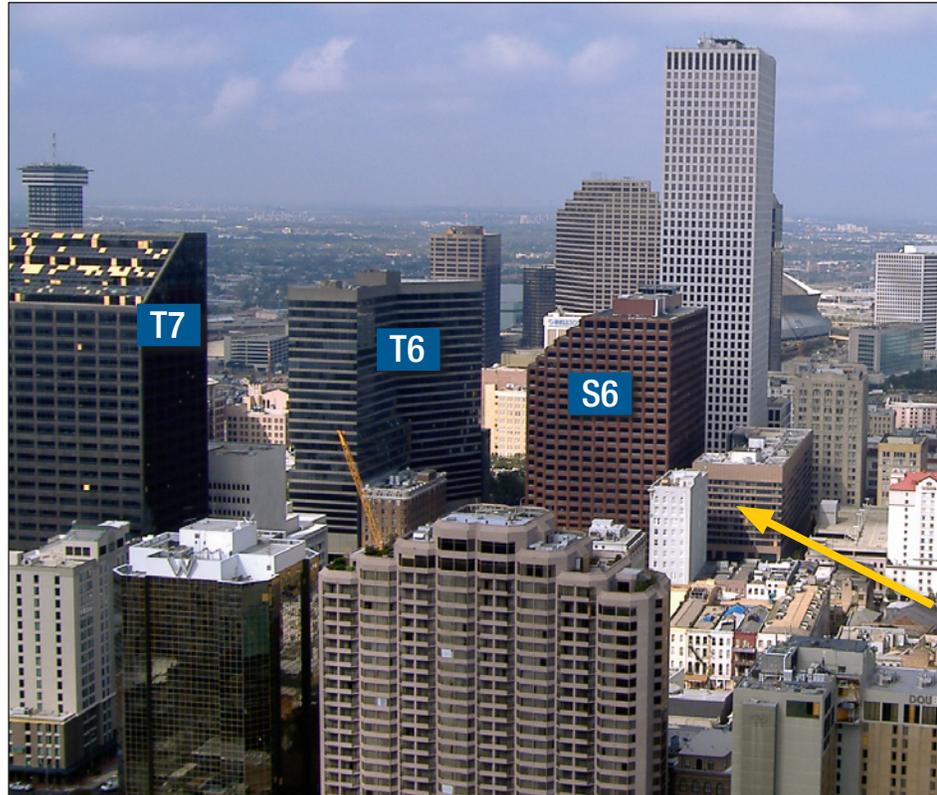
Figure 5-94.
The stair-stepped roofs
of S6 (red arrow) were
aggregate surfaced.
Some of the metal
roof panels had also
blown away (yellow
circle). The black area
(yellow arrow) is a roof
membrane installed after
the hurricane (estimated
wind speed: 105 mph.
New Orleans, Louisiana).

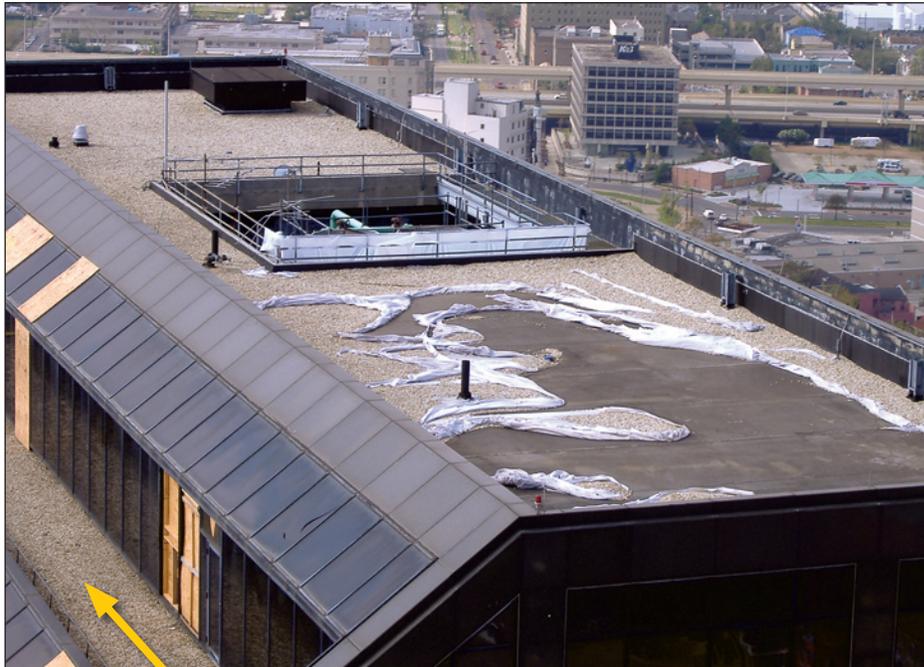
Figure 5-96. Aggregate ballast was scoured and blown from a large portion of the T7 roof. Aggregate also occurred at one, but not all of the stair-stepped roofs (yellow arrow) (estimated wind speed: 105 mph. New Orleans, Louisiana).

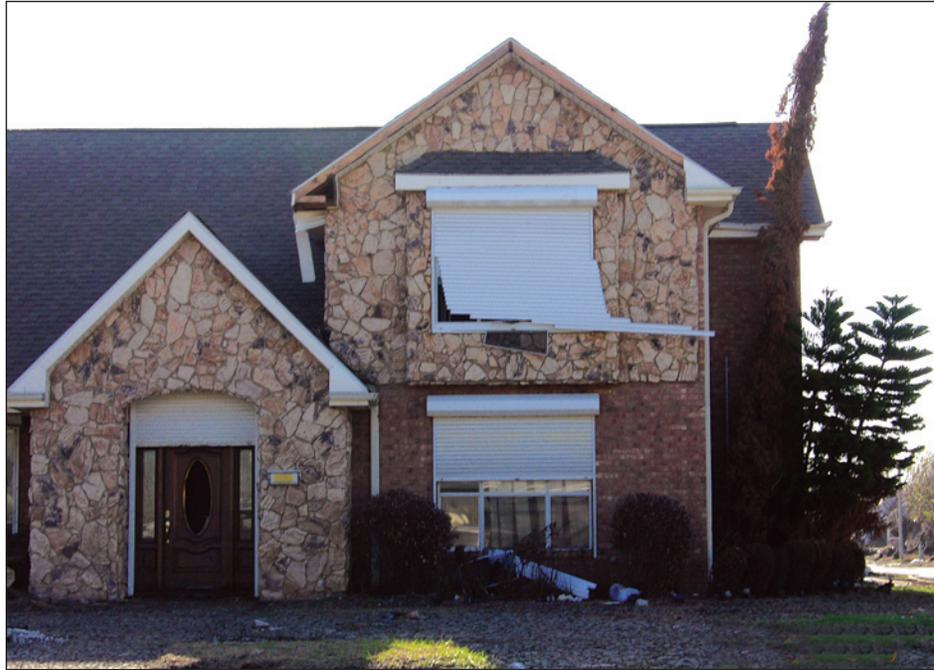
Figure 5-100.
This plastic shutter did not completely cover the
window. The lower window was broken (estimated
wind speed: 105 mph. Pascagoula, Mississippi).

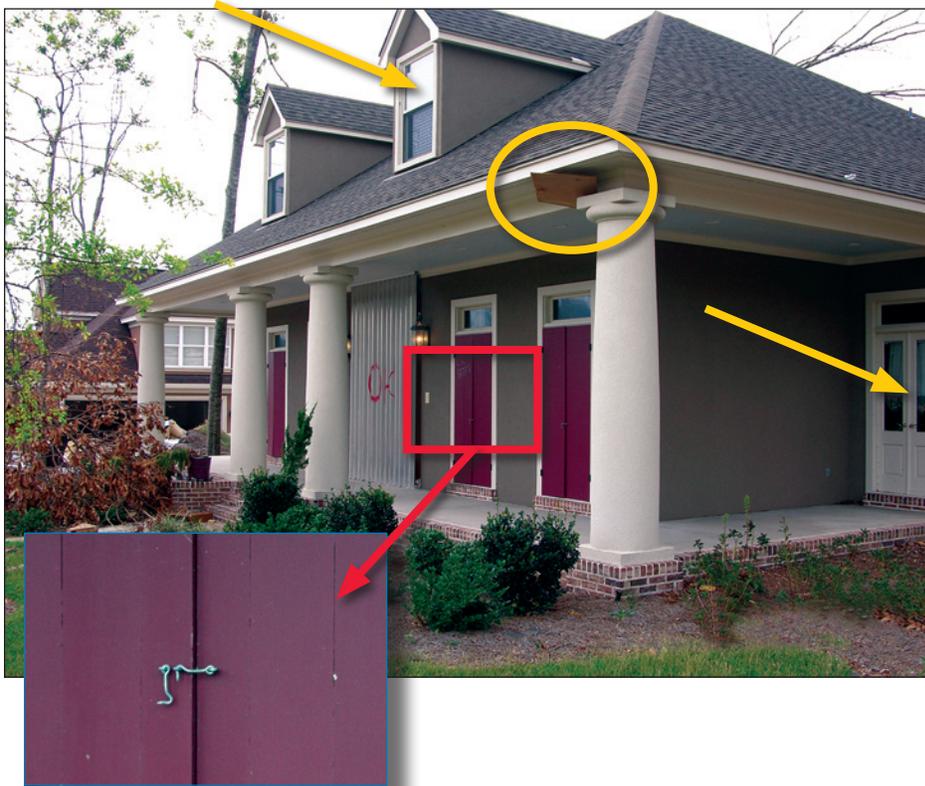
Figure 5-101. Metal shutters were over the main doors, and swinging wood shutters were over the larger first floor windows. However, several windows were unprotected (yellow arrows). The shutter latch (inset) was susceptible to unlatching. Note the wood sheathing debris (yellow circle) (estimated wind speed: 130 mph. Long Beach, Mississippi).

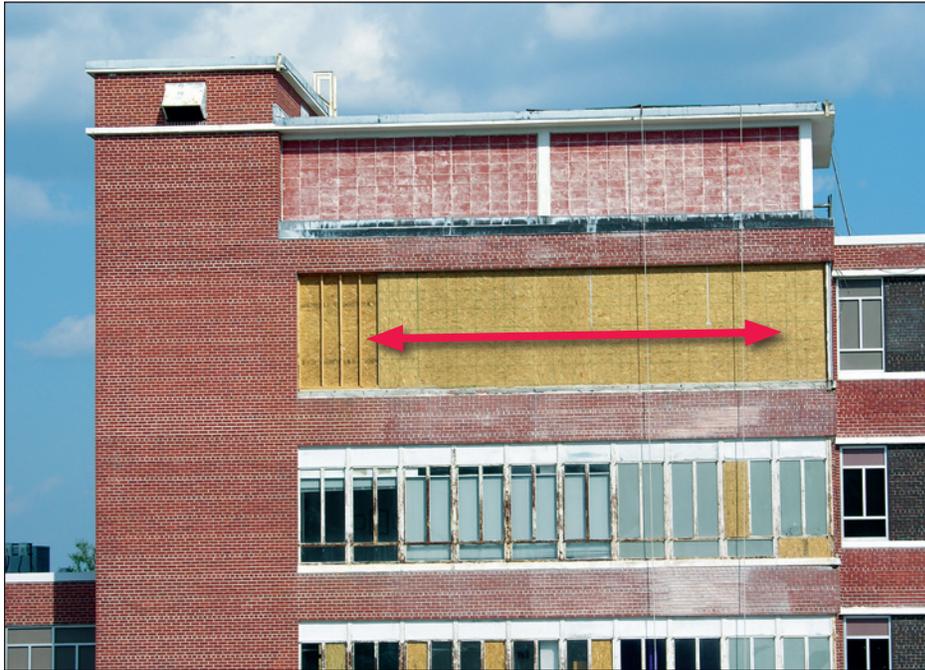
Figure 5-104. The window frames on the upper floor failed (red arrow). Some of the windows on the lower level were broken by pressure or debris (estimated wind speed: 130 mph. Gulfport, Mississippi).

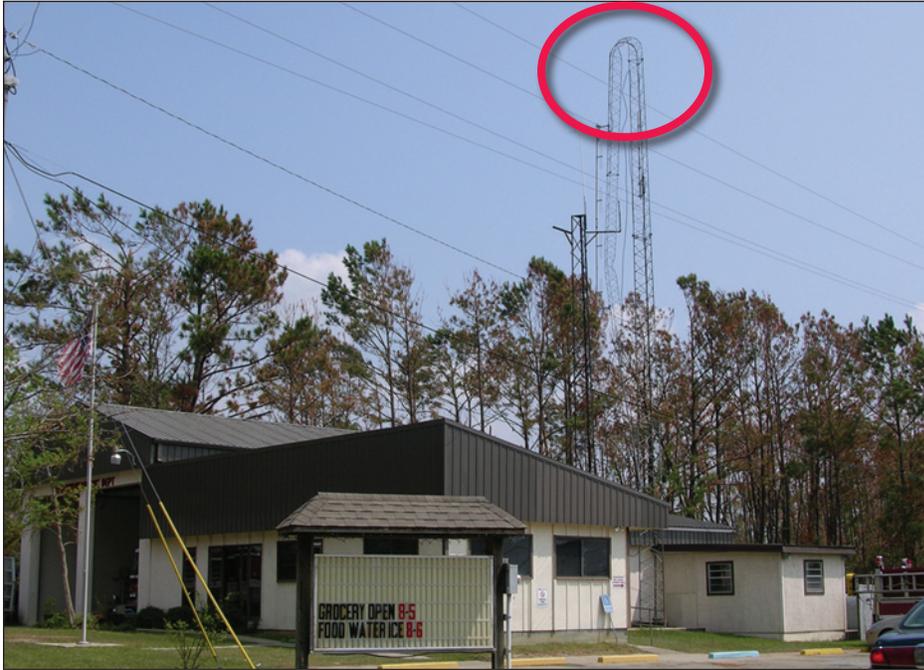
Figure 5-119.
The antenna tower at this fire station buckled (estimated wind speed: 120 mph. Diamondhead, Mississippi).
