HURRICANE

Katrina

IN THE GULF COAST

6. Historic Buildings

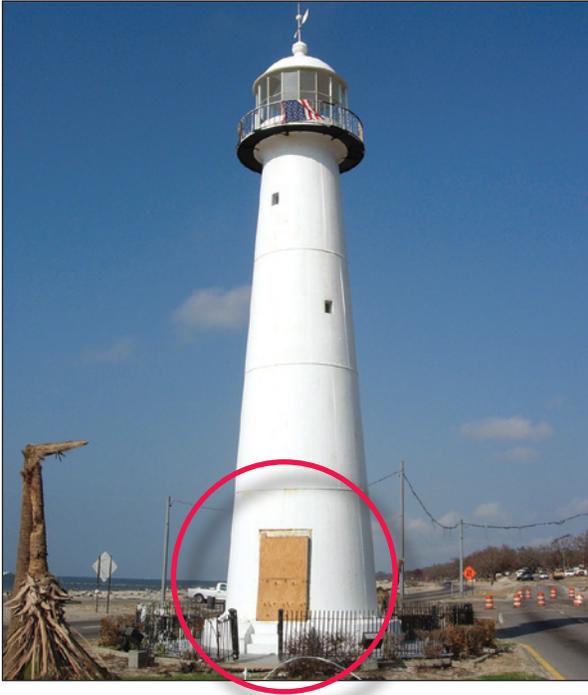
Figure 6-1.

The Biloxi lighthouse was built in 1848 just off the beach waterfront. It is constructed of brick encased by cast iron painted white. The height of the tower is 61 feet. Other than losing the door and one piece of glass, the Biloxi lighthouse suffered little damage and was one of the few successes (Figure 6-1).

Other than losing the door (circled) and one piece of glass, the Biloxi lighthouse suffered little damage from Hurricane Katrina (Biloxi, Mississippi).

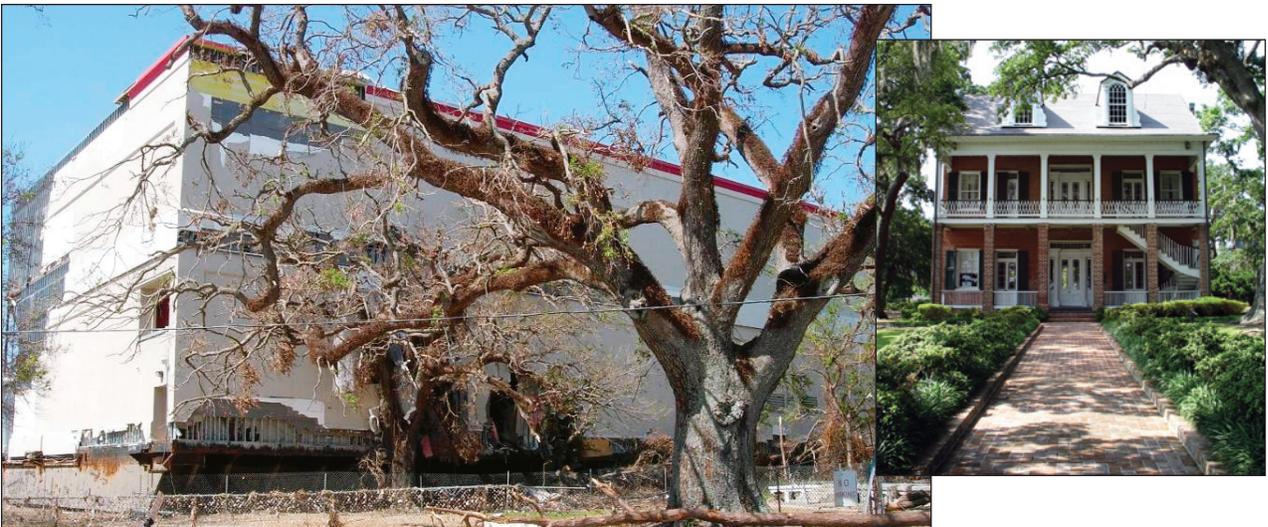
Figure 6-2.

Built in 1856, the Tullis-Toledano House was an example of Greek Revival architecture with rich architectural detail. The house was furnished in a period style to interpret Biloxi's antebellum history. Badly damaged by Hurricane Camille, it was purchased by the City of Biloxi in 1975 and restored as a historic house museum and recreational area. The house was completely destroyed by a casino barge during Hurricane Katrina (see Figure 6-2). It is likely the house would have survived, although heavily damaged, had it not been struck by the barge.

A casino barge moved by high surge completely destroyed the Tullis-Toledano House and now sits where the house was located. The inset shows the house prior to Hurricane Katrina (Biloxi, Mississippi).

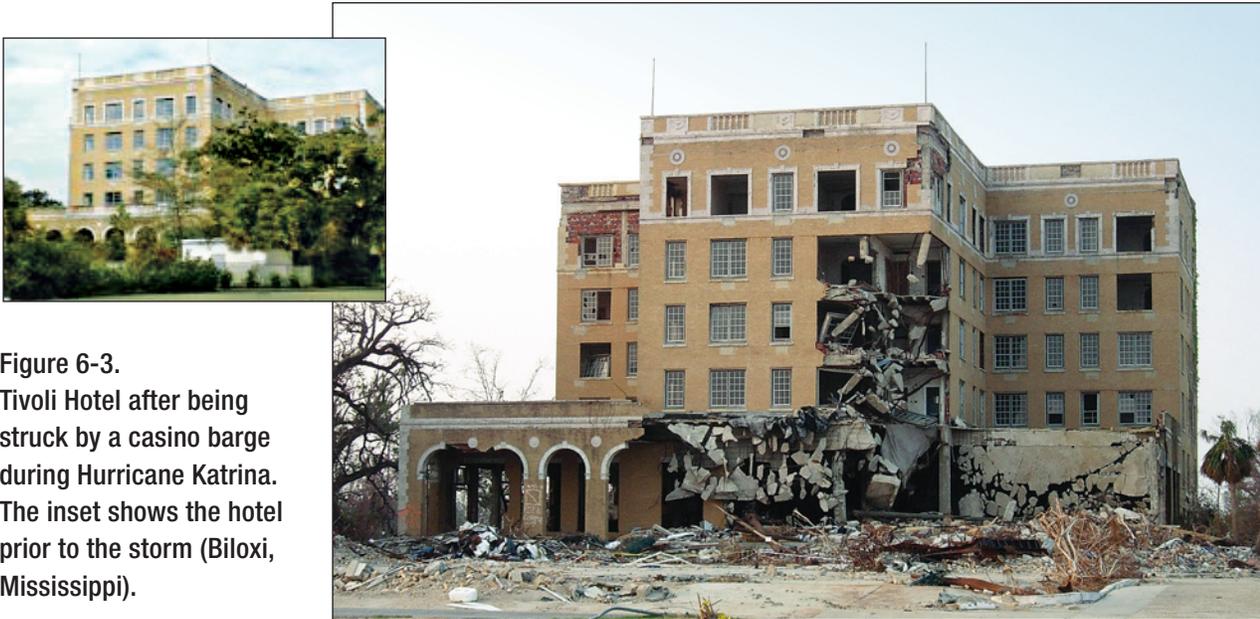
Built in 1927, the Tivoli Hotel, a 64-room luxury hotel, sat abandoned prior to Hurricane Katrina, waiting to be restored to its former glory. In 2003, the Mississippi Heritage Trust called the Tivoli Hotel one of the state’s 10 most endangered historic places. With the surge from Katrina, a casino barge struck and destroyed the colonnade and four floors at the southeast corner of the hotel (see Figure 6-3).

Figure 6-3. Tivoli Hotel after being struck by a casino barge during Hurricane Katrina. The inset shows the hotel prior to the storm (Biloxi, Mississippi).

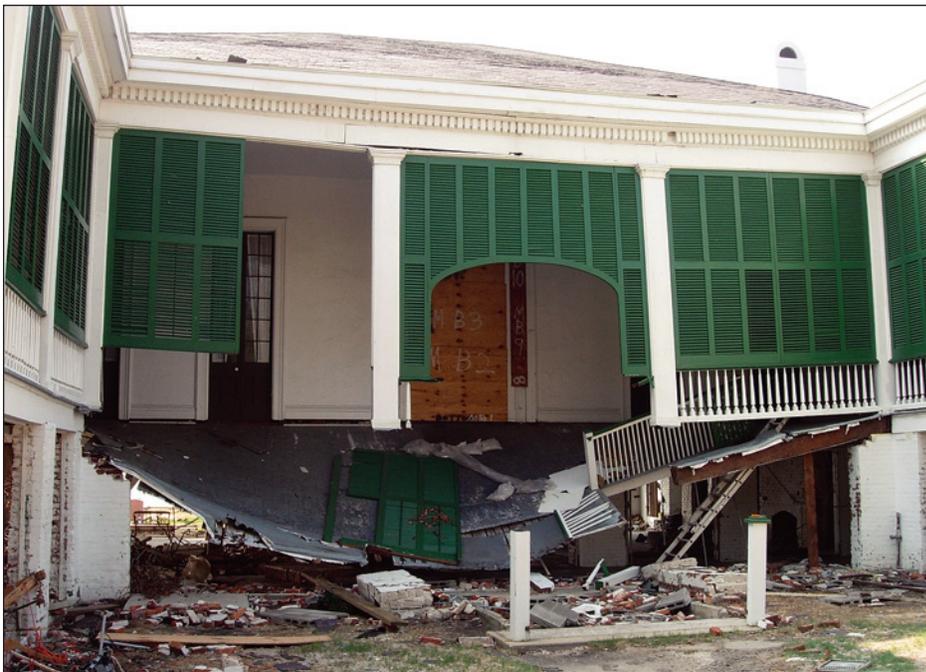
Built in 1848, Beauvoir (see Figure 6-4) and the surrounding structures sustained serious flood (velocity flow) damage from Hurricane Katrina. Approximately 75 percent of the main house still stands, except for the front, side, and rear porches (see Figures 6-5 and 6-6). Many windows, doors, and columns are also gone.

Figure 6-6.
Rear elevation of
Beauvoir after Hurricane
Katrina (Biloxi,
Mississippi)

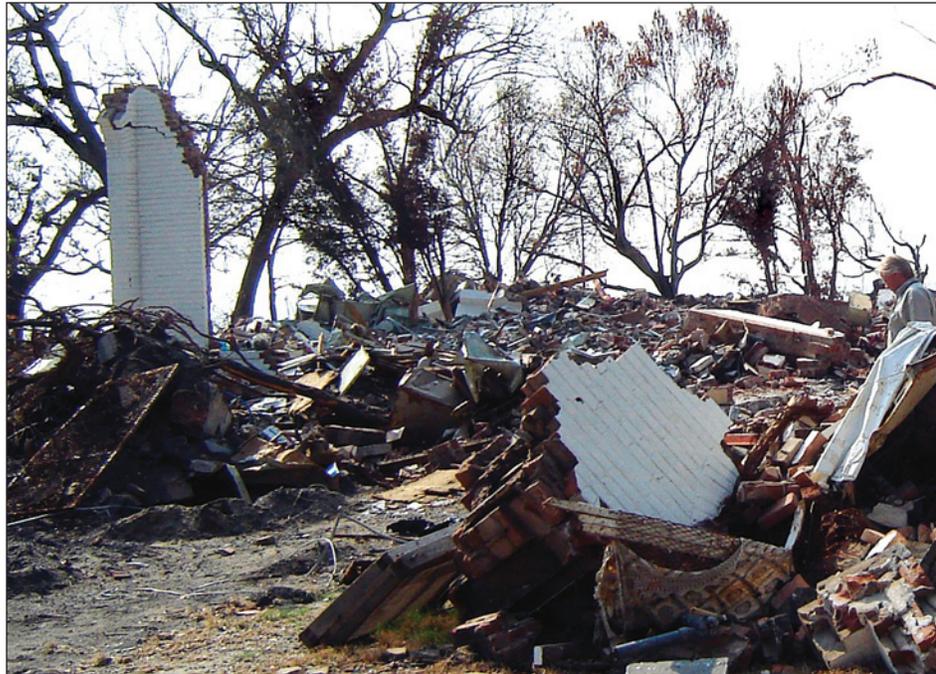
Figure 6-7.
Gift shop at Beauvoir
completely destroyed by
Hurricane Katrina (Biloxi,
Mississippi)

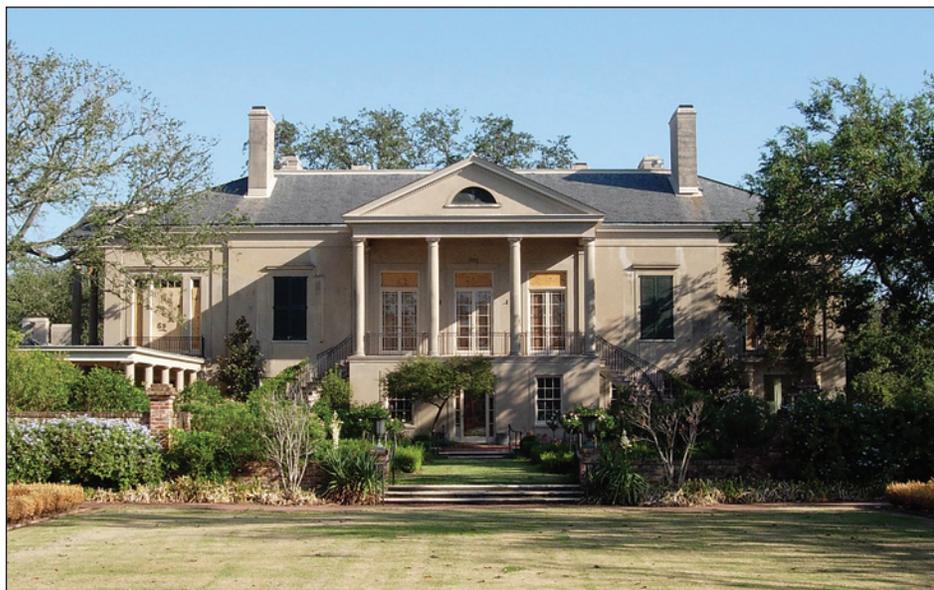
Built in 1924, and rebuilt between 1939 and 1942 to its present state, the Longue Vue House and Gardens property borders the 17th Street Canal about 2 miles south of where the levee failed. The basement was completely flooded and water was within inches of the main level. During the MAT’s visit, the water was being pumped out and staff members were working to stabilize the condition of the resident collection of museum pieces, composed of paintings, books, and other artifacts. The gardens, after a multi-year restoration, were badly damaged from immersion. Figures 6-8 and 6-9 show the front elevation and garden areas of this site, respectively.

Figure 6-8.
Front elevation of Longue
Vue after Hurricane
Katrina (New Orleans,
Louisiana)

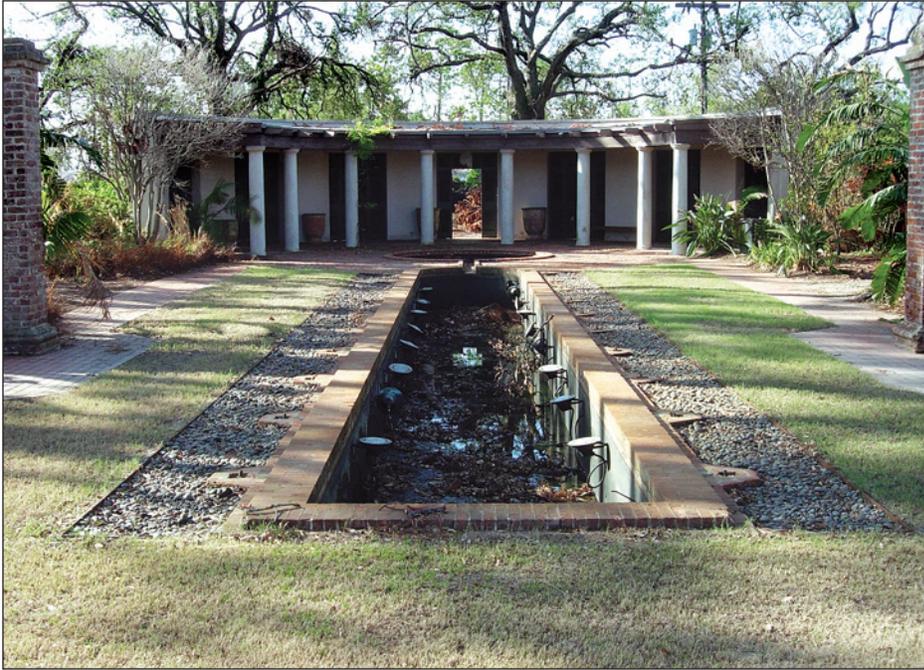
Figure 6-9.
Garden and fountain
at Longue Vue after
Hurricane Katrina (New
Orleans, Louisiana)

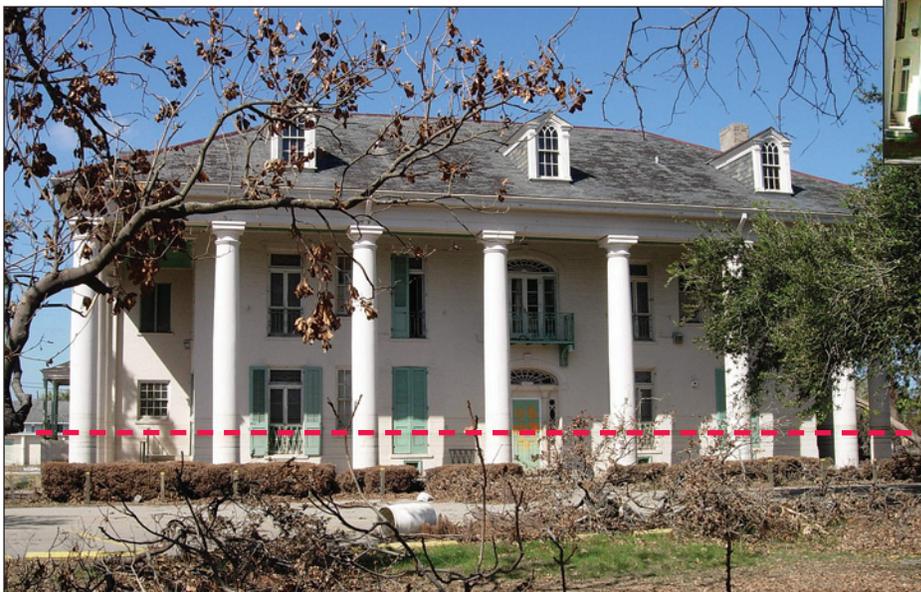
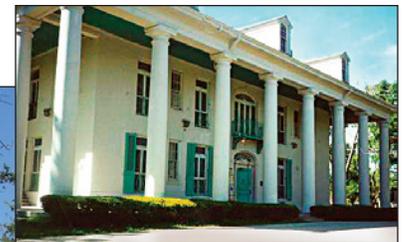
Established in 1933, Milne Boys Home is a collection of large antebellum-style, white-columned buildings that housed orphans and wayward youths until 1986. Operated by the New Orleans Welfare Department, Milne is famous for its most notable non-resident, Louis Armstrong. Armstrong, contrary to popular lore, was never a resident at Milne. The Armstrong Manhood Development Program, however, provides assistance to wayward boys. The building experienced approximately 3 feet of flooding as shown in Figure 6-10.

Figure 6-10.
Front elevation of
Milne Boys Home after
Hurricane Katrina. Note
the high water line
midway up the front
door. The inset shows the
home prior to the storm
(New Orleans, Louisiana).

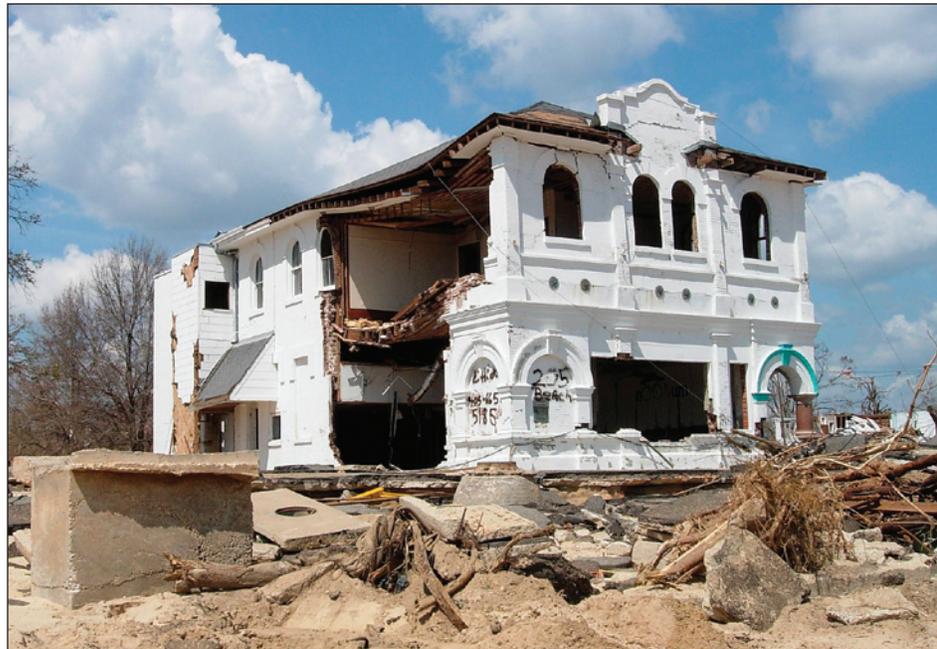
The "before" picture of this empty bank building (see Figure 6-11) was taken 2 weeks before Hurricane Katrina. Surge waters moved through the front windows and door, collapsing the side elevation and part of the second floor (see Figure 6-12).

Figure 6-12.
View of front and side
elevations of bank after
Hurricane Katrina (Bay St.
Louis, Mississippi)

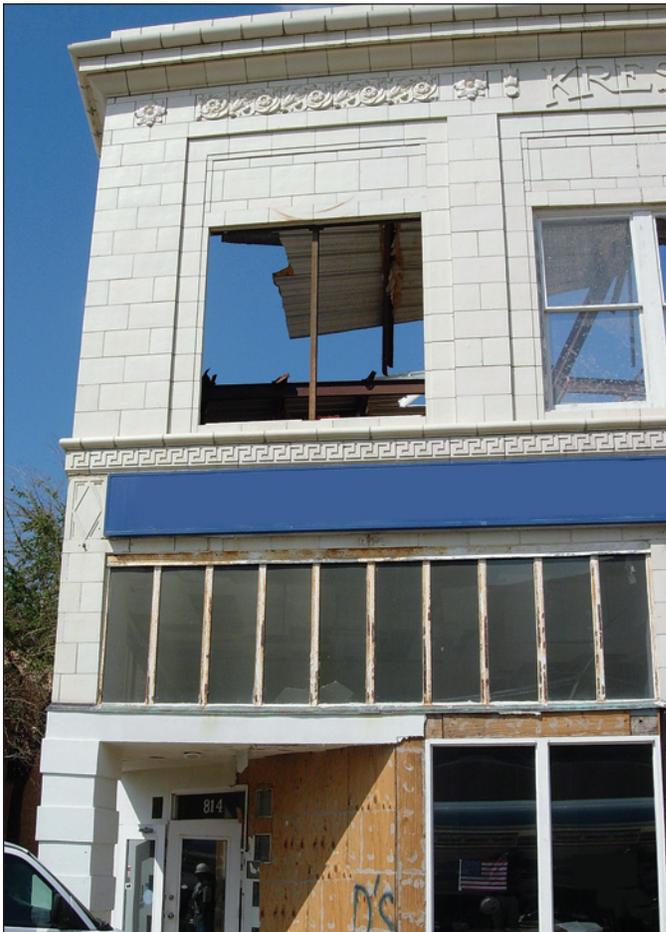
Built in 1920, the Kress Building lost its exterior windows, allowing the wind to lift and tear off the roof. The original roof of the Kress Building was wood joist/rafters at 16 inches on center, which was lost in a fire. The replacement roof is light gauge steel framing with purlins at 4 feet on center and a standing seam metal roof covering. When the roof was replaced, the spacing of the fasteners holding down the roof covering was increased from 16 inches on center to 4 feet on center, contributing to its failure from uplift.

Figure 6-13.
Internal pressure from wind through the broken windows lifted the roof (Biloxi, Mississippi).

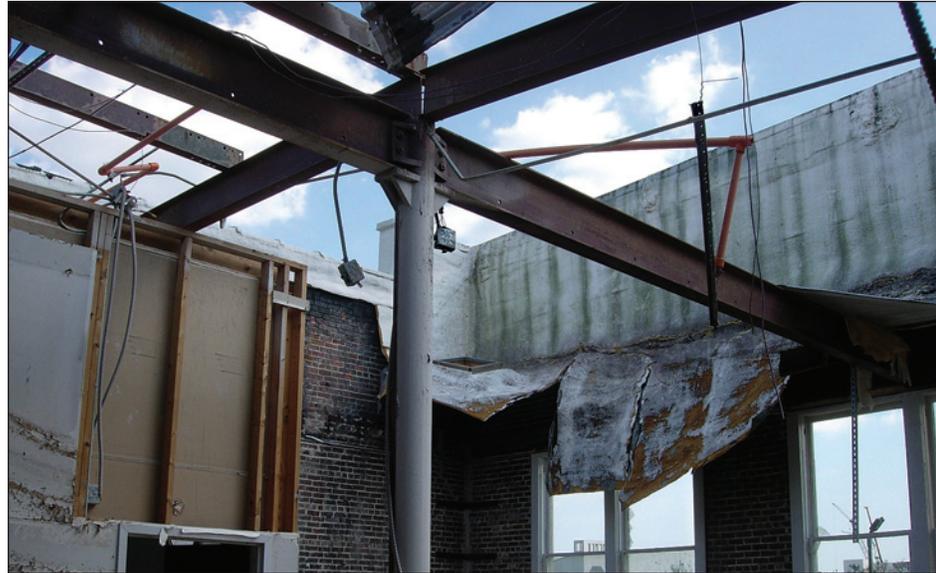
Figure 6-14.
Interior view of the Kress
Building showing roof torn
away (Biloxi, Mississippi)

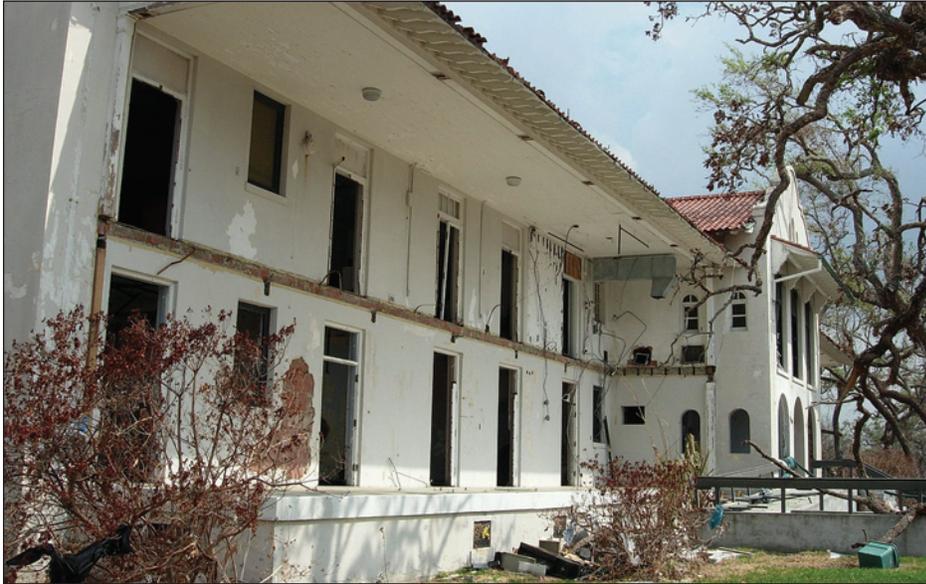
Built in 1917, the Gulfport Veterans Affairs Medical Center (VAMC) is a campus plan of a dozen historic structures. Although the VAMC in Gulfport lost the entire second floor porch and roof supports to velocity-flow floodwaters, the integral framing of the roof structure allowed the overhang to successfully survive the wind uplift from Hurricane Katrina (see Figure 6-15).

Figure 6-15. Loss of the entire second floor porch and roof supports to flooding; the main roof stayed successfully intact due to integral framing of the roof structure (Gulfport, Mississippi).

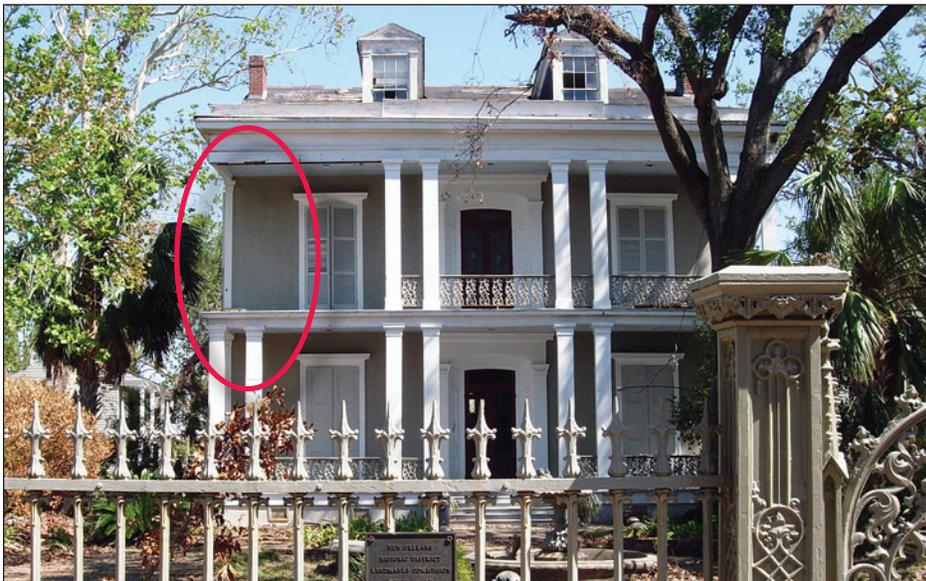
Built in 1858, the Benachi House lost two columns from the second floor front elevation from wind forces, as well as roof covering (see Figure 6-16). Its cottage house sustained structural damage from fallen trees (see Figure 6-17). The dead lawn and shrubs are an indication of long-term flooding.

Figure 6-16. Wind damage to the second floor columns of the Benachi House. Note missing columns (circle) (New Orleans, Louisiana).

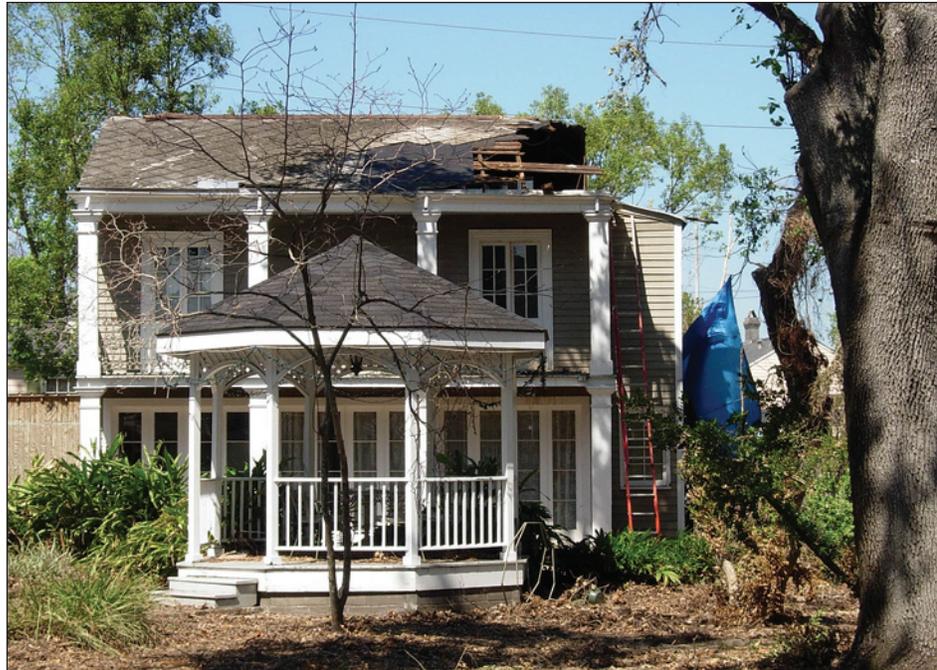
Figure 6-17.
Tree damage to the rear
cottage house of the
Benachi House (New
Orleans, Louisiana)

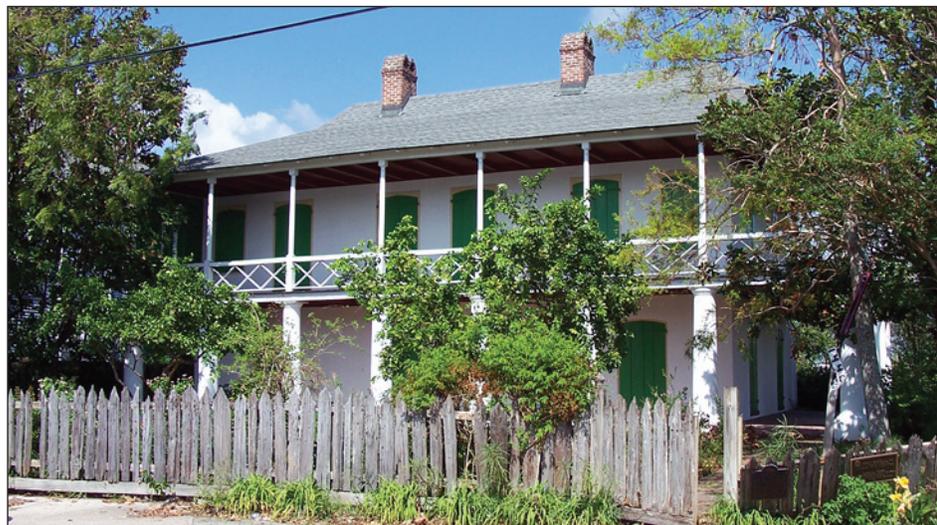
The Pitot House Museum successfully weathered Hurricane Katrina in part due to the presence of shutters on the windows, which protected the building’s glazings and prevented wind penetration into the museum (see Figures 6-18 and 6-19).

Figure 6-18.
Front elevation of Pitot
House showing damage to
the front wood fence. The
house survived very well,
with no evidence of flood
damage and little wind
damage (New Orleans,
Louisiana).

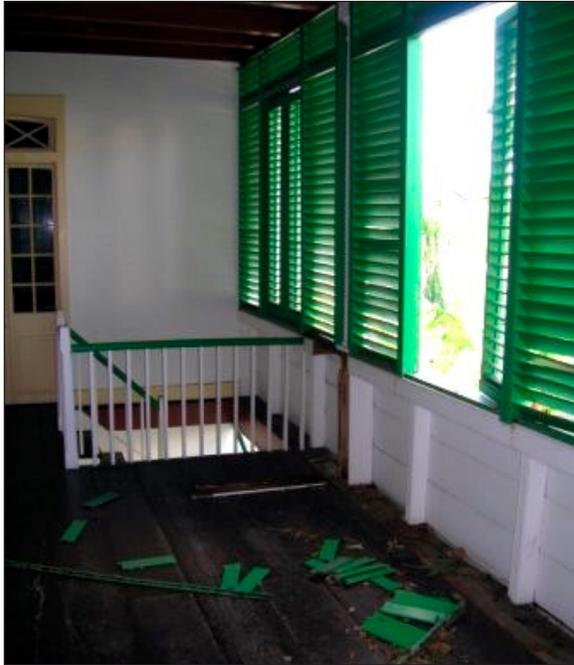
Figure 6-19. Although one window did sustain damage from windborne debris, the remaining windows of the Pitot House were not damaged (New Orleans, Louisiana).

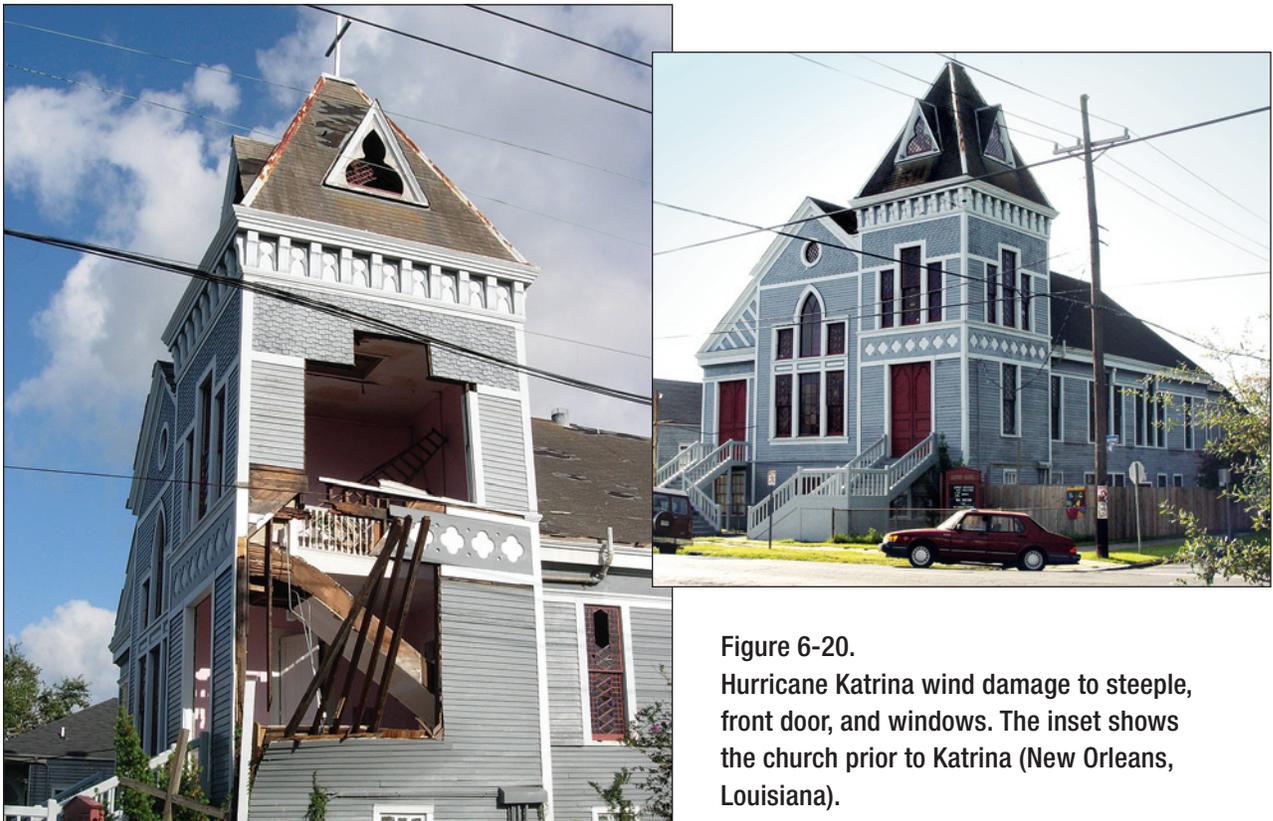
Built in 1886, the wood-framed Valence Street Baptist Church, registered as a historic building, sustained wind damage, which allowed water intrusion (see Figure 6-20).

Figure 6-20. Hurricane Katrina wind damage to steeple, front door, and windows. The inset shows the church prior to Katrina (New Orleans, Louisiana).

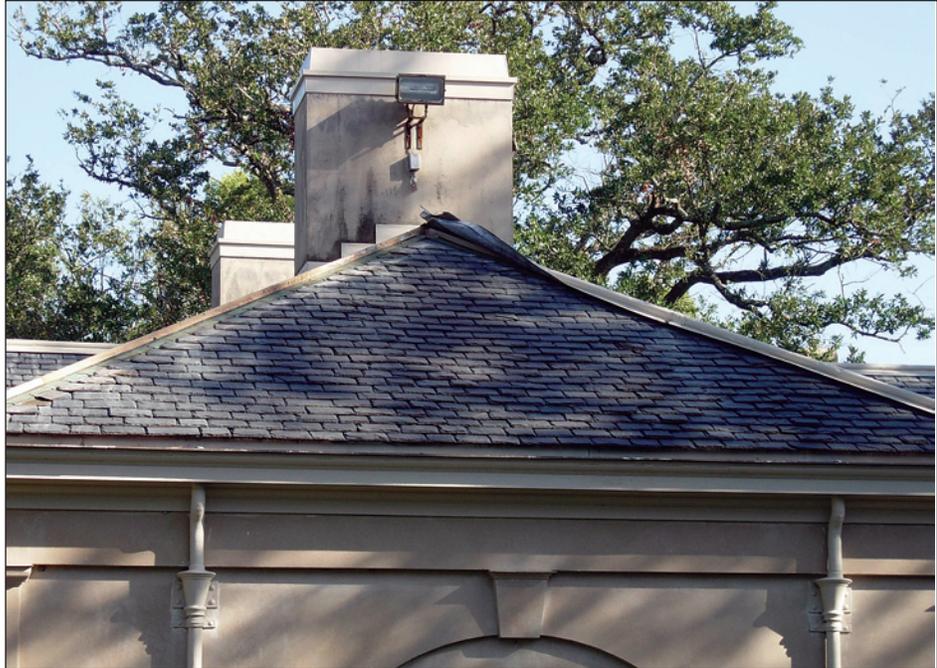
Longue Vue House and Gardens, described in Section 6.1.5, suffered wind damage to shutters and roof covering materials during Hurricane Katrina (see Figures 6-21 and 6-22).

Figure 6-21.
View of wind damage to flashing along rake of Longue Vue after Hurricane Katrina (New Orleans, Louisiana)

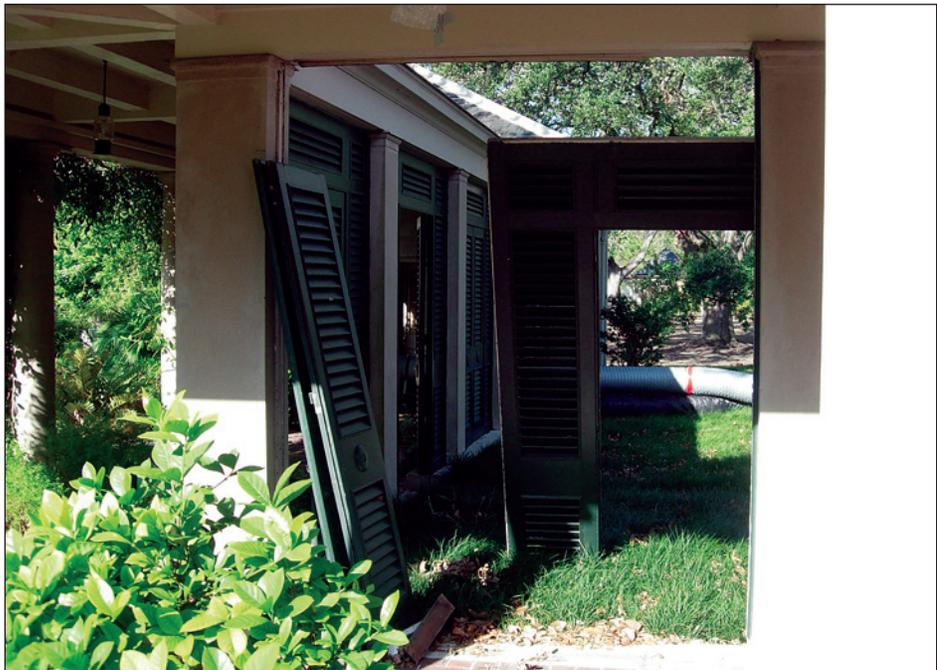
Figure 6-22.
View of wind damage to shutters of Longue Vue after Hurricane Katrina (New Orleans, Louisiana)
