HURRICANE

*Katrina*

IN THE GULF COAST

## 7. Performance of Critical and Essential Facilities

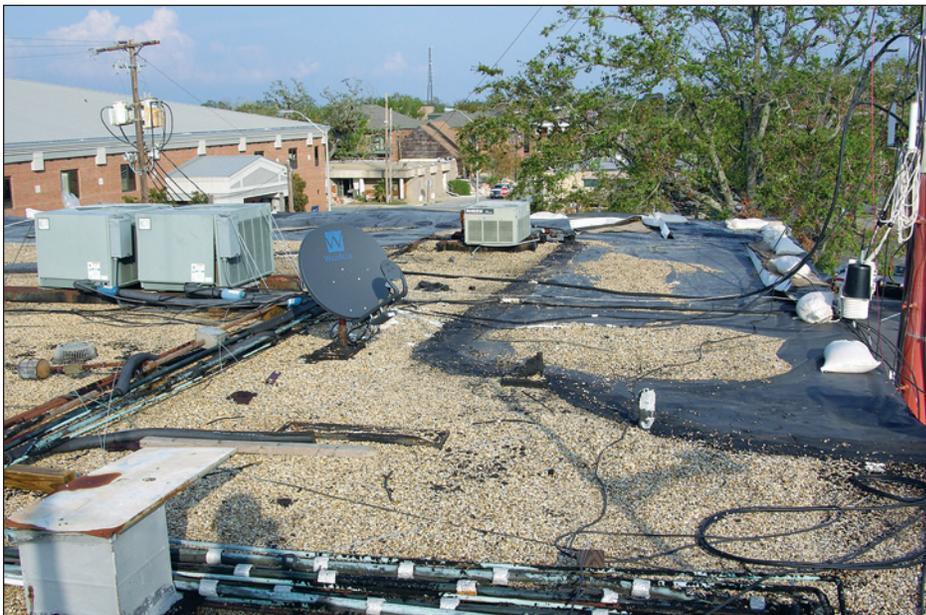
Floodwater rose to about an inch below the first floor, which is approximately 4-1/2 feet above grade. Wind blew off a portion of the roof membrane and blew aggregate from the roof (see Figure 7-1). The roof blow-off initiated with the metal edge flashing, which had a 5-inch vertical face that was uncleaned, making it susceptible to lifting and peeling. The communications tower was also toppled (see Figure 7-2). The rooftop condensers were strapped to their curbs (Figure 7-2 inset), but the straps and their connections appeared inadequate; the condensers would have likely blown away if the winds had approached the current design wind speed.

**Figure 7-1.** The roof membrane blew off at the far end and along a portion of the right side of the roof. Aggregate was also blown off. An emergency roof repair was made prior to the MAT's observation (estimated wind speed: 105 mph. Pascagoula, Mississippi).<sup>1</sup>

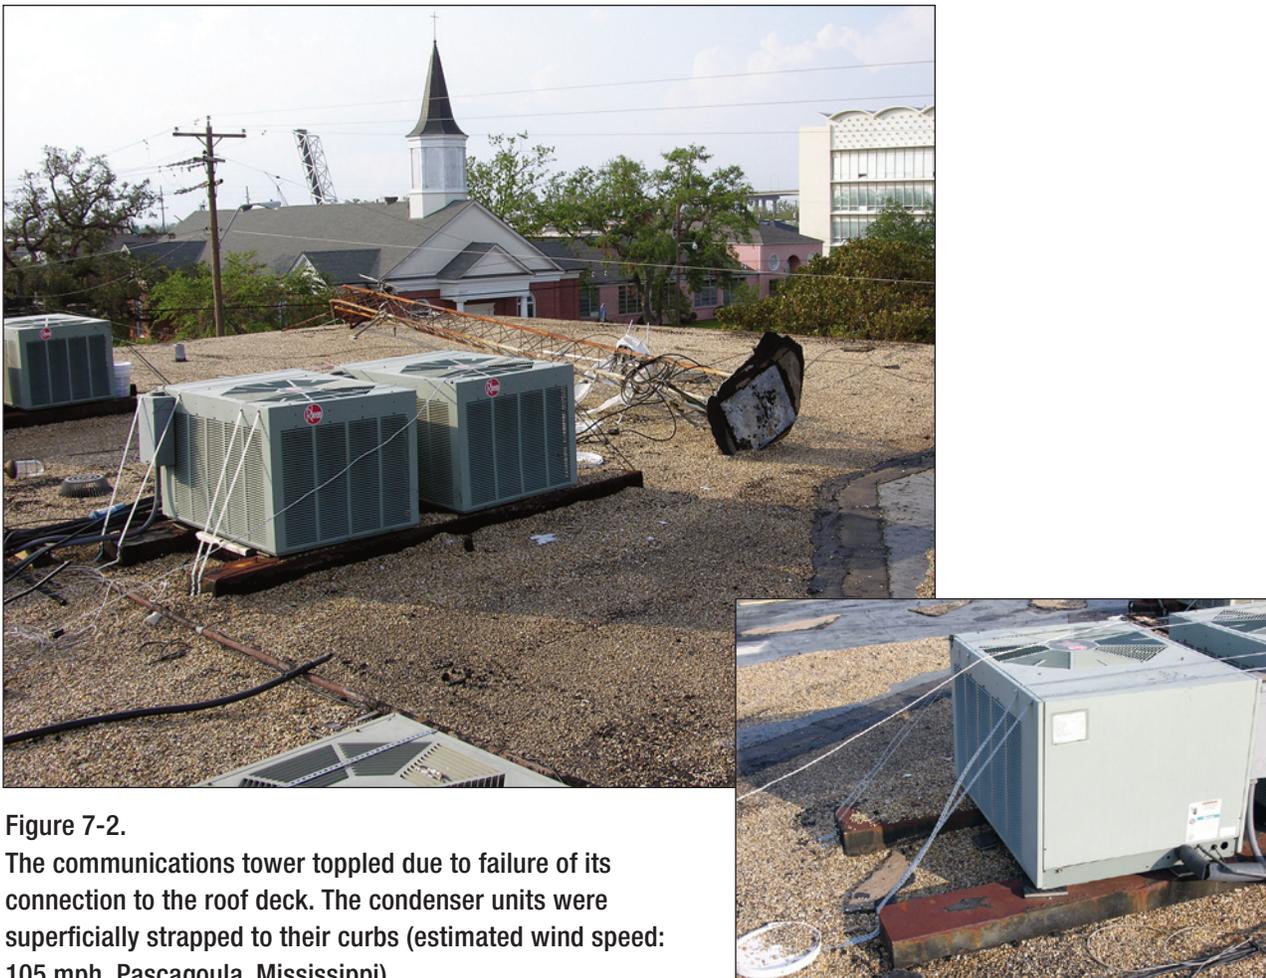
Figure 7-2. The communications tower toppled due to failure of its connection to the roof deck. The condenser units were superficially strapped to their curbs (estimated wind speed: 105 mph. Pascagoula, Mississippi).

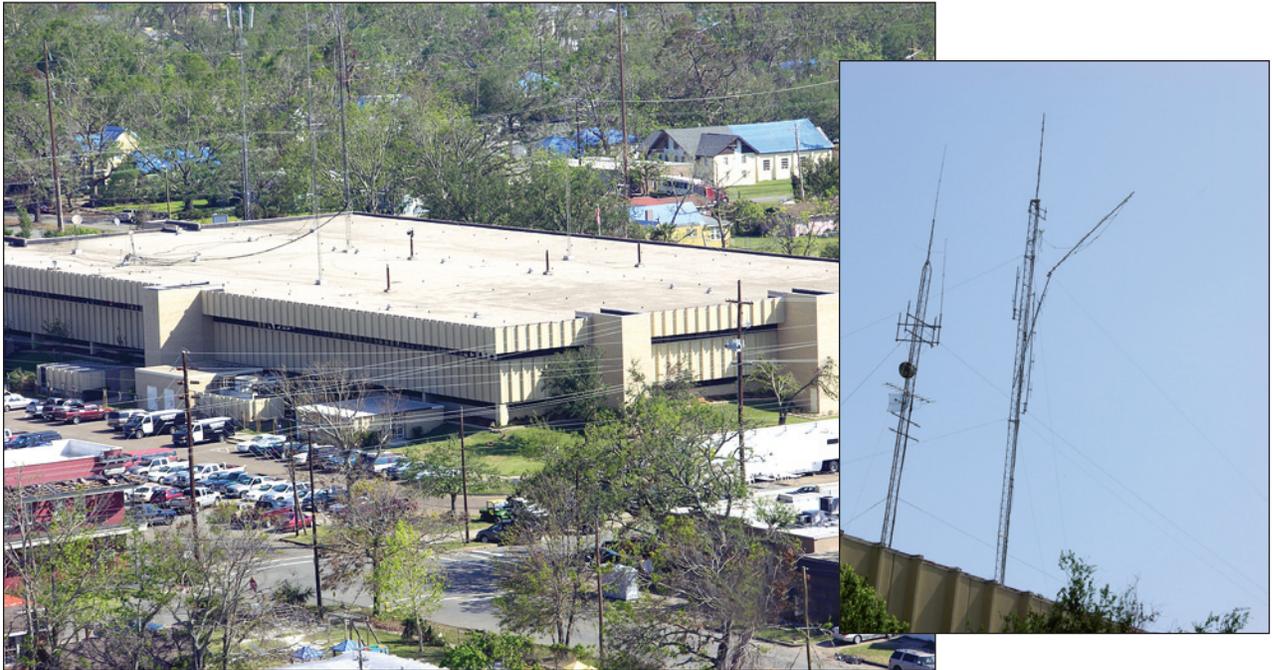
Figure 7-3.

The EOC is located near the center of the first floor of the First Judicial District Courthouse. A portion of one of the communications towers was damaged by wind (estimated wind speed: 130 mph. Gulfport, Mississippi).

Even though there was a parapet, aggregate was blown from the roof and broke the windows of a large number of vehicles in the parking lot. The parapet height varied; at the roof highpoint, the parapet was 14 inches high. A few sections of coping blew off the parapet, but a progressive roof membrane failure did not occur. A small satellite dish was blown off the roof and it appeared to have been mounted on wood sleepers. Rather than anchoring the sleepers to the deck, small blocks of concrete had been placed over the sleepers. A portion of the communications tower was damaged by wind. Some rainwater leakage occurred along a portion of the east wall, but

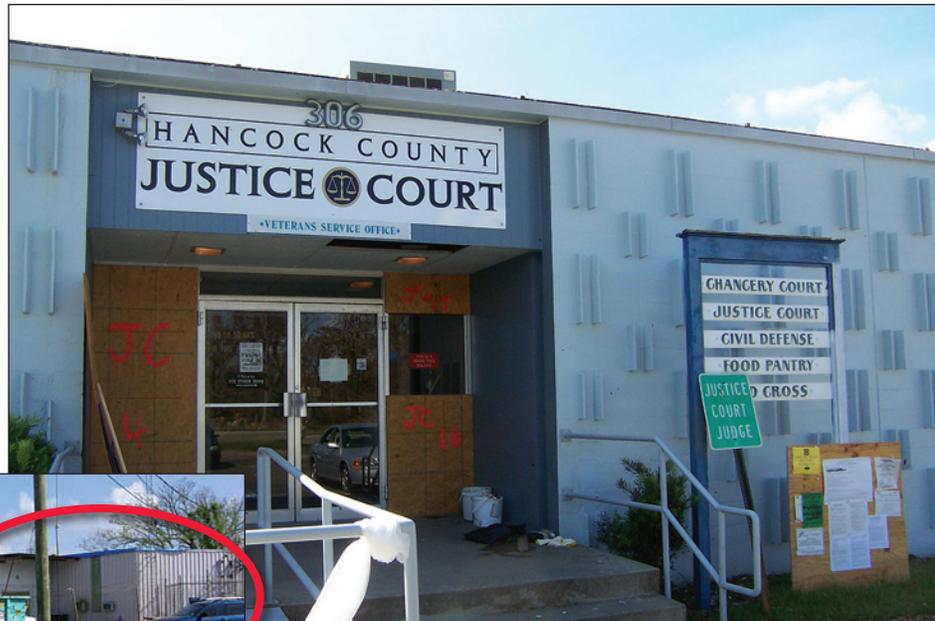
Figure 7-4. The EOC lost a portion of its roof covering, and was flooded and totally isolated by floodwater. The EOC was located in the rear portion of the building (red oval) (estimated wind speed: 125 mph. Bay St. Louis, Mississippi).

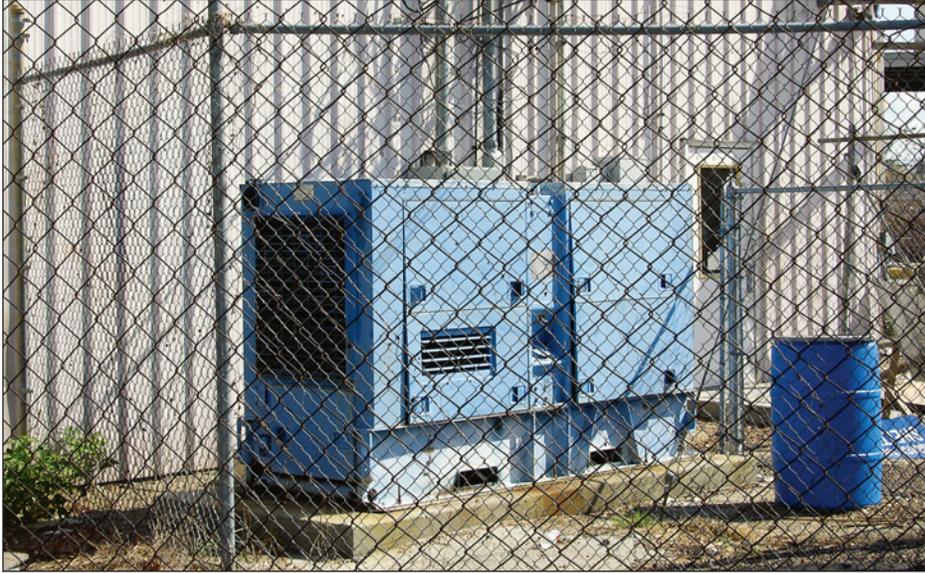
Figure 7-5. The EOC's emergency generator was exposed and inundated by floodwater (Bay St. Louis, Mississippi).

With inundation of the emergency generator, the EOC was without electrical power. Placing the generator in an exposed area was a poor practice. When exposed, a generator is susceptible to windborne debris damage. The generator was also susceptible to flooding, because it was mounted only a few inches above grade.

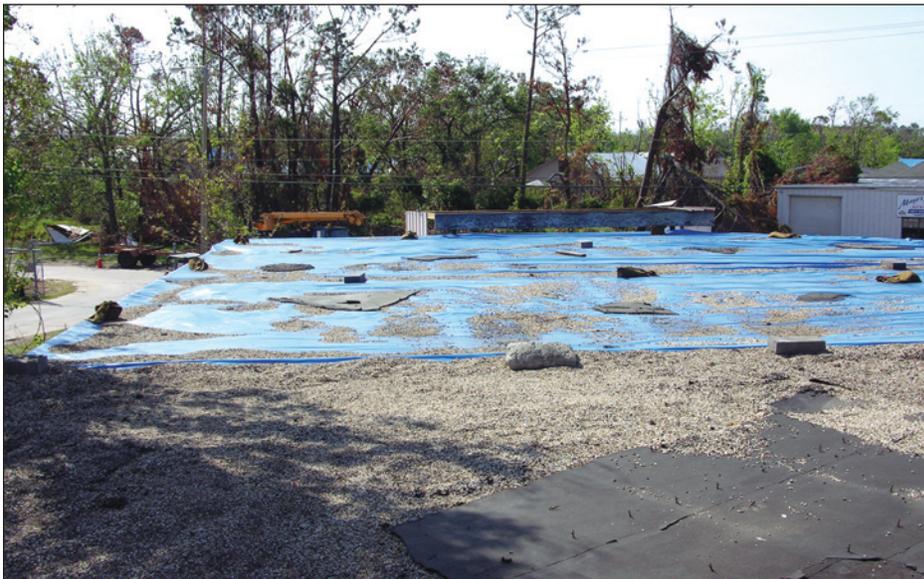
Floodwater rose to about 2 feet above the EOC floor. Wind blew off most of the roof membrane over the EOC and also blew aggregate from the roof (see Figure 7-6). The roof blow-off initiated with the metal edge flashing. It had a 5-1/4-inch vertical face that was uncleaned; therefore, it was susceptible to lifting and peeling. Hardware on the exterior door to the EOC failed and the door blew inward. A communications tower buckled and a satellite dish was blown off its support post. The satellite dish was mounted to a wooden sleeper assembly that rested on the roof surface, with small blocks of concrete over the sleepers.

**Note:** Had the winds been stronger, it is likely that some of the cementitious wood-fiber deck panels would have been blown from the steel joists. (At the time this building was constructed, the typical attachment for this type of decking offered limited uplift resistance.) Some of the wall panels may have also been blown away.

Figure 7-6. The blue tarp was used as an emergency repair where the roof membrane blew off the EOC. Although the membrane's base sheet fasteners were too far apart, the failure initiated with lifting and peeling of the metal edge flashing (estimated wind speed: 125 mph. Bay St. Louis, Mississippi).

Blow-off of the roof membrane allowed a substantial amount of water to leak into the EOC. Aggregate from the roof broke windows of several vehicles in the parking lot, but no injuries from flying aggregate were reported. At the time of the MAT observations, there was significant mold bloom in the EOC.

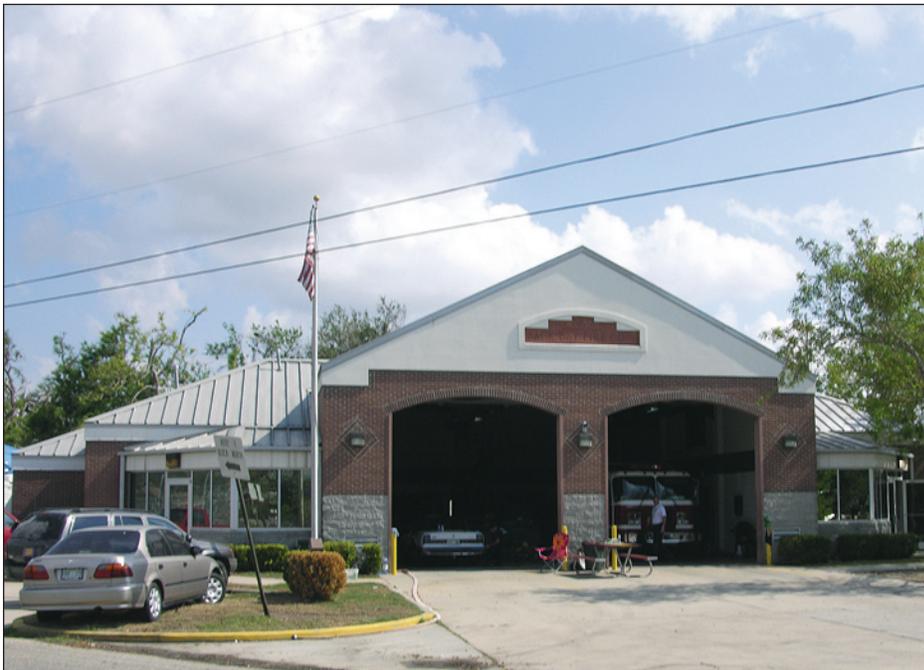
This is a relatively new one-story building with CMU and brick veneer walls and a standing seam metal roof with 16-inch rib spacing (see Figure 7-7). Floodwater rose to about 5-1/2 feet above the floor. The apparatus bay doors were bowed in (this was likely caused by floodwater, rather than wind pressure).

Figure 7-7.  
General view of Back Bay Fire Co. #4. Floodwater was about 5-1/2 feet deep inside the station (Biloxi, Mississippi).

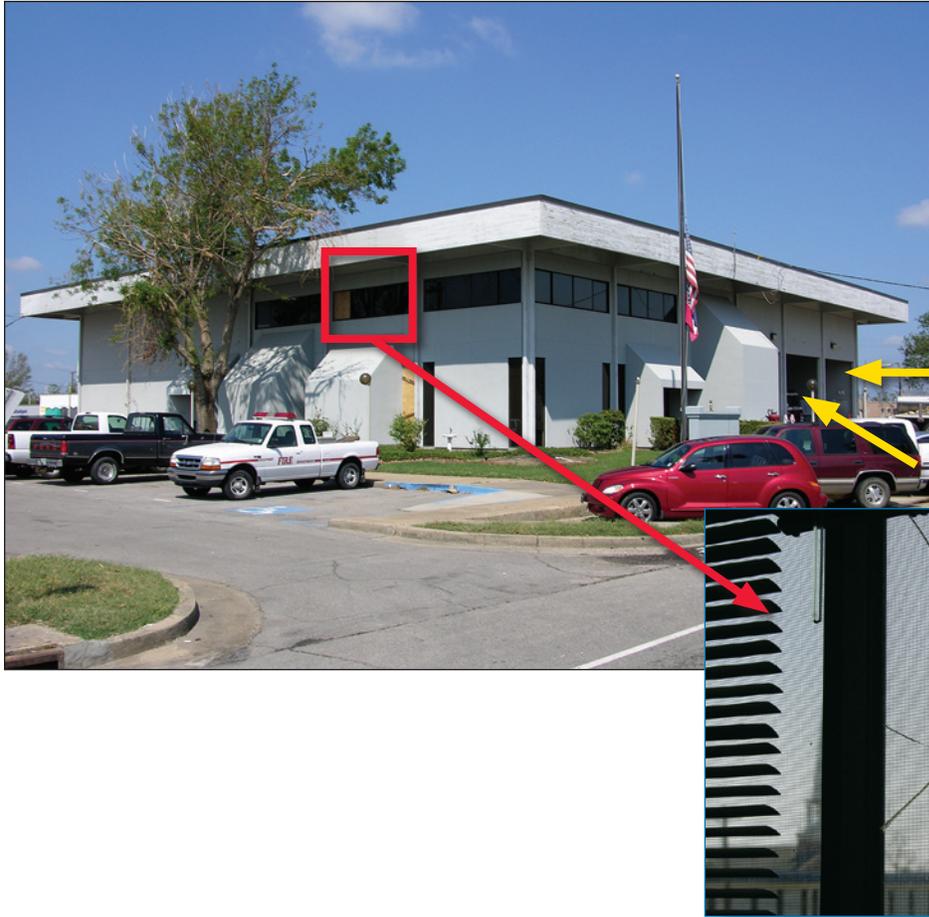
The three windward (east-facing) sectional doors were damaged by wind (see Section 5.2.3). The door damage occurred before winds peaked. In response, fire engines were moved against the damaged doors to brace them, and the three westward doors were opened. Opening the doors likely prevented them from being damaged.<sup>3</sup> With the doors at each end of the apparatus bay open or partially open, uplift load on the roof assembly was likely reduced. Had the westward doors not been opened, there likely would have been sufficient wind load to cause uplifting of the cementitious wood-fiber decking. (At the time this building was constructed, the typical attachment for this type of decking offered limited uplift resistance.) One of the deck panels at an overhang had a major crack across its entire width; however, the panel may have been cracked before the storm.

Three of the 12 upper windows on the south side of the building were broken by aggregate blown from a BUR across the street (Figure 7-8 inset). One of the lower windows was also broken.

Figure 7-8. General view of Gulfport Fire Station #1. Three of the sectional doors blew in (yellow arrows), and four windows were broken on the left side of the building (square/inset) (estimated wind speed: 130 mph. Gulfport, Mississippi).

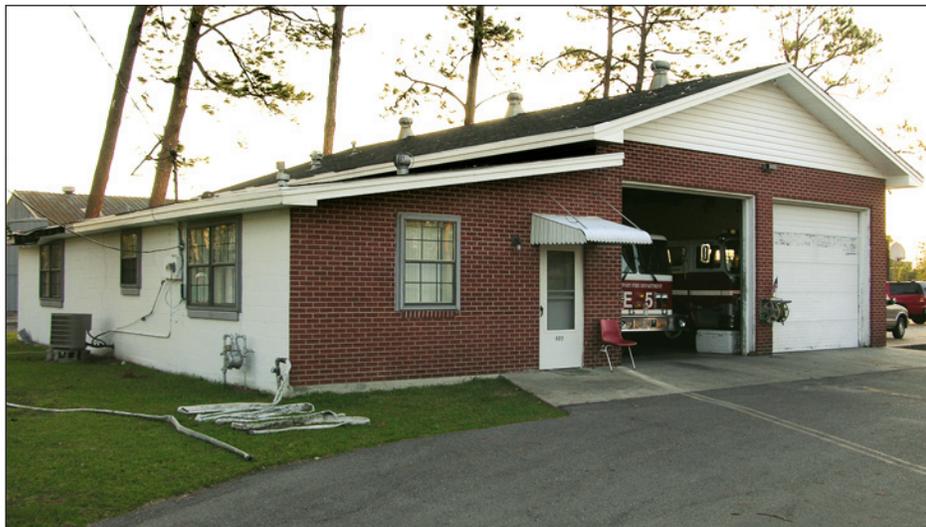
Figure 7-9 shows a general view of the building. It has CMU and brick veneer walls, wood roof framing, plywood decking, and an asphalt shingle roof. A tree fell on the lower roof and caused modest damage to the shingles, decking, fascia, and soffit. Some of the shingle tabs were also blown off.

**Figure 7-9.**  
General view of Gulfport Fire Station #5. A tree fell on the left side of the building (the tree had been removed prior to the MAT's observations) (estimated wind speed: 130 mph. Gulfport, Mississippi).

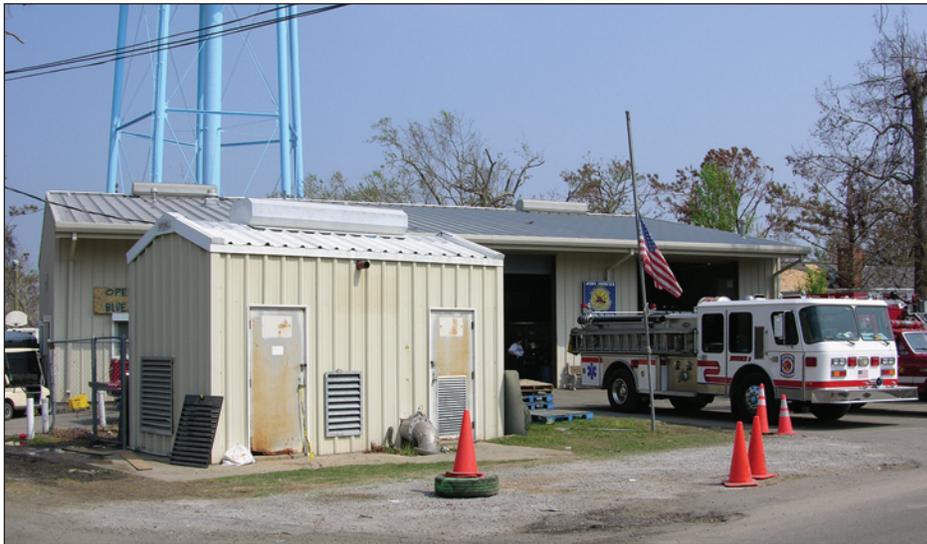
The Pass Christian Fire Department is a PEMB with metal wall panels and a structural standing-seam trapezoidal metal panel roof (see Figure 7-10). The emergency generator is housed in a free-standing PEMB. Although the walls and roof of the generator building could be penetrated by windborne debris, placing a generator in a marginal enclosure such as this is better than having it exposed as shown in Figure 7-5. Roll-down metal shutters had been installed around 1999 at the exterior windows. (This work was funded via the FEMA Hazard Mitigation Grant Program.) However, the glazing in the personnel doors was not protected from windborne debris. Some new steel columns were also located on the backside of the building; they were anchored to the structural frame to provide additional wind resistance to meet current wind loads.

In an effort to keep the doors from blowing inward, fire engines had been positioned so that they were in contact with the rolling doors. However, the slats from at least one of the rolling doors were blown out of the door track. Placing apparatus against bay doors does not increase the resistance of the doors to outward failure, nor does this practice necessarily keep doors from blowing inward on the apparatus. In lieu of using apparatus to buttress doors, doors that possess inadequate wind resistance should be replaced with doors that have sufficient strength to resist design wind loads.

Figure 7-10. General view of the Pass Christian Fire Department. The building in the foreground houses the emergency generator (estimated wind speed: 130 mph. Pass Christian, Mississippi).

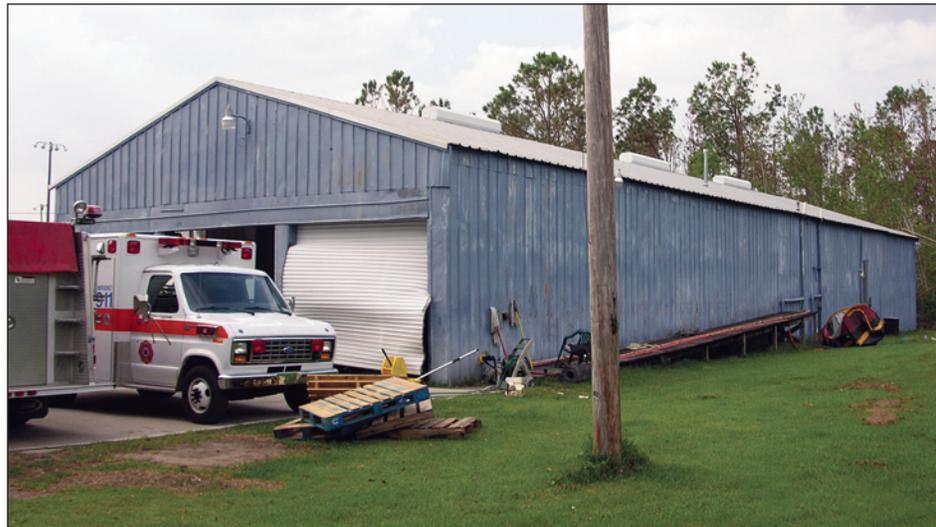
This is a PEMB with an exposed fastener metal panel roof (see Figure 7-11). It appeared that floodwater rose to about 1 foot above the floor line; however, it was reported that the water rose to a depth of 2 to 3 feet. The slats from at least one of the rolling doors at the apparatus bay dislodged from the door track (this was likely caused by wind, but may have been initiated by floodwater). The communications tower was also toppled.

**Figure 7-11.**  
General view of the Cuevas Volunteer Fire Department. Note the damaged apparatus bay door (estimated wind speed: 130 mph. Pass Christian, Mississippi).

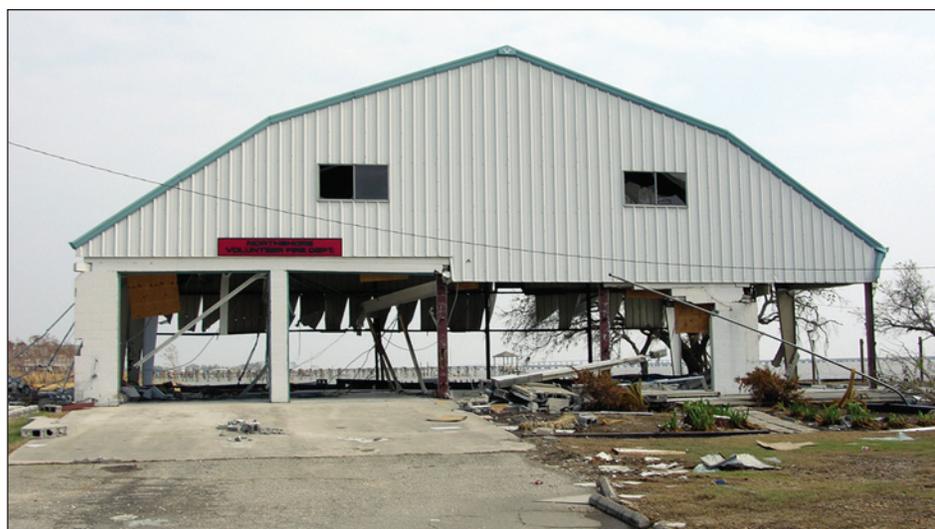
This is a PEMB with unreinforced CMU walls and metal wall panels. The building was severely damaged by storm surge and waves from nearby Lake Pontchartrain (see Figure 7-12).

**Figure 7-12.**  
General view of the Northshore Volunteer Fire Department. Exposure C (estimated wind speed: 115 mph. Slidell, Louisiana).

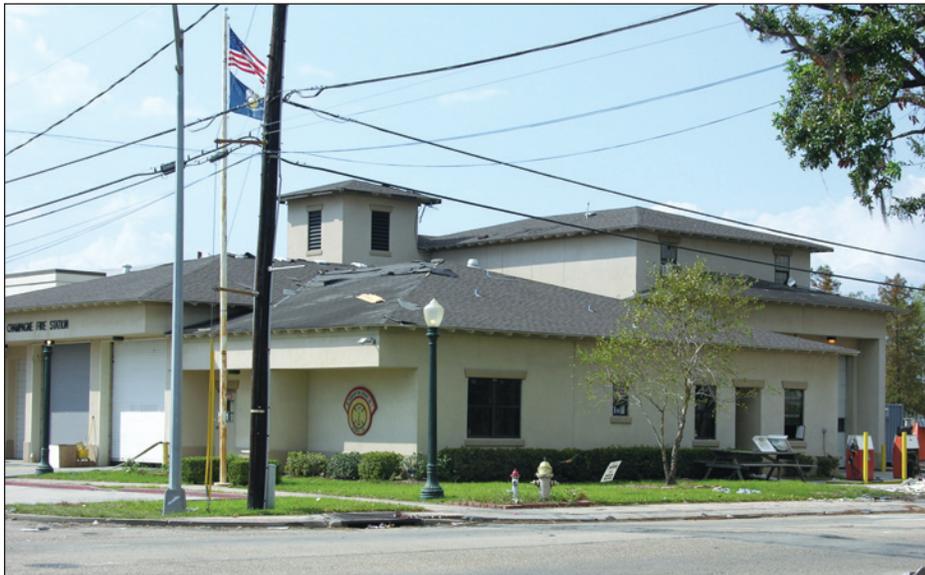
This two-story building was constructed in 1952 and remodeled in 1989 (see Figure 7-13). It has a wood-frame structure, EIFS over unreinforced CMU and brick veneer, a cementitious wood-fiber deck, and asphalt shingles. Floodwater rose to several feet above the floor line. There was flood/flotation damage to pad-mounted mechanical equipment located outside the building. Several of the shingles were blown away, some rooftop exhaust fans were damaged, and the communications tower collapsed.

Figure 7-13.  
General view of the  
A. J. Champagne Fire  
Station (estimated wind  
speed: 115 mph. Slidell,  
Louisiana)

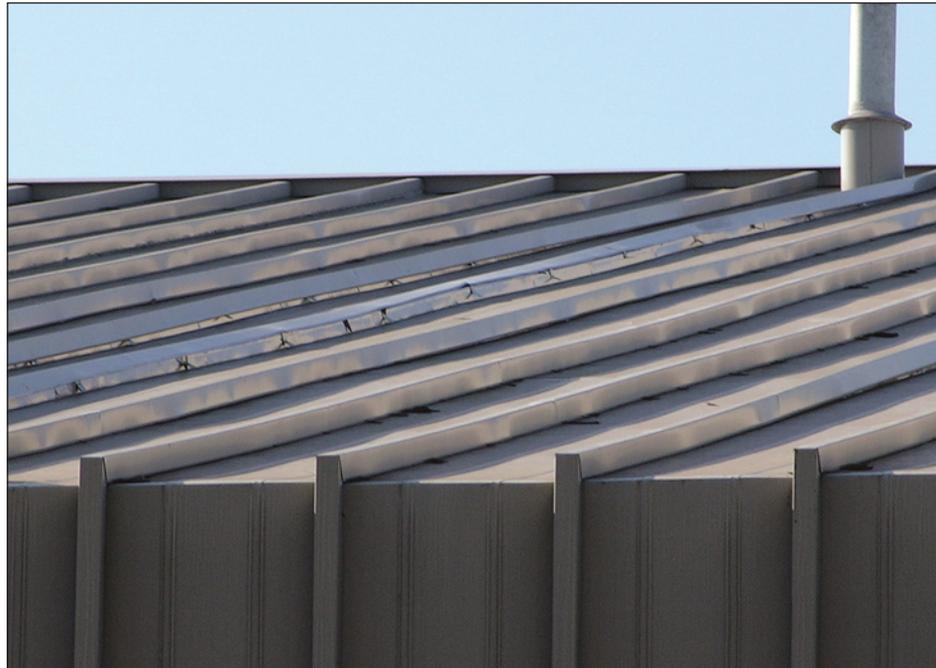
were still attached, but they had lifted and it appeared that fatigue cracks occurred along the standing seams (see Figure 7-14).

**Figure 7-14.**  
This portion of the roof was not blown off, but some of the batten covers lifted. It appeared that fatigue cracks occurred along the standing seams (estimated wind speed: 105 mph. New Orleans, Louisiana).

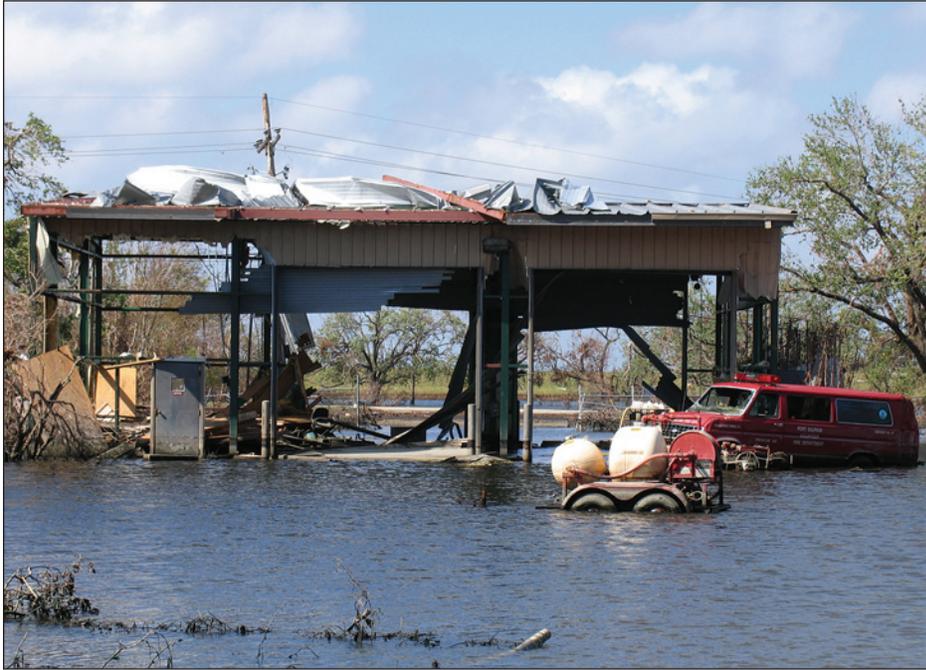
This is a PEMB with metal wall panels and a structural standing-seam trapezoidal metal panel roof (see Figure 7-15). Storm surge severely damaged the rolling doors and walls. Wind blew off a portion of the roof panels.

Figure 7-15. General view of the Port Sulphur Volunteer Fire Department showing damage caused by storm surge and wind. Note the inundated apparatus in the foreground (estimated wind speed: 125 mph. Port Sulphur, Louisiana).

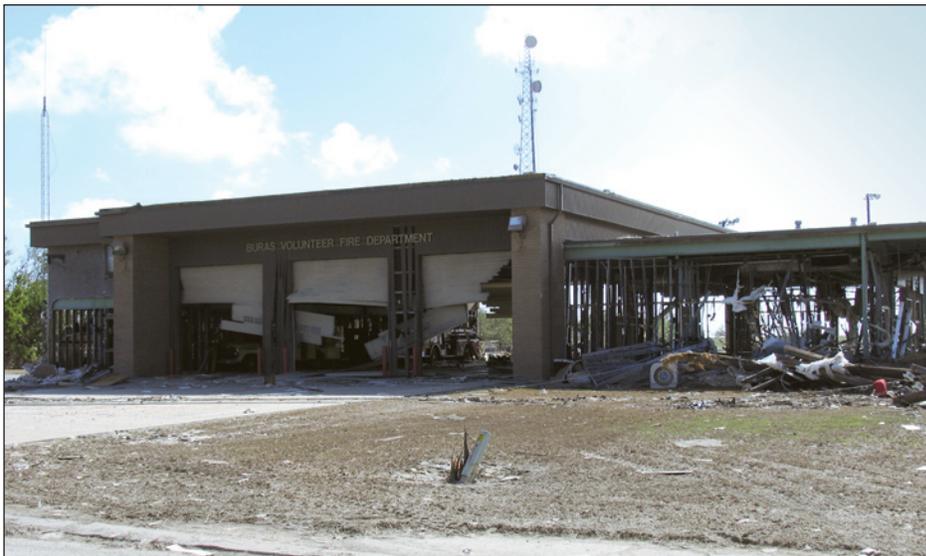
Storm surge severely damaged the rolling doors and walls (see Figure 7-16).

Figure 7-16. General view of the Buras Volunteer Fire Department (estimated wind speed: 130 mph. Buras, Louisiana)

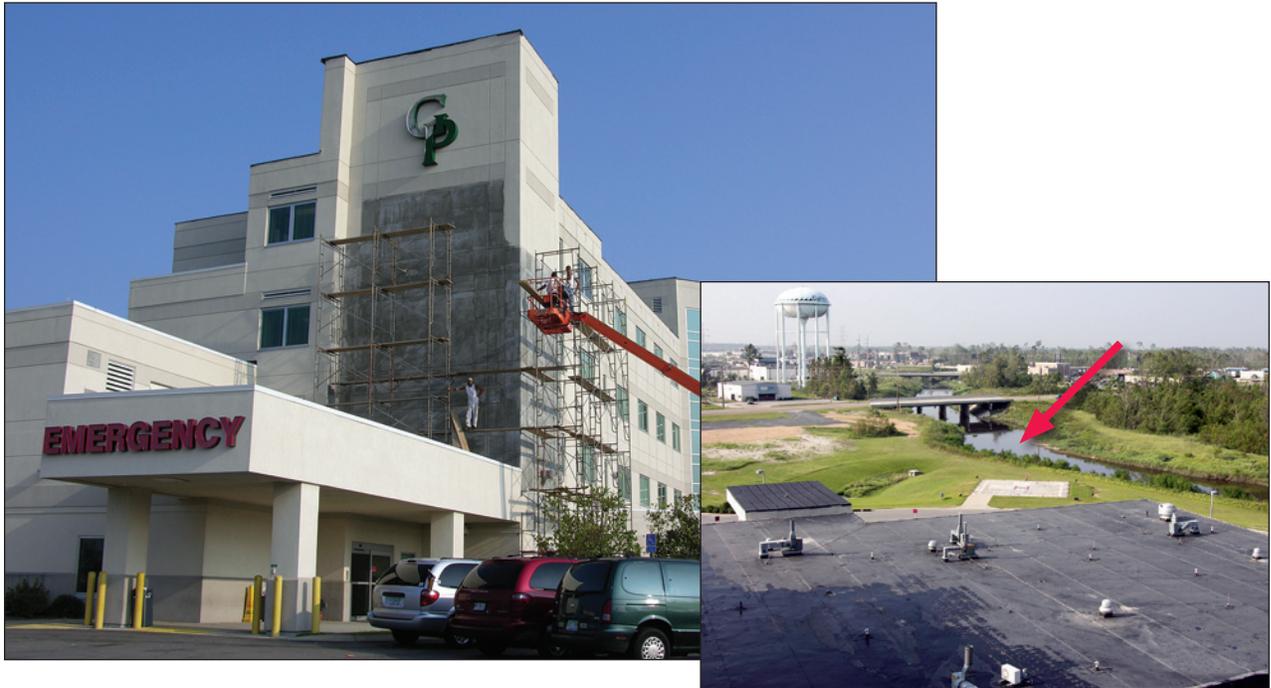
The nearby Flat Branch Creek (Figure 7-17 inset) rose above its banks and reached a depth of about 6 inches inside the hospital. The EIFS blew off the hospital in a few areas (detachment of the gypsum board from the studs was the primary failure mode). With loss of the EIFS, water was able to enter the wall cavities. A penthouse door was blown off its hinges (see Figure 5-5). The roof membrane lifted and peeled back in some areas, and in other areas it ballooned. Rubber walkway pads were blown away and the roof membrane was punctured in several areas (some of the punctures were likely caused by the lightning protection conductors and/or air terminals that became detached; see Figures 5-122 and 5-123). Some of the vents for the lightweight insulating concrete (LWIC) and an exhaust fan were damaged by windborne debris (see Figure 7-18). (Note: unless in a penthouse or protected by screen walls, rooftop equipment is vulnerable to debris damage.) Some fan cowlings were blown off (see Figure 5-114) and several of the storm caps over exhaust ducts were blown away (Figure 7-18 inset).

Figure 7-17. General view of Garden Park Medical Center. EIFS repairs were underway at the time the photo was taken. The inset shows one of the hospital's lower roofs and Flat Branch Creek beyond (arrow) (estimated wind speed: 130 mph. Gulfport, Mississippi).

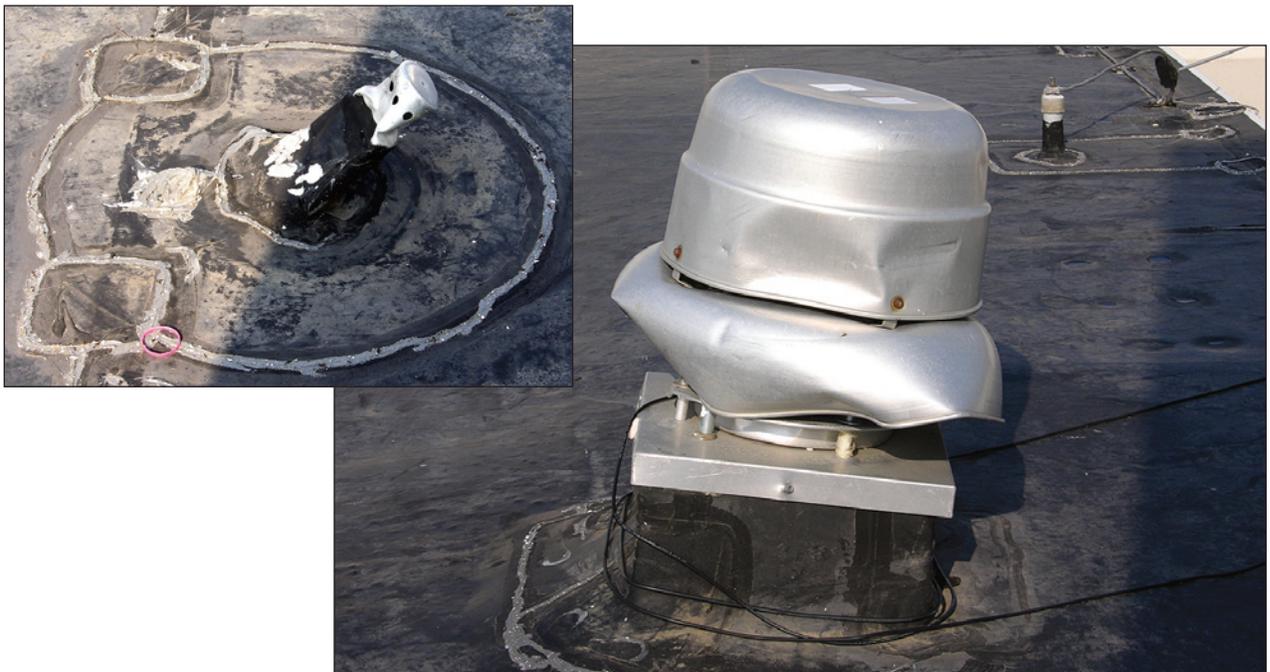
Figure 7-18. This exhaust fan was struck by windborne debris. The inset shows a LWIC vent that was also hit by debris. Water could enter the roof where the vent cap was knocked off (estimated wind speed: 130 mph. Gulfport, Mississippi).

Although no exhaust fans were blown from their curbs, they were only marginally attached. At one fan that was on a 28 x 28-inch curb, the fan was only attached with one screw per side. Had the fan been attached in accordance with the guidance in the Hurricane Katrina Recovery Advisory section on attachment of rooftop equipment (Appendix E), there would have been six screws per side.

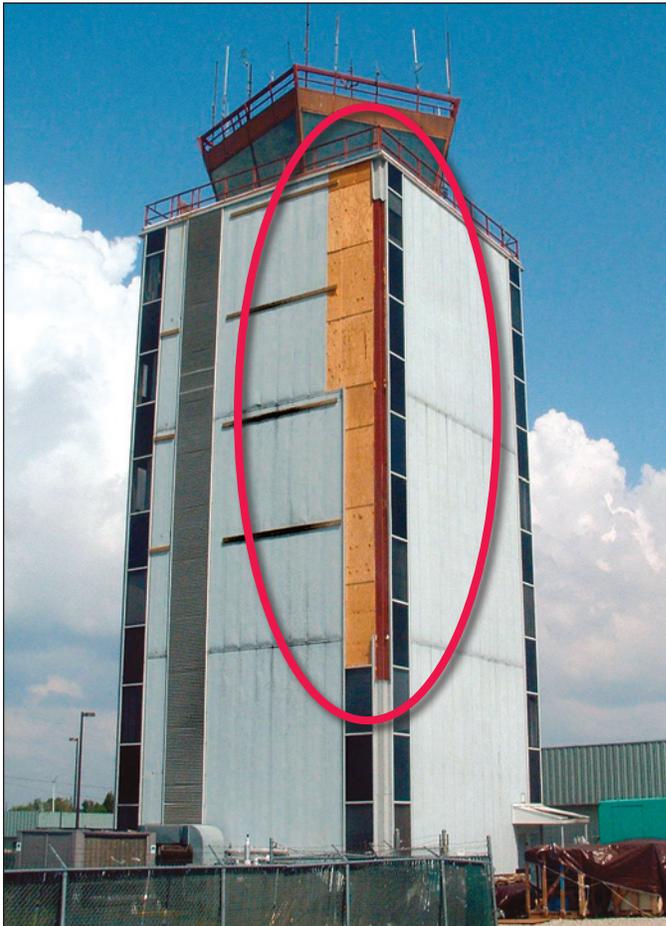
Damage to the airport control tower is shown in Figure 7-19. Wind pressure and windborne debris broke about 30 percent of the tower wall glazing and damaged the metal wall cladding.

Figure 7-19. Airport control tower. Note damaged glazing and cladding (circle) (estimated wind speed: 130 mph. Gulfport, Mississippi).

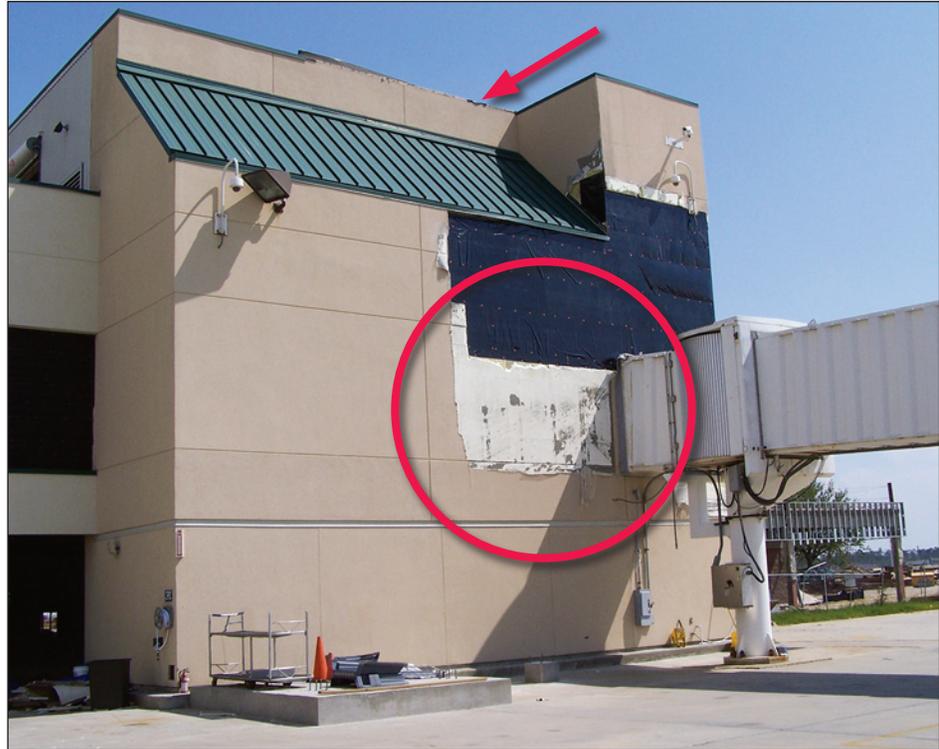
Figure 7-20.  
Damaged terminal gate at the Gulfport-Biloxi International Airport. Note the damaged roof coping (arrow) and the wind damaged EIFS (circle) (estimated wind speed: 130 mph. Gulfport, Mississippi).

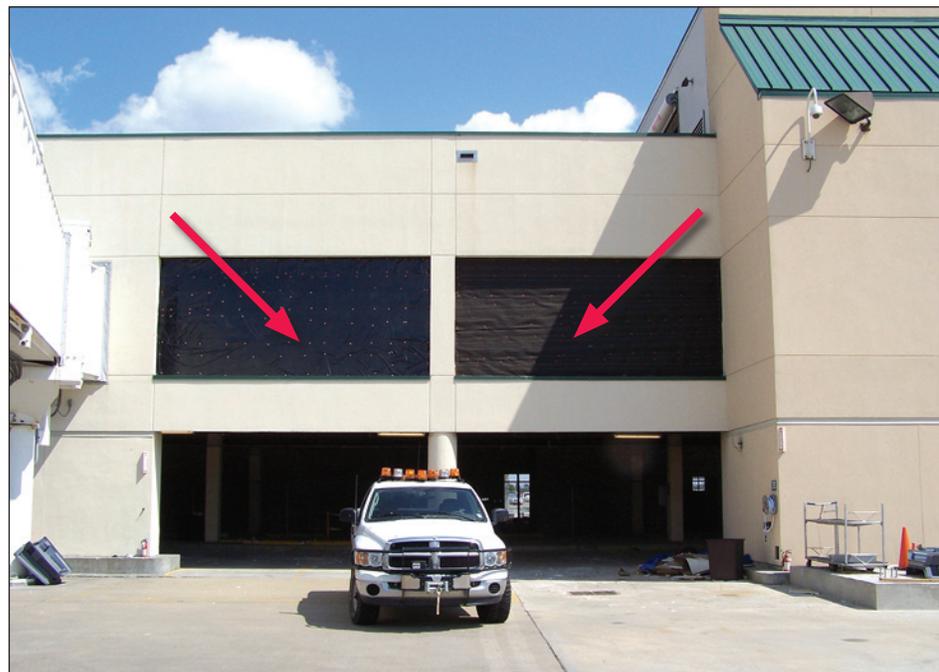
Figure 7-21.  
Glazed curtain wall pushed inward by wind pressure. Note the location of damaged curtain walls with temporary weather seal (arrows) (estimated wind speed: 130 mph. Gulfport, Mississippi).

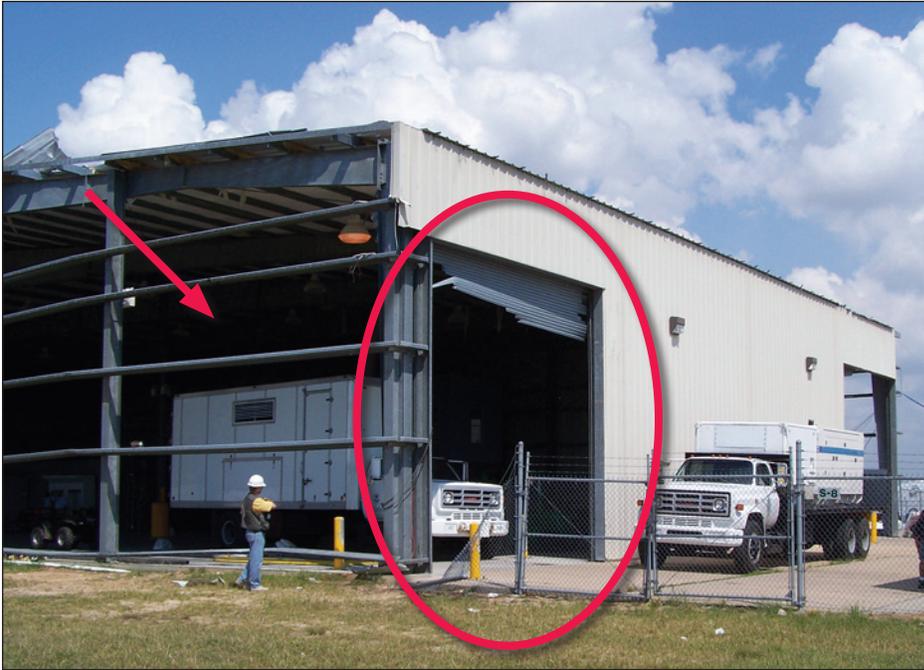
Figures 7-22 and 7-23 portray the wind damage to the airport cargo building. The building was constructed with a pre-engineered metal building frame with metal siding. Damage to the building resulted when positive wind forces pushed in the two large rolling doors. The building became internally pressurized, causing the loss of most of the wall panels on the west side of the building and some of the roof panels.

Figure 7-22. Wind damage to the southwest corner of the airport cargo building. Note the pressure damaged rolling door (circle) and the west wall panels removed by combined internal and external pressures (arrow) (estimated wind speed: 130 mph. Gulfport, Mississippi).

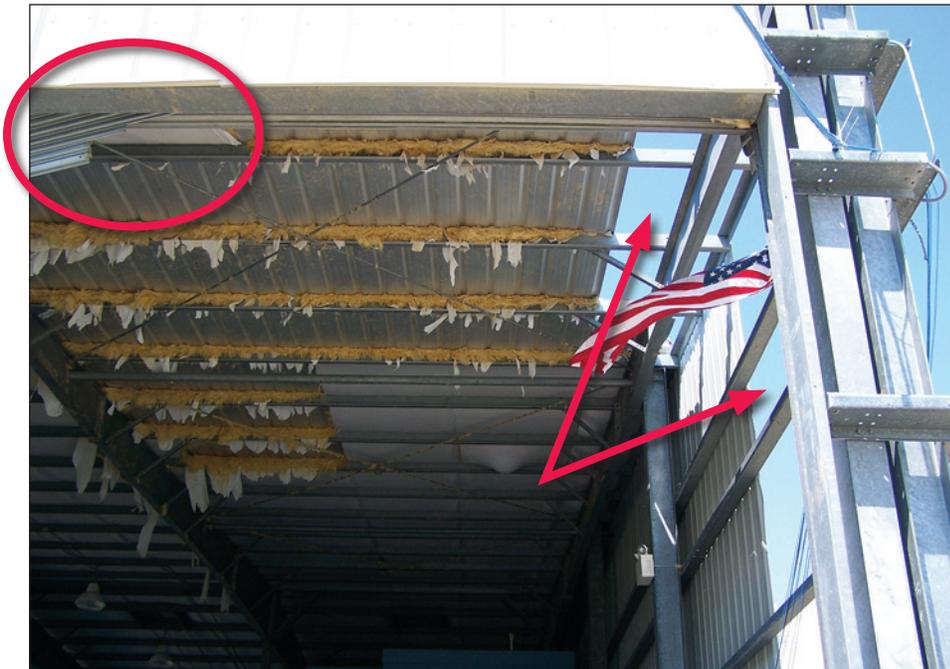
Figure 7-23. Roof and wall panel damage at the airport cargo building. Note the damaged rolling door at the southeast corner (circle) and roof and wall damage (arrows) (estimated wind speed: 130 mph. Gulfport, Mississippi).

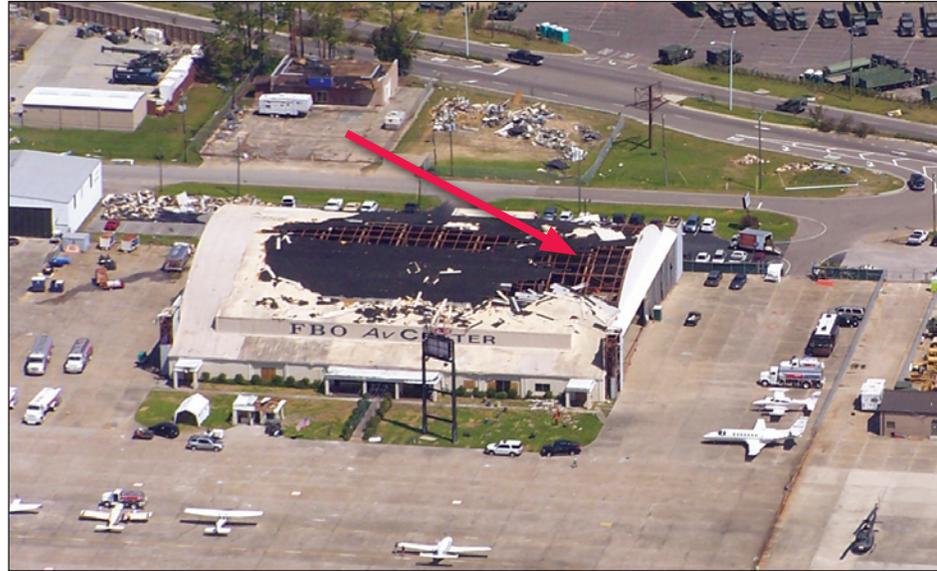
The airport Fixed Based Operator (FBO) building servicing general aviation experienced roof decking and roofing removal when one of its large sliding hangar doors was blown into the building. This failure allowed the building to become internally pressurized. Figure 7-24, an aerial view, portrays the extent of the roof damage. Figure 7-25 shows the hangar door on the ground.

Figure 7-24.  
Airport FBO building. Note  
the decking and roofing  
materials removed by  
wind pressure (arrow)  
(estimated wind speed:  
130 mph. Gulfport,  
Mississippi).

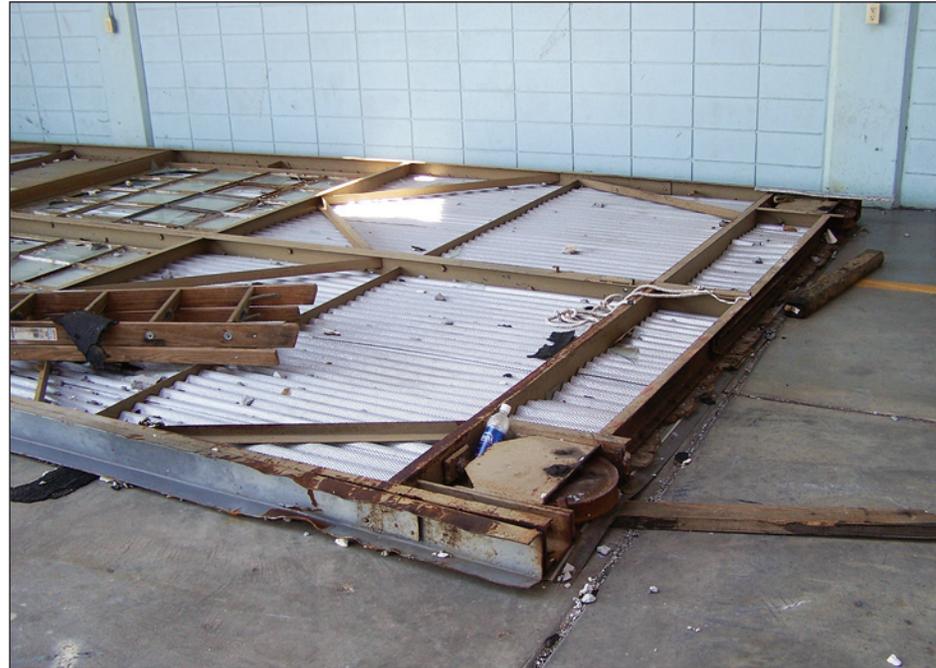
Figure 7-25.  
Sliding door blown into  
hangar (estimated wind  
speed: 130 mph. Gulfport,  
Mississippi)
