## 2.0 OBSERVATIONS OF FLOOD DAMAGE AND COASTAL FLOODPLAIN CONSTRUCTION

## 2.2 POIPU BEACH

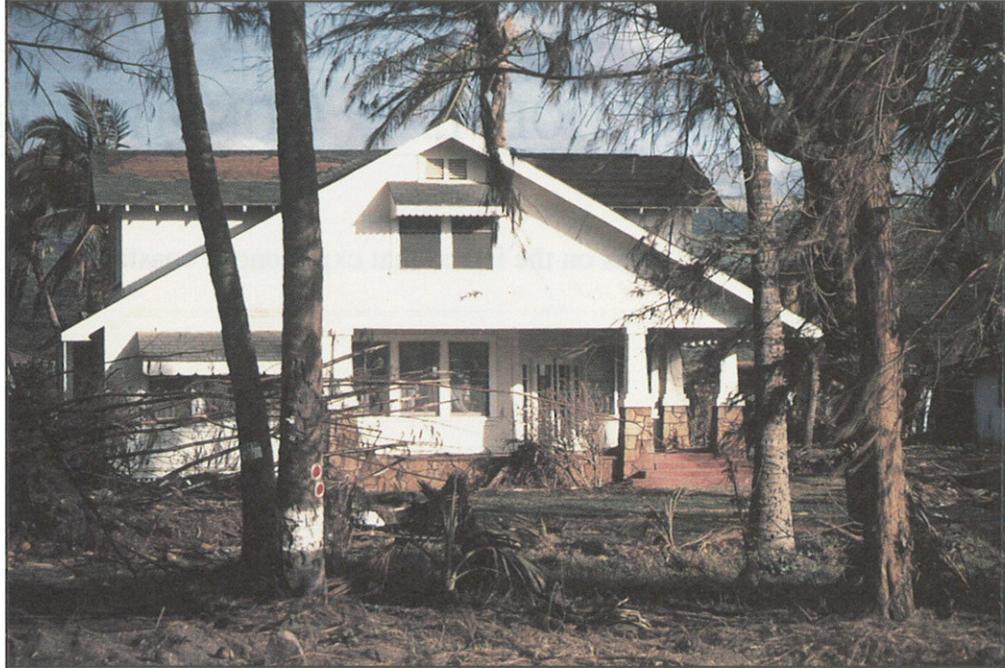
- The lowest floors of some buildings were elevated above the ground surface. While the elevation was only 2 to 3 feet above grade on a crawlspace foundation, it was sufficient in this area to prevent water from entering several homes (FIGURE 5).

*FIGURE 5. Flood damage to this coastal house in Kekaha was minimized because the house is elevated 2 to 3 feet off the ground and is located a considerable distance from the shoreline.*

Clearly, the flood damage sustained, and the flood damage prevented, in Kekaha reinforce the importance of properly elevating new and substantially improved construction above predicted flood levels in this and other flood hazard areas.

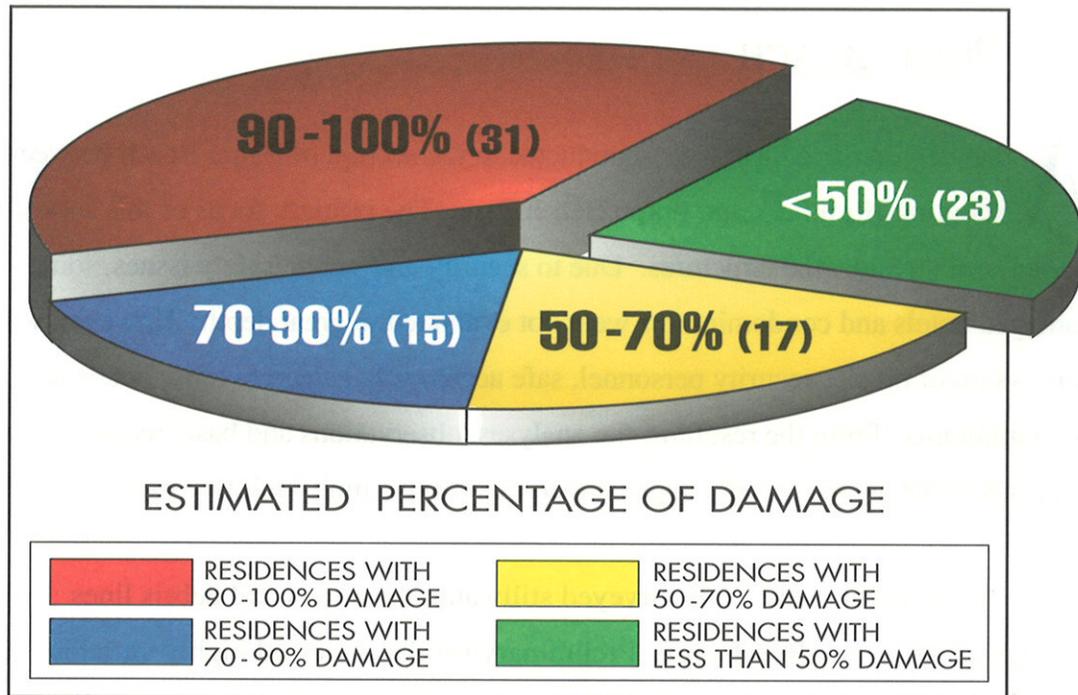
Coastal flooding in the section from Spouting Horn Park to Poipu Beach Park was severe and widespread, resulting in substantial damage to an estimated 60 or more single-family, detached residences (FIGURE 6). Several condominiums and hotels fronting the ocean also sustained significant flood damage to their lowest (ground level) units. Table 1 provides a preliminary inventory of damaged buildings for particular segments. The damage was caused by direct wave impact on buildings that were constructed without adequate consideration of the potential flood hazard. Additional damage was caused by debris impact. This debris included lava rocks, trees, detached pieces of buildings, and in some cases entire buildings that rammed adjacent structures (FIGURE 7).

FIGURE 6. Results of preliminary field inventory of damaged residential buildings — Poipu Beach Park to Spouting Horn Park. Numbers in parentheses are building counts.

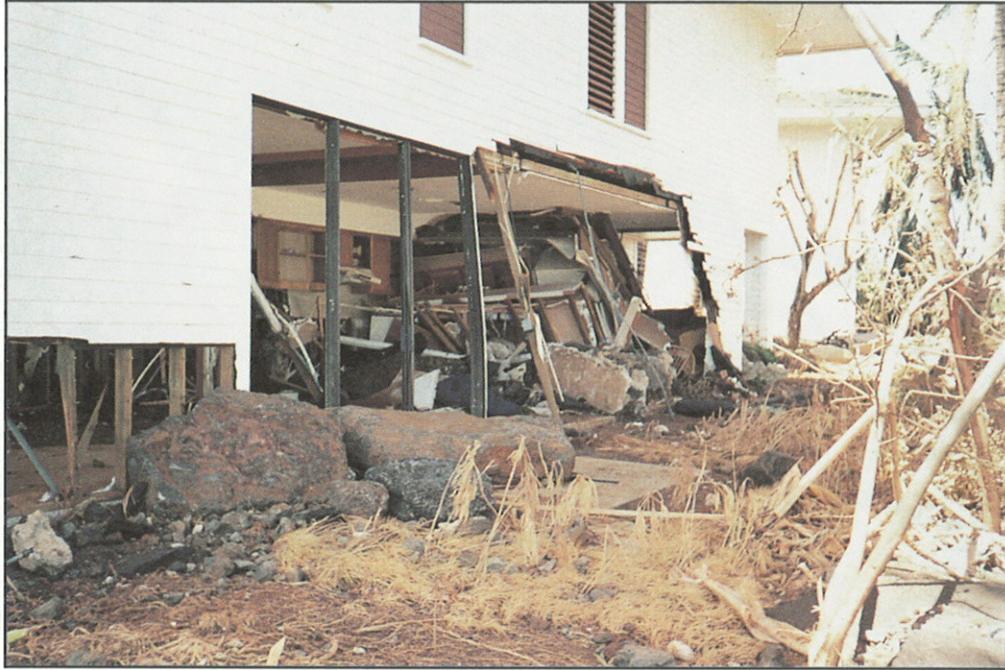
FIGURE 7. *Waterborne debris resulted in significant damage to non-elevated buildings along Poipu Beach.*

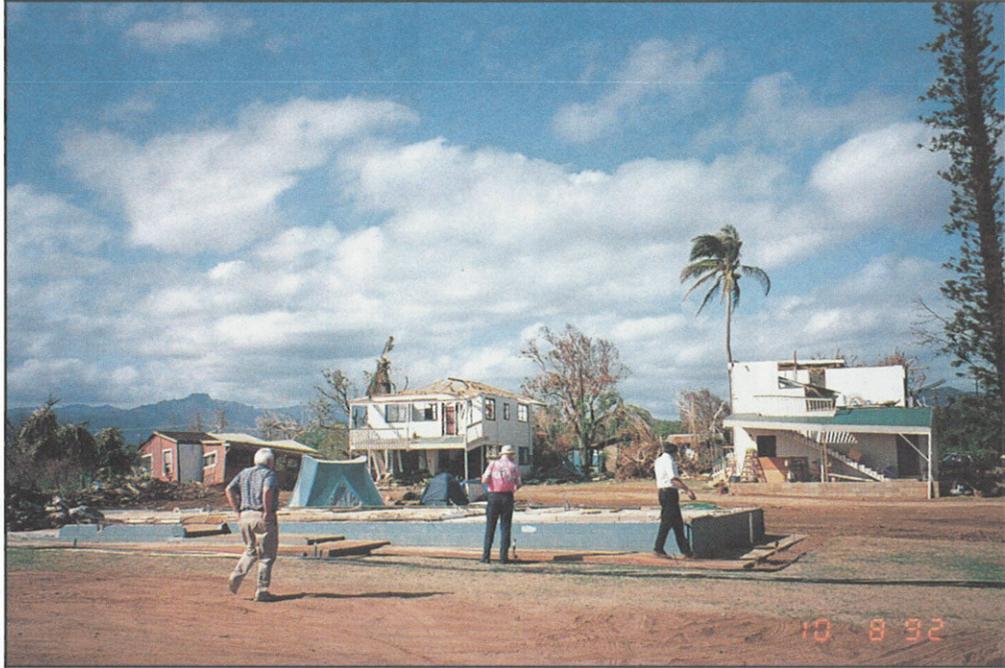
1. **Lack of Elevation.** Almost without exception, the lowest floors of buildings were constructed directly on the ground (FIGURE 8). Because the lowest horizontal structural members of buildings were not elevated to or above predicted flood heights, all (or large sections) of the buildings' walls were directly impacted by significant hydrodynamic and debris impact forces.

FIGURE 8. *Typical example of residential construction along Poipu Beach that was destroyed because it was not elevated above the flood hazard.*

The exact failure mode is inconsequential since the overriding factor was lack of elevation above the designated and/or actual flood level. Without elevating buildings to or above flood heights to allow for the free passage of velocity water underneath, it is essentially impossible (or at the least not cost-effective) to construct a building to withstand such forces.

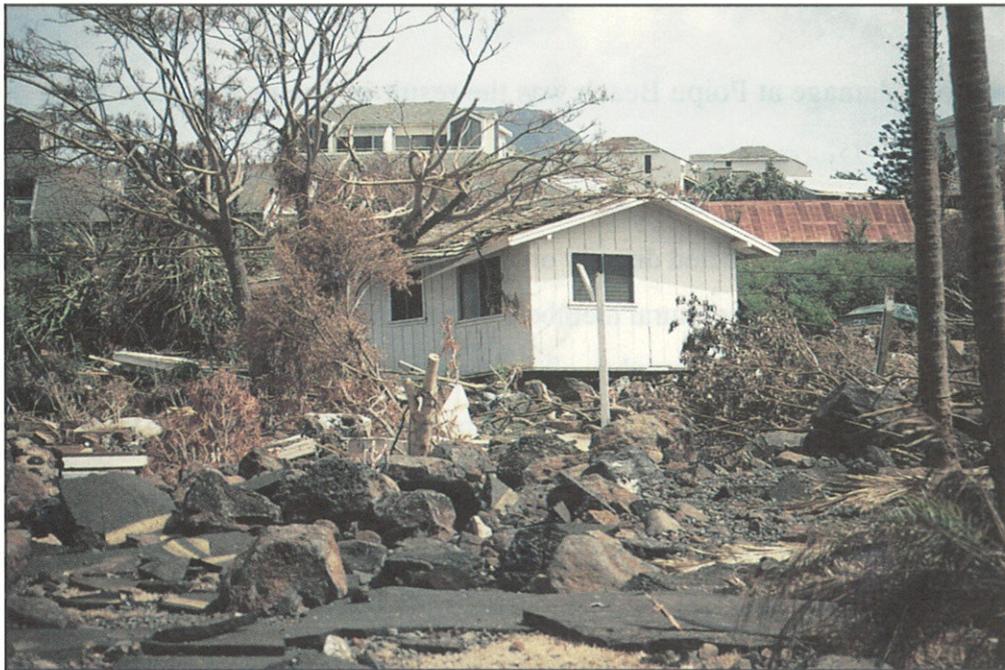
- Where buildings rested on piers with very shallow poured footings and precast concrete foundations ("tofu" blocks) with insufficient or no (i.e., gravity) connections between support posts and foundation, they were literally floated off their foundations by buoyant forces as the waters rose (FIGURE 9). In some instances, these "floaters" were carried considerable

FIGURE 9. *Non-elevated house at Poipu Beach that floated off its foundation and was transported well inland.*

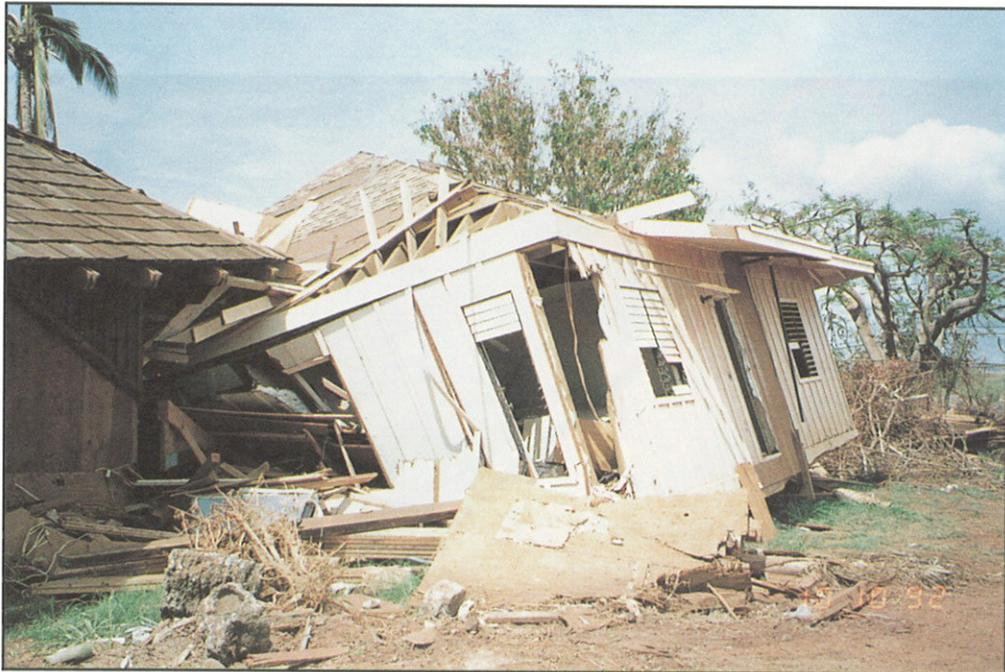
distance inland. In others, they were pinned against trees or other stable objects and then destroyed by waves (FIGURE 10). There was clear evidence that in some instances these buoyed buildings crashed into other buildings, causing further damage (FIGURE 11).

**FIGURE 10.** *Non-elevated house at Poipu Beach that floated off its foundation was pinned against another house and destroyed by waves.*

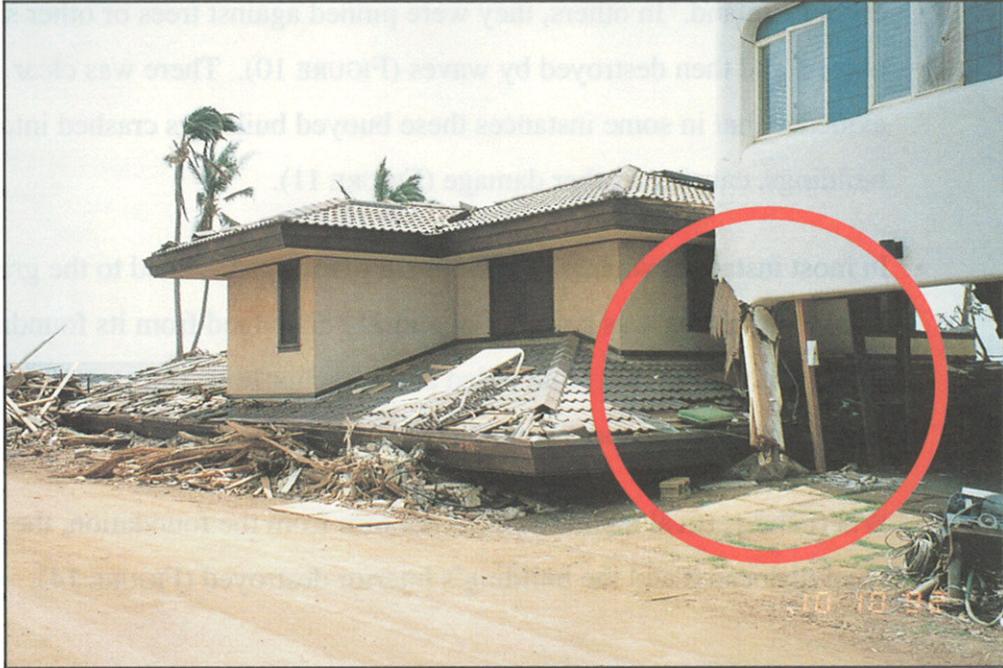
FIGURE 11. *Non-elevated building at Poipu Beach that rammed and increased damage to an adjacent building.*

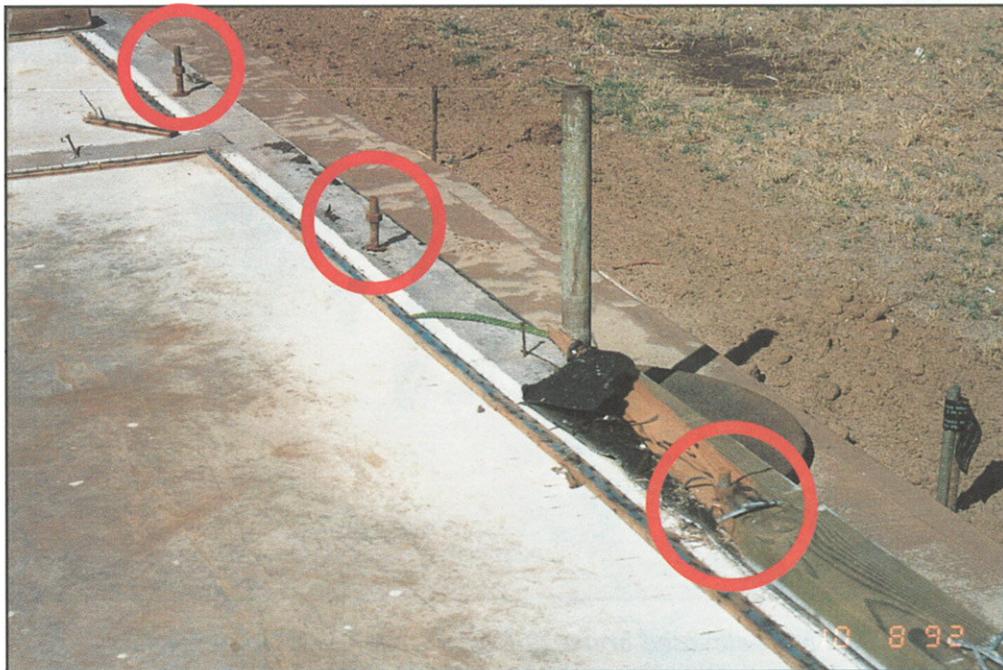
- In most instances where the bottom sill plate was fastened to the grade slab, the building was partially or entirely dislodged from its foundation. Either the wooden sill plate failed at the anchor bolts (FIGURE 12) or the vertical members (studs) were dislodged from the sill plate (FIGURE 13).
- Where the vertical members were not torn from the foundation, the walls were dislocated and the building's interior destroyed (FIGURE 14).

FIGURE 12. *Non-elevated building at Poipu Beach destroyed by coastal flooding. Sill plate ripped from anchor bolts.*

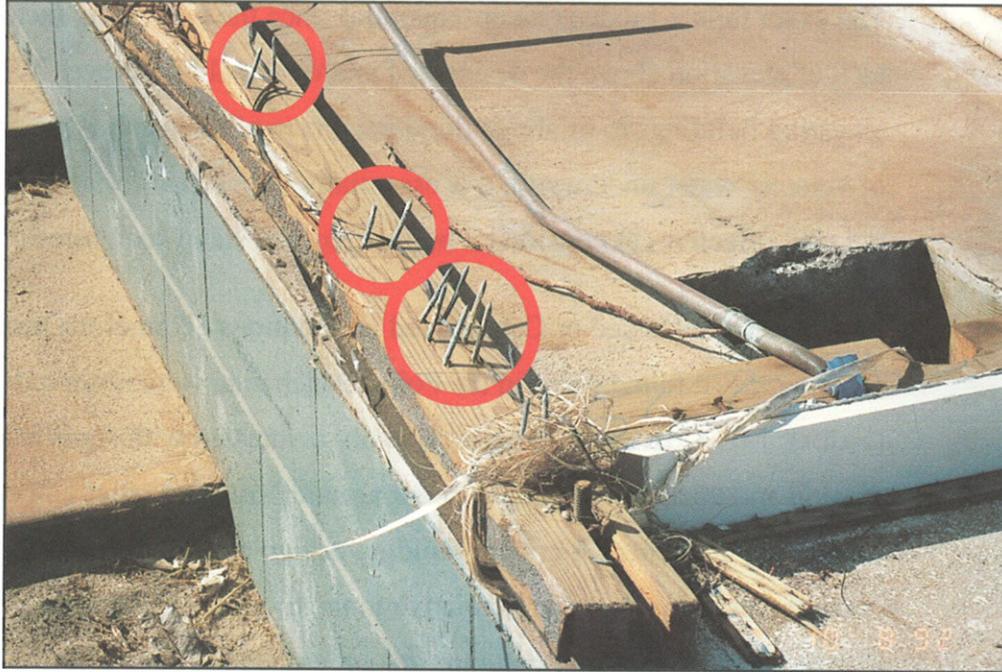
FIGURE 13. *Non-elevated building at Poipu Beach destroyed by coastal flooding. Vertical members ripped from sill plate.*

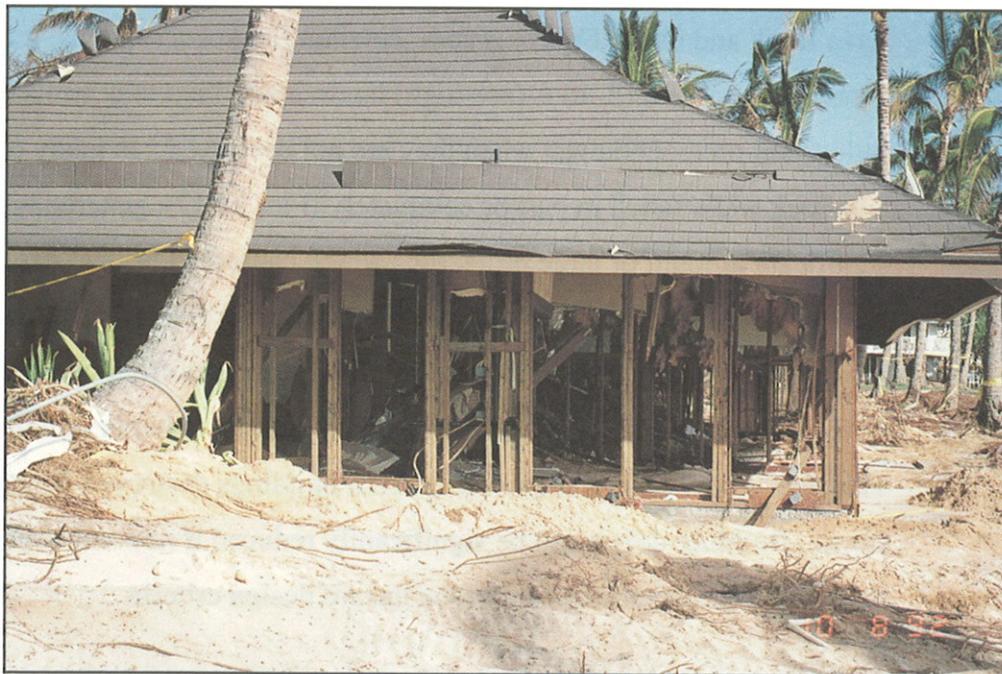
FIGURE 14. *Interior of non-elevated building at Poipu Beach destroyed by coastal flooding.*

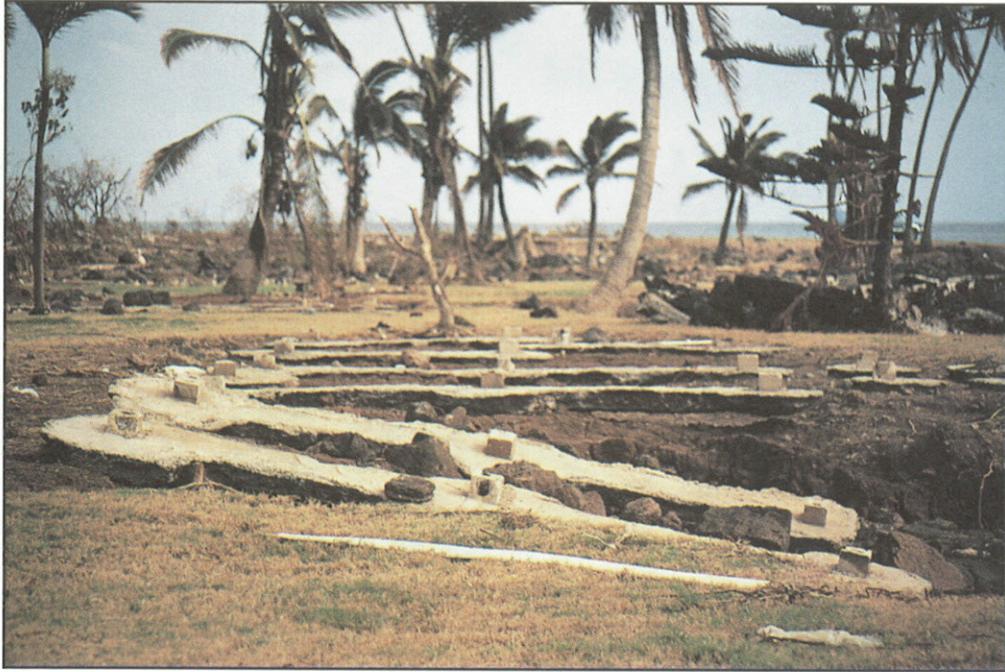
2. **Improperly Embedded or Constructed Foundations.** Numerous instances of undermined foundations in the Poipu Beach area were observed (FIGURE 15). Coastal flooding is typically associated with significant erosion and localized or conical scour around posts and other embedded foundation elements. A critical building design consideration is the embedment of the foundation relative to the erosion depth caused by such storms. If piers, posts, or columns are not embedded deep into unconsolidated sediment or securely connected to natural lava rock deposits, the foundation of even a properly elevated building can be undermined and the building destroyed (FIGURE 16).

FIGURE 15. *Foundation at Poipu Beach undermined by erosion.*

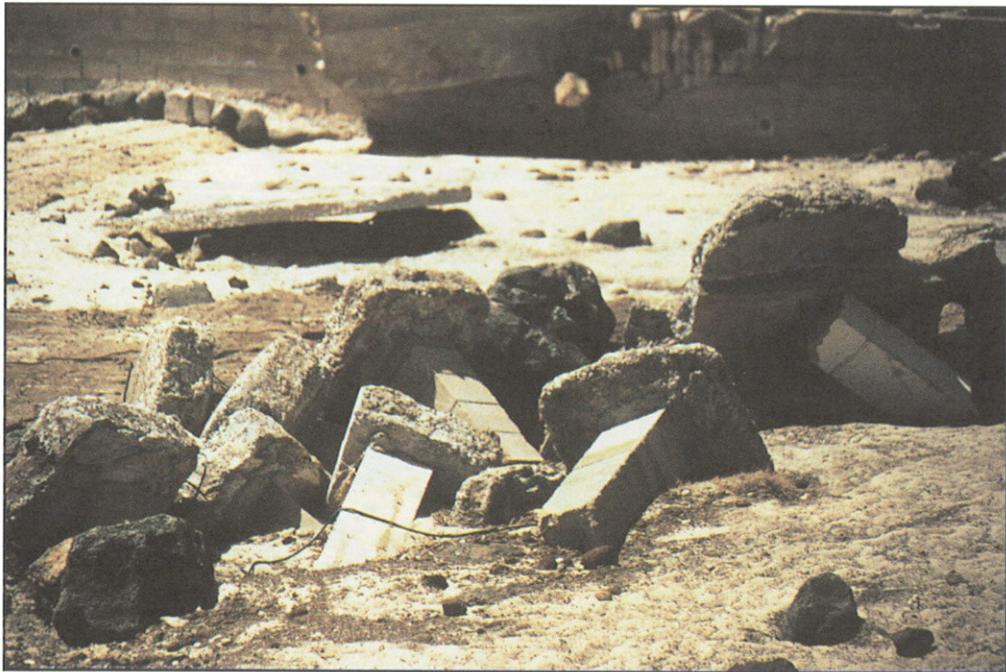
FIGURE 16. *Undermining of shallow pier foundation at Poipu Beach due to lack of sufficient embedment below erosion depth.*

In addition, the horizontal structural members supporting the lowest floor must bear on piles or columns to allow velocity waters to freely pass beneath the lowest floor of buildings. These foundations must also be affixed securely to resistant lava rock or be sufficiently embedded in unconsolidated sediment to withstand the erosion and localized scour caused by hurricane-induced waves. While foundation types and construction materials may differ for condominiums or hotels, the basic minimum elevation and foundation-embedment and/or anchoring principles apply. Proper implementation of these basic design standards, which are required under the NFIP, will considerably reduce future hurricane and tsunami flood damages in Kauai County.

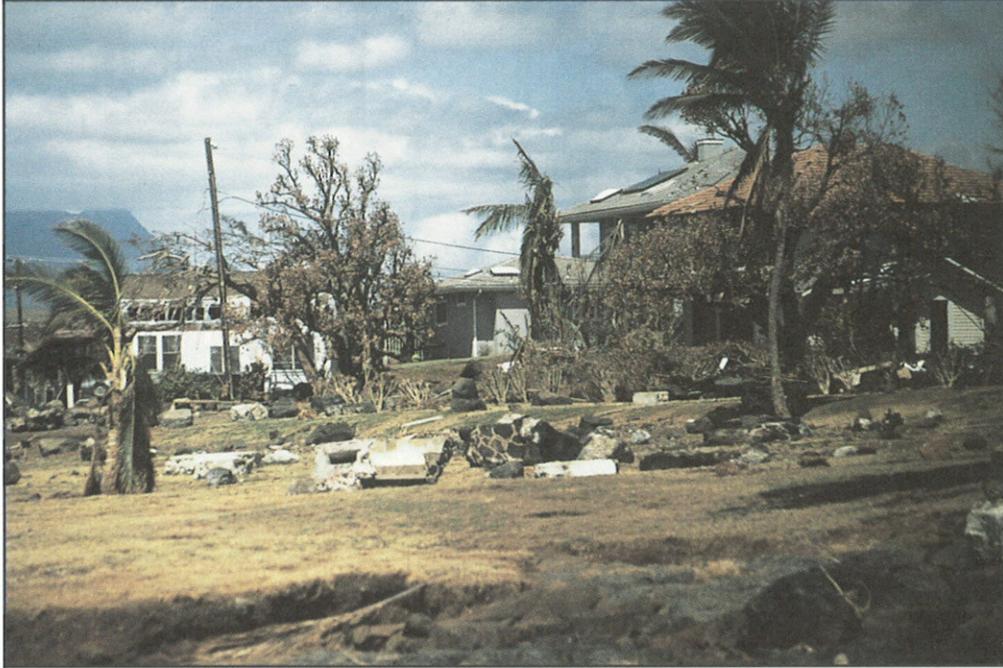
3. **Lava Rock and Other Debris.** From detailed field observations, it can be concluded that low (2- to 4-foot-high) landscaping lava rock walls offer little flood protection even when they are not destroyed. In many cases, lava rock walls failed in part or completely (FIGURE 17), generating a significant amount of large projectiles which caused additional damage to buildings landward and/or to neighboring buildings (FIGURE 18). Design professionals should reconsider the suitability of oceanfront lava rock walls seaward of buildings. Other debris also acted to batter buildings. This debris was generated primarily from buildings destroyed during the storm. Building debris can be significantly reduced if new construction is built with consideration of the flood hazard design criteria.

FIGURE 17. *Breakup of grouted lava rock walls at Poipu Beach generated waterborne projectiles.*

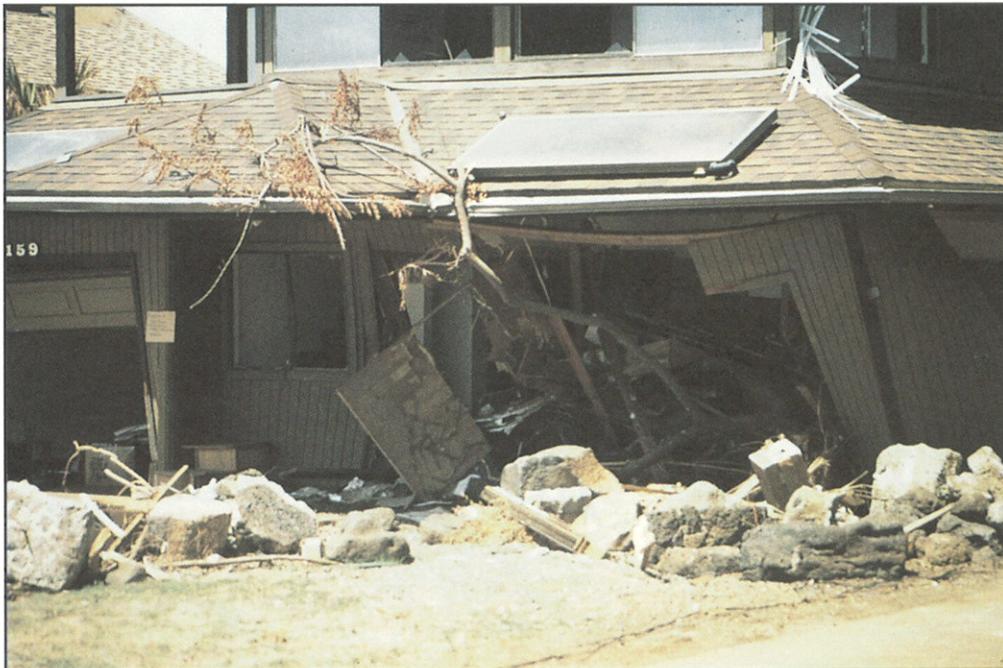
FIGURE 18. *Waterborne lava rock projectiles at Poipu Beach increased damage to non-elevated buildings.*

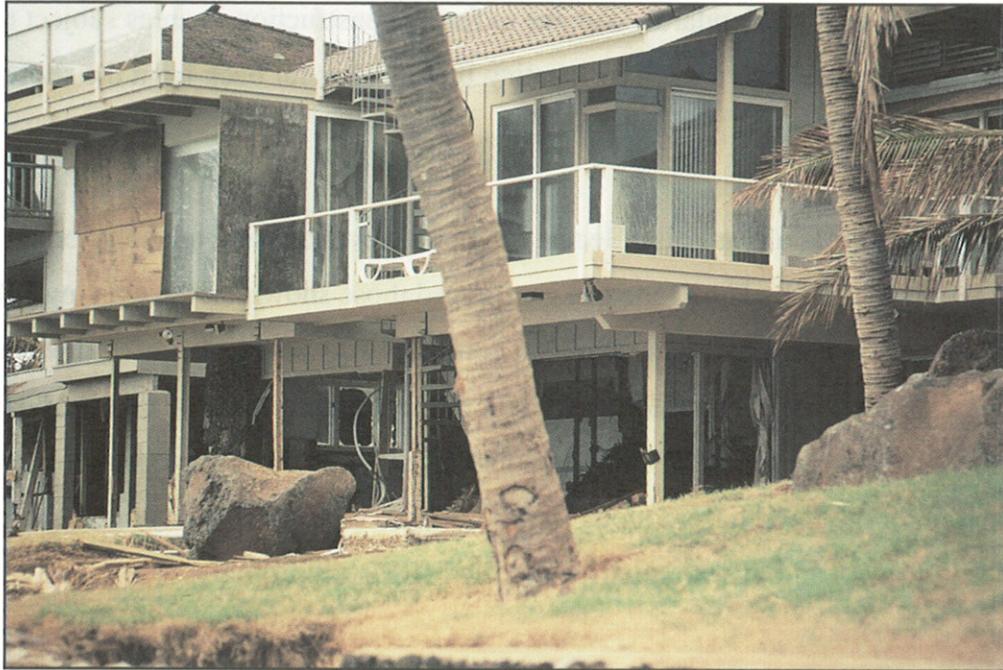
Where foundations of multi-story or split-level residential buildings were not undermined, the lower areas were significantly damaged, but the upper levels suffered less damage (FIGURE 19). For condominiums and hotels with engineered foundations and shear-wall construction, the architectural components of the ground-level units were completely gutted by wave forces (FIGURE 20), while second-story units experienced no flood damage. These examples further attest to the prudence of elevating buildings above the flood hazard.

FIGURE 19. *Non-elevated buildings at Poipu Beach. Lower area gutted; upper area suffered much less flood damage. Note transported lava rock debris, which can cause additional damage.*

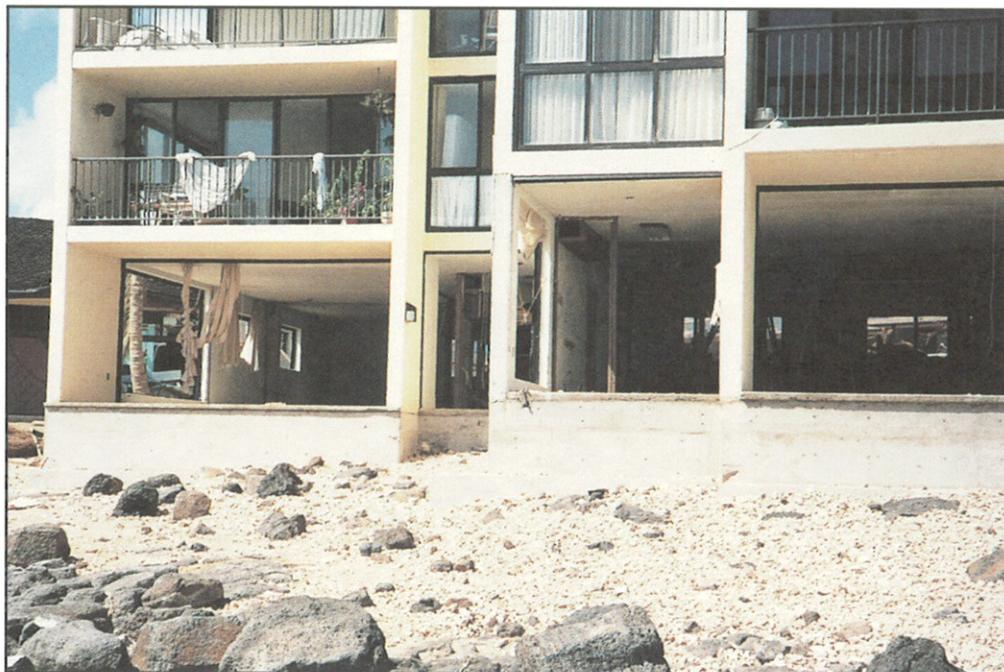
FIGURE 20. *Typical non-elevated condominium or hotel. Interiors of lower units destroyed; upper units suffered considerably less flood damage. Elevating a building's lowest floor and keeping lower areas clear to allow passage of velocity water can significantly reduce future flood damage.*
