2.0 SITE OBSERVATIONS

2.2 OBSERVATIONS OF WIND-RELATED DAMAGES

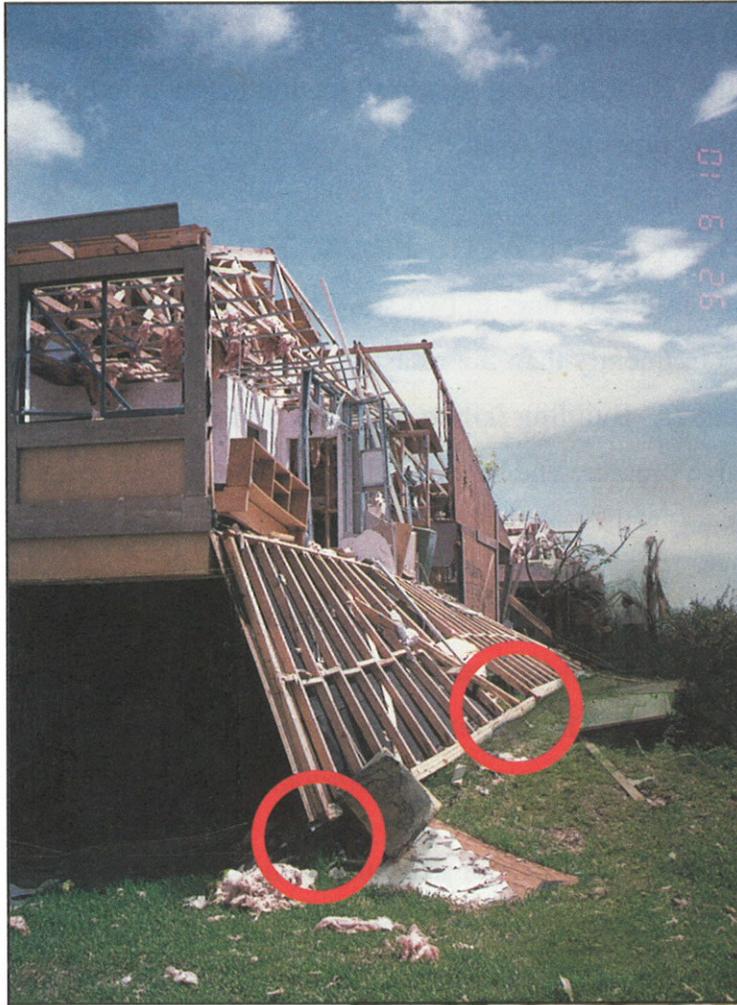
An absence of or improper installation of framing connections, load transfer straps, or bracing from non-loadbearing walls to connecting wall and roof components was noted. This condition contributed significantly to the primary failure of the framing system (SEE FIGURES 4 AND 5).

FIGURE 4.
Exterior wood-frame non-loadbearing wall. Transfer of wind forces from wall to adjoining structure was not sufficient.

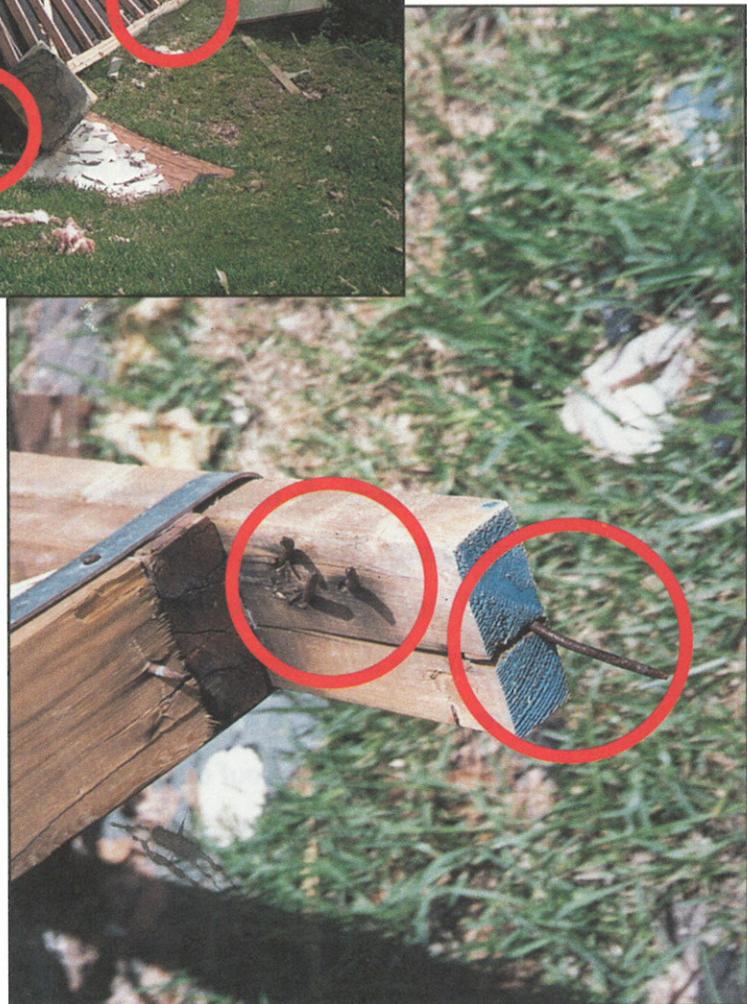
FIGURE 5.
End of exterior non-loadbearing wall top plate. Transfer of forces on entire wall depended on a limited number of nails.

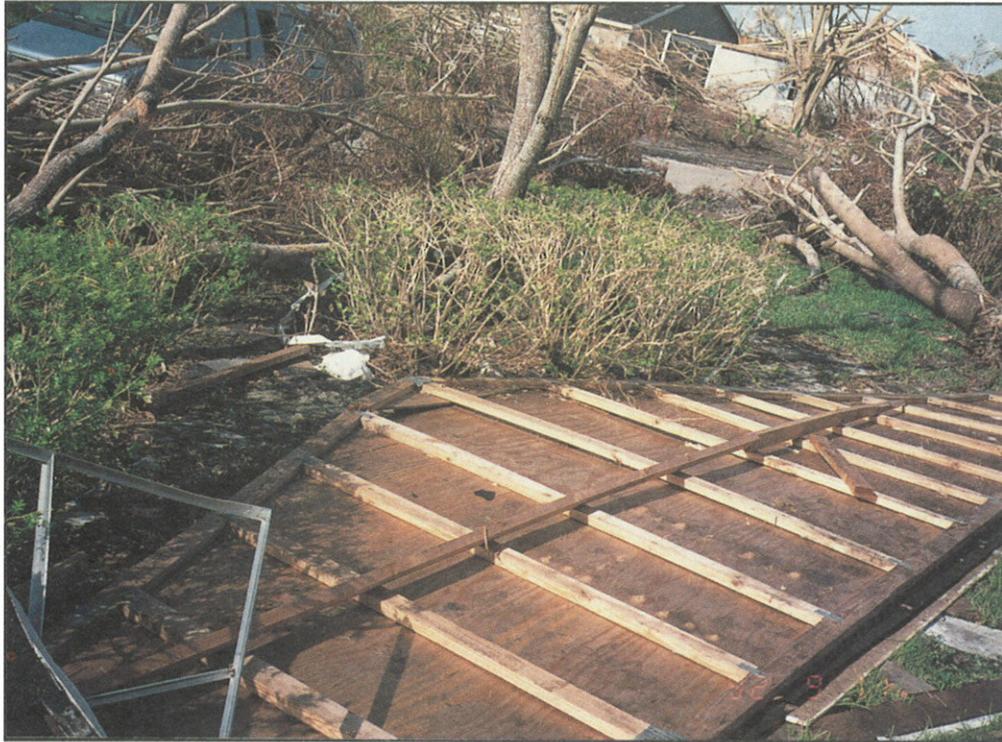
The wood-frame gable ends of roof structures were found to be especially failure-prone. Wood-frame gable ends are effectively a vertical continuation of windward/leeward wall systems and require bracing from within the roof structure for lateral force resistance. A lack of an adequately defined load transfer path for the gable ends was evident. Bracing of the wood-frame gable ends was not performed with the consistency and completeness required to effectively resist and transfer the wind loads in the absence of roof sheathing. This indicates a lack of a clear understanding of the gable sections’ importance to the integrity of the overall structural system during a wind storm by those responsible for the design and construction of such systems. (SEE FIGURES 6 AND 7). The reliance on plywood sheathing to act as the sole stiffener of the roof diaphragm left buildings susceptible to structural damage from roof truss collapse when sheathing separated from the roof trusses.

FIGURE 6. *Entire wood gable separation. Bracing connection, if completed, may have prevented this from occurring.*

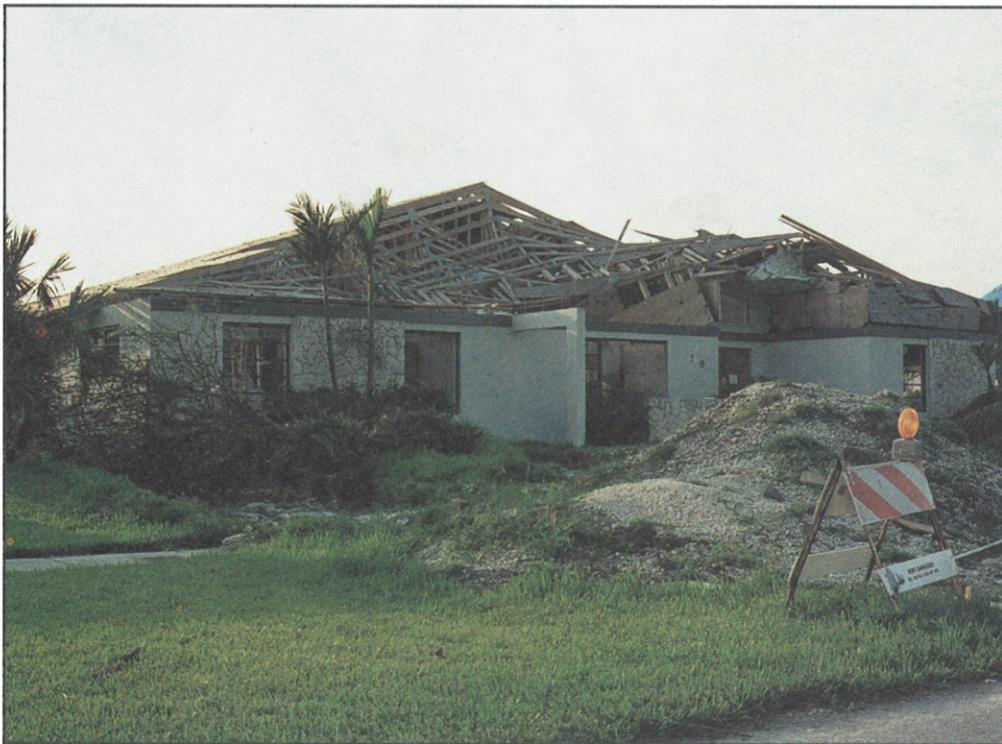
FIGURE 7. *Typical gable failure. Inadequate bracing support and ridge blocking evident in inward collapse.*

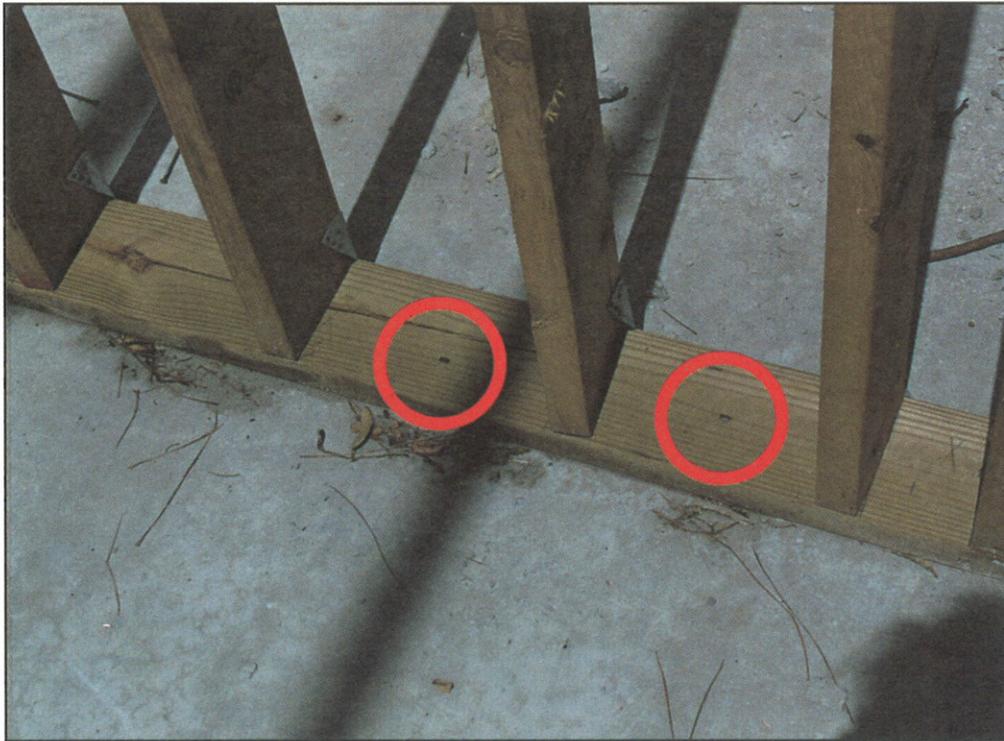
Individual structural members were observed to have been built and connected without adequate attention to design and construction details. Deficiencies included improper sill-to-masonry and sill-to-concrete foundation connections (SEE FIGURE 8), unbraced stud-columns, inadequate connections between exterior and interior shear walls (SEE FIGURE 9), and faulty spliced wall top-plate systems (SEE FIGURE 10). These deficiencies compromised the integrity of entire wall and roof systems.

FIGURE 8. *Bolts not used in sill plate. Cut nails had no capacity to prevent pullout.*

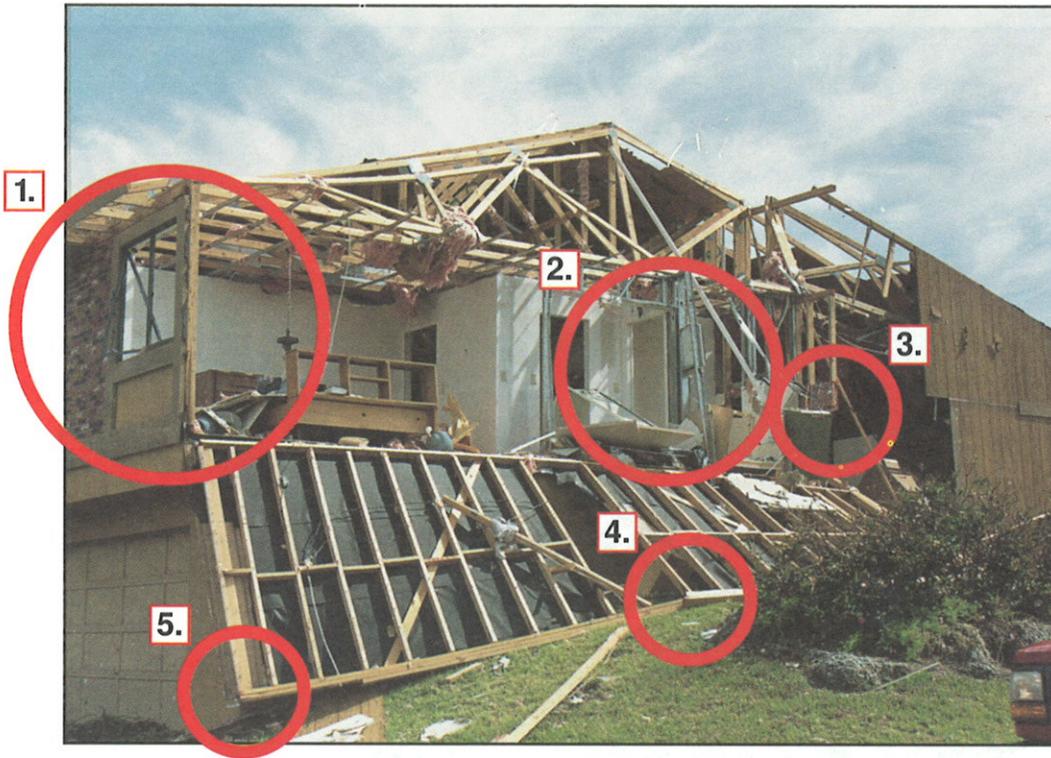
FIGURE 9. *Failure of non-loadbearing wall. Connections of exterior wall were not adequate.*

- 1. End column separated from roof.*
- 2. Load transfer from outside wall to interior shear wall inadequate.*
- 3. Beam separated from beam seat/connector.*
- 4. Improperly spliced composite tie-beam/connector.*
- 5. End of top plate connection inadequate.*

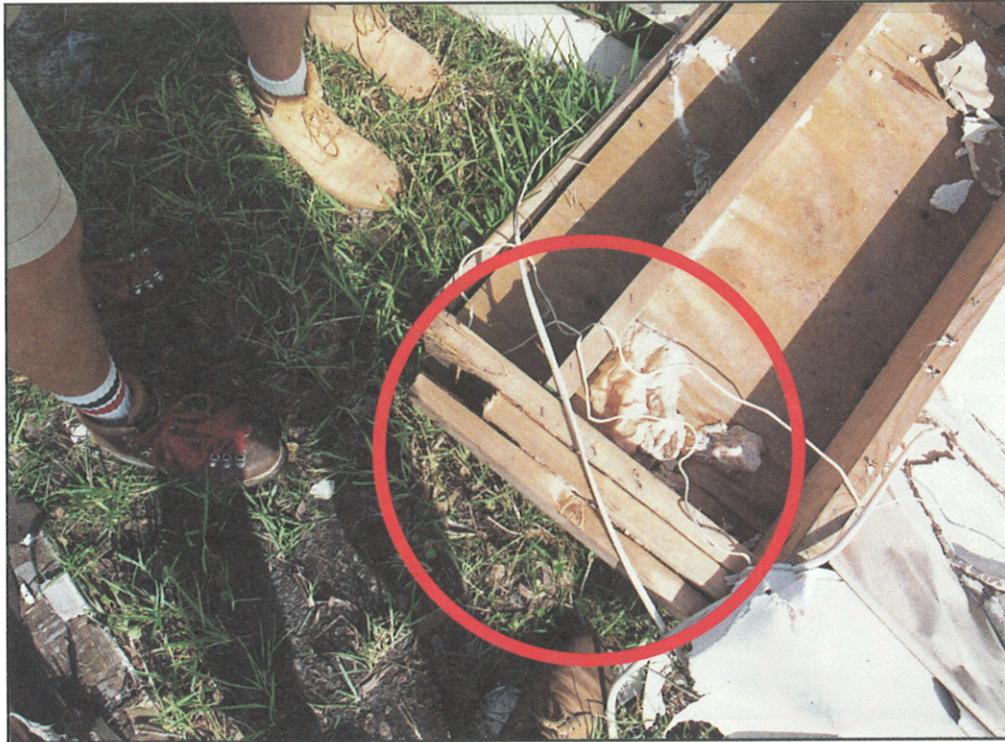
FIGURE 10. *Top plate splice not able to transfer horizontal loads.*

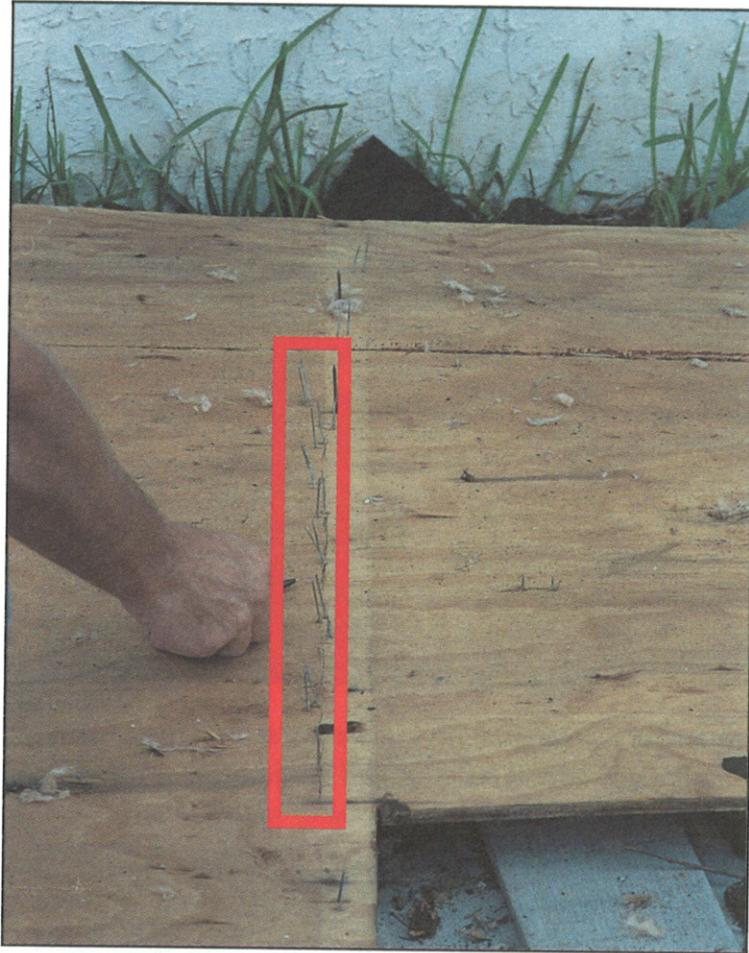
The roof framing systems observed were composed typically of prefabricated light wood trusses and plywood sheathing. While the trusses were found to have performed well under the wind forces, the connection of the sheathing (which forms the horizontal diaphragm of the building system) to the trusses was inadequate. Substandard workmanship in the anchoring of sheathing to trusses (by either improper stapling or improper nailing) was evident (SEE FIGURE 11).

FIGURE 11.
Roof sheathing found in debris. Staples were off-line and therefore not connected to supporting truss top chord.

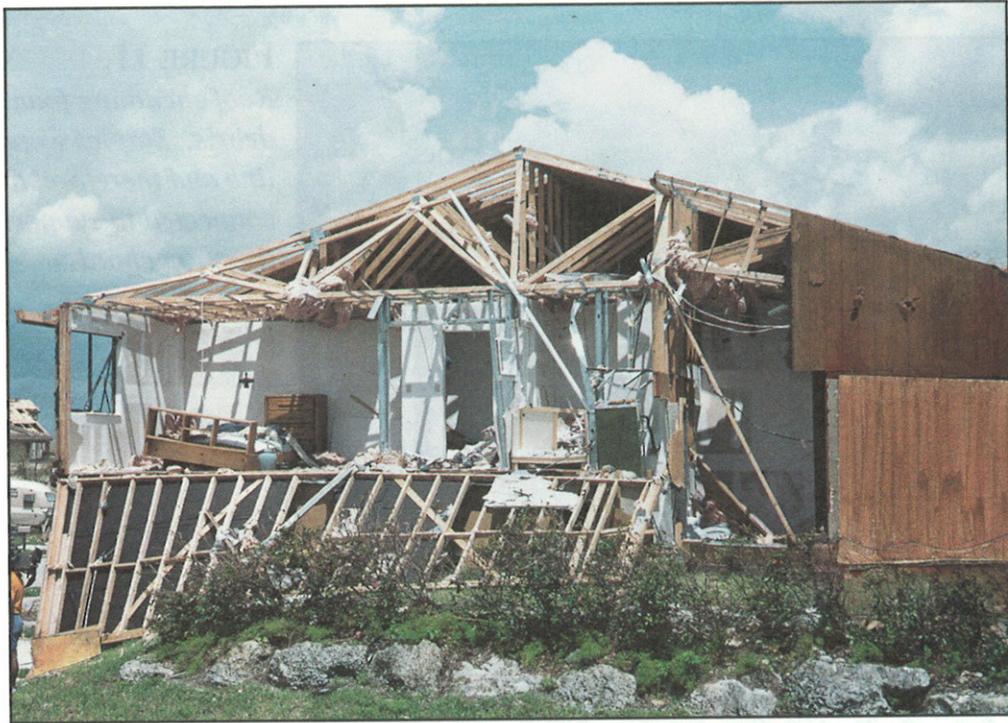
The lack of adequate truss bridging, improper system-wide lateral bracing, inadequate cross-bracing at end trusses, and the lack of stiffening of gable ends were determined to have compromised the integrity of the structural roof systems. It is the opinion of the assessment team that reliance on sheathing for truss-roof bracing, and the corresponding loss of the sheathing, was a major cause of the total damage of the building systems. (SEE FIGURES 12, 13, AND 14.)

FIGURE 12. *End wall failure of typical first floor masonry/second floor wood-frame building. Truss bridging and lateral bracing, and adequately installed roof sheathing, would have greatly reduced the likelihood of such a failure.*

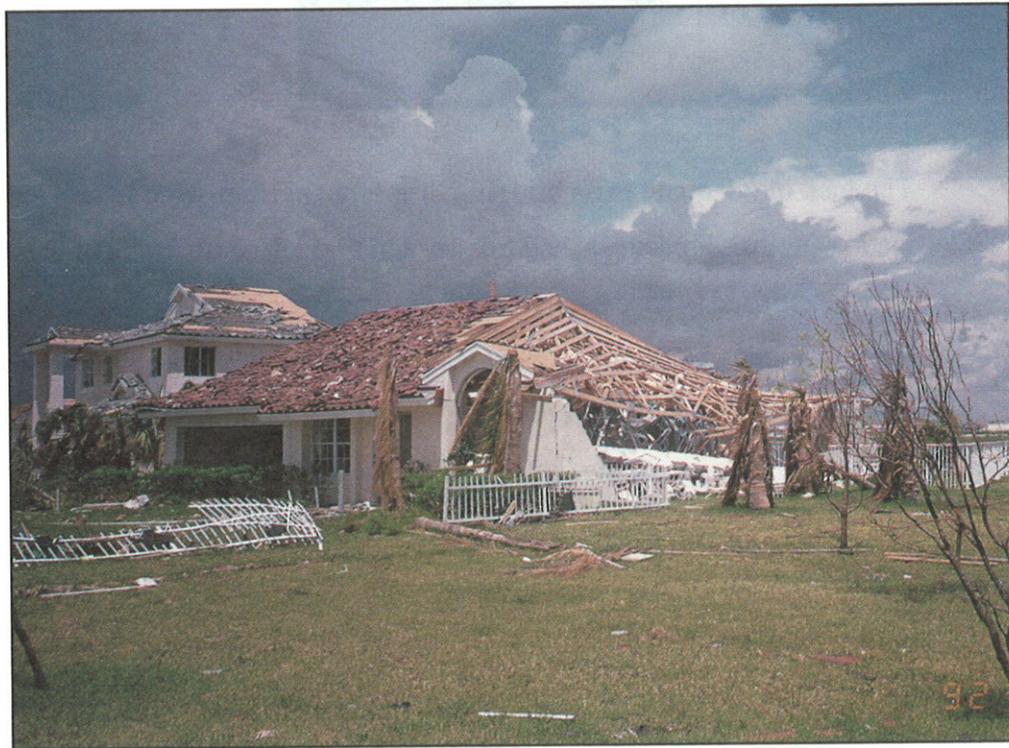
FIGURE 13. *Roof structure failure due to inadequate bracing.*

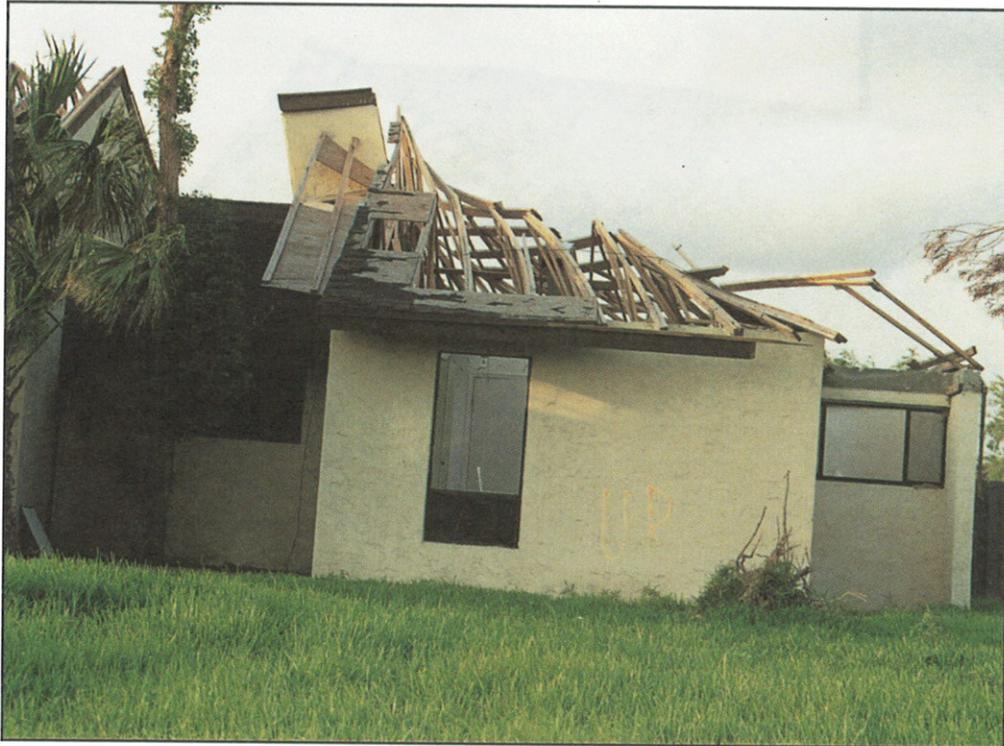
FIGURE 14. *Roof structure failure due to inadequate bracing.*

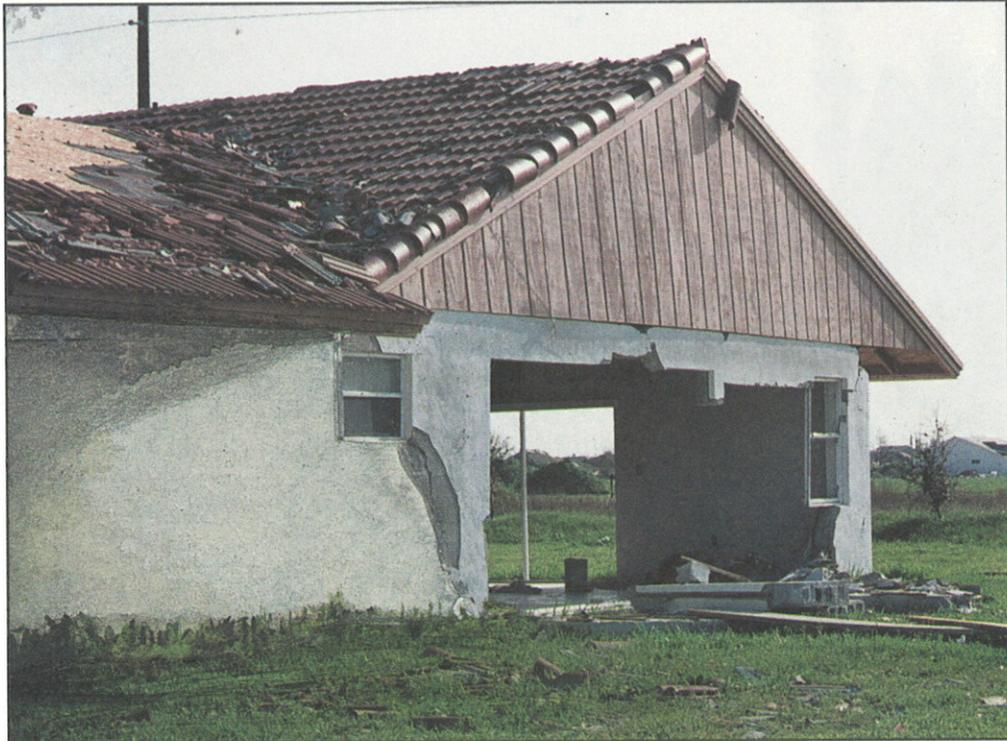
The main cause of failure of masonry buildings was a lack of vertical wall reinforcing (SEE FIGURE 15). Typically, concrete block and stucco (CBS) systems performed much better than all-wood-frame construction. This was due primarily to the heavier mass of the masonry walls and the tendency of a continuously constructed system to be less prone to failure from a lack of attention to design and construction details.

FIGURE 15. *Masonry construction building. Wall separated from building envelope due to inadequate vertical wall reinforcing in connection to horizontal tie-beam.*

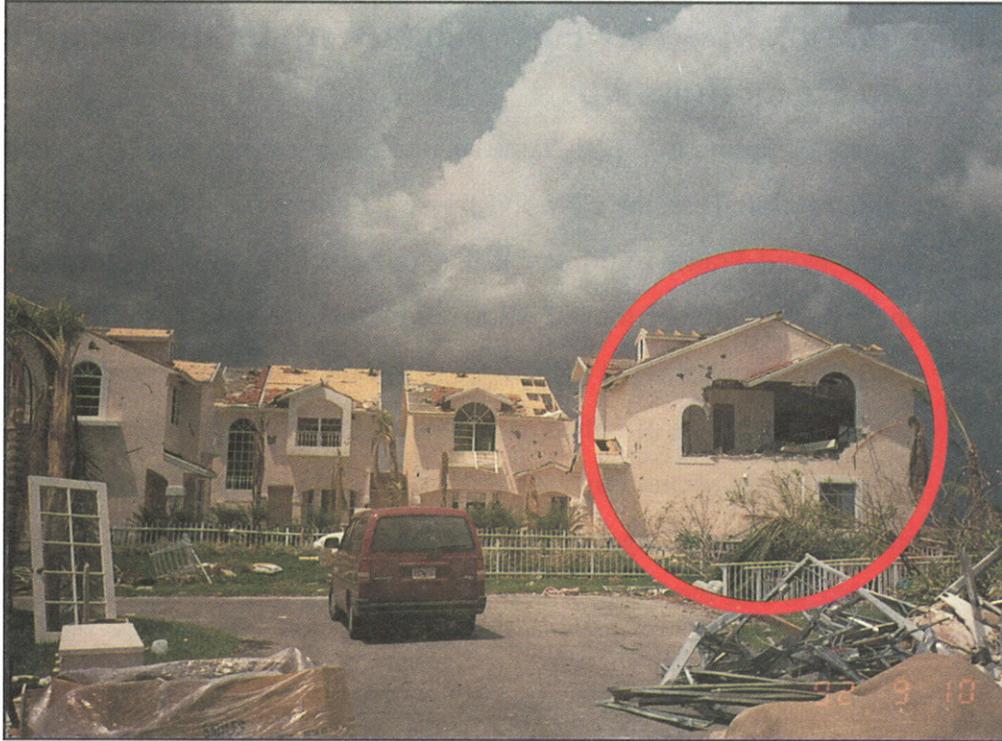
Where failures of the buildings did occur, the following conditions were observed: poor mortar joints between wall and monolithic slab pours; lack of tie-beams (SEE FIGURE 16), horizontal reinforcing, tie columns, and tie-anchors; and misplaced or missing hurricane straps between walls and roof structure.

FIGURE 16. Two-story masonry buildings. Lack of continuous tie-beam led to failure of wall that was already weakened in design by window openings.

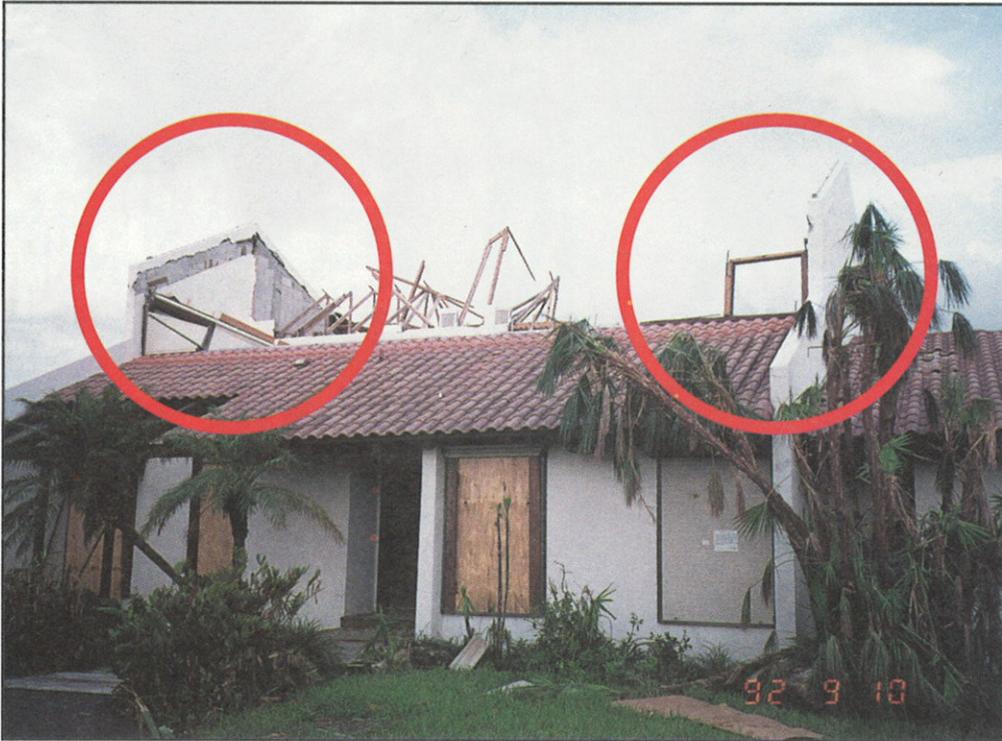
Discontinuous second-story CBS walls (typical firewall design) were prone to failure at their connecting edges and suffered separation from various building envelopes. Improved wall performance through continuous CBS construction was observed in the performance of gable ends that were CBS-constructed (SEE FIGURE 17).

FIGURE 17. Two-story masonry building. While forces were sufficient to blow off entire roof structure, continuous masonry gables held.

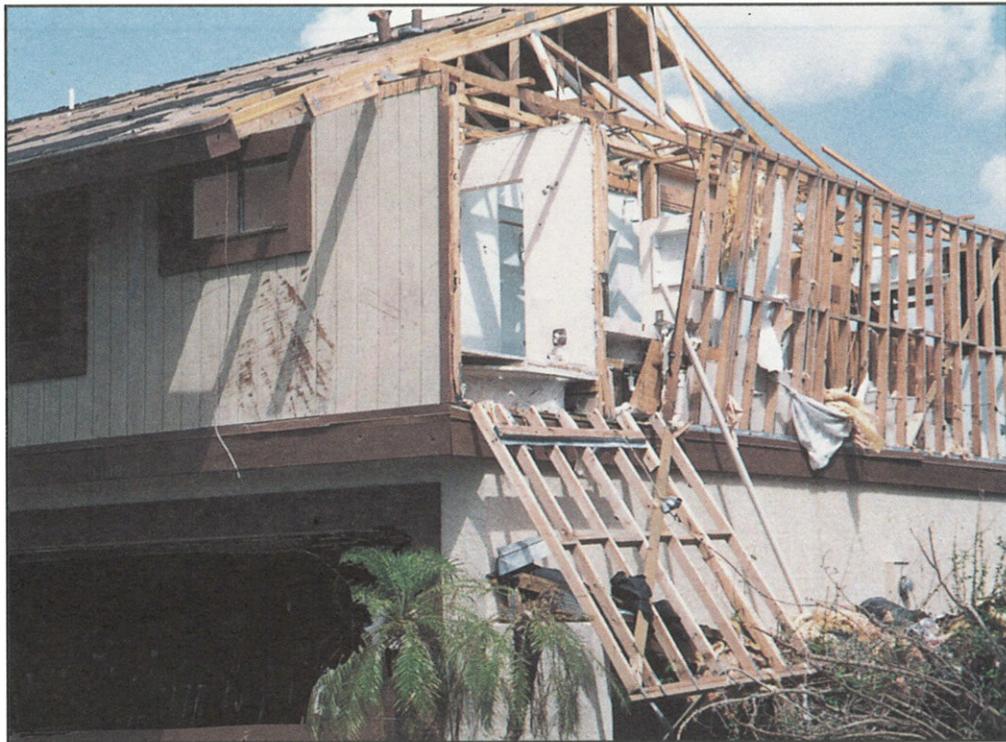
Typically, failure of wood-frame second floor systems was observed to be similar to failure of the all-wood-frame buildings (see “One- to Two-Story Light Wood-Frame Buildings”). The failure of the wood-frame gable ends, the failure of connections of wood sill plates to first-story CBS walls, and inadequate anchoring of sole plates to masonry were observed. Where sufficient numbers of bolted anchors may have been provided, some of the bolts were not secured by nuts and washers. In many instances, the use of unapproved anchoring methods (e.g., cut nails) was observed. (SEE FIGURE 18.) (ALSO SEE FIGURE 8, WHICH SHOWS A SILL PLATE CONNECTED TO A CONCRETE FOUNDATION WITH CUT NAILS.)

FIGURE 18. *Second story wood framing (on first story masonry). End gable and wall failure.*

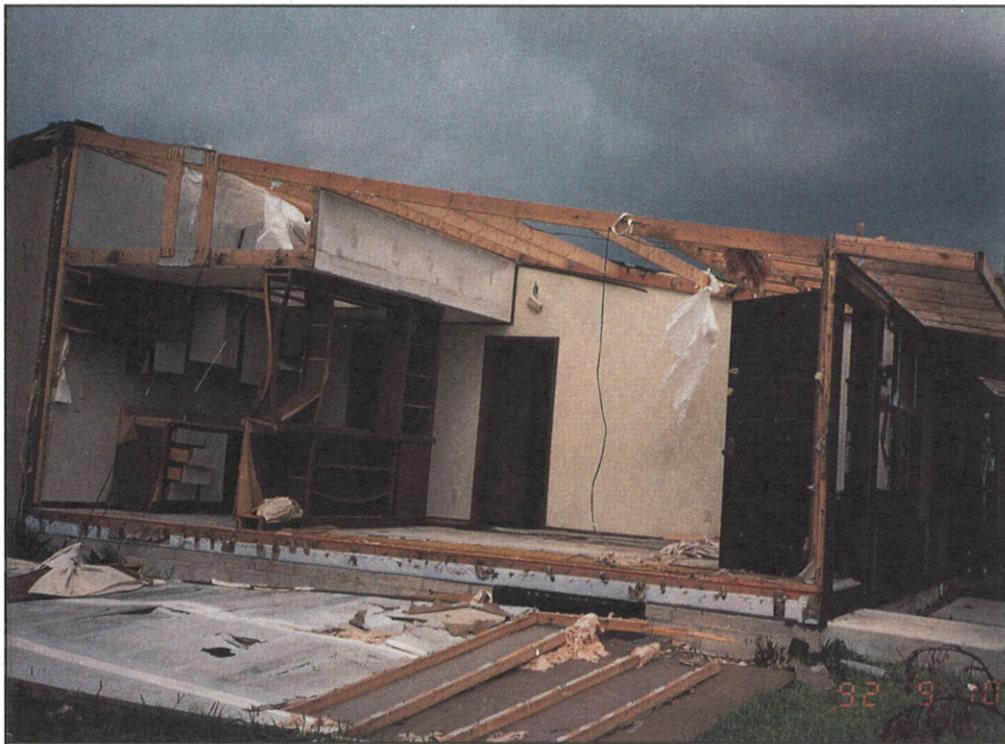
Two end-wall (end wall of end modules) failures were observed in a modular home subdivision. Poor connection of the tops of the walls to the roof diaphragms was evident in these instances. Some roof sheathing was observed missing from rafters, judged to be due either to building envelope breach (window and/or door failure) or to external wind and debris. Generally, the rafters themselves were left entirely intact, because of the inherent rigidity developed by the relatively short spans and secure connections. (SEE FIGURES 19 AND 20.)

FIGURE 19. *Modular home. End wall of end unit separated from unit; withdrawal of nails along eave line and roof sheathing failure were also observed.*

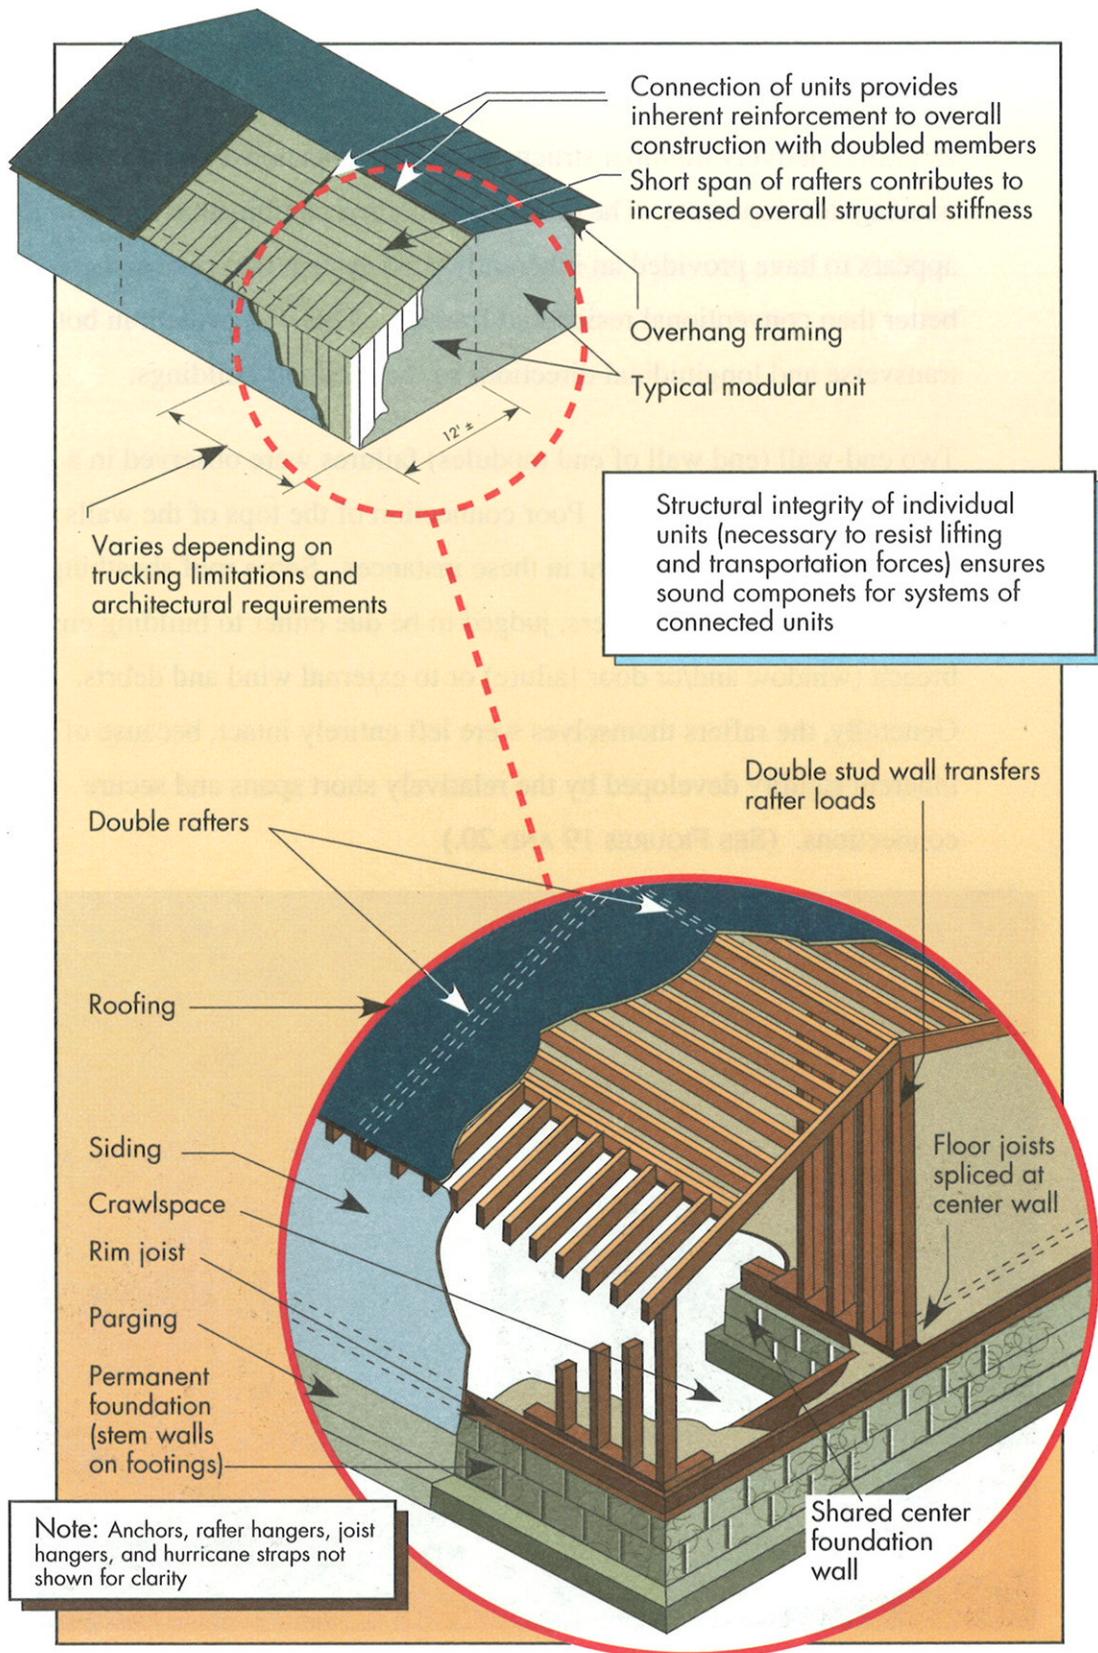
FIGURE 20. *Inherent structural strength of modular construction.*

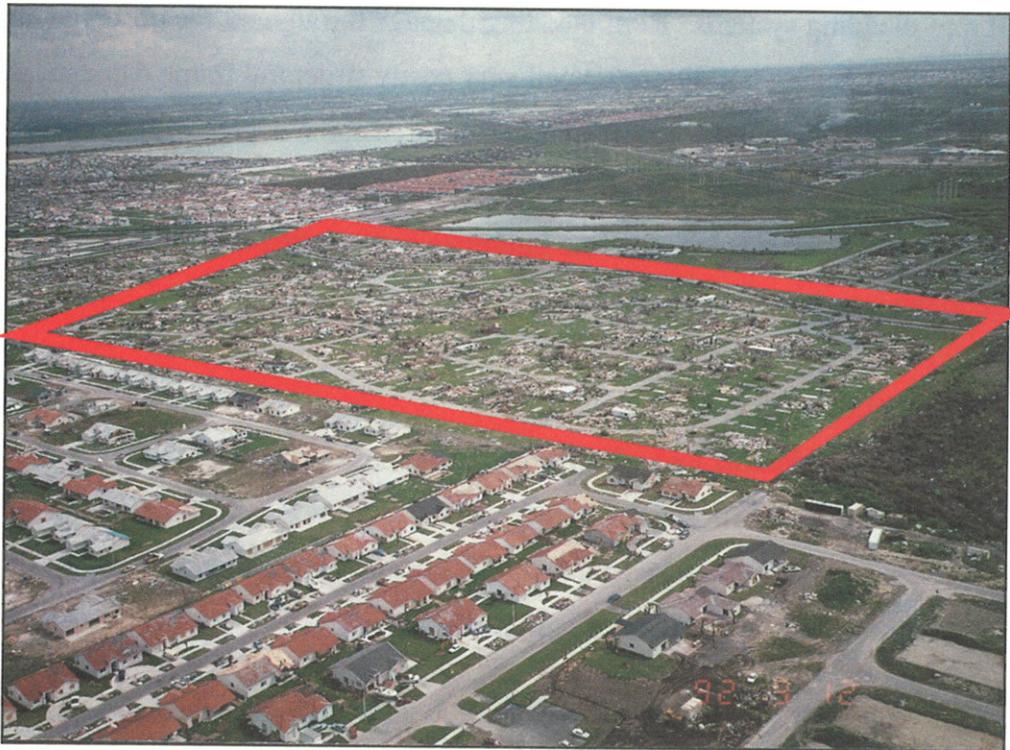
Manufactured homes possessed poor ability to withstand the high wind loads generated by Hurricane Andrew (SEE FIGURE 21). In several subdivisions, many of these homes suffered total losses.

FIGURE 21. Aerial photo of damage area. Shows building performance difference between manufactured homes (outlined in center) and conventional residential buildings (lower left).

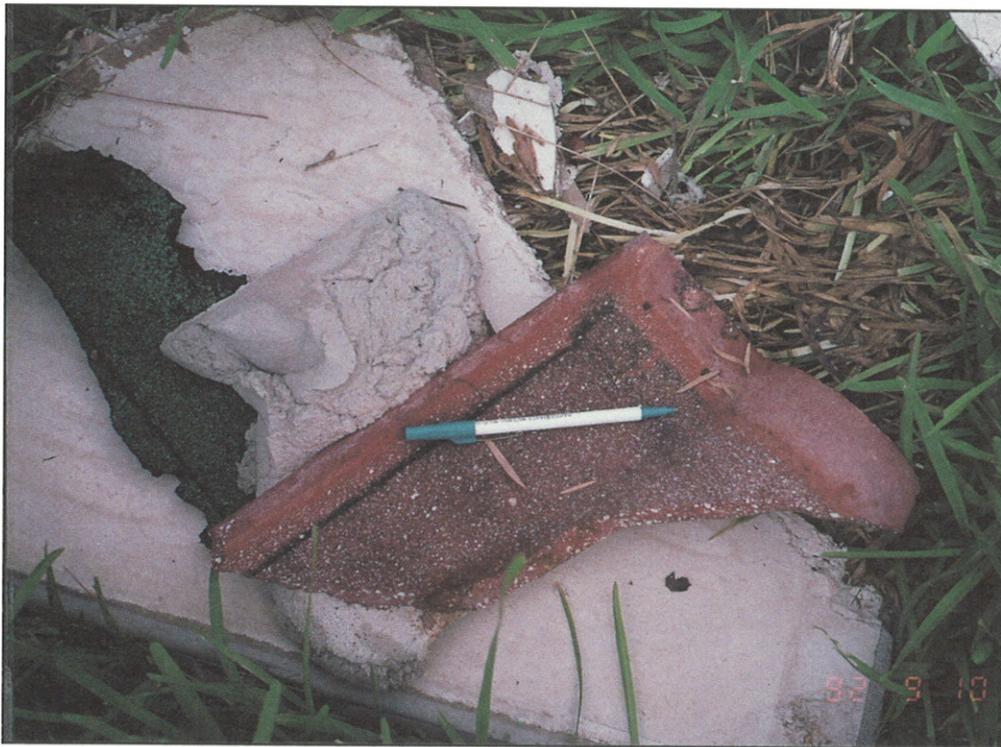
In general, the assessment team observed a failure of both the nailing and/or mortar connections that are integral to the attachment of precast and molded tile systems. A failure of the underlayment, lack of bond between underlayment and mortar, and lack of bond between mortar and tile were all observed (SEE FIGURES 22, 23, AND 24), although it appeared that lack of bond between the mortar and tile was the common cause of failure.

FIGURE 22. *Typical failure of roof sheathing-to-underlayment attachment. (Bond between underlayment and mortar pad, and between mortar pad and tile effective.)*

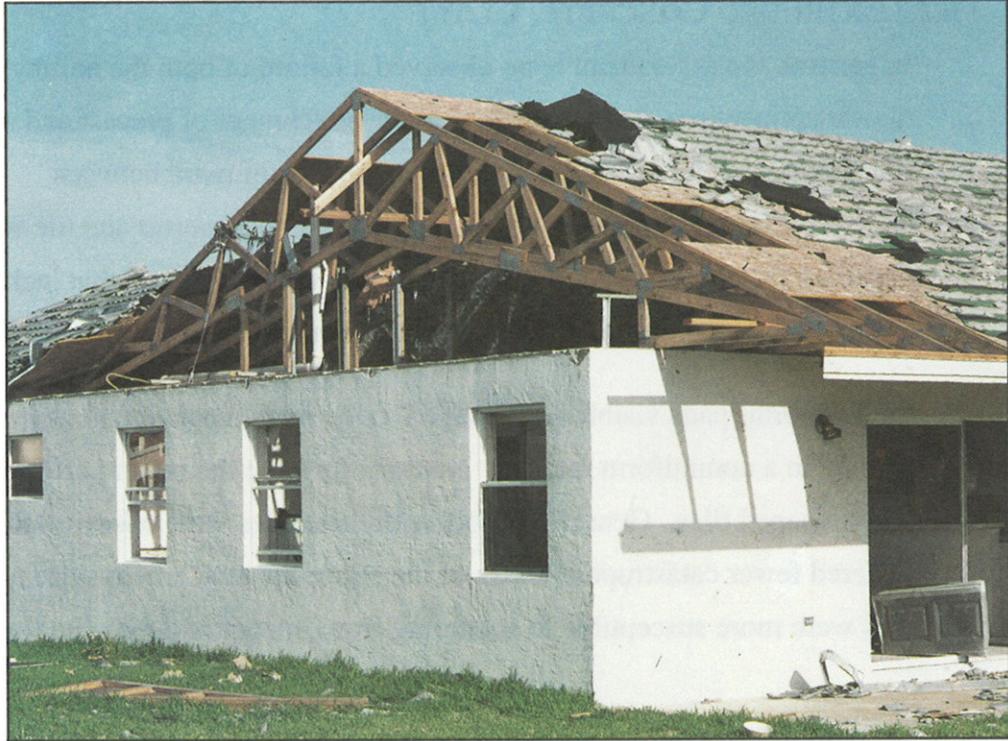
FIGURE 23. *Typical roofing failure. Failure of sheathing, underlayment, and extruded concrete tiles.*

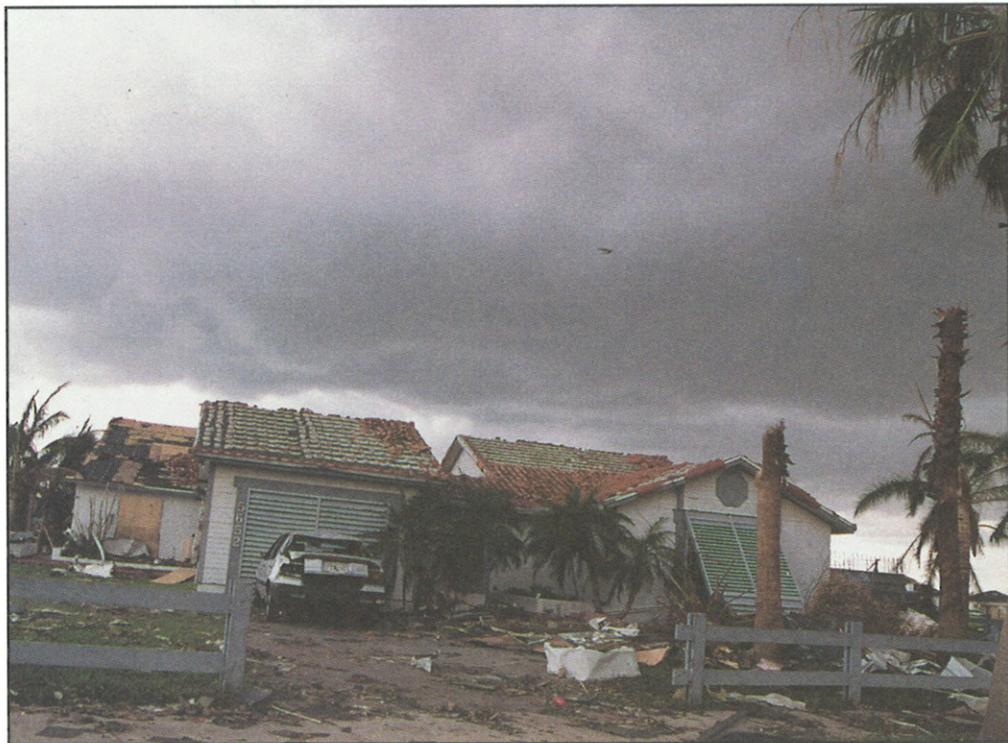
FIGURE 24. *Typical roofing failure. Failure between tiles and mortar pads.*

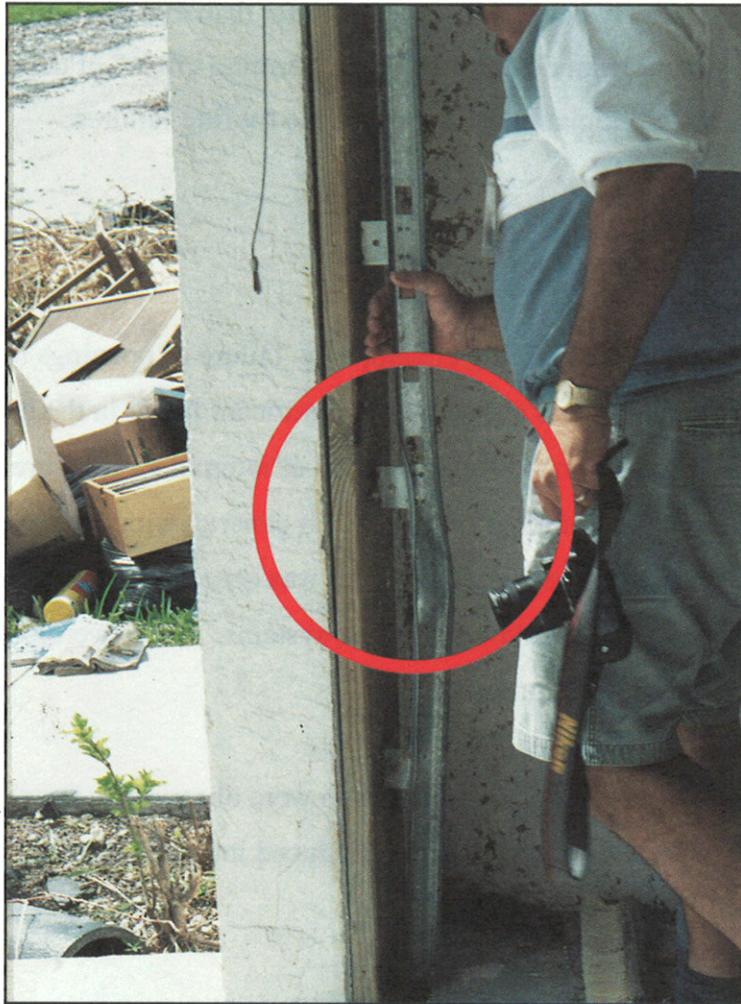
The failure of garage doors was determined to have promoted a great deal of damage to buildings. It appears that garage doors failed when the door deflection exceeded the amount allowed for in the manufacturer's design. The deflection of the doors caused excessive deformation of the entire assembly (panel rollup doors and glider wheel tracks) and ultimately the separation of the door from the opening. Excessive rotations of the tracks followed by pullout of the door pins and glider wheels from the track was the sequence of failure (SEE FIGURE 25). Loss of the doors resulted in an envelope breach and a sudden increase in internal pressures to the buildings.

FIGURE 25. *Garage door failure. Rotation of track, and pullout of brackets at wall support.*
