2 Site Observations

2.1 TYPICAL PRE-FIRM AND POST-FIRM CONSTRUCTION

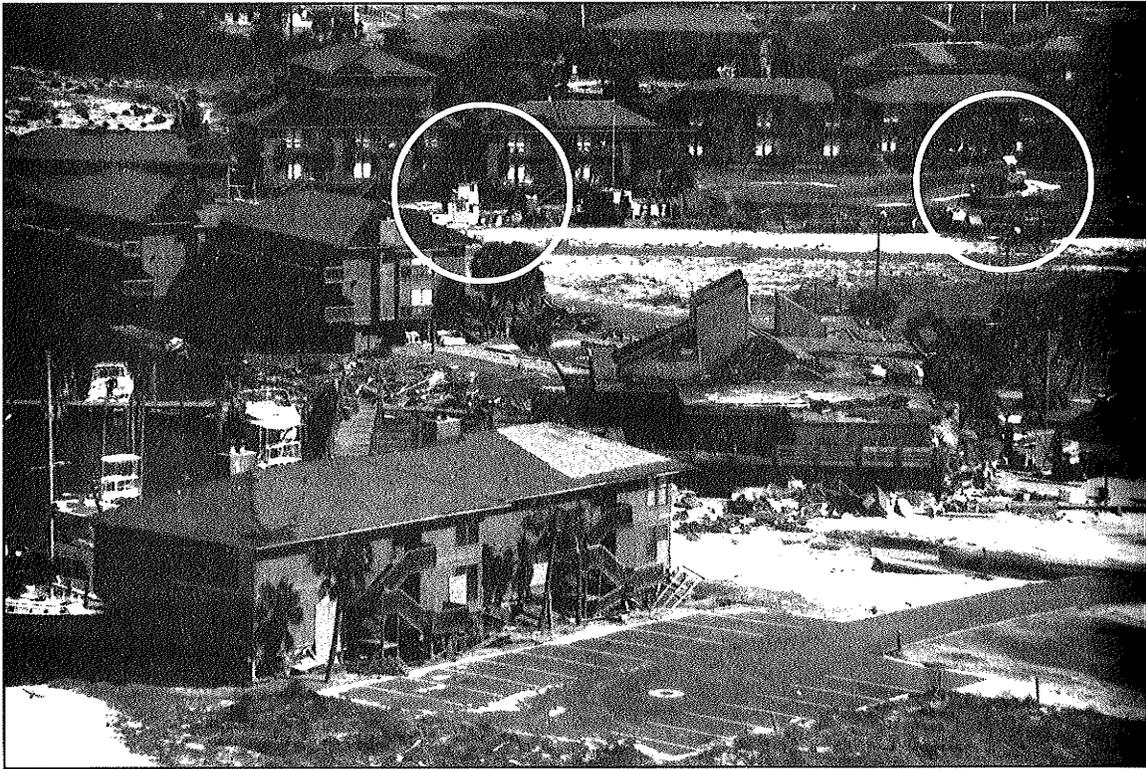
Flood damage was observed along the Gulf of Mexico shoreline at all sites visited by the BPAT (see Figures 2-1 and 2-2). Structures damaged by flood forces generally fell into the following categories:

Figure 2-1 Debris washed inland as a result of surge action from Hurricane Opal (note circled boats).

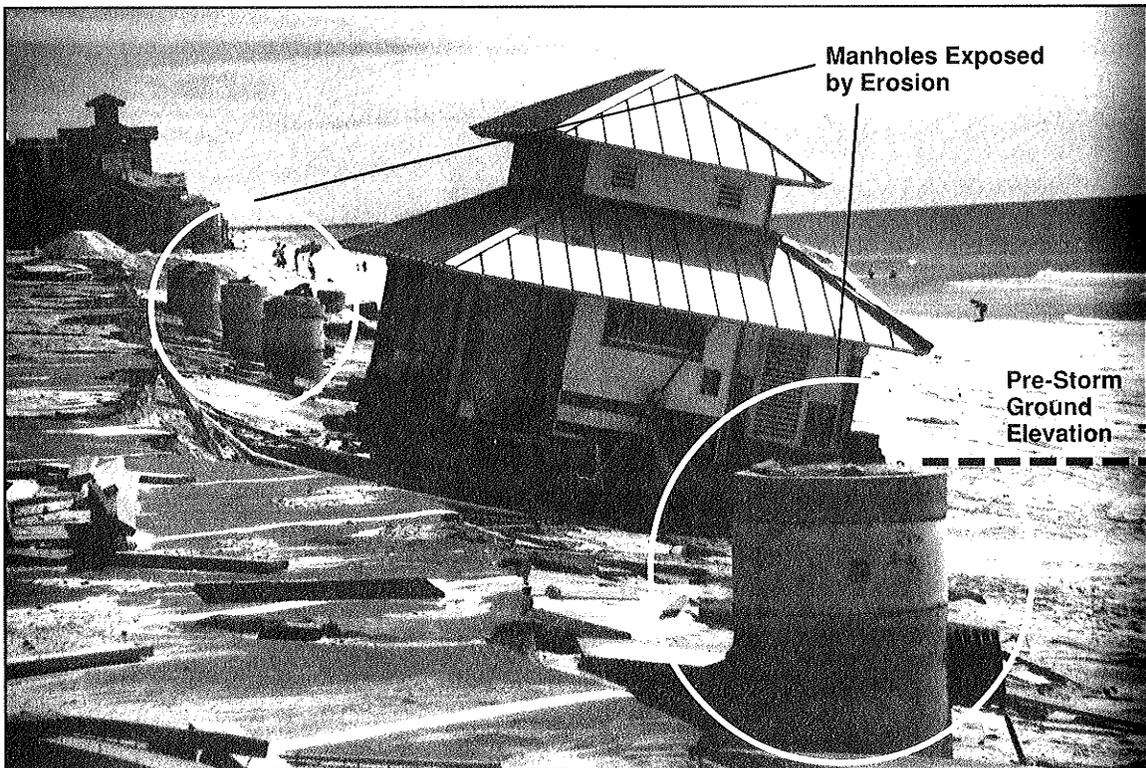
Figure 2-2 Beach erosion caused major damage to structures, as well as roads and utilities.

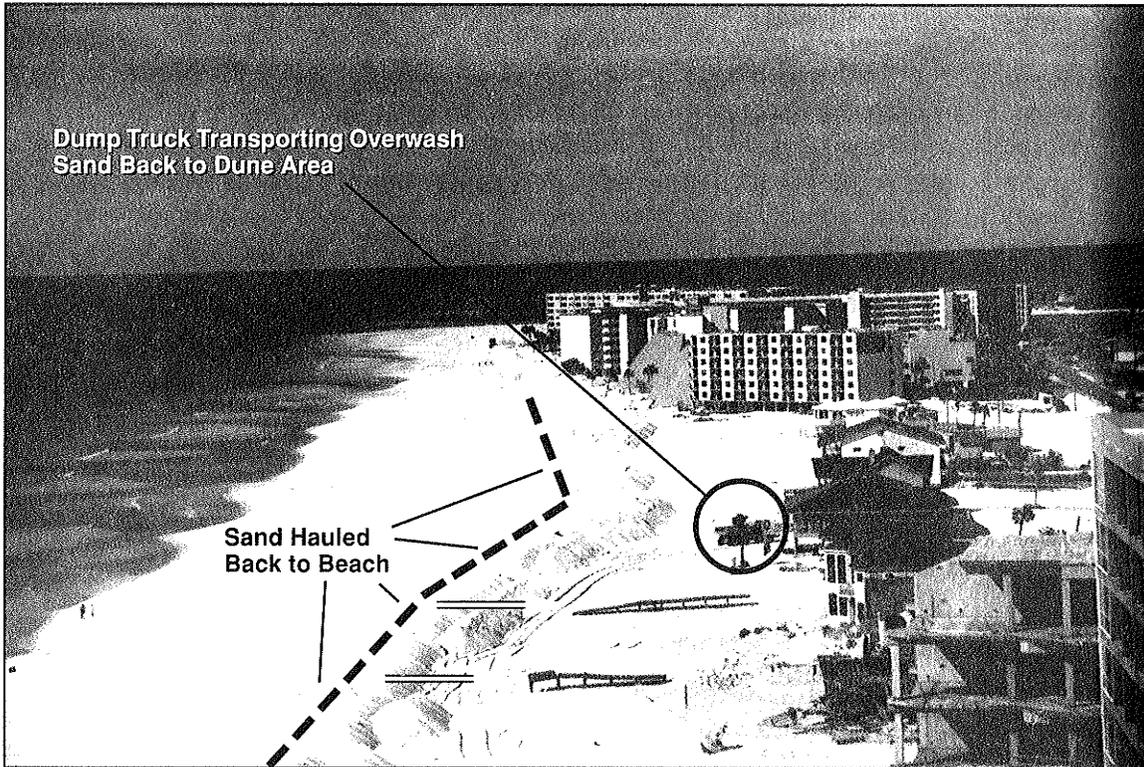
Where sand dunes existed before Hurricane Opal, significant loss of dune height and width was observed. Many dunes were breached or flattened (see Figure 2-3). Those that remained after the storm were scarped and weakened. Duneface retreat of 75 feet to 100 feet was observed in several locations. Overwash of eroded dune sediments was common, sometimes extending over 500 feet inland and causing burial of roads and at-grade construction by 1 to 4 feet of sand.

Figure 2-3 Beach erosion eliminated protection for structures. It is important that the beach and dunes be rebuilt as soon as possible. Arrows point to walkways used to traverse dune that has been washed away.

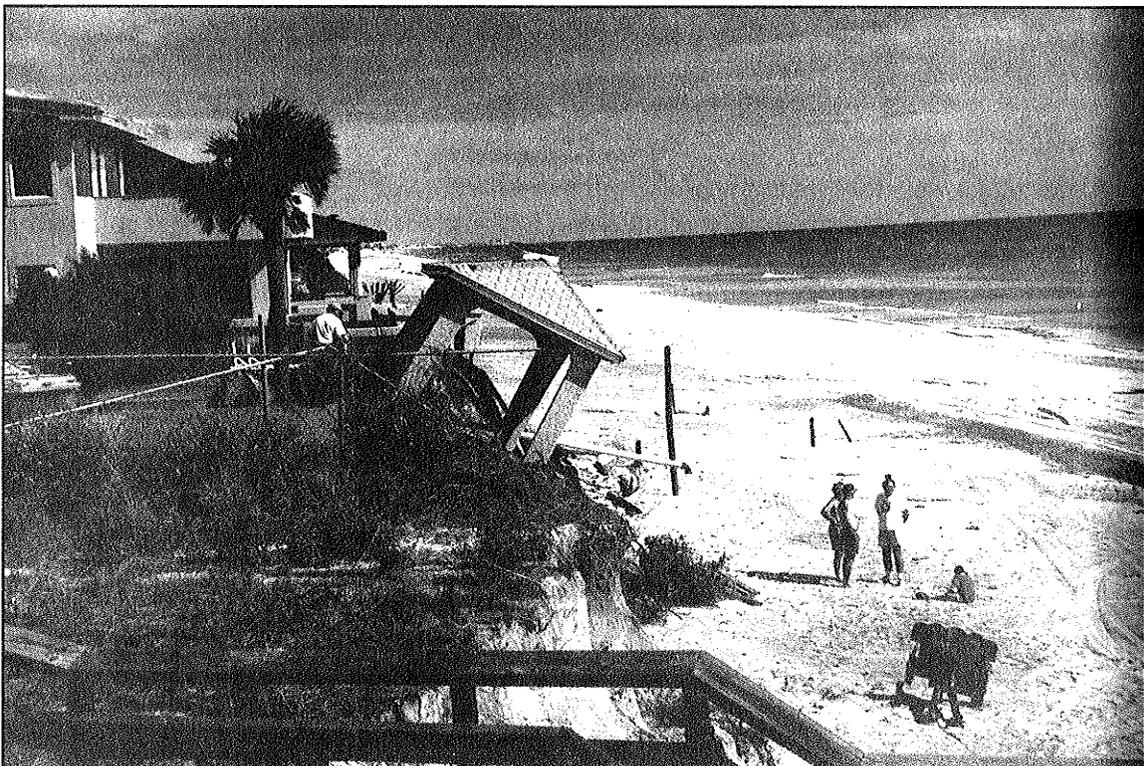
In some cases, an estimated 10 to 20 feet of vertical relief was lost at the seaward edge of high dune and bluff areas. Many structures atop high dunes or bluffs collapsed because of a loss of support, either from the undermining of slab foundations or from inadequate pile embedment (see Figure 2-4).

Figure 2-4 Erosion such as this took place along the gulf coast, causing structures to be undermined and resulting in damage.

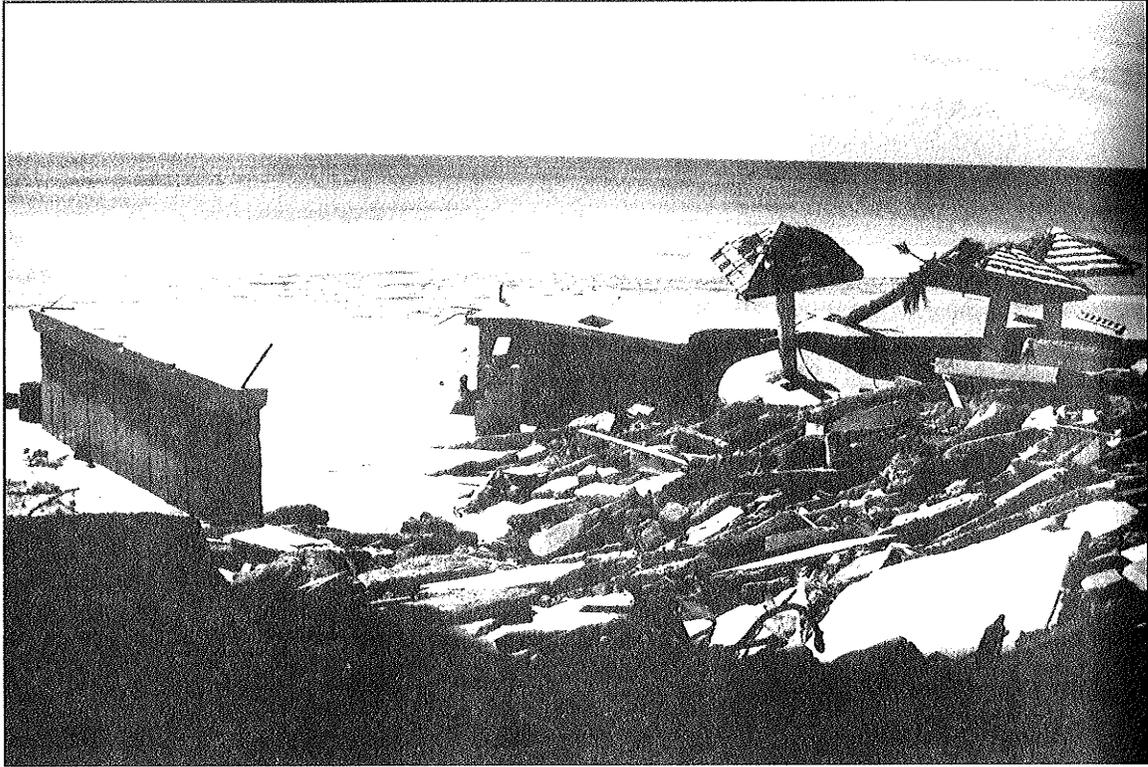
Small debris was widespread, ranging from household items to construction materials. These items did not cause structural damage to buildings, foundations, or other building components. Evidence of much larger debris shifted by floodwaters was also observed, including pier piles and braces, concrete slabs, dumpsters, automobiles, boats, and collapsed houses (see Figure 2-5). Many of these objects washed into buildings, and some caused structural damage.

Figure 2-5 Debris, consisting of broken concrete and wood framing systems, generated by surge action.

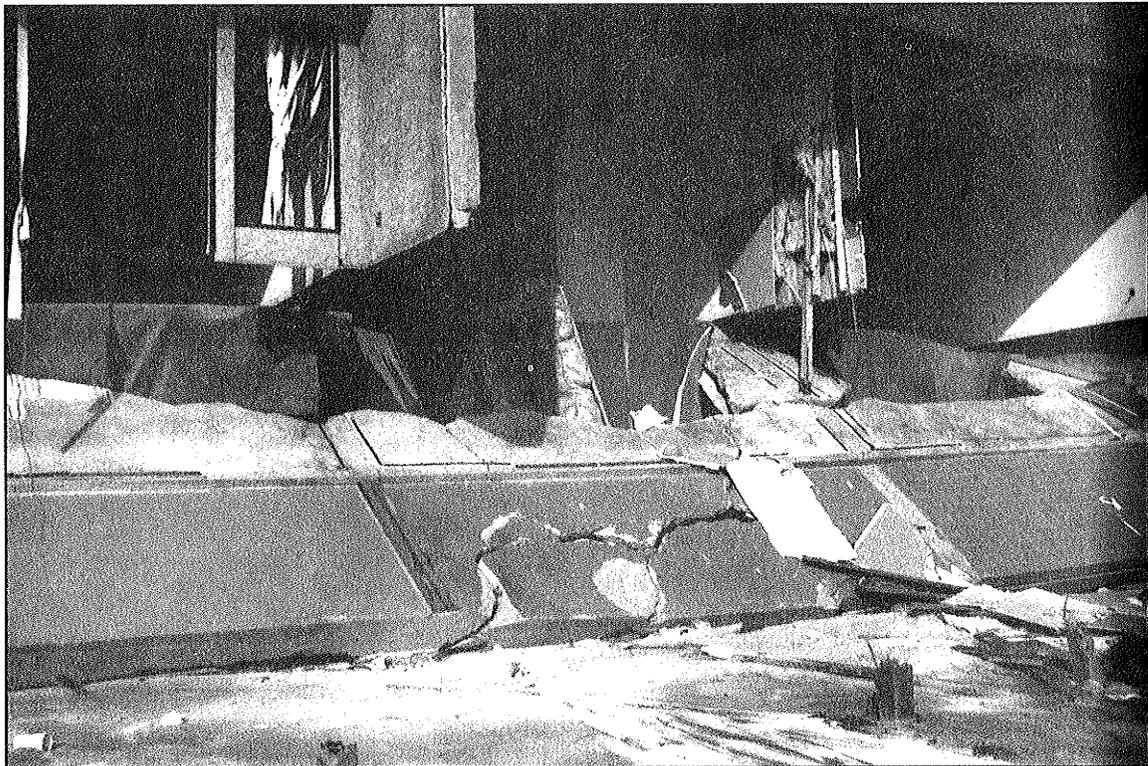
Many slab failures were noted in all types of structures (see Figure 2-6). The major reason for these failures was the loss of support coupled with a lack of reinforcing in the slabs. Welded reinforcing wire fabric was observed in many slabs but did not prevent failure of the slabs once they were undermined.

Figure 2-6 Undermining of concrete decks and floor slabs caused the failure of many unreinforced concrete structures.

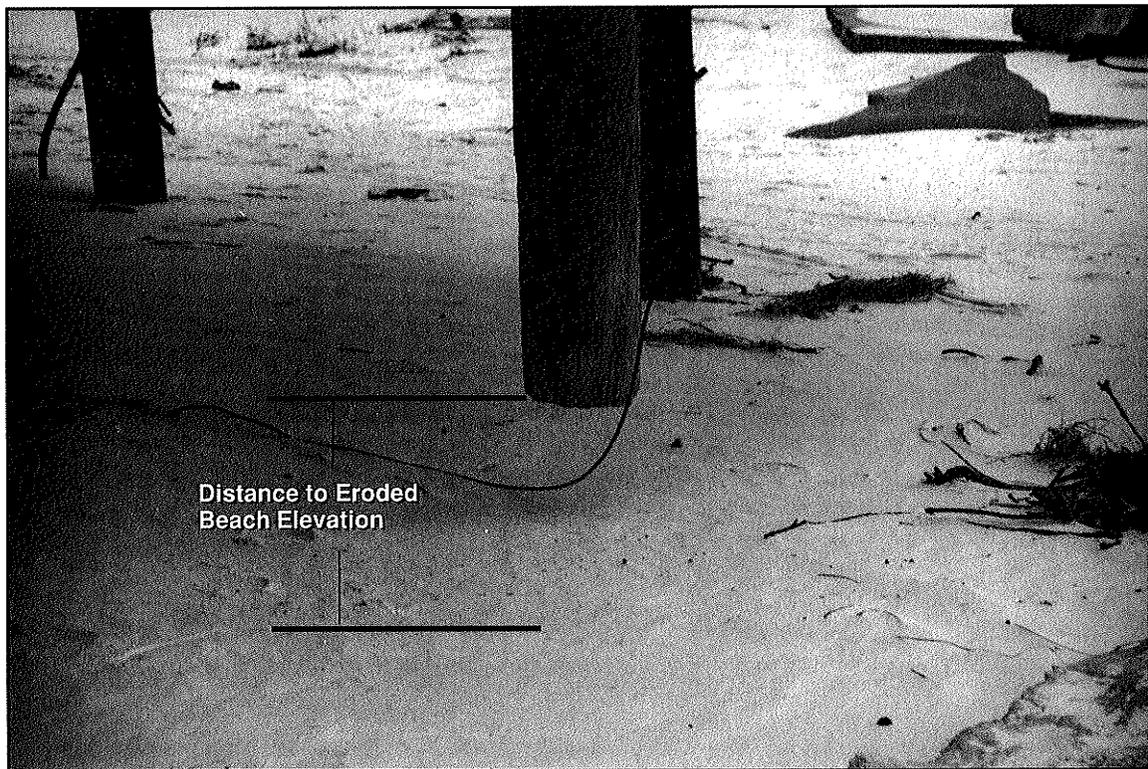
Three to seven feet of vertical erosion at the seaward row of piles was common (see Figure 2-7). This erosion, coupled with insufficient penetration of the piles on many structures, led to structural damage to or collapse of primarily pre-FIRM structures. Undersized piles (6-inch diameter timber in some instances) were not sufficient to resist storm forces; they generally failed and resulted in structural damage or collapse. Piers constructed of concrete blocks on shallow footings frequently collapsed as a result of erosion. Well-designed and well-constructed pile and pier foundations withstood the forces exerted by the storm. Use of splicing techniques was also observed on some eroded piles (see Figure 2-8). Although the splicing of piles placed these structures at increased risk of failure, no failures related to spliced piles were observed.

Figure 2-7 These piles were not embedded deep enough to survive the erosion of the sand. As a result, there is now a large gap between the bottoms of the pilings and the ground surface.

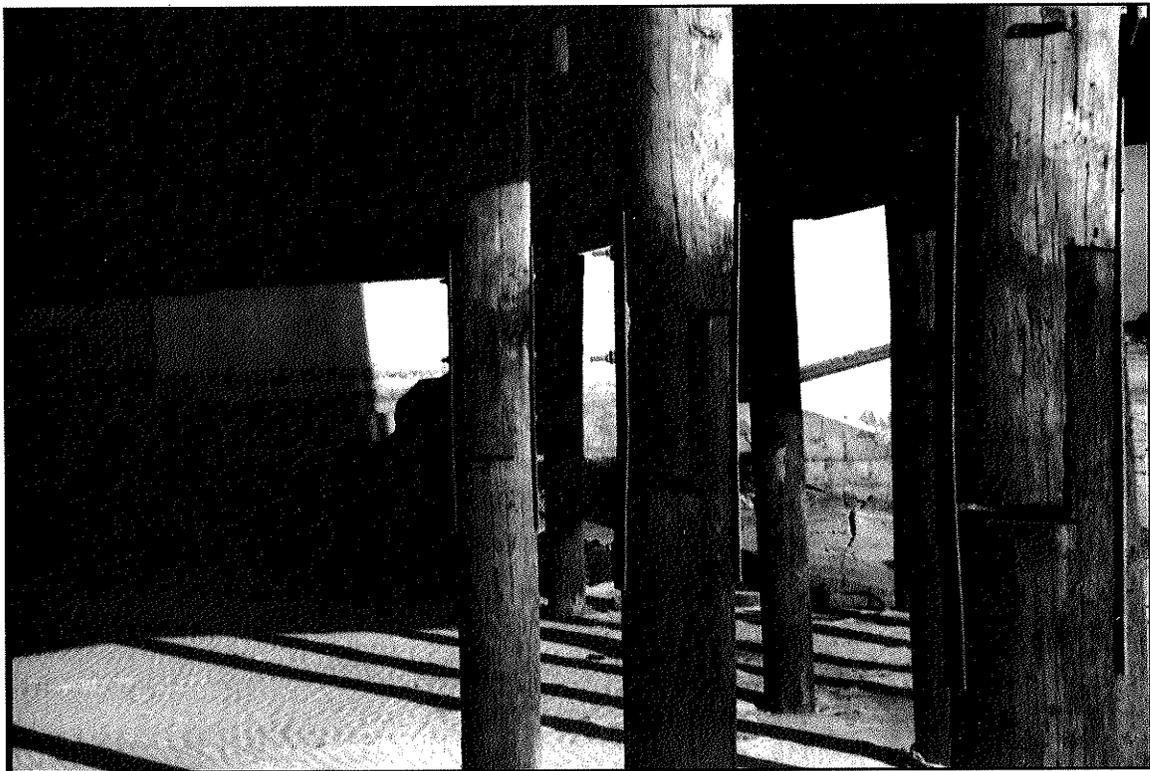
Figure 2-8 These piles were not long enough and were spliced to add depth. The splicing was exposed by storm-induced erosion.

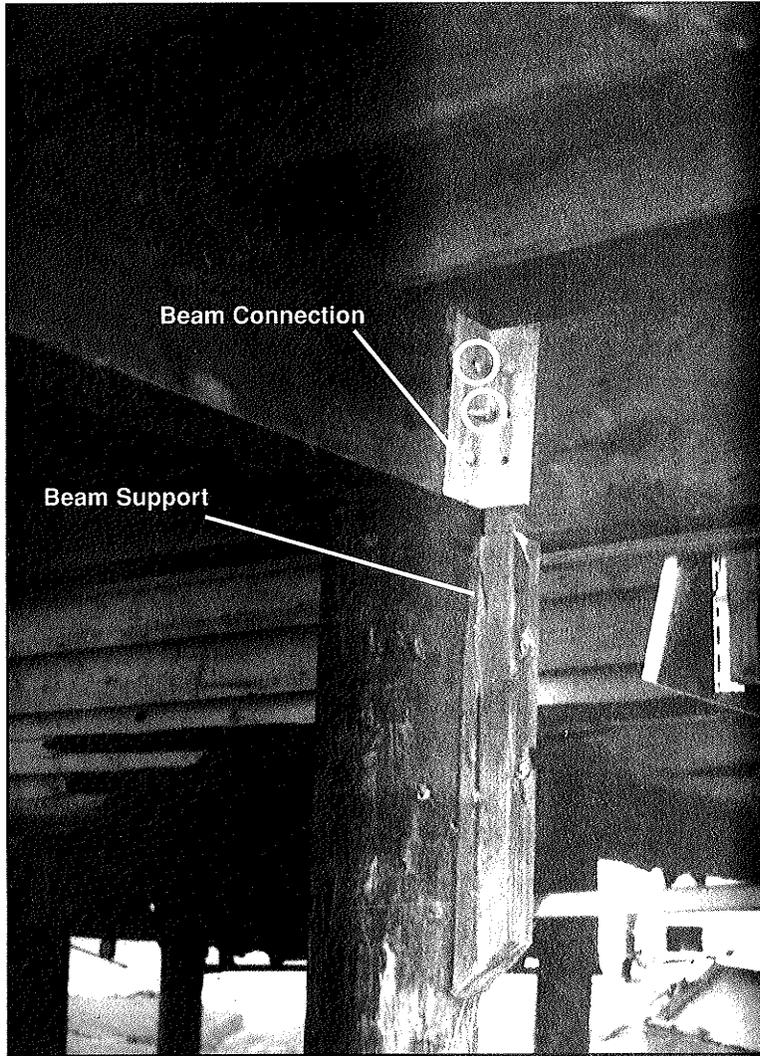
The BPAT observed some galvanized strap connectors between piles, beams and joists (in otherwise good condition) that failed as a result of insufficient nailing or because storm forces exceeded the design forces (see Figure 2-9). This was not a common mode of failure, however. The BPAT also found evidence that structural components had pulled away from one another when acted on simultaneously by flood and wind forces, despite the presence of the galvanized connectors. In some instances, foundation piles and beams were well-connected and withstood storm forces, while walls or upper structure components were poorly connected and were damaged or destroyed by wind forces, flood forces, or both.

*Figure 2-9
The floor beam connection and beam support shown here illustrate the lack of design and proper construction observed on many damaged structures. Note the bolt pullouts (circled). Also, the beam support is attached to the pile with lag bolts rather than bolts that extend through the pile.*

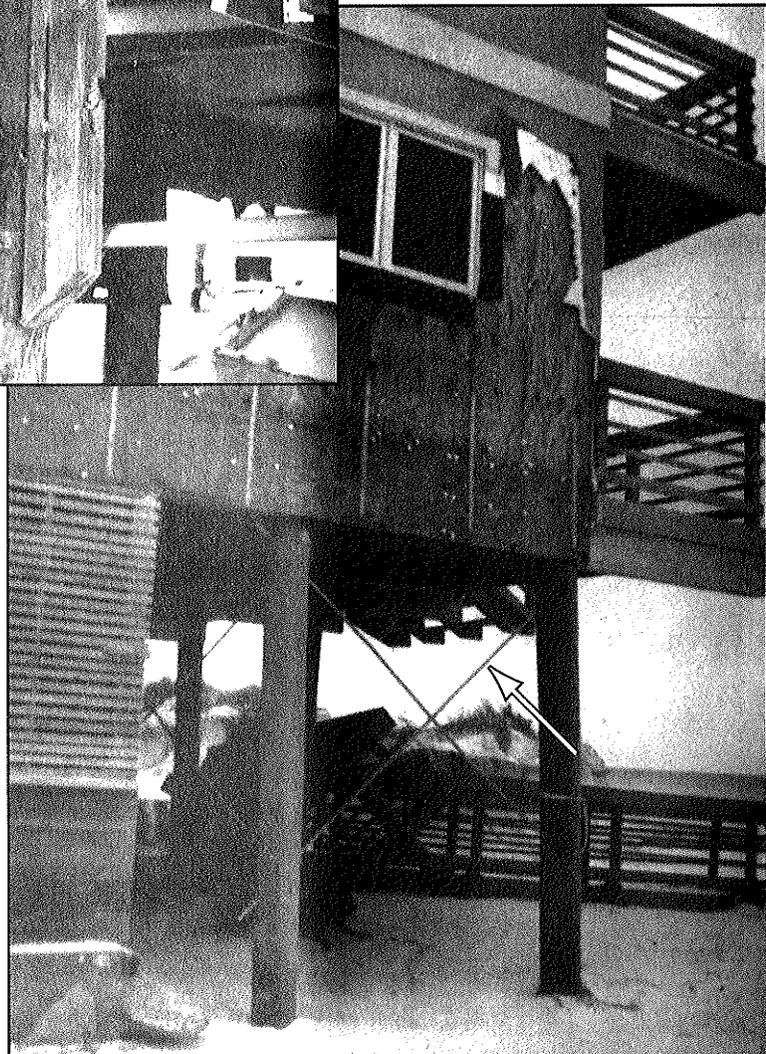
The use of 2 x 8 or similar timber cross-bracing between timber piles was common beneath elevated wood-frame structures. Some bracing failures were observed that were apparently due to horizontal loading from water, debris, or both. The use of threaded galvanized rods and turnbuckles as cross-bracing was less common (see Figure 2-10). No failures of this type of bracing

*Figure 2-10
This undamaged threaded rod & turnbuckle (arrow) cross-bracing continues to provide additional support as designed.*

were noted, but debris was trapped by the bracing, and in some instances, the rods were bent by lateral loads imposed by the force of flood waters acting on the trapped debris.

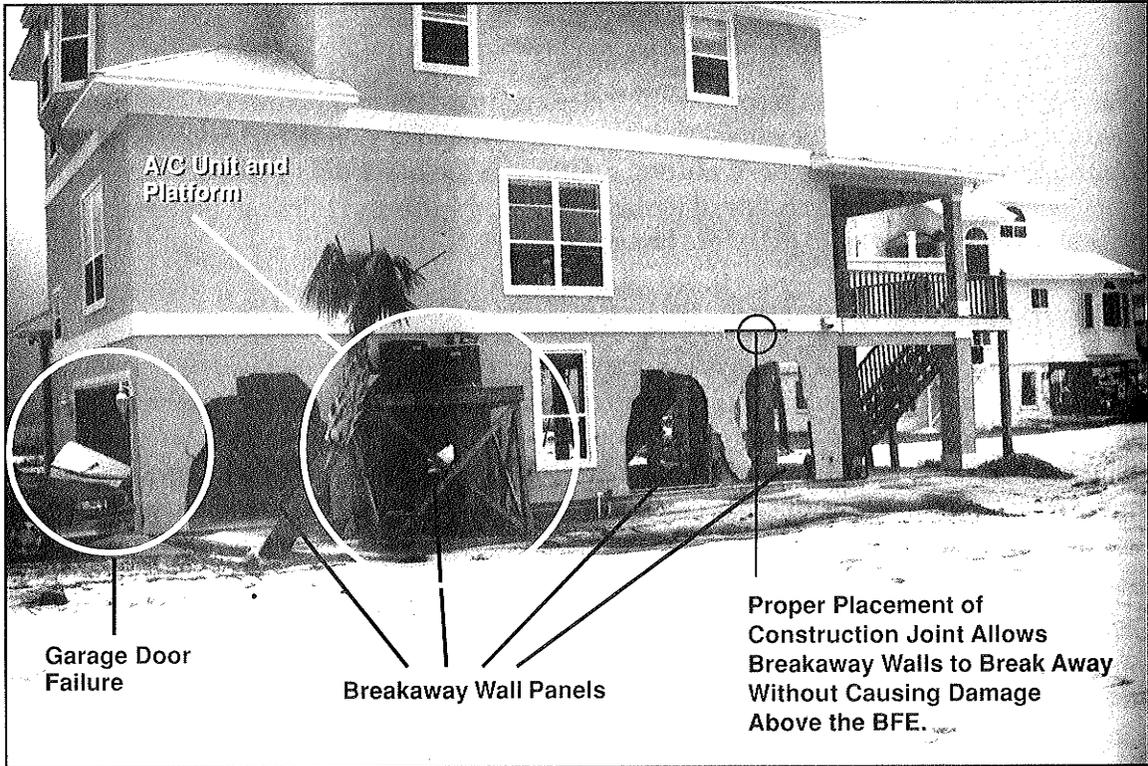
There were a number of damaged or destroyed enclosures below elevated structures (see Figure 2-11), many with electrical wiring attached to breakaway walls. The presence of breakaway walls indicates the designer was aware of potential flood impacts. However, the placement or attachment of utilities to breakaway walls below the elevated portions of the structures demonstrates, at a minimum, lack of awareness of local, CCCL, and NFIP regulations by owners or contractors, or possibly disregard of those regulations.

In some post-FIRM structures with breakaway walls below the lowest habitable floor, the walls broke away as intended but in doing so, damaged exterior sheathing and wall finishes above the lowest floor. The damage above the breakaway wall was usually minor but could have been prevented by better design and construction of this detail (as shown in Figure 2-11). Rolldown garage doors were damaged or destroyed in pre-FIRM and post-FIRM construction alike (see Figure 2-11).

Figure 2-11 *These breakaway walls functioned as designed, lessening the pressures of water, sand, and debris on the structure.*

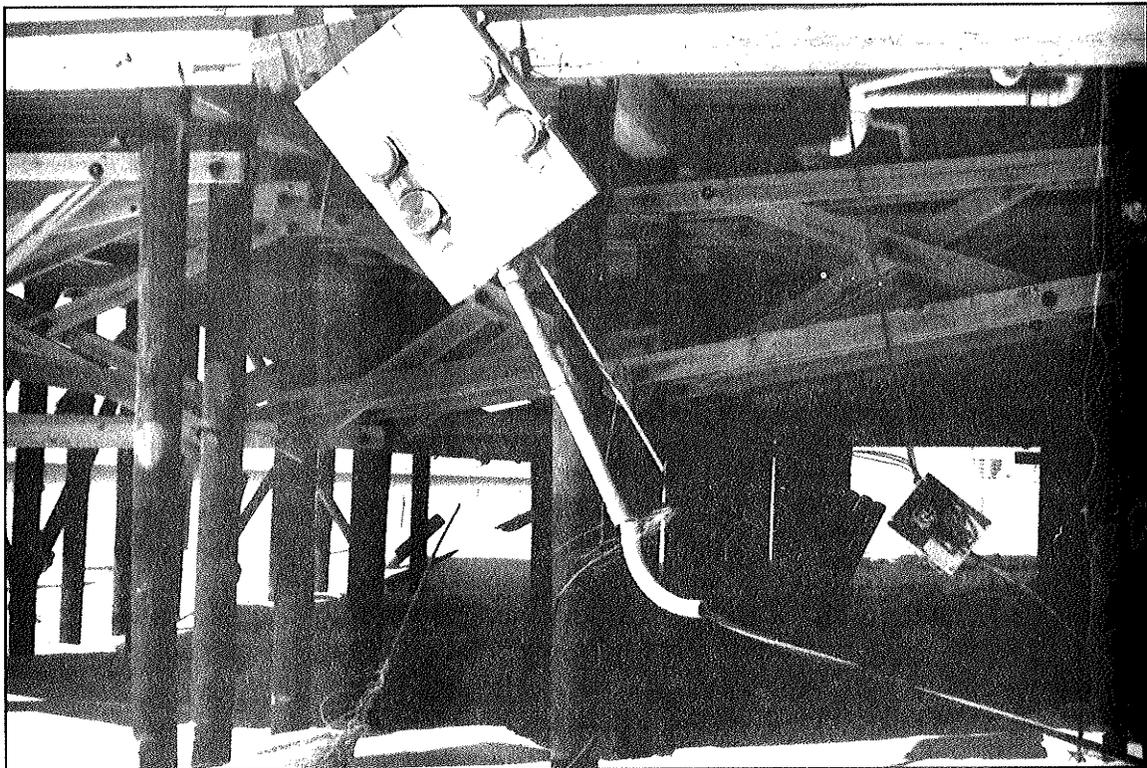
- Placement of electric meters, panels, boxes, and wiring below a building's lowest habitable floor, rendering that equipment vulnerable to storm surge, wave, debris and overwash damage (see Figure 2-12).

Figure 2-12 *Utility lines and boxes dislocated by hurricane forces. Note that the cross-bracing and pile support system remain in good condition after the storm.*

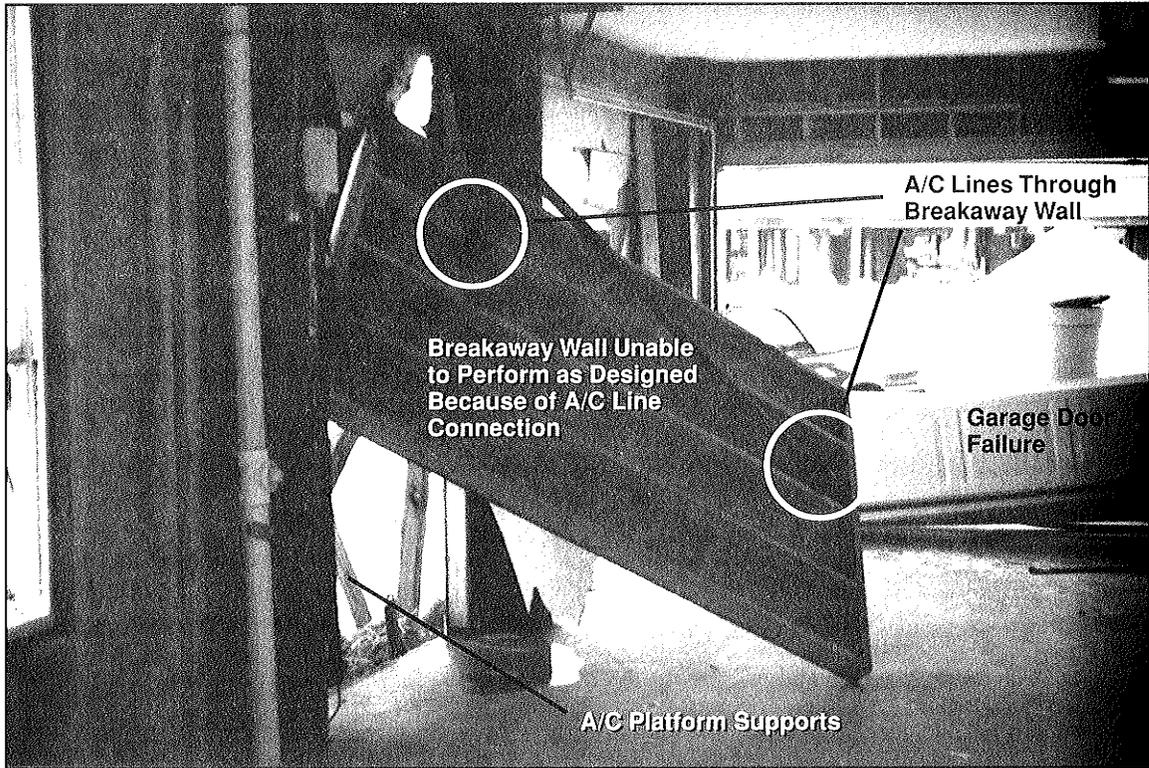
- Attachment of wiring, conduit, and electrical panels to breakaway walls (see Figure 2-13).
- Failure to adequately support and fasten air conditioning compressor units (see Figure 2-14). Many support platforms were destroyed, leading to compressor damage. Some platforms survived, while unfastened compressor units were blown or washed away. Units not properly supported and attached were also observed to have caused damage to exterior walls of some structures.

Figure 2-13 Interior view of breakaway wall blocked by air conditioning unit and support platform (see Figure 2-11). Electric and cooling lines were extended through the breakaway panel.

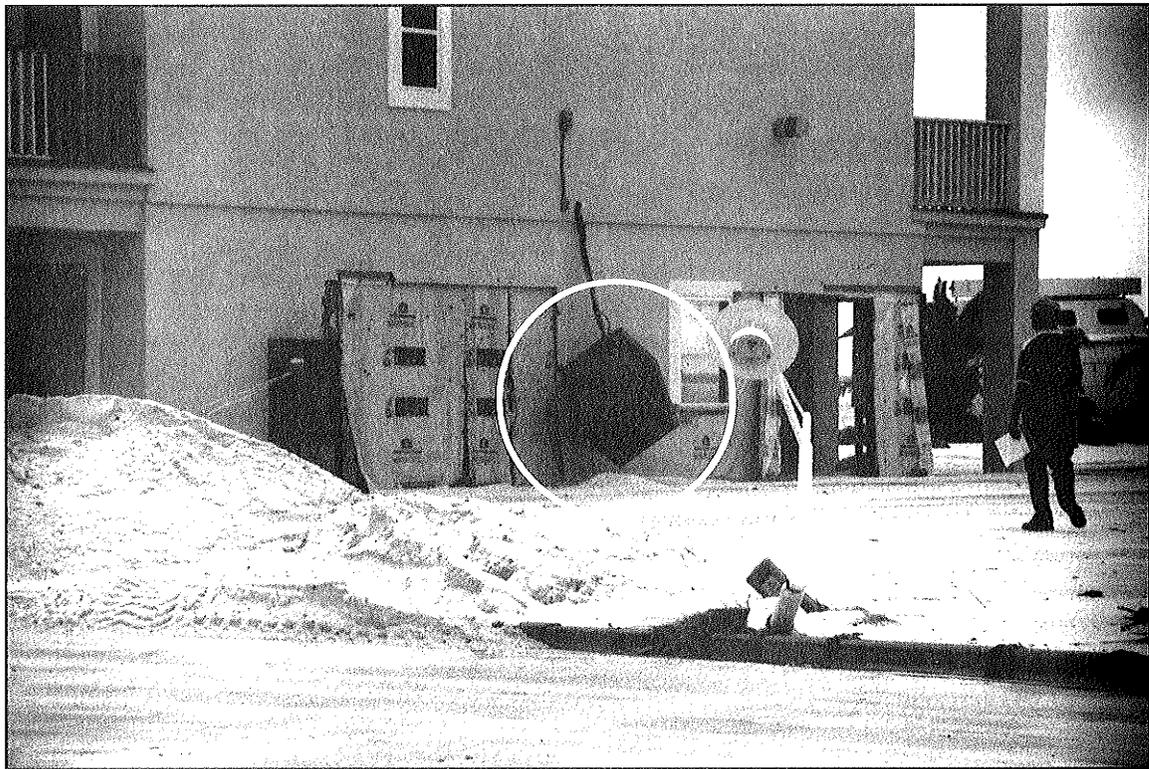
Figure 2-14 These breakaway panels functioned as designed. Note the loss of the air conditioning unit platform.

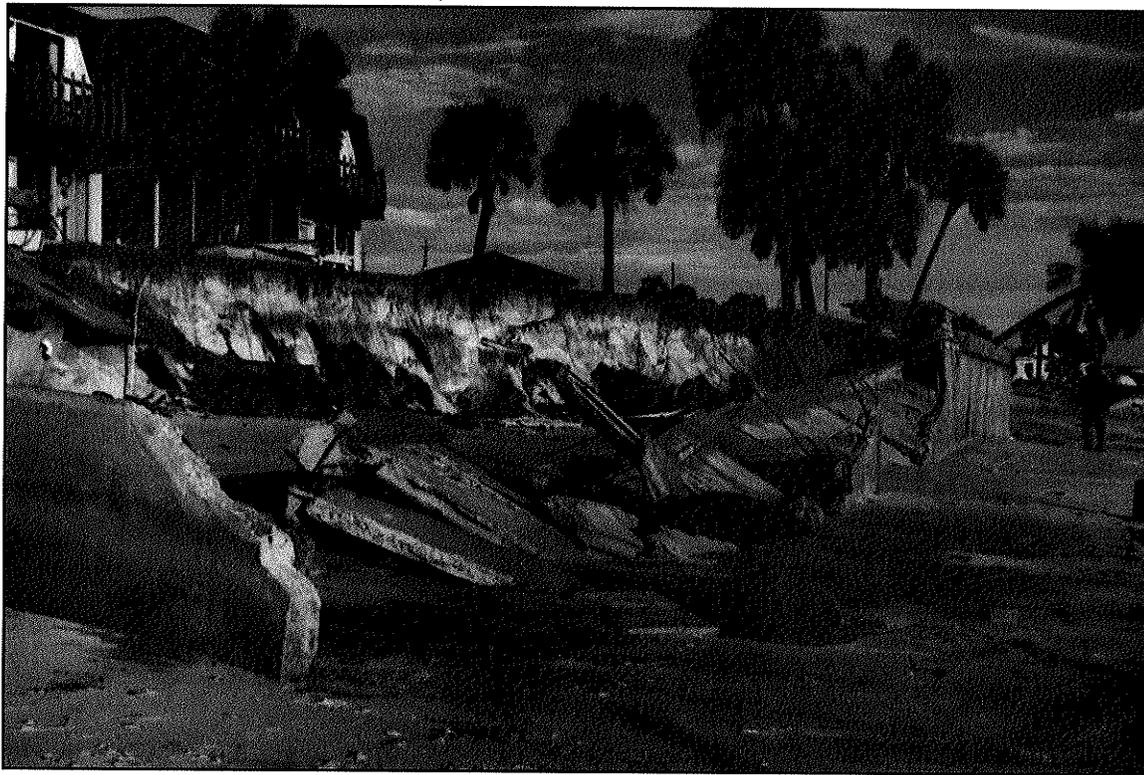
The BPAT observed widespread failure of seawalls and bulkheads along the Gulf of Mexico shoreline (see Figure 2-15). Damage figures from the State of Florida revealed that over 3 miles of seawalls and bulkheads were destroyed by Hurricane Opal, including 1.3 miles of concrete walls, 1.0 mile of concrete block walls, and 0.8 mile of timber walls (FDEP 1995). Failed walls contributed to damage of buildings, pools, and other structures, due to loss of backfill and generation of debris.

Many walls appeared to have failed because wing walls or return walls were flanked by erosion and scour. Many seawall returns flanked by erosion and scour were no more than 20 to 30 feet long, although some longer returns (50 feet to 75 feet) were also flanked.

Seawalls were usually destroyed when backfill was washed from behind the walls because of overtopping, insufficient wall embedment, or return wall flanking. Habitable structures founded on slabs or shallow foundations, swimming pools, and other structures that relied on seawalls to retain supporting soil, were frequently undermined and destroyed when seawalls failed.

Figure 2-15 Fractured seawall, damaged by storm forces. Note the erosion of the bank behind the wall.

The BPAT noted that retaining walls constructed of concrete blocks were particularly vulnerable to damage by Hurricane Opal. Walls most likely to have survived were observed to have:

- reinforced concrete slab or sheetpile construction
- sufficient wall height or backfill protection to prevent significant overtopping and loss of backfill

- sufficient anchorage and embedment to prevent collapse from seaward rotation of the cap or toe
- return walls extending landward of the seaward face of the building or structure being protected and landward of the effects of erosion and scour
