# 7 Recommendations

## 7.1 Residential

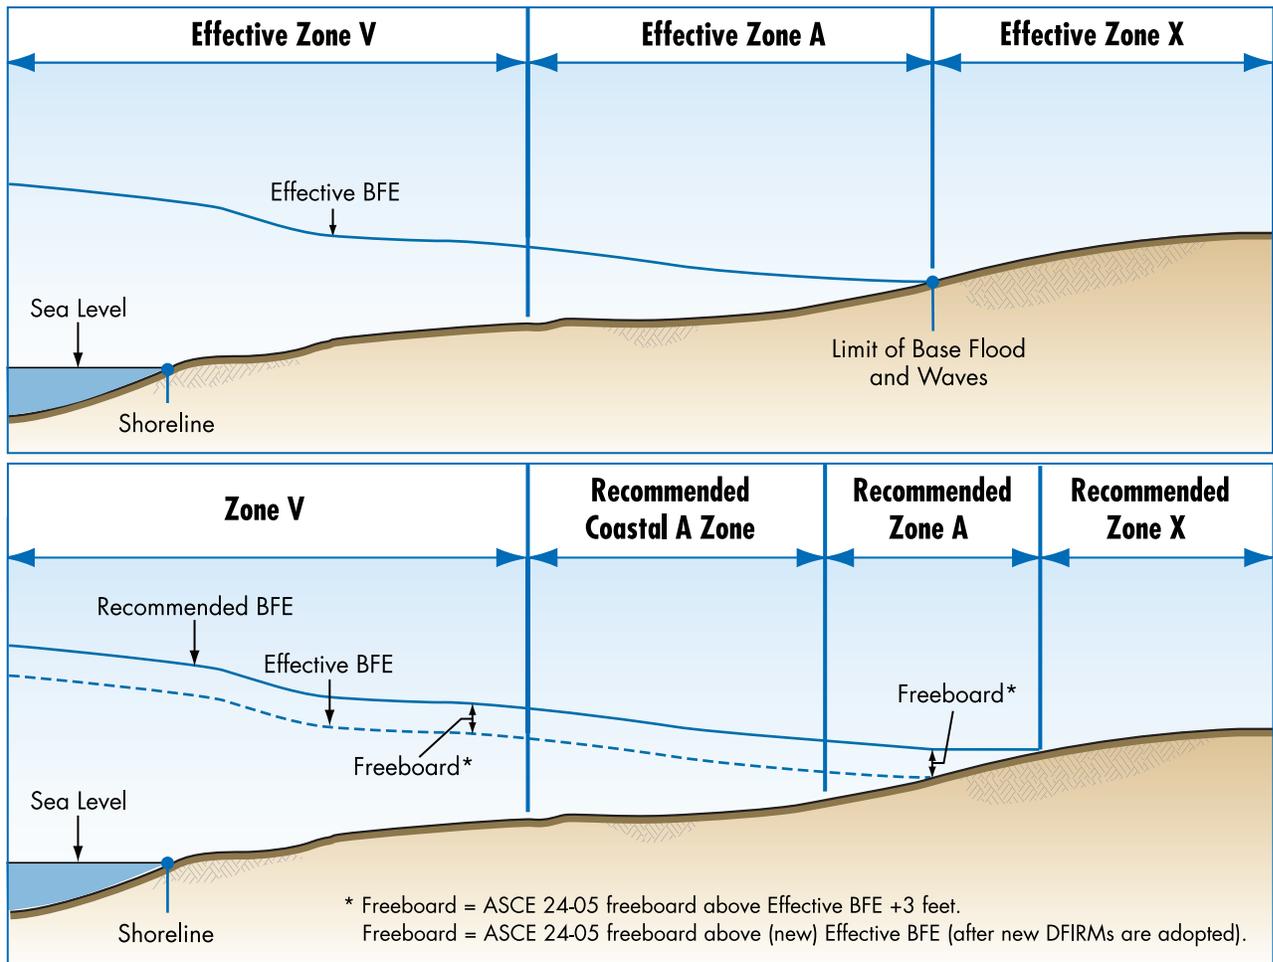
**Recommendation #4:** Until new DFIRMs are available and adopted, the MAT recommends requiring the following freeboard above the currently Effective BFEs for new construction, substantial improvements, and repair

of substantial damage: freeboard specified by ASCE 24-05, plus 3 feet. Once new DFIRMs are available and adopted, the MAT recommends requiring new construction, substantial improvements, and repair of substantial damage to be elevated to or above the freeboard elevation specified by ASCE 24-05.

**Recommendation #5:** Enforce Zone A design and construction standards in the area between the Effective SFHA landward limit and a ground elevation equal to the adjacent Zone A Effective BFE plus freeboard. This recommendation should be implemented before and following the adoption of new DFIRMs.

**Recommendation #6:** Enforce ASCE 24-05’s Coastal A Zone design and construction requirements in areas presently mapped as Zone A on the Effective FIRM. This recommendation should be implemented before the adoption of new DFIRMs; following adoption, Coastal A Zone requirements should be adopted in the area between the LiMWA and Zone V.

Figure 7-1. Comparison of Effective BFEs and flood hazard zones (upper figure), with MAT-recommended freeboard and flood hazard zones (lower figure)

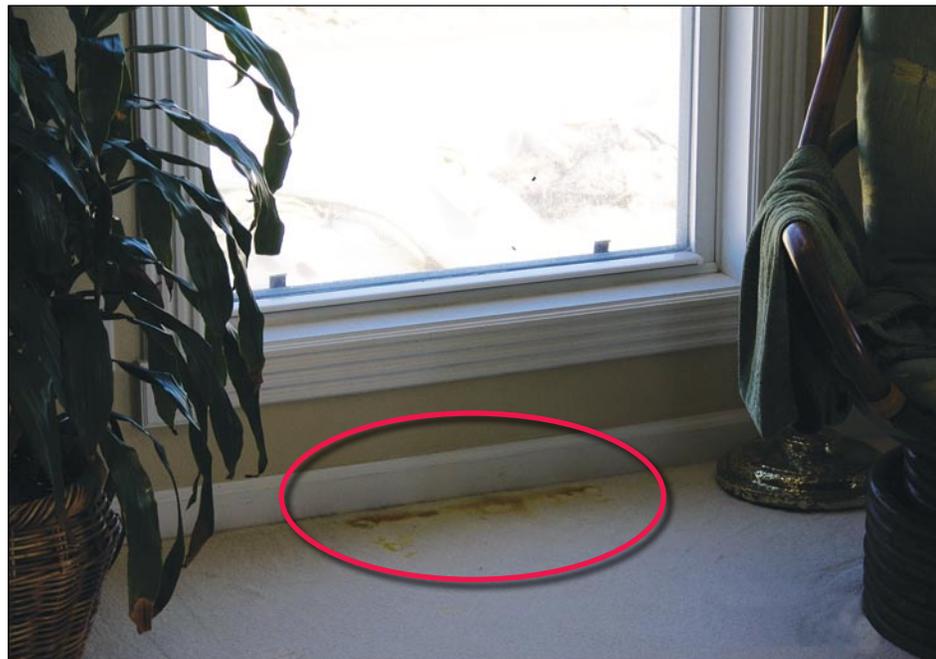
**Windows and Shutters.** The MAT observed interior water damage due to window leakage (Figure 7-2). The current minimum test pressures used to assess the resistance of windows to wind-driven rain are substantially below the design wind pressures. Hence, current minimum testing is inadequate to evaluate leakage potential during hurricanes.

Figure 7-2.  
Several windows at this house on Bolivar Peninsula leaked and wetted the carpet

**Recommendation #42:** It is recommended that the window/curtain wall industry re-evaluate the test pressures that are currently used to assess resistance to wind-driven rain.

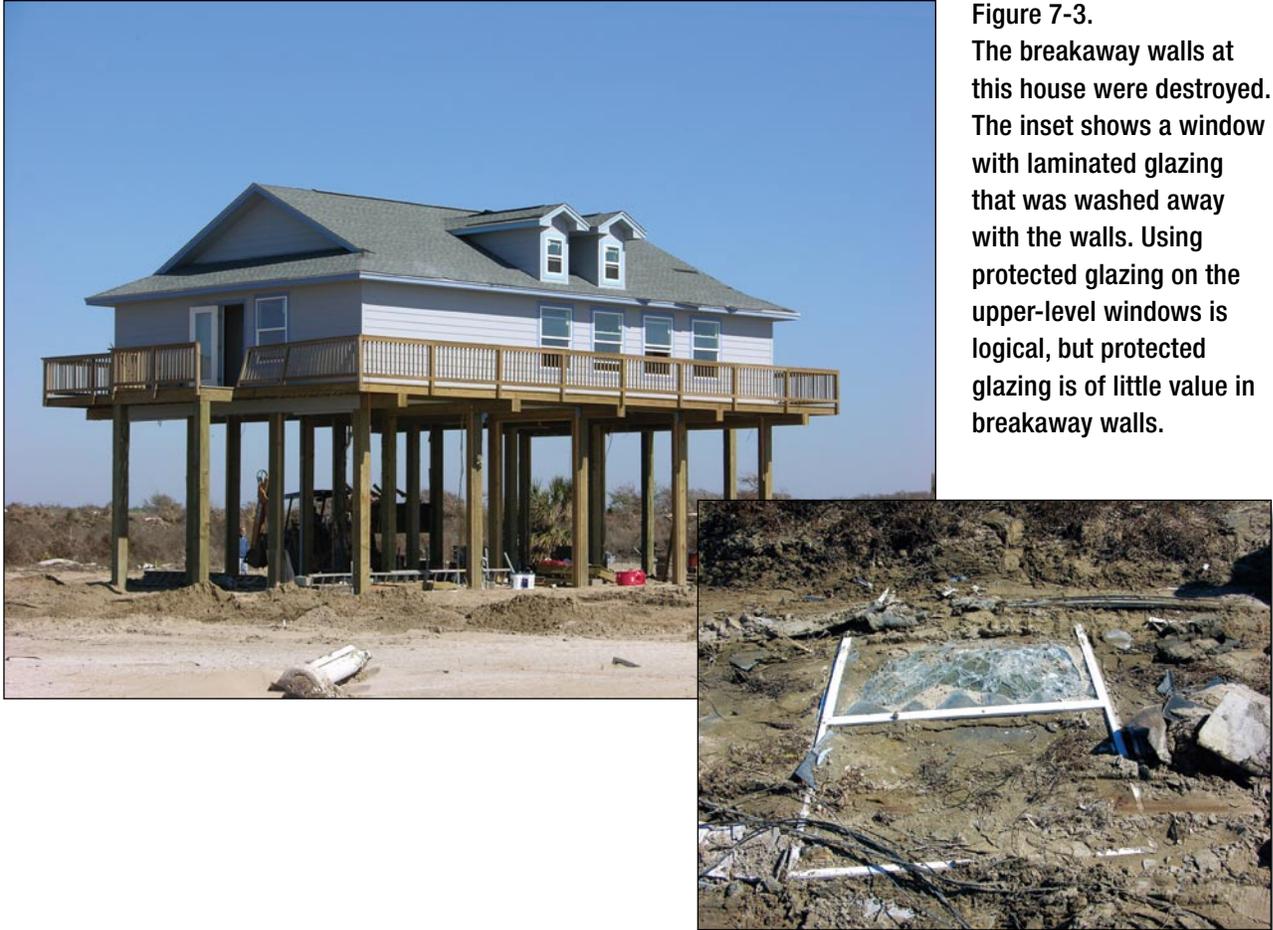
The MAT observed a house under construction on Bolivar Peninsula (Figure 7-3) that had protected glazing in a breakaway wall. The breakaway walls and the window were destroyed by flooding. Currently, if a building is in a windborne debris region, ASCE 7, IBC, and IRC require protected glazing, including the glazing in breakaway walls. However, if the walls break away because of flooding, the windows will likely be destroyed as shown in the inset in Figure 7-3.

**Figure 7-3.** The breakaway walls at this house were destroyed. The inset shows a window with laminated glazing that was washed away with the walls. Using protected glazing on the upper-level windows is logical, but protected glazing is of little value in breakaway walls.

**Recommendation #43:** Because glazing in breakaway walls is far more susceptible to flood damage than windborne debris, it is recommended that an exception be added to ASCE 7, IBC, and IRC that would allow the glazing in breakaway walls to be unprotected. Such an exception would reduce the cost of providing protected glazing, yet would not significantly increase the risk of damage.
