4 Performance of Critical Facilities

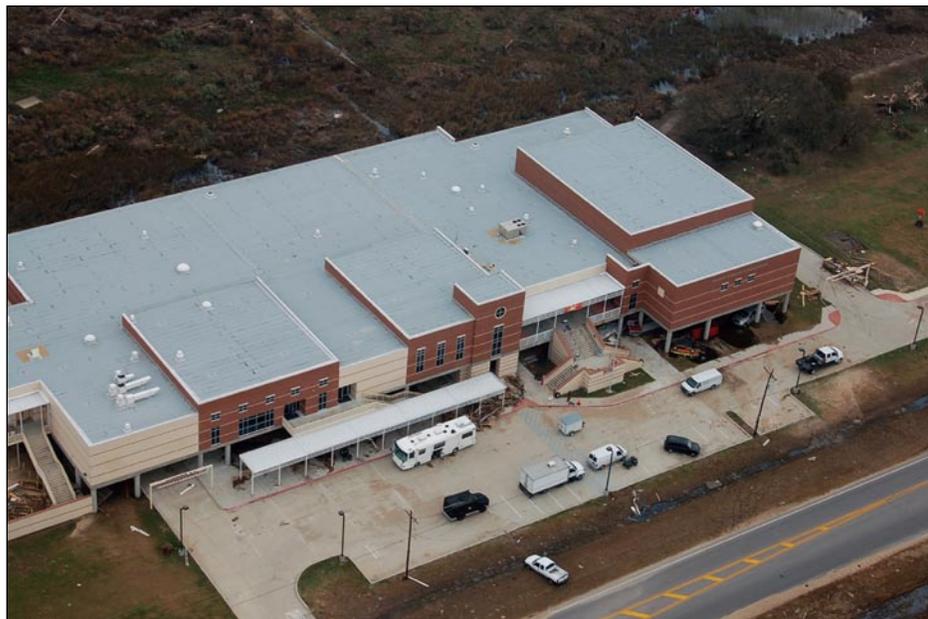
Figure 4-1.
September 19, 2008,
aerial view of Crenshaw
Elementary and Middle
School

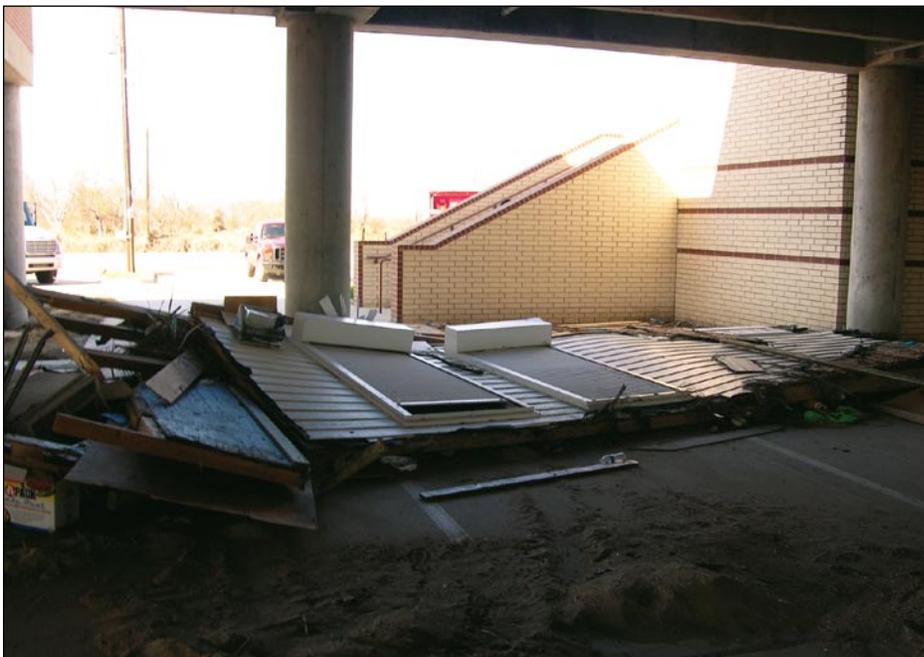
Figure 4-2.
General view of Crenshaw
Elementary and Middle
School

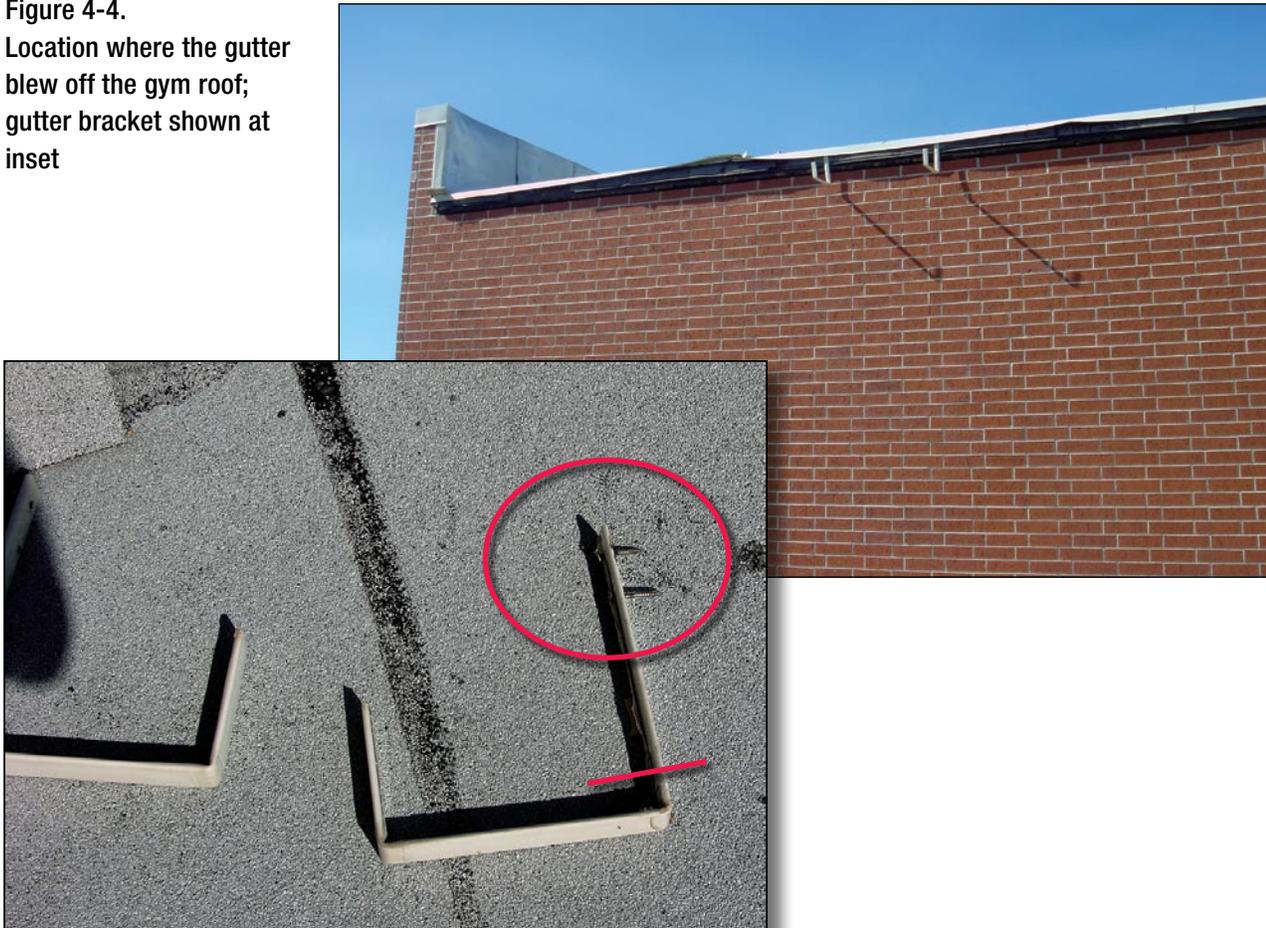
The gutter and most of its brackets blew off the gym roof (Figure 4-4), but the roof membrane did not progressively peel as is typically the case when a gutter is blown away. The brackets were attached with two ring-shank nails, both of which were located near the top of the bracket, as shown in the inset in Figure 4-4. Since both fasteners were near the top of the bracket, they provided little resistance to outward rotation (moment) as the wind pulled and lifted the gutter away from the building. Significant permanent outward deformation was observed at gutters at other roof areas of the building (similar to the condition shown by the inset at Figure 4-4). To resist the moment force, a screw should have been placed near the lower edge of the bracket, as shown by the red line in the inset at Figure 4-4. Screws should be used to attach brackets because they are more resistant than nails to dynamically induced pull-out forces. The gutter brackets were not attached to the gutter (see discussion in Section 4.3.2).

Figure 4-4.
Location where the gutter
blew off the gym roof;
gutter bracket shown at
inset

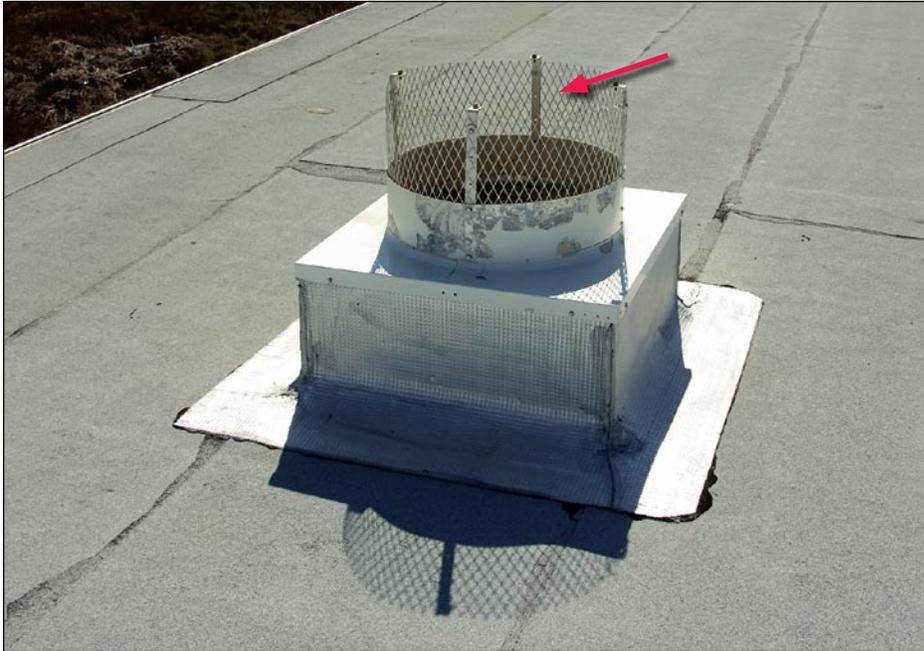
The MAT observed the rooftop equipment on the facility. The rooftop exhaust fans had too few fasteners, although none of the fans blew away during this storm. The exhaust fans were attached with two screws per side; for this location, FEMA 543, *Design Guide for Improving Critical Facility Safety from Flooding and High Winds: Providing Protection to People and Buildings* (2007), recommends six screws per side. The hood blew off two units, which allowed rain to enter the building (Figure 4-5).

Figure 4-5.
Wind blew off the hood,
allowing rain to directly
enter the building

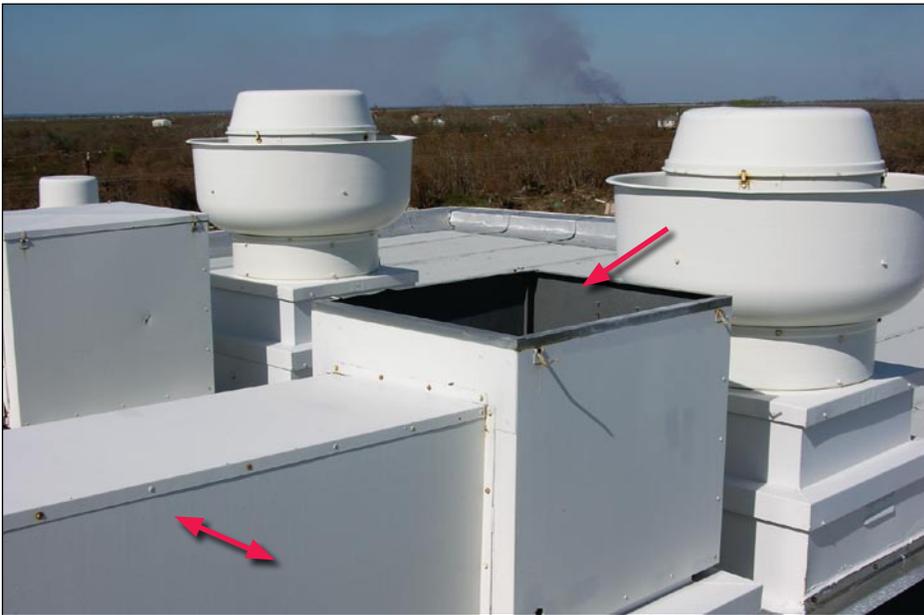
Access panels blew off a few pieces of rooftop equipment. As shown in Figure 4-6, rain was able to directly enter the building during the storm and was still able to at the time of the MAT visit. The ductwork shown in Figure 4-6 was easy to shake back and forth by hand (illustrated by the double-headed red arrow). Had the winds been near design conditions, the ductwork may have blown away.

Figure 4-6.
Missing access panel
allowed rain intrusion;
ductwork could be easily
flexed

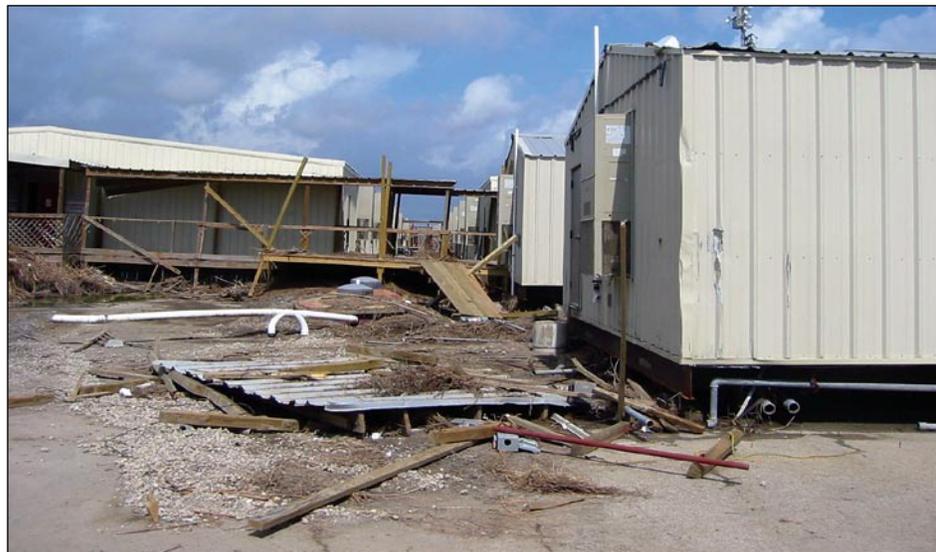
Figure 4-7.
Damage to South Cameron Parish School modular units

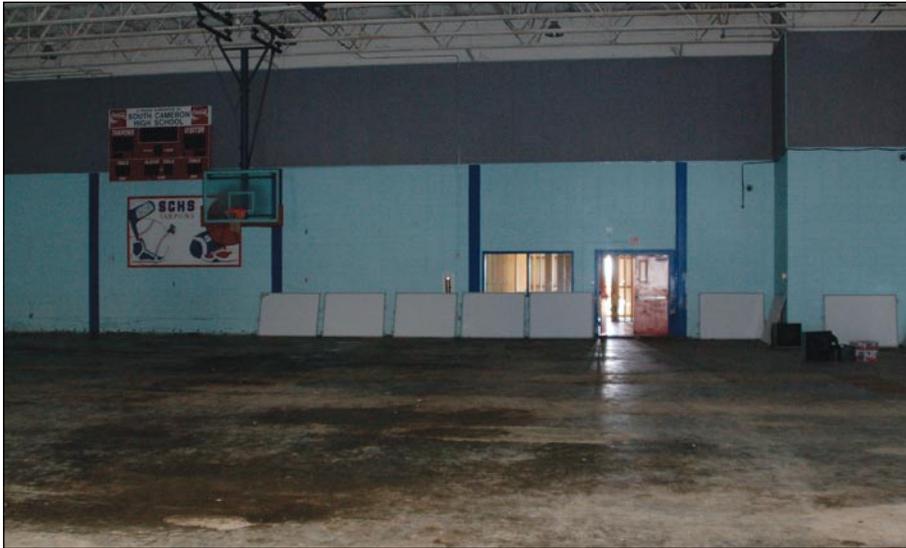
Figure 4-8.
High school gymnasium
at South Cameron Parish
School

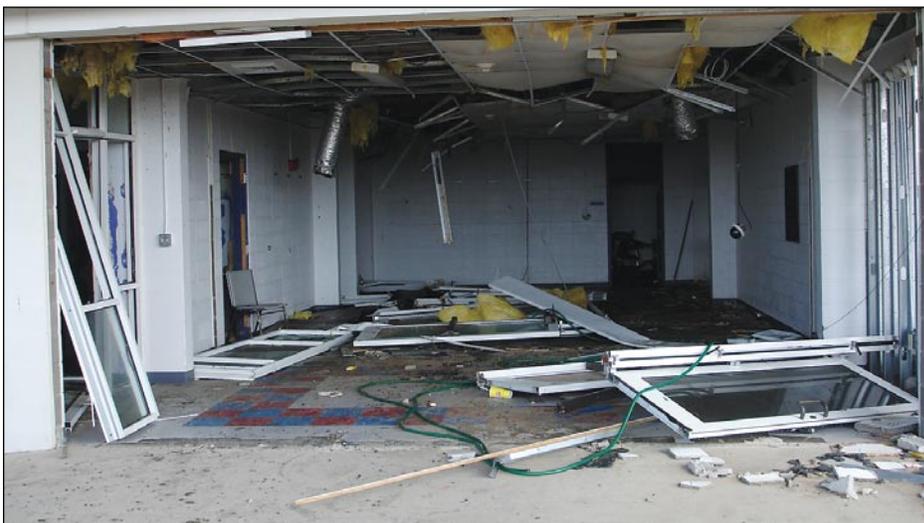
General Flood Damage. The facility was flooded by storm surge with depths reaching 5 to 6 feet. Some masonry walls were flood damaged, as were interior walls, furnishings, and electrical systems (Figures 4-9 through 4-12).

Figure 4-9.
Johnson's Bayou School
interior building damage

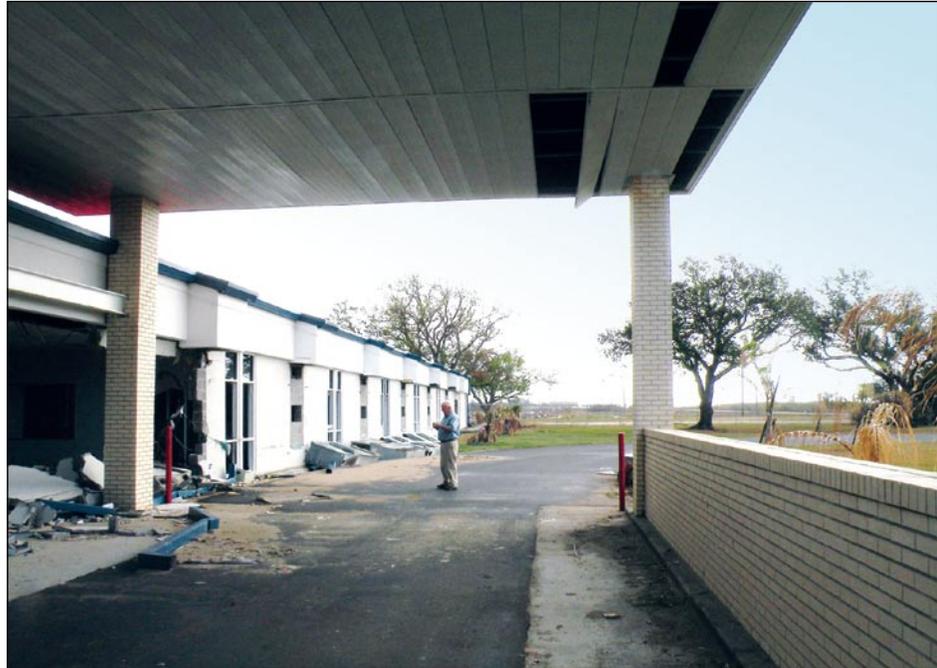
Figure 4-10.
Johnson's Bayou School –
damage to wall on front
side of facility (soffit of
driveway canopy was also
damaged)

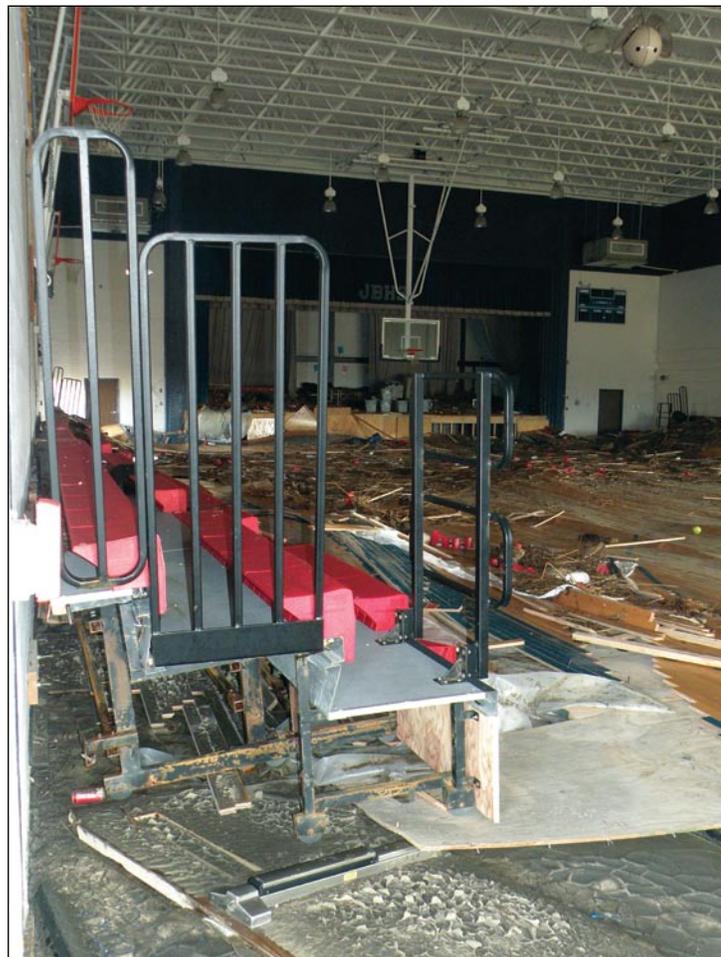
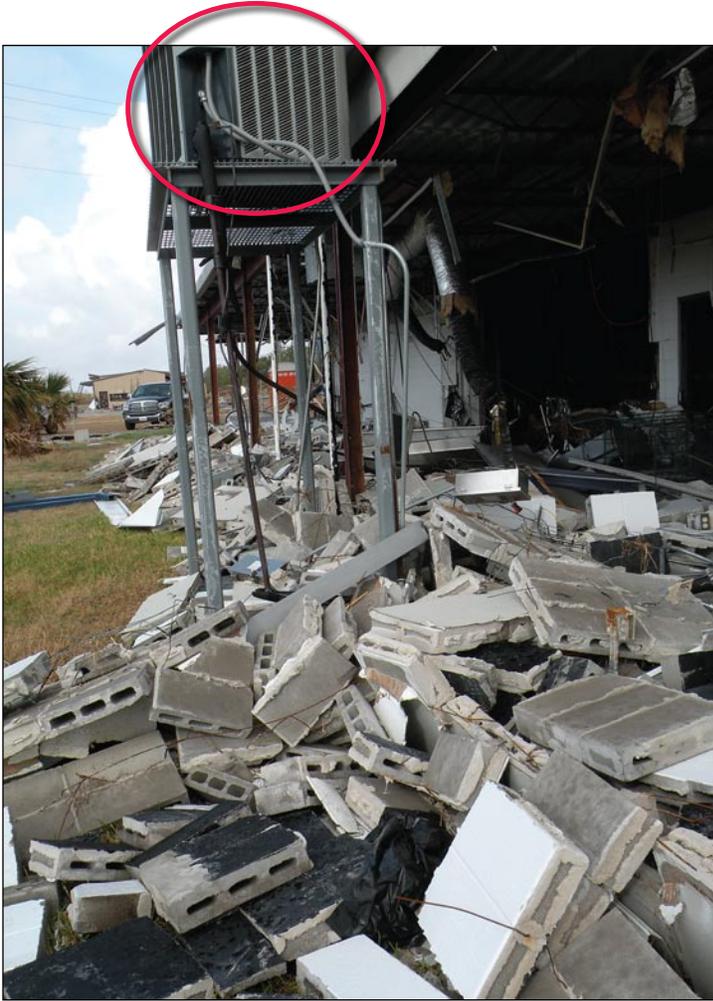
Figure 4-12.

Johnson's Bayou School CMU wall collapse. (Note: HVAC units that had previously been damaged were relocated to an elevated platform under the FEMA Public Assistance Program.)

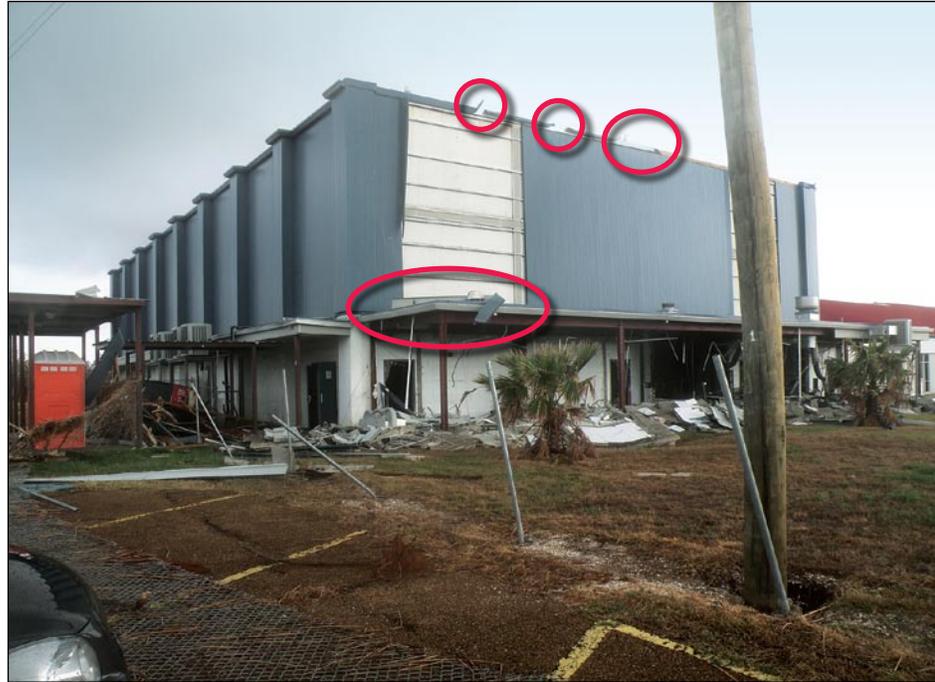
General Wind Damage. Significant wind damage occurred to the roof system for the school gymnasium (Figure 4-13). Figure 4-13 also shows the significant damage to the walkway canopy. The Johnson's Bayou School experienced damage to roof coverings and rooftop equipment. The breached building envelopes allowed widespread rainwater damage and storm surge floodwater intrusion to the interior.

Figure 4-13.
Johnson's Bayou
School gymnasium. The
red ovals indicate damage
to canopy and roof.

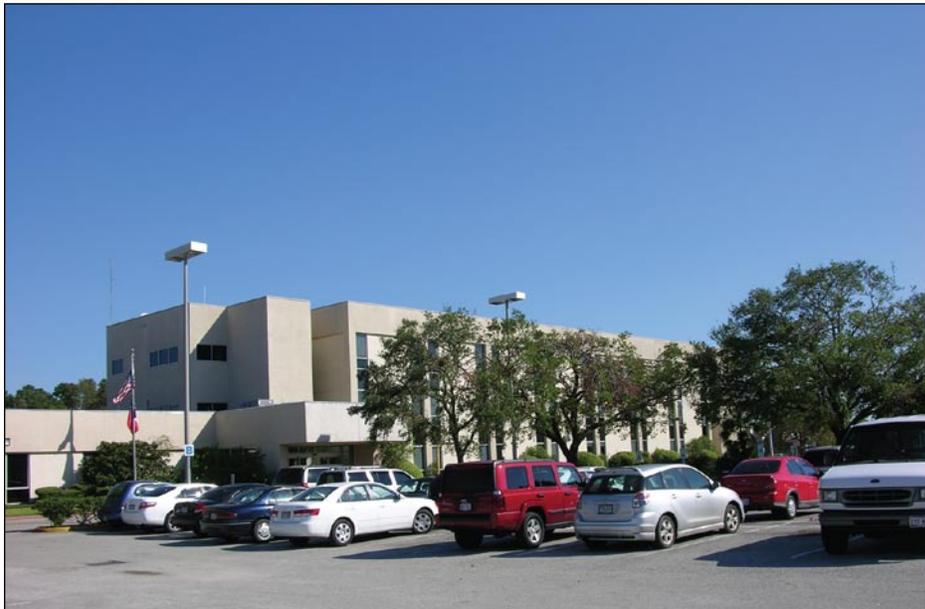
General Wind Damage. The facility experienced some water leakage at the three-story wing shown in Figure 4-14. Some of this leakage was likely due to damaged rooftop equipment. The MAT observation of the roof on this portion of the facility indicated that at least one fan cowling was blown away. No special attachment was provided for the fan cowlings (such as that shown in FEMA 577, *Design Guide for Improving Hospital Safety in Earthquakes, Floods, and High Winds: Providing Protection to People and Buildings* [2007]). However, special attachment was provided for the condenser shown in Figure 4-15. Strapping condensers is a practice that is recommended in FEMA 543 and 577. Unless strapped, condensers frequently topple over.

Figure 4-14.
General view of San
Jacinto Methodist Hospital

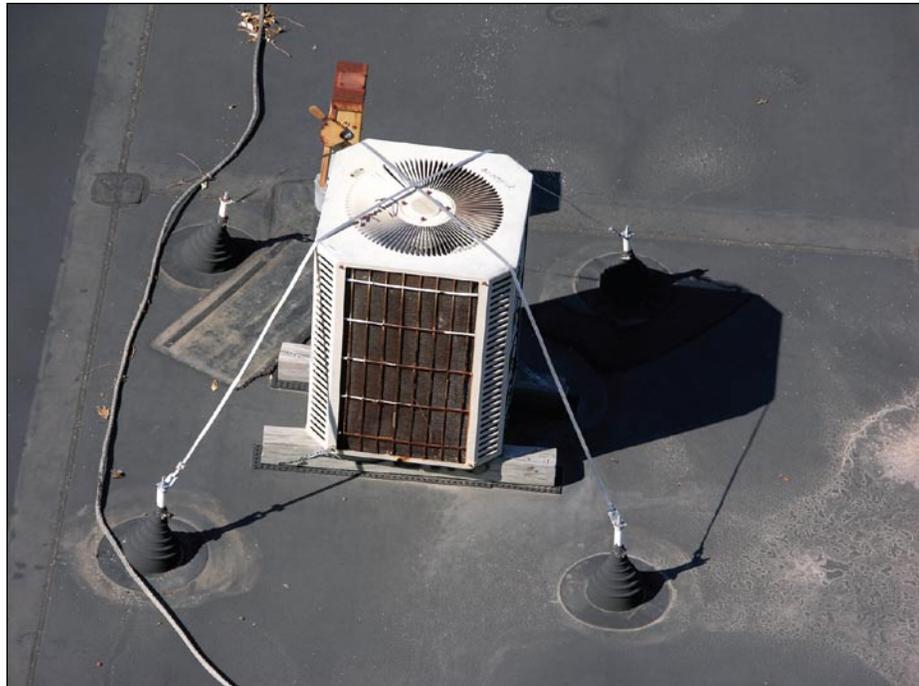
Figure 4-15.
Condenser with tie-down
cables

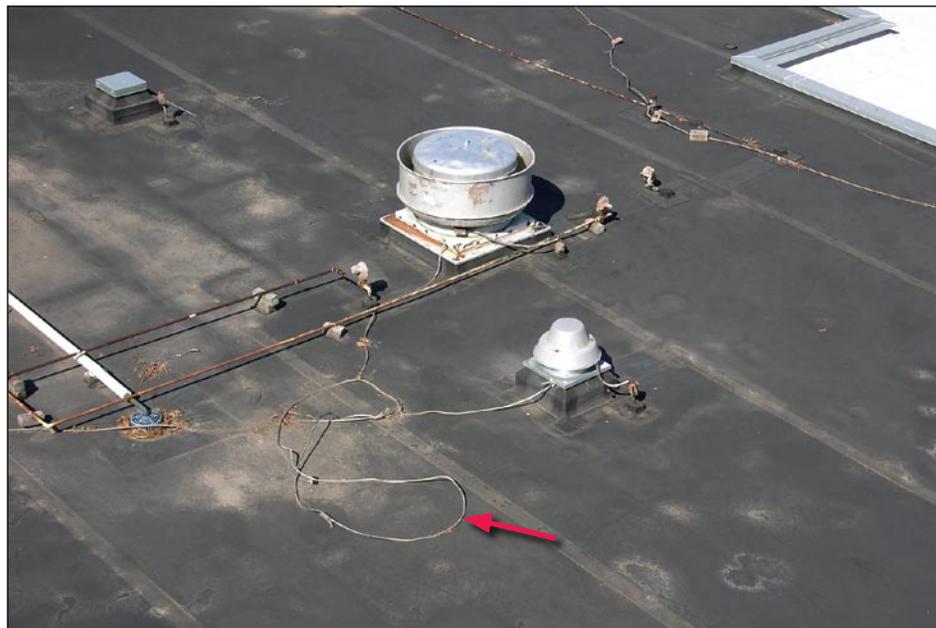
In a few areas, the lightning protection system (LPS) conductors became detached from the roof membrane (Figure 4-16). Loose conductors can puncture and tear roof membranes, and they no longer provide the intended protection. FEMA 543 and 577 provide guidance for attachment of LPSs to resist wind.

Figure 4-16.
Detached LPS conductor

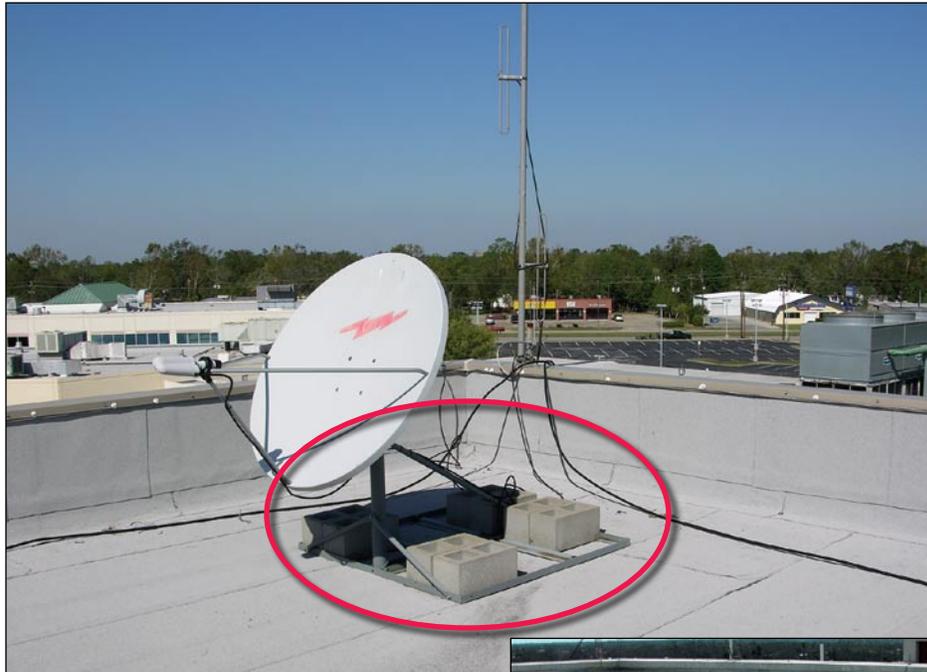
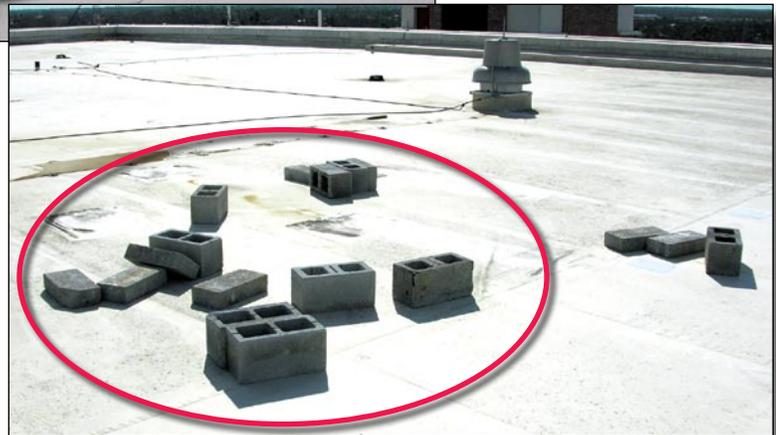
The satellite dish shown in Figure 4-17 was held down only with CMU. This attachment technique was adequate for the winds experienced at this site, but dishes attached by this method have failed in other hurricanes, as shown in the inset at Figure 4-17. The dish shown in the inset was blown completely off the roof; only the CMU remained (FEMA 488).

Figure 4-17.
This satellite dish was held down with CMU only; inset shows all that remains from a similarly mounted dish after a strong hurricane

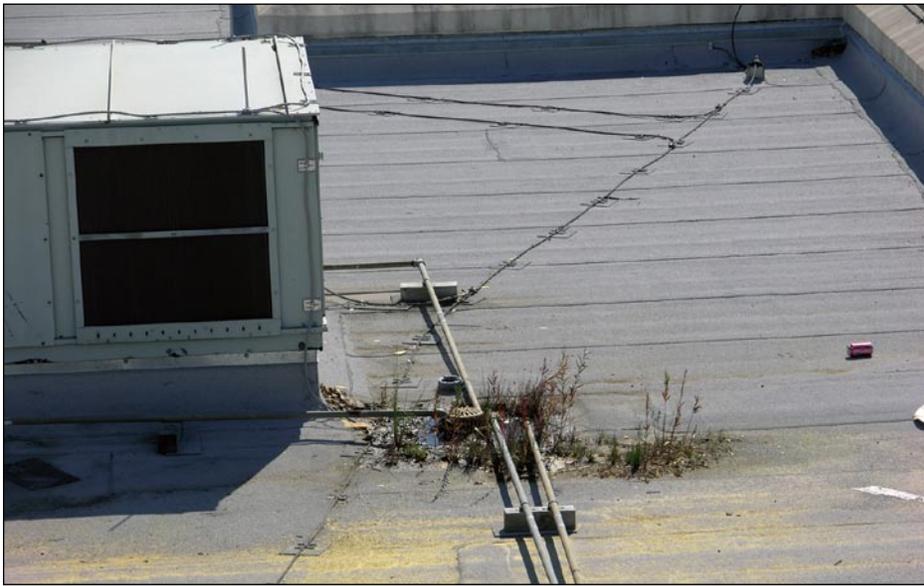
The MAT also observed a lack of adequate pre-storm preparations. As part of the pre-storm preparations, hospital roof areas should be checked. As part of this check, roof drains, scuppers, and gutters should be cleaned of debris so that they are capable of draining the roof during the hurricane (some of which produce a tremendous quantity of rain). Figure 4-18 is a view of one of the mitigated roofs. Clearly this roof drain area had not been cleared of debris for quite some time.

Figure 4-18. View of one of the mitigated roofs. Note the vegetation growth in the vicinity of the roof drain, indicating a lack of maintenance.

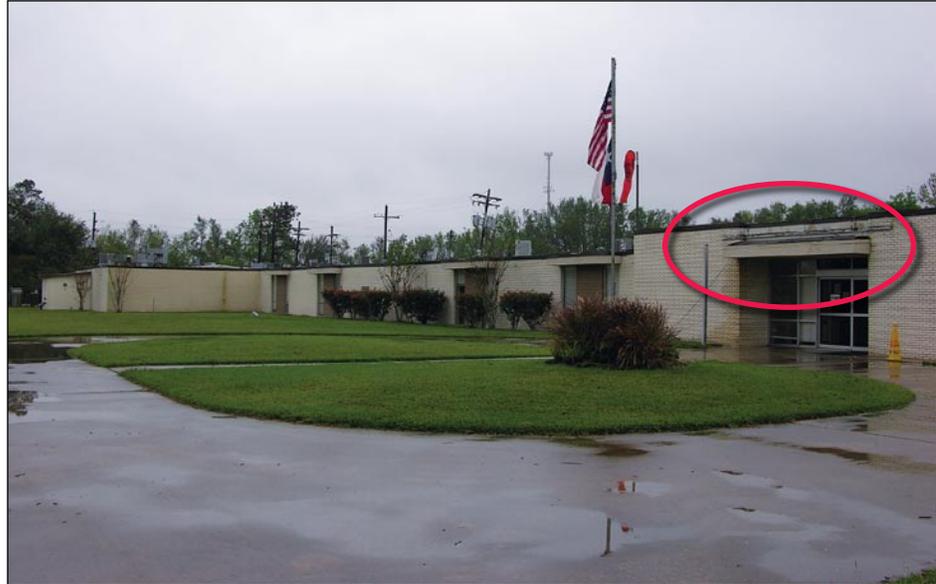
General Wind Damage. An entry canopy blew away (Figure 4-19). A few windows were broken (likely by windborne debris) and wind-driven water entered at several of the windows. At one area, a portion of the edge flashing deformed outward and the nailer lifted, which caused a few of the bricks at the top course to fall. Had the winds been somewhat stronger, the edge flashing would likely have lifted and caused a portion of the roof membrane to blow away.

Figure 4-19.
A Winnie Community
Hospital entry canopy (red
oval) blew away

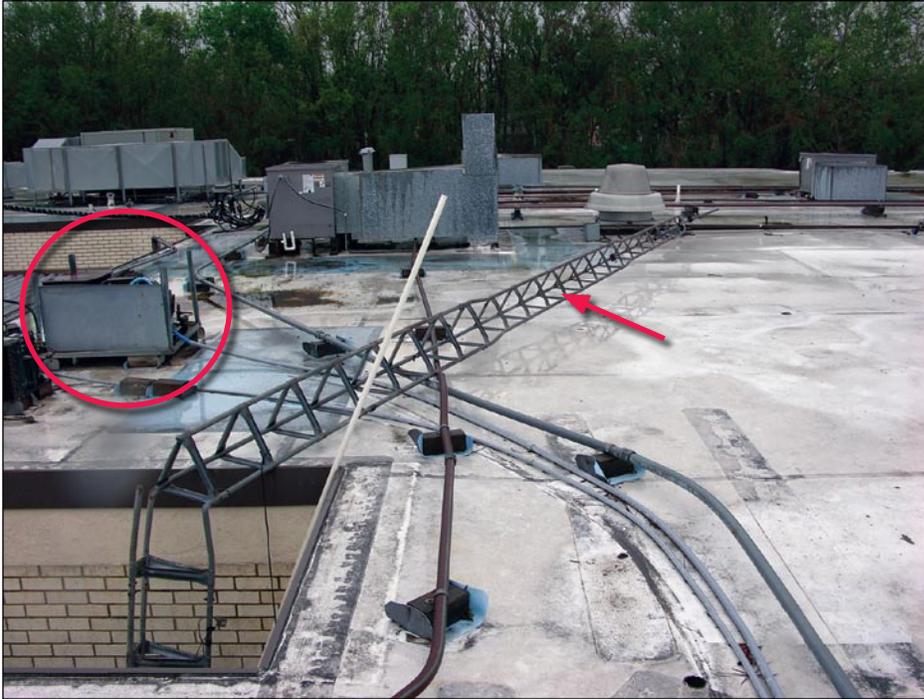
Numerous pieces of HVAC equipment were on the roof. Many condensers toppled, but apparently none punctured the single-ply roof membrane. However, water entered the building where some rooftop ductwork blew away (Figure 4-20). Access panels were blown away at a piece of equipment and the communications tower collapsed (both shown in Figure 4-21).

Figure 4-21.
Collapsed communications tower and blown-away access panels (red circle)

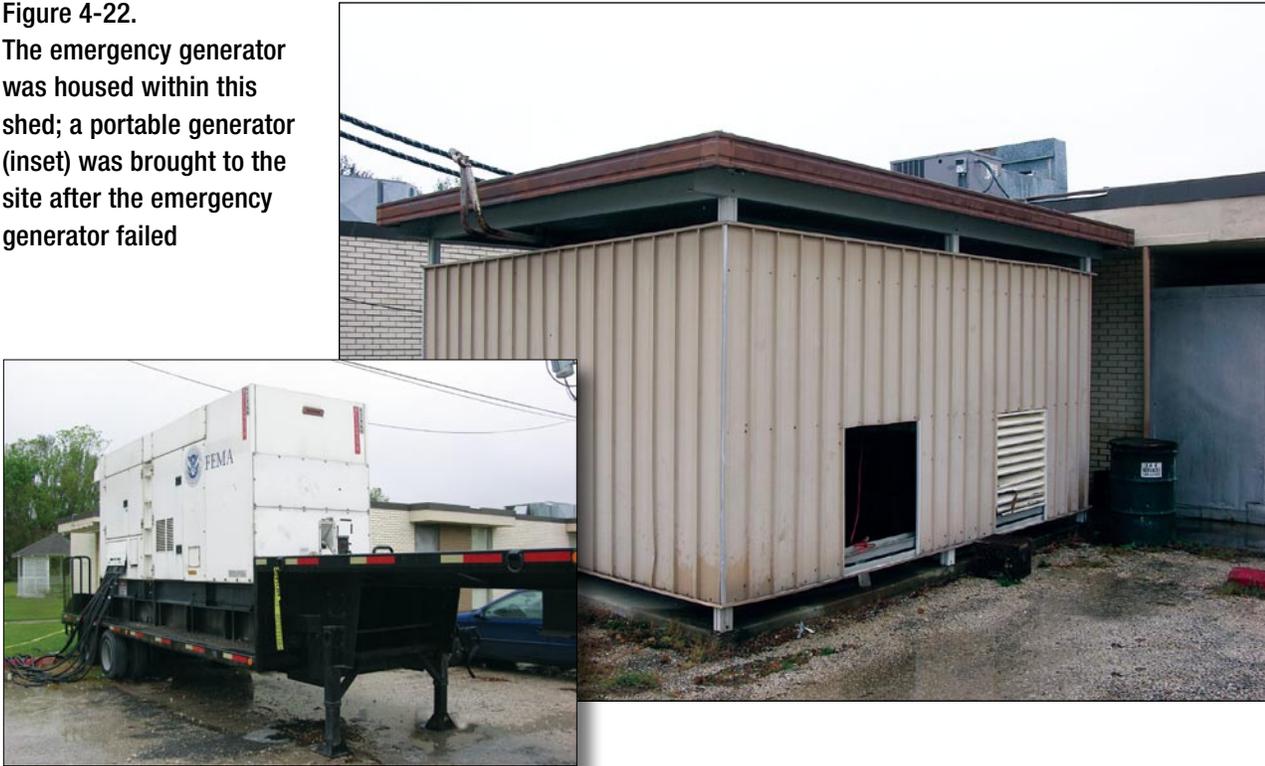
Functional Loss. At the time the hospital was reoccupied, municipal power was out, so power was provided by the hospital's emergency generator. After 2 days, the generator's governor failed, leaving the hospital without power and unable to provide urgent care services. The generator failure caused a power surge, which damaged several pieces of hospital equipment (including refrigerators). This, in turn, resulted in the loss of vaccines, medications, lab reagents, and food. Equipment had to be retested to ensure that it was safe for use.

Figure 4-22.
The emergency generator was housed within this shed; a portable generator (inset) was brought to the site after the emergency generator failed

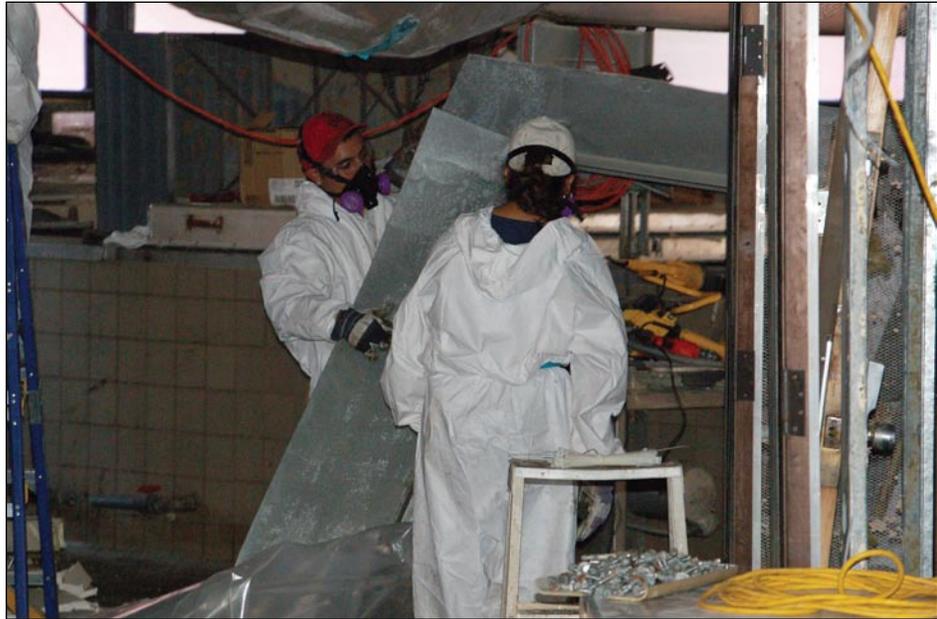
Figure 4-24.
Clean-up underway inside the basement of UTMB Building 1. All the laboratory equipment, office and classroom contents, and interior finishes had to be decontaminated and removed for disposal.

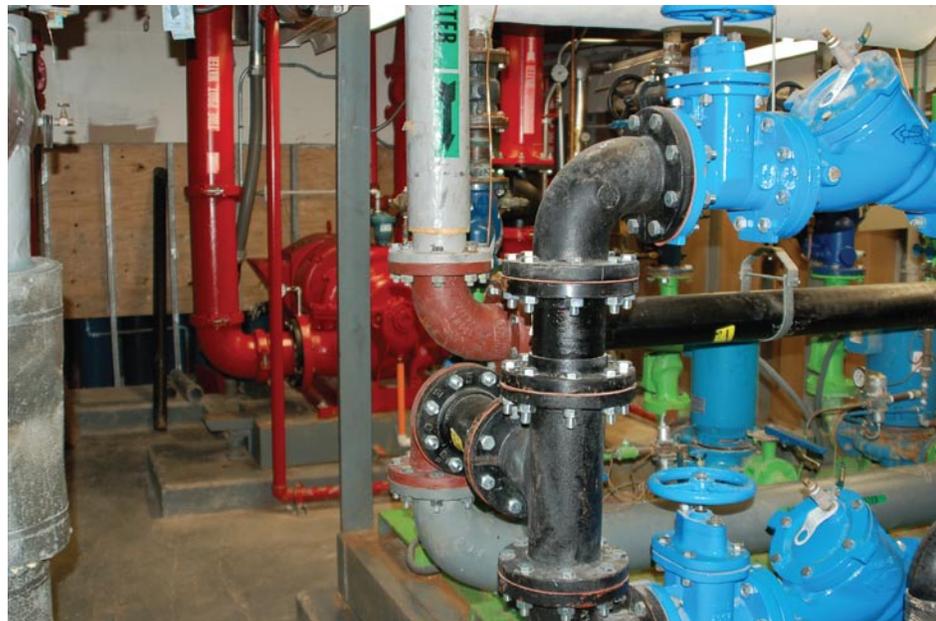
Figure 4-25.
The Ike flood level in UTMB Building 56 pump room was approximately 30 inches above the floor, and controls and equipment were damaged.

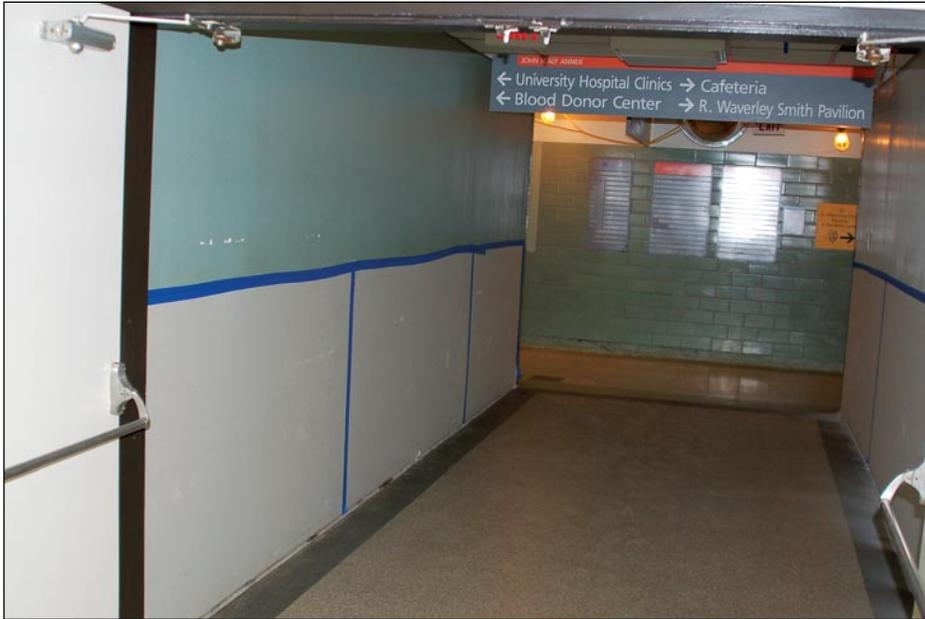
Figure 4-26.
Replaced lower interior
wall sections leading to
UTMB Building 90

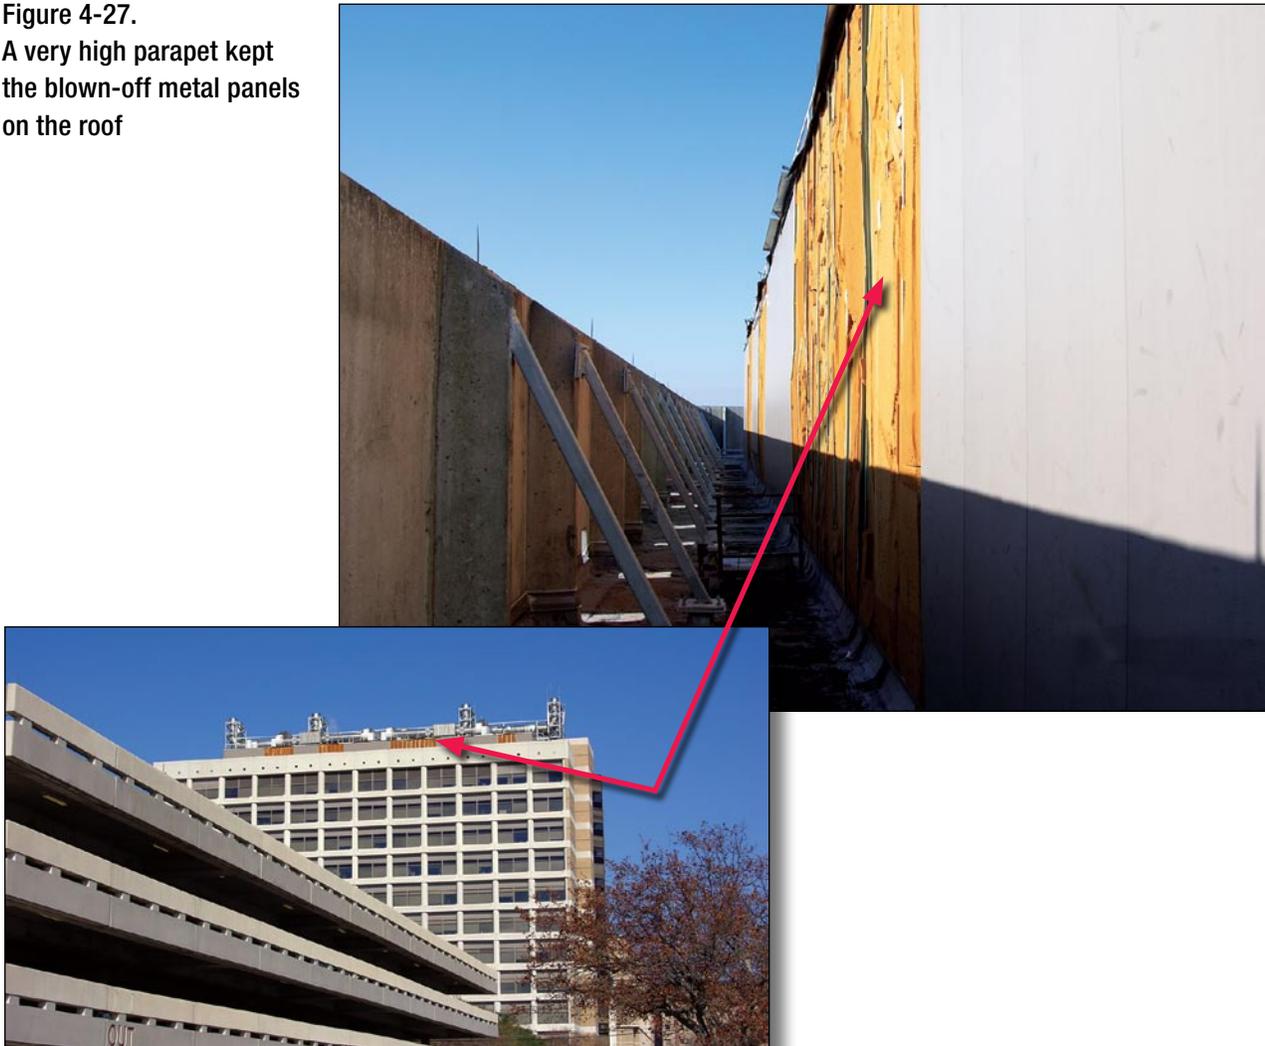
Figure 4-27.
A very high parapet kept
the blown-off metal panels
on the roof

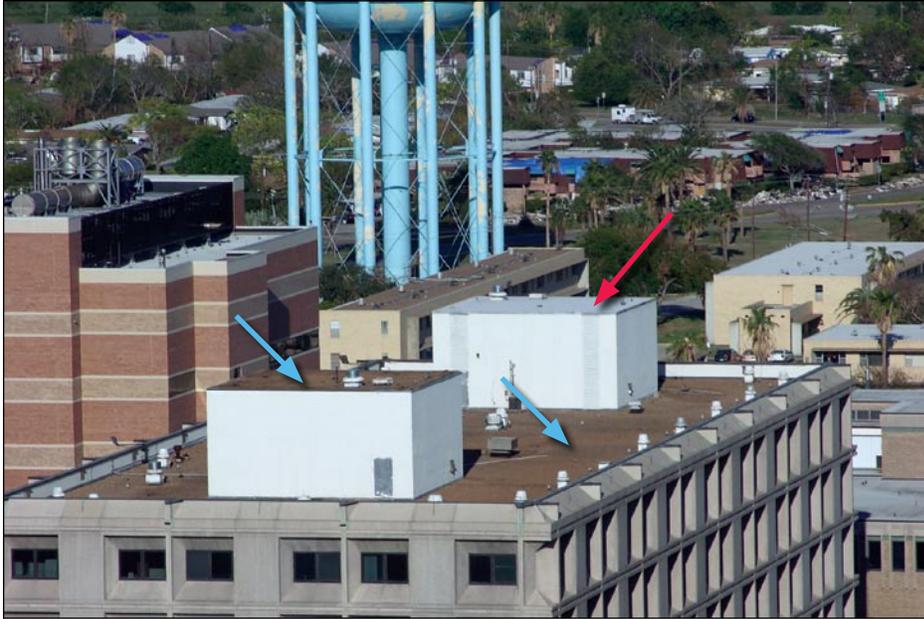
At the time Hurricane Alicia struck this campus in 1983, many of the buildings had aggregate-surfaced BURs and several windows on the campus were broken by wind-blown aggregate. Since Alicia, when buildings have been reroofed, they were not replaced with aggregate surfacing. However, at the time of Hurricane Ike, some aggregate-surfaced BURs still existed, such as that shown in Figure 4-28. One of the penthouse roofs was blown off during the storm. At the time of the MAT observation, that roof had been replaced by the white membrane shown by the red arrow.

Figure 4-28. The roofs shown by the blue arrows were aggregate-surfaced BURs at the time Ike struck; the roof shown by the red arrow is a new roof replacing one that blew off

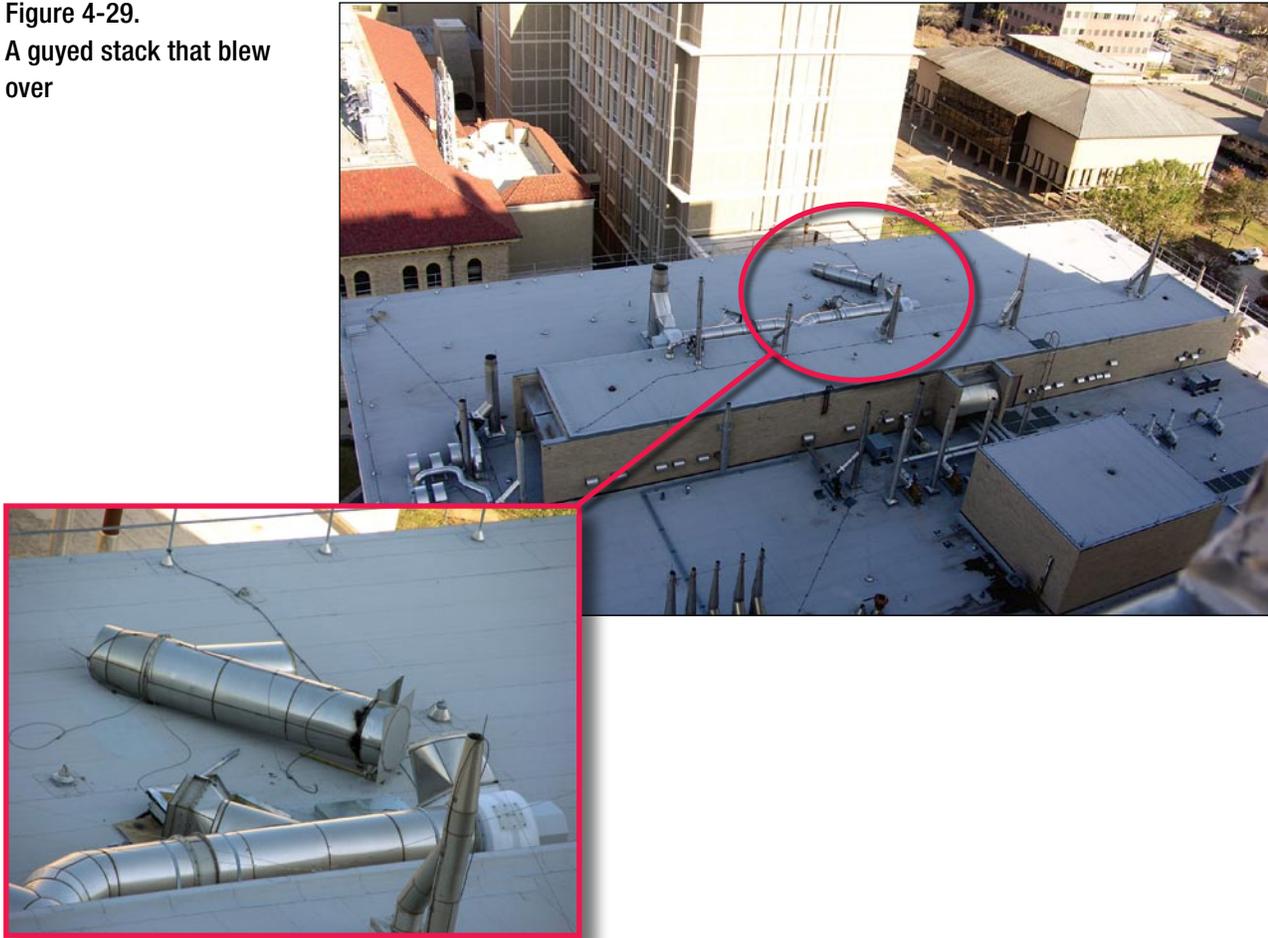
Figure 4-29.
A guyed stack that blew over

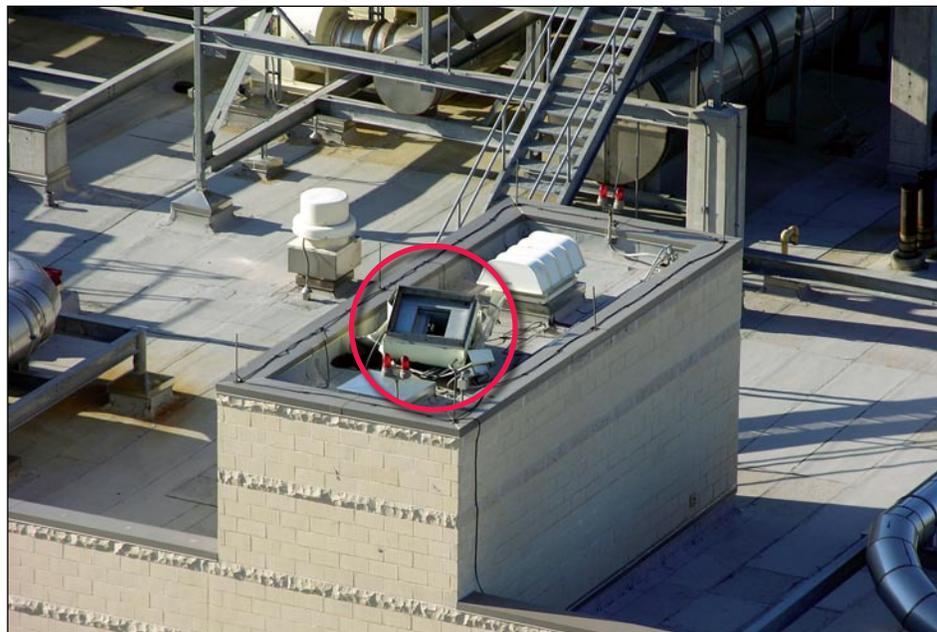
Figure 4-30.
A relief air hood blew off the curb allowing rainwater to enter the building

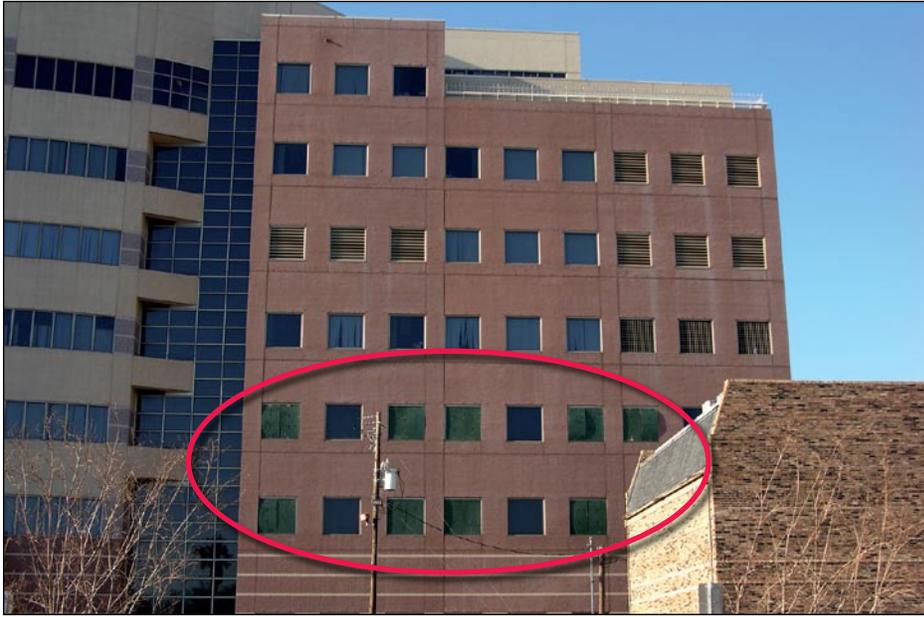
Figure 4-31.
Nine broken windows are shown in the red oval; the brown openings above the oval are louvers

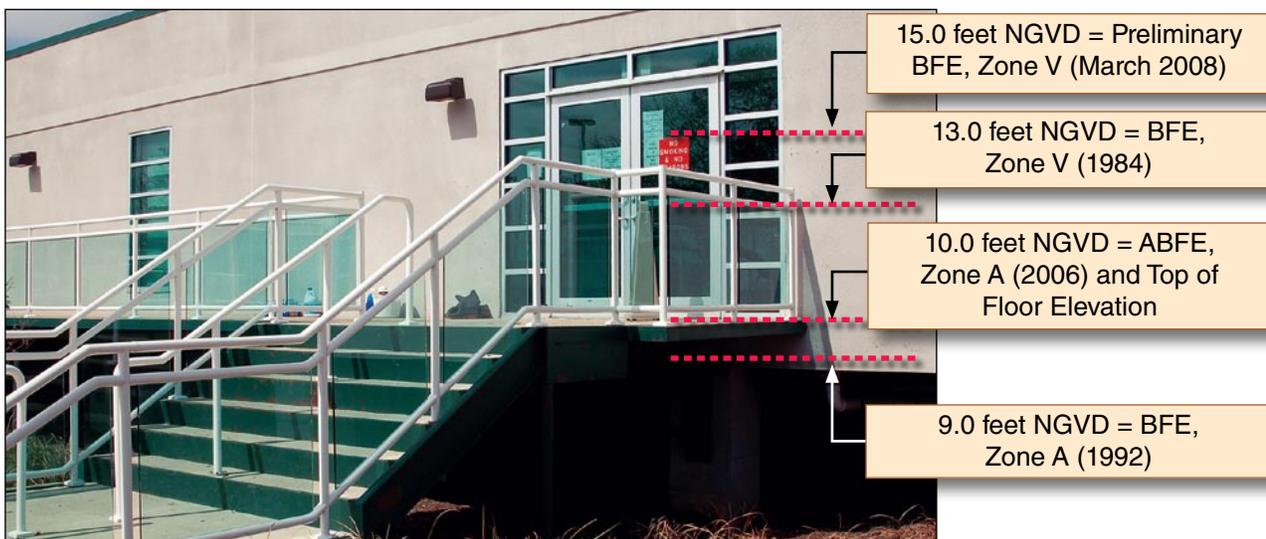
The reconstructed hospital did not comply with the ASCE 24-05 elevation requirements (see Table 4-2). While the floor height satisfied the requirements in effect at the time of construction, the utilities did not—either the utilities should have been located above the lowest floor level or the entire facility should have been elevated higher to allow the suspended pipes and conduits to meet the ASCE 24-05 utility elevation requirement. The latter approach is clearly preferable since it would raise the floor level another 3 feet and provide an added factor of safety against flooding.

Figure 4-32. Hurricane Ike crested approximately 6 inches below the floor of the South Cameron Parish Hospital. BFEs and flood hazard zones are shown for the site for the period 1984 to 2008 (Note: the building code may require freeboard above the BFEs shown).
