4 Performance of Critical Facilities

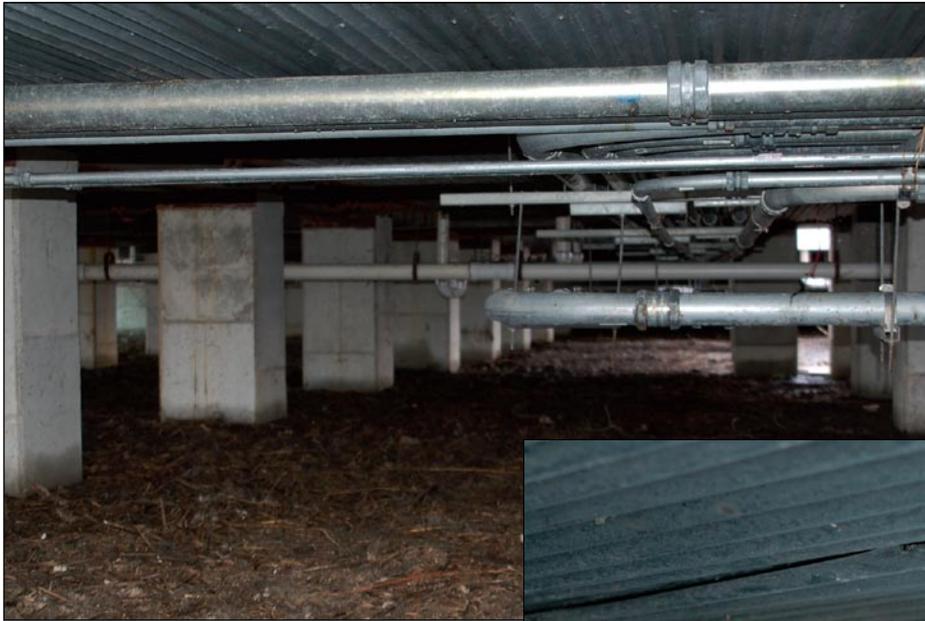
Figure 4-33. Conduits and pipes beneath South Cameron Parish Hospital. Vegetation was noted between the floor system and the steel plate of the foundation. A connection between the plate and the floor system was not visible.

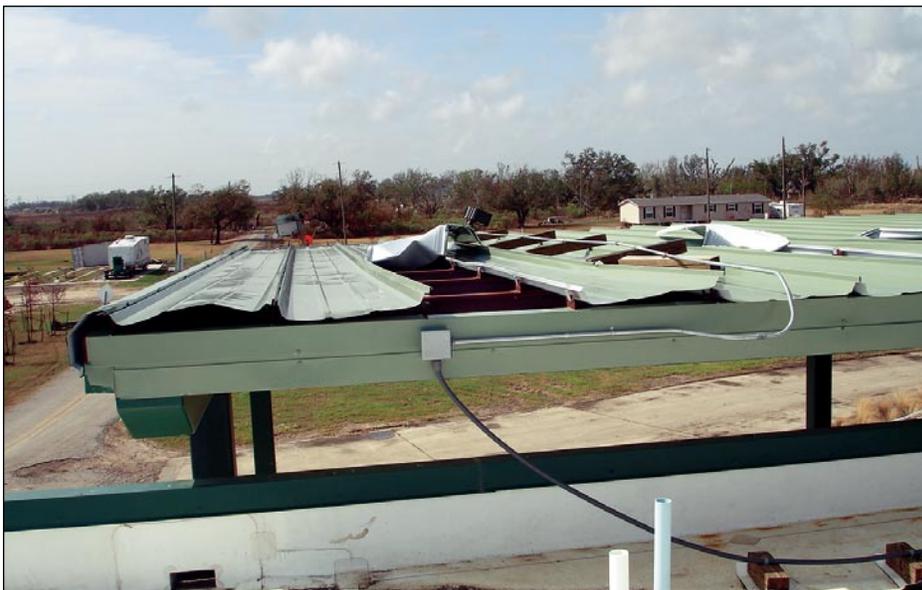
General Wind Damage. The main building roof system performed well during the event. However, some damage was sustained by the canopy over the hospital's emergency room entrance driveway (Figure 4-34). The MAT also observed that some rooftop mechanical equipment was not properly fastened (Figure 4-35).

Figure 4-34. Damage to canopy over emergency room entrance driveway

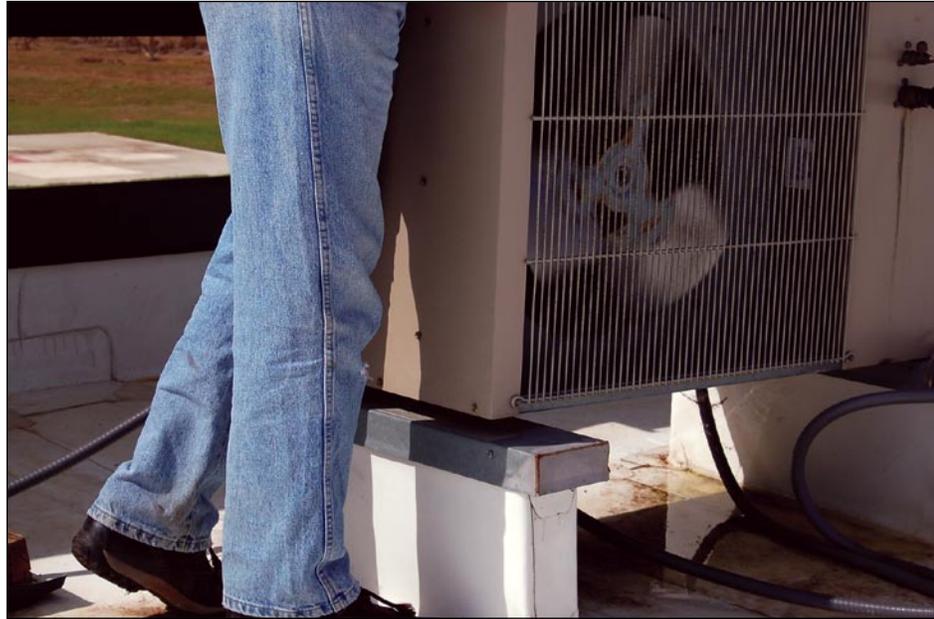
Figure 4-35.
Lack of proper fastening of rooftop equipment—a MAT member was able to easily lift this condenser unit off the curb. All equipment should be fastened to resist uplift and blow-off.

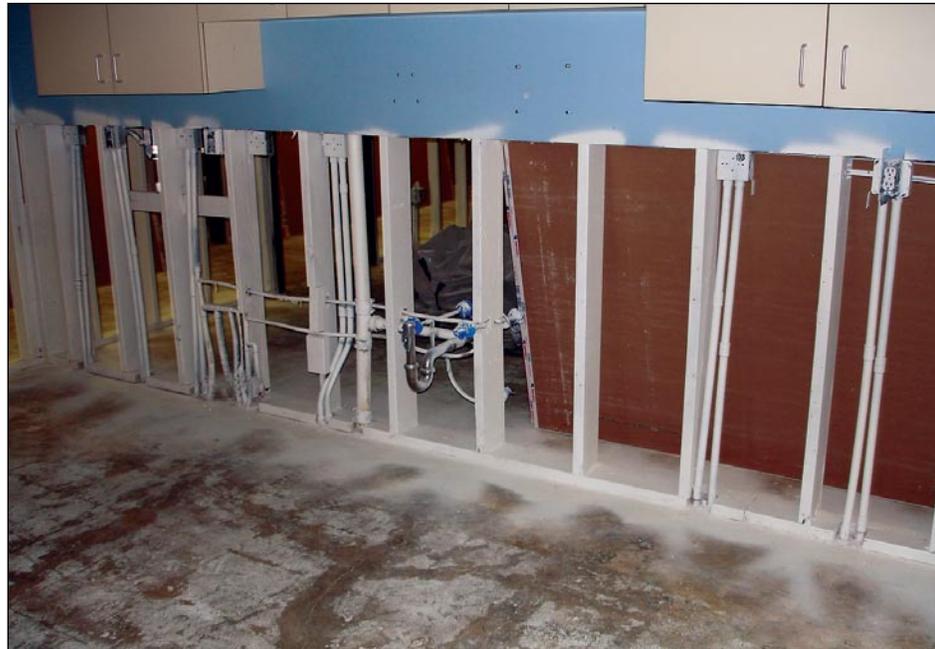
General Flood Damage. During Hurricane Ike, the facility was inundated with 3 to 4 feet of floodwater. Interior walls were damaged, as well as contents. Water-damaged gypsum board had been removed to a height of 5 feet above the floor (Figure 4-37) and was being replaced at the time of the MAT visit.

Figure 4-37.
Hackberry Rural Medical
Clinic interior repairs in
progress

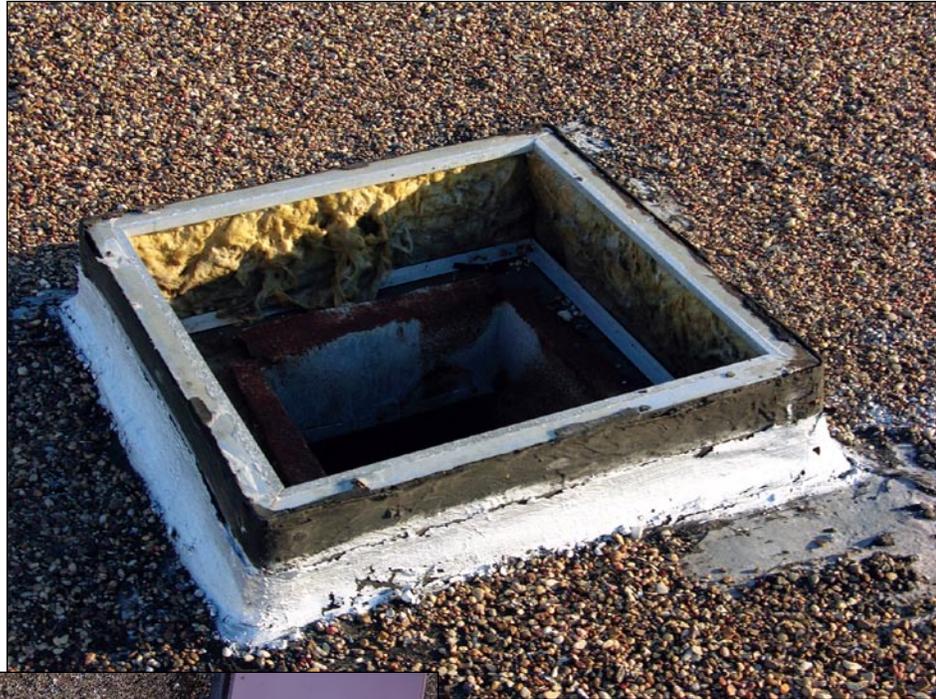
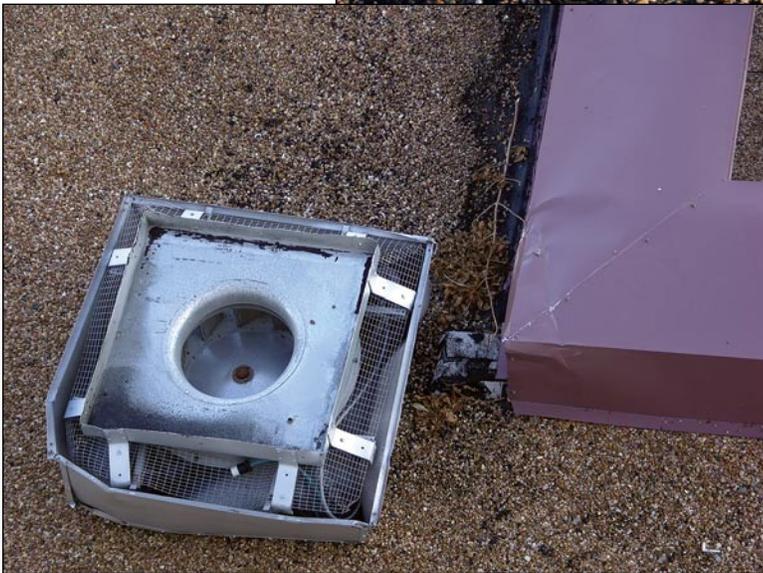
Figure 4-39.
The fan shown in the inset
blew off of this curb

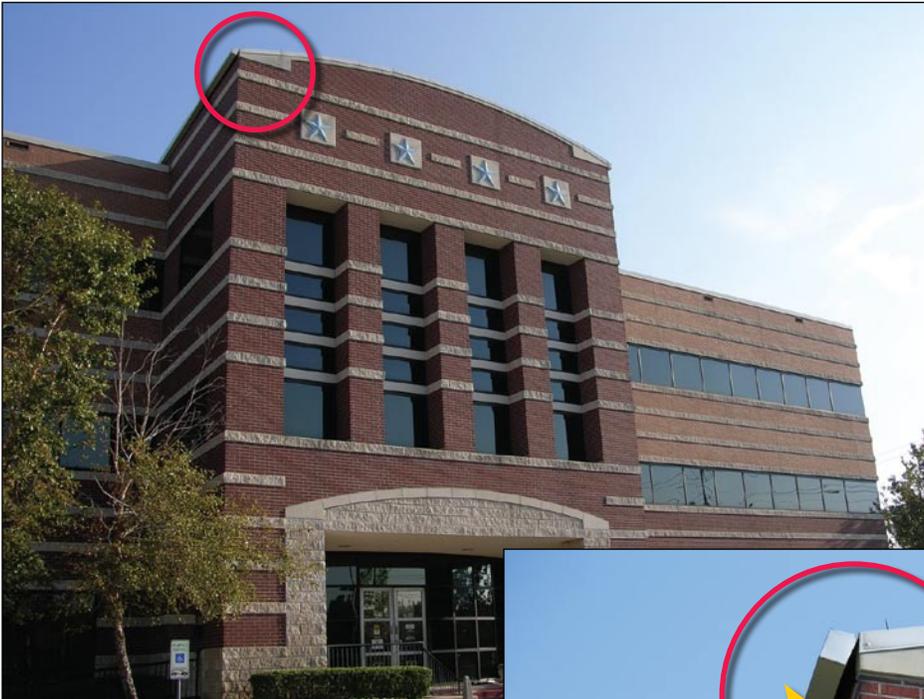
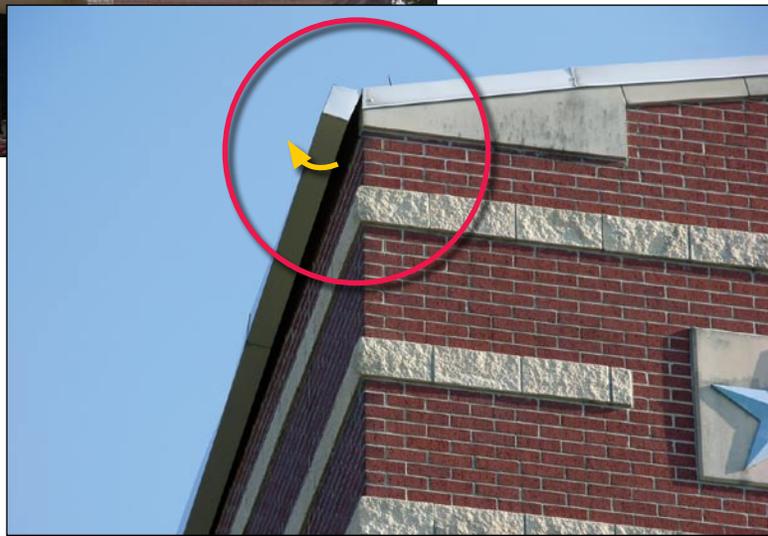
Figure 4-41.
Houston Transtar Regional
EOC; significant permanent
outward deformation
occurred at the gutter
shown in the inset

General Wind Damage. Hurricane Ike caused outward deformation of the gutter shown in the Figure 4-41 inset. Had the winds been stronger, the gutter would have likely blown off. Additionally, several pieces of coping blew off the building. The outer face of the coping is 8 inches and the inner face is 4 inches (Figure 4-42). Continuous cleats are located along both sides of the parapet. The cleats were attached with roofing nails driven through the horizontal flange (blue arrow at Figure 4-42). In addition, a few widely-spaced nails were driven through the vertical flange (red arrow in Figure 4-42). The nailing provided very little resistance to outward deflection of the cleat and coping. While most of the continuous inner and outer cleats remained on the building, several sections of coping and at least one cleat blew off once the amount of deflection was sufficient for the coping to disengage from the cleat. The blown-off cleat had a face nail that was 75 inches in from the end of the cleat, hence over 6 feet of this cleat was unrestrained from outward deformation.

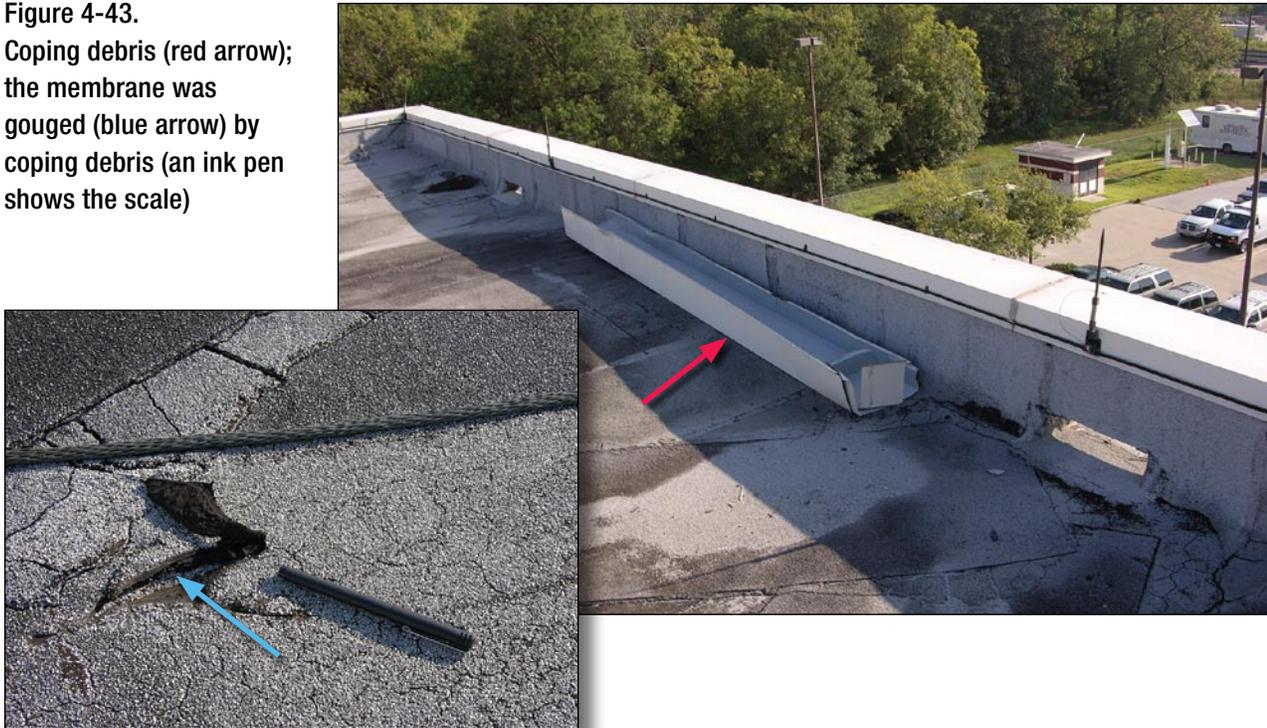
Figure 4-43.
Coping debris (red arrow);
the membrane was
gouged (blue arrow) by
coping debris (an ink pen
shows the scale)

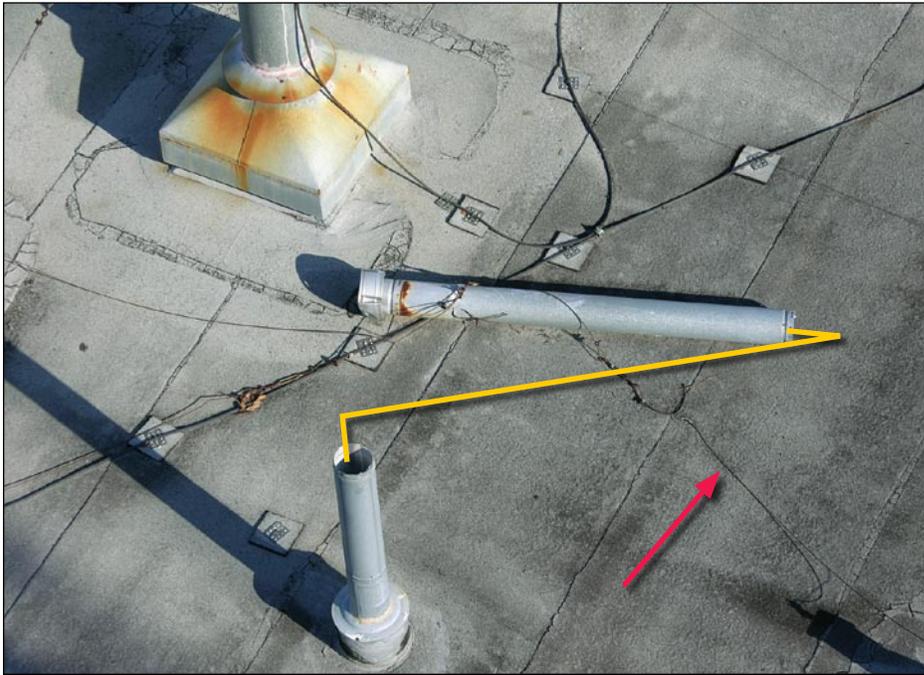
Additional damage included minor leakage at a building expansion joint and toppling of a tall flue on a lower level roof, even though it was guyed (Figure 4-45). The tautness of guys should be checked annually to avoid toppling of flues.

Figure 4-45.
Guyed flue blew over (red arrow indicates one of the guys)

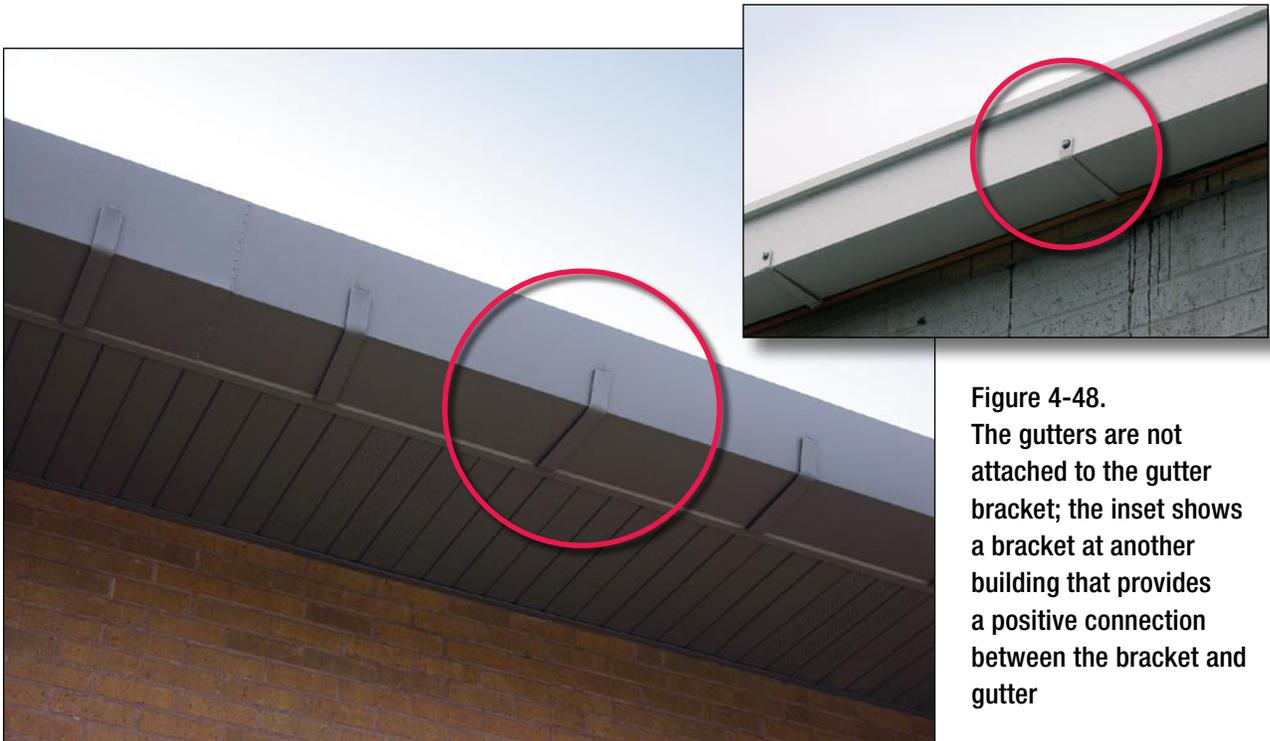
Figure 4-48.
The gutters are not
attached to the gutter
bracket; the inset shows
a bracket at another
building that provides
a positive connection
between the bracket and
gutter

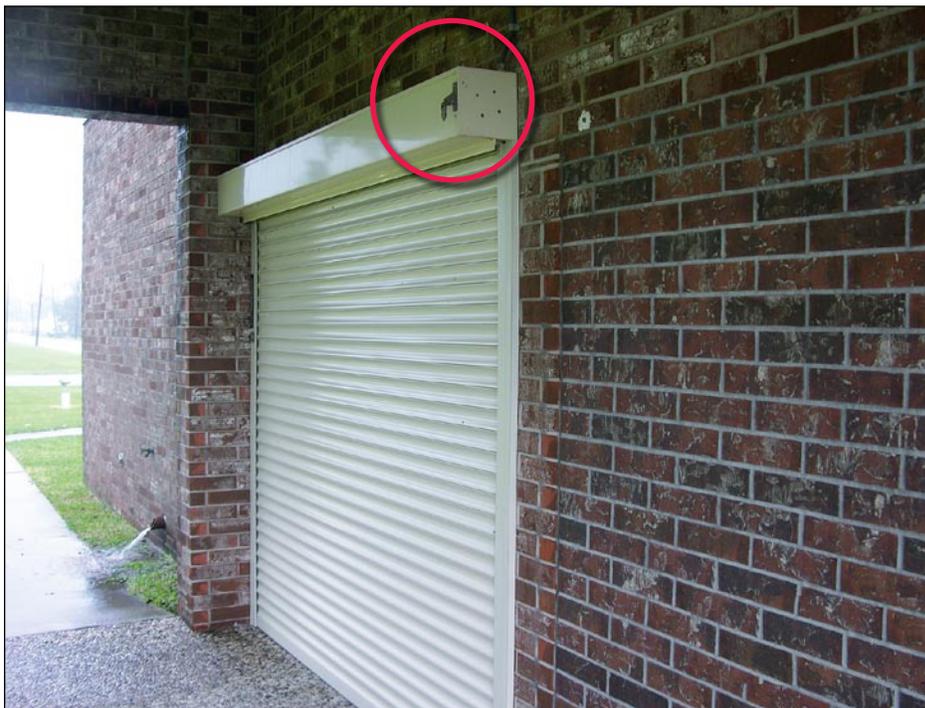
Figure 4-51.
View of a new motorized
shutter; the toggle in
the red circle allows the
shutter to be manually
raised

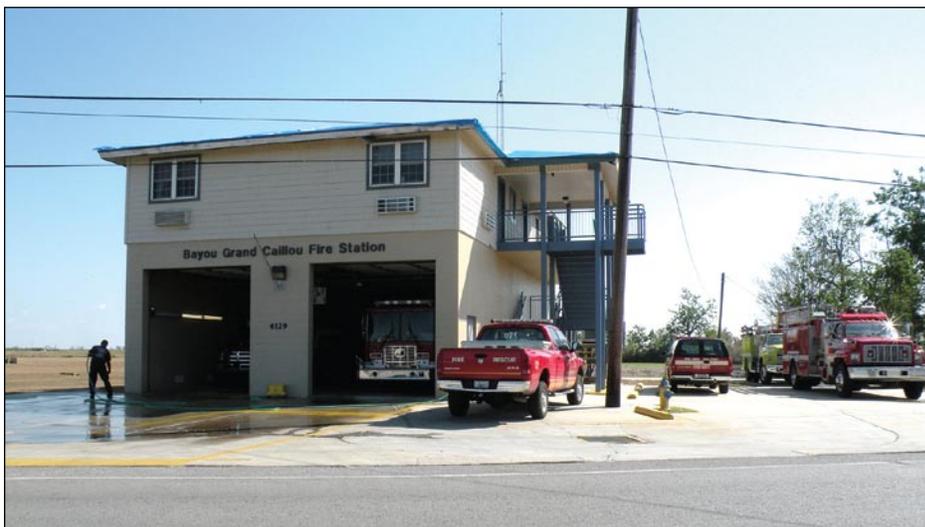
Figure 4-55. The Bayou Grand Caillou Fire Station is elevated above the ABFE and sustained no damage

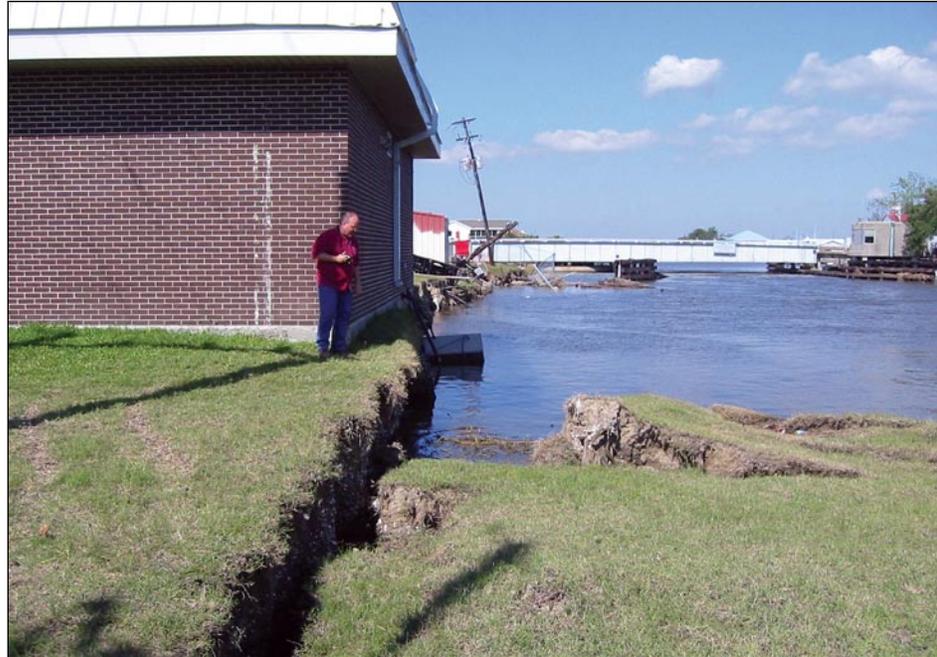
Figure 4-57.
7th Ward Fire District No.1
Fire Station; wall repairs
were in progress during
MAT inspection

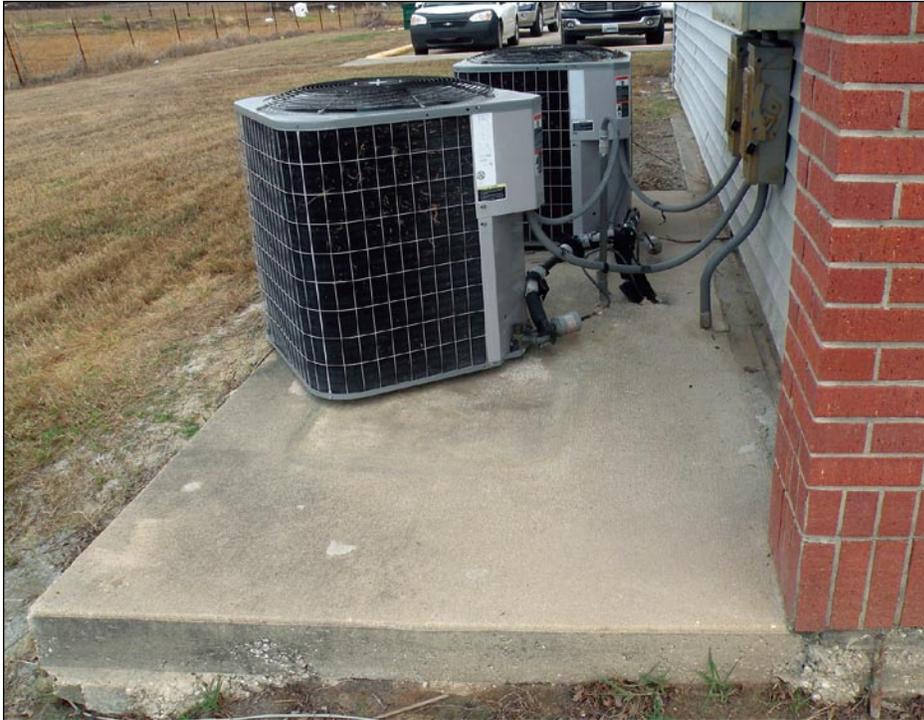
Figure 4-58.
Condenser units were installed at Hackberry Fire Station after Ike and are vulnerable to future flooding

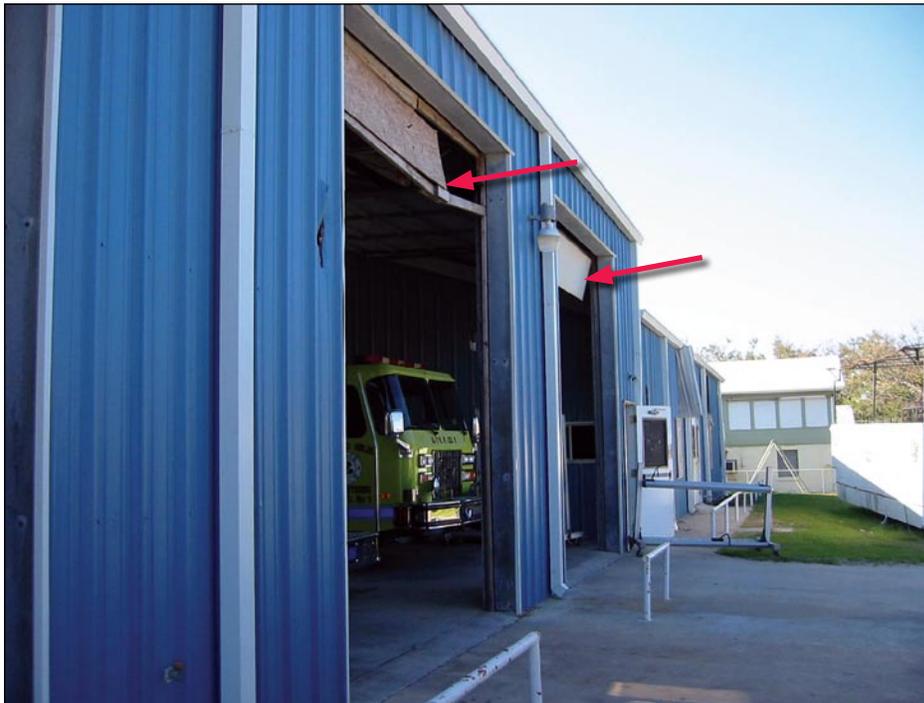
Figure 4-59.
Wind damage (red arrows) to Grand Isle Fire Station remaining from Hurricane Katrina

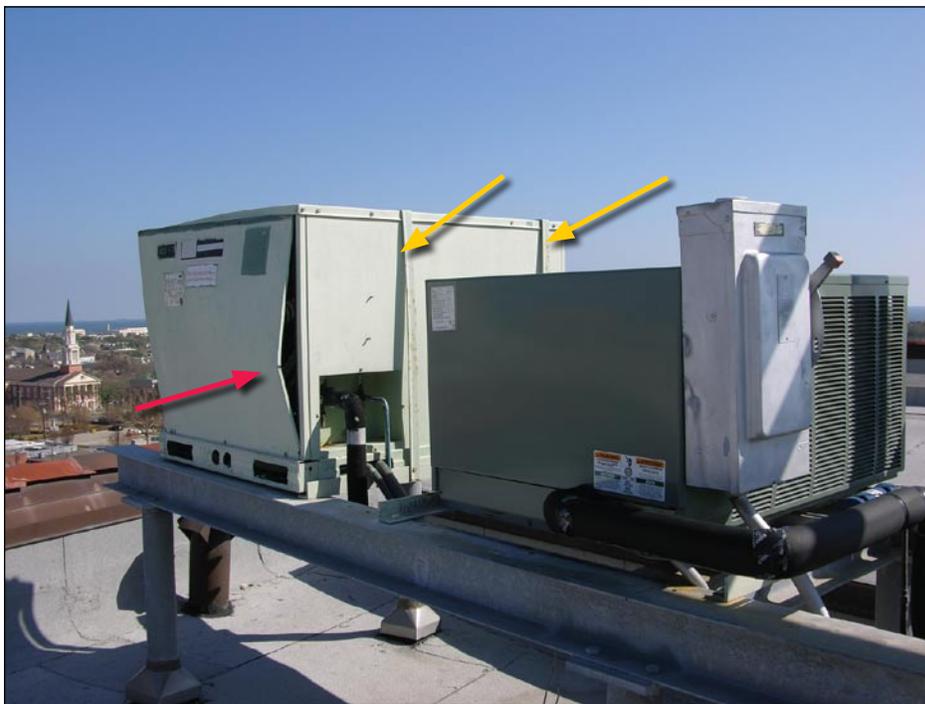
Figure 4-64.
The access panel (red arrow) nearly blew away; the yellow arrows indicate supplementary anchor straps

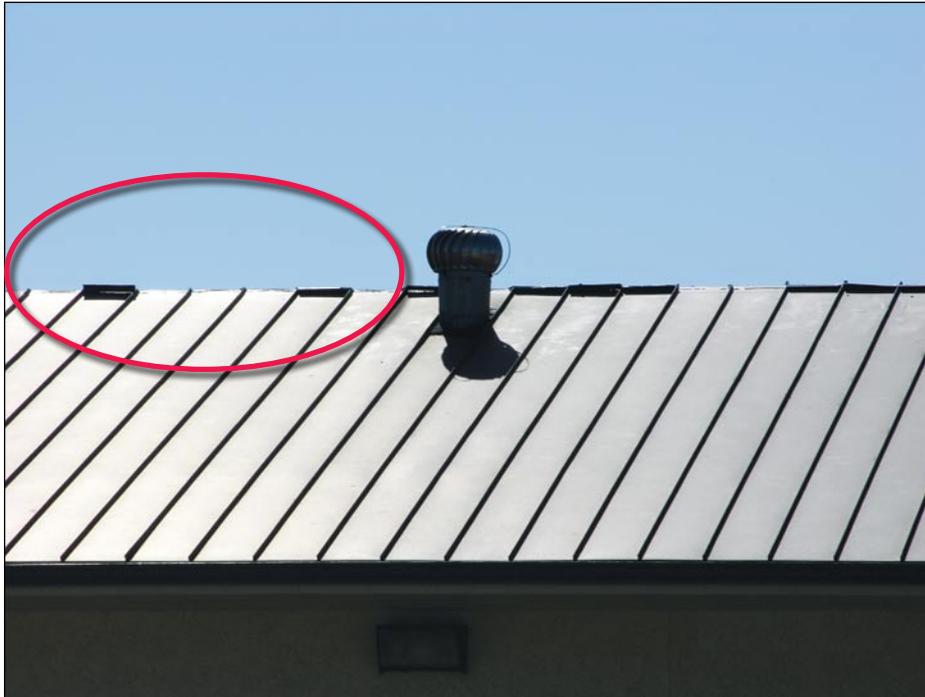
Figure 4-67.
The oval shows where
ridge flashing blew away
