HURRICANE  
**IKE**  
& IN TEXAS  
& LOUISIANA

# 6 Conclusions

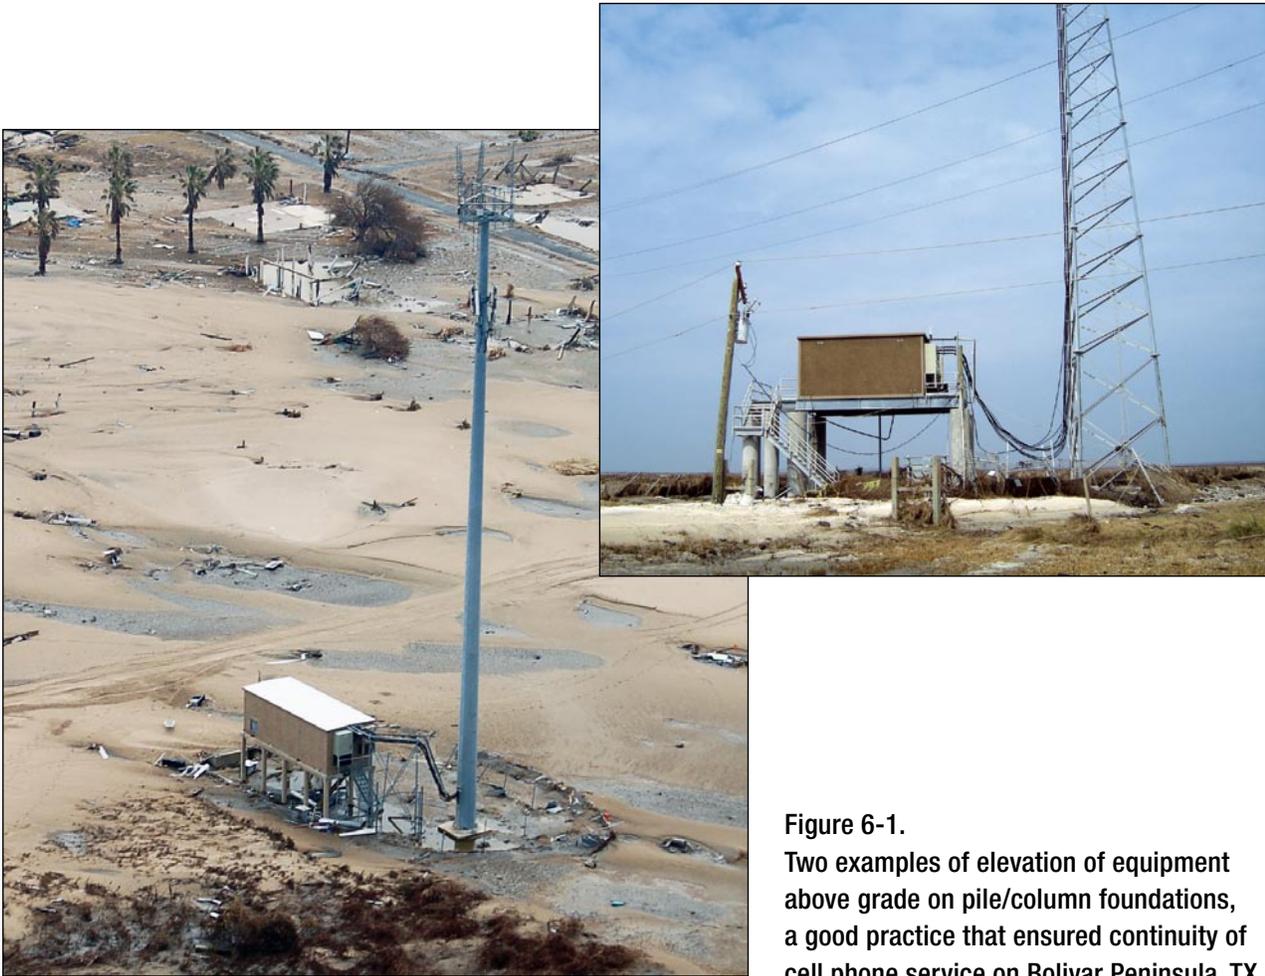
The Federal Communications Commission studied communications related to response activities following Hurricane Katrina; this study included a consideration of emergency power requirements for cell towers. The MAT noted and benefited from the elevation of cell phone tower equipment and powering by emergency generators on Bolivar Peninsula (Figure 6-1). When the MAT was in the field 5 days after Hurricane Ike, it had cell phone coverage and was able to access maps and other information from the Internet, despite the fact that much of the commercial and residential development on the Peninsula lay damaged or in ruins.

Figure 6-1. Two examples of elevation of equipment above grade on pile/column foundations, a good practice that ensured continuity of cell phone service on Bolivar Peninsula, TX

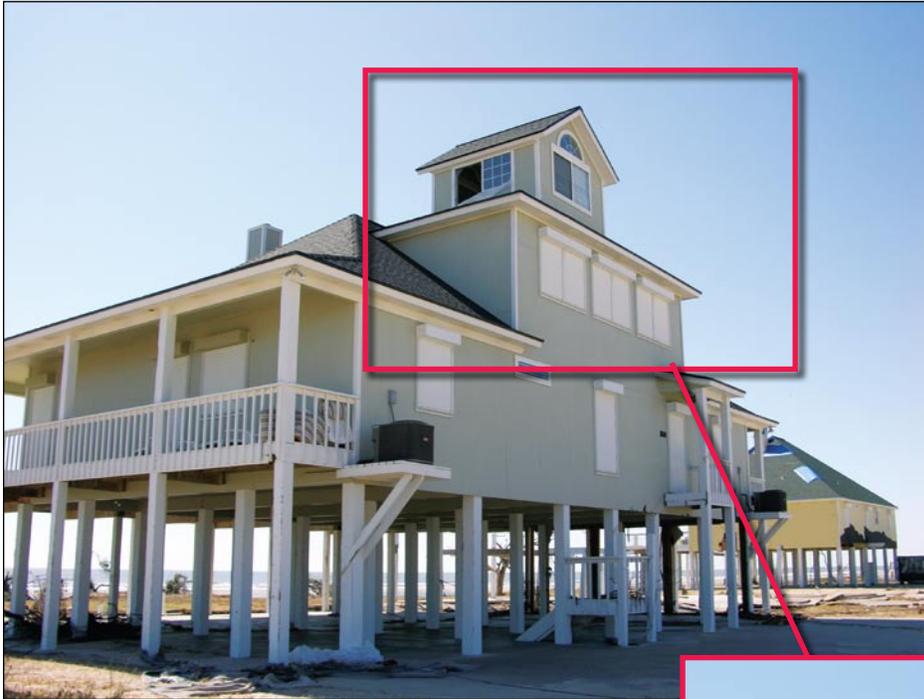
**Doors, Windows, and Shutters.** Few impact-resistant glazed window units were observed by the MAT. Most houses observed by the MAT had some form of shutter to provide debris impact protection. The shutter type varied from simple plywood to expensive roll-down shutters. The MAT observed numerous instances where plywood shutters were not properly anchored to the building structure, but rather to window frames and wall cladding. Though few debris impacts were observed, it appeared that most shuttering was effective in this less-than-design wind event. It was further observed that some homeowners chose not to shutter all windows (Figure 6-2). In some instances, shutters were only placed on the seaward facing windows, and the unshuttered north facing windows left vulnerable to Ike's backside winds.

**Figure 6-2.**  
The upper windows on this Seabrook, TX, residence were not shuttered and were vulnerable to windborne damage

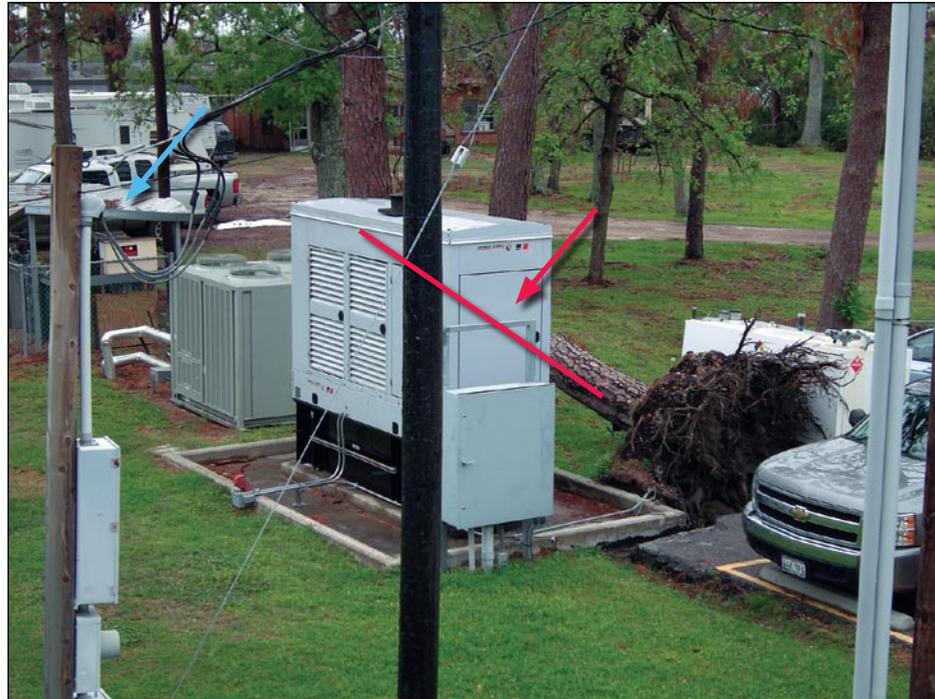
**Figure 6-3.**

generators from wind and windborne debris at the vast majority of critical facilities that were observed. The majority of the generators were located outdoors and were susceptible to wind and windborne debris damage. For critical facilities that need to be operational during a hurricane, it is beneficial to house the generators within a building. The advantage of doing so is that if there is an equipment failure, repairs can be performed during the storm. Conversely, when generators are located outdoors, it is often unsafe to work on them during an event. Also, when housed within a building that is resistant to wind, windborne debris, and tree-fall (as recommended in FEMA 543 and 577), the generator is protected from these hazards (Figure 6-3).

The tree shown by the red line nearly fell on the hospital's emergency generator (red arrow). The tree hit and damaged a metal roof that was over the compressed gas cylinders (blue arrow).

For critical facilities where a total loss of power for several days is tolerable (for instance, a community center that serves to house emergency workers brought in after a storm), it can be appropriate to save money and locate the generator outdoors. For facilities where loss of power is not tolerable (such as hospitals and EOCs), however, it is very unwise to place them outdoors or in enclosures that lack sufficient wind and windborne debris resistance.

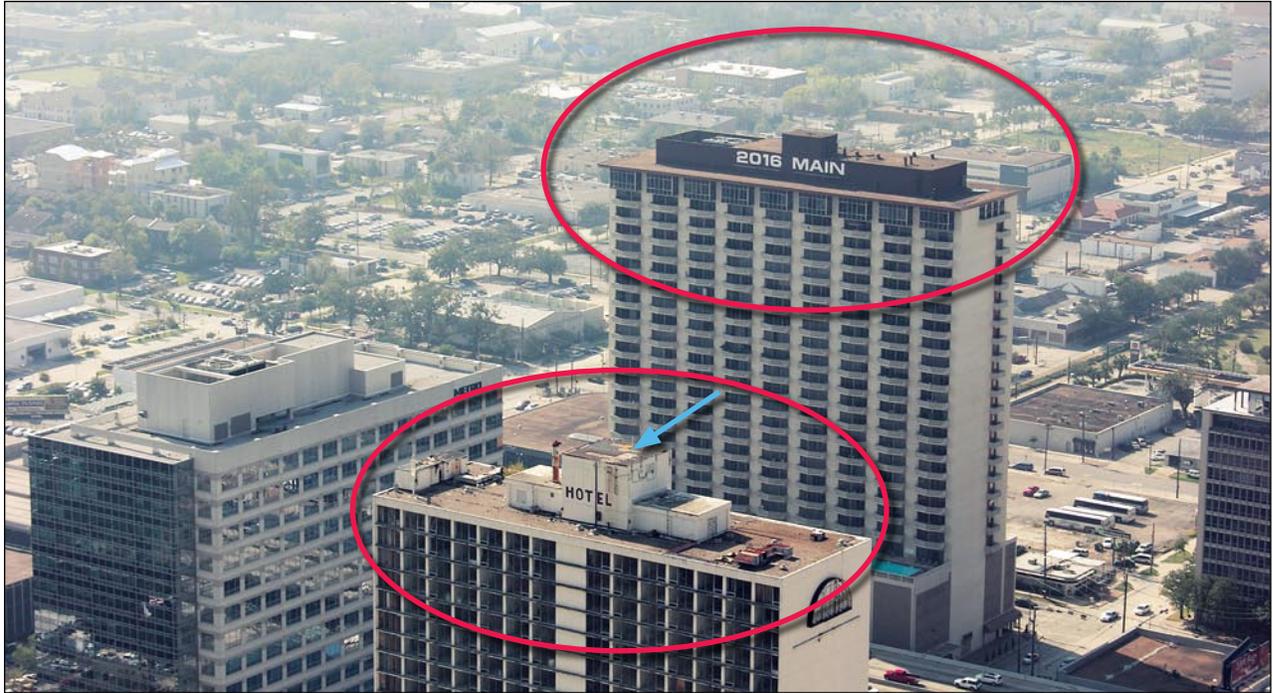
Figure 6-4.

**Aggregate-Surfaced BURs.** Twenty-five years ago, aggregate blow-off during Hurricane Alicia caused extensive and expensive glazing damage in Houston. Therefore, it was surprising to observe that there were still aggregate-surfaced BURs in the area (see Chapter 5). Because wind speed increases as the roof height increases, the risk of aggregate blow-off also increases with roof height. It was therefore particularly surprising to observe aggregate surfacing on mid-rise buildings (such as those shown in Figure 6-4), where their presence presents enhanced opportunity for damage to surrounding buildings.

Aggregate-surfaced BURs on two mid-rise buildings on the periphery of Houston's central business district. The roof membrane blew off the penthouse roof, shown by the blue arrow (Figure 5-19 inset shows building locations).

To avoid aggregate-induced glazing damage in urban areas in hurricane-prone regions, aggregate should be removed from built-up and sprayed polyurethane foam roofs.
