Mitigation Assessment Team Report on

Hurricane Ike

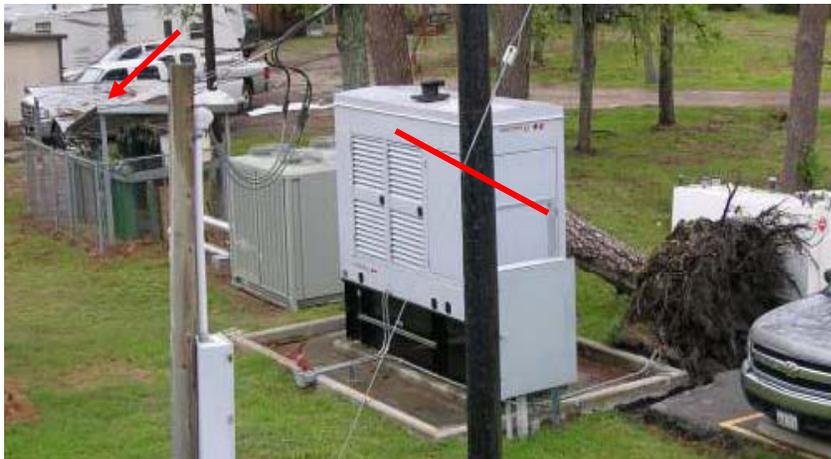
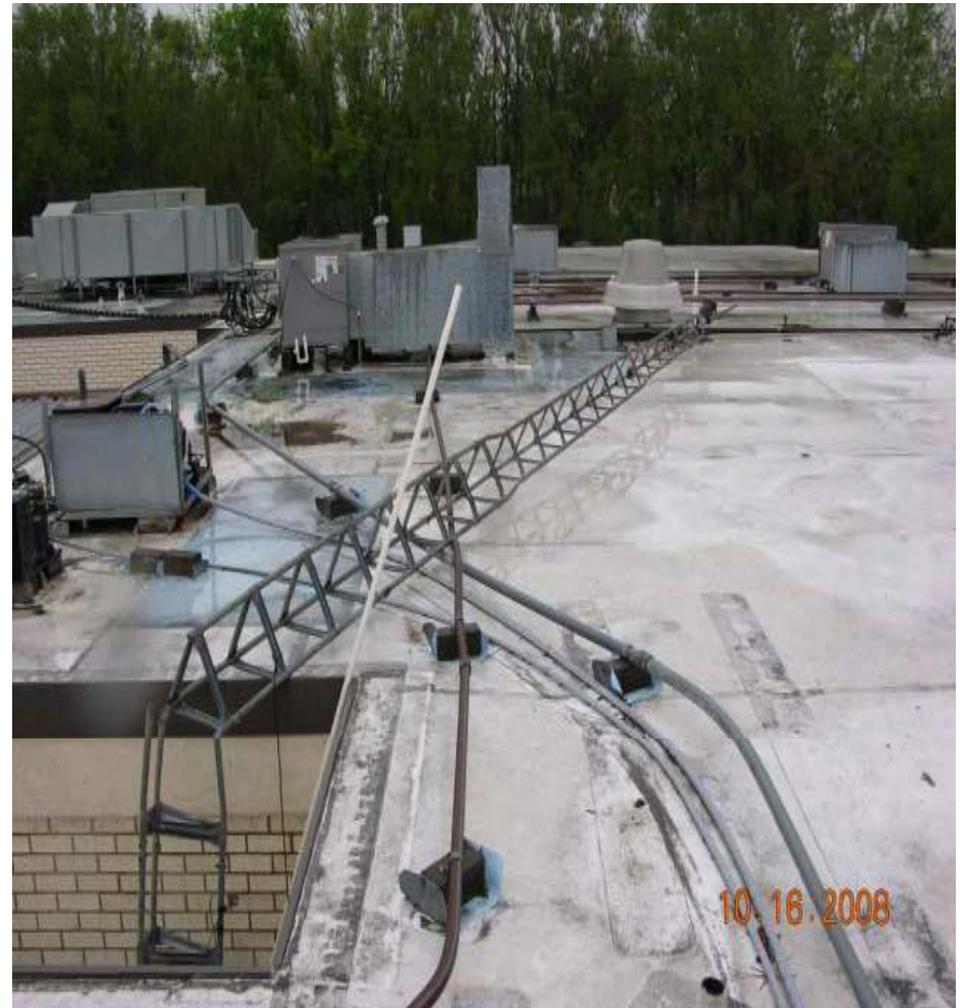
- Observation: Most critical facilities had wind vulnerabilities -- some were significant

- Existing facilities: perform comprehensive vulnerability assessment of wind-force resisting system and building envelope
 - Mitigation: Consider Guidance in FEMA 543 and 577. If recommendations not implemented, base decision on deliberation and consideration of residual risks
 - Mitigation projects: 2-stage peer review.
-

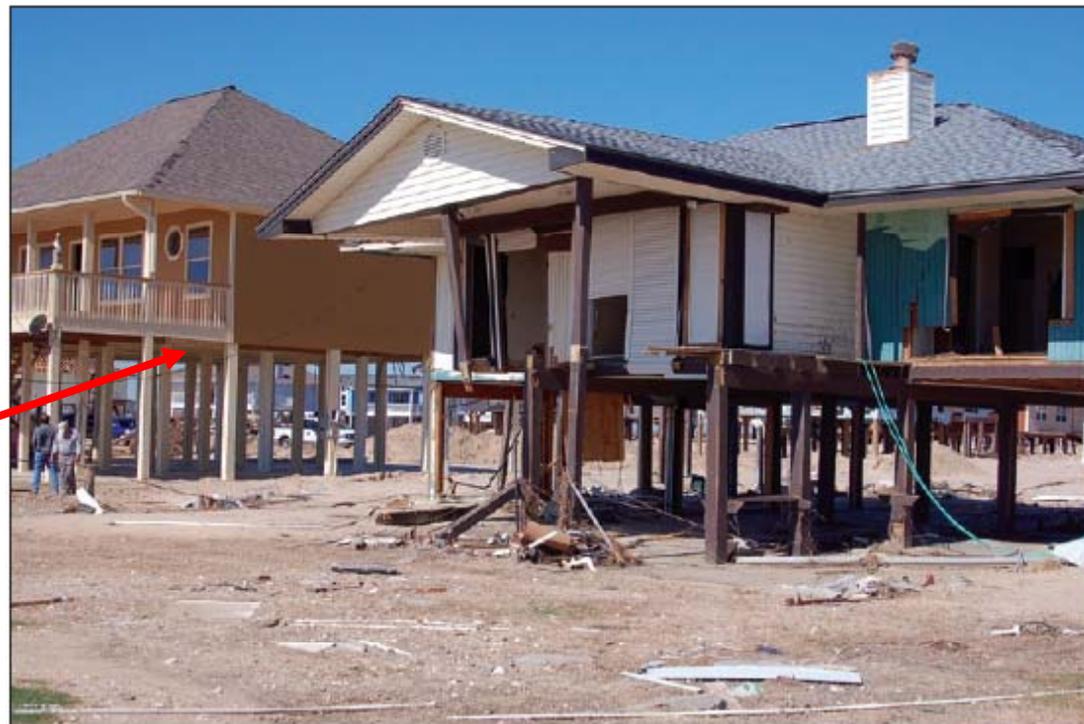
- **Observation: Ike Flood Levels reached 2-5 ft above the BFE across much of the study area**
- **Homes elevated several ft above BFE survived**

**BFE = 16 ft NGVD,
Floor at 21.5 ft**

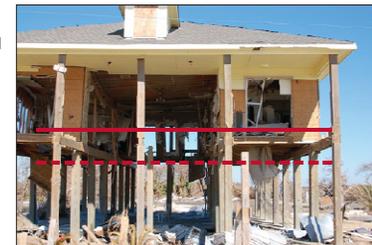
Figure 2. Bolivar Peninsula, TX, V zone house constructed with the lowest floor (bottom of floor beam) at the BFE (dashed line). The estimated wave crest level during Ike (solid line) was 3 to 4' above the BFE at this location.

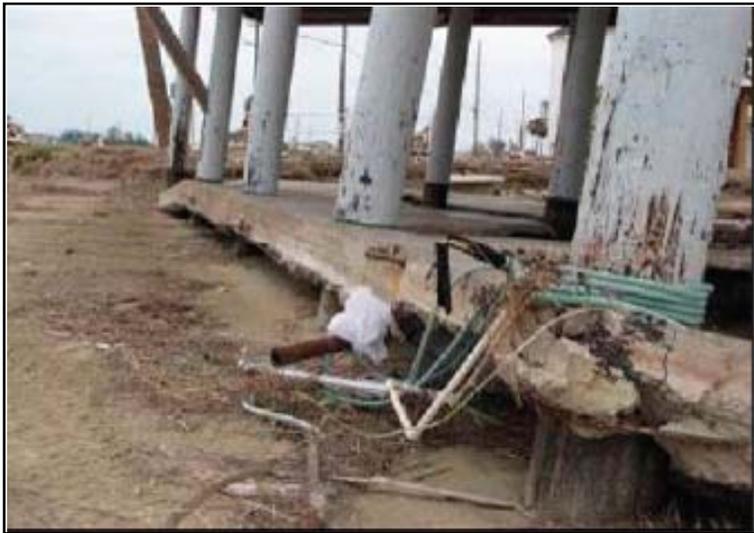
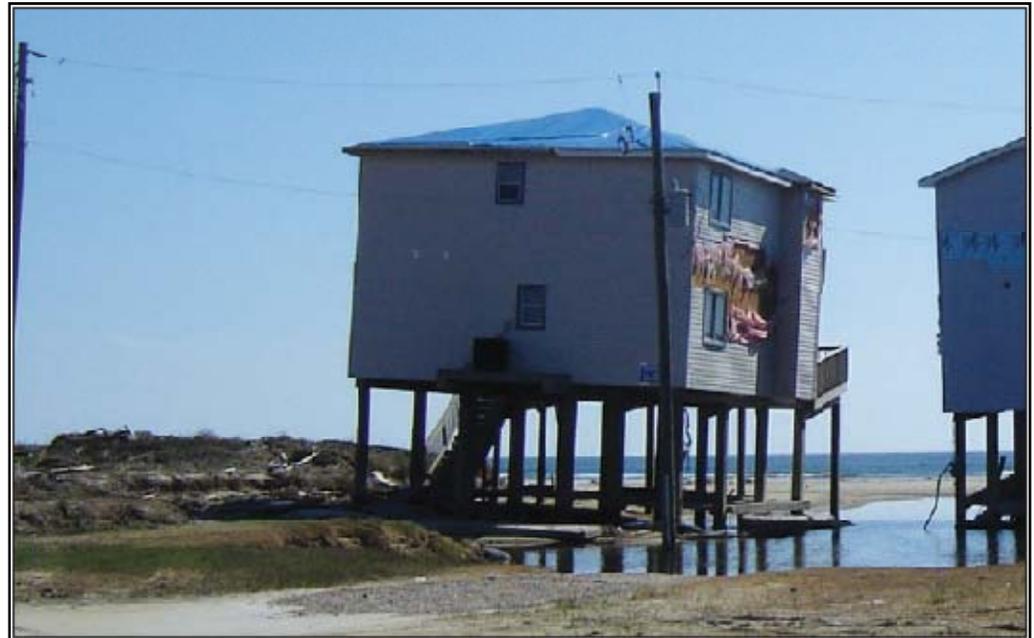
- **Observation: Many foundations failed due to lack of embedment and/or scour/erosion**

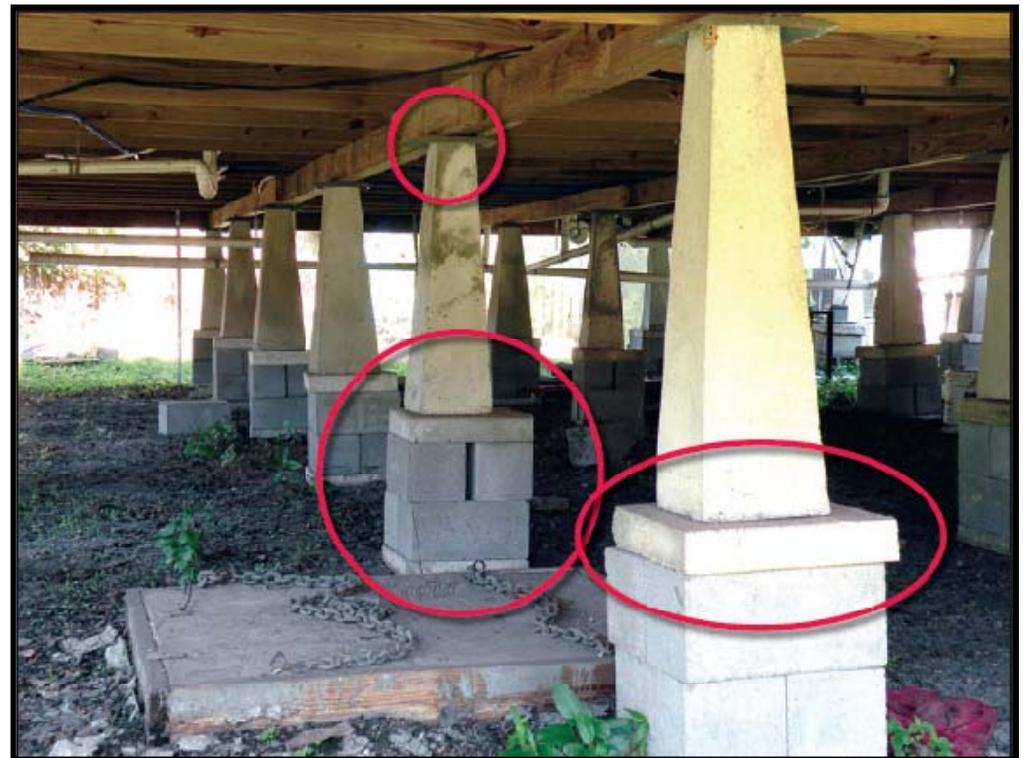
- MAT viewed 31 homes that had been elevated
- **Good News:** none sustained flood damage during Ike
- **Bad News:** many of the homes lacked continuous load paths from elevated home to foundation to ground; other problems

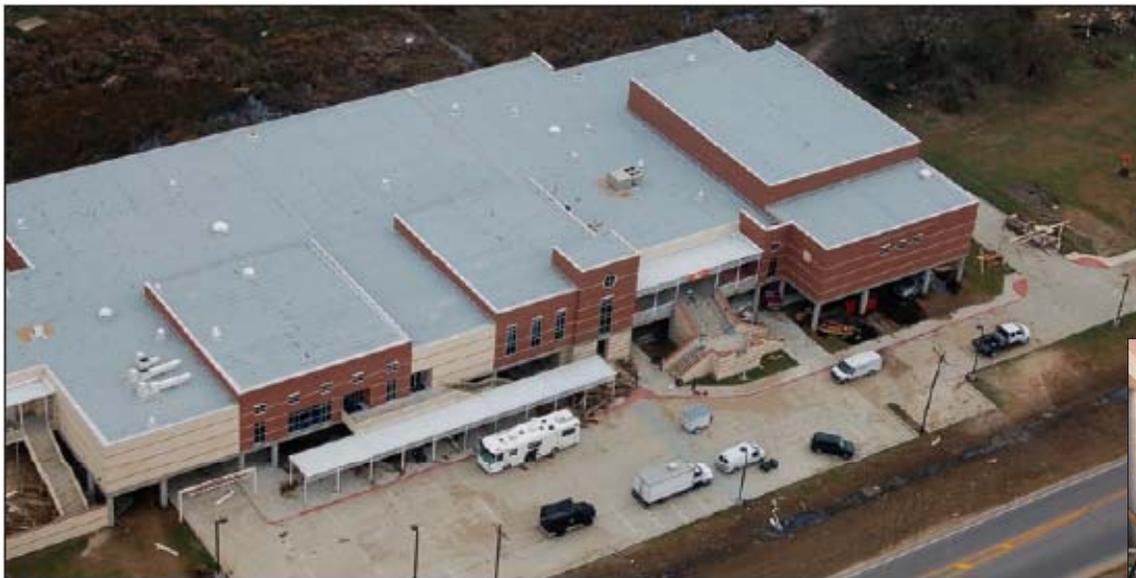
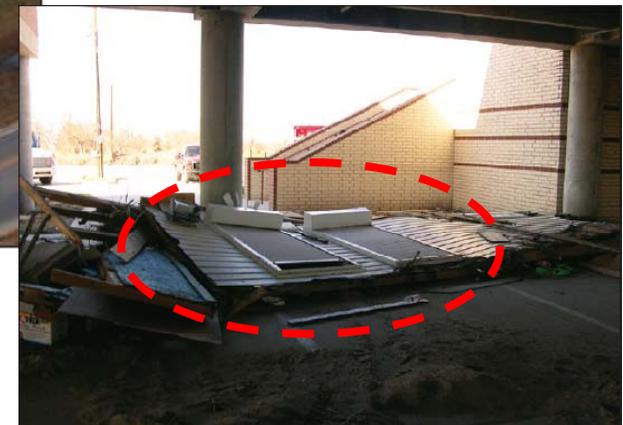
**Crenshaw Elementary
and Middle School,
Bolivar Peninsula**

**Elevated 10 ft above
grade, Ike surge reached
5 ft above grade**

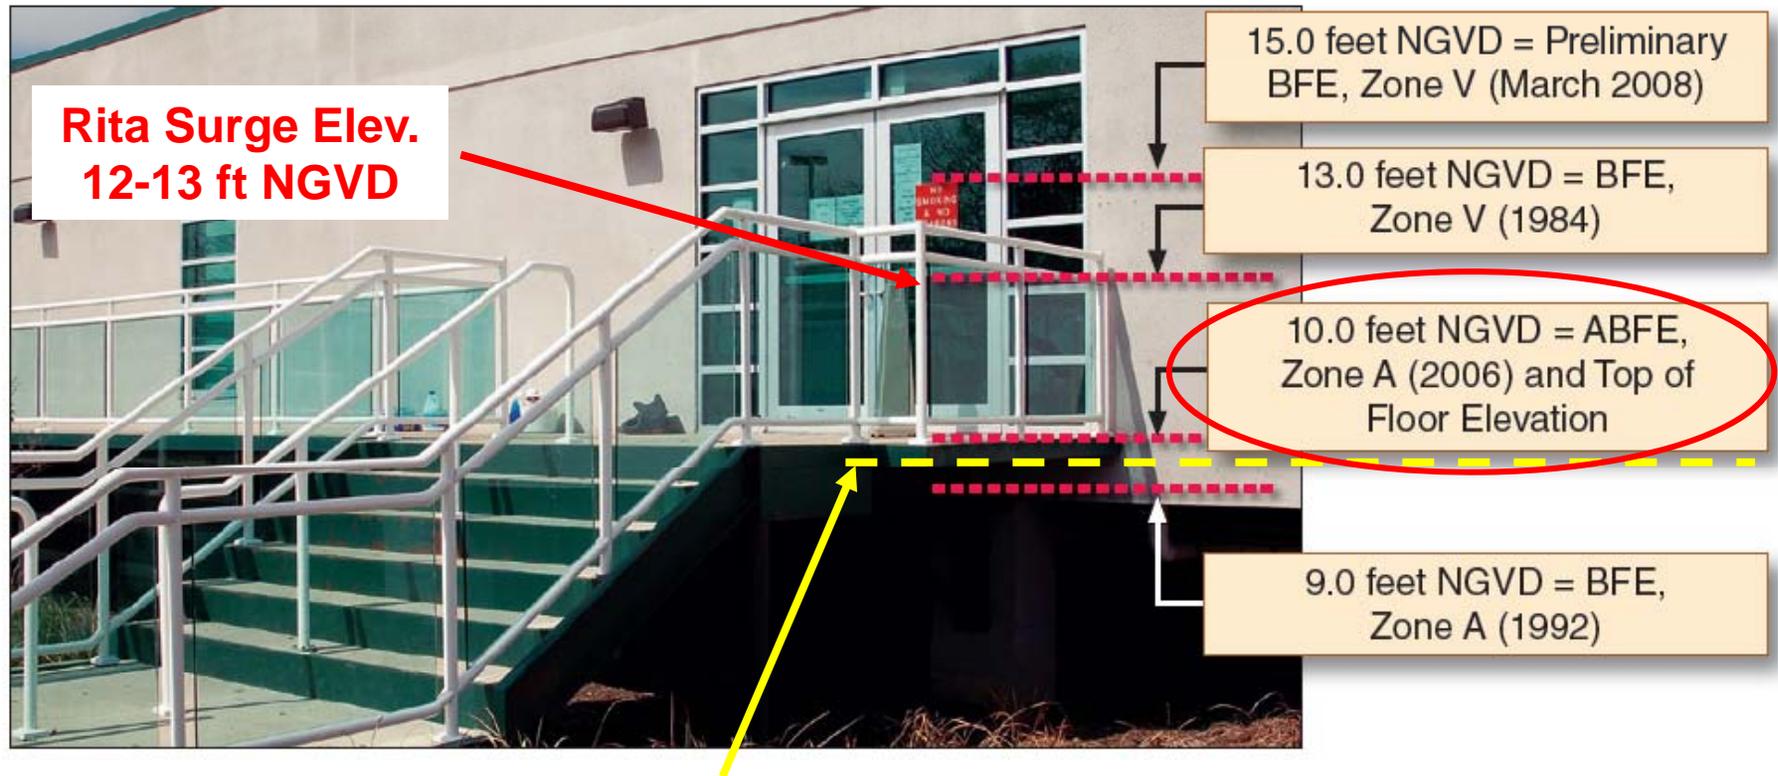
South Cameron Hospital

- Constructed in 1963, 6 years after Audrey, with floor elevation ~ 8 ft NGVD (several feet below Audrey surge level)
- Destroyed by Rita in 2005 (storm surge at site ~ 12-13 ft NGVD)
- Rebuilt in 2008, with top of floor elevation at 10 ft NGVD
- Ike water level was just below floor, utilities were damaged

Ike Water Level just below top of floor
