Observations on the Behavior of Storm Surge, Waves and Flooding on the Mississippi Coast, Hurricane Katrina, 2005: A Protocol Study

Developed by FEMA, Mitigation Division
Hazards & Performance Analysis Group

FEMA-DR-1604-MS - Jackson - AFO

May 2006

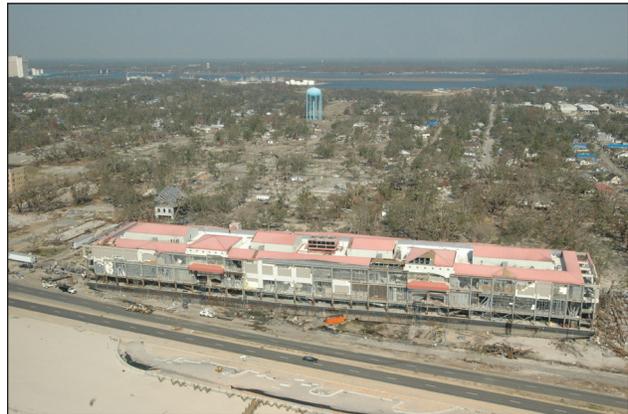
Several casino barges were ripped from their moorings. This one came to rest across Highway 90, several hundred feet from the water.

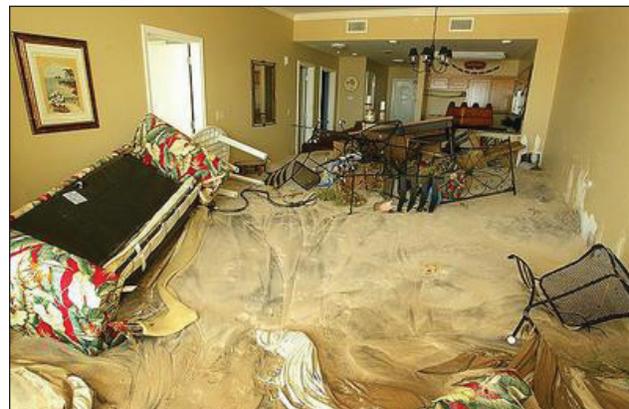
Sediment deposition and furniture displacement.
The Inn at Dauphin Island
Photo by al.com

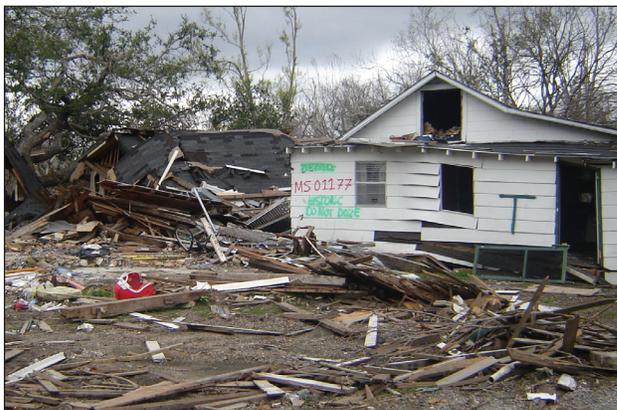
Two houses that became buoyant, crashed into each other and came to rest against a tree several yards from their foundations in Pass Christian

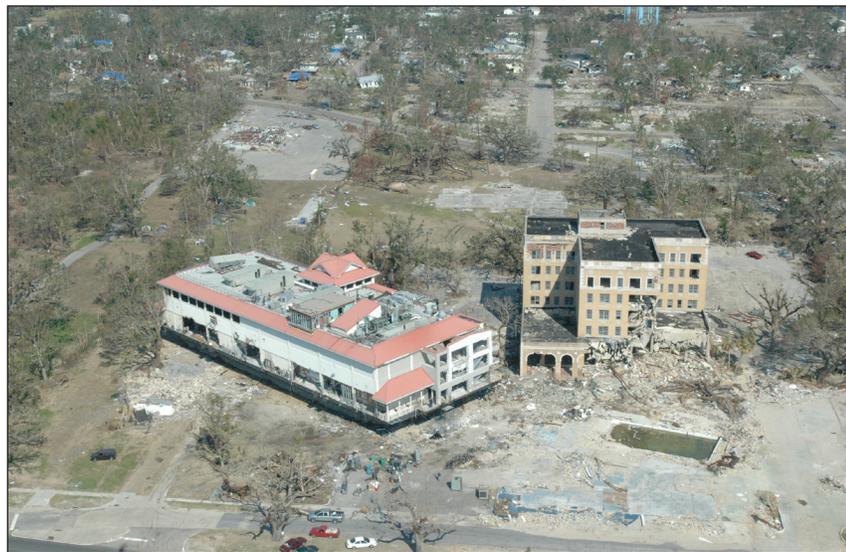
Building damaged by a loosed casino barge

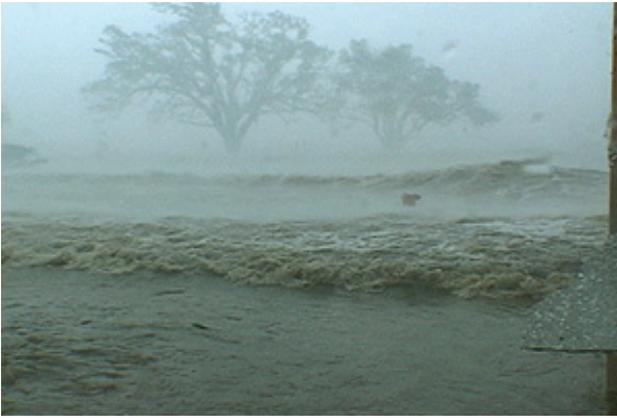
Photo 1-1

Wave series on top of surge, coming ashore in Gulfport, MS.

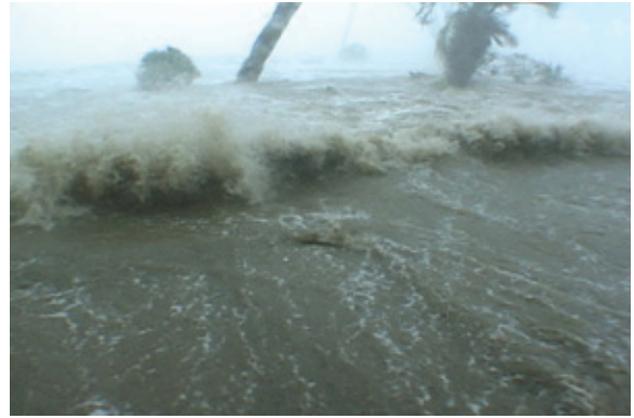
Photo 1-2

Wave on top of surge, showing hydraulics of water, Gulfport, MS.

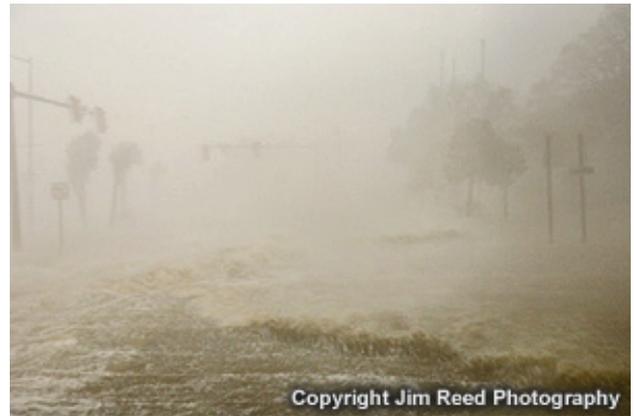
Photo 1-4

Surge and waves covering Route 90, Gulfport, MS.

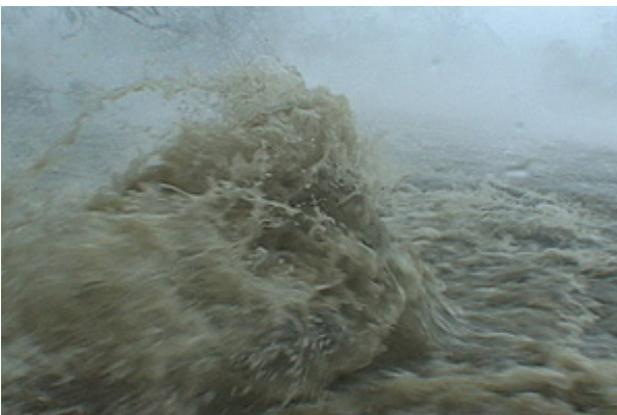
Photo 1-5

Close-up of wave traveling on surge, Gulfport, MS.

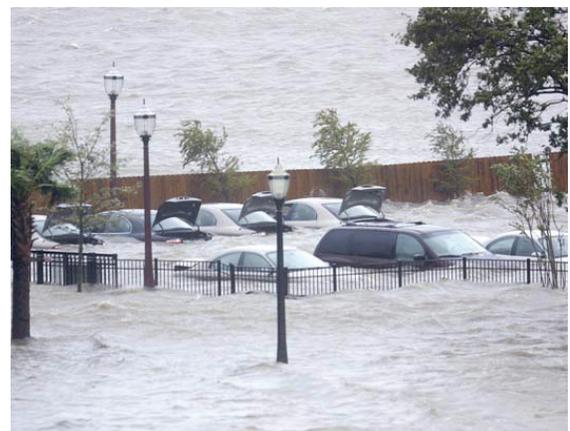
Photo 1-6

Surge depth and pressures causes car trunks to pop open, Gulfport, MS.

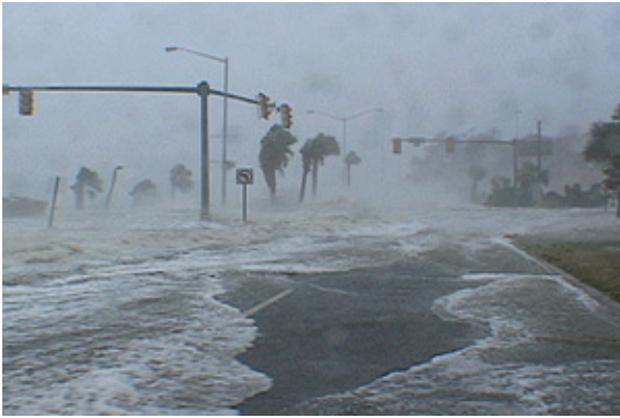
Photo 1-7

Surge on highway in Gulfport, MS.

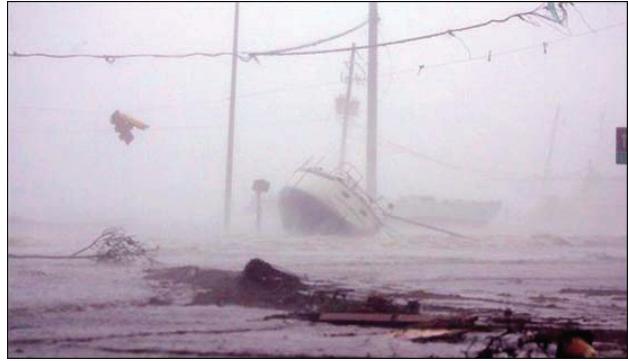
Photo 1-8

Waves crash against boat washed on to Highway 90, Gulfport, MS.

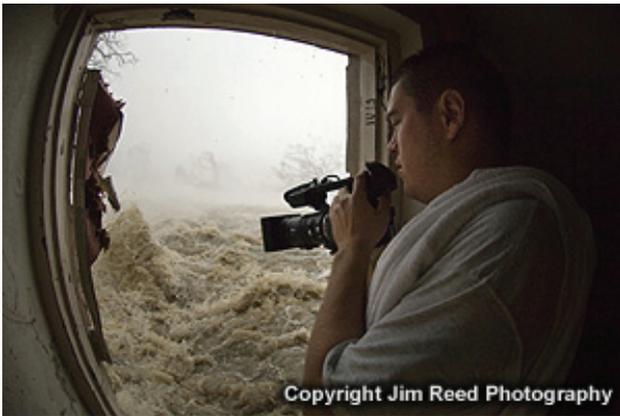
Photo 1-9

Surge and waves as observed in Gulfport, MS.

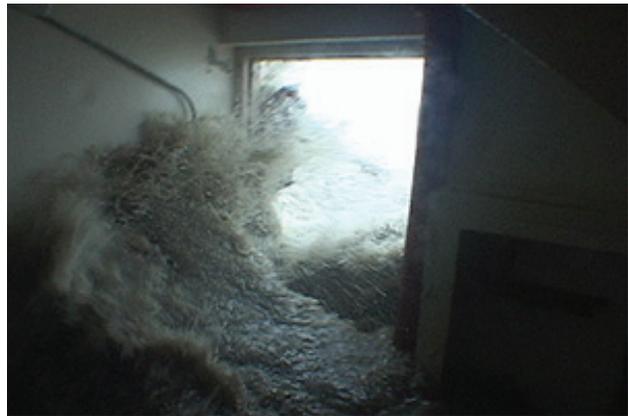
Photo 1-10

Surge and waves entering hotel door in Gulfport, MS.

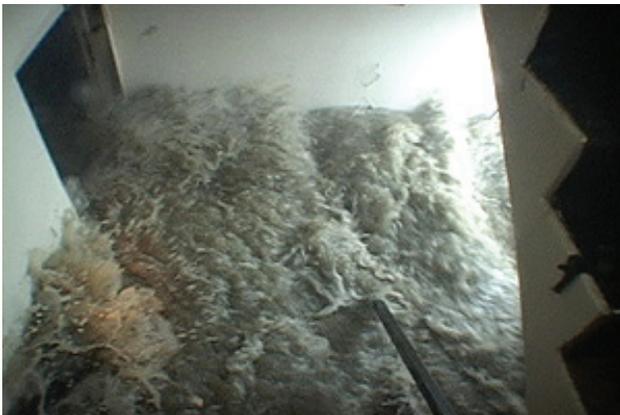
Photo 1-11

Surge advances and retreats at high velocity through hotel doorways, Gulfport, MS.

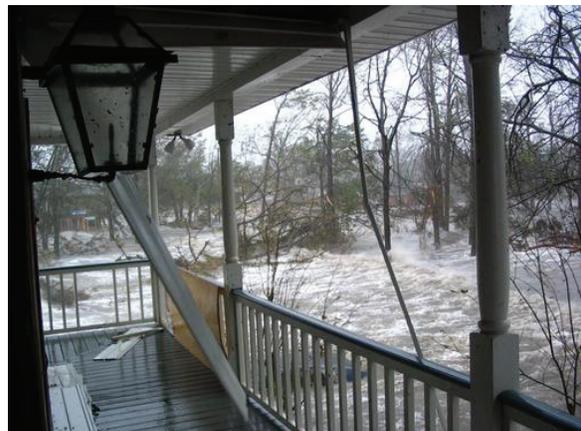
Photo 1-12

Surge and waves pass through Eagle Point near Ocean Springs, MS.

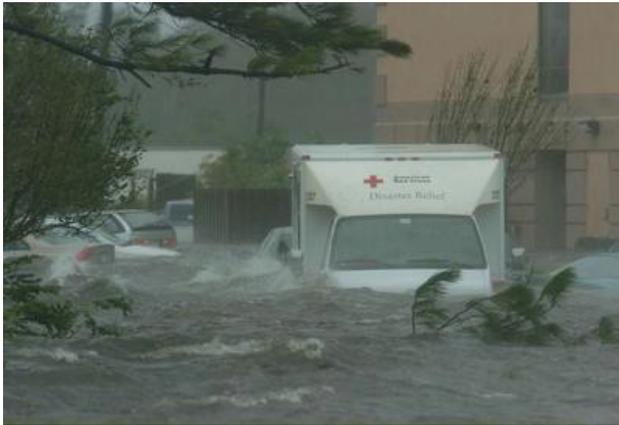
Photo 1-13

Vehicles battered by surge and waves.

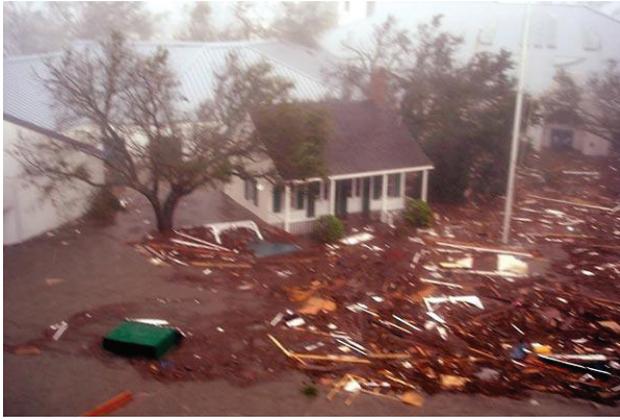
Photo 2-1

Debris battered and weakened structures as it was pushed along by the surge velocity and waves (2:1). Structures that might have otherwise survived the surge height and waves collapsed because of the weakening or total destruction caused by battering debris (2:9, 10) on both the in-coming and retreating waters.

Debris in surge, outside Biloxi City Hall, Biloxi, MS.

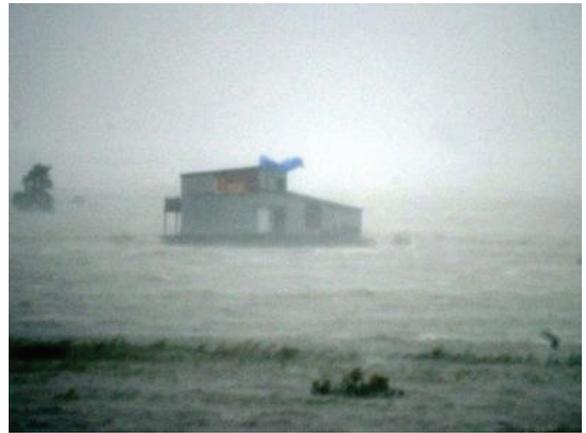
Photo 2-2

House lifted by buoyant forces, swept towards Interstate-10 bridge, Mobile Bay, AL.

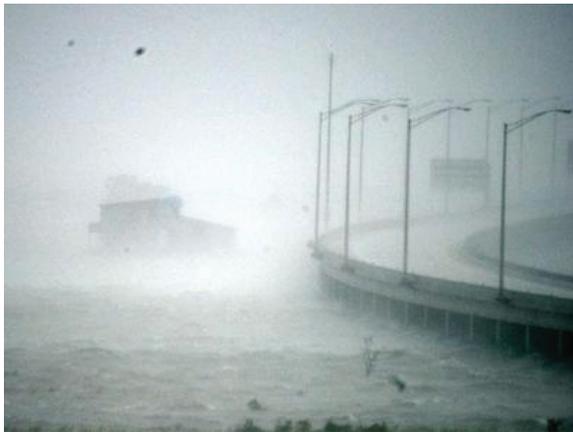
Photo 2-3

House lifted by buoyant forces, swept towards Interstate-10 bridge, Mobile Bay, AL.

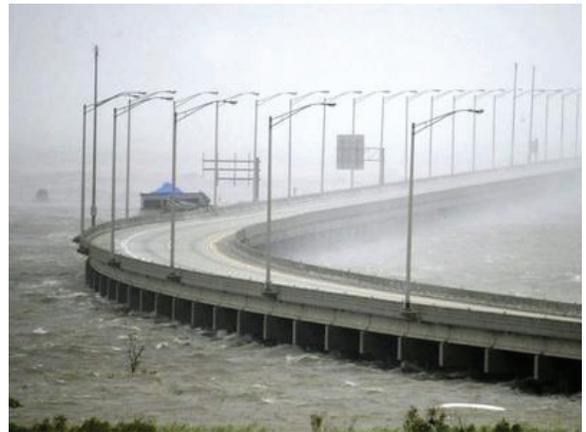
Photo 2-4

House lifted by buoyant forces, swept into Interstate-10 bridge, Mobile Bay, AL

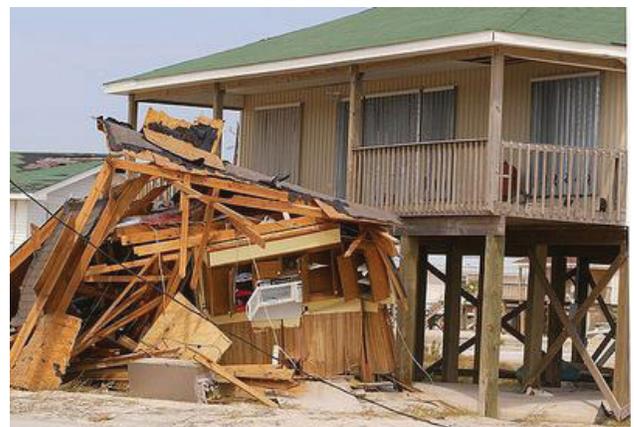
Photo 2-6

Destroyed house transported by surge, crashed into nearby house, Dauphin Island, AL.

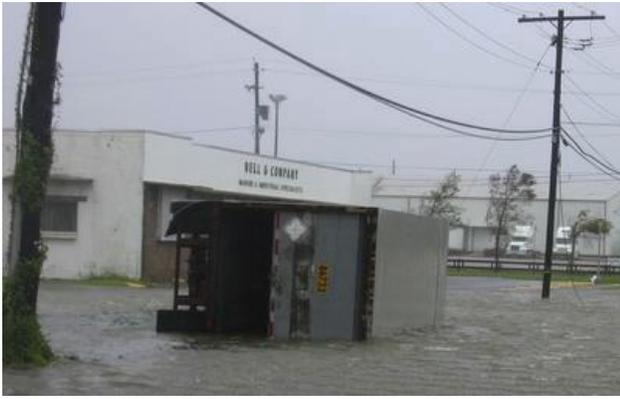
Photo 2-7

A truck overturned and transported by the surge, Mobile, AL.

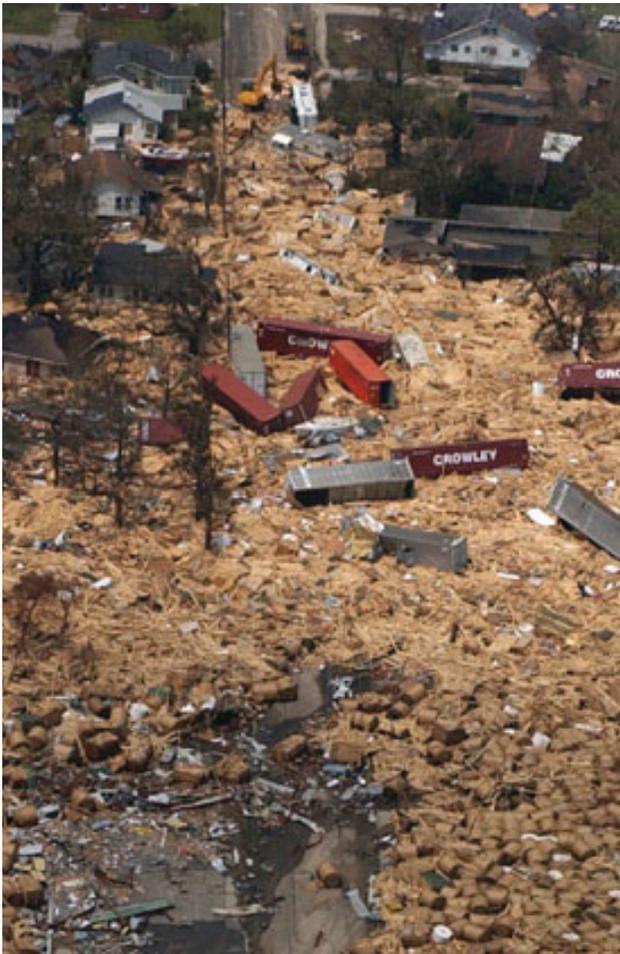
Photo 2-9

Similarly, an industrial-sized Chevron fuel tank was loosed during the hurricane and moved with the floodwaters, finally settling in the westbound lanes of Interstate #10 in Diamondhead (2:5). A barge at the port that became loose carried industrial rolls of brown paper product, approximately 3 ft in diameter and 6 feet tall. Although these rolls were extremely heavy, they traveled with the surge and were strewn several blocks inland (2:9)

Debris, including shipping containers, transported by the surge, Gulfport, MS.

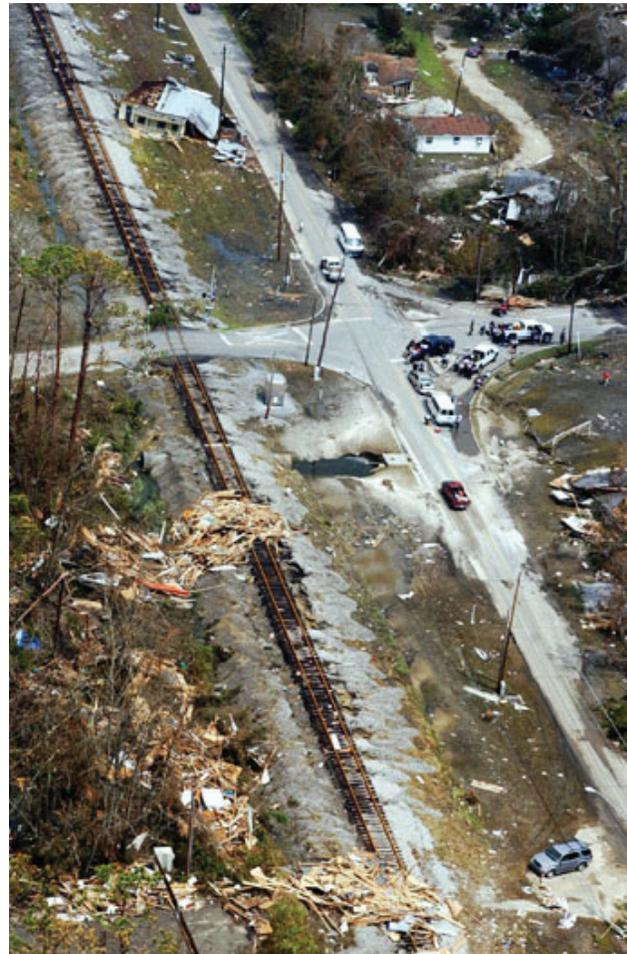
Photo 2-10

Debris and destroyed houses, Waveland, MS.

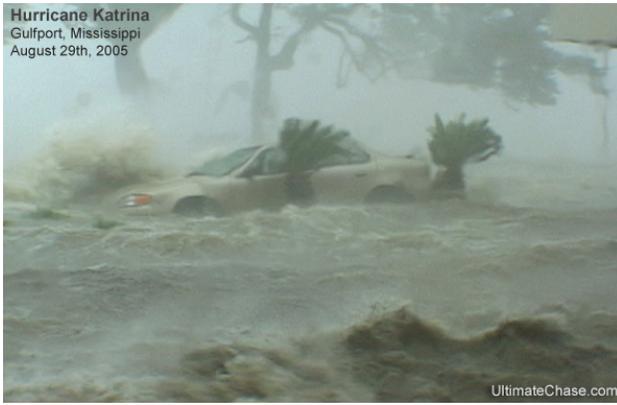
Photo 3-1

Surge and waves float and transport a car, Gulfport, MS.

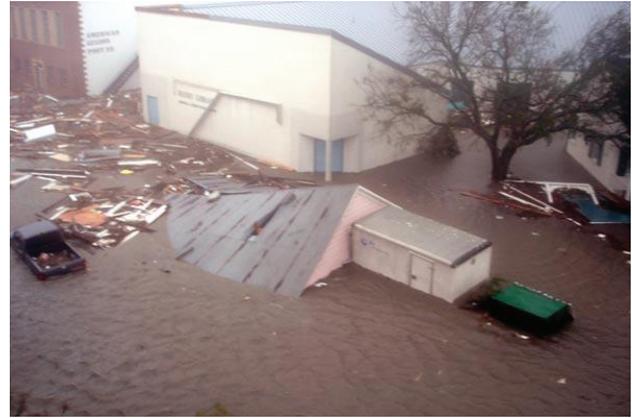
Photo 3-2

Vehicles and other debris washes down Lamese Street, Biloxi, MS.

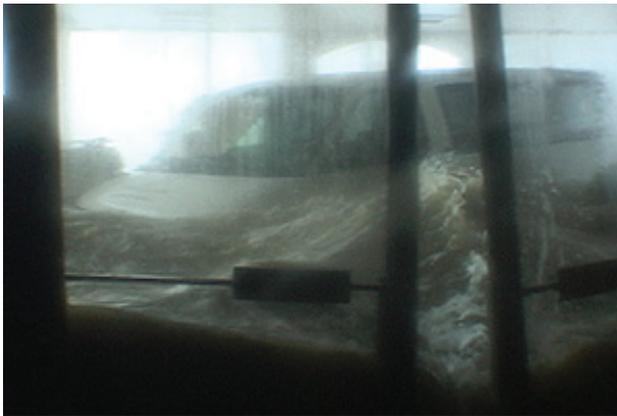
Photo 3-3

Surge and waves carry a vehicle towards a hotel lobby, Gulfport, MS.

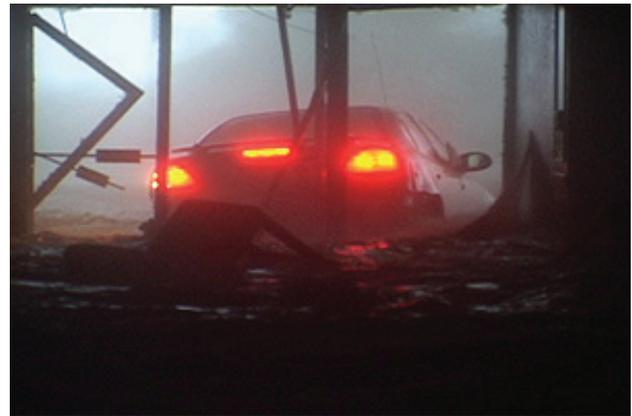
Photo 3-4

Car transported by surge enters a hotel lobby (its lights shorted on), Gulfport, MS.

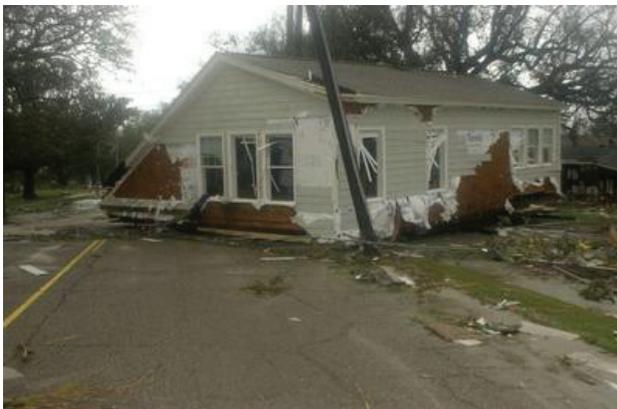
Photo 3-5

House that floated off its foundation ends up in a street, Pascagoula, MS.

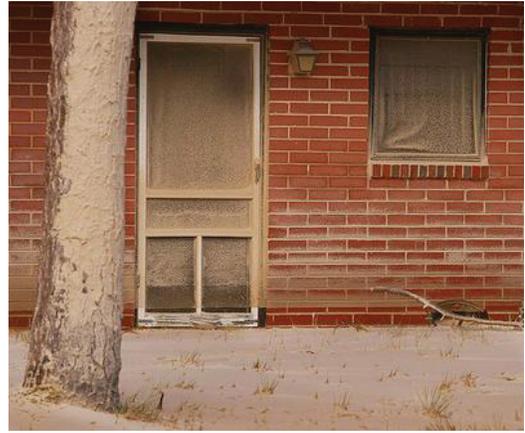
Photo 4-2

Water and wind-carried sand deposited on Dauphin Island, AL.

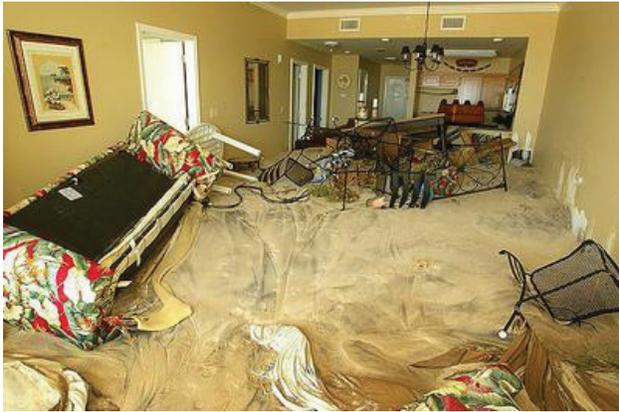
Photo 4-3

Sand deposited in ground floor of a hotel on Dauphin Island, AL.

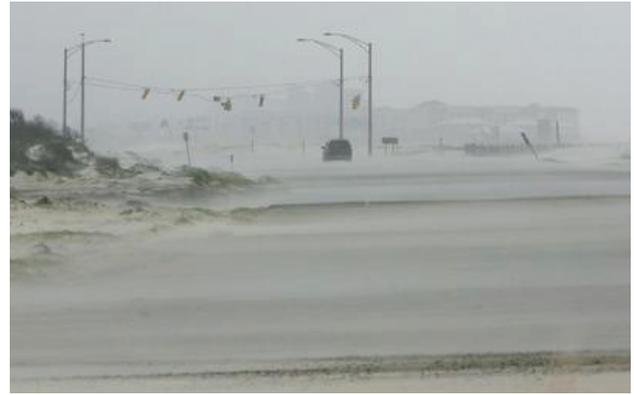
Photo 4-4

Sand deposition on the road between Gulf Shores and Orange Beach, AL.
