## MIDWEST FLOODS of 2008 & IN IOWA & WISCONSIN

# 6 Conclusions

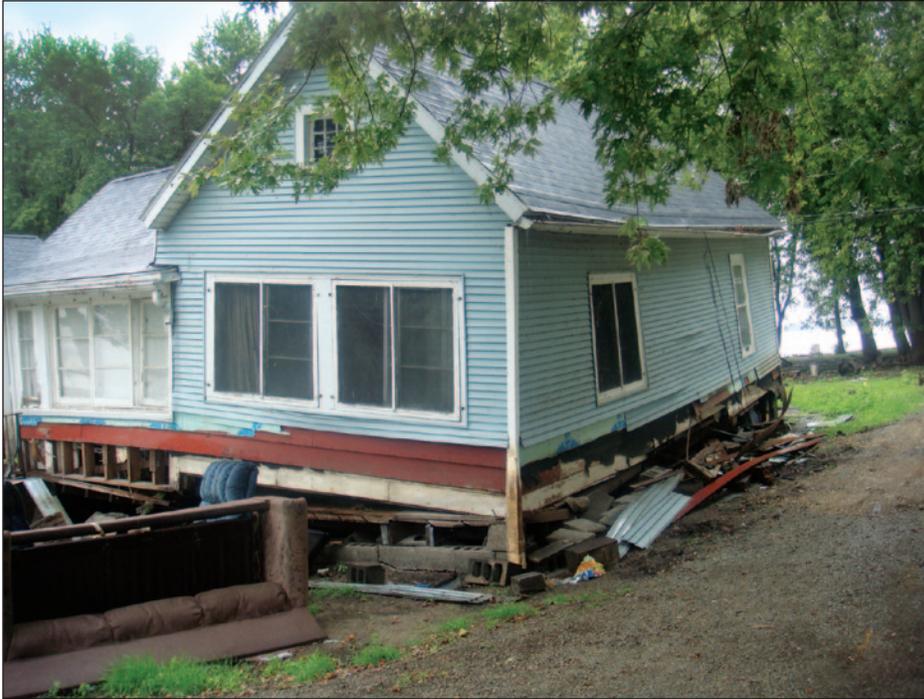
Figure 6-1 illustrates a pre-FIRM foundation that was exposed to hydrodynamic forces as wind-driven waves flowed from Lake Koshkonong to the Rock River. Figure 6-2 illustrates a residential building that was situated behind a levee and removed from its foundation by high-velocity floodwater when the protective structure was overtopped.

**Figure 6-1.**  
The foundation of this residential building was exposed to floodwater flowing from Lake Koshkonong to the Rock River (Newville, Wisconsin).

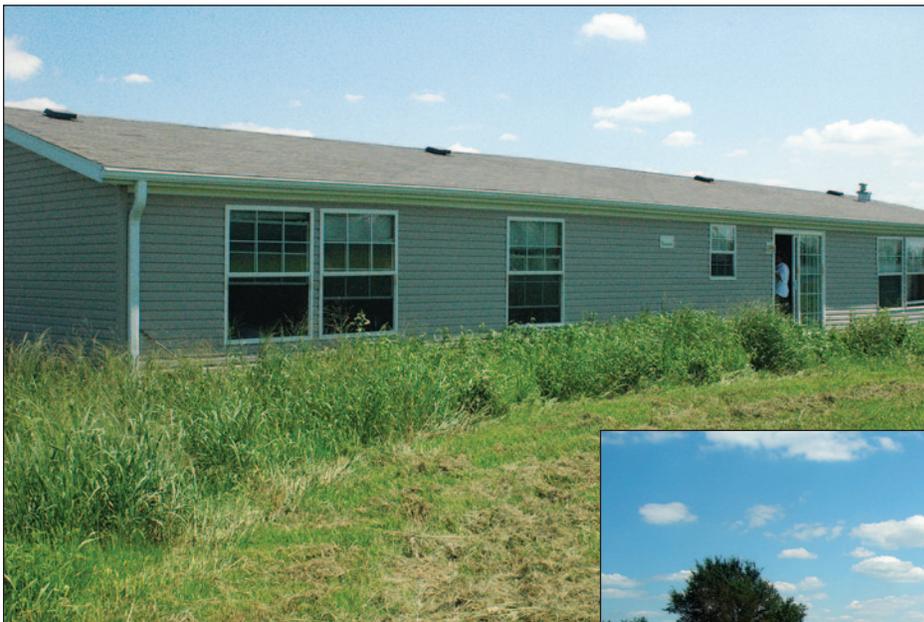
**Figure 6-2.**  
This home was moved several hundred feet away from its foundation after floodwater overtopped a levee in Oakville, Iowa.

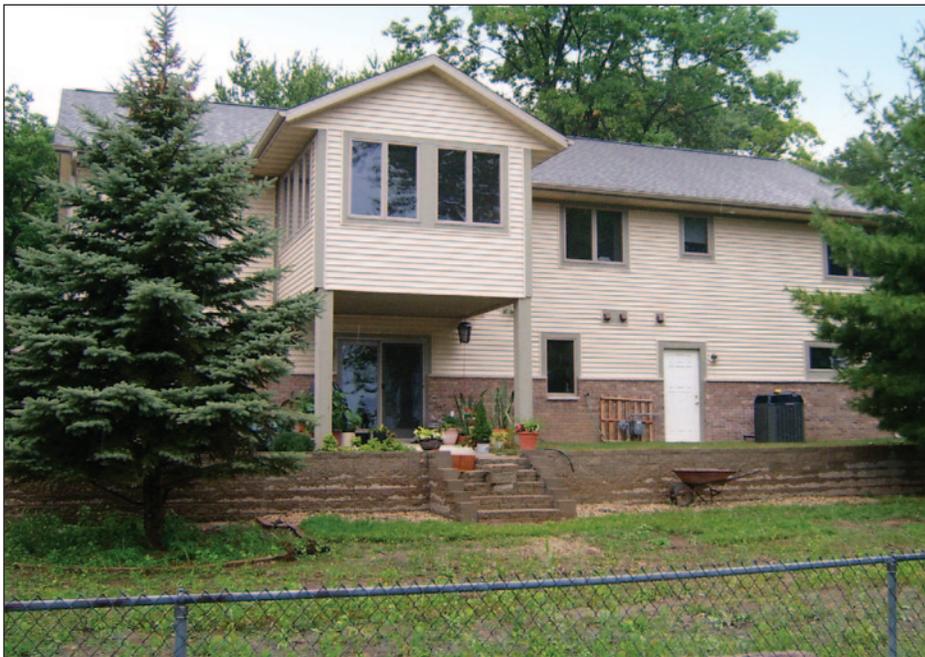
Although little new construction was observed in the floodplain, most of the buildings that were elevated above the BFE performed well and had limited damages. However, some that were elevated to the minimum requirements of the NFIP (i.e., at BFE) were still not high enough to avoid damage. Others were damaged because they were constructed pre-FIRM and had what, if constructed today, would be considered NFIP compliance issues, such as basements, utilities, or other functions located below the BFE. As expected, newer buildings performed best when elevated higher on proper foundations. Figure 6-4 is an example of a property constructed on fill so that the first floor elevation was 2 feet above the BFE.

**Figure 6-4.**  
This property was elevated 2 feet above the BFE and sustained minimal damages, whereas the adjacent pre-FIRM properties built at grade had over 4 feet of flooding (Milton, Wisconsin).

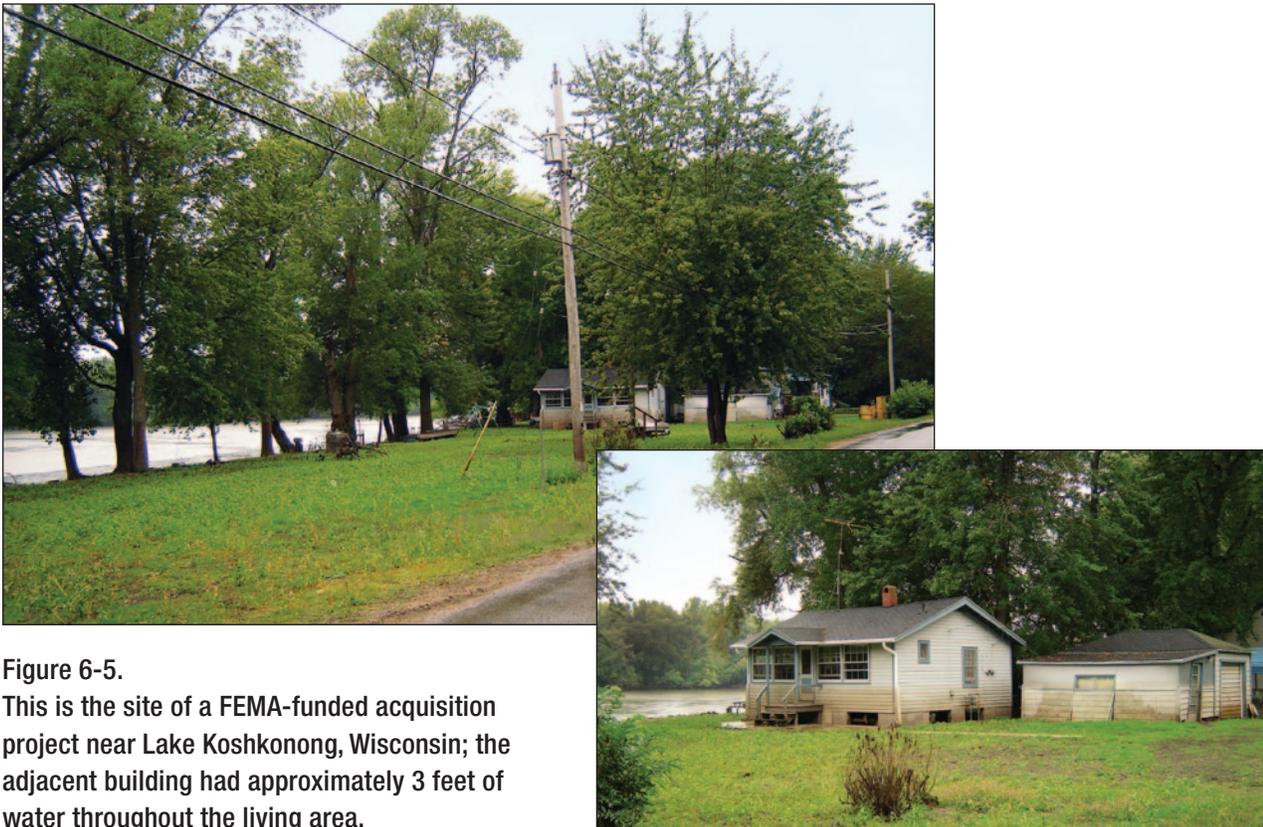
**Figure 6-5.**  
This is the site of a FEMA-funded acquisition project near Lake Koshkonong, Wisconsin; the adjacent building had approximately 3 feet of water throughout the living area.

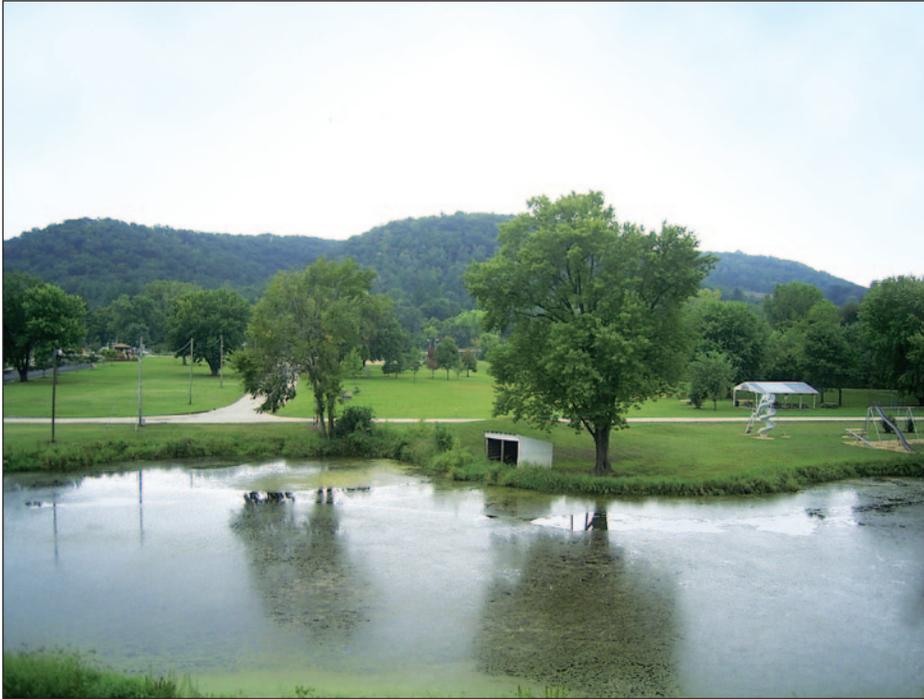
**Figure 6-6.** This park/open area was once the site of Soldier's Grove, Wisconsin, but in the early 1970s the community began to relocate after repetitive flooding; although the park was damaged, the acquisition/relocation program was successful in avoiding damage to residential and commercial properties that had been relocated.
