# MIDWEST FLOODS of 2008

& IN IOWA  
 & WISCONSIN

## 4 Critical and Essential Facilities

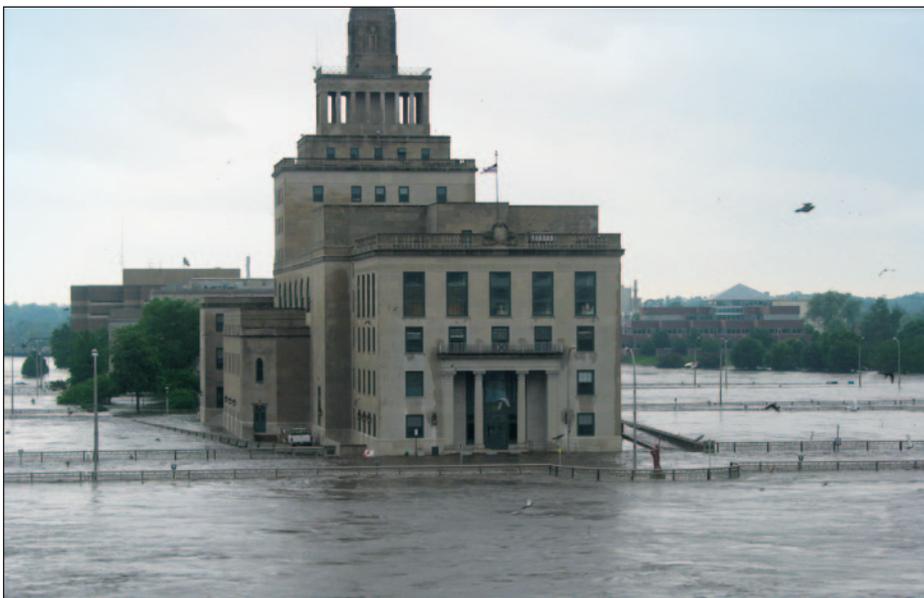
Figure 4-2. Mays Island, including City Hall, flooded as the Cedar River rose (Cedar Rapids, Iowa).

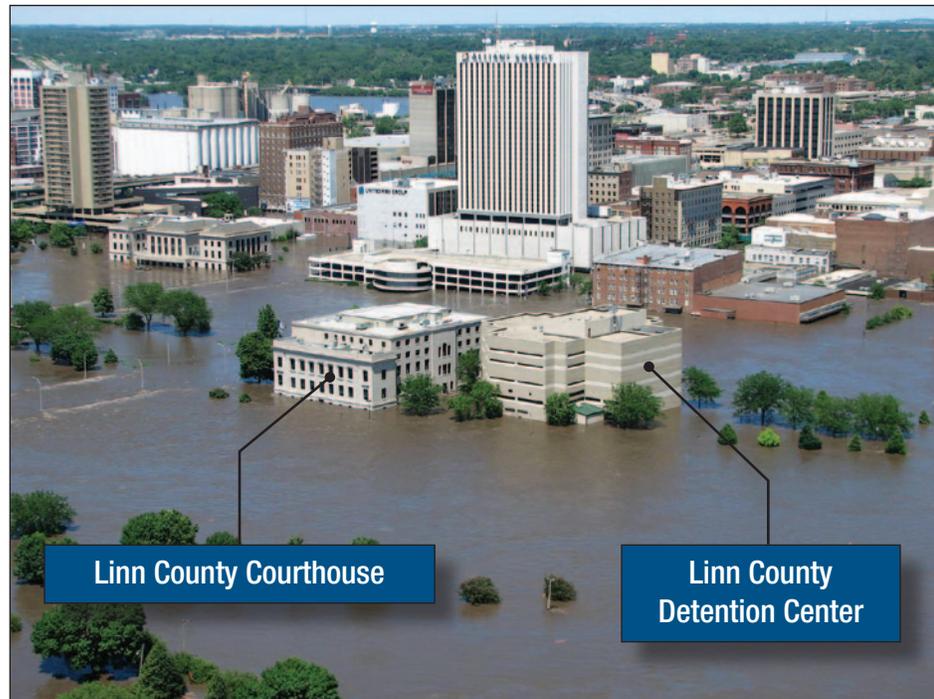
Figure 4-4.  
The Mays Island  
underground parking  
structure connects to  
City Hall and the County  
Courthouse and was a  
major source of floodwater  
intrusion into both buildings  
(Cedar Rapids, Iowa).

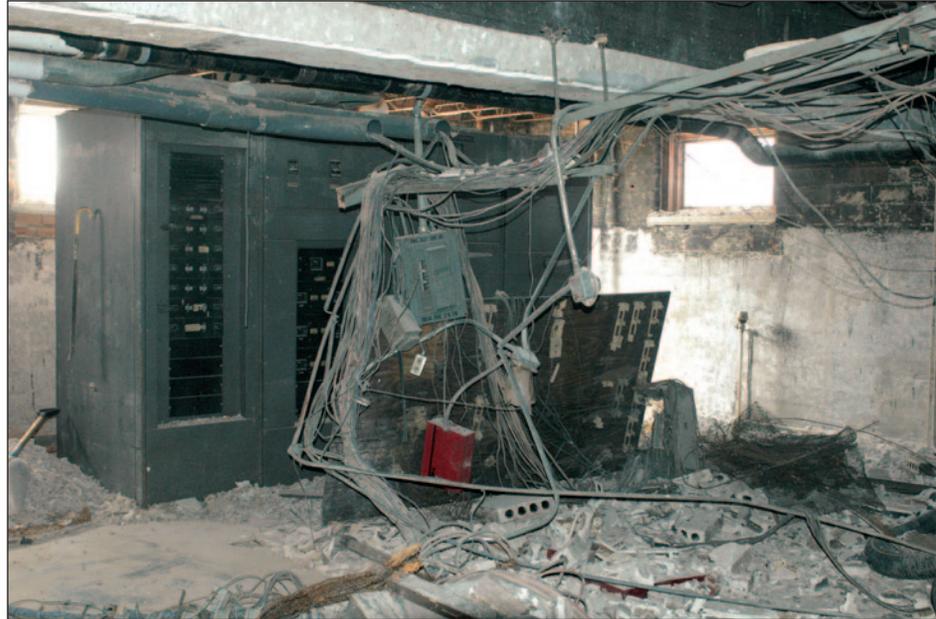
**Summary of Damages:** Both the City Hall and Courthouse lost all interior architectural finishes in their basements as well as significant interior finishes on ground floor levels. In both cases, clean-up was complicated and prolonged by the presence of asbestos building materials, which had to be remediated prior to the rehabilitation of the buildings. Both buildings lost their electrical and mechanical distribution systems including the main electrical service equipment, communications equipment, and life safety equipment (Figure 4-6).

**Figure 4-6.**  
City Hall and the  
Courthouse lost their  
electrical systems. Cleanup  
and replacement were  
prolonged because of  
asbestos abatement  
(Cedar Rapids, Iowa).

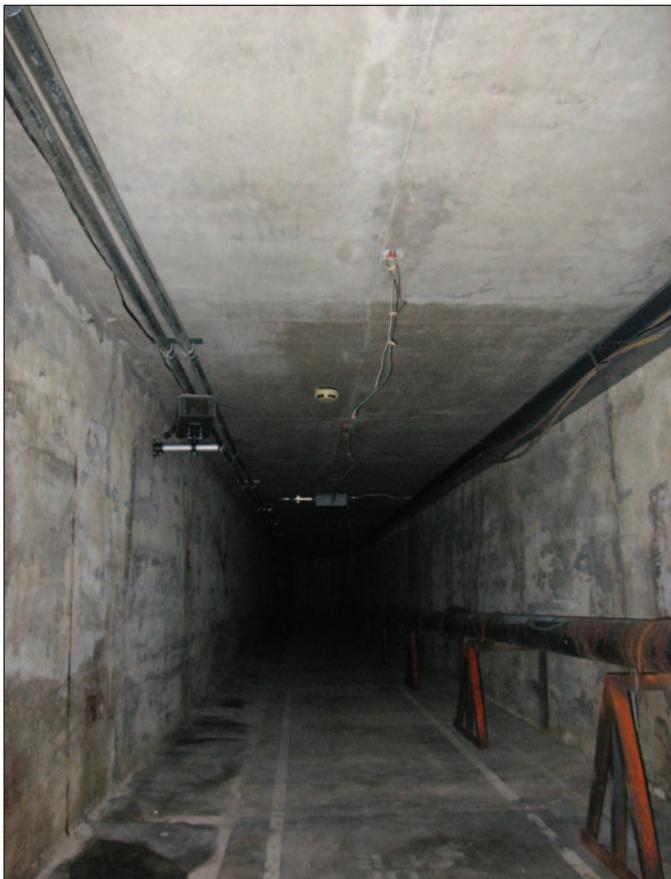
**Key Issues:** The Linn County Detention center experienced significant flooding of the basement level and 2 feet of flooding on the ground floor. Flooding in the basement was primarily due to flooding in underground access tunnels that connect it to the underground parking garage on Mays Island. Significant damages were sustained by the electrical, mechanical, and elevator equipment on the basement level and by inmate-detention system electronics and equipment on the ground floor. A last-minute evacuation of inmates occurred after the jail lost power.

**Figure 4-8.**  
Access tunnel to the Courthouse  
(Cedar Rapids, Iowa)

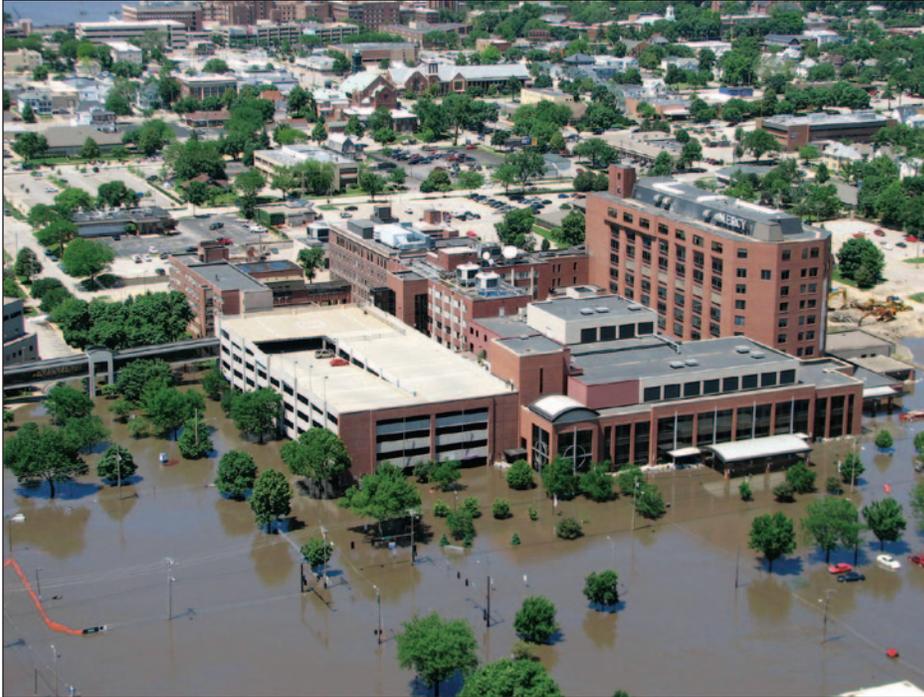
**Figure 4-10.** Mercy Medical Center, which sits just outside the 0.2-percent-annual-chance floodplain, was surrounded by 3 feet of water (Cedar Rapids, Iowa).

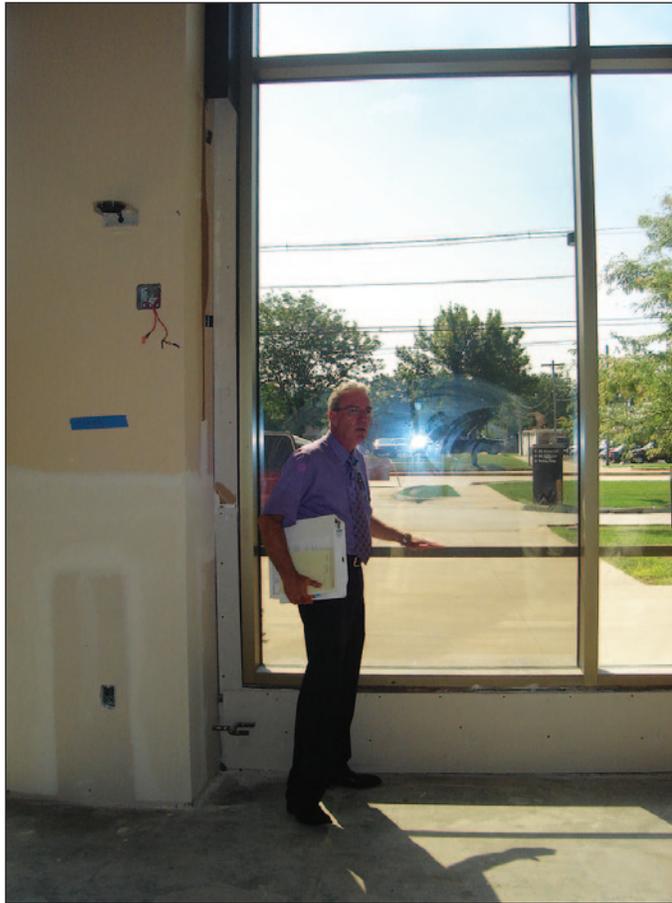
Figure 4-11.  
Water rose to the level of the window bar outside of Mercy. Massive volunteer efforts helped to keep water levels to a few inches inside (Cedar Rapids, Iowa).

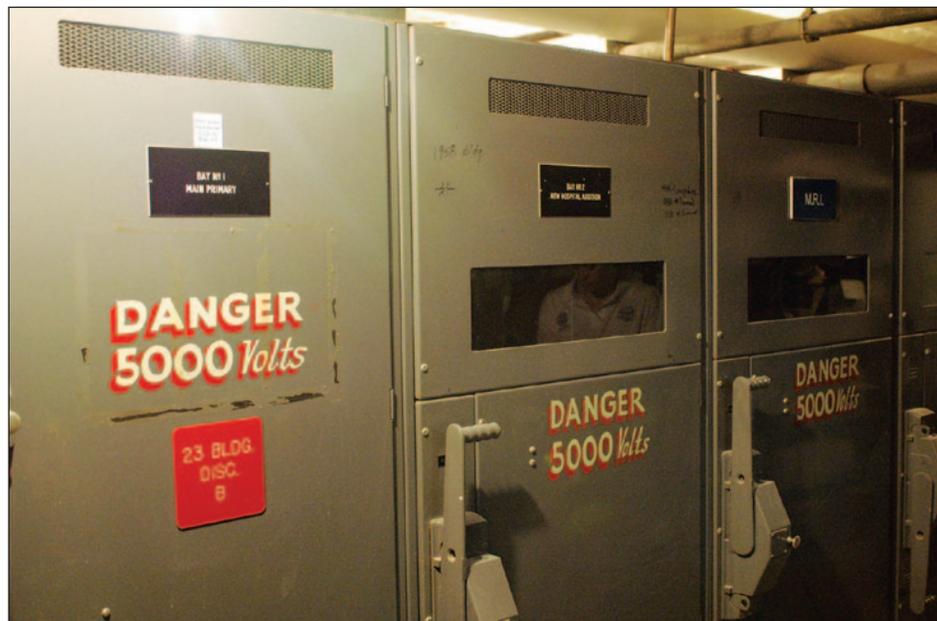
Flooding in the basement of the Nursing Building led to irreparable damage to medical equipment including a Magnetic Resonance Imaging (MRI) machine, two Computed Tomography (CT) computers, and pharmaceutical robotics. In addition, the communications systems, UPS systems, electrical distribution panels, mechanical controls, elevators, security systems, and radio center suffered severe damages (Figure 4-12).

Figure 4-12.  
Electrical equipment in the basement of Mercy Medical Center, which was exposed to a few inches of water (Cedar Rapids, Iowa)

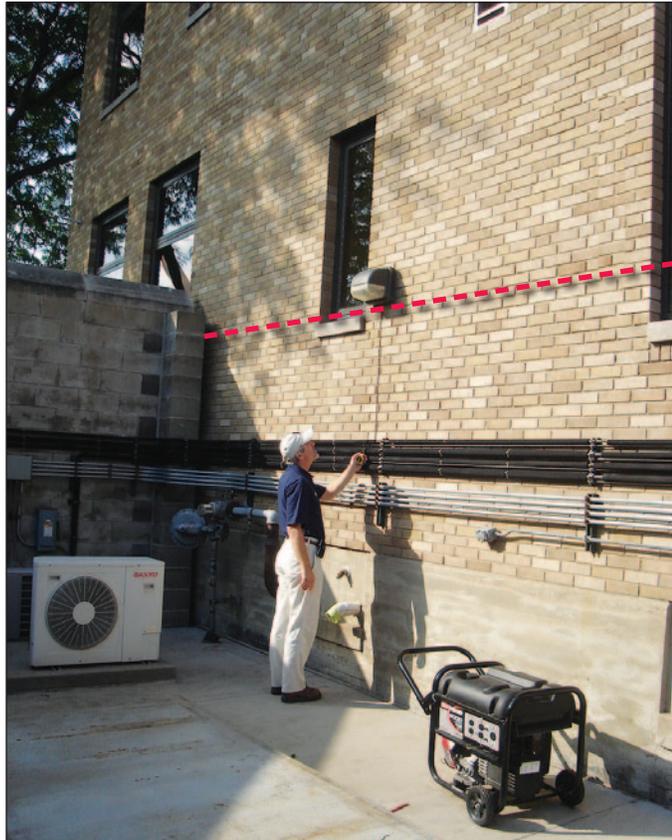
**Summary of Damages:** Several overhead garage doors were damaged. In addition, the emergency generator, which was kept in an outdoor enclosure, was completely submerged (Figure 4-14). The Sheriff's Department also lost significant equipment, including the electrical and mechanical distribution systems, and communications and data systems. There was also damage to interior architectural finishes.

The emergency generator was kept in an outdoor enclosure and was completely submerged. The water reached the floodlight near the second floor window (Cedar Rapids, Iowa).

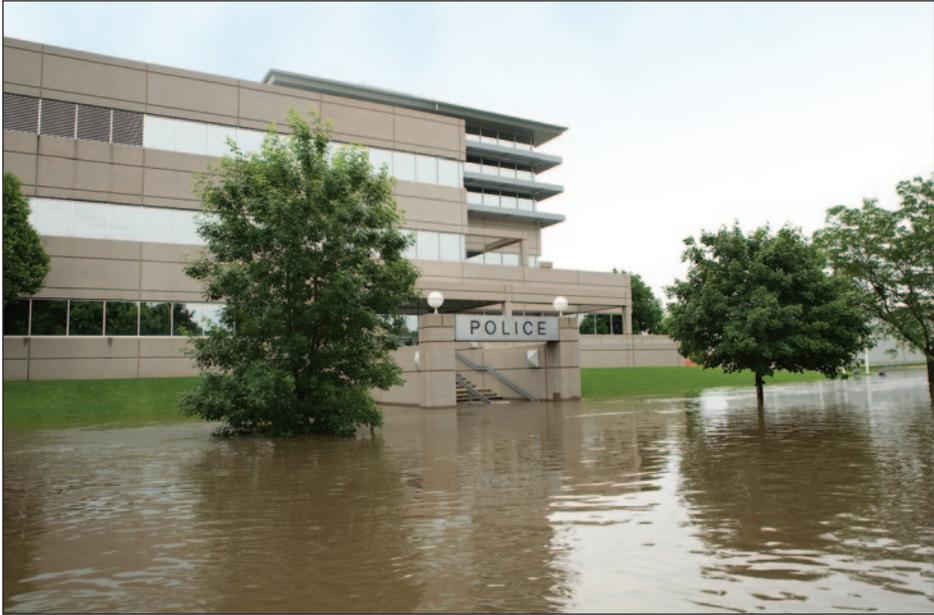
Figure 4-15. The CRPD Headquarters had 7 feet of water in its ground floor. The stairs shown here lead up to the first floor (Cedar Rapids, Iowa).

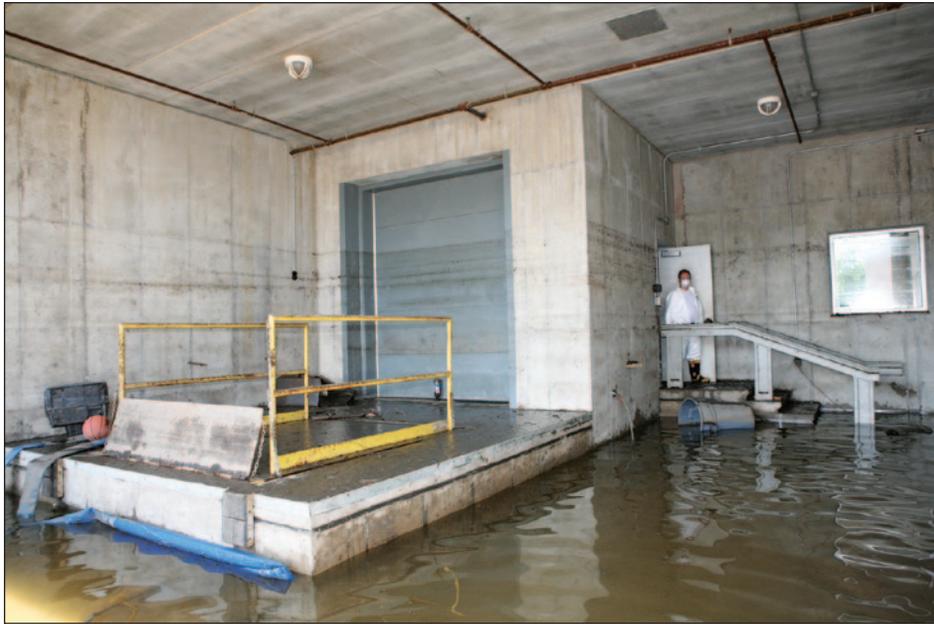
Figure 4-16. Much of the water that entered the CRPD building came in through the loading dock (Cedar Rapids, Iowa).

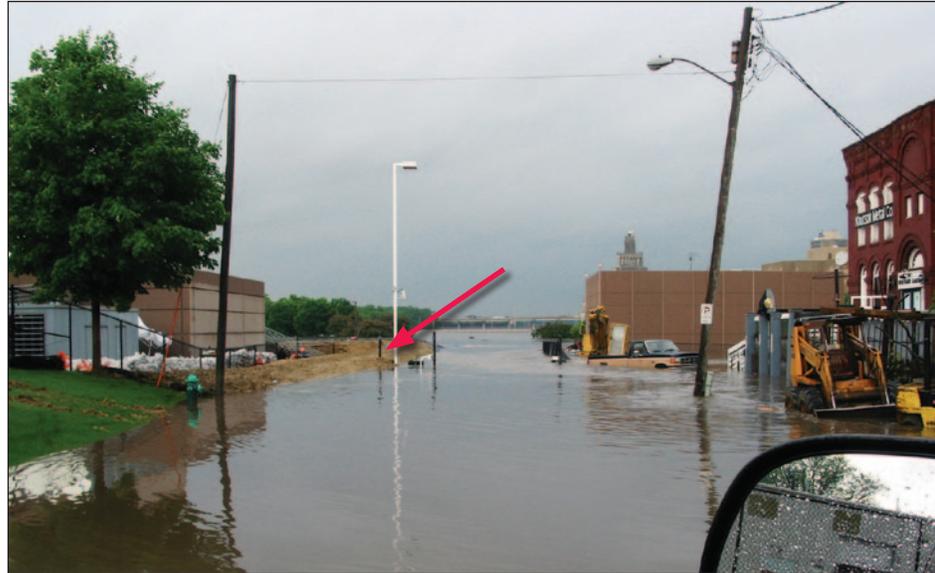
A temporary dike was built along the back of the CRPD building (Cedar Rapids, Iowa).

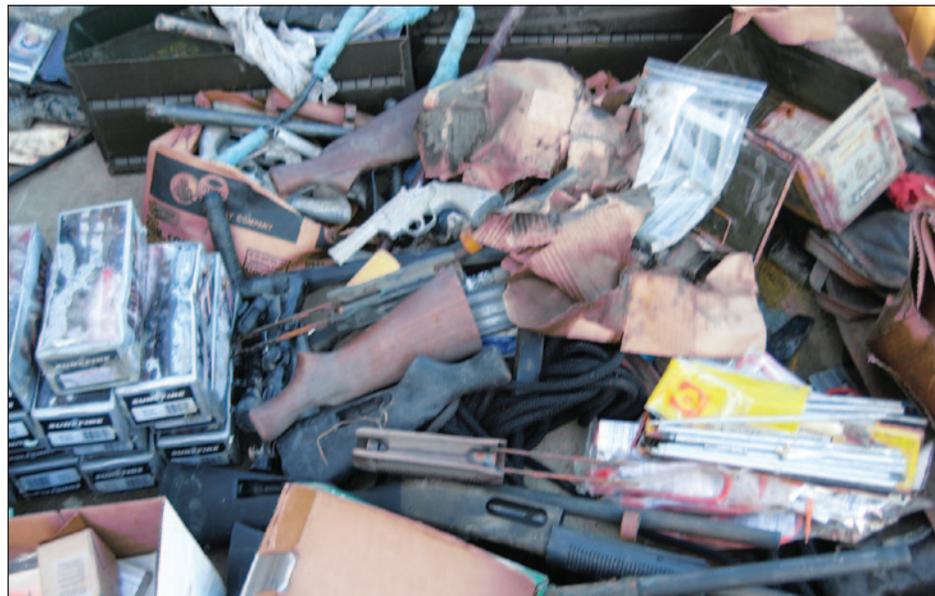
**Functional Loss:** While components such as computers, generators, and electrical equipment within the police department building were re-located after the flood, many of these components were operational within a few weeks of the event. However, all basement functions, including the crime lab, fitness and weight rooms, locker rooms, the Quartermaster (uniform distribution), and the armory were destroyed and required replacement. In addition, many files, evidence, equipment, and other contents that were stored in the basement were damaged beyond repair or restoration (Figure 4-18).

Contents stored in the basement, including weapons and ammunition, were damaged (Cedar Rapids, Iowa).

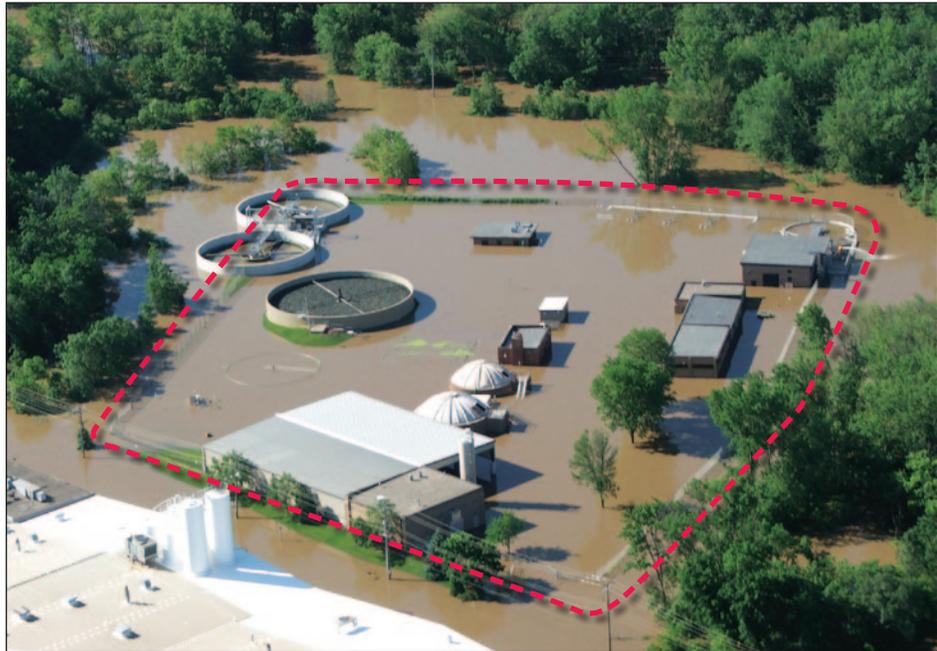
Figure 4-22.  
Reedsburg WWTF flooded on June 9, 2008. The red line follows the berm (Reedsburg, Wisconsin).

**Summary of Damages:** The Reedsburg WWTF was inundated with nearly 4.5 feet of water on June 9, 2008. During the flooding, the berm held, but was overtopped by the adjacent Baraboo River. Wet wells overflowed. Effluent from the surcharged sewer system started flooding the WWTF. Groundwater “boiled up” from the paved surfaces of the parking and facility areas. The access roads to the WWTF were inundated, and the facility was accessible only by boat (see Figure 4-23).

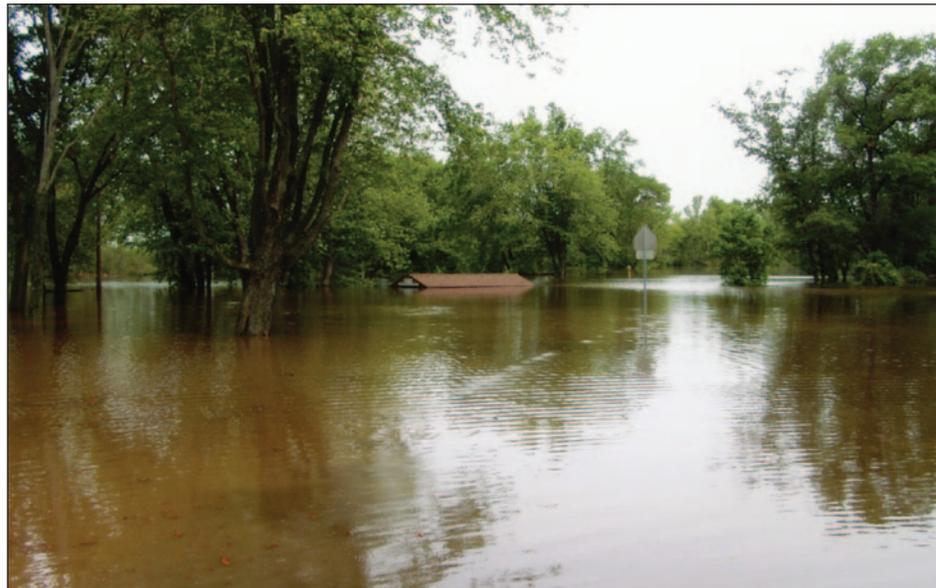
Figure 4-23.  
Reedsburg WWTF access road flooded (Reedsburg, Wisconsin).

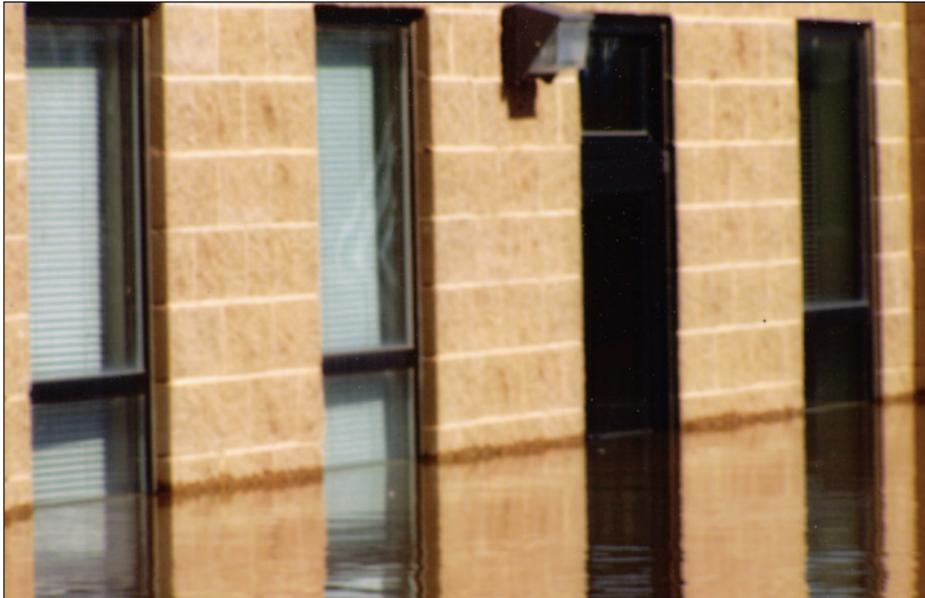
- Electrical transformer and main breaker flooded.
- Entire lab, including all furniture and equipment were lost.
- Office drywall, casework, doors, and flooring were destroyed.
- Underground electrical wiring was damaged (some electrical equipment was cleaned and refurbished).
- Some computers were lost.
- Some vehicles were lost.
- Variable Frequency Drives (VFDs) could not be salvaged and needed to be replaced.
- Future mitigation plans include raising the berm surrounding the facility nearly 5 feet higher than its current elevation and acquiring additional emergency pumps.

Figure 4-24.  
Reedsburg WWTF offices  
and processing facilities  
flooded (Reedsburg,  
Wisconsin).

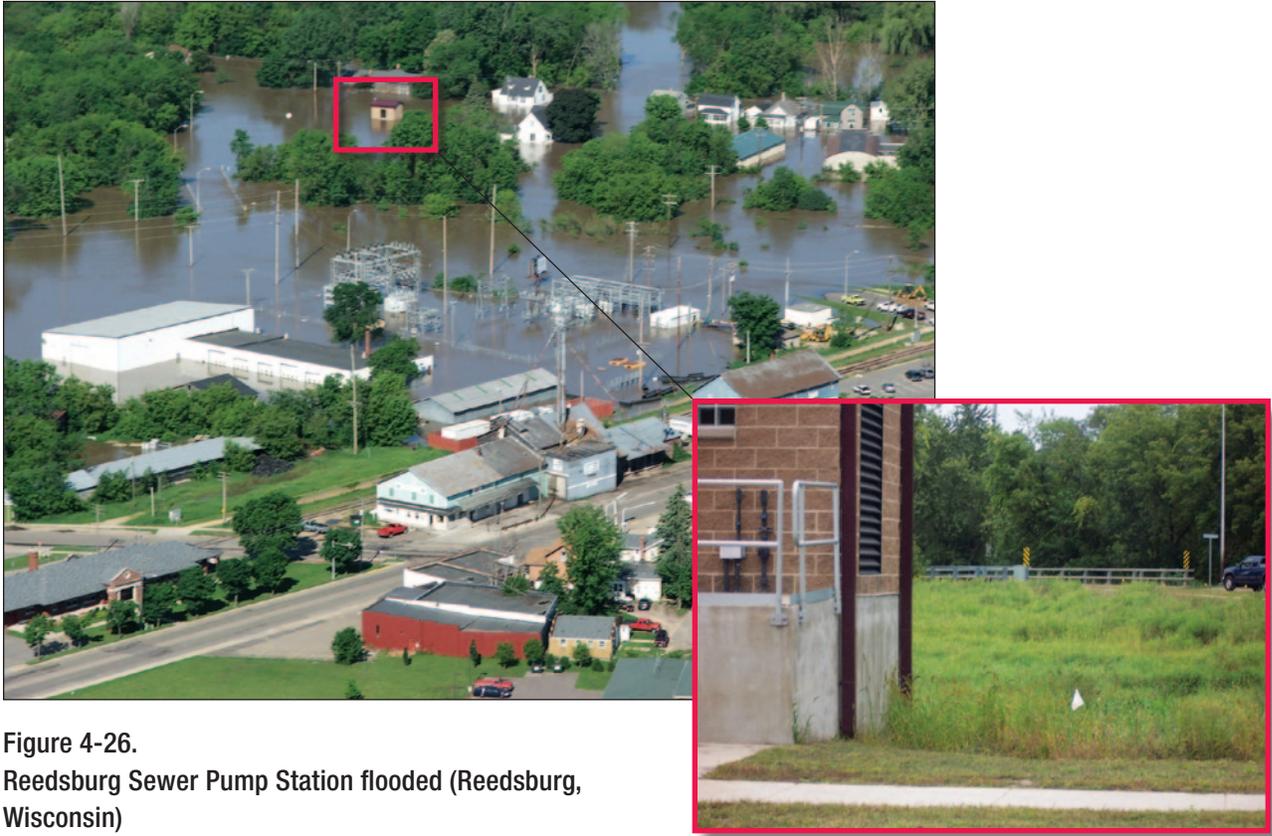
**Key Issues:** When power at the Reedsburg Sewer Pump Station was lost, the emergency generator could not be run because natural gas had been shut off by the city as part of its emergency procedures. As a result, the Sewer Pump Station failed, and the incoming raw sewage at the station could not be pumped from the drainage area. The pump station's wet well and portions of the sewer collection system backed up and became surcharged. This event resulted in sewer backups in homes, commercial buildings, and public facilities.

Figure 4-26.  
Reedsburg Sewer Pump Station flooded (Reedsburg,  
Wisconsin)

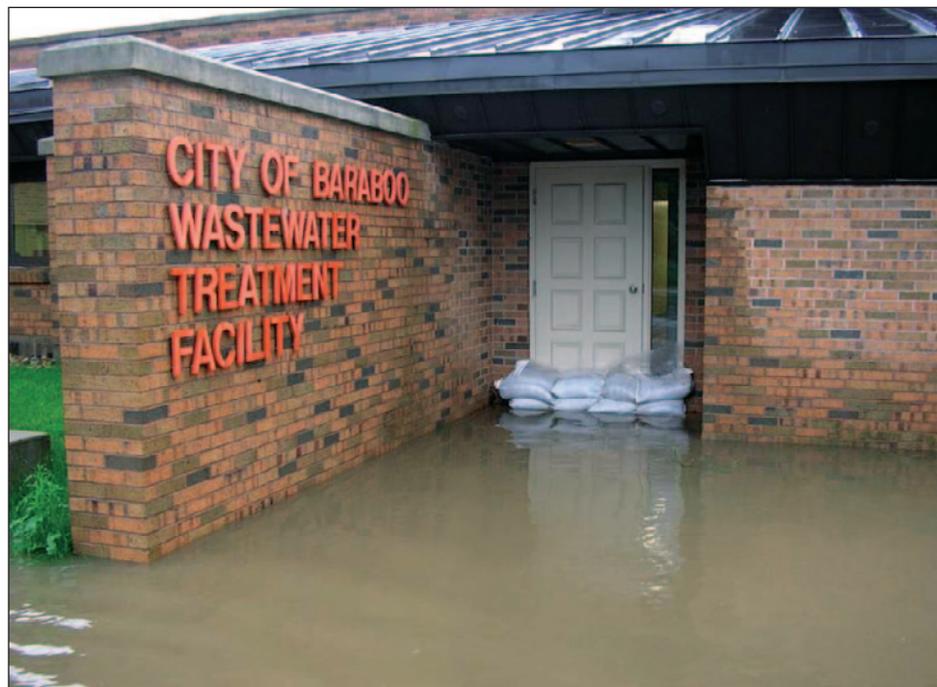
Figure 4-28. Sandbagging protecting the office building (Baraboo, Wisconsin)

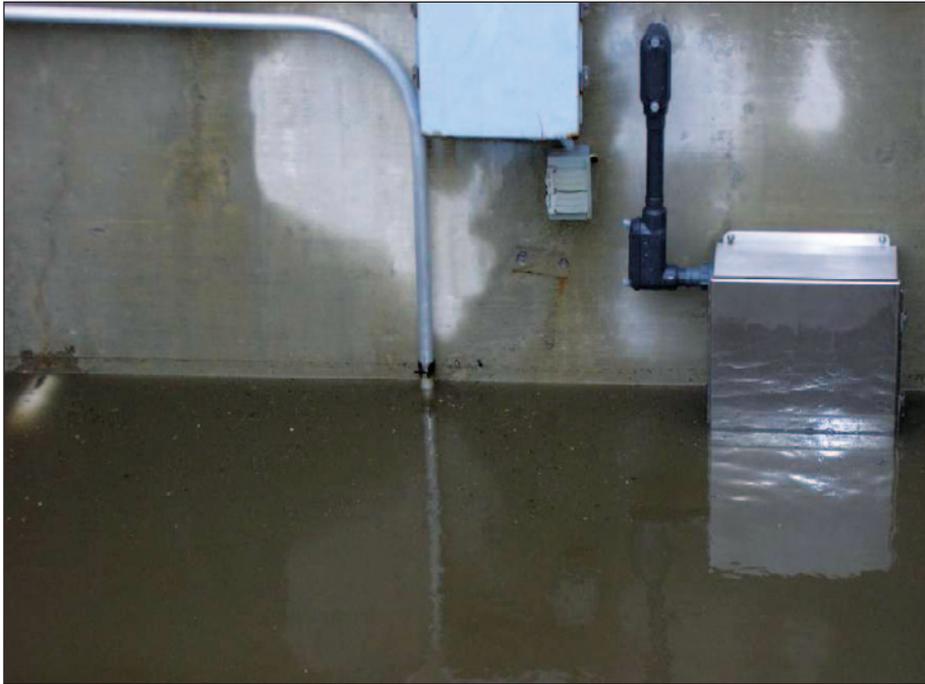
**Summary of Damages:** During the June 2008 storms, the facility retained 1.5 feet of standing ground and surface water. The facility was capable of handling the excess inflows; however, operators were unable to keep river flow from entering the site. The major equipment was not damaged, except for level sensors (Figure 4-29).

**Figure 4-29.**  
Some electrical equipment elevated on concrete pads and on wall (Baraboo, Wisconsin)

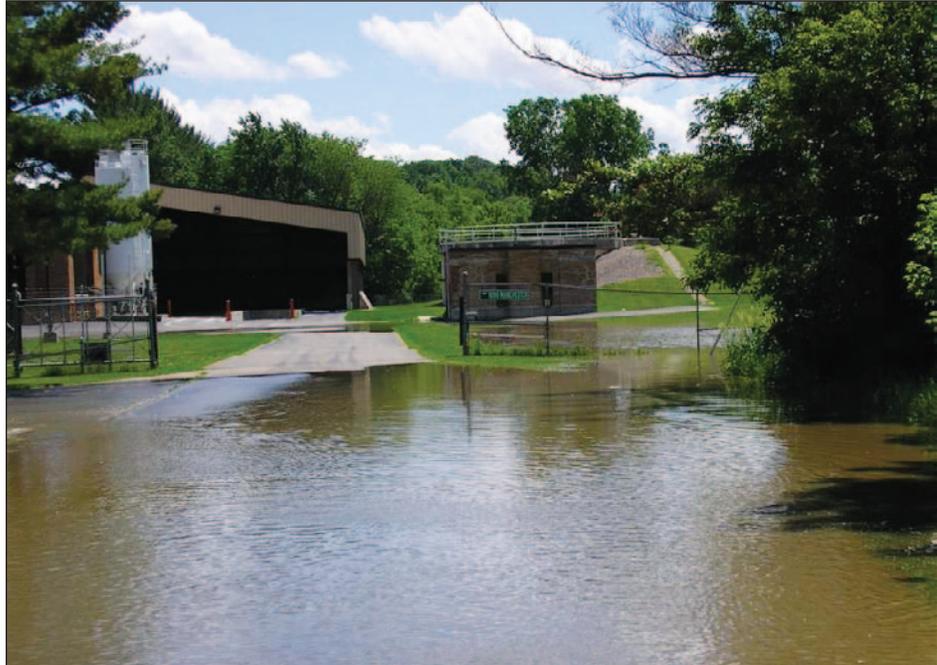
**Figure 4-30.**  
Flooded access road at the  
Baraboo WWTF (Baraboo,  
Wisconsin).

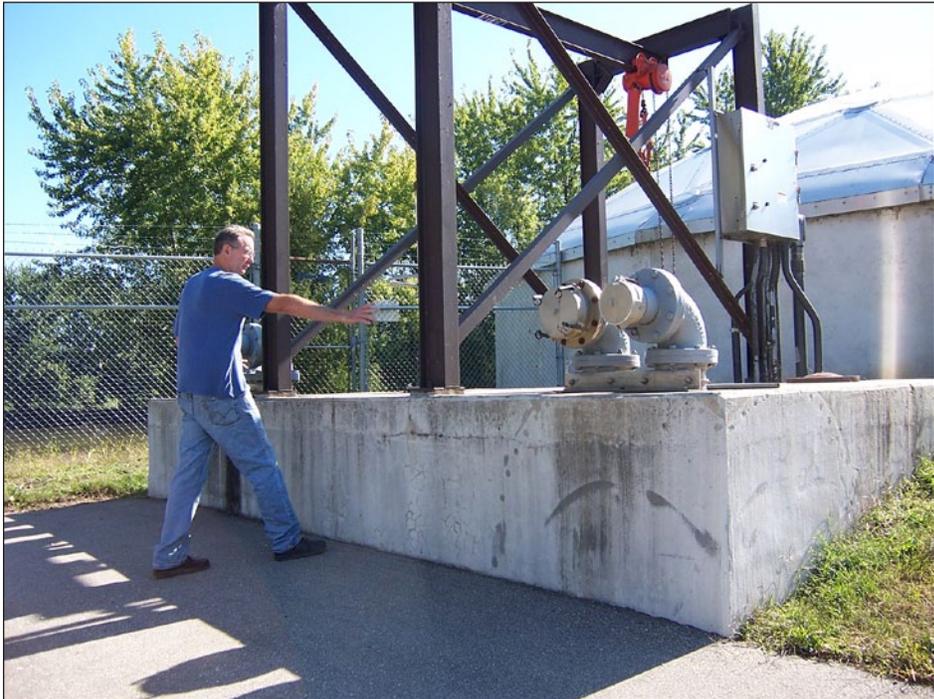
Figure 4-32. Discharge pump platform with space and hook ups for emergency diesel pump (Jefferson, Wisconsin)

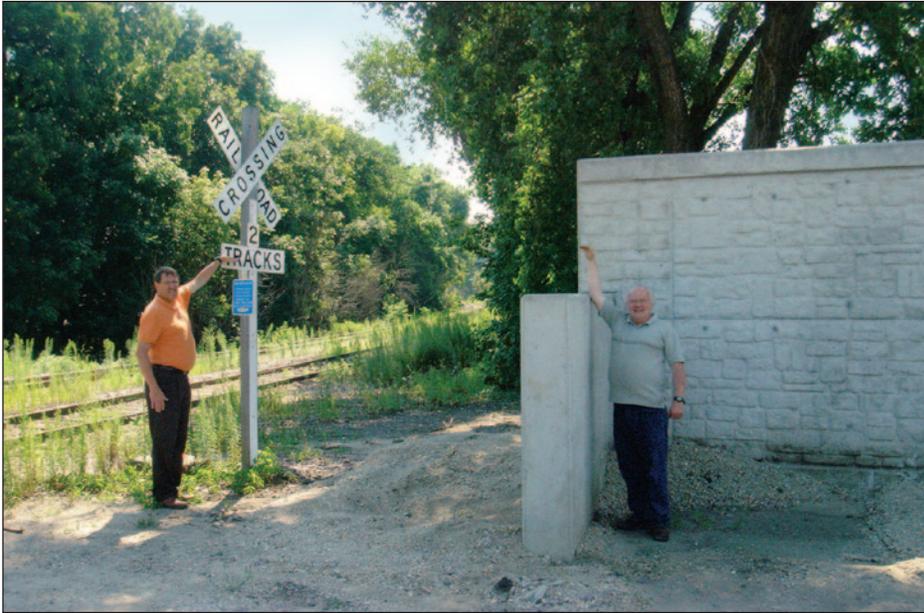
**Summary of Damages:** Damage to the utility plant was approximately \$5 million, and additional damage to the utility complex was approximately \$2.5 million. Most of the equipment inside the plant, including feed pumps and coal mills, was damaged. Plant staff estimated that total repairs would cost approximately \$15 million.

Figure 4-36. The water level at the Cedar Falls power plant was approximately 2 feet higher than the anticipated flood levels and overtopped the floodwalls (Cedar Falls, Iowa).

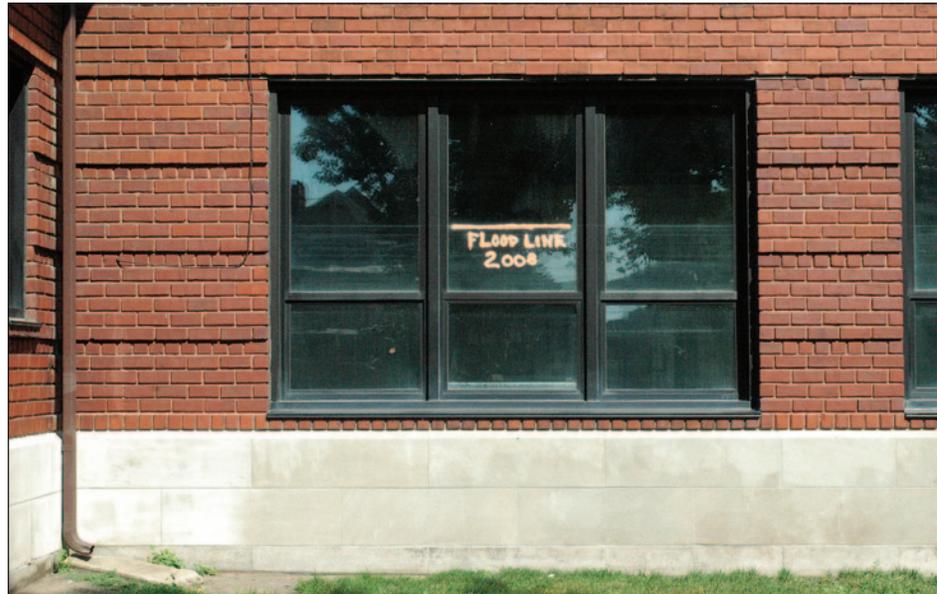
**Figure 4-37.**  
The ESC had about 8 feet of water on its ground floor, in addition to a flooded basement (Cedar Rapids, Iowa).

**Summary of Damages:** The ESC basement housed the building's emergency generator, which was completely submerged. The generator ran on natural gas, which was shut off by the local utility provider during the flood; therefore, even if the generator had been moved from the basement, it would not have been operational. Other losses included the electrical and mechanical systems, as well as interior architectural finishes. Plaster walls and ceilings and wood flooring on the ground floor were damaged. Clean-up and repairs were complicated by the presence of asbestos building materials.

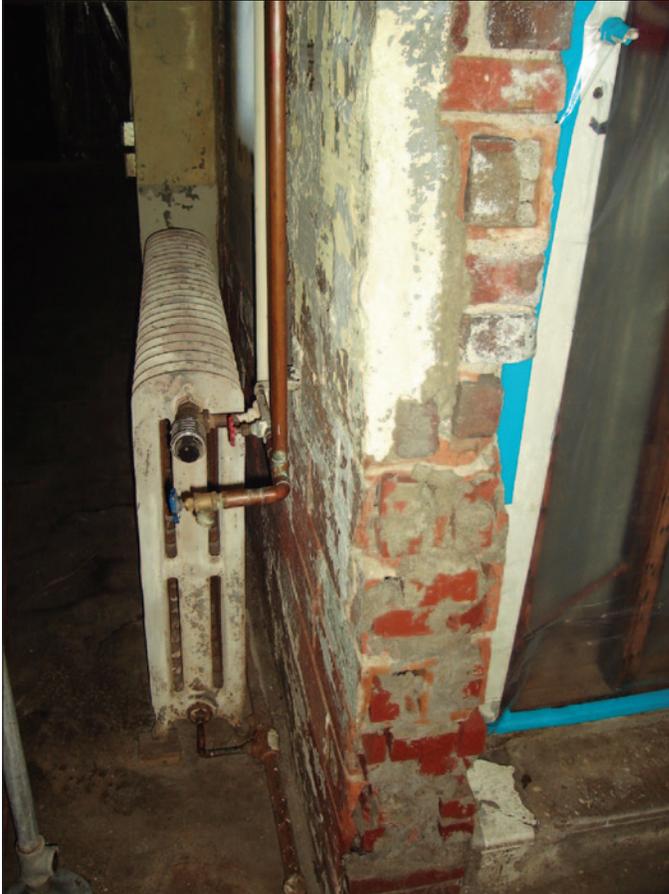
Figure 4-38.  
Clay tile wall system of the ESC Annex (Cedar Rapids, Iowa)

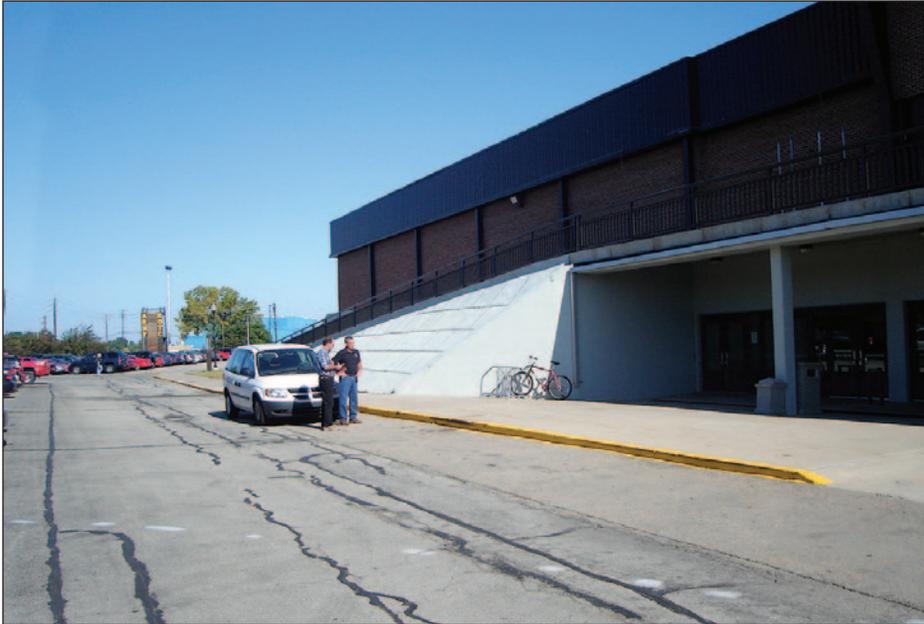
Figure 4-44. The curb and sidewalk along the entrance to the Kolf Center had been raised as part of a previous mitigation project to prevent water that collected in the parking lot from entering the building and, thus, to provide positive drainage per local building codes (Oshkosh, Wisconsin).

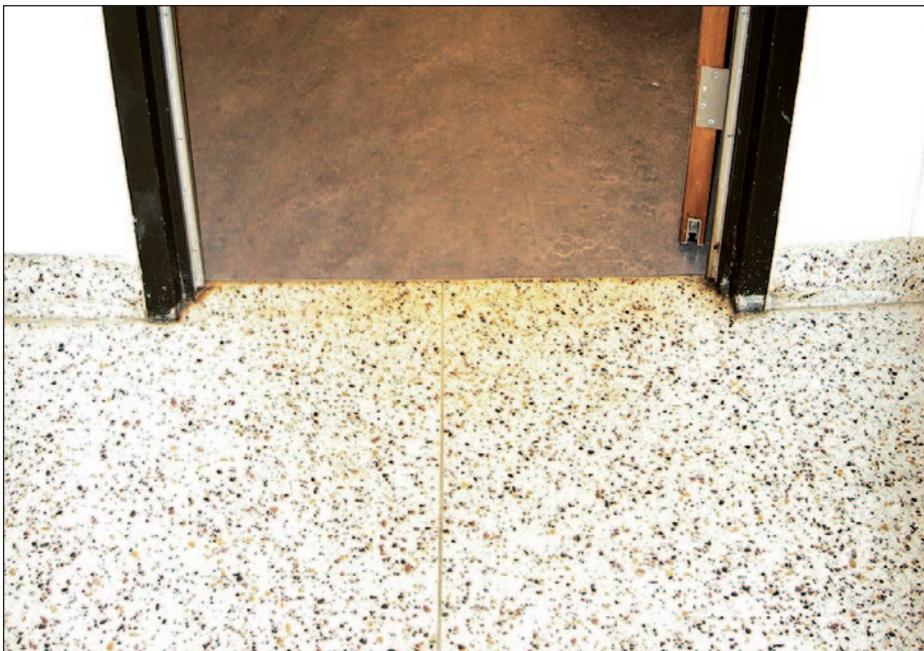
Figure 4-45. Carpeting was replaced with flood damage-resistant vinyl flooring throughout the damaged academic buildings (Oshkosh, Wisconsin).

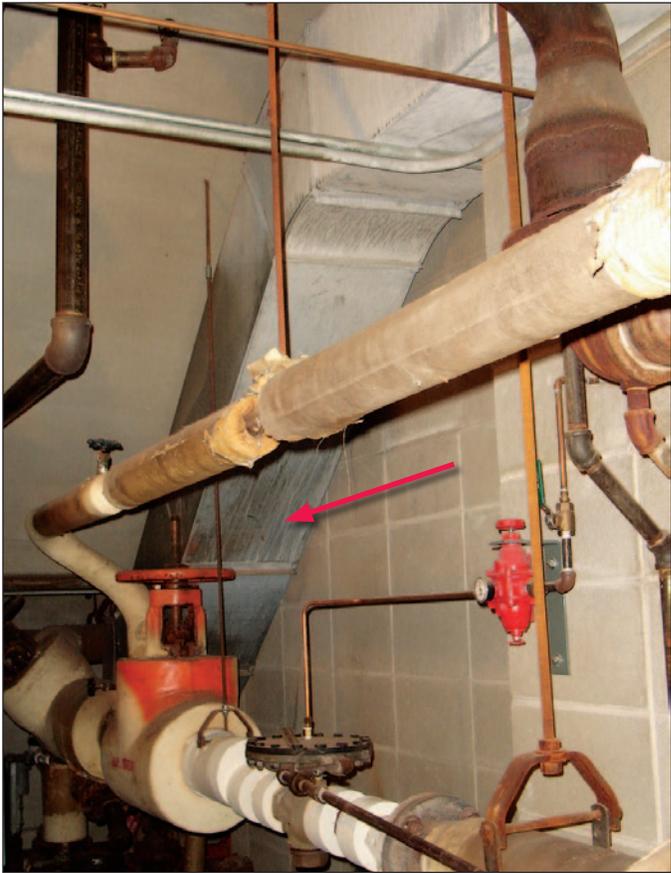
Figure 4-47. Water entered academic buildings through steam conduits, like the one in the background (Oshkosh, Wisconsin).

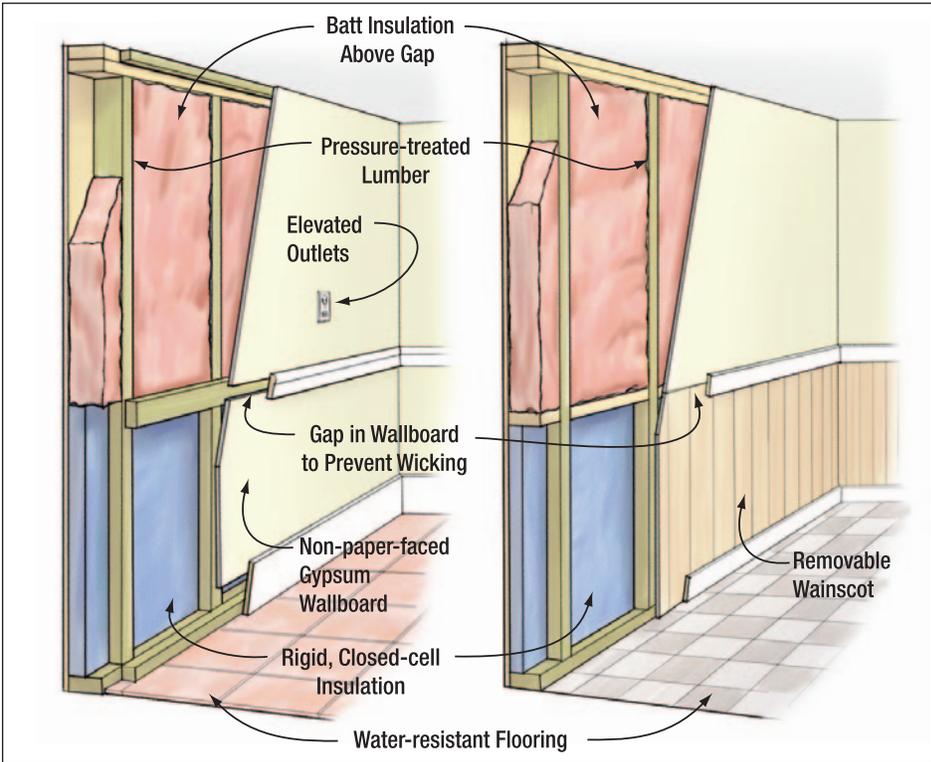
Figure 4-48. Air gap in drywall to prevent wicking

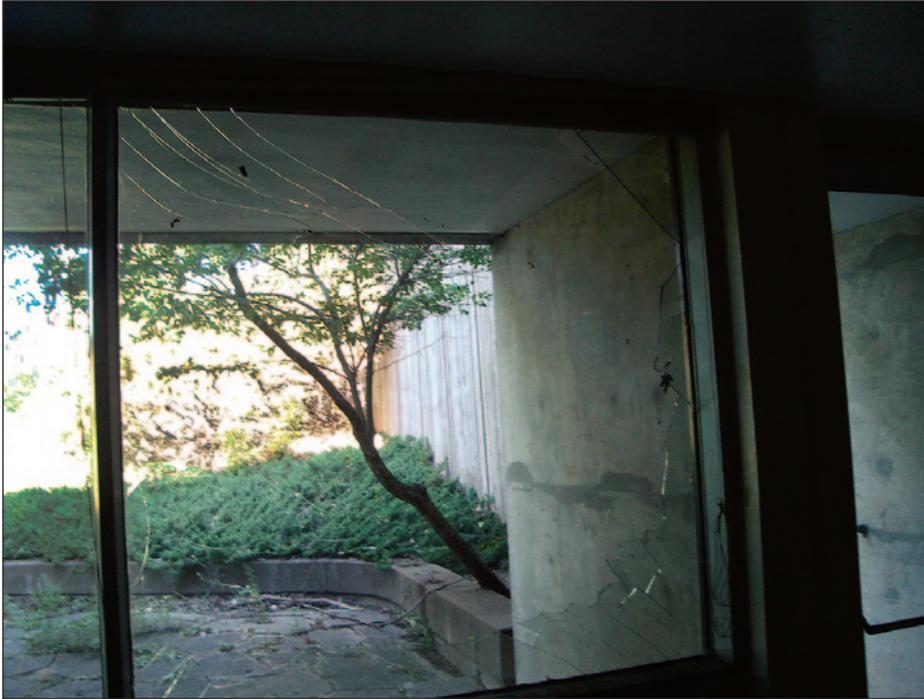
Figure 4-50. Water pressure in the basement courtyard caused glass windows to shatter (Oshkosh, Wisconsin).

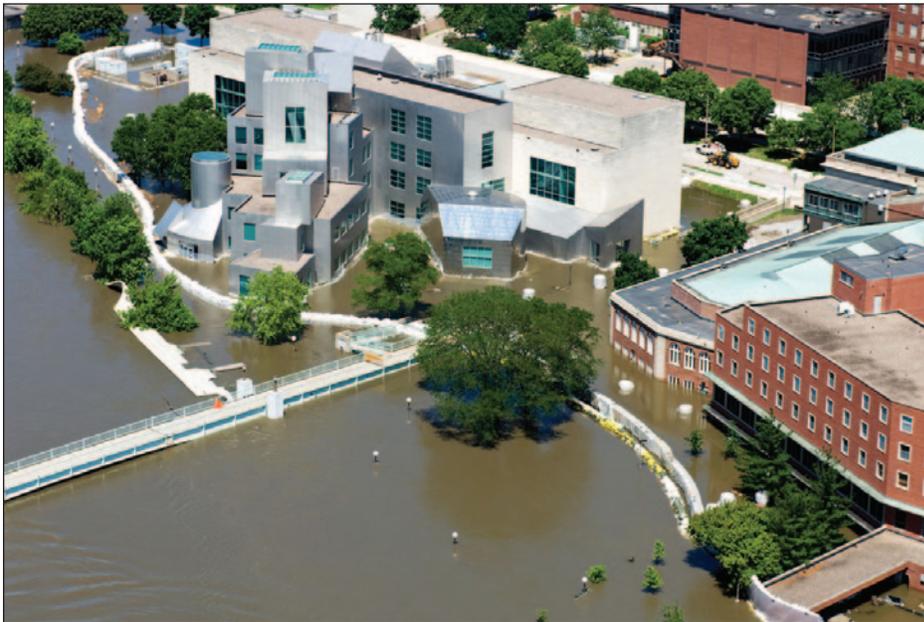
Figure 4-52. Flooding of IATL and IMU (Source: University of Iowa Office of University Relations)

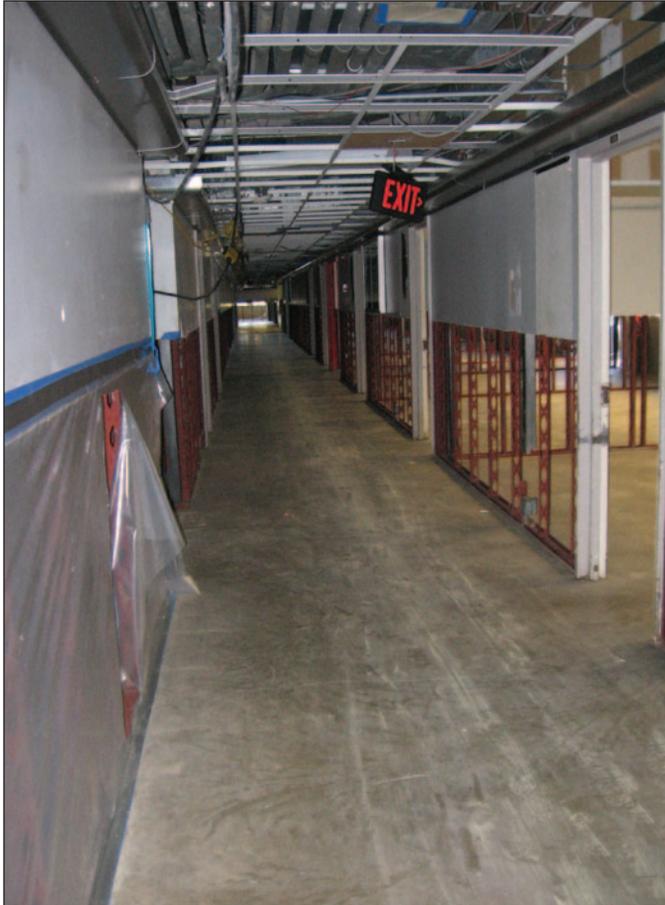
Figure 4-53.  
Interior damage at Voxman Building (Iowa City, Iowa)

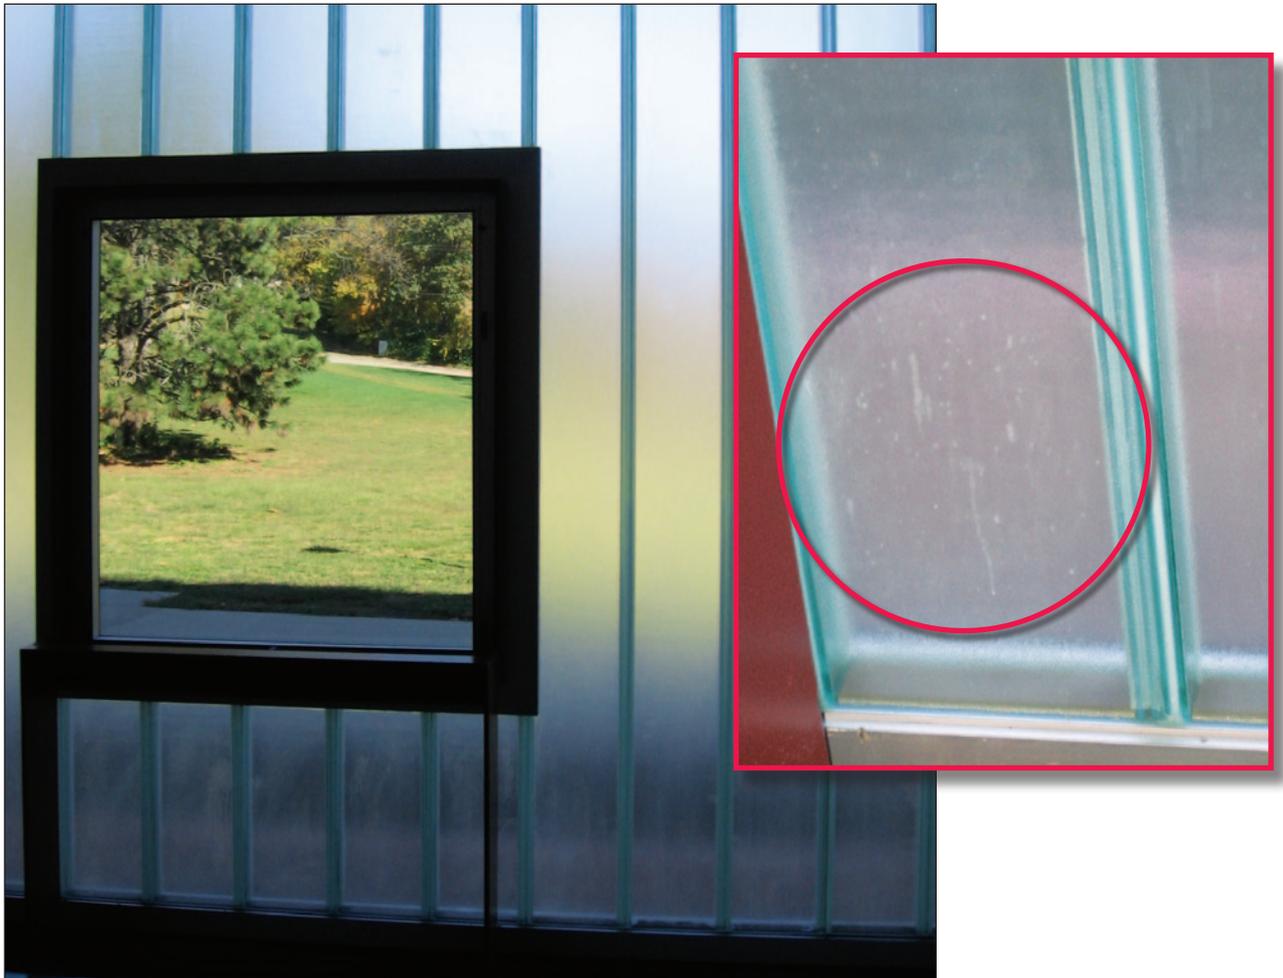
Figure 4-54. Double glass panels trapped river water between panes in structural glass walls at the Art Building West (Iowa City, Iowa).

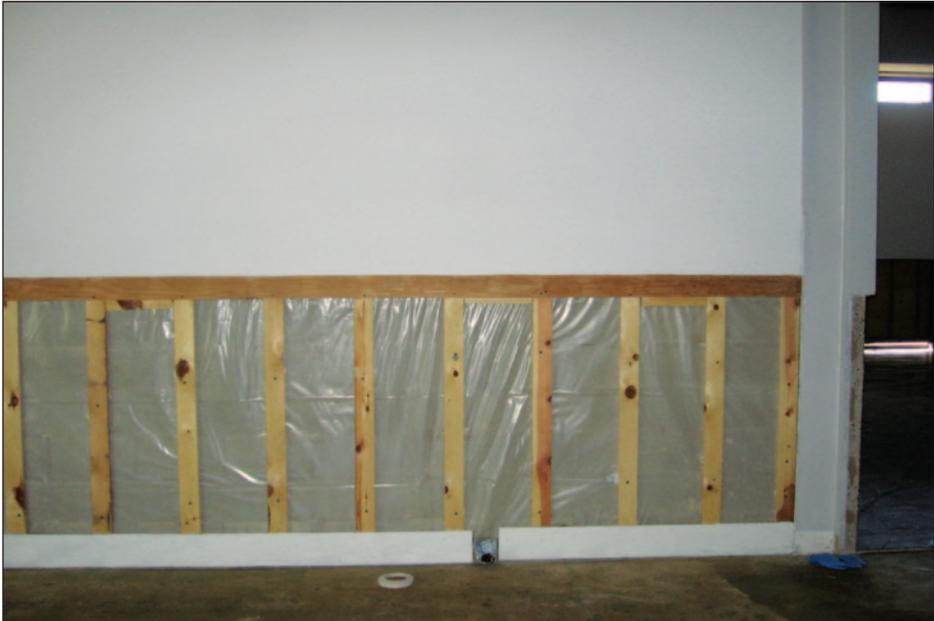
**Figure 4-55.** Drywall damage on first floor of Art Museum (Iowa City, Iowa)
