# MIDWEST FLOODS of 2008

& IN IOWA  
 & WISCONSIN

## 4 Critical and Essential Facilities

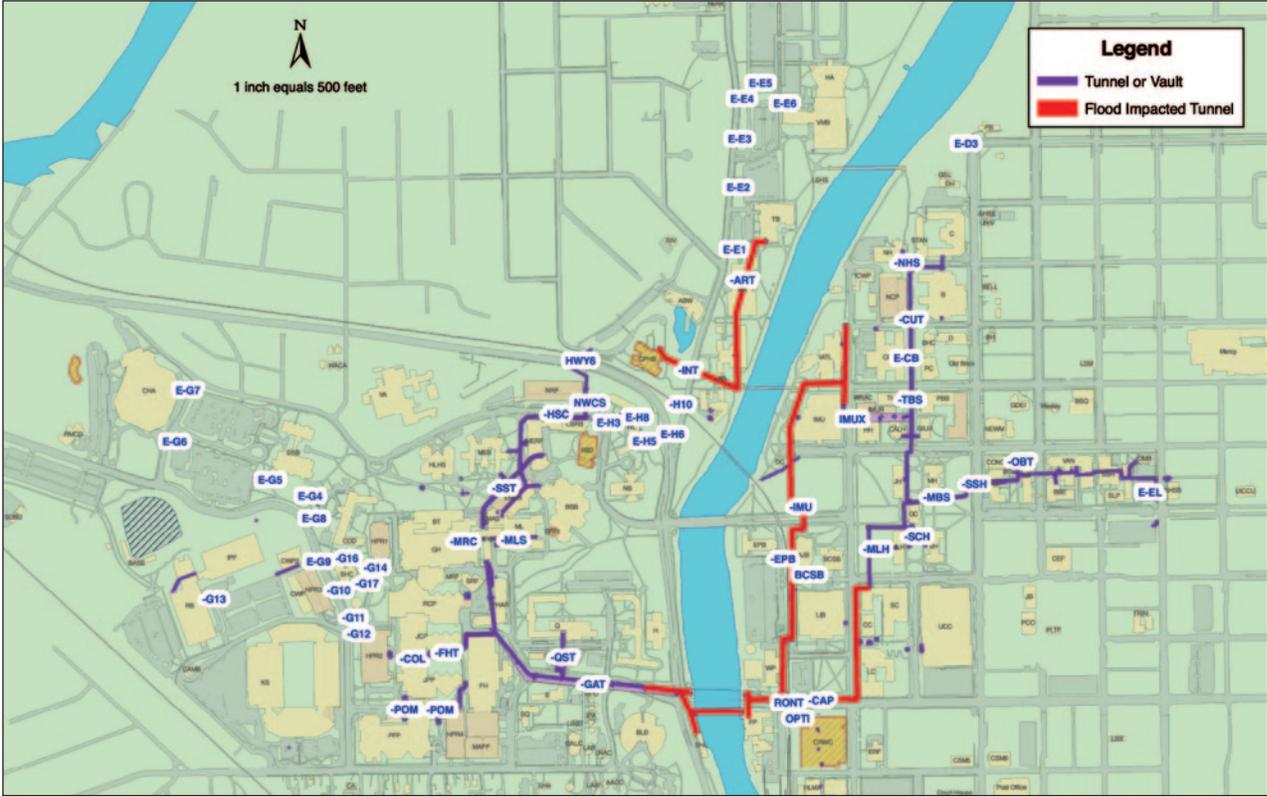
**Utility Tunnels:** Water entered campus utility tunnels through access hatches and tunnel vents, and through tunnel openings in the Power Plant. The utility tunnels, which run from the Power Plant carrying steam and water piping and communication lines throughout the campus, were flooded in the following locations:

Figure 4-58. Schematic layout of campus tunnels indicating flooded areas
