**HAZARD MITIGATION TECHNICAL ASSISTANCE PROGRAM
CONTRACT No. EMW-2000-CO-0247**

TASK ORDER # 007
HARRISON CENTRAL HIGH SCHOOL STRUCTURAL WIND RETROFIT ASSESSMENT
REPORT
FEMA-1604-MS

FINAL REPORT
AUGUST 29, 2006

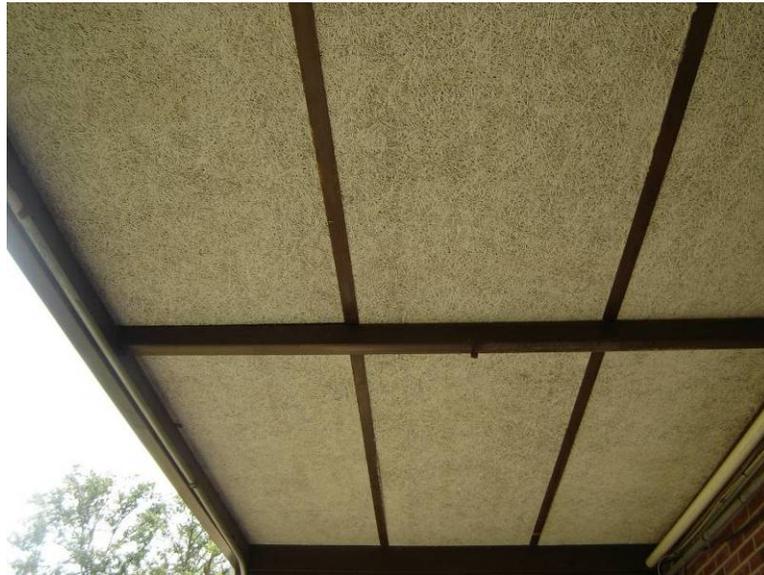
Most of the roof decks on the buildings located at the site utilize two to three inch fiber board roof panels supported by structural steel angles or similar steel supports (see Photograph 1 in Appendix B). Once this type of deck is exposed to moisture for a prolonged period of time, the fiber board loses most of its strength and becomes soft (see Photograph 2 in Appendix B). Also, this type of system does not perform well in uplift; the bulb tees that support the deck are capable of supporting gravity loads but do not have any holding capacity when uplift pressure is applied, such as that applied by wind as it goes over the roof. With the moisture damage, it is unlikely that this roof deck can transfer lateral loads as a roof diaphragm. This deck is also easily penetrated by wind borne debris.

Photograph 1: Fiber Board Roof Panels

There is no feasible way to retrofit a fiber board roof panel system. The best solution to this problem is to remove the existing fiber board deck and replace it with a 1½-inch steel roof deck and acoustical panels. The replacement of a fiber deck with a steel deck would be too cost-prohibitive, and thus is not considered an option in this report.

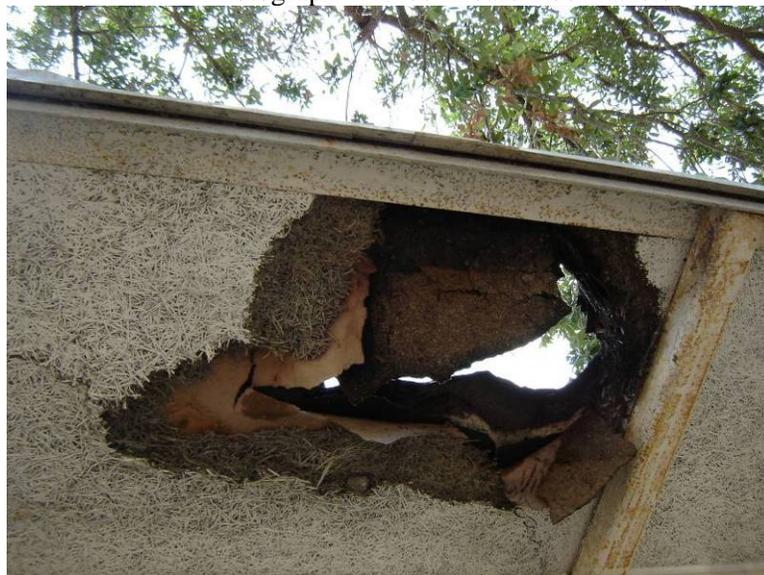
Photograph 2: Example of Moisture-Compromised
Fiber Board Roof Panels

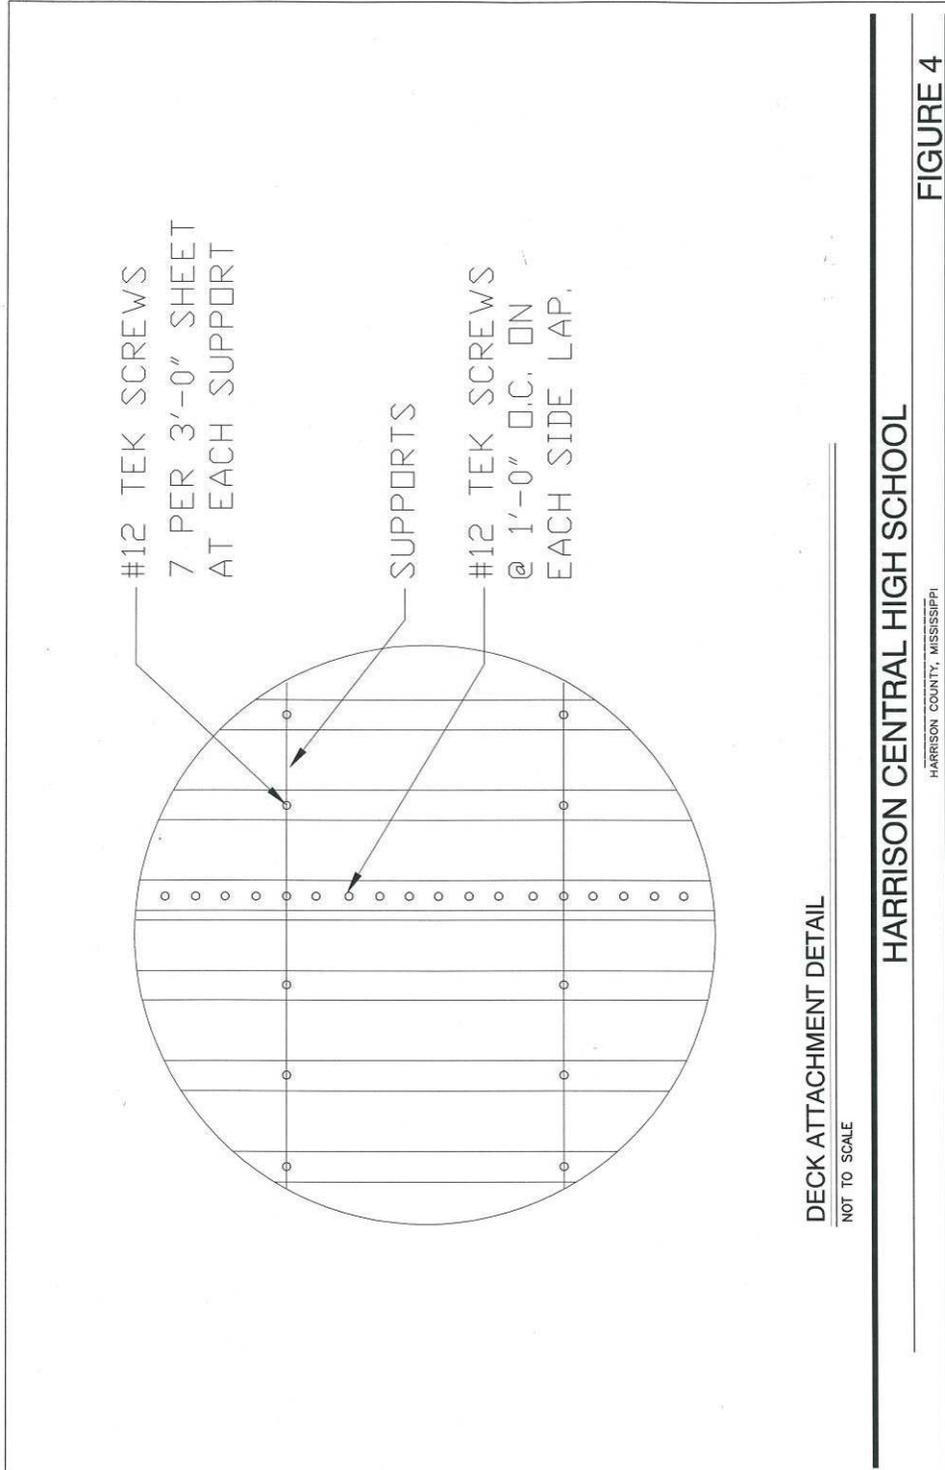
The existing roofing system utilizes a metal deck and bar joists supported by load-bearing exterior and interior masonry block walls. The roofing will need to be removed in order to reattach the roof deck throughout with sufficient rigidity to allow it to act as a diaphragm. Based on our analysis, the individual roof deck panels need to be fastened to the joists at each rib. Furthermore, the sidelap connection to the adjacent panels on each side needs to be accomplished with sufficient frequency to achieve adequate diaphragm action. When this retrofit has been completed, then the building should be re-roofed and sealed at all flashings and penetrations. See Figure 4 in Appendix C.
