# Field Investigation of Continuous Seawall

South Side of U.S. Highway 90 in Mississippi

*July 10, 2007*

URS Group, Inc.

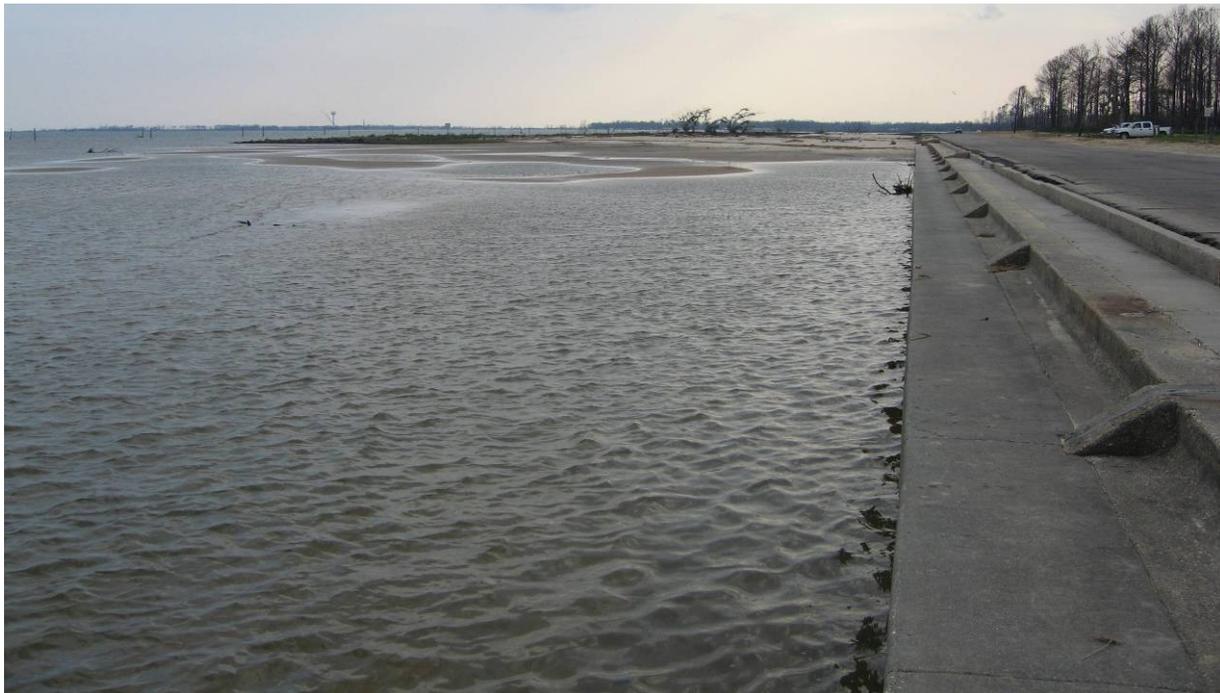
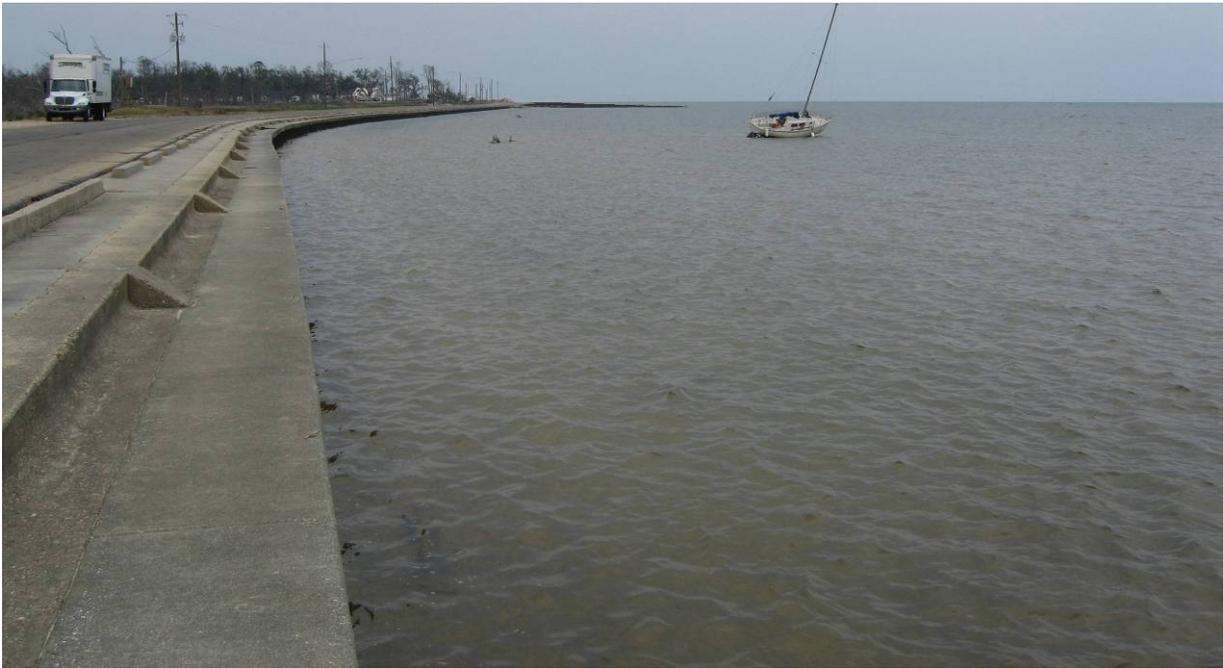
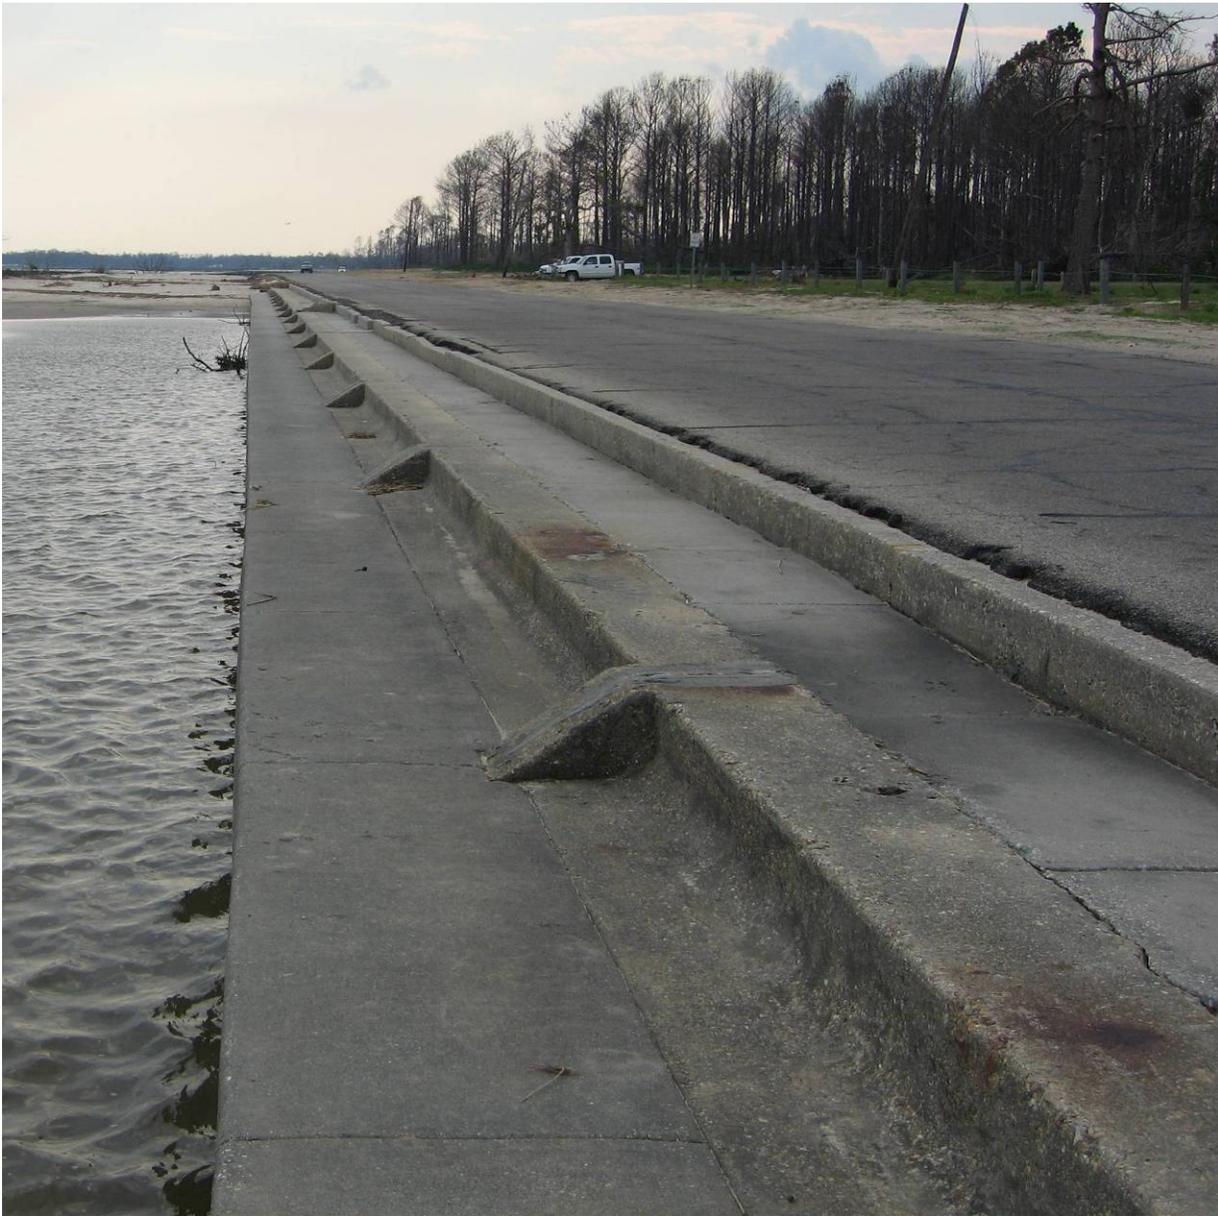
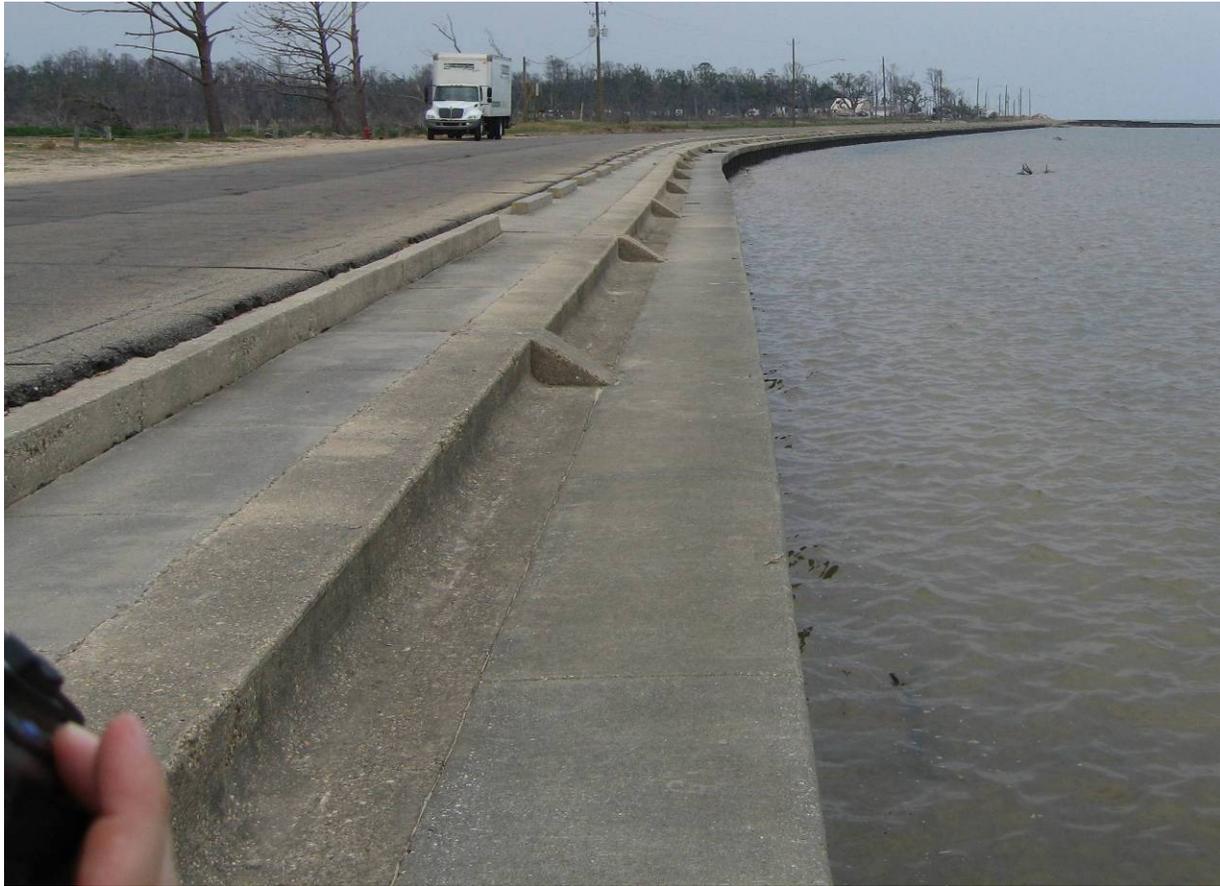
Notice recent wrack lines and spots where the sidewalk adjoining the landward side of the top of the seawall has failed due to failure of underground stormwater drainage structures during the storm. Note where the road or sidewalk failed on the landward of the seawall. The seawall never failed.
